Re: Illinois Environmental Protection Agency v. C. John Blickhan
IEPA File No. 94-09-AC; 0010650002—Adams County

ADMINISTRATIVE CITATION

AC 09-46
(IEPA No. 94-09-AC)
FINAL

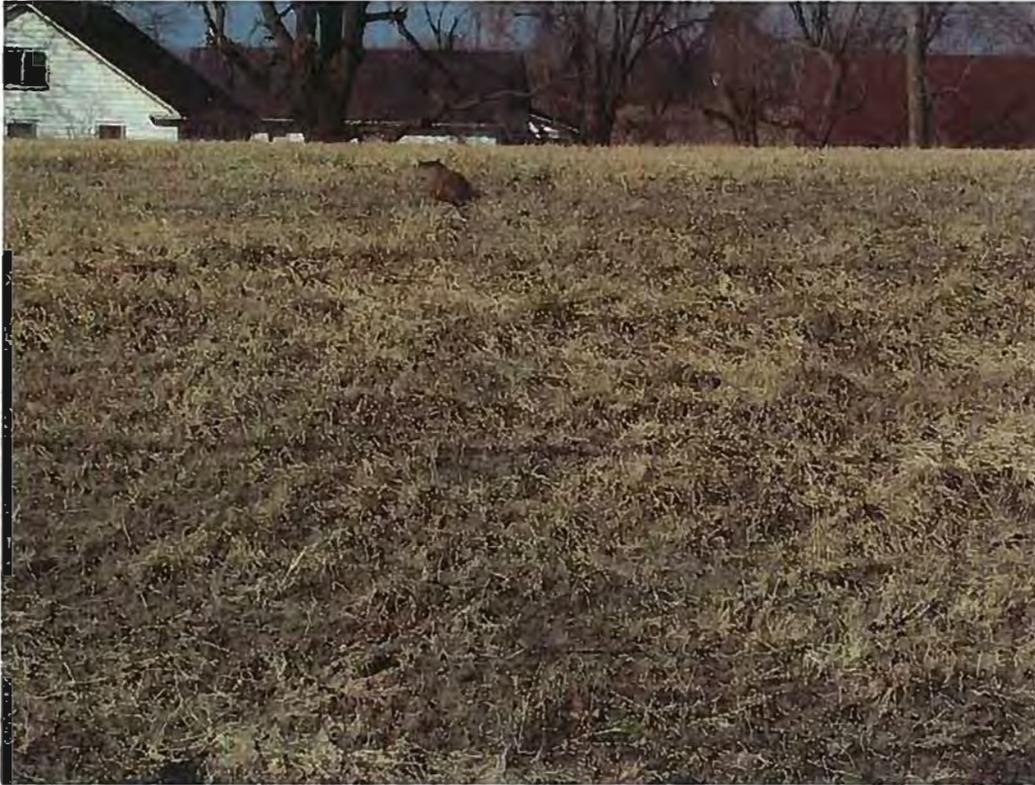
Photographs 001 shows a ground hog (wood chuck) on top of Site No. 2 near the east side of the fill area. Photograph 008 shows a ground hog hole in the cap of Site No. 2 (also along the east side). Pieces of broke brick, broken glass, mortar, and scraps of shingles debris were observed pushed out of the burrow.

Date: March 17, 2009
Time: 10:25 AM
Direction: W
Photo by: Eisenbrandt
Exposure #: 001
Comments: A ground hog on top of Site No. 2.

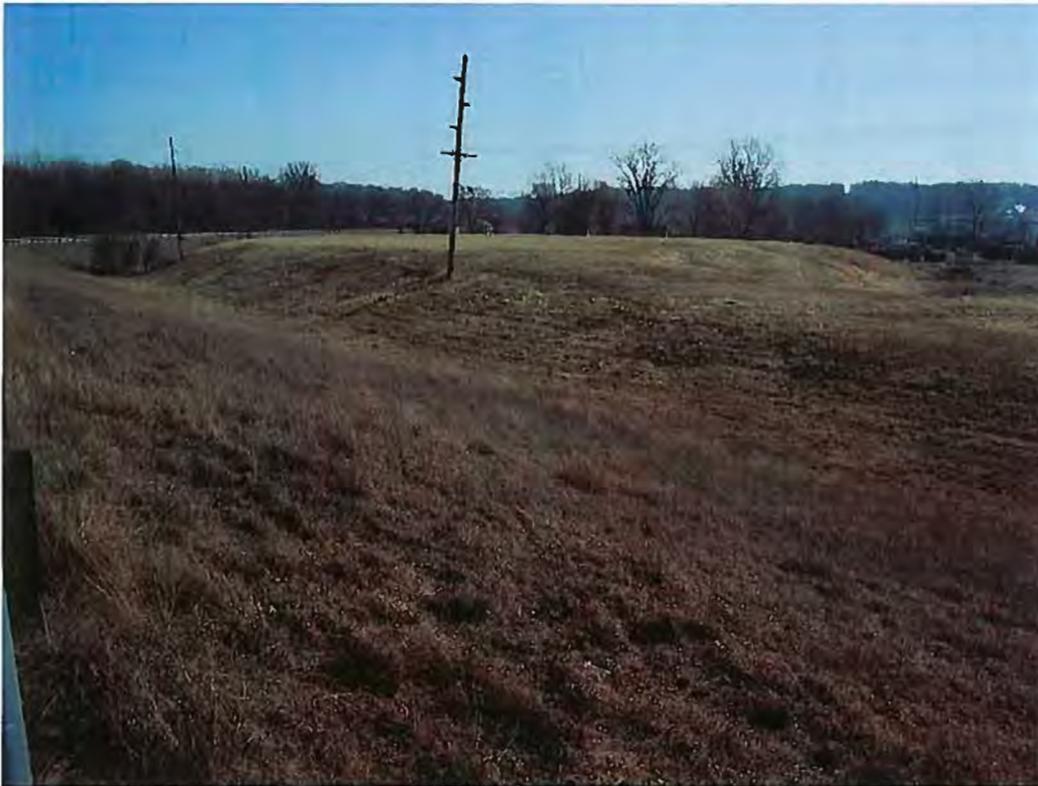
Photographs 002 & 003 show the west side of Site No. 1 landfill. No debris was observed on this side of the landfill. The vegetative cover appeared well maintained.

Date: March 17, 2009
Time: 10:33 AM
Direction: NE
Photo by: Eisenbrandt
Exposure #: 002
Comments: Site No. 1.

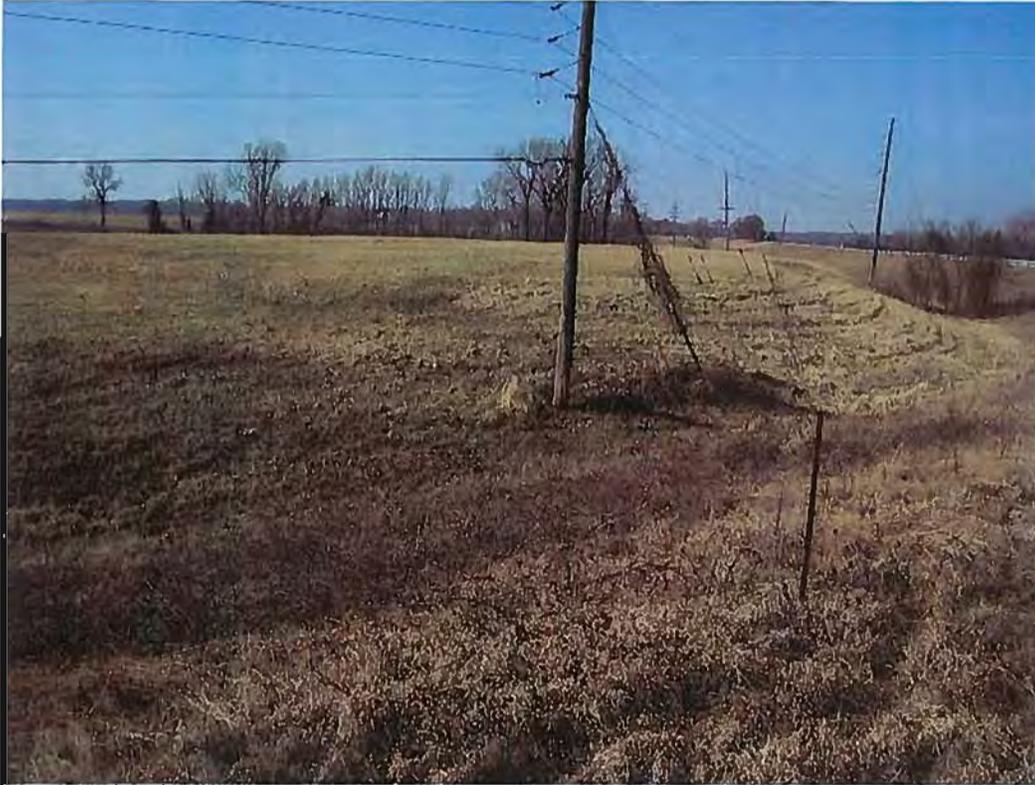
Date: March 17, 2009
Time: 10:34 AM
Direction: S
Photo by: Eisenbrandt
Exposure #: 003
Comments: Site No. 1.

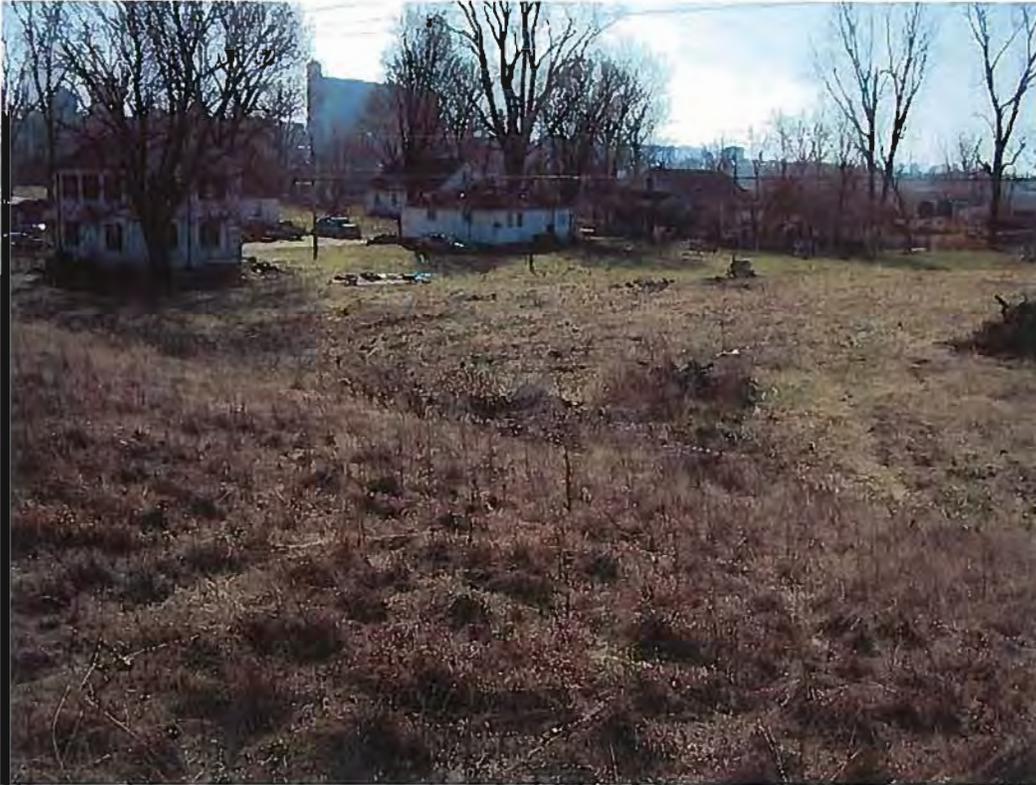
Date: March 17, 2009
Time: 10:35 AM
Direction: SE
Photo by: Eisenbrandt
Exposure #: 005
Comments: Blick's Village in background of photograph. In foreground of photograph, the thicket of immature trees have been removed.

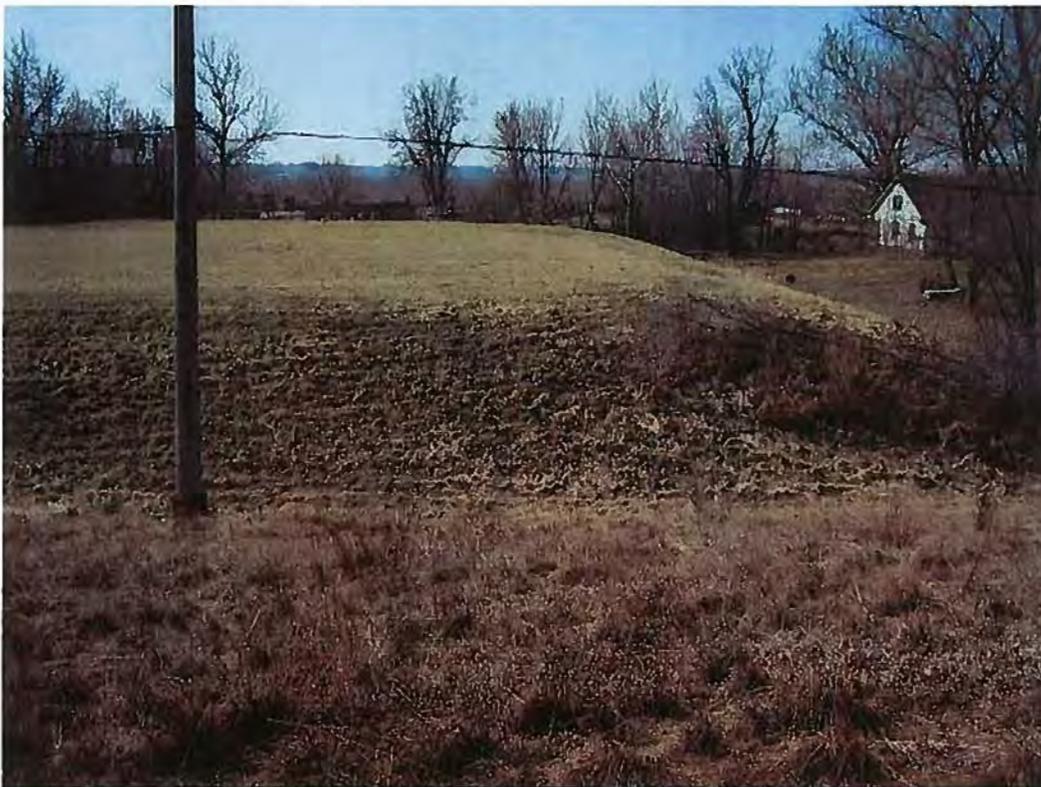
Photograph 006 shows the west side of Site No.2 landfill. The vegetative cover appears well maintained and no debris was observed.

Date: March 17, 2009
Time: 10:37 AM
Direction: S
Photo by: Eisenbrandt
Exposure #: 006
Comments: Site No. 2.

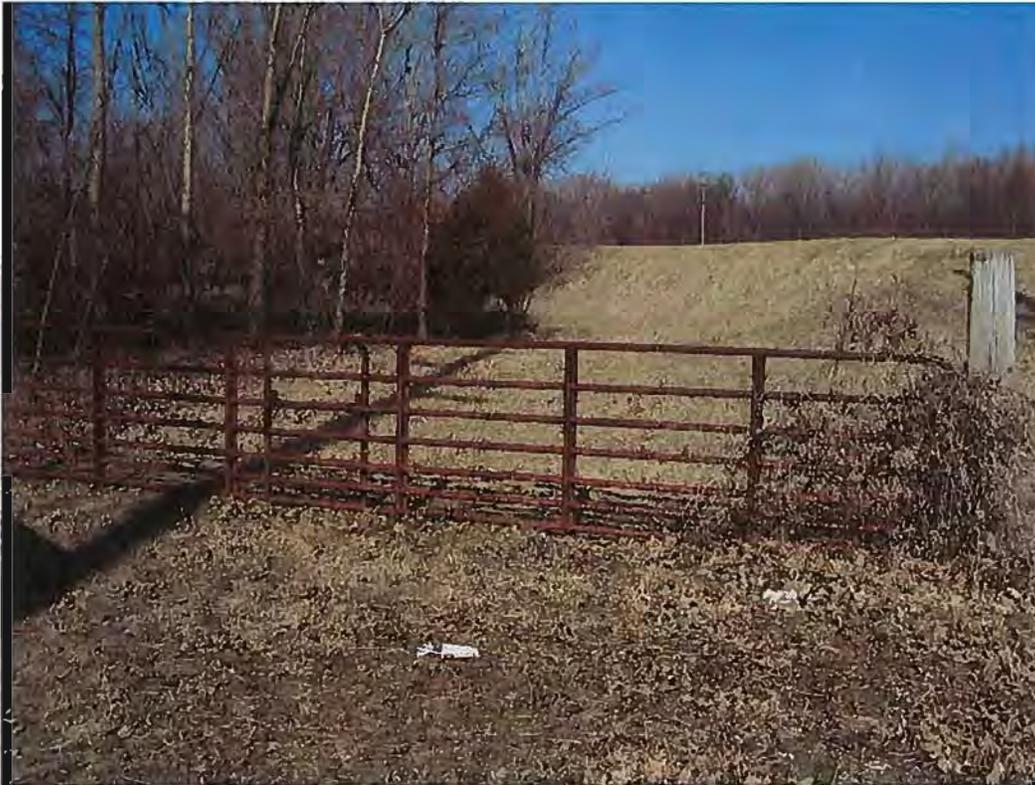
Photograph 007 shows the main gate to Site No. 2. A few pieces of litter were observed on the ground in front of the gate. The gate was properly locked.

Date: March 17, 2009
Time: 10:52 AM
Direction: NW
Photo by: Eisenbrandt
Exposure #: 007
Comments: Main gate to Site No. 2.

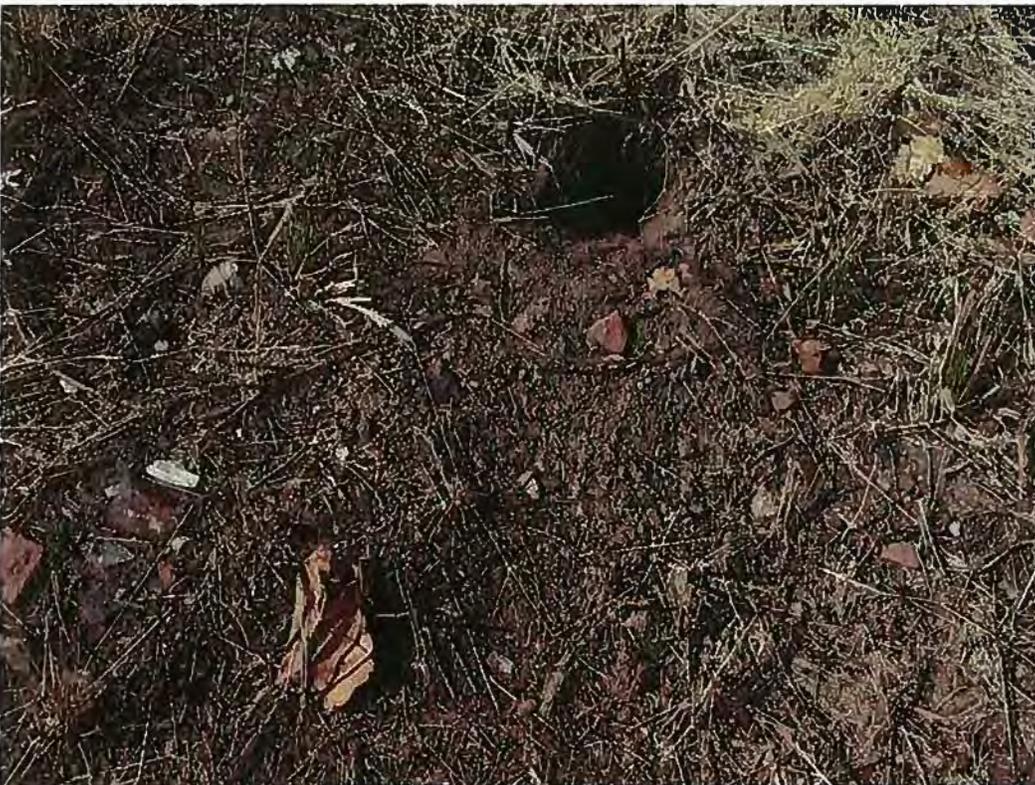
The apparent violations observed at Blickhan Landfill are indicated on the attached Part 807 Landfill Inspection Checklist. Section 22.17(a) and (b) were cited for failure to monitor the landfill during post-closure care as five rodent holes were observed in the landfill's cap and remedial action was not taken to correct the problem.

Date: March 17, 2009
Time: 10:53 AM
Direction: W
Photo by: Eisenbrandt
Exposure #: 008
Comments: Ground hog hole in cap on east side of Site No. 2. Pieces of brick, broken glass, mortar, and scraps of shingle debris were observed.

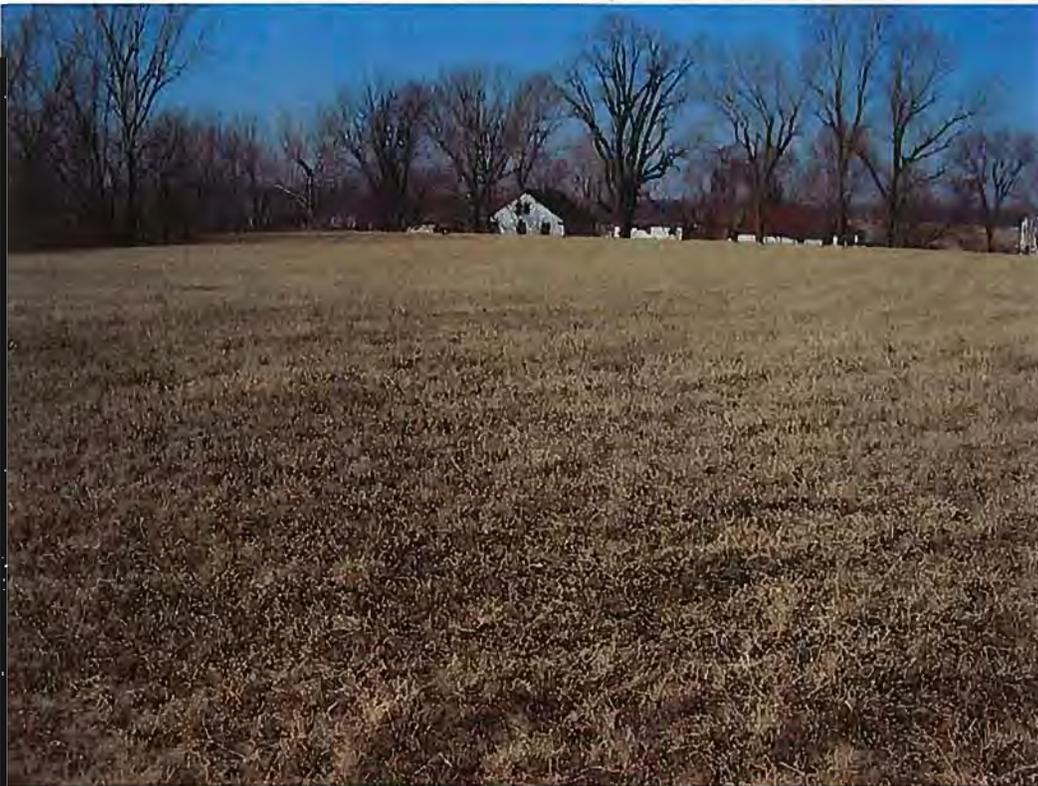
Date: March 17, 2009
Time: 10:56 AM
Direction: W
Photo by: Eisenbrandt
Exposure #: 010
Comments: Well established and well maintained vegetative cover on Site No. 2.

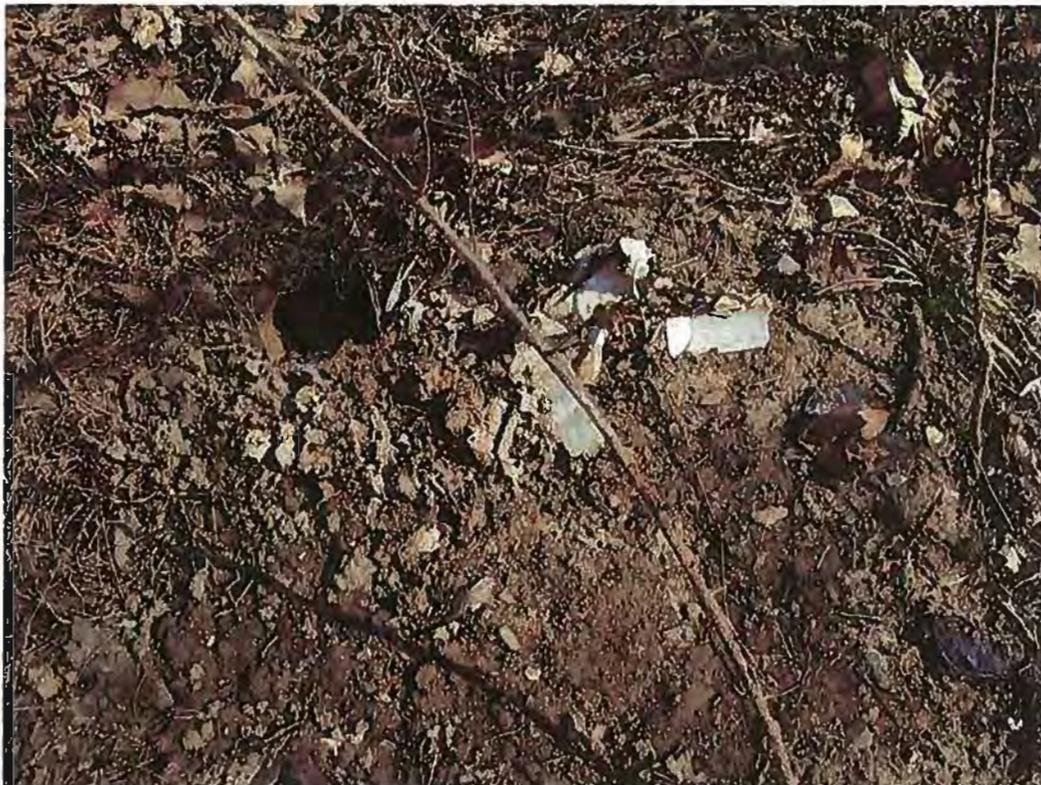
Photograph 011 shows a second rodent hole observed in the landfill on Site No. 2 along its south side. The rodent hole is near well G106 on the side slope of the landfill. Rusty metal, aluminum scrap, black plastic, and a piece of plastic beverage cup were observed near the hole.

Date: March 17, 2009
Time: 10:59 AM
Direction: N
Photo by: Eisenbrandt
Exposure #: 011
Comments: Rodent hole in landfill cap on the south side of Site No. 2. Rusty metal, aluminum scrap, black plastic, and a piece of plastic beverage cup were observed near the hole.

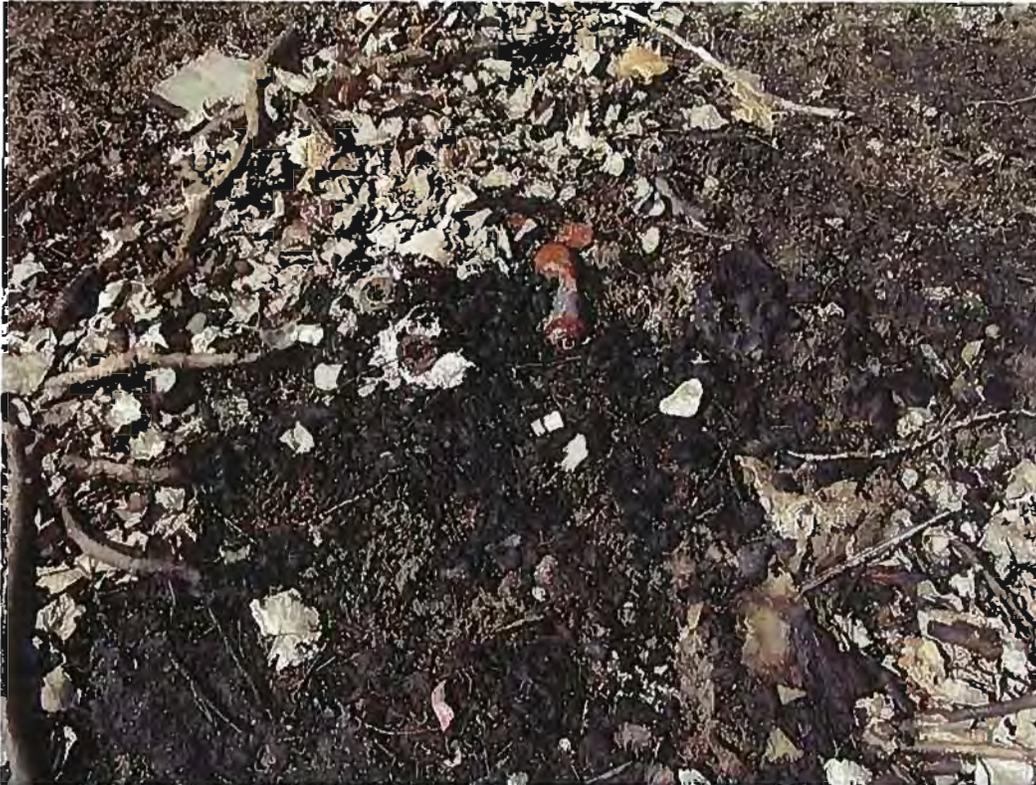
Photograph 013 shows a debris pile of ash and charred waste east of House 3 in Blick's Village. The tenant for the last 20 years came out of the house and spoke with the inspector. She stated she has not burned anything since Mr. Blickhan notified her of the Agency's previous inspection last year. The ash and charred waste (rusty aerosol cans, processed lumber, nails, and scrap metal) are considered open dumped waste until properly disposed at an Illinois EPA permitted solid waste facility.

Date: March 17, 2009
Time: 11:05 AM
Direction: S
Photo by: Eisenbrandt
Exposure #: 013
Comments: Ash and charred waste open dumped east of House 3 in Blick's Village.

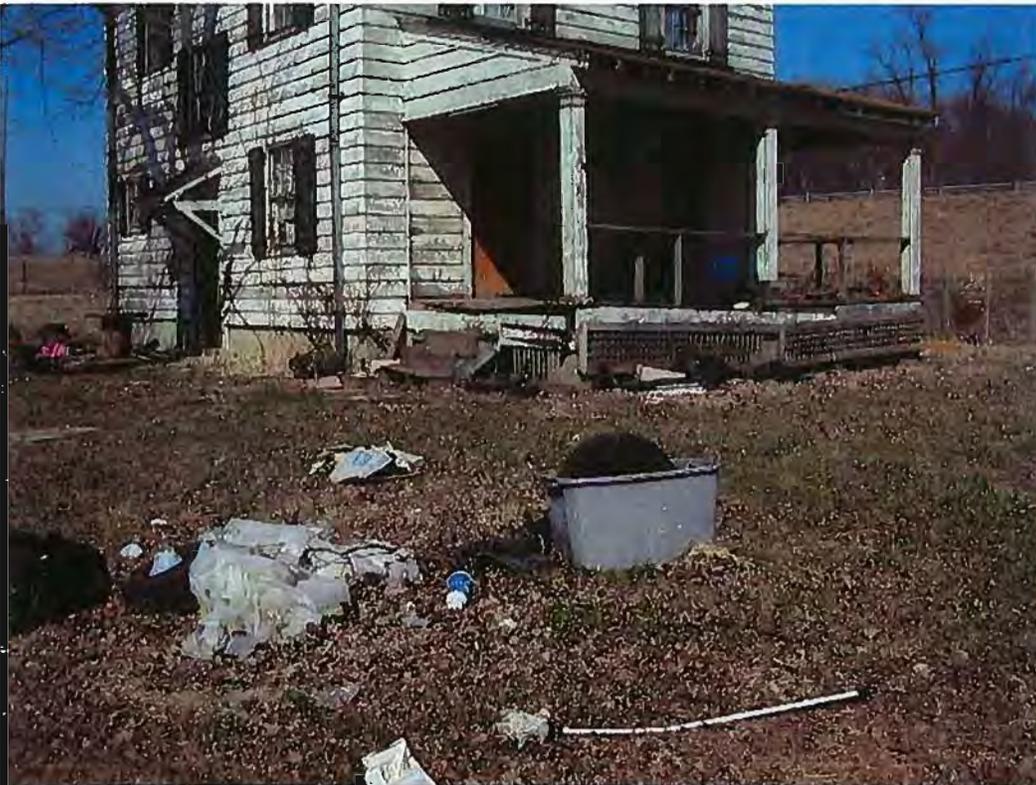
Photograph 014 shows open dumped waste on the southeast corner of House 6 in Blick's Village. A mop, a grey plastic tote, a used tire, cardboard boxes, black plastic bags of household garbage, plastic sheeting, clothes, and a small diameter tire were observed in the front yard near the road. Another used tire, more bags of garbage, and debris was also observed on and in front of the porch.

Date: March 17, 2009
Time: 11:10 AM
Direction: NW
Photo by: Eisenbrandt
Exposure #: 014
Comments: Open dumped waste southeast of House 6 in Blick's Village.

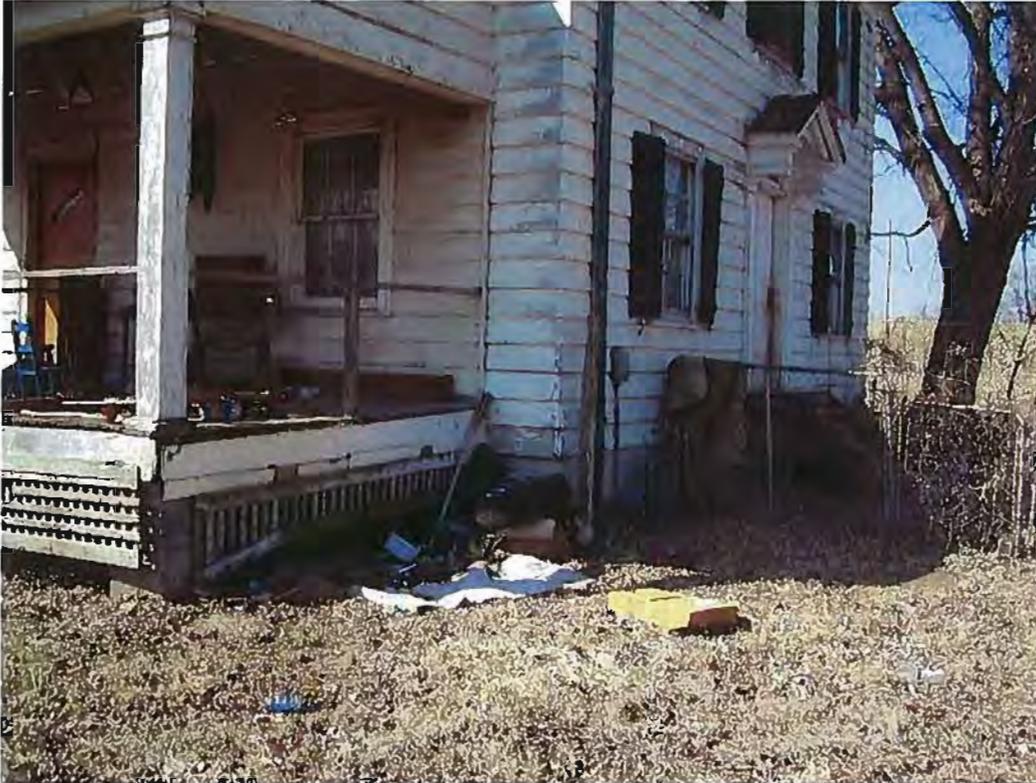
Photograph 015 shows open dumped waste on the north side of the front porch of House 6. A used tire, a basket, a plastic bowl, food wrappers, beverage cans and bottles, a tiki torch, and carpet were among other household wastes observed.

Date: March 17, 2009
Time: 11:11 AM
Direction: SW
Photo by: Eisenbrandt
Exposure #: 015
Comments: Open dumped waste on north side on House 6.

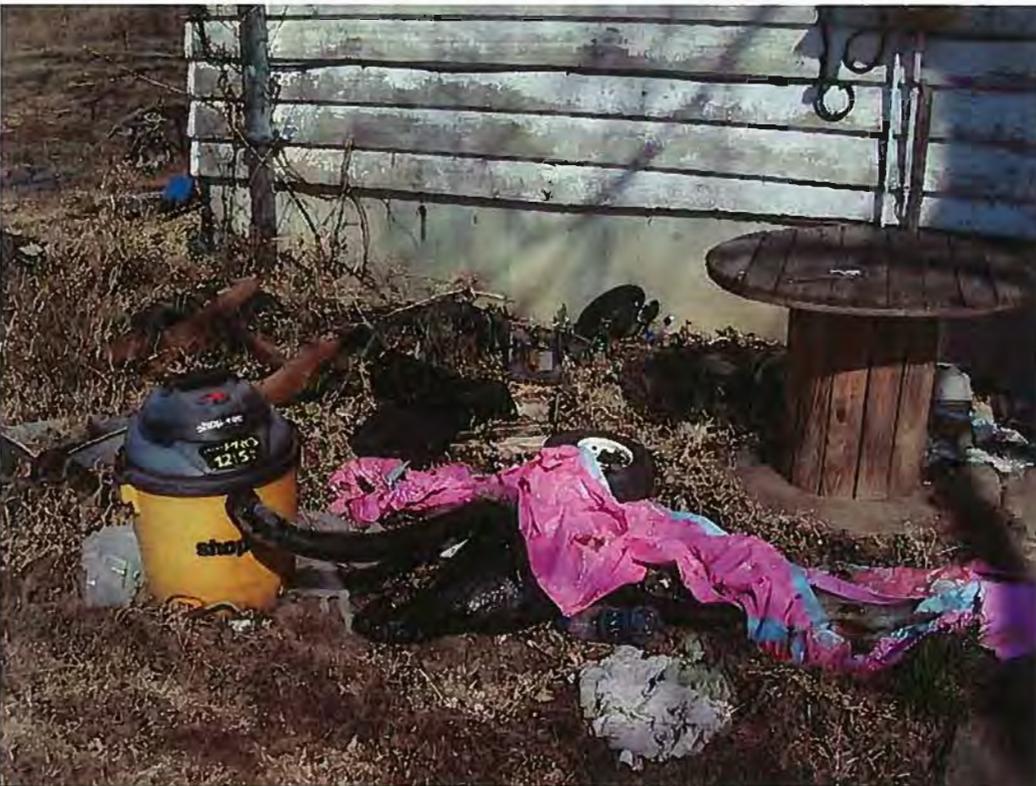
Photograph 016 shows open dumped waste on the south side of House 6. A yellow and black shop vacuum, a small used tire, plastic bags, a wooden frame to a chair, a black plastic case, a pink plastic inflatable toy, disassembled electrical components, a bag of household garbage, plastic beverage bottles, clothes, drapery, and miscellaneous items were among the observed

Date: March 17, 2009
Time: 11:12 AM
Direction: NW
Photo by: Eisenbrandt
Exposure #: 016
Comments: Open dumped waste on south side of House 6.

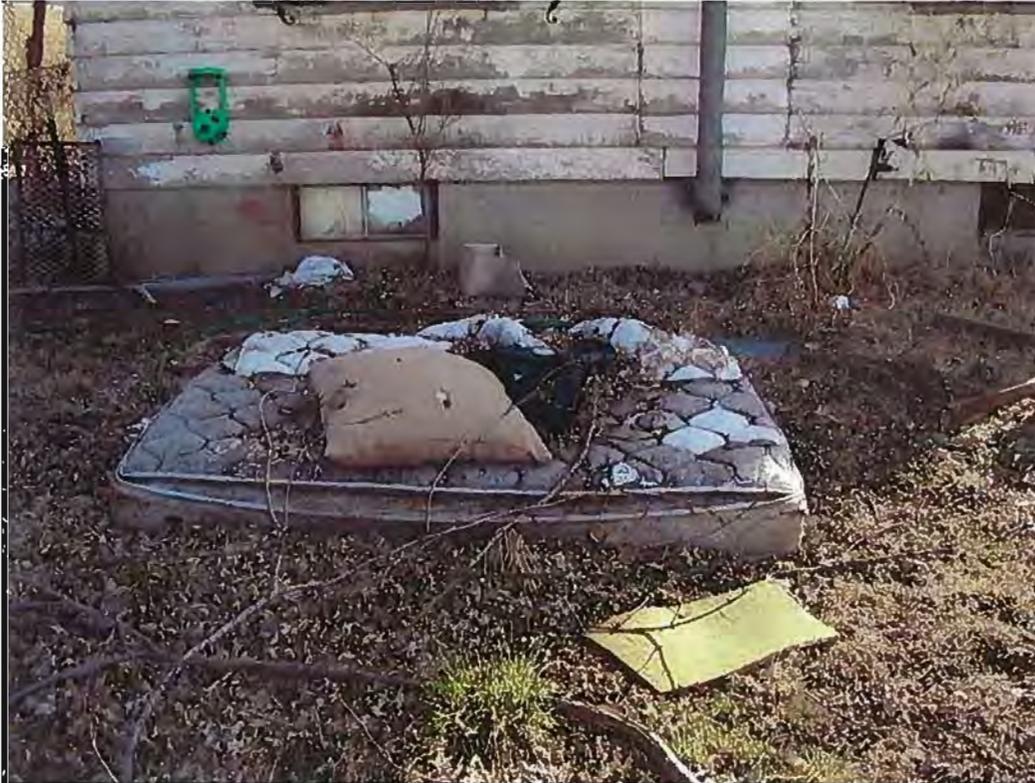
Photograph 017 shows open dumped waste on the west side of House 6. A torn mattress, a pillow, foam padding, a garden hose, clothing, cardboard boxes, scrap lumber, scrap metal, and miscellaneous wastes were observed.

Date: March 17, 2009
Time: 11:13 AM
Direction: E
Photo by: Eisenbrandt
Exposure #: 017
Comments: Open dumped waste on west side of House 6.

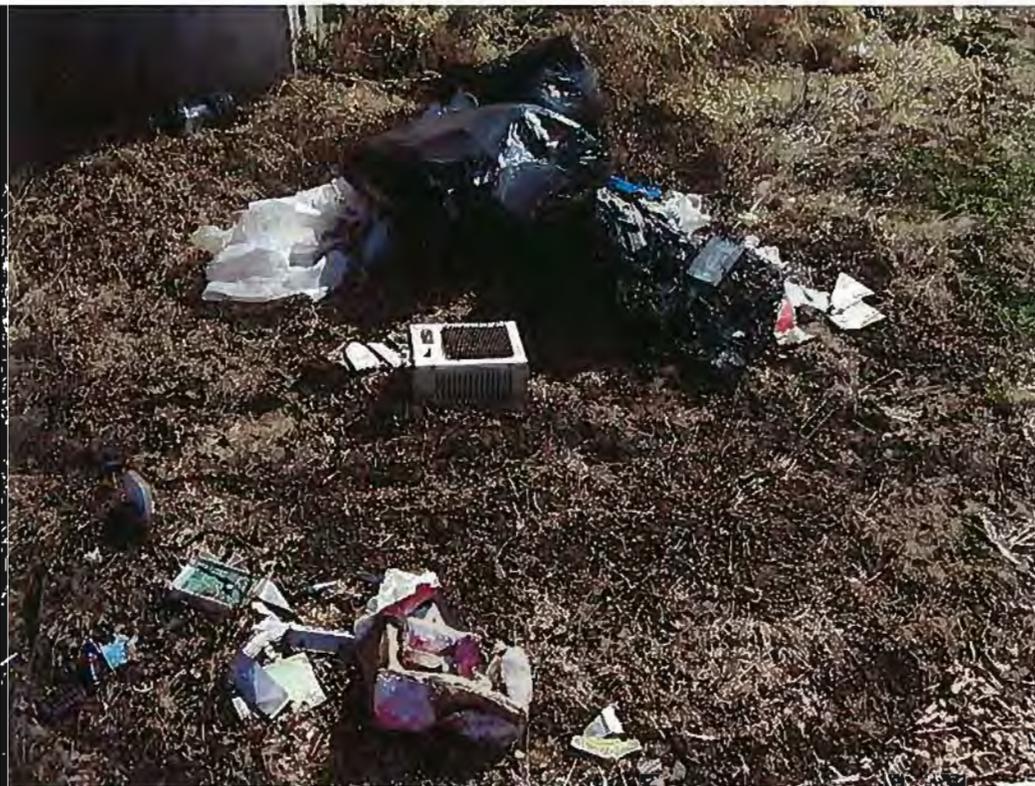
Photograph 018 shows more open dumped waste off the southwest corner of House 6. Several bags of household garbage, an electric space heater, video tapes, a fluorescent lantern, a vehicle stereo, and miscellaneous waste were observed.

Date: March 17, 2009
Time: 11:13 AM
Direction: E
Photo by: Eisenbrandt
Exposure #: 018
Comments: More open dumped waste observed off the southwest corner of House 6.

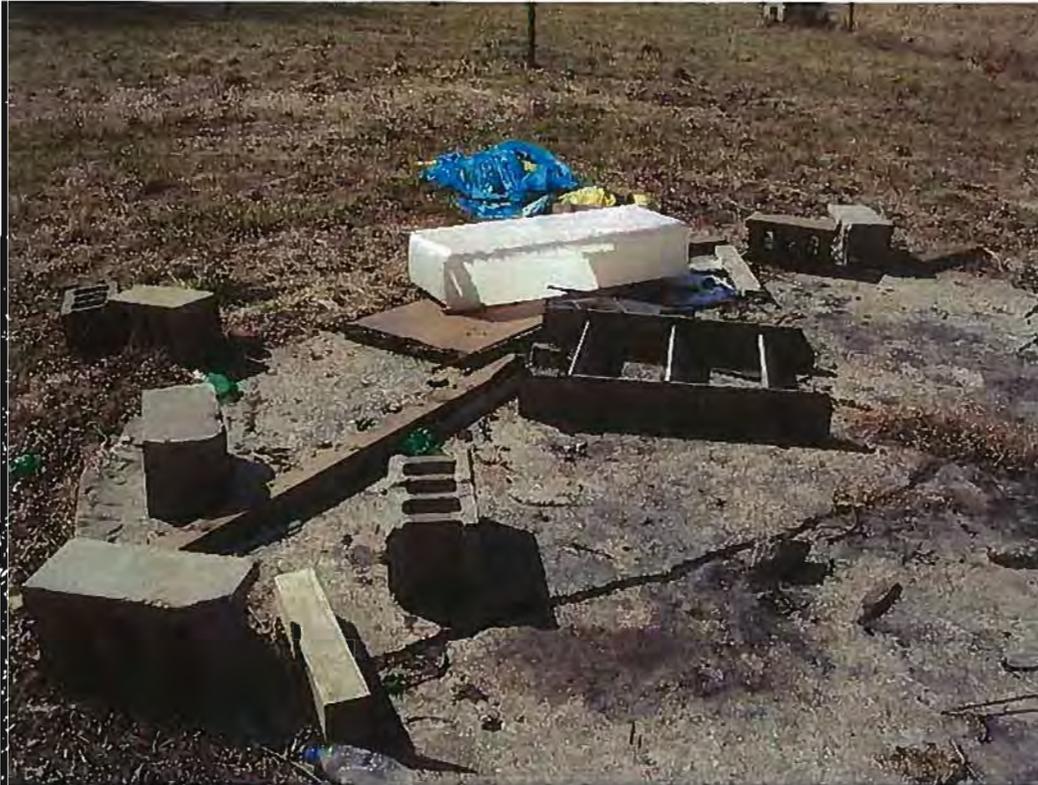
Date: March 17, 2009
Time: 11:14 AM
Direction: S
Photo by: Eisenbrandt
Exposure #: 019
Comments: Open dumped waste on a concrete pad west of House 6 that was previously used for open burning.

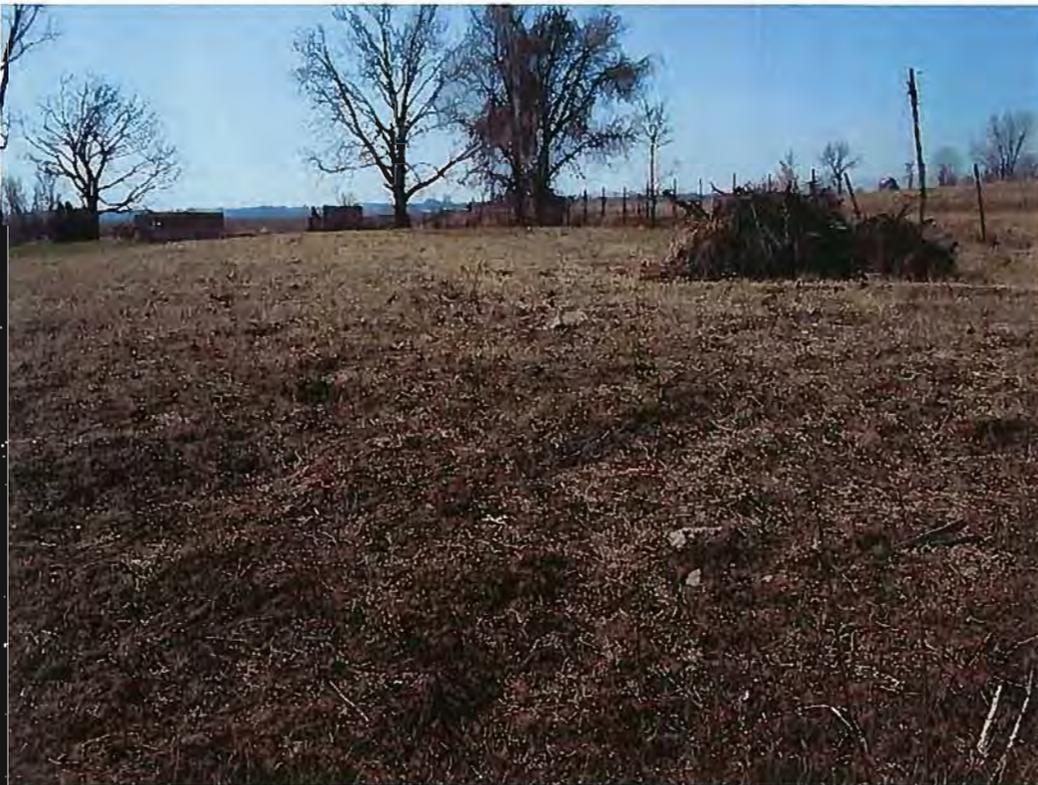
Photograph 020 shows all of the immature trees have been removed from behind Houses 5 and 6. It appears that all of the construction and demolition debris has been cleaned up from this yard. A large pile of landscape waste was still observed in the area.

Date: March 17, 2009
Time: 11:14 AM
Direction: S
Photo by: Eisenbrandt
Exposure #: 020
Comments: All of the young trees have been removed from behind Houses 5 & 6. It appears that all of the construction and demolition debris has been cleaned up. A large pile of landscape waste is still on site.

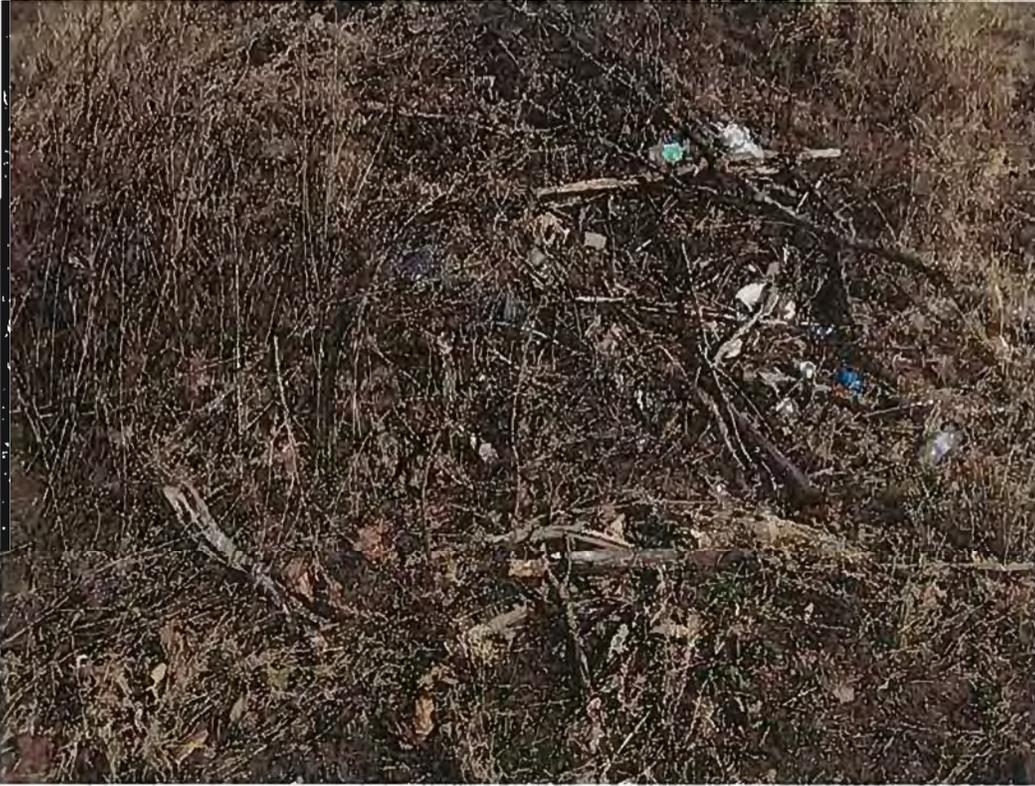
Photograph 021 shows that within the pile of landscape waste seen in Photograph 020 are plastic bags, plastic bottles, aluminum cans, and miscellaneous household waste. The waste must be removed and properly disposed prior to burning the landscape waste.

Date: March 17, 2009
Time: 11:16 AM
Direction: N
Photo by: Eisenbrandt
Exposure #: 021
Comments: Within the pile of landscape waste, plastic bags, plastic bottles, and miscellaneous household waste were observed.

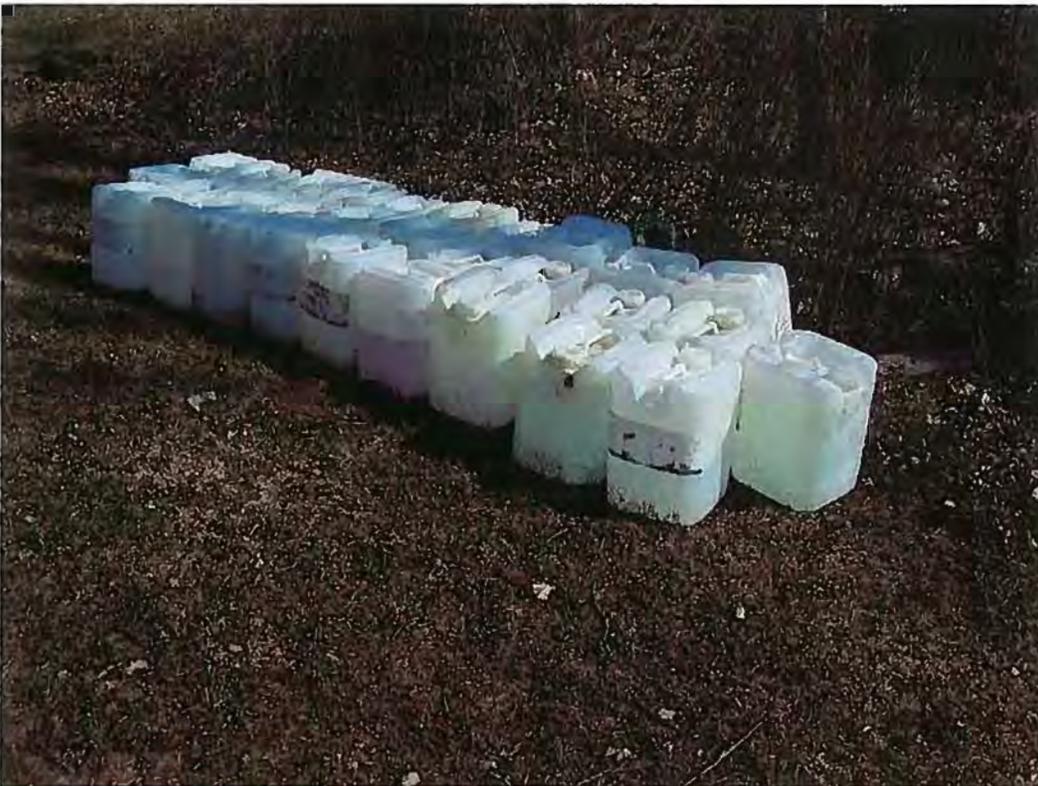
Photograph 022 shows thirty-one 5-gallon plastic containers that were observed southwest of House 4. The visible portions of the partial labels indicated the plastic jugs were originally storing car wash detergent or car wax liquid. The jugs appeared to be mostly filled with water or water and soap mixtures.

Date: March 17, 2009
Time: 11:17 AM
Direction: NE
Photo by: Eisenbrandt
Exposure #: 022
Comments: Thirty-one 5-gallon plastic containers were observed southwest of House 4. The partial labels indicated the plastic jugs were originally storing car wash or car wax liquid. The jugs appeared to be mostly filled with water or water & soap mixtures.

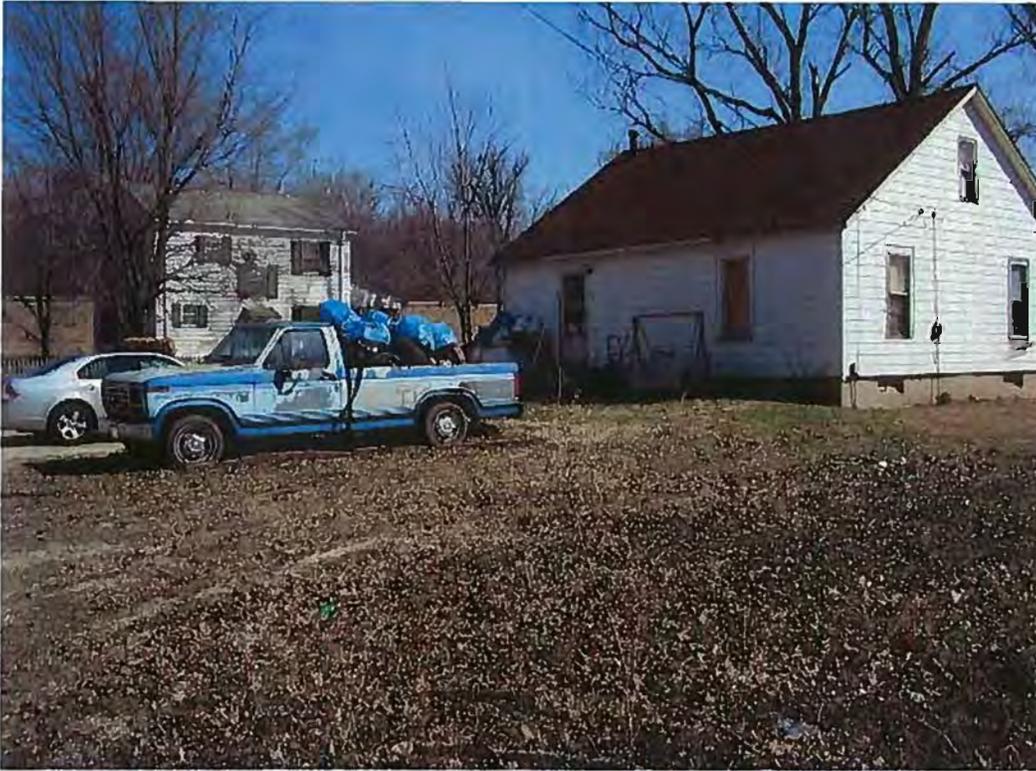
Photograph 023 shows the front yard of House 2. Previously a community dumpster was staged here. No dumpster was observed within Blick's Village. The photograph also shows garbage stored in the back of a two tone blue pickup truck and near the front door of the house.

Date: March 17, 2009
Time: 11:20 AM
Direction: NE
Photo by: Eisenbrandt
Exposure #: 023
Comments: The community dumpster was no longer staged in front of House 2 and was not observed in Blick's Village.

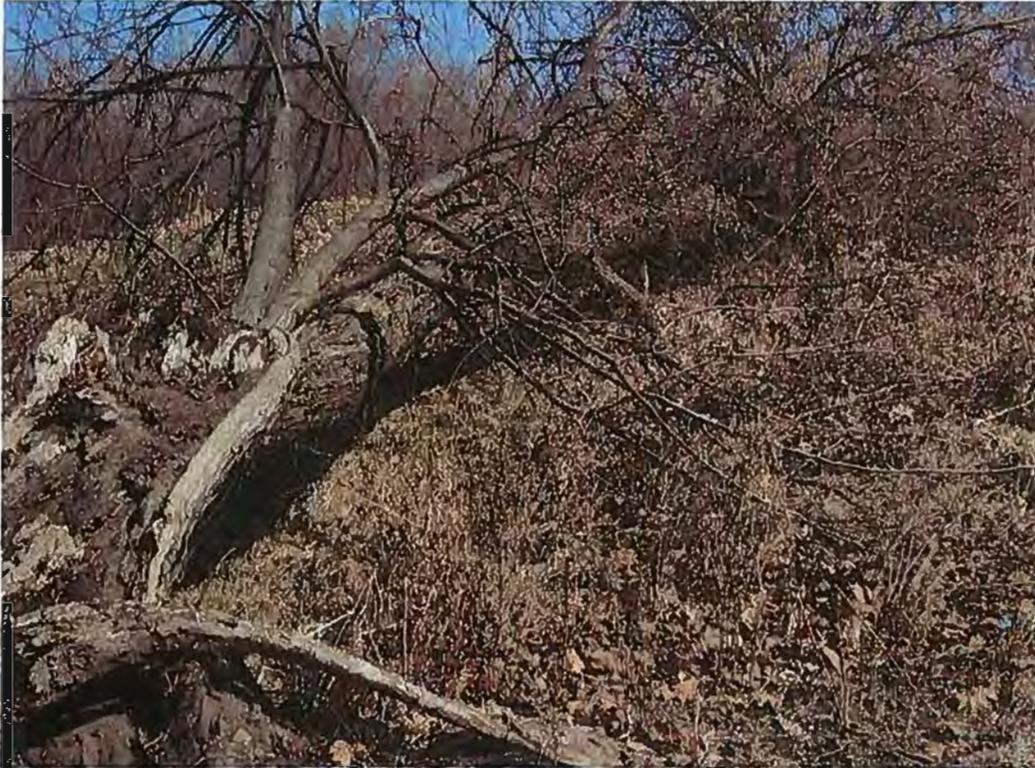
Photograph 025 shows a fallen tree observed on the southwest corner of Site No. 2. The tree needs to be removed so normal mowing schedules will not be hampered.

Date: March 17, 2009
Time: 11:21 AM
Direction: NW
Photo by: Eisenbrandt
Exposure #: 025
Comments: A fallen tree was observed on the southwest corner of Site No. 2.

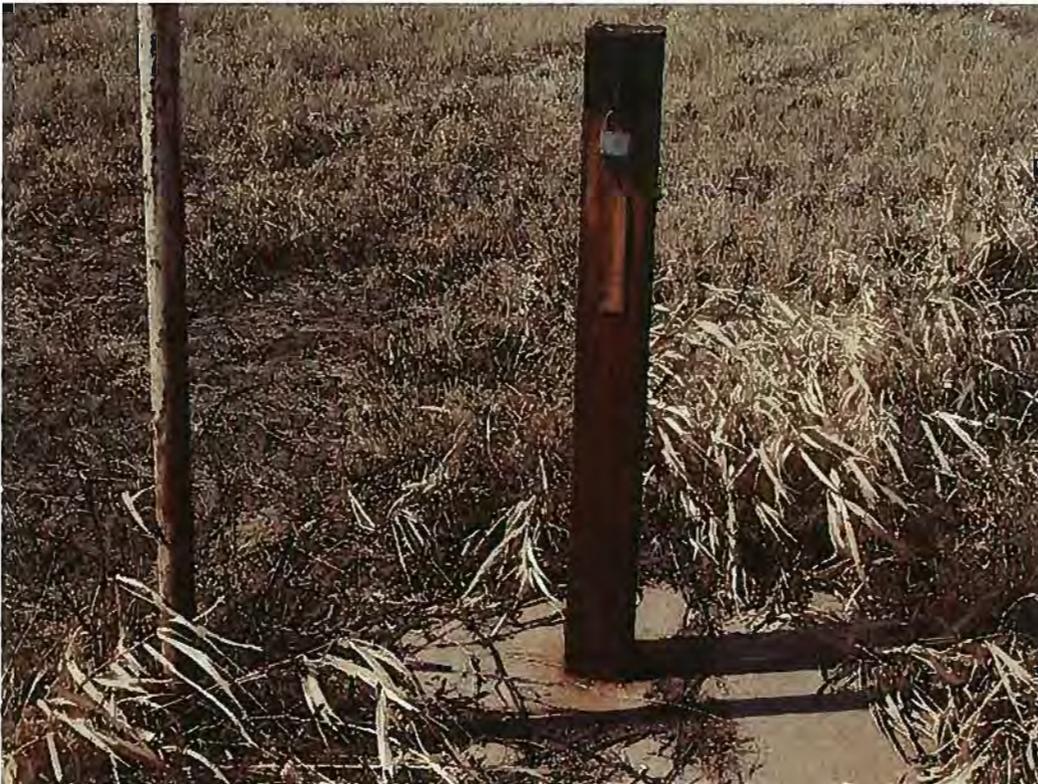
Photograph 028 shows well G105 on the south side of Site No. 1. The outer casing appeared rusty.

Date: March 17, 2009
Time: 11:43 AM
Direction: SW
Photo by: Eisenbrandt
Exposure #: 028
Comments: Well G105
appeared rusty.

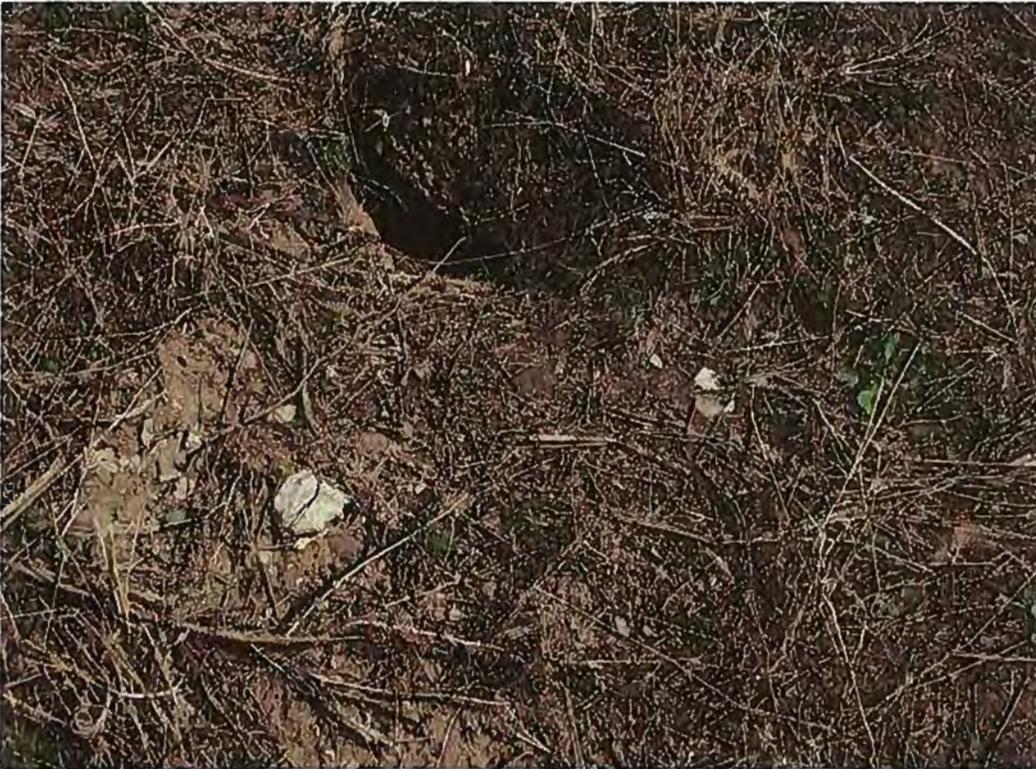
Photographs 029 and 031 show three rodent holes along the southern perimeter in the landfill cap of Site No. 1. Unlike the other two holes described earlier, dirt and gravel were the only media observed pushed out by the animal.

Date: March 17, 2009
Time: 11:45 AM
Direction: N
Photo by: Eisenbrandt
Exposure #: 029
Comments: Rodent hole
in cap along the south side
of Site No. 1.

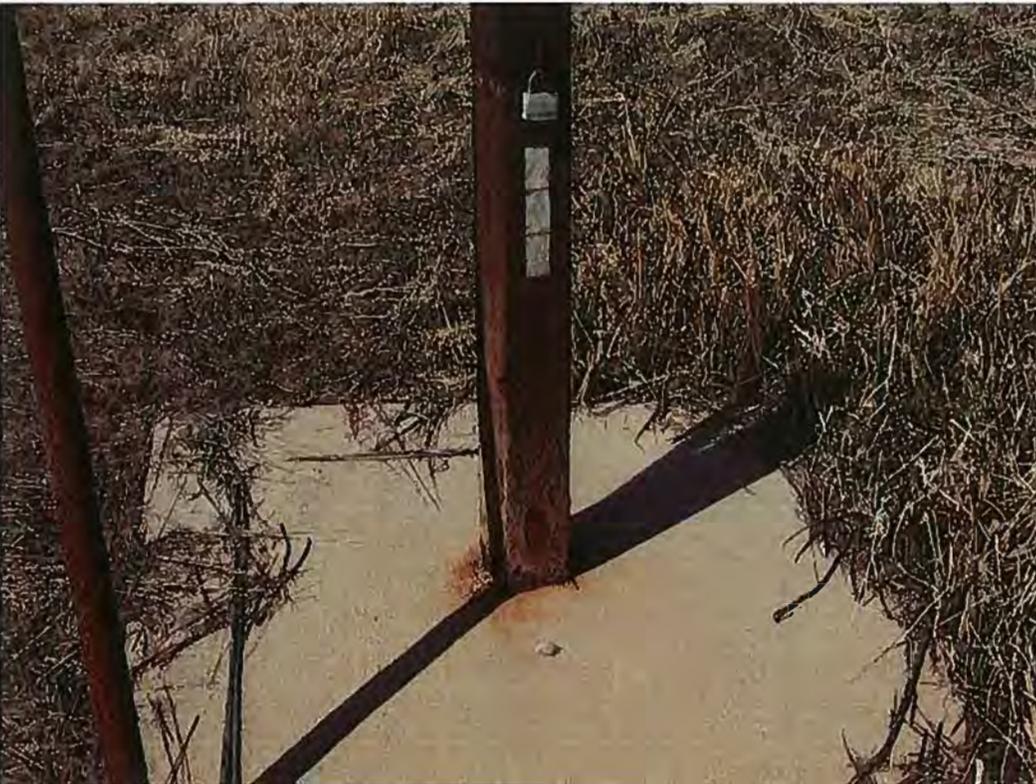
Date: March 17, 2009
Time: 11:47 AM
Direction: W
Photo by: Eisenbrandt
Exposure #: 030
Comments: Rusty well
G107. The grass to the
south (left) appears as if
there is a drainage
problem.

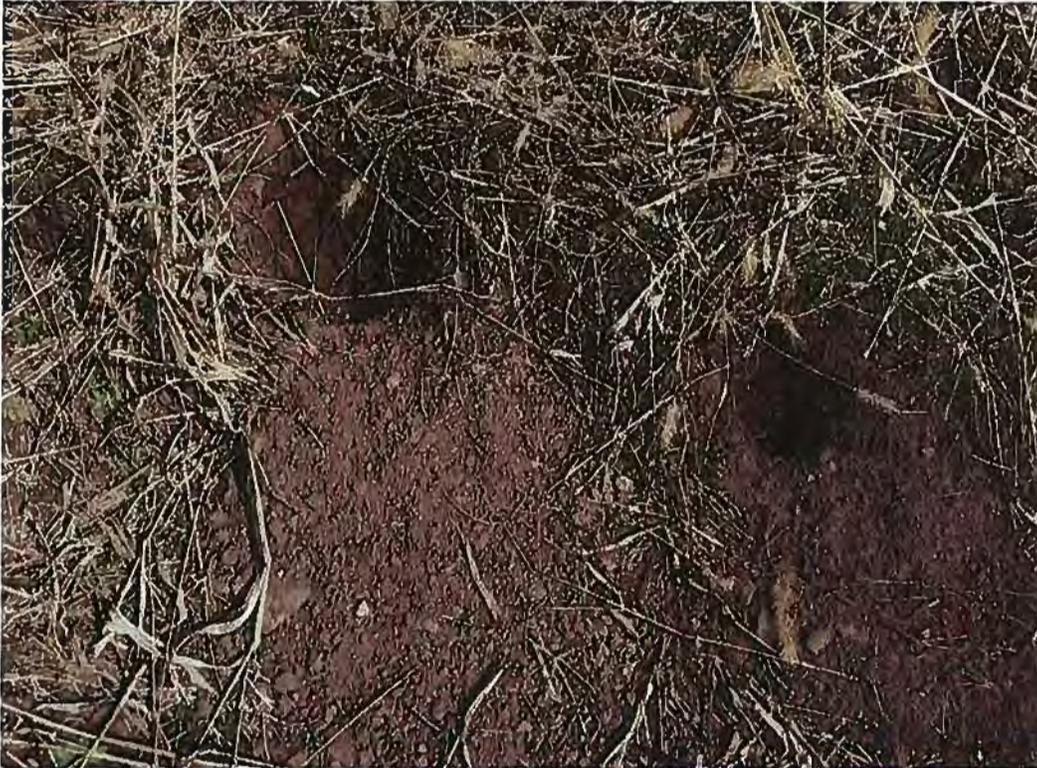
Date: March 17, 2009
Time: 11:47 AM
Direction: N
Photo by: Eisenbrandt
Exposure #: 031
Comments: Two additional rodent holes observed on the south side of Site No. 1.
