Re: Illinois Environmental Protection Agency v. C. John Blickhan
IEPA File No. 94-09-AC; 0010650002—Adams County

ADMINISTRATIVE CITATION

AC 09-46
(IEPA No. 94-09-AC)
FINAL

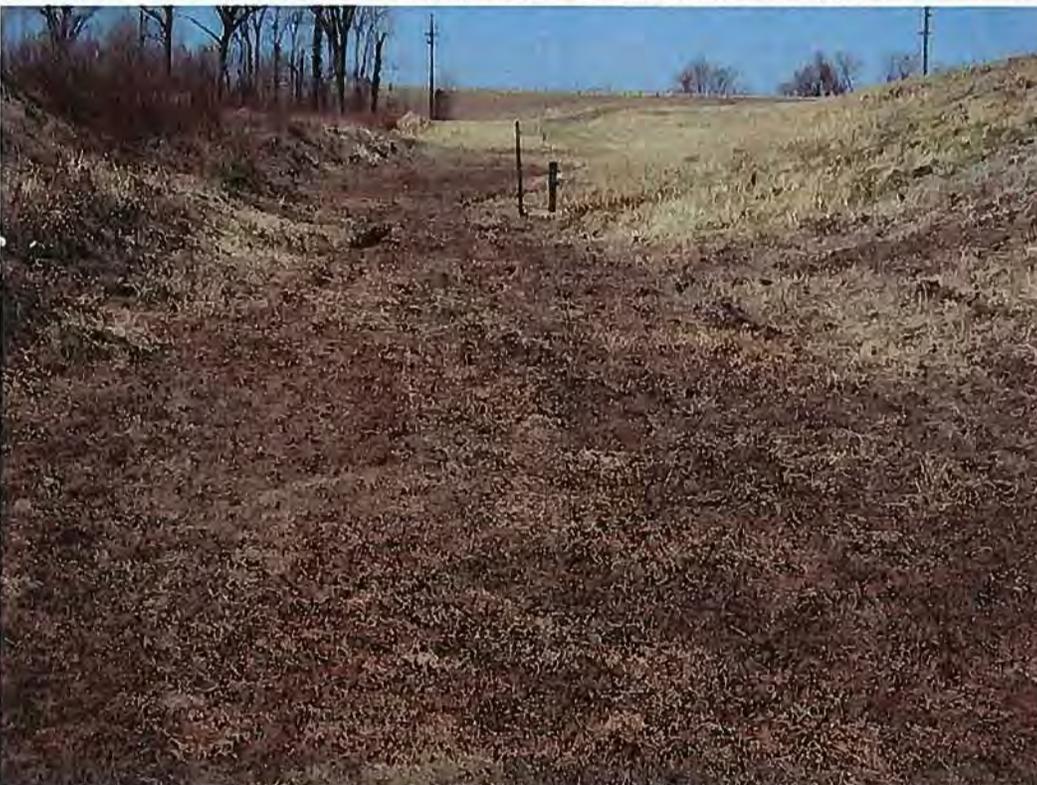
Date: March 17, 2009
Time: 11:48 AM
Direction: W
Photo by: Eisenbrandt
Exposure #: 032
Comments: The swale between Blickhan Landfill (Site No. 1) and Blickhan Family Corporation property to the south appears to retain water. The precipitation runoff from the landfill no longer drains to the south. The vegetative cover was dirty and stressed as if subjected to standing water.
