AC 10-08
(IEPA No. 283-09-AC)

ADMINISTRATIVE CITATION

Open Dump Inspection Checklist

County: Sangamon LPC#: 1678220075 Region: 5 - Springfield
 Location/Site Name: Springfield Township/Info Corner Materials, Inc.
 Date: 09/17/2009 Time: From 11:30 am To 12:32 pm Previous Inspection Date: 01/09/2009
 Inspector(s): Rich Johnson Weather: @ 70 - 75 degrees F, clear, dry soil
 No. of Photos Taken: # 27 Est. Amt. of Waste: 1900 yds³ Samples Taken: Yes # No
 Interviewed: Todd Donley, V-P & General Manager of Donley Trucking, Inc. Complaint # C-09-073-C

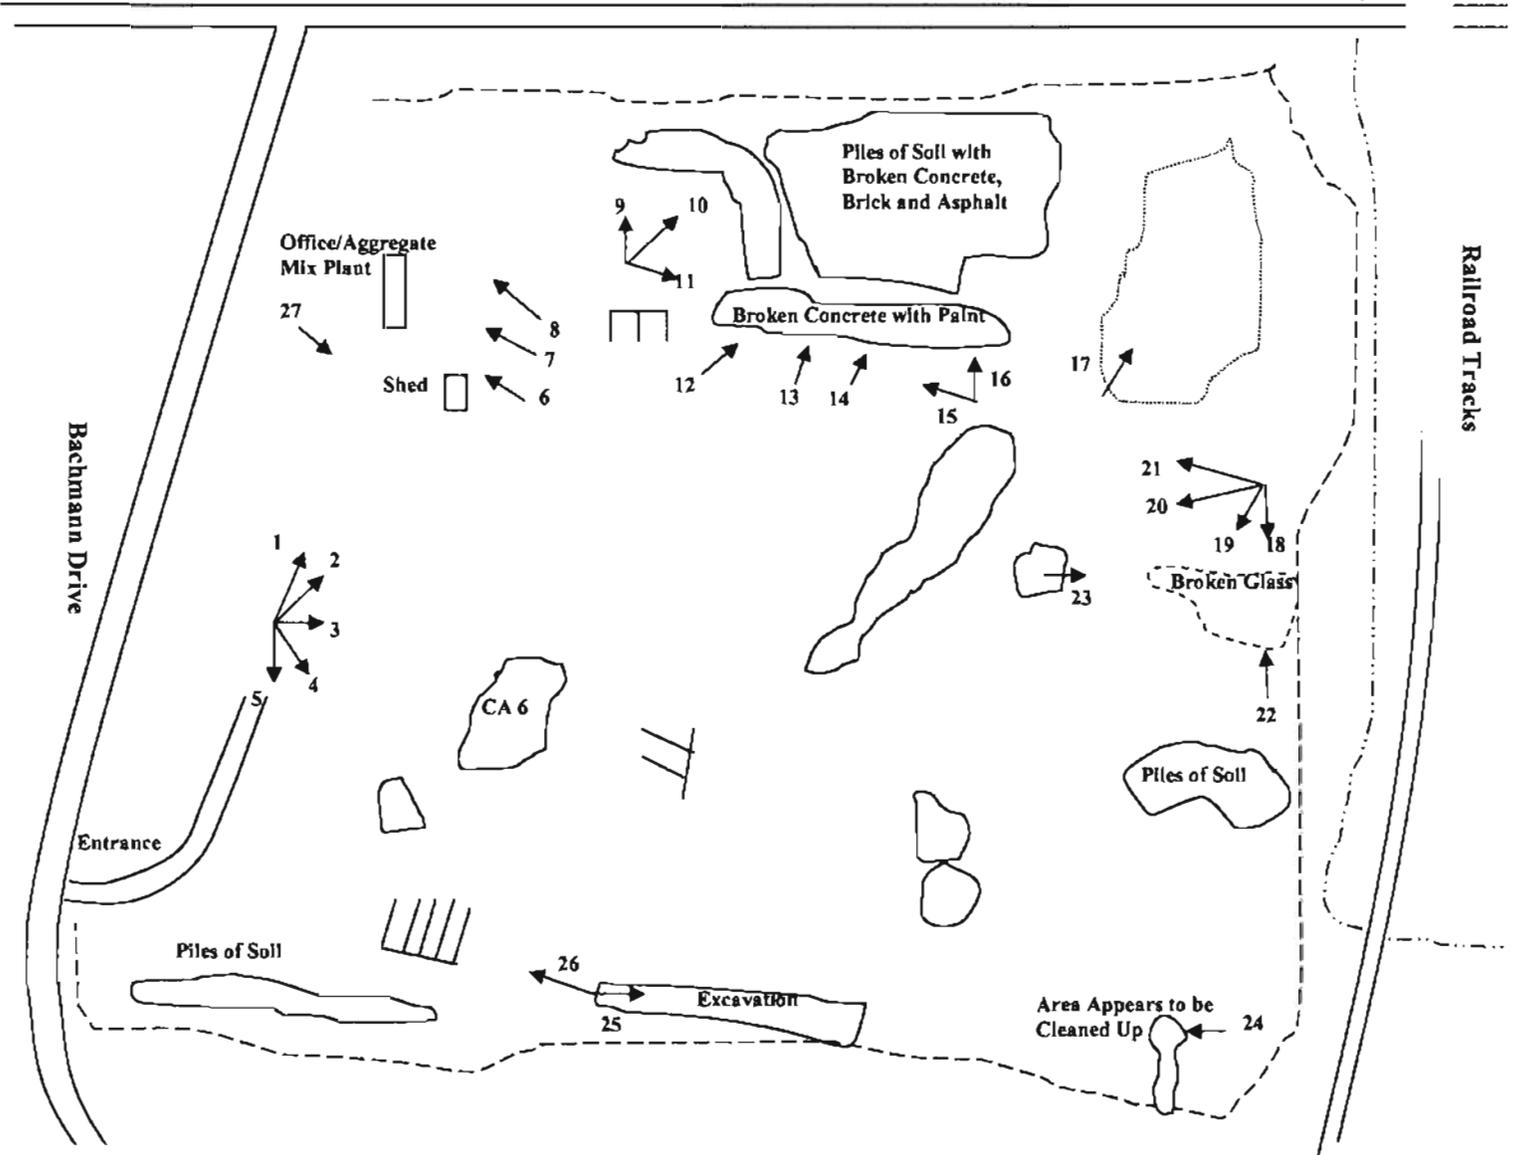
Concrete Truck Clean Out
Broken Glass with Plastic
Milled Asphalt, Broken Concrete & Gravel
Piles

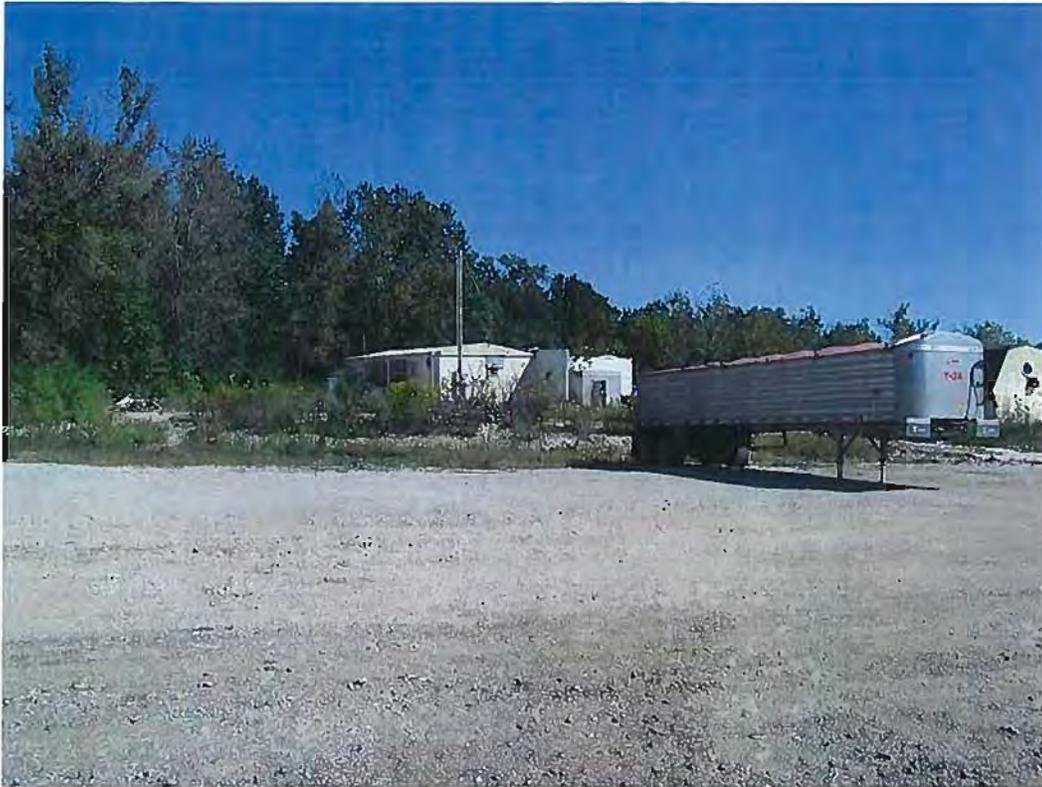
Date: September 17, 2009
Time: 11:27 am
Direction:
North/northeast
Photo by: Rich Johnson
Exposure #: 001
Comments: Photograph shows the deserted office building located at the northwest region of the site. Note that the aggregate mixing plant previously located east of the office is no longer present.

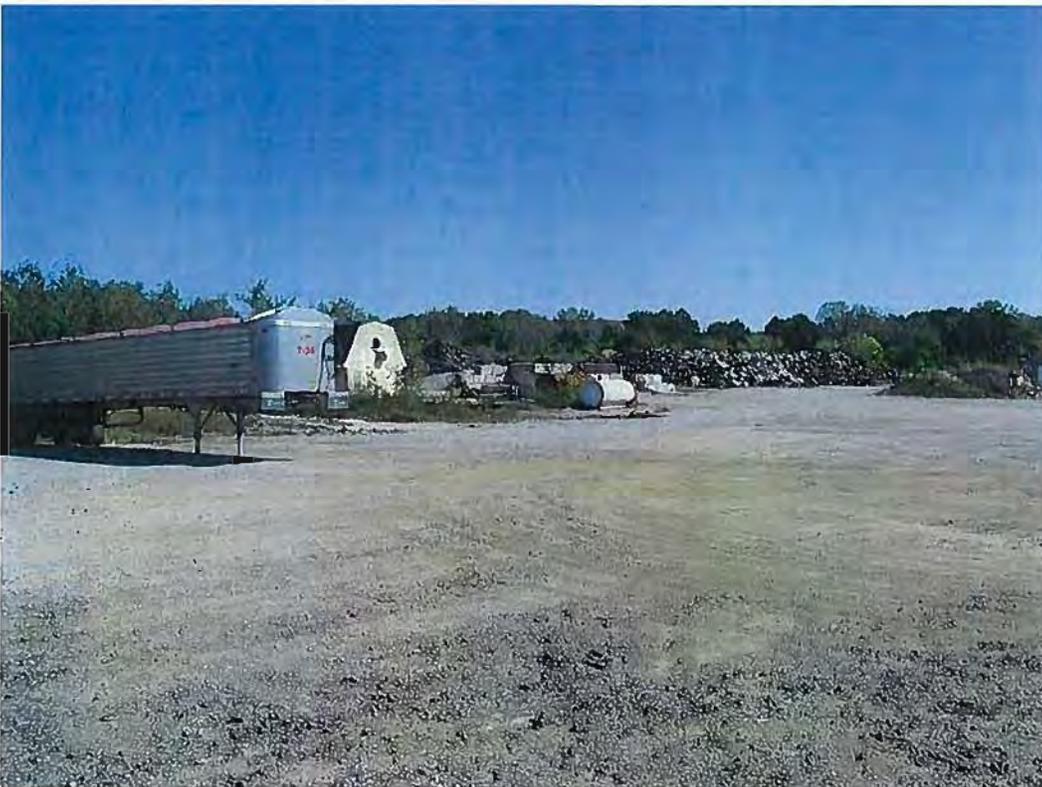
Date: September 17, 2009
Time: 11:28 am
Direction: Northeast
Photo by: Rich Johnson
Exposure #: 002
Comments: Photograph taken from the west side of the site shows a truck trailer, a small shed behind the trailer, and some of the onsite broken concrete piles.

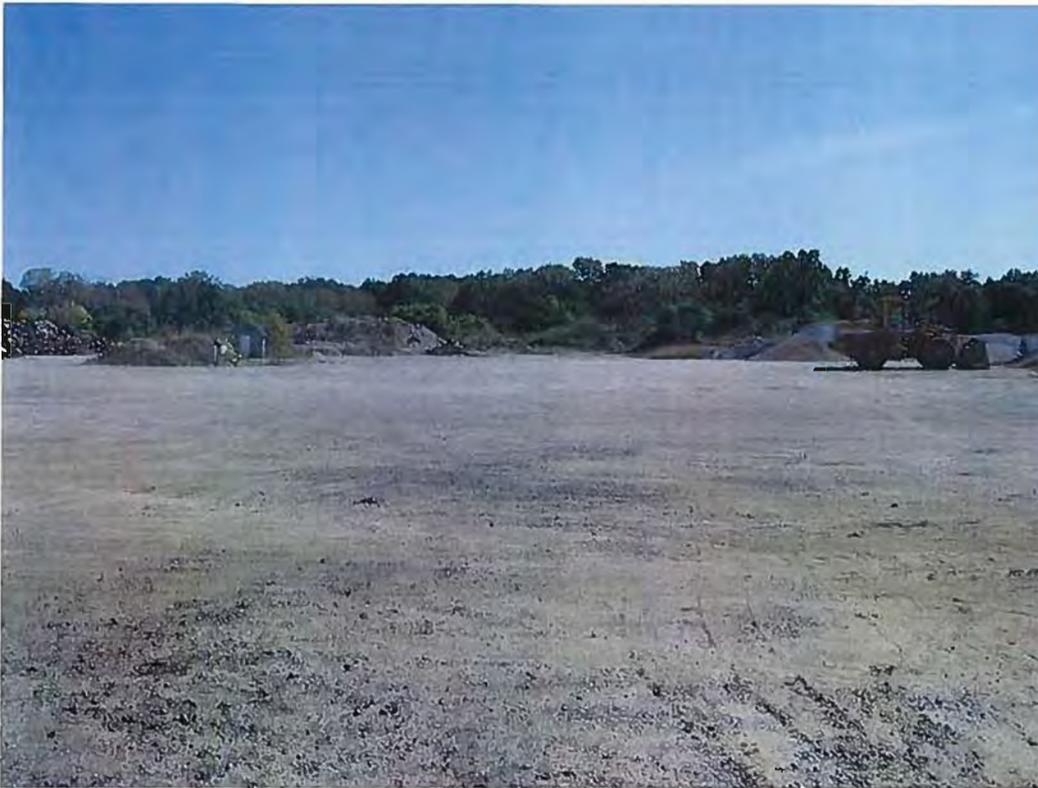
Date: September 17, 2009
Time: 11:28 am
Direction: East
Photo by: Rich Johnson
Exposure #: 003
Comments: Photograph shows part of the central region of the site. Note the parked end-loader.

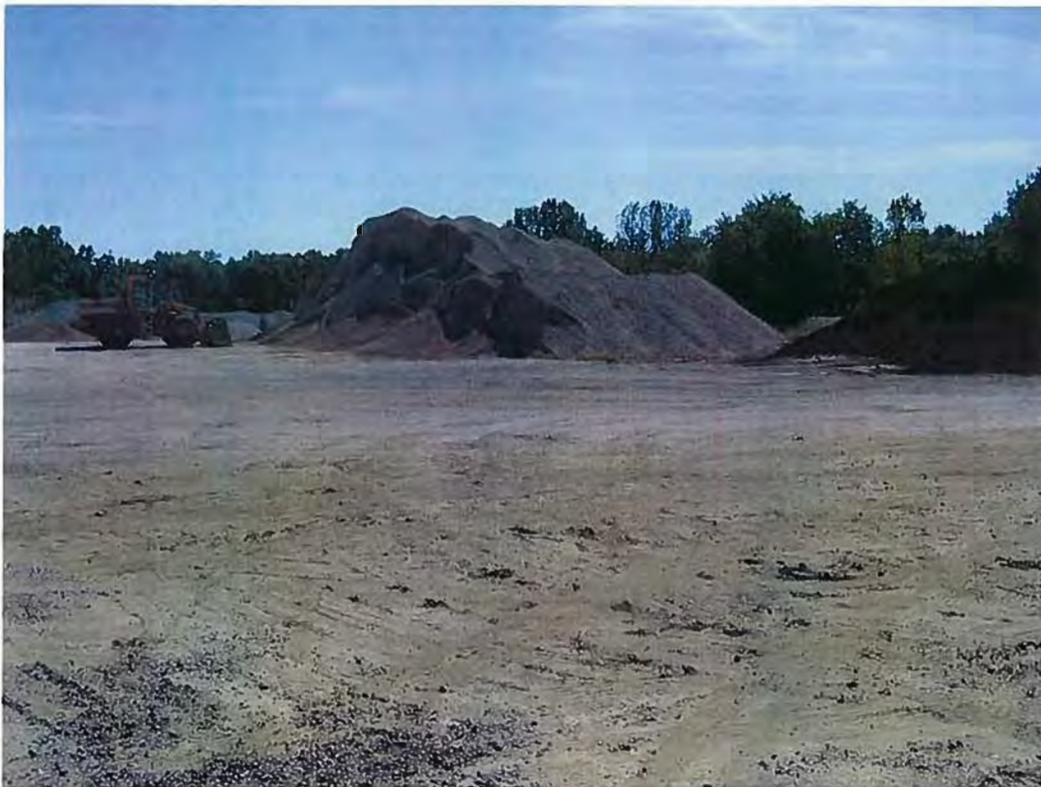
Date: September 17, 2009
Time: 11:28 am
Direction: Southeast
Photo by: Rich Johnson
Exposure #: 004
Comments: Photograph shows a pile of graded rock and a smaller pile of milled asphalt located in the central and southwest regions of the site.

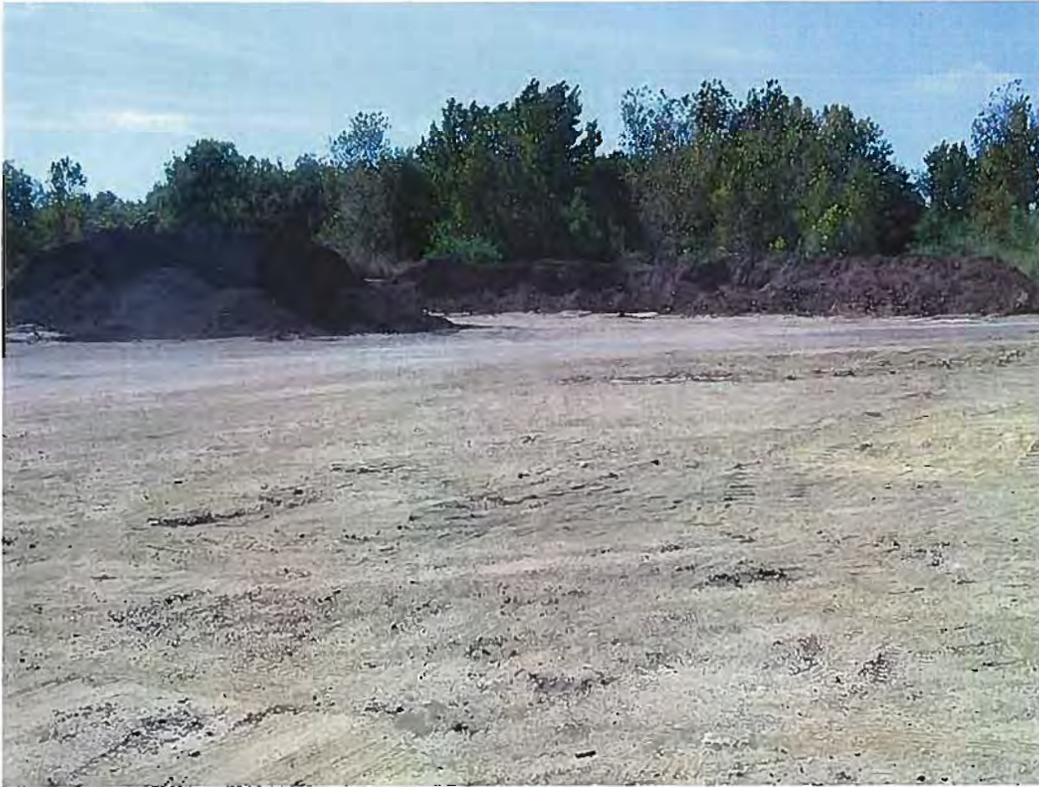
Date: September 17, 2009
Time: 11:28 am
Direction: South
Photo by: Rich Johnson
Exposure #: 005
Comments: Photograph shows the pile of milled asphalt and behind the pile several piles of soil located in the southwest region of the site.

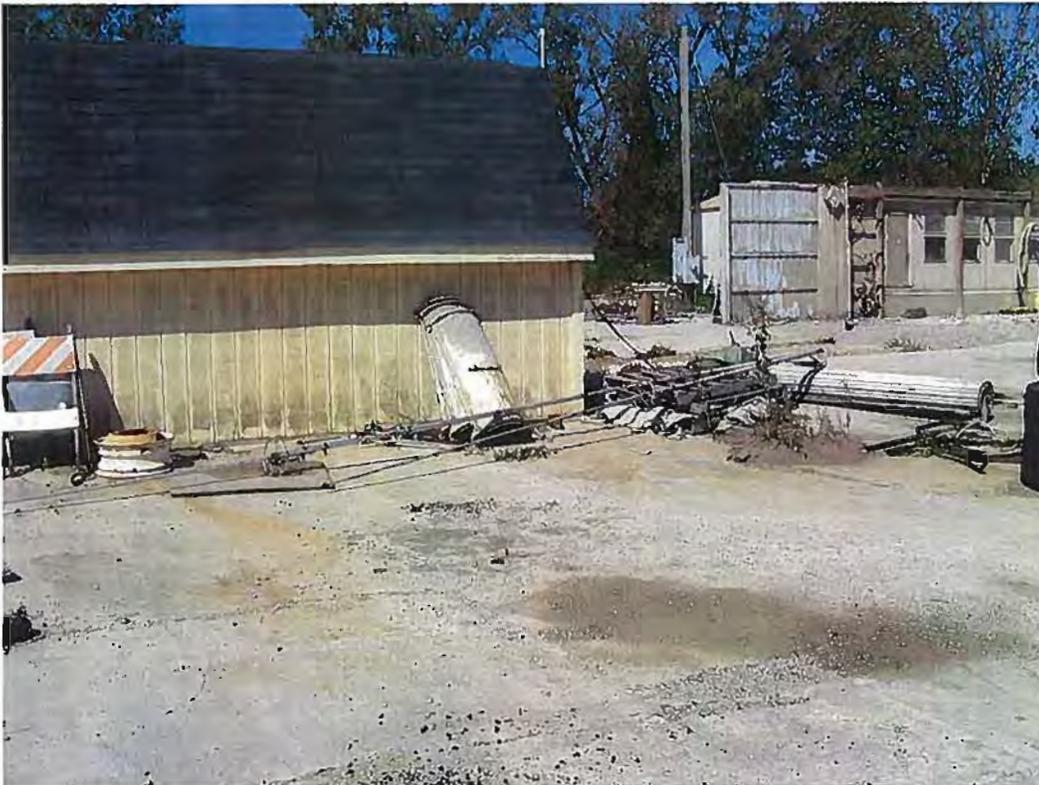
Other changes at the site include the removal of 55-gallon drums observed during my January 9, 2009-investigation. The drums that had been located along the east side of a small wood shed (see photo 6), and east of the office/plant (see photos 7 and 8) were gone. According Delmar Donley's February 24, 2009, letter the drums contained (used) oil and water from changing oil in the concrete trucks. The used oil and water in the drums was reportedly burned in the onsite used oil space heater at Donley Trucking facility located near Williamsville, Illinois.

Date: September 17, 2009
Time: 11:31 am
Direction: Northwest
Photo by: Rich Johnson
Exposure #: 006
Comments: Photograph shows the small shed and the back of the office located in the northwest region of the site. Note that the 55-gallon drums observed on the previous inspection setting along the shed were no longer present.

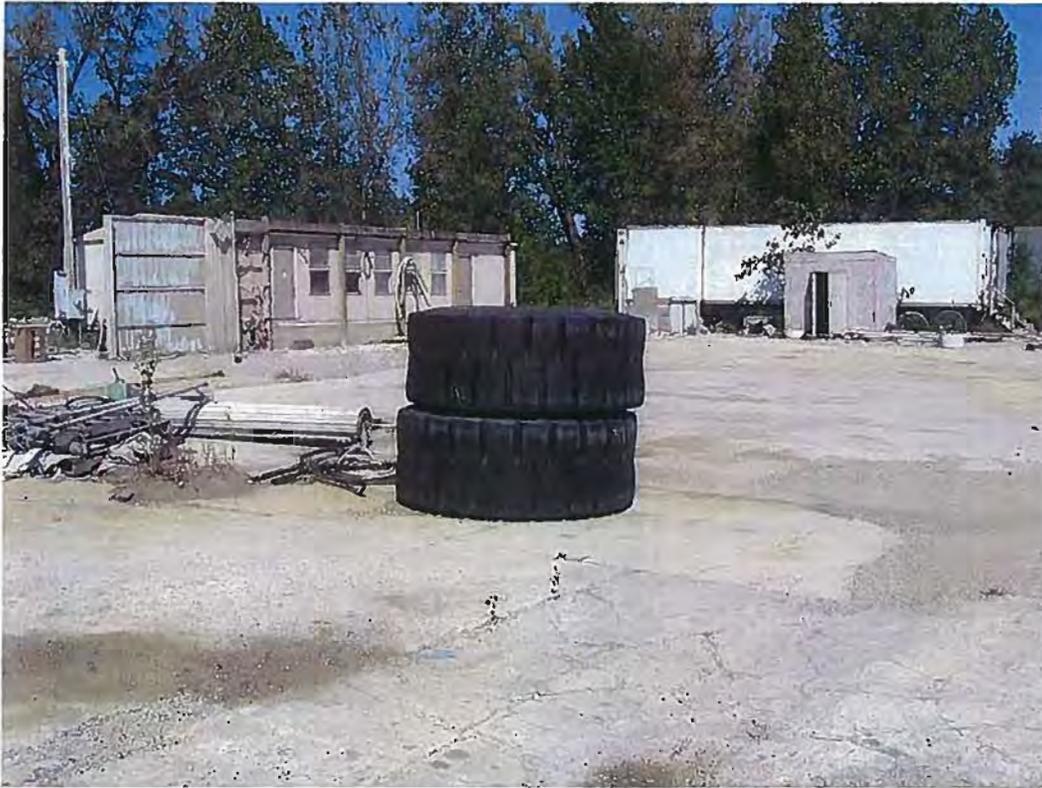
Date: September 17, 2009
Time: 11:31 am
Direction: Northwest
Photo by: Rich Johnson
Exposure #: 007
Comments: Photograph shows 2 new heavy equipment tires setting near the shed and office in the northwest region of the site. Note the aggregate mixing plant located east of the office is gone.

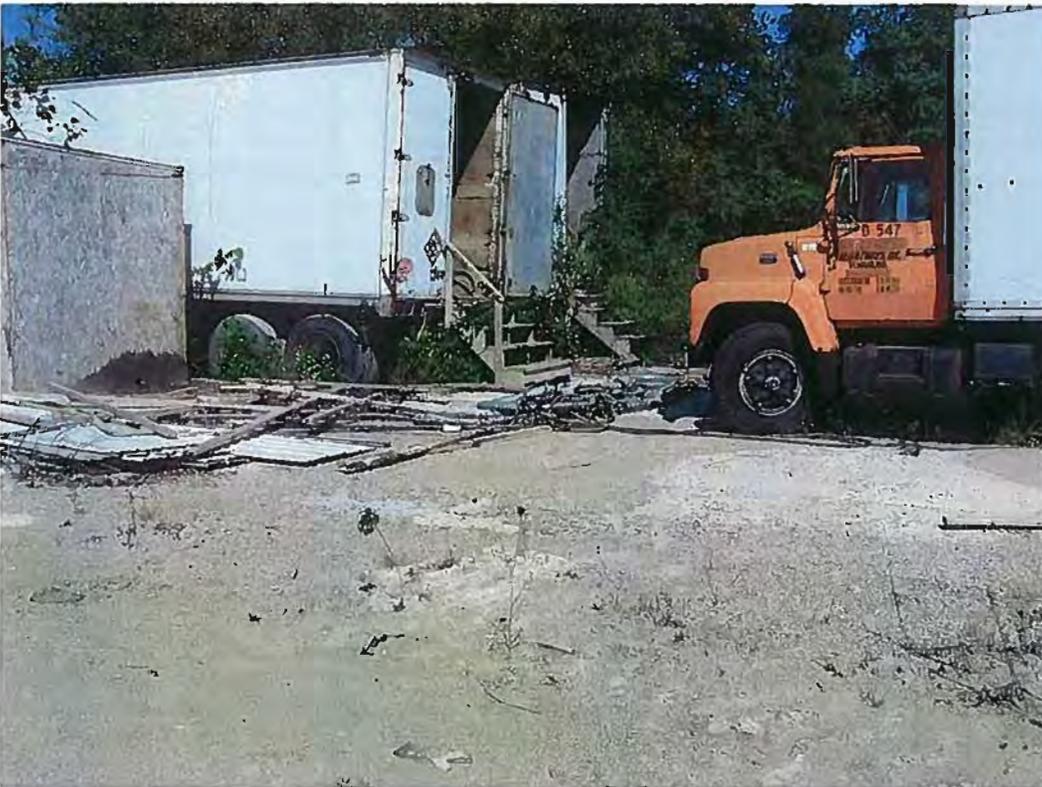
Date: September 17, 2009
Time: 11:32 am
Direction: Northwest
Photo by: Rich Johnson
Exposure #: 008
Comments: Photograph shows an area where 55-gallon drums had been observed in the northwest region of the site on the previous inspection. Note that the drums are now gone.

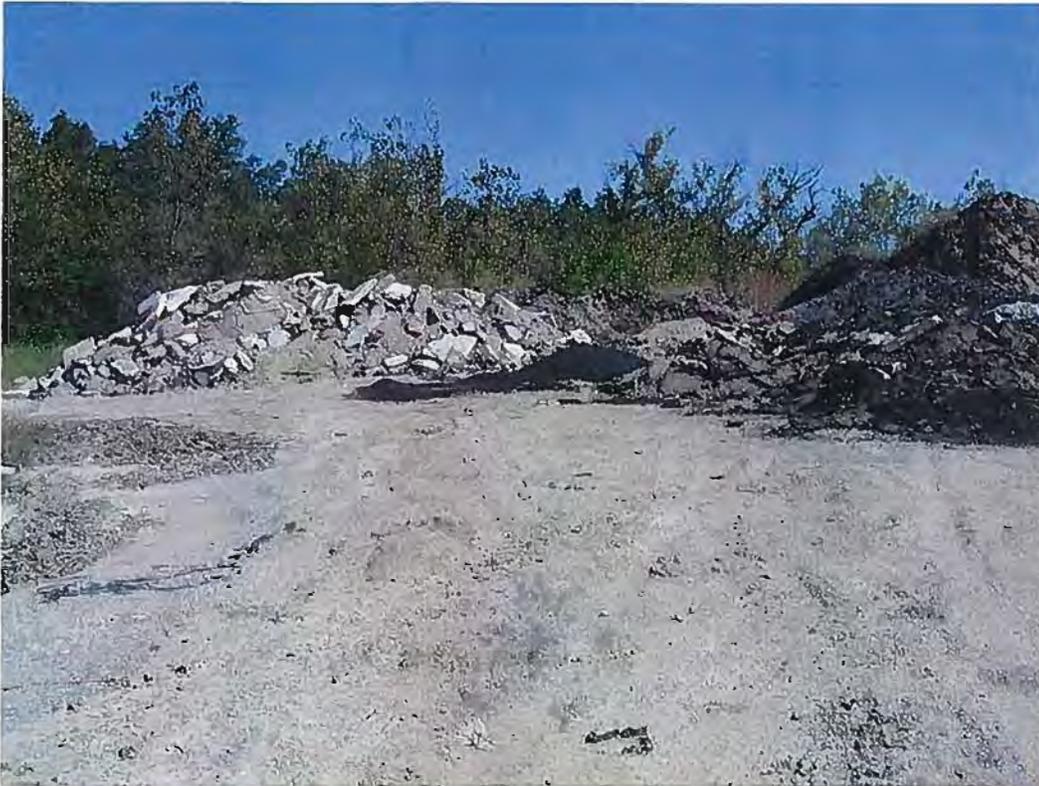
Date: September 17, 2009
Time: 11:34 am
Direction: North
Photo by: Rich Johnson
Exposure #: 009
Comments: Photograph shows piles of broken concrete, and a small amount of asphalt located in the northcentral region of the site.

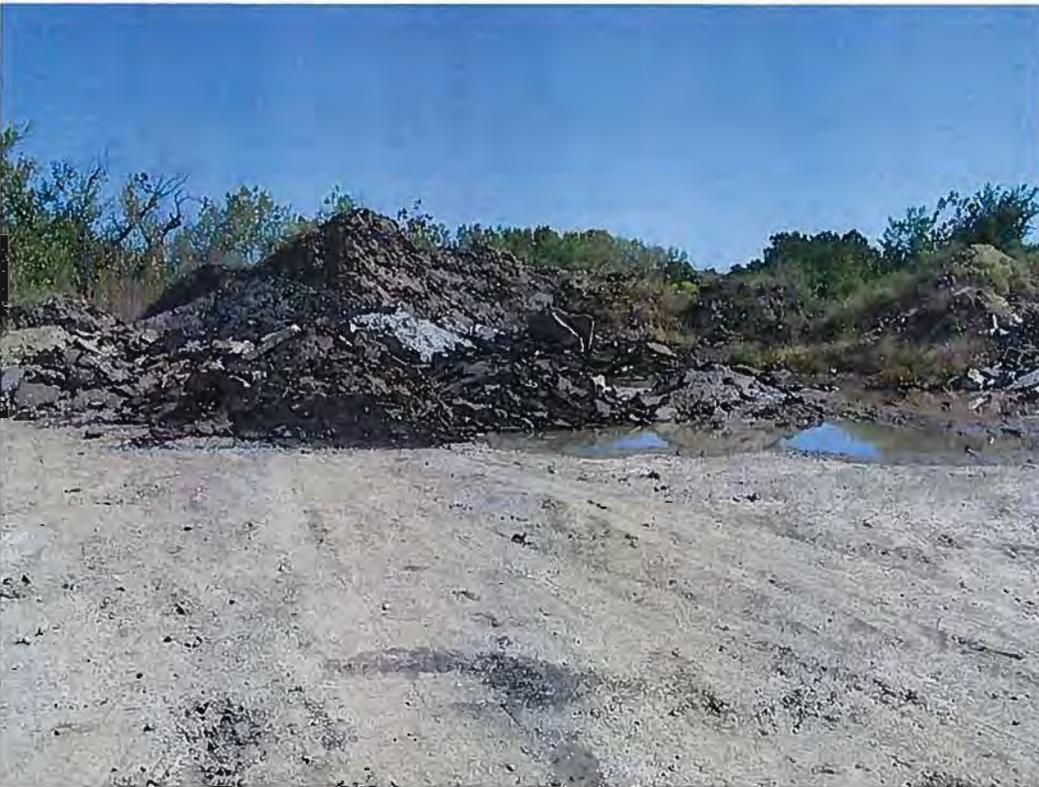
Date: September 17, 2009
Time: 11:34 am
Direction: Northeast
Photo by: Rich Johnson
Exposure #: 010
Comments: Photograph shows piles of milled and broken asphalt, soil, and some broken concrete located in the northcentral region of the site.

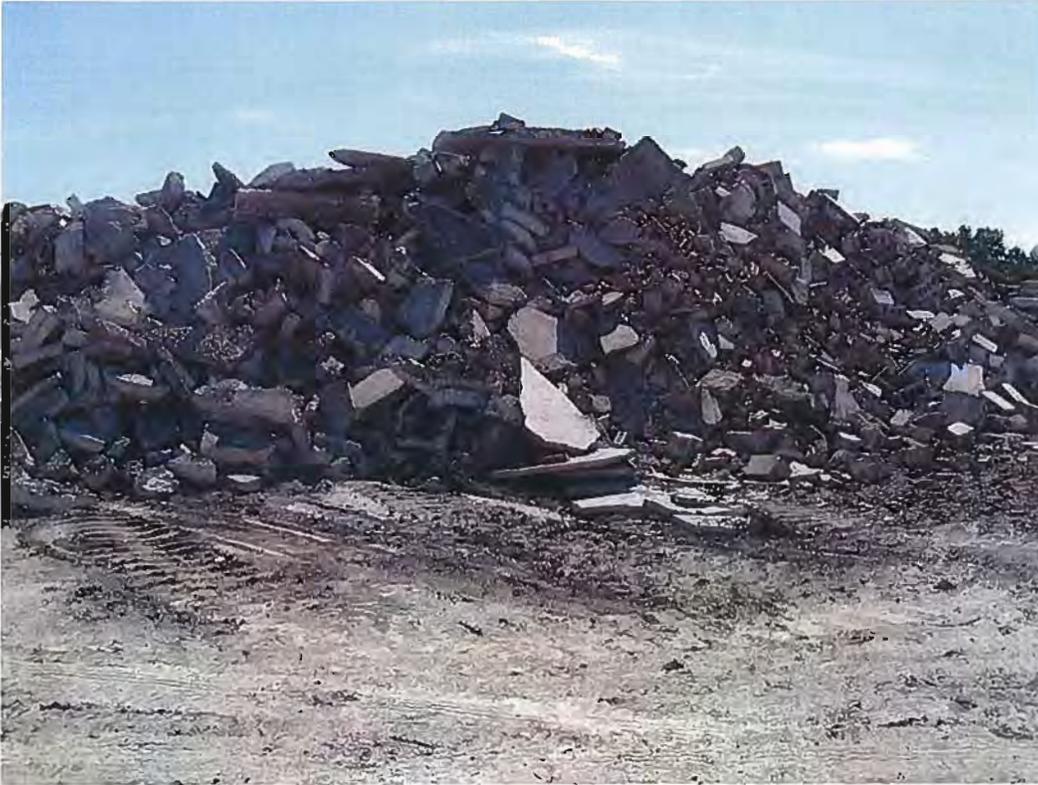
Date: September 17, 2009
Time: 11:34 am
Direction: Southeast
Photo by: Rich Johnson
Exposure #: 011
Comments: Photograph shows piles of broken concrete along with concrete blocks and bricks setting in the northcentral region of the site. Note that some of the broken concrete has paint on them.

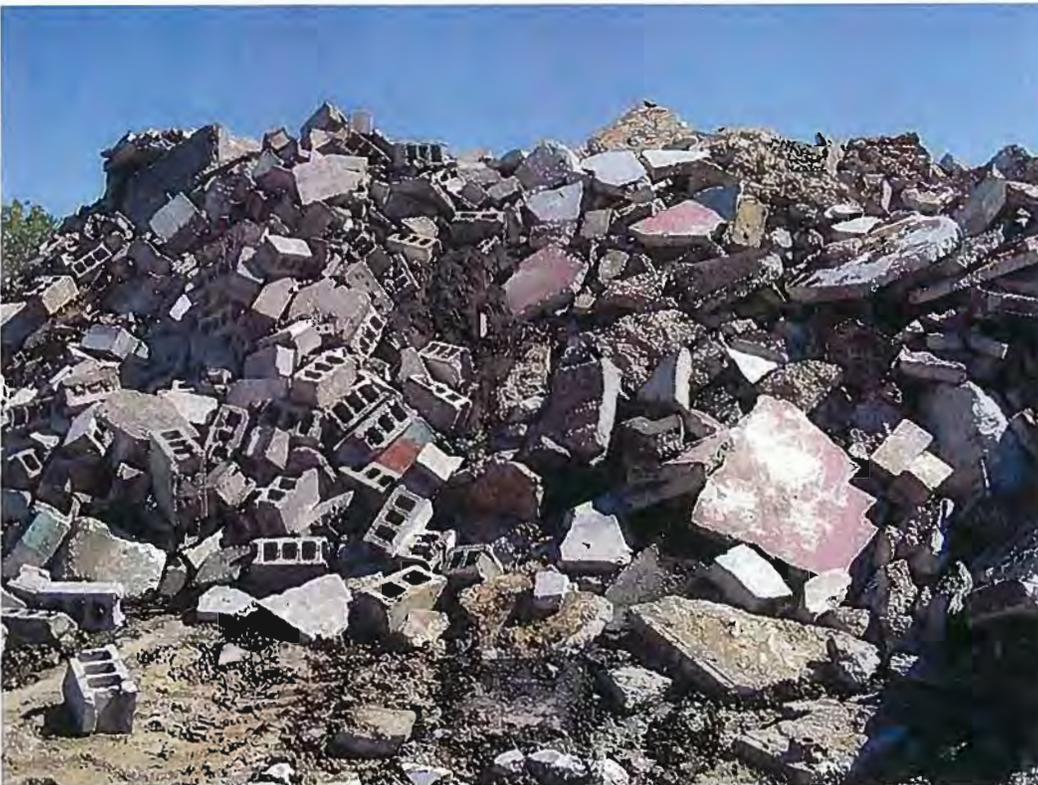
Date: September 17, 2009
Time: 11:36 am
Direction: Northeast
Photo by: Rich Johnson
Exposure #: 012
Comments: Photograph shows a pile of broken concrete and concrete blocks located in the northcentral region of the site. Note that some of the broken concrete has paint on them.

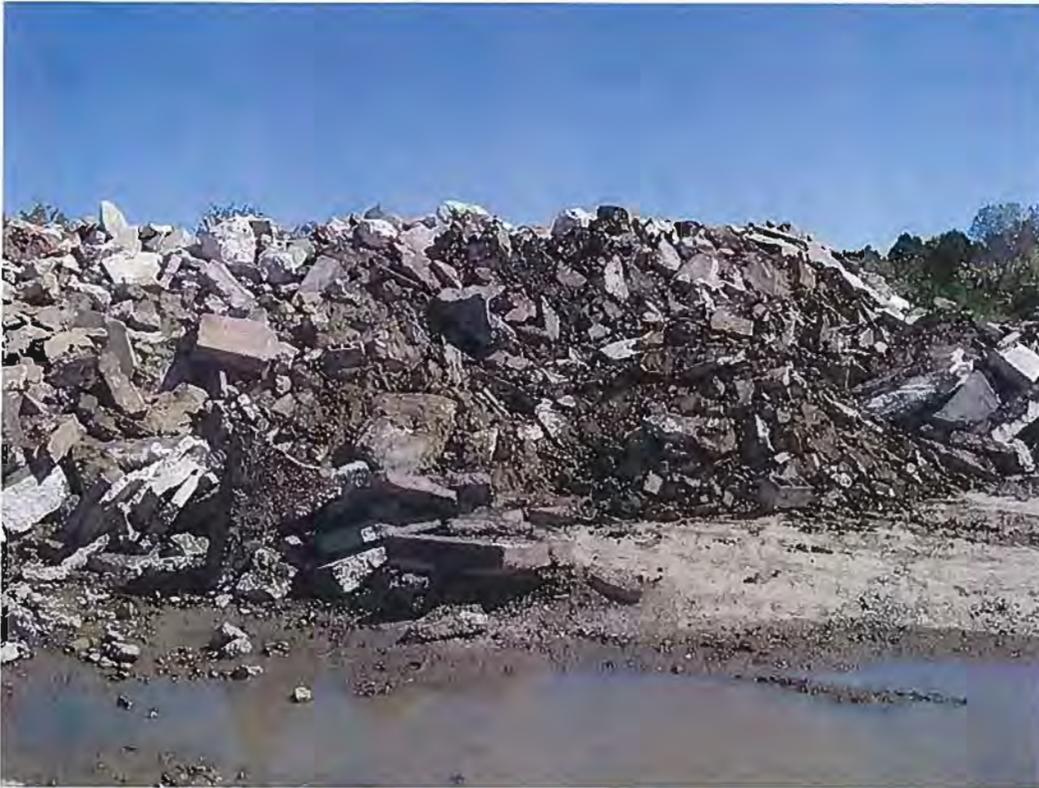
Date: September 17, 2009
Time: 11:36 am
Direction: Northeast
Photo by: Rich Johnson
Exposure #: 013
Comments: Photograph shows a pile of broken concrete and concrete blocks located in the northcentral region of the site. Note a few of the broken concrete pieces have paint on them.

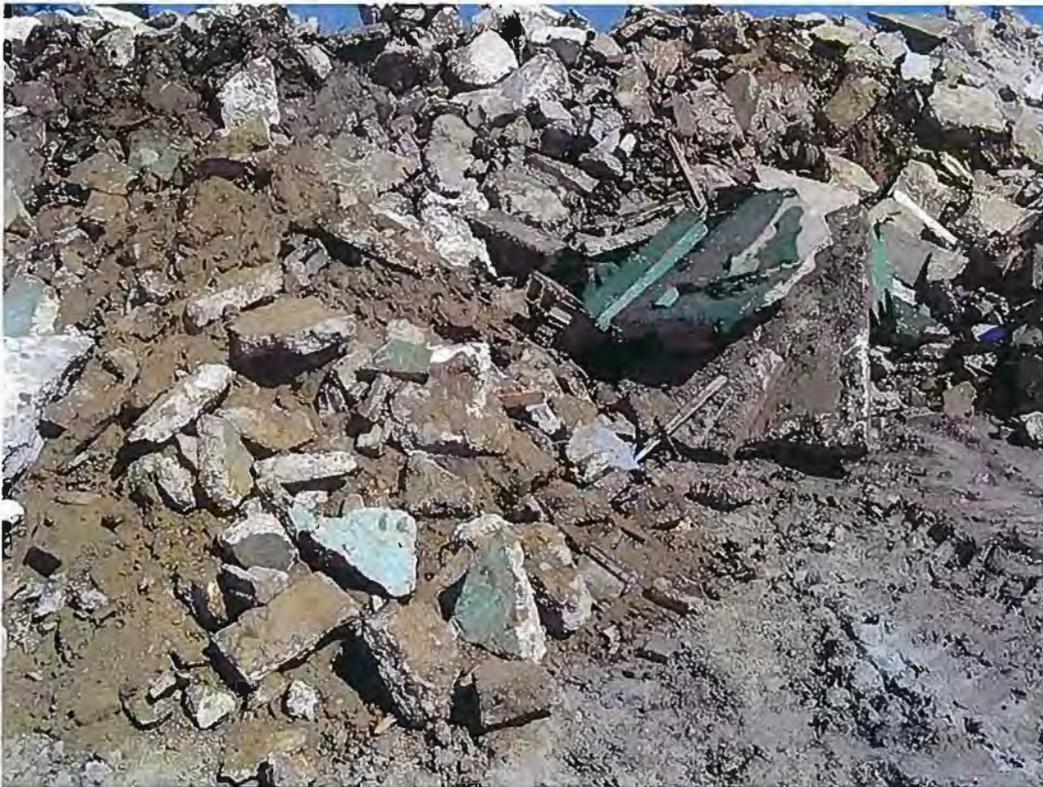
Date: September 17, 2009
Time: 11:37 am
Direction: North/northeast
Photo by: Rich Johnson
Exposure #: 014
Comments: Photograph shows a pile of broken concrete s located in the northcentral region of the site. Note a few of the broken concrete pieces have paint on them, and one has remnants of green carpeting.

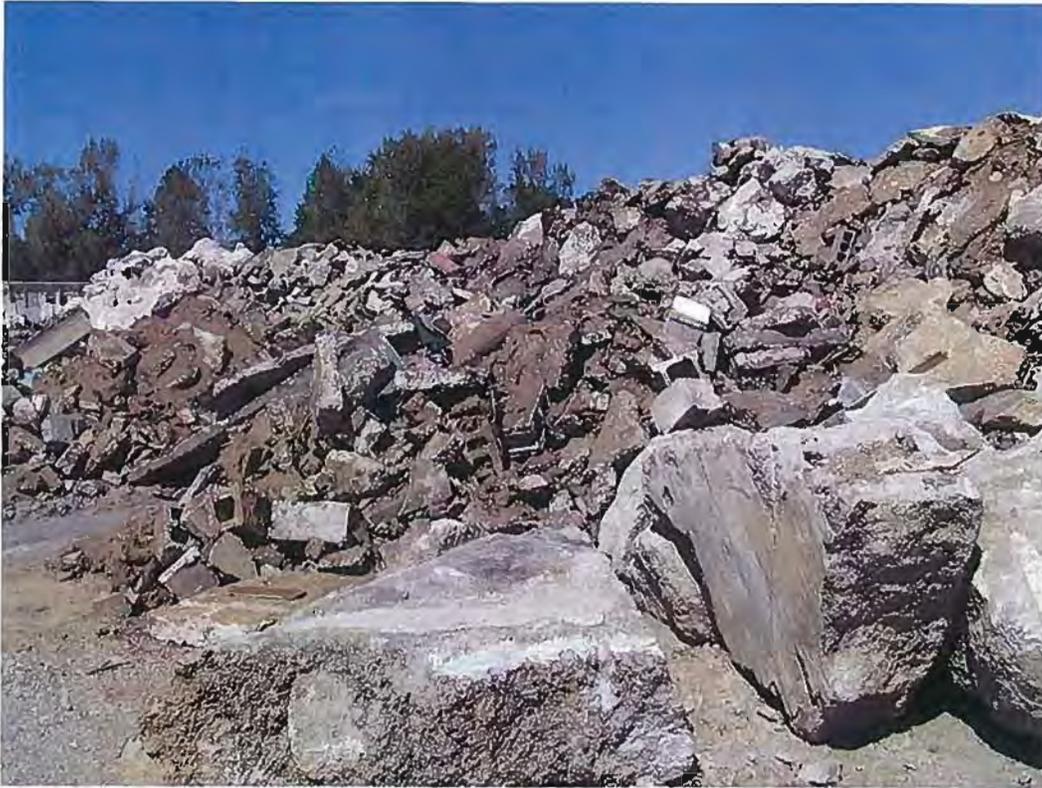
Date: September 17, 2009
Time: 11:38 am
Direction:
West/northwest
Photo by: Rich Johnson
Exposure #: 015
Comments: Photograph shows a pile of broken concrete and concrete blocks located in the northcentral region of the site. Note a few of the broken concrete pieces have paint on them.

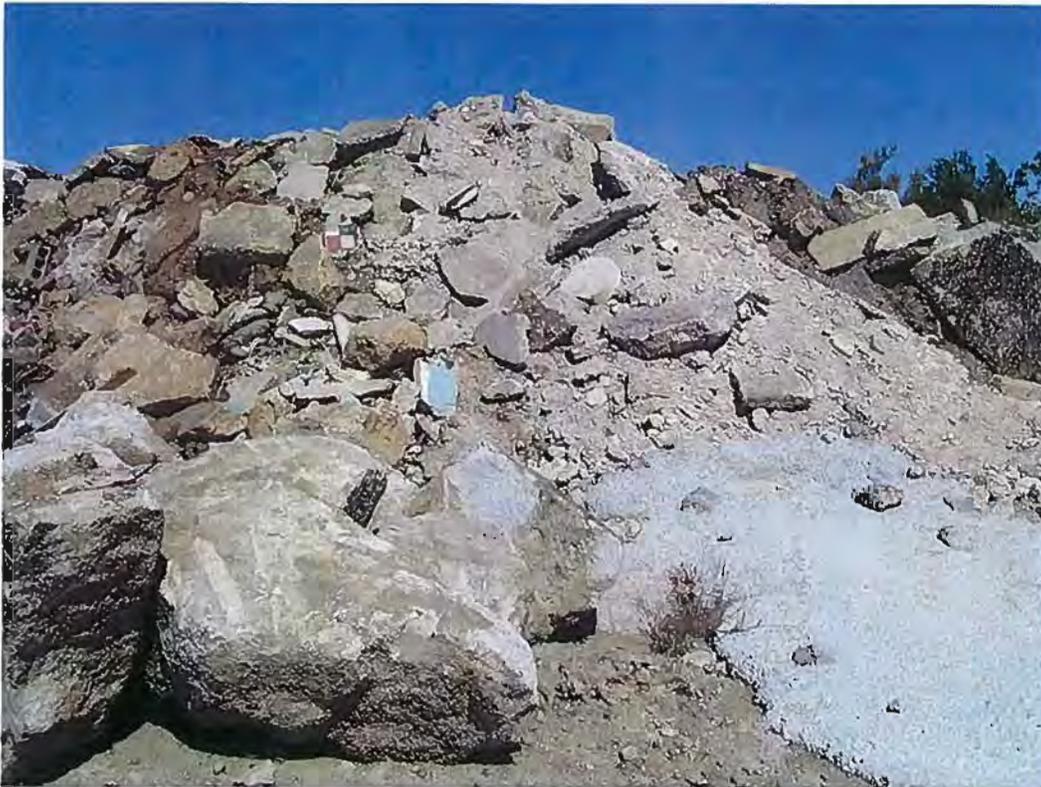
Date: September 17, 2009
Time: 11:38 am
Direction: North
Photo by: Rich Johnson
Exposure #: 016
Comments: Photograph shows a pile of broken concrete and soil located in the northcentral region of the site. Note a few of the broken concrete pieces have paint on them.

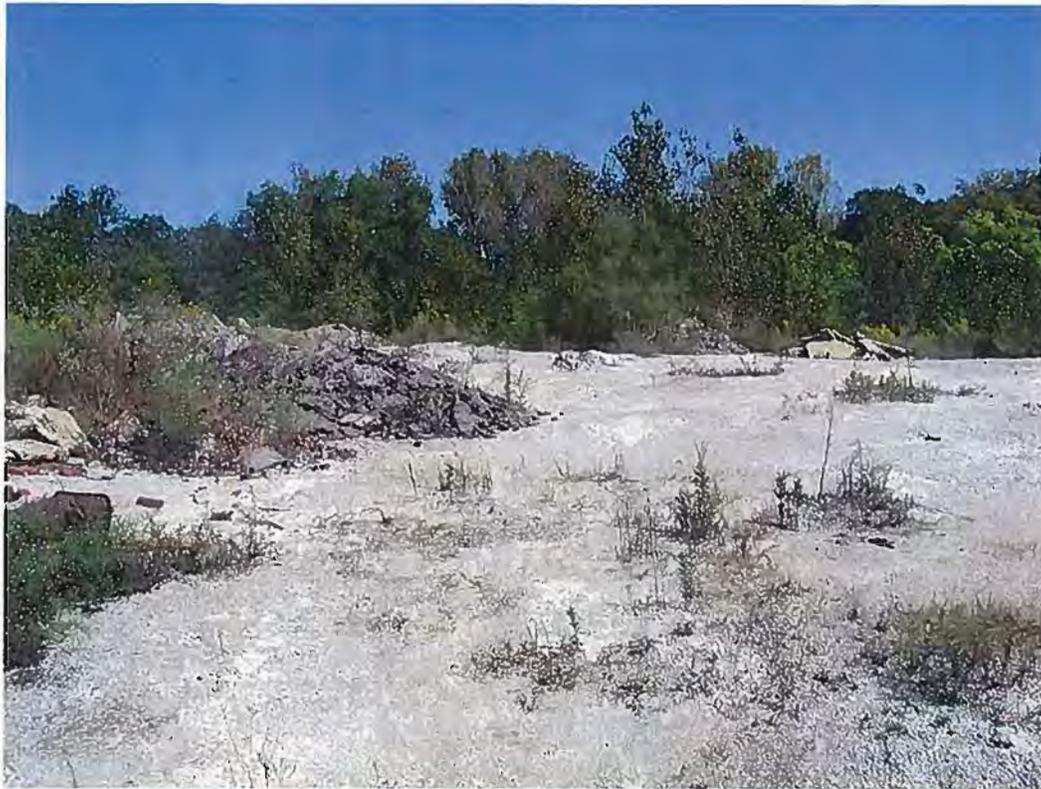
Date: September 17, 2009
Time: 11:39 am
Direction: Northeast
Photo by: Rich Johnson
Exposure #: 017
Comments: Photograph shows part of the area in the northeast region where concrete has been cleaned out of concrete mixing trucks.

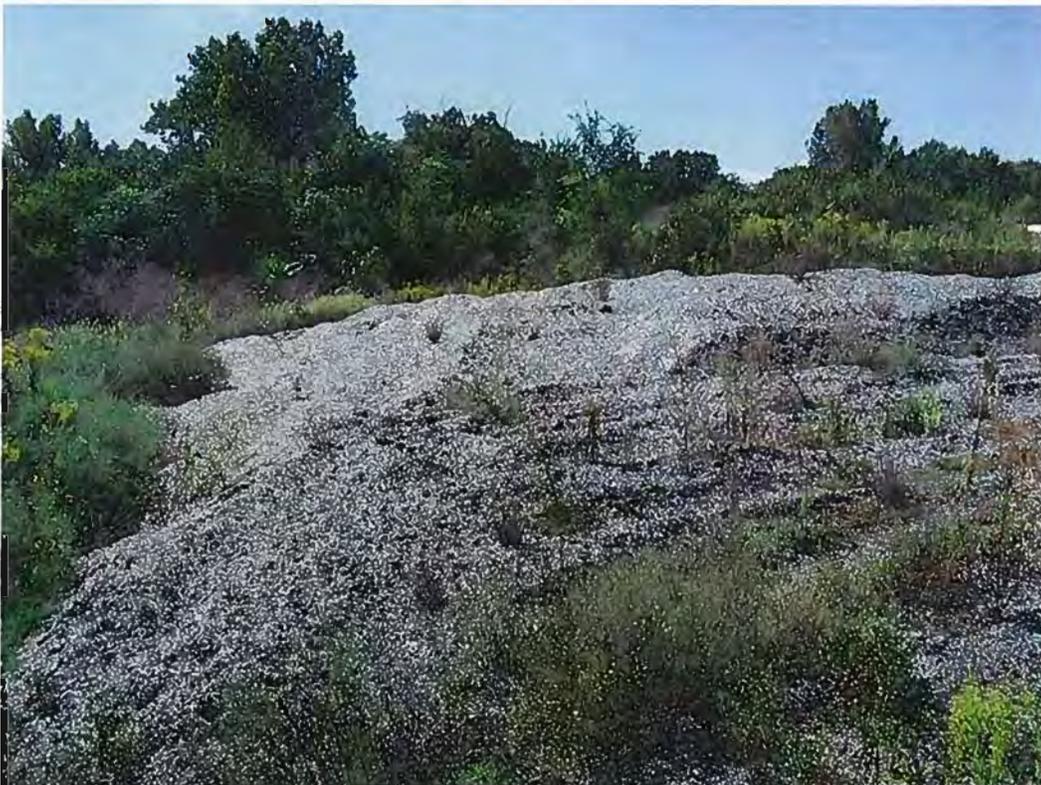
Walking south from the northeast region, I observed a large pile of waste near the east slope (see photos 18, 19, 22 and 23). On inspecting the pile it was found to be small pieces of broken glass with plastic and other debris. The glass ranged from pebble to gravel size, and of various colors (clear, green, yellow, blue, brown, etc.). Measuring the area by “stepping it off,” I found it to be about 119 feet wide (at its widest), about 78 feet long to where it narrows to about 19 feet wide, and then another 54 feet long. Looking at the depth of broken glass from the south edge of the pile it looked 5 feet deep. Using these measurements, it was figured that there were approximately 1909 cubic yards of broken glass and debris in the area. Since this was near the eastern edge of the property, away from the different other piles that appeared to be part of the concrete/asphalt recycling it was determined that the glass was apparently discarded or abandoned. The mixture of broken glass and other waste is not considered “clean construction or demolition debris,” as defined in Section 3.160(b) of the Act. Therefore, it cannot be stored or disposed of at this site without an Illinois EPA permit. Todd Donley was informed that the waste glass was required to be properly disposed offsite. He said he was aware that the glass was to be disposed of at an Illinois EPA permitted landfill (or transfer station), but that Donley Trucking had been so busy that it hadn’t made time to remove the waste. I asked about the waste glass observed by concrete bins in the southcentral region of the site. Todd Donley said that the waste glass from this site had been added to the waste glass in the eastcentral region.

Date: September 17, 2009
Time: 11:42 am
Direction: South
Photo by: Rich Johnson
Exposure #: 018
Comments: Photograph shows broken glass piled in the eastcentral region of the site.

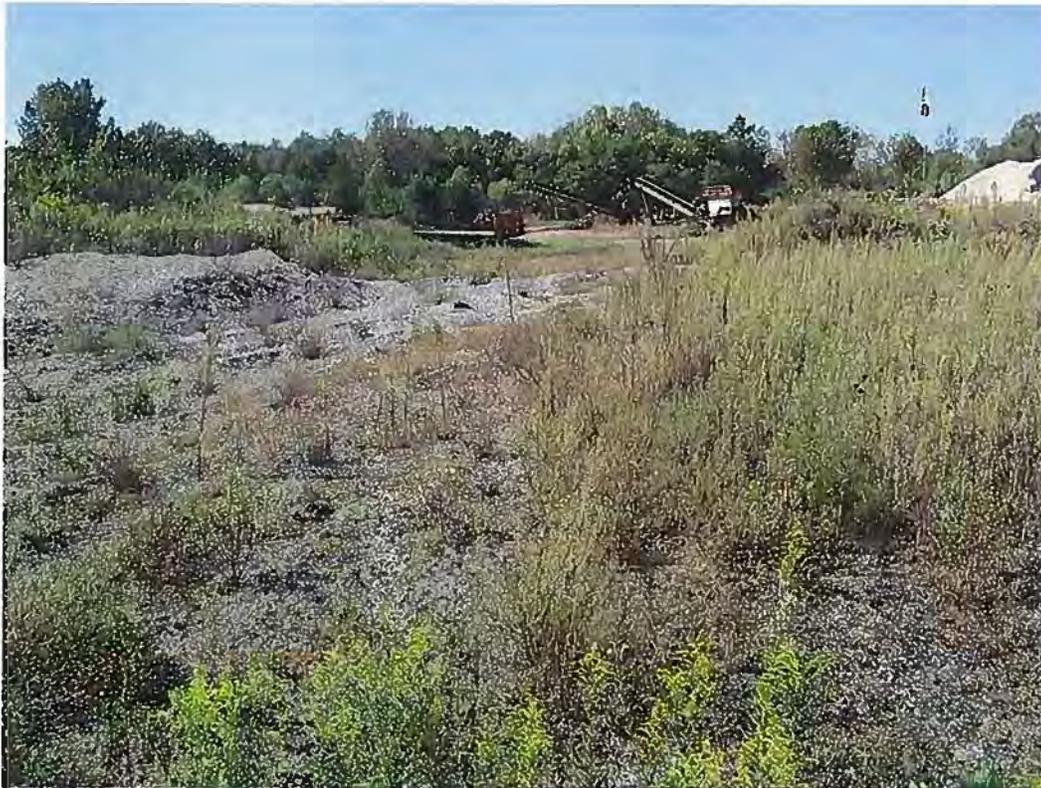
Date: September 17, 2009
Time: 11:42 am
Direction: Southwest
Photo by: Rich Johnson
Exposure #: 019
Comments: Photograph shows broken glass piled in the eastcentral region of the site. Note in the background a conveyor set up with a concrete crusher.

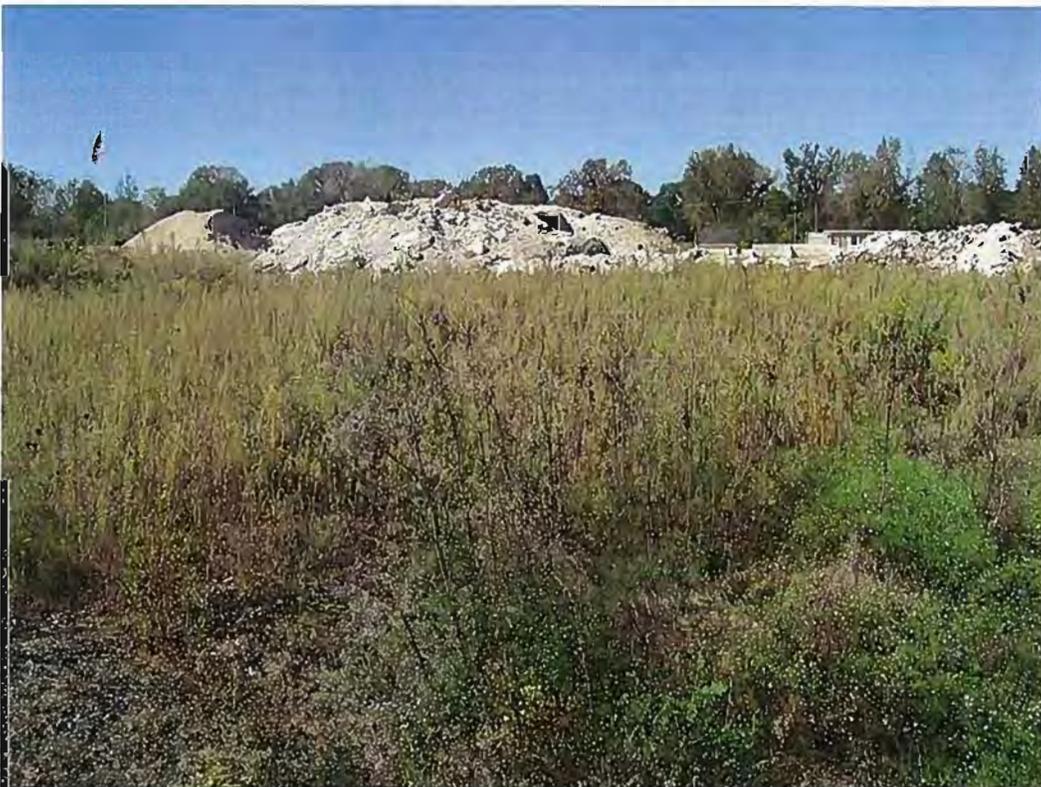
Date: September 17, 2009
Time: 11:42 am
Direction: West/southwest
Photo by: Rich Johnson
Exposure #: 020
Comments: Photograph shows piles of broken concrete in the central/eastcentral region of the site.

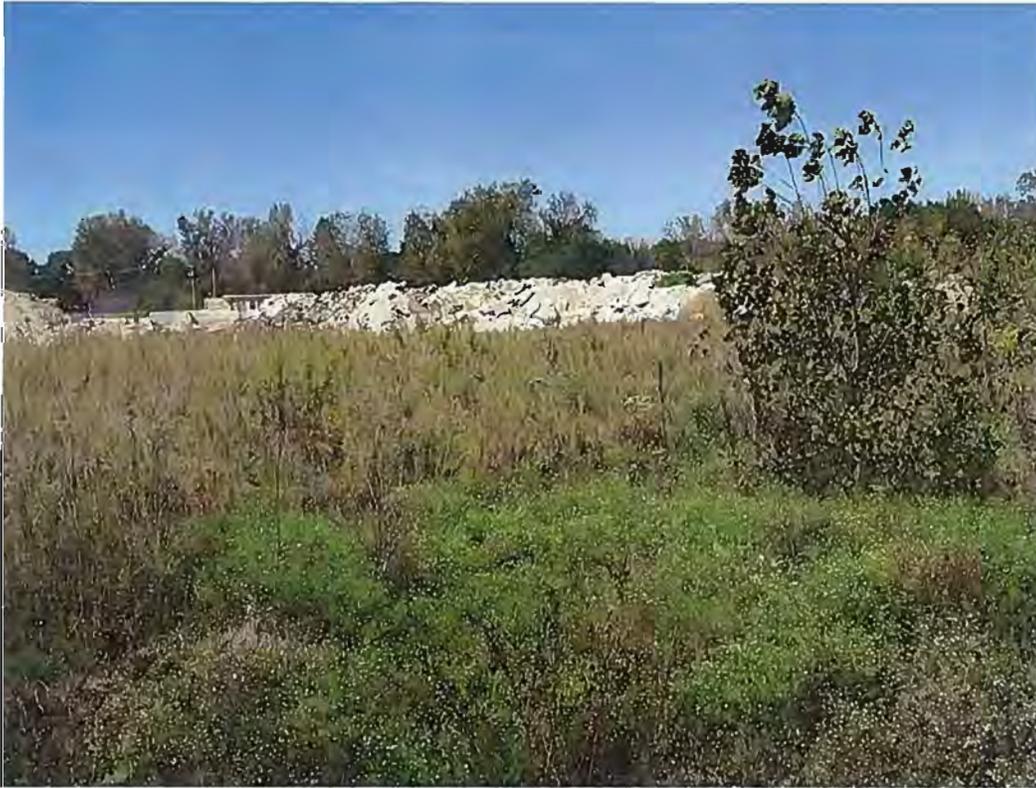
Date: September 17, 2009
Time: 11:42 am
Direction: Northwest
Photo by: Rich Johnson
Exposure #: 021
Comments: Photograph shows piles of broken concrete in the central/eastcentral region of the site.

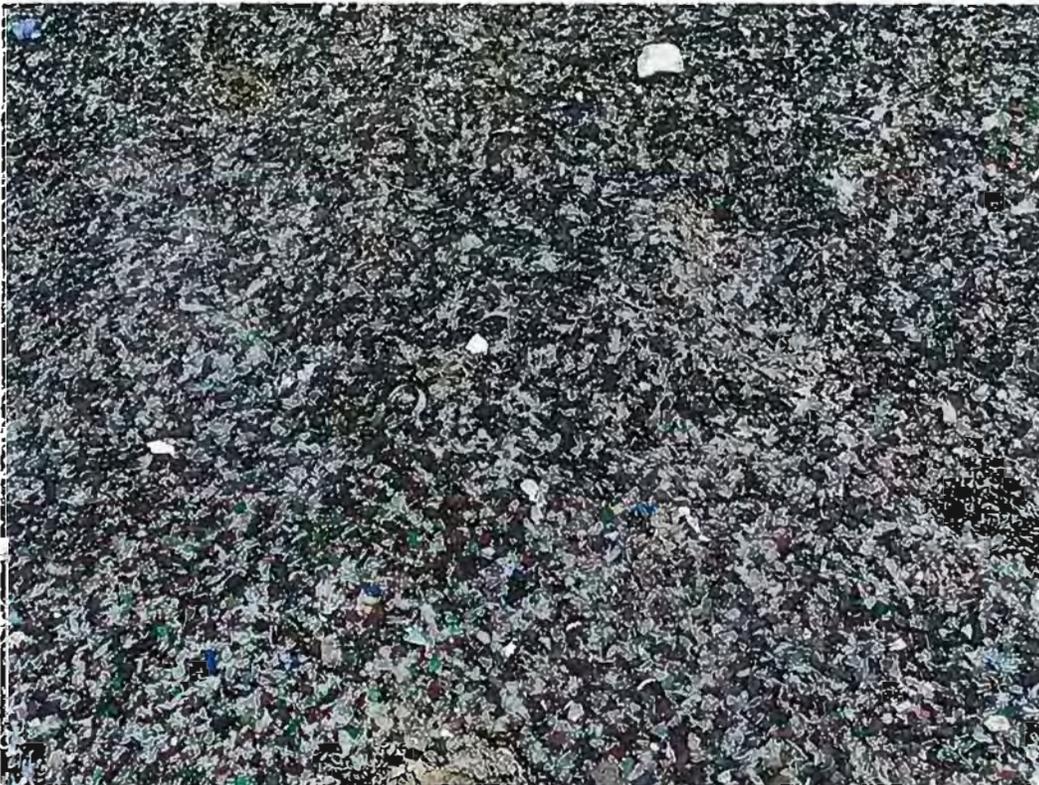
Date: September 17, 2009
Time: 11:44 am
Direction: North
Photo by: Rich Johnson
Exposure #: 022
Comments: Photograph shows broken glass piled in the eastcentral region of the site.
