AC 10-08
(IEPA No. 283-09-AC)

ADMINISTRATIVE CITATION

Open Dump Inspection Checklist

County: Sangamon LPC#: 1678220075 Region: 5 - Springfield
 Location/Site Name: Springfield Township/Info Corner Materials, Inc.
 Date: 09/17/2009 Time: From 11:30 am To 12:32 pm Previous Inspection Date: 01/09/2009
 Inspector(s): Rich Johnson Weather: @ 70 - 75 degrees F, clear, dry soil
 No. of Photos Taken: # 27 Est. Amt. of Waste: 1900 yds³ Samples Taken: Yes # No
 Interviewed: Todd Donley, V-P & General Manager of Donley Trucking, Inc. Complaint # C-09-073-C

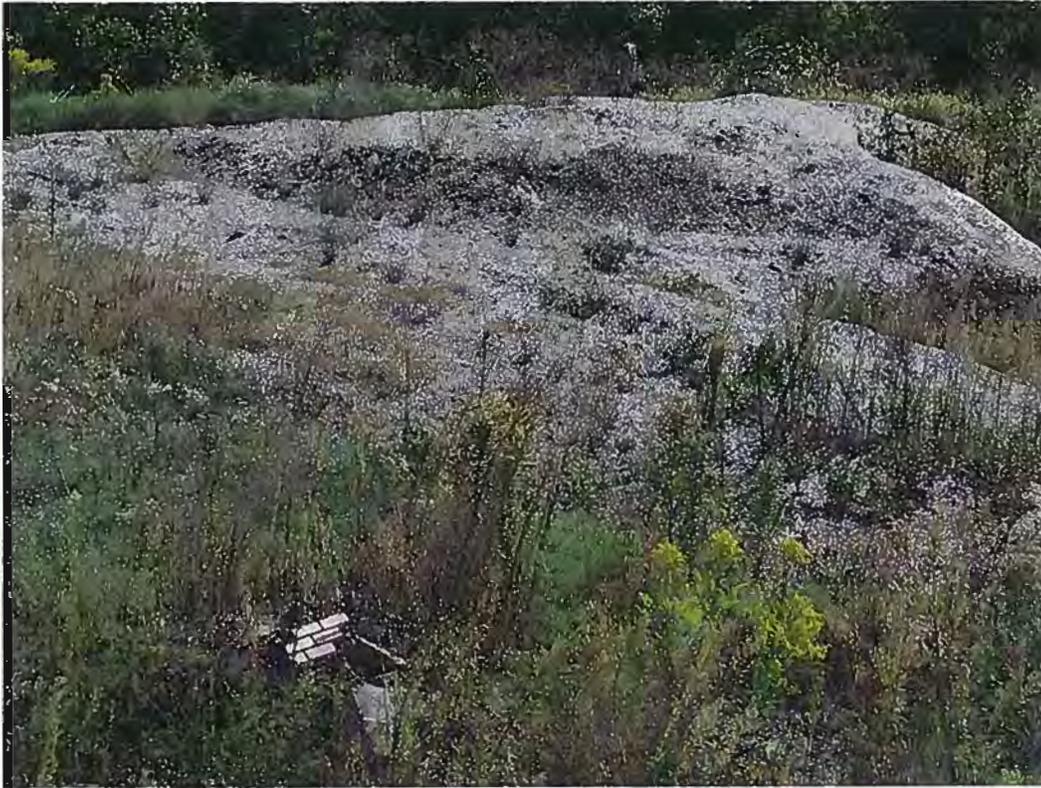
Walking south from the northeast region, I observed a large pile of waste near the east slope (see photos 18, 19, 22 and 23). On inspecting the pile it was found to be small pieces of broken glass with plastic and other debris. The glass ranged from pebble to gravel size, and of various colors (clear, green, yellow, blue, brown, etc.). Measuring the area by “stepping it off,” I found it to be about 119 feet wide (at its widest), about 78 feet long to where it narrows to about 19 feet wide, and then another 54 feet long. Looking at the depth of broken glass from the south edge of the pile it looked 5 feet deep. Using these measurements, it was figured that there were approximately 1909 cubic yards of broken glass and debris in the area. Since this was near the eastern edge of the property, away from the different other piles that appeared to be part of the concrete/asphalt recycling it was determined that the glass was apparently discarded or abandoned. The mixture of broken glass and other waste is not considered “clean construction or demolition debris,” as defined in Section 3.160(b) of the Act. Therefore, it cannot be stored or disposed of at this site without an Illinois EPA permit. Todd Donley was informed that the waste glass was required to be properly disposed offsite. He said he was aware that the glass was to be disposed of at an Illinois EPA permitted landfill (or transfer station), but that Donley Trucking had been so busy that it hadn’t made time to remove the waste. I asked about the waste glass observed by concrete bins in the southcentral region of the site. Todd Donley said that the waste glass from this site had been added to the waste glass in the eastcentral region.

Date: September 17, 2009
Time: 11:47 am
Direction: East
Photo by: Rich Johnson
Exposure #: 023
Comments: Photograph shows broken glass piled in the eastcentral region of the site.

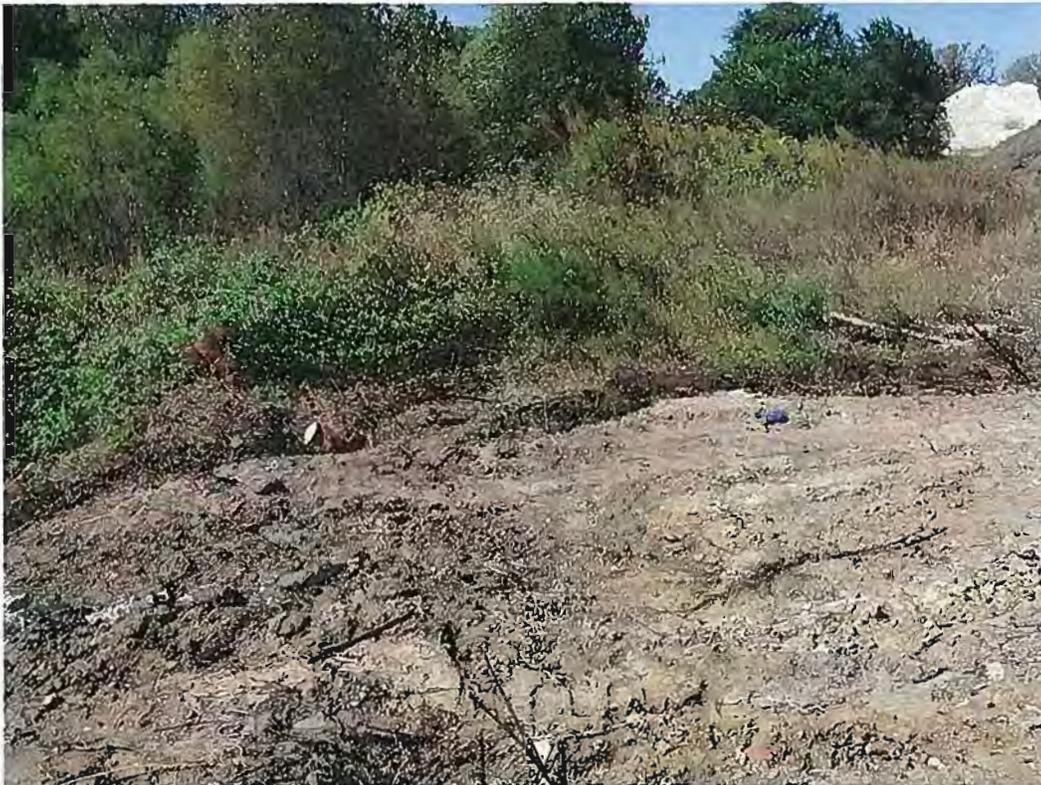
Date: September 17, 2009
Time: 11:51 am
Direction: West
Photo by: Rich Johnson
Exposure #: 024
Comments: Photograph shows an area in the southwest region of the site where open dumped refuse had been observed during the previous inspection of the site.

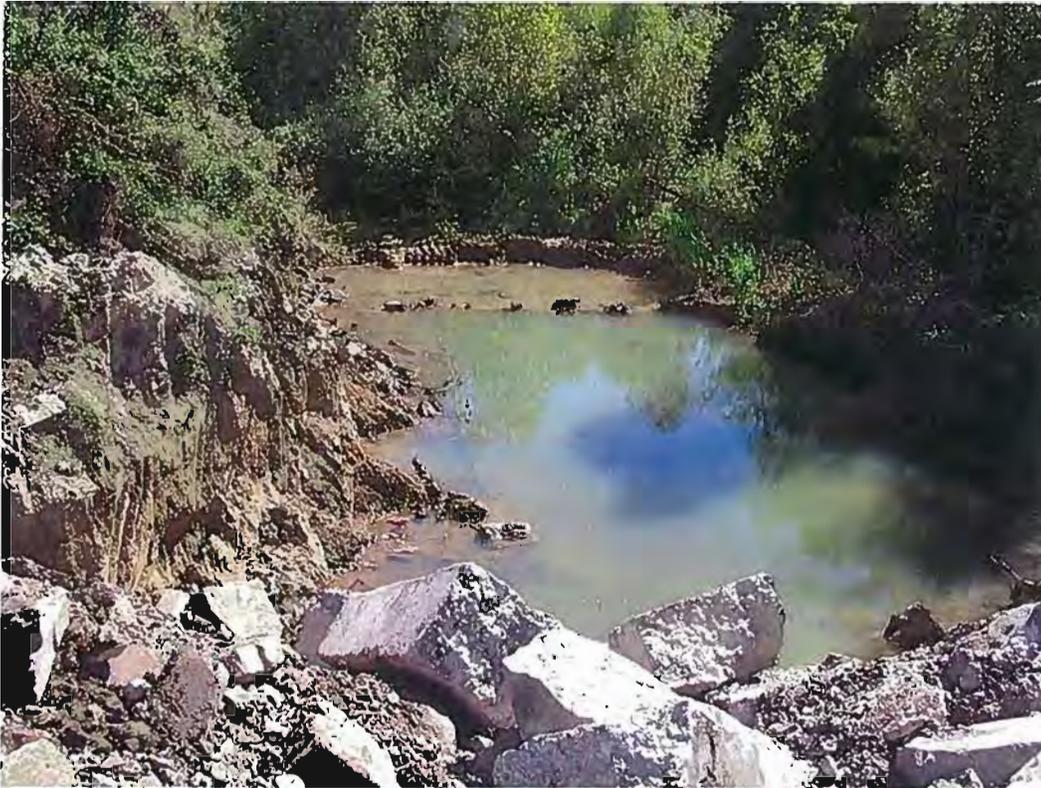
Date: September 17, 2009
Time: 12:01 pm
Direction: East
Photo by: Rich Johnson
Exposure #: 025
Comments: Photograph shows an area in the southcentral region of the site where concrete from concrete mixing trucks had previously been observed. Note that the concrete has been dug out and soil below the concrete excavated.

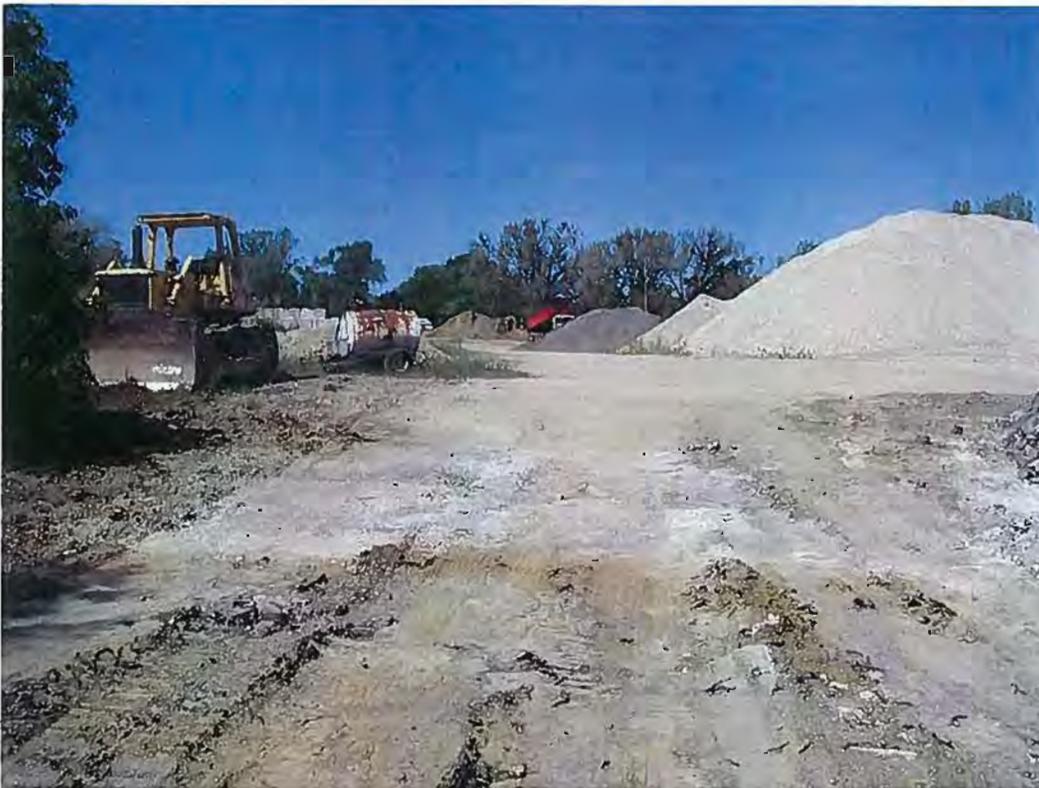
Dimensional lumber that had been previously observed in the southcentral region west of the concrete truck clean out area was also gone (see photo 26). Mr. Donley said that the dimensional lumber in this large pile was properly managed, but how it was managed was not indicated.

Date: September 17, 2009
Time: 12:01 pm
Direction: West/northwest
Photo by: Rich Johnson
Exposure #: 026
Comments: Photograph shows an area in the southcentral region of the site where a pile of dimensional lumber had been located on the last inspection. Note the lumber is gone.

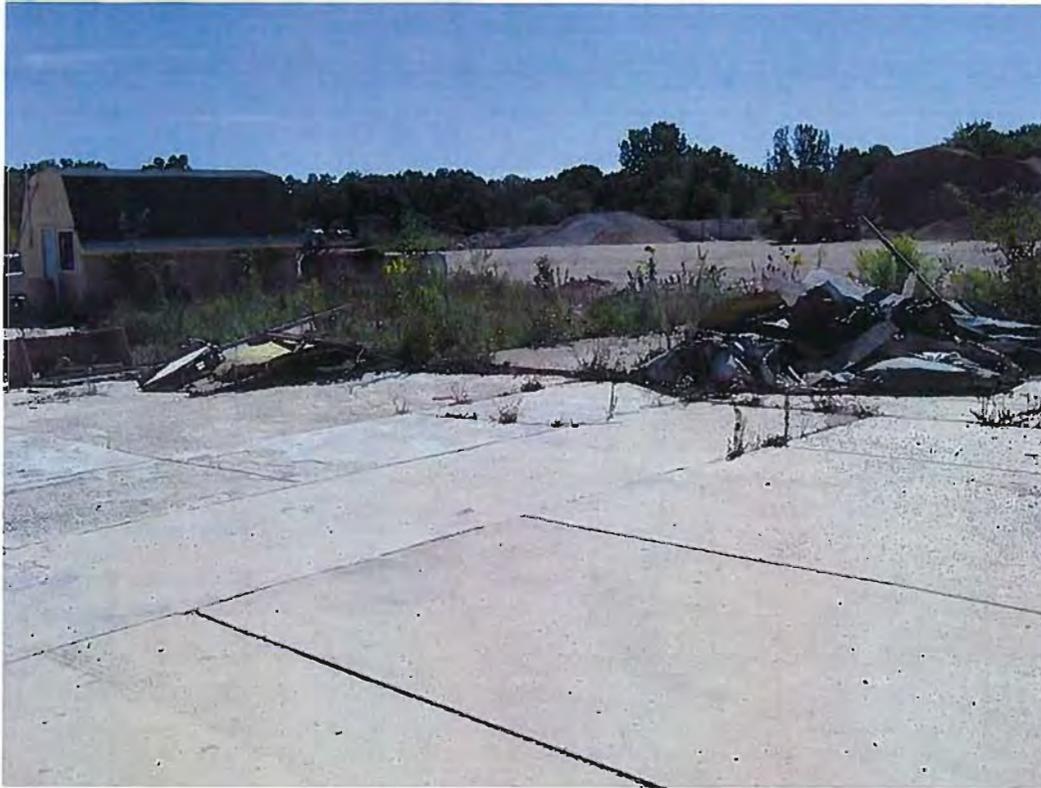
the time of the investigation it was noted that the office in front of the plant was deserted and the plant itself did not appear operational. During the current re-inspection on September 17, 2009, it was found that the entire building along with the equipment for the admixture plant has been removed (see photos 1, 6 and 7). Mr. Donley confirmed that the plant had been sold and removed sometime prior to my re-inspection. There remains some of the debris left from the dismantling of the plant on a concrete pad south of the trailer (see photo 27). Mr. Donley said he would have someone from Donley Trucking come out and collect and properly dispose the remaining waste from the plant.

Date: September 17, 2009
Time: 12:17 pm
Direction: Southeast
Photo by: Rich Johnson
Exposure #: 027
Comments: Photograph shows a few left over items from when the aggregate mix plant was operating in the northwest region of the site.
