ILLINOIS ENVIRONMENTAL PROTECTION AGENCY

ADMINISTRATIVE CITATION

ILLINOIS ENVIRONMENTAL PROTECTION AGENCY
Open Dump Inspection Checklist

ILLINOIS ENVIRONMENTAL PROTECTION AGENCY MEMORANDUM

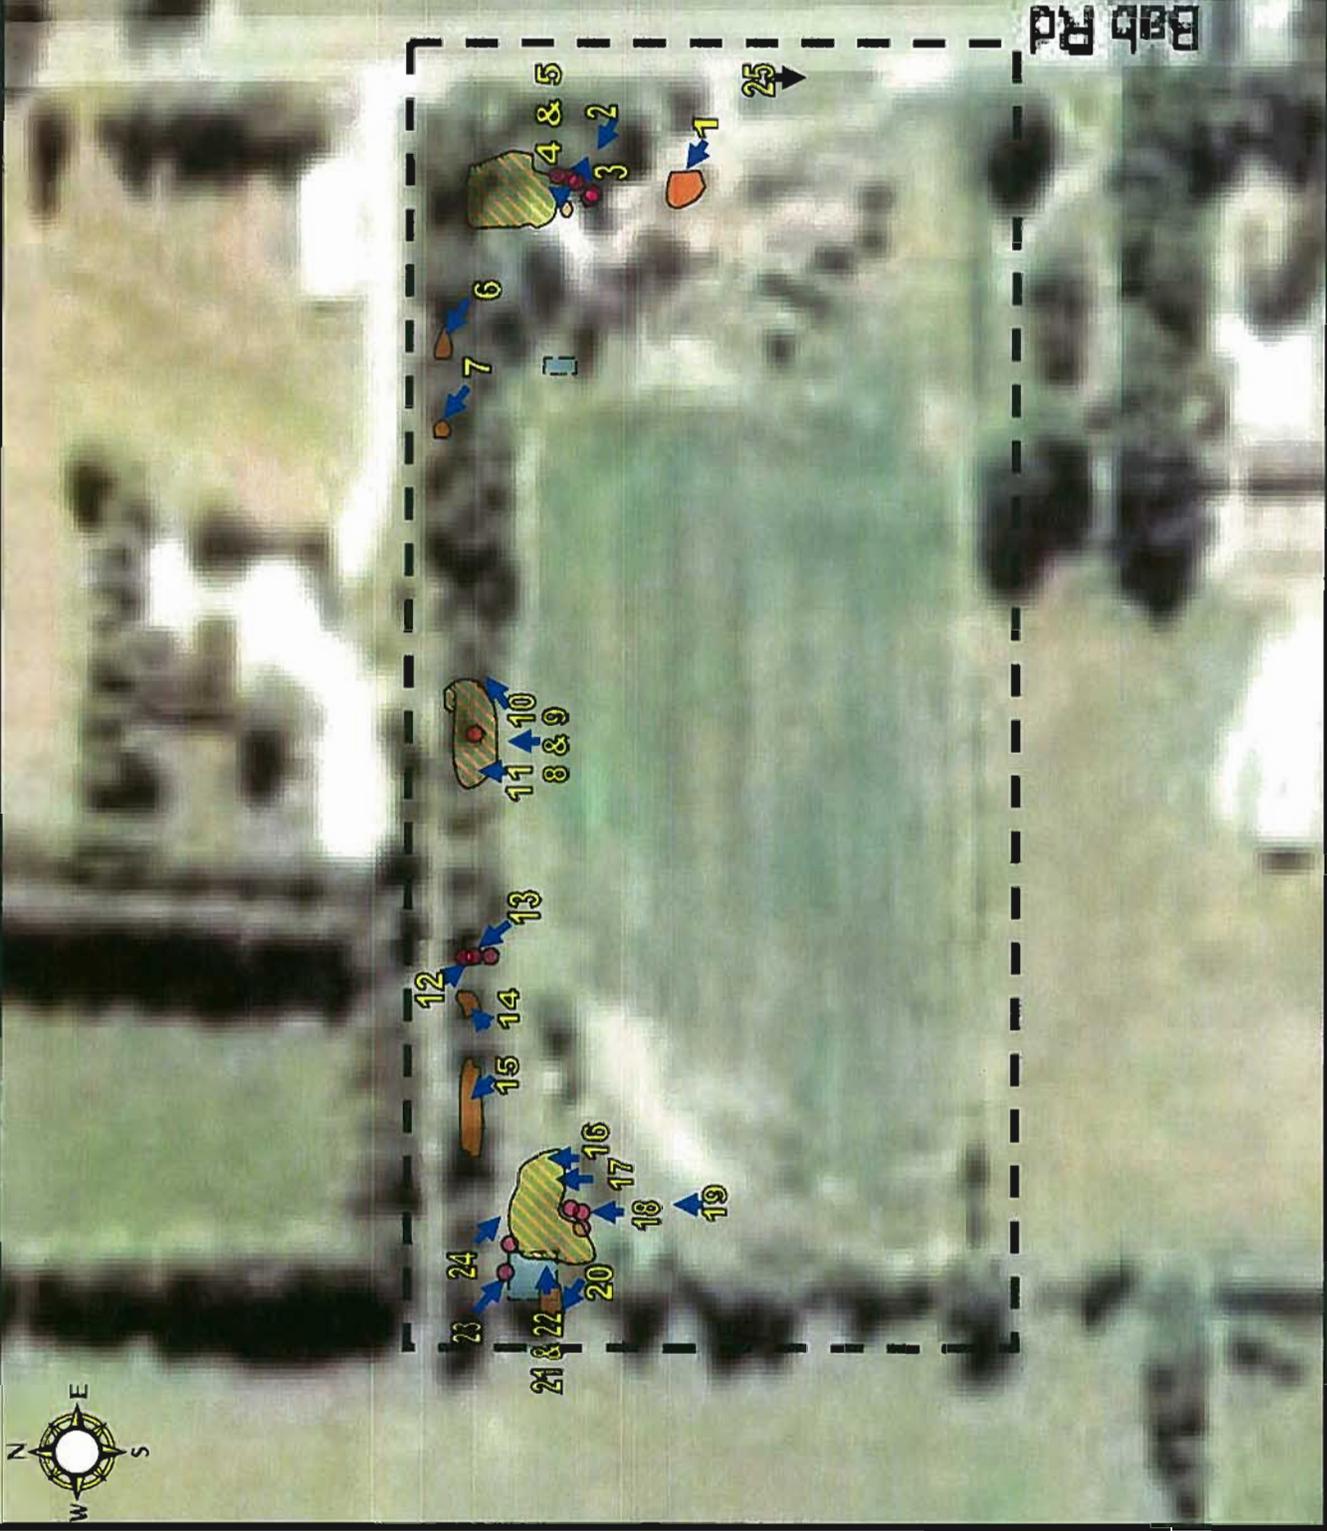
The shed and some of the waste previously seen has been removed. Three large piles of brush (containing tree limbs and bushes) were observed. All three large piles were on the north half of the property with one nearer the street, one near the midpoint of the lot, and one near the backside of the lot. Refer to the Site Sketch that accompanies this report for their approximate locations.

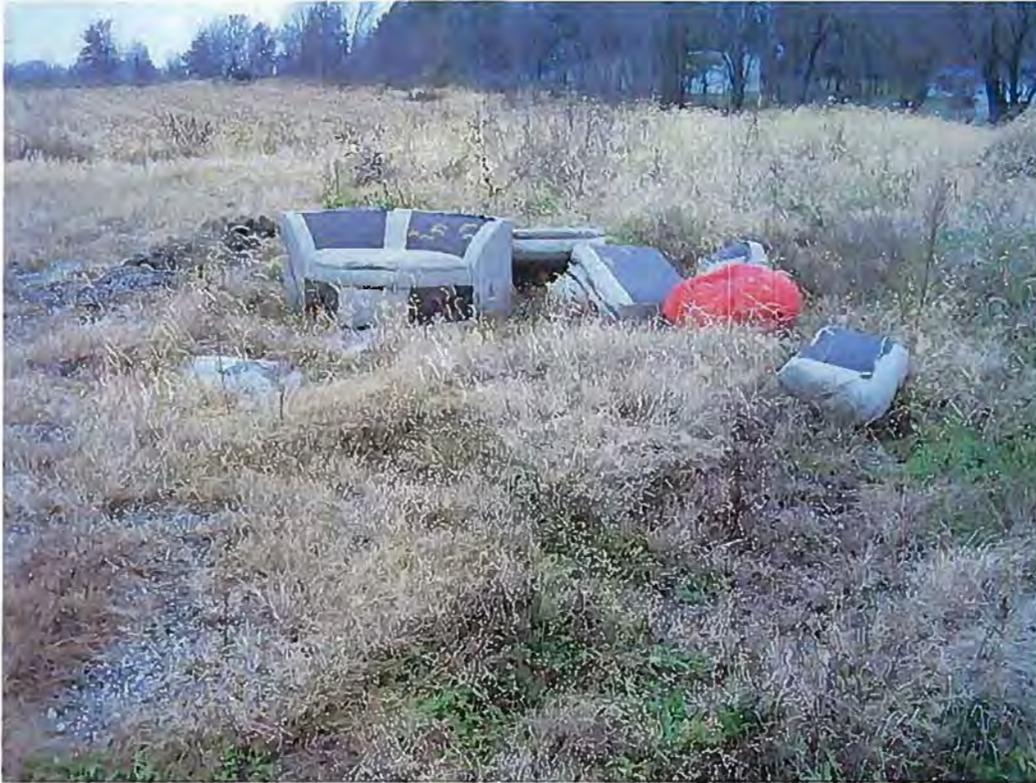
Upon arriving at the site it was immediately obviously that some new waste had been deposited since the January 2009 inspection. Up near and visible from the street, the inspector observed a beige suede sectional coach and a bright red bean bag chair that had been recently dumped (see Photograph 001). The mailbox had been knocked down and was observed lying on the ground. Access to the property is not restricted, and no one lives at the site.

Date: November 25, 2009
Time: 10:37 AM
Direction: NW
Photo by: Eisenbrandt
Exposure #: 001
Comments: A beige suede sectional couch and a red bean bag chair have been dumped on the site near the road since the January 2009 inspection.

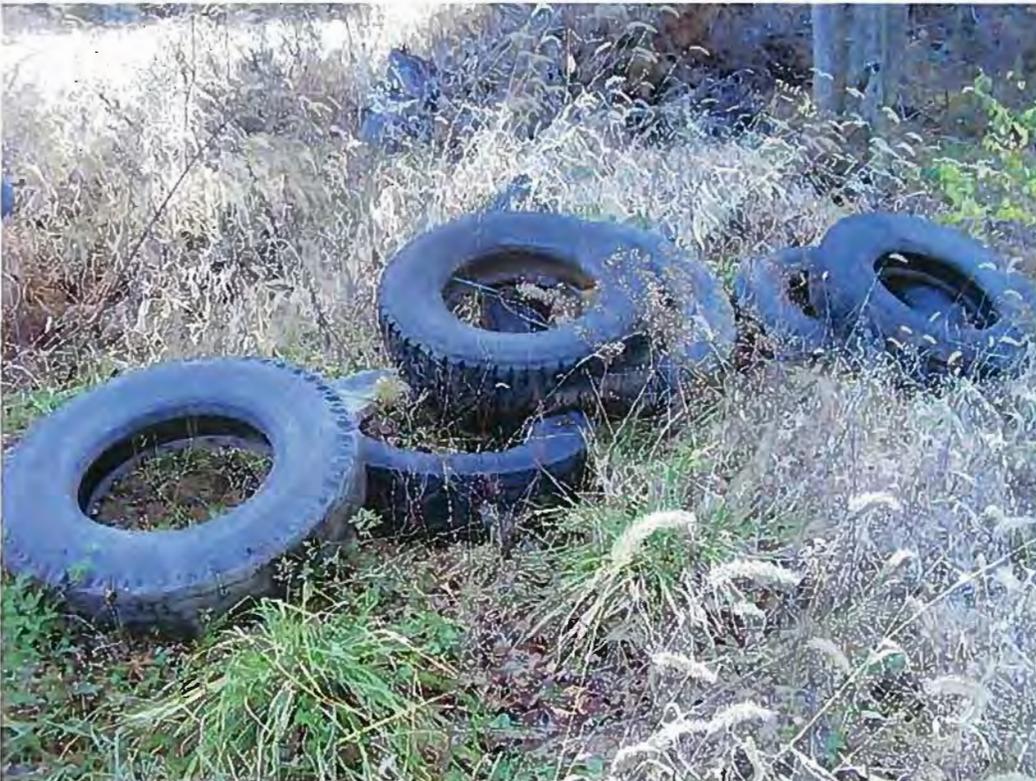
As the inspector walked north from the waste seen in Photograph 001, the inspector observed nine off-rim used truck tires that had been dumped near the large debris pile in the northeast corner (see Photograph 002). The truck tires previously observed partially buried as a makeshift landscaping border were moved and the holes in the ground remained. The nine off-rim used truck tires were observed within twenty feet of the previous makeshift landscape border. Some of the used tires may have been the partially buried tires; some appear to be newly dumped onsite. Photograph 003 shows one of the many waste tires that had stagnant water and decaying leaves inside.

Date: November 25, 2009
Time: 10:37 AM
Direction: N-NW
Photo by: Eisenbrandt
Exposure #: 002
Comments: Nine off-rim used truck tires have been dumped on the northeast corner of the site.

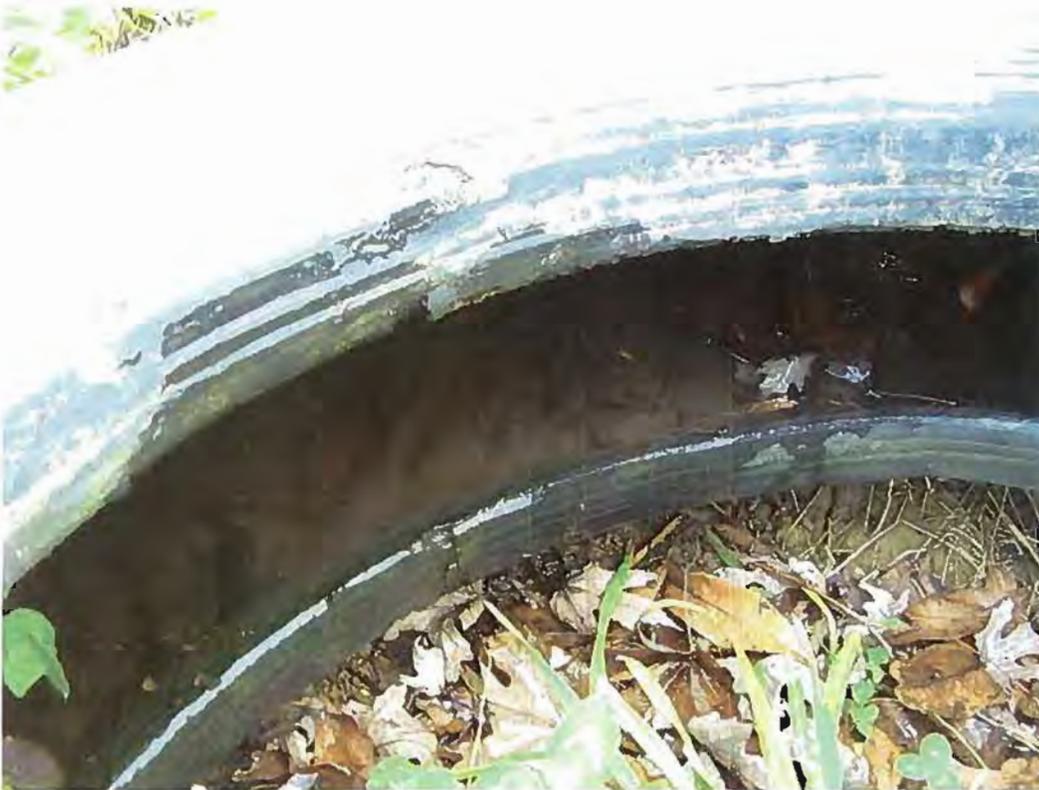
Date: November 25, 2009
Time: 10:38 AM
Direction: SW
Photo by: Eisenbrandt
Exposure #: 003
Comments: Some of the used tires seen in Photograph 2 had stagnant water and decaying leaves.

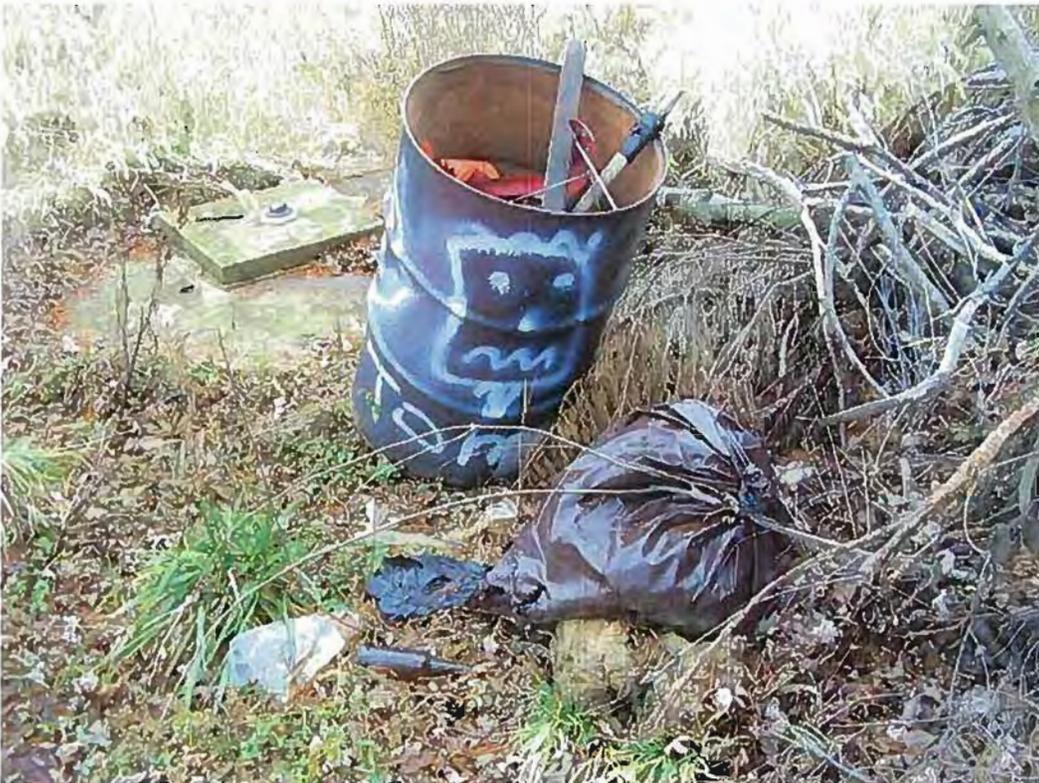
Up against the northeast debris pile, a 55-gallon drum was observed used as a waste barrel. A brown plastic bag, a beer bottle and some miscellaneous waste was also seen around the drum

and can be seen in Photograph 004. Photograph 005 shows the contents of the waste barrel. A Dairy Queen cup, a plastic water bottle, a red plastic bicycle fender and chain guard, several aluminum cans, plastic dinnerware, a wire coat hanger, scrap metal, a wooden handle, and miscellaneous debris were among the wastes observed in the barrel.

Date: November 25, 2009
Time: 10:39 AM
Direction: W
Photo by: Eisenbrandt
Exposure #: 004
Comments: A 55-gallon drum used as a waste barrel a brown plastic bag, a beer bottle, and some miscellaneous waste was observed near a landscape debris pile in the northeast corner of the site. Several pieces of rotting plywood and some miscellaneous waste were observed in the landscape waste pile.

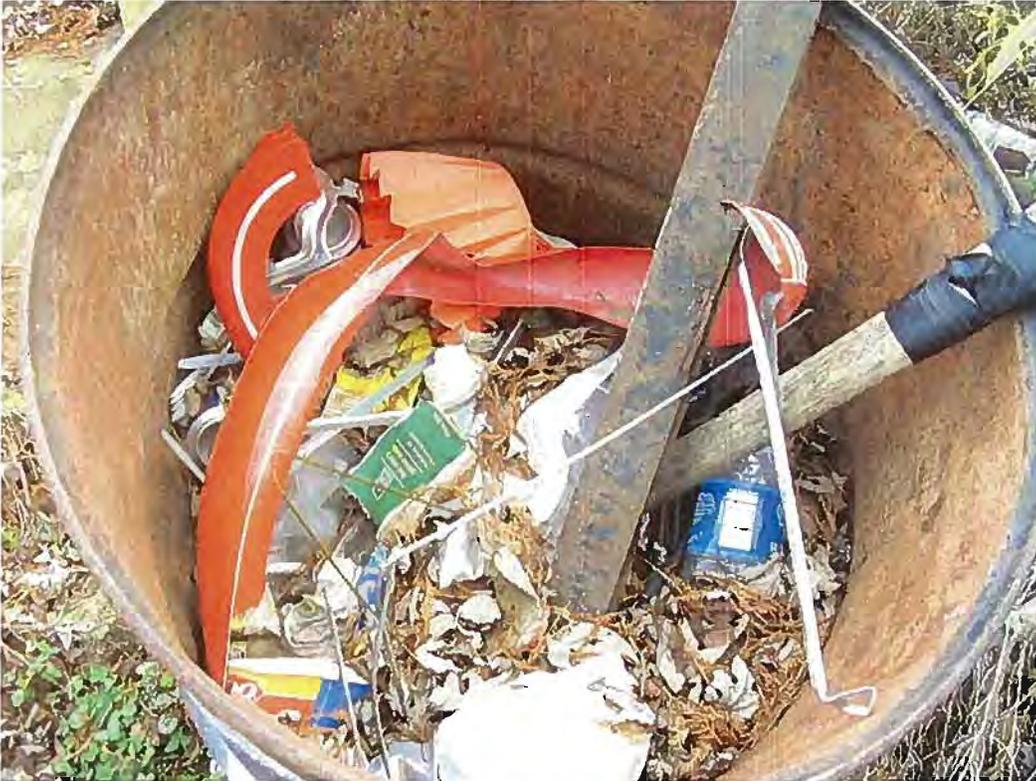
Date: November 25, 2009
Time: 10:40 AM
Direction: W
Photo by: Eisenbrandt
Exposure #: 005
Comments: View of the waste in barrel. A Dairy Queen cup, a plastic water bottle, a red plastic bicycle fender and chain guard, several aluminum cans, plastic dinnerware, a wire coat hanger, scrap metal a wooden handle, and miscellaneous waste were observed in the barrel.

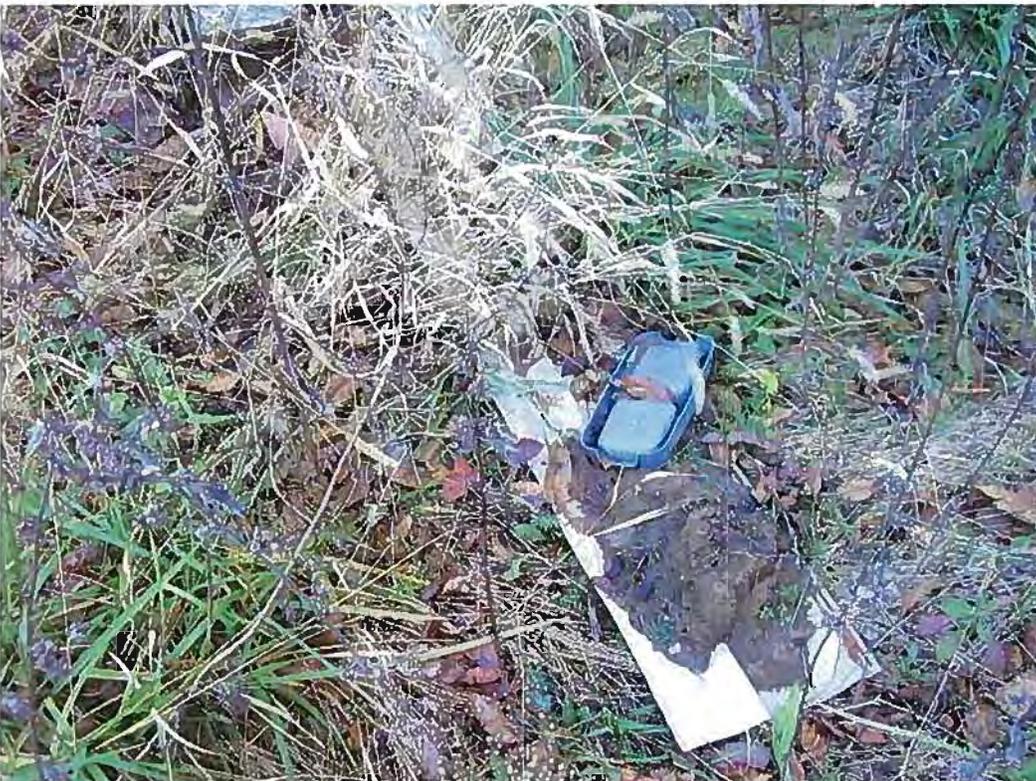
The inspector began walking west along the northern boundary that is lined with trees and brush. Photograph 006 shows a blue plastic pet food dish and a section of dirty white vinyl siding observed in the weeds. Their approximate location is illustrated on the accompanying Site Sketch.

Date: November 25, 2009
Time: 10:42 AM
Direction: NW
Photo by: Eisenbrandt
Exposure #: 006
Comments: A blue pet food dish, and a section of white vinyl siding were observed.

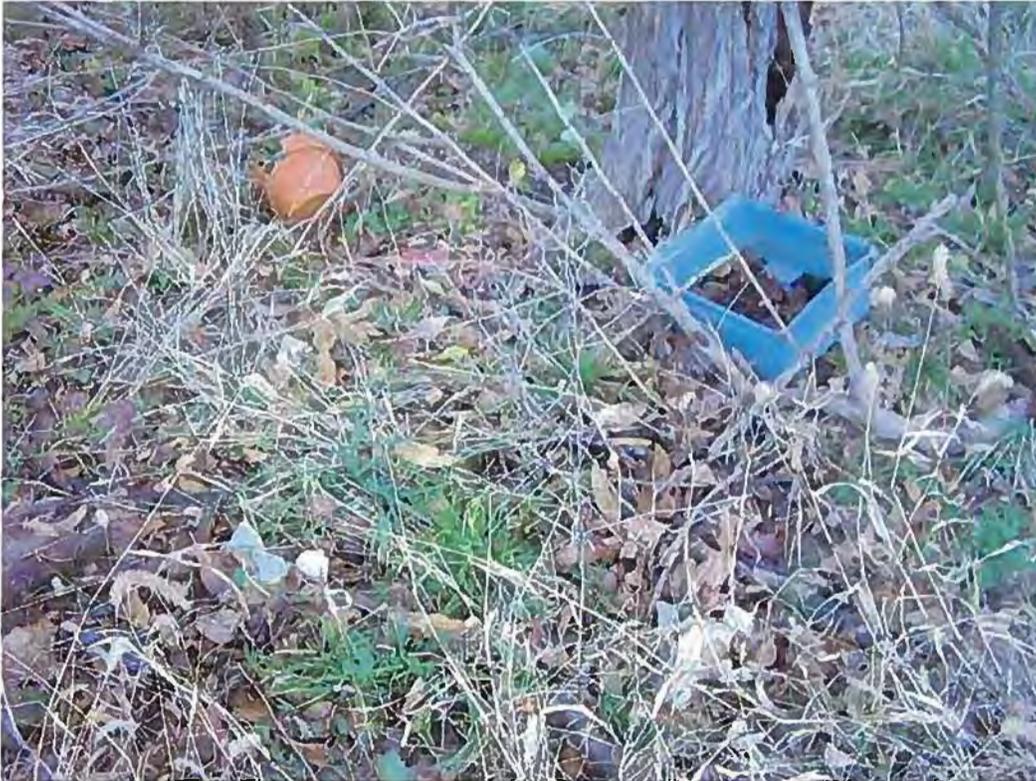
A bluish-green crisper drawer (from a refrigerator) and a broken plastic clay colored pot were observed near a tree (see Photograph 007).

Date: November 25, 2009
Time: 10:43 AM
Direction: NW
Photo by: Eisenbrandt
Exposure #: 007
Comments: A bluish-green crisper drawer from a refrigerator and a broken clay colored plastic pot were observed among the trees on the northern side of the site.

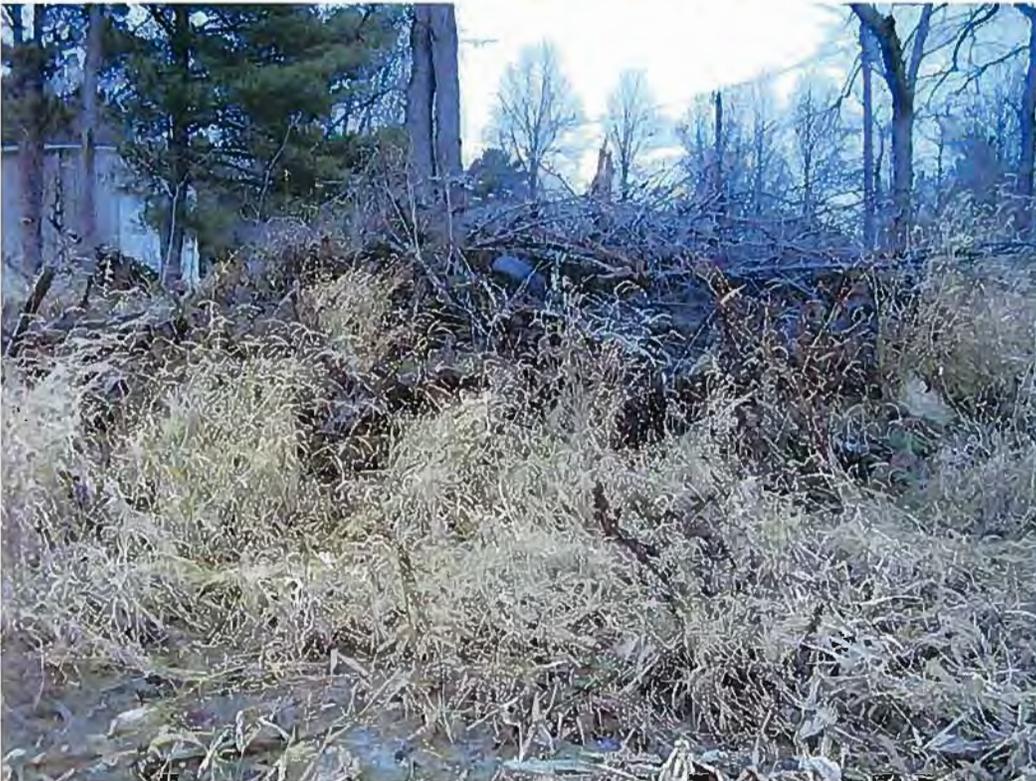
Photograph 008 shows the second landscape waste pile that was observed near the midpoint of the northern property line. A used tire is visible in the waste pile. Photograph 009 shows a close up of the used tire seen in Photograph 008. Photograph 010 shows a beige broken plastic container (tote or bin style) beside the waste pile. Photograph 011 shows a piece of scrap metal protruding from the landscape waste pile.

Date: November 25, 2009
Time: 10:44 AM
Direction: N
Photo by: Eisenbrandt
Exposure #: 008
Comments: A pile of landscape waste was observed near the midpoint of the northern property line. A used tire is visible in the waste pile.

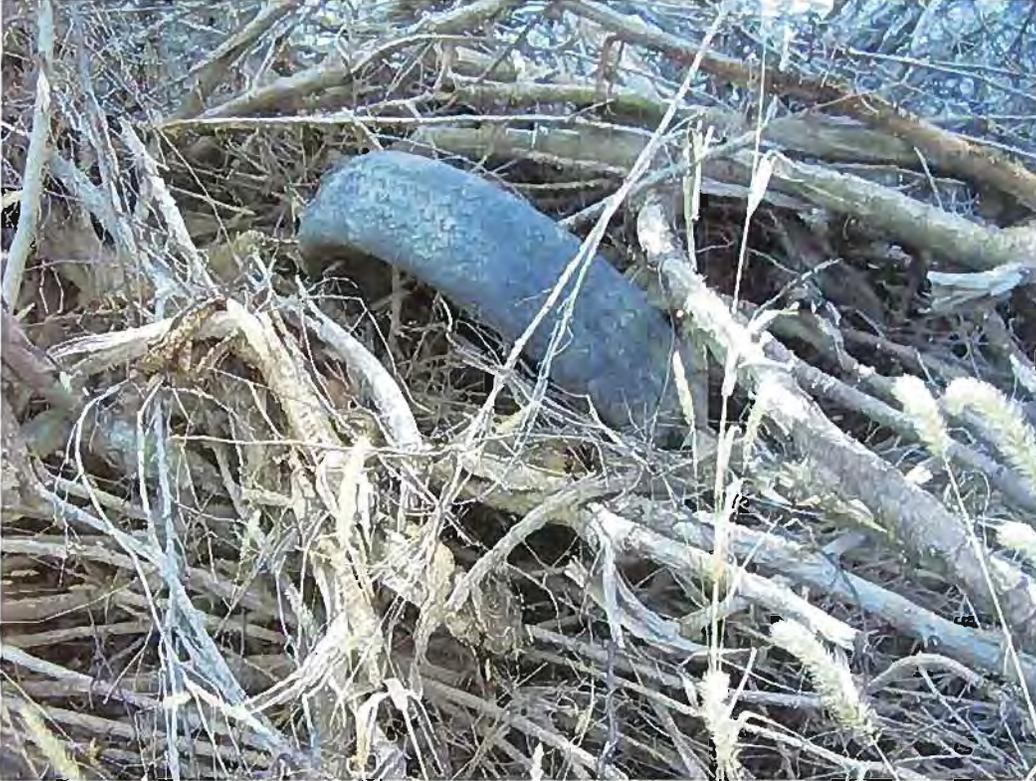
Date: November 25, 2009
Time: 10:45 AM
Direction: N
Photo by: Eisenbrandt
Exposure #: 009
Comments: An off-rim used tire observed in the landscape waste pile seen in Photograph 008.

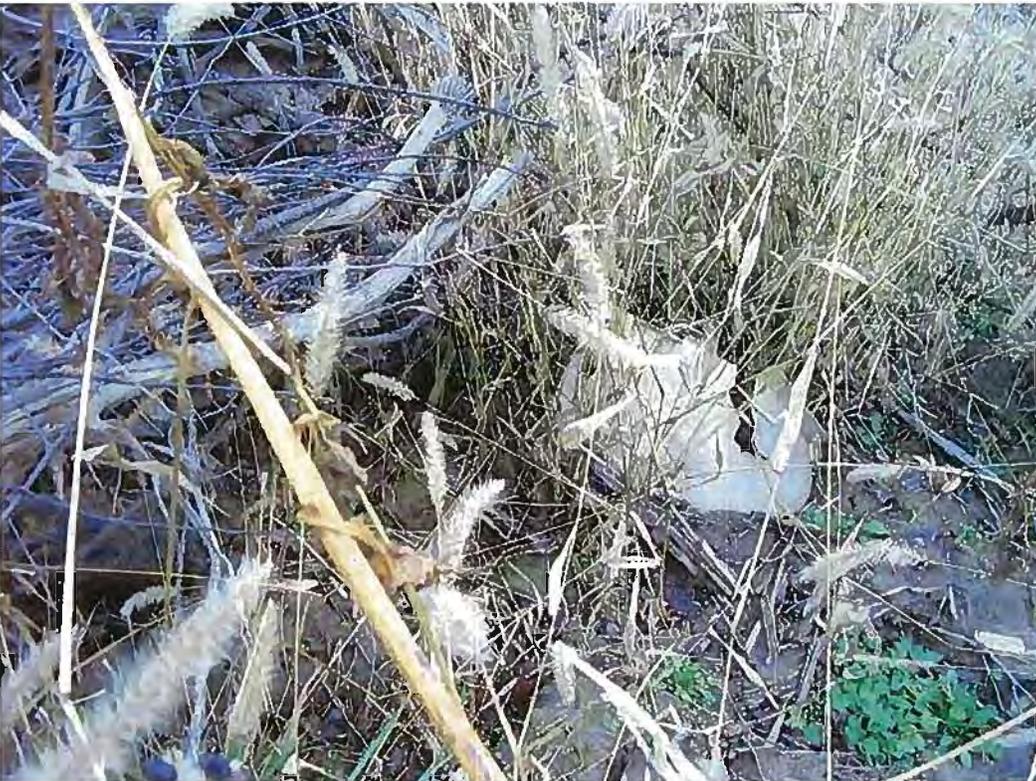
Date: November 25, 2009
Time: 10:45 AM
Direction: NE
Photo by: Eisenbrandt
Exposure #: 010
Comments: A beige broken plastic container was observed in the landscape waste pile seen in Photograph 008.

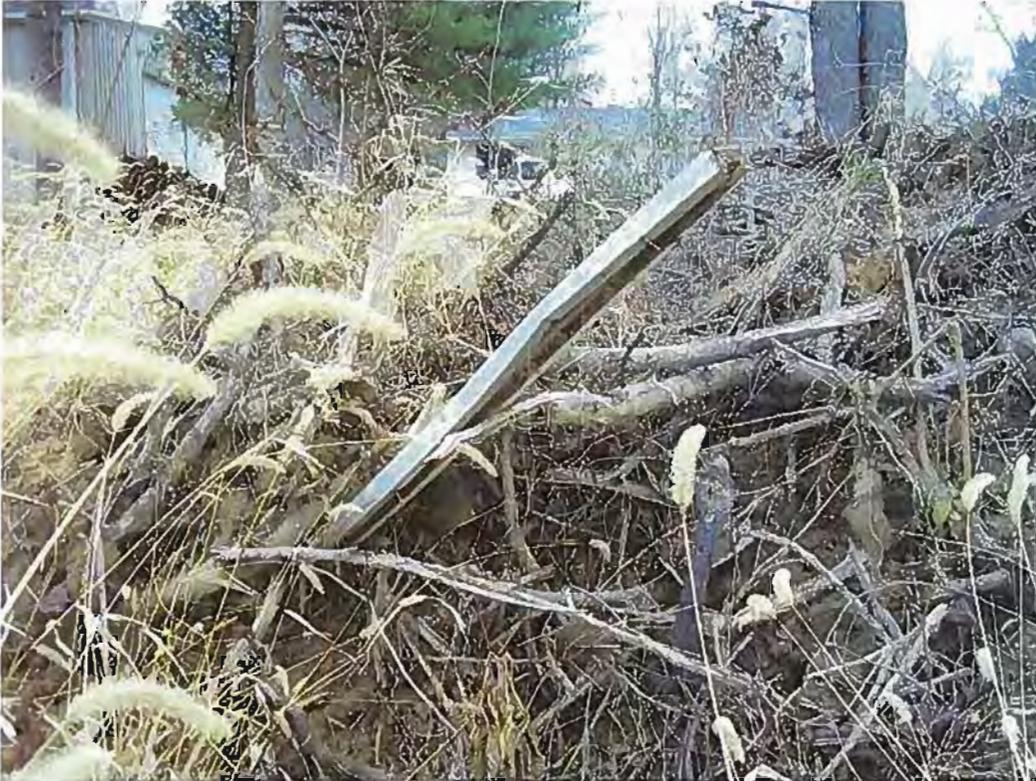
Date: November 25, 2009
Time: 10:45 AM
Direction: N
Photo by: Eisenbrandt
Exposure #: 011
Comments: Scrap metal was also observed in the landscape waste pile seen in Photograph 008.

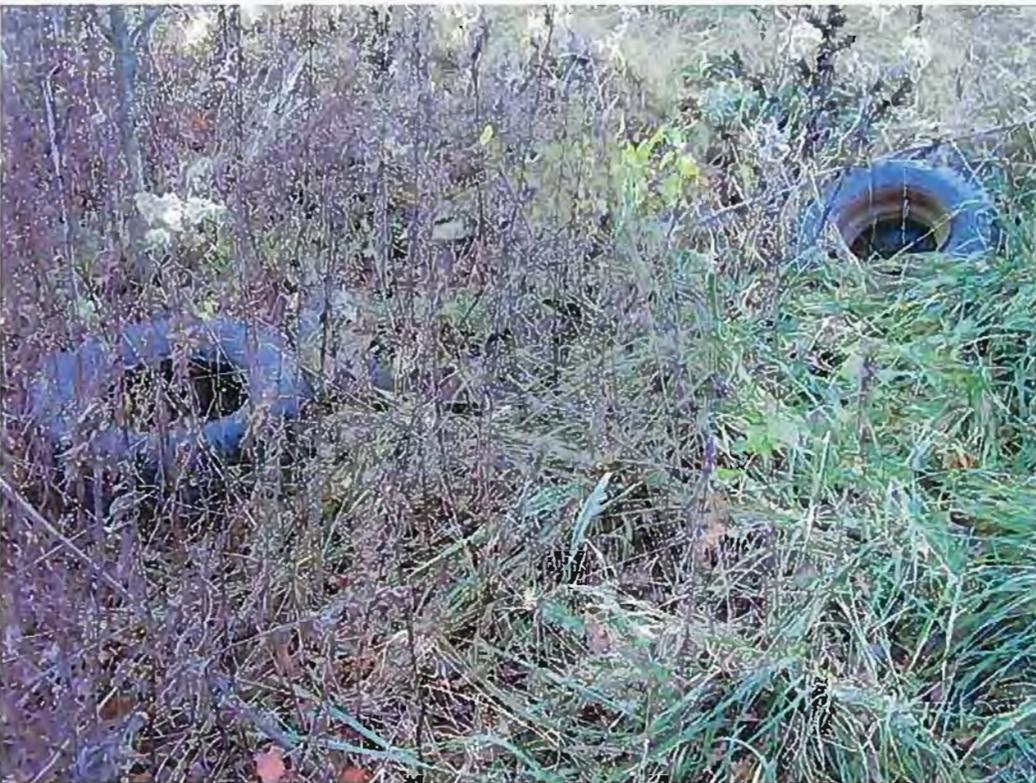
Three used tires (one on rim) were observed near an opening in the northern tree line (See Photographs 012 and 013. During the past two inspections (July 2008 and January 2009) these used tires were observed at this same location

Date: November 25, 2009
Time: 10:46 AM
Direction: SE
Photo by: Eisenbrandt
Exposure #: 012
Comments: Three used tires (one on rim) were observed near an opening in the northern tree line. During the previous two inspections (July 2008 & January 2009) used tires were observed at this same location.

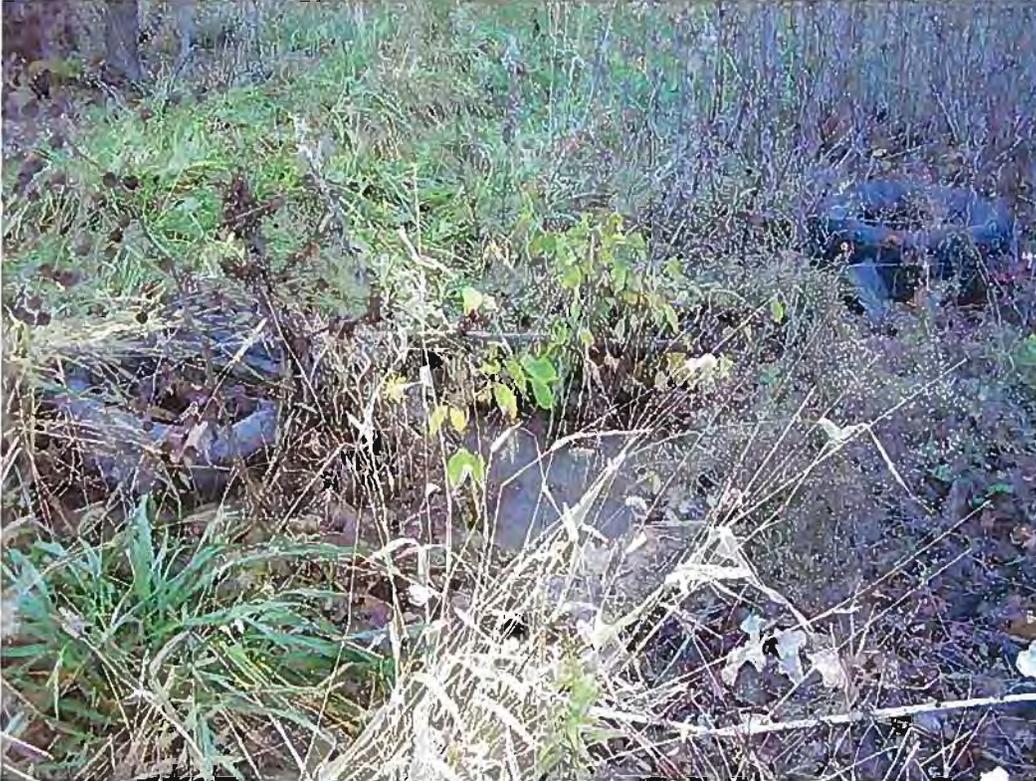
Date: November 25, 2009
Time: 10:46 AM
Direction: NW
Photo by: Eisenbrandt
Exposure #: 013
Comments: Alternate view of the three used tires seen in Photograph 012.

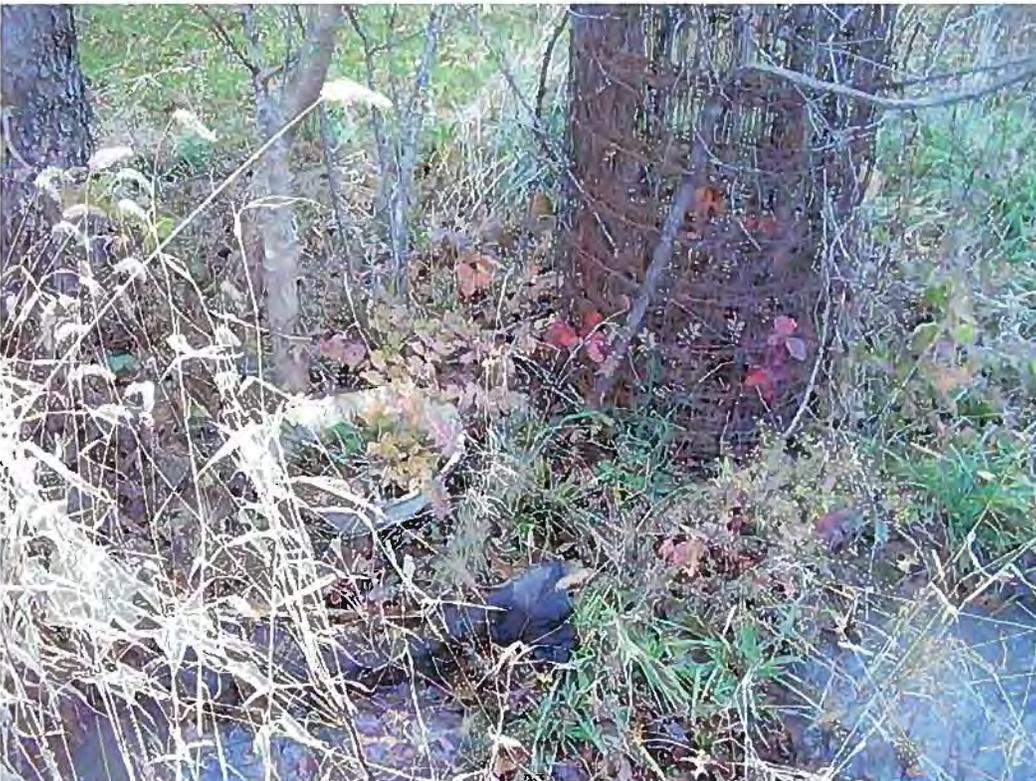
A rusty bundle of wire fencing and a white pan were observed, as previously, along the northern tree line.

Date: November 25, 2009
Time: 10:47 AM
Direction: NE
Photo by: Eisenbrandt
Exposure #: 014
Comments: A rusty bundle of wire fencing and miscellaneous waste observed in the northern tree line. Waste had previously been observed during prior the two prior inspections.

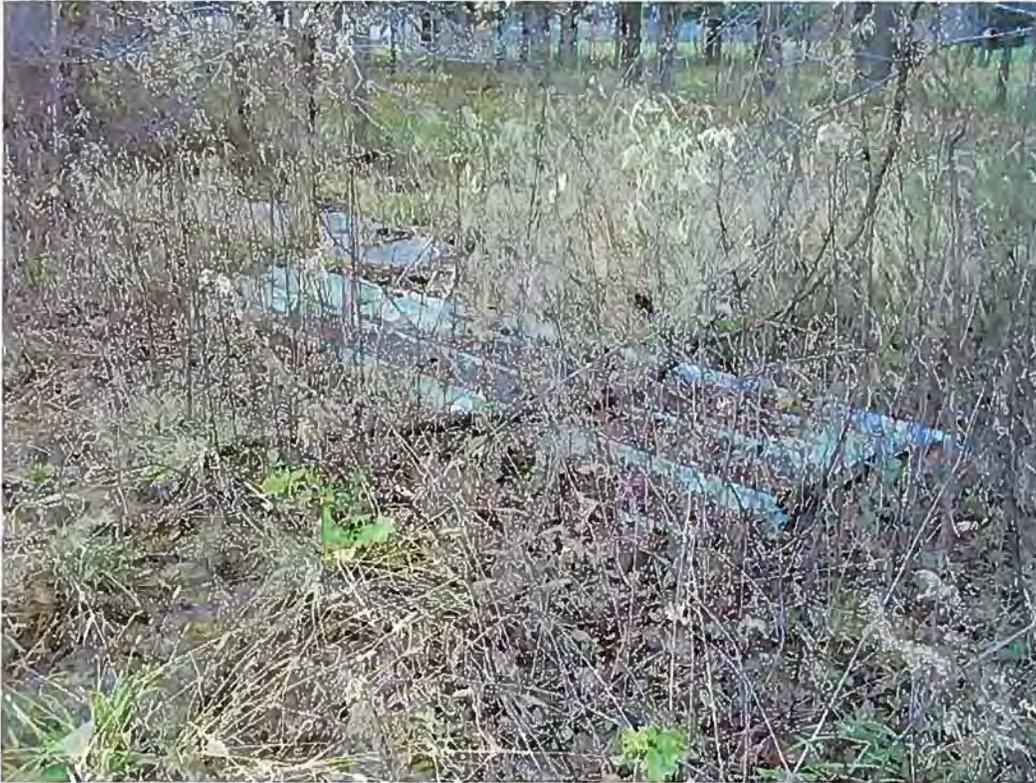
Several sections of rusty corrugated sheet metal and green fiberglass panels can be seen in Photograph 015. These panels are we again observed in the northern tree line and appear to be untouched since the first inspection.

Date: November 25, 2009
Time: 10:47 AM
Direction: NW
Photo by: Eisenbrandt
Exposure #: 015
Comments: Several sections of rusty corrugated sheet metal and green fiberglass panels are still observed in the northern tree line.

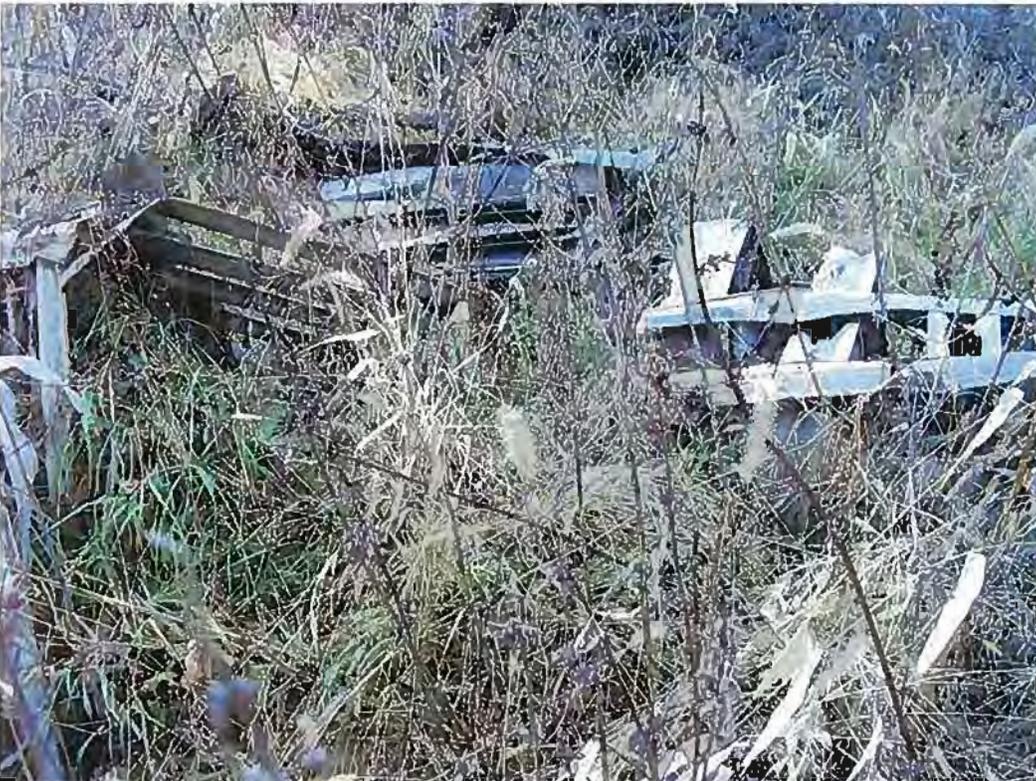
The inspector continued west to the large debris pile on the north western side of the property. Photograph 016 shows some mangled cattle fencing and scrap metal. It appears to be the crude fencing that had sectioned off this corner of the property for livestock. Since the January 2009 inspection the fence, and previously observed scrap metal has been pushed into a large landscape waste and miscellaneous debris pile.

Date: November 25, 2009
Time: 10:48 AM
Direction: N
Photo by: Eisenbrandt
Exposure #: 016
Comments: Mangled cattle fencing and scrap metal.

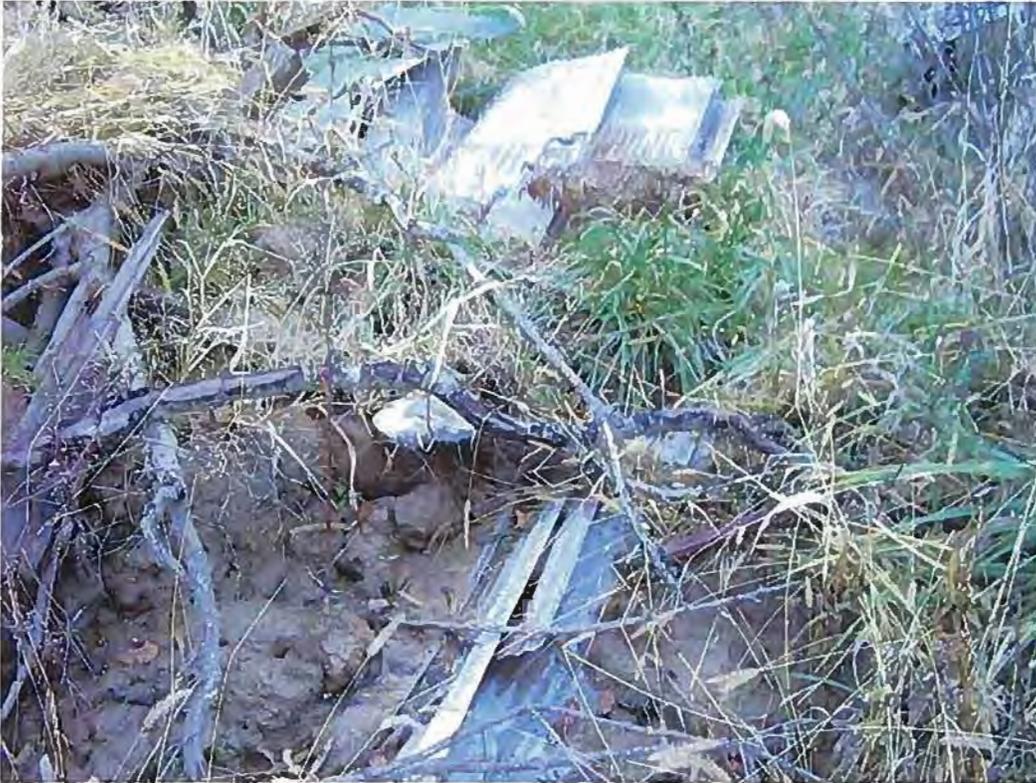
Photograph 017 shows some previously observed waste, such as several pieces of corrugated sheet metal and metal scrap near the debris pile.

Date: November 25, 2009
Time: 10:48 AM
Direction: N
Photo by: Eisenbrandt
Exposure #: 017
Comments: It appears some of the previously observed wastes have been pushed into a large debris pile. In this photograph several pieces of corrugated sheet metal and metal scrap can be seen.

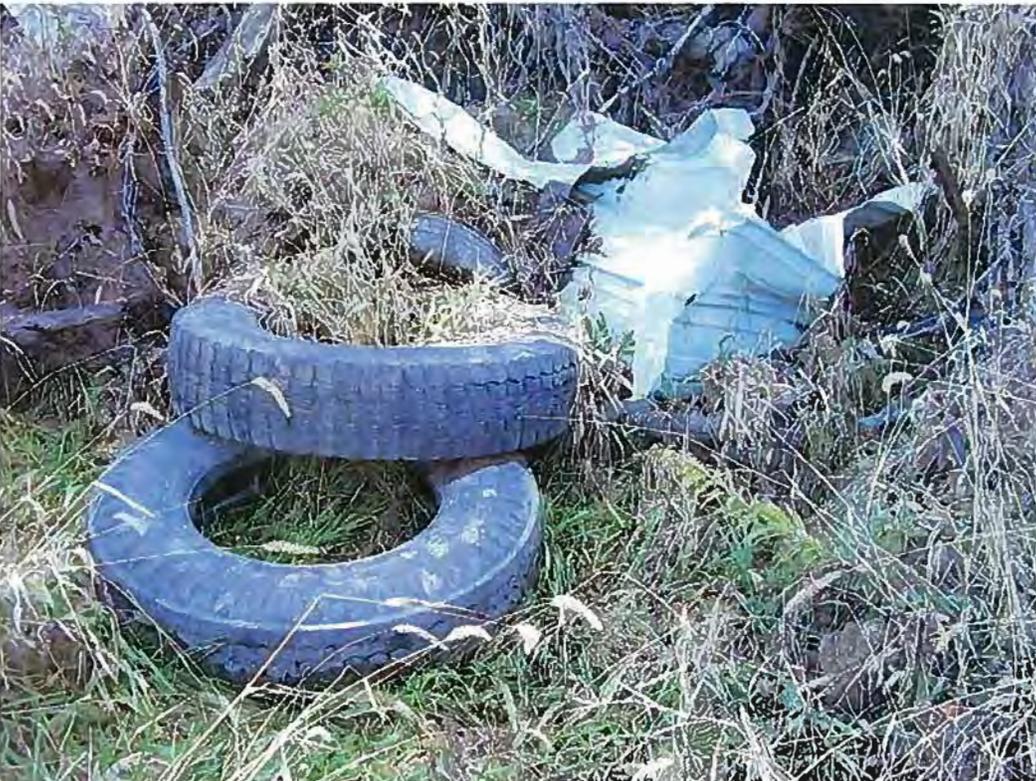
Three off-rim used tires and some bent sheet metal were observed mixed in with landscape waste in the large debris pile (see Photograph 018). Photograph 019 shows the large debris pile observed in the northwest corner of the site.

Date: November 25, 2009
Time: 10:48 AM
Direction: N
Photo by: Eisenbrandt
Exposure #: 018
Comments: Metal wire, three off rim used tires, and sheet metal were observed mixed with landscape waste in the large debris pile.

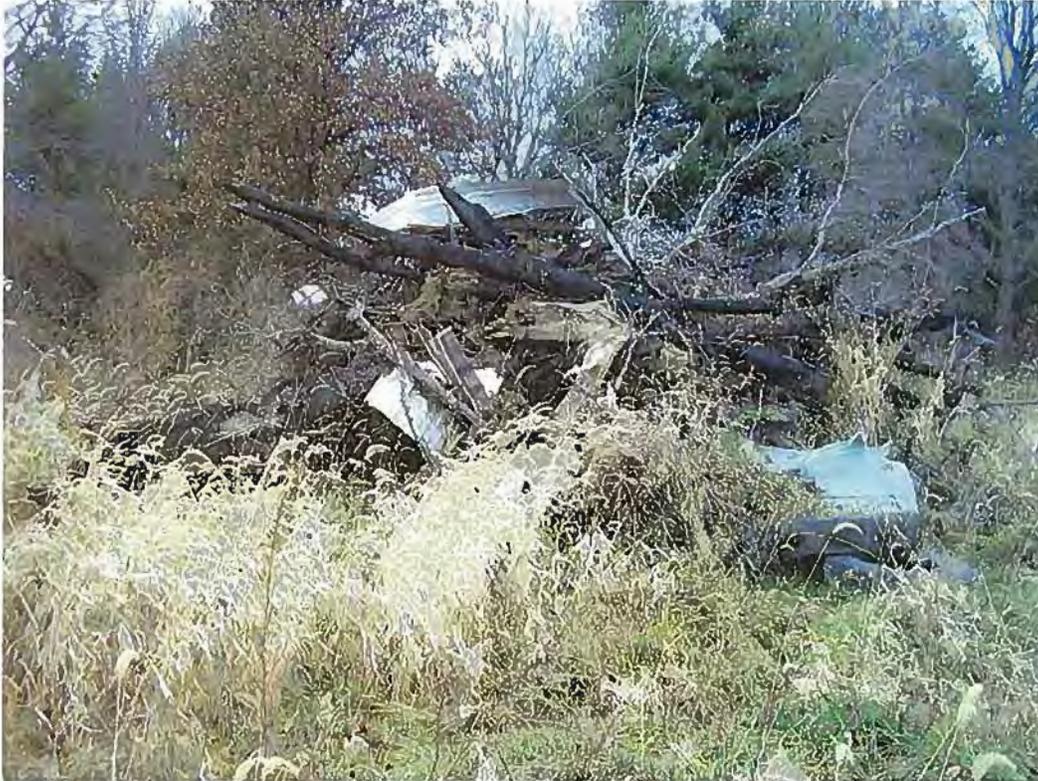
Date: November 25, 2009
Time: 10:48 AM
Direction: N
Photo by: Eisenbrandt
Exposure #: 019
Comments: Large debris pile observed in the northwest corner of the site.

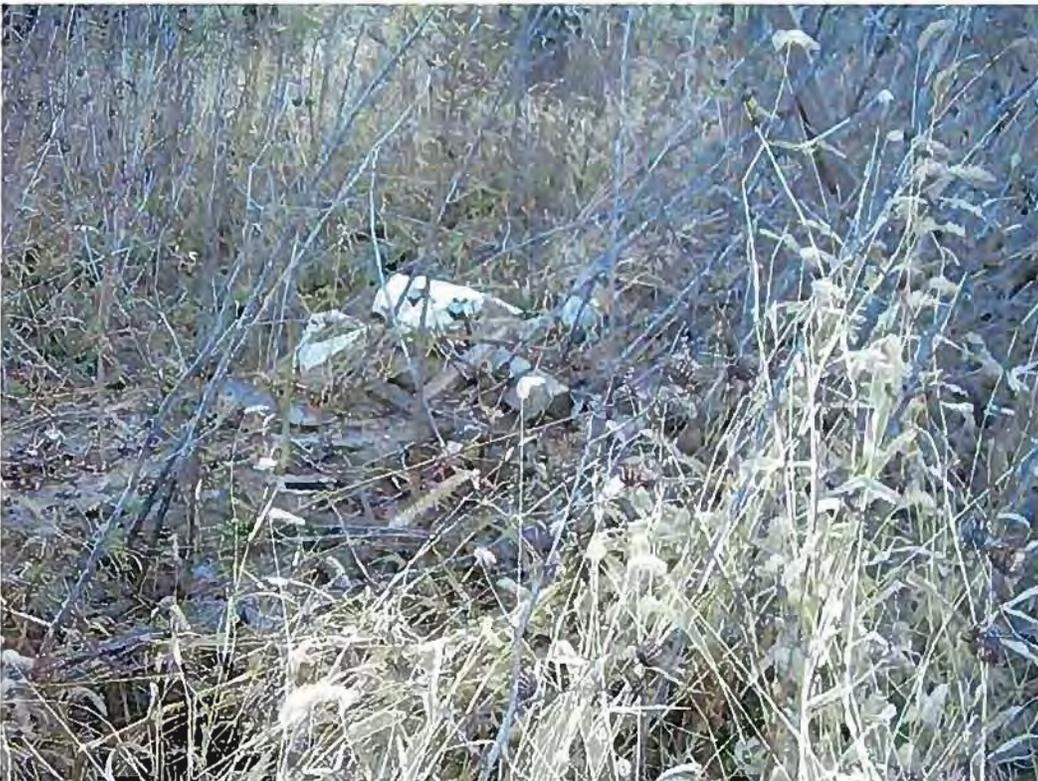
Small debris mounds were observed west of the large debris pile and among the tall weeds as can be seen in Photograph 020.

Date: November 25, 2009
Time: 10:49 AM
Direction: NW
Photo by: Eisenbrandt
Exposure #: 020
Comments: Small debris pile observed among the tall weeds in the northwest corner of the site.

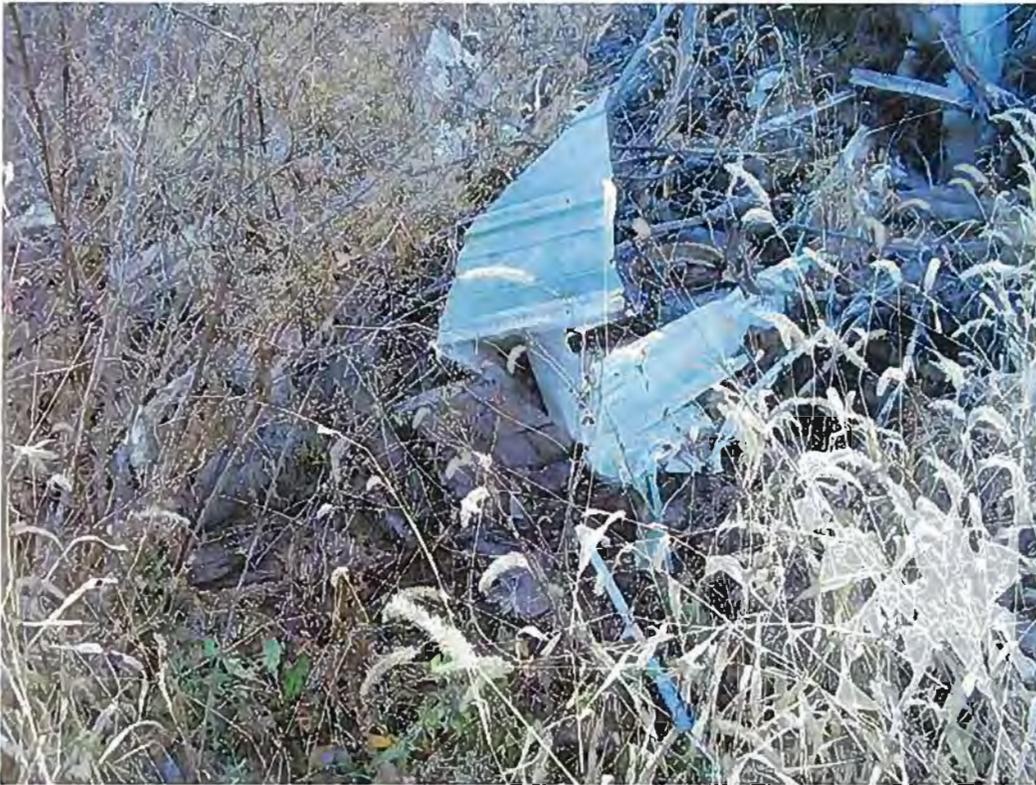
Date: November 25, 2009
Time: 10:49 AM
Direction: E
Photo by: Eisenbrandt
Exposure #: 021
Comments: Additional used tire, sheet metal and miscellaneous debris mixed with landscape waste.

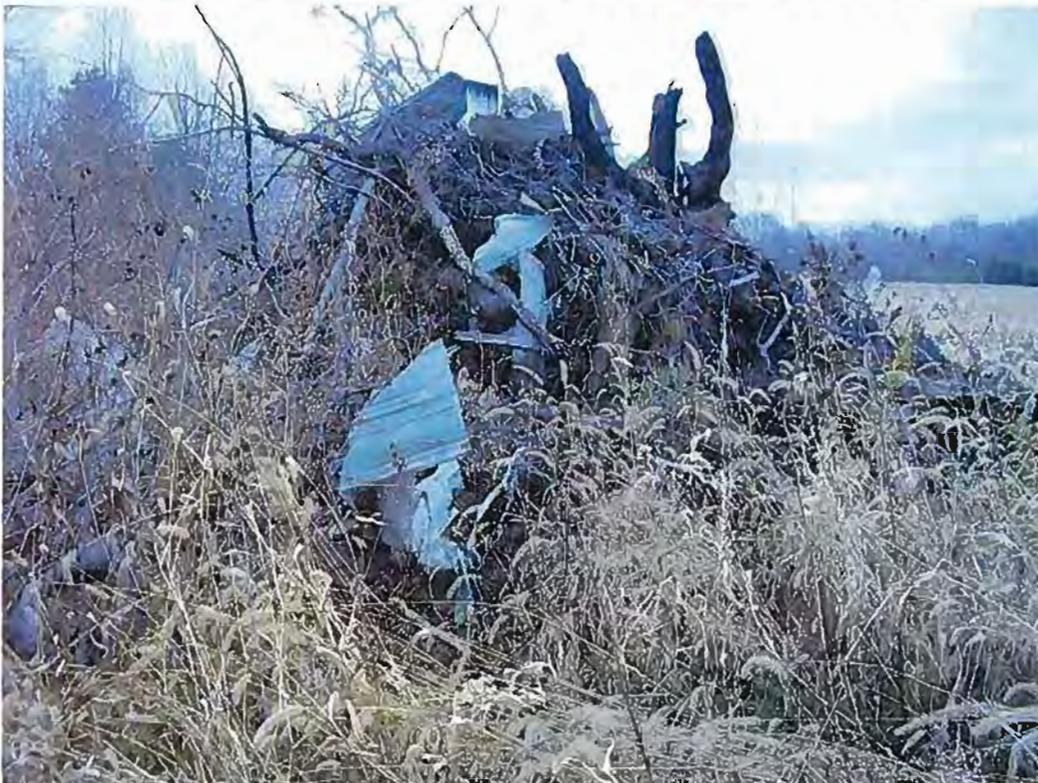
Date: November 25, 2009
Time: 10:49 AM
Direction: E
Photo by: Eisenbrandt
Exposure #: 022
Comments: Alternate photograph of the large debris pile in the northwest corner of the site.
