ILLINOIS ENVIRONMENTAL PROTECTION AGENCY

ADMINISTRATIVE CITATION

ILLINOIS ENVIRONMENTAL PROTECTION AGENCY
Open Dump Inspection Checklist

ILLINOIS ENVIRONMENTAL PROTECTION AGENCY MEMORANDUM

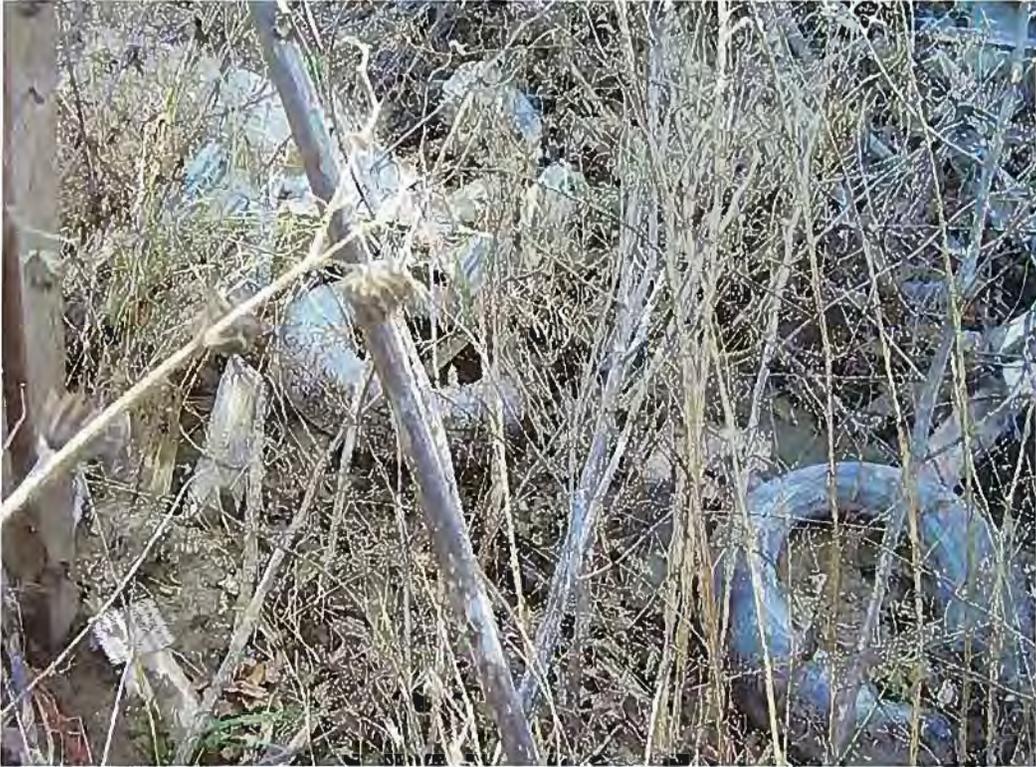
Date: November 25, 2009
Time: 10:50 AM
Direction: SE
Photo by: Eisenbrandt
Exposure #: 023
Comments: Off-rim used tires and sheet metal near the large debris pile.

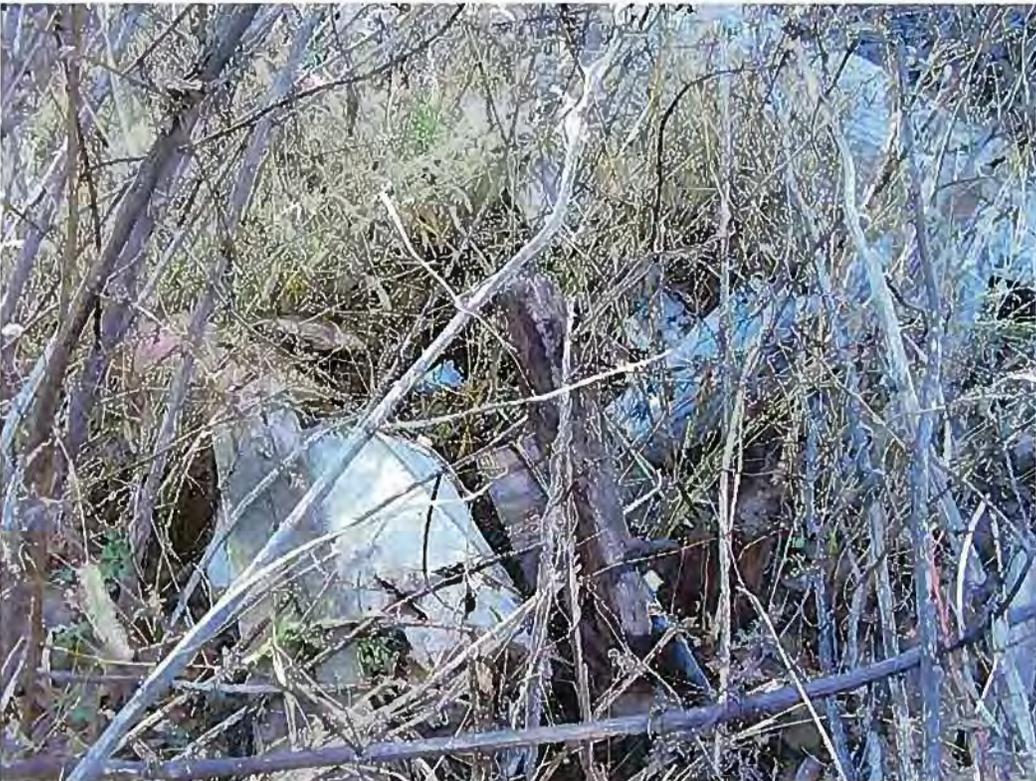
Date: November 25, 2009
Time: 10:50 AM
Direction: SE
Photo by: Eisenbrandt
Exposure #: 024
Comments: Sheet metal mixed with landscape waste.

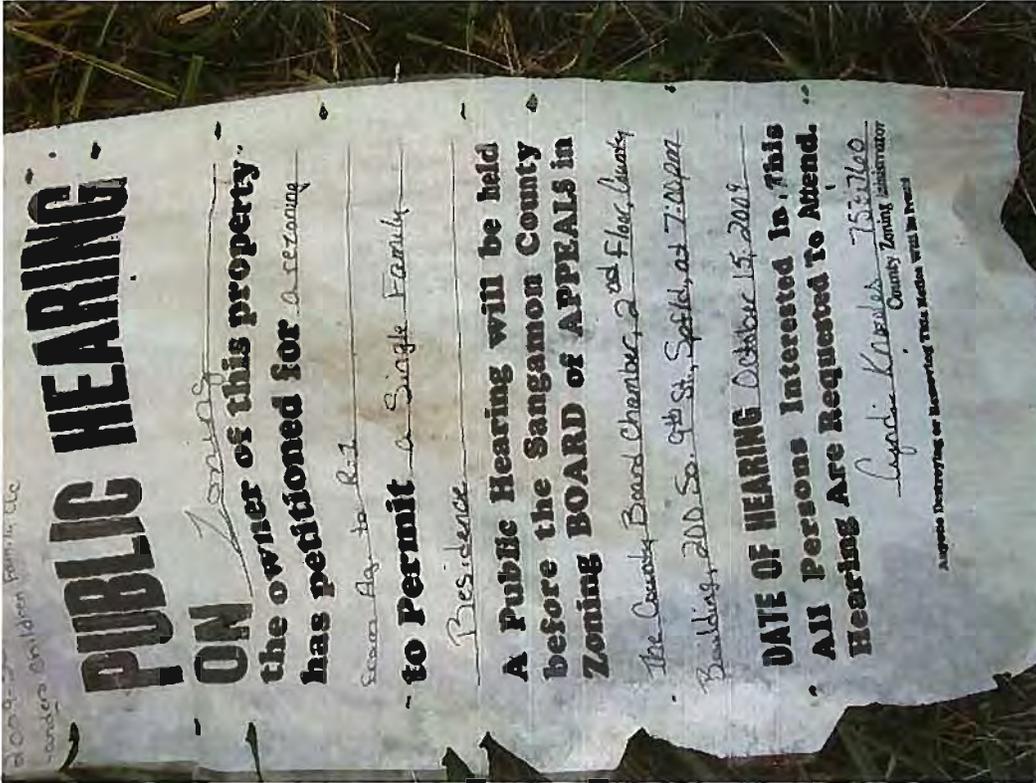
Date: November 25, 2009
 Time: 11:16 AM
 Direction: S
 Photo by: Eisenbrandt
 Exposure #: 025
 Comments: Notice of public hearing to rezone the 5-acre parcel from Ag to R1.
