BEFORE THE ILLINOIS POLLUTION CONTROL BOARD

RESIDENTIAL SITE OPEN DUMPING VIOLATIONS

CORPORATE SITE OPEN BURNING

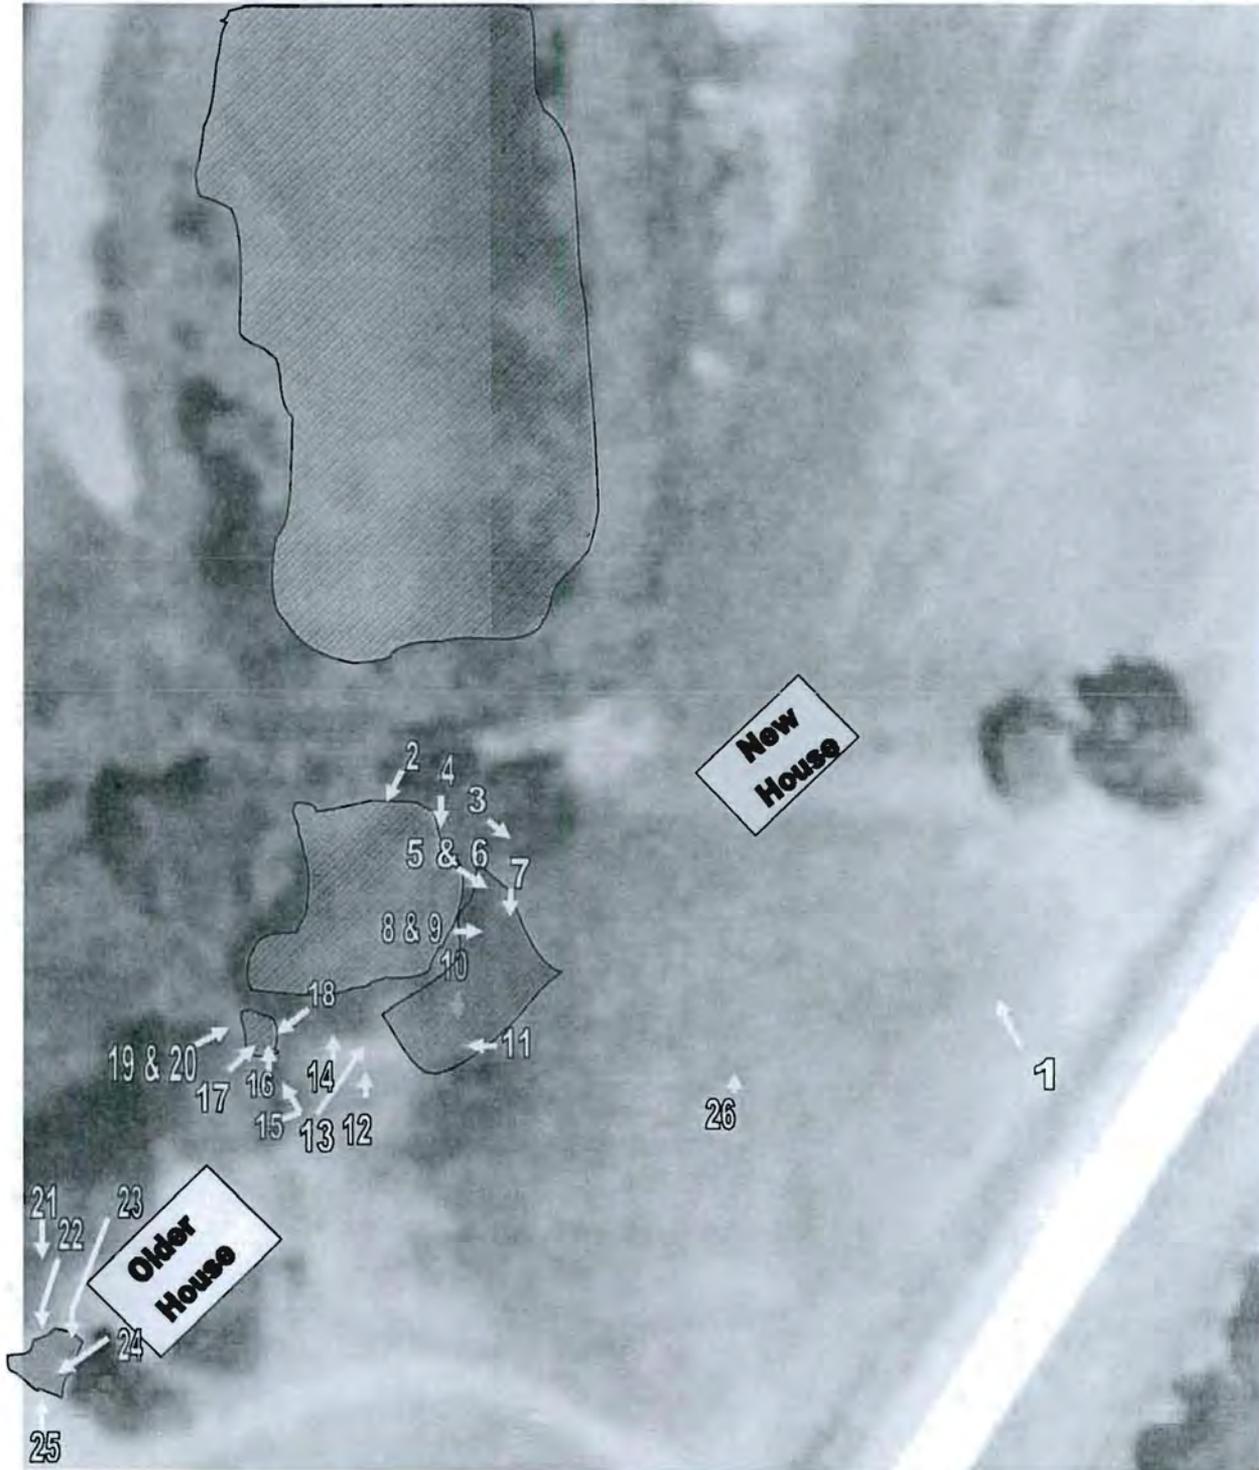
SITE SKETCH

Measurements Approximate
Direction of Photo
Not to Scale

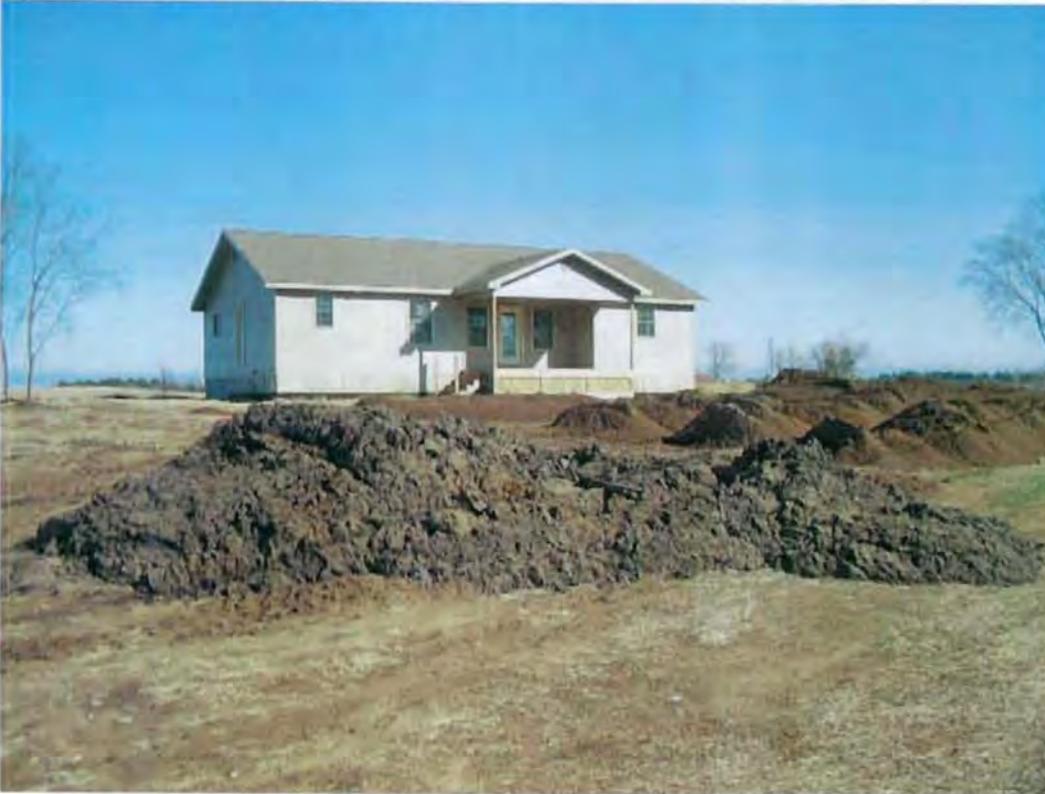
Date: March 23, 2011
Time: 9:45 AM
Direction: NW
Photo by: Eisenbrandt
Exposure #: 001
Comments: Front elevation view of house from Manito Road. Fill materials have been dumped in the front yard.

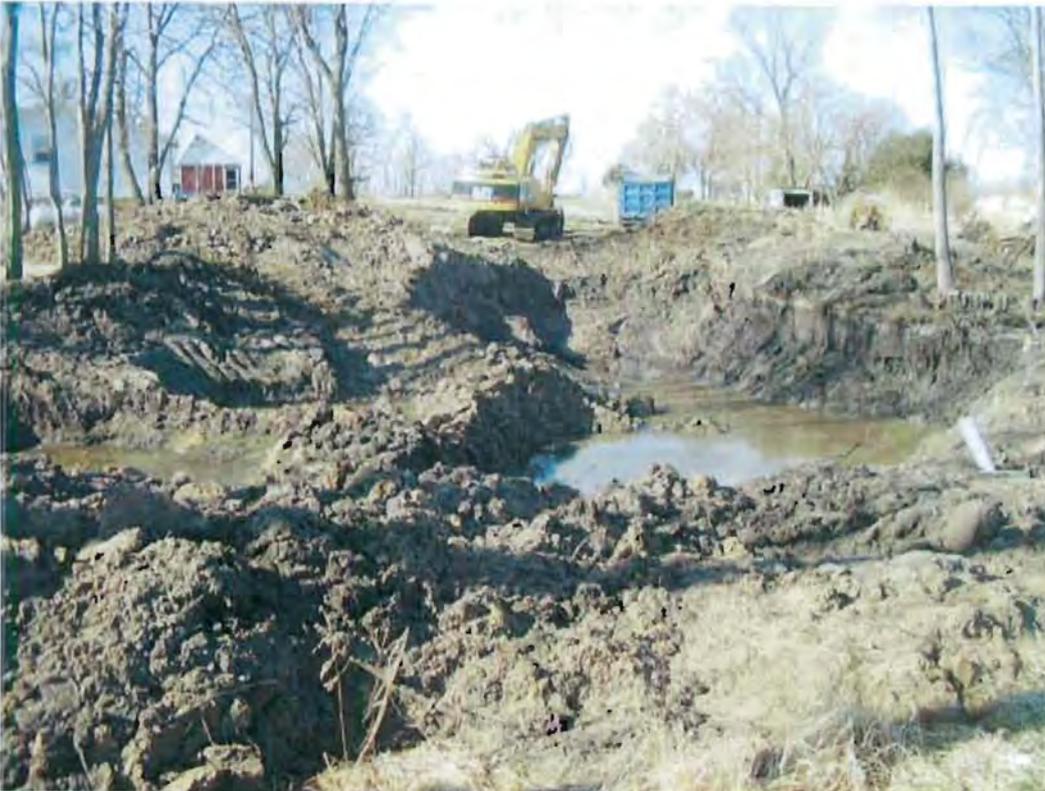
Date: March 23, 2011
Time: 9:47 AM
Direction: SW
Photo by: Eisenbrandt
Exposure #: 002
Comments: The smaller pond that was algae covered has been drained and dredged.

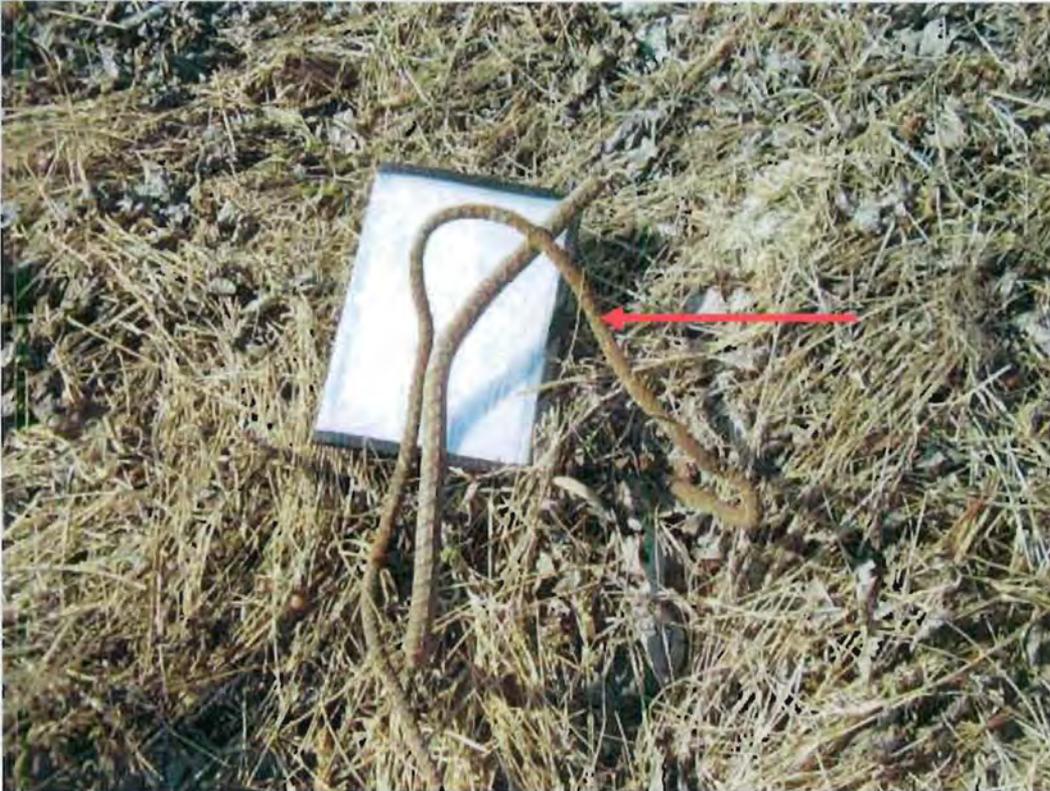
Date: March 23, 2011
Time: 9:48 AM
Direction: SE
Photo by: Eisenbrandt
Exposure #: 003
Comments: Twisted rebar.

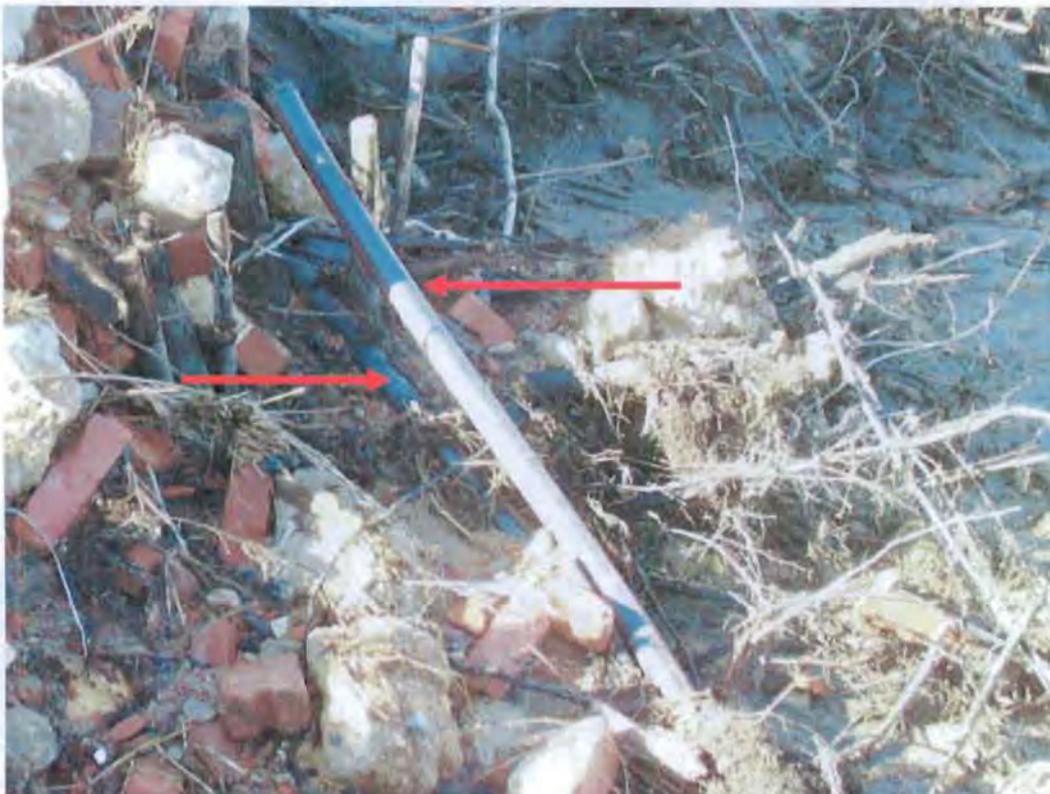
Date: March 23, 2011
Time: 9:49 AM
Direction: S
Photo by: Eisenbrandt
Exposure #: 004
Comments: Black plastic pipe and pieces of brick, concrete, and mortar.

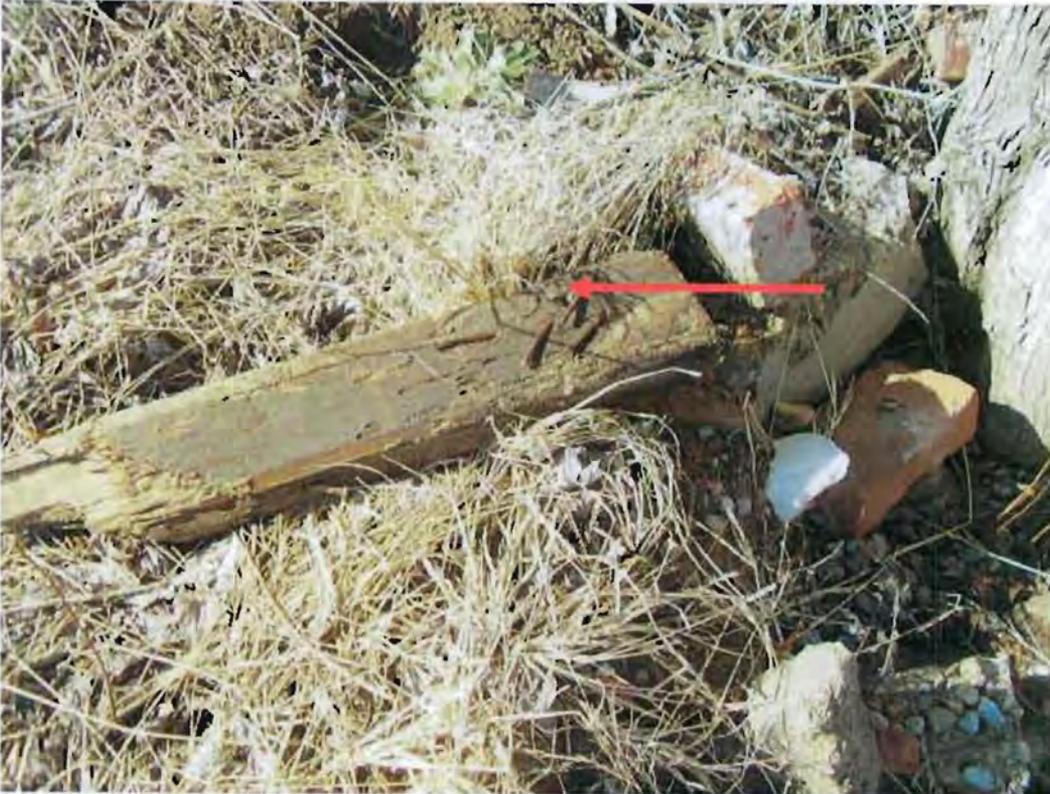
Date: March 23, 2011
Time: 9:49 AM
Direction: SE
Photo by: Eisenbrandt
Exposure #: 005
Comments: Damaged dimensional lumber scrap with nails and brick and mortar.

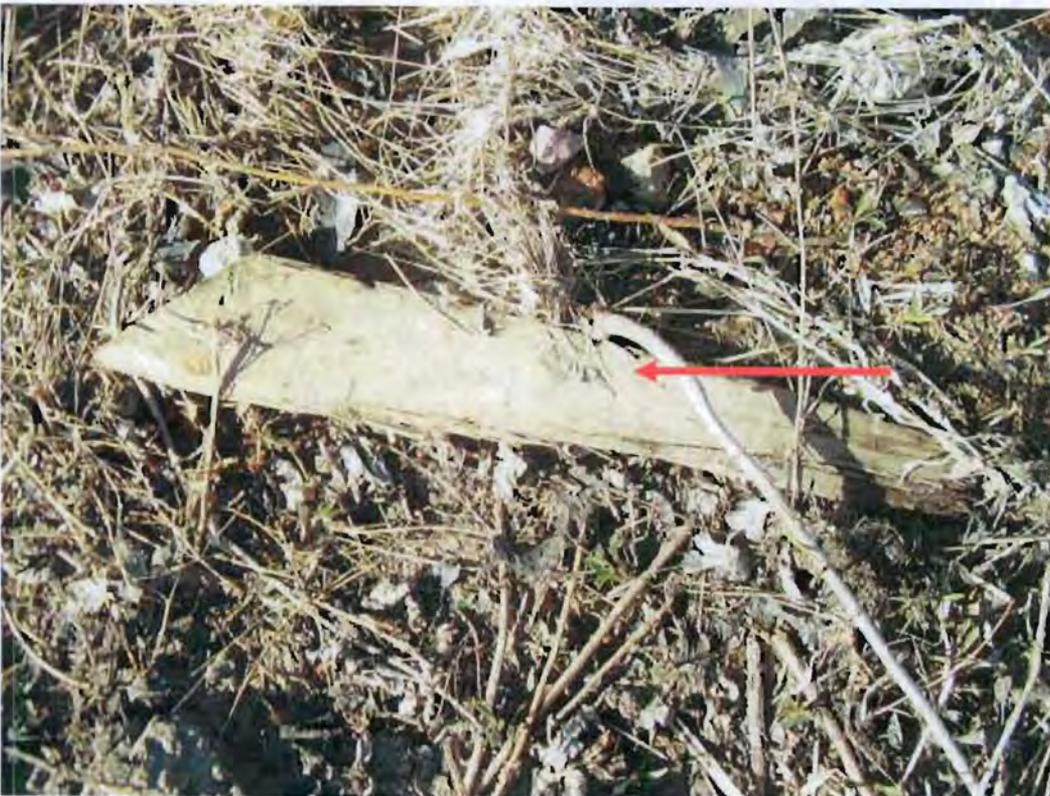
Date: March 23, 2011
Time: 9:50 AM
Direction: SE
Photo by: Eisenbrandt
Exposure #: 006
Comments: Dimensional lumber scrap.

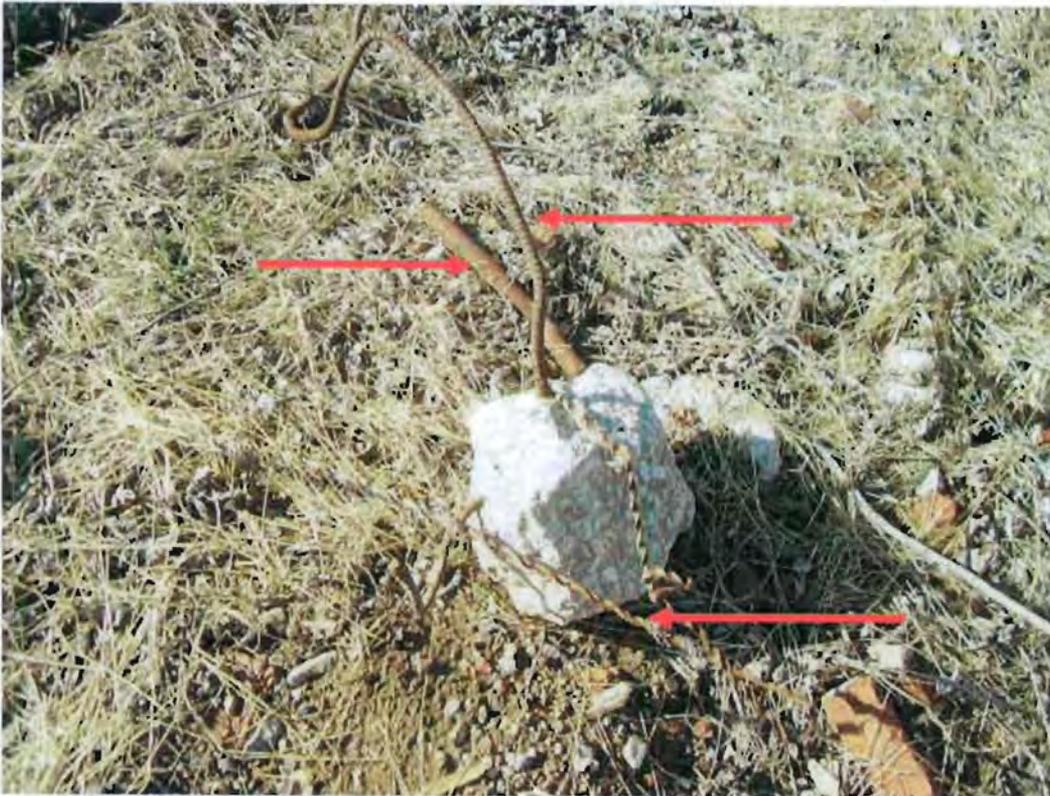
Date: March 23, 2011
Time: 9:50 AM
Direction: S
Photo by: Eisenbrandt
Exposure #: 007
Comments: Concrete with protruding rebar, a rusty steel pipe, and unraveled flexible electric conduit.

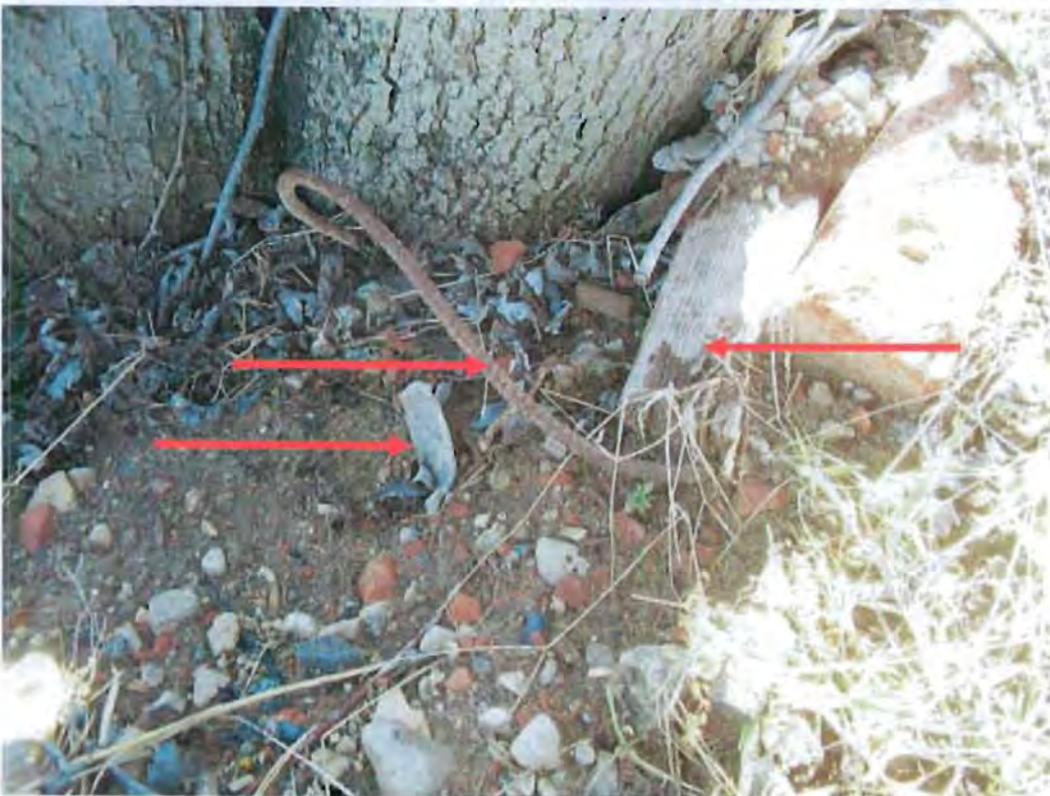
Date: March 23, 2011
Time: 9:50 AM
Direction: E
Photo by: Eisenbrandt
Exposure #: 008
Comments: Rebar, metal scrap, and dimensional lumber among crushed brick and concrete.

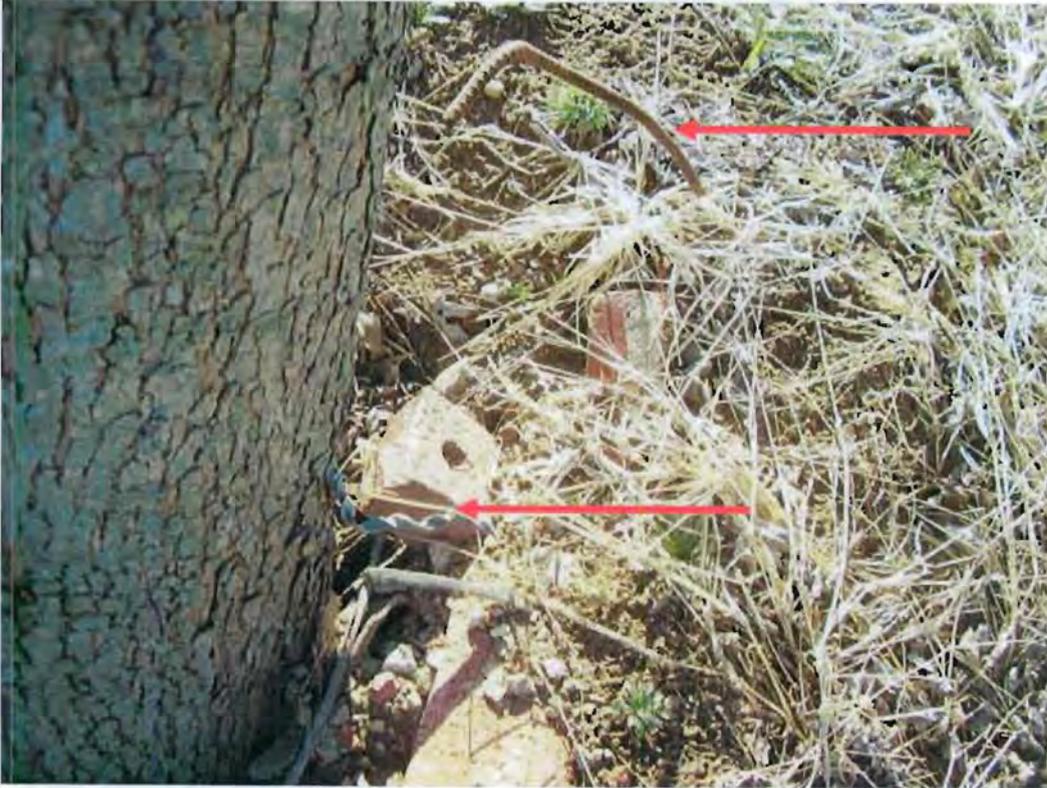
Date: March 23, 2011
Time: 9:50 AM
Direction: E
Photo by: Eisenbrandt
Exposure #: 009
Comments: Rebar, twisted metal, and brick.

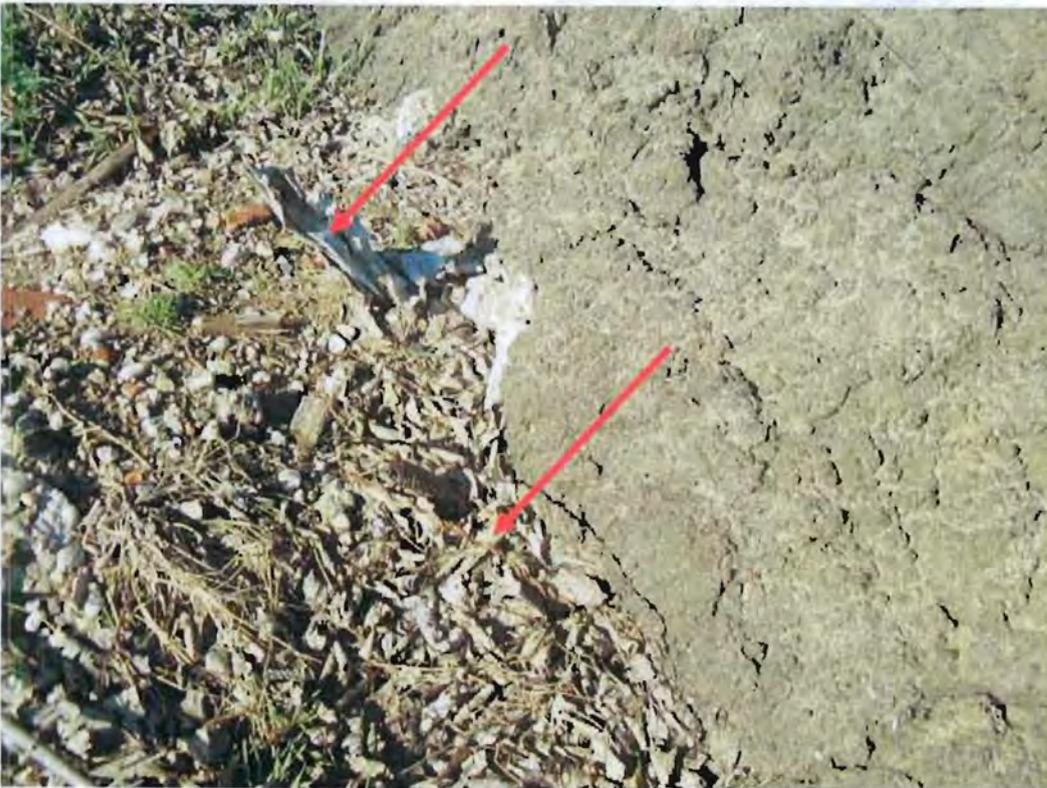
Date: March 23, 2011
Time: 9:51 AM
Direction: S
Photo by: Eisenbrandt
Exposure #: 010
Comments: Metal and twisted wire.

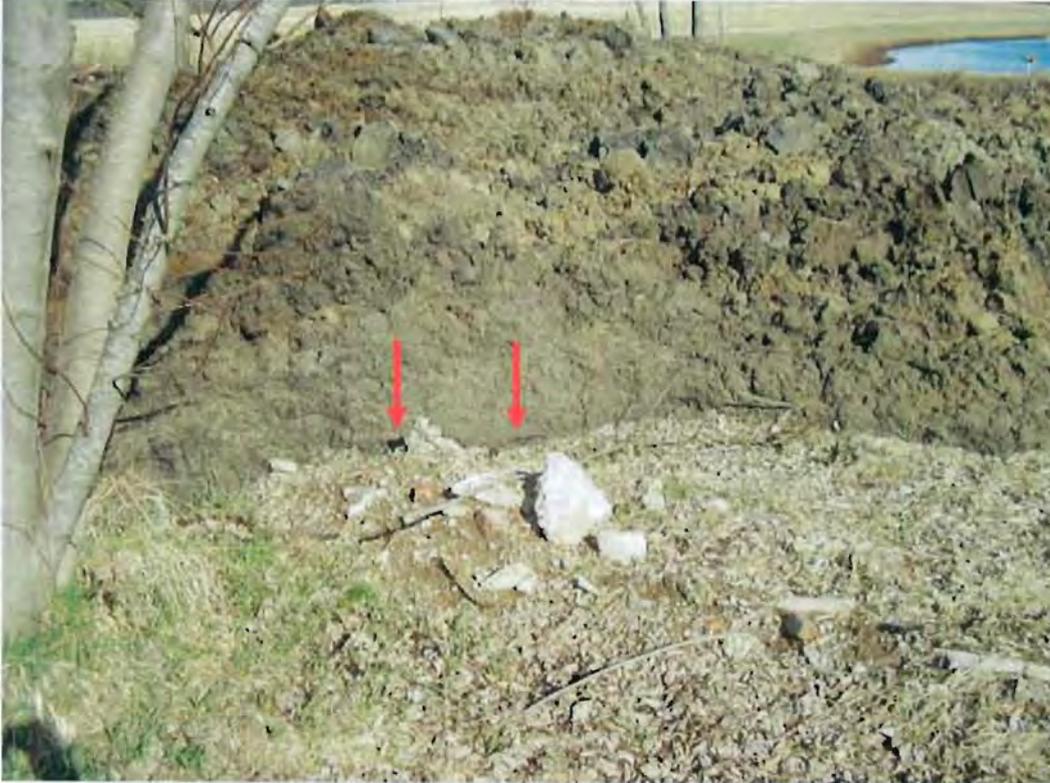
Date: March 23, 2011
Time: 9:51 AM
Direction: W
Photo by: Eisenbrandt
Exposure #: 011
Comments: Waste also seen in Photograph 010 at base of dredged material.

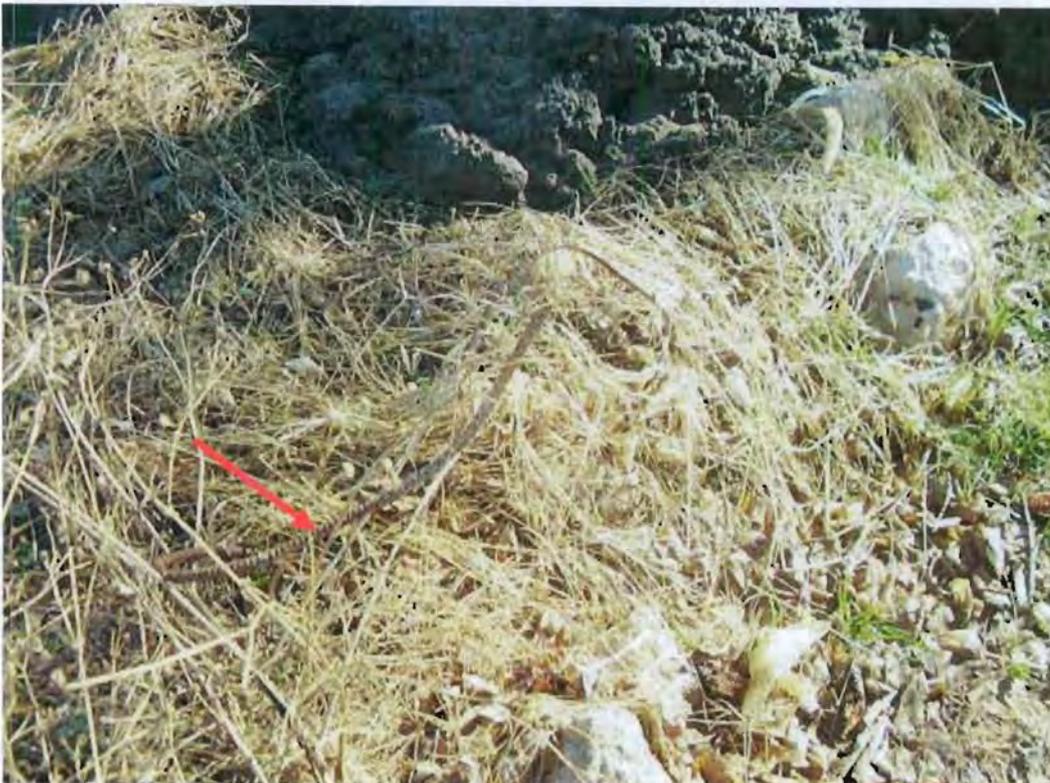
Date: March 23, 2011
Time: 9:52 AM
Direction: N
Photo by: Eisenbrandt
Exposure #: 012
Comments: Rebar.

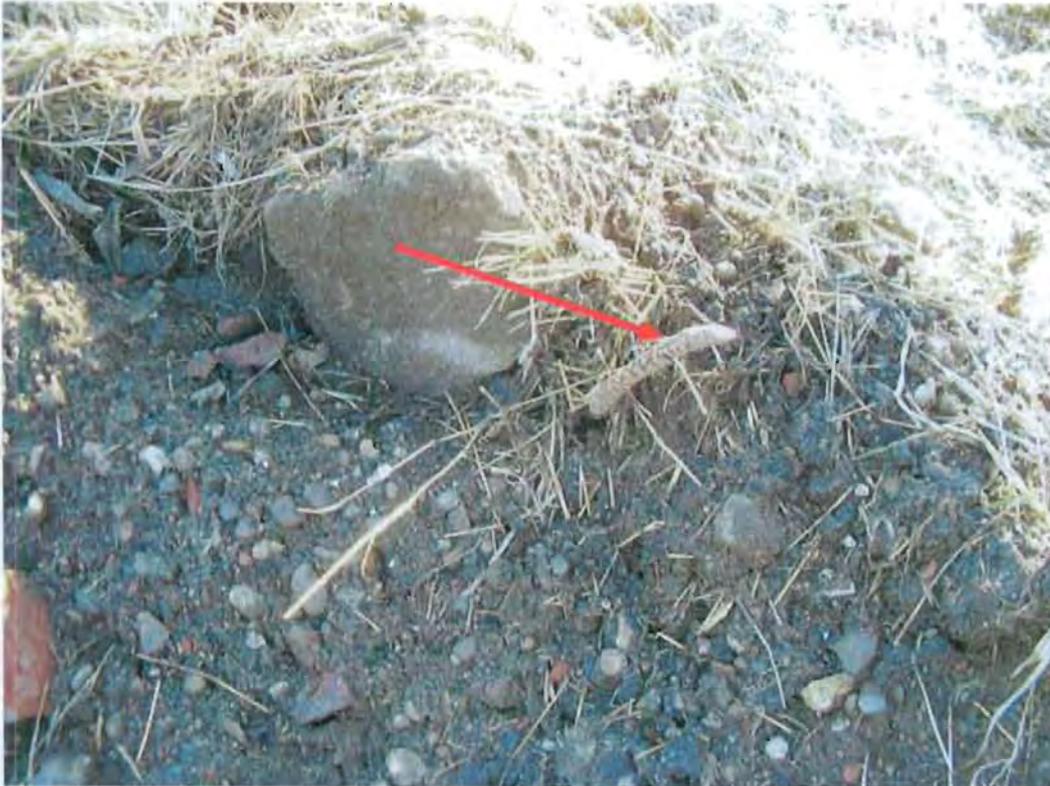
Date: March 23, 2011
Time: 9:52 AM
Direction: NE
Photo by: Eisenbrandt
Exposure #: 013
Comments: Rebar.

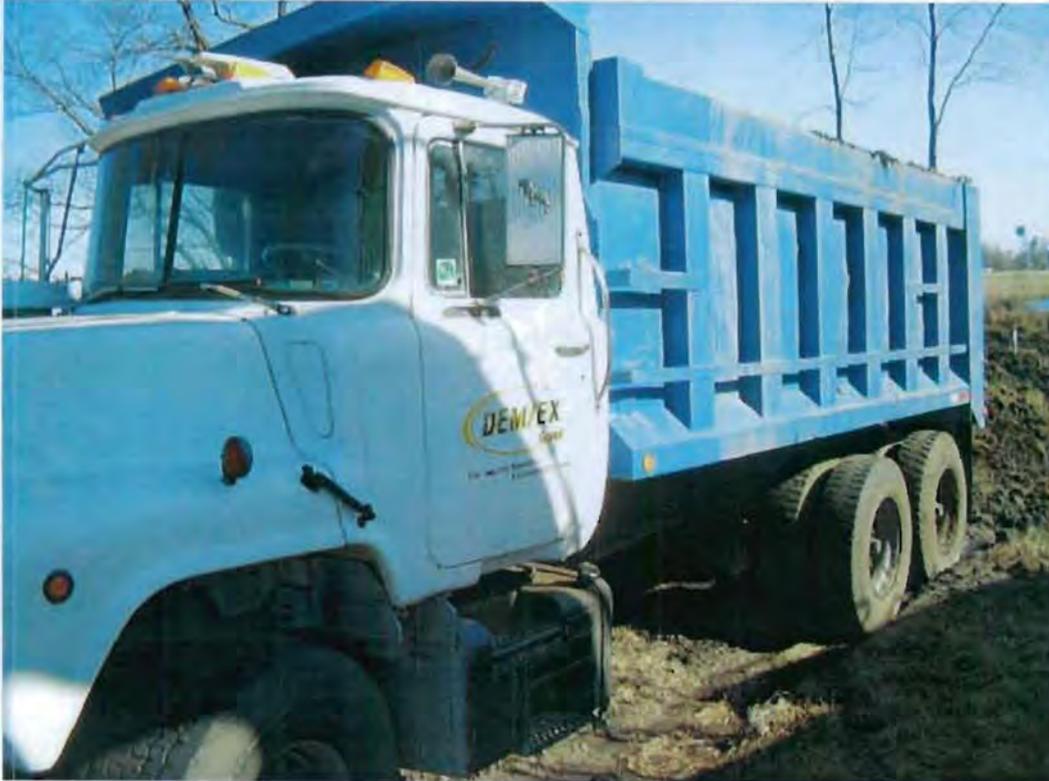
Date: March 23, 2011
Time: 9:53 AM
Direction: NW
Photo by: Eisenbrandt
Exposure #: 015
Comments: DEM/EX
dump truck.

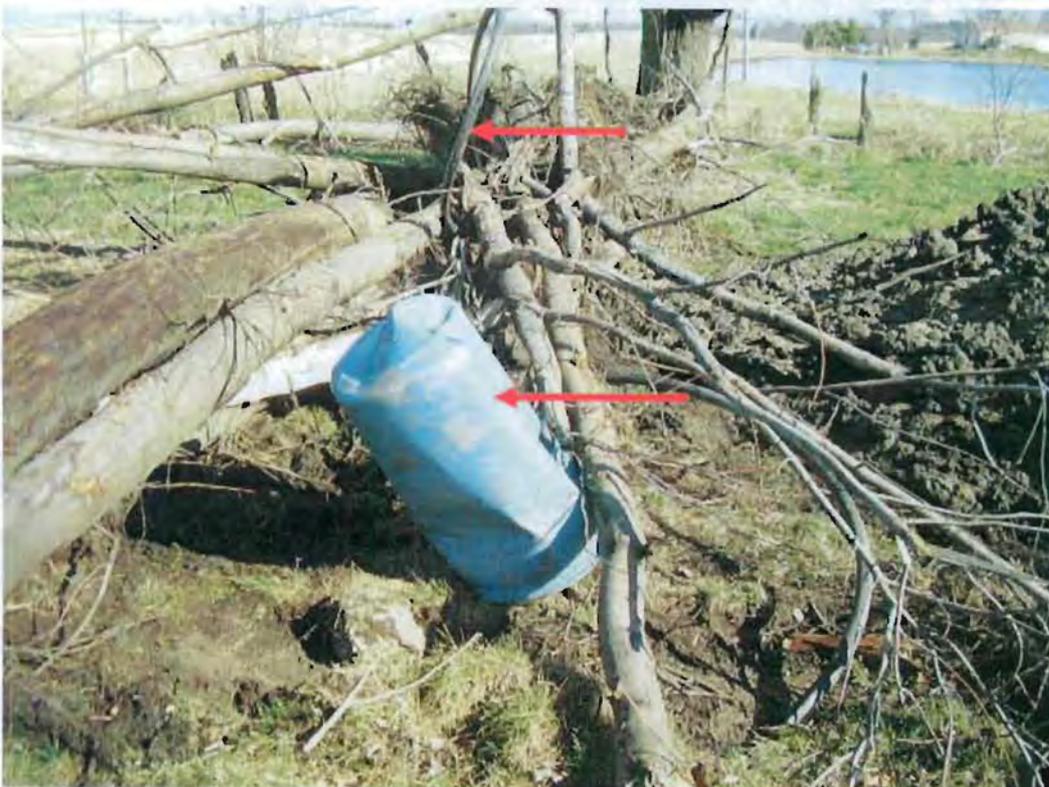
Date: March 23, 2011
Time: 9:53 AM
Direction: N
Photo by: Eisenbrandt
Exposure #: 016
Comments: Black plastic
pipe and a partially
crushed blue plastic drum.

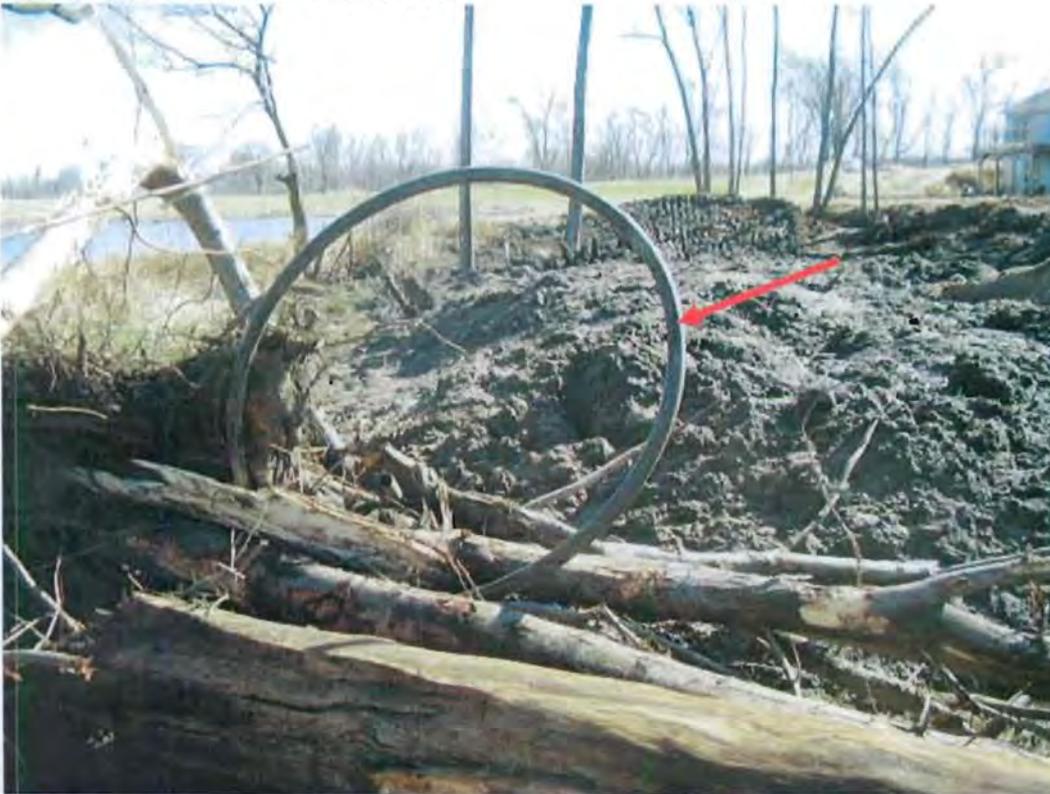
Date: March 23, 2011
Time: 9:54 AM
Direction: N-NE
Photo by: Eisenbrandt
Exposure #: 017
Comments: Black plastic pipe.

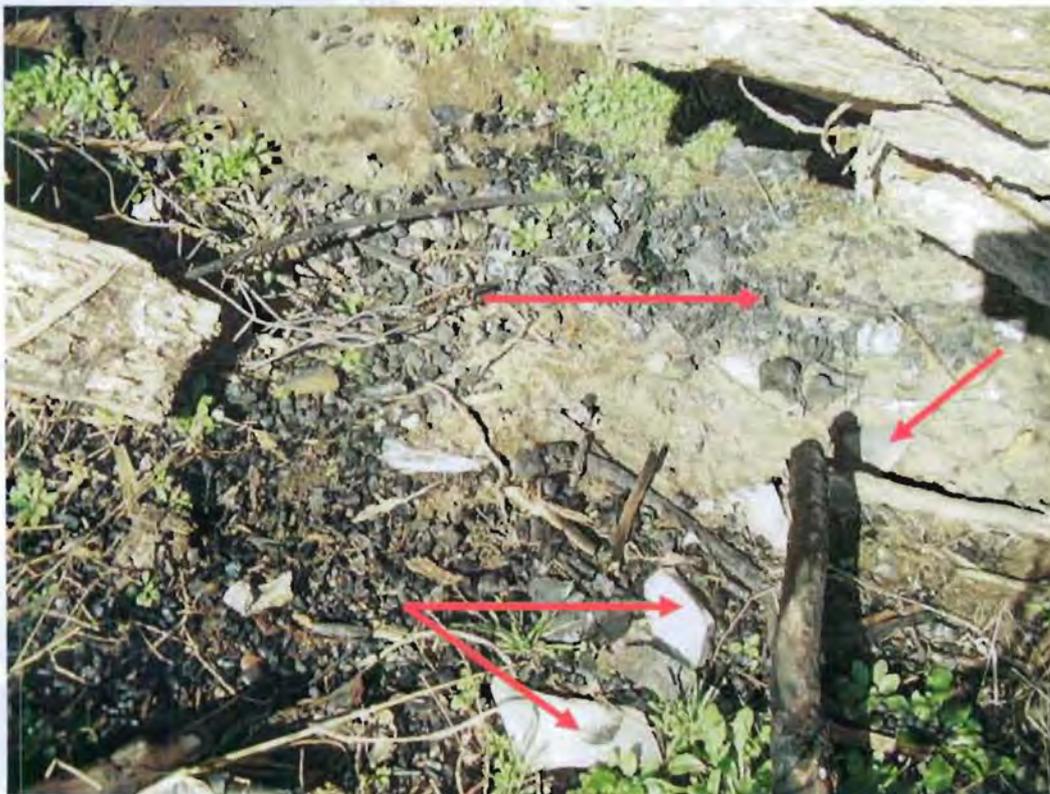
- j. Ash, charred wood, glass fragments, nails, scrap metal, and broken porcelain in a landscape waste pile *See* Complainant's Exhibit 1, (March 23, 2011, inspection photograph # 018);

Date: March 23, 2011
Time: 9:55 AM
Direction: SW
Photo by: Eisenbrandt
Exposure #: 018
Comments: Ash, charred wood, glass fragments, nails, scrap metal, and broken porcelain in a landscape waste pile.

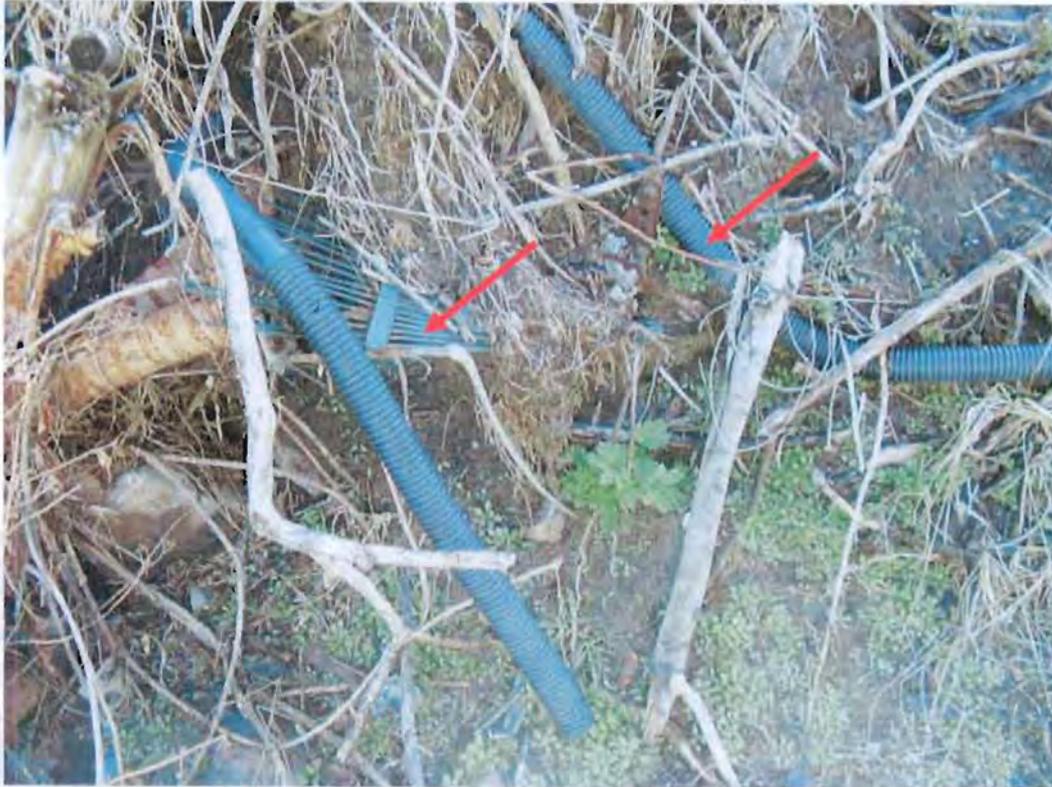
Date: March 23, 2011
Time: 9:56 AM
Direction: NE
Photo by: Eisenbrandt
Exposure #: 019
Comments: Black plastic hose and a fan rake intermixed with landscape waste.

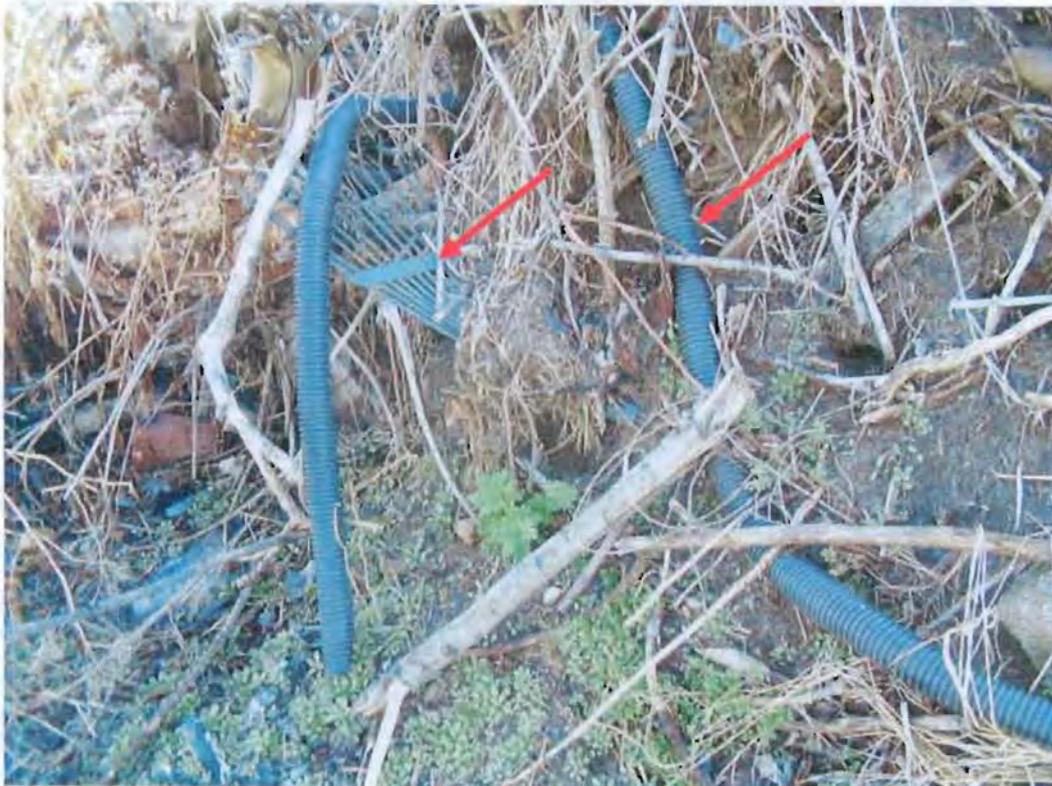
Date: March 23, 2011
Time: 9:56 AM
Direction: NE
Photo by: Eisenbrandt
Exposure #: 020
Comments: Black plastic hose and a fan rake intermixed with landscape waste.

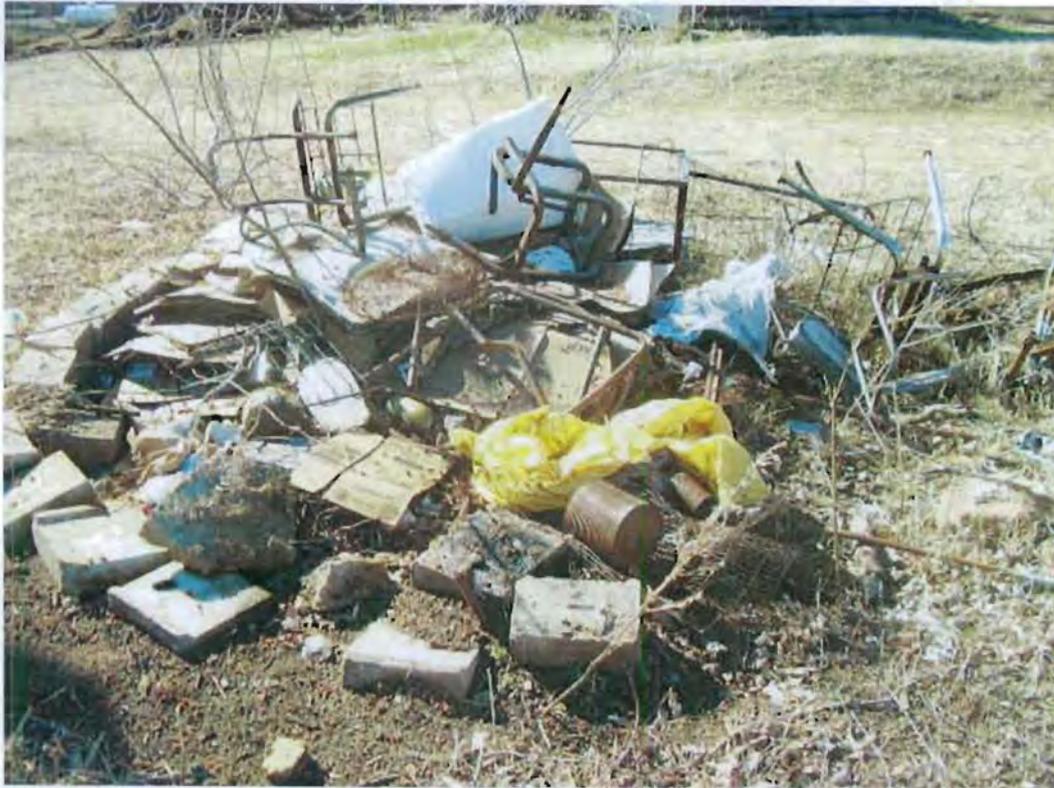
Comments: Debris pile ringed with rock west of the older house.

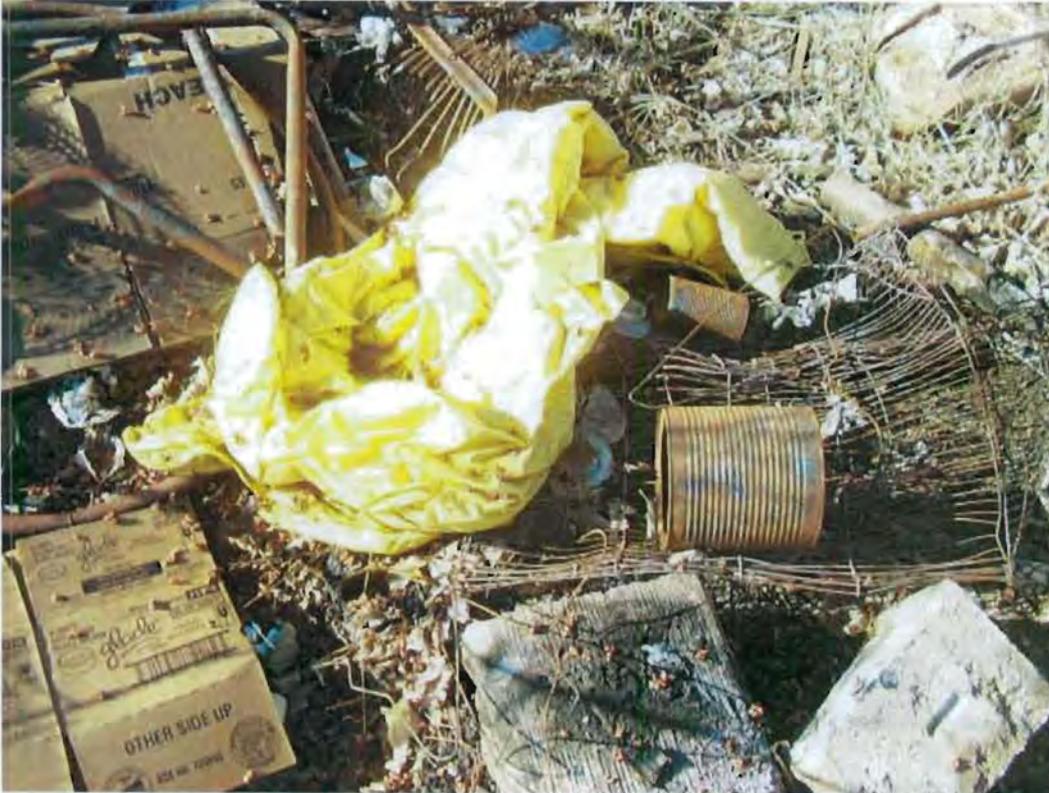
Date: March 23, 2011
Time: 9:58 AM
Direction: S
Photo by: Eisenbrandt
Exposure #: 023
Comments: A yellow rain coat, the head of a fan rake, wire fencing, and metal bars were among the waste.

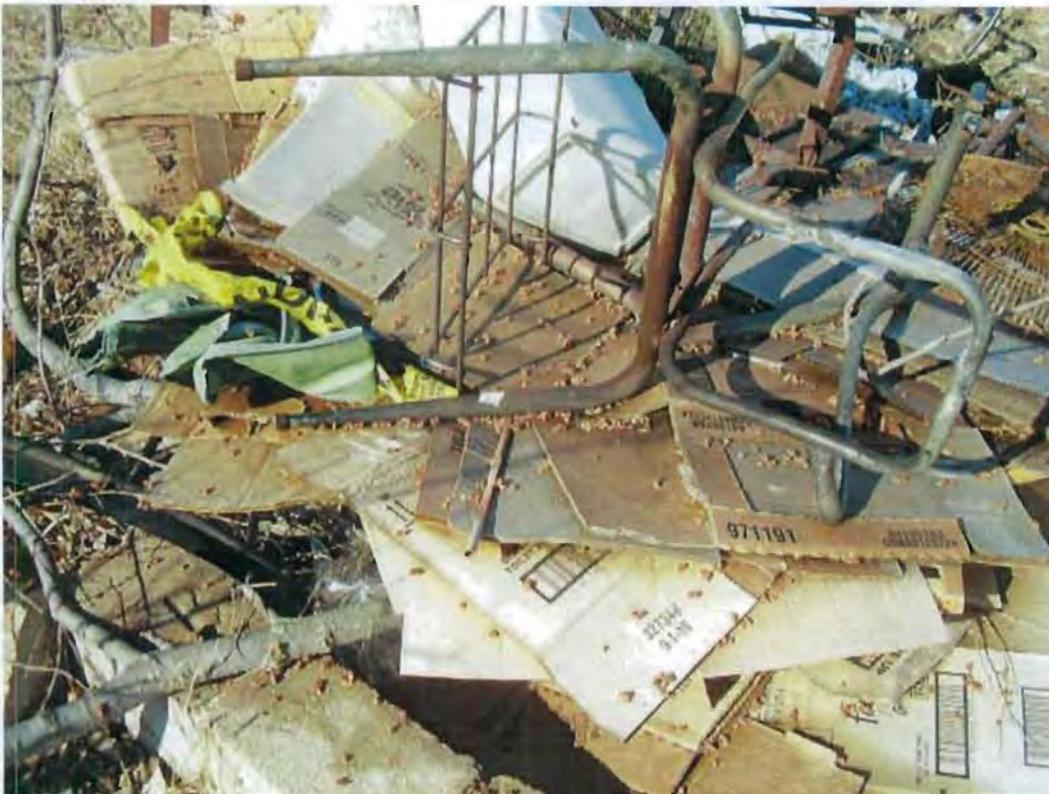
Date: March 23, 2011
Time: 9:58 AM
Direction: SW
Photo by: Eisenbrandt
Exposure #: 024
Comments: A metal frame to a school-like chair, yellow caution tape, cardboard boxes, a green folding chair, a wire fan shield were among the waste.

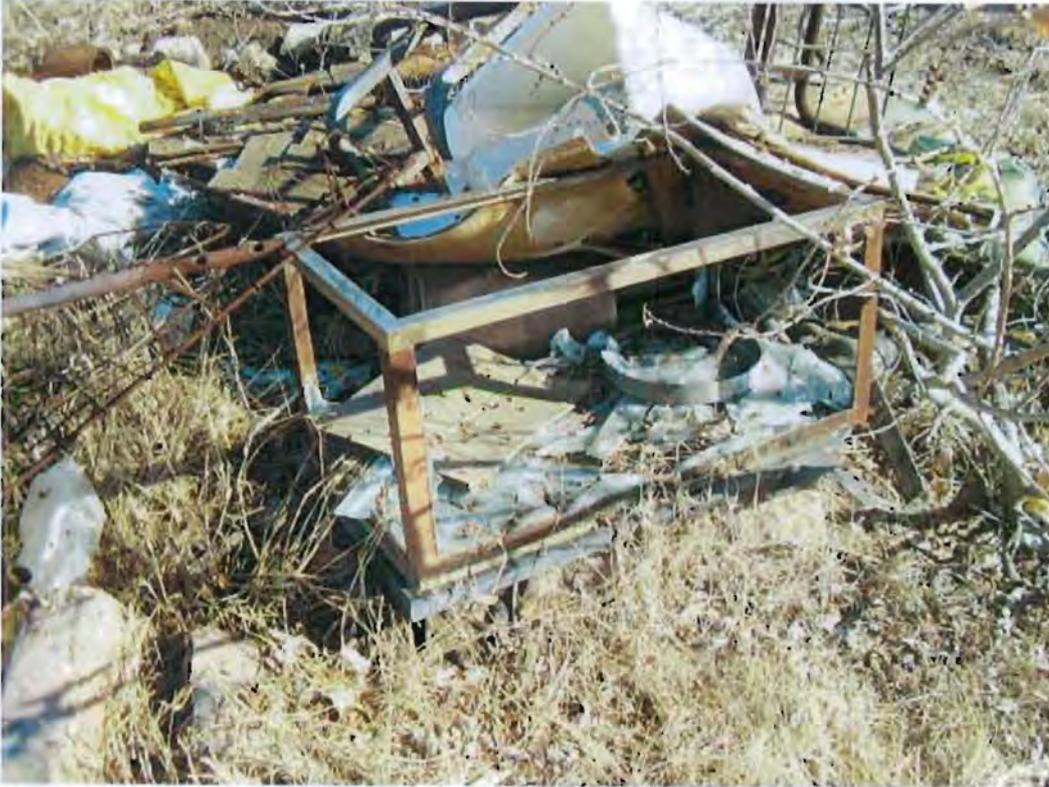
Date: March 23, 2011
Time: 9:58 AM
Direction: N
Photo by: Eisenbrandt
Exposure #: 025
Comments: A white plastic garbage can, an aquarium frame, broken glass, a mattress frame, aluminum cans, a bed sheet, plastic cups, a St. Louis Zoo drink cup, and a plastic pitcher were among the waste.

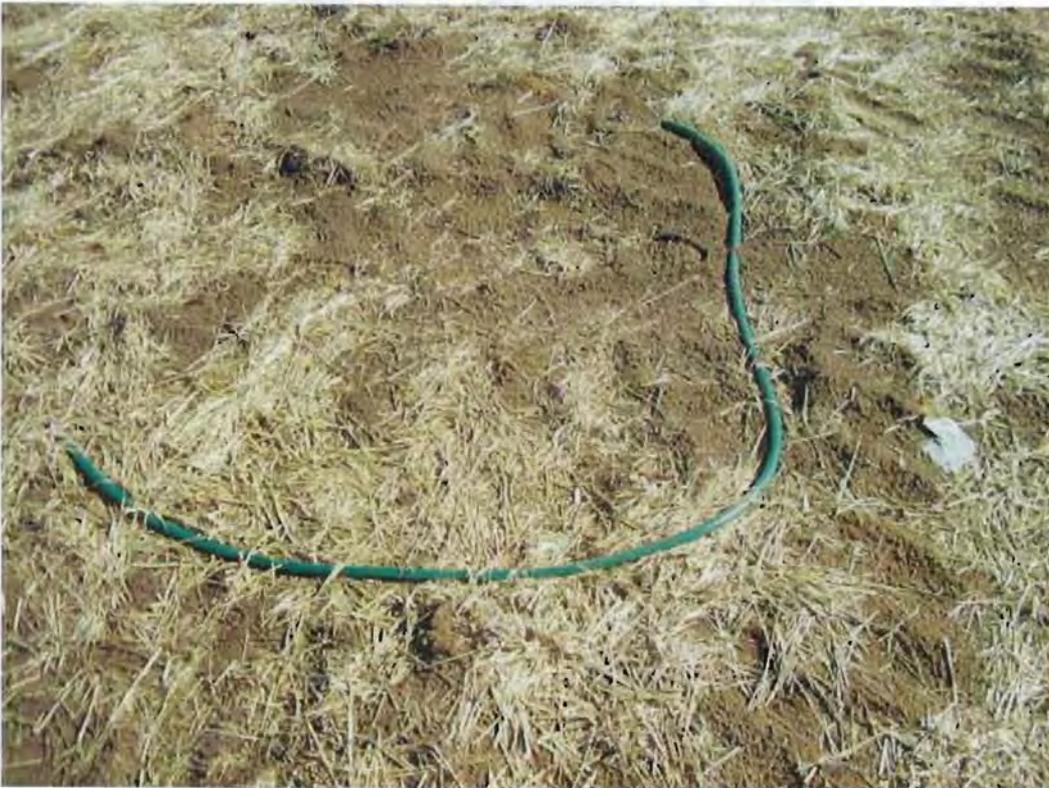
Date: March 23, 2011
Time: 10:05 AM
Direction: N
Photo by: Eisenbrandt
Exposure #: 026
Comments: A section of green garden hose.
