BEFORE THE ILLINOIS POLLUTION CONTROL BOARD

RESIDENTIAL SITE OPEN DUMPING VIOLATIONS

CORPORATE SITE OPEN BURNING

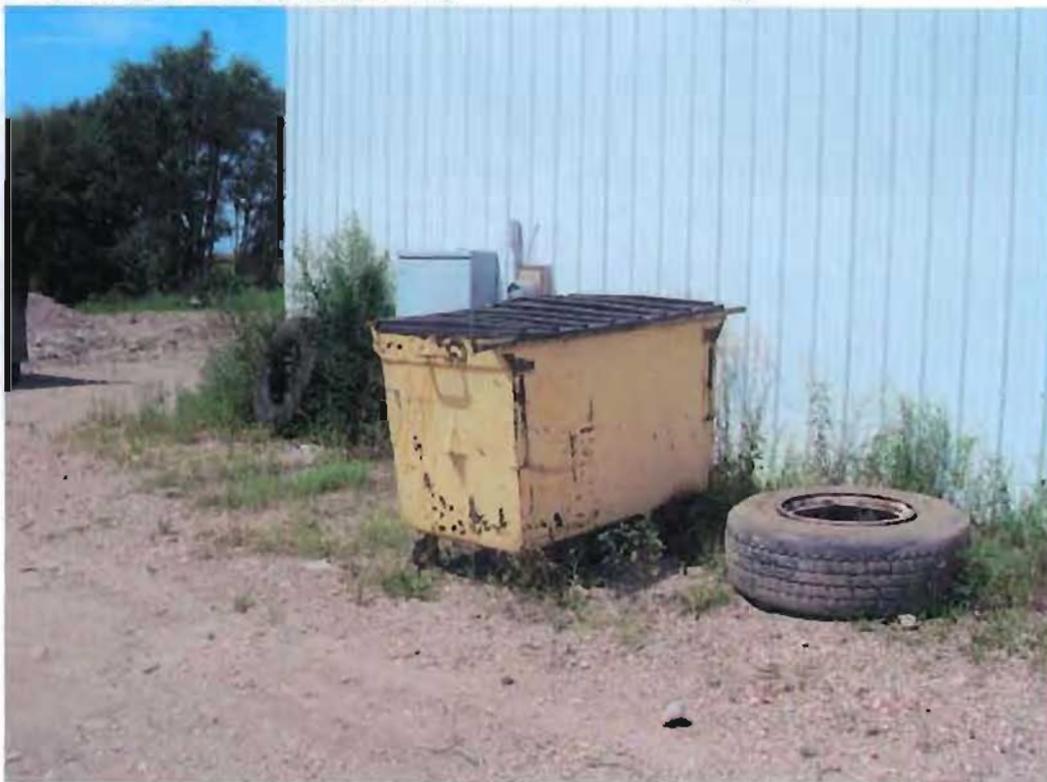
Date: August 4, 2010.
Time: 11:41 AM
Direction: SW
Photo by: Eisenbrandt
Exposure #: 003
Comments: Two used tires on the east side of the maintenance garage.

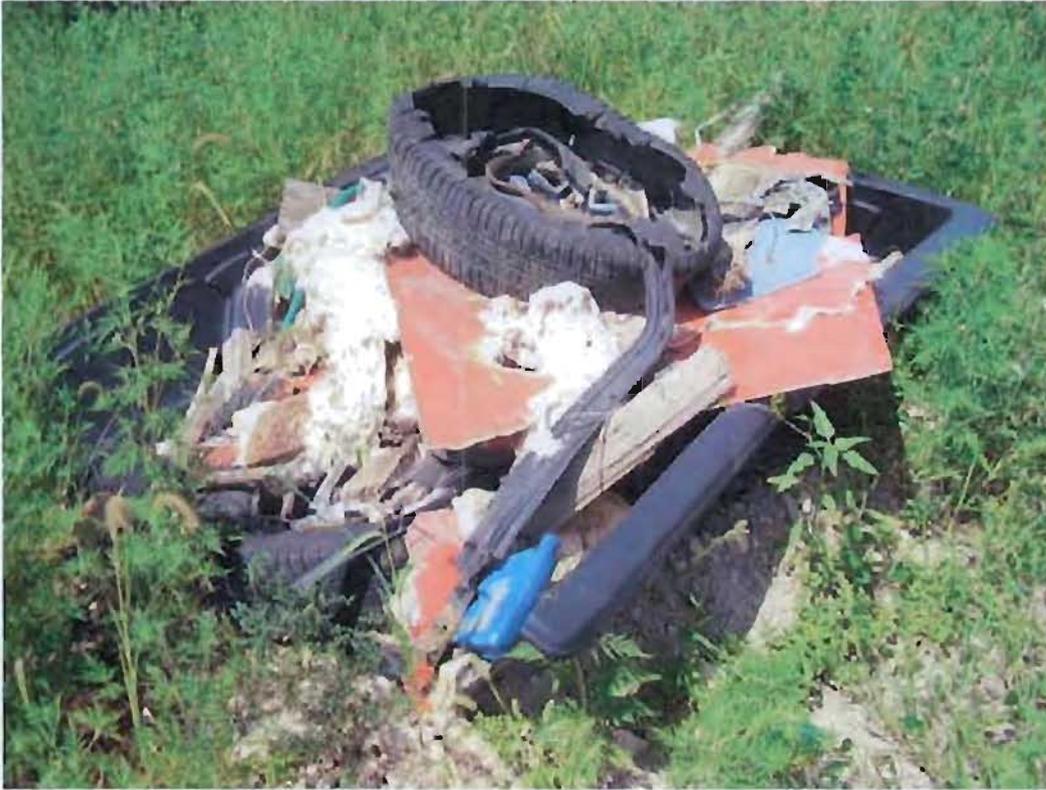
Date: August 4, 2010.
Time: 11:43 AM
Direction: SE
Photo by: Eisenbrandt
Exposure #: 005
Comments: A pickup truck bed liner filled with waste. Two used tires (both off-rim), fiberglass insulation, damage scrap lumber, plastic sheeting, a garden hose, and a plastic bottle were among the waste observed.

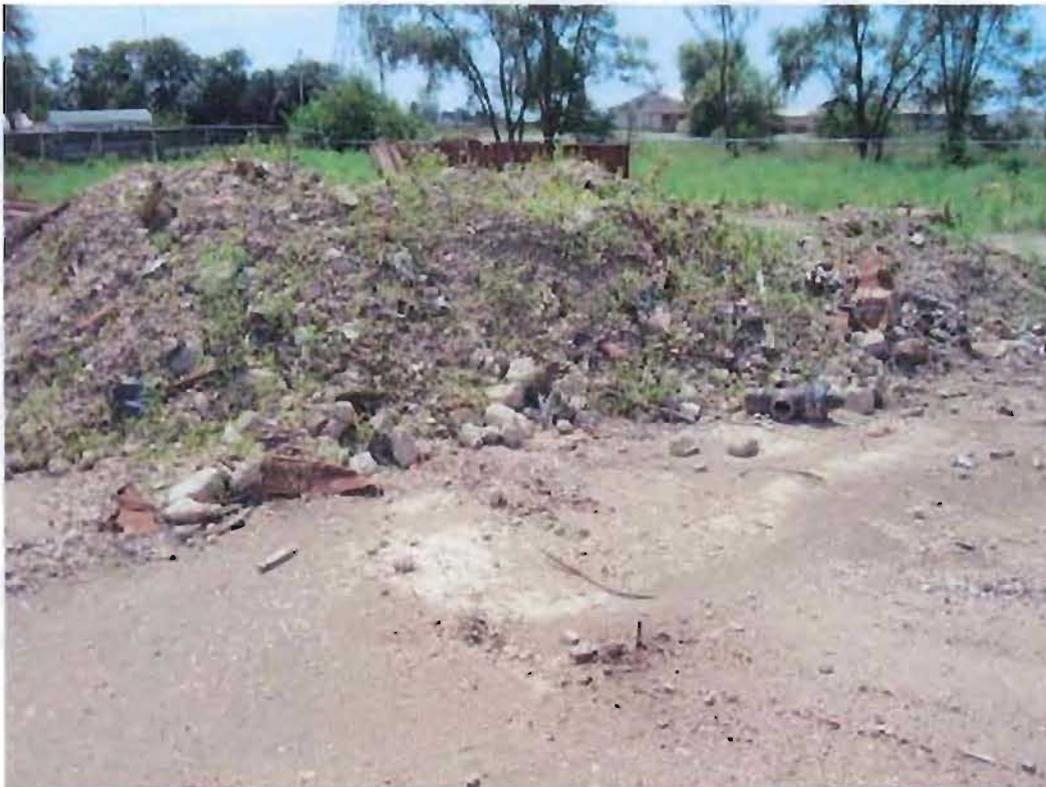
Date: August 4, 2010.
Time: 11:45 AM
Direction: SE
Photo by: Eisenbrandt
Exposure #: 006
Comments: A pile of demolition debris with the start of weedy vegetation.

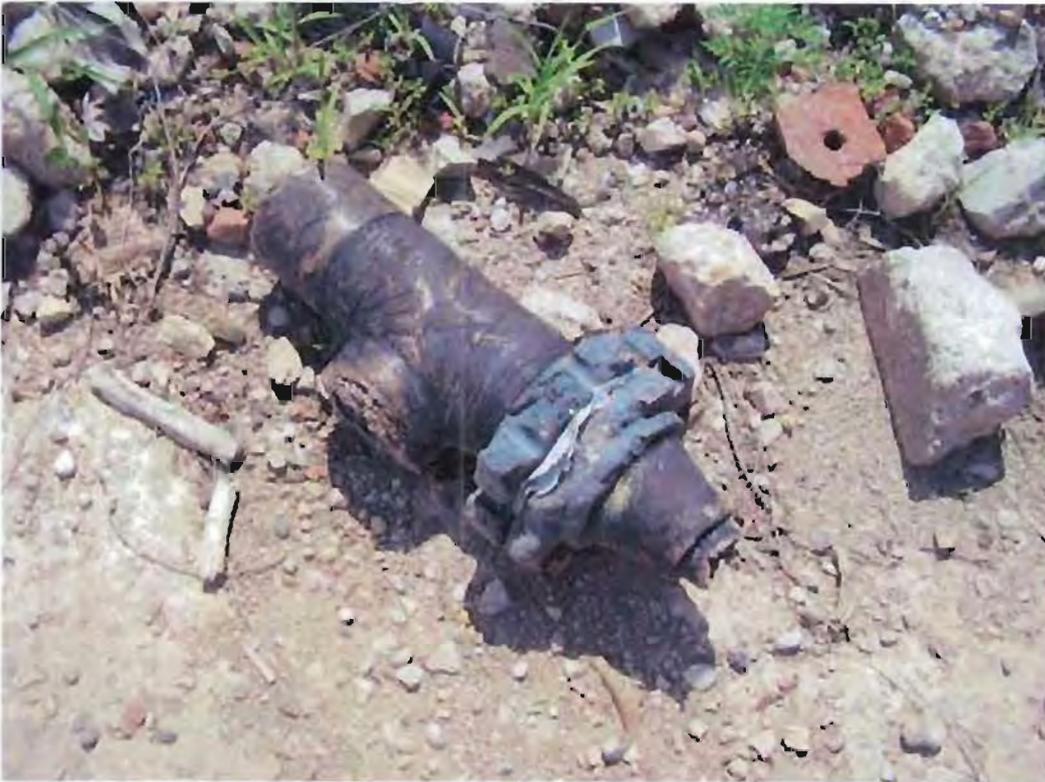
Date: August 4, 2010.
Time: 11:45 AM
Direction: SE
Photo by: Eisenbrandt
Exposure #: 007
Comments: Crushed splinters of lumber, a section of pipe, brick, and concrete were observed in the debris pile.

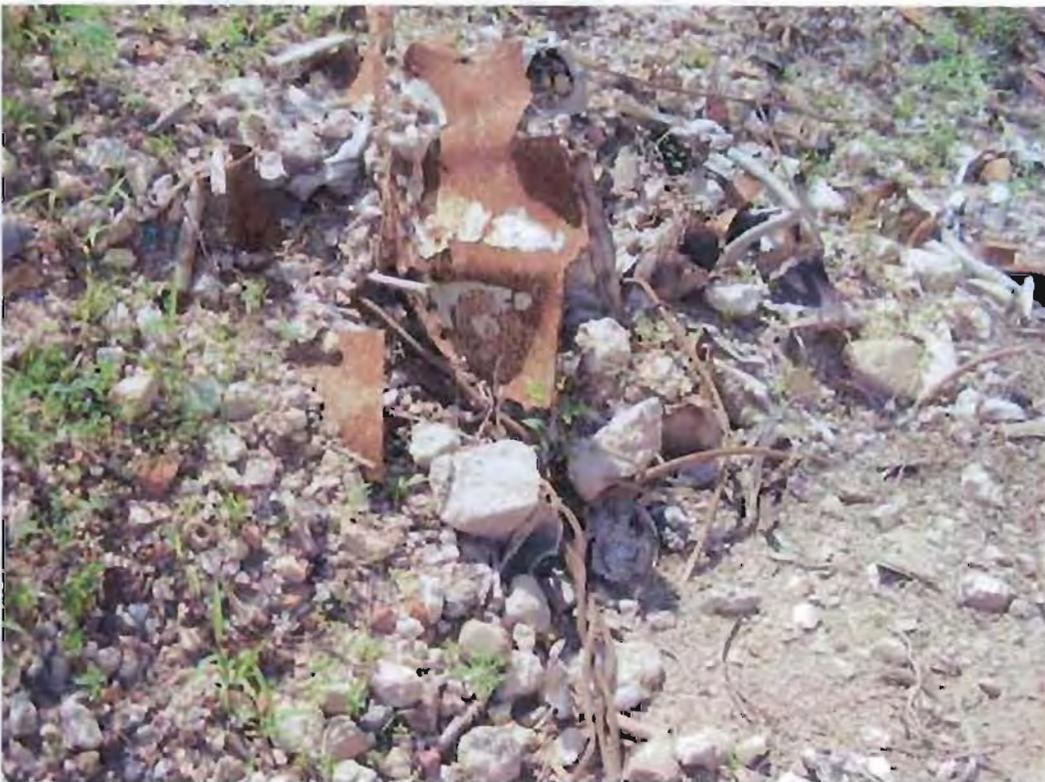
Date: August 4, 2010.
Time: 11:45 AM
Direction: S
Photo by: Eisenbrandt
Exposure #: 008
Comments: The demolition debris pile also contained copious amounts of rusty scrap metal.

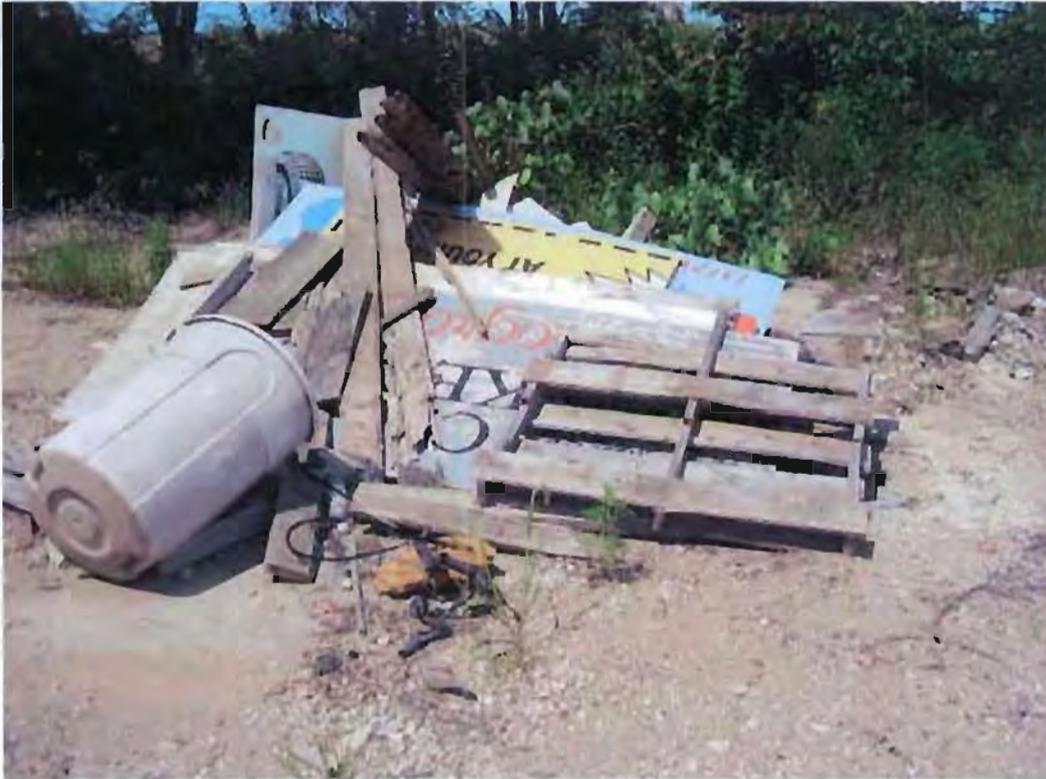
Date: August 4, 2010.
Time: 11:45 AM
Direction: SW
Photo by: Eisenbrandt
Exposure #: 009
Comments: A pile of waste. Broken pallets, damaged dimensional lumber, discarded signage, metal bands, and foam insulation were among the waste observed.

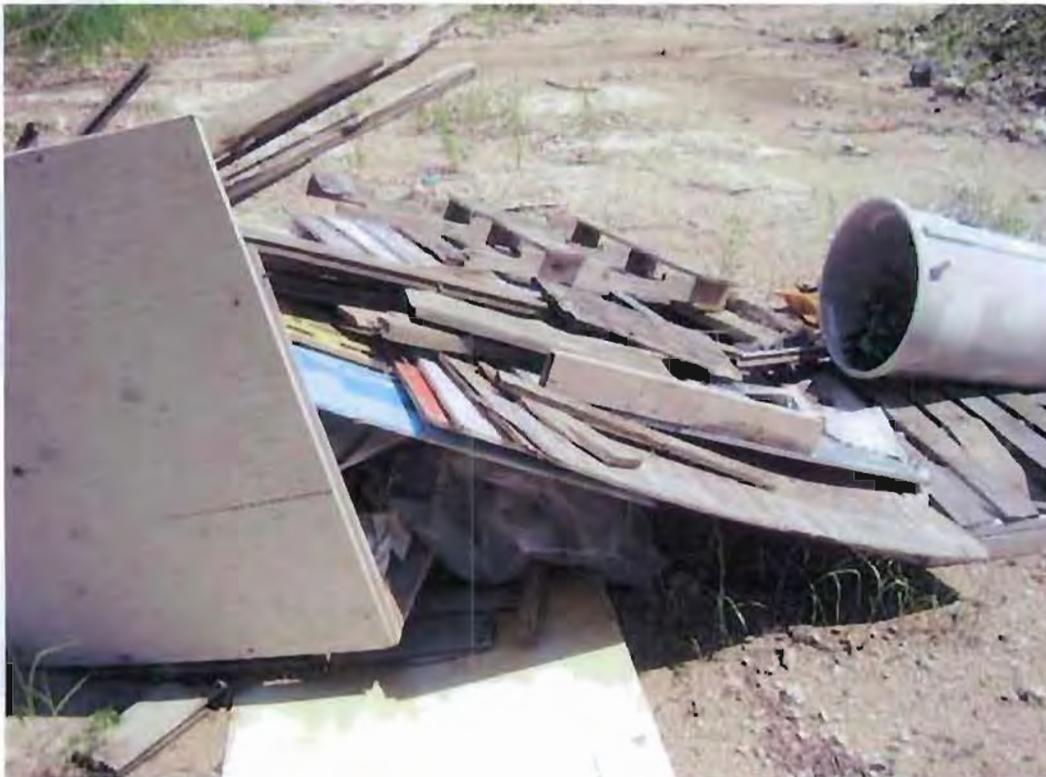
Date: August 4, 2010.
Time: 11:45 AM
Direction: N
Photo by: Eisenbrandt
Exposure #: 010
Comments: Alternate view of the pile of waste. Plywood, processed lumber, and plastic sheeting were observed.

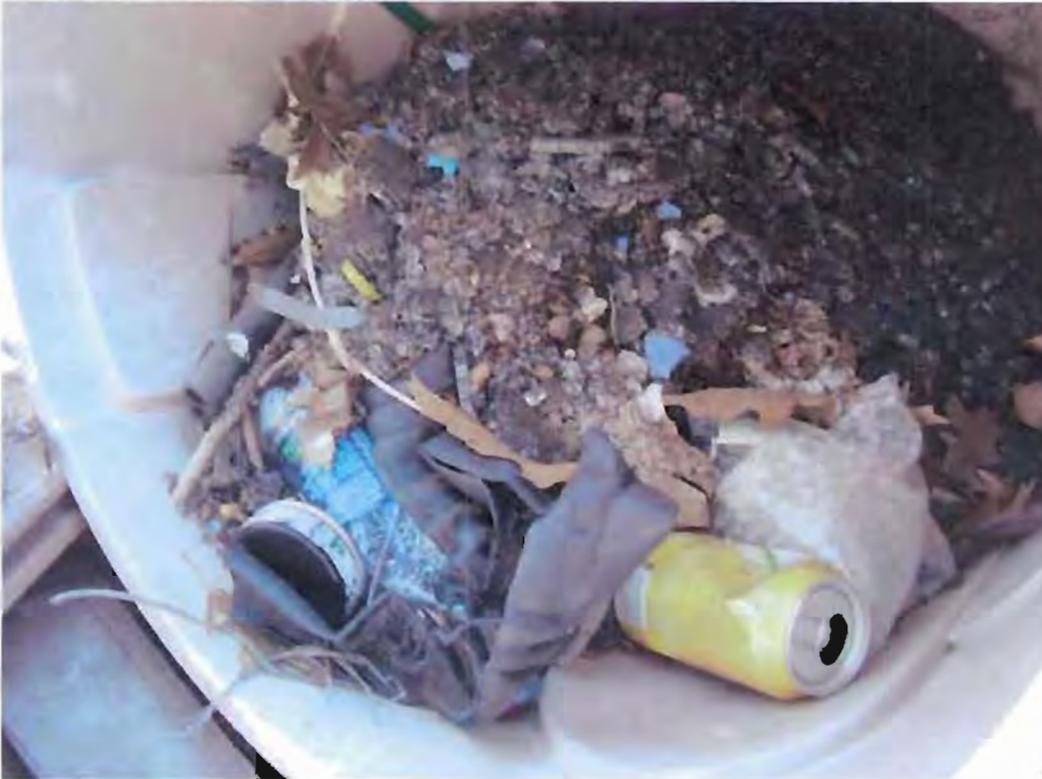
Date: August 4, 2010.
Time: 11:45 AM
Direction: E
Photo by: Eisenbrandt
Exposure #: 011
Comments: The beige plastic garbage can (on its side and seen in the previous two photographs) contained broken glass, plastic, a piece rubber hose, an aluminum can, and miscellaneous waste.

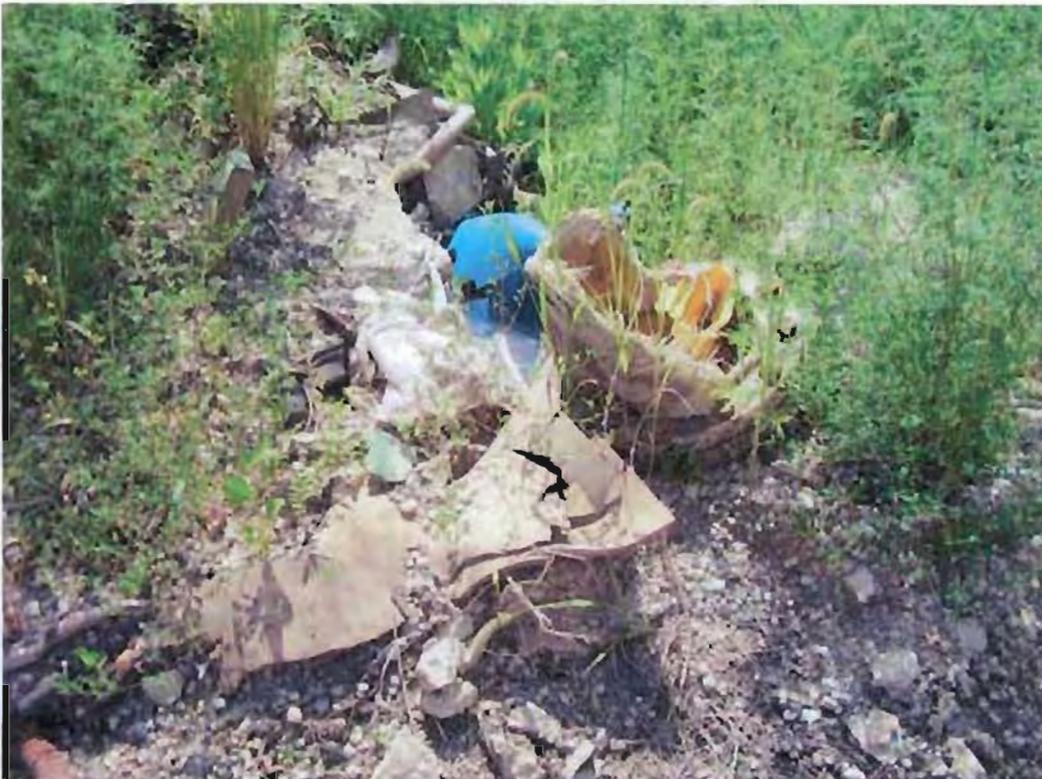
Date: August 4, 2010.
Time: 11:46 AM
Direction: SE
Photo by: Eisenbrandt
Exposure #: 012
Comments: Fiberglass pipe, blue plastic scrap, insulation, and scrap metal.

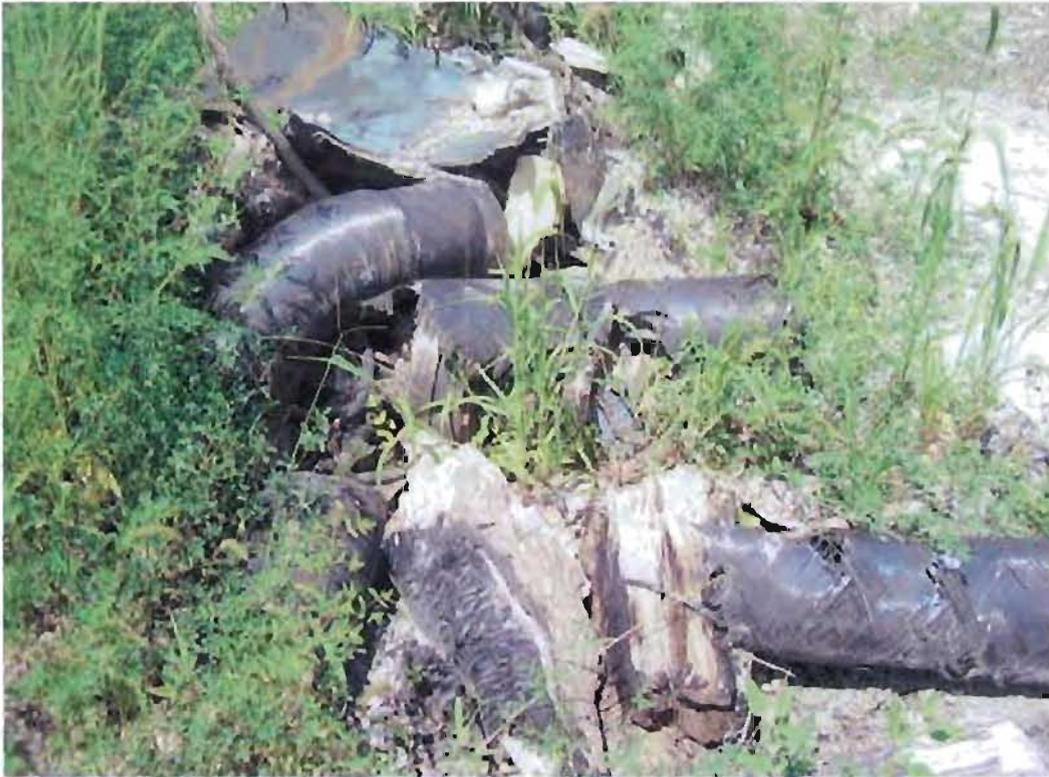
Date: August 4, 2010.
Time: 11:46 AM
Direction: W
Photo by: Eisenbrandt
Exposure #: 013
Comments: Fiberglass pipe, charred landscape debris, and miscellaneous waste.

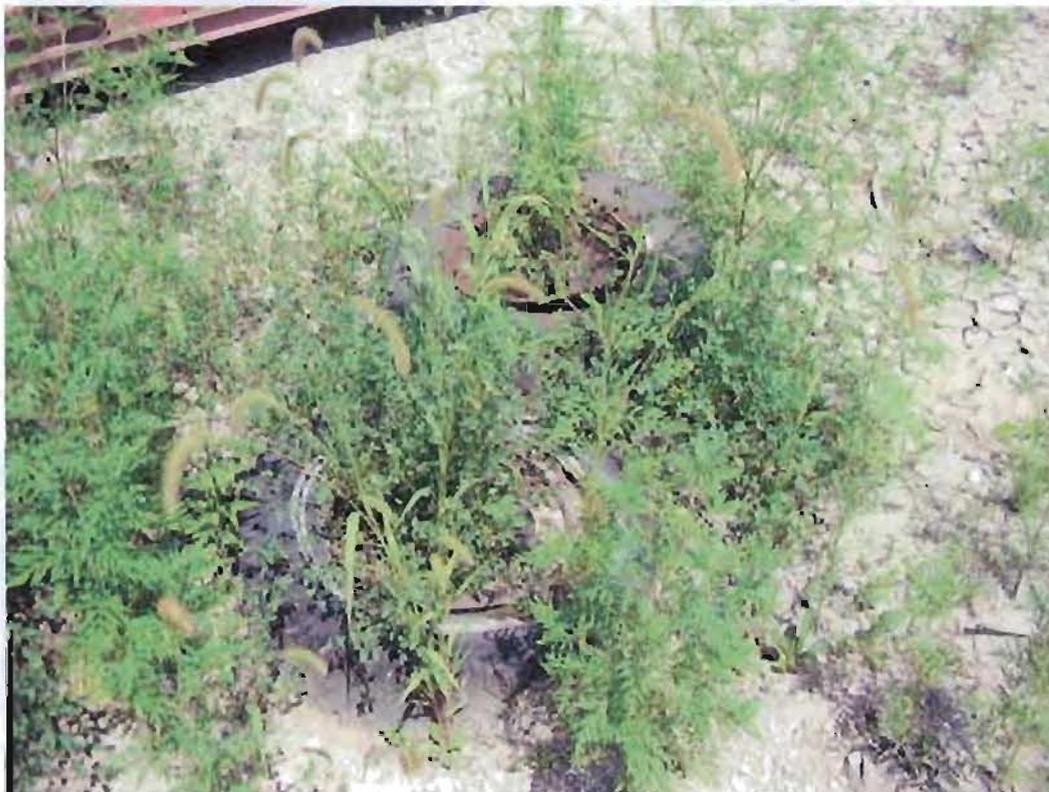
Date: August 4, 2010.
Time: 11:47 AM
Direction: SE
Photo by: Eisenbrandt
Exposure #: 014
Comments: Two on-rim used tires with weedy vegetation growing through them.

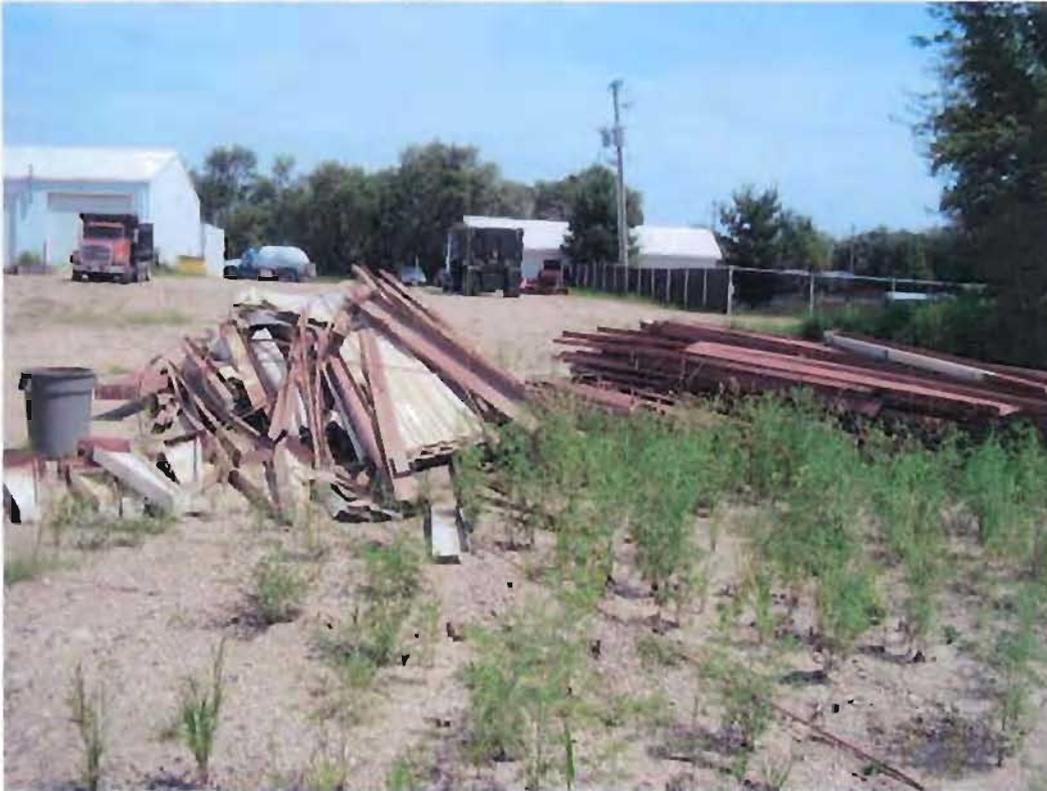
Date: August 4, 2010.
Time: 11:48 AM
Direction: N
Photo by: Eisenbrandt
Exposure #: 015
Comments: Stacked steel.

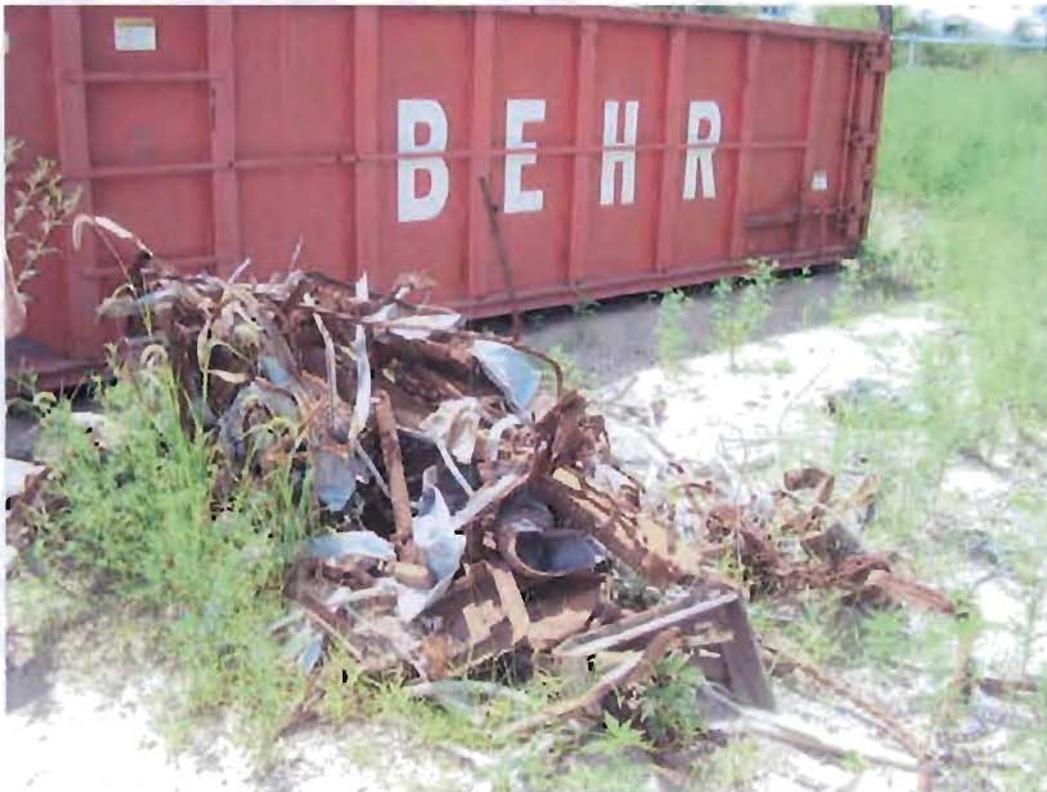
- k. A pile of scrap metal beside a recycling dumpster (Complainant's Exhibit 2, August 4, 2010, Exposure 16, p. 8);
- l. A rusty spring, rusty scrap metal, and plastic debris strewn on the ground (Complainant's Exhibit 2, August 4, 2010, Exposure 17, p. 9);

Date: August 4, 2010.
Time: 11:48 AM
Direction: SE
Photo by: Eisenbrandt
Exposure #: 016
Comments: A pile of scrap metal beside a recycling dumpster.

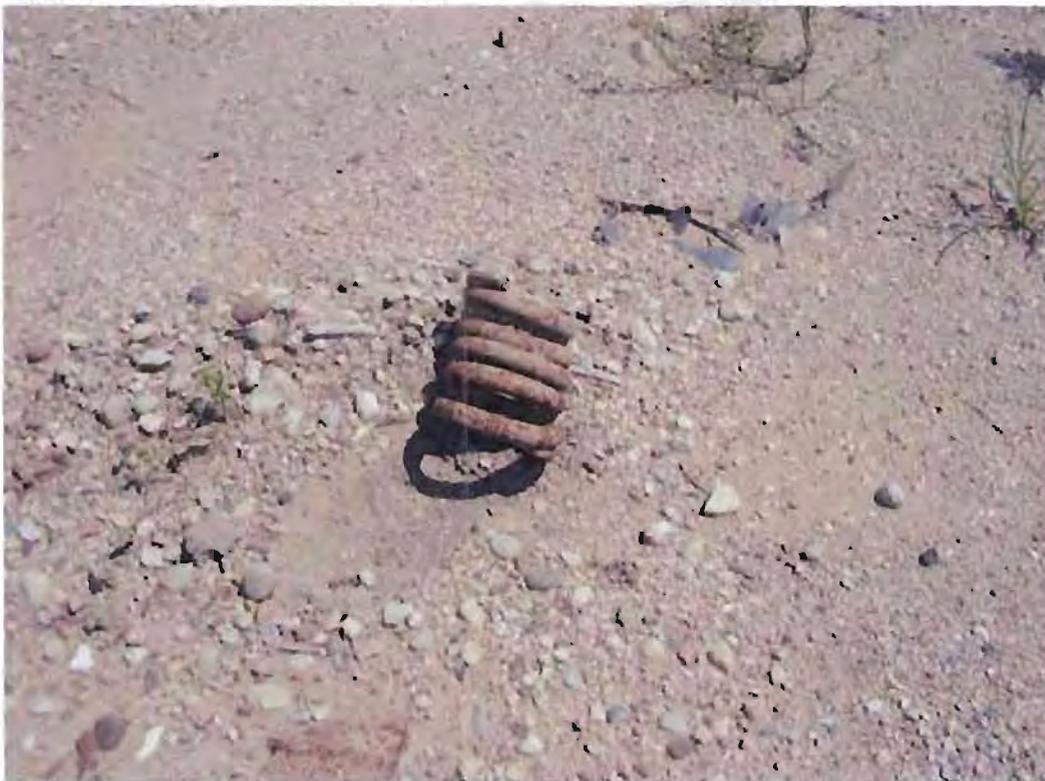
Date: August 4, 2010.
Time: 11:48 AM
Direction: E
Photo by: Eisenbrandt
Exposure #: 017
Comments: A rusty spring, rusty scrap metal, and plastic debris observed on the ground.

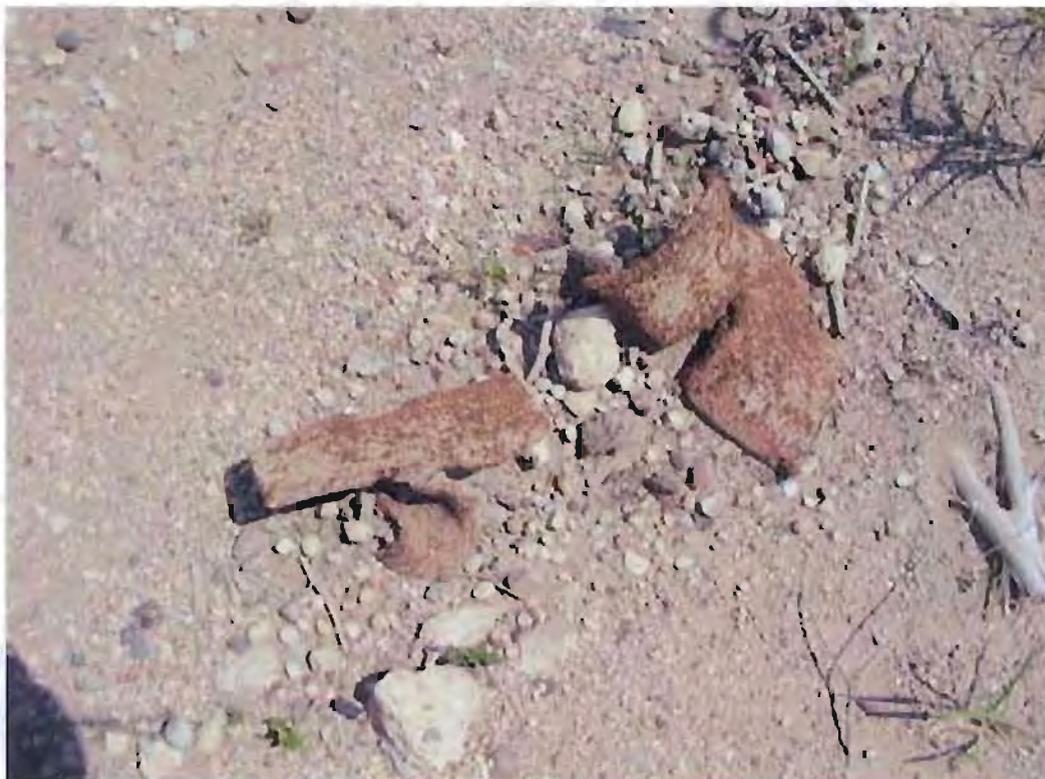
- m. Pieces of rusty scrap metal strewn on the ground (Complainant's Exhibit 2, August 4, 2010, Exposure 18, p. 9);

Date: August 4, 2010.
Time: 11:48 AM
Direction: NE
Photo by: Eisenbrandt
Exposure #: 018
Comments: Pieces of rusty scrap metal on the ground.

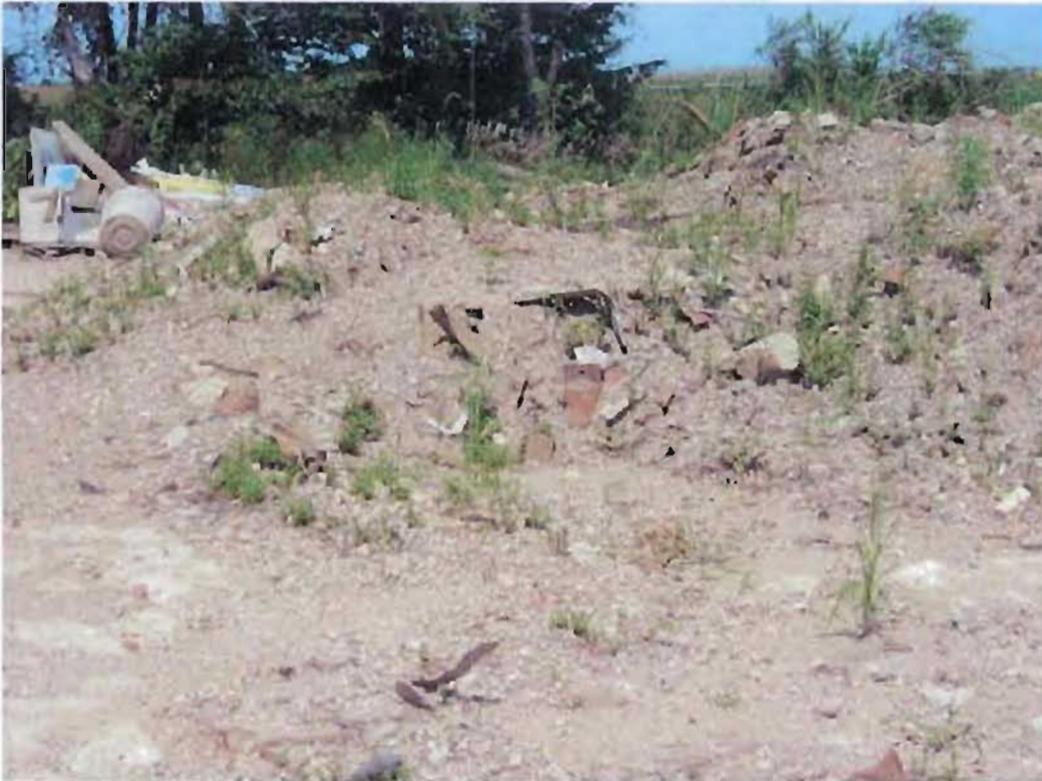
Date: August 4, 2010.
Time: 11:49 AM
Direction: SW
Photo by: Eisenbrandt
Exposure #: 019
Comments: A debris pile with copious amounts of scrap metal, splintered wood, and miscellaneous waste.

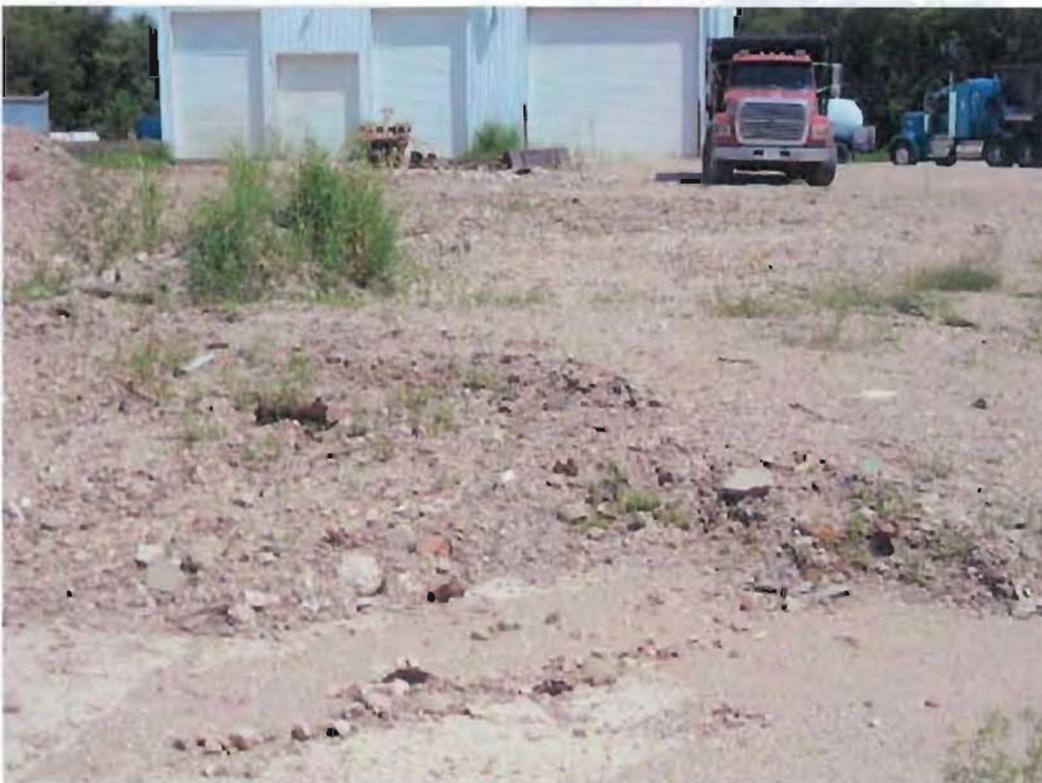
Date: August 4, 2010.
Time: 11:49 AM
Direction: N
Photo by: Eisenbrandt
Exposure #: 020
Comments: Ground surface south of the maintenance garage. Scrap metal, concrete, and brick were intermixed with miscellaneous demolition debris.

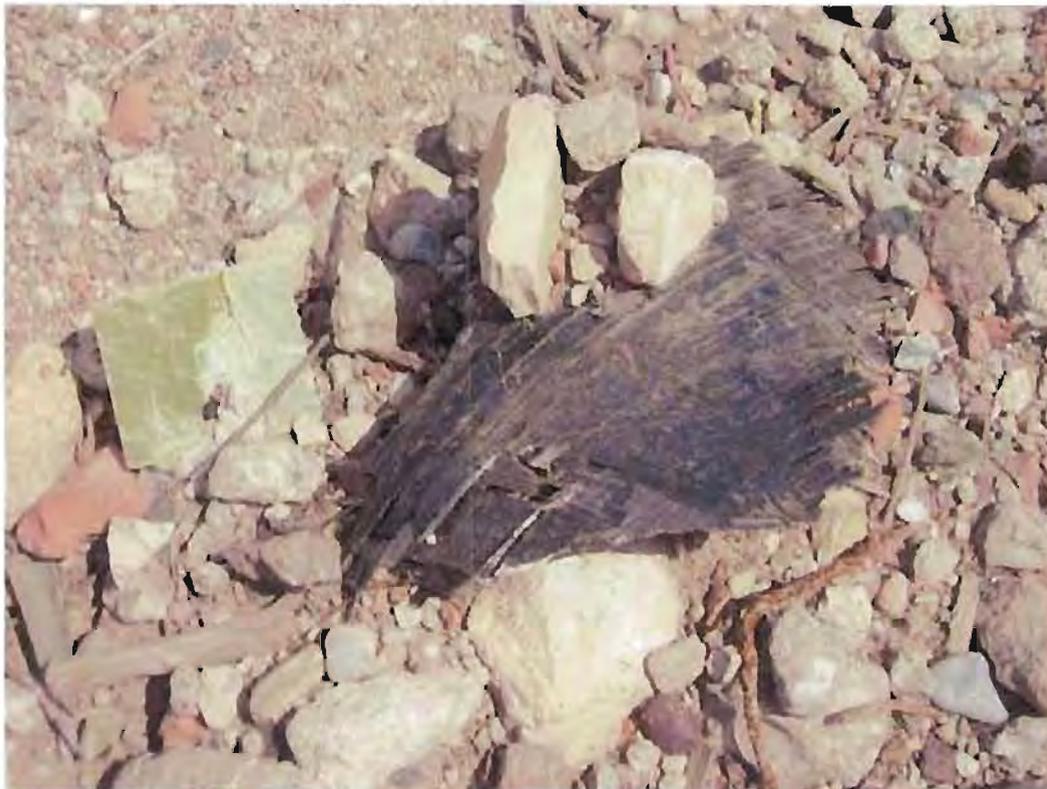
Date: August 4, 2010.
Time: 11:49 AM
Direction: N
Photo by: Eisenbrandt
Exposure #: 021
Comments: A close up photograph of the ground surface seen in Photograph 020. Rusty scrap metal, fiberglass, wire, splintered lumber, and scraps of plastic were observed intermixed with concrete, mortar, and brick fragments.

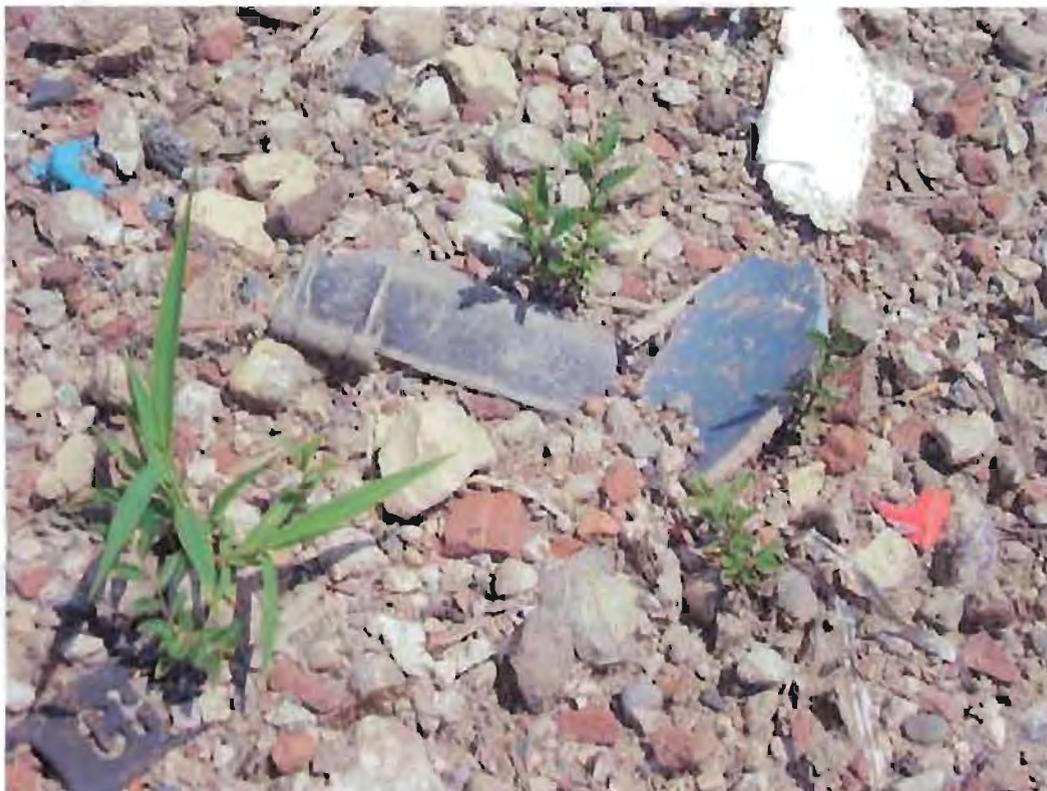
Date: August 4, 2010.
Time: 11:49 AM
Direction: SE
Photo by: Eisenbrandt
Exposure #: 022
Comments: Red, blue, and black plastic, carpet, black rubber, cast iron, and splinters of wood were observed on the ground.

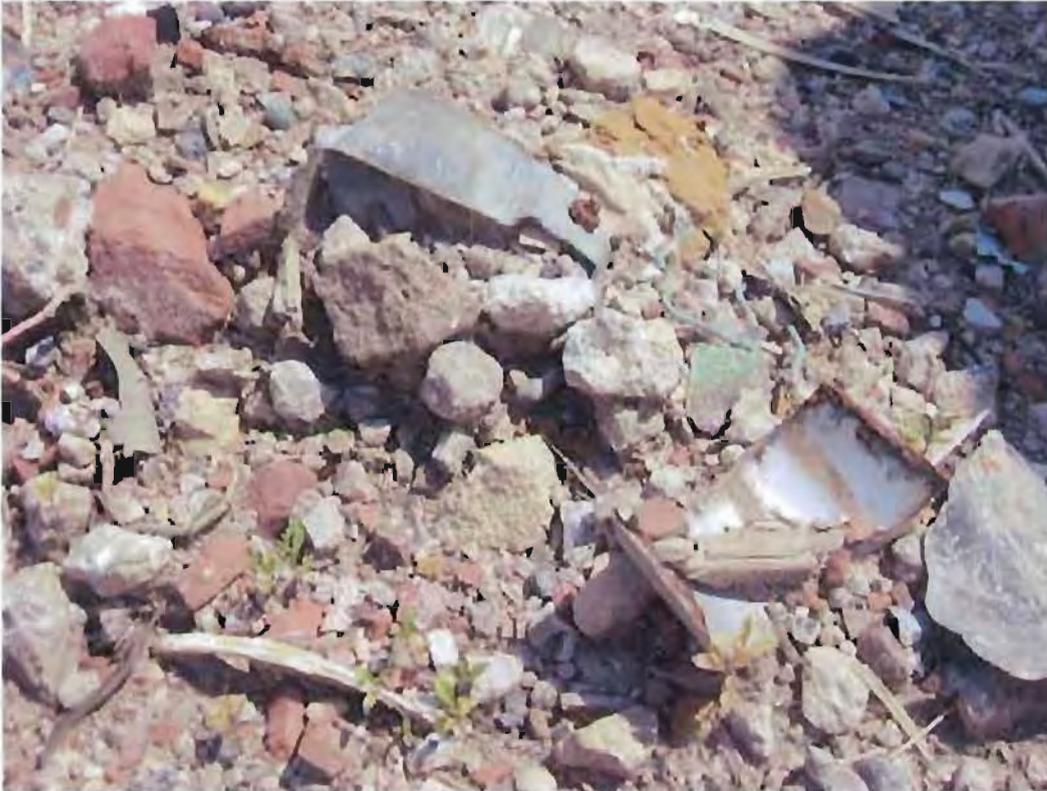
Date: August 4, 2010.
Time: 11:49 AM
Direction: NE
Photo by: Eisenbrandt
Exposure #: 023
Comments: Another example of the demolition debris spread across the site. Copper wire, scrap metal, electrical wire, foam, and asphalt materials were observed on the ground.

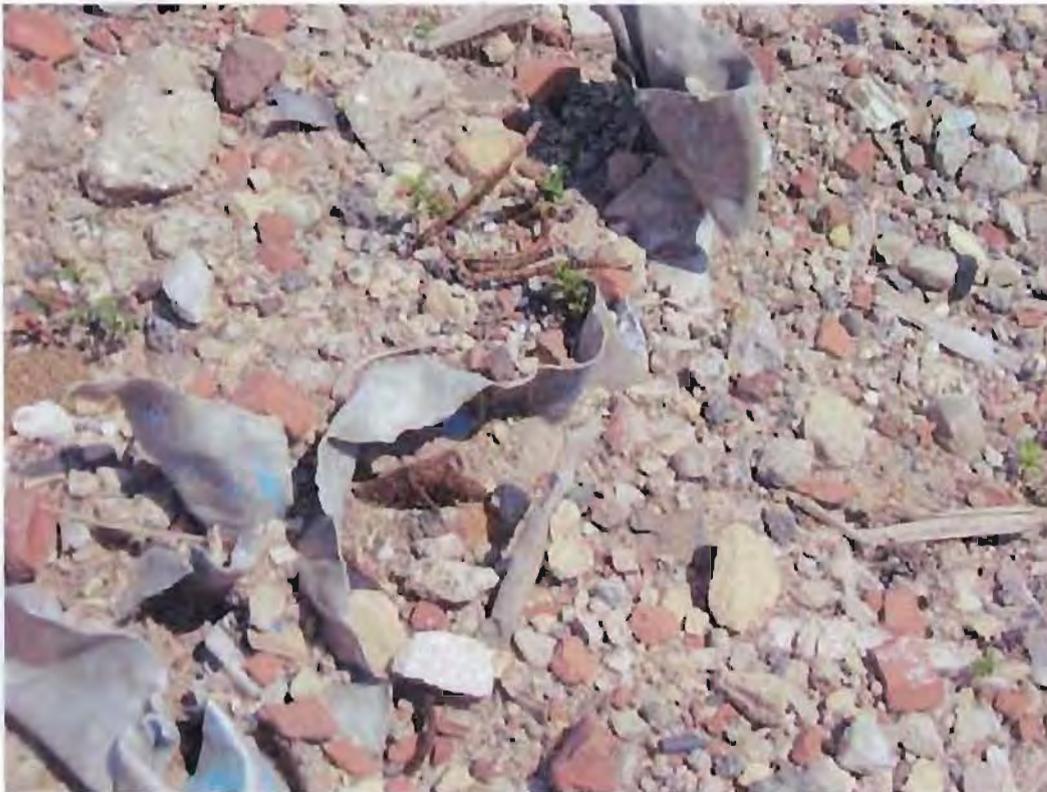
Date: August 4, 2010.
Time: 11:50 AM
Direction: NE
Photo by: Eisenbrandt
Exposure #: 024
Comments: Rusty iron fragments, fiberglass, splintered wood, and malleable metal were observed on the ground surface.

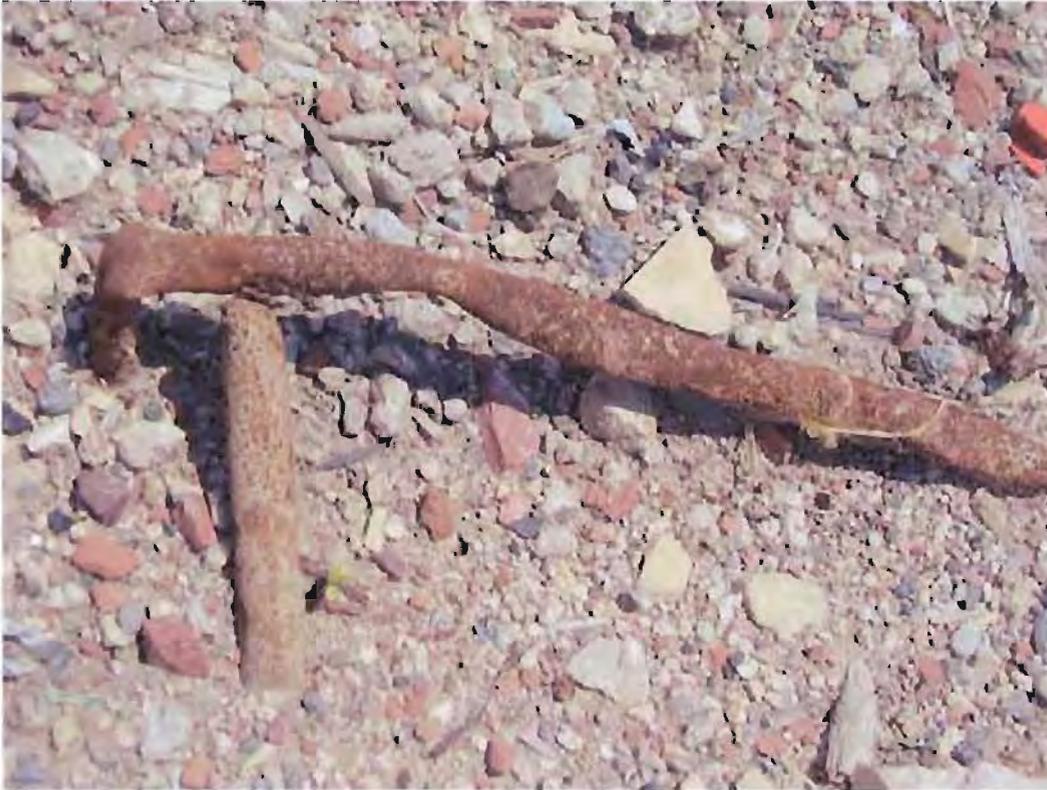
Date: August 4, 2010.
Time: 11:50 AM
Direction: N
Photo by: Eisenbrandt
Exposure #: 025
Comments: Rusty scrap metal and miscellaneous waste observed on the ground surface.

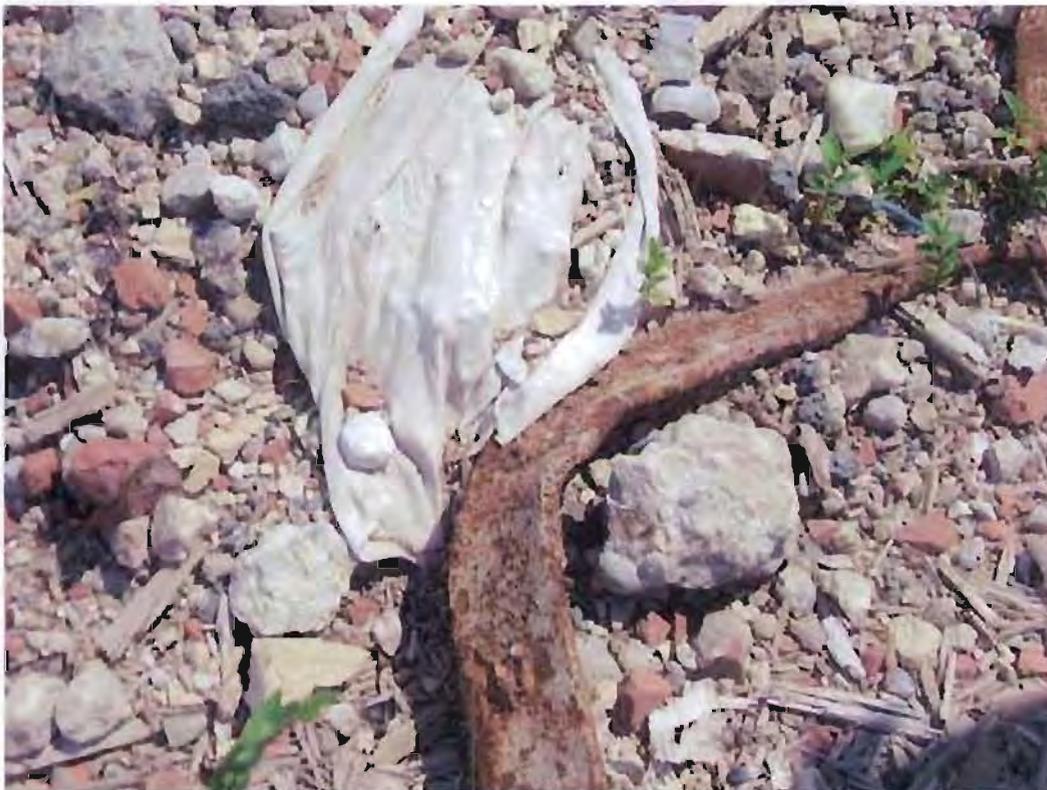
Date: August 4, 2010.
Time: 11:50 AM
Direction: N
Photo by: Eisenbrandt
Exposure #: 026
Comments: Scrap metal, splintered wood, fabric-like material, and metal wire were observed on the ground.

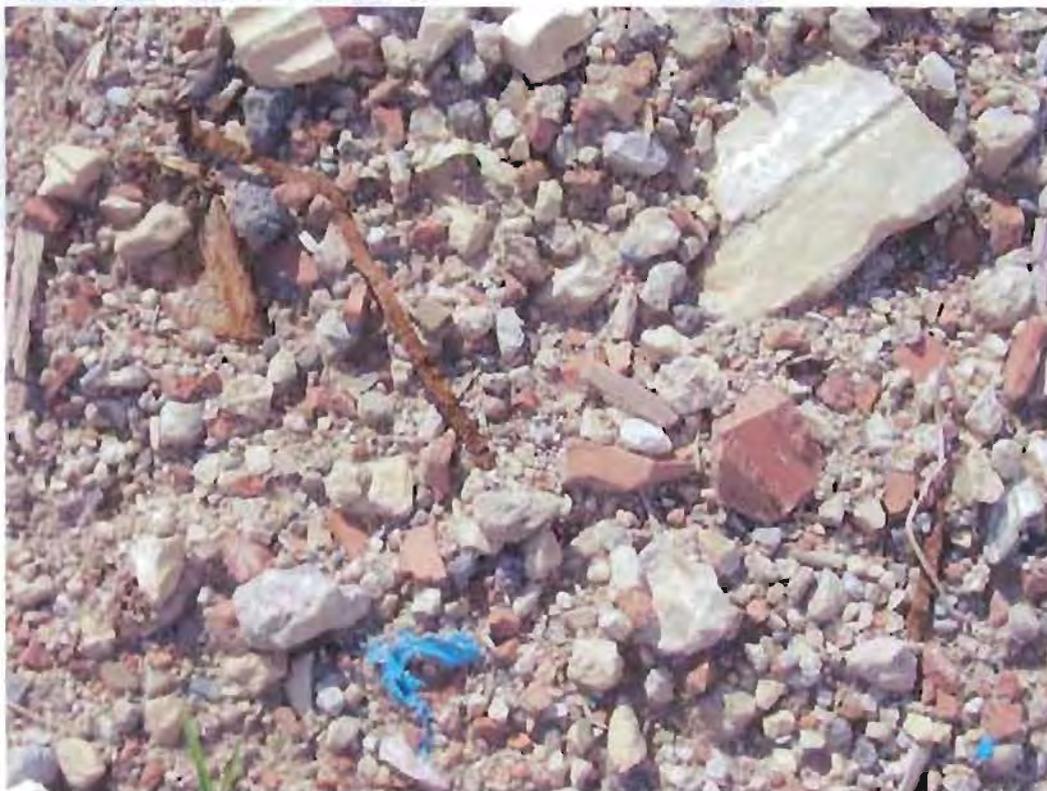
Date: August 4, 2010.
Time: 11:50 AM
Direction: SW
Photo by: Eisenbrandt
Exposure #: 027
Comments: Wire, blue plastic, scrap wood, and rusty metal on the ground.

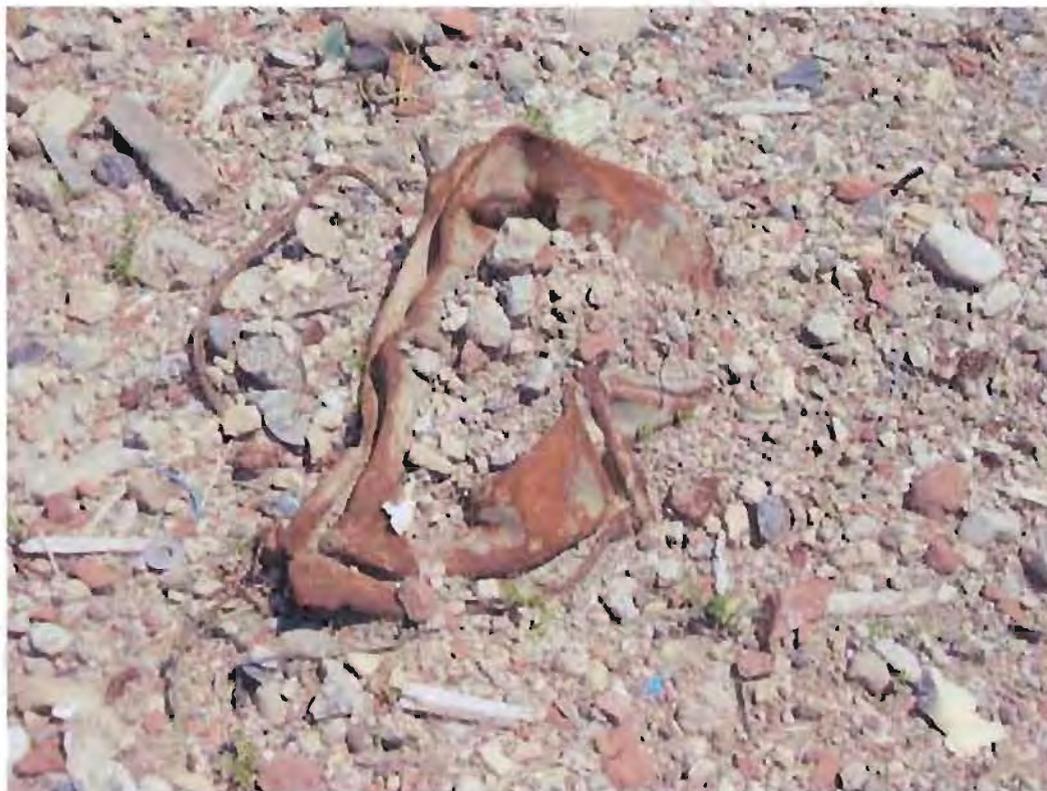
Date: August 4, 2010.
Time: 11:50 AM
Direction: NE
Photo by: Eisenbrandt
Exposure #: 028
Comments: Rusty scrap metal intermixed with demolition debris on the ground.

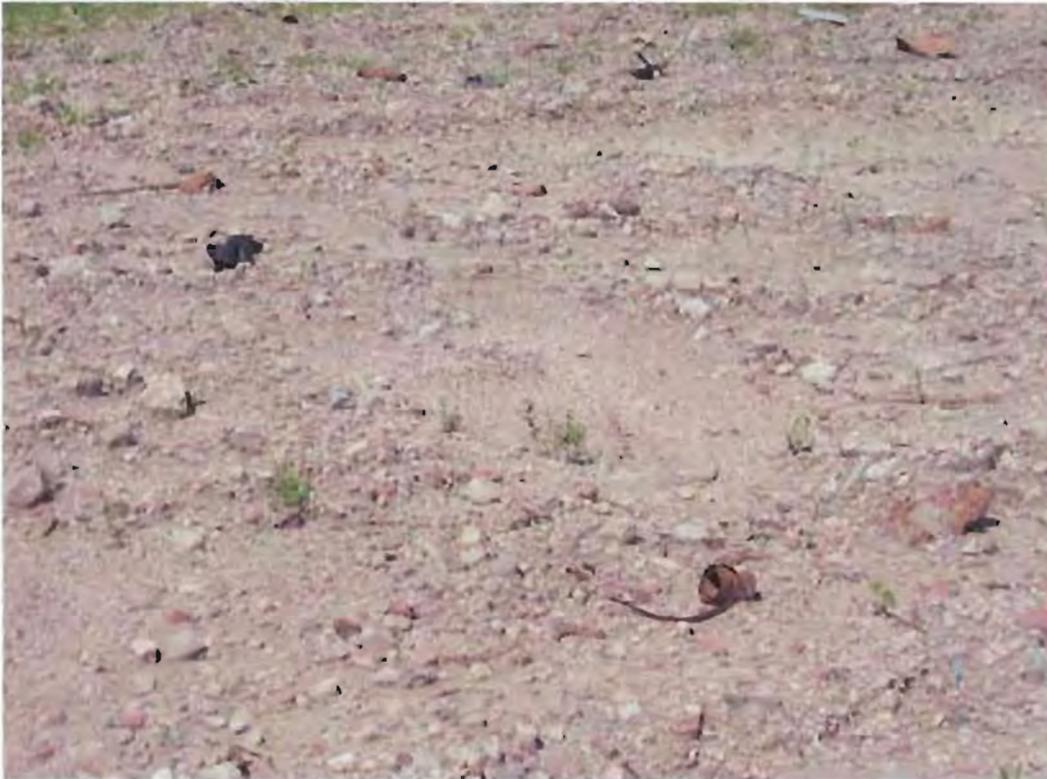
Date: August 4, 2010.
Time: 11:51 AM
Direction: SW
Photo by: Eisenbrandt
Exposure #: 029
Comments: More waste observed on the ground.
