BEFORE THE ILLINOIS POLLUTION CONTROL BOARD

RESIDENTIAL SITE OPEN DUMPING VIOLATIONS

CORPORATE SITE OPEN BURNING

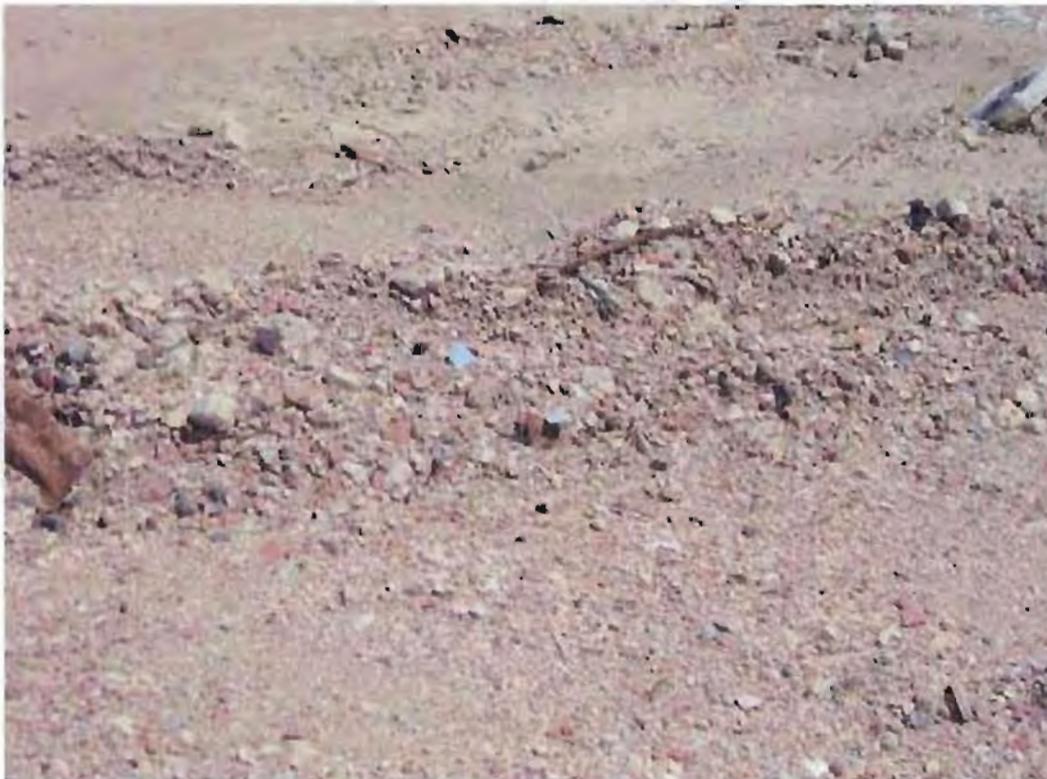
Date: August 4, 2010.
Time: 11:51 AM
Direction: S
Photo by: Eisenbrandt
Exposure #: 030
Comments: More waste observed on the ground.

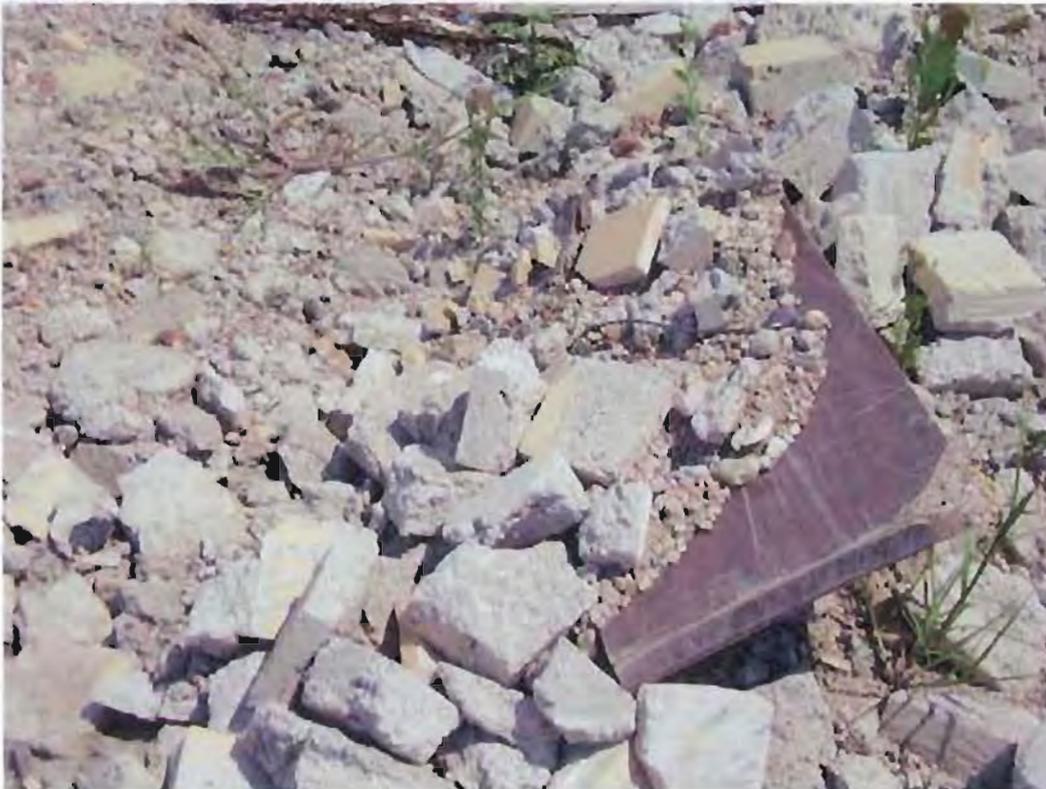
Date: August 4, 2010.
Time: 11:51 AM
Direction: W
Photo by: Eisenbrandt
Exposure #: 031
Comments: More waste partially buried.

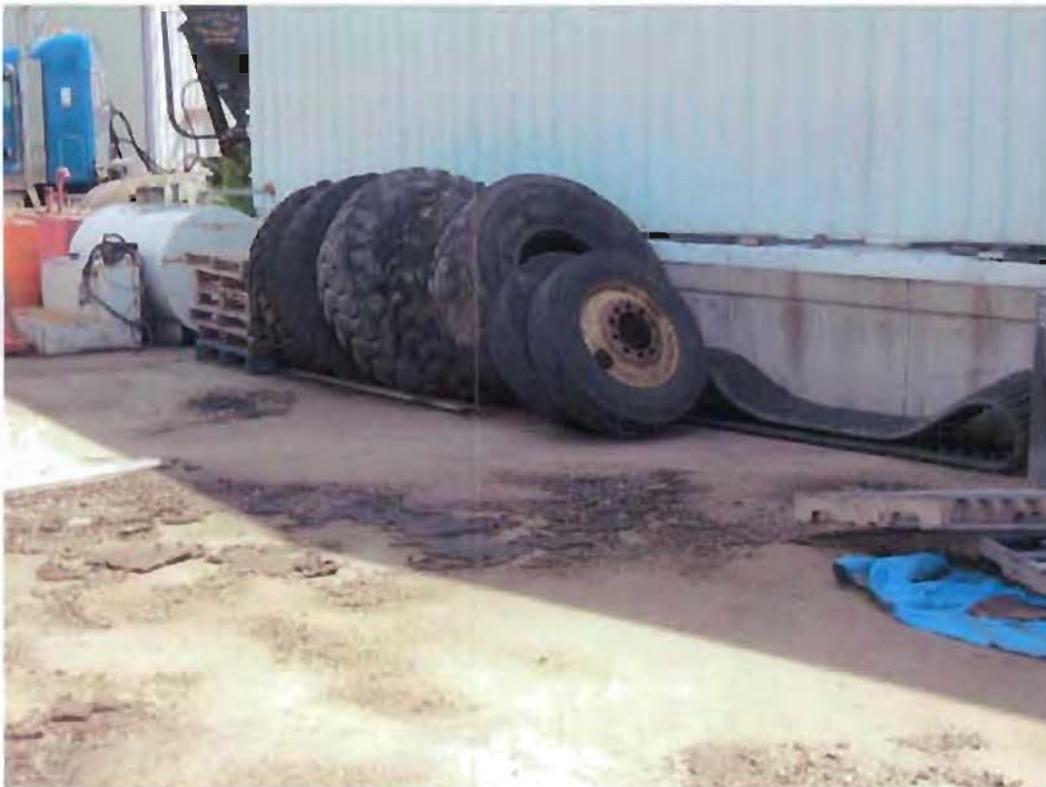
Date: August 4, 2010.
Time: 11:52 AM
Direction: NE
Photo by: Eisenbrandt
Exposure #: 032
Comments: Used tires stored along the west wall of the maintenance building.

Date: August 4, 2010.
Time: 11:53 AM
Direction: E
Photo by: Eisenbrandt
Exposure #: 033
Comments: Water was observed in the used tires seen in Photograph 032

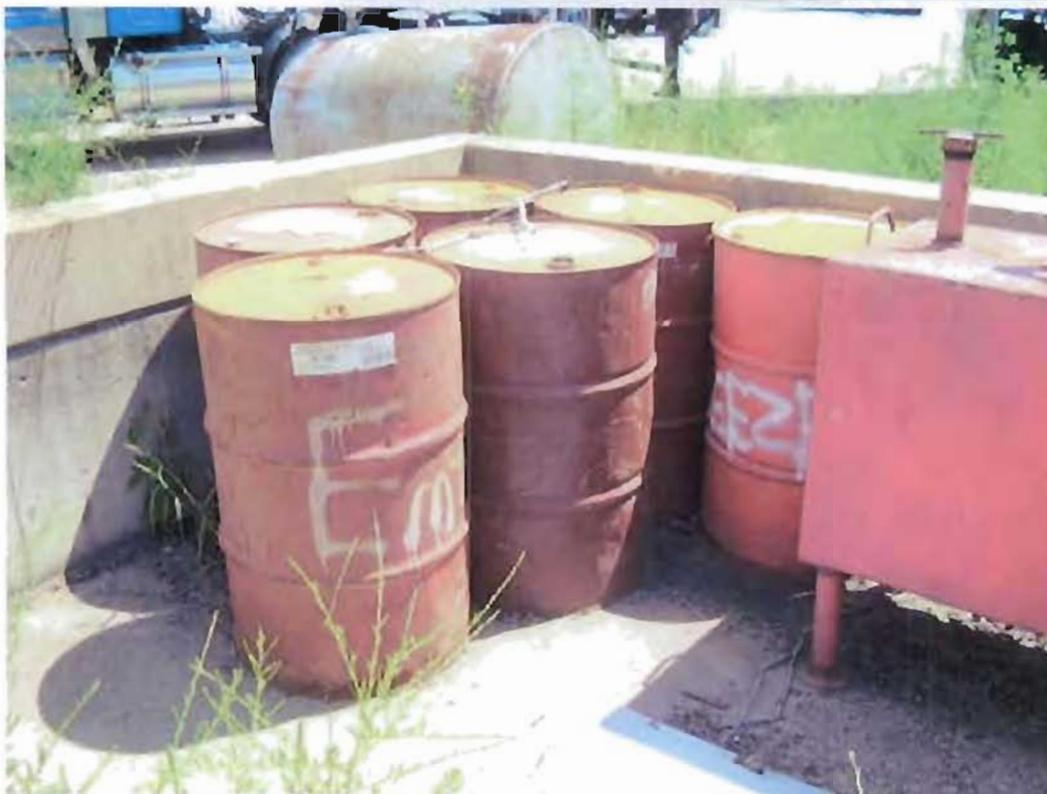
Date: August 4, 2010.
Time: 11:53 AM
Direction: NE
Photo by: Eisenbrandt
Exposure #: 034
Comments: Six 55-gallon drums stored in the concrete containment area. One of the drums was labeled antifreeze and appeared full. Another drum was labeled "Empty" yet was full of liquid.

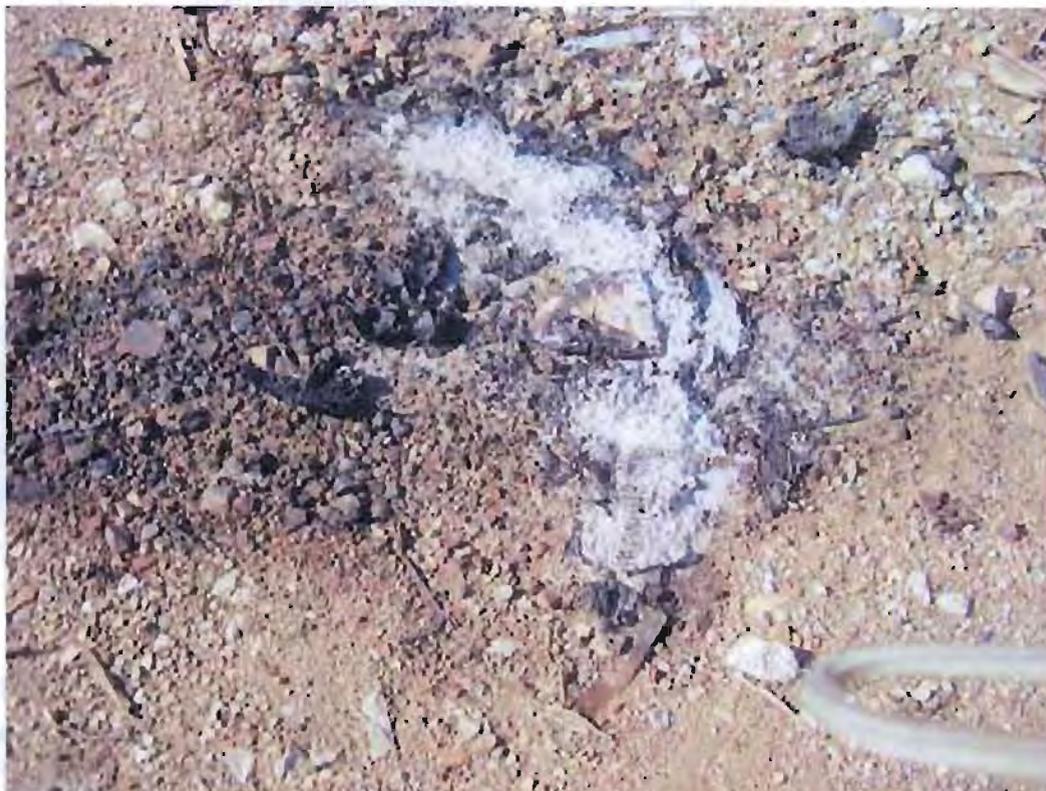
Date: March 23, 2011
Time: 10:21 AM
Direction: S
Photo by: Eisenbrandt
Exposure #: 001
Comments: Ash, charred paper, and soot covered gravel.

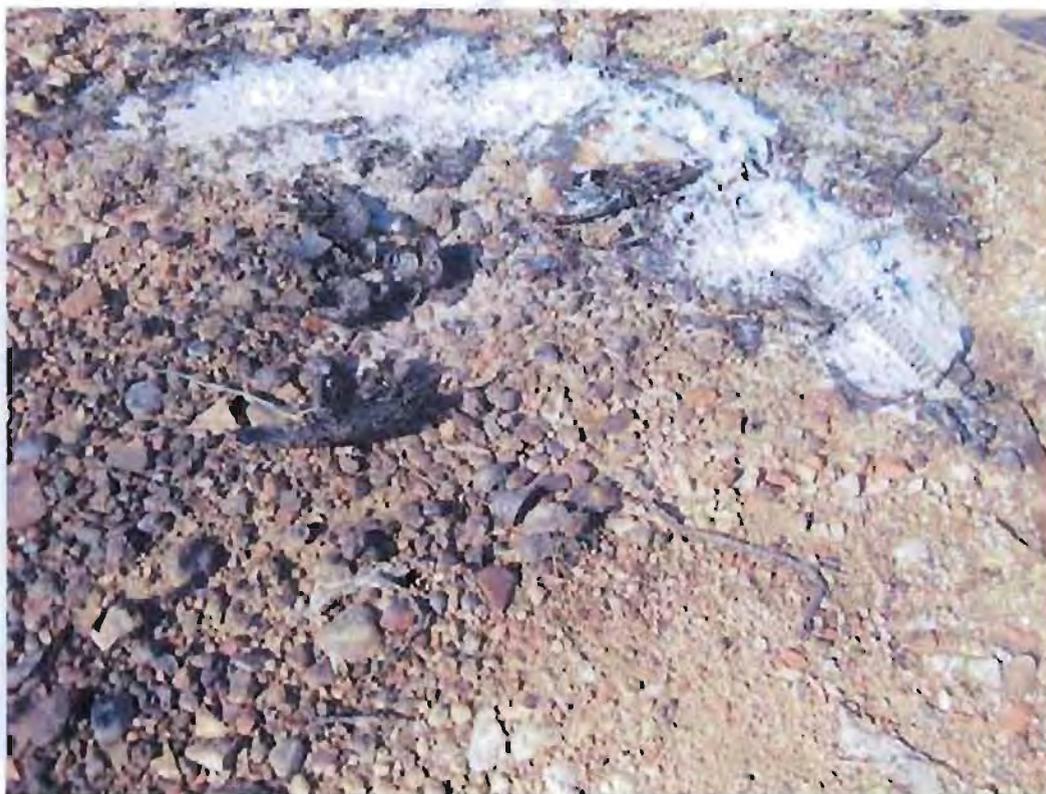
Date: March 23, 2011
Time: 10:21 AM
Direction: SW
Photo by: Eisenbrandt
Exposure #: 002
Comments: Another picture of the recent open burning debris pile at DEM/EX. A wire spiral binding and singed paper were recognizable among the charred debris.

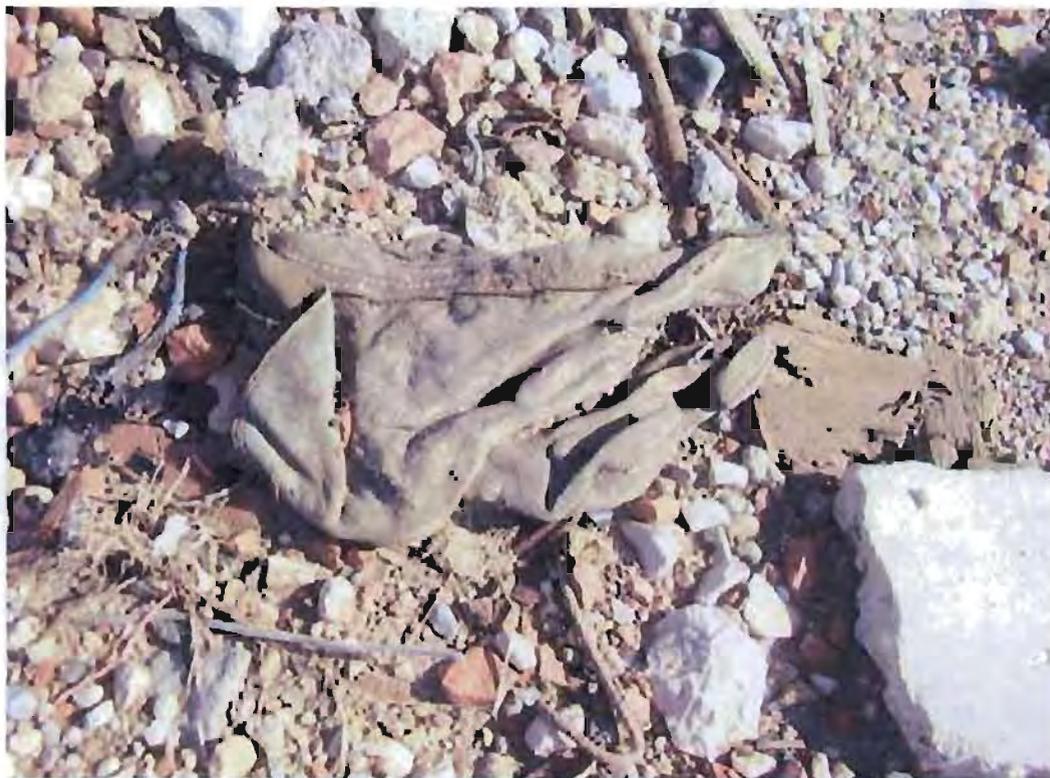
Date: March 23, 2011
Time: 10:24 AM
Direction: NE
Photo by: Eisenbrandt
Exposure #: 003
Comments: The parking lot was covered with crushed concrete, brick, cinder block, and mortar. Intermixed with the demolition debris, and seen in this photograph, are a leather glove, splinted wood, rusty wire, and blue sheathed electrical wire.

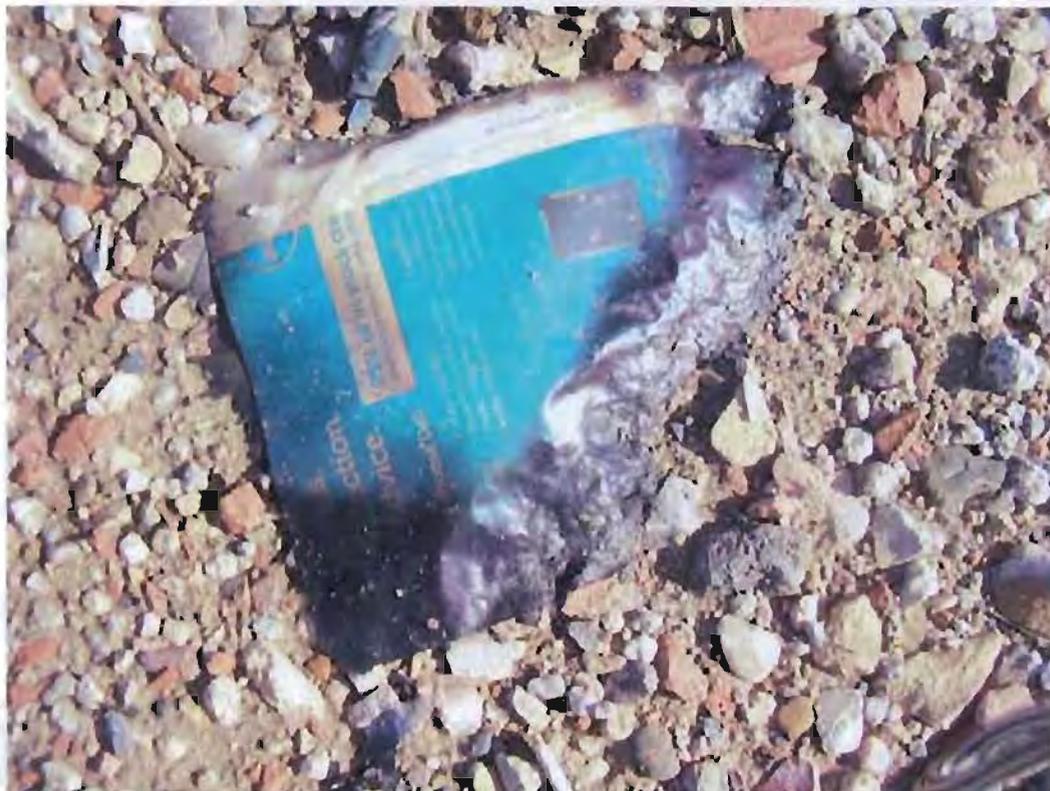
Date: March 23, 2011
Time: 10:24 AM
Direction: N
Photo by: Eisenbrandt
Exposure #: 004
Comments: Partially burned paper.

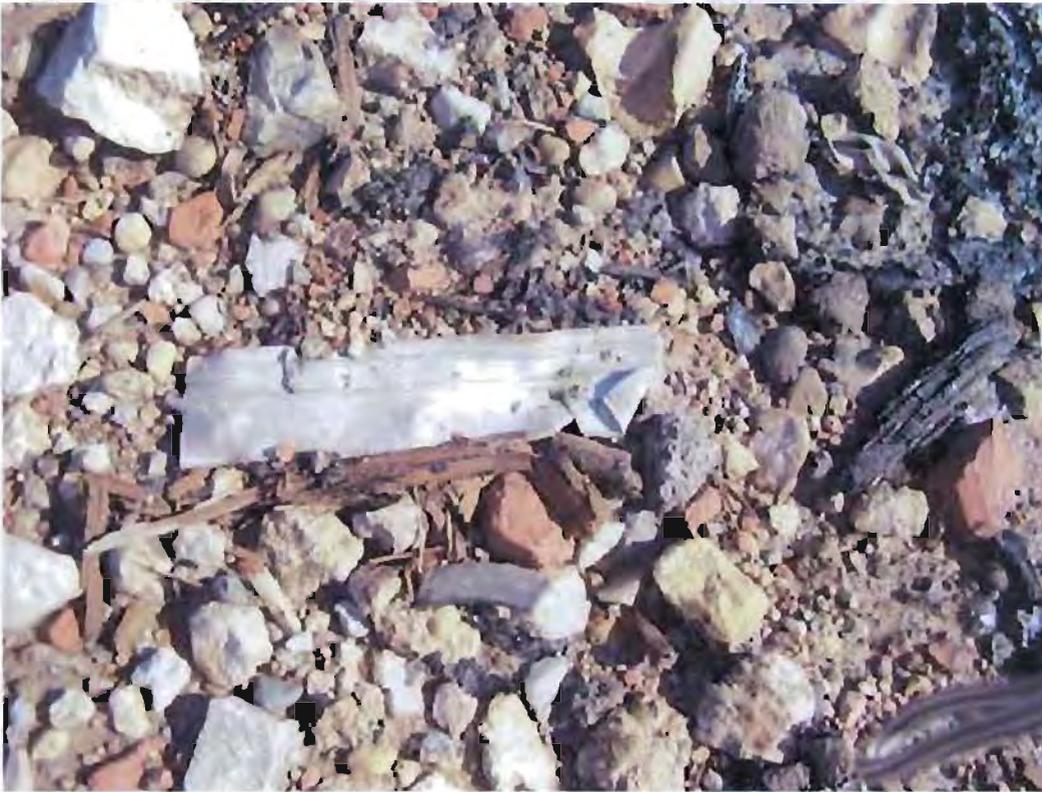
Date: March 23, 2011
Time: 10:24 AM
Direction: N
Photo by: Eisenbrandt
Exposure #: 005
Comments: Scrap aluminum, charred waste, splintered wood, and scrap metal.

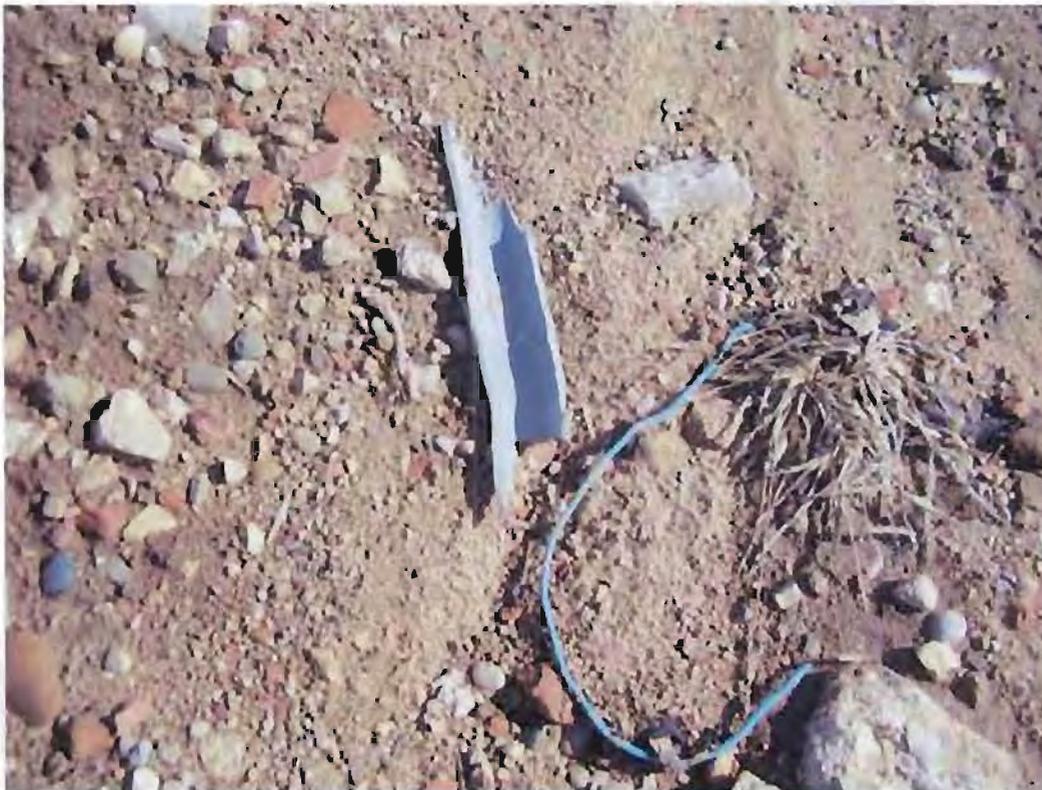
Date: March 23, 2011
Time: 10:24 AM
Direction: SE
Photo by: Eisenbrandt
Exposure #: 006
Comments: Electrical wire and a broken piece of grey plastic pipe.

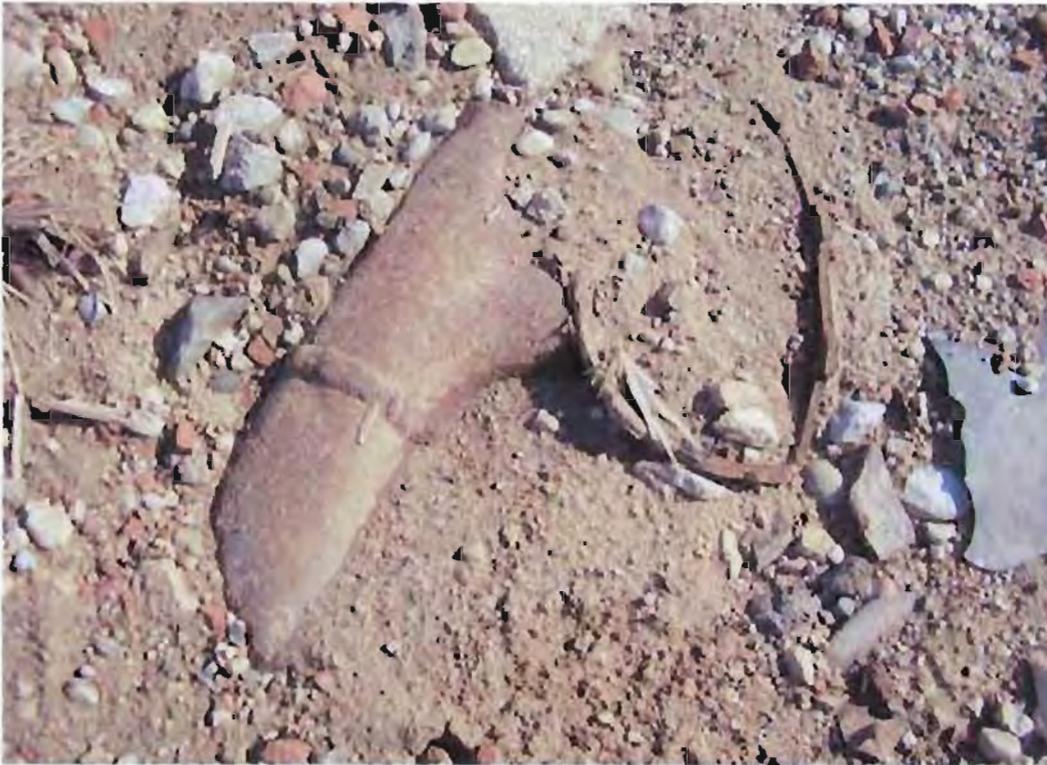
Date: March 23, 2011
Time: 10:24 AM
Direction: NE
Photo by: Eisenbrandt
Exposure #: 007
Comments: Scrap iron
and black plastic.

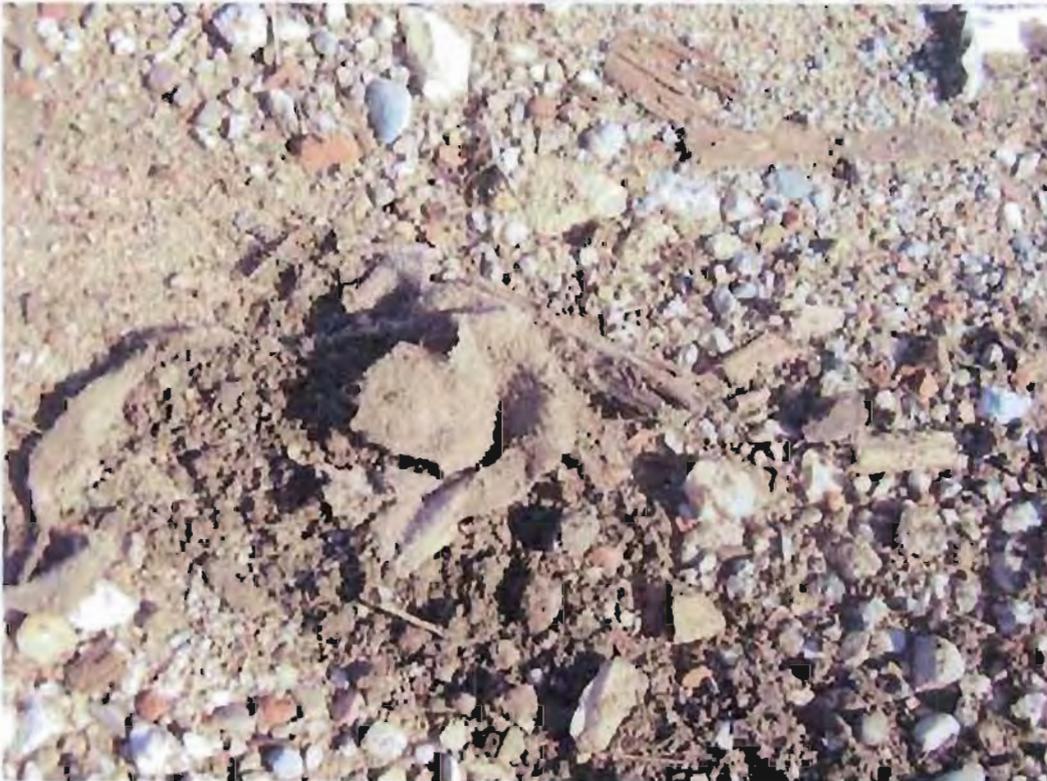
Date: March 23, 2011
Time: 10:24 AM
Direction: N
Photo by: Eisenbrandt
Exposure #: 008
Comments: Splintered
wood and carpet.

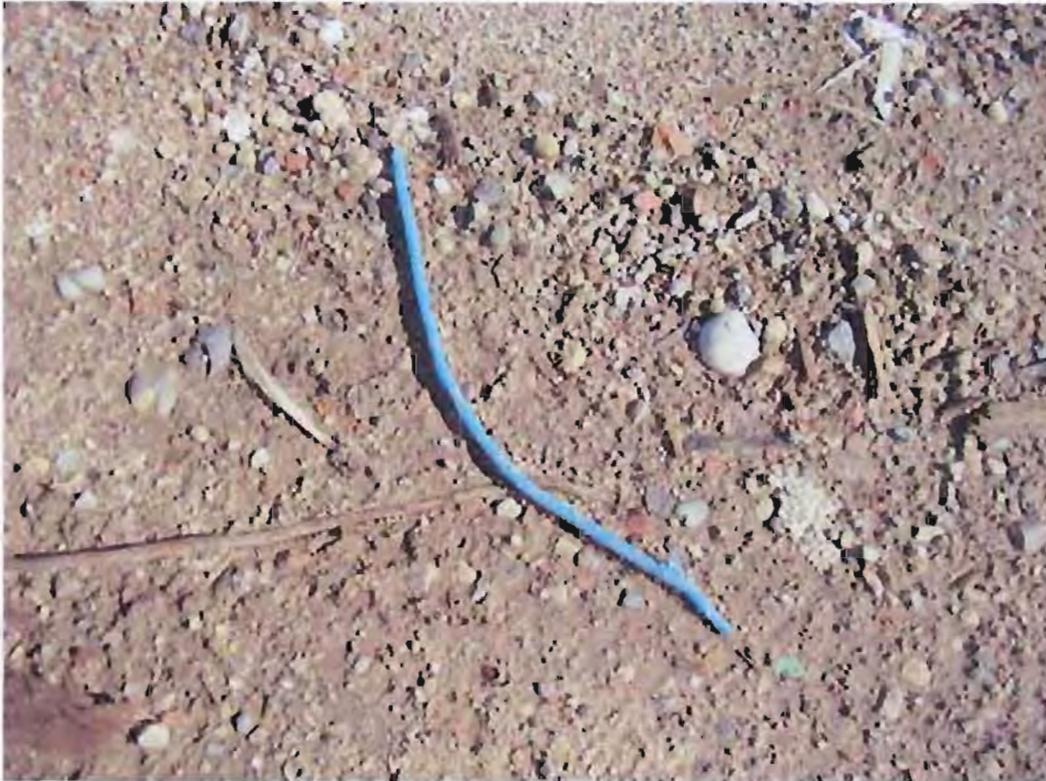
Date: March 23, 2011
Time: 10:25 AM
Direction: N
Photo by: Eisenbrandt
Exposure #: 009
Comments: Electrical wire, shiny scrap metal, rusty wire, and copious amounts of splintered wood intermixed with the fill material.

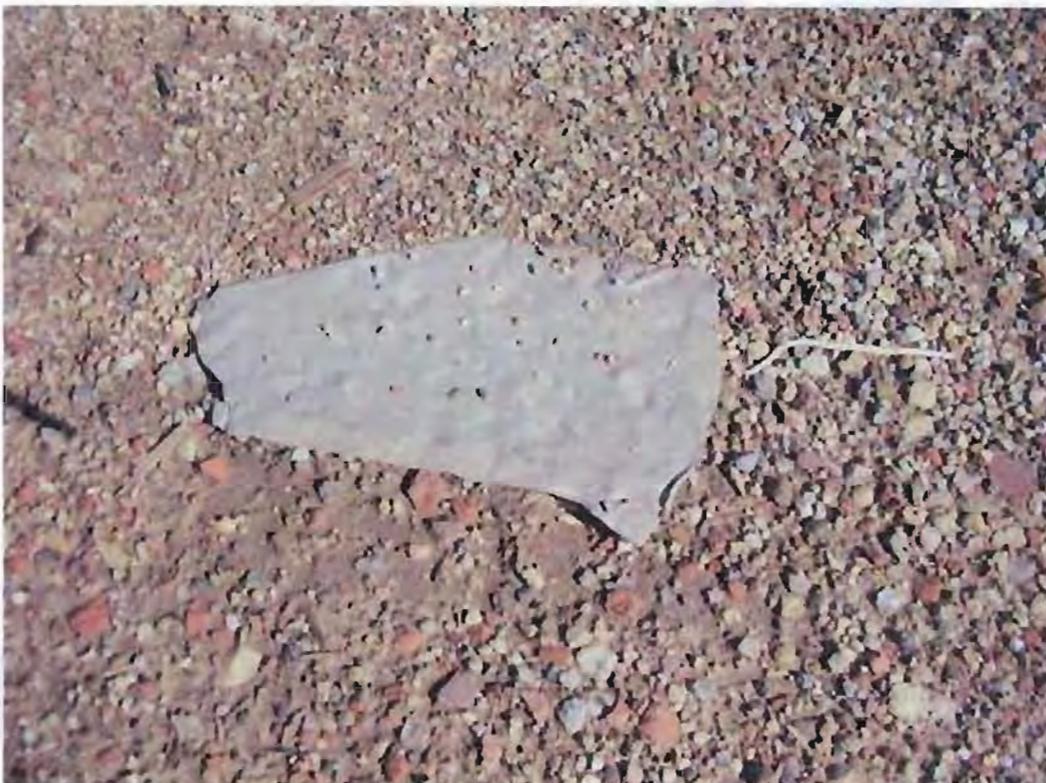
Date: March 23, 2011
Time: 10:25 AM
Direction: N
Photo by: Eisenbrandt
Exposure #: 010
Comments: Malleable metal scrap.

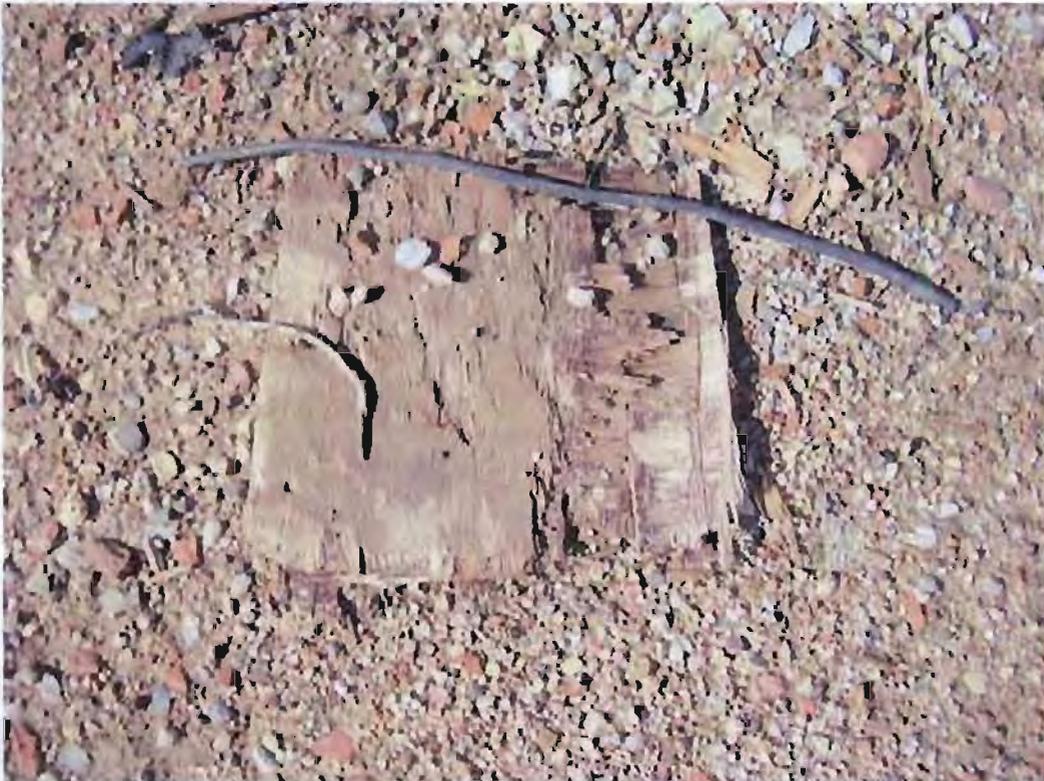
Date: March 23, 2011
Time: 10:25 AM
Direction: S
Photo by: Eisenbrandt
Exposure #: 011
Comments: Electrical wire and a splintered piece of plywood.

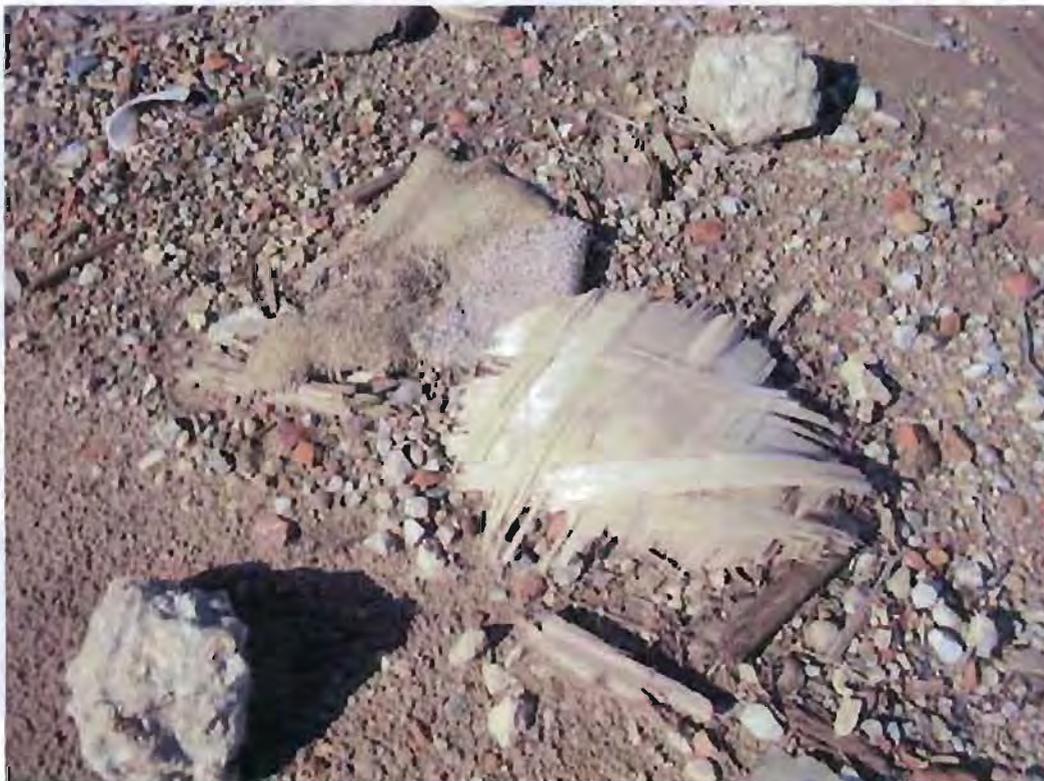
Date: March 23, 2011
Time: 10:25 AM
Direction: SW
Photo by: Eisenbrandt
Exposure #: 012
Comments: Fiber glass, carpet, wire, wood, and plastic scrap intermixed in the parking lot.

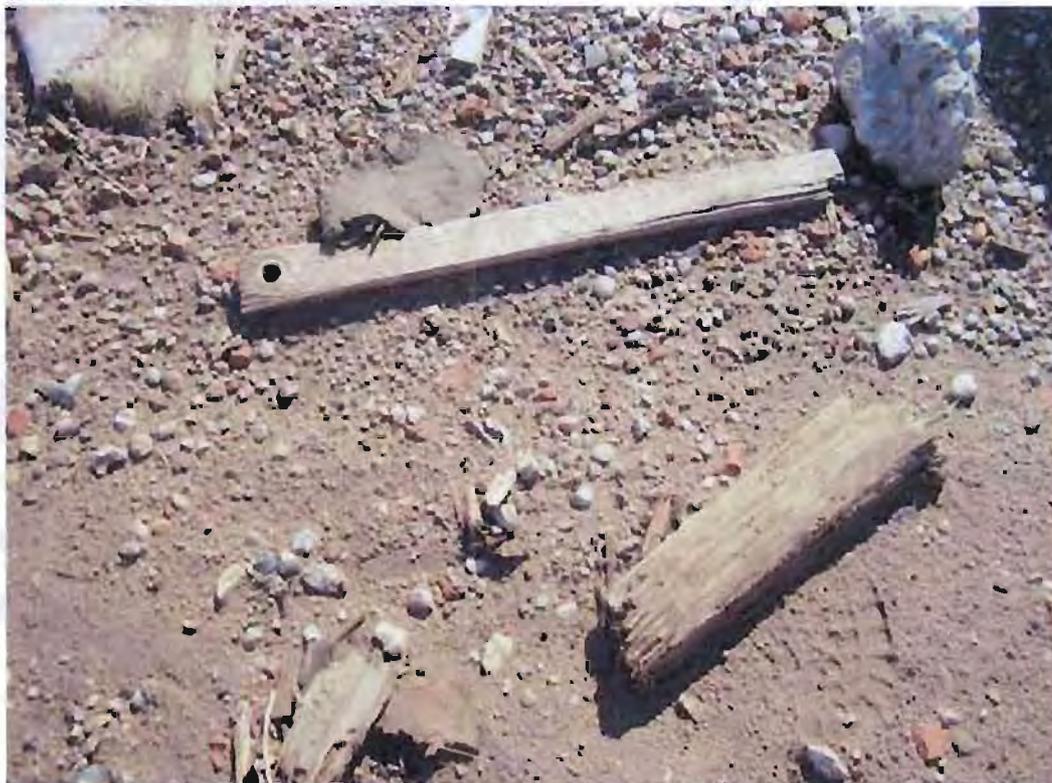
Date: March 23, 2011
Time: 10:26 AM
Direction: SE
Photo by: Eisenbrandt
Exposure #: 013
Comments: Carpet scrap
and dimensional lumber
scrap.

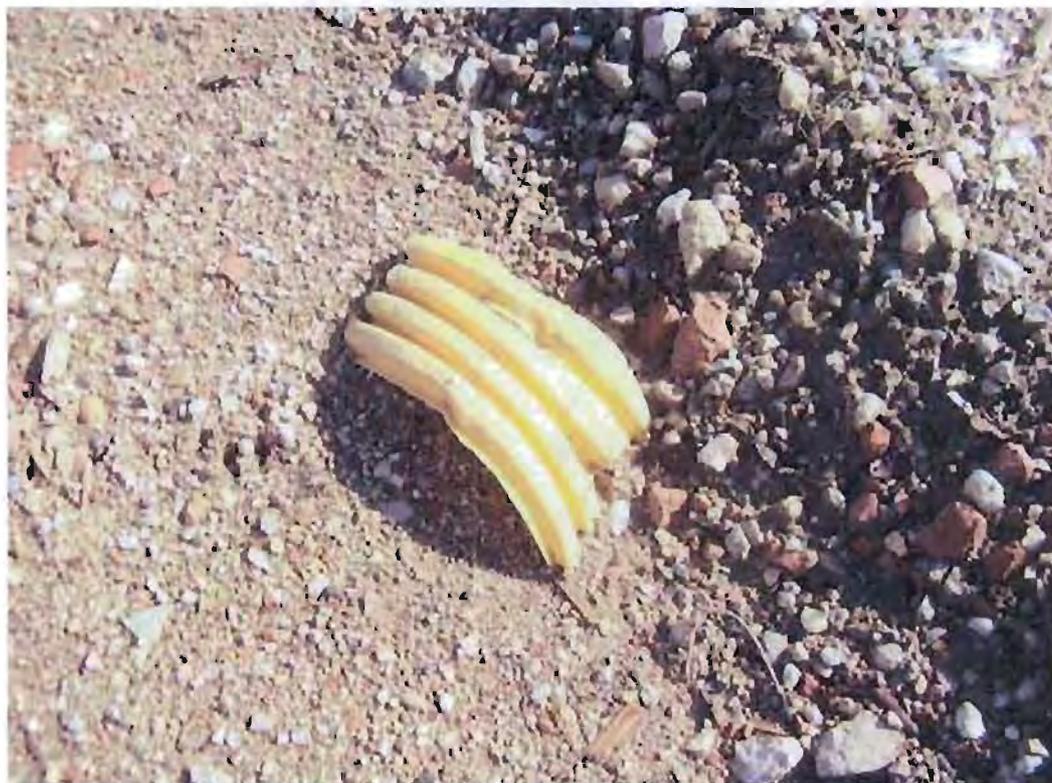
Date: March 23, 2011
Time: 10:26 AM
Direction: E
Photo by: Eisenbrandt
Exposure #: 014
Comments: Yellow plastic
pipe scrap and wire.

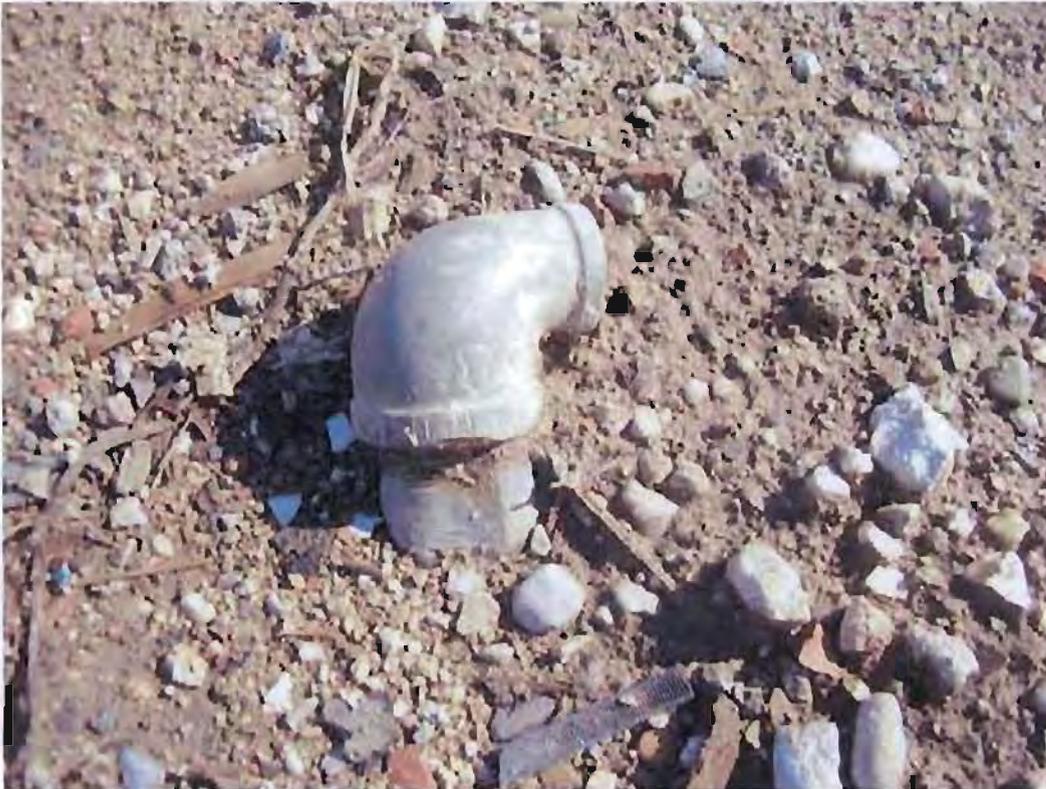
Date: March 23, 2011
Time: 10:26 AM
Direction: E
Photo by: Eisenbrandt
Exposure #: 015
Comments: A galvanized plumbing elbow, splinters of wood, and a piece of black plastic.

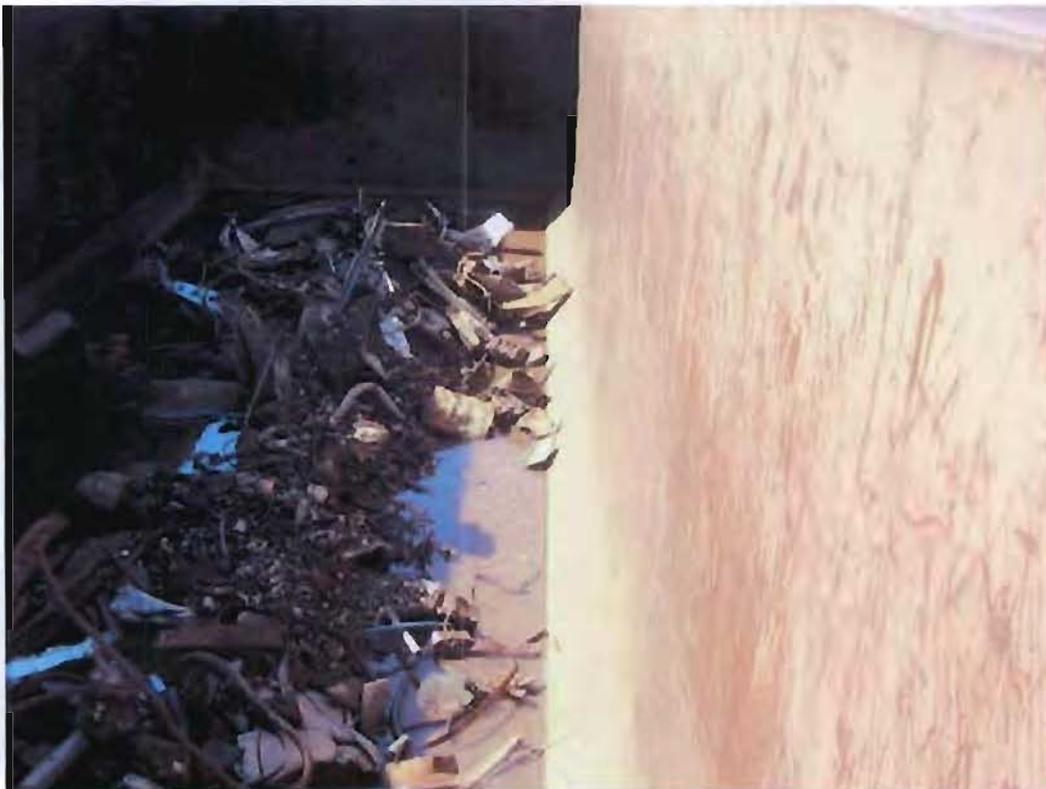
Date: March 23, 2011
Time: 10:26 AM
Direction: S
Photo by: Eisenbrandt
Exposure #: 016
Comments: View inside a BEHR recycling dumpster that was onsite.

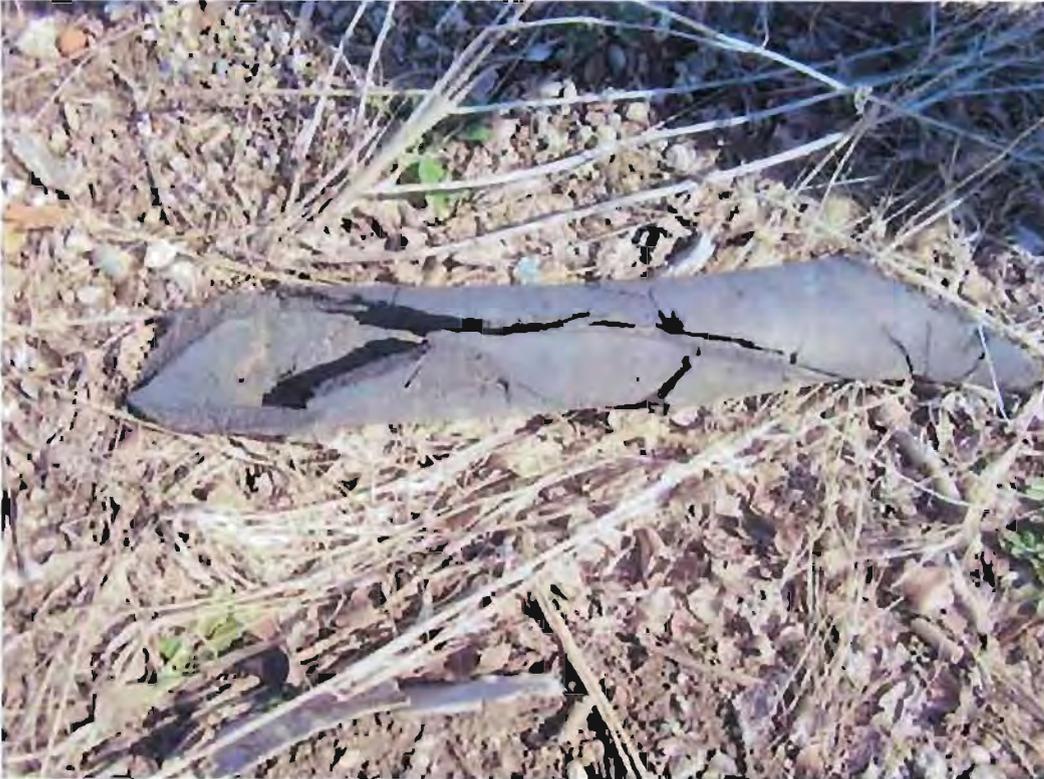
Date: March 23, 2011
Time: 10:27 AM
Direction: N
Photo by: Eisenbrandt
Exposure #: 017
Comments: Black foam pipe wrap.

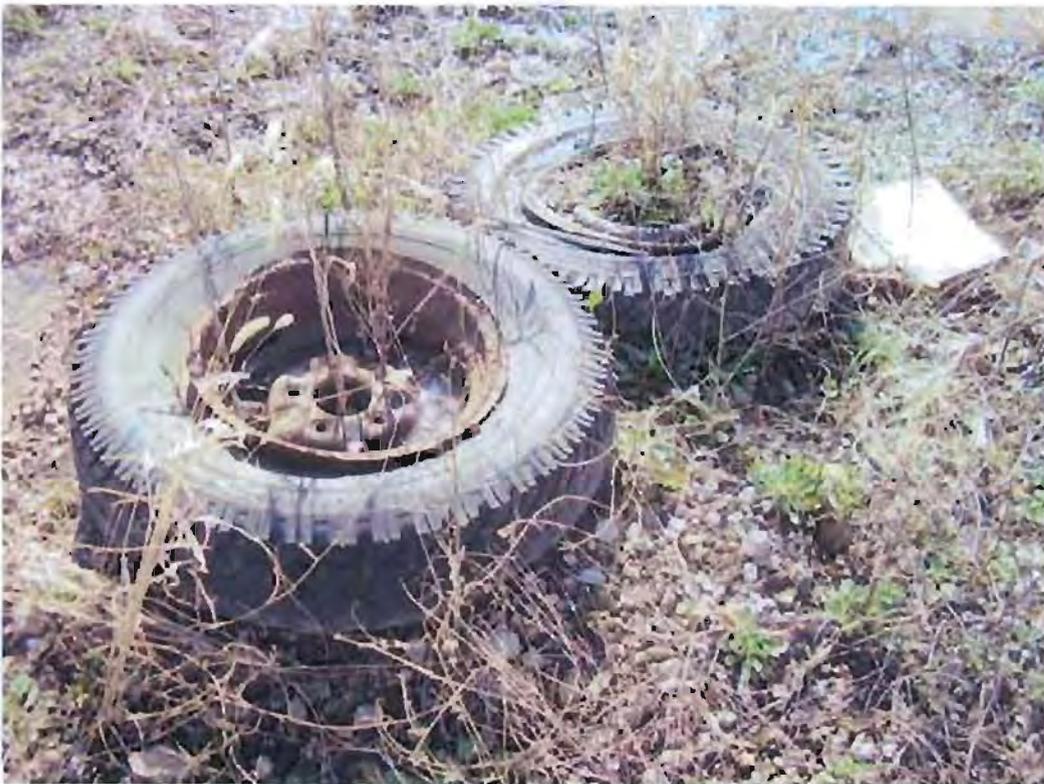
c. Two flat, used tires with damaged rims with weeds growing through them (Complainant's Exhibit 2, March 23, 2011, Exposure 18, p. 27);

Date: March 23, 2011
Time: 10:27 AM
Direction: SE
Photo by: Eisenbrandt
Exposure #: 018
Comments: Two flat used tires with damaged rims, with weeds growing through them, illustrating long term deposition.

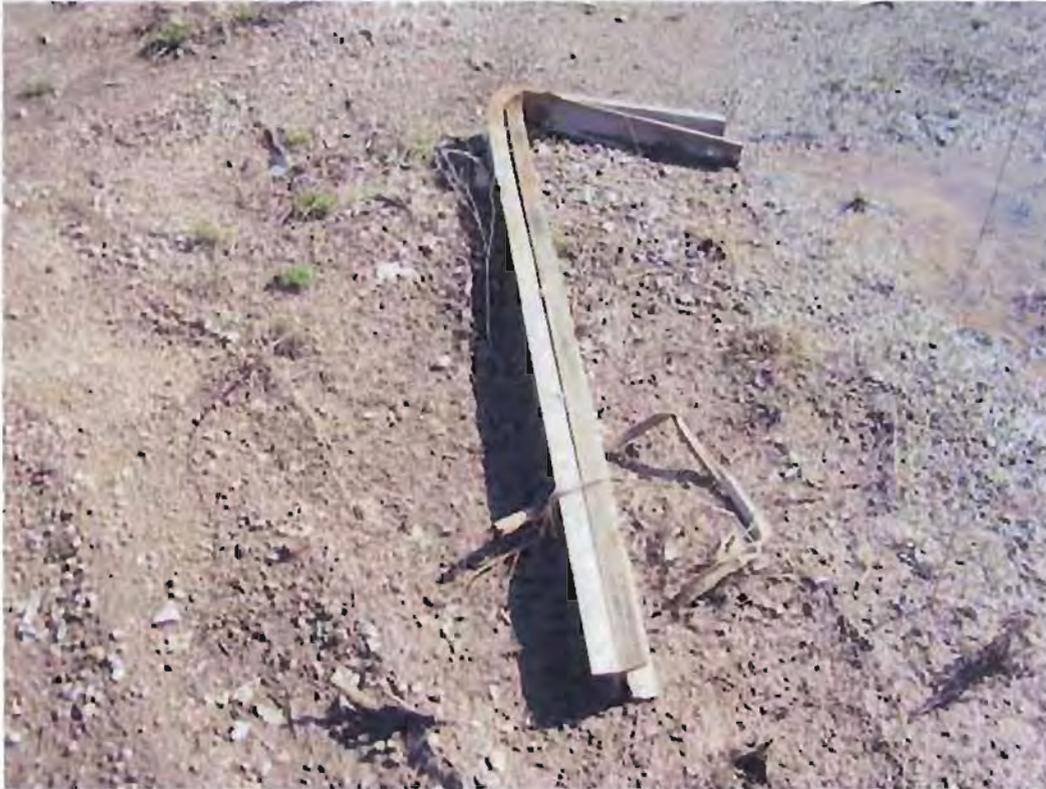
Date: March 23, 2011
Time: 10:27 AM
Direction: NE
Photo by: Eisenbrandt
Exposure #: 019
Comments: Scrap metal.

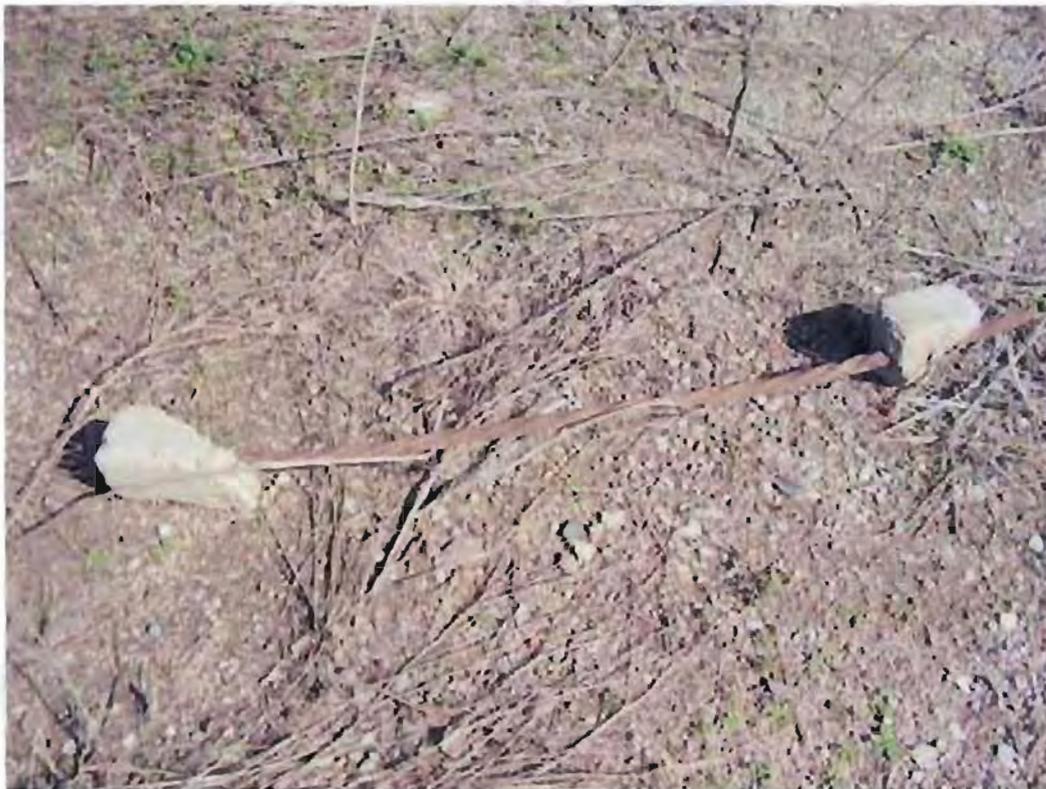
Date: March 23, 2011
Time: 10:27 AM
Direction: N
Photo by: Eisenbrandt
Exposure #: 020
Comments: Concrete attached to rebar.

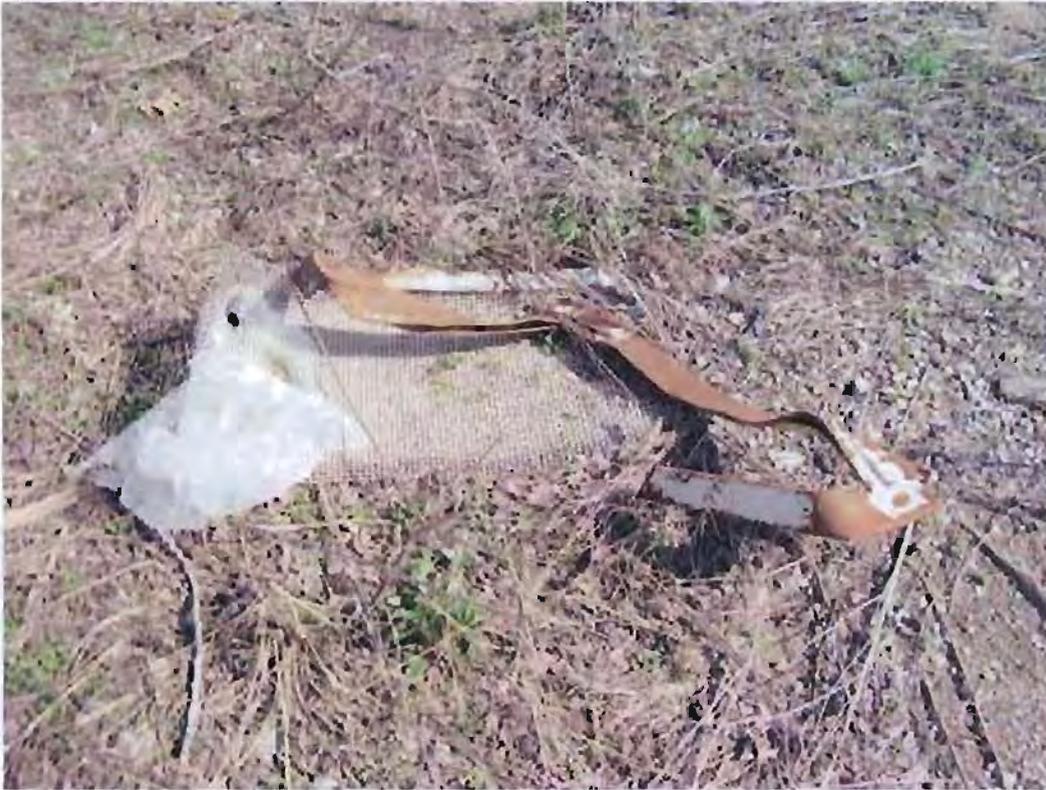
Date: March 23, 2011
Time: 10:27 AM
Direction: N
Photo by: Eisenbrandt
Exposure #: 021
Comments: Scrap metal.

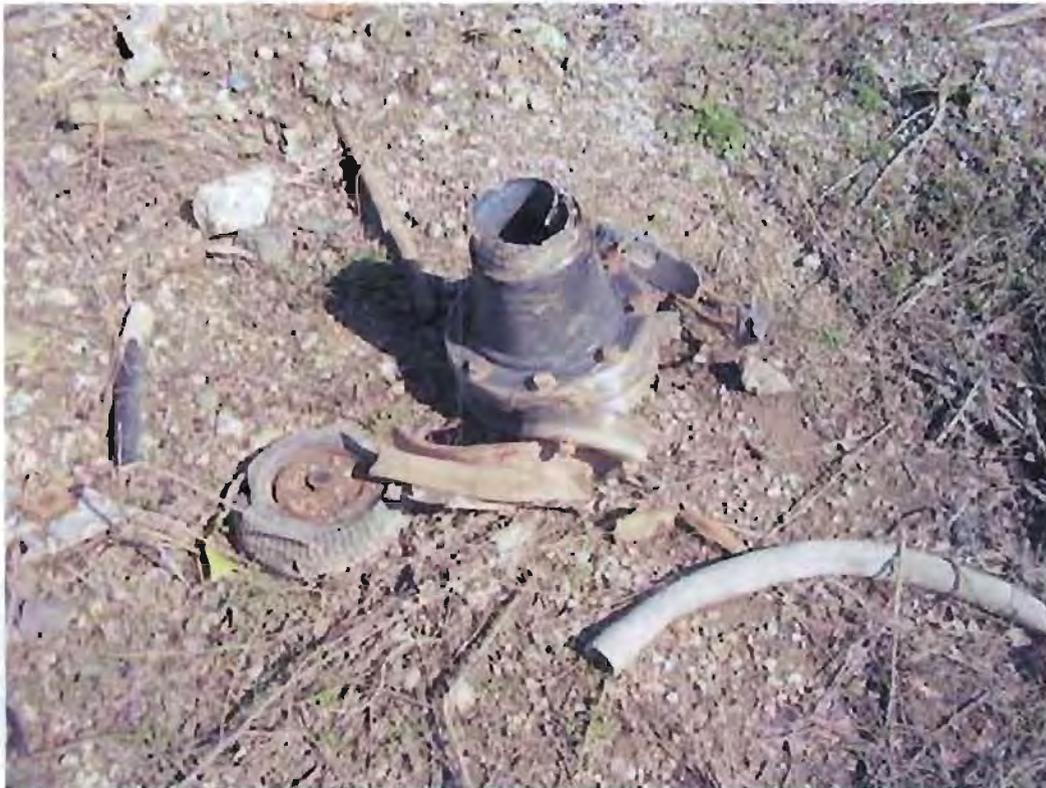
Date: March 23, 2011
Time: 10:28 AM
Direction: N
Photo by: Eisenbrandt
Exposure #: 022
Comments: Apparent open dumped demolition waste that includes a pipe fitting, a wheel, conduit, and miscellaneous debris
