BEFORE THE ILLINOIS POLLUTION CONTROL BOARD

RESIDENTIAL SITE OPEN DUMPING VIOLATIONS

CORPORATE SITE OPEN BURNING

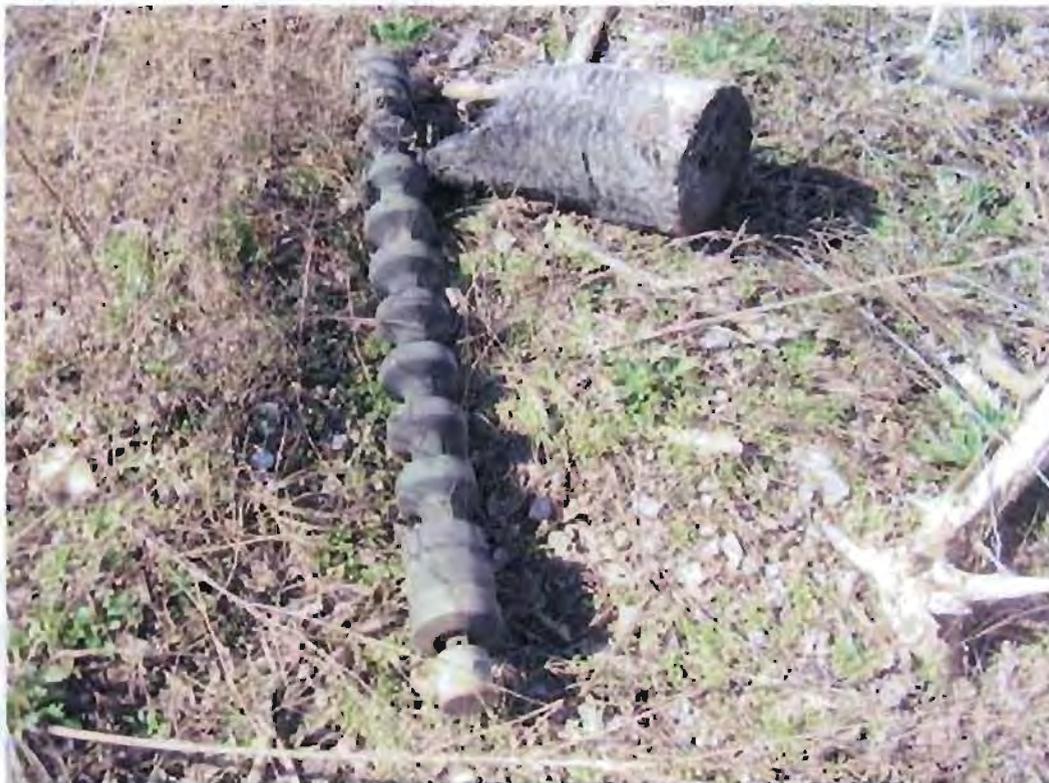
Date: March 23, 2011
Time: 10:28 AM
Direction: S
Photo by: Eisenbrandt
Exposure #: 023
Comments: Scrap metal
among weedy vegetation.

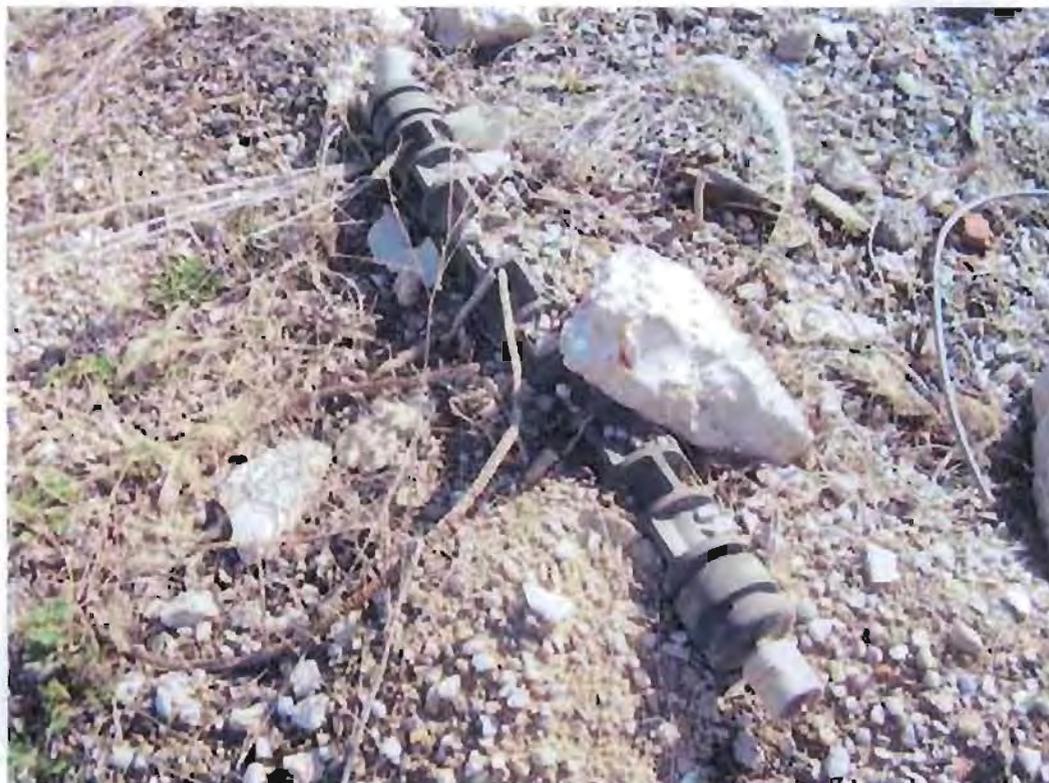
Date: March 23, 2011
Time: 10:28 AM
Direction: E
Photo by: Eisenbrandt
Exposure #: 024
Comments: Rebar, scrap
metal, wire, and processed
lumber scrap.

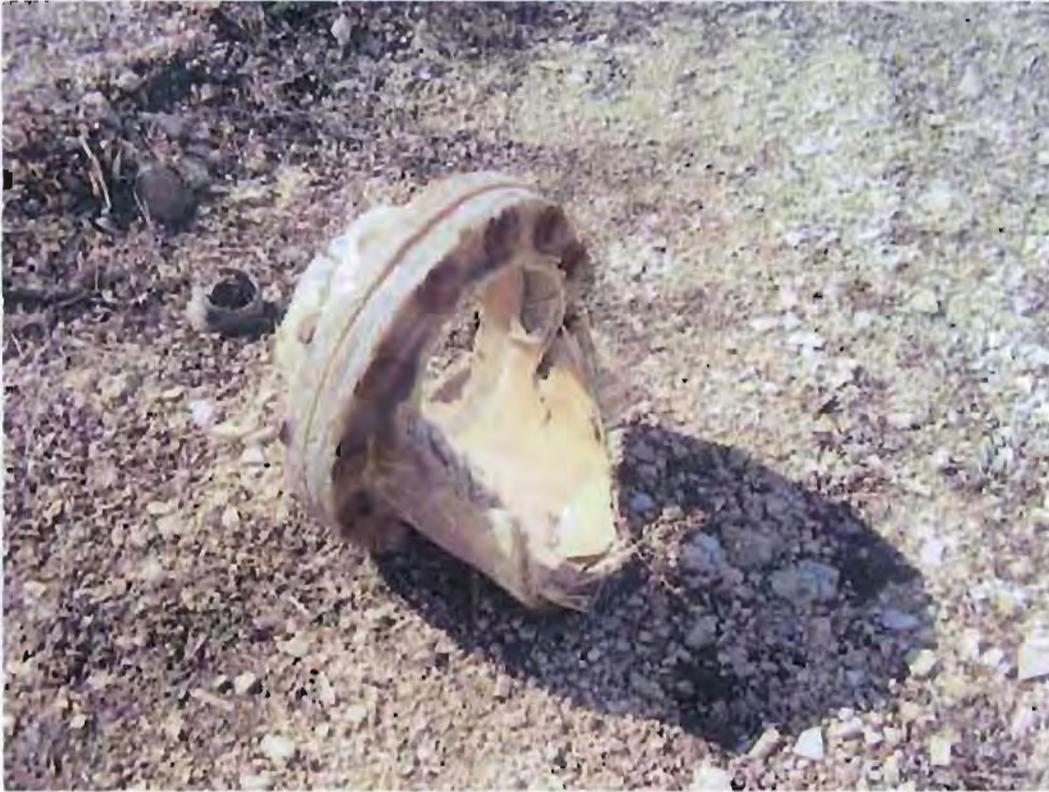
Date: March 23, 2011
Time: 10:28 AM
Direction: S
Photo by: Eisenbrandt
Exposure #: 025
Comments: Fiberglass pipe waste.

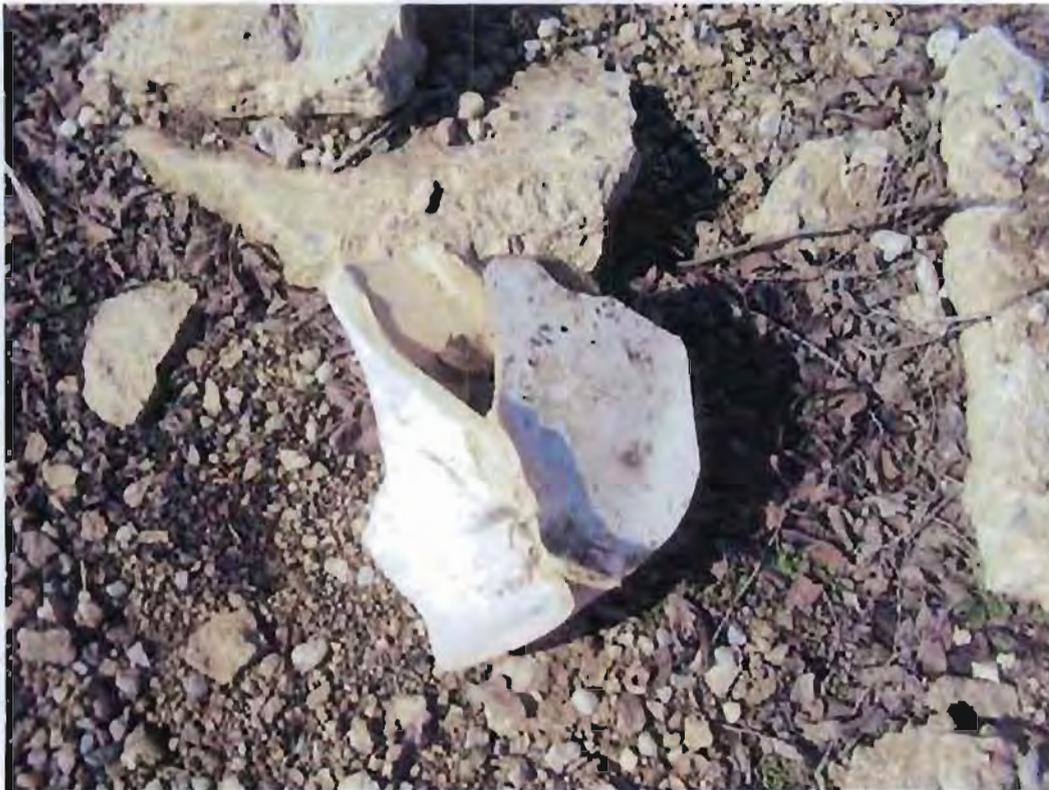
Date: March 23, 2011
Time: 10:28 AM
Direction: W
Photo by: Eisenbrandt
Exposure #: 026
Comments: Porcelain.

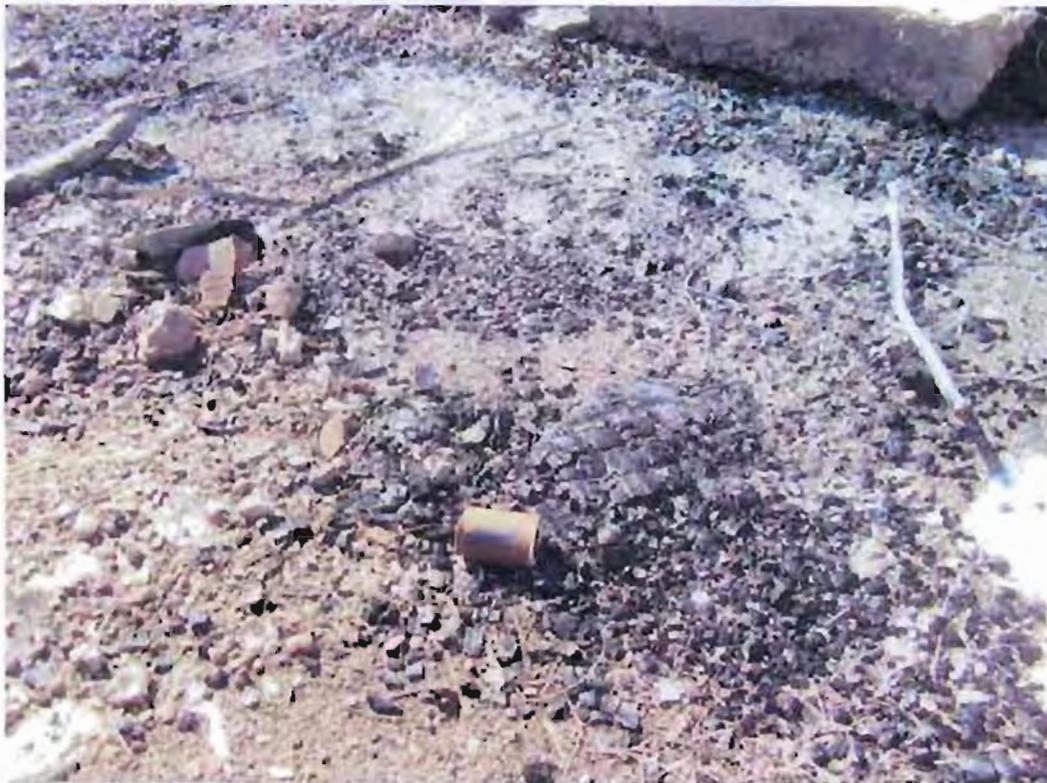
Date: March 23, 2011
Time: 10:29 AM
Direction: SW
Photo by: Eisenbrandt
Exposure #: 027
Comments: A second burn pile.

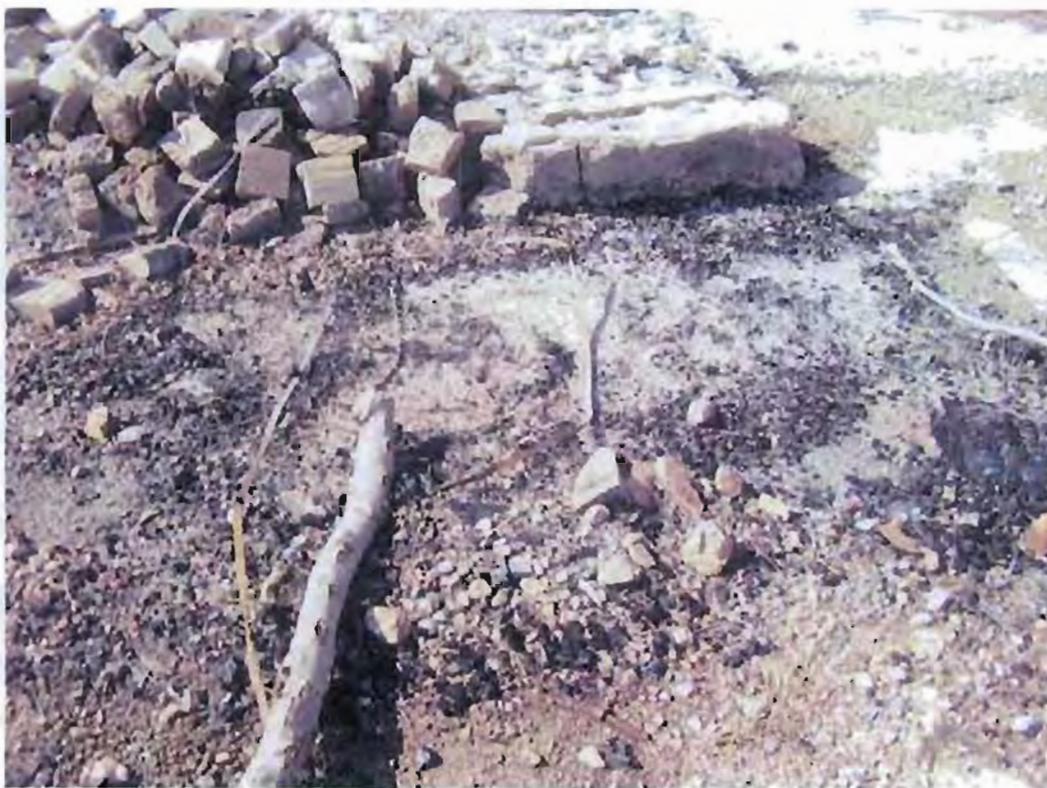
d. A second burn pile containing metal banding, a rusty tin cap, and scrap metal (Complainant's Exhibit 2, March 23, 2011, Exposures 27 and 28, p. 32);

Date: March 23, 2011
Time: 10:29 AM
Direction: S
Photo by: Eisenbrandt
Exposure #: 028
Comments: The burn pile contained metal banding, a rusty tin can, and scrap metal.

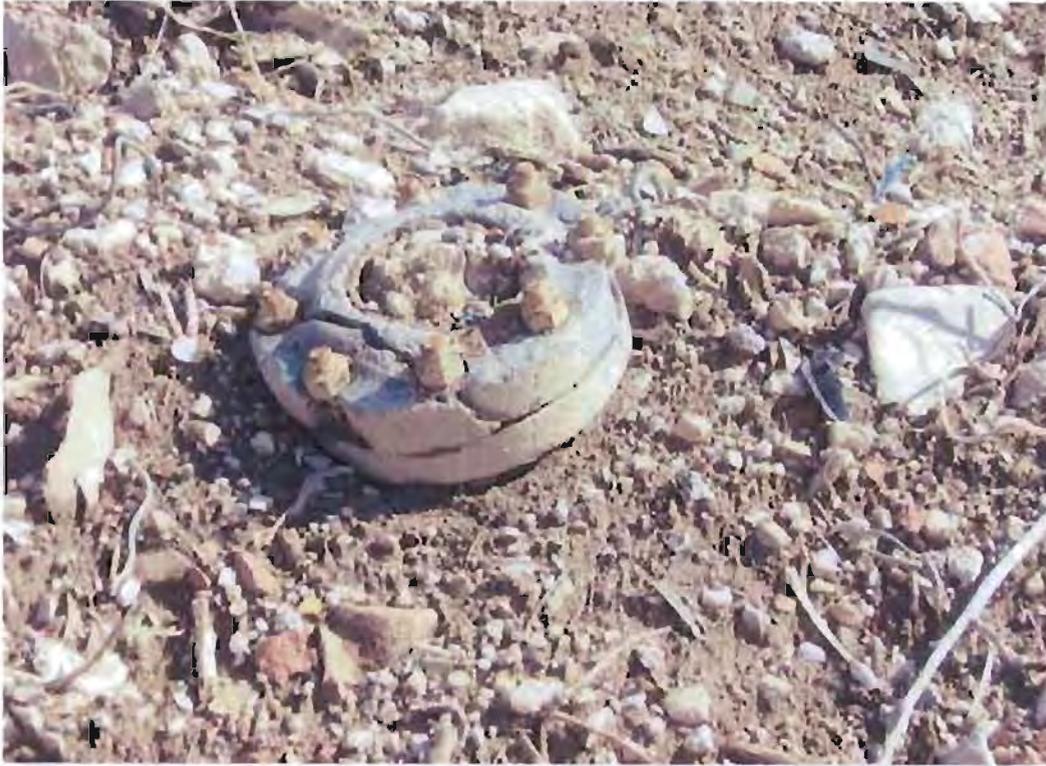
Date: March 23, 2011
Time: 10:29 AM
Direction: NE
Photo by: Eisenbrandt
Exposure #: 029
Comments: Copious amounts of waste intermixed with the demolition debris. Plumbing fitting, electrical wire, rusty scrap metal, splinted wood, and plastic.

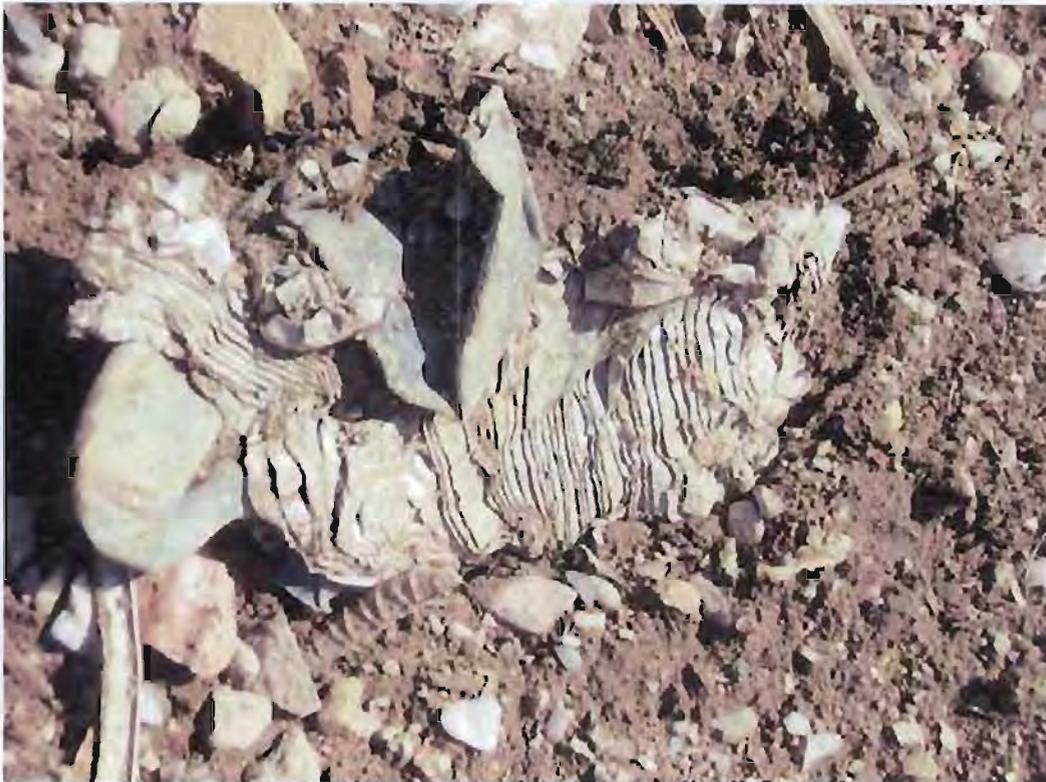
Date: March 23, 2011
Time: 10:30 AM
Direction: NE
Photo by: Eisenbrandt
Exposure #: 030
Comments: A close up photograph of protruding rebar and metal waste.

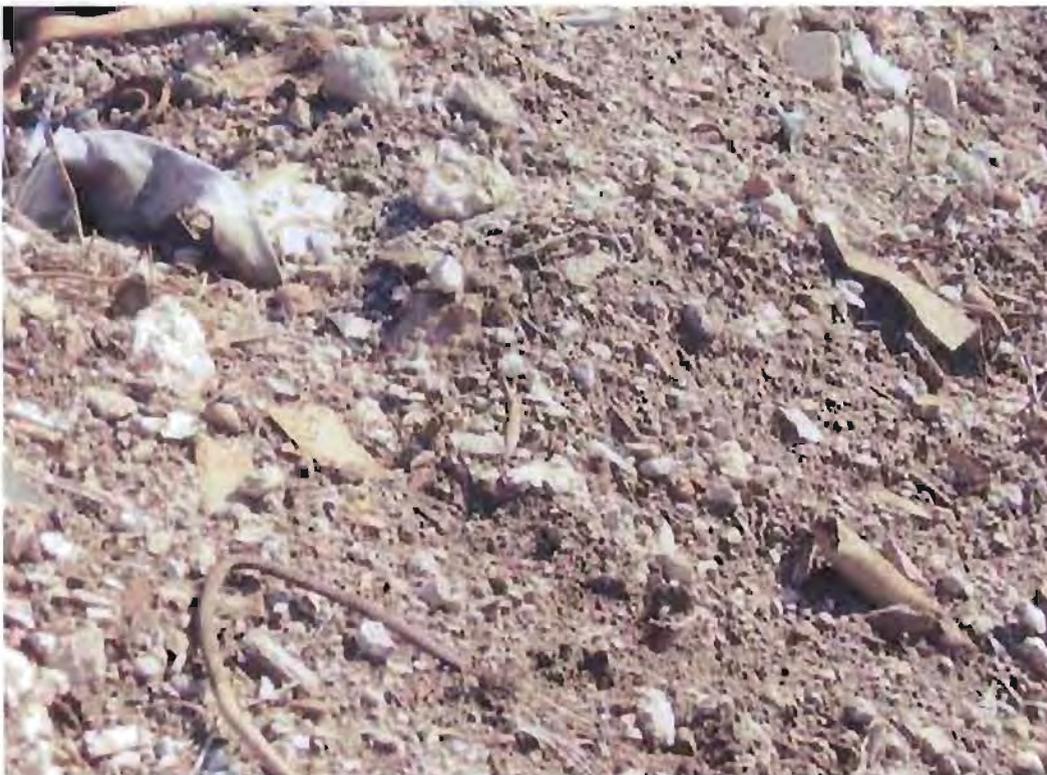
Date: March 23, 2011
Time: 10:30 AM
Direction: NE
Photo by: Eisenbrandt
Exposure #: 031
Comments: Rusty scrap metal visible in the pile of demolition debris.

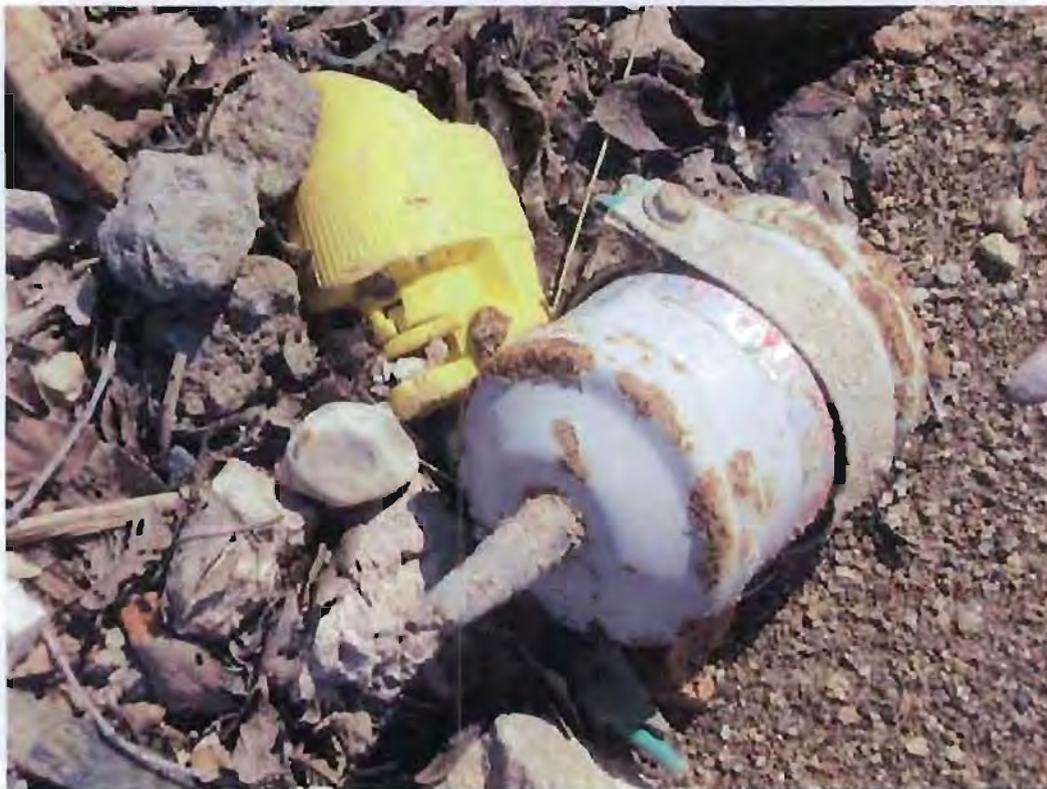
Date: March 23, 2011
Time: 10:33 AM
Direction: E
Photo by: Eisenbrandt
Exposure #: 032
Comments: Waste intermixed in the debris pile.

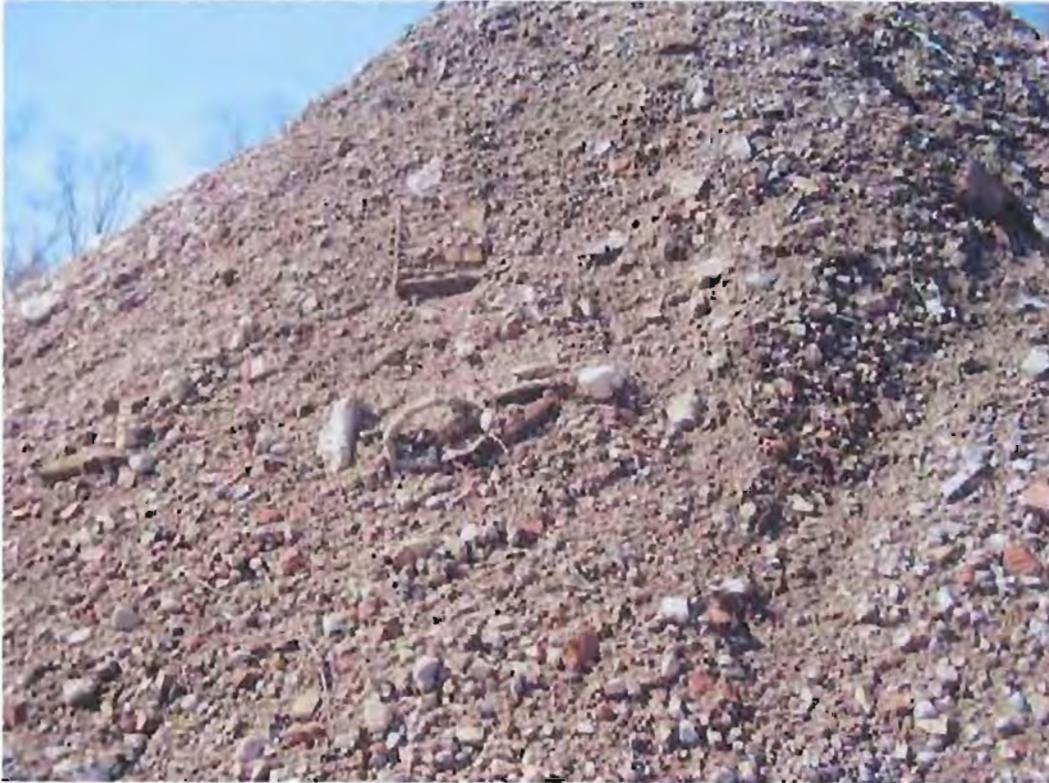
Date: March 23, 2011
Time: 10:39 AM
Direction: W
Photo by: Eisenbrandt
Exposure #: 033
Comments: Scrap metal protruding from the debris pile.

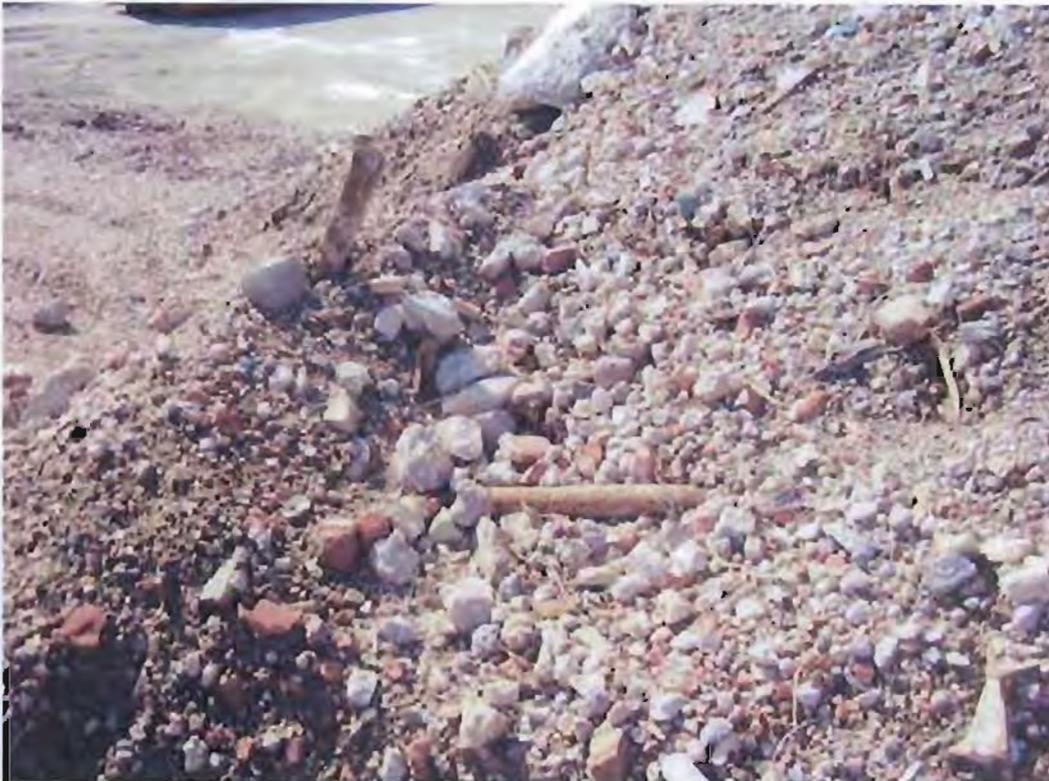
Date: March 23, 2011
Time: 10:39 AM
Direction: SE
Photo by: Eisenbrandt
Exposure #: 034
Comments: Obvious scrap metal protruding from the demolition debris pile.

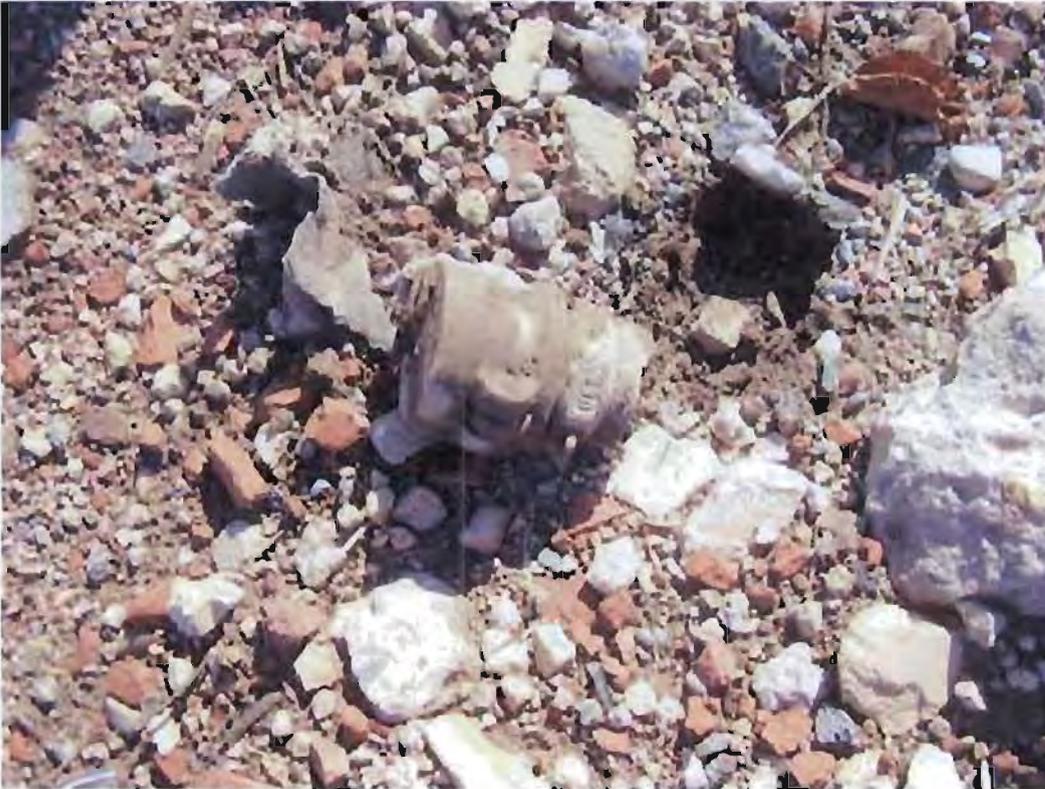
Date: March 23, 2011
Time: 10:39 AM
Direction: SE
Photo by: Eisenbrandt
Exposure #: 035
Comments: More waste observed intermixed in the demolition debris pile.

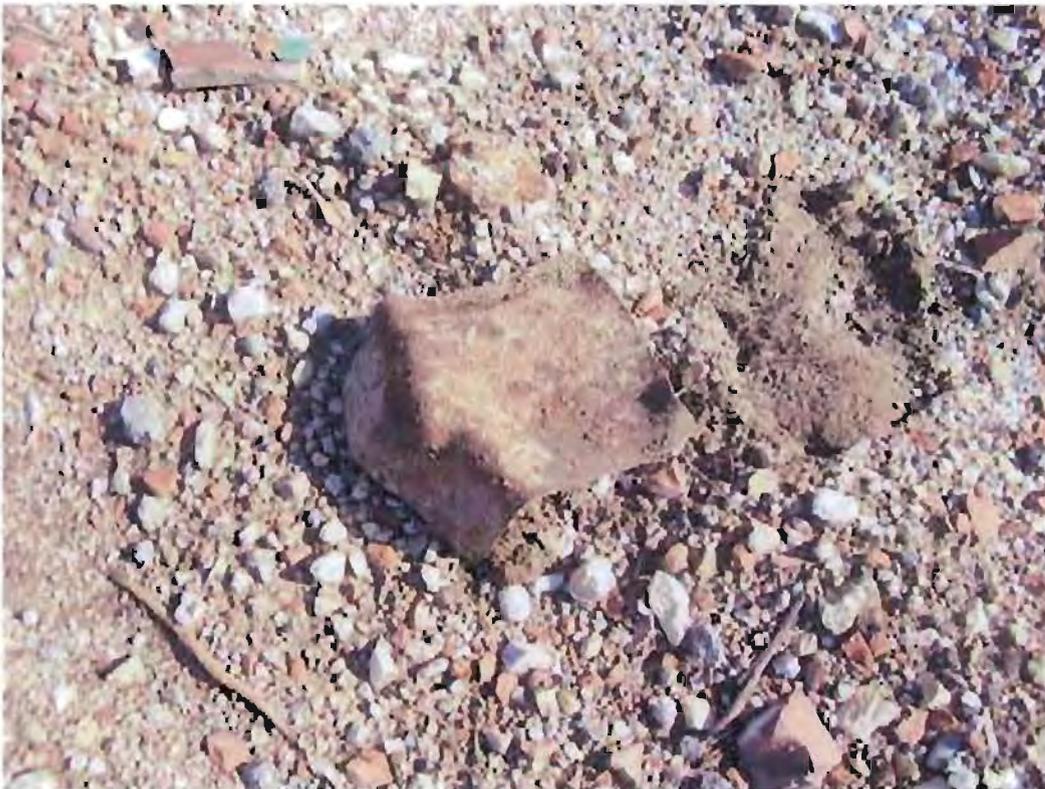
Date: March 23, 2011
Time: 10:39 AM
Direction: E
Photo by: Eisenbrandt
Exposure #: 036
Comments: Rusty scrap metal

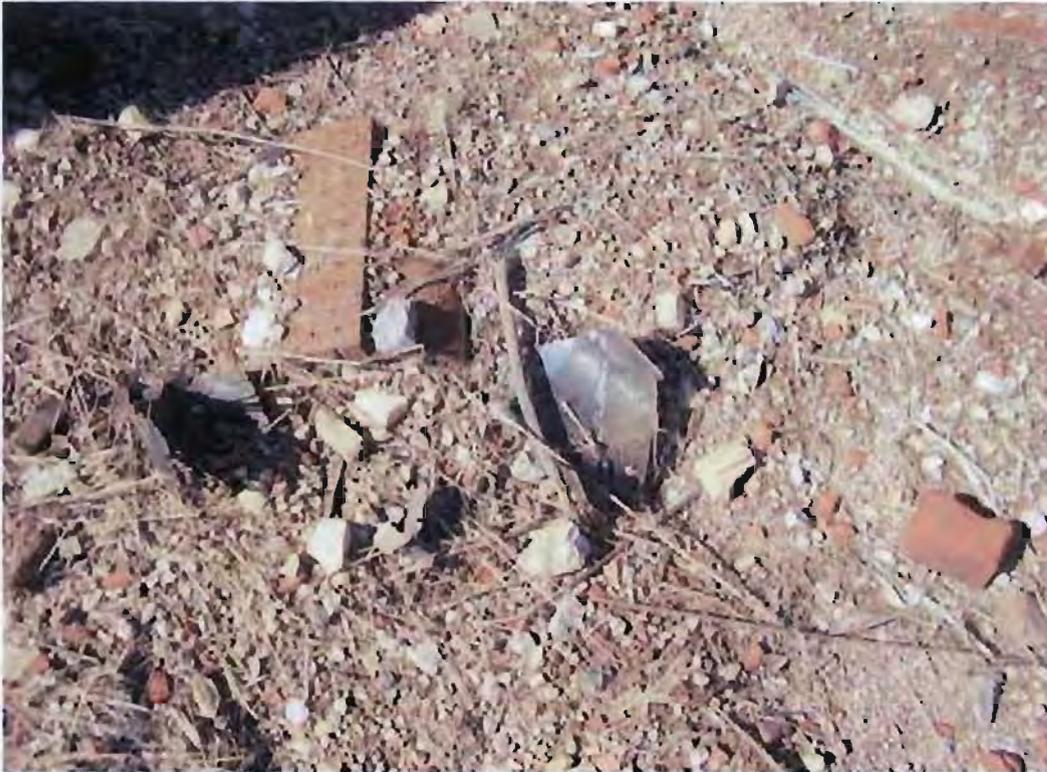
Date: March 23, 2011
Time: 10:40 AM
Direction: W
Photo by: Eisenbrandt
Exposure #: 037
Comments: Plastic, fiberglass, electrical wire, and scrap metal on the ground.

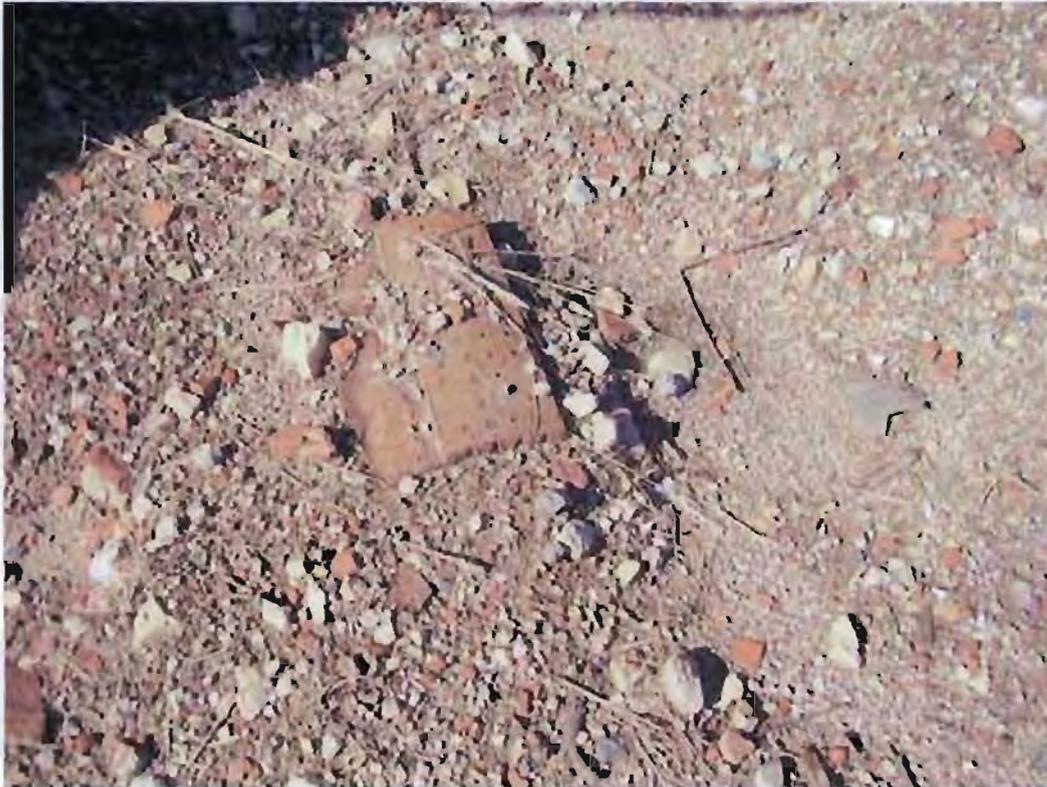
Date: March 23, 2011
Time: 10:40 AM
Direction: SW
Photo by: Eisenbrandt
Exposure #: 038
Comments: Scrap metal and splinters of wood.

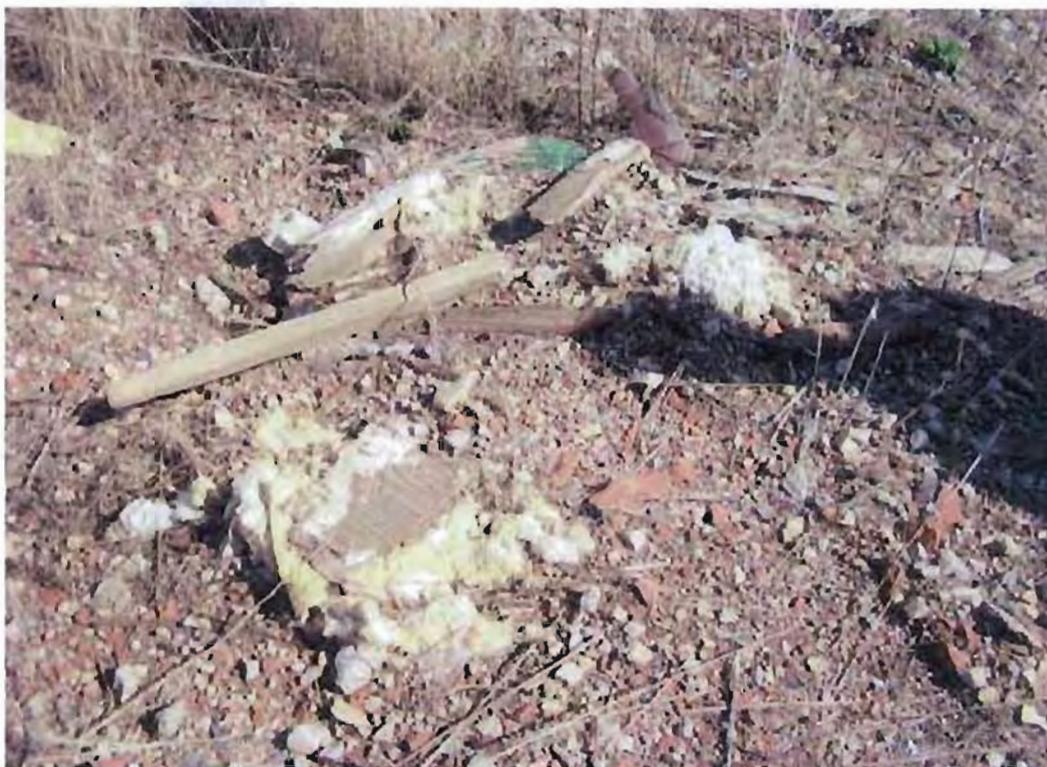
Date: March 23, 2011
Time: 10:40 AM
Direction: N
Photo by: Eisenbrandt
Exposure #: 039
Comments: Weathered wood and insulation.

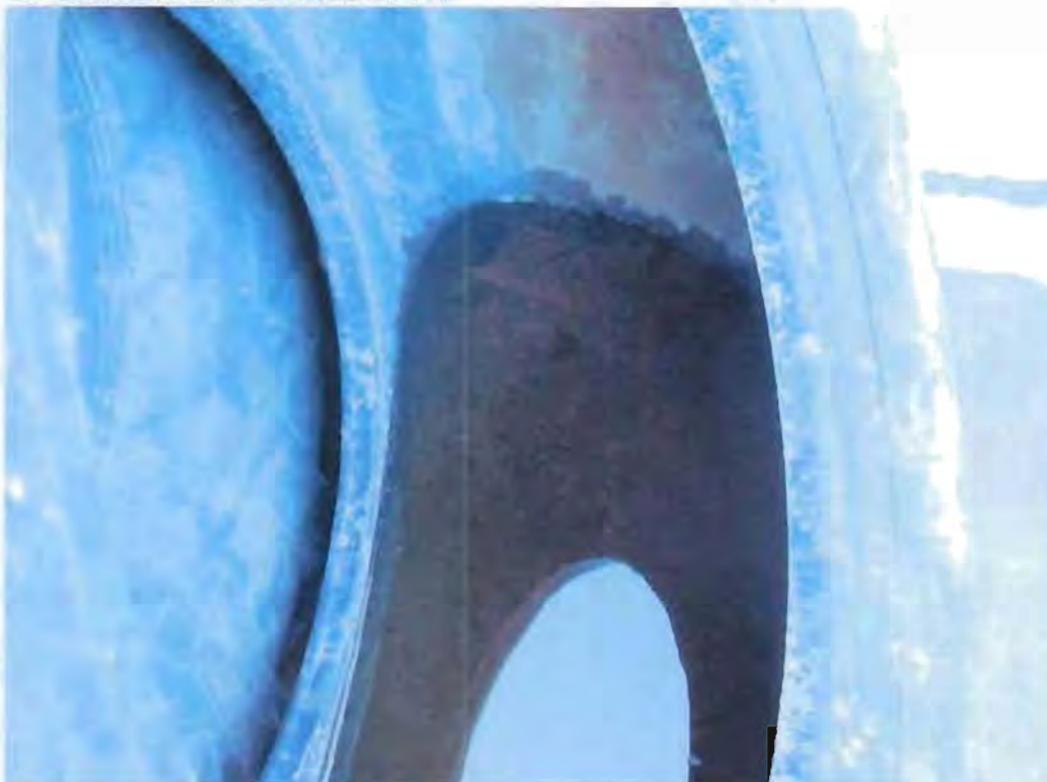
Date: March 23, 2011
Time: 10:42 AM
Direction: NE
Photo by: Eisenbrandt
Exposure #: 041
Comments: Water in the used tires.

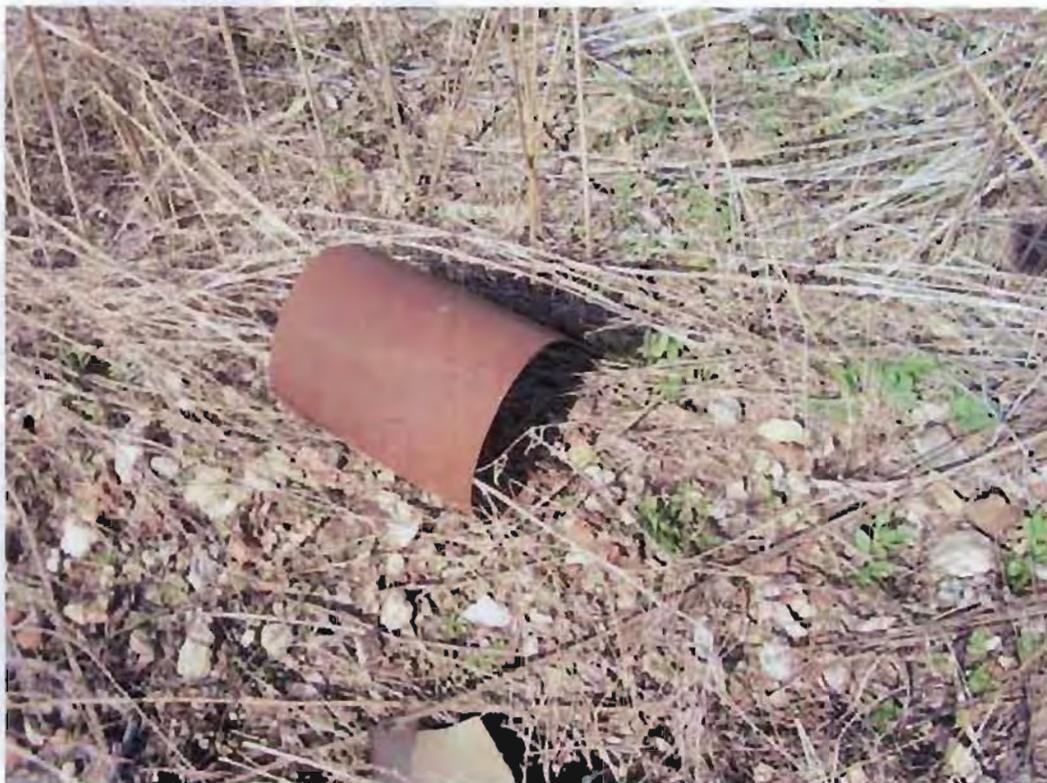
Date: March 23, 2011
Time: 10:44 AM
Direction: W
Photo by: Eisenbrandt
Exposure #: 042
Comments: More scrap metal.
