**BEFORE THE ILLINOIS POLLUTION CONTROL BOARD**

PEOPLE OF THE STATE OF ILLINOIS,	)	
	)	
Complainant,	)	
	)	
v.	)	PCB No. 13-3
	)	(Enforcement-Land)
EDWARD W. FISHER, RHONDA L.	)	
FISHER, and DEM/EX GROUP, INC.,	)	
(an Illinois corporation),	)	
	)	
Respondents.	)

**COMPLAINANT'S MOTION FOR SUMMARY JUDGMENT PURSUANT TO 35 ILL. ADM. CODE 101.516(b) AGAINST RESPONDENT DEM/EX GROUP INC.**

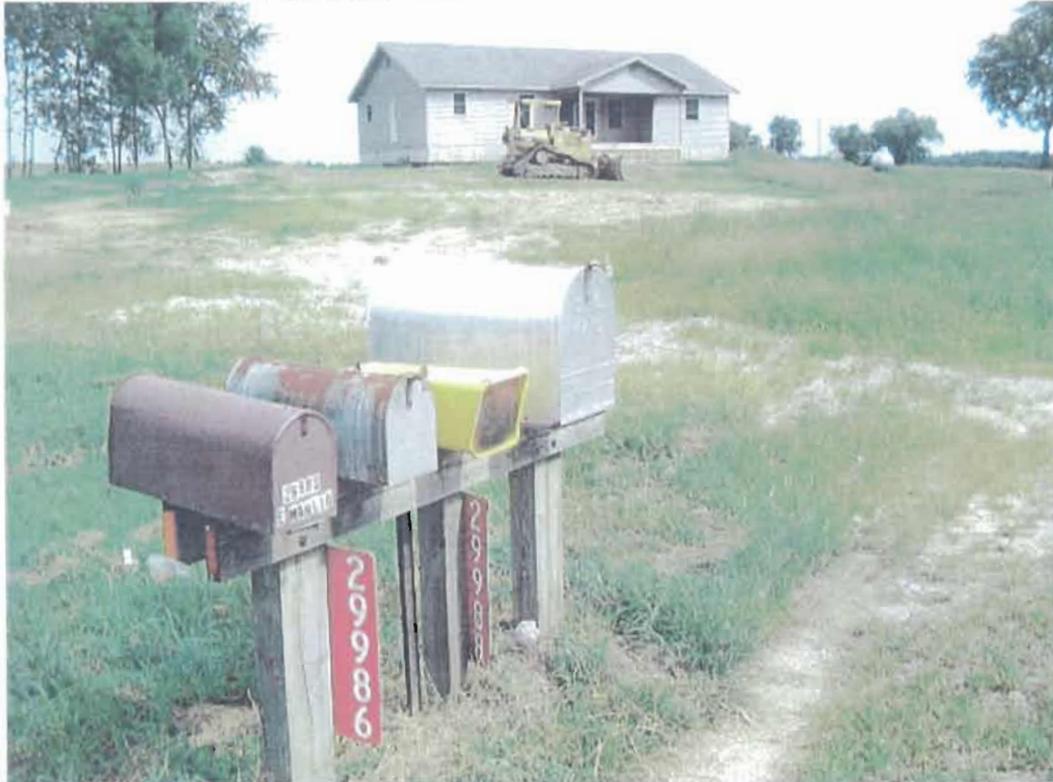
**Date:** August 4, 2010  
**Time:** 10:14 AM  
**Direction:** NW  
**Photo by:** Eisenbrandt  
**Exposure #:** 001  
**Comments:** Front elevation view of house from Manito Road.

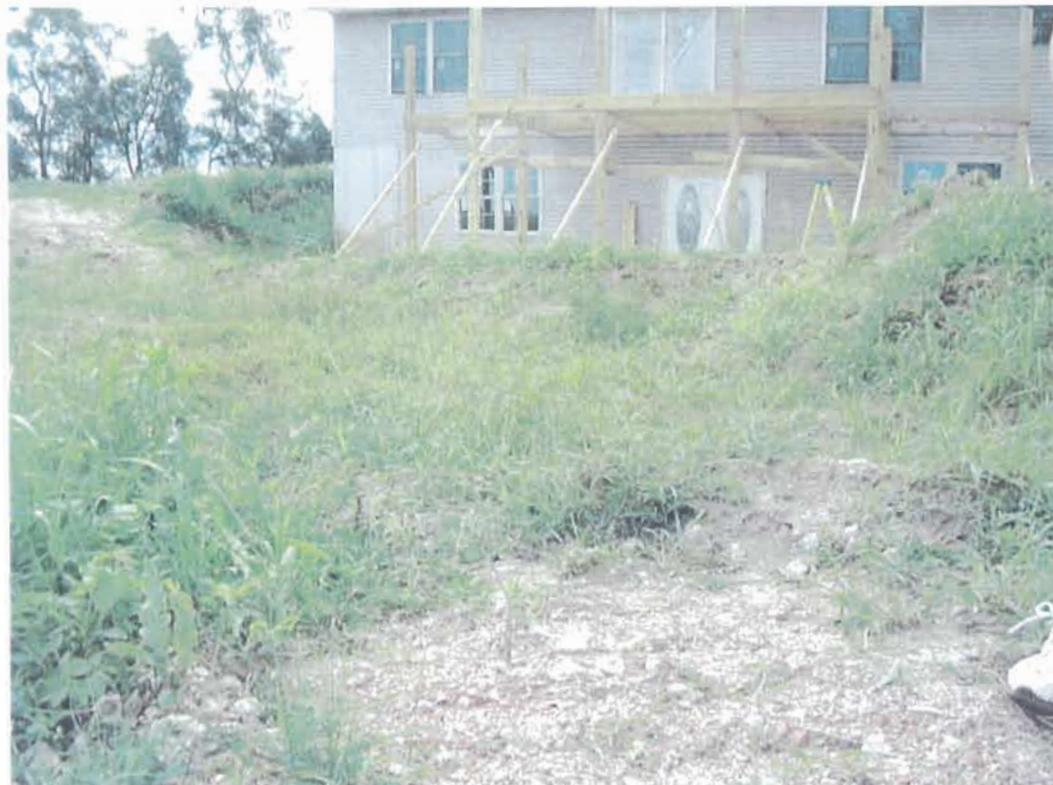
**Date:** August 4, 2010  
**Time:** 10:24 AM  
**Direction:** NE  
**Photo by:** Eisenbrandt  
**Exposure #:** 002  
**Comments:** Rear side of house under construction. Ground covered with broken brick and mortar.

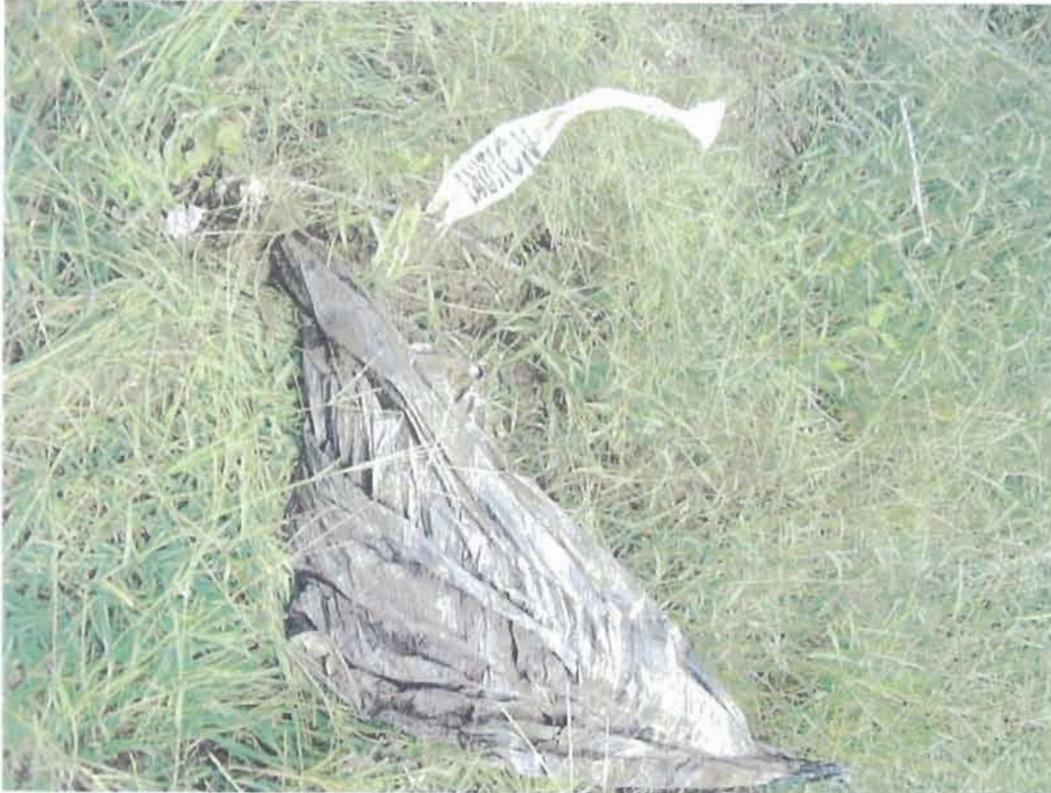
**Date:** August 4, 2010  
**Time:** 10:27 AM  
**Direction:** W  
**Photo by:** Eisenbrandt  
**Exposure #:** 003  
**Comments:** Dirty black plastic bag and a piece of plastic "Caution" tape among the weeds.

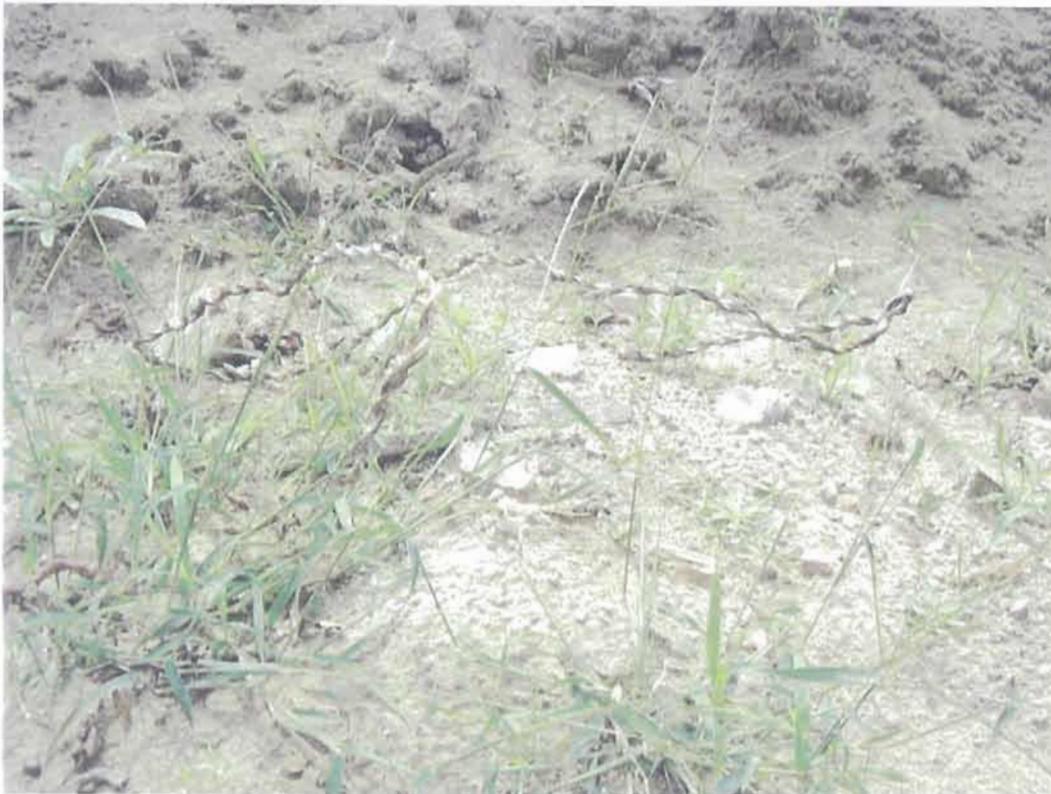
Photograph 004 shows a rusty unwound piece of Greenfield (flexible conduit) and pieces of brick and mortar.

**Date:** August 4, 2010  
**Time:** 10:27 AM  
**Direction:** E  
**Photo by:** Eisenbrandt  
**Exposure #:** 004  
**Comments:** A rusty unwound piece of Greenfield (flexible conduit) and pieces of brick and mortar.

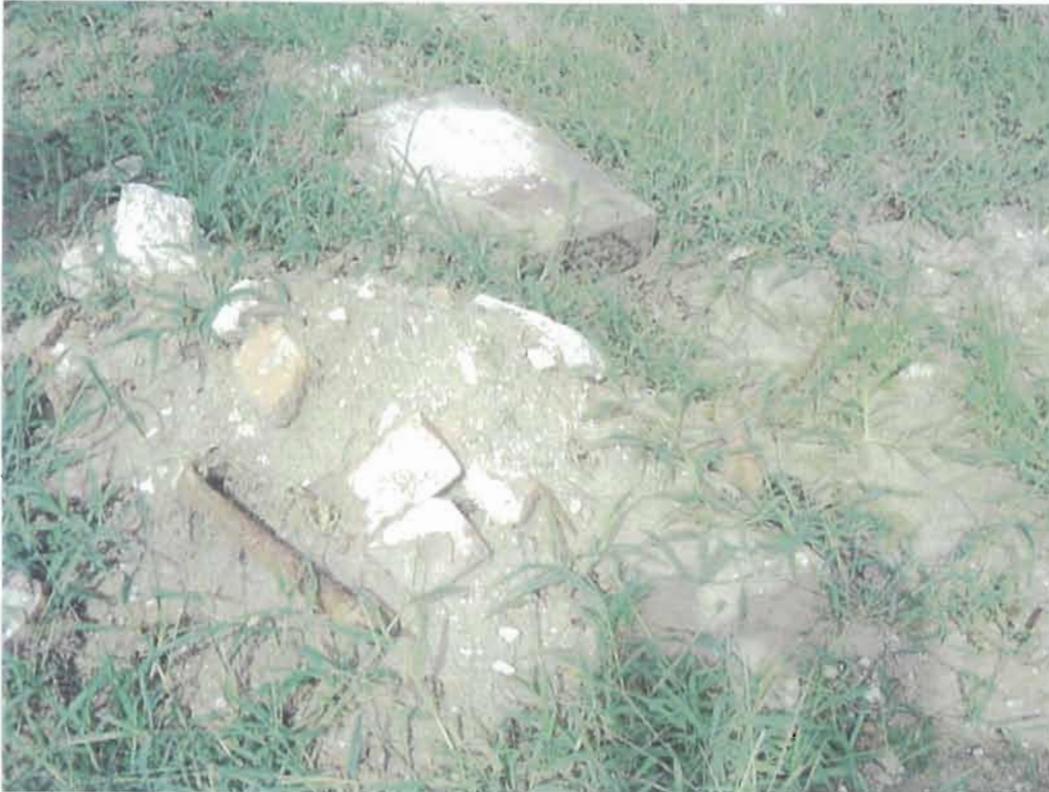
**Date:** August 4, 2010  
**Time:** 10:30 AM  
**Direction:** W  
**Photo by:** Eisenbrandt  
**Exposure #:** 005  
**Comments:** A cut-off section of a glue-lam beam, chunks of brick, concrete, scraps of rusty metal were observed in the fill material.

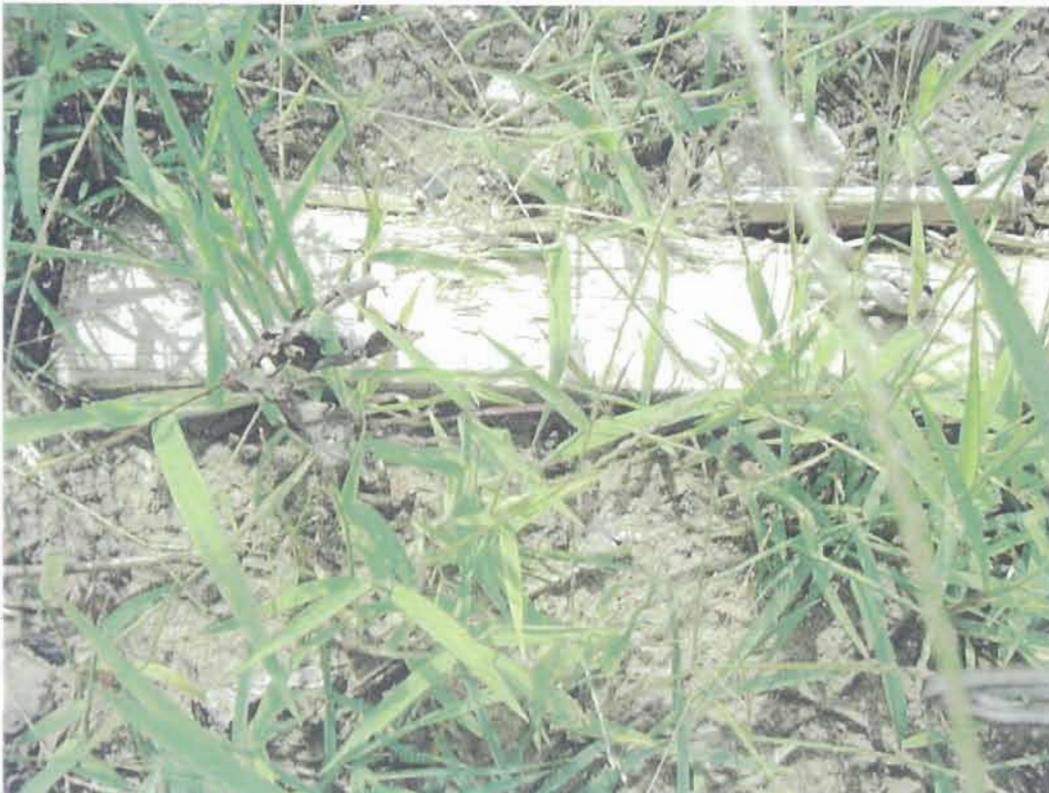
**Date:** August 4, 2010  
**Time:** 10:32 AM  
**Direction:** E  
**Photo by:** Eisenbrandt  
**Exposure #:** 006  
**Comments:** Damage dimensional lumber and mortar.

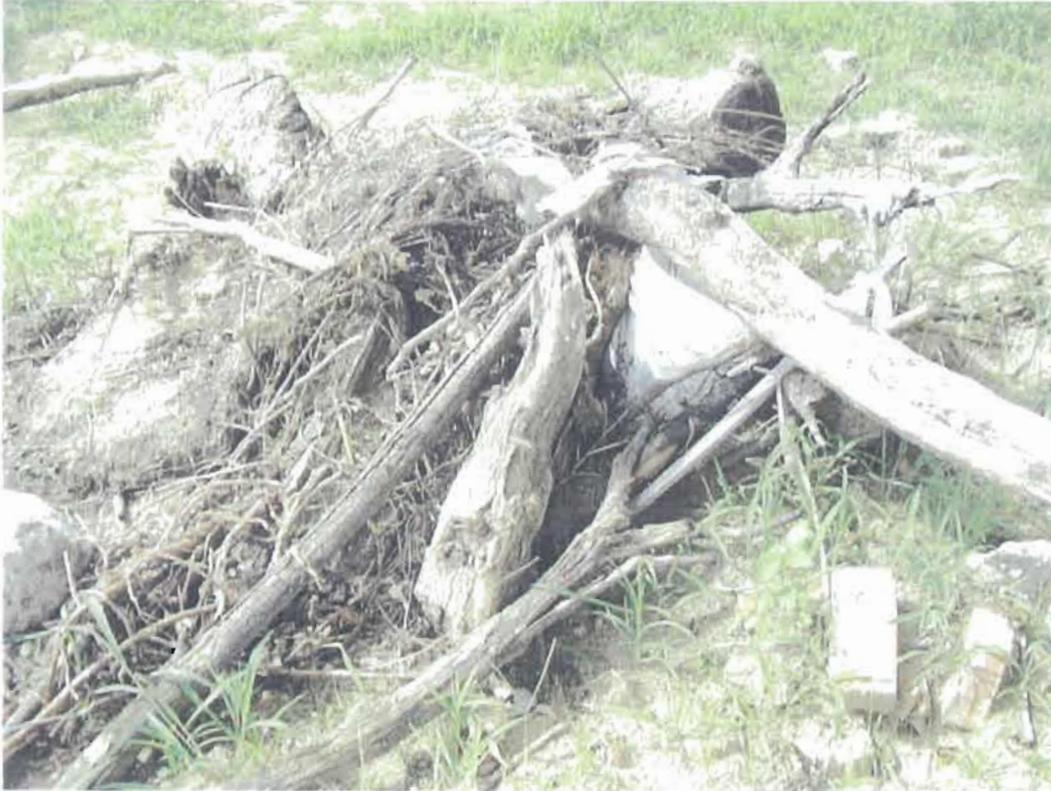
**Date:** August 4, 2010  
**Time:** 10:32 AM  
**Direction:** SE  
**Photo by:** Eisenbrandt  
**Exposure #:** 007  
**Comments:** A debris pile containing landscape waste, brick, a white plastic bucket, a survey stake, and metal wire.

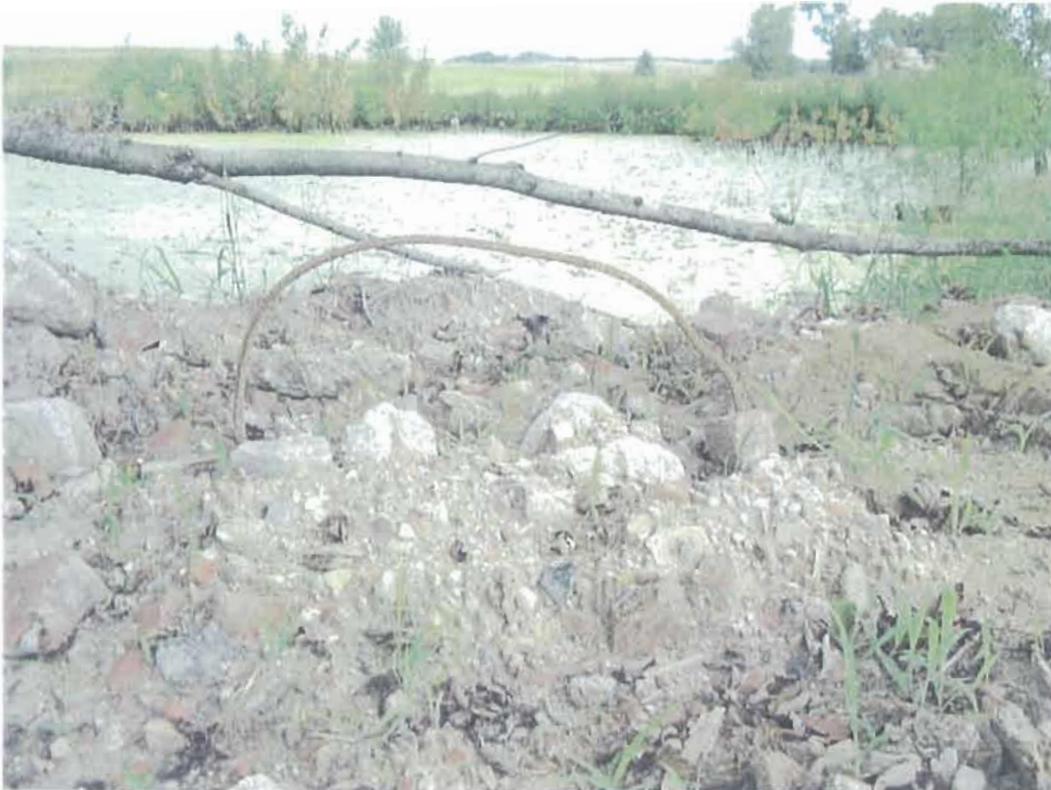
**Date:** August 4, 2010  
**Time:** 10:34 AM  
**Direction:** NW  
**Photo by:** Eisenbrandt  
**Exposure #:** 008  
**Comments:** Brick and mortar, and a piece of protruding rebar on the edge of the pond. Black plastic, carpet, asphalt shingles, and broken glass were observed in the unclean fill material.

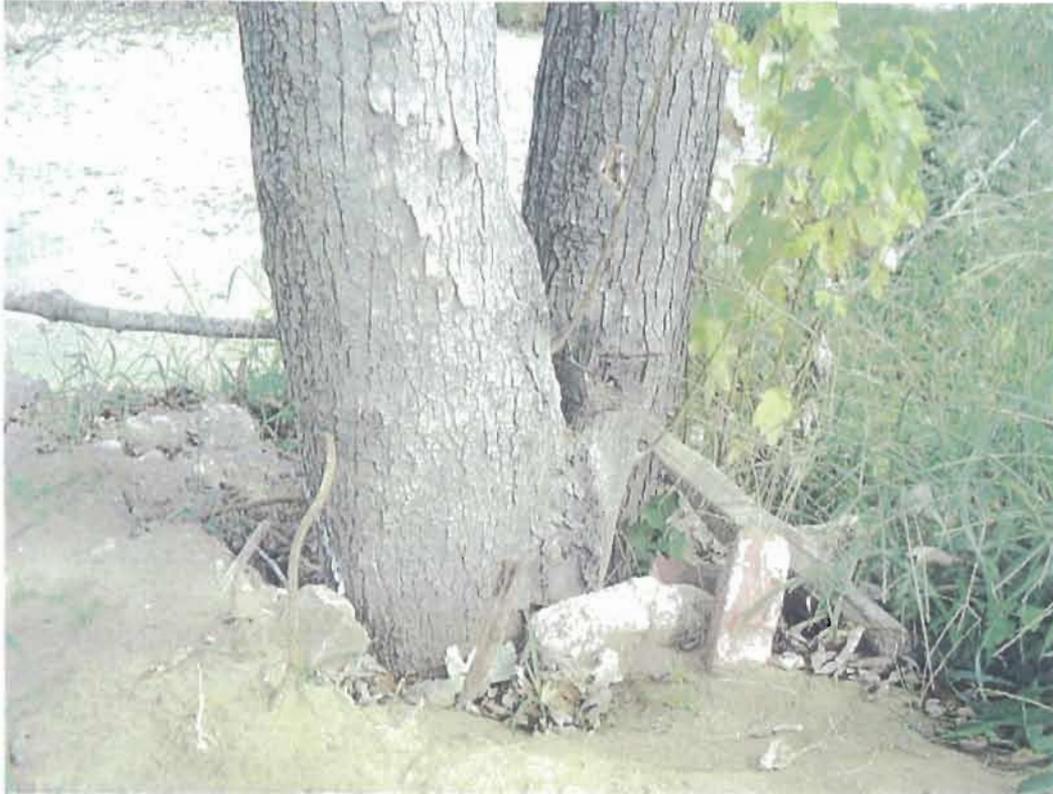
Date: August 4, 2010  
Time: 10:34 AM  
Direction: W  
Photo by: Eisenbrandt  
Exposure #: 009  
Comments: Dimensional  
lumber scrap, metal, rusty  
rebar, brick, and concrete.

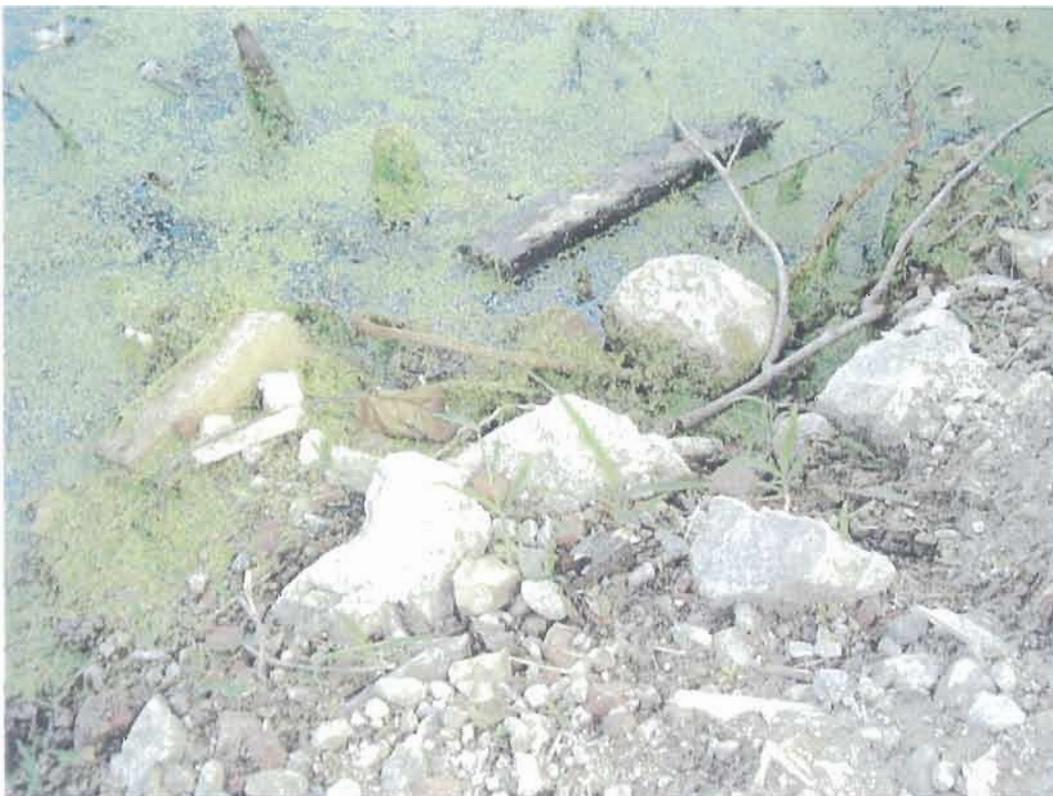
Date: August 4, 2010  
Time: 10:36 AM  
Direction: NW  
Photo by: Eisenbrandt  
Exposure #: 010  
Comments: Rebar, scrap  
lumber, brick, and concrete  
in the pond.

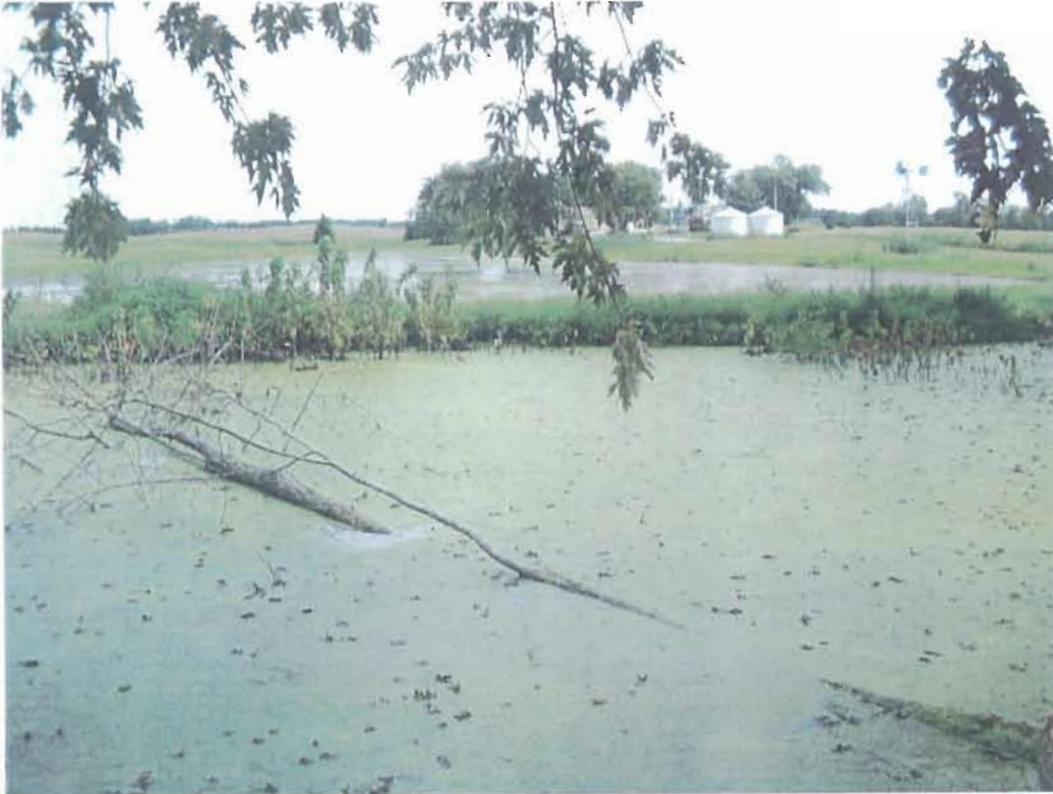
Date: August 4, 2010  
Time: 10:36 AM  
Direction: NW  
Photo by: Eisenbrandt  
Exposure #: 011  
Comments: View of wetland.

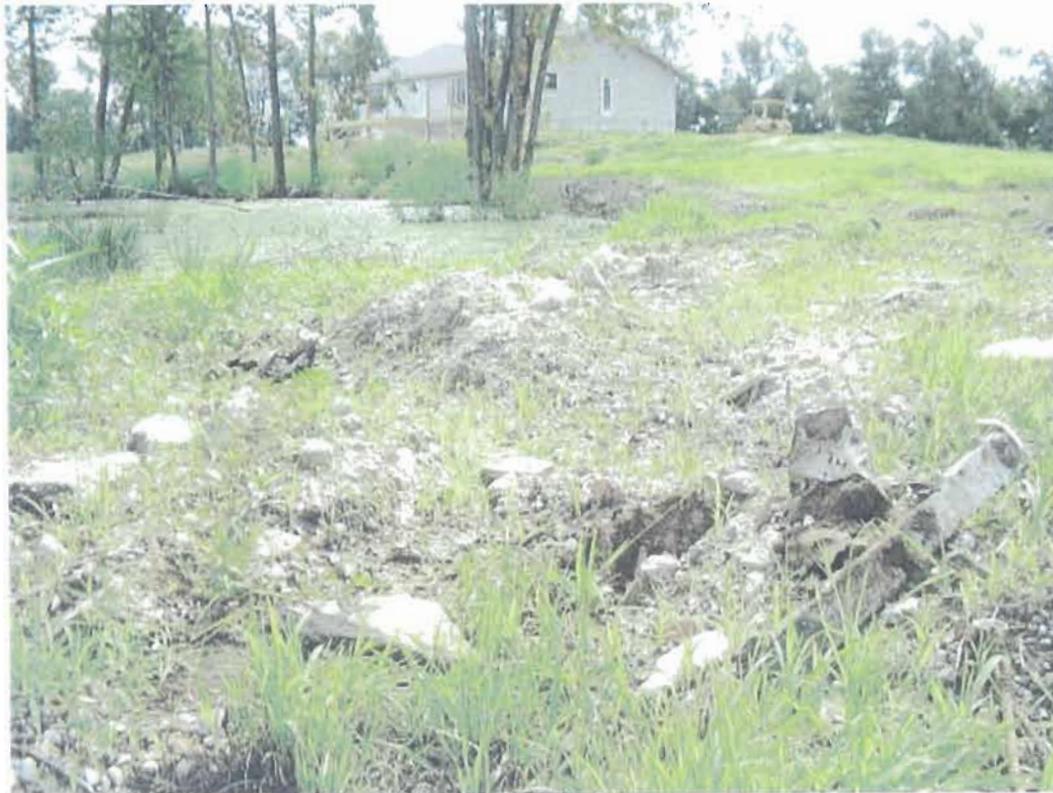
Date: August 4, 2010  
Time: 10:46 AM  
Direction: NE  
Photo by: Eisenbrandt  
Exposure #: 012  
Comments: Scrap metal visible in the foreground.

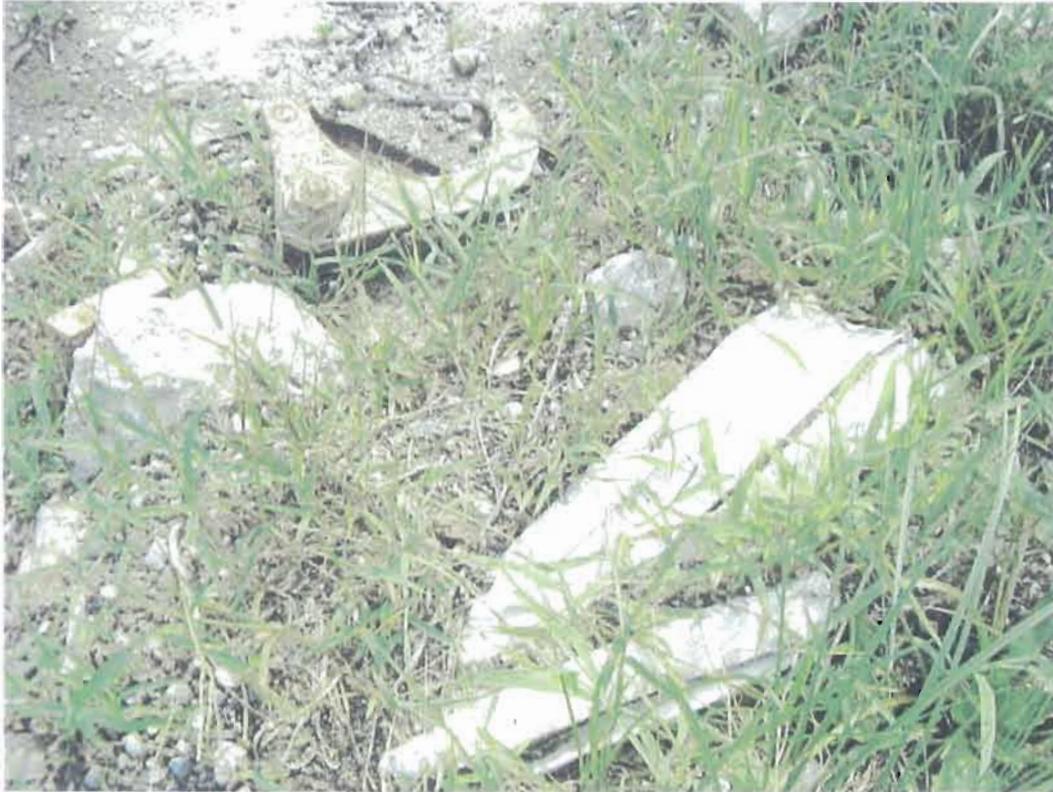
**Date:** August 4, 2010  
**Time:** 10:47 AM  
**Direction:** E  
**Photo by:** Eisenbrandt  
**Exposure #:** 013  
**Comments:** Rusty iron and scrap aluminum intermixed with fill material.

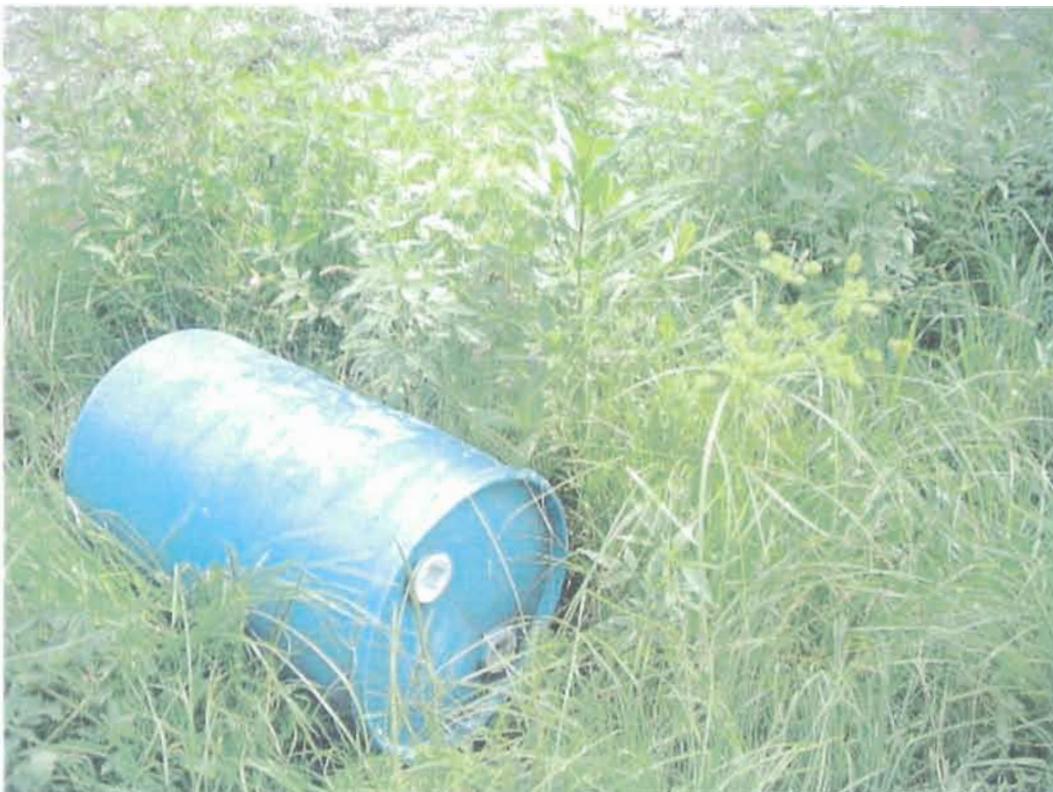
**Date:** August 4, 2010  
**Time:** 10:49 AM  
**Direction:** NE  
**Photo by:** Eisenbrandt  
**Exposure #:** 014  
**Comments:** An open dumped blue plastic drum. Drum appeared mostly empty with a small amount of liquid residue.

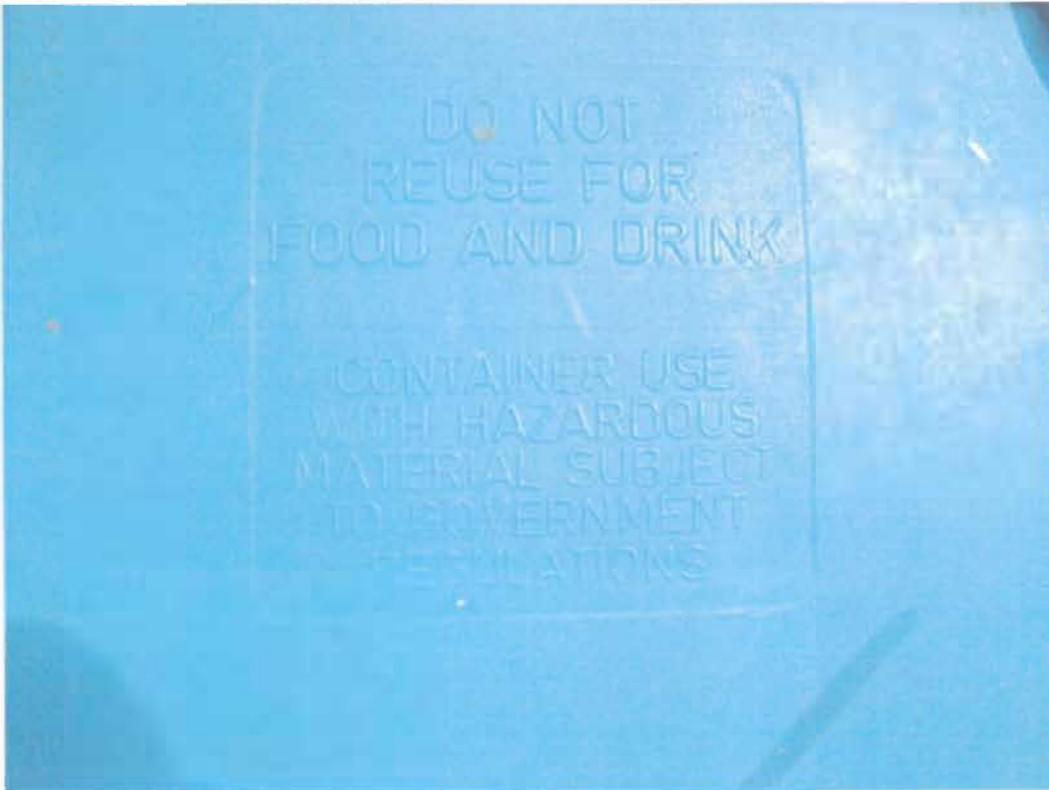
Date: August 4, 2010  
Time: 10:49 AM  
Direction: SW  
Photo by: Eisenbrandt  
Exposure #: 015  
Comments: Labeling imprinted on drum.

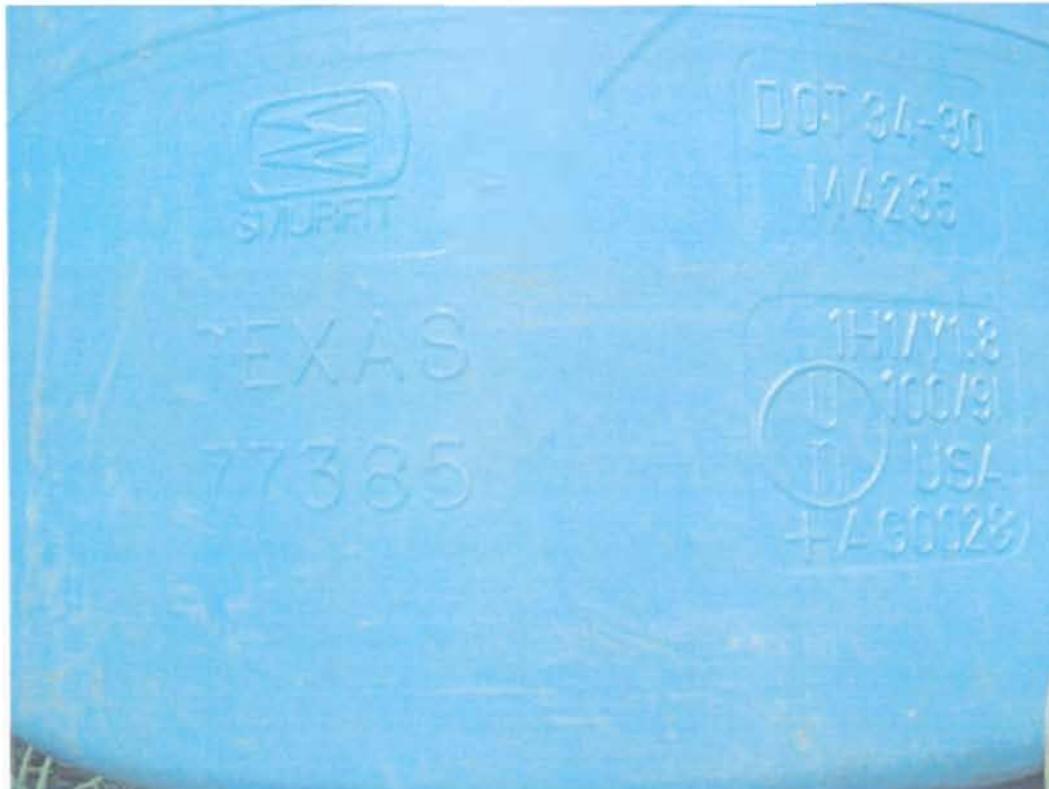
Date: August 4, 2010  
Time: 10:50 AM  
Direction: SW  
Photo by: Eisenbrandt  
Exposure #: 016  
Comments: Labeling imprinted on drum.

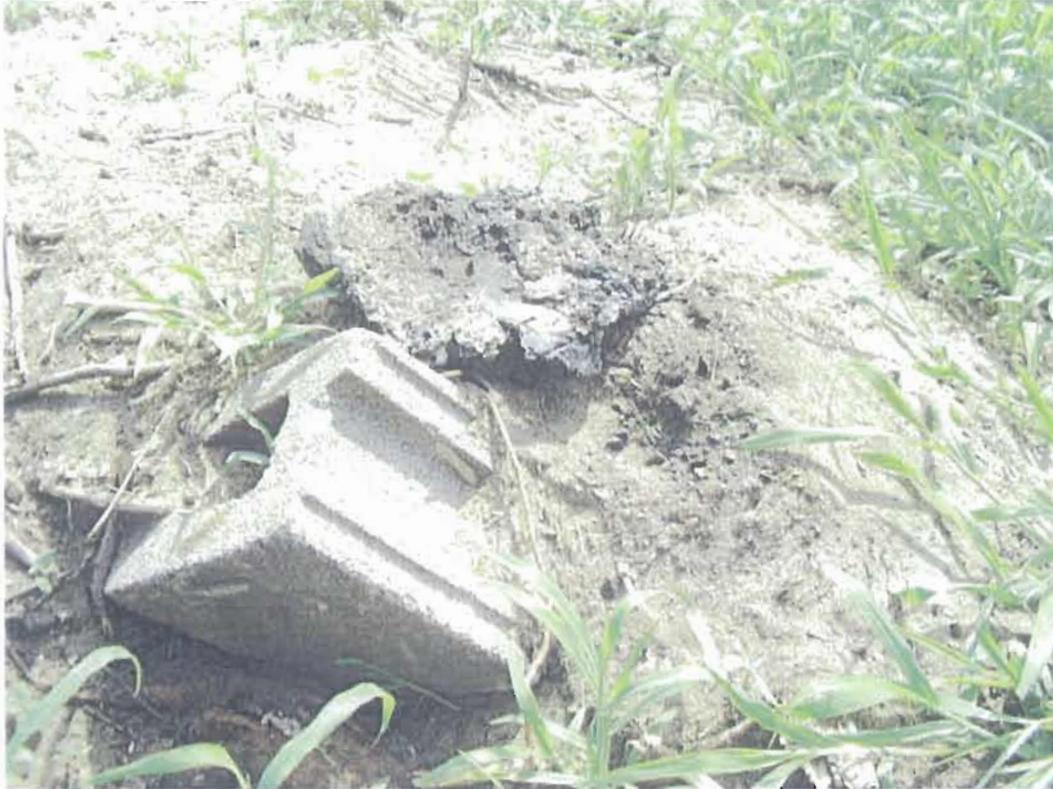
**Date:** August 4, 2010  
**Time:** 10:52 AM  
**Direction:** NE  
**Photo by:** Eisenbrandt  
**Exposure #:** 017  
**Comments:** A cinder block, rusty scrap metal, and charred wood.

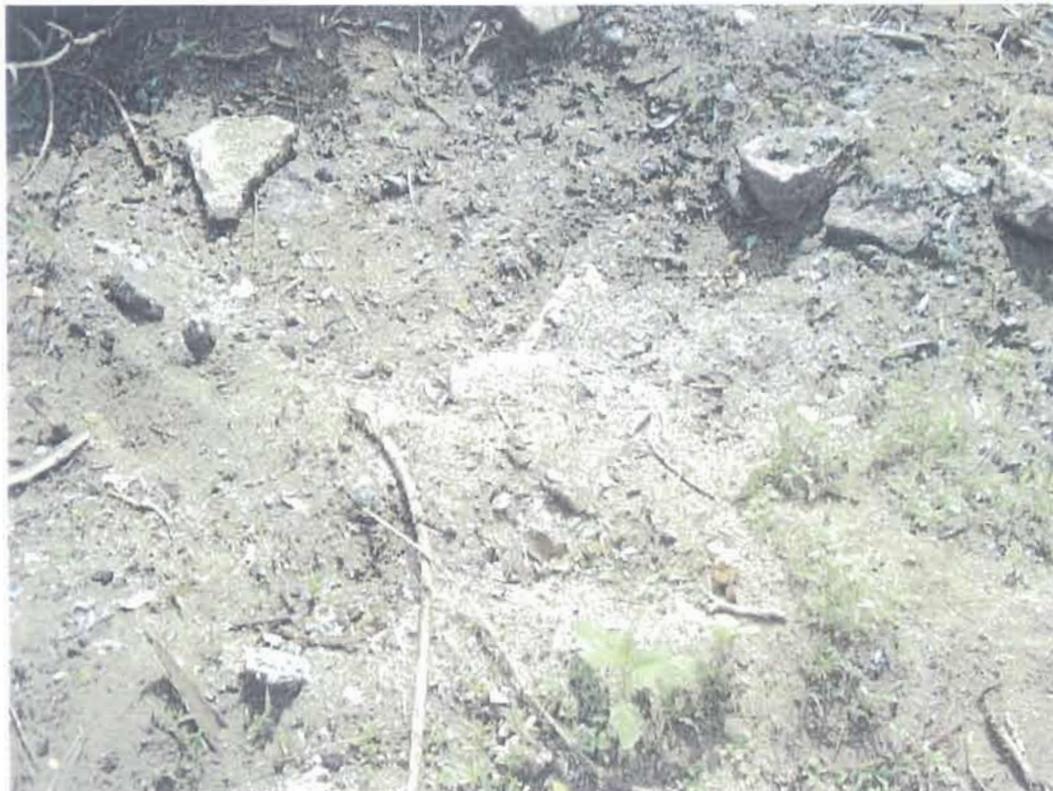
**Date:** August 4, 2010  
**Time:** 10:52 AM  
**Direction:** NE  
**Photo by:** Eisenbrandt  
**Exposure #:** 018  
**Comments:** Ash and charred waste. A blue green residue was also observed in the ashes.

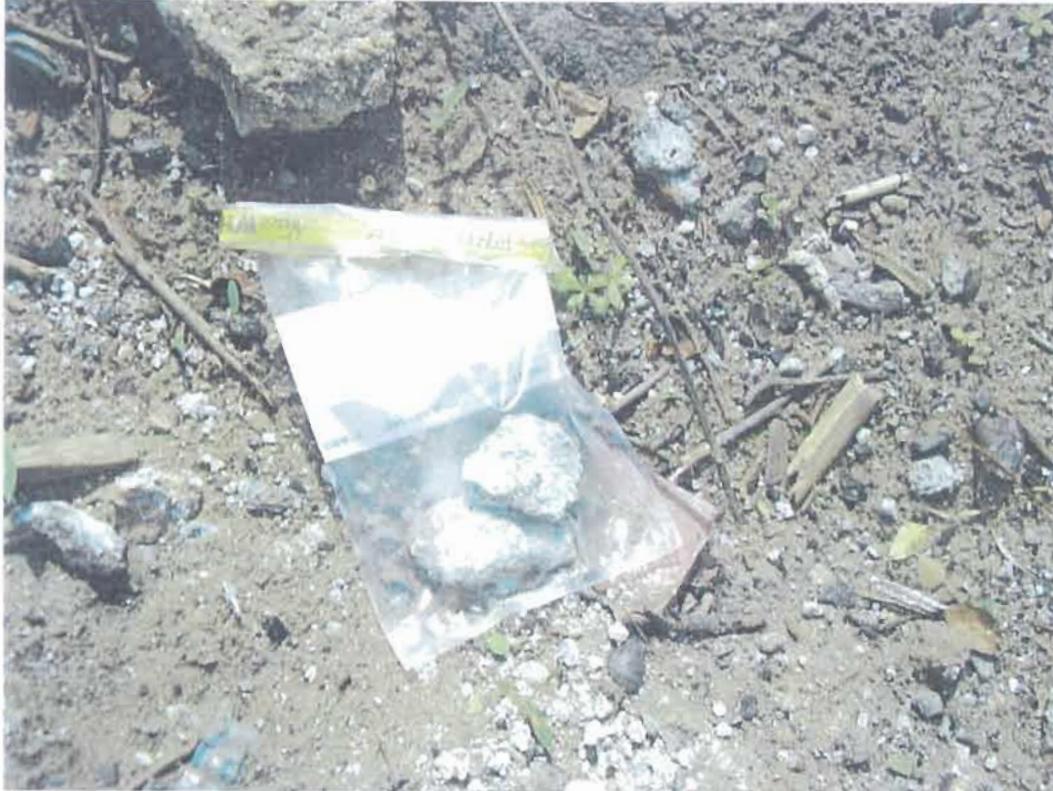
**Date:** August 4, 2010  
**Time:** 10:54 AM  
**Direction:** E  
**Photo by:** Eisenbrandt  
**Exposure #:** 019  
**Comments:** Sample of the blue green residue collected from the burn pile.

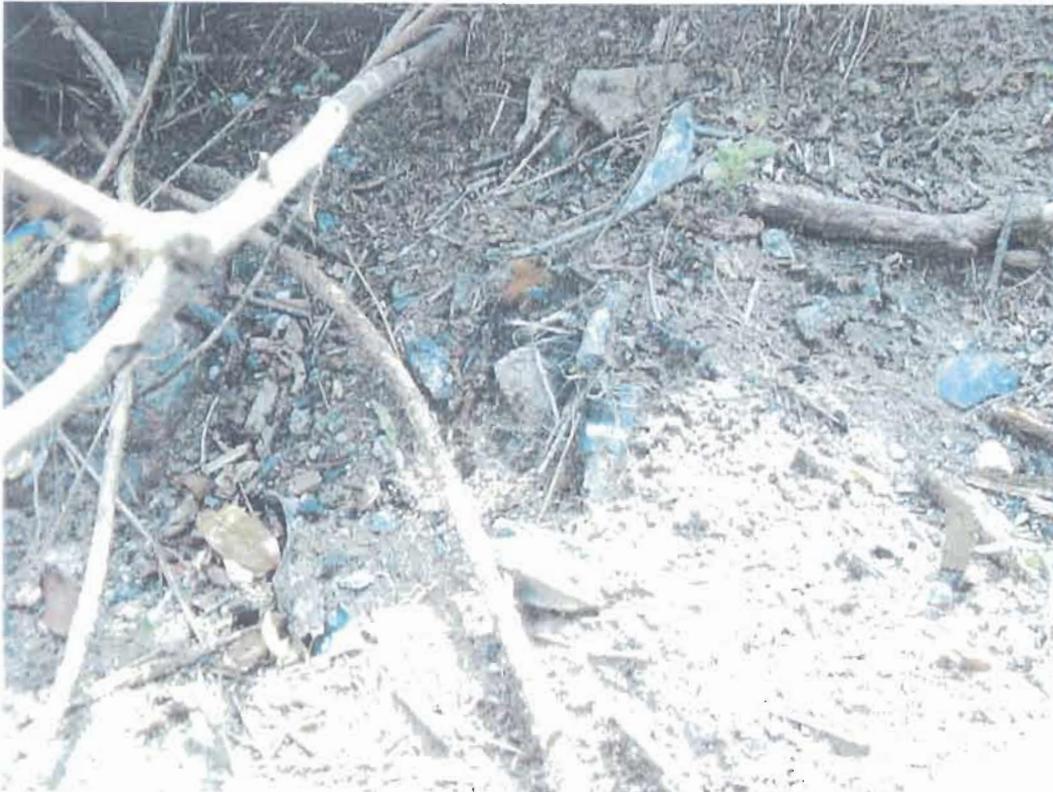
**Date:** August 4, 2010  
**Time:** 10:54 AM  
**Direction:** E  
**Photo by:** Eisenbrandt  
**Exposure #:** 020  
**Comments:** Broken glass, scrap metal, and charred waste.

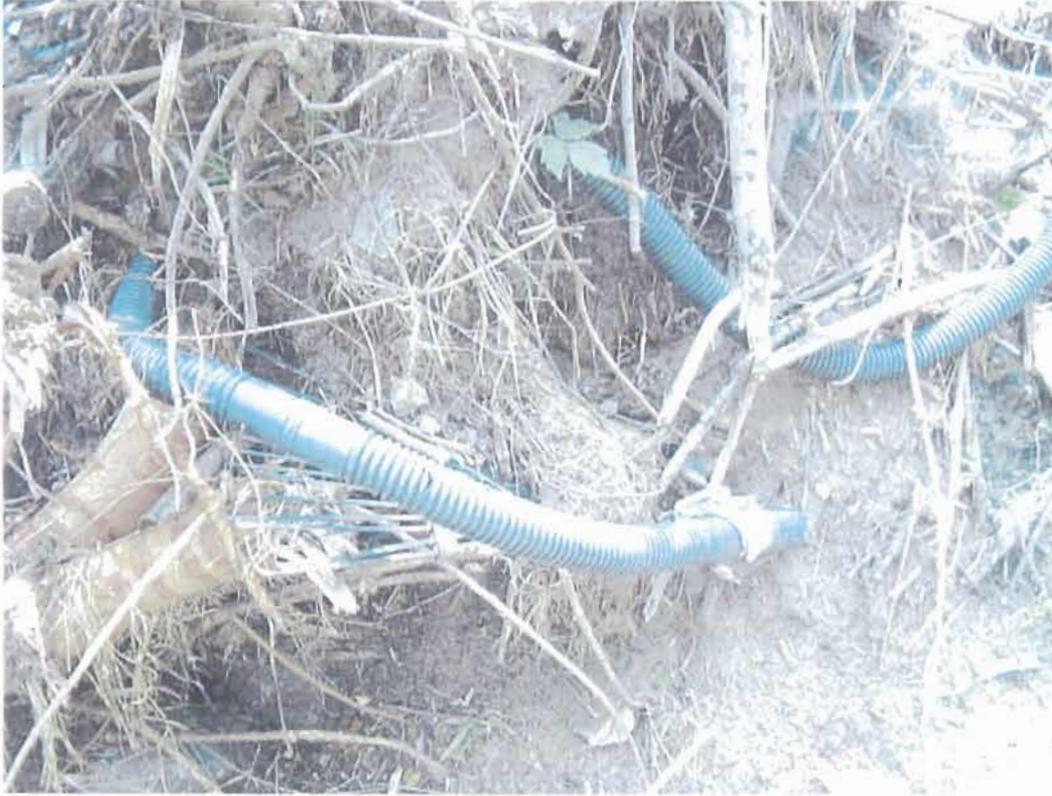
Date: August 4, 2010  
Time: 10:54 AM  
Direction: E  
Photo by: Eisenbrandt  
Exposure #: 021  
Comments: Black plastic hose, a fan rake, broken glass, intermixed with landscape waste in a partially burnt debris pile.

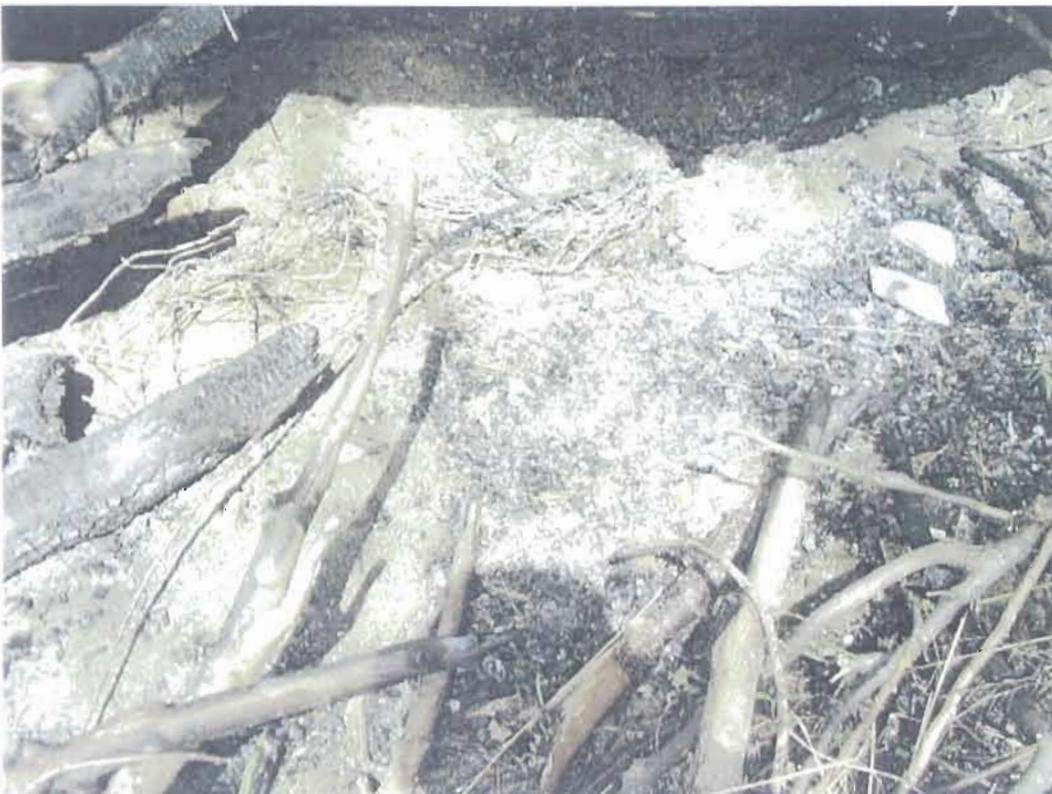
Date: August 4, 2010  
Time: 10:56 AM  
Direction: W  
Photo by: Eisenbrandt  
Exposure #: 022  
Comments: Charred wire and broken porcelain among the ash and landscape waste.

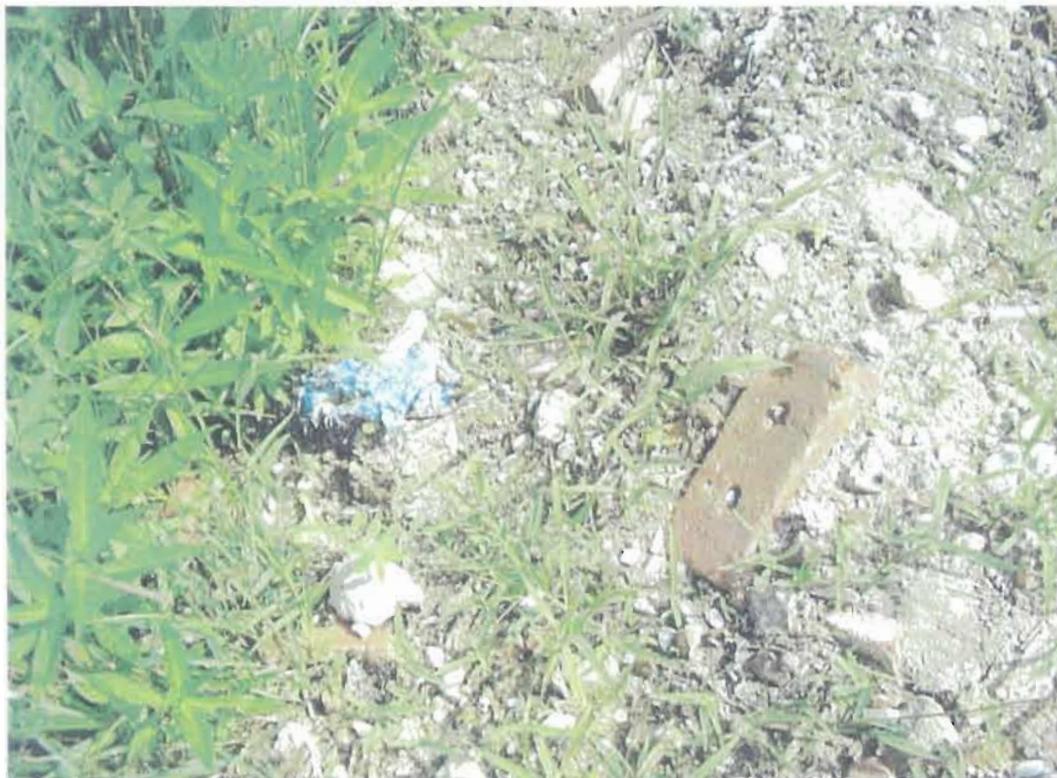
**Date:** August 4, 2010  
**Time:** 10:57 AM  
**Direction:** N  
**Photo by:** Eisenbrandt  
**Exposure #:** 023  
**Comments:** Brick, mortar,  
and blue debris intermixed  
with the fill material.

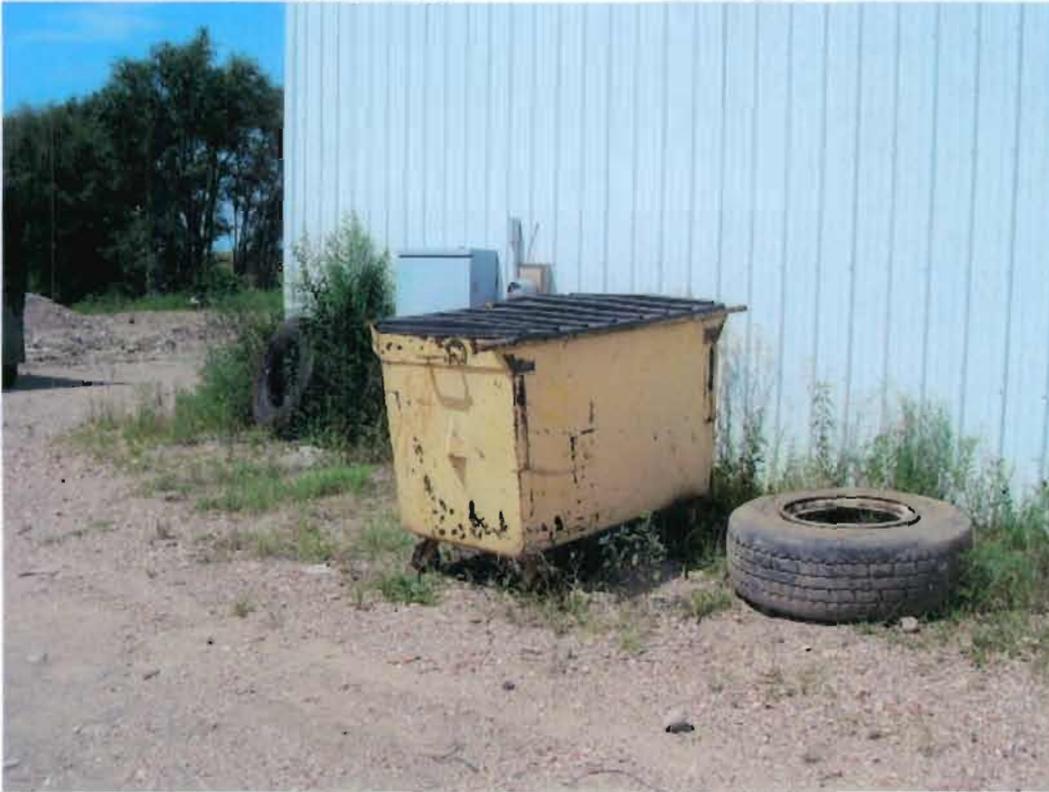
**Date:** August 4, 2010.  
**Time:** 11:41 AM  
**Direction:** SW  
**Photo by:** Eisenbrandt  
**Exposure #:** 003  
**Comments:** Two used tires on the east side of the maintenance garage.

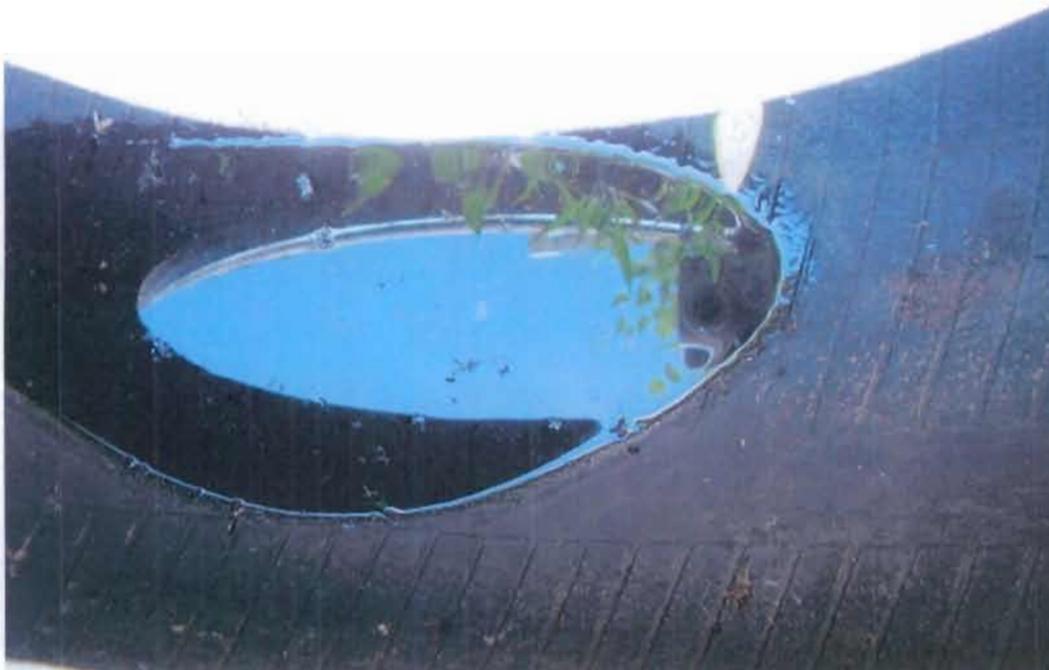
The Respondent caused or allowed water to accumulate in used or waste tires at the corporate site as depicted in Complaint Exhibit 2, August 4, 2010, Exposures 4, 33, pp. 2, 17, and March 23, 2011, Exposures 40 and 41 pp. 38 and 39. (See, Paragraph 18, Count IV of the Complaint and Eisenbrandt Affidavit).

**Date:** August 4, 2010.  
**Time:** 11:42 AM  
**Direction:** W  
**Photo by:** Eisenbrandt  
**Exposure #:** 004  
**Comments:** The used tire (seen in the photograph above) leaning against the building was off-rim and contained water.

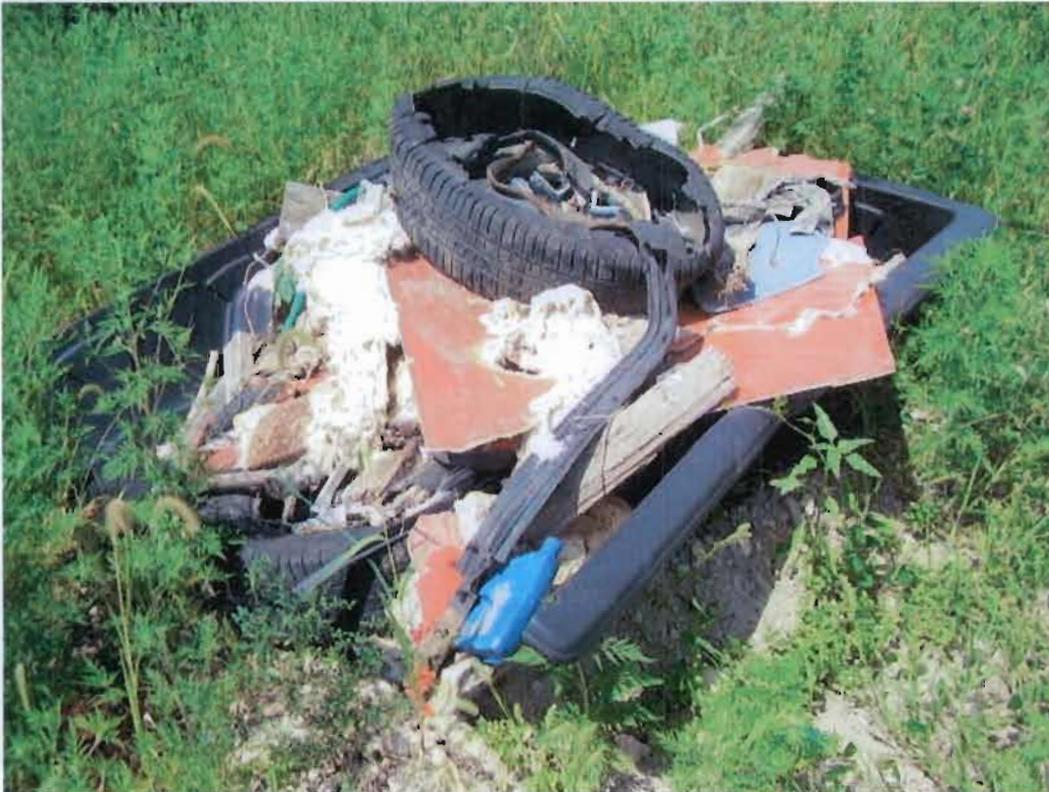
**Date:** August 4, 2010.  
**Time:** 11:43 AM  
**Direction:** SE  
**Photo by:** Eisenbrandt  
**Exposure #:** 005  
**Comments:** A pickup truck bed liner filled with waste. Two used tires (both off-rim), fiberglass insulation, damage scrap lumber, plastic sheeting, a garden hose, and a plastic bottle were among the waste observed.
