**BEFORE THE ILLINOIS POLLUTION CONTROL BOARD**

PEOPLE OF THE STATE OF ILLINOIS,	)	
	)	
Complainant,	)	
	)	
v.	)	PCB No. 13-3
	)	(Enforcement-Land)
EDWARD W. FISHER, RHONDA L.	)	
FISHER, and DEM/EX GROUP, INC.,	)	
(an Illinois corporation),	)	
	)	
Respondents.	)

**COMPLAINANT'S MOTION FOR SUMMARY JUDGMENT PURSUANT TO 35 ILL. ADM. CODE 101.516(b) AGAINST RESPONDENT DEM/EX GROUP INC.**

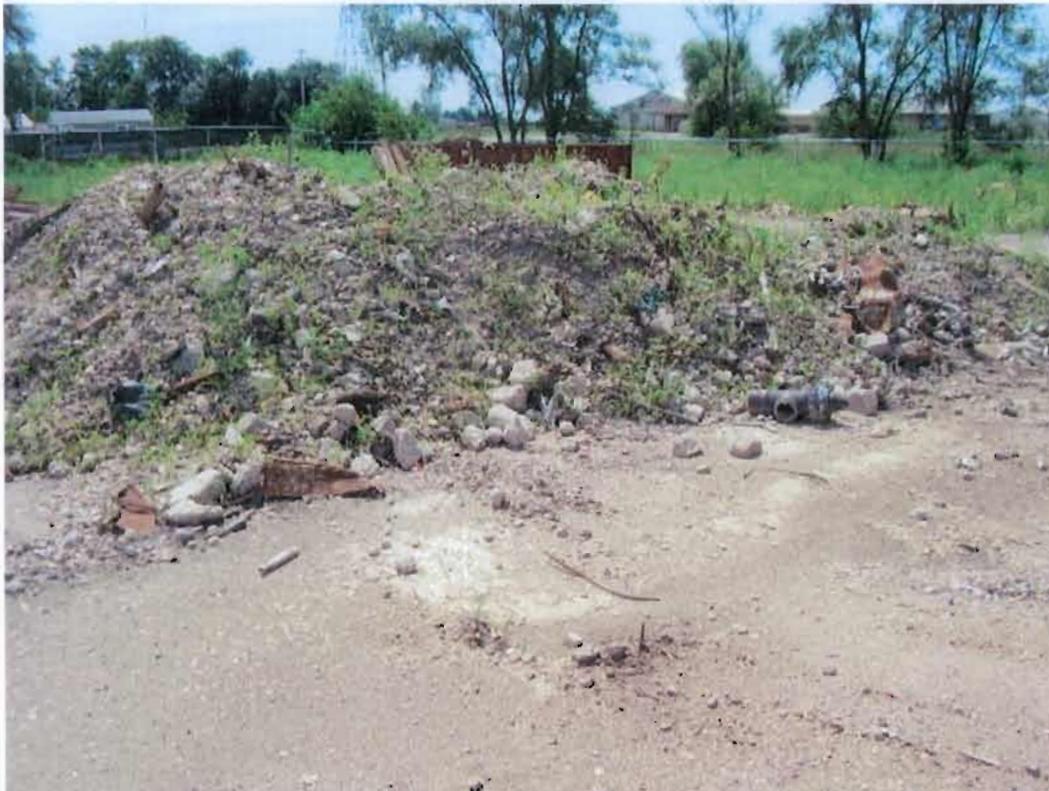
**Date:** August 4, 2010.  
**Time:** 11:45 AM  
**Direction:** SE  
**Photo by:** Eisenbrandt  
**Exposure #:** 006  
**Comments:** A pile of demolition debris with the start of weedy vegetation.

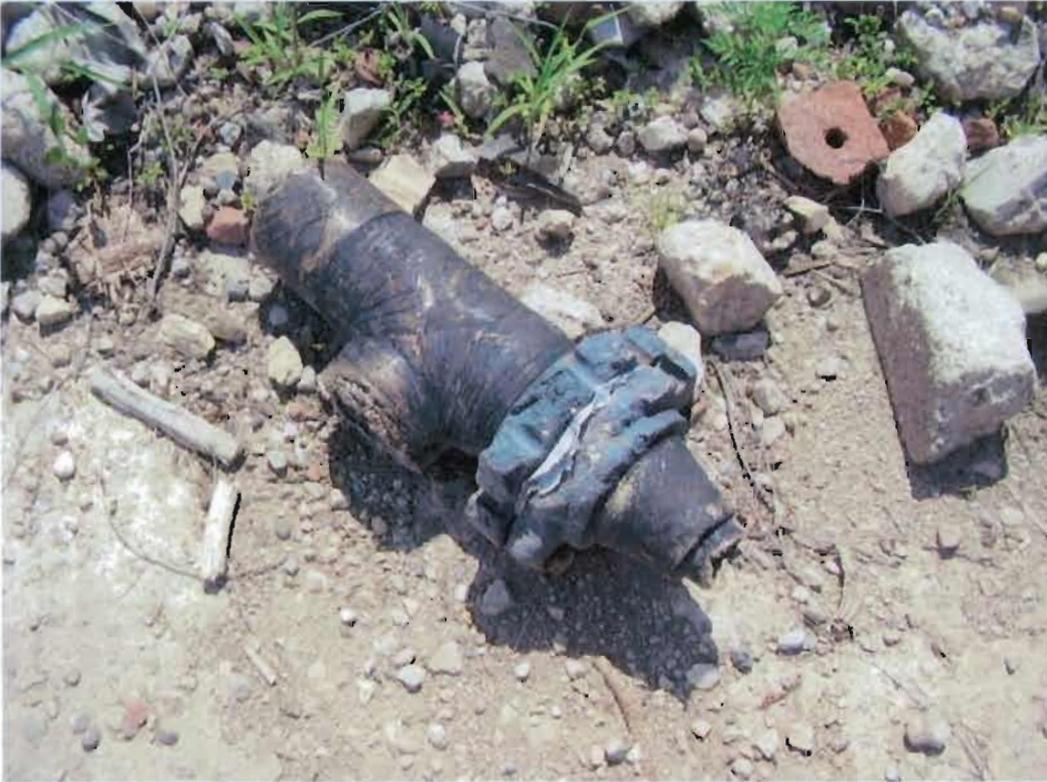
**Date:** August 4, 2010.  
**Time:** 11:45 AM  
**Direction:** SE  
**Photo by:** Eisenbrandt  
**Exposure #:** 007  
**Comments:** Crushed splinters of lumber, a section of pipe, brick, and concrete were observed in the debris pile.

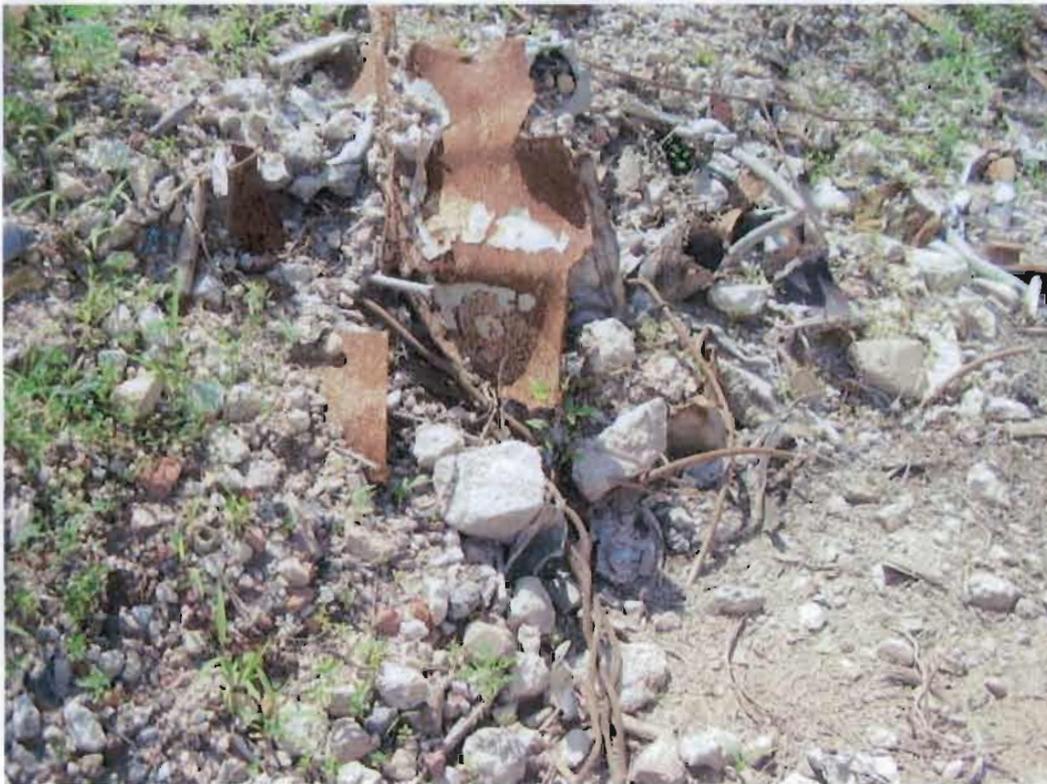
**Date:** August 4, 2010.  
**Time:** 11:45 AM  
**Direction:** S  
**Photo by:** Eisenbrandt  
**Exposure #:** 008  
**Comments:** The demolition debris pile also contained copious amounts of rusty scrap metal.

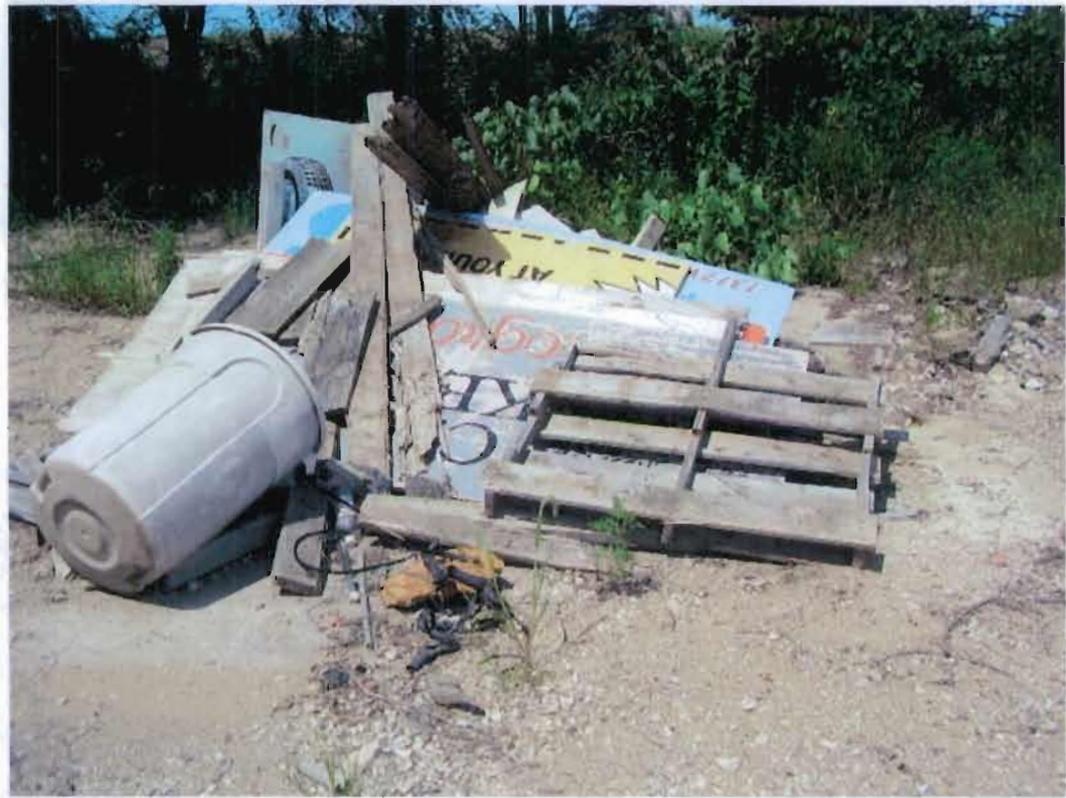
**Date:** August 4, 2010.  
**Time:** 11:45 AM  
**Direction:** SW  
**Photo by:** Eisenbrandt  
**Exposure #:** 009  
**Comments:** A pile of waste. Broken pallets, damaged dimensional lumber, discarded signage, metal bands, and foam insulation were among the waste observed.

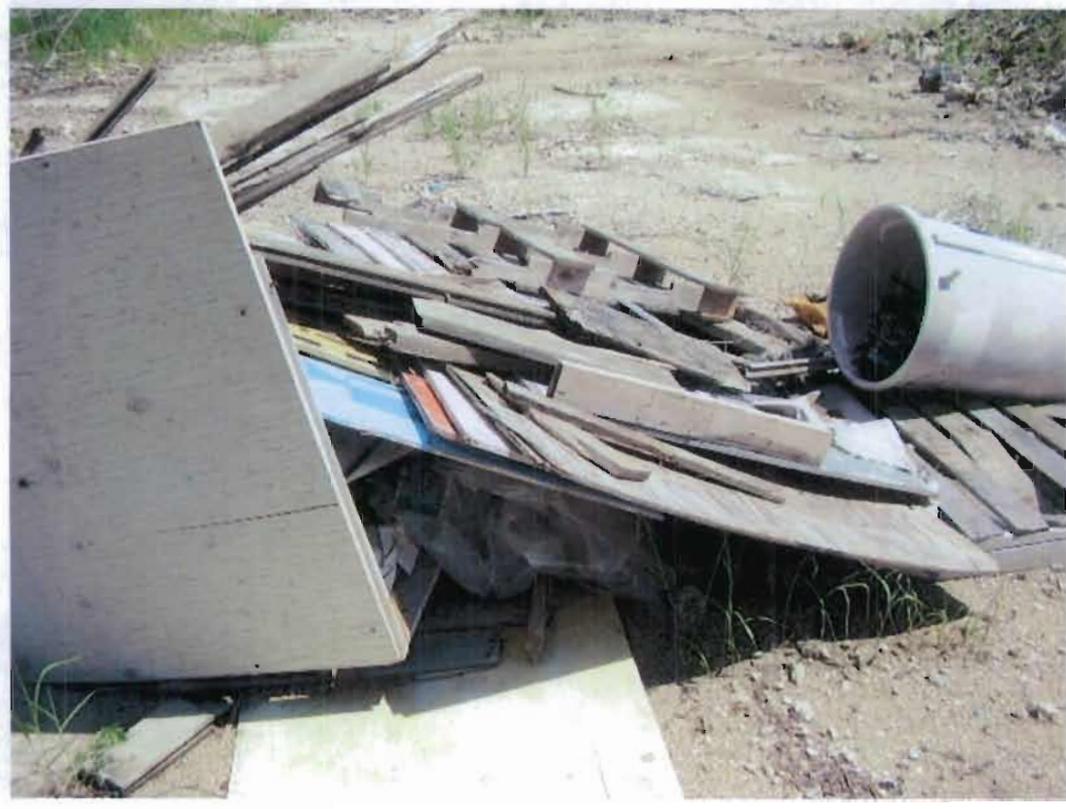
**Date:** August 4, 2010.  
**Time:** 11:45 AM  
**Direction:** N  
**Photo by:** Eisenbrandt  
**Exposure #:** 010  
**Comments:** Alternate view of the pile of waste. Plywood, processed lumber, and plastic sheeting were observed.

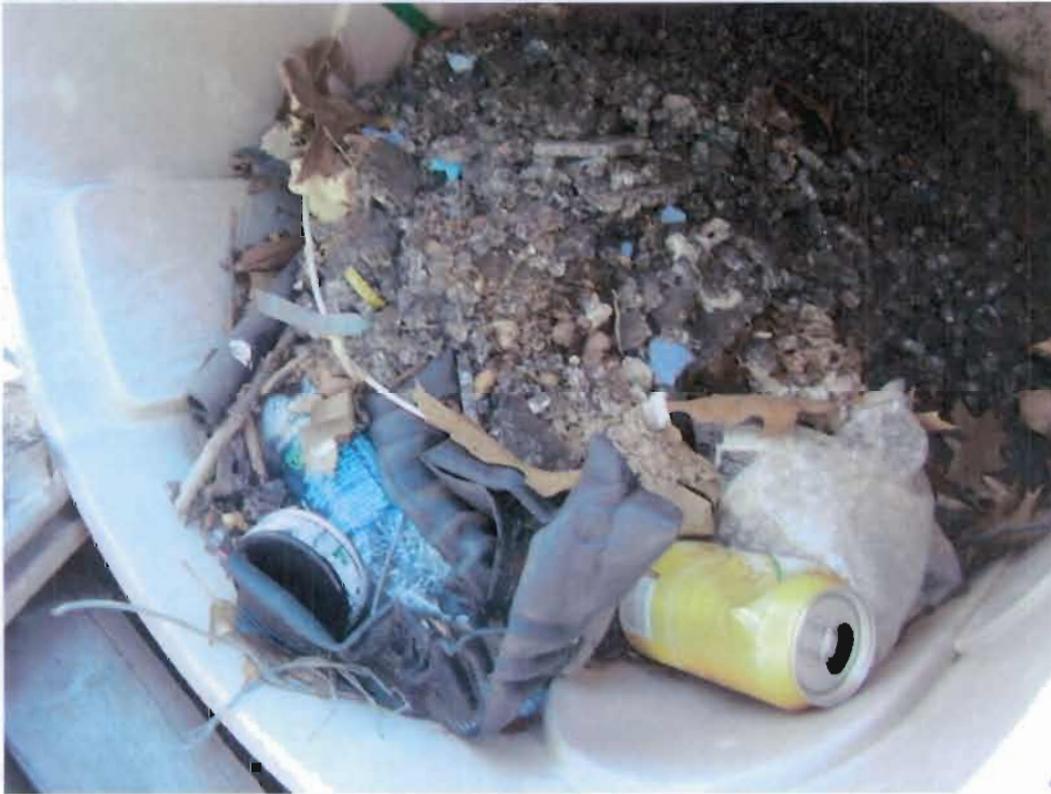
**Date:** August 4, 2010.  
**Time:** 11:45 AM  
**Direction:** E  
**Photo by:** Eisenbrandt  
**Exposure #:** 011  
**Comments:** The beige plastic garbage can (on its side and seen in the previous two photographs) contained broken glass, plastic, a piece rubber hose, an aluminum can, and miscellaneous waste.

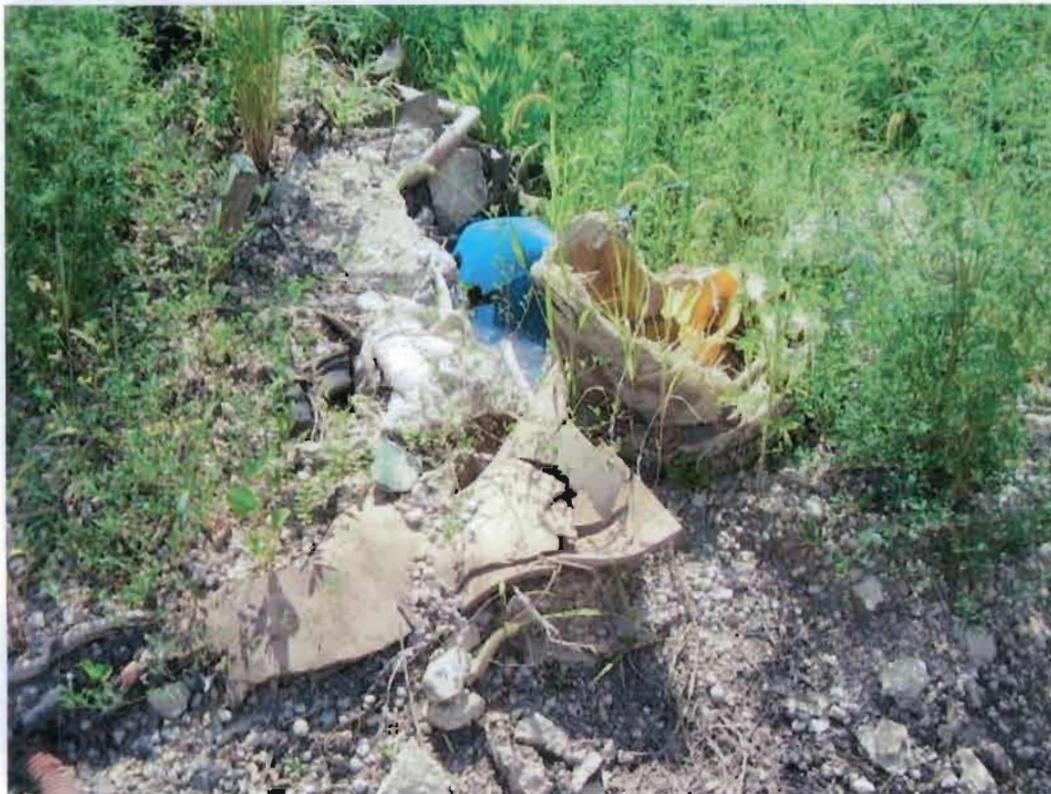
**Date:** August 4, 2010.  
**Time:** 11:46 AM  
**Direction:** SE  
**Photo by:** Eisenbrandt  
**Exposure #:** 012  
**Comments:** Fiberglass pipe, blue plastic scrap, insulation, and scrap metal.

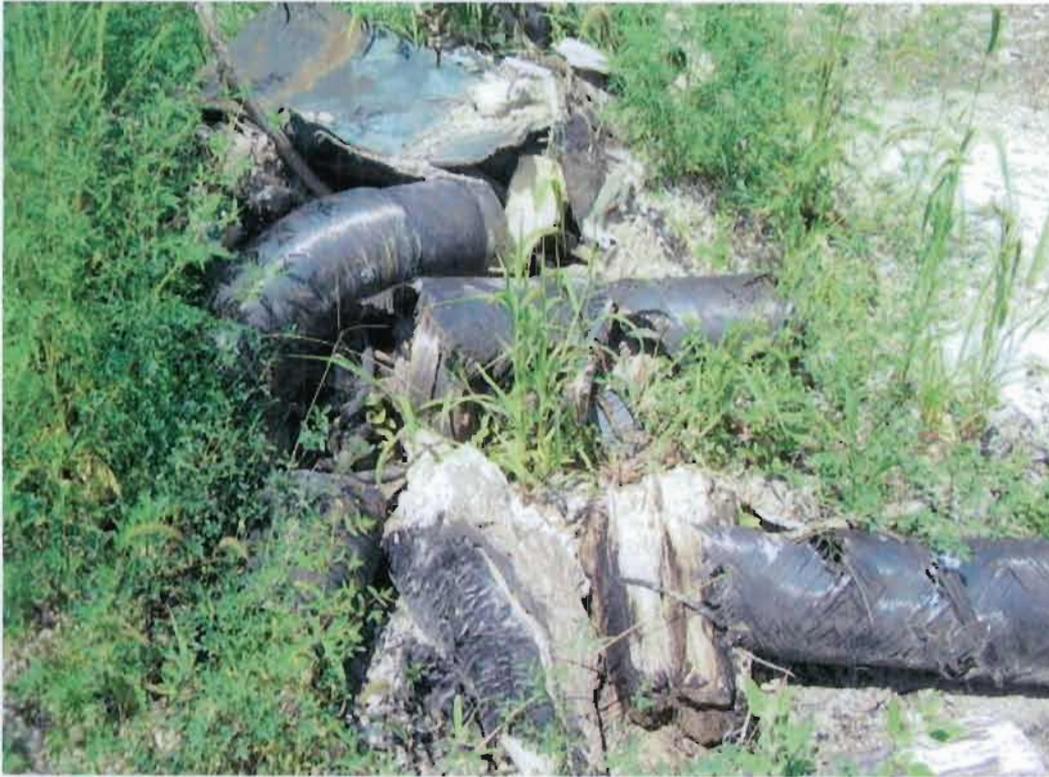
**Date:** August 4, 2010.  
**Time:** 11:46 AM  
**Direction:** W  
**Photo by:** Eisenbrandt  
**Exposure #:** 013  
**Comments:** Fiberglass pipe, charred landscape debris, and miscellaneous waste.

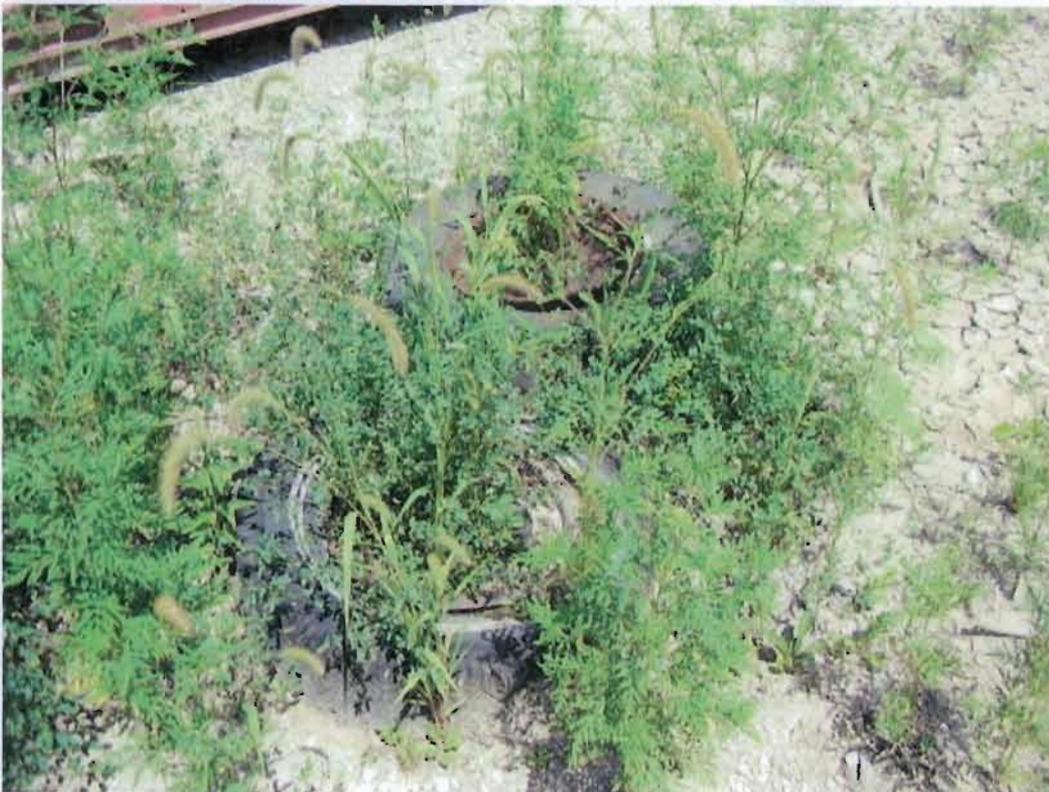
**Date:** August 4, 2010.  
**Time:** 11:47 AM  
**Direction:** SE  
**Photo by:** Eisenbrandt  
**Exposure #:** 014  
**Comments:** Two on-rim used tires with weedy vegetation growing through them.

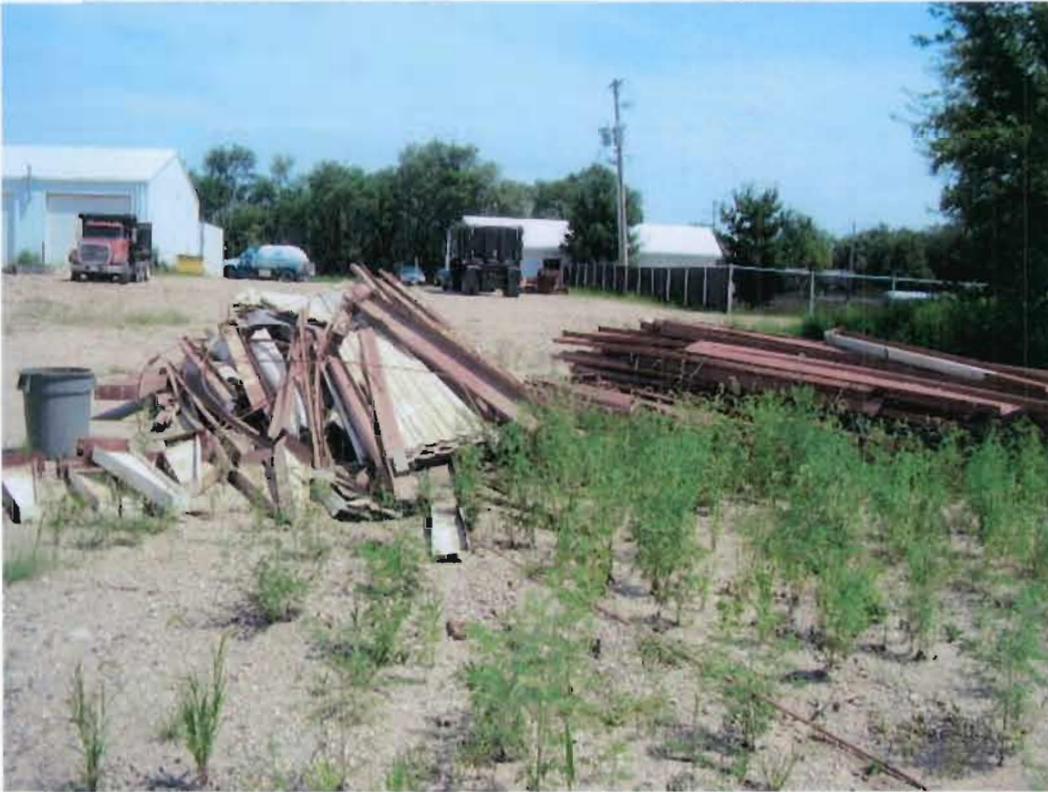
**Date:** August 4, 2010.  
**Time:** 11:48 AM  
**Direction:** N  
**Photo by:** Eisenbrandt  
**Exposure #:** 015  
**Comments:** Stacked steel.

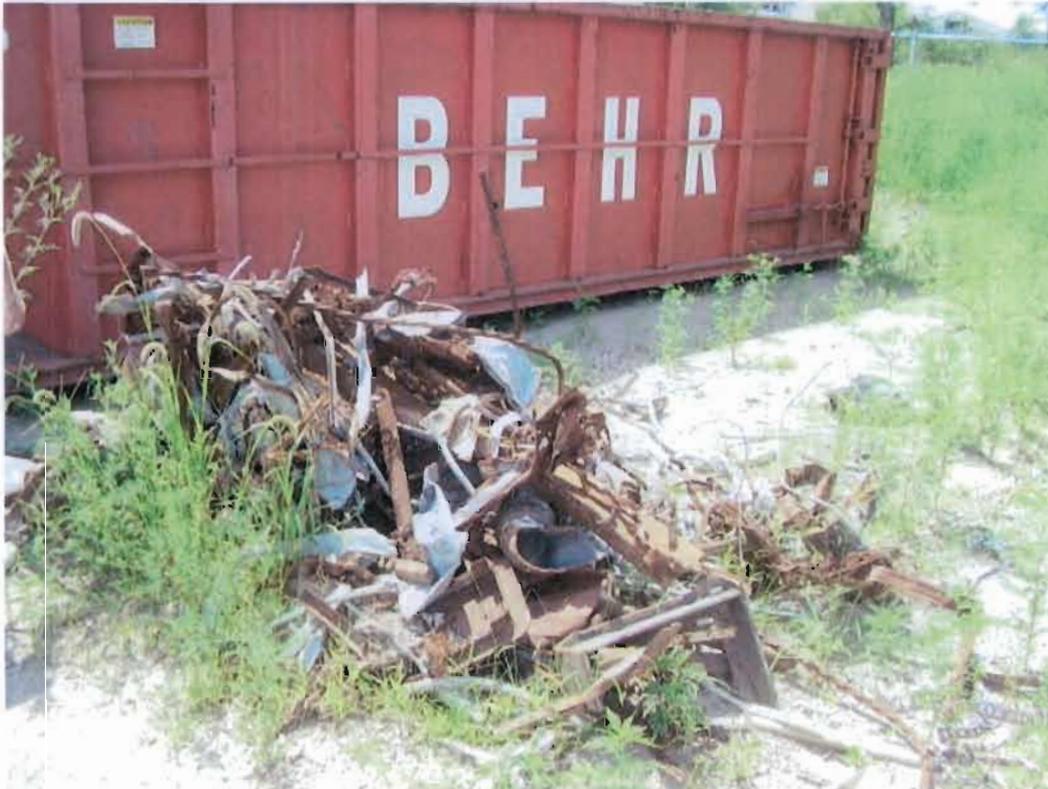
**Date:** August 4, 2010.  
**Time:** 11:48 AM  
**Direction:** SE  
**Photo by:** Eisenbrandt  
**Exposure #:** 016  
**Comments:** A pile of scrap metal beside a recycling dumpster.

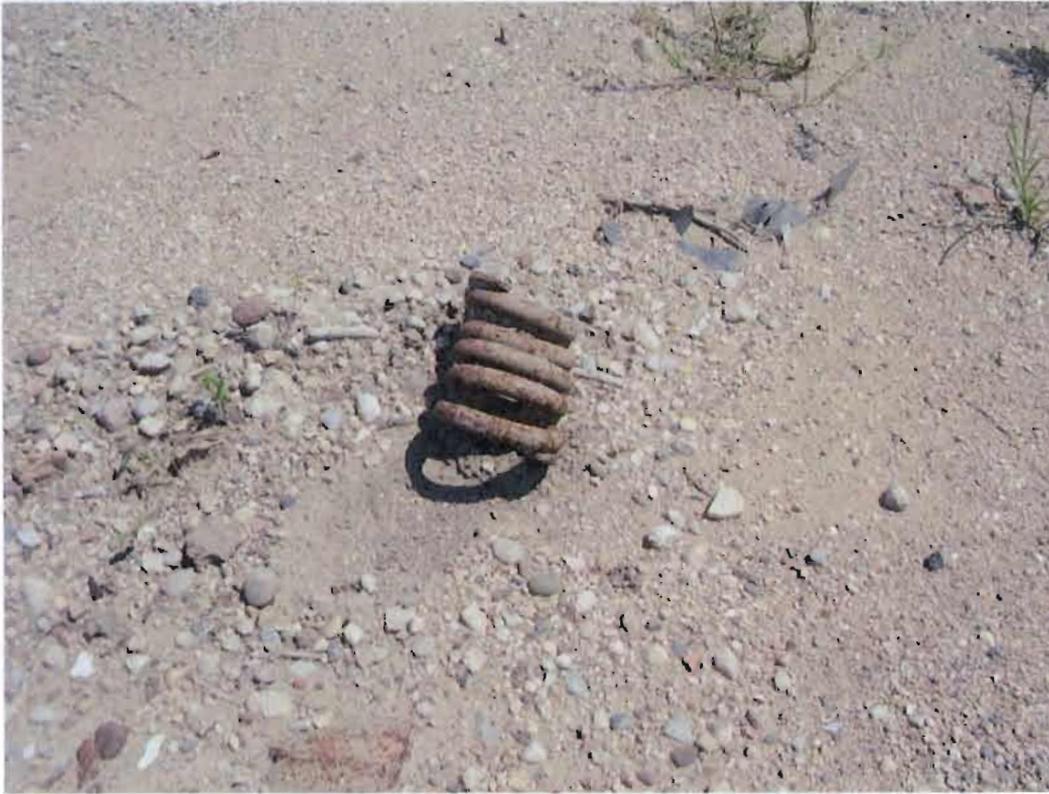
**Date:** August 4, 2010.  
**Time:** 11:48 AM  
**Direction:** E  
**Photo by:** Eisenbrandt  
**Exposure #:** 017  
**Comments:** A rusty spring, rusty scrap metal, and plastic debris observed on the ground.

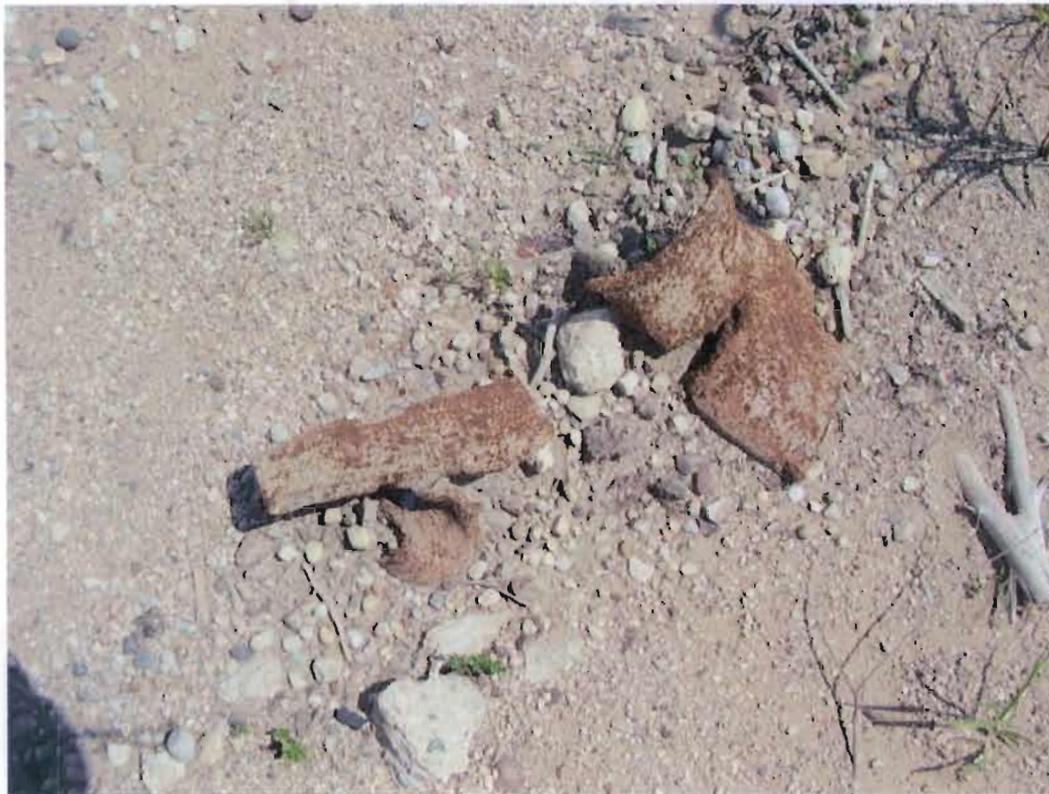
**Date:** August 4, 2010.  
**Time:** 11:48 AM  
**Direction:** NE  
**Photo by:** Eisenbrandt  
**Exposure #:** 018  
**Comments:** Pieces of rusty scrap metal on the ground.

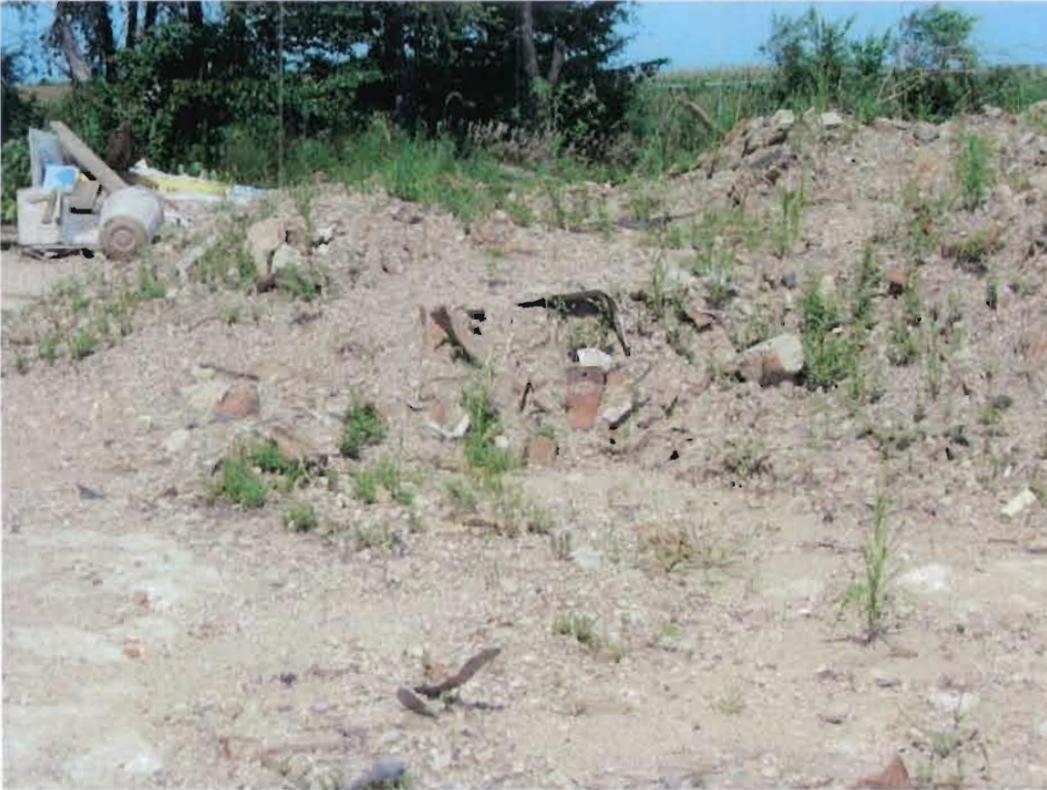
**Date:** August 4, 2010.  
**Time:** 11:49 AM  
**Direction:** SW  
**Photo by:** Eisenbrandt  
**Exposure #:** 019  
**Comments:** A debris pile with copious amounts of scrap metal, splintered wood, and miscellaneous waste.

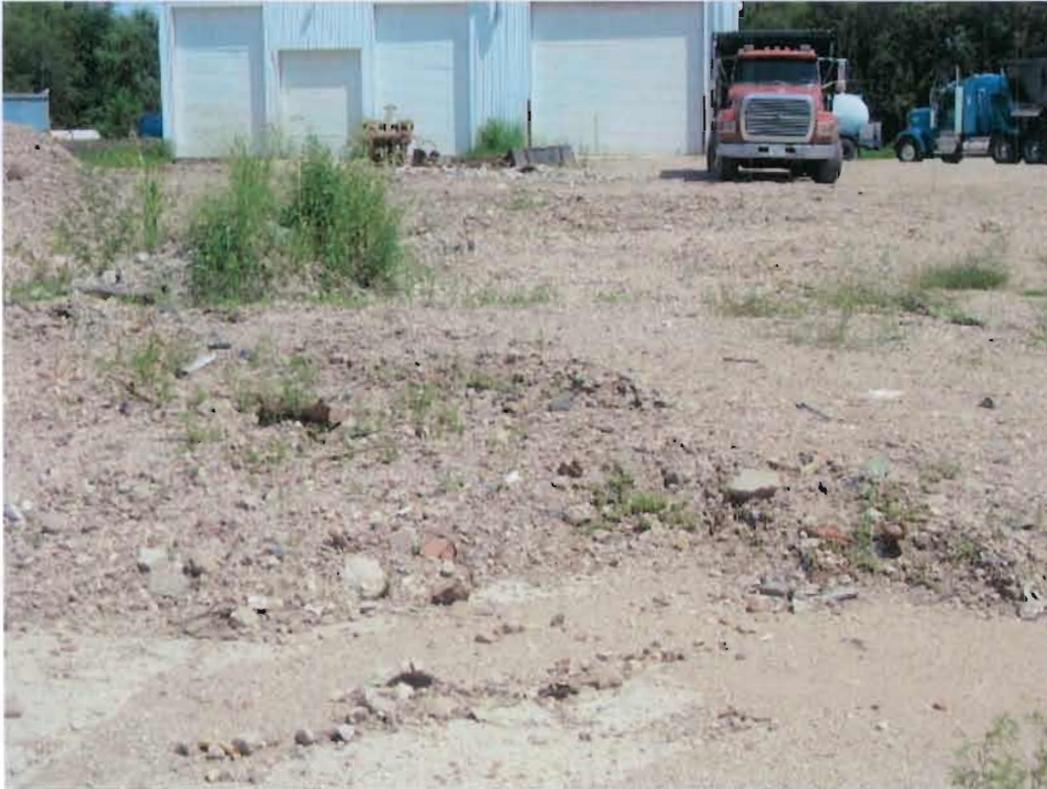
**Date:** August 4, 2010.  
**Time:** 11:49 AM  
**Direction:** N  
**Photo by:** Eisenbrandt  
**Exposure #:** 020  
**Comments:** Ground surface south of the maintenance garage. Scrap metal, concrete, and brick were intermixed with miscellaneous demolition debris.

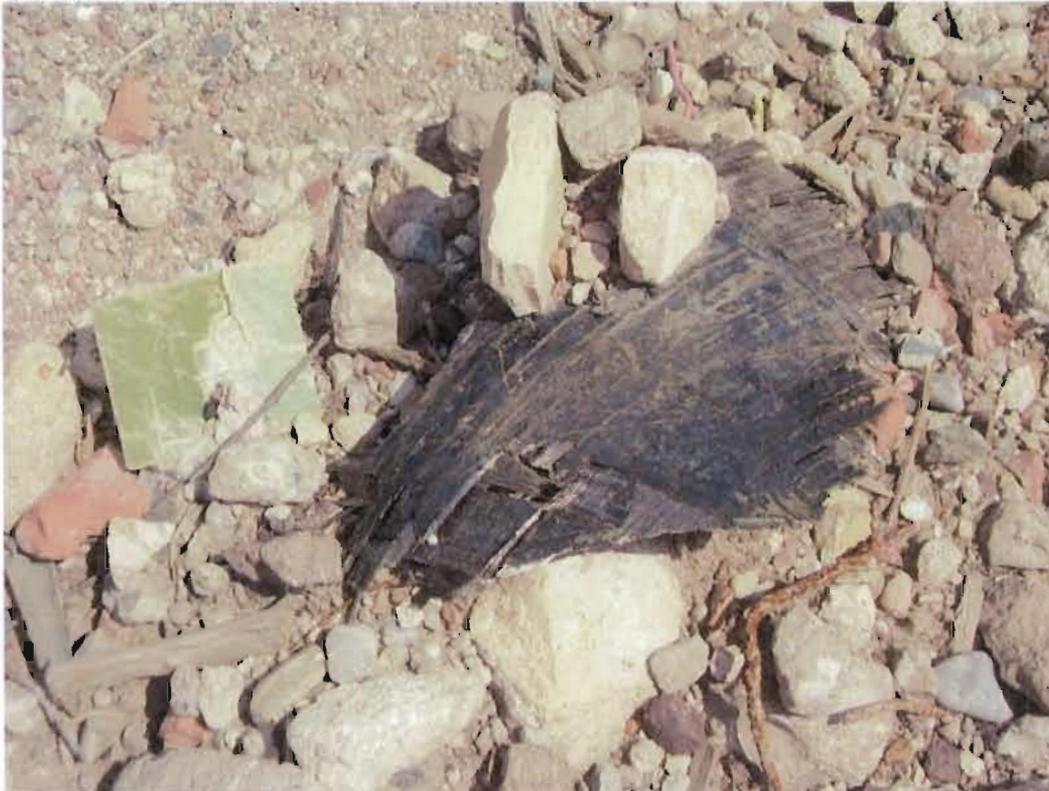
**Date:** August 4, 2010.  
**Time:** 11:49 AM  
**Direction:** N  
**Photo by:** Eisenbrandt  
**Exposure #:** 021  
**Comments:** A close up photograph of the ground surface seen in Photograph 020. Rusty scrap metal, fiberglass, wire, splintered lumber, and scraps of plastic were observed intermixed with concrete, mortar, and brick fragments.

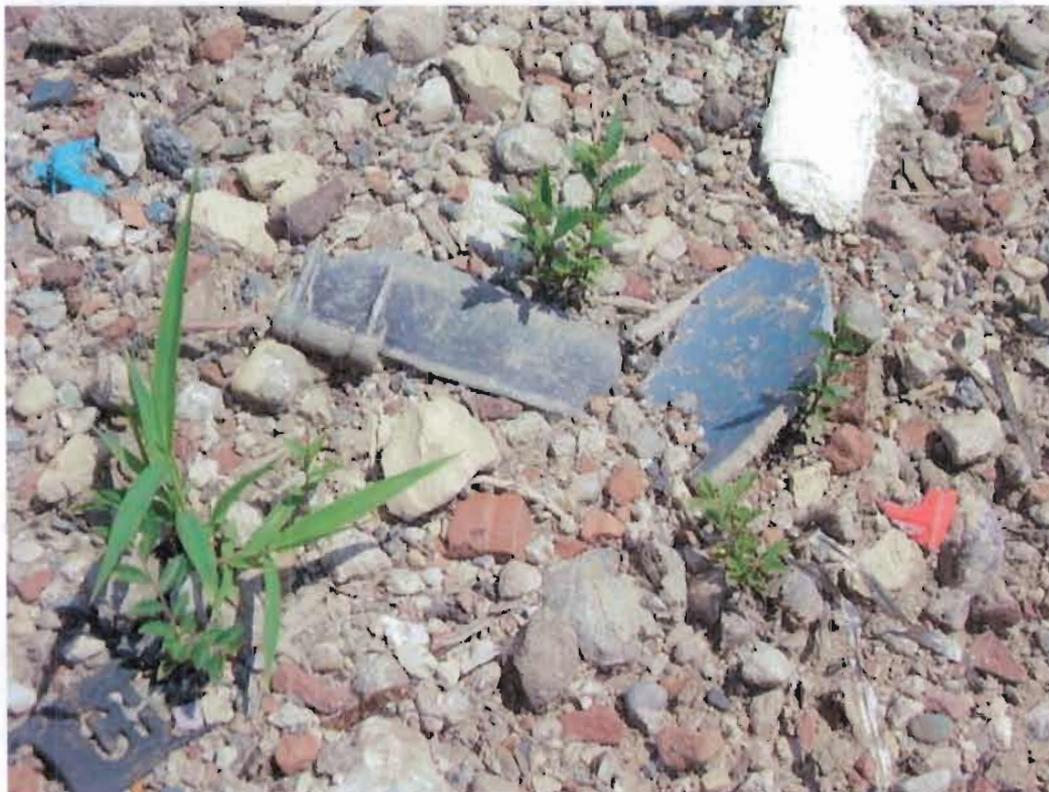
**Date:** August 4, 2010.  
**Time:** 11:49 AM  
**Direction:** SE  
**Photo by:** Eisenbrandt  
**Exposure #:** 022  
**Comments:** Red, blue, and black plastic, carpet, black rubber, cast iron, and splinters of wood were observed on the ground.

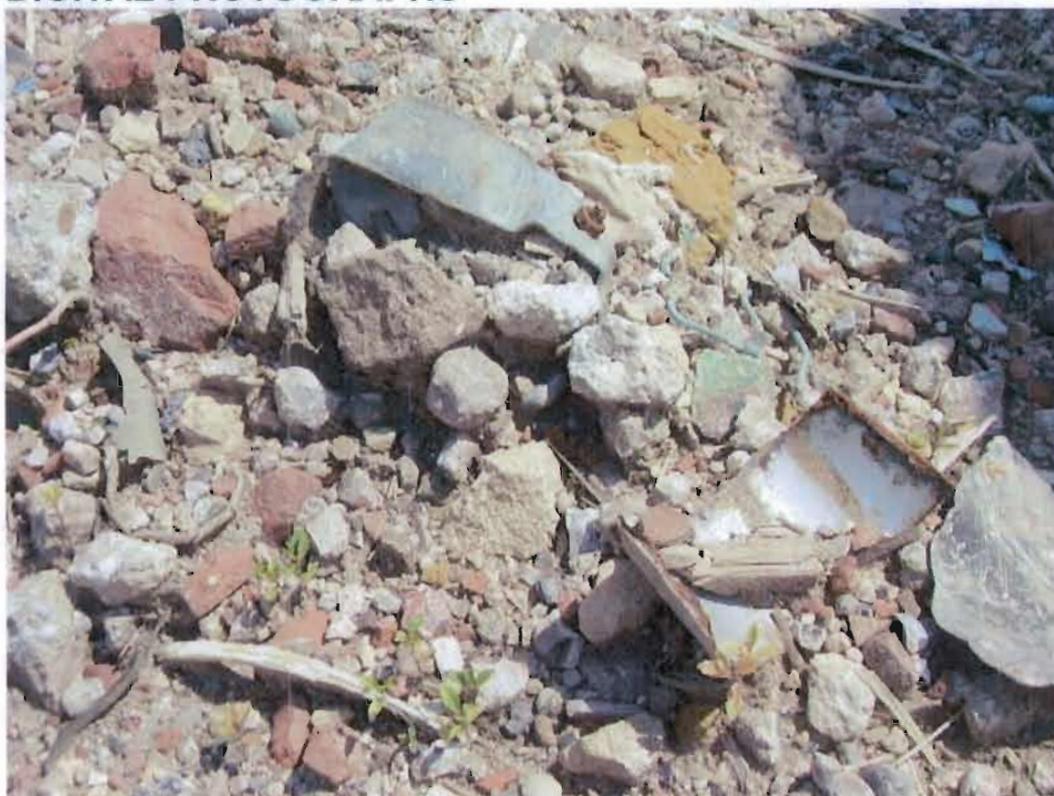
**Date:** August 4, 2010.  
**Time:** 11:49 AM  
**Direction:** NE  
**Photo by:** Eisenbrandt  
**Exposure #:** 023  
**Comments:** Another example of the demolition debris spread across the site. Copper wire, scrap metal, electrical wire, foam, and asphalt materials were observed on the ground.

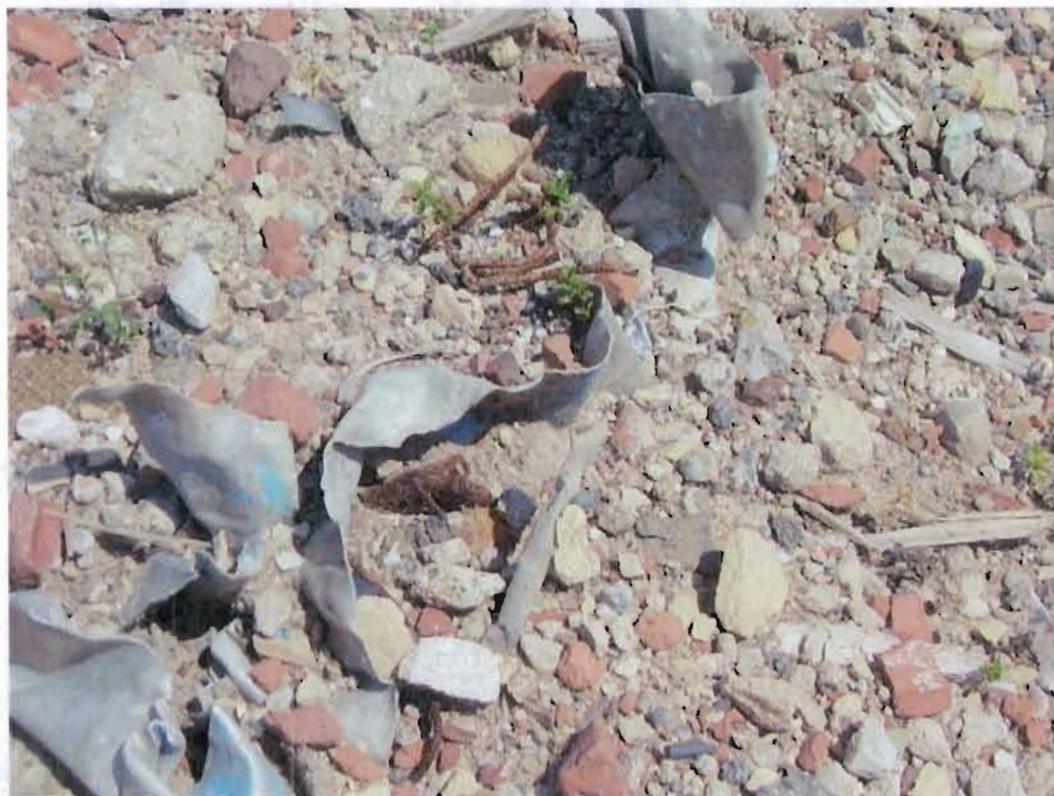
**Date:** August 4, 2010.  
**Time:** 11:50 AM  
**Direction:** NE  
**Photo by:** Eisenbrandt  
**Exposure #:** 024  
**Comments:** Rusty iron fragments, fiberglass, splintered wood, and malleable metal were observed on the ground surface.

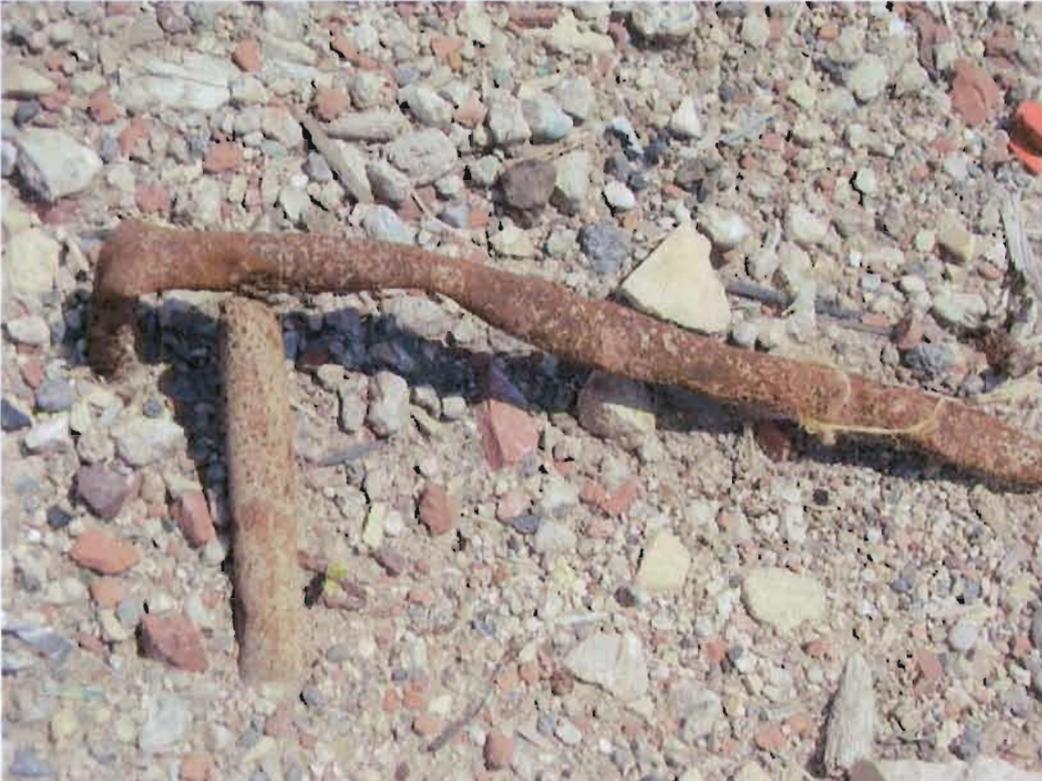
**Date:** August 4, 2010.  
**Time:** 11:50 AM  
**Direction:** N  
**Photo by:** Eisenbrandt  
**Exposure #:** 025  
**Comments:** Rusty scrap metal and miscellaneous waste observed on the ground surface.

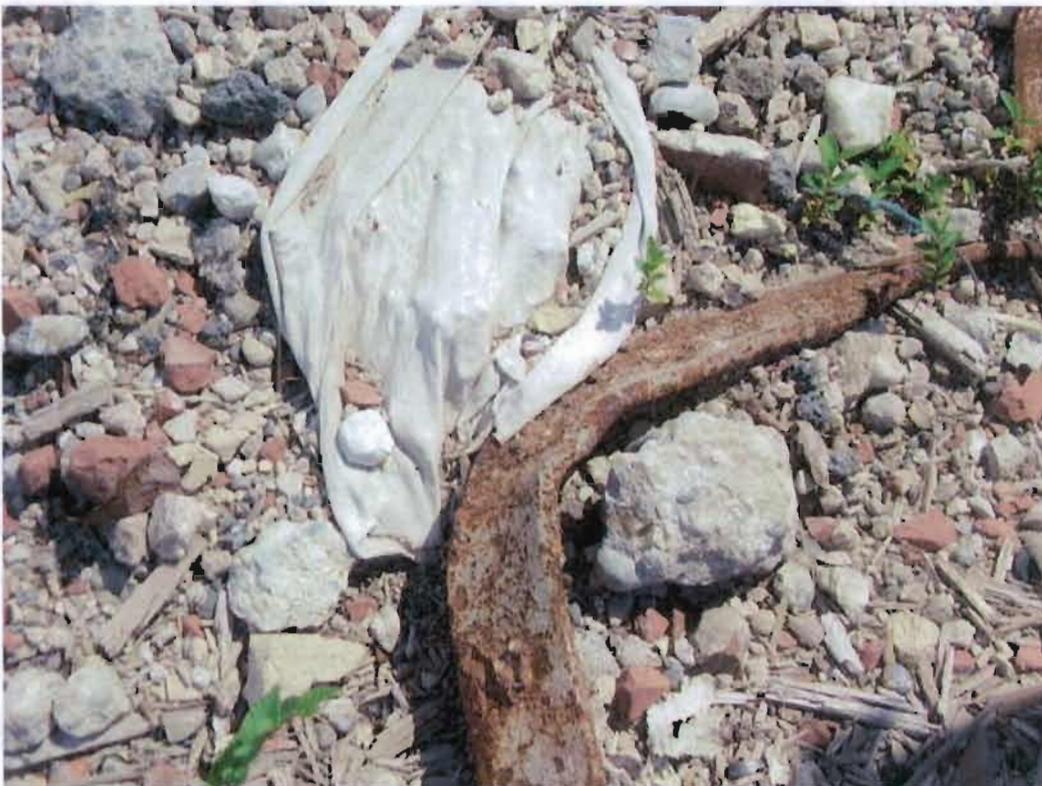
**Date:** August 4, 2010.  
**Time:** 11:50 AM  
**Direction:** N  
**Photo by:** Eisenbrandt  
**Exposure #:** 026  
**Comments:** Scrap metal, splintered wood, fabric-like material, and metal wire were observed on the ground.

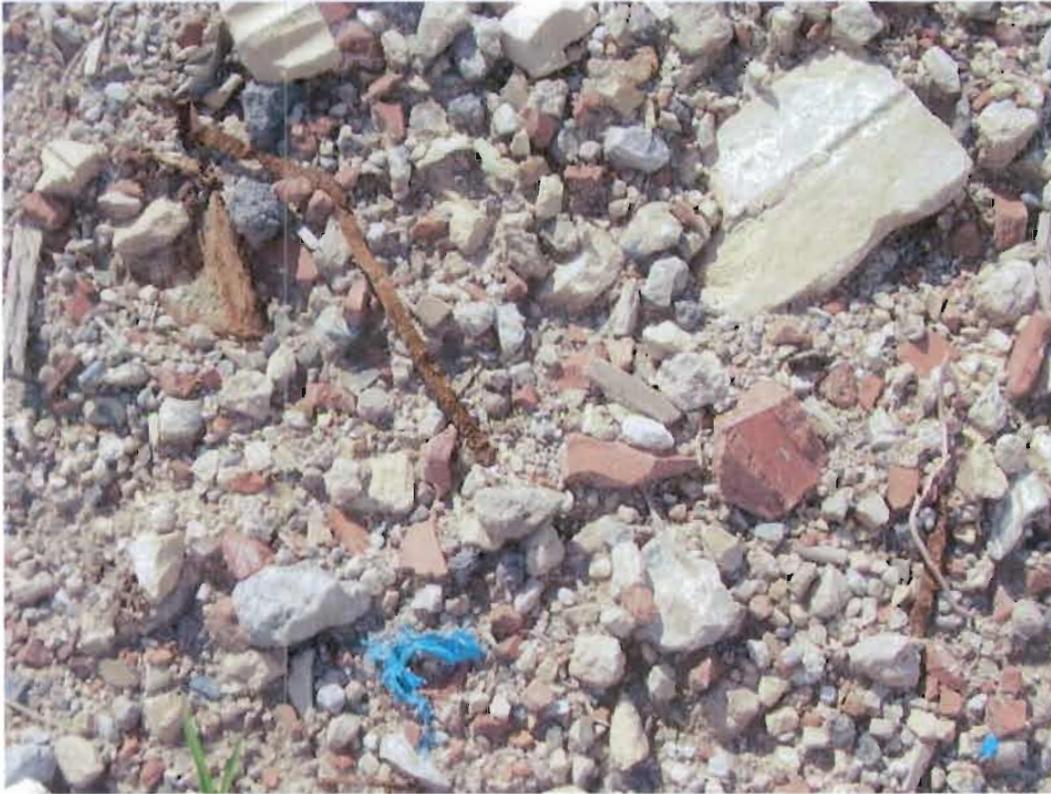
**Date:** August 4, 2010.  
**Time:** 11:50 AM  
**Direction:** SW  
**Photo by:** Eisenbrandt  
**Exposure #:** 027  
**Comments:** Wire, blue plastic, scrap wood, and rusty metal on the ground.

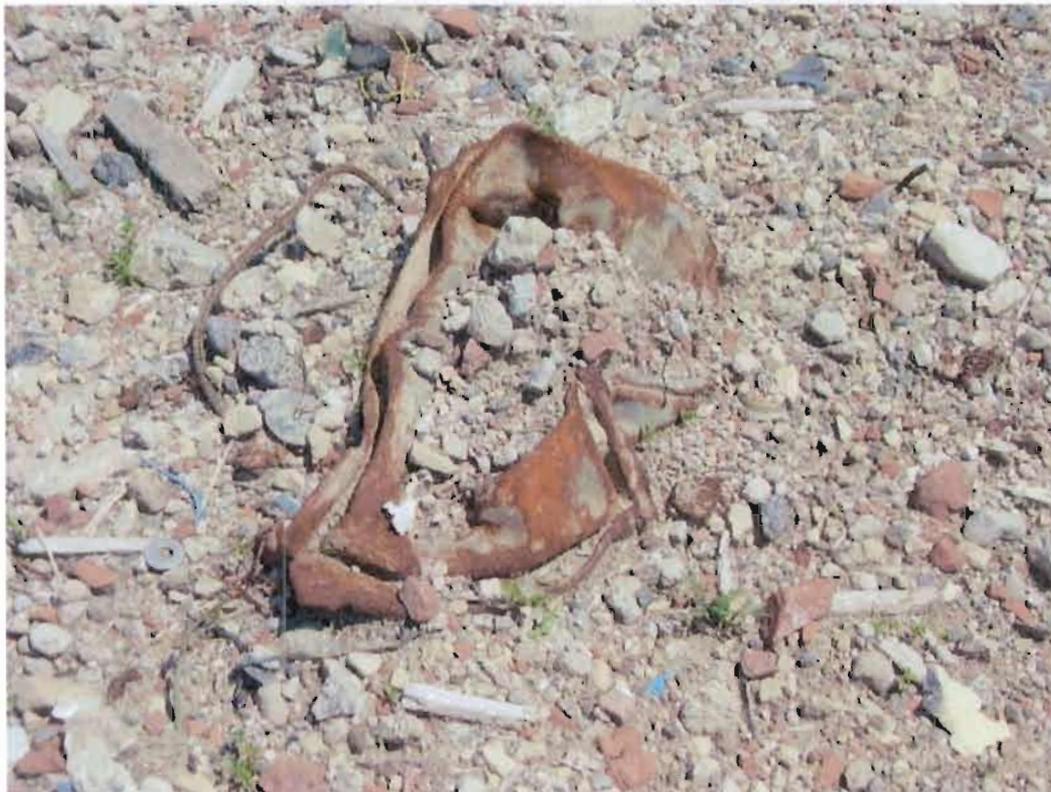
**Date:** August 4, 2010.  
**Time:** 11:50 AM  
**Direction:** NE  
**Photo by:** Eisenbrandt  
**Exposure #:** 028  
**Comments:** Rusty scrap metal intermixed with demolition debris on the ground.

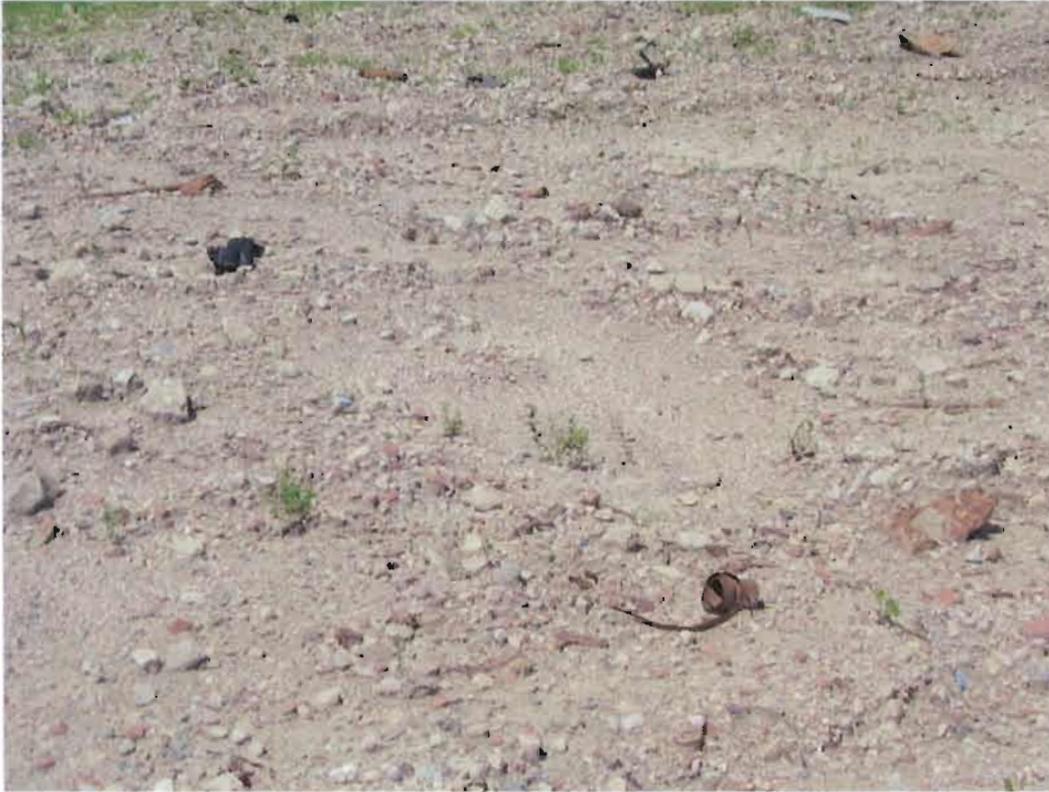
**Date:** August 4, 2010.  
**Time:** 11:51 AM  
**Direction:** SW  
**Photo by:** Eisenbrandt  
**Exposure #:** 029  
**Comments:** More waste observed on the ground.

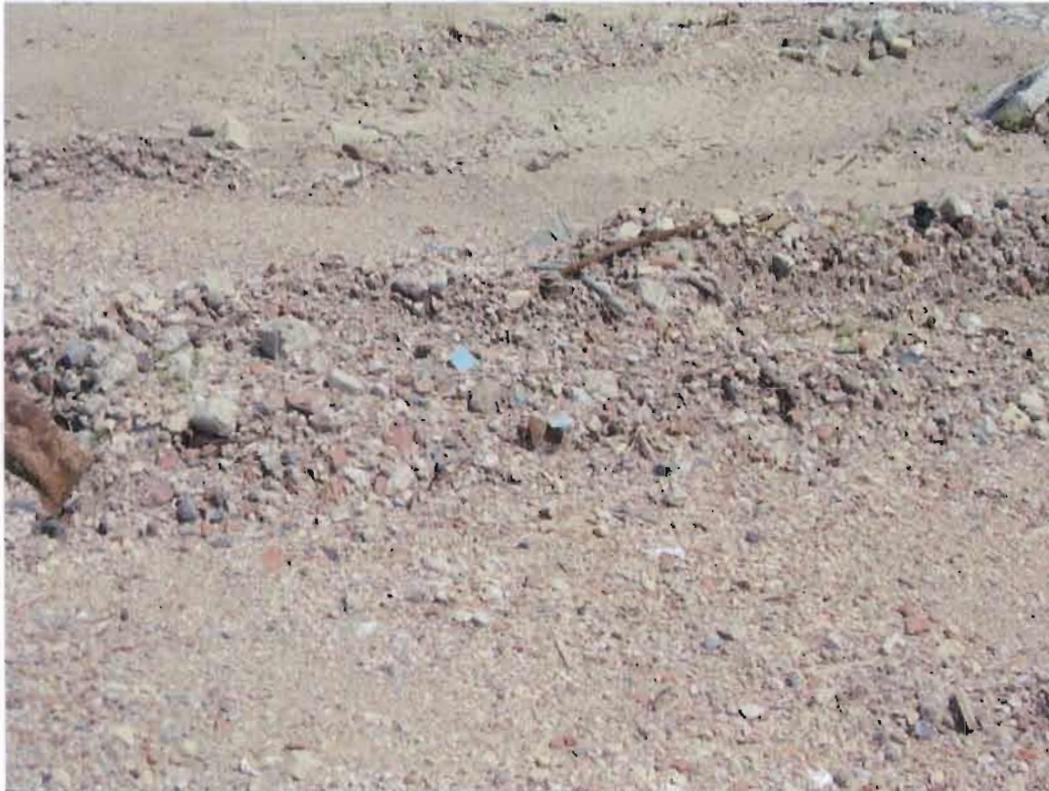
**Date:** August 4, 2010.  
**Time:** 11:51 AM  
**Direction:** S  
**Photo by:** Eisenbrandt  
**Exposure #:** 030  
**Comments:** More waste observed on the ground.
