**BEFORE THE ILLINOIS POLLUTION CONTROL BOARD**

PEOPLE OF THE STATE OF ILLINOIS,	)	
	)	
Complainant,	)	
	)	
v.	)	PCB No. 13-3
	)	(Enforcement-Land)
EDWARD W. FISHER, RHONDA L.	)	
FISHER, and DEM/EX GROUP, INC.,	)	
(an Illinois corporation),	)	
	)	
Respondents.	)

**COMPLAINANT'S MOTION FOR SUMMARY JUDGMENT PURSUANT TO 35 ILL. ADM. CODE 101.516(b) AGAINST RESPONDENT DEM/EX GROUP INC.**

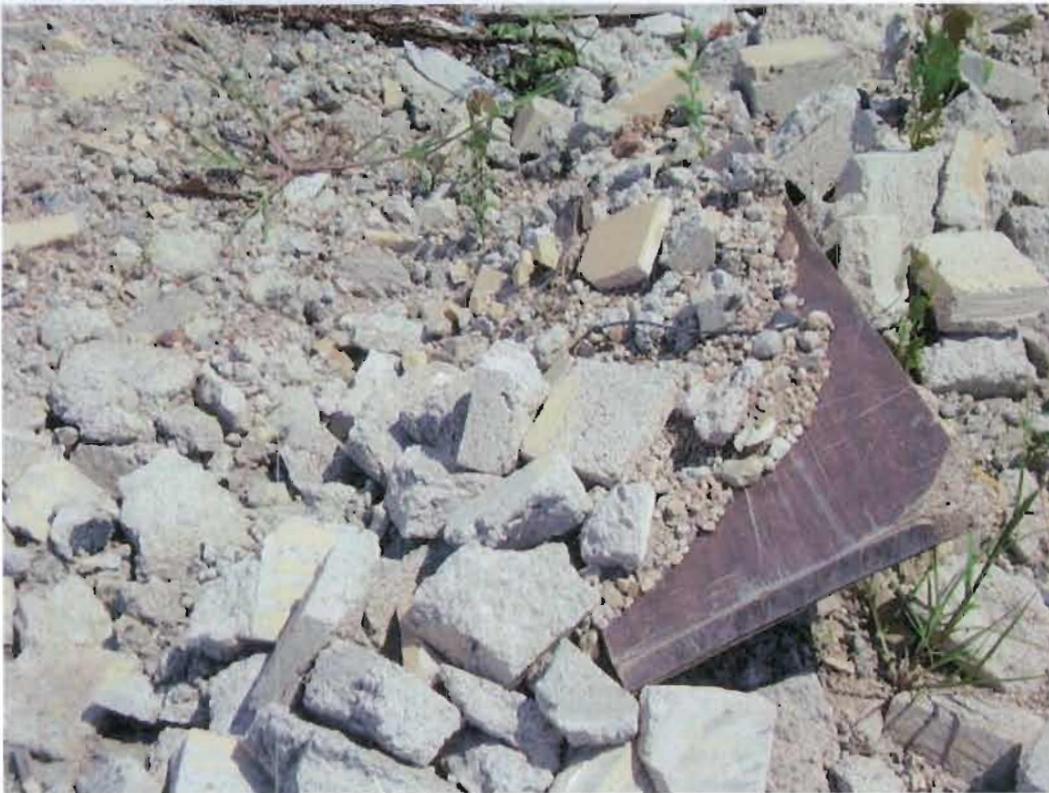
**Date:** August 4, 2010.  
**Time:** 11:51 AM  
**Direction:** W  
**Photo by:** Eisenbrandt  
**Exposure #:** 031  
**Comments:** More waste partially buried.

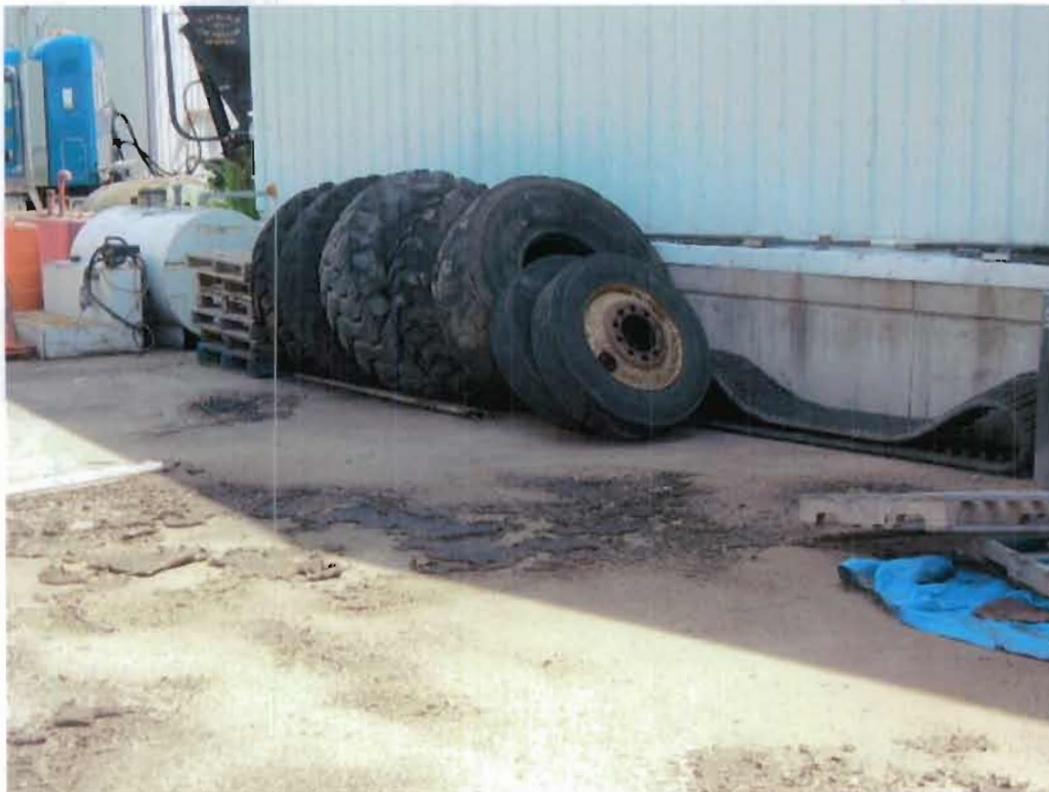
**Date:** August 4, 2010.  
**Time:** 11:52 AM  
**Direction:** NE  
**Photo by:** Eisenbrandt  
**Exposure #:** 032  
**Comments:** Used tires stored along the west wall of the maintenance building.

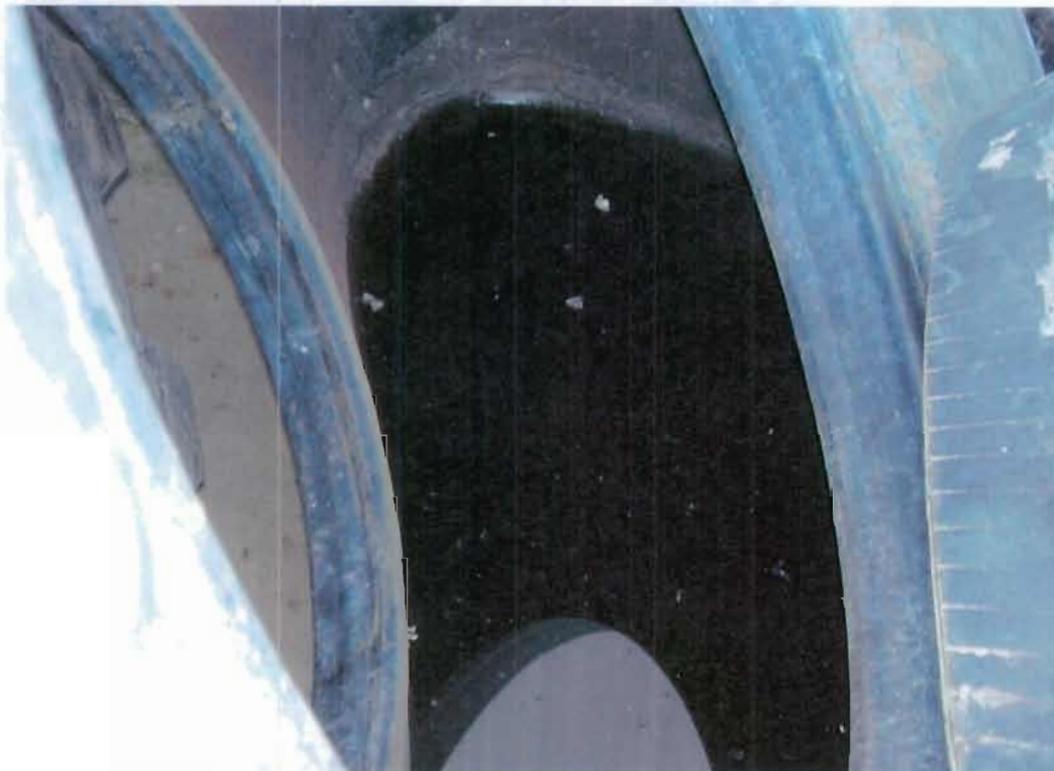
The Respondent caused or allowed water to accumulate in used or waste tires at the corporate site as depicted in Complaint Exhibit 2, August 4, 2010, Exposures 4, 33, pp. 2, 17, and March 23, 2011, Exposures 40 and 41 pp. 38 and 39. (See, Paragraph 18, Count IV of the Complaint and Eisenbrandt Affidavit).

**Date:** August 4, 2010.  
**Time:** 11:53 AM  
**Direction:** E  
**Photo by:** Eisenbrandt  
**Exposure #:** 033  
**Comments:** Water was observed in the used tires seen in Photograph 032.

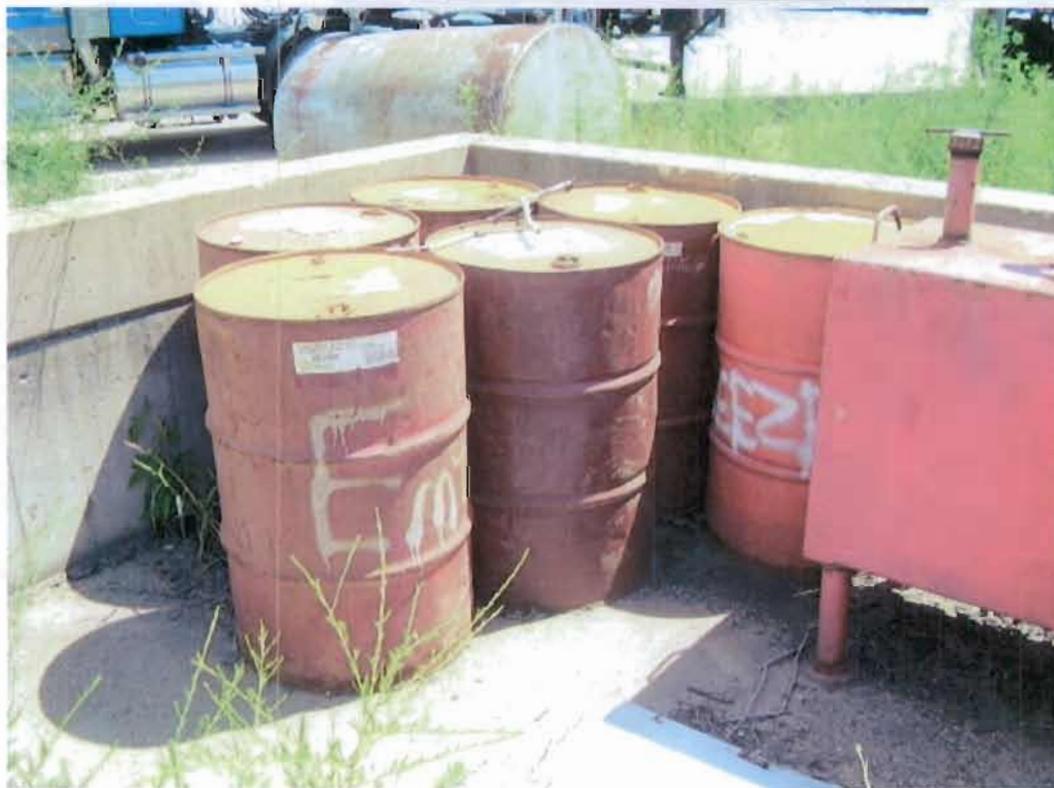
**Date:** August 4, 2010.  
**Time:** 11:53 AM  
**Direction:** NE  
**Photo by:** Eisenbrandt  
**Exposure #:** 034  
**Comments:** Six 55-gallon drums stored in the concrete containment area. One of the drums was labeled antifreeze and appeared full. Another drum was labeled "Empty" yet was full of liquid.
