EXHIBIT ONE
EVIDENCE OF HISTORICAL MINING ACTIVITIES
CLOSED COLLINSVILLE LANDFILL
COLLINSVILLE, ILLINOIS

EXHIBIT 1-2

Aerial Photos with Notations of Historical Activities

1-2 RESULTS OF AERIAL PHOTOGRAPH EVALUATION **(EXCERPT FROM ASSESSMENT MONITORING REPORT, CLOSED** **COLLINSVILLE LANDFILL, JANUARY 2008, TETRA TECH, SUPPLEMENTAL** **PERMIT NO. 2008-019-SP)**

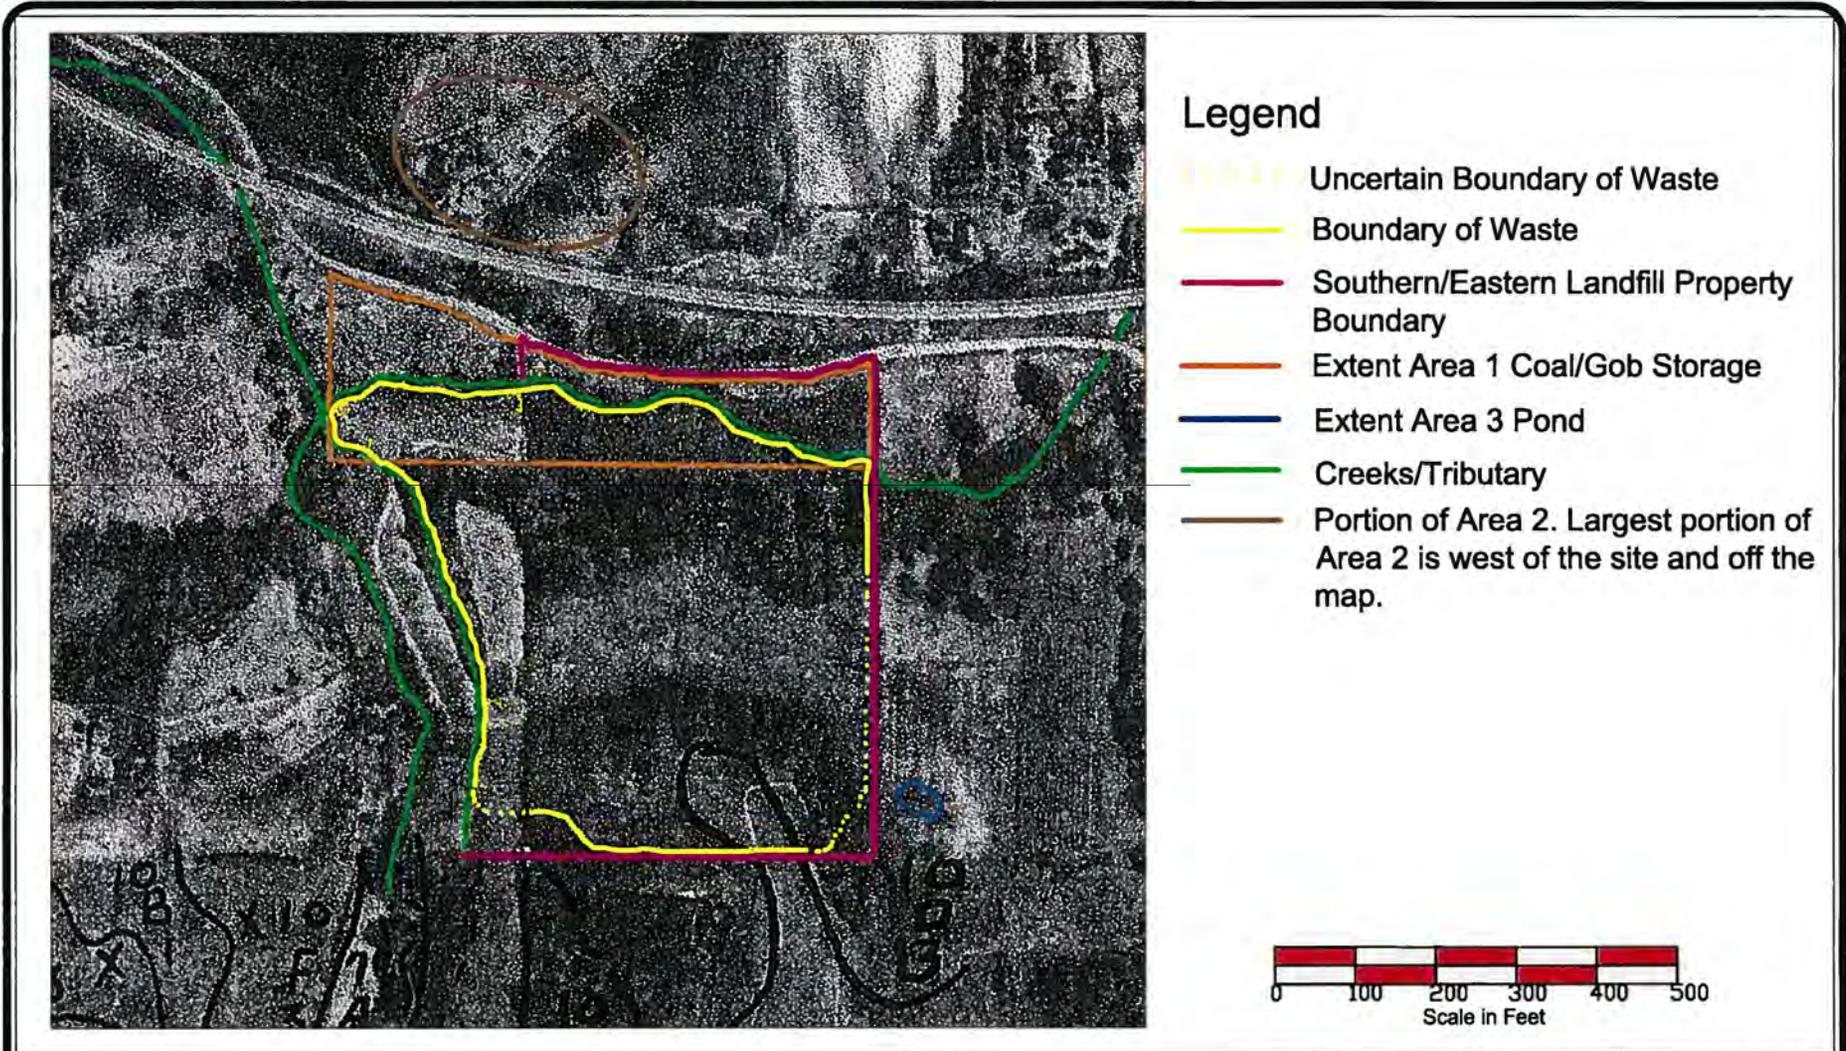
B-1

The earliest available aerial photograph, dated 1941, showed no landfill activity at the project site. Forested areas, open fields, cultivated areas and several disturbed areas surrounded Canteen Creek and the project site. Several farms or homesteads were visible west of project site, but the housing area known as Lumaghi Heights was not present. Using the 1941 photo, Tetra Tech identified disturbed areas described below. Areas 1 through 3 are shown in Figure B-1.

Area 1, Coal/Gob Storage Area

A coal or gob storage area was present on both sides of Canteen Creek south of Lebanon Road. In 1941, this area measured approximately 400 feet by 125 feet and was located along the northern perimeter of the current project site. Details of this area are not apparent in the photo.

Area 2, Disturbed Areas Associated with Canteen Mine Number 2

The Lumaghi Coal Company owned the project site and surrounding land and mined coal on their property from 1900 until 1950. The mine covered the entire project site and was known as Canteen Mine Number 2 (Figure 3). The mine shafts for Canteen Mine Number 2 and two other mines were located northwest of the project site and are not shown in Figure B-1. Disturbed areas, debris piles and heavily scarred land with many structures were present north and

northwest of the project site and attested to the mining activities in the area. A small portion of Area 2, shown in Figure B-1, is located northwest of the site, north of Lebanon Road.

Area 3, Small Disturbed Area or Pond

A small disturbed area that may represent a small pond was visible just outside the southeast corner of the project site near the current location of MW-3. Cultivated fields were adjacent to this area.

1941 Aerial Photograph

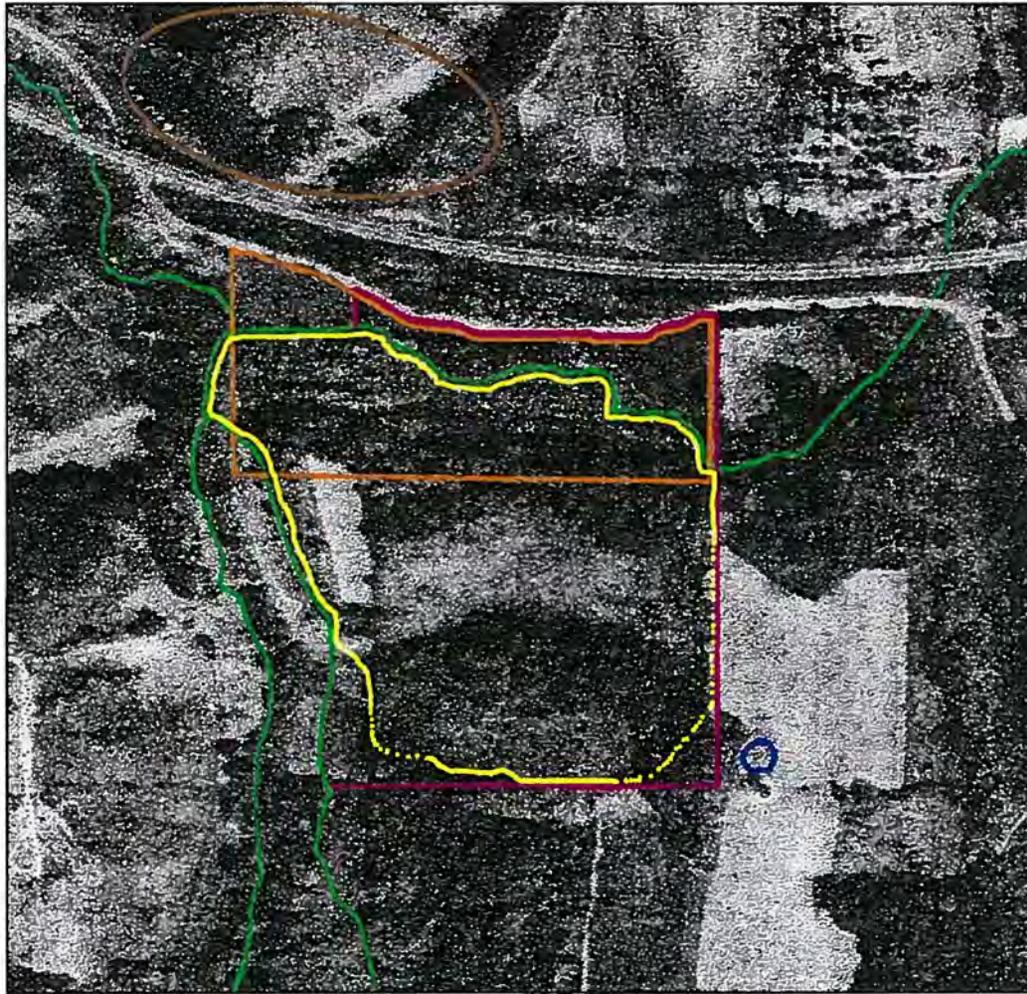
B-2

Based on an analysis of 1941 and 1956 aerial photos, few changes in land use occurred between 1941 and 1956 and no landfill activity was apparent. However, the size of the Coal/Gob Storage Area expanded to an area measuring approximately 200 feet by 600 feet (Figure B2). The material stored south of Canteen Creek is visually different than the material stored north of the creek. The area south of the creek appears as a linear feature in the photo. The expansion of this storage area most likely occurred between 1941 and closure of the mine in 1950.

The residential area, Lumaghi Heights, was apparent on the 1956 aerial photograph and a small portion of the disturbed area associated with the mine shaft (Area 2) and the possible pond (Area 3) remained visible.

1956 Aerial Photograph

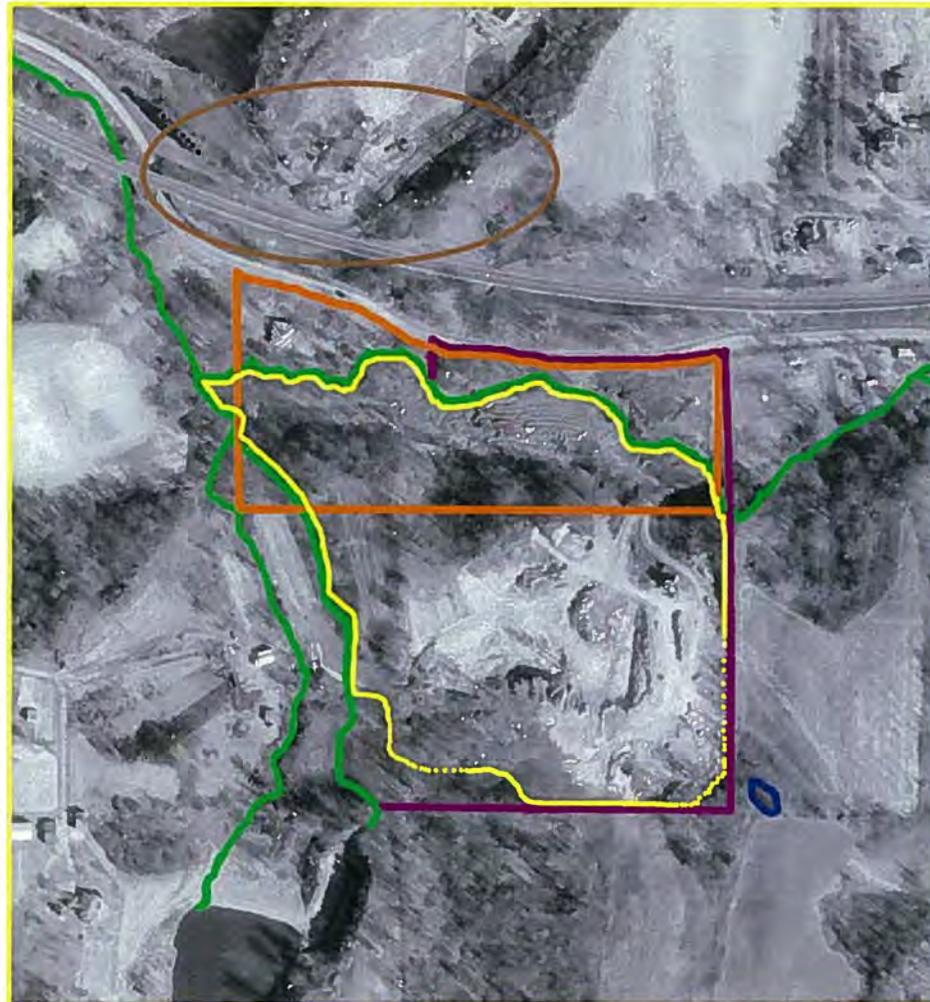
According to records, the Closed Collinsville Landfill began operation under IEPA Permit Number 1972-71 in the early 1970s. However, extensive activity, characterized by disturbed and denuded soil, was visible in the 1968 aerial photograph. Based on the warranty deed for the property, the Lumaghi Coal Company sold the property to the City of Collinsville in 1960 (Exhibit 4-1). The activity shown in the 1968 aerial photo, occurred in the southeast quadrant of the project site. In the 1968 photo (Figure B-3), trenches, pits, roads and vehicles were visible in this area and some old scarring was apparent in the far southwest corner of the project site.

Based on the presence of vehicles, pits, ridges and dirt road, the working boundaries of the landfill appeared to extend from the center of the project site to an area close to the southeastern tip of property boundary and immediately adjacent to southern property boundary. The back slope of a ridge located near the eastern property boundary appeared near on the property line. No evidence of disposal was apparent along this back slope. The top of the slope was a roadway. In 1968, the small disturbed area located well outside the southeast corner of the site (Area 3) was covered with trees and not visible. No activity was apparent in this area. Forested areas were present along the western perimeter of the landfill.

The coal/gob storage area (Area 1) remained visible along the northern boundary of the property, but trees and vegetation encroached on the southern perimeter. This photograph has better resolution than the other aerials and shows greater details. Area 1 appears to consist of two distinct and different areas – one smaller area on the north side of Canteen

Creek and a substantially larger area located south of the creek (Figures B-3 through B-5). The smaller coal/gob area north of the creek appears dark in color and the dendritic drainage and erosion patterns are more typical of fine-grained material such as coal. The material present in the larger area south of the creek appears as sinuous ridges more characteristic of gob.

Drawing Description
1968 Aerial Photograph

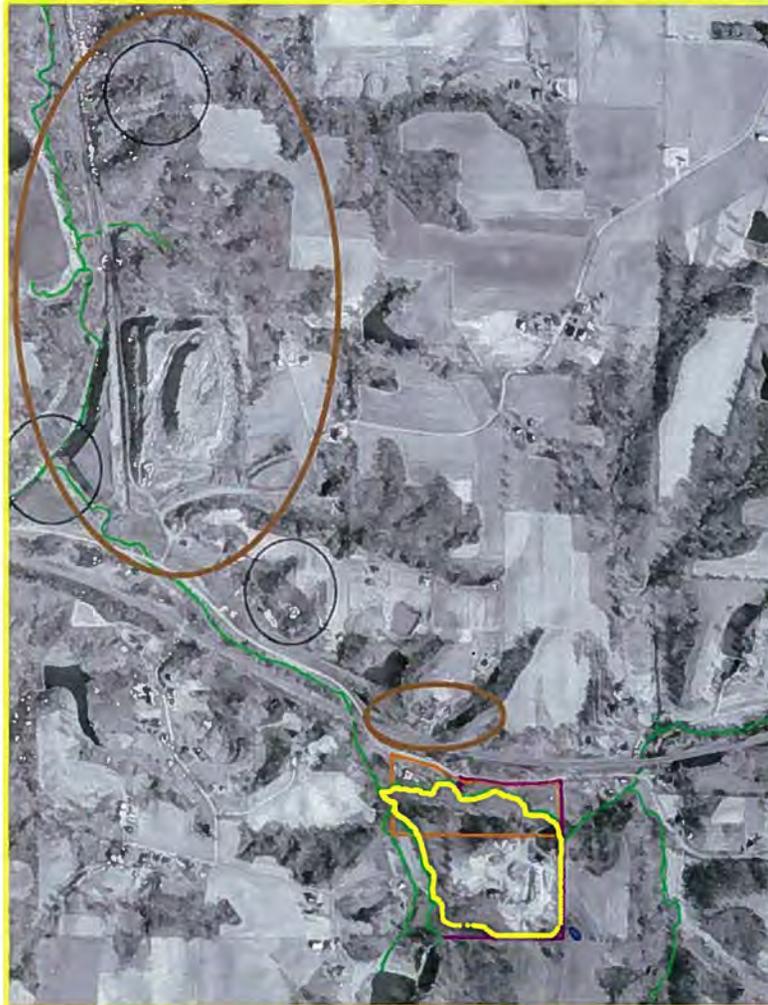
B-4

Adjacent to the western boundary of project site, new structures were visible on the west side of the unnamed southern tributary and the north side of Canteen Creek. The lake currently present south of the Closed Collinsville Landfill, but not visible on the 1956 aerial photograph, was apparent in 1968. Disturbed Area 2 associated with the mine shaft northwest of the project site remained visible in 1968 and an extremely large gob pile measuring approximately 750 feet by 500 feet was located further west near the intersection of Lebanon Road and Clay School Road. Area 2 is shown in Figure B4 and details of Area 1 are shown in Figure B-5.

1968 Aerial Photograph

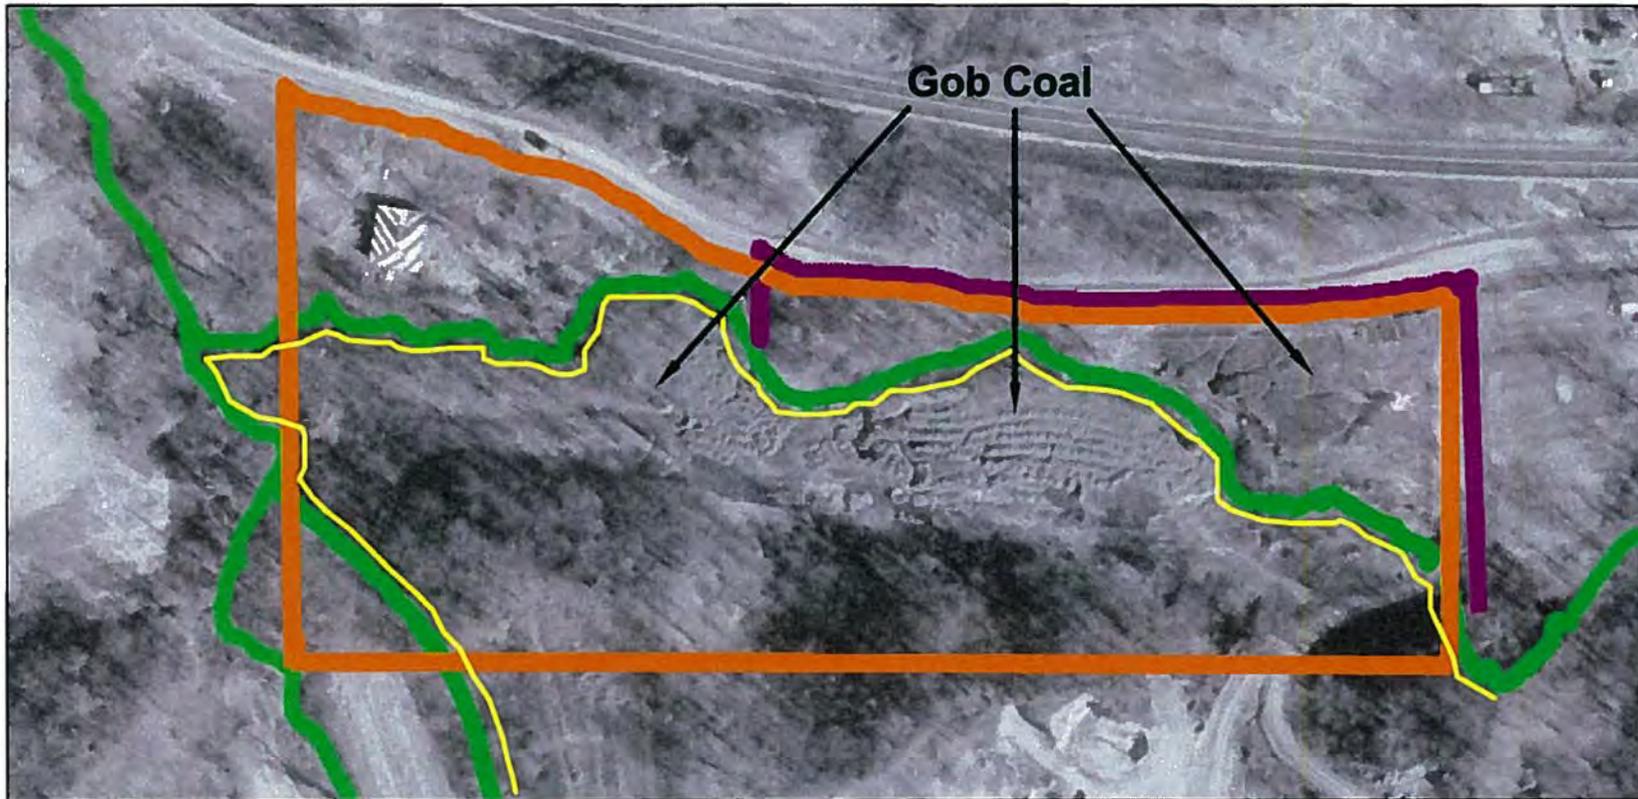
B-5

Gob is a coal mine waste that originates from the initial physical processing of coal that strips off the undesirable high sulfur pyrite. Coal associated with the Herrin Number 5 coal seam mined at Canteen Mine Number 2 contained three percent sulfur (USGS, 2002). Coal waste such as gob contains a higher percentage of pyrite and other sulfide minerals than the processed coal. The sulfur-containing waste produces acid mine drainage (AMD) when exposed to oxidation and contact with surface water or groundwater (Anderson, et.al., 2000; Rose and Cravotta, 1998; USGS, 2004).

1968 Aerial Photograph

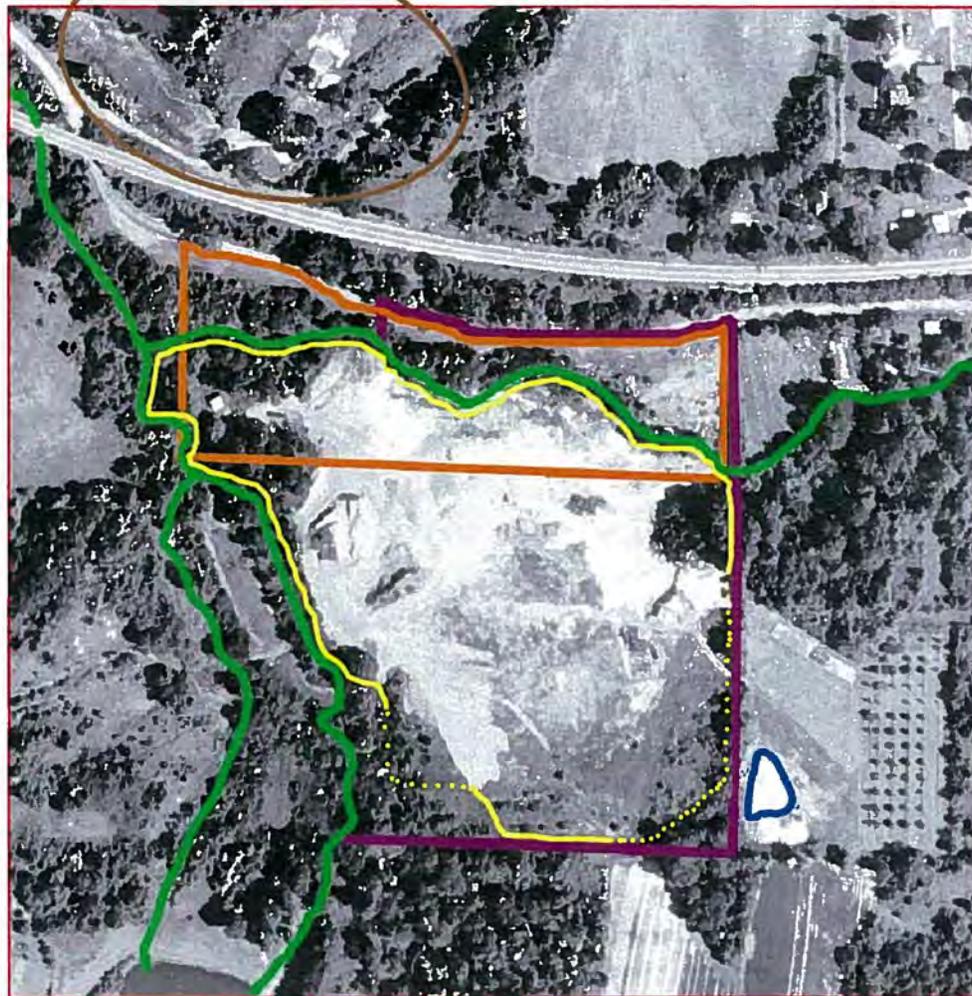
B-6

By 1974 (Figure B-6), the activity at the landfill shifted to the northern and eastern portions of the project site. This area appeared disturbed and no vegetation was visible. Canteen creek marked the northern extent of the landfill and the northwestern edge of the landfill extended to within 50 to 100 feet of the unnamed southern tributary. During this time, the southwestern edge of the landfill was approximately 150 feet from the southern ephemeral drainageway. The eastern edge of the landfill did not appear to extend beyond the eastern property boundary. The majority of the former gob storage area located on the south side of Canteen Creek (Area 1) was incorporated into the northern half of the landfill and only the northeast corner of Area 1 (coal area) remained visible. The southeastern quadrant of the project site appeared vegetated, but scarred. Area 3, identified in 1941 and 1956, was again visible, but was much larger. Erosional features surrounding Area 3 make the area appear even larger. According to City of Collinsville personnel, Area 3 was not a part of the landfill, but the area may have provided fill or cover during landfill operation (Tognarelli and Clark, 2006). The large gob pile and disturbed area located near the former mine shaft (Area 2, Figure B-4) remained visible, but a larger percentage of the area was converted to cultivated fields.

1974 Aerial Photograph

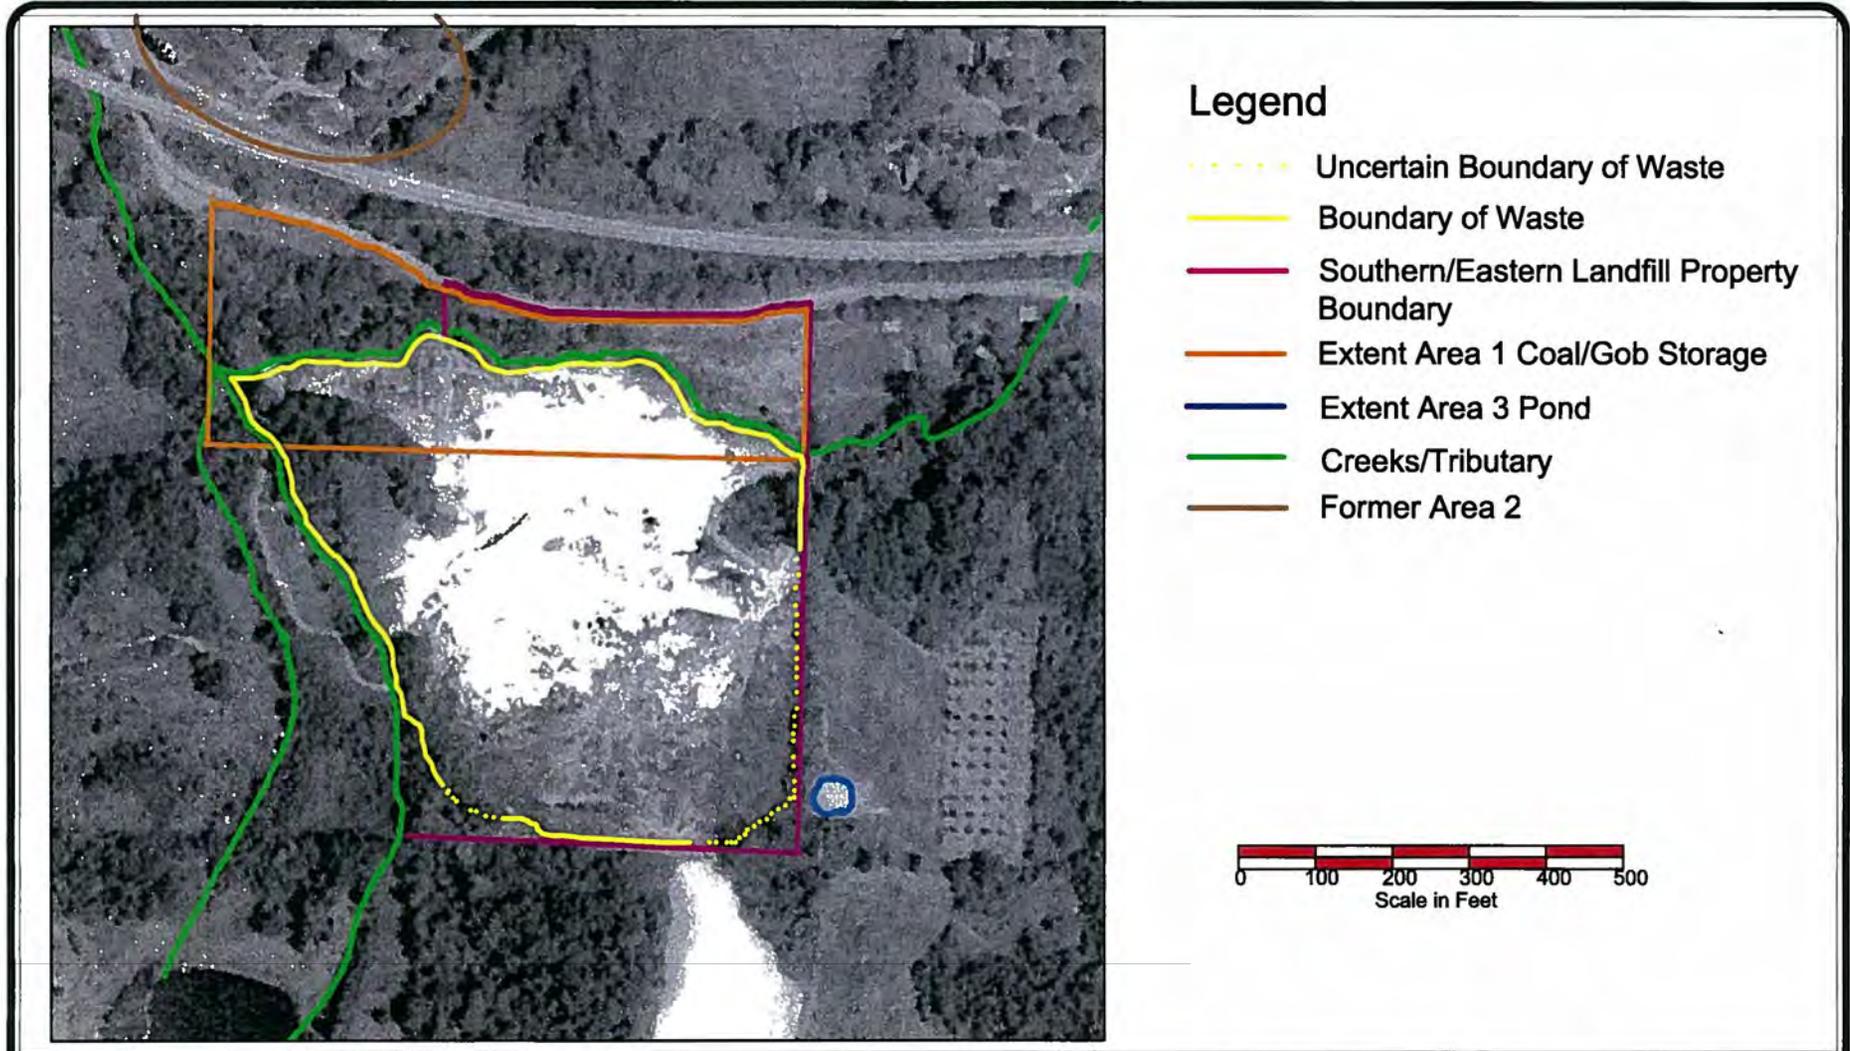
B-7

In 1978, landfill activities were concentrated in the center and northern half of the project site (Figure A-7). In the northwest and southeast corners of the site, no activity was observed, but scarring was apparent. In the northwest corner, linear scars representing trenches, extended to within approximately five to 10 feet of Canteen Creek in the area that formerly stored gob (Area 1). To the south, linear scars extended to the property boundary. The western half of the site appeared graded, vegetated and partially forested. However, no activity was visible in the

southwest corner of the project site. This area remained forested. The northeast corner of the coal/gob storage area (Area 1) remained visible. Disturbed Area 3, surrounded by woods, an open field and an orchard, was visible as a rectangular area similar to a barrow pit. The large gob pile located northwest of the site remained visible (not shown), but Area 2 was smaller and was vegetated or cultivated (not shown).

1978 Aerial Photograph

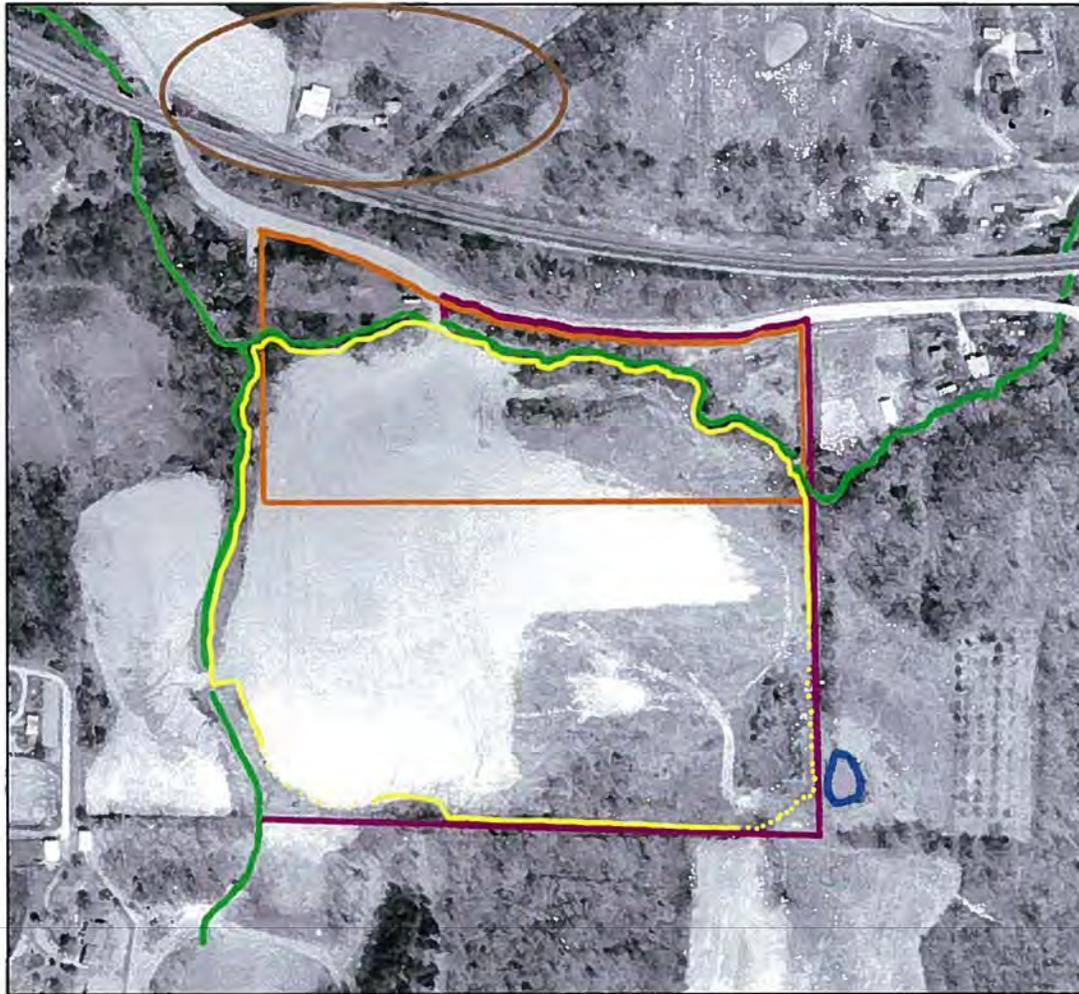
B-8

By 1986, no vehicles or landfill activities were apparent (Figure B-8). The configuration of the closed landfill was similar to the current configuration. With the exception of remnants of a road and patches of sparse vegetation in the southeast quadrant, no scarring of the land surface was visible in the 1986 aerial photo. New vegetation covered the entire landfill surface bordering Canteen Creek, the unnamed southern tributary, the ephemeral southern drainageway and the eastern property boundary. The southwest corner of the landfill that appeared forested in 1978 was also graded and vegetated. The perimeter of the graded landfill appeared to extend to within 10 to 50 feet of the surrounding creeks and drainageway. On the western side of the southern tributary, the borrow area used for the landfill cap was visible in this photo. This area measured approximately 400 feet by 150 feet. Based on a comparison of the earlier aerial photographs to the 1986 aerial, the development of the landfill altered the course of Canteen Creek and the unnamed southern tributary. In 1986, Area 3 was visible as a pond but only the northeast corner of Area 1 was visible. The large gob pile located northwest of the project site appeared graded and vegetated and the disturbed Area 2 was present but less distinct (Area 2 not shown). A residential development was visible in the 1986 photograph south of the lake and landfill and new structures were present north of the railroad tracks.

1986 Aerial Photograph

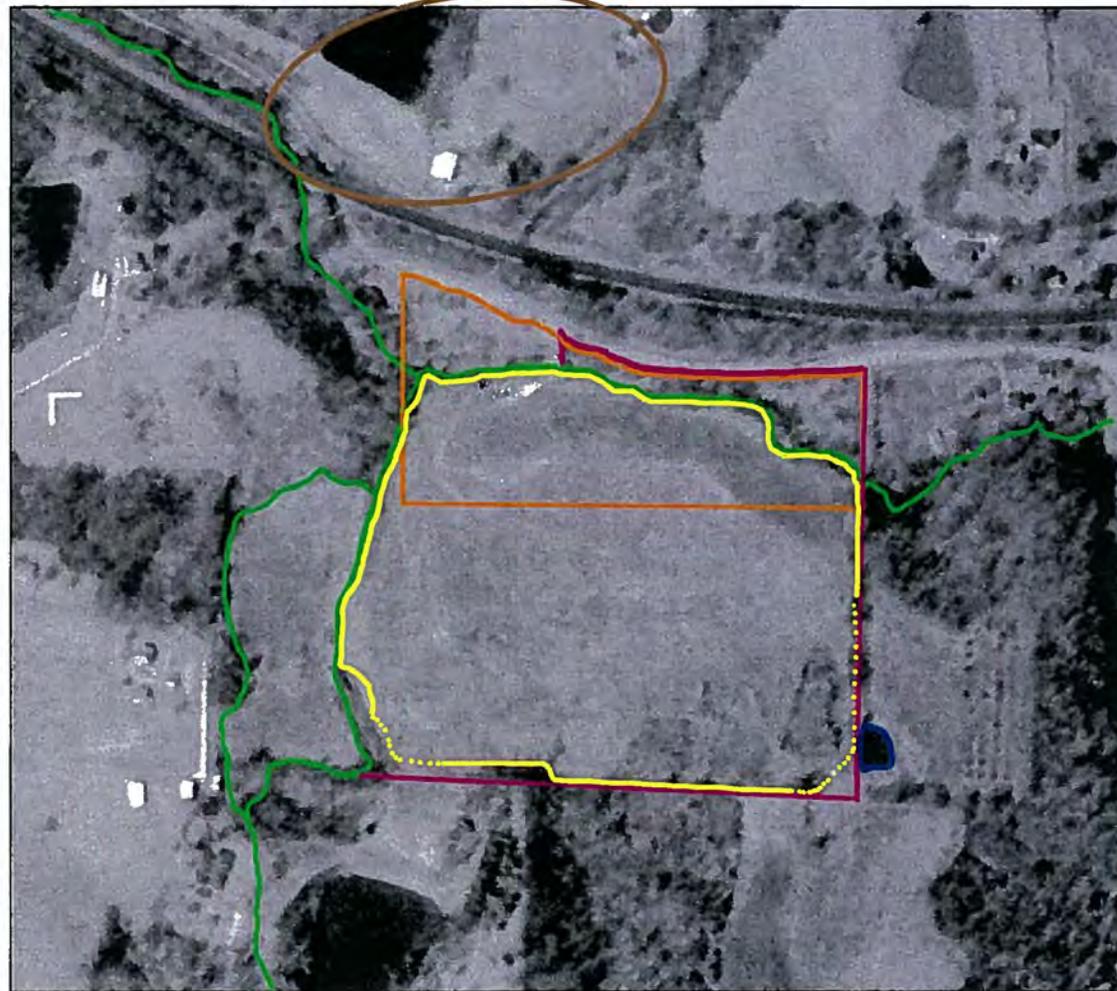
B-9

By 1988 (Figure B-9), the vegetated surface of the landfill and borrow area appeared well established and traces of roads and scarred areas were absent. Area 3 remained a pond and details of the northeast corner of Area 1 were not apparent due to the blurred image. Residential development continued south of the project site. The disturbed areas associated with Area 2 appeared smaller and vegetation was well established.

1988 Aerial Photograph

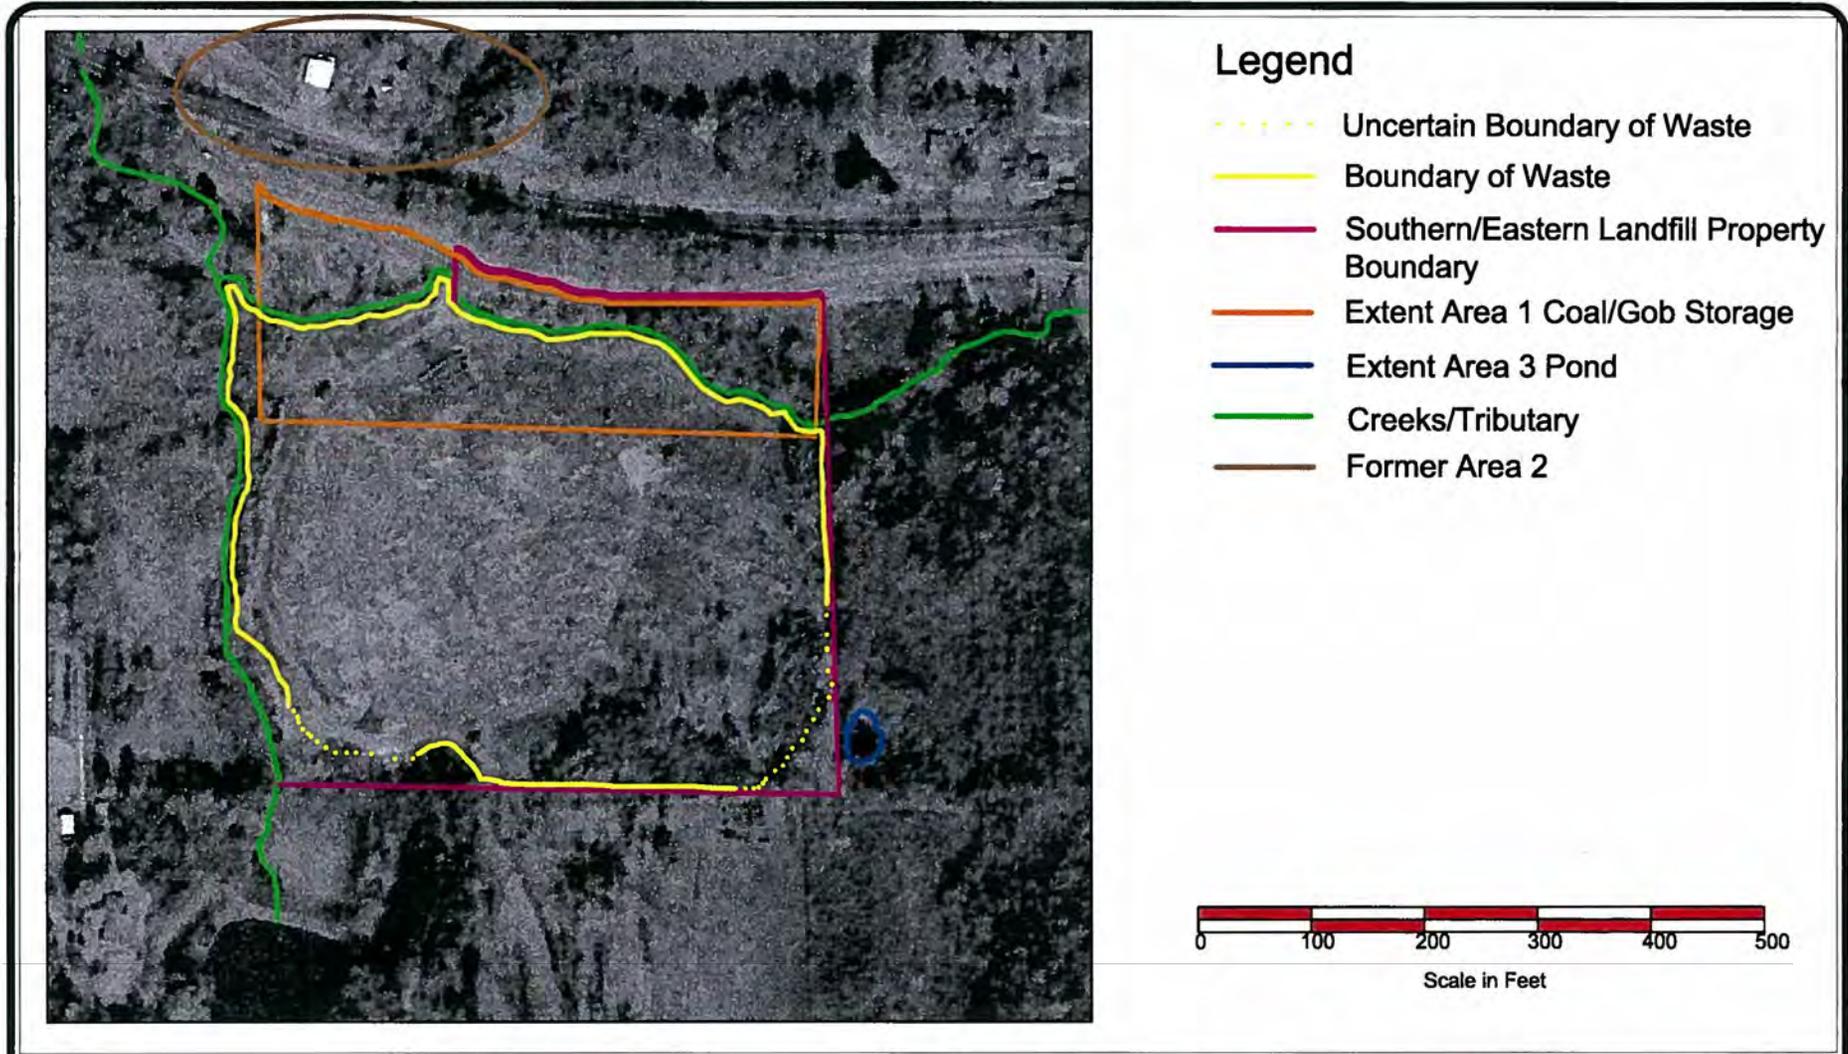
B-10

As shown in Figure B-10, conditions at the Closed Collinsville Landfill in 1993 were nearly identical to current conditions. An access road, two leachate extraction buildings and one shed were visible at the project site. A forested area covered the northeast corner of the former coal/gob storage area (Area 1) and the remainder of the coal/gob storage area was beneath or incorporated into the landfill. The pond located adjacent to but outside of the southeast corner of the project site (Area 3) remained visible. The restored gob pile and the former disturbed areas near the mine shaft (Area 2) were not included in this portion of the aerial photograph. Additional residential development south of the landfill and lake was apparent.

1993 Aerial Photograph

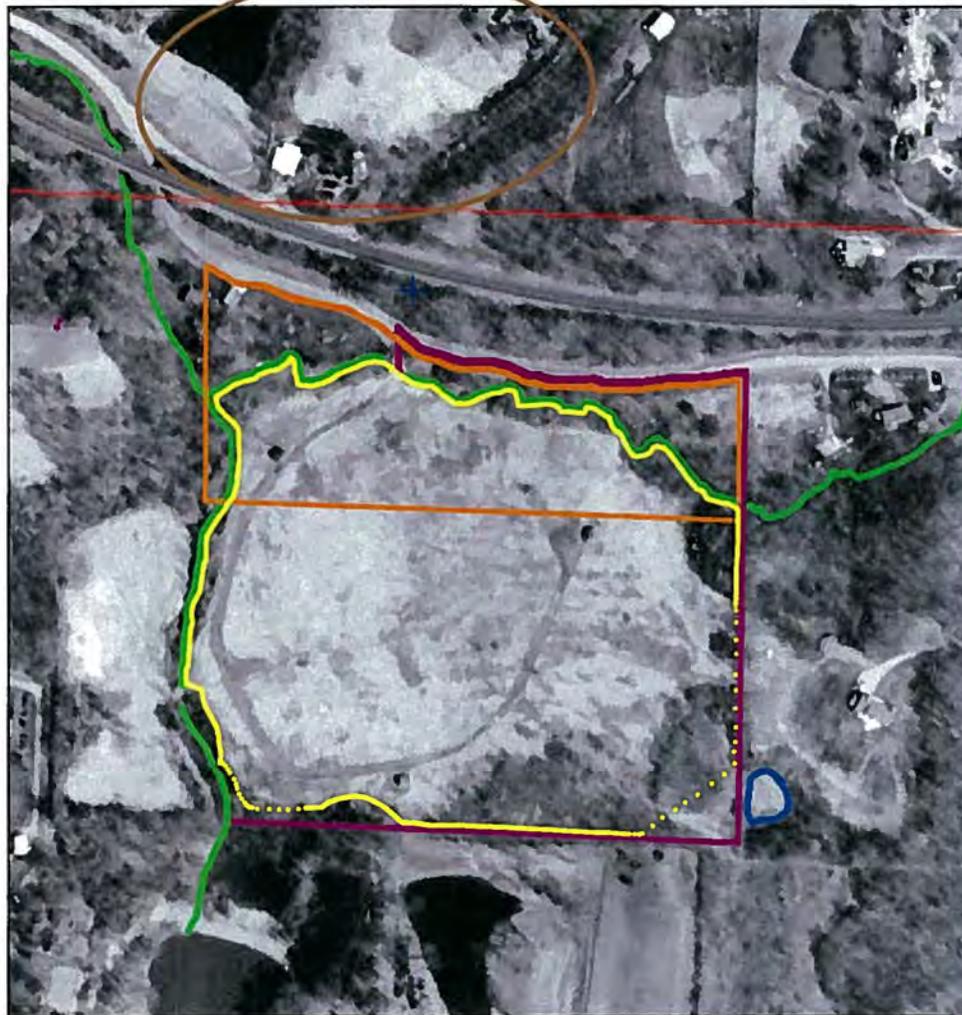
B-11

The 1998 aerial photo is identical to the 1993 photo except that the vegetation on the landfill cap is well developed and a residence has been constructed on the property to the east of the

1998 Aerial Photograph

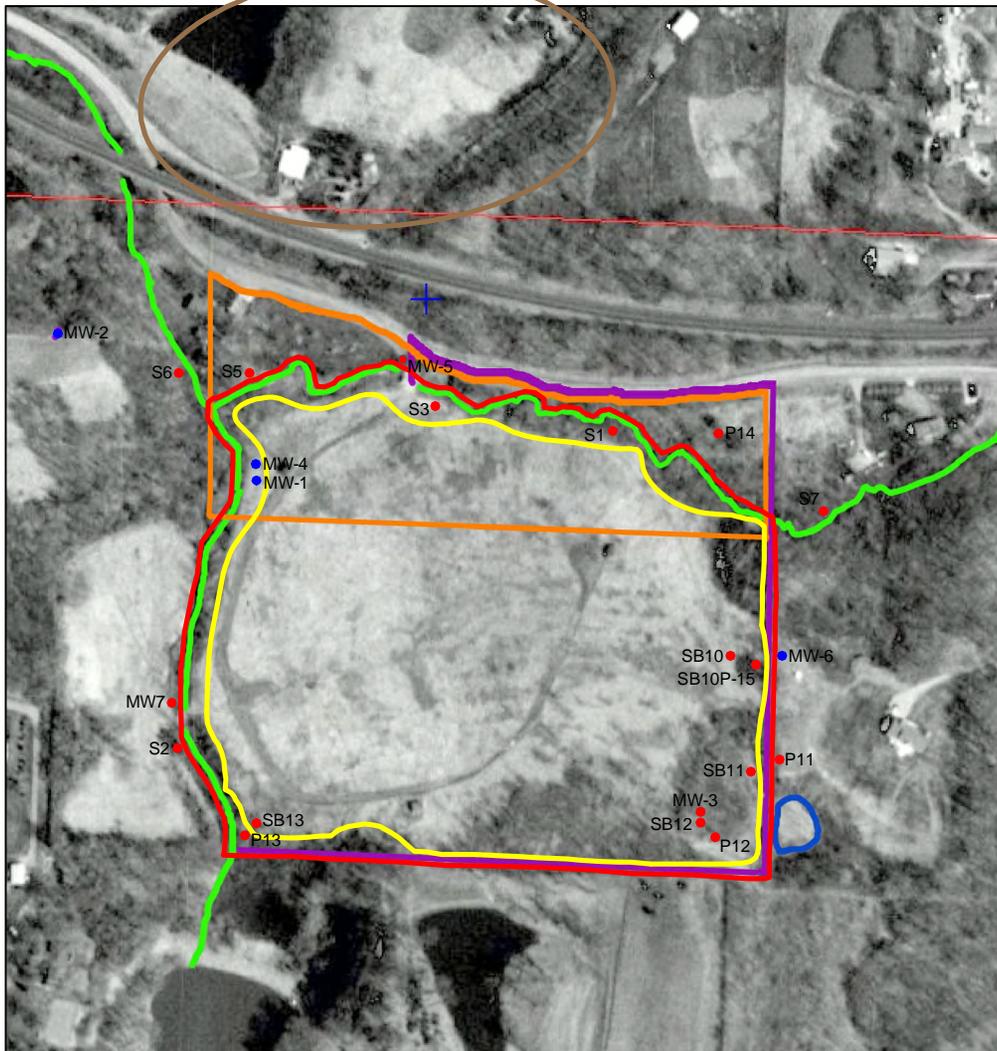
landfill. The locations of the borings proposed in the addendum to the work plan are shown in Figure B-12 and the actual boundary of the landfilled waste is outlined with a solid red line.

Drawing Description
1998 Aerial Photograph
Sample Locations
