BEFORE THE ILLINOIS POLLUTION CONTROL BOARD

ADMINISTRATIVE CITATION

Site: JH Concrete Construction  
Inc (0010655365)  
Adams County

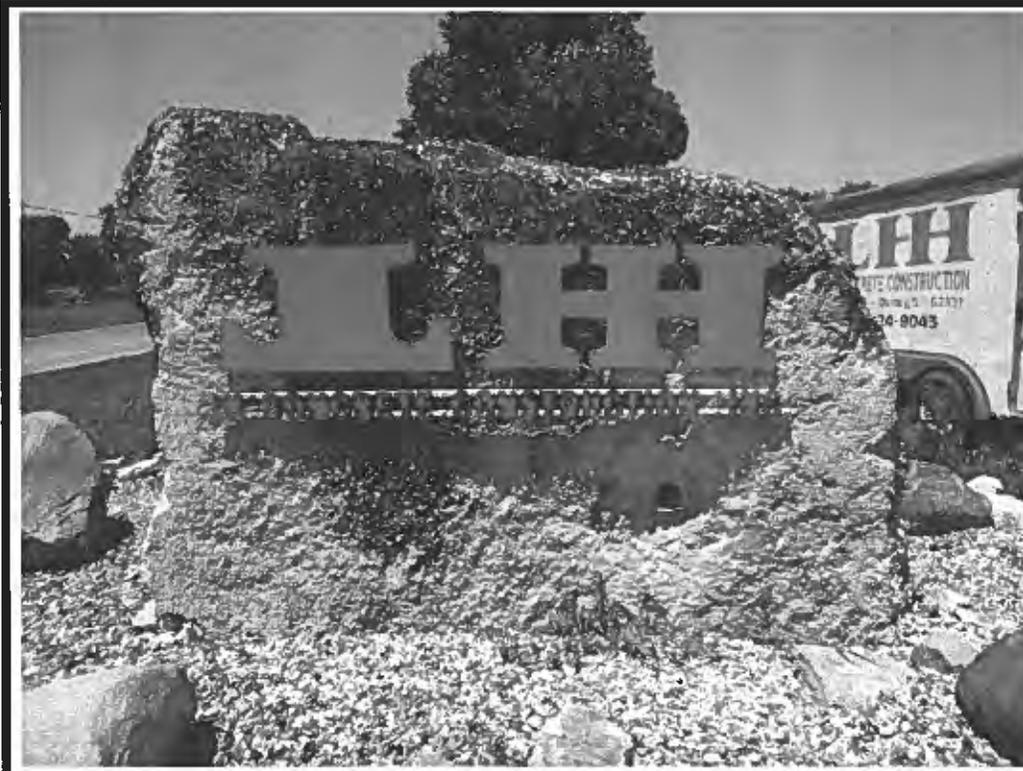
Photo ID: 1  
Photo Date: 6/29/2018  
Photo Time: 13:49:24  
Direction: N  
Taken By: Paul Eisenbrandt

Business signage near entrance  
to the property.

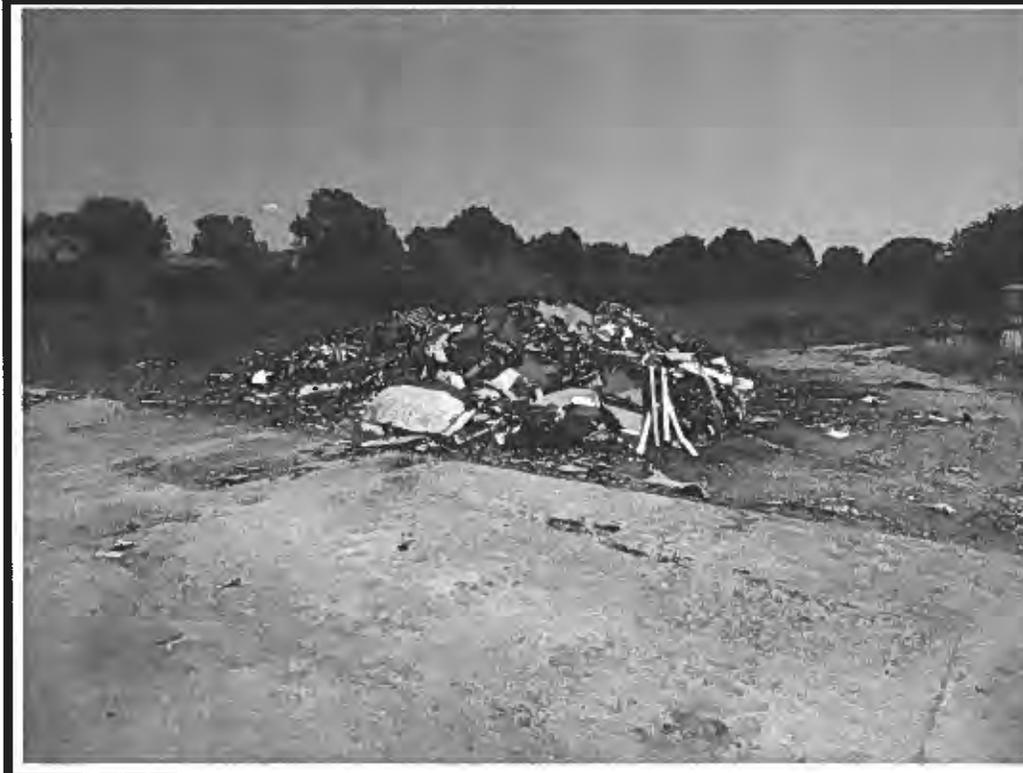
Photo ID: 2  
Photo Date: 6/29/2018  
Photo Time: 13:54:57  
Direction: SE  
Taken By: Paul Eisenbrandt

Off-site generated business  
waste, GCDD, litter, and  
landscape waste open dumped  
behind the facility.

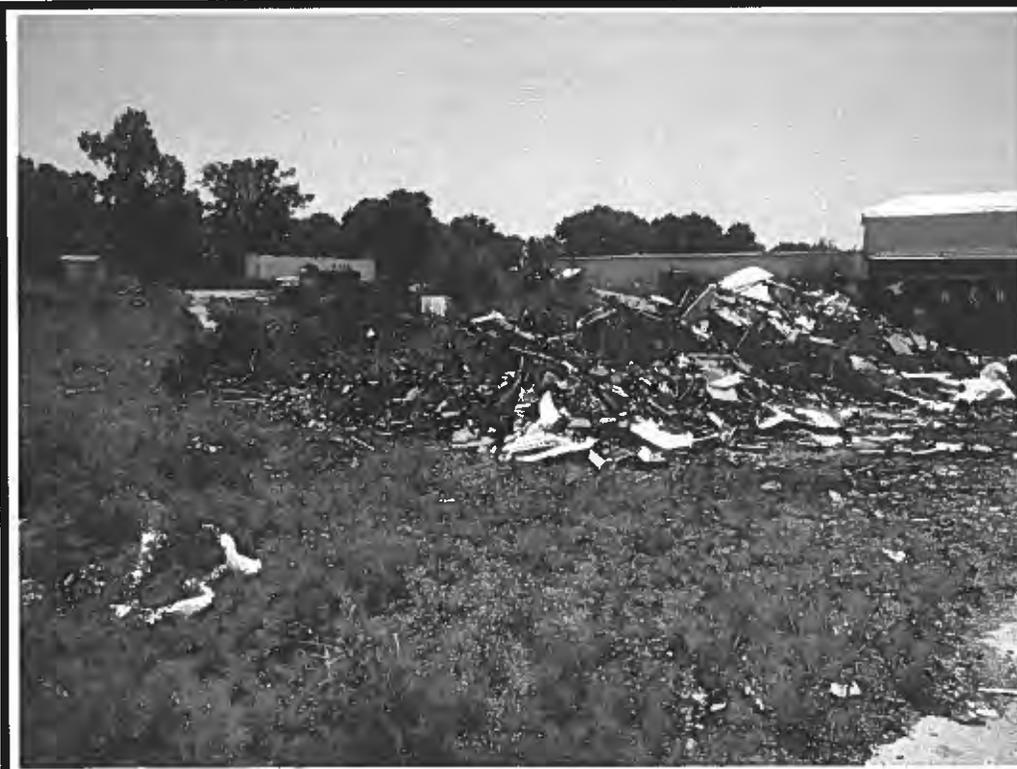
Photo ID: 3  
Photo Date: 6/29/2018  
Photo Time: 13:55:28  
Direction: SW  
Taken By: Paul Eisenbrandt

I walked to the location described in the complaint on the back side of the property. There, I found a large open burn debris pile about 36 ft. wide by 54 ft. long and up to 6 ft. high (see photographs 2, 3, 5, 6, 8, and 13). Please refer to the attached Site Sketch dated June 29, 2018 for the approximate photograph locations. The burn pile contained charred litter, business waste, general construction or demolition debris (GCDD), and landscape waste. I observed bathroom sinks, electrical conduit, fiberglass pieces of a shower or tub, numerous rolls of wallpaper, several doors, tubes of caulk, fiber ceiling tiles, garage door moldings, pieces of rubber, ceramic tile, beer cans, cardboard, beverage bottles, dimensional lumber, plastic sheeting, wooden pallets, business receipts and cancelled checks, vinyl siding, OSB sheathing, fiber board sheathing, and crushed paint cans among other miscellaneous waste on the north side of the debris pile. There were no apparent buildings under construction or demolition at the site during this inspection, indicating the GCDD was off-site generated. To the north of the large open burn pile, there was a segregated pile of melted aluminum, wire, and rusty scrap metal apparently scavenged from the open burn pile (see Photograph 4). To the east, there was a small pond with litter along the bank, shoreline, in among the cattails, and waste was visible in the center (see Photograph 7). There was an empty blue poly 55-gallon drum resting on its side along the shoreline. Photograph 12 shows open dumped waste in contact with standing waste along the east side of the large debris pile.

The large open burn debris pile  
was about 36 ft. wide by 54 ft.  
long and up to 6 ft. high.

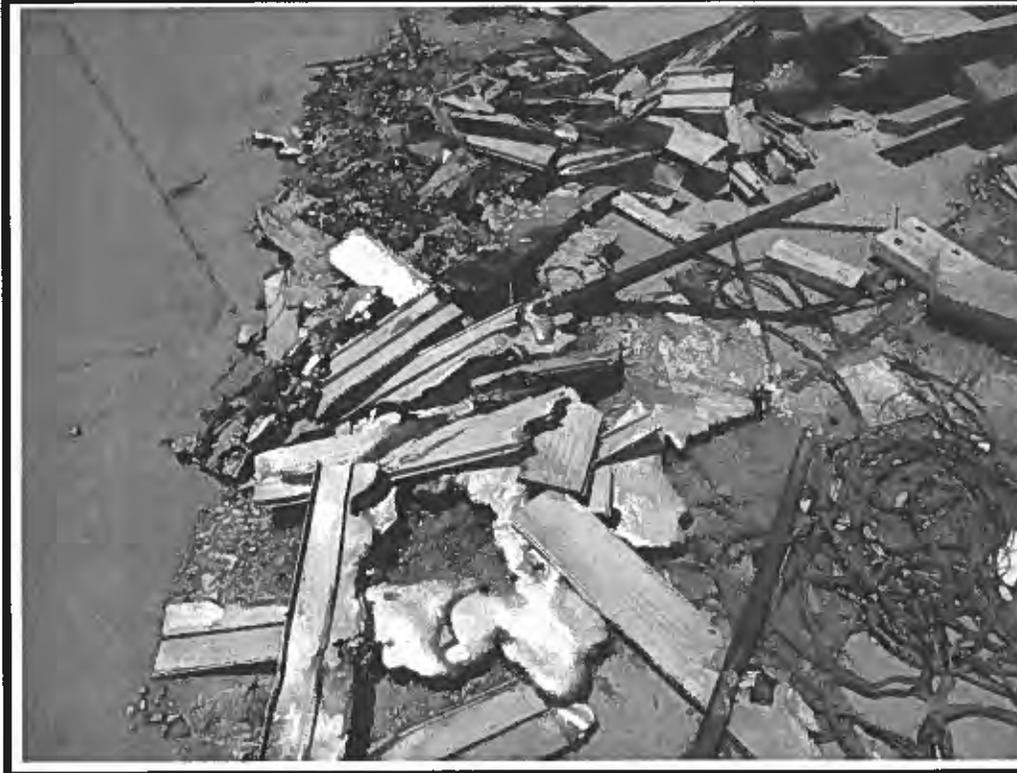
Photo ID: 4  
Photo Date: 6/29/2018  
Photo Time: 13:55:38  
Direction: W  
Taken By: Paul Eisenbrandt

Melted aluminum, wire, and  
rusty scrap metal apparently  
scavenged from the open burn  
pile.

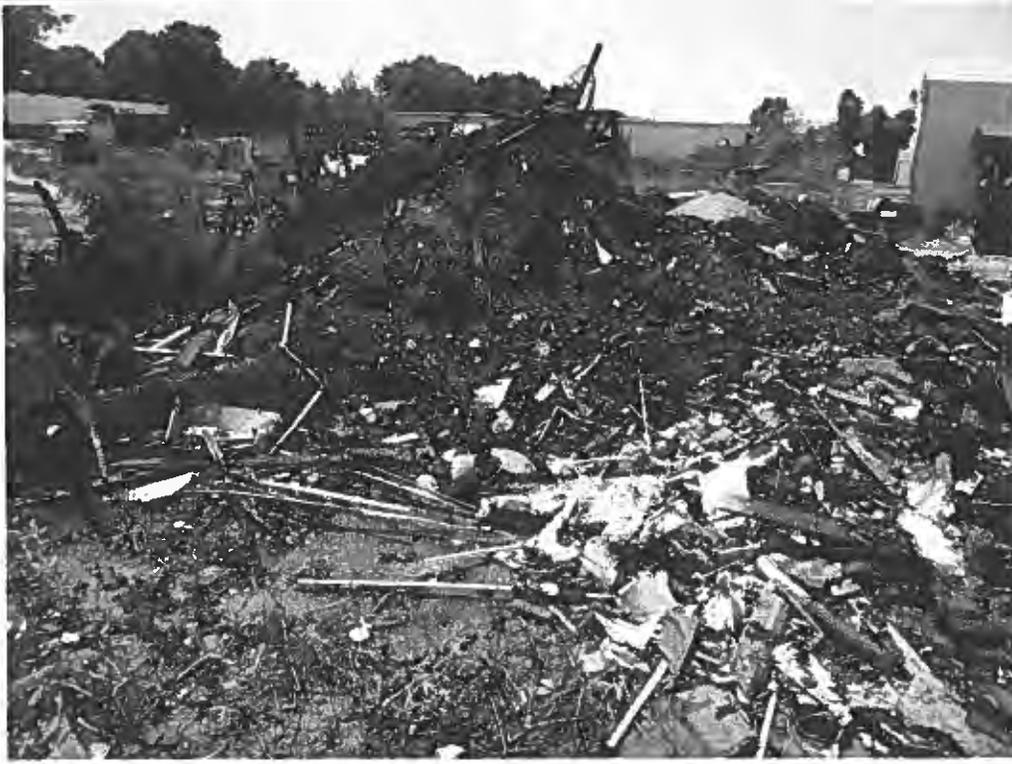
Photo ID: 5  
Photo Date: 6/29/2018  
Photo Time: 13:56:00  
Direction: W  
Taken By: Paul Eisenbrandt

Charred waste, ash, and rusty  
scrap metal.

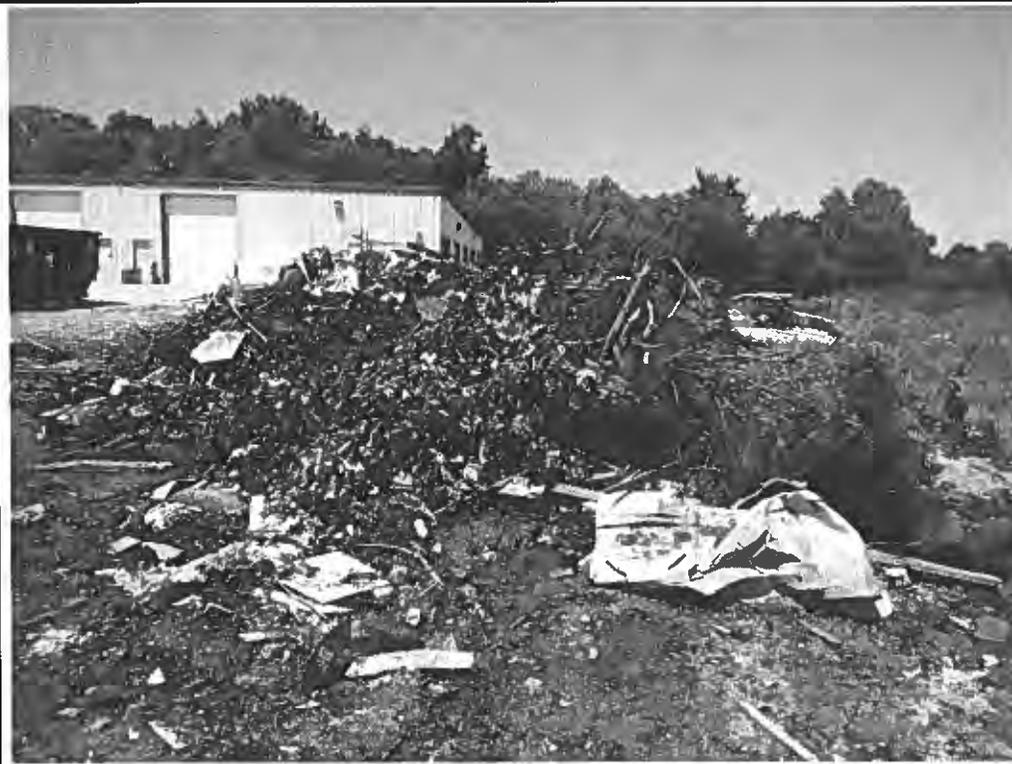
Photo ID: 6  
Photo Date: 6/29/2018  
Photo Time: 13:56:55  
Direction: N  
Taken By: Paul Eisenbrandt

The landscape waste accounted  
for less than 10 percent of the  
off-site generated debris in the  
open burn pile.

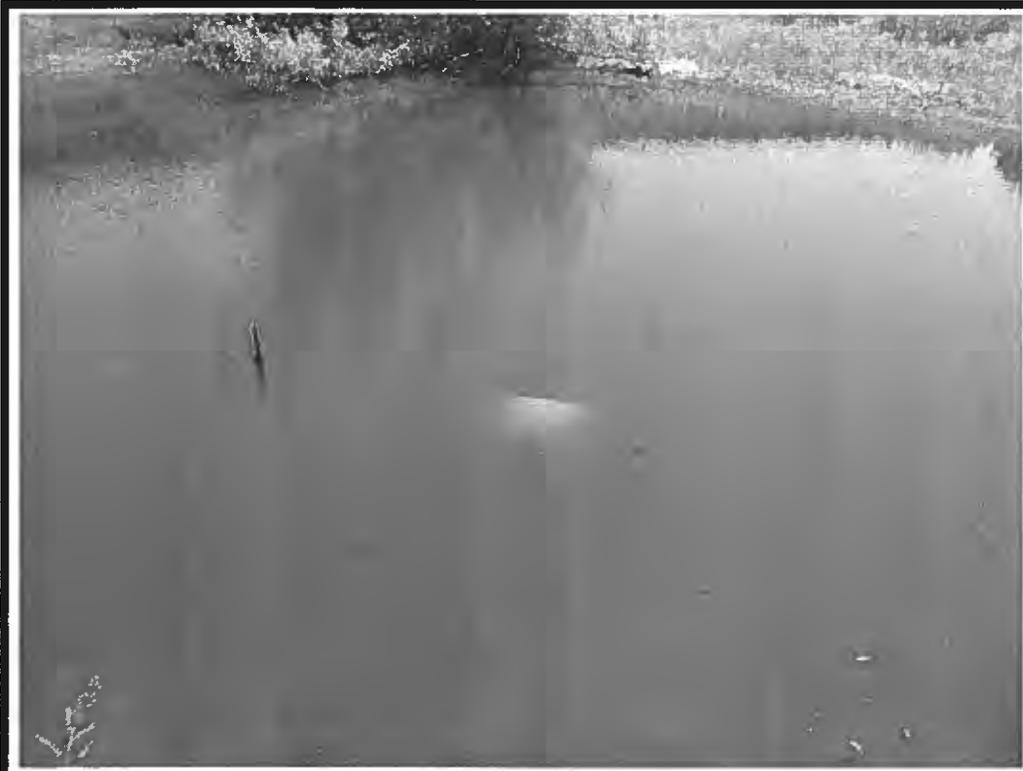
Photo ID: 7  
Photo Date: 6/29/2018  
Photo Time: 13:57:40  
Direction: E  
Taken By: Paul Eisenbrandt

Open dumped litter in a pond.

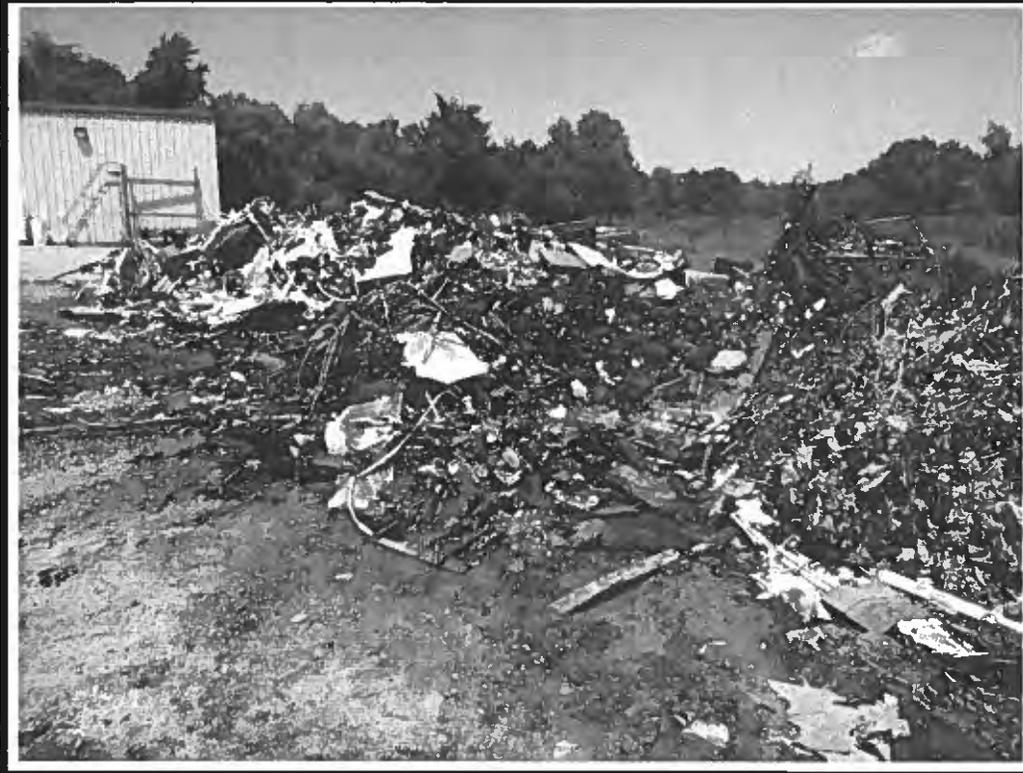
Photo ID: 8  
Photo Date: 6/29/2018  
Photo Time: 13:58:08  
Direction: N  
Taken By: Paul Eisenbrandt

Alternate view of the off-site  
generated open dumping and  
open burning operation.

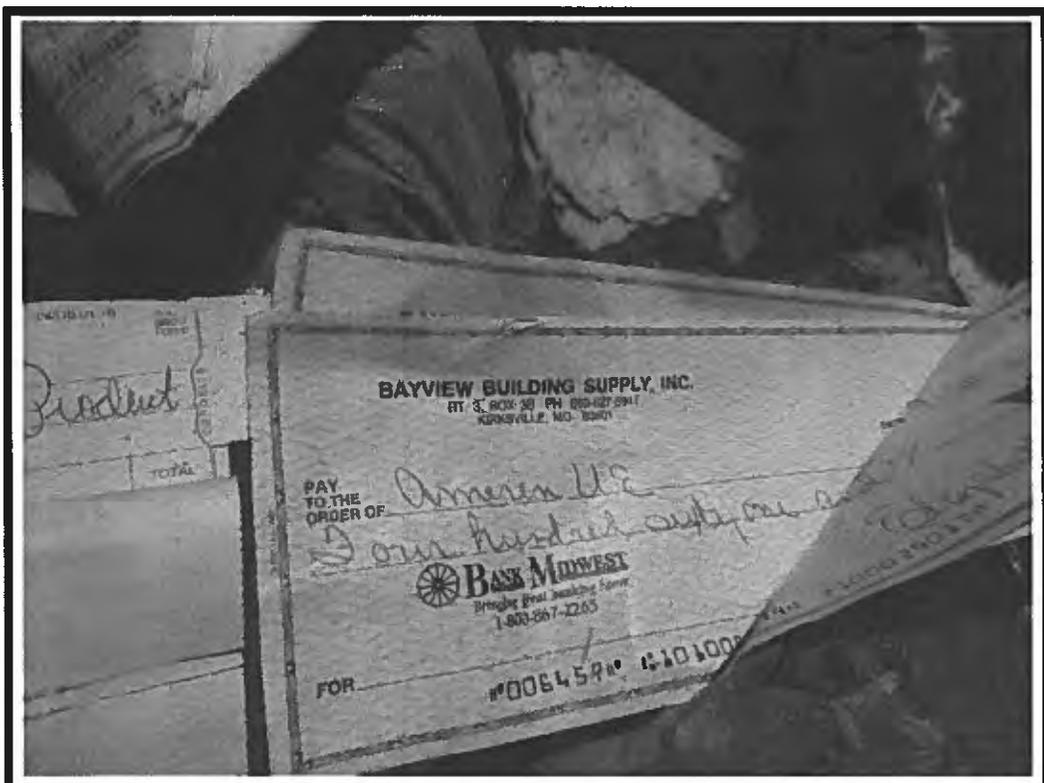
Photo ID: 9  
Photo Date: 6/29/2018  
Photo Time: 14:06:11  
Direction: S  
Taken By: Paul Eisenbrandt

There were a variety of business receipts and cancelled checks in the burn pile that did not match JH Concrete's name or the location address. Photograph 9 shows a Bayview Building Supply, Inc. cancelled check from Kirksville, Mo. pay to the order of Ameren UE. Photograph 10 shows a Boatmen's Bank of Quincy deposit ticket. Photograph 11 shows a Bayview Building Supply, Inc. order slip from an address in Quincy. The business receipts further demonstrate off-site generated waste was transport into the site for disposal.

A Bayview Building Supply, Inc. check from Kirksville, MO. demonstrating off-site generated waste was transport into the site for disposal.

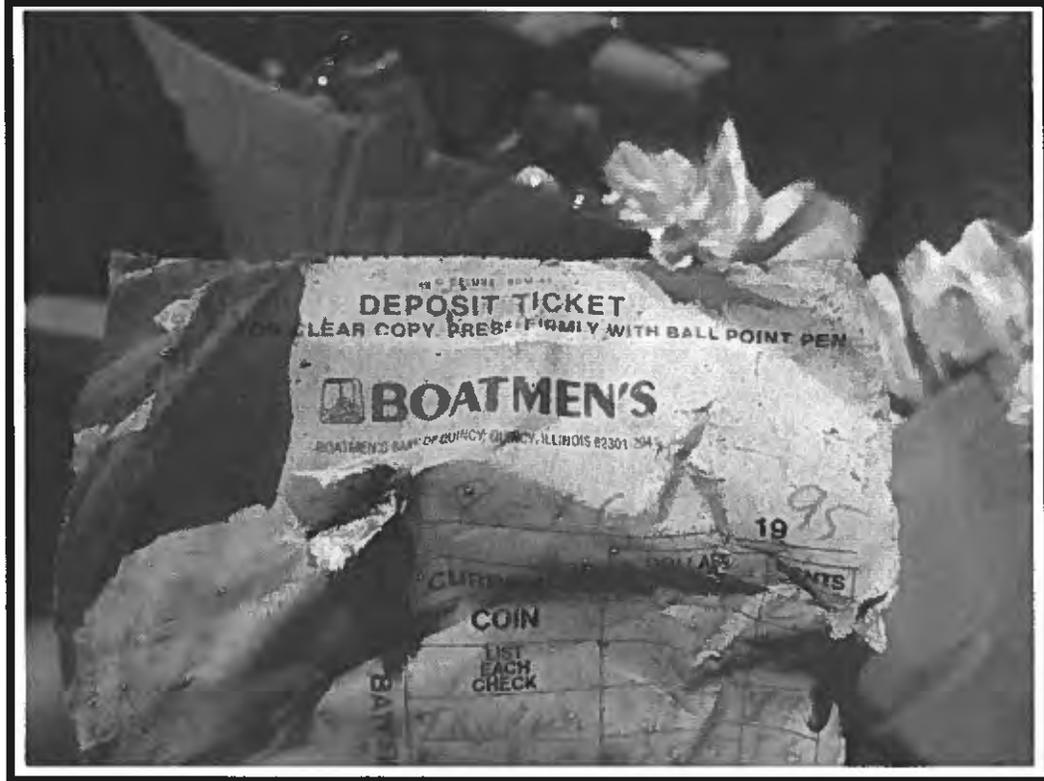
Photo ID: 10  
Photo Date: 6/29/2018  
Photo Time: 14:06:43  
Direction: S  
Taken By: Paul Eisenbrandt

A Boatmen's Bank of Quincy deposit ticket demonstrating off-site generated waste was transport into the site for disposal.

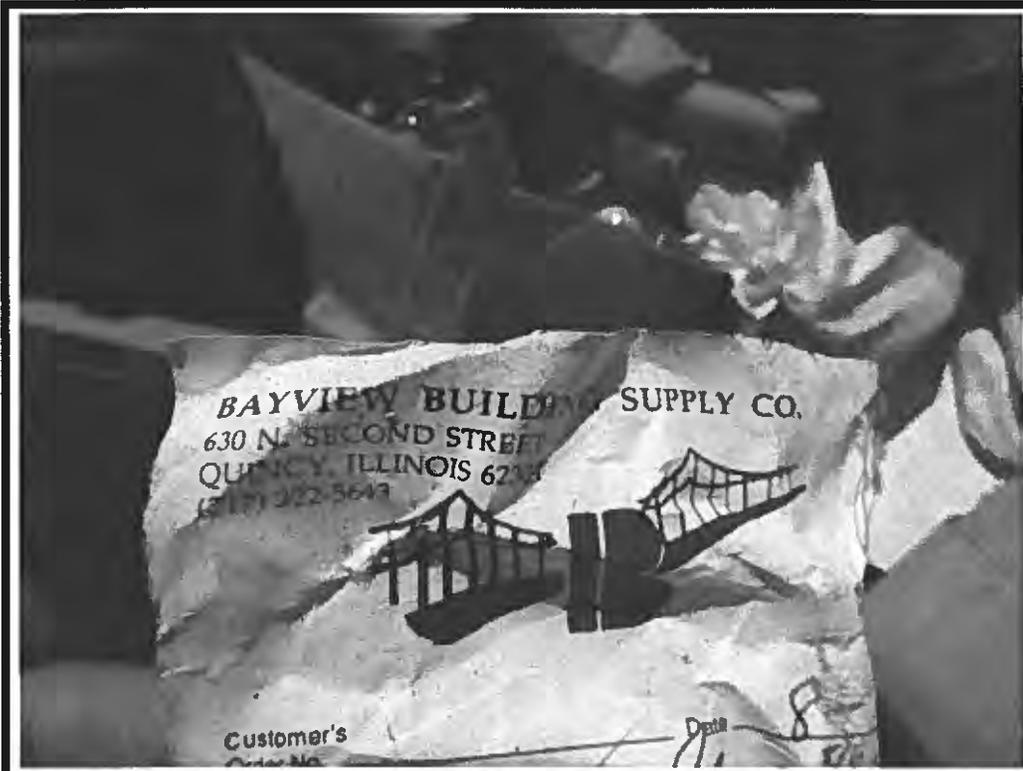
Photo ID: 11  
Photo Date: 6/29/2018  
Photo Time: 14:07:16  
Direction: S  
Taken By: Paul Eisenbrandt

A Bayview Building Supply  
Co. of Quincy, IL. invoice  
demonstrating off-site  
generated waste was transport  
into the site for disposal.

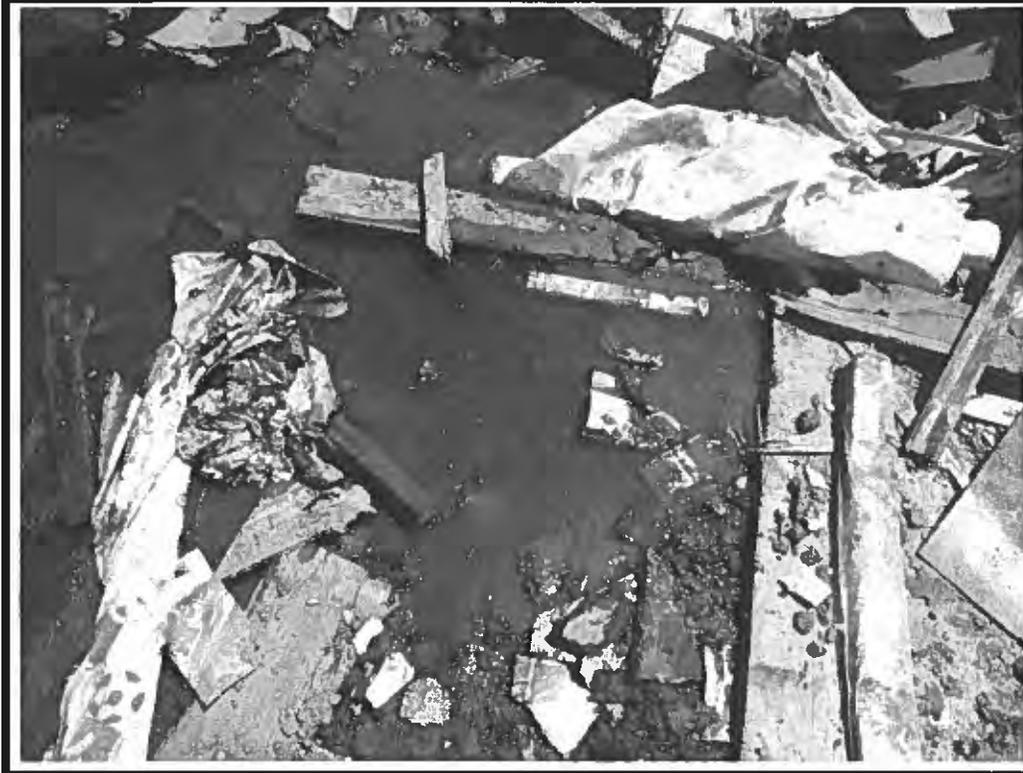
Photo ID: 12  
Photo Date: 6/29/2018  
Photo Time: 14:07:33  
Direction: S  
Taken By: Paul Eisenbrandt

Open dumped waste in contact  
with standing water.

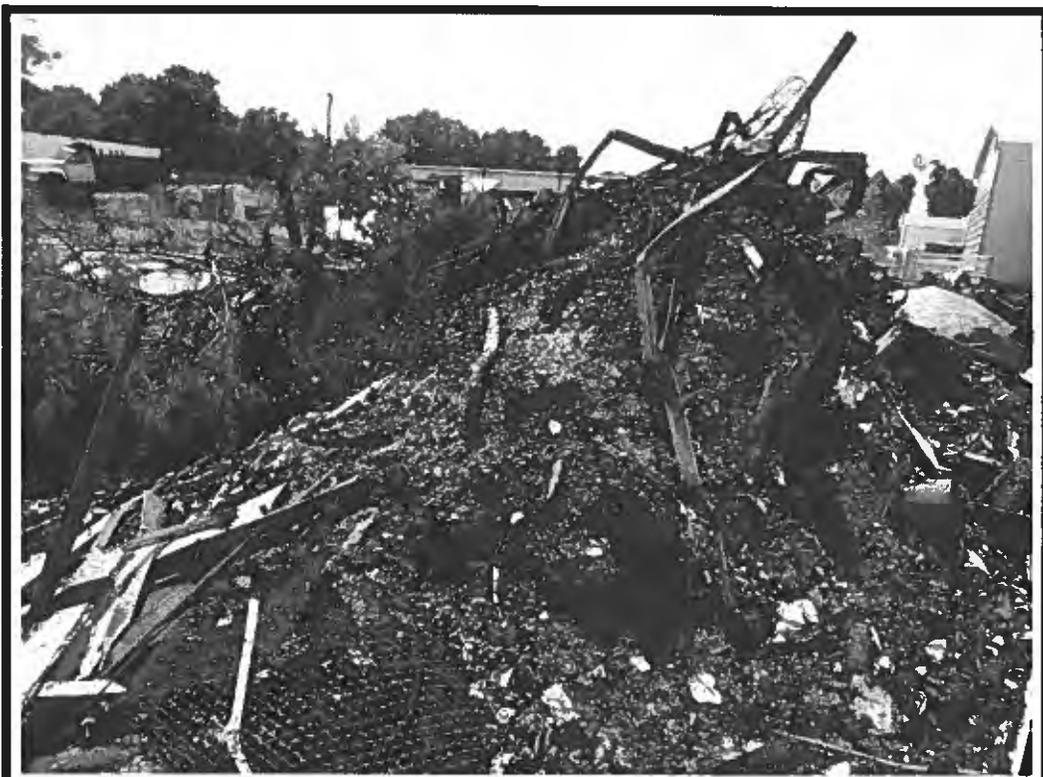
Photo ID: 13  
Photo Date: 6/29/2018  
Photo Time: 14:08:44  
Direction: W  
Taken By: Paul Eisenbrandt

Charred debris and ash.

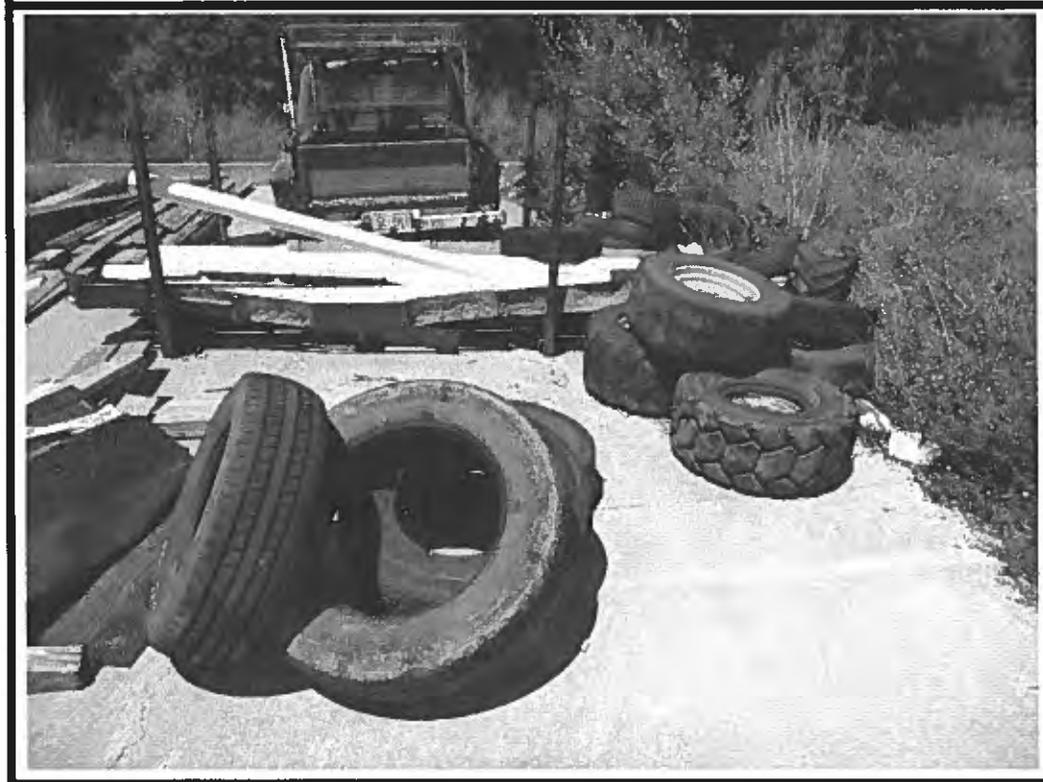
Photo ID: 18  
Photo Date: 6/29/2018  
Photo Time: 14:15:45  
Direction: NE  
Taken By: Paul Eisenbrandt

Approximately 35 used tires stored outside of which about 20 were off-rim and contained water accumulation.

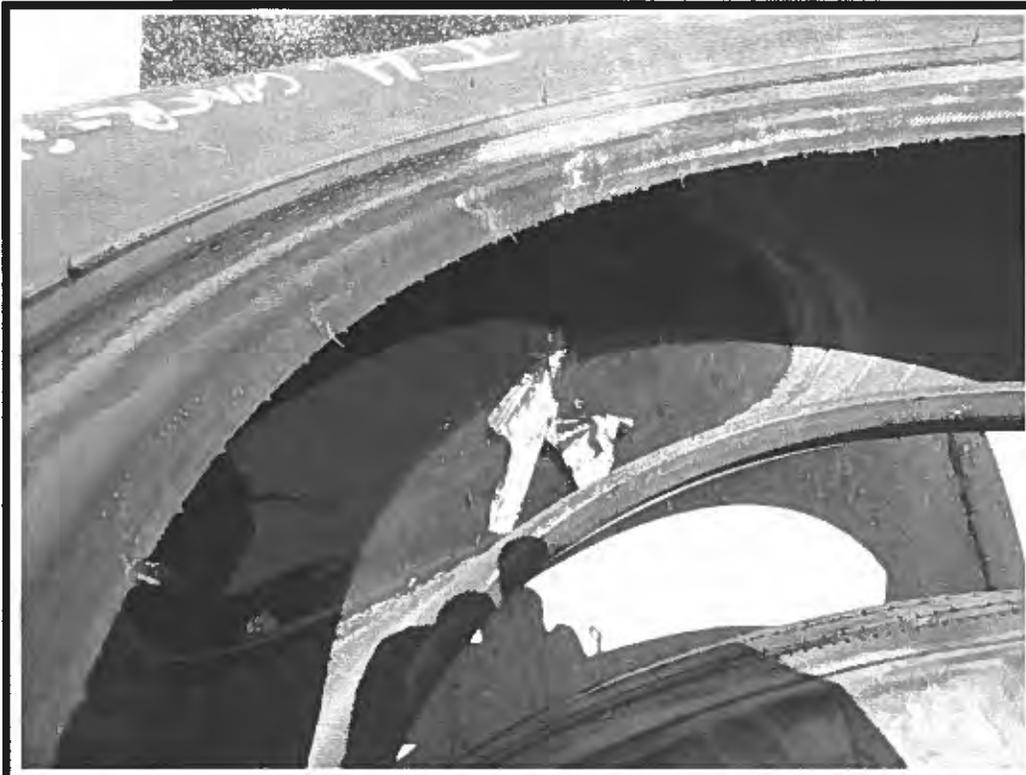
Photo ID: 19  
Photo Date: 6/29/2018  
Photo Time: 14:15:54  
Direction: S  
Taken By: Paul Eisenbrandt

Water accumulation in a used  
tire seen in Photograph 18.

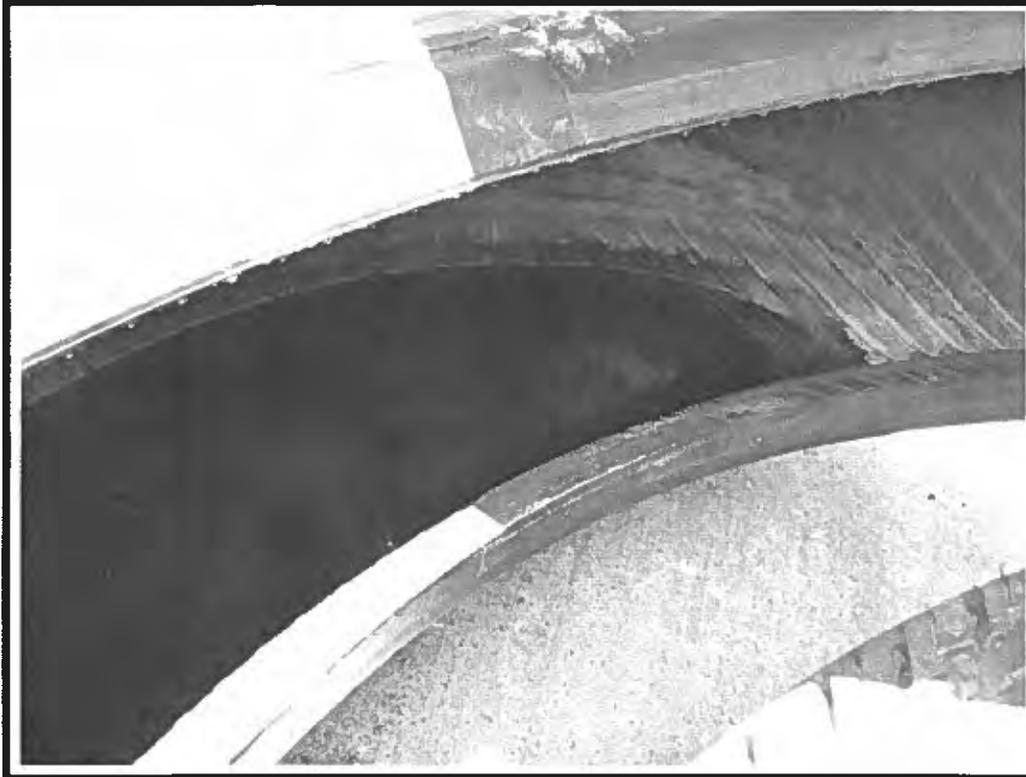
Photo ID: 20  
Photo Date: 6/29/2018  
Photo Time: 14:16:03  
Direction: E  
Taken By: Paul Eisenbrandt

Water accumulation in a used  
tire seen in Photograph 18.

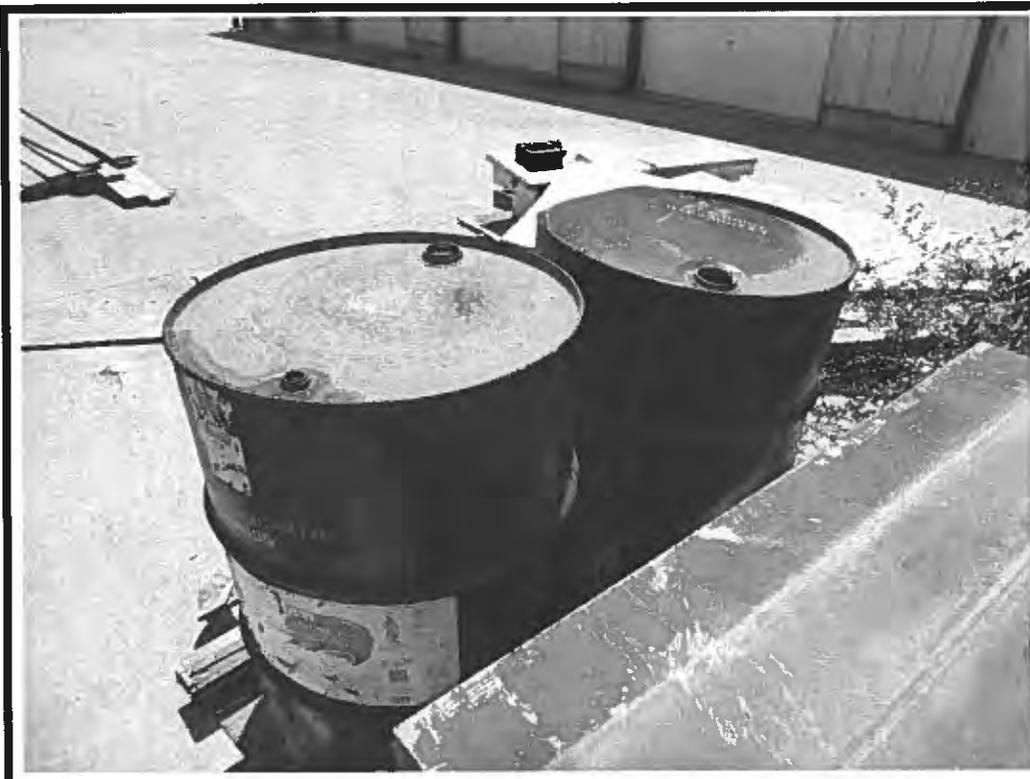
Two unmarked 55-gallon drums of used oil. One of the drums had an open bung cap and was dented.

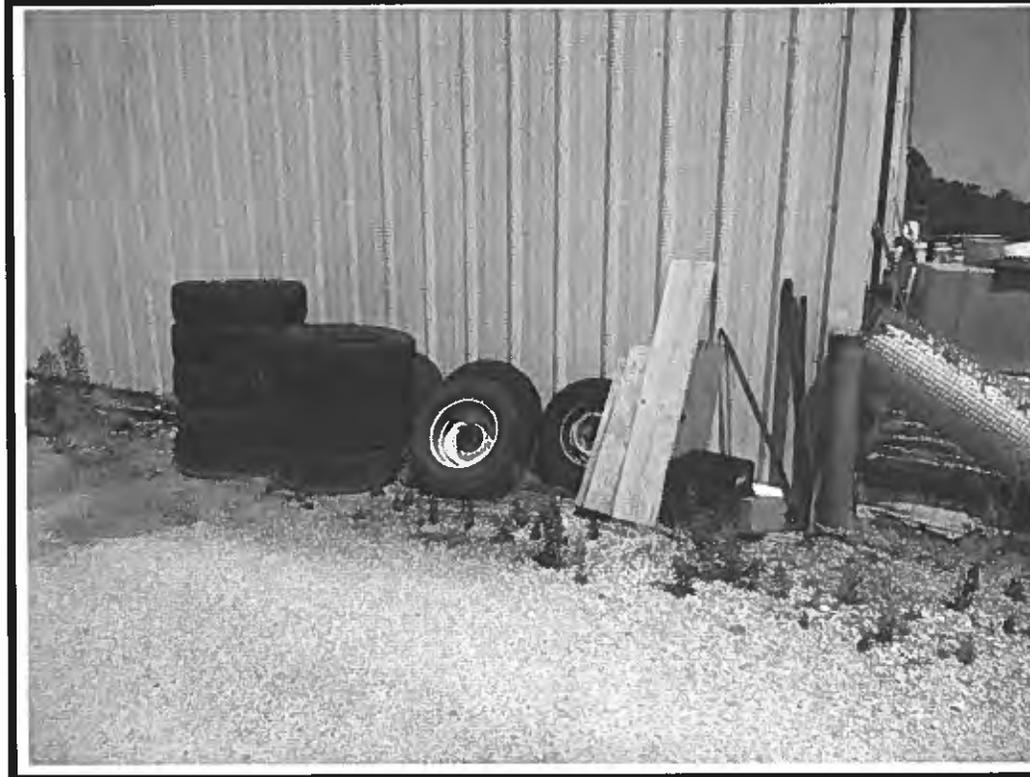
Thirteen (13) used tires stored outside of which 9 were off-rim and contained water accumulation.

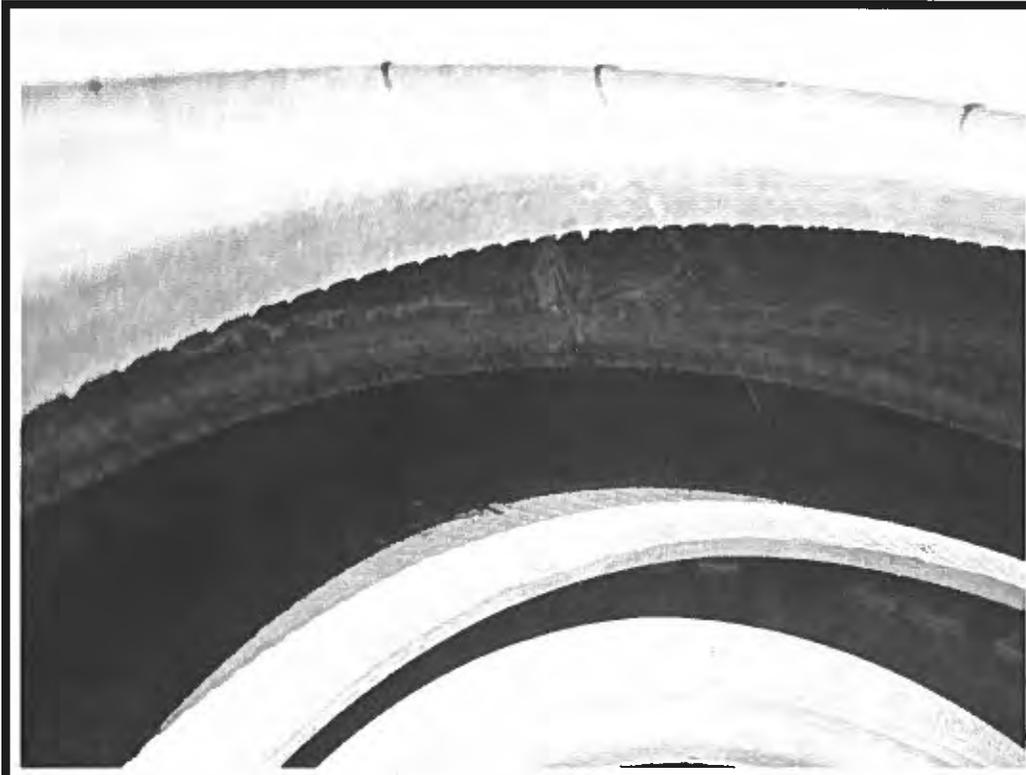
Water accumulation in a used  
tire seen in Photograph 22.

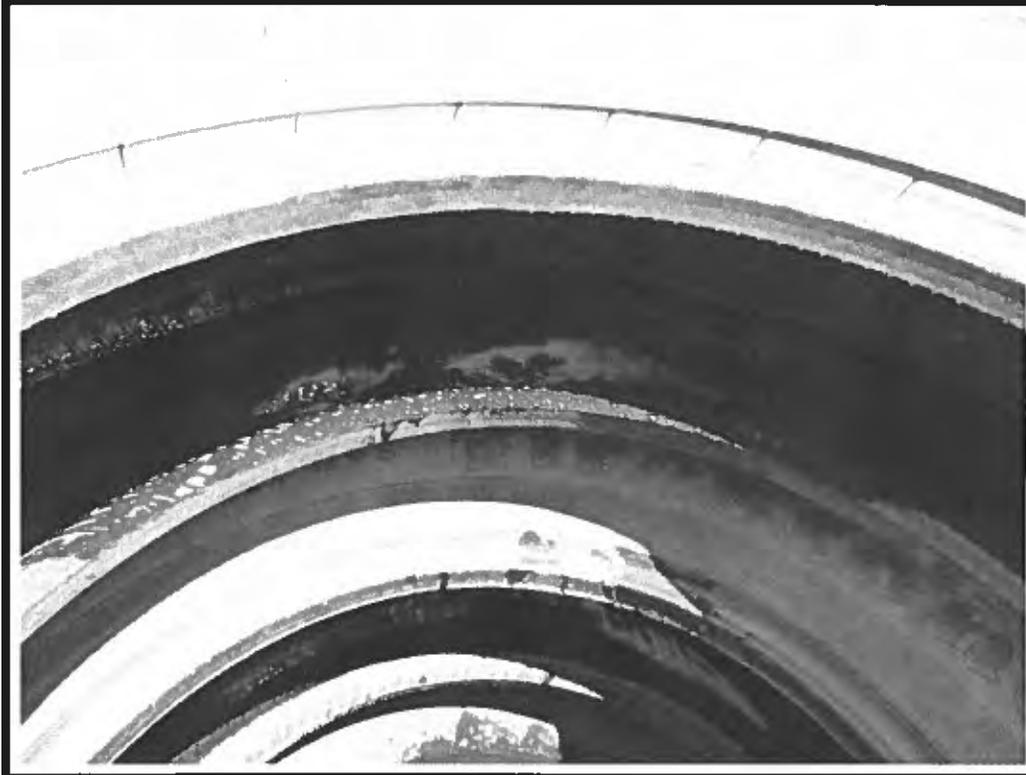
Water accumulation in two used  
tires seen in Photograph 22.

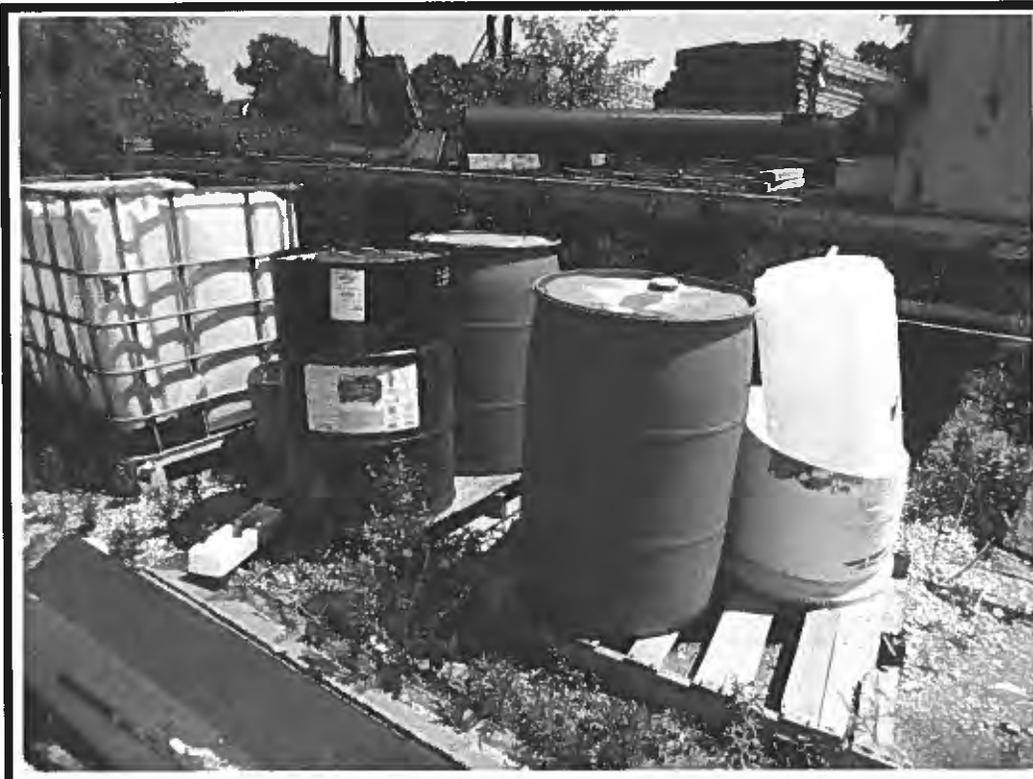
There were three full 55-gallon drums (1 black steel and 2 blue poly) on pallets near an empty IBC tote (see Photograph 25). The black drum had two open bung caps (see Photograph 26). The ground surface around the drums was free of stains.

Three unmarked 55-gallon drums of chemical. The black drum had two open bung caps.

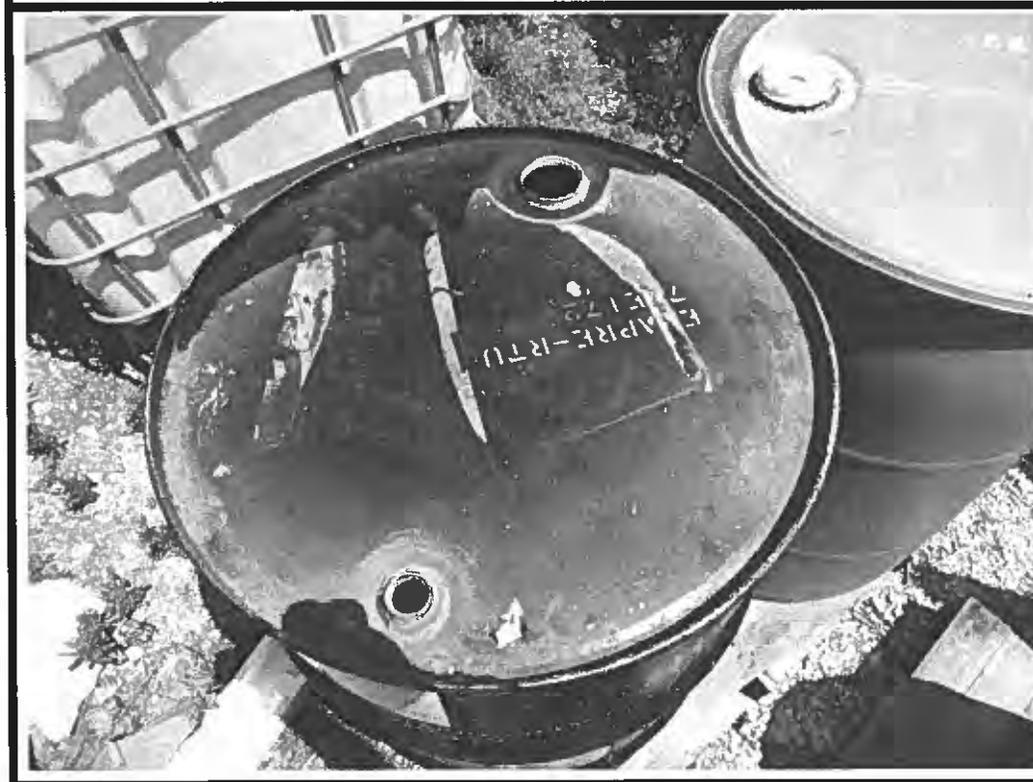
The black drum seen in Photograph 25 had two open bung caps.

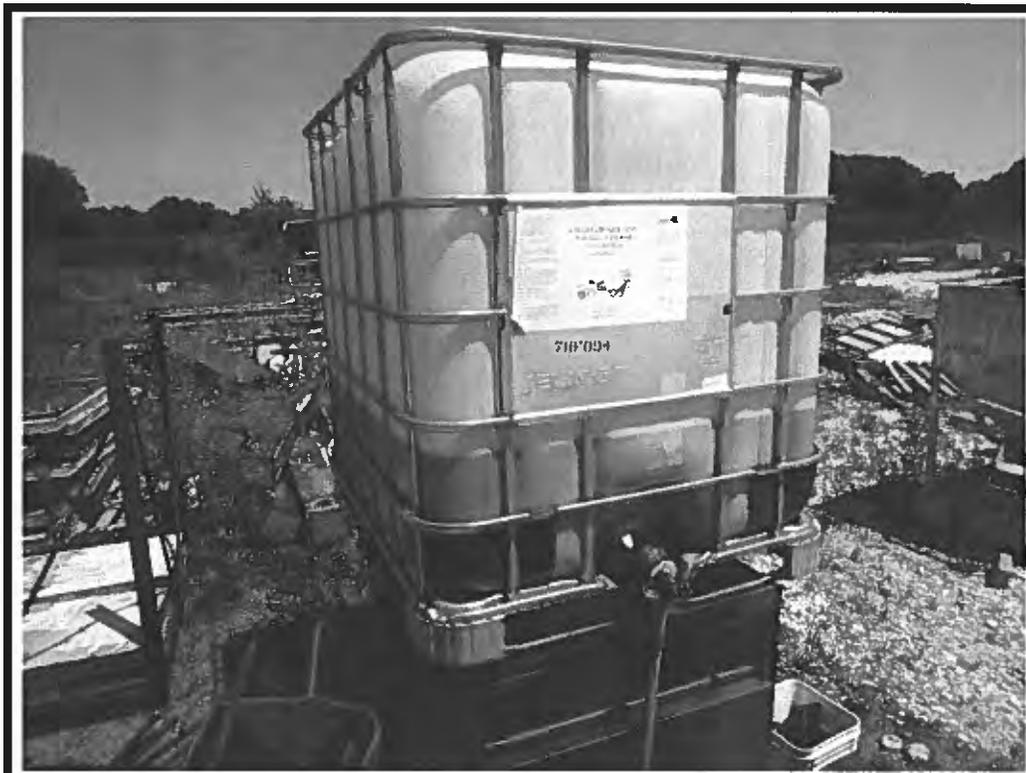
There was an elevated leaky IBC tote approximately  $\frac{1}{3}$  full of a chemical (see Photograph 27). The label read "CW Clearcote Duo – Multi Reactive Form Oil – VOC compliant" (see Photograph 28). The chemical was actively leaking from the retrofitted spigot on the bottom of the IBC tote (see Photograph 29). Note the steady stream dripping from the valve guard plate seen in Photograph 29. Photograph 30 shows an oily-looking amber colored liquid coating the scrap lumber, tote stand, and litter below the IBC tote. The chemical was pooled on the gravelly ground surface to the north and east of the tote and stained the gravel several feet to the west and south of the tote (see Photographs 30-32). The spilled chemical

followed the gradient greater the ten feet to the northeast. The area had a strong citrus odor. After the inspection, Jerry Holtschlag commented that it was okay the IBC tote was leaky since it was a VOC compliant oil.

A leaky IBC tote approximately 1/3 full of a chemical.

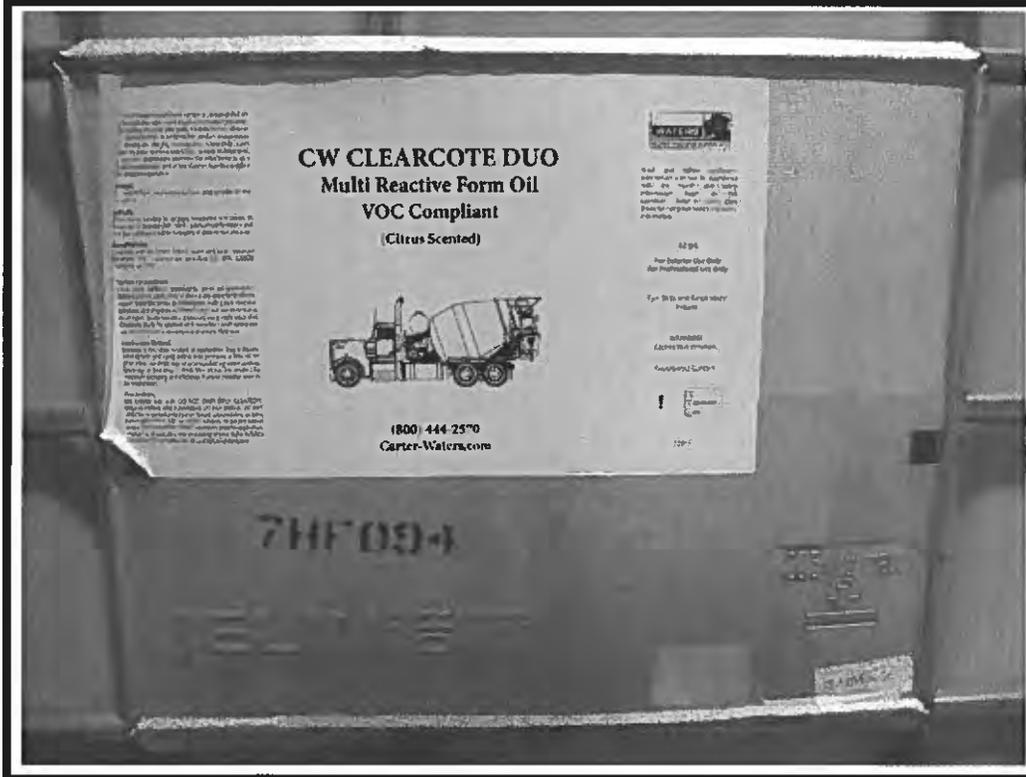
The label from the IBC tote seen in Photograph 27 read "CW Clearcote Duo - Multi Reactive Form Oil - VOC Compliant".

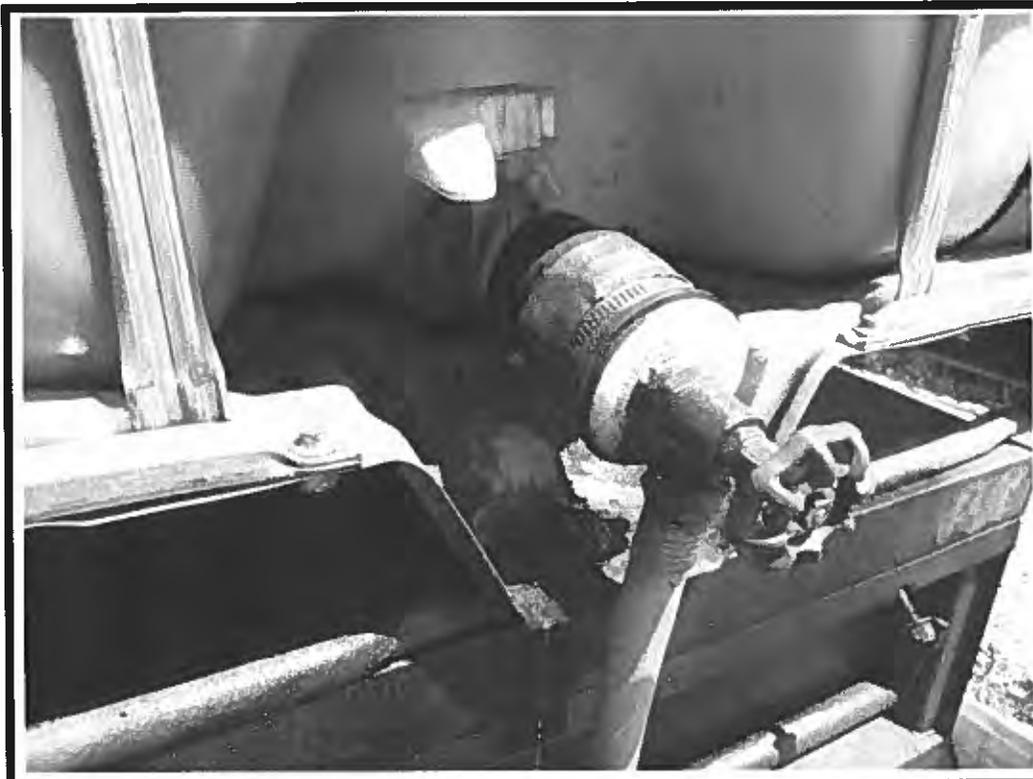
Chemical leaking from the retrofitted spigot on the bottom of the IBC tote seen in Photograph 27. Note the steady stream dripping from the valve guard plate.

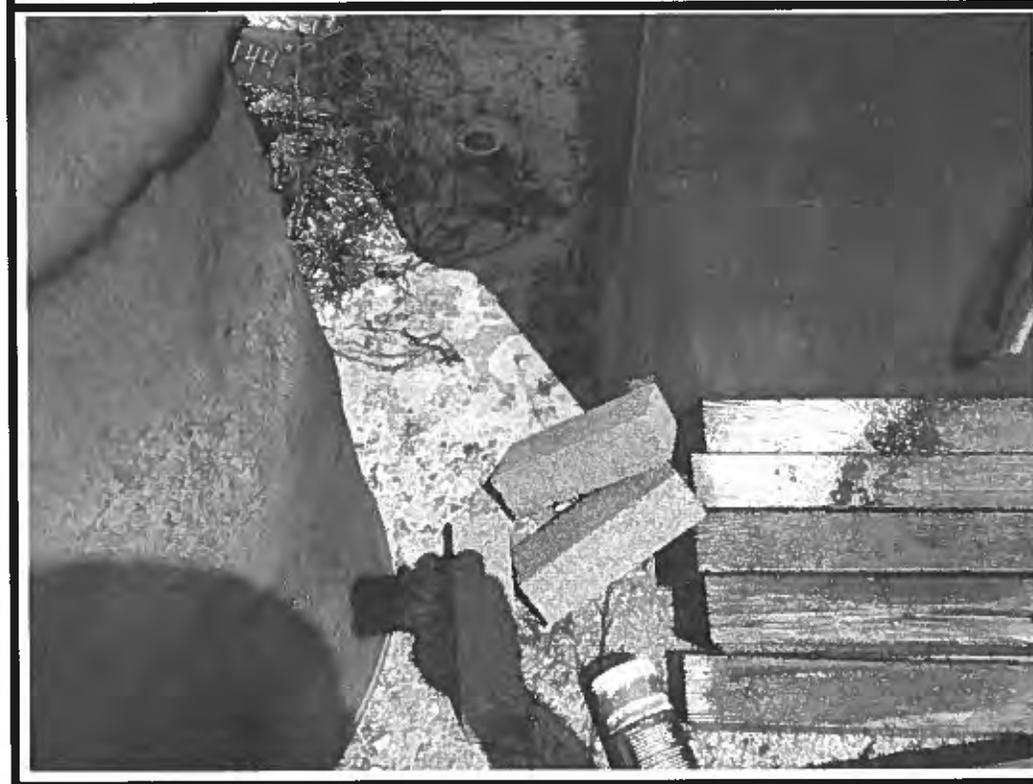
An oily-looking amber colored liquid coated the scrap lumber, block, and litter below the IBC tote and the chemical pooled on the gravelly ground surface.
