BEFORE THE ILLINOIS POLLUTION CONTROL BOARD

ADMINISTRATIVE CITATION

Site: JH Concrete Construction  
Inc (0010655365)  
Adams County

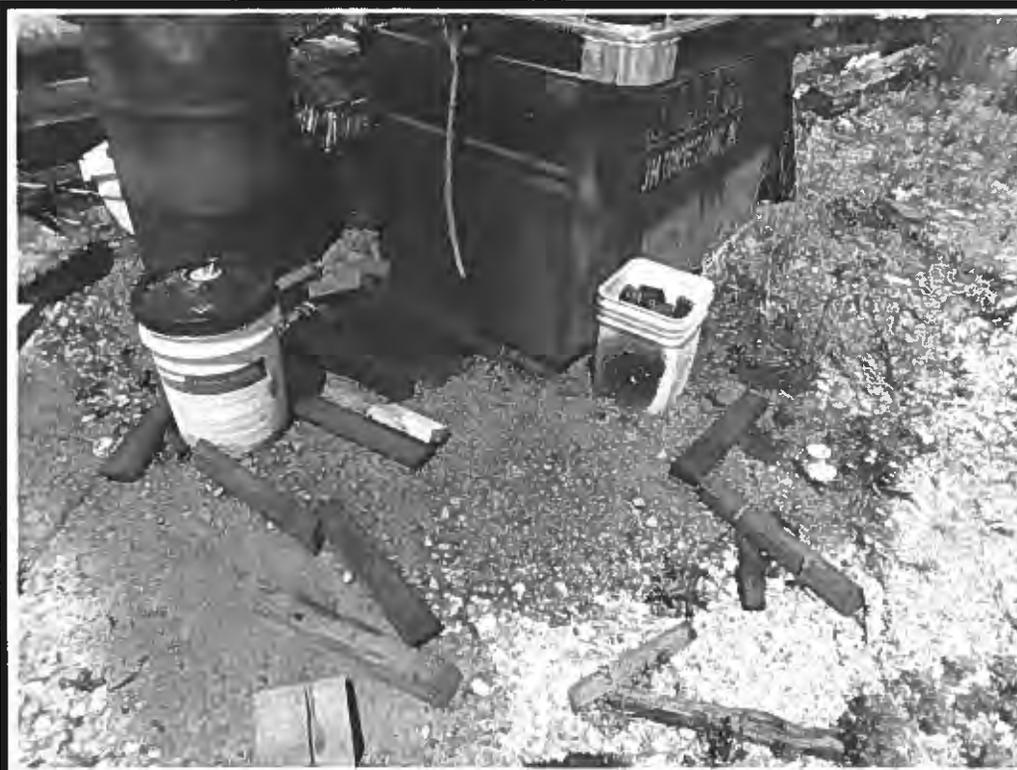
Oil looking stained gravel and  
litter below the IBC tote.

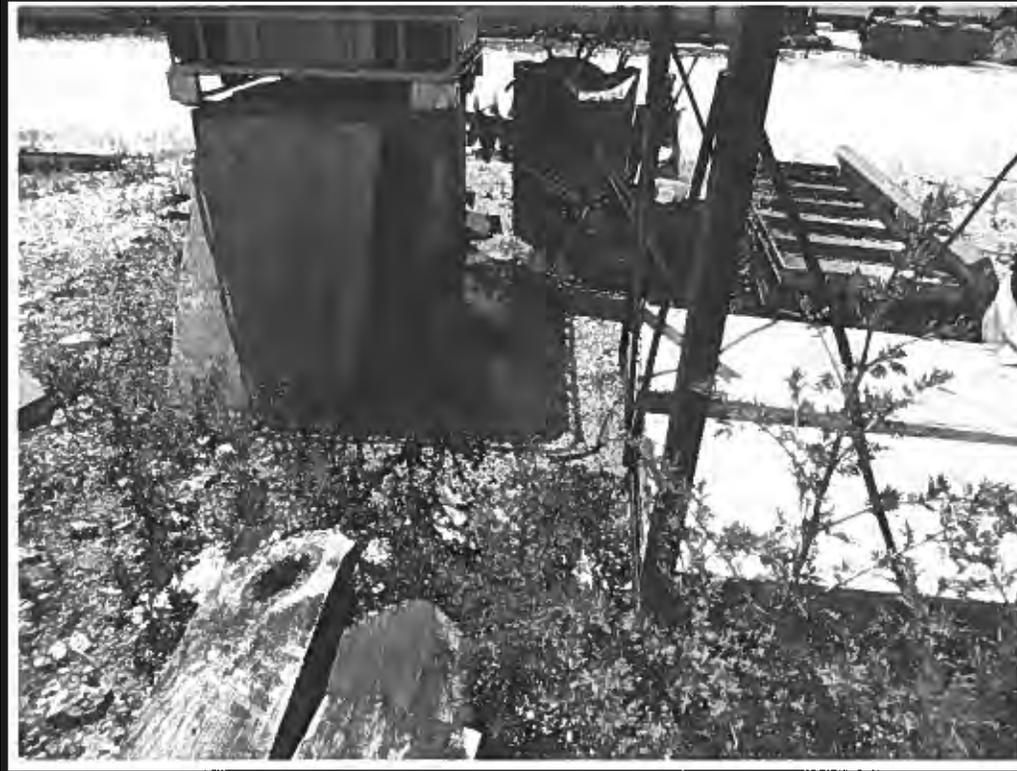
Amber colored liquid pooled  
beside the IBC tote and an oily-  
looking stain covered the gravel  
radially behind the IBC tote.

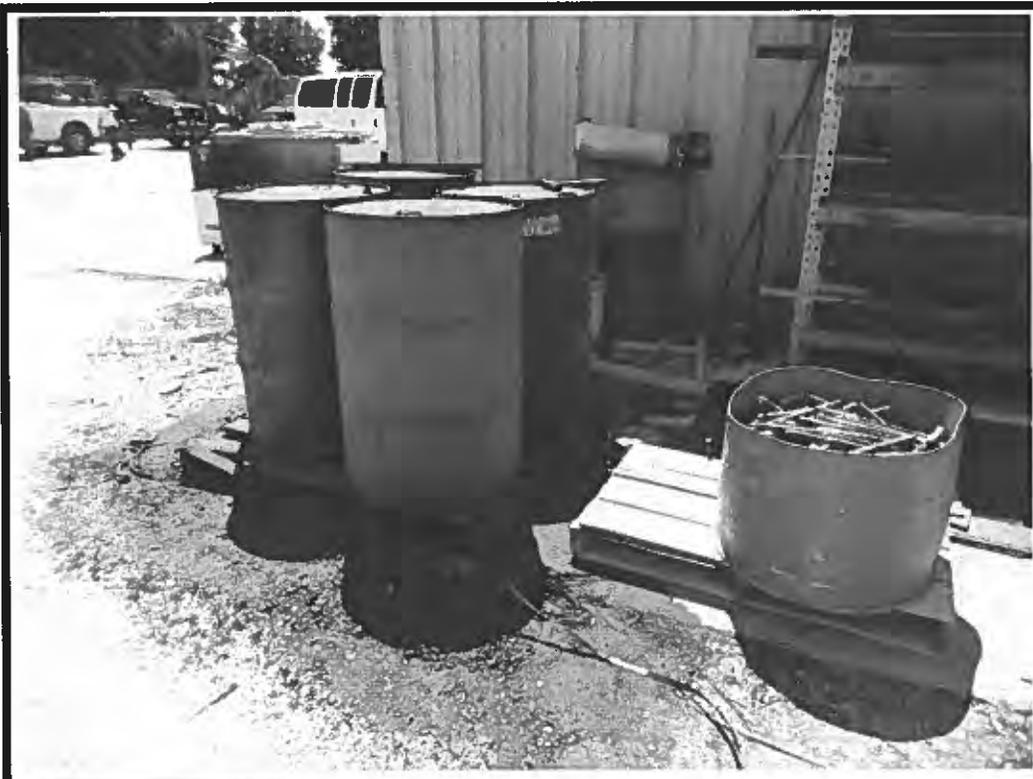
There were four unmarked 55-gallon drums of used oil off the east-southeast corner of the maintenance shop (see Photographs 33 and 34). The bung caps were closed on the drums. The outer skins of the drums were covered with an oily grime layer as was the oil-saturated wooden pallet below the drum. The concrete and gravel ground surfaces below the drums were stained with a dark oily-looking hydrocarbon odorous chemical. After the inspection, Jerry Holtschlag confirmed the four drums contained used oil.

Four unmarked 55-gallon drums of used oil. Note the dark oily-looking stained concrete and gravel beneath the drums and the saturated wooden pallet.

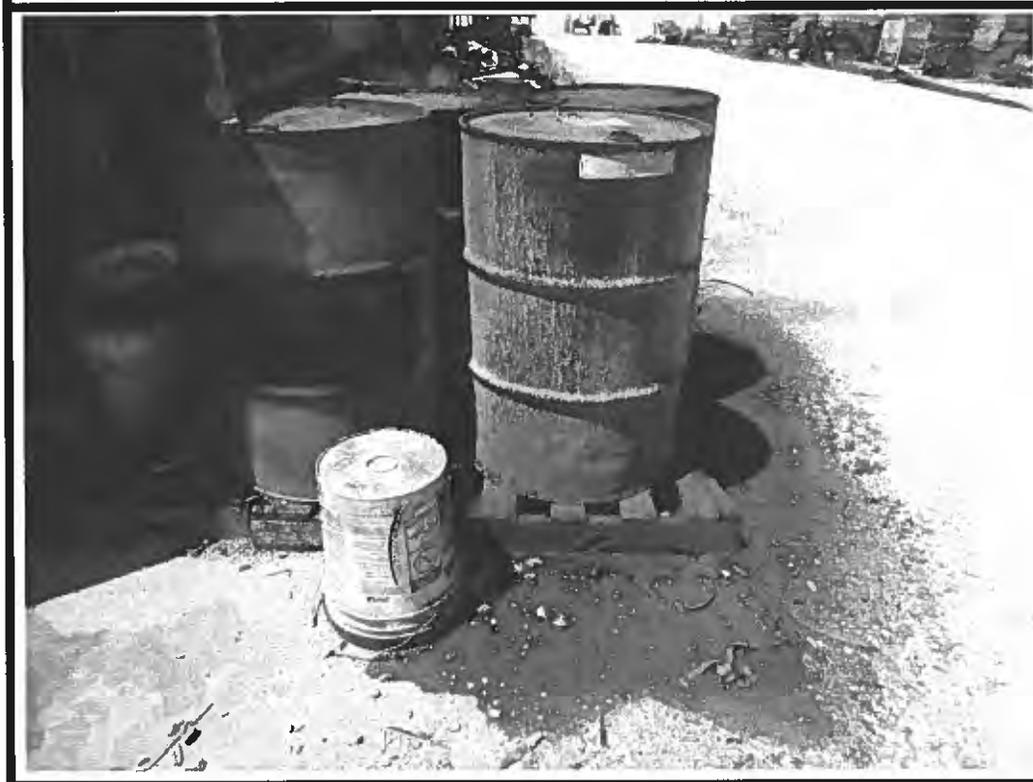
Four unmarked 55-gallon drums of used oil (also seen in Photograph 33). Note the dark oily-looking stained concrete and gravel.

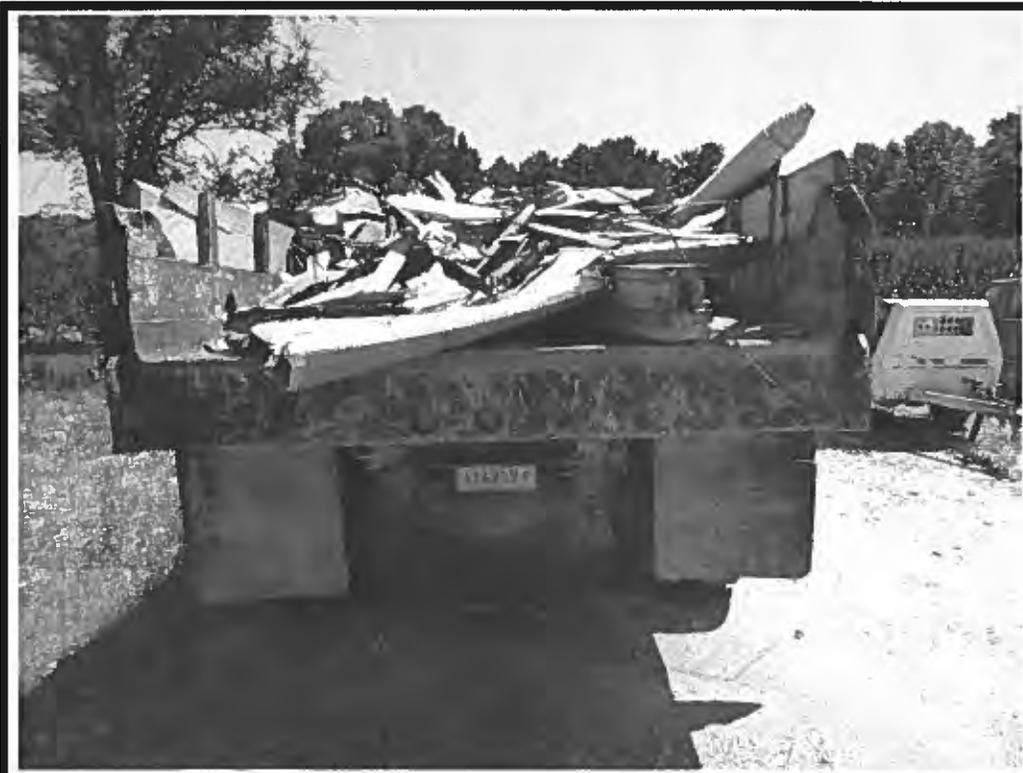
There was a blue GMC truck with a load of apparent off-site generated GCDD along southern edge of the property (see Photographs 35 and 36). The truck's license plate sticker was due to expire at the end of June 2018. After the inspection, Jerry Holtschlag stated the truck needed repair.

A blue GMC truck load of off-site generated GCDD (also seen in Photograph 36).

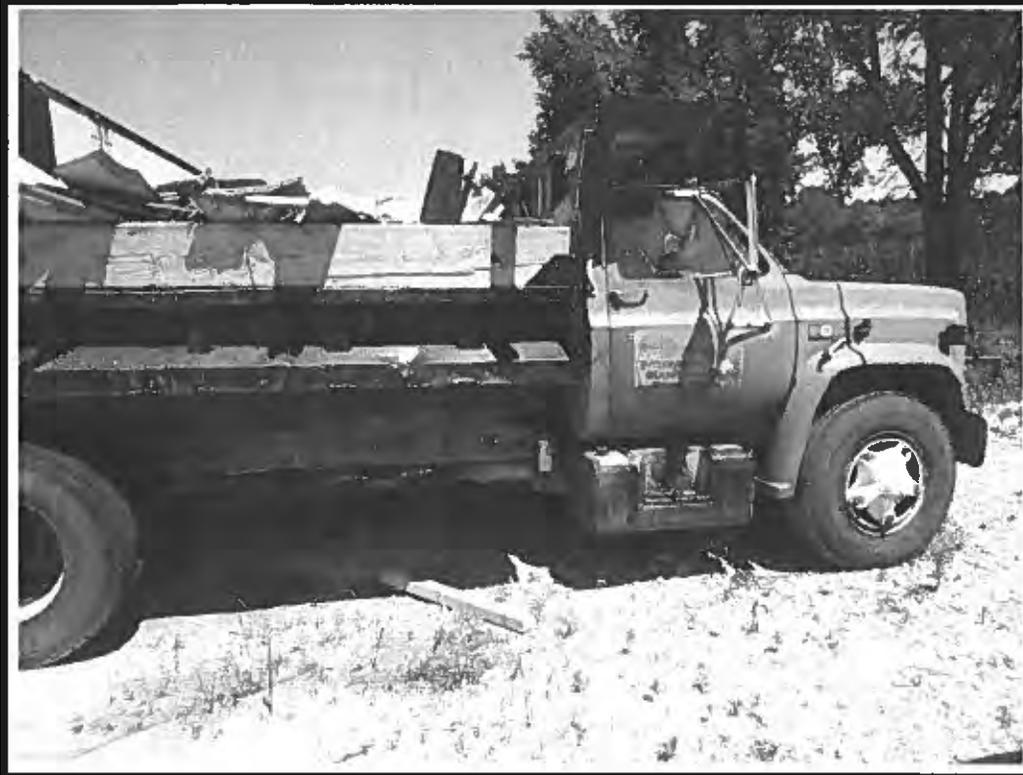
A truck load of off-site generated GCDD (also see in Photograph 35). The blue GMC's license plate sticker expires June 2018.

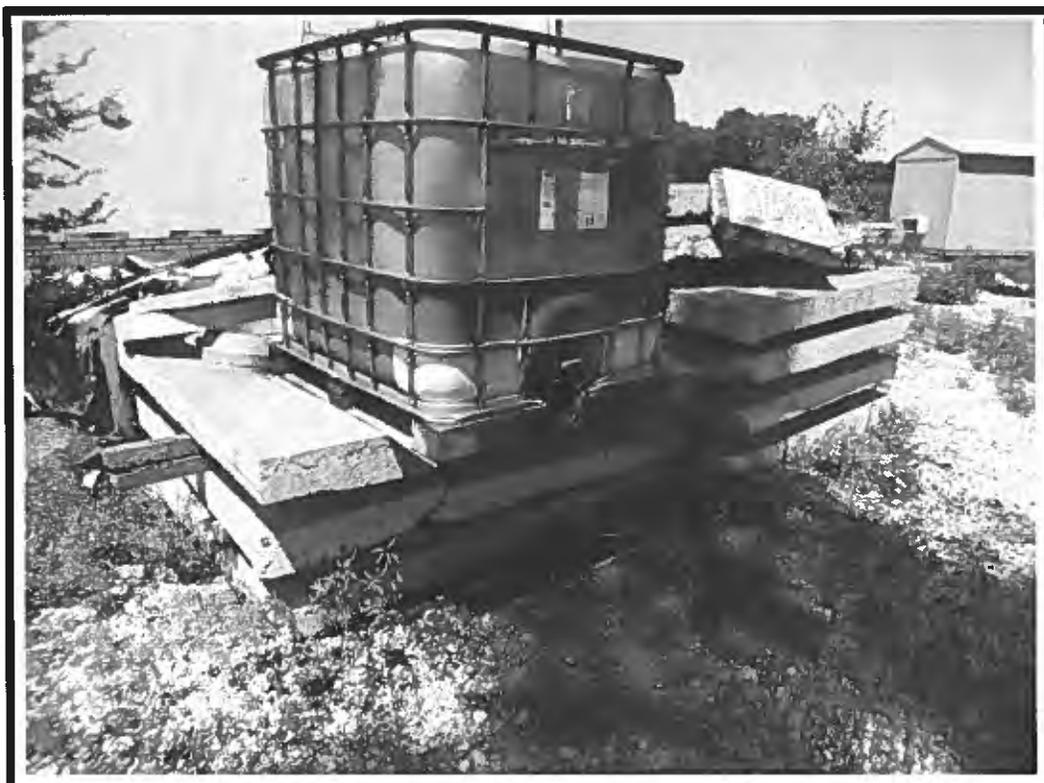
Photograph 37 shows an IBC tote approximately 1/3 full of a chemical on the south side of the site. The ground surface below the silcock was stained with a dark oily-looking grime. The area had a faint chemical odor. The label on the IBC tote read "Clean Strip J1A" (see Photograph 38).

An IBC tote approximately 1/3 full of a chemical. The ground surface below the silcock was stained with a dark oily-looking grime.

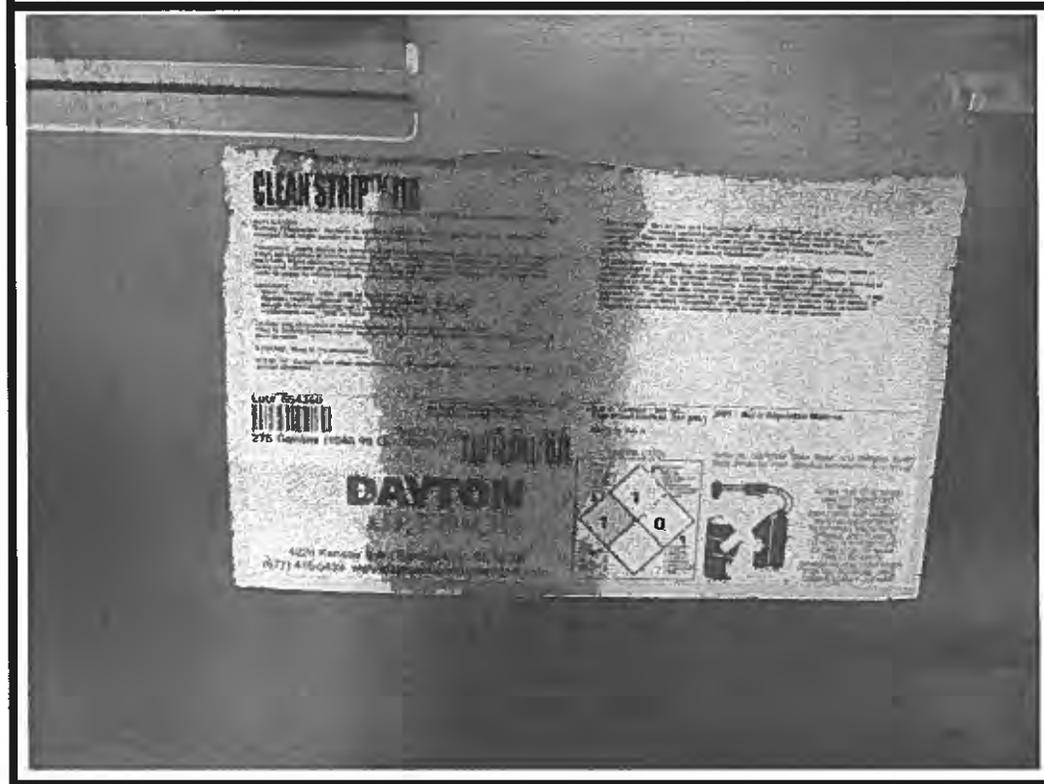
The label on the IBC tote seen in Photograph 37 read "Clean Strip J1A".

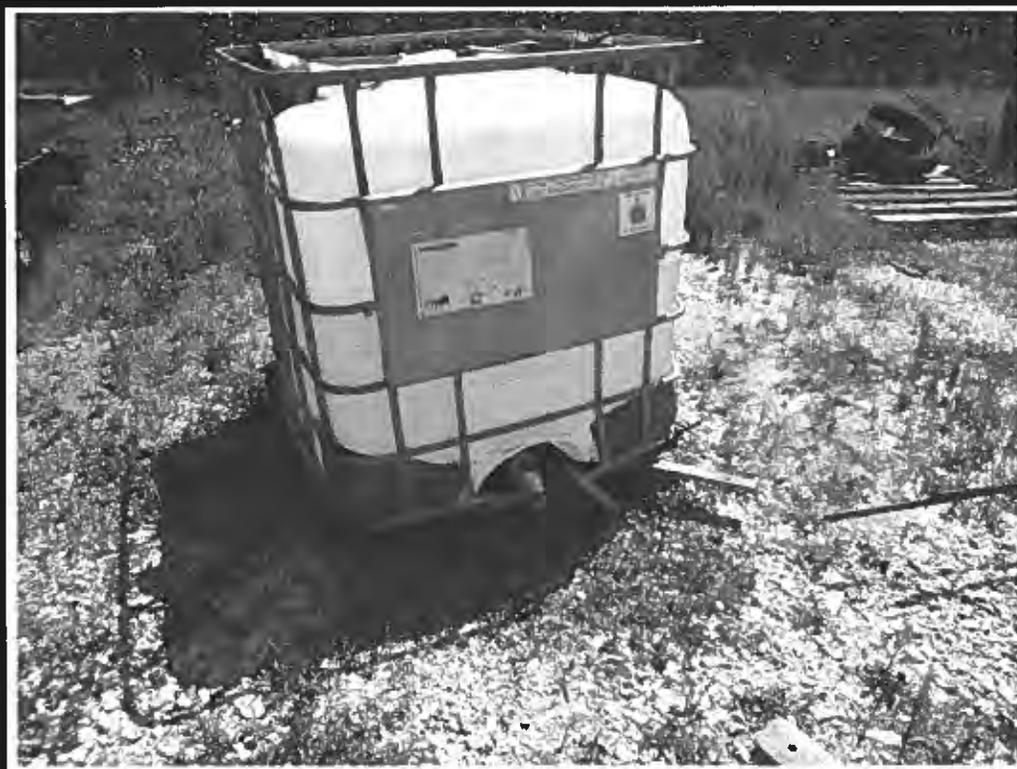
There was another IBC tote approximately 1/2 full of chemical also on the south side of the property (see Photograph 39). The label read "Strip Eez Form Release." There was minor staining on the ground near the front of the IBC tote. I didn't notice a chemical odor.

An IBC tote approximately 1/2 full of a chemical. The label read "Strip Eez Form Release." There was minor gravel staining near the front of the IBC tote.

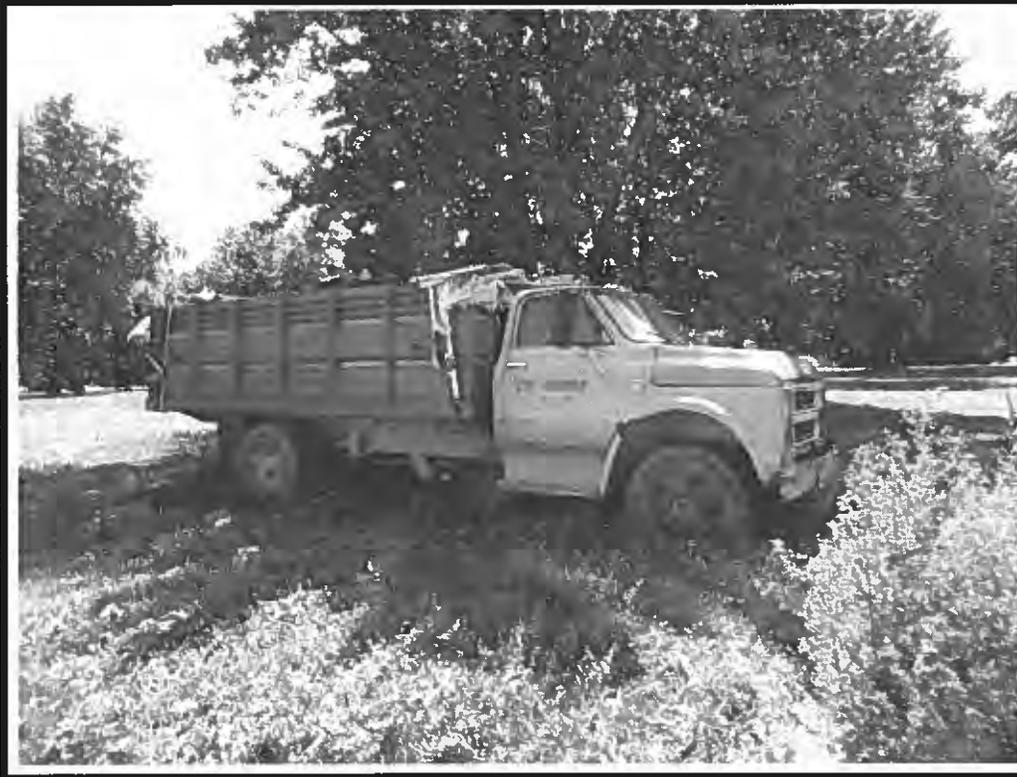
A green Chevrolet truck with red bed full of GCDD and used tires. The truck had Iowa tags.

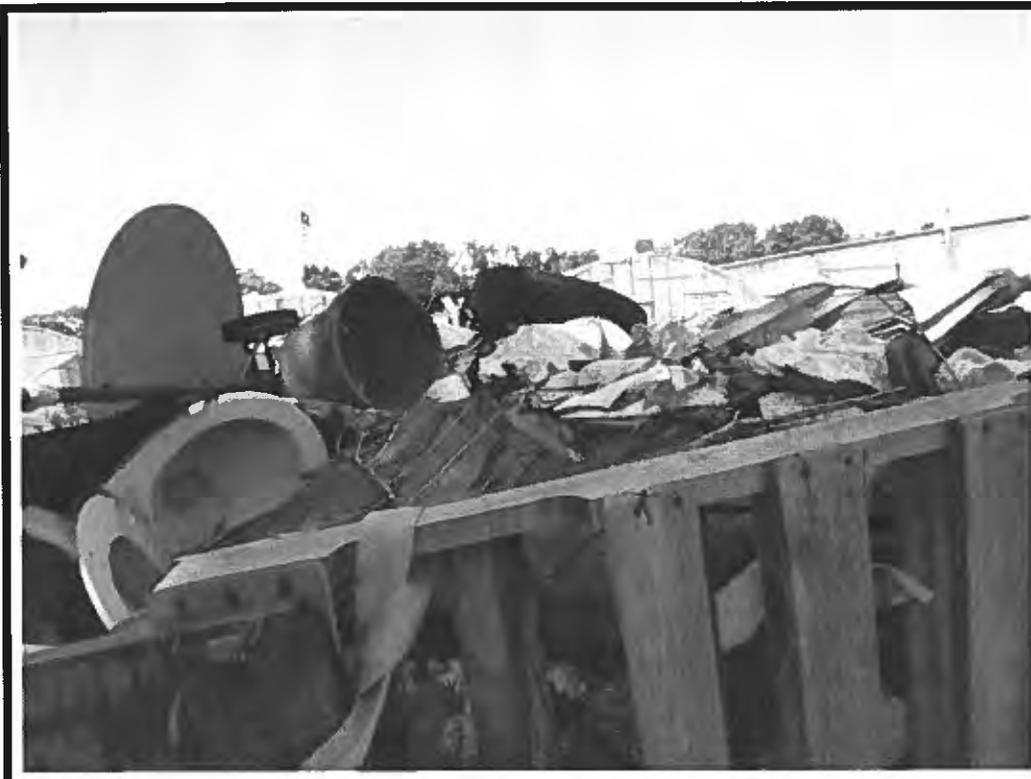
Truckload of GCDD and used  
tires in the back of the truck  
seen in Photograph 40.

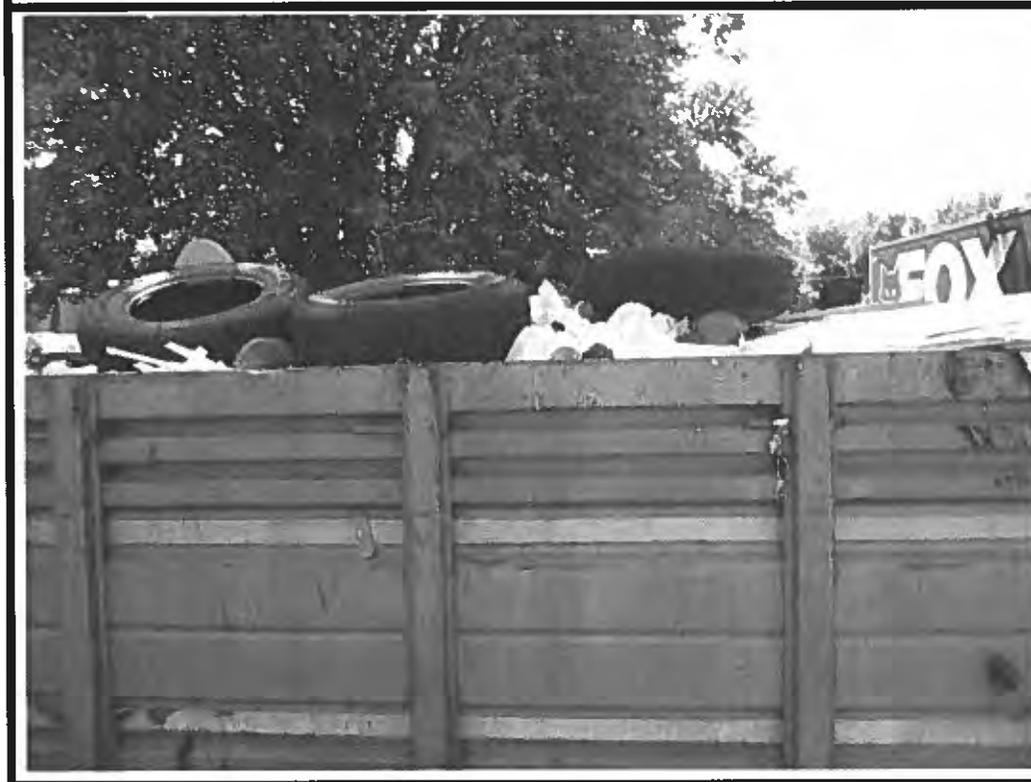
Photo ID: 42  
Photo Date: 6/29/2018  
Photo Time: 14:34:28  
Direction: W  
Taken By: Paul Eisenbrandt

Three off-rim used tires  
intermixed with the GCDD in  
the back of the Chevrolet truck  
seen in Photograph 40.

There was a green Chevrolet truck with a red bed full of apparent off-site generated GCDD and used tires (see Photographs 40 through 42). The truck had Iowa tags. At least two of the used tires were off-rim. After the inspection, Jerry Holtschlag said the truck didn't belong to them. The truck allegedly broke down on 12th Street in front of the business and they allowed the truck to be temporarily parked on the property.

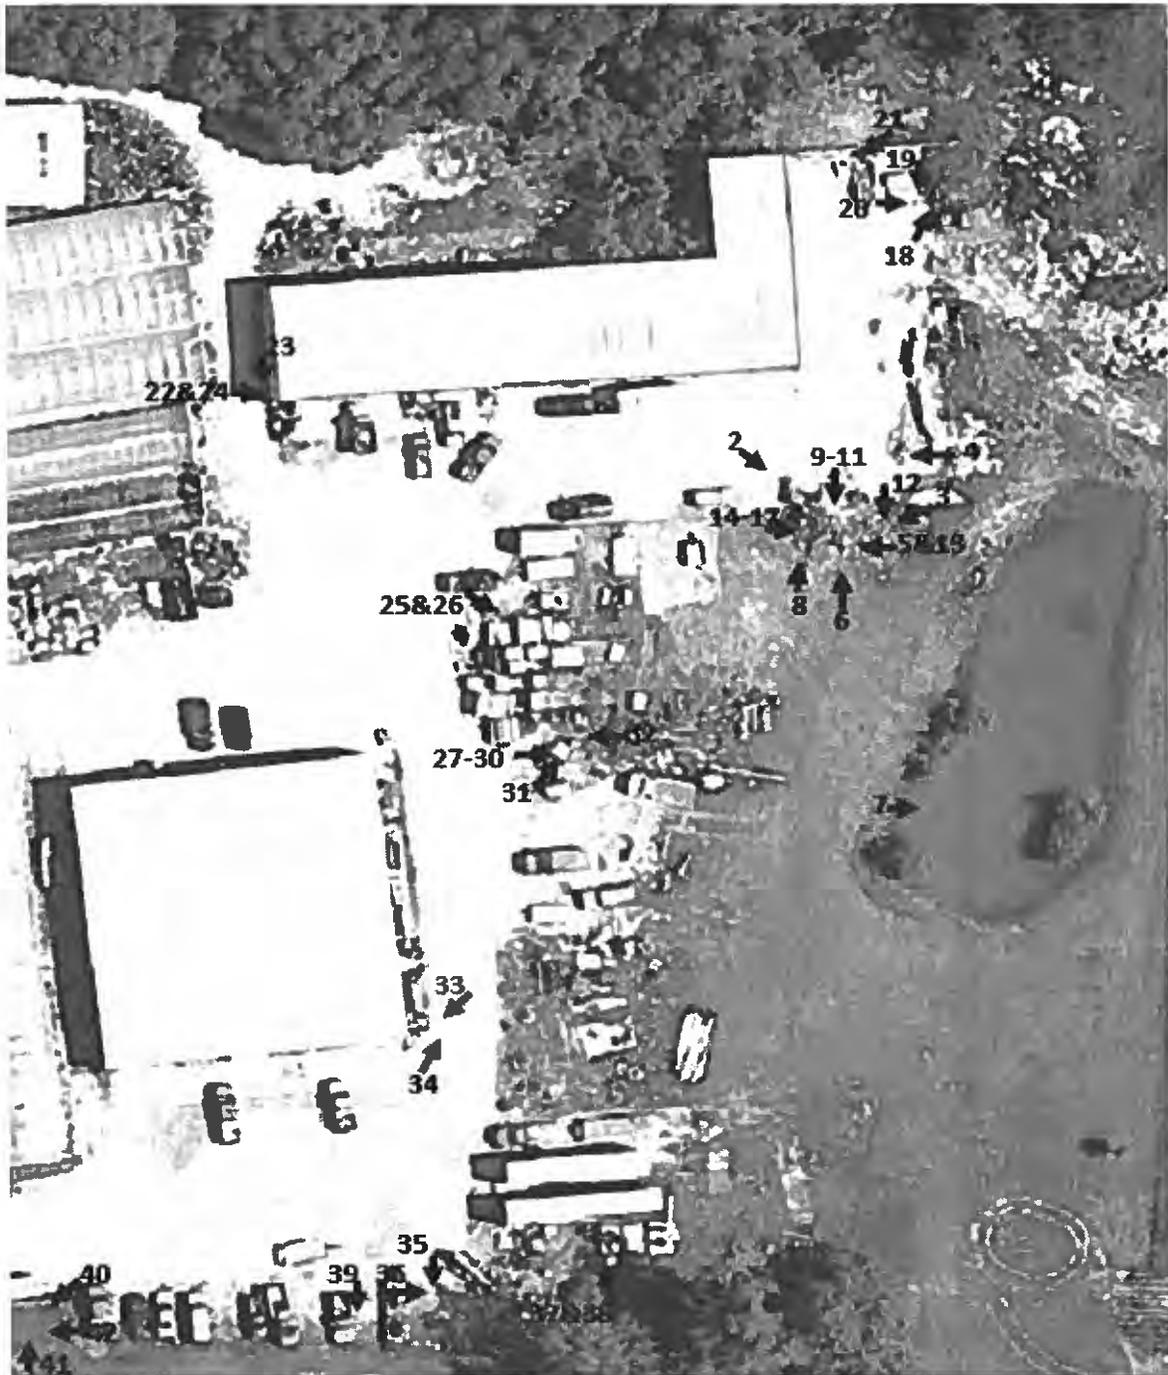
Site Diagram 6: June 29, 2018 • JH Concrete Construction Inc (0010655365) • Adams County

Photograph 1 taken to near the entrance of the facility facing north. Please see the Google GPS coordinate map.
