ADMINISTRATIVE CITATION

**Evaluation Report****General Facility Information**

<b>Evaluation Type</b>	Open Dump Inspection
<b>Evaluation Date</b>	12/13/2018
<b>Inspector(s)</b>	Wagner, Robert
<b>Person(s) Interviewed</b>	None
<b>Previous Inspection Date</b>	7/17/2018

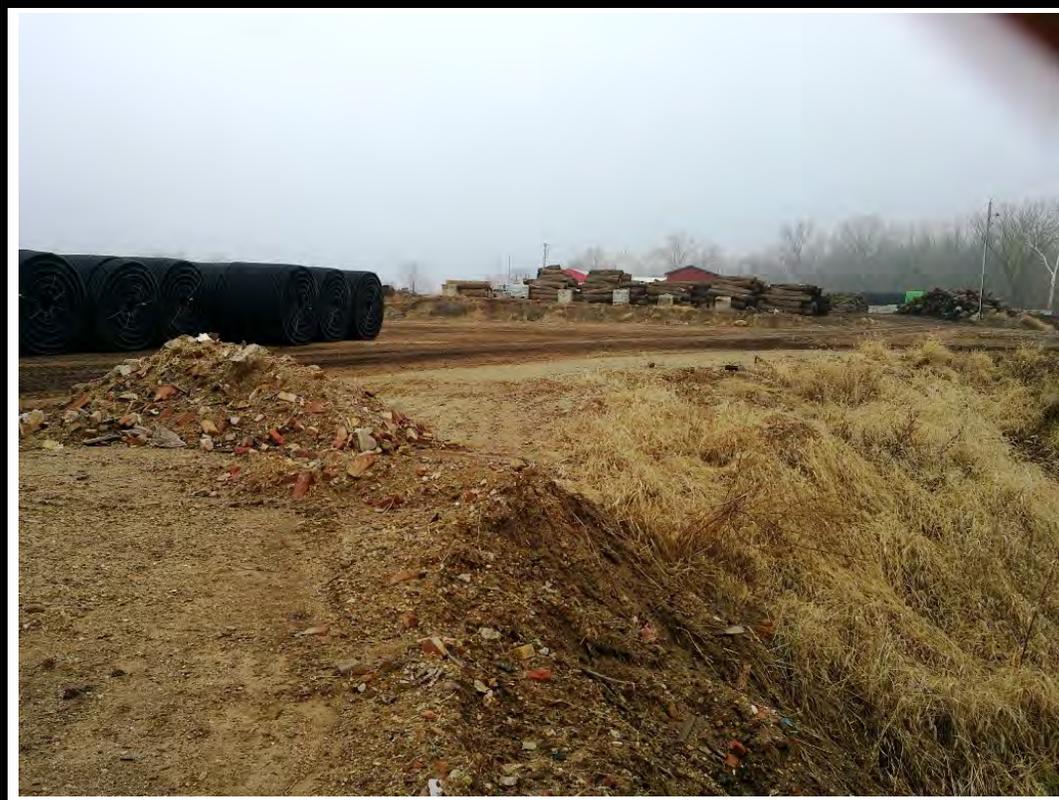
Photo ID: 1  
Photo Date: 12/13/2018  
Photo Time: 14:08:45  
Direction: north  
Taken By: Robert Wagner

Photographs 1, 4, and 5 shows red brick, processed wood, gravel, dirt, chunks of concrete, green artificial grass, nylon rope, galvanized pipe, binding fiber, dead vegetation, tree branches, and painted brick comingled in a pile along the top of a man-made hole. The man-made hole was created because general construction or demolition debris has been placed around a pond. The pond is currently dry.

Photograph 1 shows red brick, processed wood, gravel, dirt, chunks of concrete, green artificial grass, nylon rope, galvanized pipe, binding fiber, dead vegetation, tree branches, and painted brick comingled in a pile along a man-made hole.

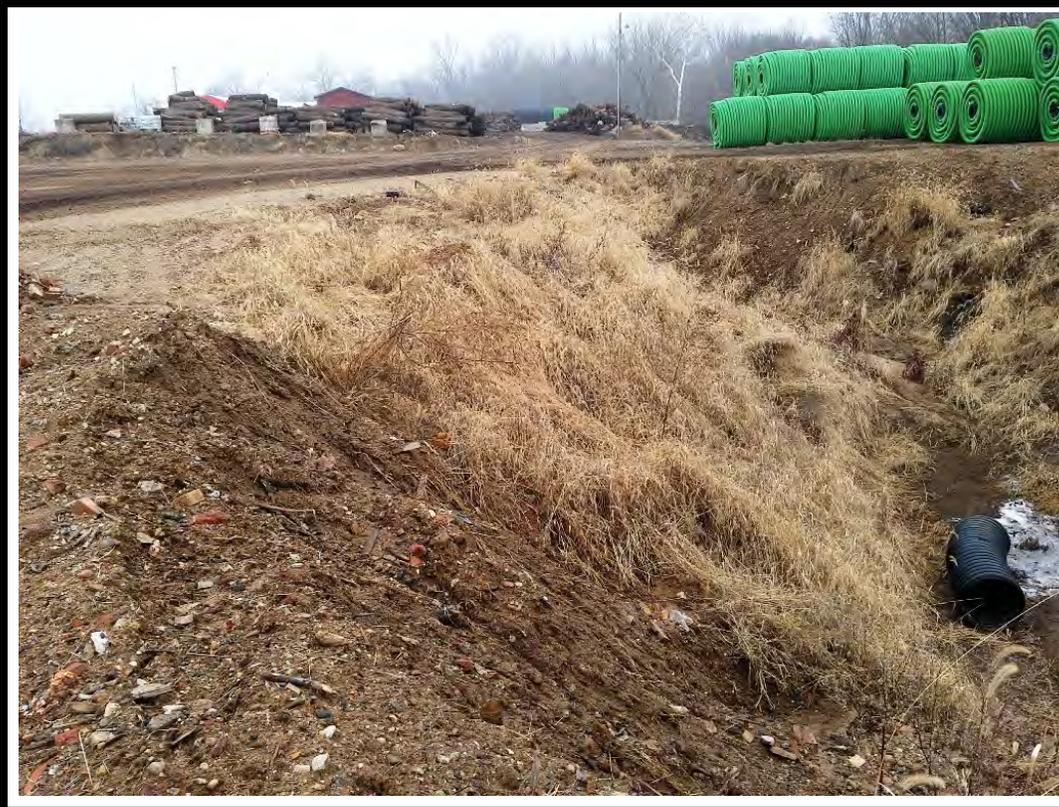
Photo ID: 2  
Photo Date: 12/13/2018  
Photo Time: 14:08:51  
Direction: north  
Taken By: Robert Wagner

Photographs 2 and 3 show rusted iron sewer pipe, processed wood, red brick, chunks of concrete, tree branches, dead vegetation, and metal debris protruding from the west slope of the man-made hole.

Photograph 2 shows a rusted iron sewer pipe, processed wood, red brick, chunks of concrete, tree branches, dead vegetation, and metal debris protruding from the west slope of the man-made hole.

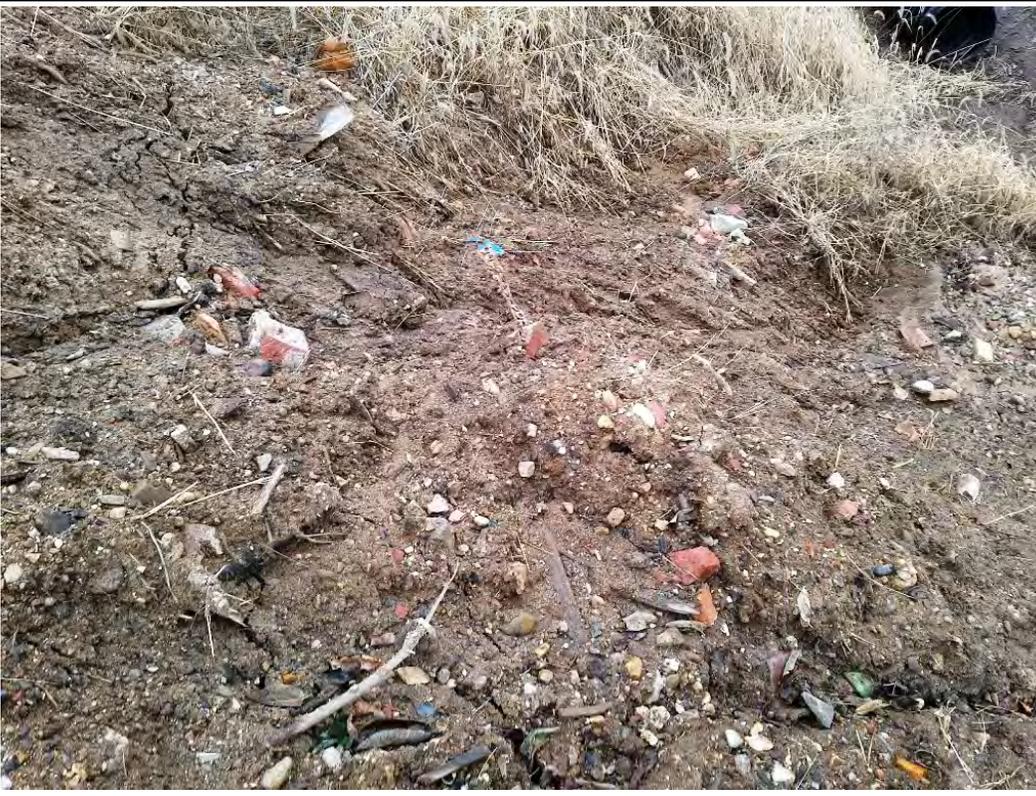
Photo ID: 3  
Photo Date: 12/13/2018  
Photo Time: 14:09:25  
Direction: northeast  
Taken By: Robert Wagner

Photograph 3 shows a rusted iron sewer pipe, processed wood, red brick, chunks of concrete, tree branches, dead vegetation, and metal debris protruding from the west slope of the man-made hole.

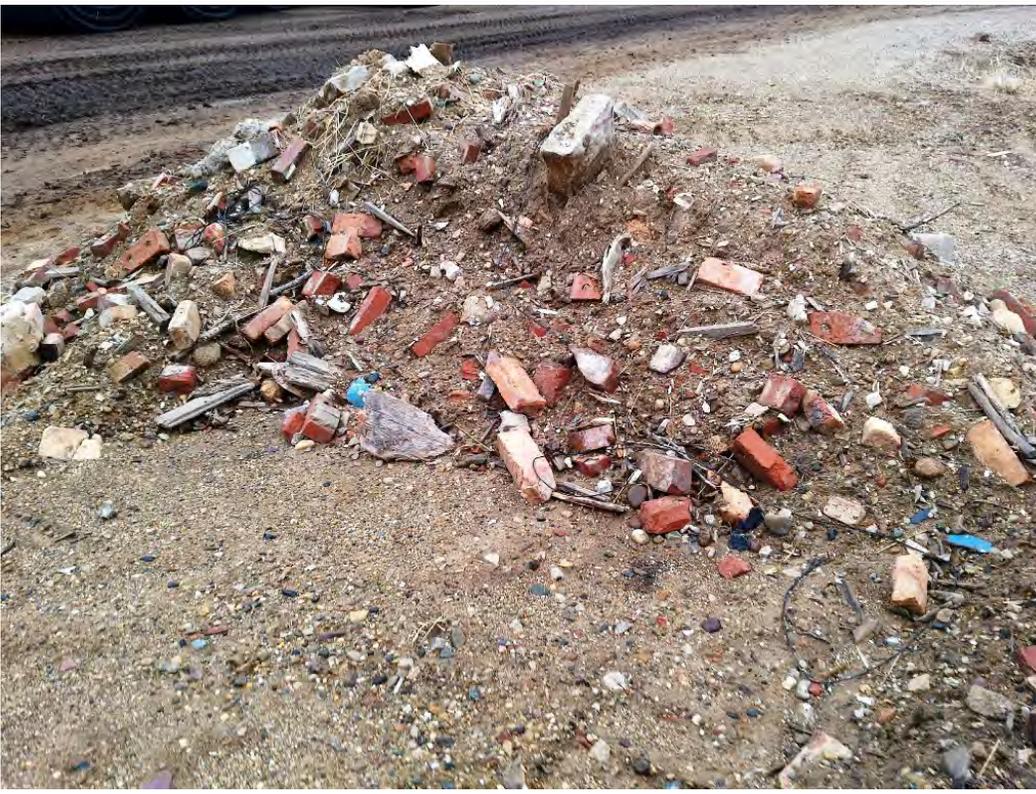
Photo ID: 4  
Photo Date: 12/13/2018  
Photo Time: 14:09:40  
Direction: northwest  
Taken By: Robert Wagner

Photograph 4 shows red brick, processed wood, gravel, dirt, chunks of concrete, green artificial grass, nylon rope, galvanized pipe, binding fiber, dead vegetation, tree branches, and painted brick comingled in a pile along a man-made hole.

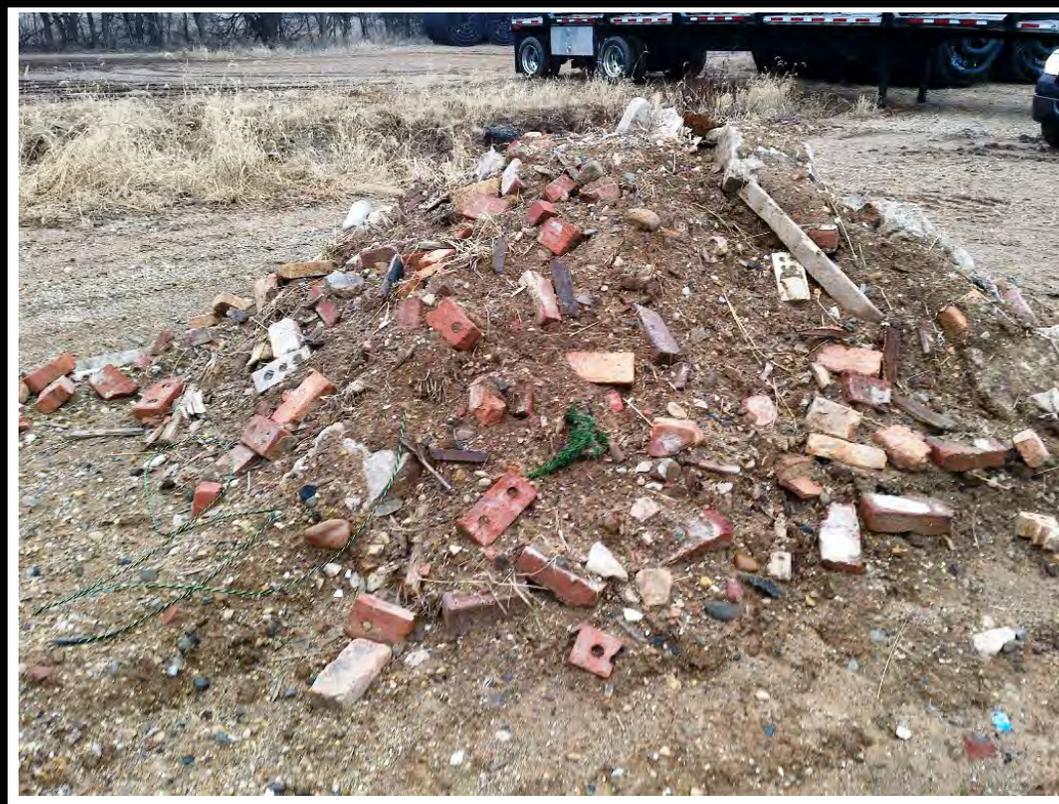
Photo ID: 5  
Photo Date: 12/13/2018  
Photo Time: 14:09:56  
Direction: southwest  
Taken By: Robert Wagner

Photograph 5 shows red brick, processed wood, gravel, dirt, chunks of concrete, green artificial grass, nylon rope, galvanized pipe, binding fiber, dead vegetation, tree branches, and painted brick comingled in a pile along a man-made hole.

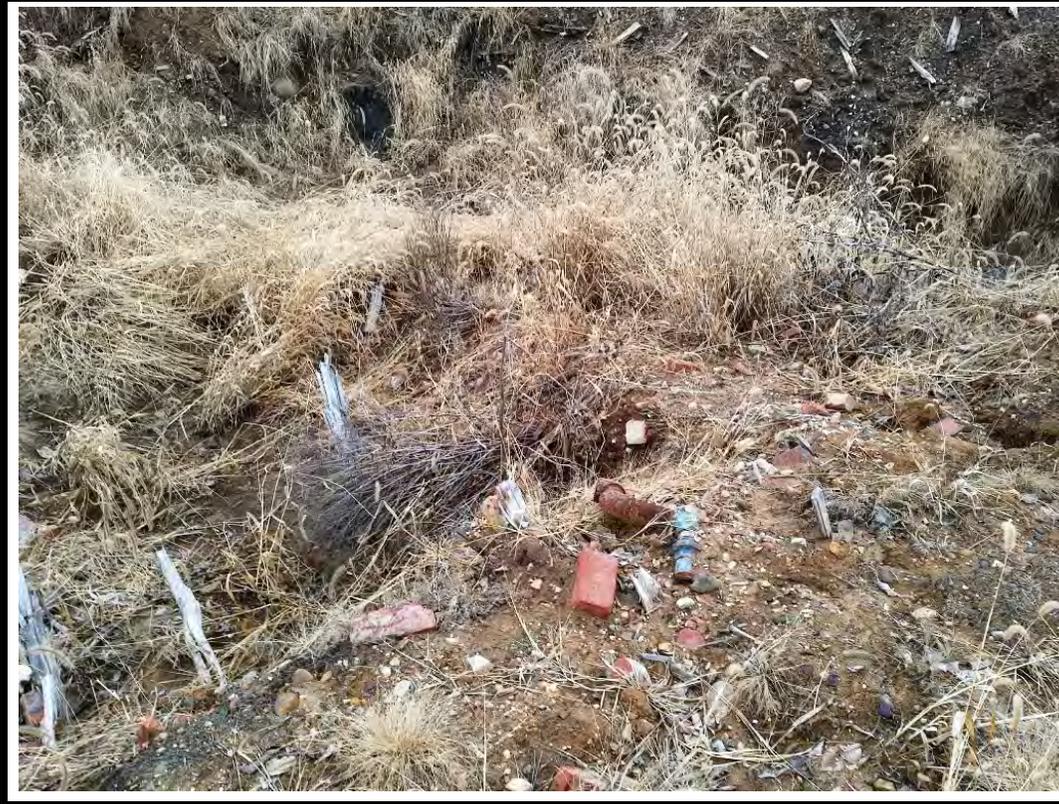
Photo ID: 6  
Photo Date: 12/13/2018  
Photo Time: 14:12:27  
Direction: east  
Taken By: Robert Wagner

Photograph 6 shows a rusted galvanized elbow pipe, processed wood, red brick, chunks of concrete, and tree branches protruding from the top of the west slope of the man-made hole. The rusted galvanized elbow pipe was photographed in the same place during the July 17, 2018 re inspection of the property.

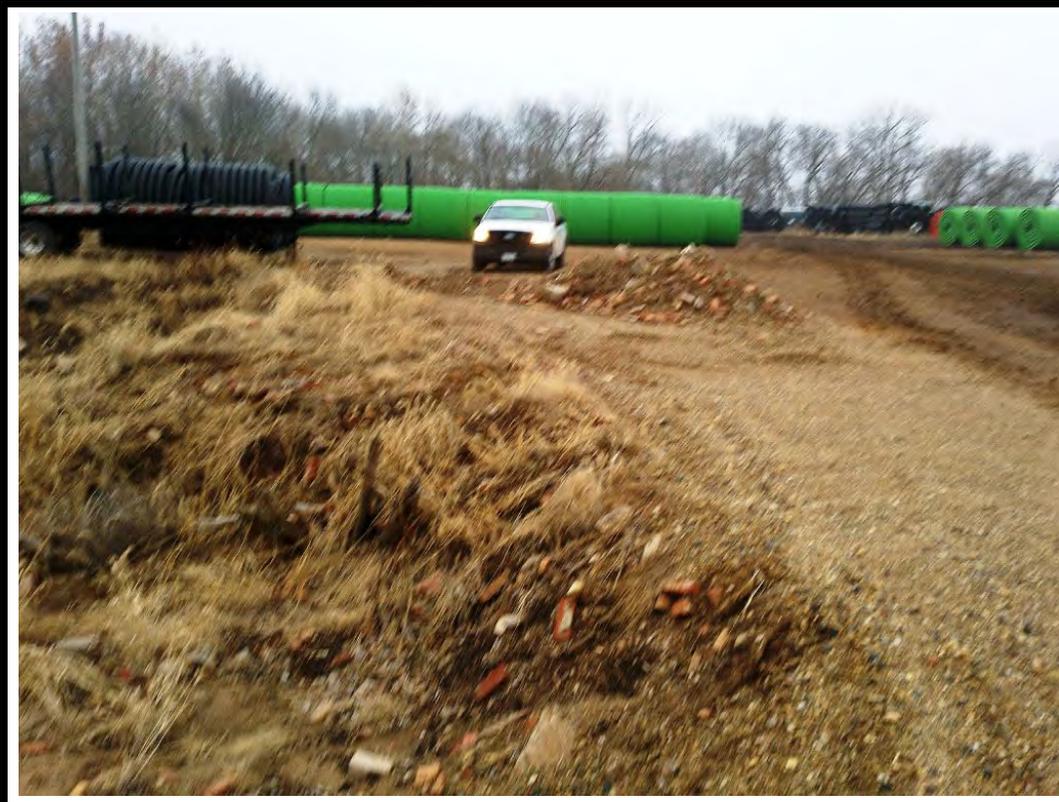
Photo ID: 7  
Photo Date: 12/13/2018  
Photo Time: 14:12:52  
Direction: south  
Taken By: Robert Wagner

Photograph 7 shows processed wood, red brick, chunks of concrete, and tree branches protruding from the west slope of the man-made hole.

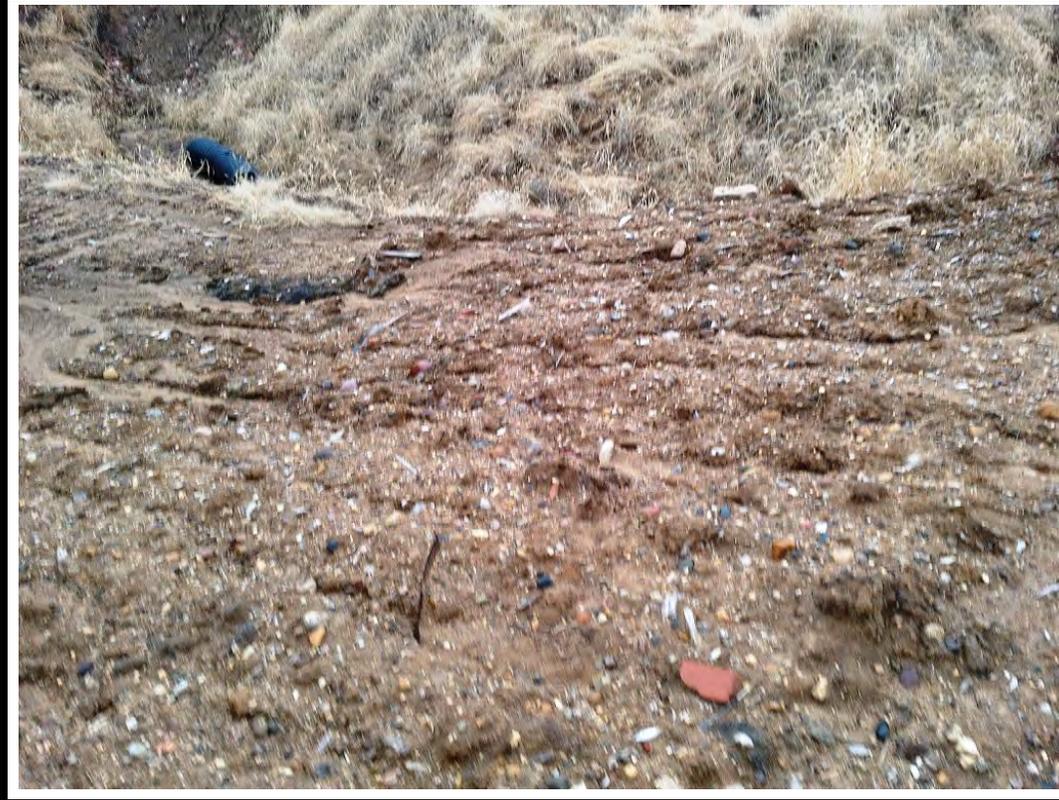
Photo ID: 8  
Photo Date: 12/13/2018  
Photo Time: 14:15:43  
Direction: south  
Taken By: Robert Wagner

Photograph 8 shows processed wood, red brick, chunks of concrete, and tree branches protruding from the top edge of the north slope and the south slope of the man-made hole.

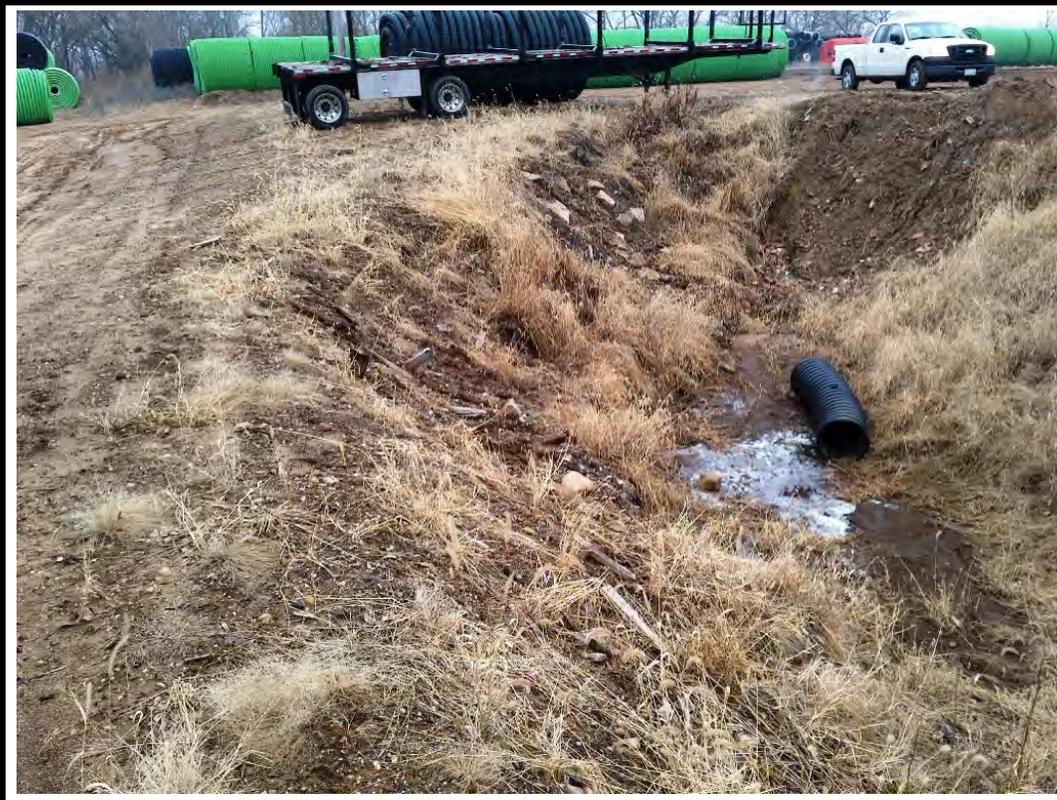
Photo ID: 9  
Photo Date: 12/13/2018  
Photo Time: 14:16:17  
Direction: south  
Taken By: Robert Wagner

Photographs 9 and 10 show processed wood, red brick, chunks of concrete, and tree branches protruding from the east slope and the south slope of the man-made hole.

Photograph 9 shows processed wood, red brick, chunks of concrete, and tree branches protruding from the east slope and the south slope of the man-made hole.

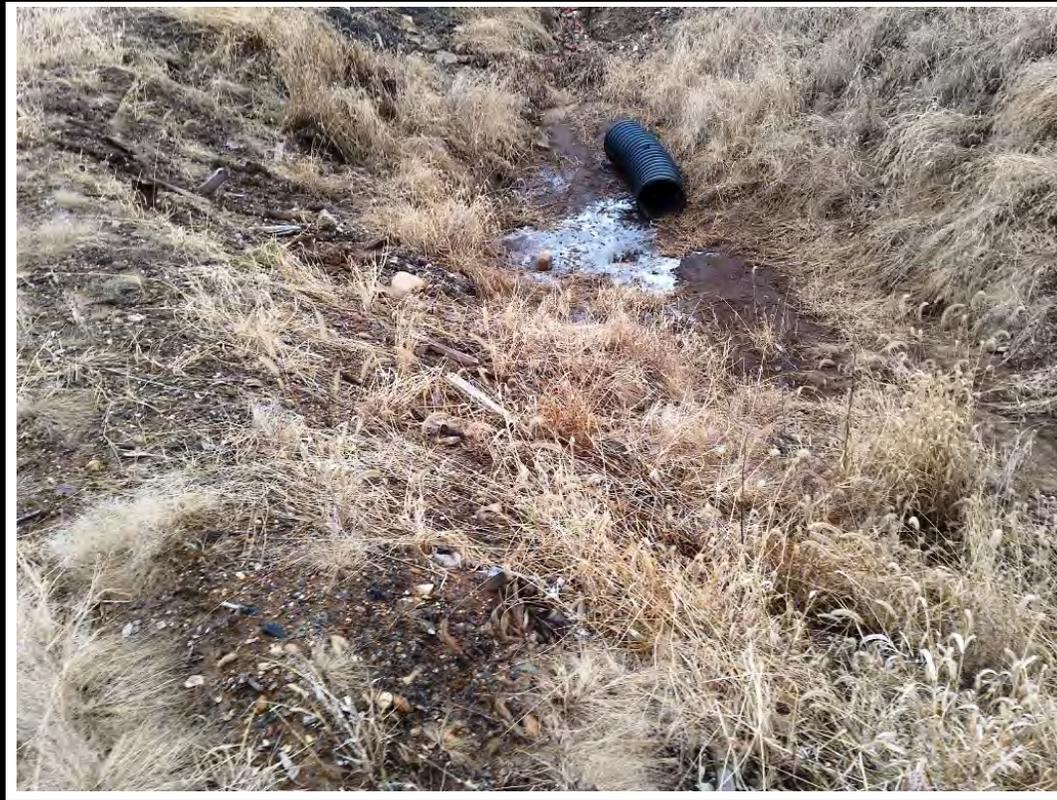
Photo ID: 10  
Photo Date: 12/13/2018  
Photo Time: 14:16:25  
Direction: south  
Taken By: Robert Wagner

Photograph 10 shows processed wood, red brick, chunks of concrete, and tree branches protruding from the east slope and the south slope of the man-made hole.

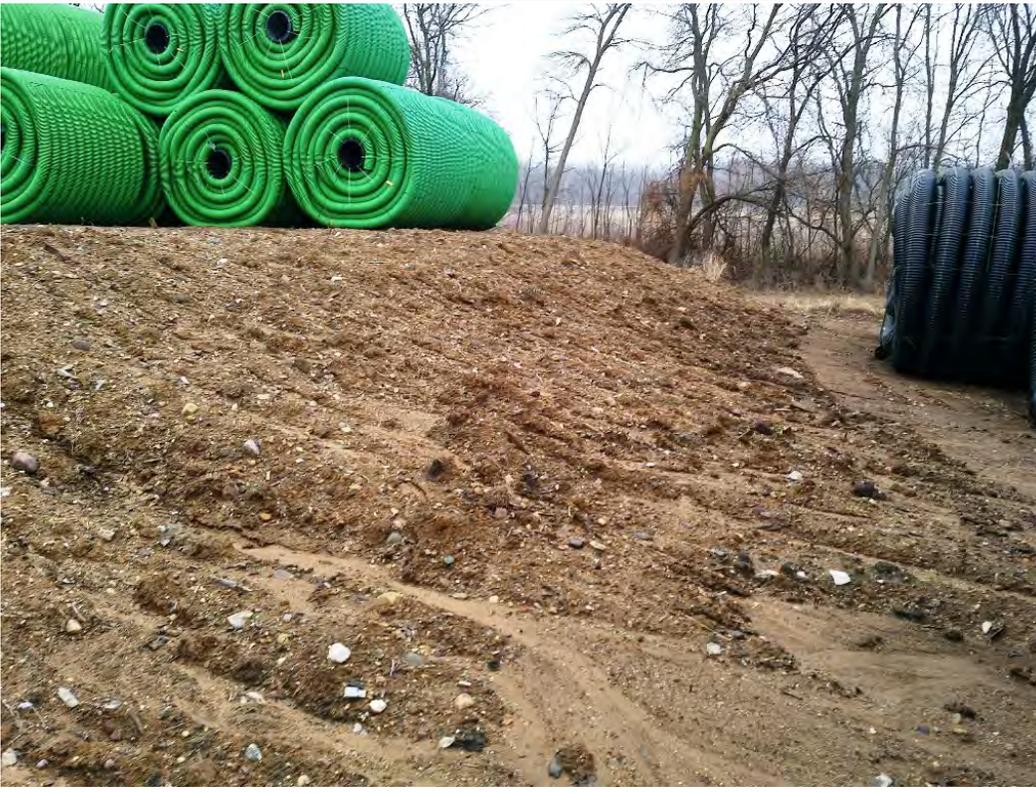
Photo ID: 11  
Photo Date: 12/13/2018  
Photo Time: 14:17:12  
Direction: east  
Taken By: Robert Wagner

Photograph 11 shows processed wood, red brick, chunks of concrete, and tree branches protruding from an area located to the east of the man-made hole.

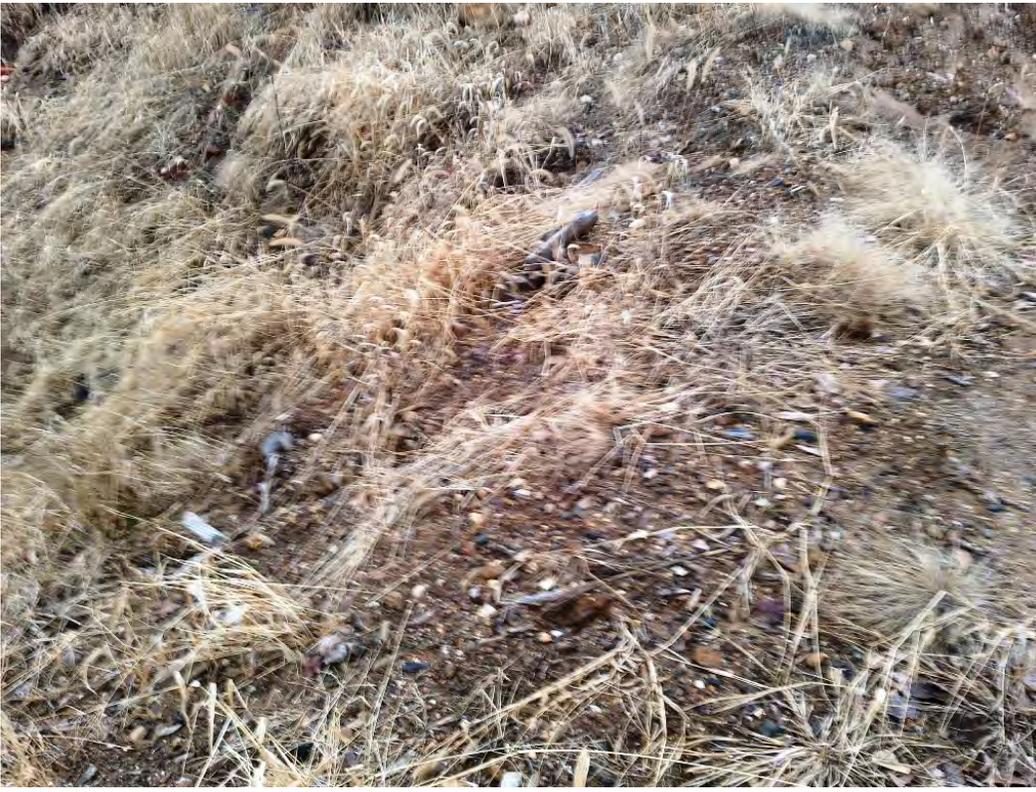
Photo ID: 12  
Photo Date: 12/13/2018  
Photo Time: 14:18:31  
Direction: north  
Taken By: Robert Wagner

Photograph 12 shows processed wood protruding from the east slope of the man-made hole.

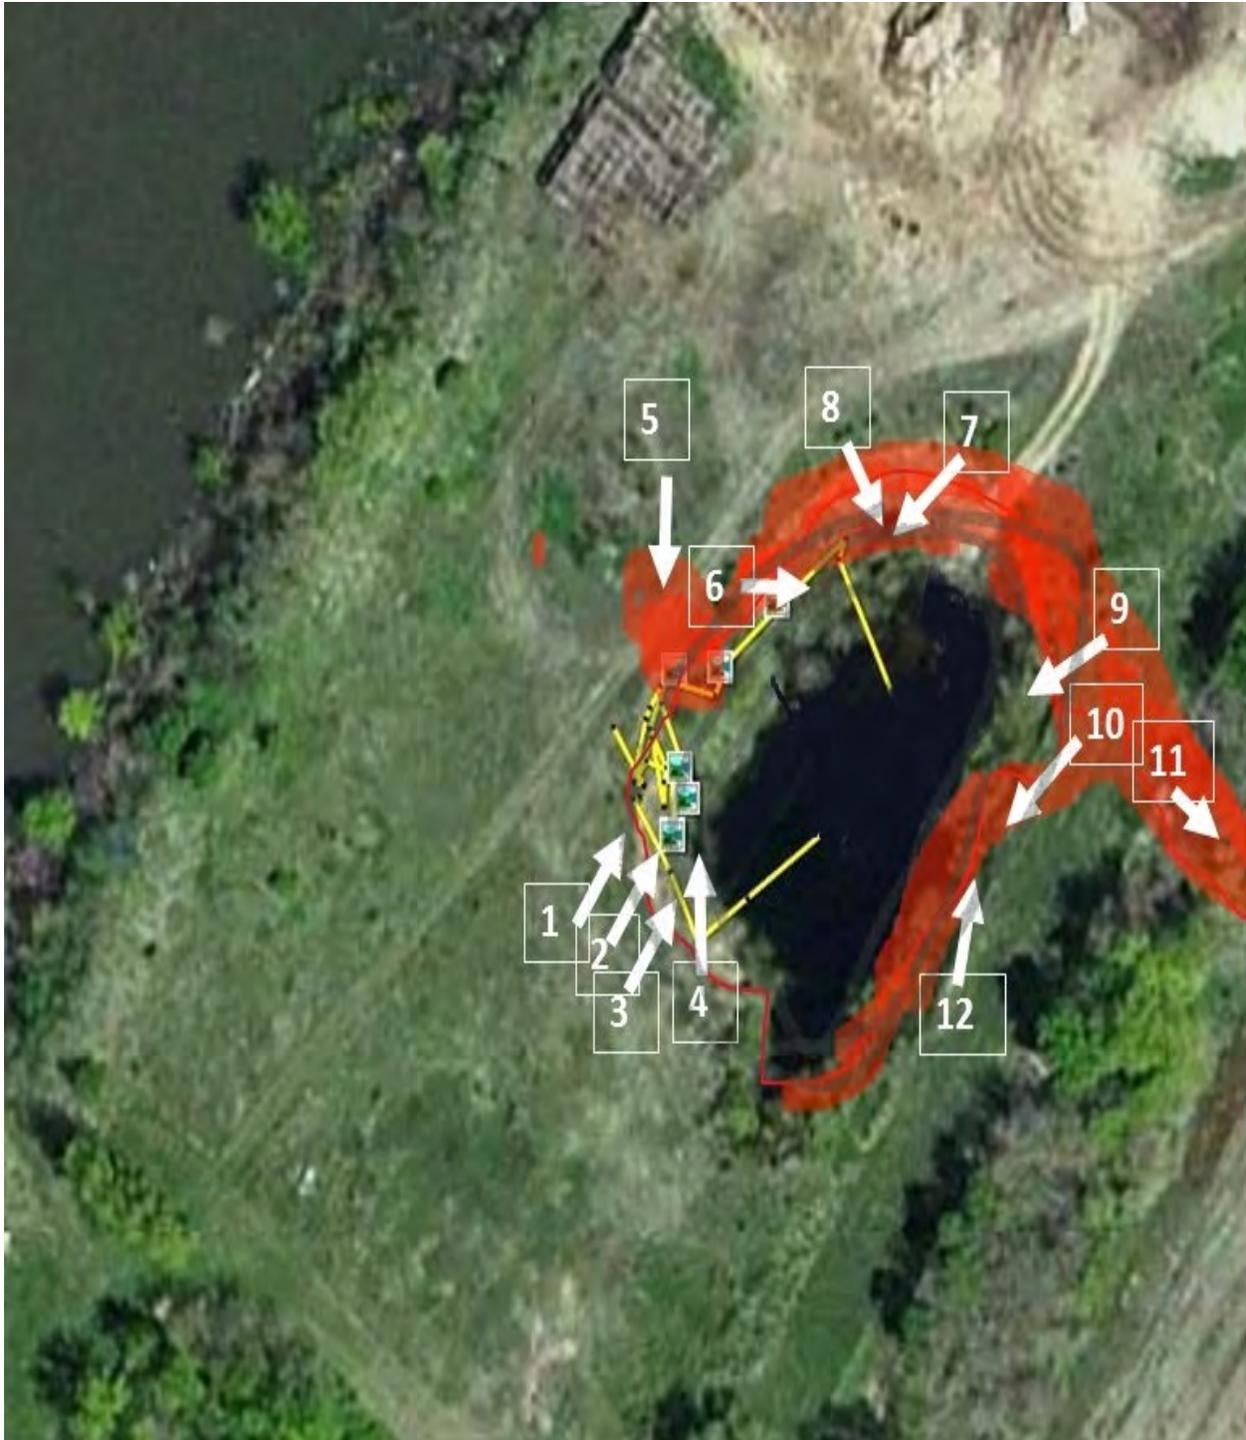
Site Diagram 1: December 13, 2018 • Poignant Harold (1230105027) • Marshall County

I arrived at the Poignant Property at 1400. I walked and photographed the property. During the inspection I observed red bricks, galvanized pipe, sewer pipe, tree branches, pieces of processed wood, and chunks of concrete protruding from the ground in a man-made fill area. The man-made fill area appears to be above the elevation of the adjacent property. Photographs 1, 2, 3, 4, 5, 6, 7, 8, 9, 10, 11, and 12 show the man-made fill area of the property where open dumping occurred. After reviewing google earth's aerial photographs it appears that the area's topography has changed since April 1994 and approximately 122,435 square feet of general construction or demolition debris has been used as fill on the property.
