BEFORE THE ILLINOIS POLLUTION CONTROL BOARD

ADMINISTRATIVE CITATION

Inspection Report

Solid Waste Program - Open Dump Inspection

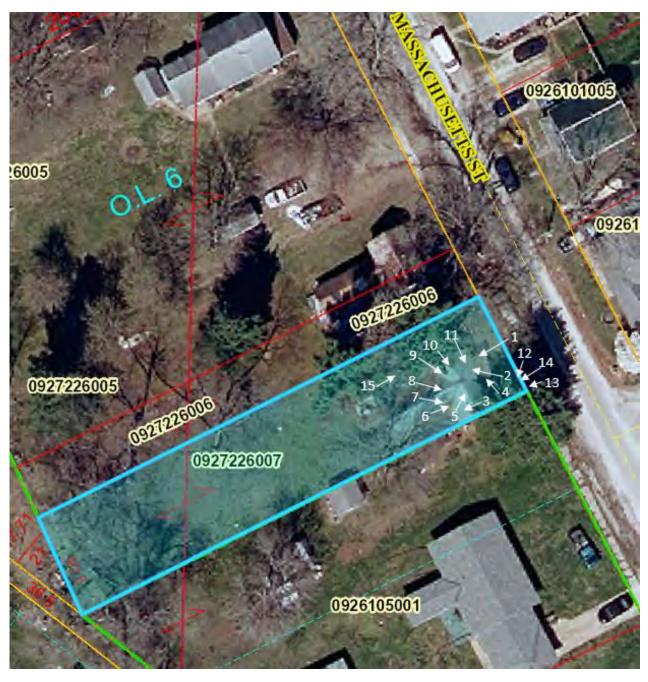
Bureau Id: 1690055005 Photo No.: 1 Photo Date: 2/14/2023 Photo Time: 11:12:23 AM Direction: west Taken By: Douglas Johnson

A view of the subject property from Massachusetts Street, which shows a demolished on-site residence that appeared to have been recently burned.

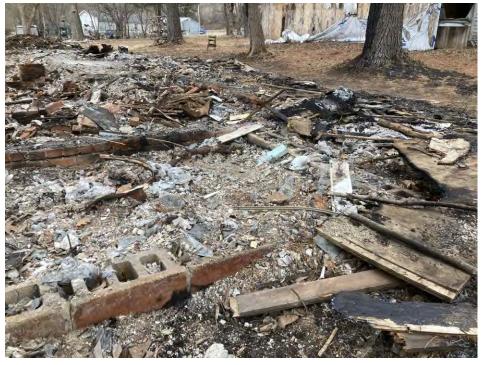
Bureau Id: 1690055005 Photo No.: 2 Photo Date: 2/14/2023 Photo Time: 11:12:38 AM Direction: west Taken By: Douglas Johnson

A closer view of the demolished on-site residence and debris that appeared to have been recently burned. The debris shown in this photograph consisted of concrete cinder blocks, clay bricks, wood, and landscape waste.

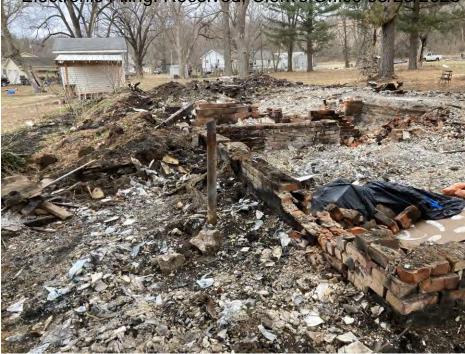
Bureau Id: 1690055005 Photo No.: 3 Photo Date: 2/14/2023 Photo Time: 11:13:22 AM Direction: west Taken By: Douglas Johnson

Another view of the demolished on-site residence and debris. The debris shown in this photograph consisted of clay bricks, dimensional lumber, and siding material.

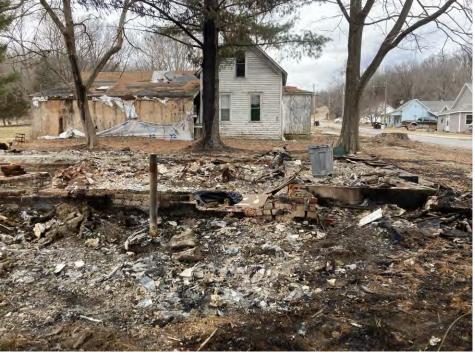
Bureau Id: 1690055005 Photo No.: 4 Photo Date: 2/14/2023 Photo Time: 11:13:38 AM Direction: north Taken By: Douglas Johnson

A view of the demolished on-site residence and debris, facing to the north direction.

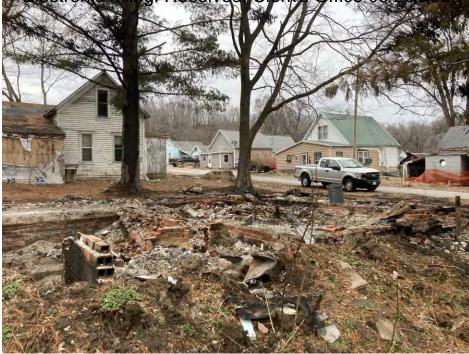
Bureau Id: 1690055005 Photo No.: 5 Photo Date: 2/14/2023 Photo Time: 11:13:56 AM Direction: north Taken By: Douglas Johnson

Overview of the demolished on-site residence and debris with Massachusetts Street in the background

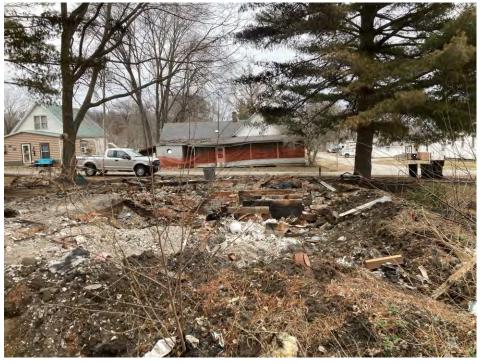
Bureau Id: 1690055005 Photo No.: 6 Photo Date: 2/14/2023 Photo Time: 11:14:10 AM Direction: east Taken By: Douglas Johnson

Another view of the demolished on-site residence and debris, facing to the east direction.

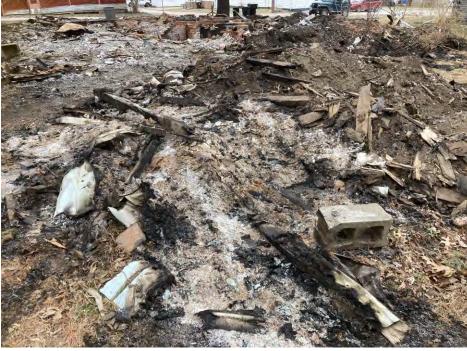
Bureau Id: 1690055005 Photo No.: 7 Photo Date: 2/14/2023 Photo Time: 11:14:26 AM Direction: east Taken By: Douglas Johnson

A closer view of burnt debris consisting of concrete cinder blocks, siding material, and dimensional lumber.

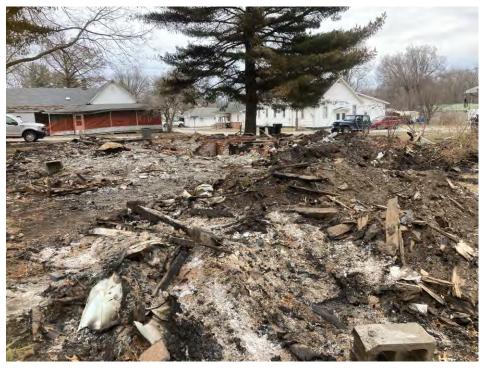
Bureau Id: 1690055005 Photo No.: 8 Photo Date: 2/14/2023 Photo Time: 11:14:27 AM Direction: east Taken By: Douglas Johnson

Another view of the demolished on-site residence and debris.

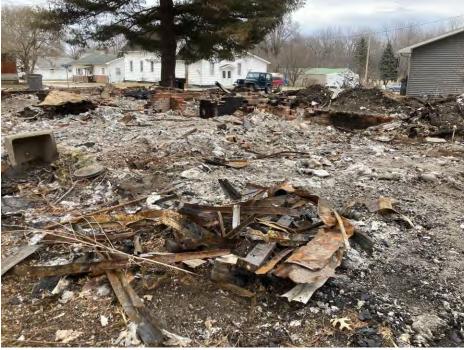
Bureau Id: 1690055005 Photo No.: 9 Photo Date: 2/14/2023 Photo Time: 11:14:35 AM Direction: east Taken By: Douglas Johnson

A pile of mixed metals near the foundation of the on-site residence.

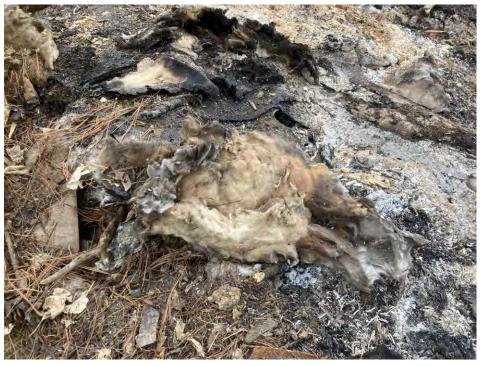
Bureau Id: 1690055005 Photo No.: 10 Photo Date: 2/14/2023 Photo Time: 11:14:43 AM Direction: east Taken By: Douglas Johnson

Partially burnt insulation material near the foundation of the on-site residence.

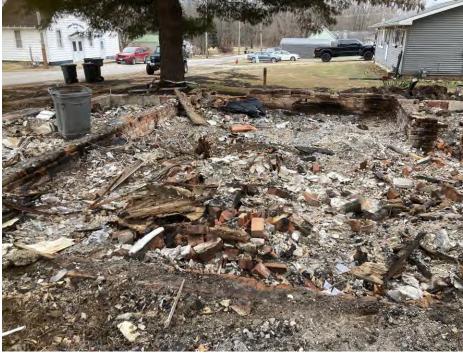
Bureau Id: 1690055005 Photo No.: 11 Photo Date: 2/14/2023 Photo Time: 11:14:51 AM Direction: south Taken By: Douglas Johnson

A view of debris inside the foundation of the on-site residence, which consisted o clay bricks, dimensional lumber, and miscellaneous household waste.

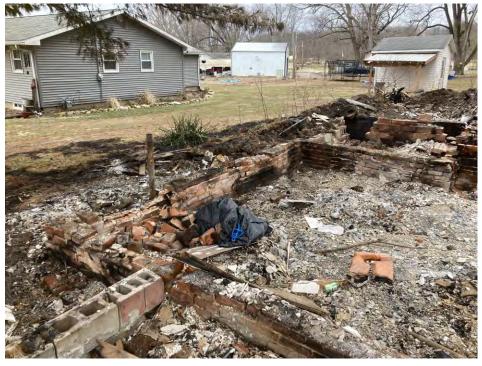
Bureau Id: 1690055005 Photo No.: 12 Photo Date: 2/14/2023 Photo Time: 11:15:21 AM Direction: south Taken By: Douglas Johnson

A view of household waste inside the foundation of the on-site residence

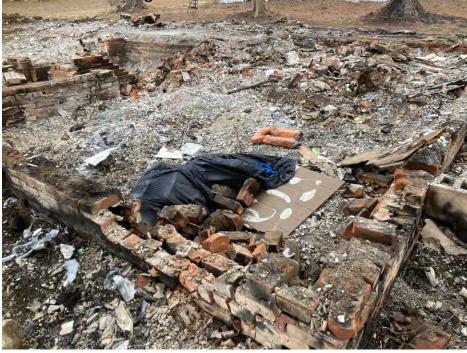
Bureau Id: 1690055005 Photo No.: 13 Photo Date: 2/14/2023 Photo Time: 11:17:37 AM Direction: west Taken By: Douglas Johnson

A closer view of a garbage bag inside the foundation of the on-site residence.

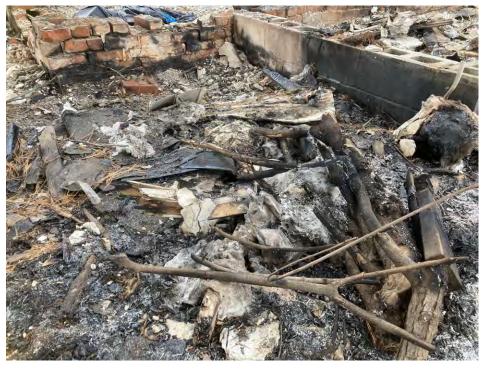
Bureau Id: 1690055005 Photo No.: 14 Photo Date: 2/14/2023 Photo Time: 11:17:25 AM Direction: west Taken By: Douglas Johnson

Burnt landscape waste that was intermingled with insulation material and other debris around the outside of the foundation.

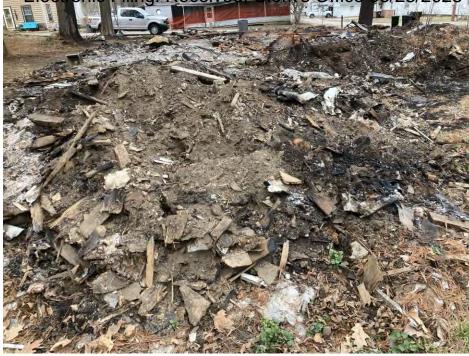
Bureau Id: 1690055005 Photo No.: 15 Photo Date: 2/14/2023 Photo Time: 11:14:19 AM Direction: east Taken By: Douglas Johnson

Demolition waste, along the outside of the foundation, illustrates that the residence was razed prior to the burning of the structure.
