Testimony of Wendell Watson PowerPoint Demonstrative

AS 2021-006: IN THE MATTER OF: PETITION OF SOUTHERN ILLINOIS POWER COOPERATIVE FOR AN ADJUSTED STANDARD FROM 35 ILL. ADMIN. CODE PART 845 OR, IN THE ALTERNATIVE, A FINDING OF INAPPLICABILITY

Testimony of Todd Gallenbach PowerPoint Demonstrative

Testimony of Jason McLaurin PowerPoint Demonstrative

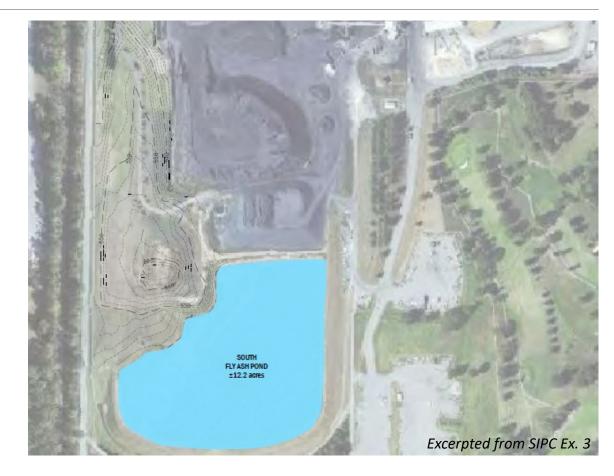
South Fly Ash Pond

- Served as a secondary, finishing pond to Emery Pond
 - Received decant water from Emery Pond until it was closed by removal and retrofitted with a linear in 2021
- Following Emery Pond's closure by removal and retrofit, this unit continues to receive rainwater runoff and facility wastewater from what is now called the "stormwater basin"
- Did not directly receive CCR from boiler operations

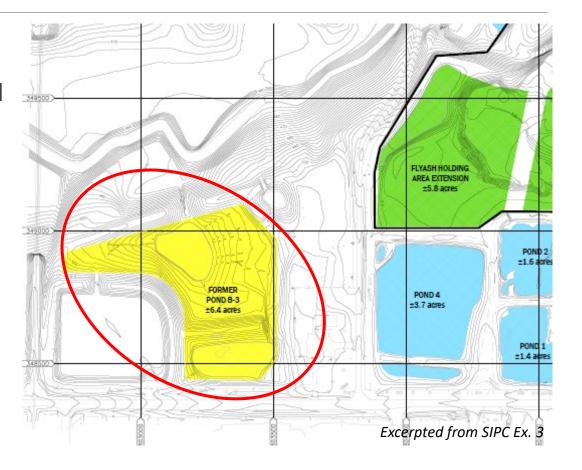
Former Pond B-3

- Used primarily as a secondary finishing pond to Pond A-1
- No longer in operation and contains no sediment or water, except for the occasional rainwater

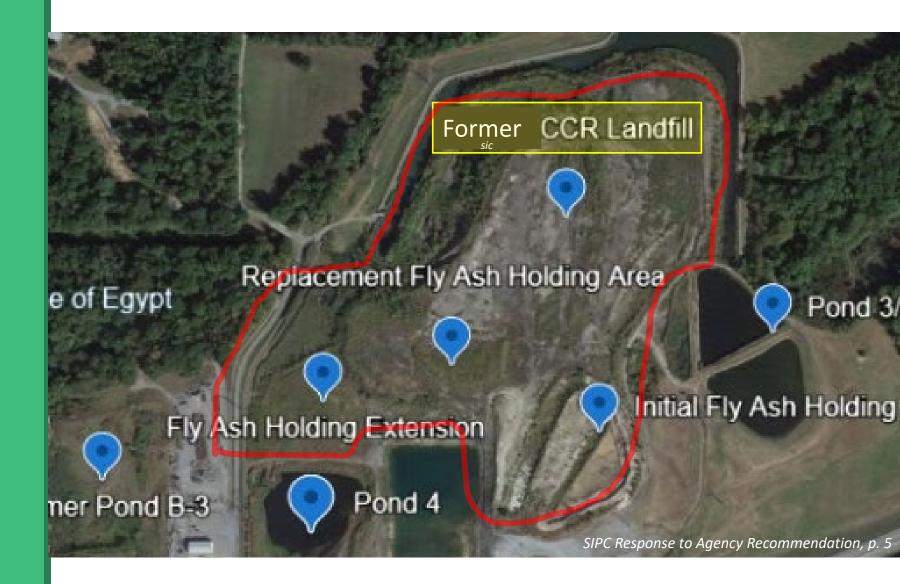
- Received scrubber sludge and fly ash
- Former CCR Landfill covers the dewatered Former Fly Ash Holding Units

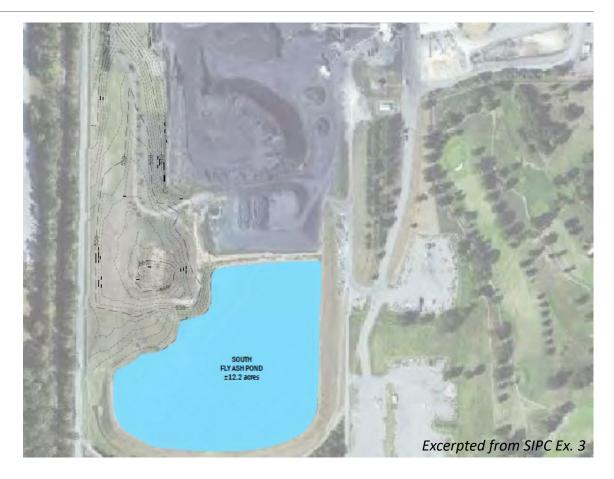
South Fly Ash Pond

- Began operating in 1989
- Constructed to serve as a replacement for Pond A-1, if needed
 - Replacement not needed because Pond A-1 continued to operate until 2003
- Did not directly receive CCR from boiler operations
- Served as a secondary finishing pond to Emery Pond
 - Received decant water from Emery Pond until Emery Pond was closed and lined fall of 2020
- Following Emery Pond's closure and lining, collects storm water runoff from the coal pile and clarified water from Emery Pond

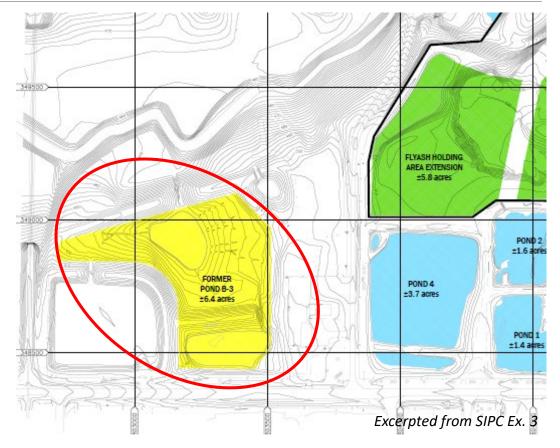
- Operated from 1985 to 2003
- Used primarily as a secondary finishing pond to Pond A-1
 - During periodic, intermittent outages of Pond A-1, Former Pond B-3 may have received some small amounts of fly ash from Units 1, 2, and 3 prior to 2003
- Dewatered and cleaned to clay in 2017
- No longer in operation and contains no sediment or water, except for the occasional rainwater

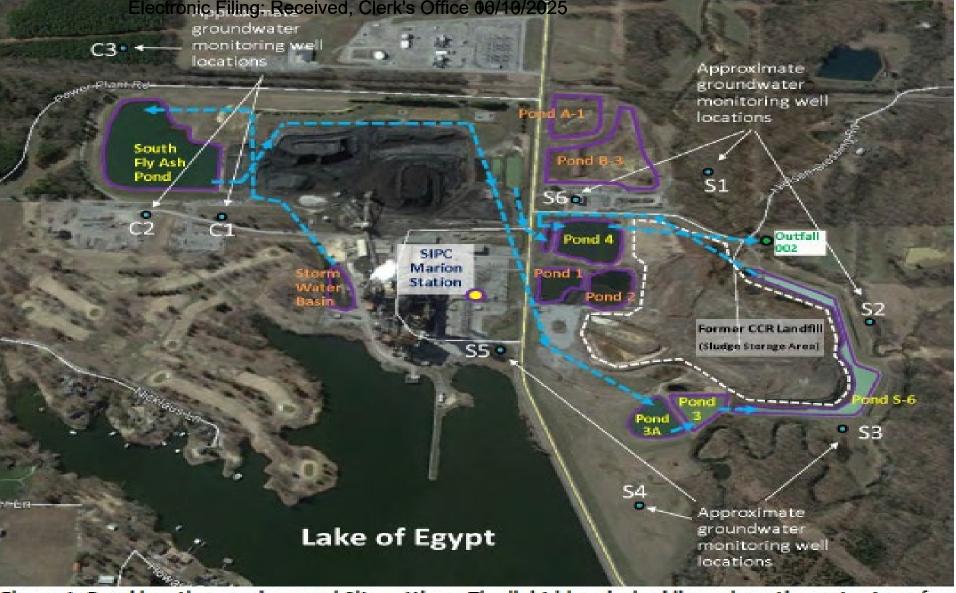
Figure 1: Pond locations and general Site settings. The light blue dashed lines show the water transfer process at the facility through the following sequence: (1) Storm Water Basin, (2) South Fly Ash Pond, (3) Pond 3A/3, (4) Pond S-6, (5) Pond 4, and (6) Outfall 002. Yellow color is used to denote the names of the Ponds included in the petition.

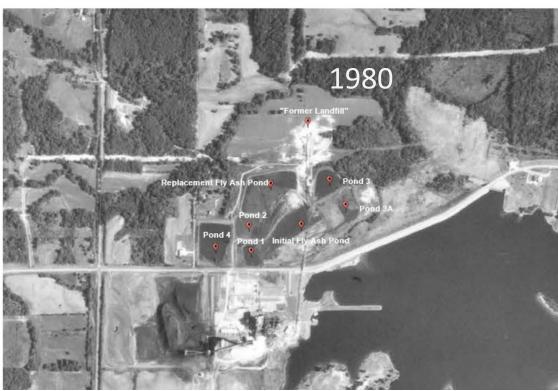
IEPA Ex. 1

Initial landfill construction occurred on dry land
