PETITION OF JO'LYN CORPORATION and FALCON WASTE AND RECYCLING, INC. for an ADJUSTED STANDARD from portions of 35 III.Adm.Code 807.103 and 35 III.Adm.Code 810.103, or in the alternative, A FINDING OF INAPPLICABILITY.

SUPPLEMENT TO AMENDED PETITION FOR ADJUSTED STANDARD

EXHIBIT K

Photos of Eclipse Dust Control

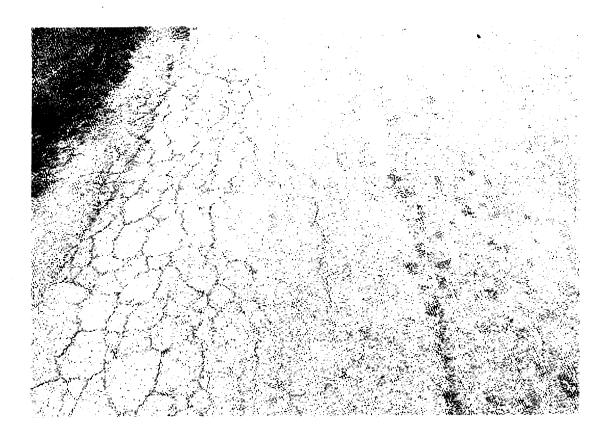
Photo #5: This photo is of a road (not using Eclipse Dust Control) done at the same time as our first application (2001). Please note the cracking.

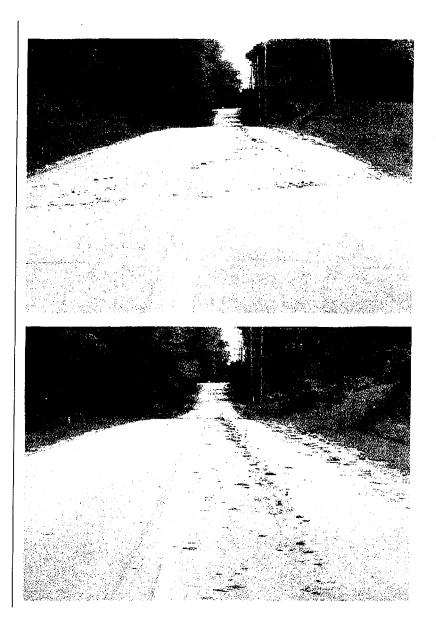
Photos #8 and #9: These are current photos of mud on the pavement, which could cause a hazardous condition and causes dust once it has dried. This could have been prevented if the farm lane (the source of the mud) was applied with Eclipse Dust Control.
