BEFORE THE ILLINOIS POLLUTION CONTROL BOARD
ADMINISTRATIVE CITATION

Open Dump Inspection Checklist

DATE: January 5, 2005
TO: Land Division File
FROM: *ofc* Charlie King, DLPC/FOS – Springfield Region
SUBJECT: LPC # 0178055003 – Cass County
Hagener Twp./Spears
C-05-013-C
FOS File

NARRATIVE RE-INSPECTION REPORT DOCUMENT

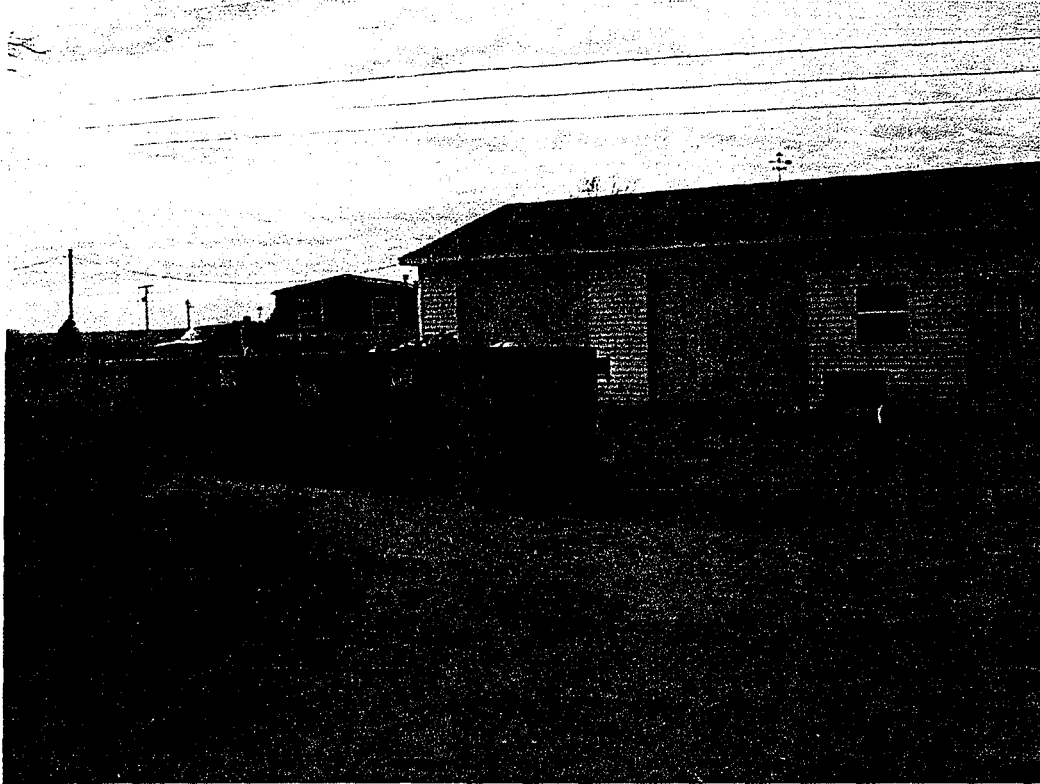
Date: December 15,
2004
Time: 1:48 p.m.
Direction: W
Photo by: Charlie King
Exposure #: 001
Comments: An Area
Disposal roll-off box
filled with refuse,
provided by Bobbye
Spears (not the
respondent), is shown.

north/south part of the continuing driveway, shown in photo # 001. This is a roll-off box that Ms. Spears stated that she provided. We exited the vehicle and initially knocked on the door front. No one answered the door. I then went to the back of the home and knocked on the back door. No one answered there either and no one was observed outside on the property. While leaving the back wooden porch, I observed a burned area in the grass approximately 15' west of the northwest corner of the house, as shown in photo # 002. This area measured approximately 12' x 8' x 1'. Wastes observed included car hoses, paper, cans, landscape wastes, car parts and apparent furniture or car seat springs.

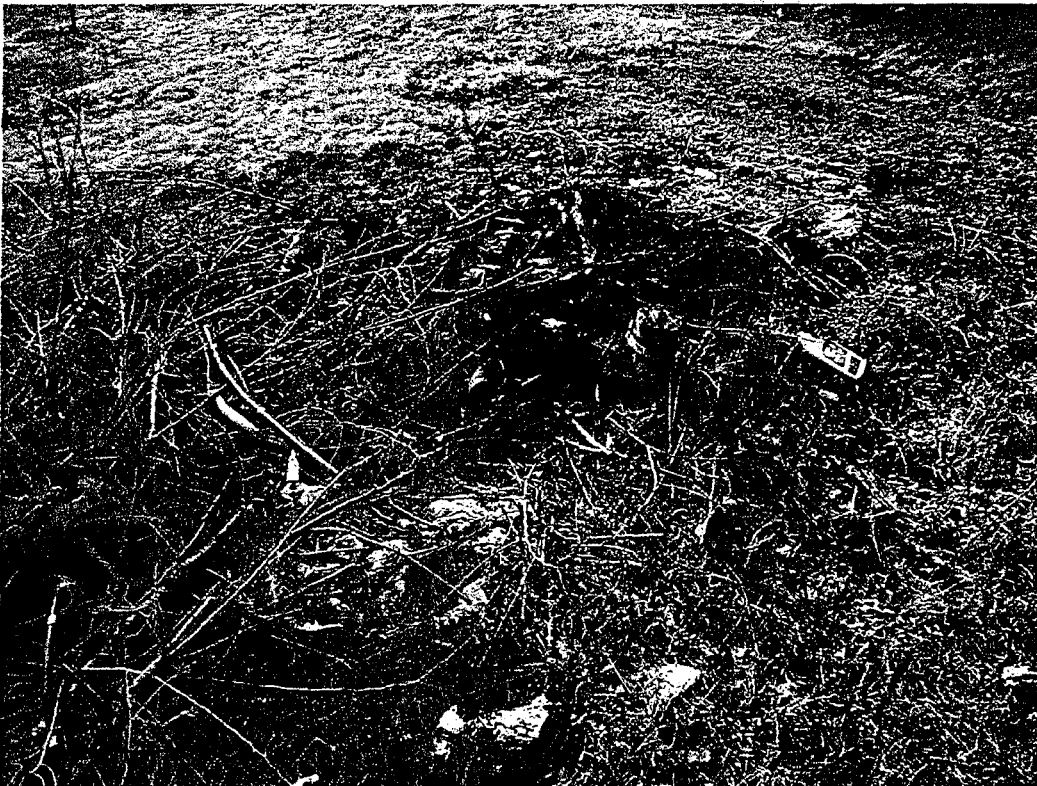
Date: December 15,
2004
Time: 1:50 p.m.
Direction: SW
Photo by: Charlie King
Exposure #: 002
Comments: Evidence
of open dumping and
open burning is shown.
This area measured
approximately 12' x 8' x
1'. Wastes observed
included car hoses,
paper, cans, landscape
waste, car parts and
springs.

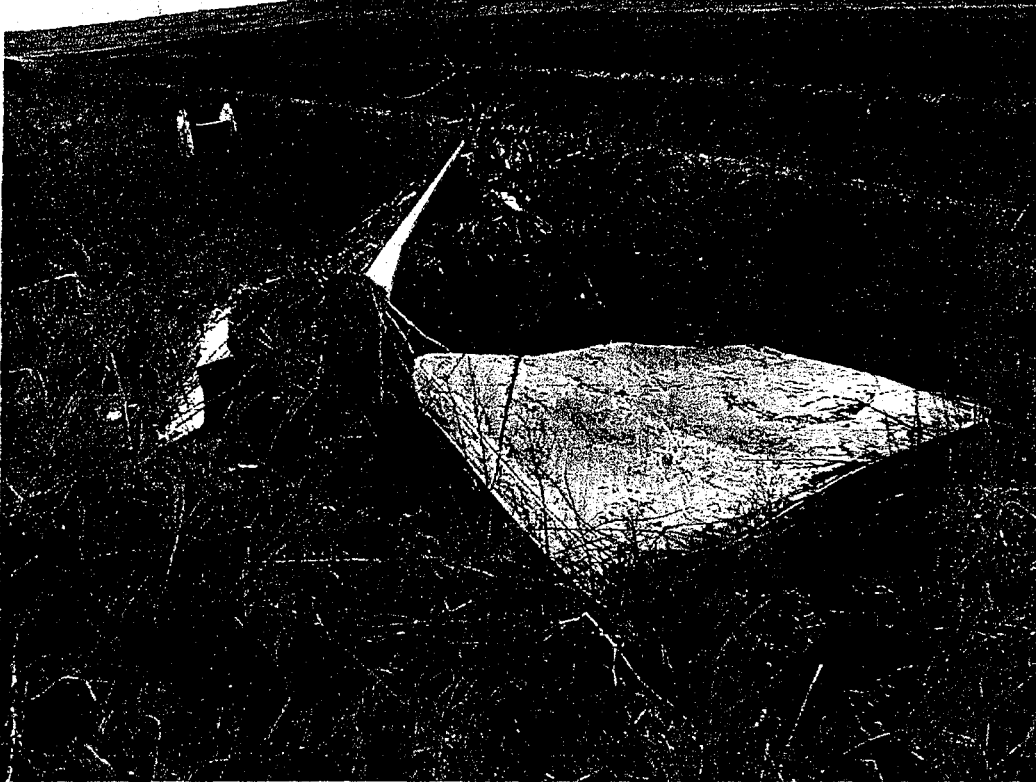
Date: December 15,
2004
Time: 1:53 p.m.
Direction: SW
Photo by: Charlie King
Exposure #: 003
Comments: A mattress
and metals measuring
approximately 7' x 8' x
2', on the west side of
the property, next to a
fence.

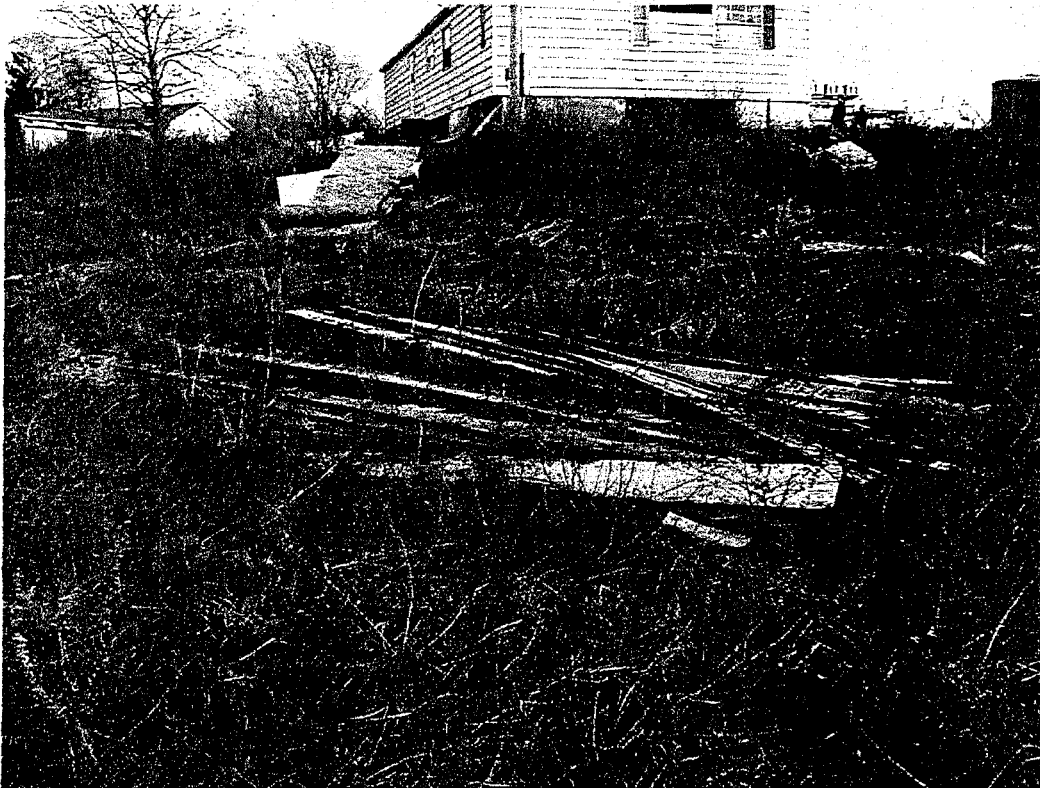
Date: December 15,
2004
Time: 1:54 p.m.
Direction: NE
Photo by: Charlie King
Exposure #: 004
Comments: Shown, is
a pile of wood
measuring
approximately 10' x 5' x
1' and rolled out
linoleum measuring
approximately 15' x 4' x
1'.

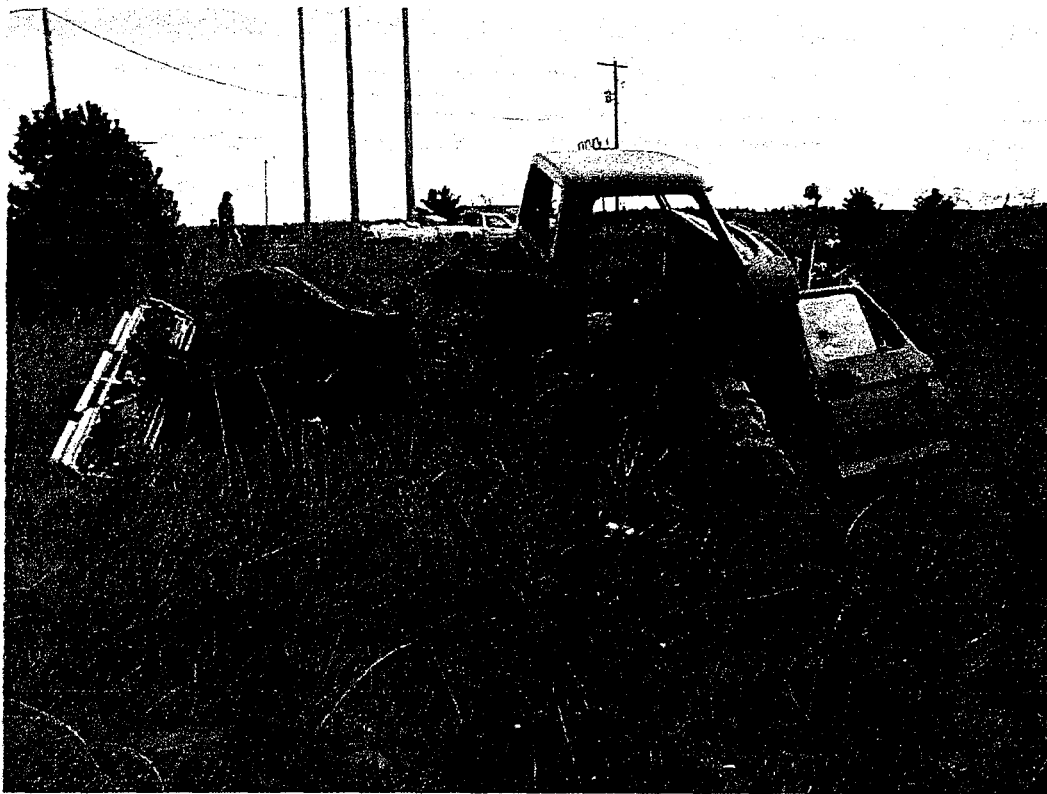
Date: December 15,
2004
Time: 1:56 p.m.
Direction: E/SE
Photo by: Charlie King
Exposure #: 005
Comments: A junk
truck is shown in this
photo, with additional
metals.

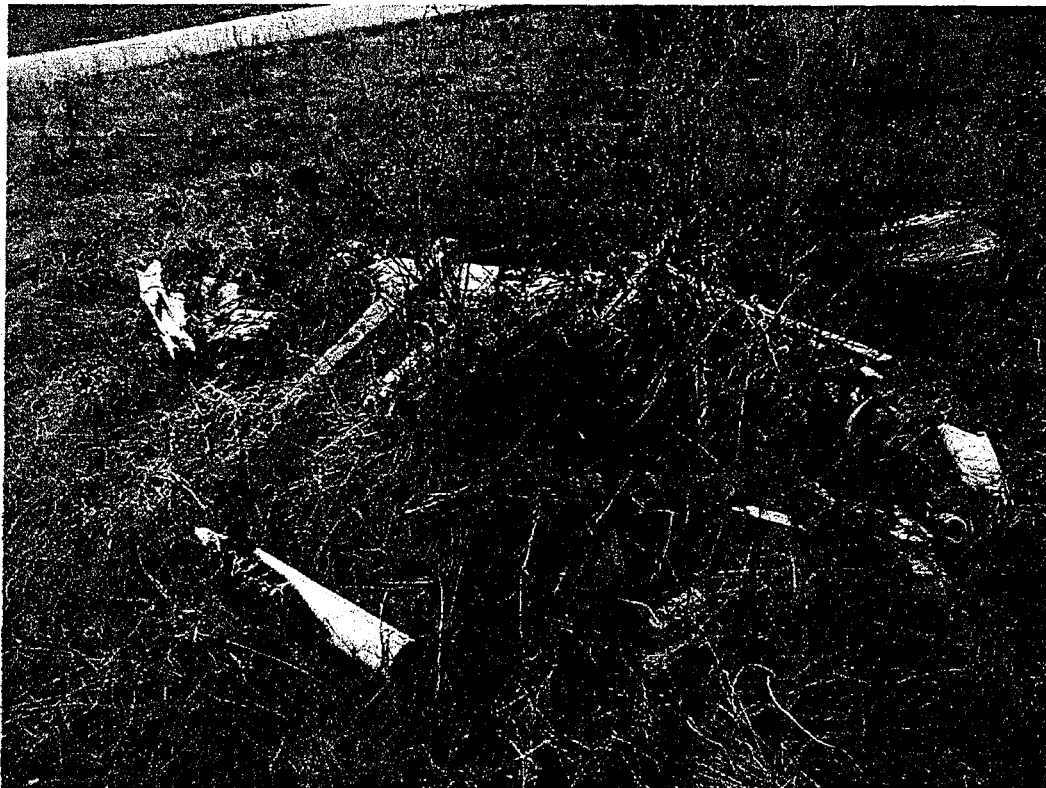
Date: December 15,
2004
Time: 1:57 p.m.
Direction: SW
Photo by: Charlie King
Exposure #: 006
Comments: A pile of
wastes measuring
approximately 5' x 6' x
2' is shown. Partially
burned PVC pipe,
wood, cans, clothes
and toys were
observed.

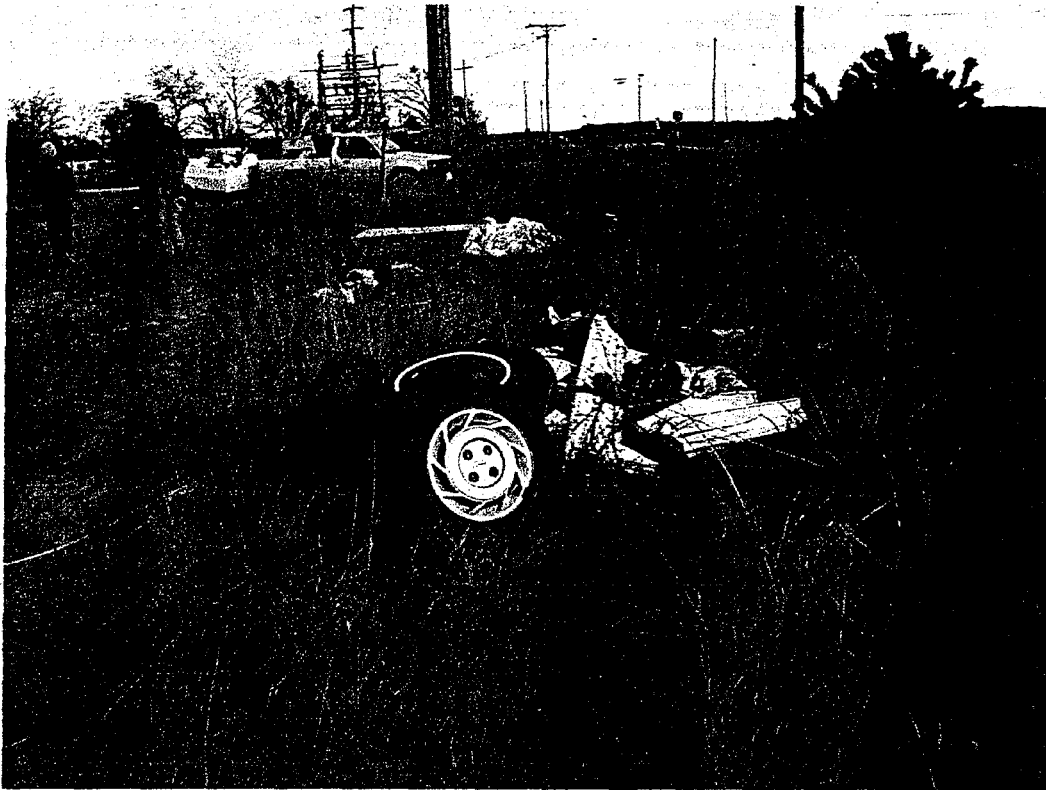
Date: December 15,
2004
Time: 1:58 p.m.
Direction: E
Photo by: Charlie King
Exposure #: 007
Comments: Used tires
(eight on-rims, one off-
rim), weights, metals,
insulation, cardboard
and empty paint cans
were observed.

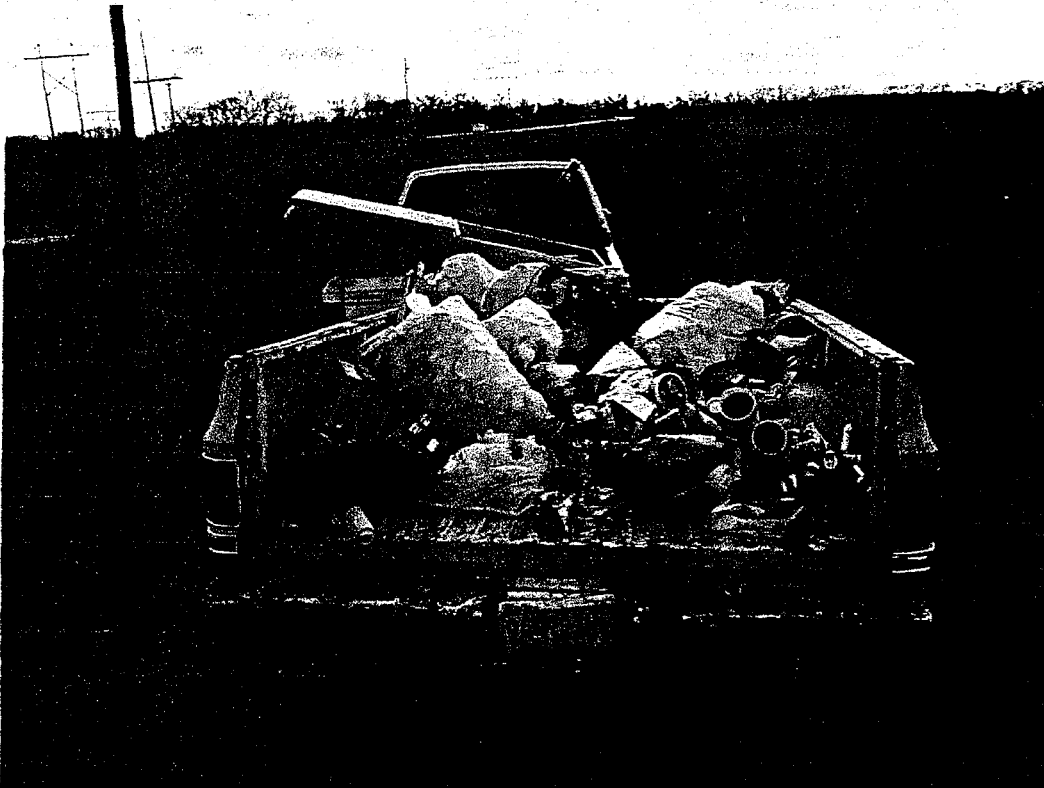
Date: December 15,
2004
Time: 2:00 p.m.
Direction: S/SW
Photo by: Charlie King
Exposure #: 008
Comments: A pickup
truck with a truck bed
converted into a trailer,
are shown. Wastes on
the trailer includes
bags of cans and at
least four old car
batteries that should
be recycled.

Mr. Jansen and Ms. Laughridge observed the contents of the roll-off box and the area around the garage on-site, while I walked to the west and then southwest of the property to examine areas where wastes were observed during the initial site inspection. I walked to an area at the far western side of the site where a mattress and metals were previously observed. They were still there in a pile measuring approximately 7' x 8' x 2', as shown in photo # 003. Walking further south and back up hill towards the east, wood was again observed in an area measuring approximately 10' x 5' x 1'. Rolled out linoleum was also observed in an area measuring approximately 15' x 4' x 1'. These wastes were observed just west of the apparently vacant double-wide mobile home on-site, as shown in photo # 004. A junk truck that was partially tarped was still present as shown in photo # 005. Additional metals leaned against the truck. Just to the southwest of the junk truck, a previously observed of wastes measuring approximately 5' x 6' x 2', shown in photo # 006. Partially burned PVC pipe, wood, cans, clothes and toys were in that pile. Used tires (eight on-rims and one off-rim), weights, metals, insulation, cardboard and empty paint cans were noted in the area as well, shown in photo # 007. A pickup truck in that area was observed with a half truck-bed converted into a pull-behind trailer loaded with wastes, shown in photo # 007. Wastes on the trailer included several bags of cans and at least four old car batteries that should be recycled. These are shown in photo # 008.

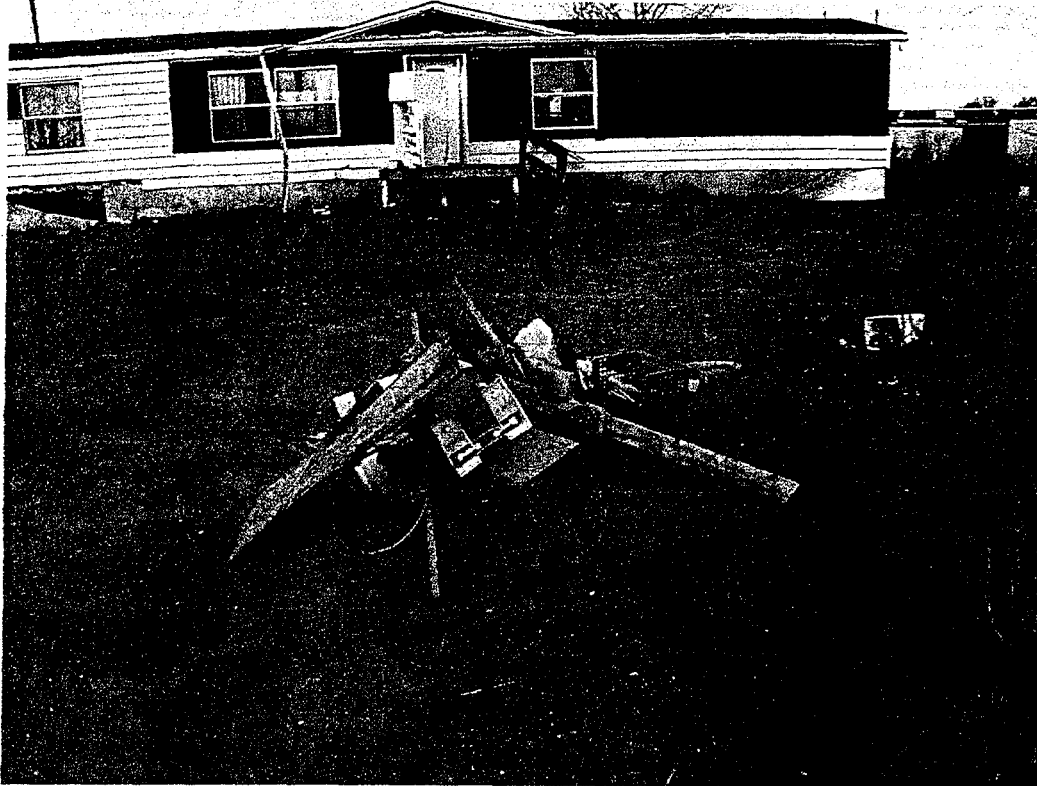
Date: December 15,
2004
Time: 2:01 p.m.
Direction: N
Photo by: Charlie King
Exposure #: 009
Comments: A pile of
cardboard, toys, carpet
and general household
refuse, measuring
approximately 9' x 6' x
3', is shown.

Walking back towards the apparently unoccupied double-wide, a pile of wastes was found approximately 35' in front of it, as shown in photo # 009. It consisted of cardboard, carpet, toys, general household refuse and measured approximately 9' x 6' x 3'. Closer to the front of that double-wide, a refrigerator was still located on the porch. During the initial site inspection, I was told that the trailer had lost power. Since the refrigerator started to stink due to rotting food, it was dragged outside onto the porch (instead of being emptied and cleaned out, inside). As shown in photo # 010, some food was still inside the open refrigerator. A television set and pieces of Styrofoam are shown on the ground. To the northwest of that double-wide, a small pile of framed photographs, a teddy bear and other toys were observed in a pile measuring approximately 6' x 5' x 1', as shown in photo # 011. Behind the doublewide trailer and just west of the new garage, an old garage or storage building with a dirt floor was observed, as shown in photo #sa. 012, 103 and 014. Photo # 012 shows metals, wood, 16 used tires (eight on-rims and eight off-rims) in a pile measuring approximately 12' x 8' x 2', located just west of the old storage building. In front, or immediately to the south of that building, another pile of wastes measuring approximately 8' x 5' x 2' was observed. It consisted of toys, a truck door, a tire on-rim, wood, and plastics, shown in photo # 013. Photo # 014 shows

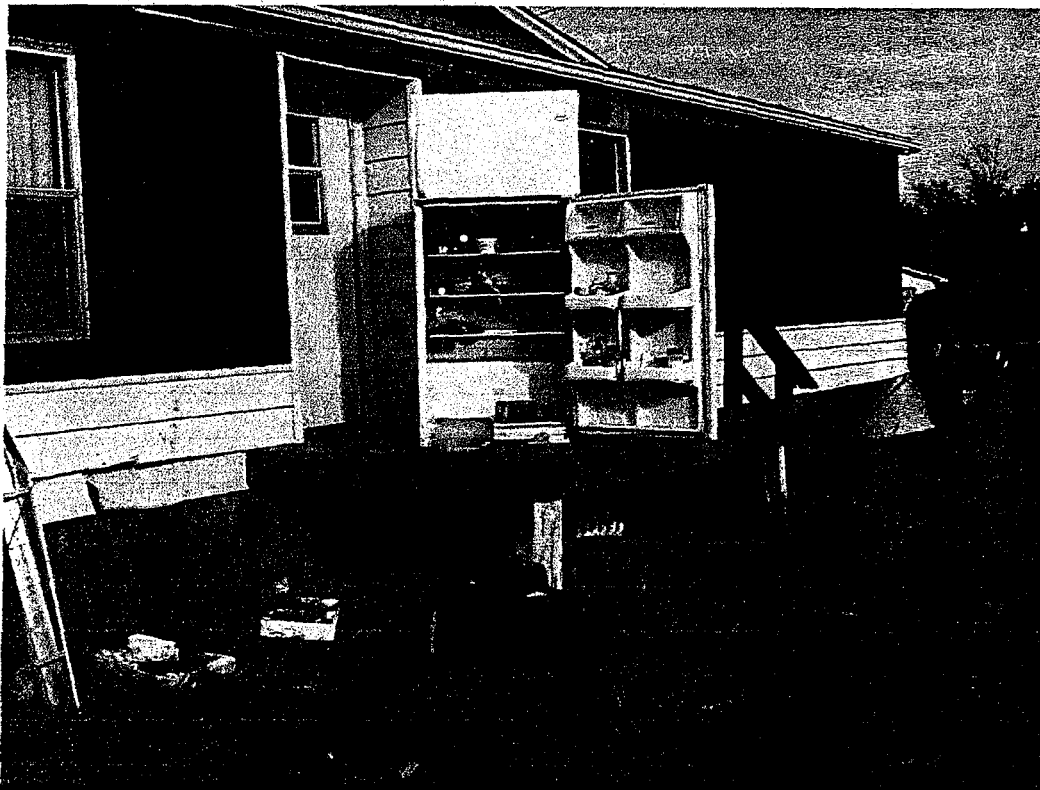
Date: December 15,
2004
Time: 2:02 p.m.
Direction: NE
Photo by: Charlie King
Exposure #: 010
Comments: A
refrigerator with an
open door on the front
porch of an
unoccupied double-
wide trailer is shown.
Waste food is also
shown. A television
set and pieces of
Styrofoam are shown
on the ground.

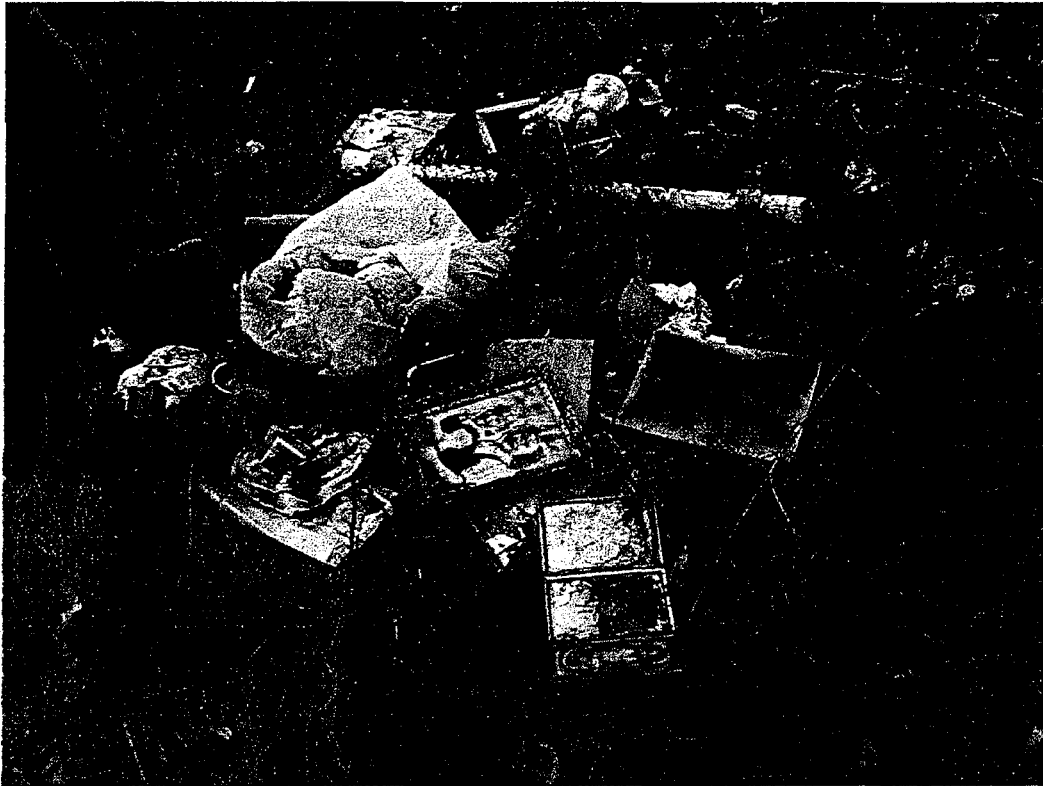
Date: December 15, 2004
Time: 2:04 p.m.
Direction: W
Photo by: Charlie King
Exposure #: 011
Comments: Framed photographs, a teddy bear and other toys, are shown in a pile measuring approximately 6' x 5' x 1'.

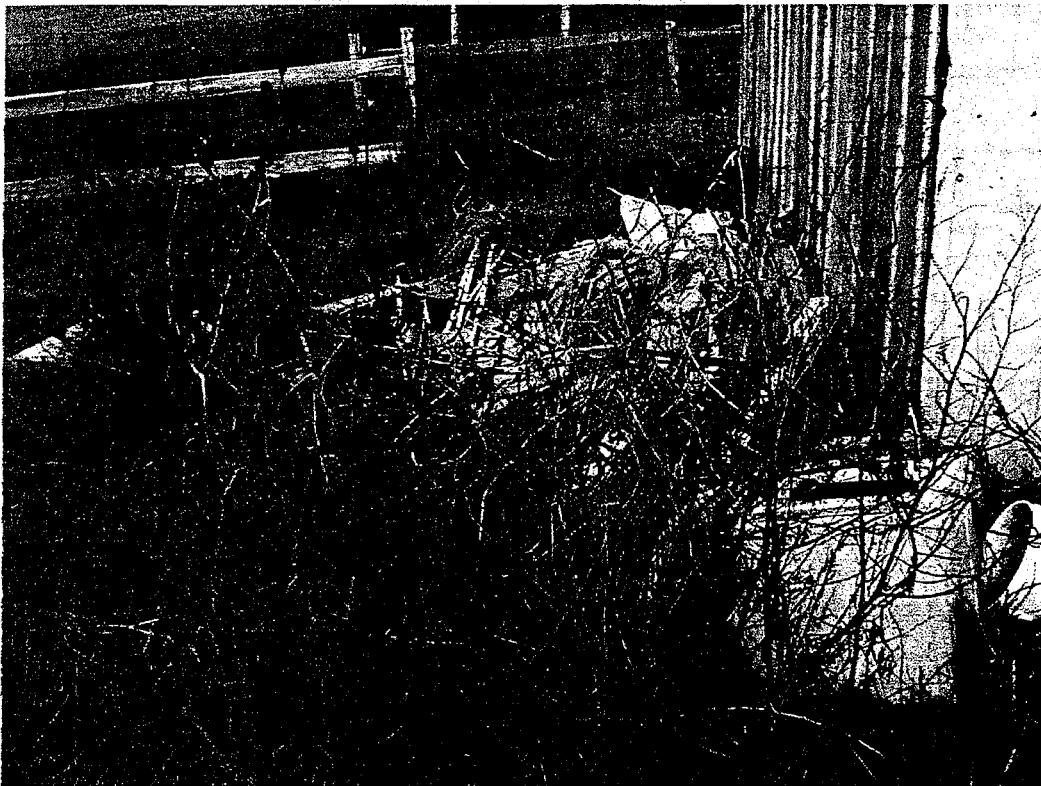
Date: December 15, 2004
Time: 2:04 p.m.
Direction: N
Photo by: Charlie King
Exposure #: 012
Comments: Metals, wood, 16 used tires (eight on-rims, eight off-rims) and cardboard are shown behind a shed west of the garage, in a pile measuring approximately 12' x 8' x 2'.

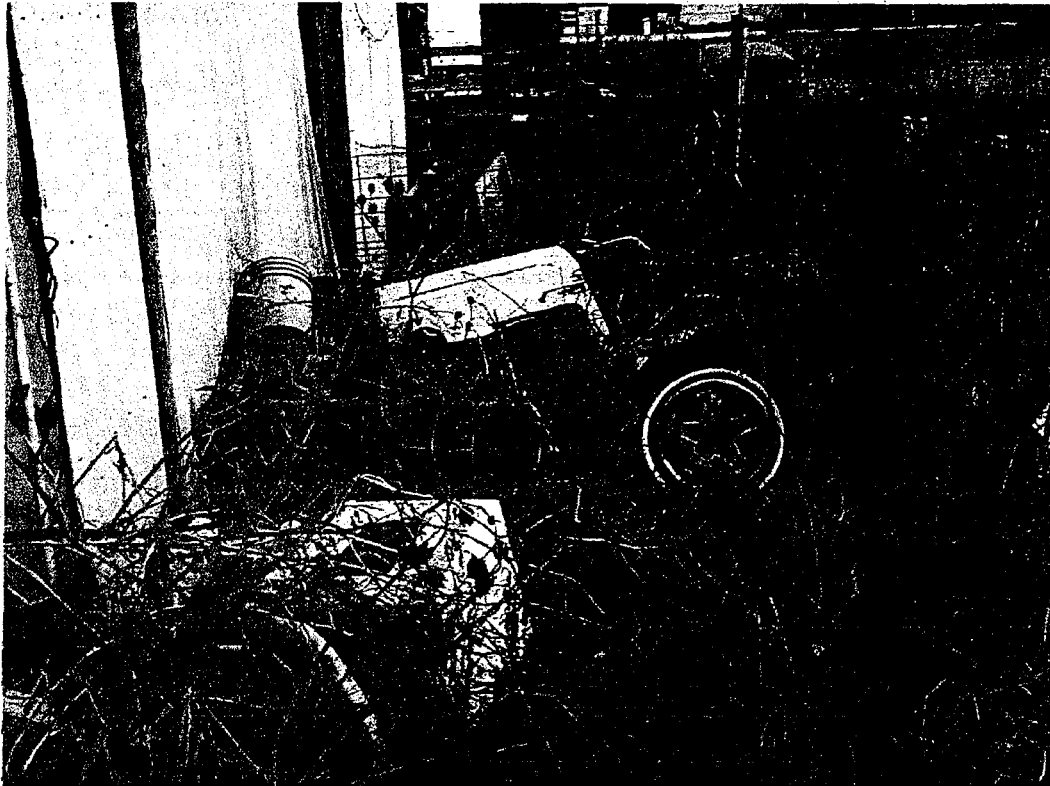
Date: December 15,
2004
Time: 2:04 p.m.
Direction: E
Photo by: Charlie King
Exposure #: 013
Comments: Toys, a
truck door, a tire on-
rim, wood, and plastics
are shown in a pile
measuring
approximately 8' x 5' x
2', in front of the shed,
west of the garage.

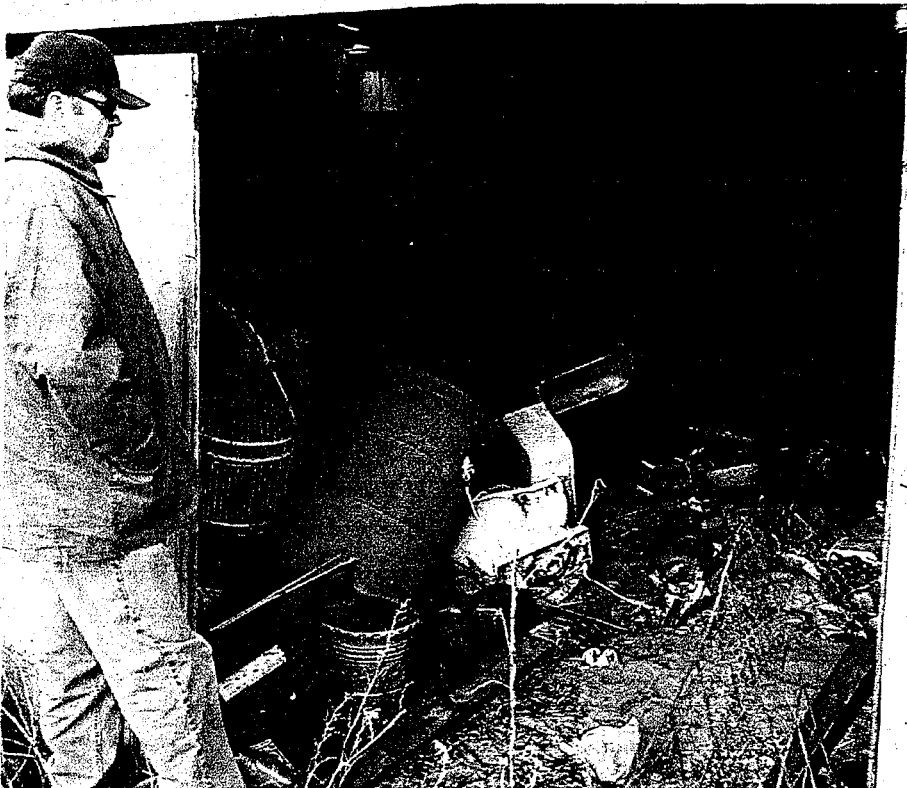
Date: December 15,
2004
Time: 2:08 p.m.
Direction: NW
Photo by: Charlie King
Exposure #: 014
Comments: Wastes,
including plastic,
metals a bird cage,
paper, cans, wood and
a toilet are shown on
the ground inside of
the open shed door.

the inside of the old storage building. Its door was found to be open. Wastes on the dirt floor, visible through the open door, include plastics, metals, a bird cage, paper, cans, wood and a toilet. These wastes will also have to be removed. Another toilet was found on the far southern end of the site, adjacent to Lock and Dam Road, also observed during the initial site inspection.
