ADMINISTRATIVE CITATION

AC 05-79  
(IEPA No. 189-05-AC)

FACILITY: New Salem/Tedrow                      SITE CODE NO.: 1498160006  
COUNTY: Pike    CIVIL PENALTY: \$1,500.00  
DATE OF INSPECTION: May 2, 2005

DATE: May 17, 2005  
TO: DLPC/Division File  
FROM: Michelle Cozadd, DLPC/FOS Springfield Region  
SUBJECT: LPC #1498160006 – Pike County  
New Salem/Tedrow  
FOS File

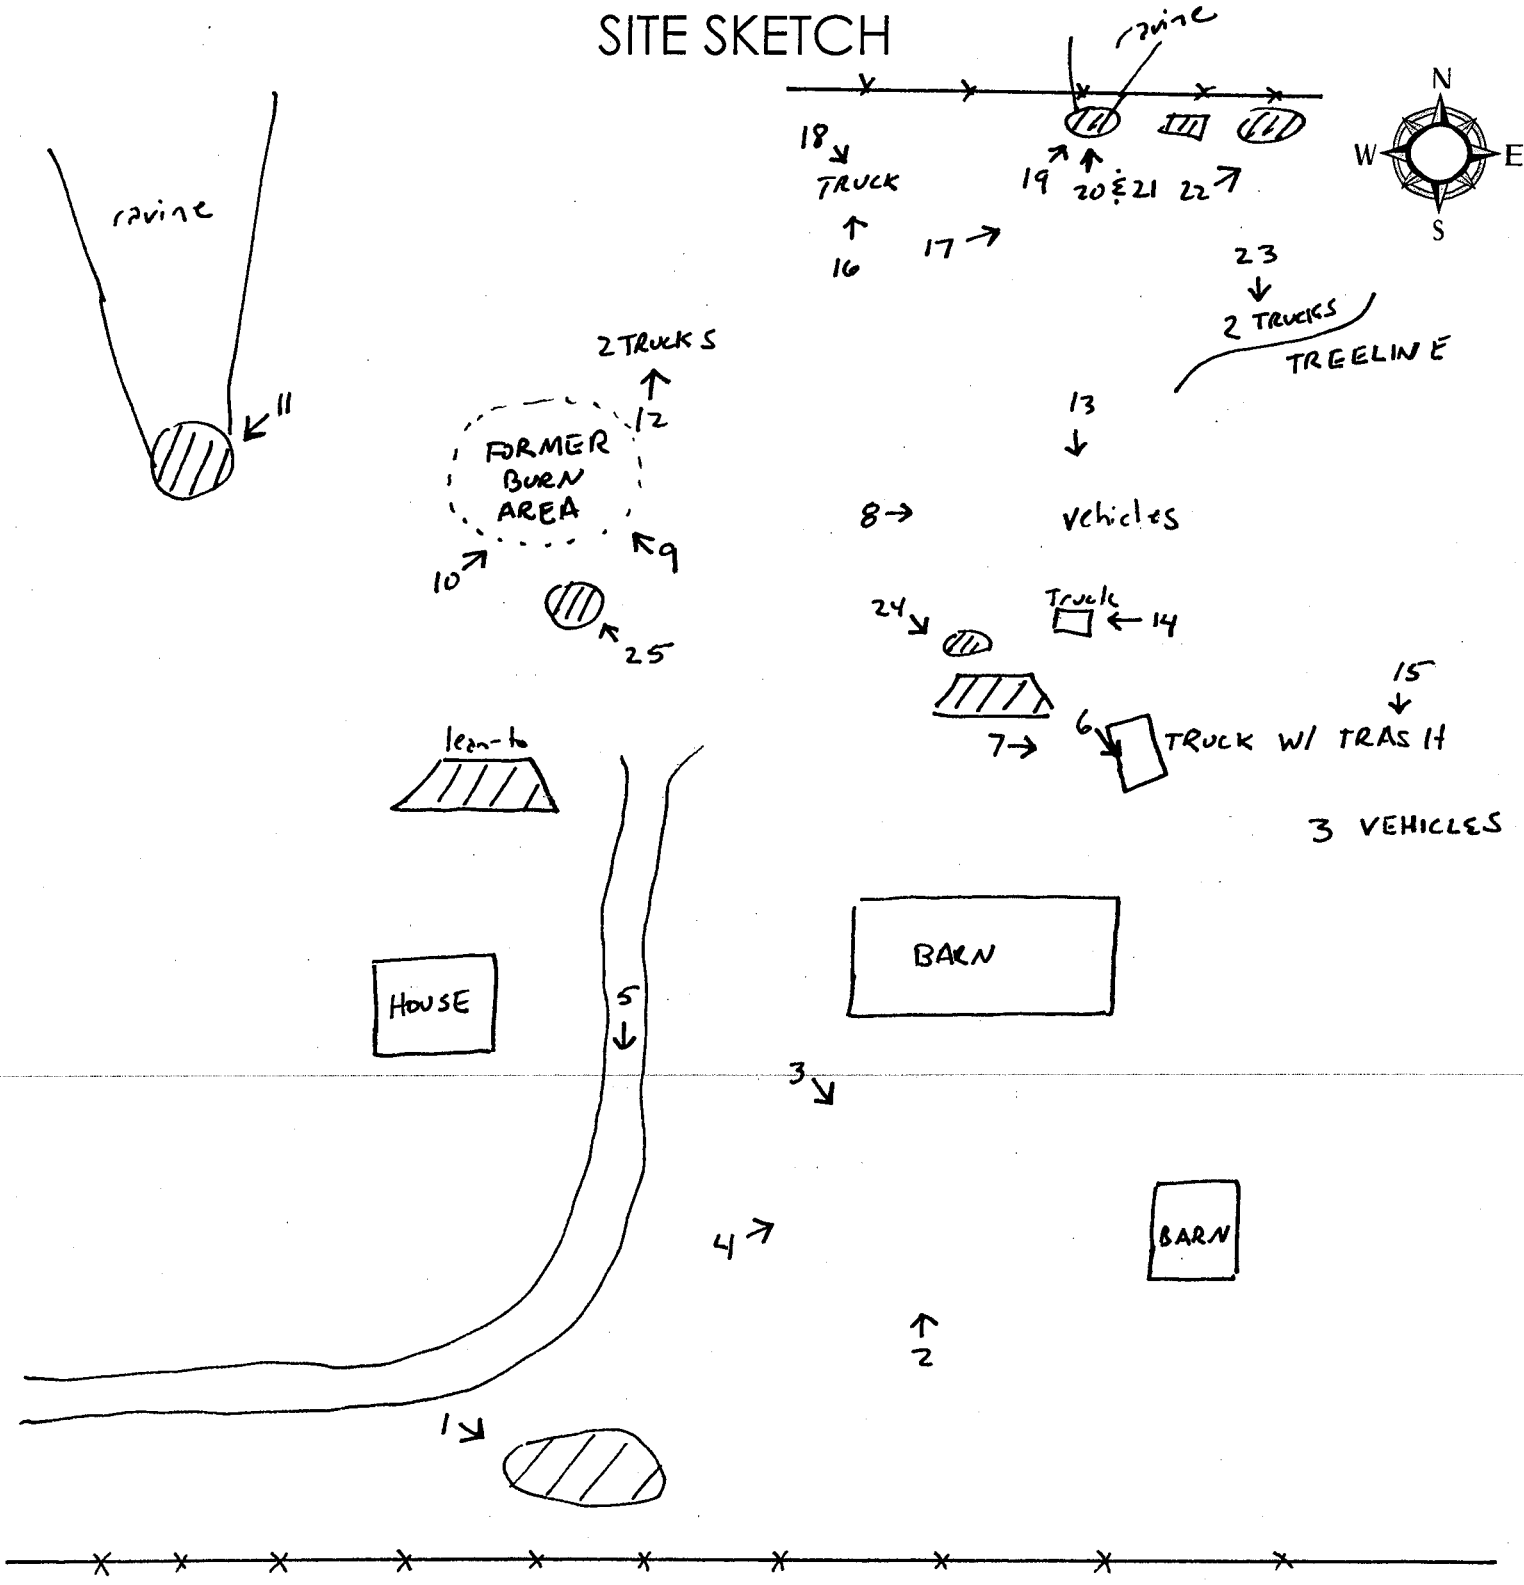
### SITE SKETCH

2 May 2005 Inspection  
Measurements Approximate  
Direction of Photo ➔  
Not to Scale

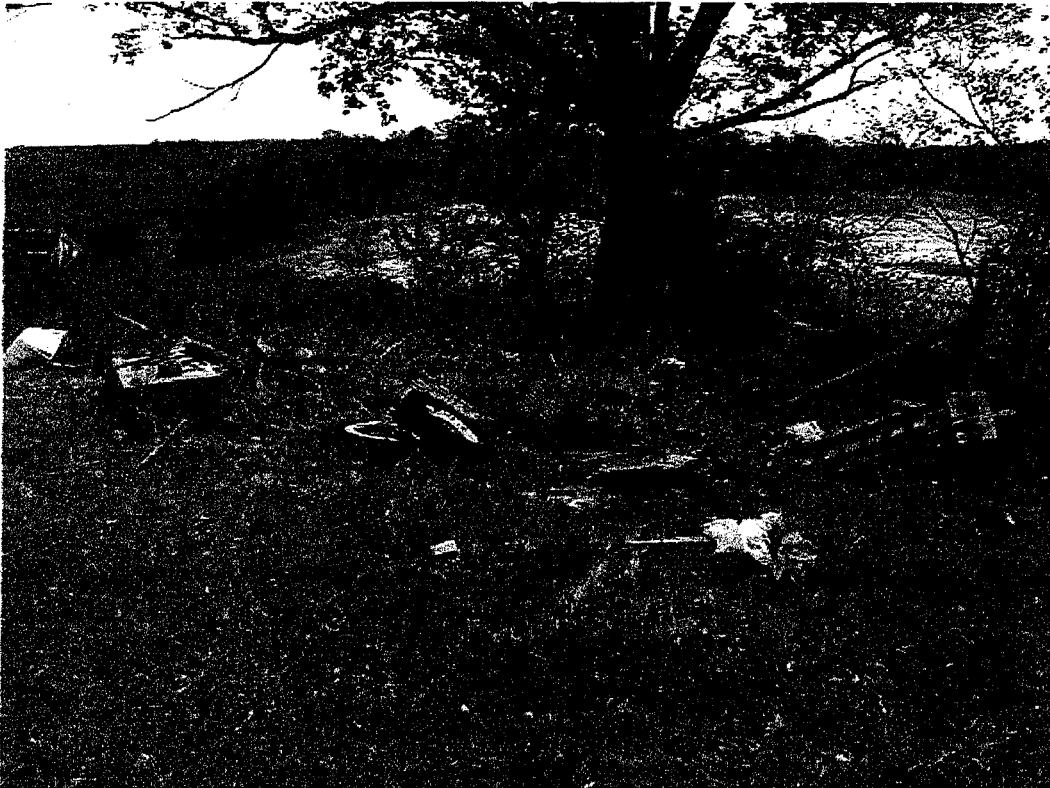
**Date:** 2 May 2005  
**Time:** 1:17 pm  
**Direction:** SE  
**Photo by:** M. Cozadd  
**Exposure #:** 001  
**Comments:** Scrap metal, used tires, damaged dimensional lumber and other miscellaneous debris

Upon arrival at the site on May 2, 2005, I called Mr. Tedrow (217.833.2565) and spoke to his son who informed us that Mr. Tedrow was not able to meet with us. After the phone call, Mr. Zierath and I proceeded with the inspection. The area on the south side of the property was inspected first. The attached photo #001 shows a small amount of scrap metal, two used tires and other miscellaneous debris scattered on the ground. Scrap metal, an animal carcass, and used tires were observed in the front yard as illustrated in the attached photo #001 through #005. During the March 29, 2005 inspection, a pickup truck full of trash was parked just south of the barn. The attached photo #002 shows the area just east of the house where the pickup truck was located. The pickup truck had been removed from the site. At the conclusion of the inspection, we drove by Mr. Tedrow's property to the north and I observed the pickup truck on his property. The bed of the truck was still full of trash. An Area Disposal dumpster was observed near the truck.

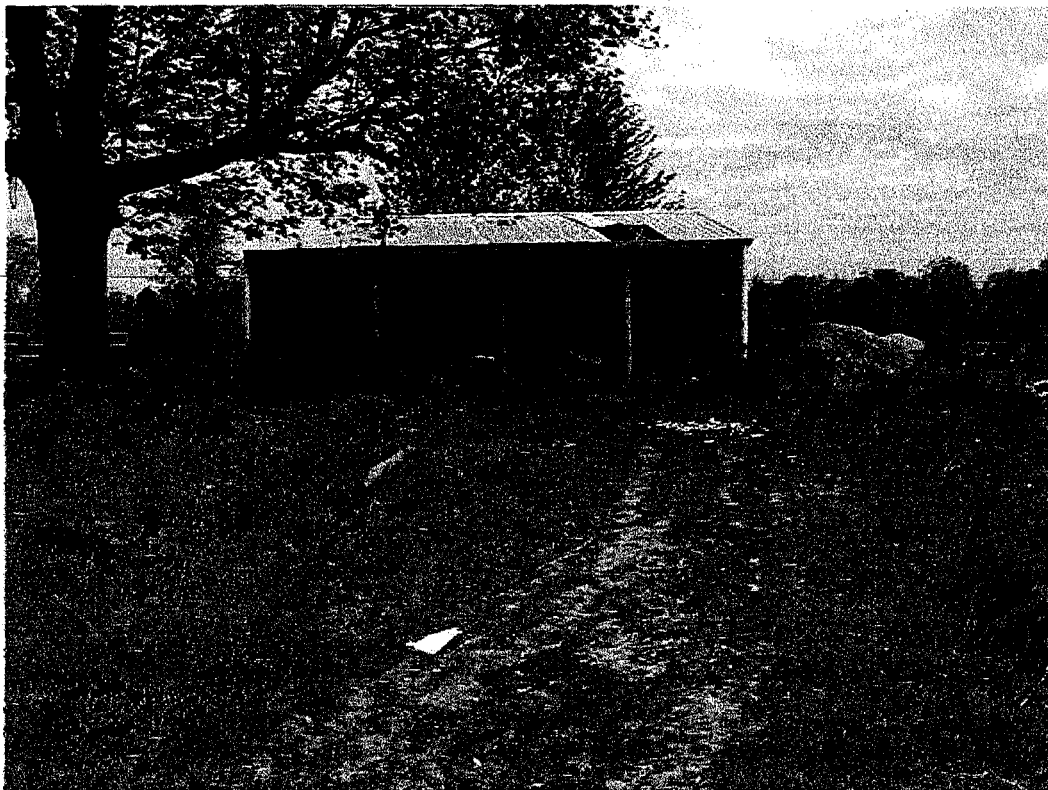
**Date:** 2 May 2005  
**Time:** 1:18 pm  
**Direction:** N  
**Photo by:** M. Cozadd  
**Exposure #:** 002  
**Comments:** Area where pickup truck full of trash was located during the March 29, 2005 inspection. Aluminum cans piled on ground. Scrap metal near tree on left side of photo.

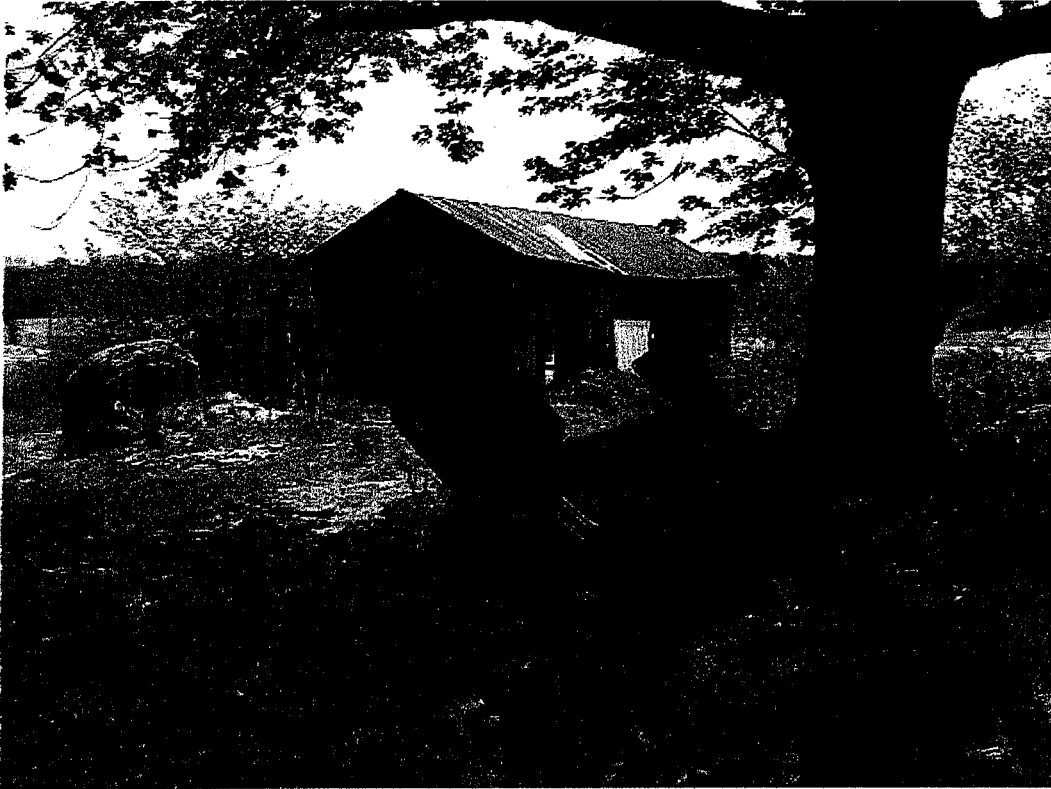
**Date:** 2 May 2005  
**Time:** 1:18 pm  
**Direction:** SE  
**Photo by:** M. Cozadd  
**Exposure #:** 003  
**Comments:** Scrap metal  
near tree

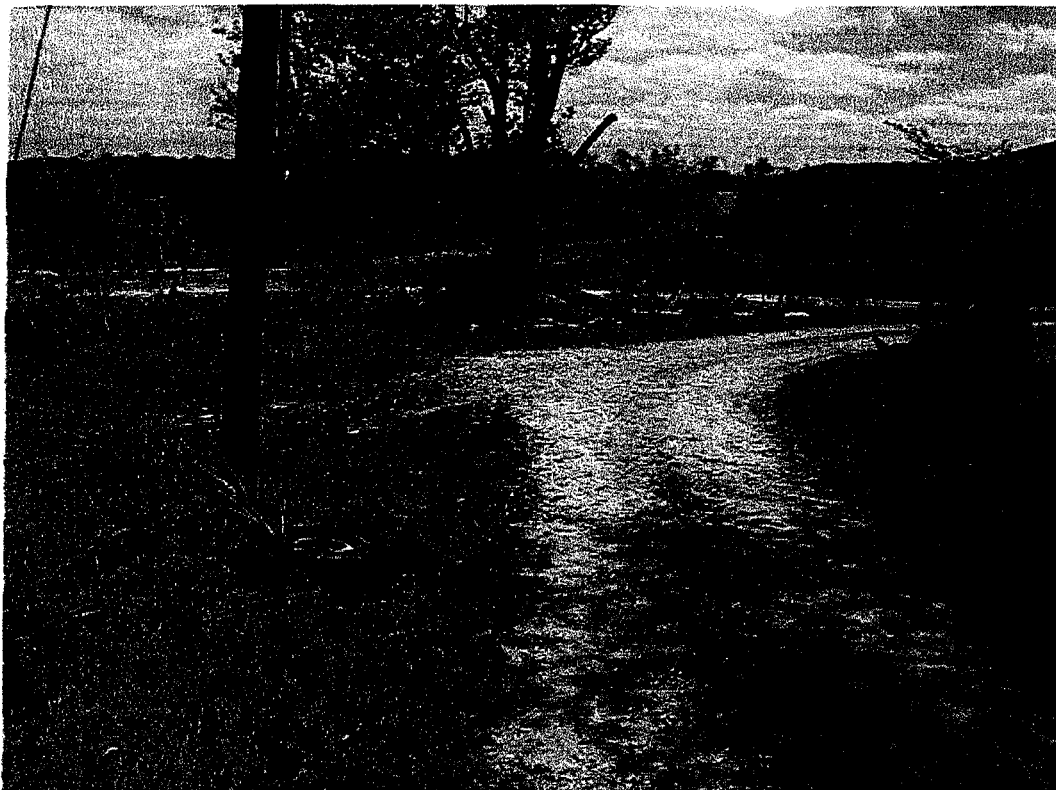
**Date:** 2 May 2005  
**Time:** 1:19 pm  
**Direction:** S  
**Photo by:** M. Cozadd  
**Exposure #:** 005  
**Comments:** Used tire just south of animal carcass in front yard. Pike County Landfill in background.

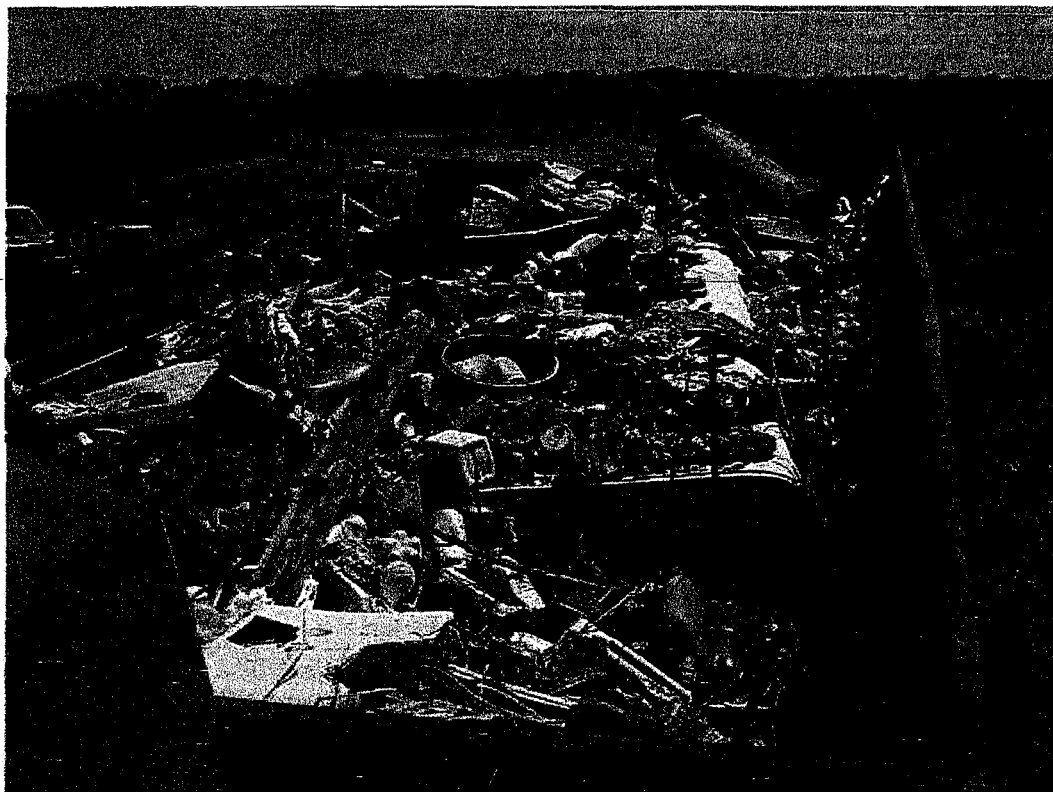
During the March 29, 2005 inspection, I observed a second truck with the truck bed full of trash on the north side of the house. This same truck was observed at the site during the May 2, 2005 inspection but now was located north of the barn. The attached photo #006 shows the contents of the truck bed. The same waste was still present in the truck bed since the previous inspection. An overview of this second truck filled with trash is shown in the attached photo #007.

**Date:** 2 May 2005  
**Time:** 1:21 pm  
**Direction:** SE  
**Photo by:** M. Cozadd  
**Exposure #:** 006  
**Comments:** Close-up of trash in bed of truck is same trash as observed in the truck bed during the March 29, 2005 inspection. Location of the truck at the site is the only difference.

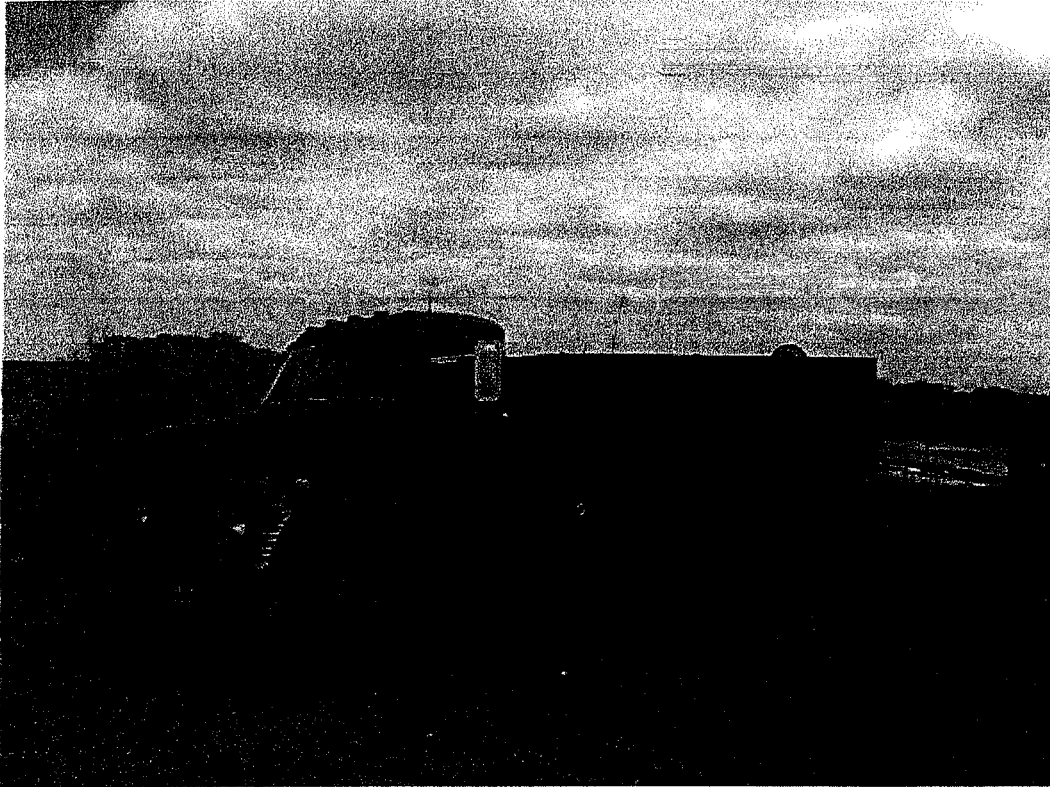
**Date:** 2 May 2005  
**Time:** 1:21 pm  
**Direction:** SE  
**Photo by:** M. Cozadd  
**Exposure #:** 007  
**Comments:** Overview of  
truck filled with trash

The vehicles observed during the inspection appear to have been abandoned. The Illinois Vehicle Code defines an "abandoned vehicle" as any vehicle in a state of disrepair rendering the vehicle incapable of being driven in its condition or any vehicle that has not been moved or used for seven consecutive days or more and is apparently deserted. The abandoned vehicles observed during the inspection would be considered "discarded material" and therefore waste. "Waste" is defined in Section 3.535 of the [Illinois] Environmental Protection Act as any "garbage...or other discarded material, including solid, liquid, semi-solid, or contained gaseous material..." All the abandoned vehicles and discarded farm equipment must be removed from the site and disposed of properly.

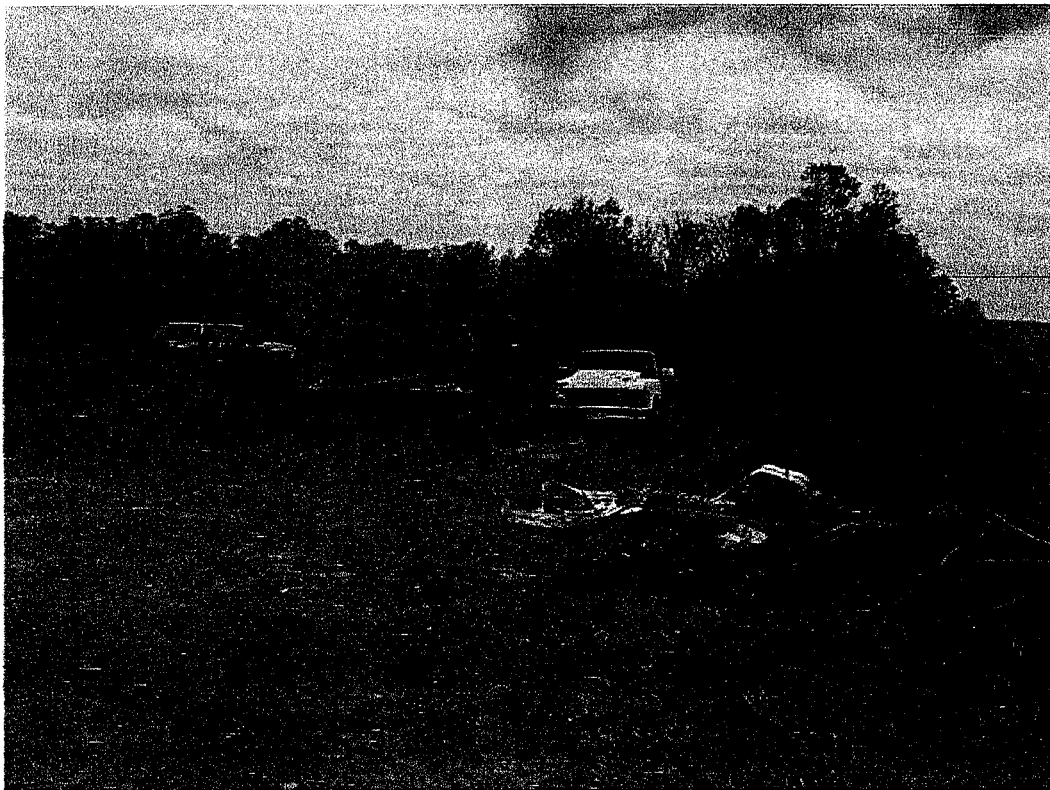
The burn area on the west side of the site had been cleaned up as shown in the attached photos #008 through #010. This office received the attached disposal receipts on May 4, 2005. The receipts indicate that 14.62 tons of debris was disposed at Pike County Landfill on April 30, 2005.

**Date:** 2 May 2005  
**Time:** 1:21 pm  
**Direction:** E  
**Photo by:** M. Cozadd  
**Exposure #:** 008  
**Comments:** Vehicles,  
and farm equipment  
north of truck filled with  
trash

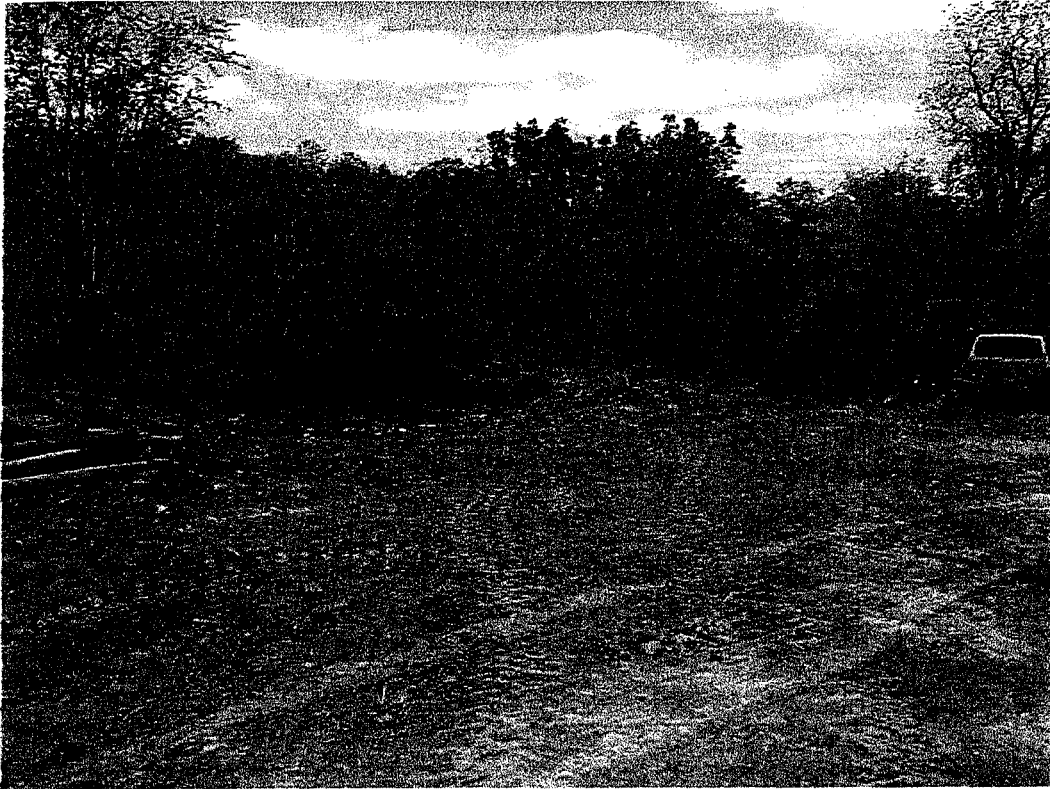
**Date:** 2 May 2005  
**Time:** 1:22 pm  
**Direction:** NW  
**Photo by:** M. Cozadd  
**Exposure #:** 009  
**Comments:** Overview of former burn area

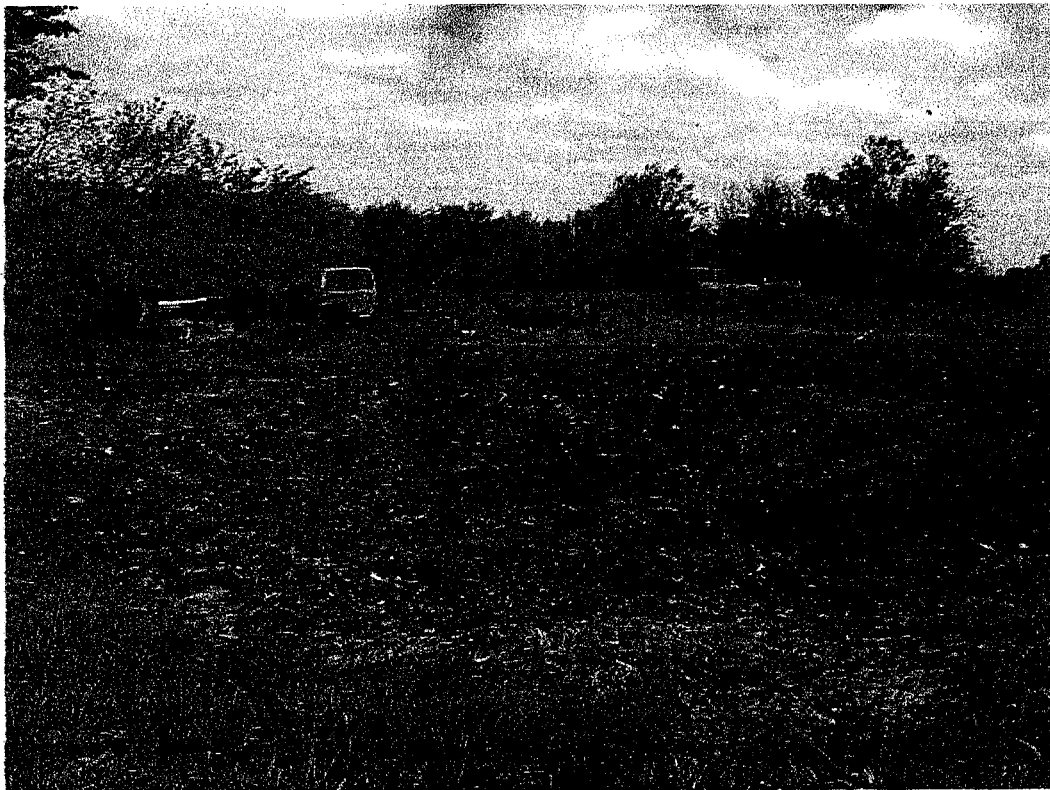
**Date:** 2 May 2005  
**Time:** 1:22 pm  
**Direction:** NE  
**Photo by:** M. Cozadd  
**Exposure #:** 010  
**Comments:** Overview of former burn area. Vehicles observed in the background

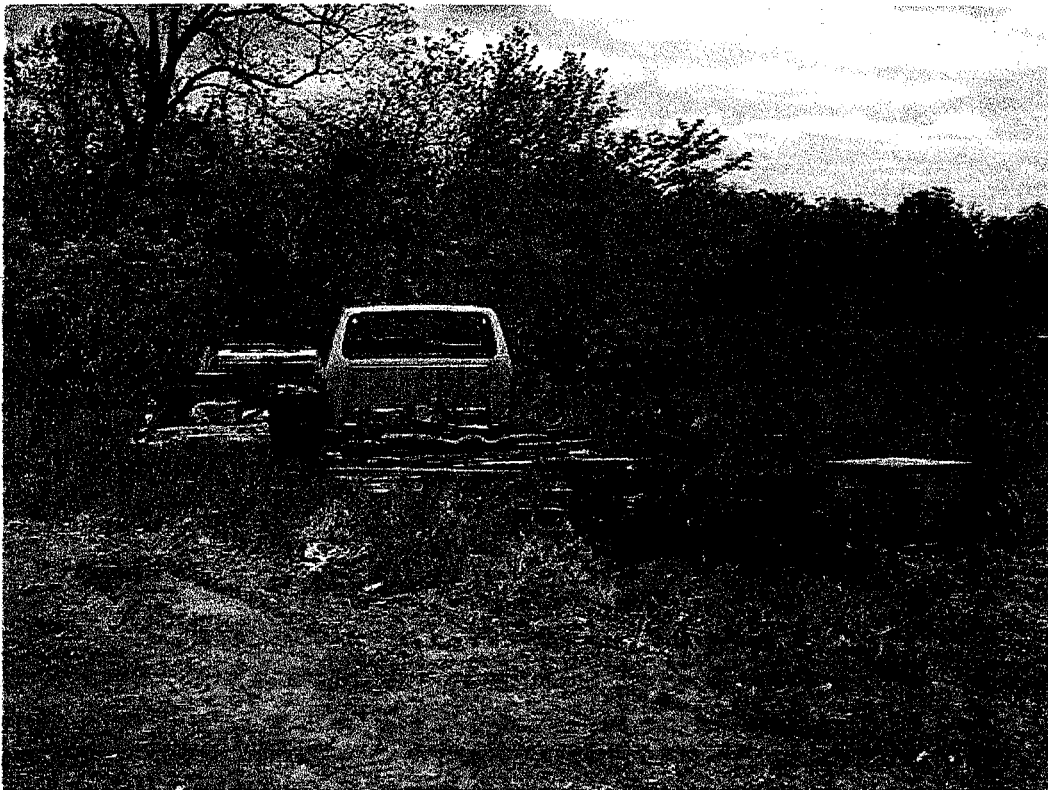
Vehicles at the site are shown in the attached photos #007 through #010, #012 through #018, and #023 through #024. A close-up of used tires and scrap metal in the bed of the blue pickup is shown in the attached photo #014. All the vehicles appear unchanged with four exceptions. One small red compact car is no longer present at the site. The large red truck full of trash is north of the barn (see attached photo #007). The small pickup full of trash in the front yard is now across the road. Lastly, a van and two cars were moved from the center of the site to the east side of the barn (see attached photo #015).

**Date:** 2 May 2005  
**Time:** 1:24 pm  
**Direction:** N  
**Photo by:** M. Cozadd  
**Exposure #:** 012  
**Comments:** Two trucks  
and metal fencing north  
of former burn area

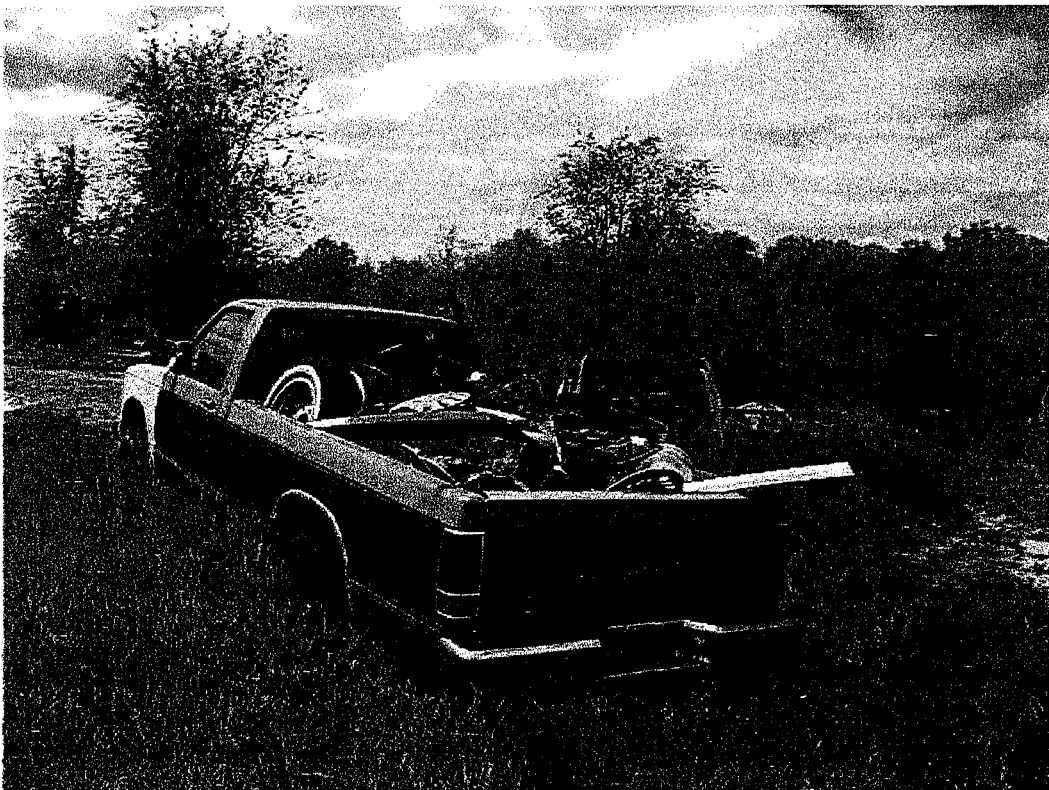
**Date:** 2 May 2005  
**Time:** 1:26 pm  
**Direction:** W  
**Photo by:** M. Cozadd  
**Exposure #:** 014  
**Comments:** Close-up of  
used tires and scrap  
metal in the bed of blue  
pickup truck

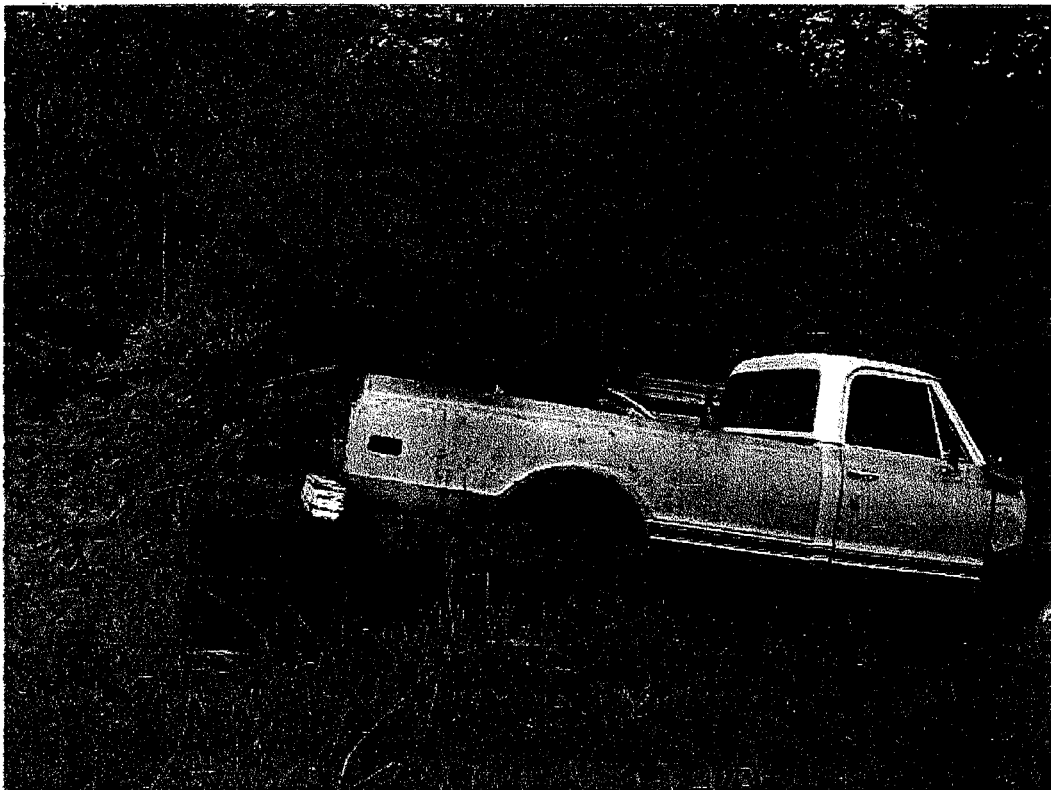
The north end of the property was inspected next. There appeared to be no change in the condition of this area. The attached photos #016 through #023 show the vehicles, parts of vehicles, used tires, scrap metal, shelters of corrugated metal sheeting, discarded farm equipment and other miscellaneous waste. A used tire was observed in the back of a truck as shown in the attached photo #018. The truck did not have an engine or front end. Scrap metal, corrugated metal sheeting, wood posts, two used tires, an extension cord, wire, shingles and damaged dimensional lumber were piled at the entrance to an erosion channel (see attached photos #019 - #021). The two trucks in the attached photo #023 have not moved since the March 29, 2005 inspection.

**Date:** 2 May 2005  
**Time:** 1:30 pm  
**Direction:** NE  
**Photo by:** M. Cozadd  
**Exposure #:** 016  
**Comments:** Truck body on north side of pasture

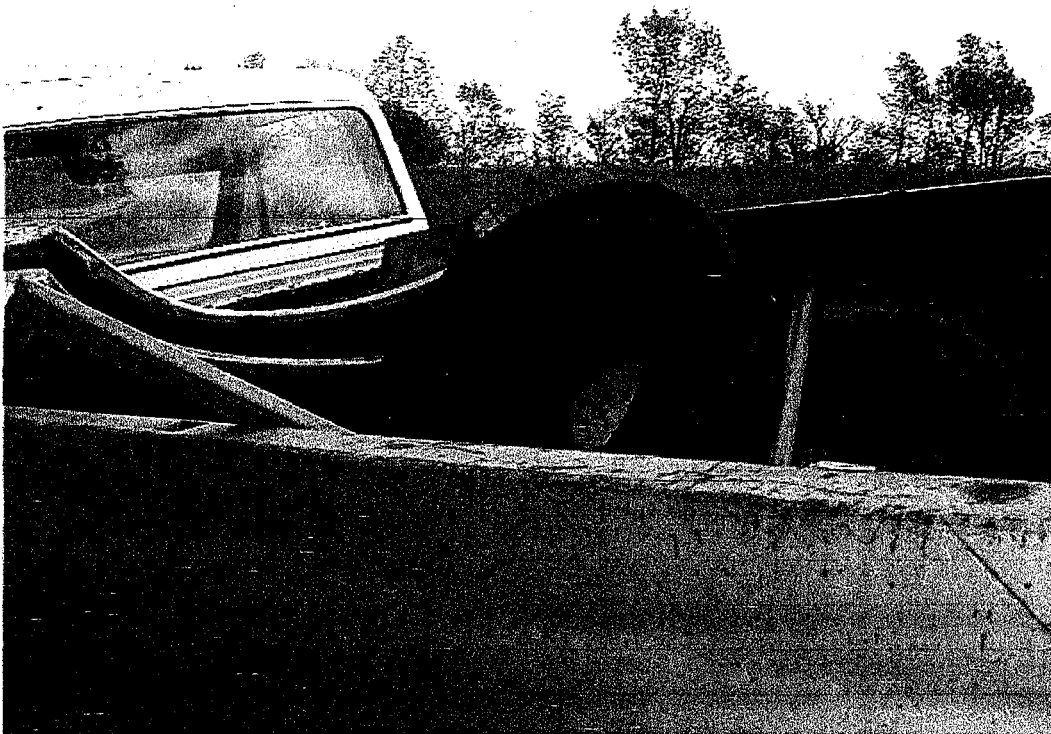
**Date:** 2 May 2005  
**Time:** 1:30 pm  
**Direction:** SE  
**Photo by:** M. Cozadd  
**Exposure #:** 018  
**Comments:** Used tire in bed of truck on north side of pasture

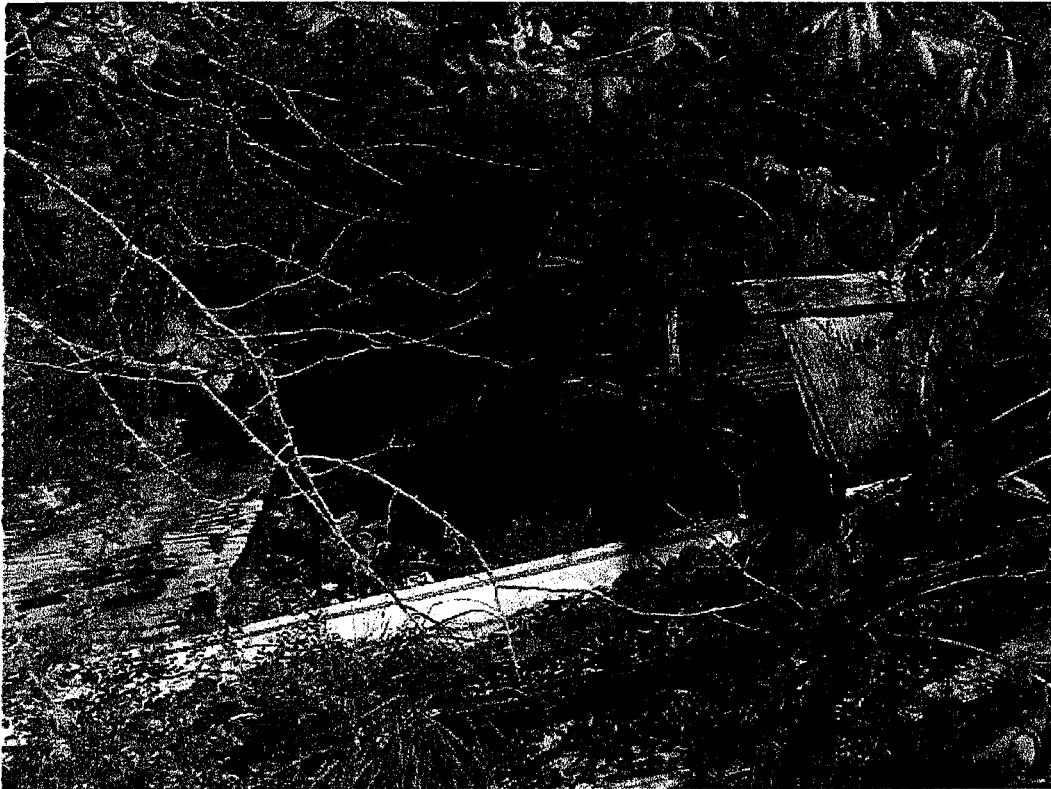
**Date:** 2 May 2005  
**Time:** 1:32 pm  
**Direction:** NE  
**Photo by:** M. Cozadd  
**Exposure #:** 019  
**Comments:** Scrap metal, corrugated metal sheeting, wood posts, two used tires, extension cord, wire, shingles and damaged dimensional lumber near entrance to a ravine on north side of pasture

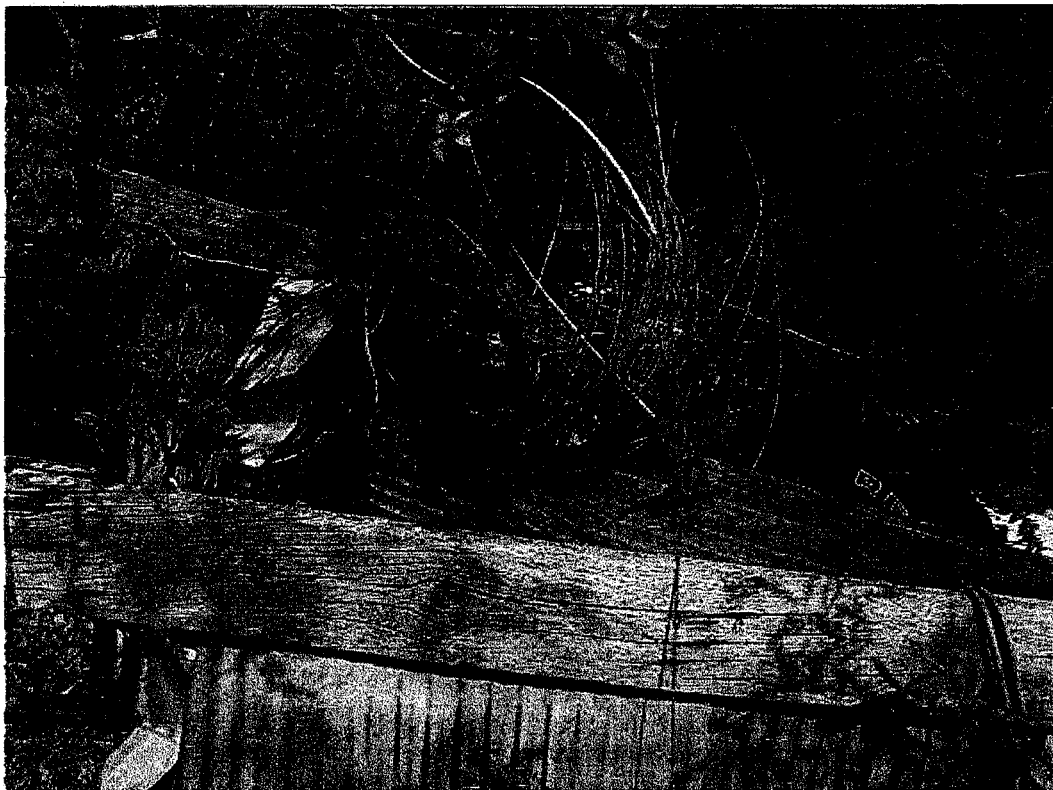
**Date:** 2 May 2005  
**Time:** 1:32 pm  
**Direction:** N  
**Photo by:** M. Cozadd  
**Exposure #:** 020  
**Comments:** Scrap metal, corrugated metal sheeting, wood posts, two used tires, extension cord, wire, shingles and damaged dimensional lumber near entrance to a ravine on north side of pasture

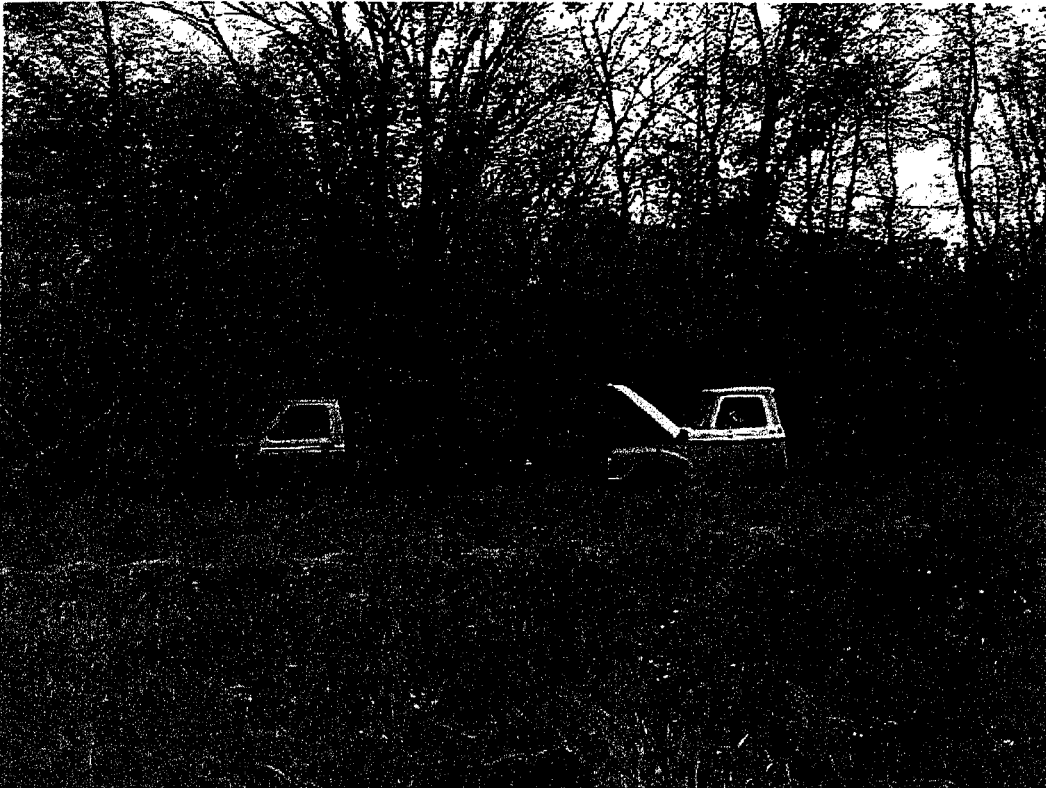
Date: 2 May 2005  
Time: 1:36 pm  
Direction: S  
Photo by: M. Cozadd  
Exposure #: 023  
Comments: Twp trucks  
on east side of pasture

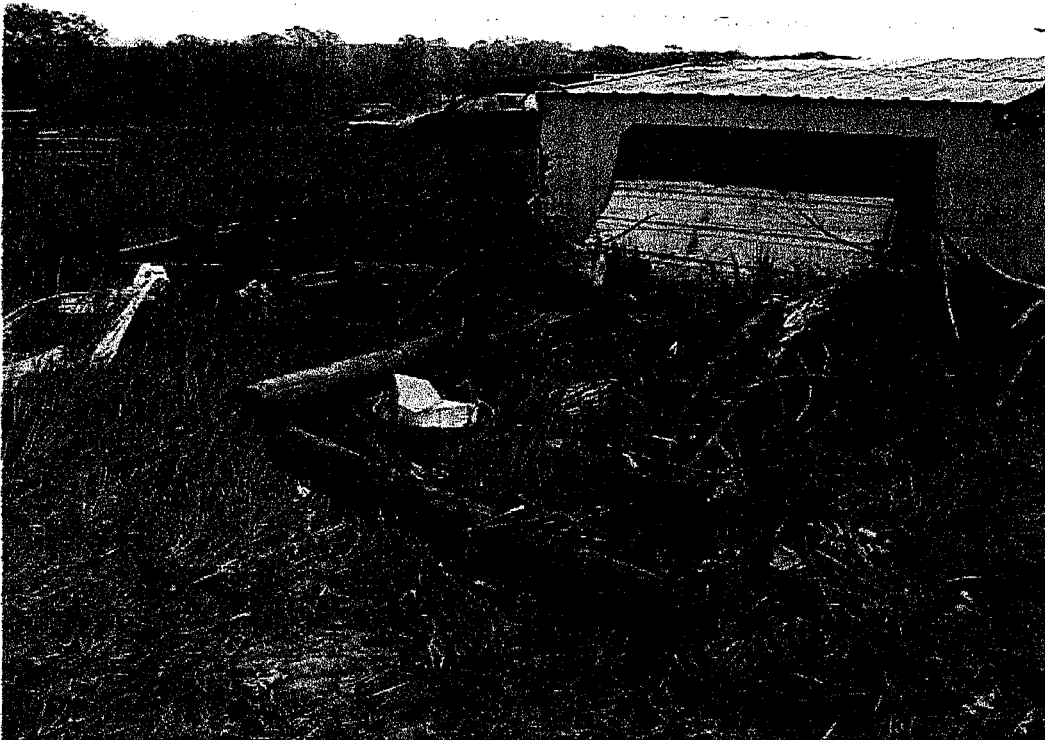
Date: 2 May 2005  
Time: 1:39 pm  
Direction: SE  
Photo by: M. Cozadd  
Exposure #: 024  
Comments: Wood  
poles, used tire and axle  
in back of lean-to

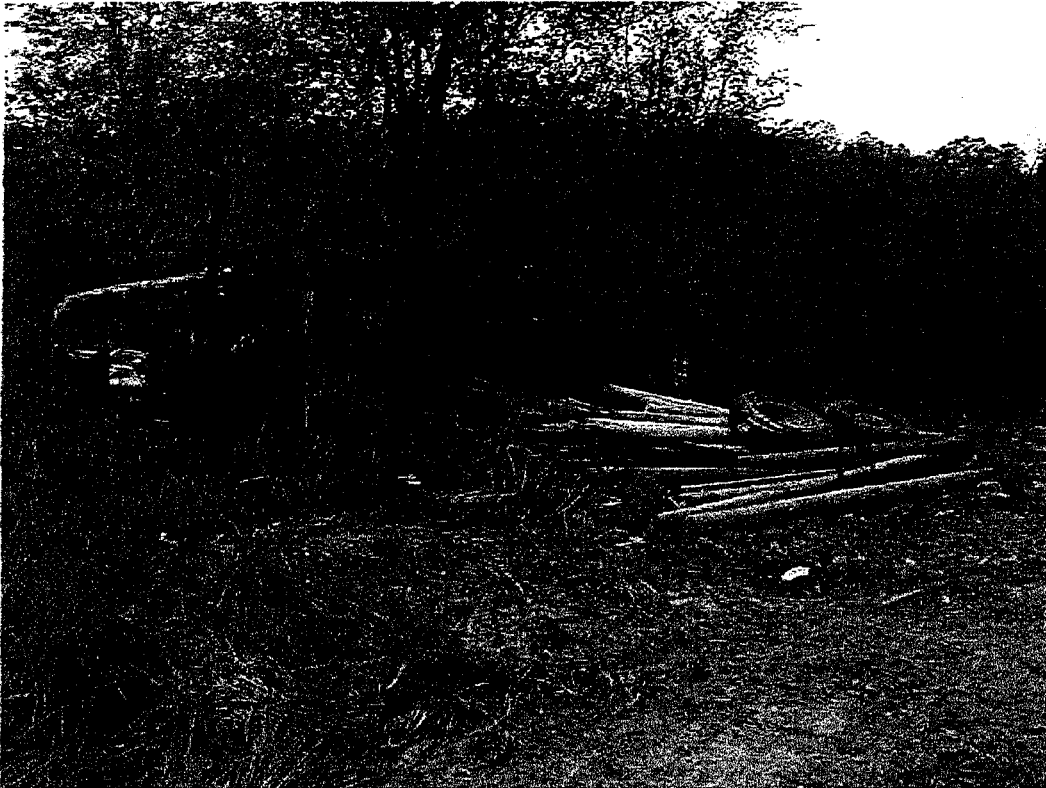
The attached photo #025 shows used tires, wood posts, and scrap metal piled just south of the former burn area.

**Date:** 2 May 2005  
**Time:** 1:39 pm  
**Direction:** NW  
**Photo by:** M. Cozadd  
**Exposure #:** 025  
**Comments:** Used tires,  
wood posts and scrap  
metal south of former  
burn area
