ILLINOIS ENVIRONMENTAL PROTECTION AGENCY
Open Dump Inspection Checklist

SUBJECT: LPC # 1498130002 -Pike County
Martinsburg Township/Spradlin
C-11-125-C
FOS File

NARRATIVE RE-INSPECTION REPORT DOCUMENT

Site name: Martinsburg Township/Spradlin County: Pike County
 LPC #: 1498130002 Date: November 3, 2011
 Inspector: Charlie King Time: 12:25 p.m. – 12:50 p.m.
 FOS File

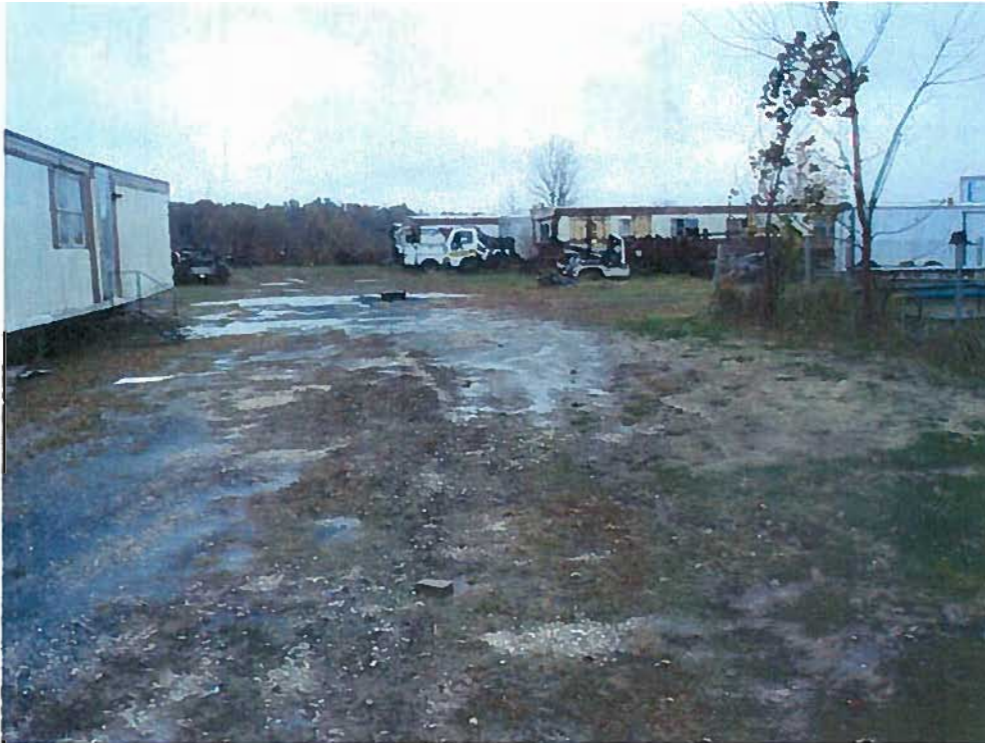
Date: November 3, 2011
Time: 12:35 p.m.
Direction: N
Photo by: Charlie King
Exposure #: 001
Comments: The drive becomes the access road into the property.

Used tires can be seen on the ground and on a hauling trailer.

Parked on-site were several mobile homes, trucks, a Bobcat loader and hauling trailers.

Photo # 001 shows the drive that becomes the access road into the property. Used tires can be seen on the ground and on a hauling trailer. Parked on-site were several mobile homes, trucks, a Bobcat loader and hauling trailers.

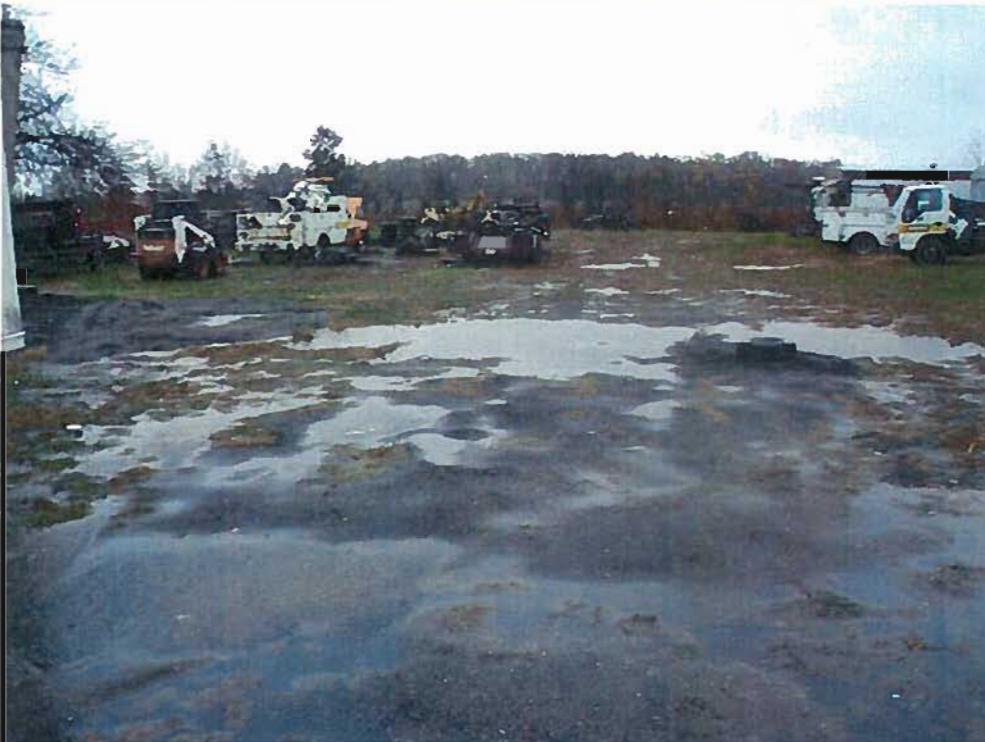
Date: November 3, 2011
Time: 12:36 p.m.
Direction: N
Photo by: Charlie King
Exposure #: 002
Comments: Further into the site access road than in photo # 001.

Used tires can be seen on the ground and on a hauling trailer.

Photo # 002 shows further into the site access road. Used tires can be seen on the ground and on a hauling trailer. The vehicles parked on-site mentioned in the photo description of photo # 001, above, are also shown in this photo.

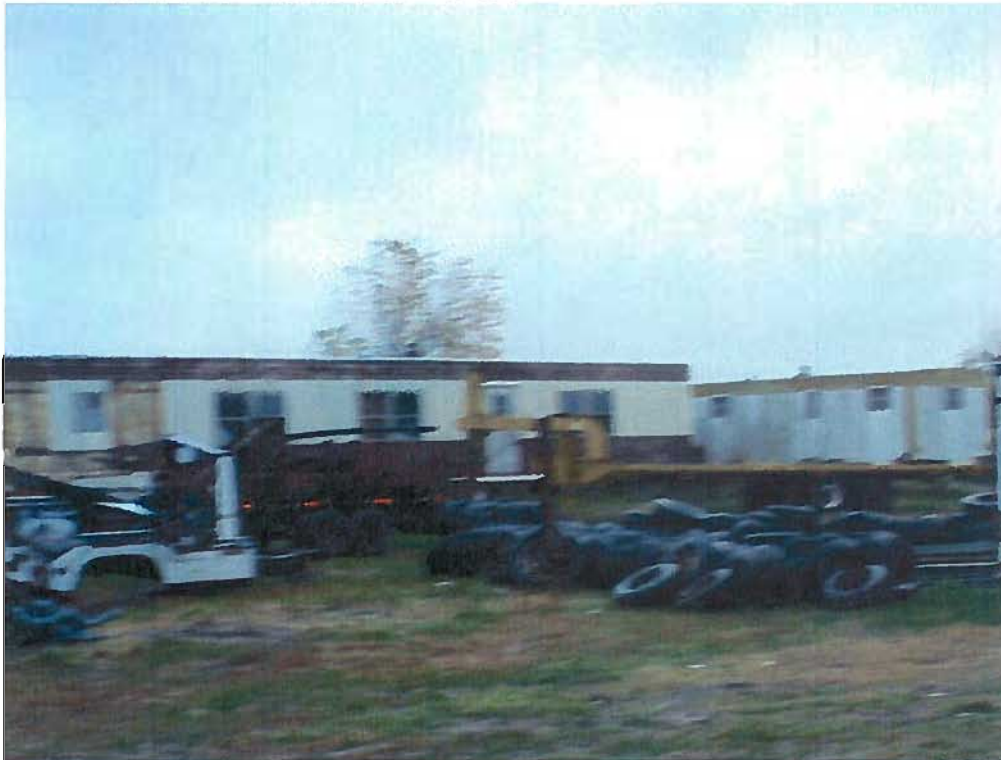
Date: November 3, 2011
Time: 12:36 p.m.
Direction: NE
Photo by: Charlie King
Exposure #: 003
Comments: These used tires were found to be on-rim.

Photo # 003 shows these used tires were found to be on-rims.

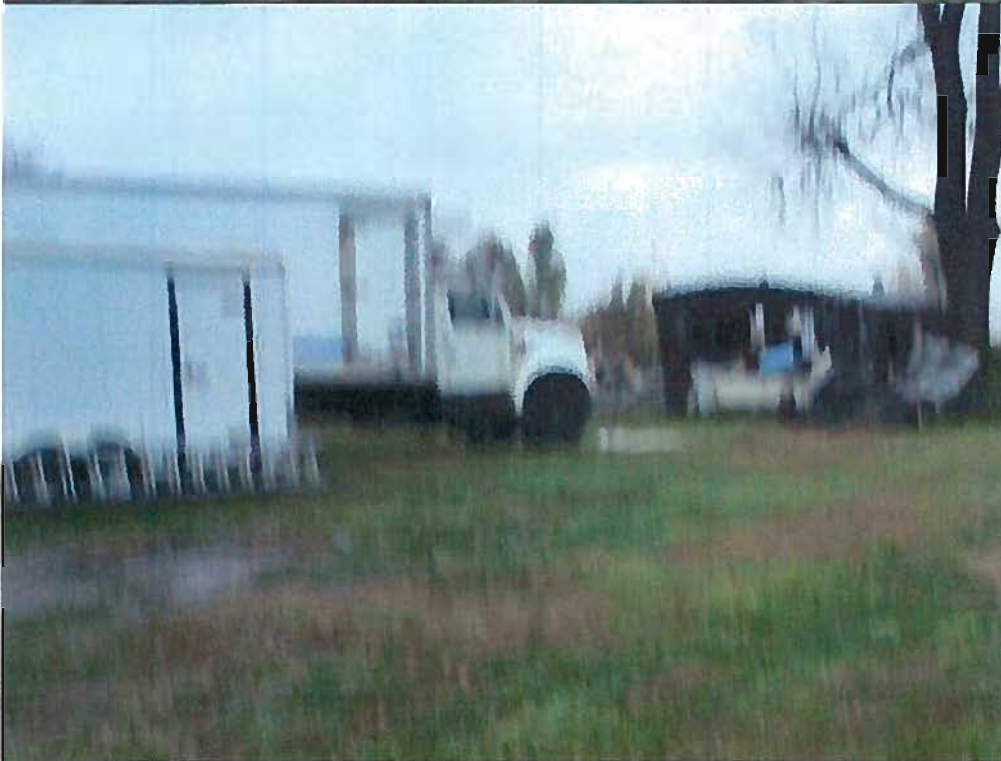
Date: November 3, 2011
Time: 12:36 p.m.
Direction: E
Photo by: Charlie King
Exposure #: 004
Comments: A partially demolished mobile home is at right. Although blurred, enough of the mobile home at right can be seen to verify that the end is missing, and items inside of the mobile home can be seen from this photo.

Photo # 004 shows a partially demolished mobile home at right. Although blurred, enough of the mobile home at right can be seen to verify that the end is missing, and items inside of the mobile home can be seen from this photo.

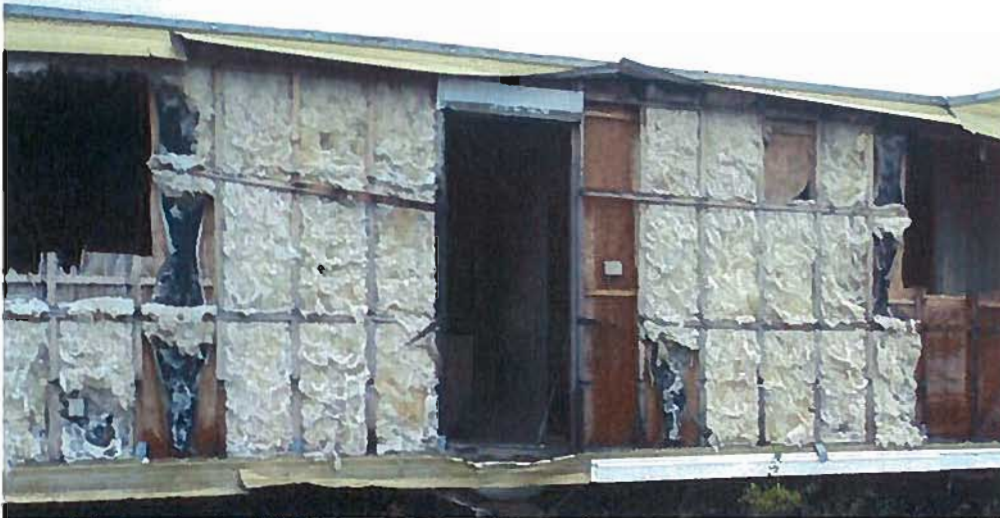
Date: November 3,
2011
Time: 12:37 p.m.
Direction: NE
Photo by: Charlie King
Exposure #: 005
Comments: A partially
stripped mobile home.

Photo # 005 shows a partially stripped mobile home.

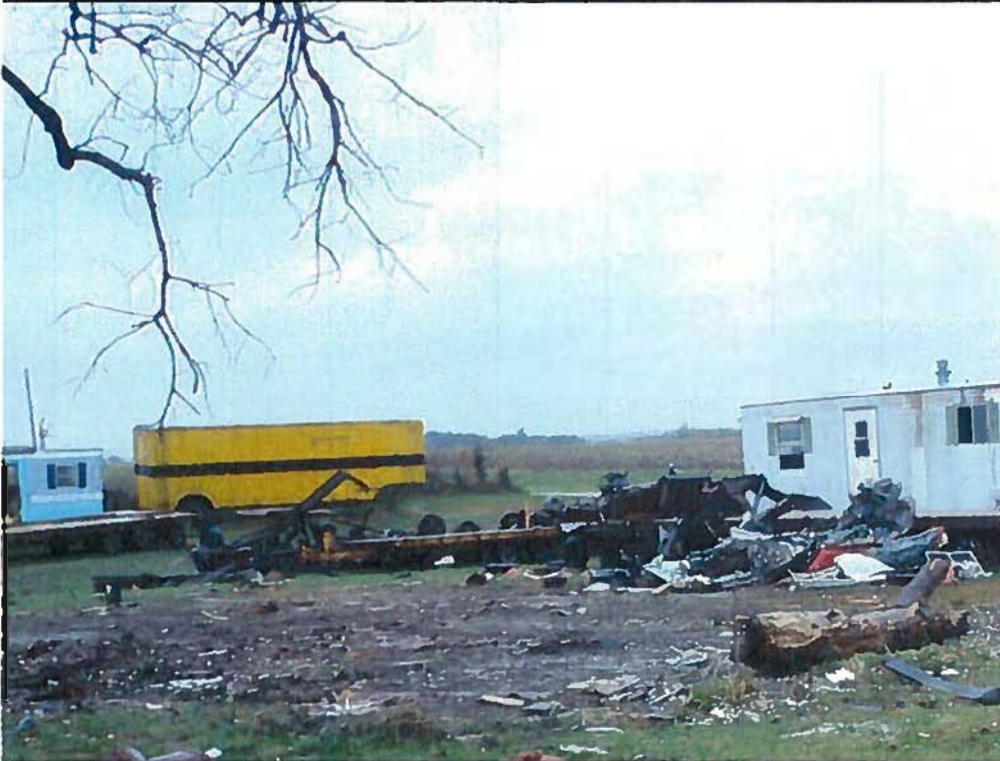
Date: November 3,
2011
Time: 12:37 p.m.
Direction: NE
Photo by: Charlie King
Exposure #: 006
Comments: Wastes,
including used tires,
can be seen on the
ground. An apparently
uninhabited mobile
home can be seen at
right.

Photo # 006 shows wastes, including used tires, on the ground. An apparently uninhabited mobile home can be seen at right.

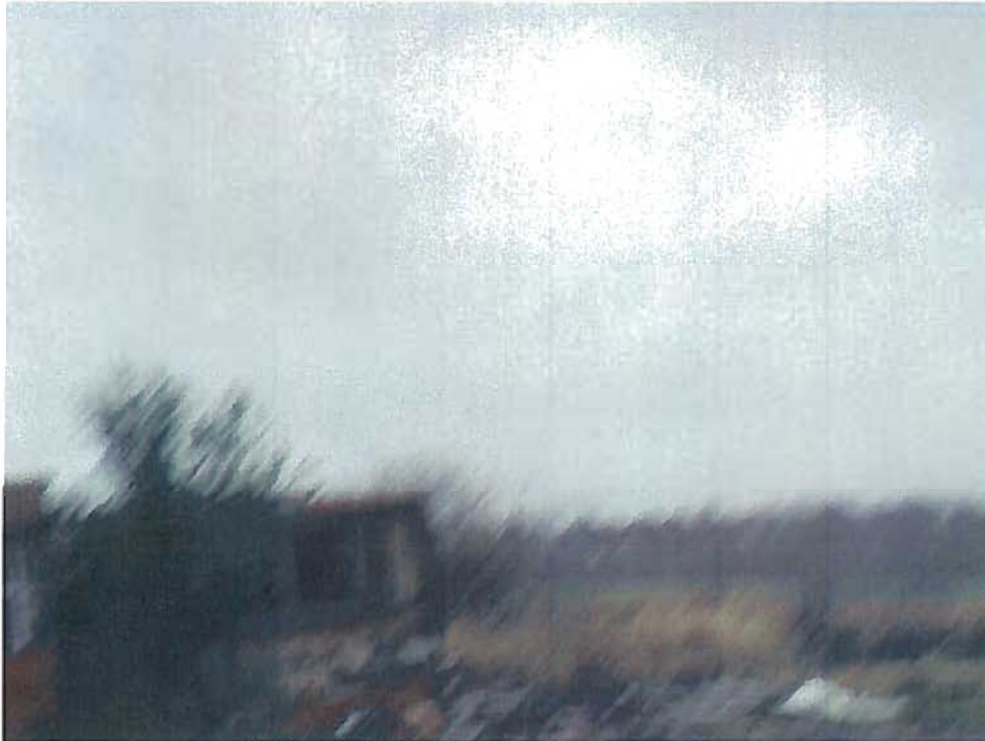
Date: November 3, 2011
Time: 12:37 p.m.
Direction: N
Photo by: Charlie King
Exposure #: 007
Comments: A very blurry photograph was supposed to show a mobile home.

Photo # 007 is a very blurry photograph that was supposed to show a mobile home.

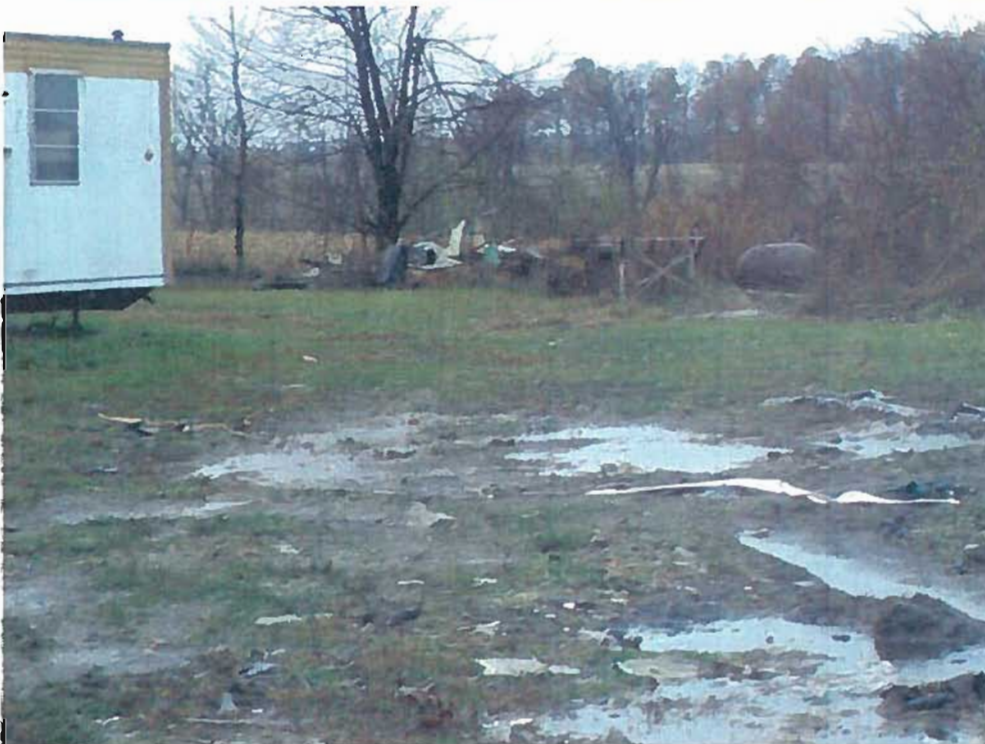
Date: November 3, 2011
Time: 12:38 p.m.
Direction: NE
Photo by: Charlie King
Exposure #: 008
Comments: A small pile of wastes measuring approximately 20' x 15' x 2', and consisting primarily of metals, plastics and wood wastes.

Photo # 008 shows a small pile of wastes measuring approximately 20' x 15' x 2', and consisting primarily of metals, plastics and wood wastes.

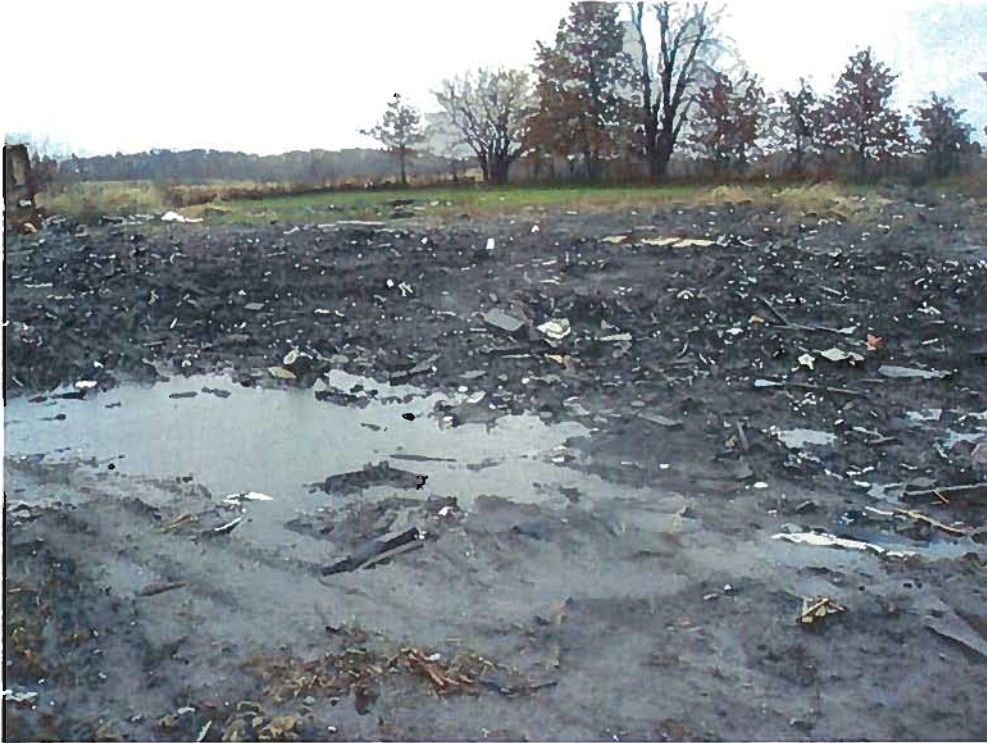
Date: November 3, 2011
Time: 12:38 p.m.
Direction: E
Photo by: Charlie King
Exposure #: 009
Comments: Scattered demolition wastes, including wastes in standing water.

Photo # 009 shows scattered demolition wastes, including wastes in standing water.

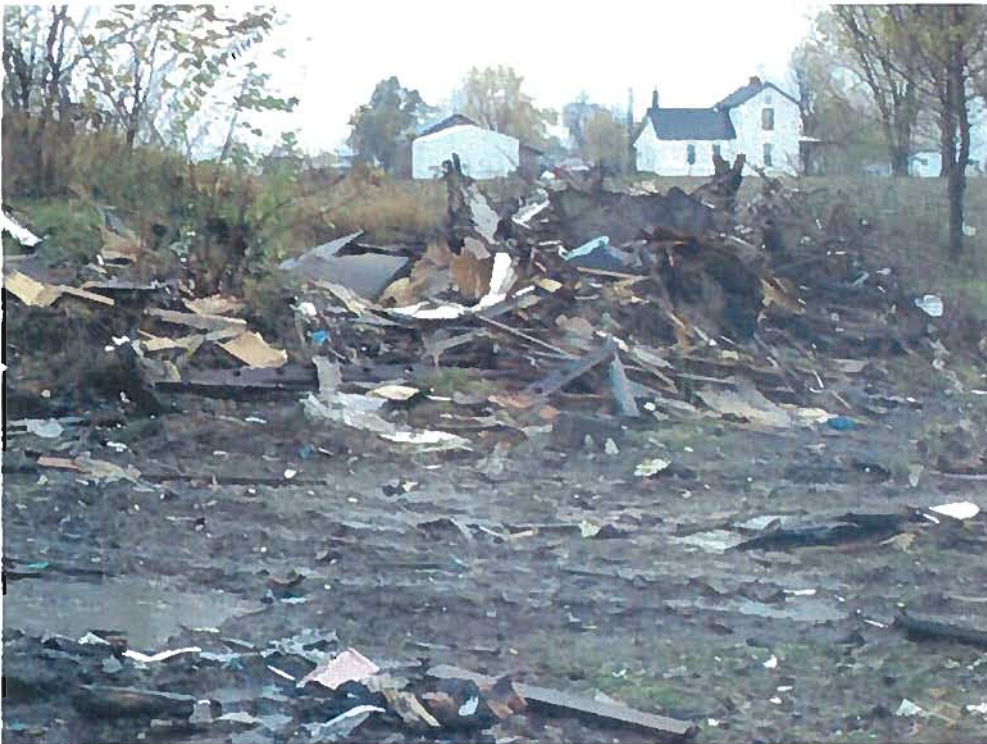
Date: November 3, 2011
Time: 12:38 p.m.
Direction: E
Photo by: Charlie King
Exposure #: 010
Comments: Wastes measuring approximately 30' x 15' x 5' at the location of the old open dump pile observed during the Initial site inspection on June 29, 2011.

Photo # 010 shows wastes measuring approximately 30' x 15' x 5' at the location of the old open dump pile observed during the initial site inspection on June 29, 2011.

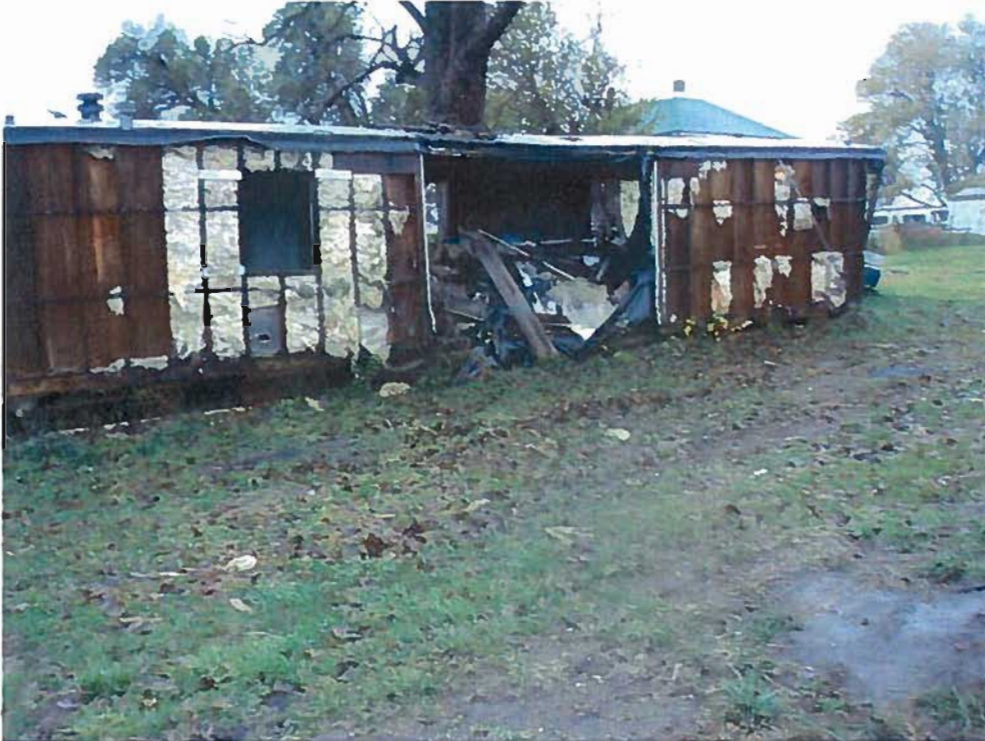
Date: November 3,
2011
Time: 12:37 p.m.
Direction: SW
Photo by: Charlie King
Exposure #: 011
Comments: A partially
stripped mobile home.

Photo # 011 shows a partially stripped mobile home.

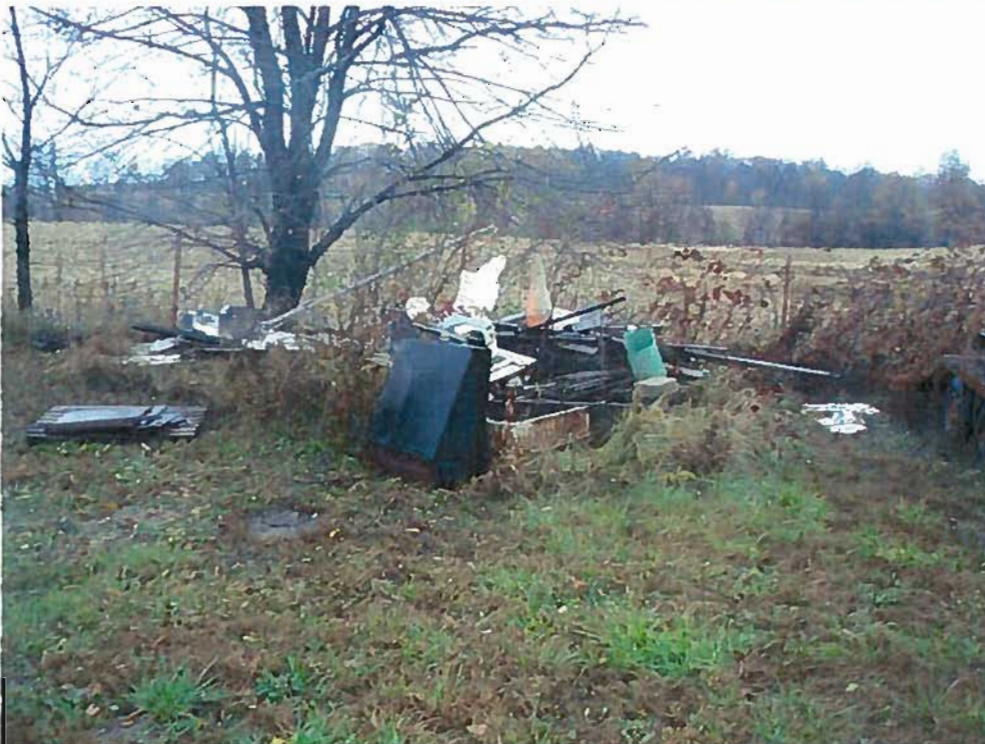
Date: November 3,
2011
Time: 12:39 p.m.
Direction: NW
Photo by: Charlie King
Exposure #: 012
Comments: The same
waste pile as shown in
photo # 008, only
closer.

Photo # 012 shows the same waste pile as shown in photo # 008, only closer.

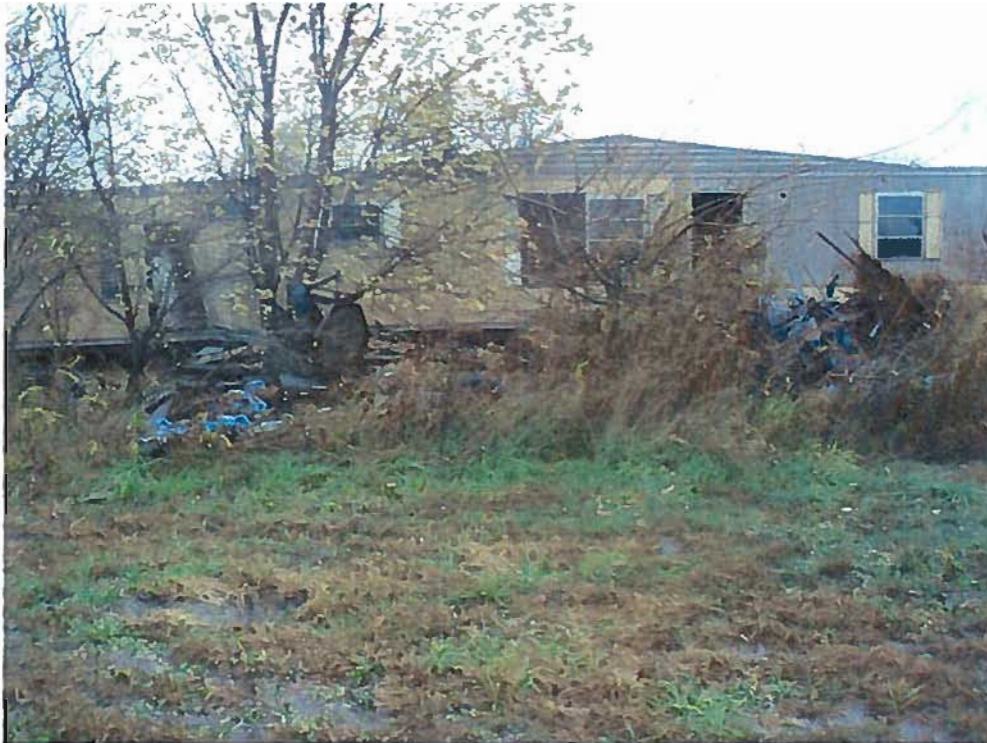
Date: November 3, 2011
Time: 12:39 p.m.
Direction: E
Photo by: Charlie King
Exposure #: 013
Comments: A pile of waste wood, tarps, metals and plastics measuring approximately 25' x 10' x 2', is shown just west of a partially stripped mobile home.

Photo # 013 shows a pile of waste wood, tarps, metals and plastics measuring approximately 25' x 10' x 2', just west of a partially stripped mobile home.

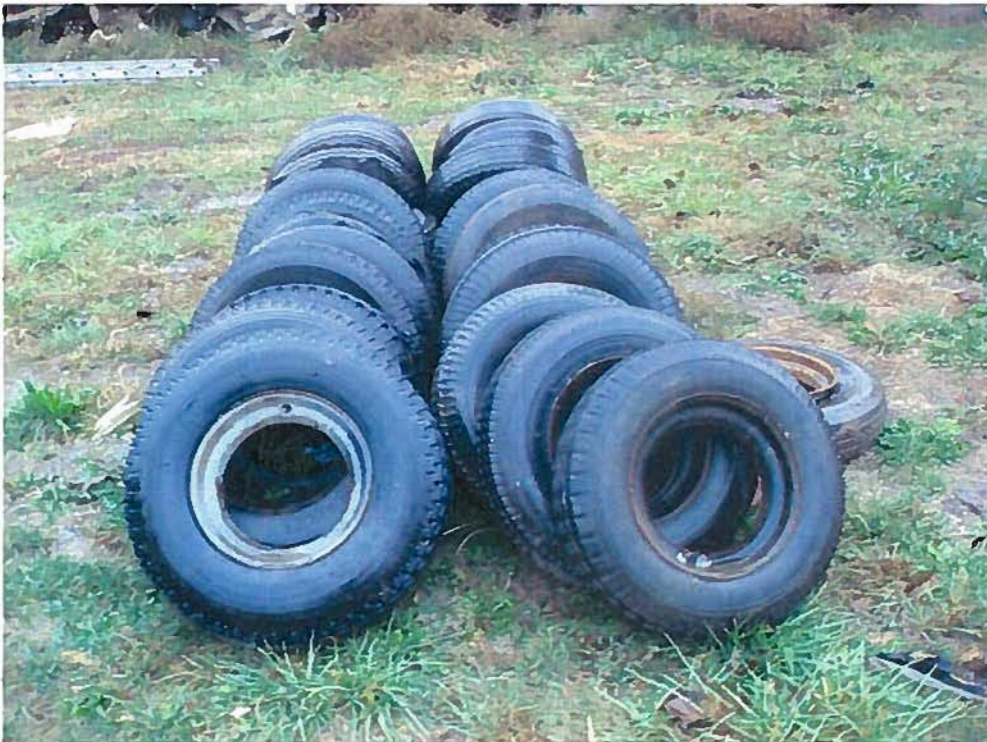
Date: November 3, 2011
Time: 12:41 p.m.
Direction: N
Photo by: Charlie King
Exposure #: 014
Comments: The used tires were on rim rounds, which are often used on mobile homes.

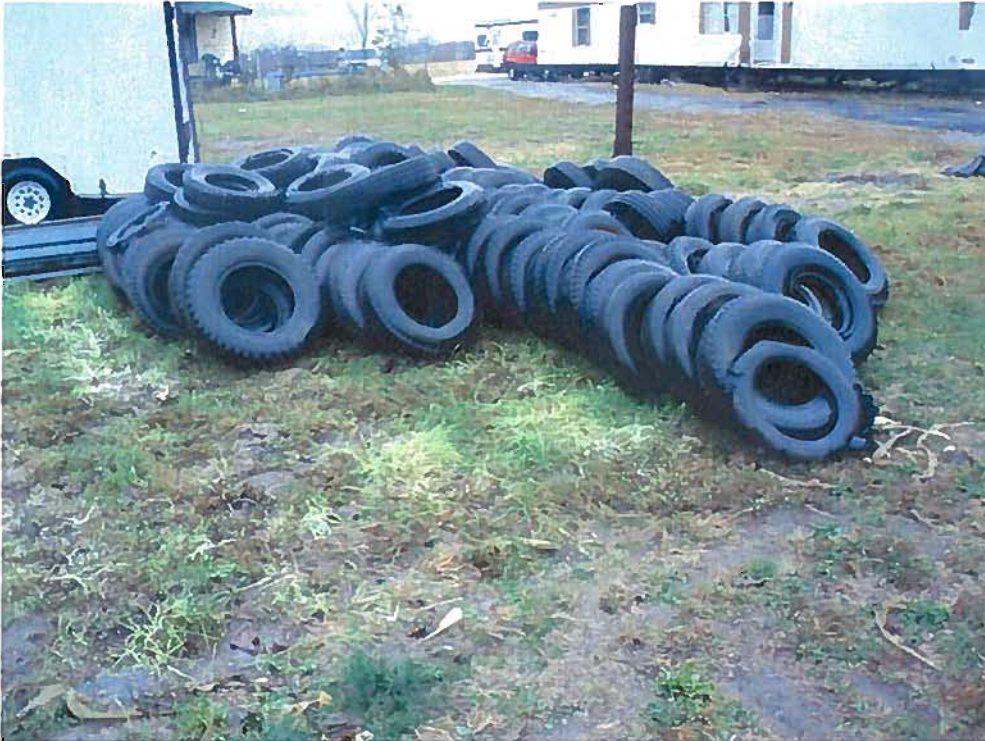
Date: November 3, 2011
Time: 12:41 p.m.
Direction: SW
Photo by: Charlie King
Exposure #: 015
Comments:
Approximately 80 off-rim used tires.

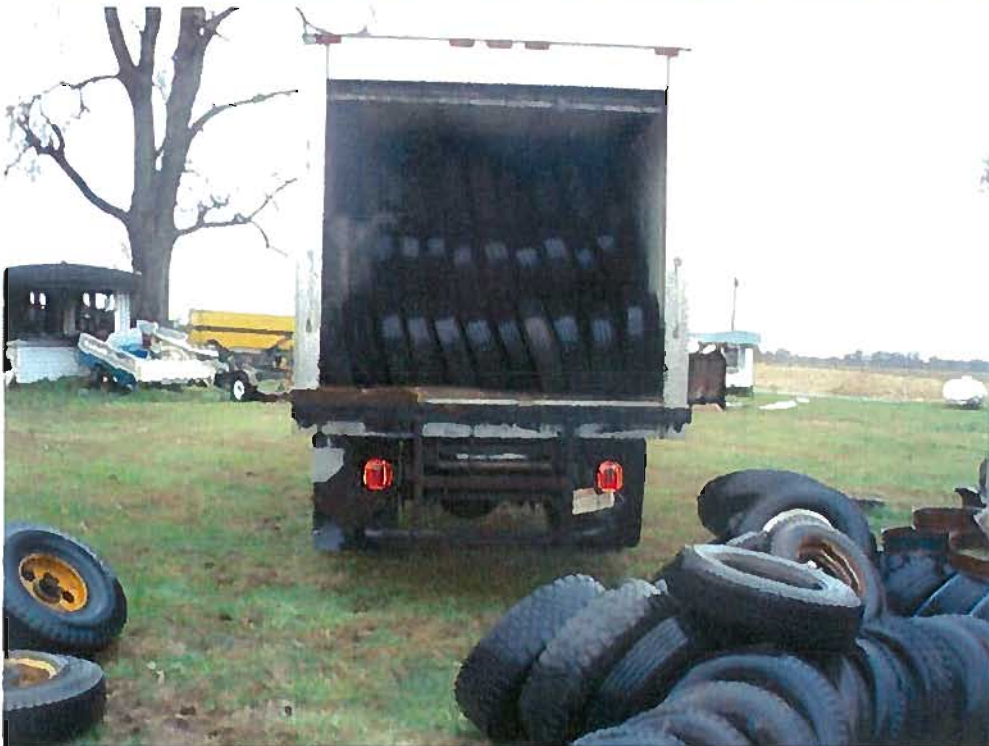
Date: November 3, 2011
Time: 12:41 p.m.
Direction: SE
Photo by: Charlie King
Exposure #: 016
Comments: Used tires are shown stacked in a truck, and on the ground.

In a telephone conversation with respondent Dale Gordon Spradlin, he stated that he owned the truck and he placed the used tires in it to get them off the ground.

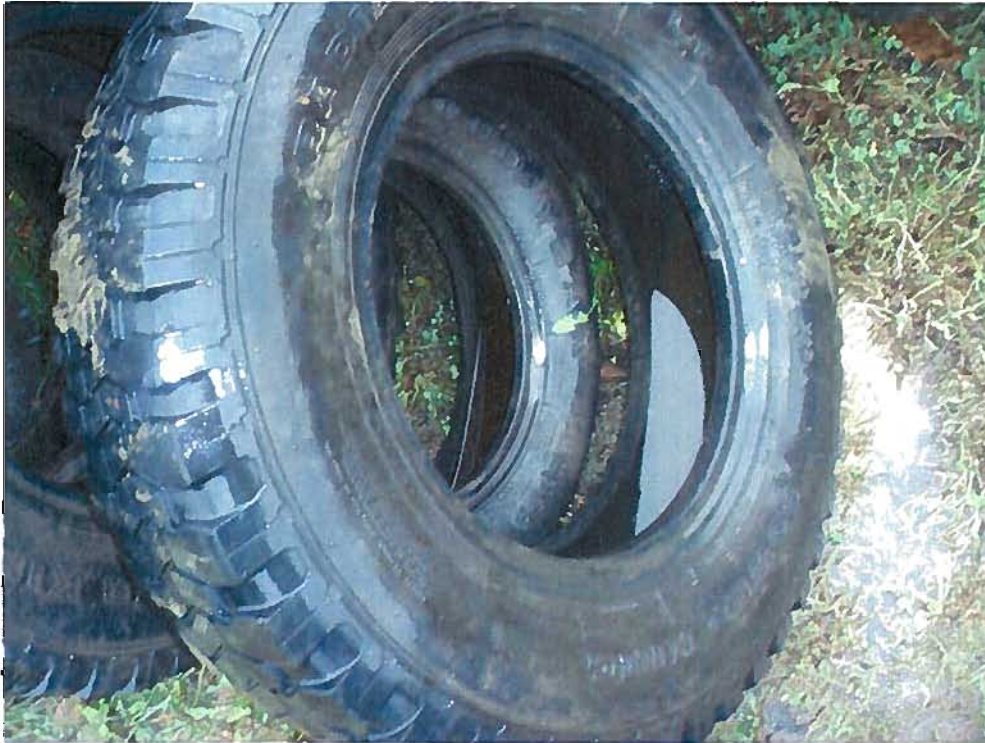
Date: November 3, 2011
Time: 12:41 p.m.
Direction: SW
Photo by: Charlie King
Exposure #: 017
Comments: Standing water was observed in many of the used tires shown in photo # 015. Two of those tires are shown here.

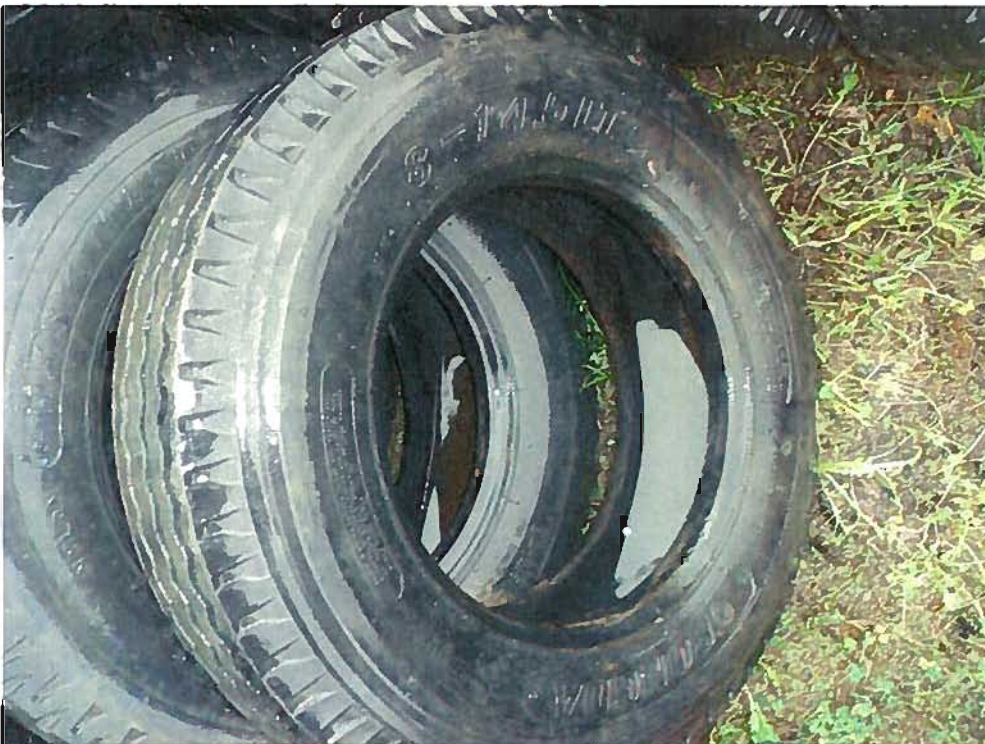
Date: November 3, 2011
Time: 12:41 p.m.
Direction: SW
Photo by: Charlie King
Exposure #: 018
Comments: More used tires containing standing water.

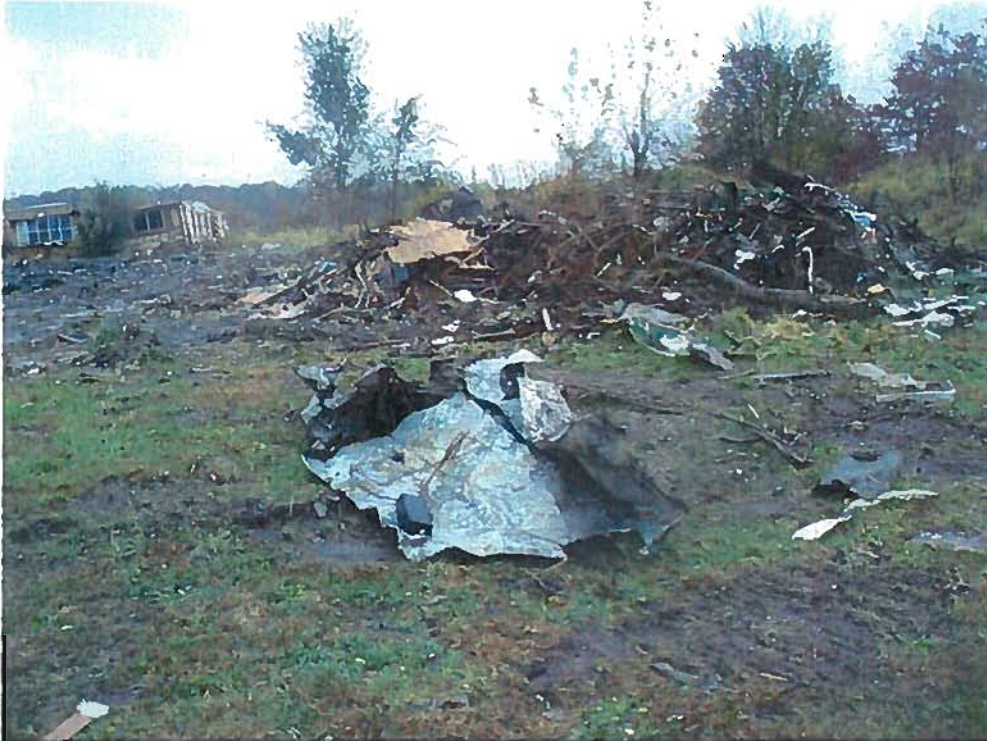
Date: November 3, 2011
Time: 12:41 p.m.
Direction: NE
Photo by: Charlie King
Exposure #: 019
Comments: Various demolition wastes, including wood, insulation, plastics, flooring, metals including tin, toys, clothing, linoleum and other wastes. Many of the wastes had been burned.

Photo # 019 shows various demolition wastes, including wood, insulation, plastics, flooring, metals including tin, toys, clothing, linoleum and other wastes. Many of the wastes had been burned.

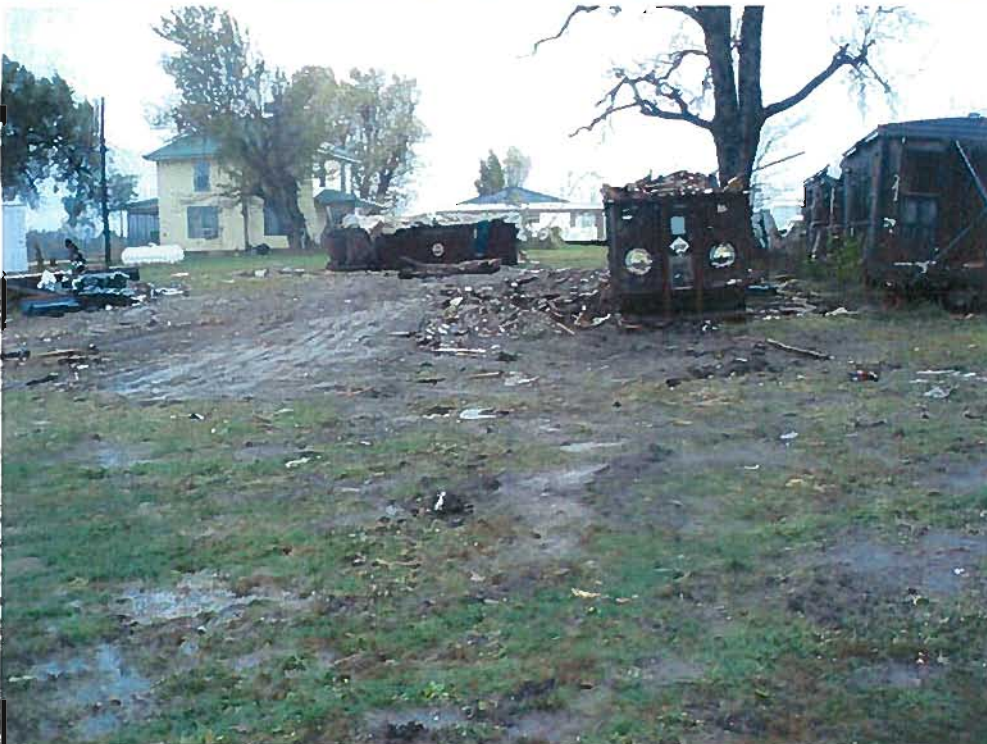
Date: November 3, 2011
Time: 12:42 a.m.
Direction: W
Photo by: Charlie King
Exposure #: 020
Comments: Two roll-off boxes filled with apparent demolition wastes, and scattered demolition wastes on the ground, located at the south end of the backyard of the property.
