ILLINOIS POLLUTION CONTROL BOARD

PETITION FOR WATER WELL SETBACK EXCEPTION PURSUANT TO 415 ILCS 5/14.2(C)

CROSS SECTION A-A'
 411 MAIN STREET
 KIRKLAND, ILLINOIS

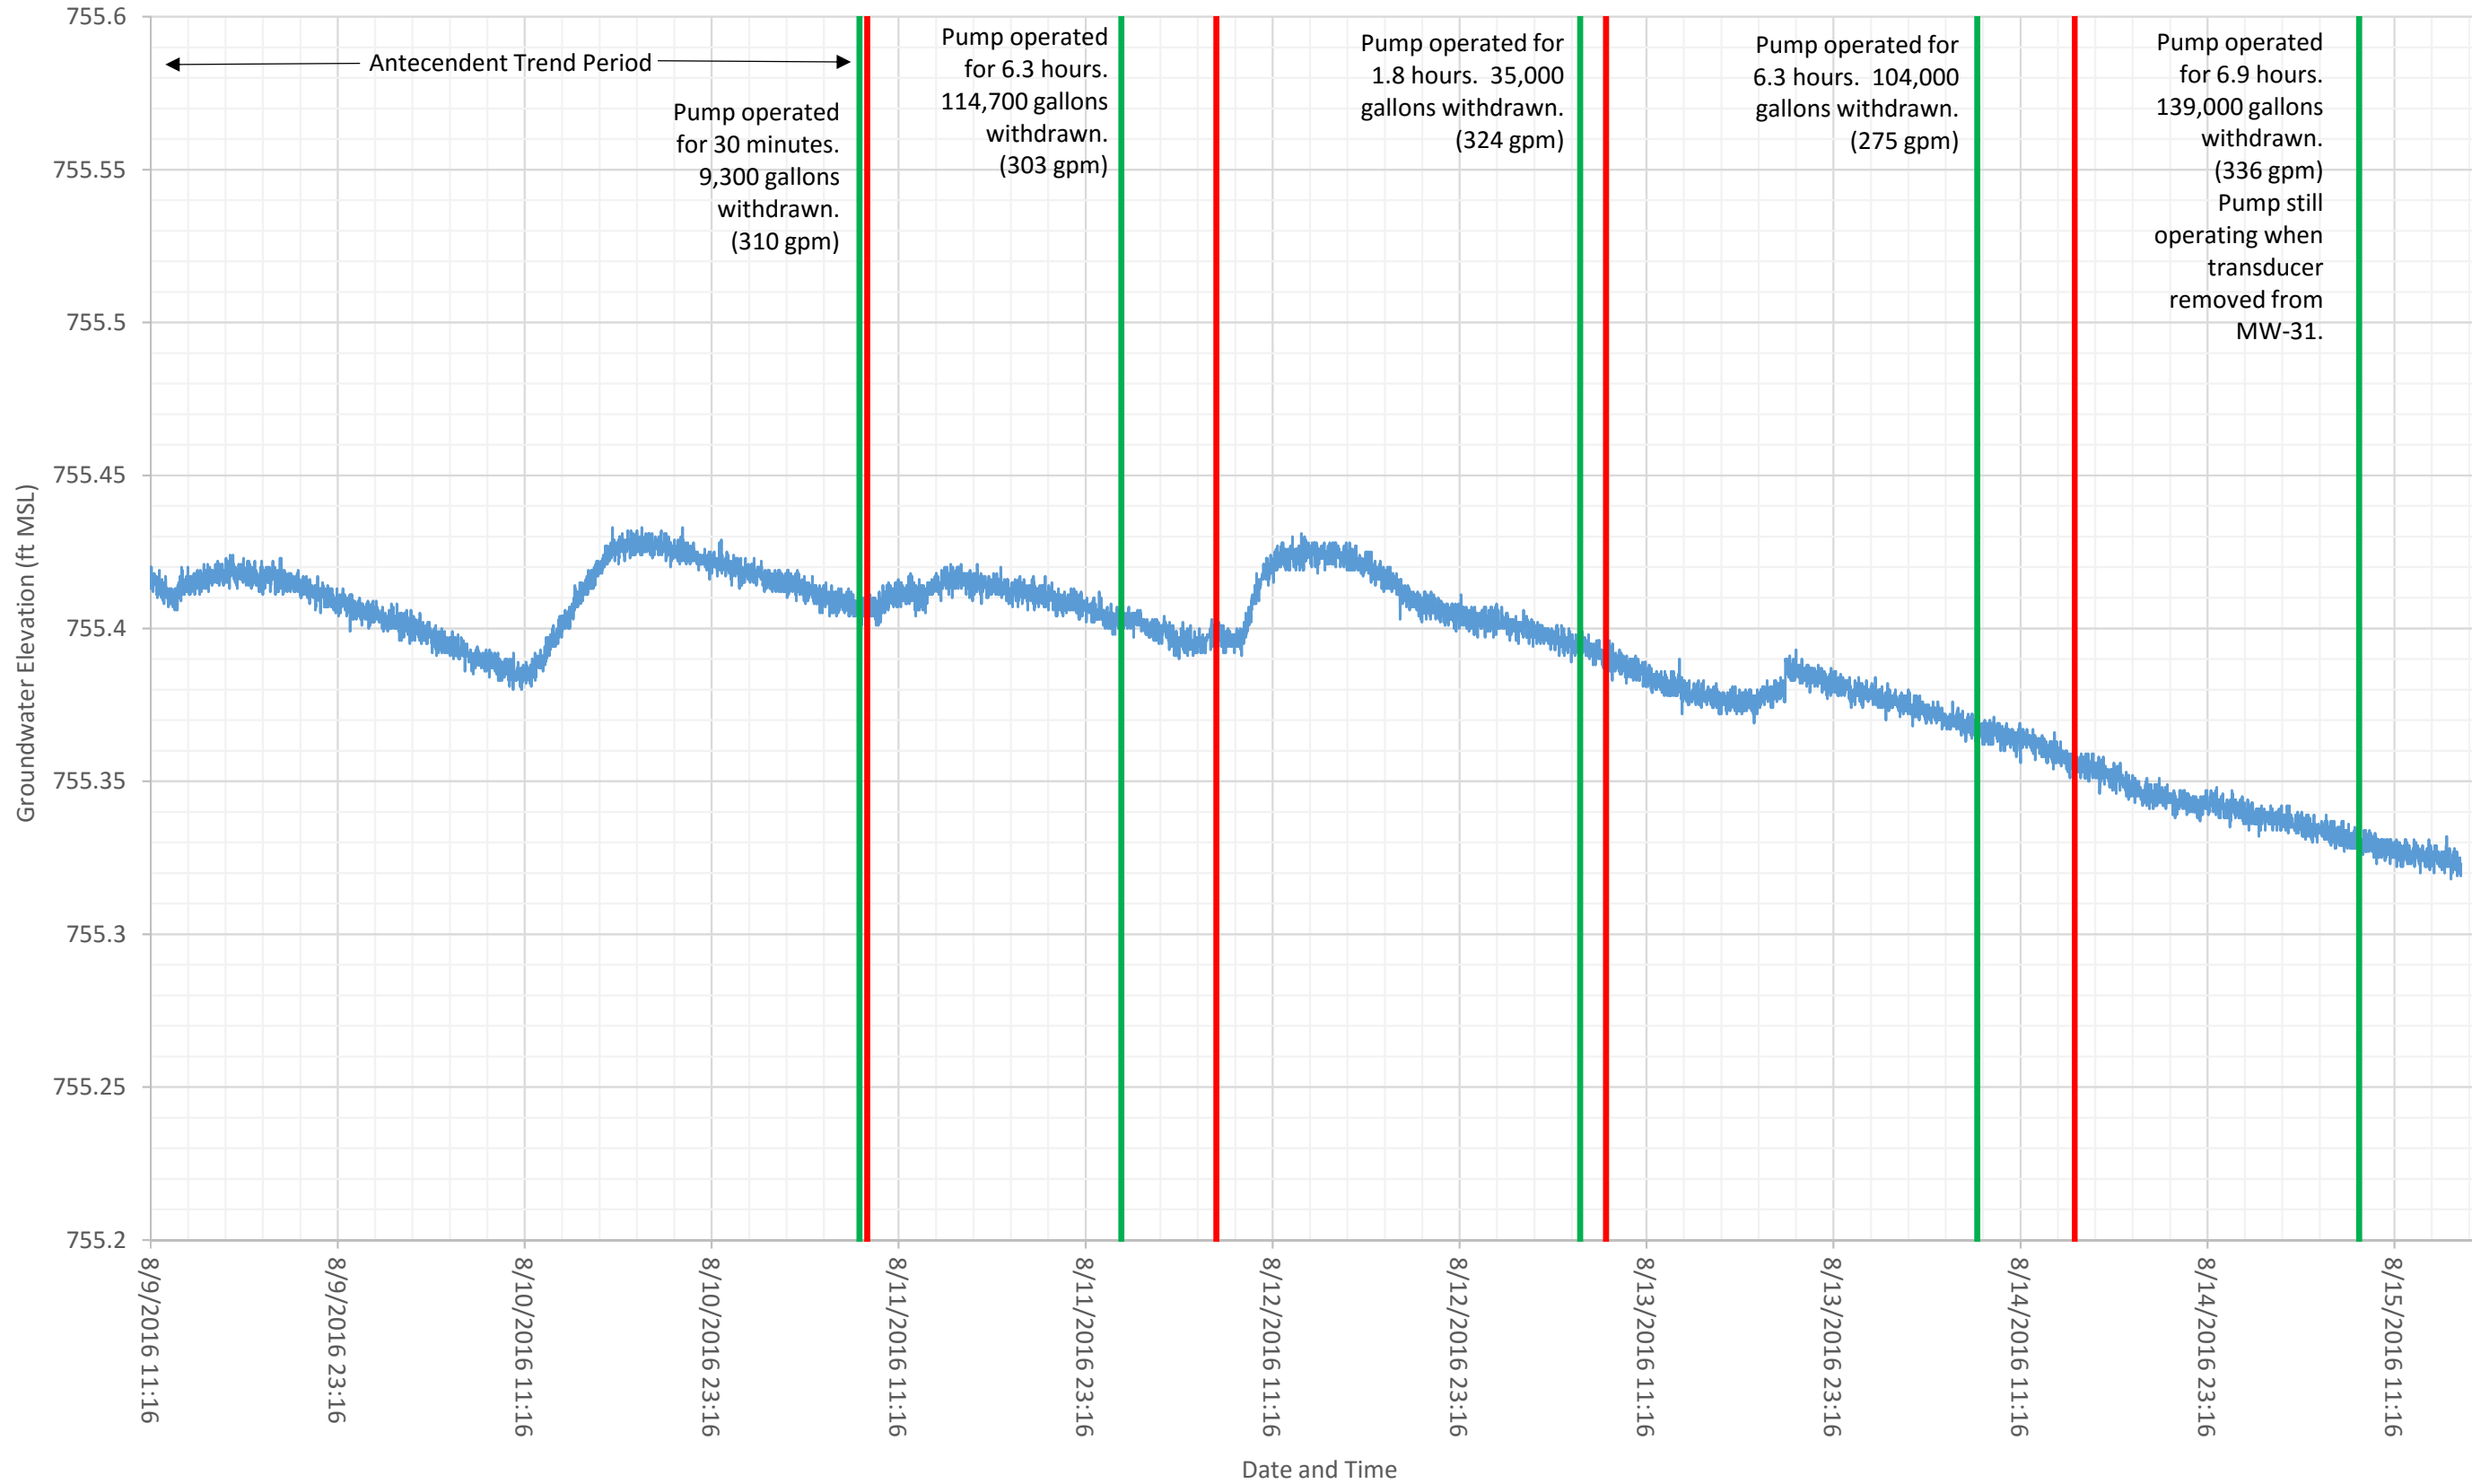
Figure 8
Water Level Data Recorded in MW-31
