BEFORE THE ILLINOIS POLLUTION CONTROL BOARD  
ADMINISTRATIVE CITATION

# Open Dump Inspection Checklist

**DATE:** October 5, 2006  
**TO:** DLPC / Division File  
**FROM:** Paul Eisenbrandt, DLPC/FOS Springfield Region  
**SUBJECT:** LPC #0010650002 – Adams County  
Quincy/Blickhan Landfill  
FOS File

The purpose of this memorandum is to serve as the Narrative Inspection Report Document of a September 20, 2006 landfill inspection at the above referenced site. The inspection took place from approximately 10:40 am to 12:40 pm, and thirty-five (35) digital photographs were taken. The weather at the time of the inspection was sunny and about 82°F. Mr. C. John Blickhan was interviewed during the inspection.

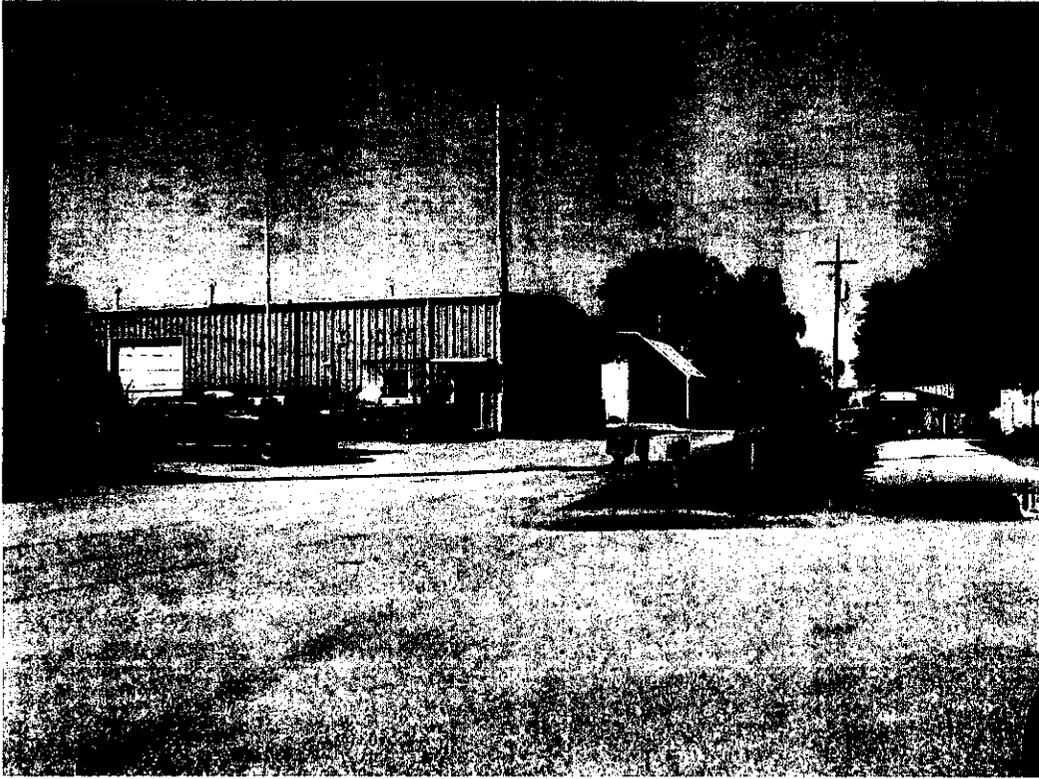
Photograph 001 shows the main entrance to Blinkhan Landfill. The gate to the landfill (Site No. 1) is located west of the office and maintenance buildings, and at the end of the access road.

**Date:** September 20, 2006  
**Time:** 10:44 AM  
**Direction:** W  
**Photo by:** Eisenbrandt  
**Exposure #:** 001  
**Comments:** Main entrance to Blickhan Landfill past Blick's Construction Company.

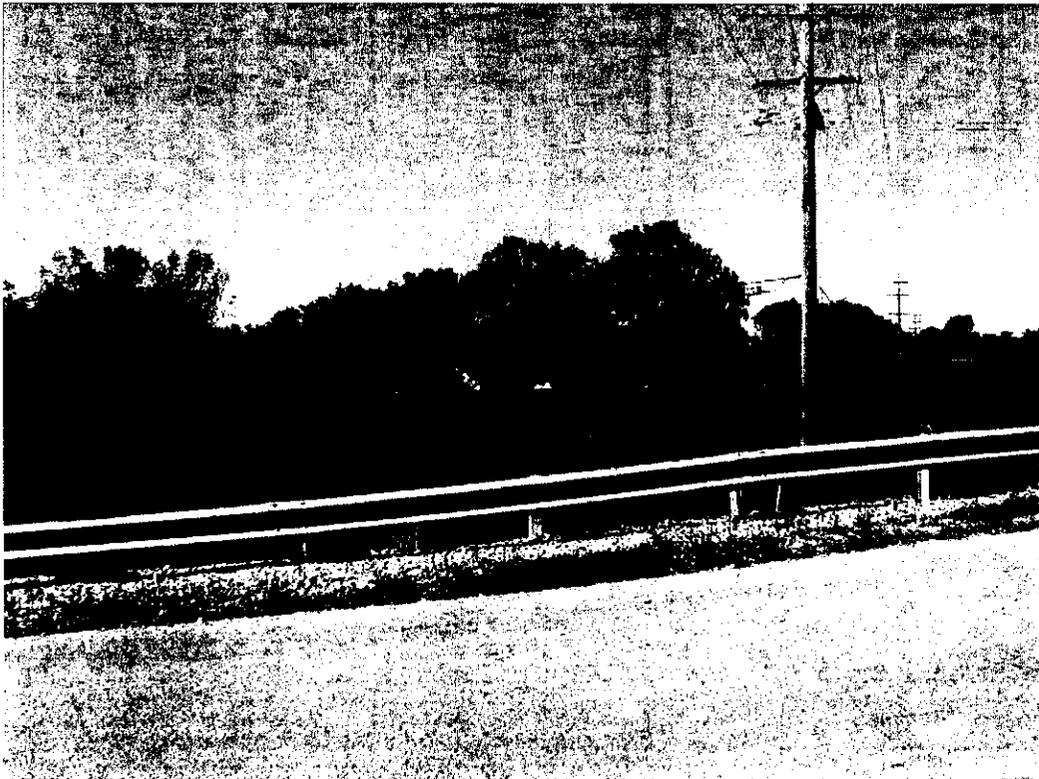
Photograph 002 shows the northeast corner of Site No. 2. No stressed vegetation, rills, or leachate seeps were observed from Lock and Dam Road.

**Date:** September 20, 2006  
**Time:** 10:44 AM  
**Direction:** W  
**Photo by:** Eisenbrandt  
**Exposure #:** 002  
**Comments:** Northeast corner of Site No. 2.

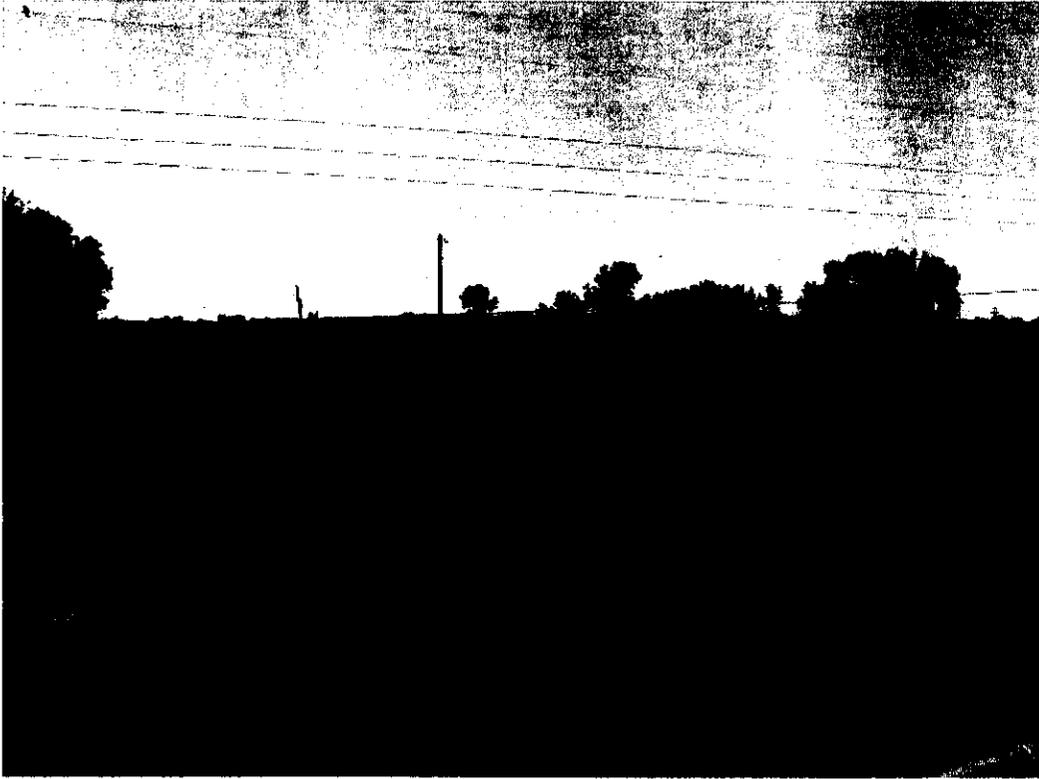
Photographs 003, 004, and 005 show the northeast and west sections of Site No.1, respectively. No areas of concern were identified from Lock and Dam Road.

**Date:** September 20, 2006  
**Time:** 10:45 AM  
**Direction:** SW  
**Photo by:** Eisenbrandt  
**Exposure #:** 003  
**Comments:** Northeast corner of Site No. 1.

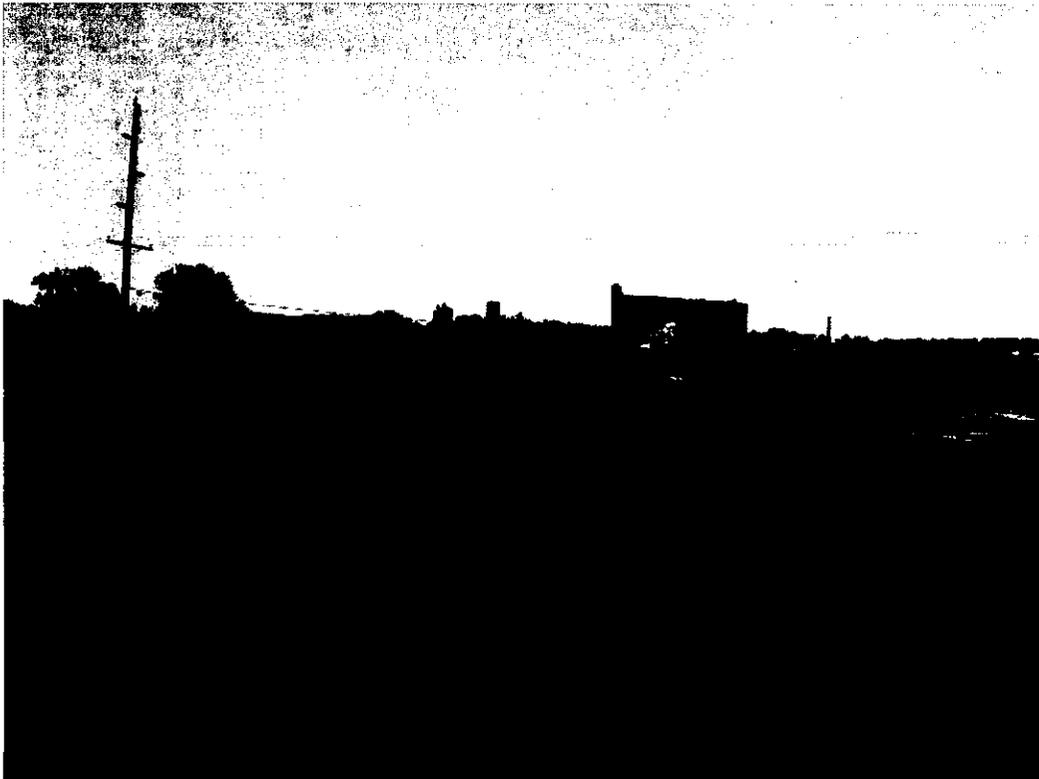
**Date:** September 20, 2006  
**Time:** 10:46 AM  
**Direction:** E  
**Photo by:** Eisenbrandt  
**Exposure #:** 004  
**Comments:** West end of Site No. 1.

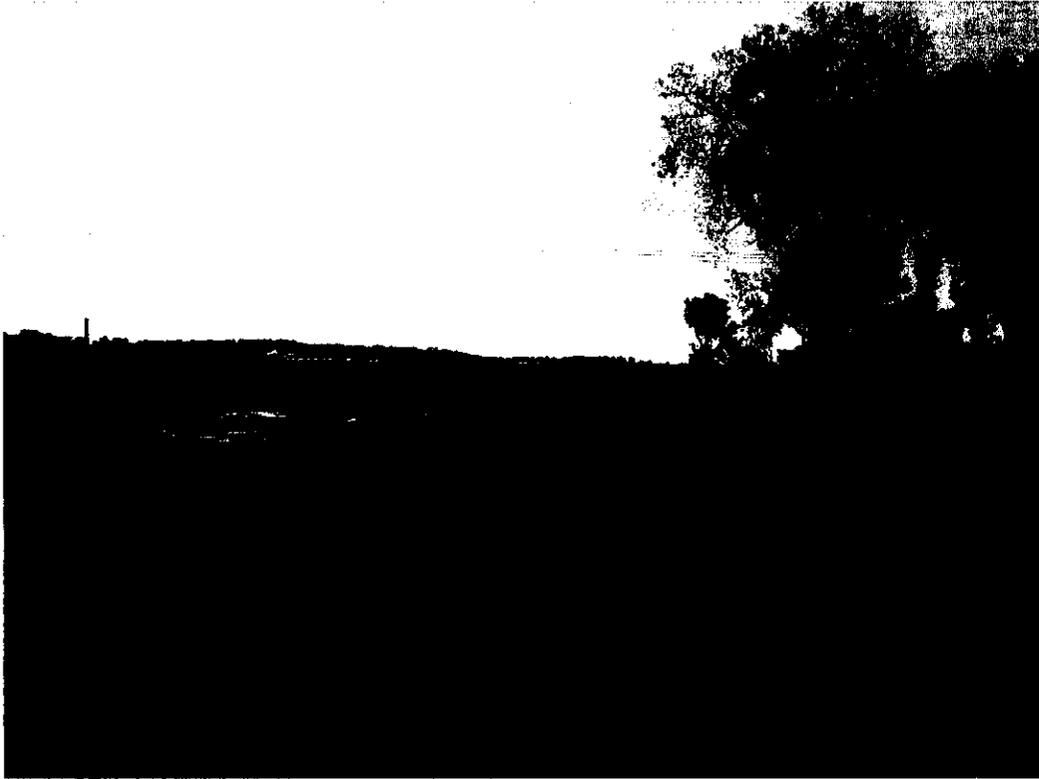
**Date:** September 20, 2006  
**Time:** 10:46 AM  
**Direction:** SE  
**Photo by:** Eisenbrandt  
**Exposure #:** 005  
**Comments:** West end of  
Site No. 1.

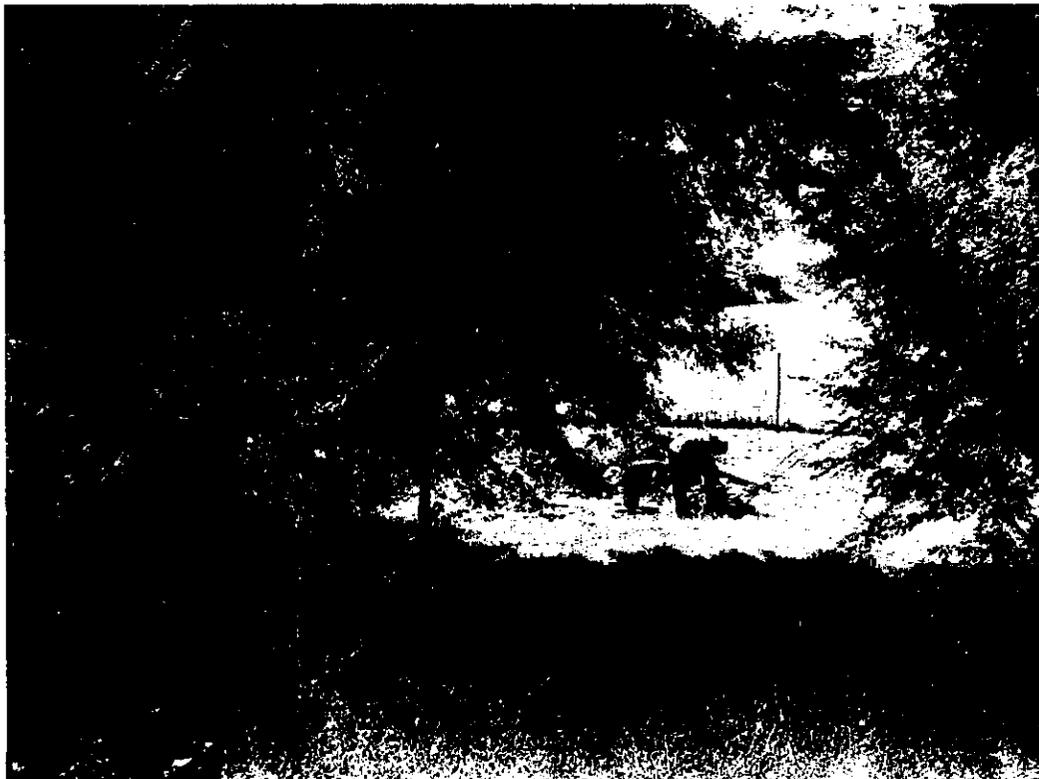
Photograph 006 shows a large burn pile located behind House No. 6 in Blick's Village (as visible from Lock and Dam Road). Smoke was observed rising from the burn pile.

**Date:** September 20, 2006  
**Time:** 10:49 AM  
**Direction:** S  
**Photo by:** Eisenbrandt  
**Exposure #:** 006  
**Comments:** Burn pile  
located at House No. 6 in  
Blick's Village.

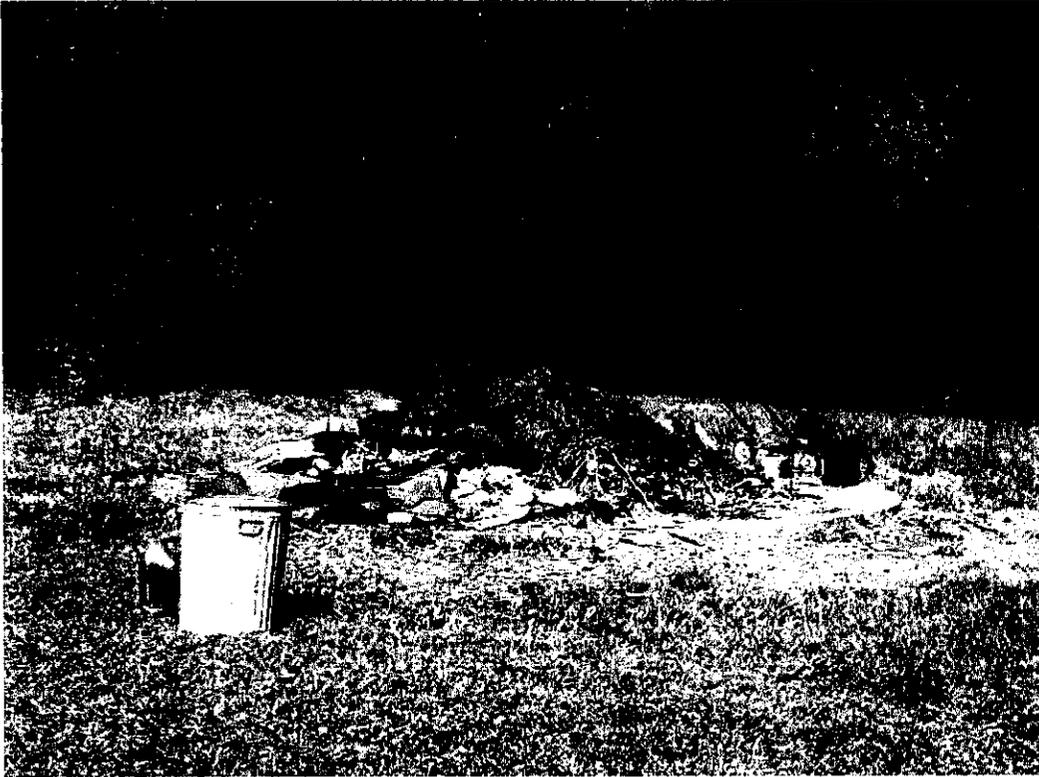
Photograph 007 shows burning garbage, construction debris, miscellaneous waste, and landscape debris behind House No. 6. Michael Lish, resident of House No. 6 for the past 1-1/2 months claimed he did not know he could not burn the garbage. Mr. Lish stated his address was 2000 Blick's Village Court, House No. 6 in Quincy, Illinois. Mr. Lish claimed he did not have a phone. He also stated he has no garbage service nor does anybody else in Blick's Village. Mr. Lish was instructed to extinguish the fire while the Illinois EPA inspector was on site. The

environmental regulations concerning open burning were discussed with Mr. Lish. He stated he would no longer burn trash.

**Date:** September 20, 2006  
**Time:** 10:52 AM  
**Direction:** NW  
**Photo by:** Eisenbrandt  
**Exposure #:** 007  
**Comments:** Burning garbage, construction debris, miscellaneous waste, and landscape debris observed at House No. 6.

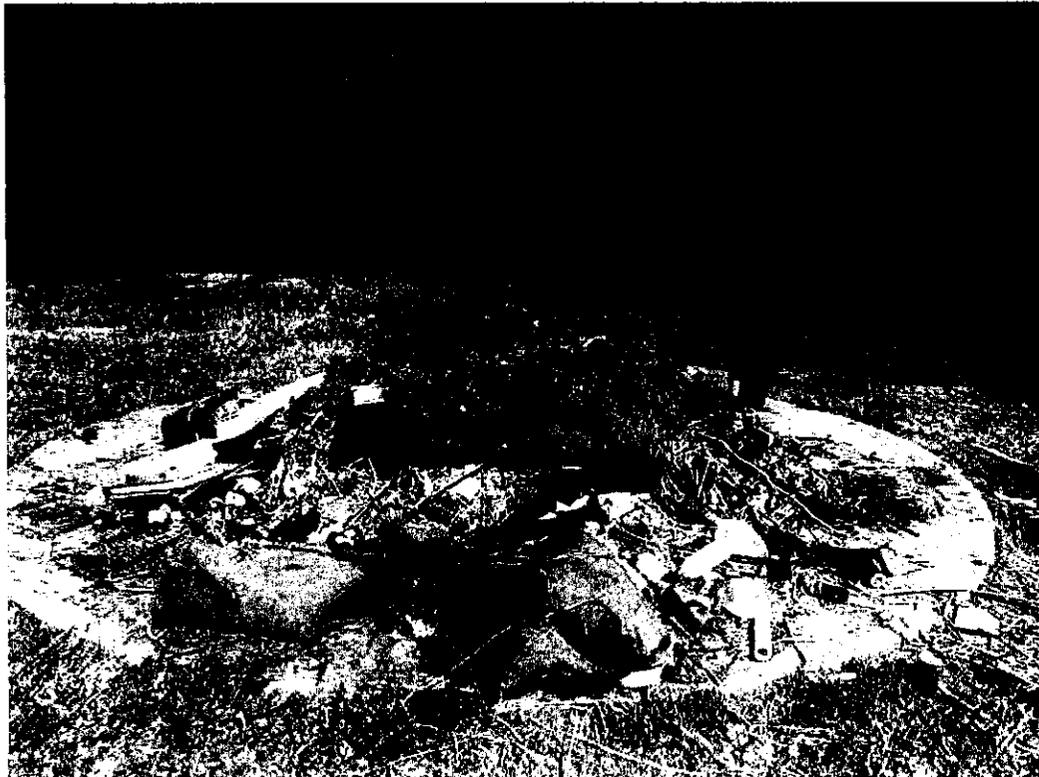
Photographs 8, 9, 10, and 11 show the large burn pile smoldering on a circular concrete pad behind House No. 6. There was approximately four cubic yards of waste on site. The charred waste included grass clippings, a mattress, asphalt shingles, plastic bottles, used paint supplies, alcohol bottles, an aluminum gutter, a toaster oven, a vanity mirror, aluminum cans, a VCR tape, screen material, paint cans, melted plastic, scrap metal, grey carpet, vinyl flooring, nails, an aerosol insecticide can, paint rollers, plastic food wrappers, fast food packaging, and miscellaneous charred wood, waste, and ash.

**Date:** September 20, 2006  
**Time:** 10:53 AM  
**Direction:** NW  
**Photo by:** Eisenbrandt  
**Exposure #:** 008  
**Comments:** Grass clippings, a mattress, asphalt shingles, plastic bottles, used paint supplies, alcohol bottles, and miscellaneous waste observed in a partially charred pile of debris. The fire was extinguished while the Illinois EPA inspector was onsite.

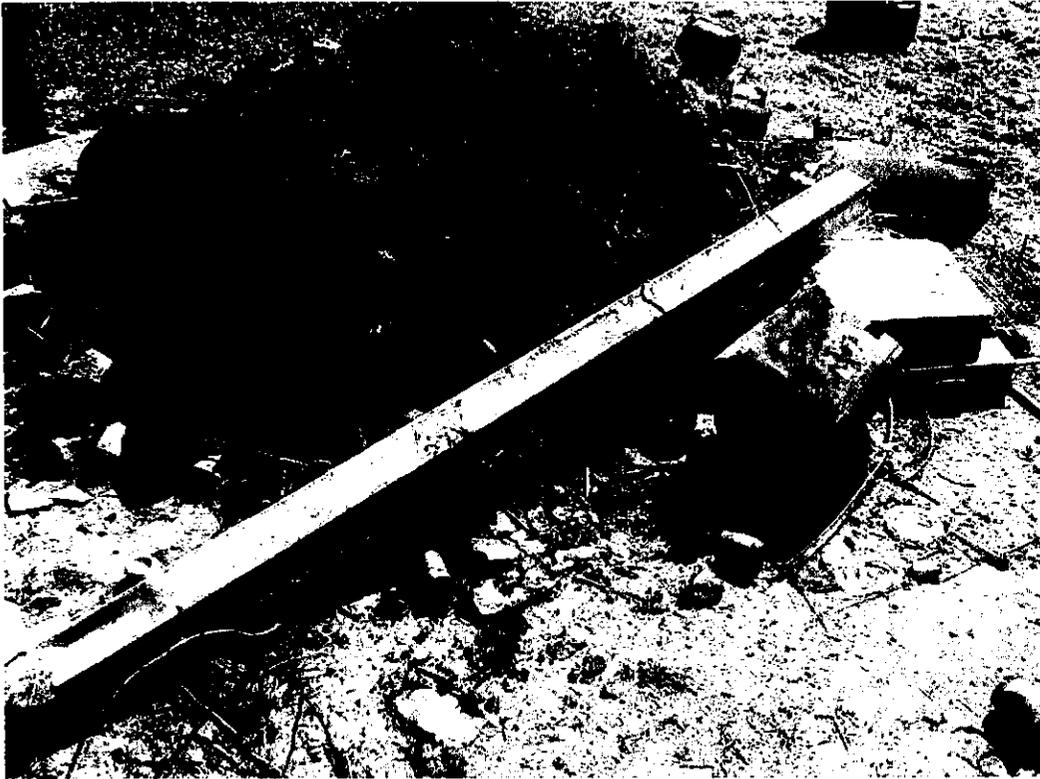
**Date:** September 20, 2006  
**Time:** 10:57 AM  
**Direction:** SE  
**Photo by:** Eisenbrandt  
**Exposure #:** 009  
**Comments:** An aluminum gutter, a burned out toasted oven, a vanity mirror, aluminum cans, and miscellaneous charred waste was observed.

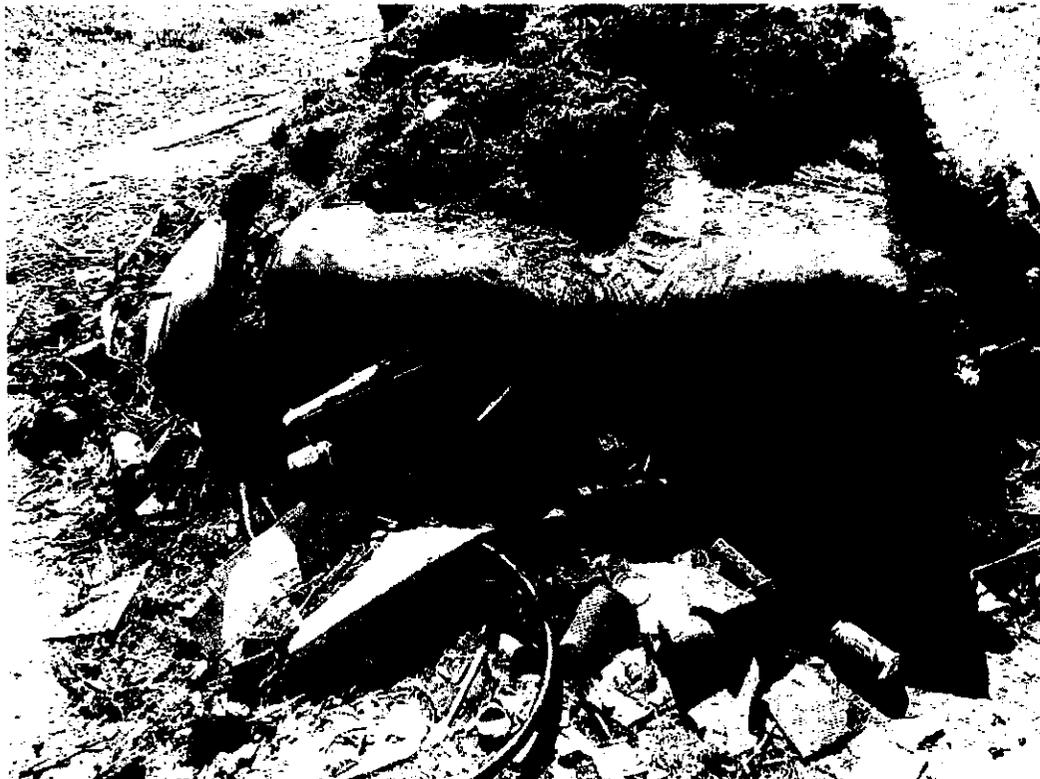
**Date:** September 20, 2006  
**Time:** 10:57 AM  
**Direction:** S  
**Photo by:** Eisenbrandt  
**Exposure #:** 010  
**Comments:** A mattress, grass clippings, a VCR tape, screen material, paint cans, melted plastic, scrap metal, grey carpet, vinyl flooring, nails, an aerosol insecticide can, paint rollers, plastic food wrappers, and fast food packaging, were observed among the charred ash and waste.

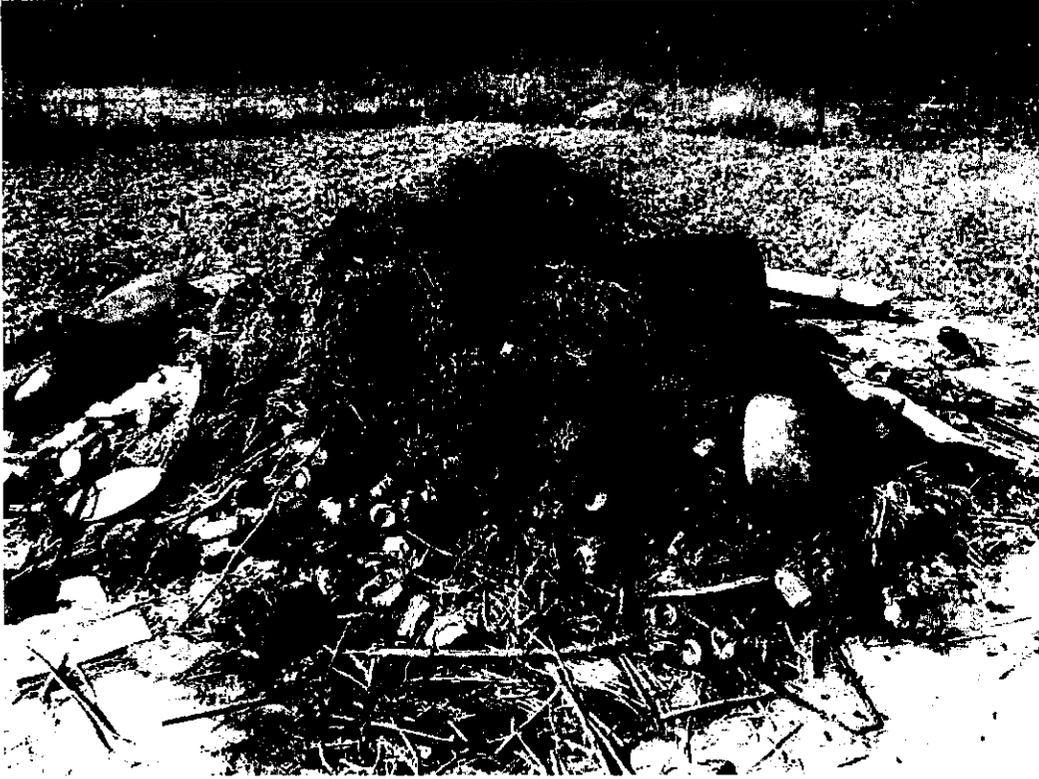
**Date:** September 20, 2006  
**Time:** 10:58 AM  
**Direction:** SW  
**Photo by:** Eisenbrandt  
**Exposure #:** 011  
**Comments:** Alternate view of the waste burn pile at House No. 6 in Blick's village.

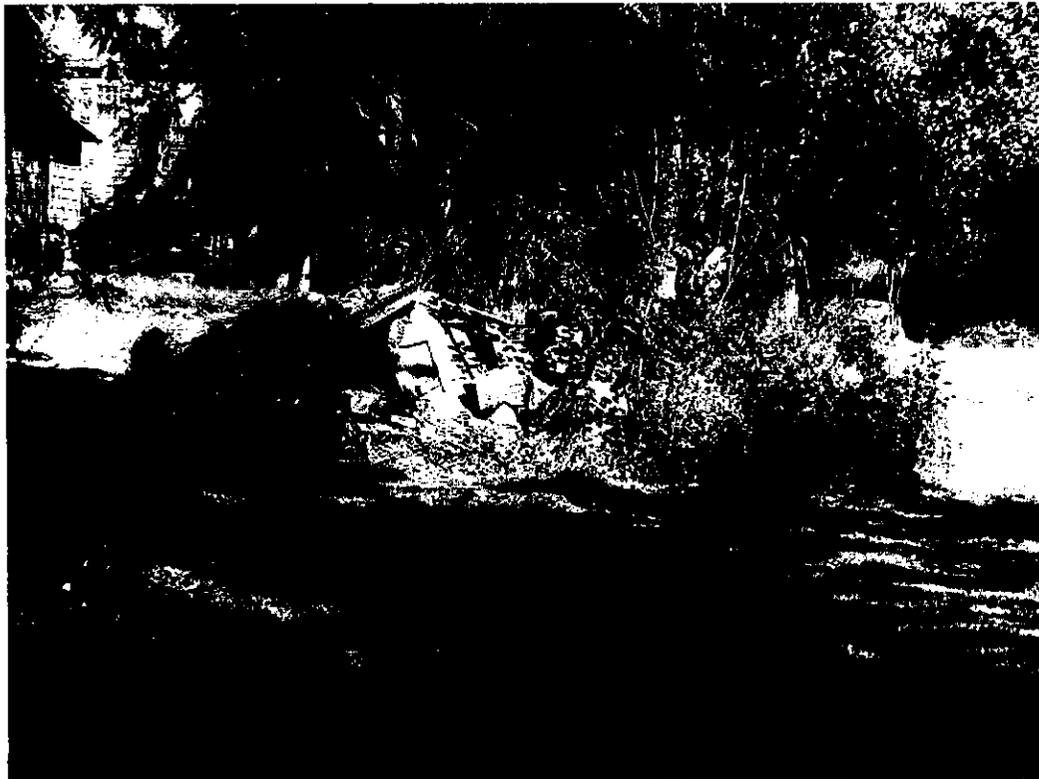
Photograph 012 shows a pile of open-dumped waste behind House No. 1.

**Date:** September 20, 2006  
**Time:** 11:04 AM  
**Direction:** N  
**Photo by:** Eisenbrandt  
**Exposure #:** 012  
**Comments:** Open dumped waste behind House No. 1 in Blick's Village.

except for the open burning and open dumping situation at Blick's Village. The Illinois EPA inspector offered a two week window opportunity for the waste at Blick's Village to be cleaned up prior to enforcement actions. As a condition of the clean-up, photographic proof and copies of waste disposal receipts would need to be received, by the Illinois EPA, within two weeks of the inspection. The two week window opportunity would expire on October 4, 2006. Ms. Graupman believed Mr. Blickhan would seize the opportunity and have the waste removed immediately.

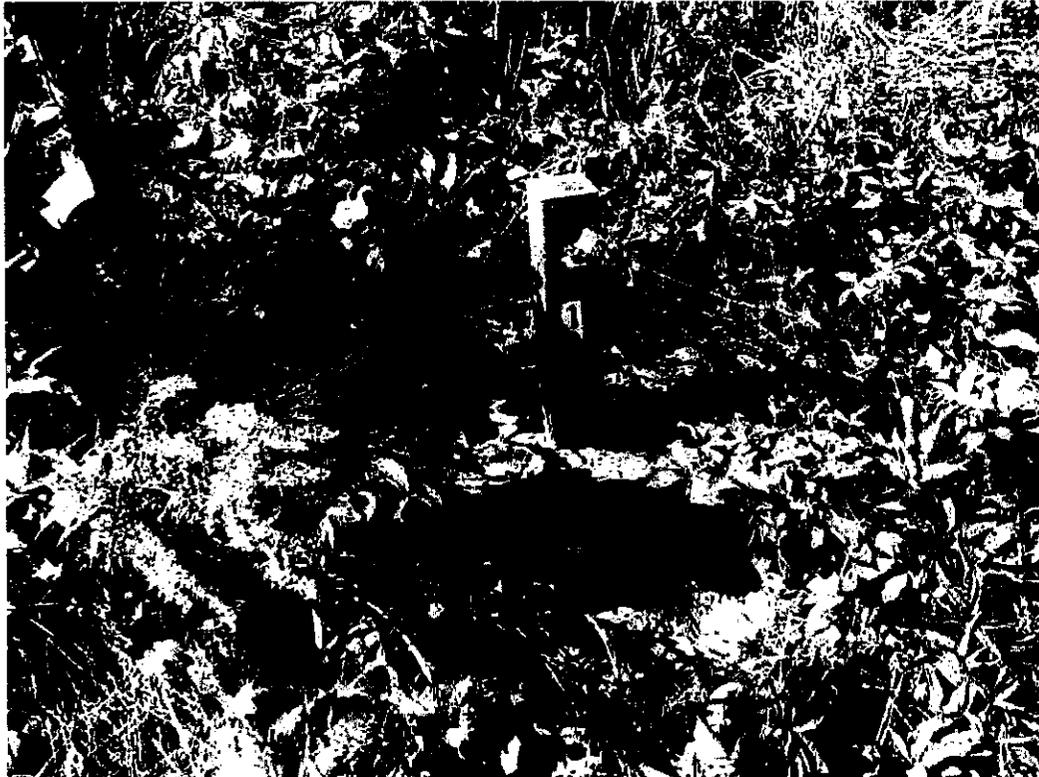
**Date:** September 20, 2006  
**Time:** 11:26 AM  
**Direction:** W  
**Photo by:** Eisenbrandt  
**Exposure #:** 014  
**Comments:**  
Groundwater monitoring well G103 after some of the weeds were cleared away for the inspection.

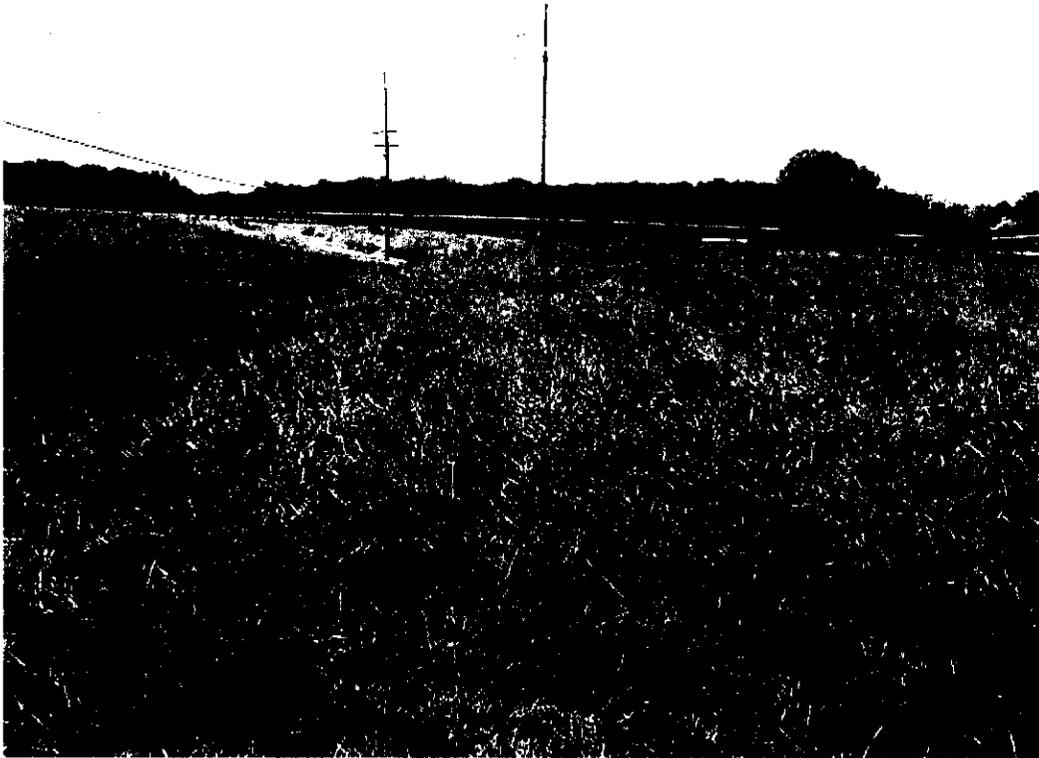
**Date:** September 20, 2006  
**Time:** 11:31 AM  
**Direction:** E  
**Photo by:** Eisenbrandt  
**Exposure #:** 015  
**Comments:** Northern edge of Site No. 2.

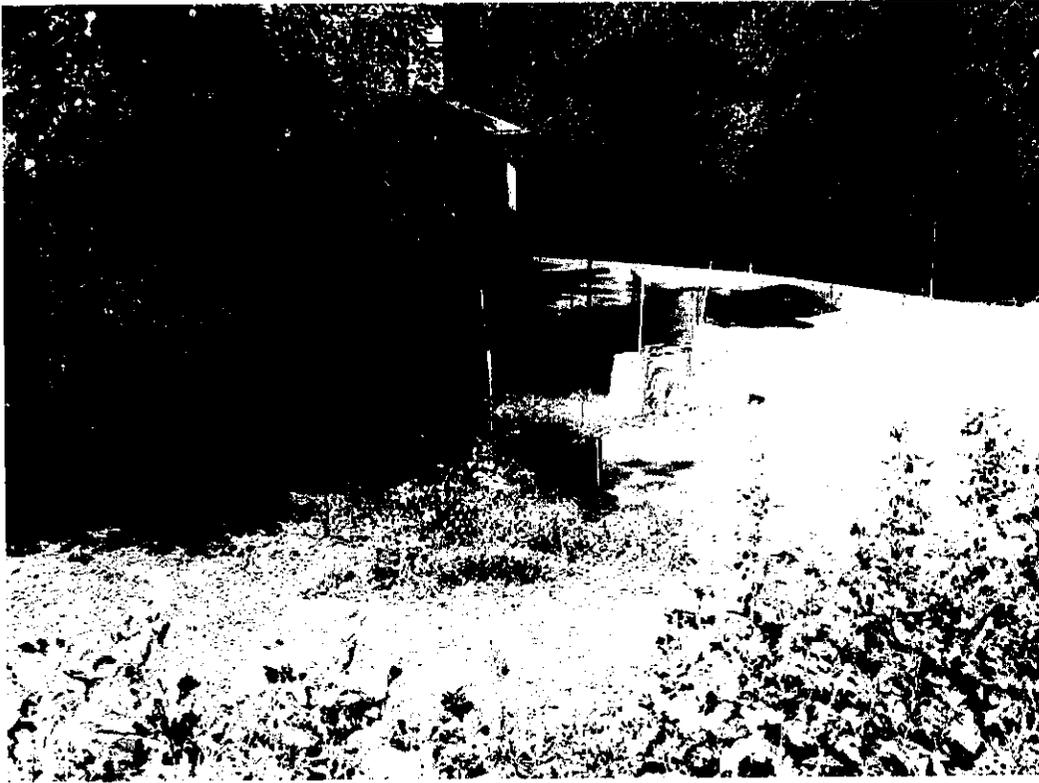
Photographs 017, 018, and 019 were exposed from the western edge of the landfill. Photograph 017 shows a pile of landscape waste and garbage burning behind house No. 3 in Blick's Village. The burn pile was smoldering while the Illinois EPA inspector was conducting the landfill inspection. Photographs 018 and 019 show two small piles of garbage behind House No. 2. The northern debris pile contained landscape waste and household garbage setting on charred waste and ash. The southern debris pile at House No. 2 appeared to be household waste dumped in the grass. Waste at this second location did not appear to have been burnt.

**Date:** September 20, 2006  
**Time:** 11:32 AM  
**Direction:** NW  
**Photo by:** Eisenbrandt  
**Exposure #:** 017  
**Comments:** Burning debris behind House No. 3 in Blick's Village.

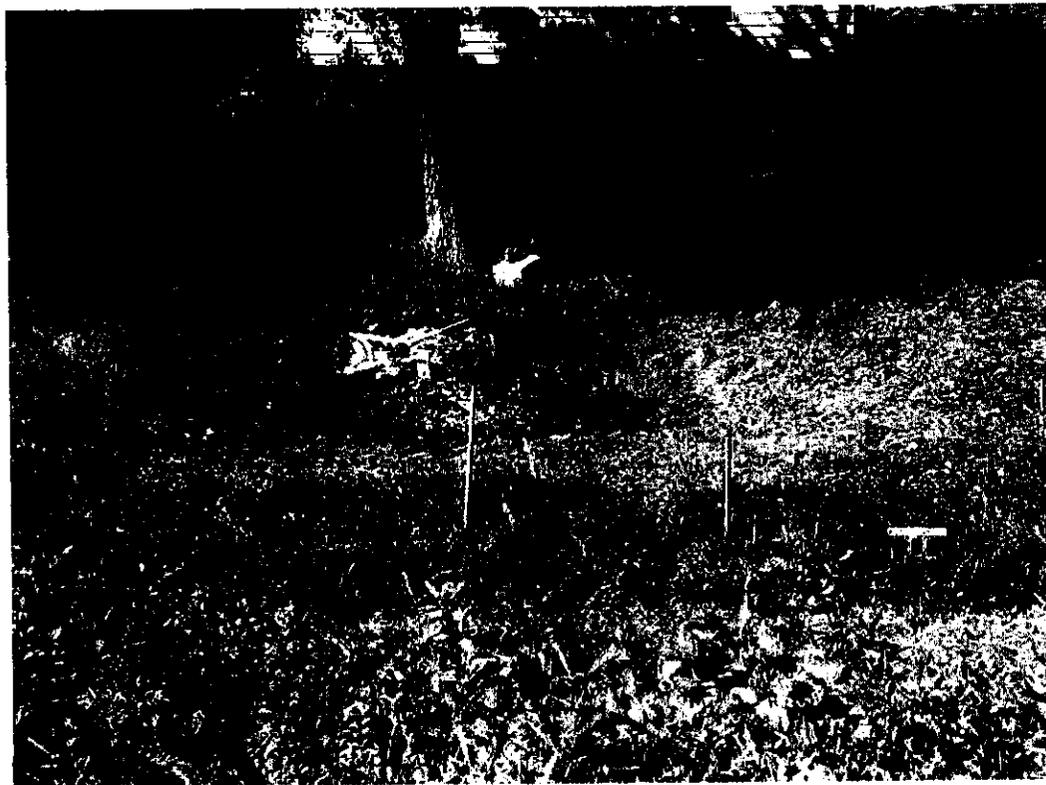
**Date:** September 20, 2006  
**Time:** 11:32 AM  
**Direction:** W  
**Photo by:** Eisenbrandt  
**Exposure #:** 018  
**Comments:** Open dumped waste was observed behind House No. 2 in Blick's Village.

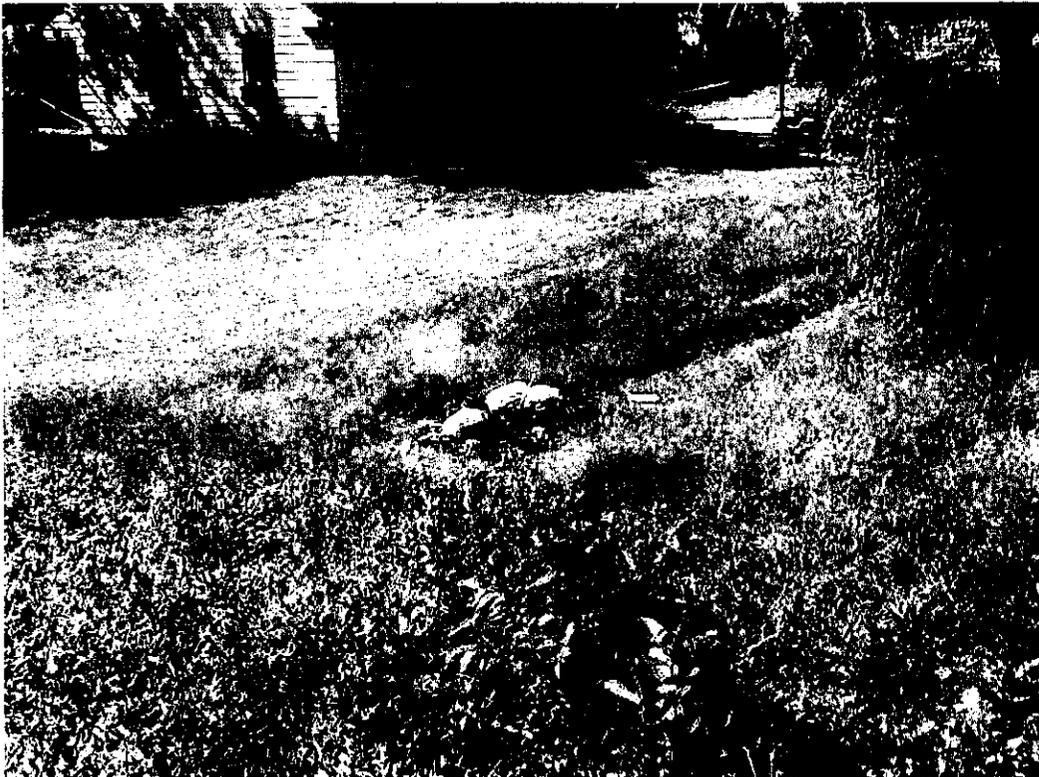
**Date:** September 20, 2006  
**Time:** 11:33 AM  
**Direction:** SW  
**Photo by:** Eisenbrandt  
**Exposure #:** 019  
**Comments:** More open dumped waste behind House No. 2 in Blick's Village.

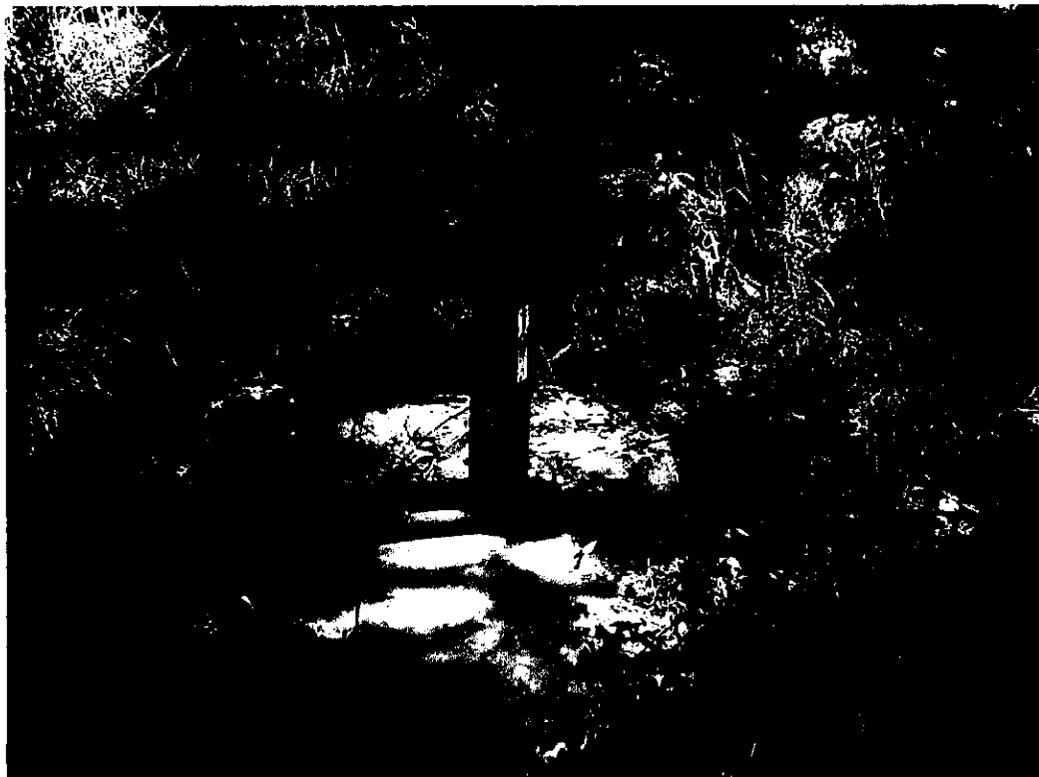
**Date:** September 20, 2006  
**Time:** 11:35 AM  
**Direction:** NE  
**Photo by:** Eisenbrandt  
**Exposure #:** 020  
**Comments:** Groundwater monitoring well G106.

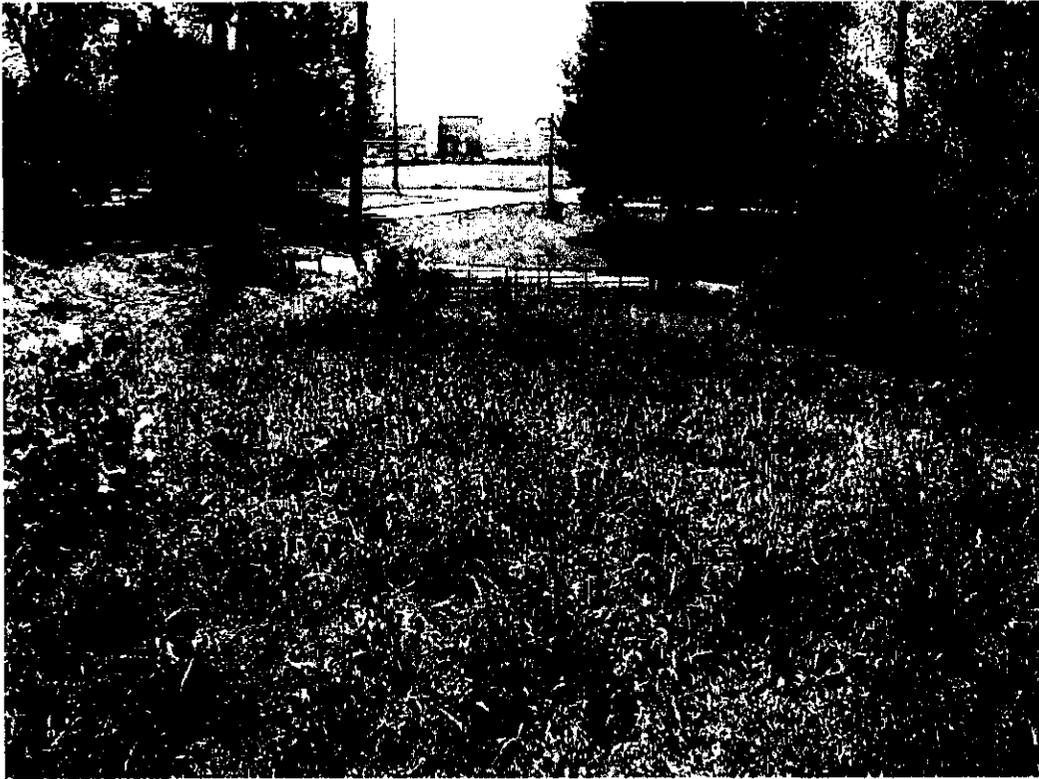
**Date:** September 20, 2006  
**Time:** 11:40 AM  
**Direction:** SE  
**Photo by:** Eisenbrandt  
**Exposure #:** 021  
**Comments:** Southeast face of Site No. 2 looking at the gated entrance.

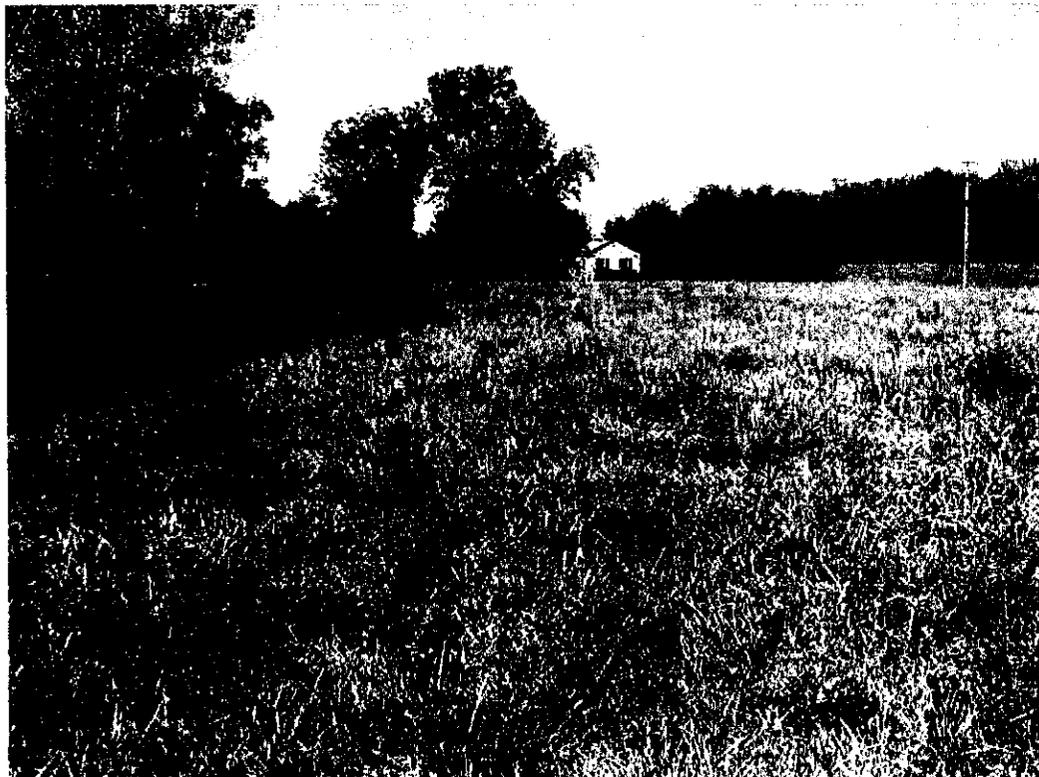
Photograph 022 shows the top of Site No. 2. The drainage off the top of the landfill appeared to be adequate. The grassy vegetation was well established. No debris was observed near or on the filled area.

**Date:** September 20, 2006  
**Time:** 11:40 AM  
**Direction:** NW  
**Photo by:** Eisenbrandt  
**Exposure #:** 022  
**Comments:** Top of Site No. 2 facing northwest.

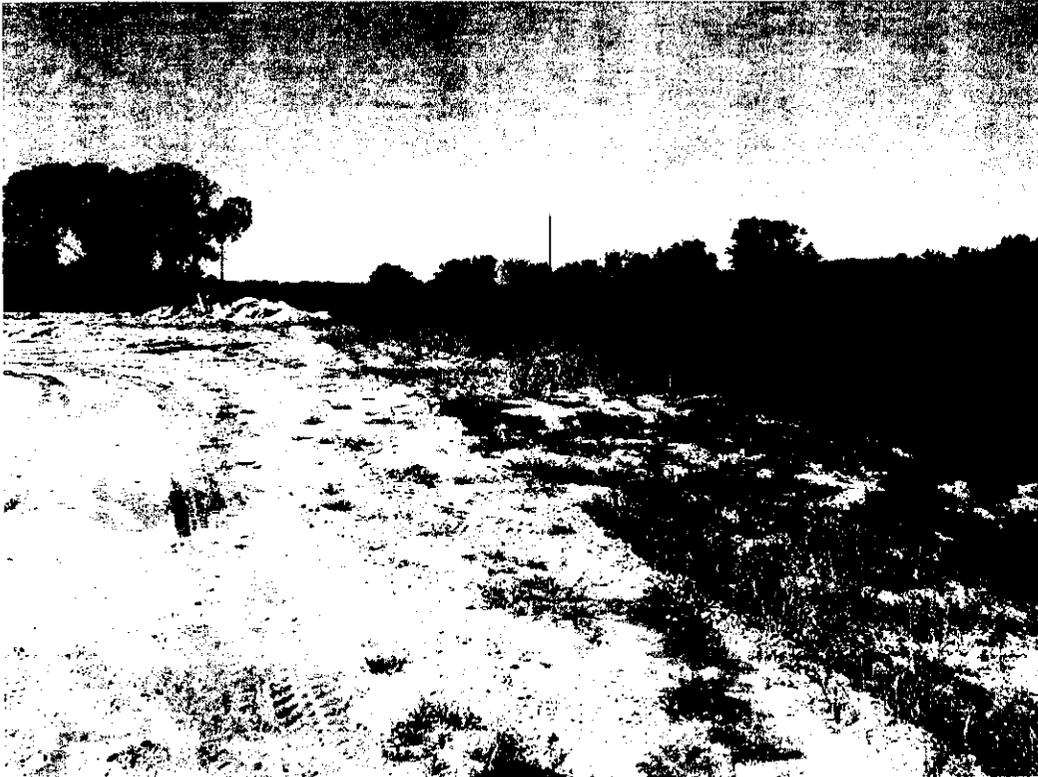
**Date:** September 20, 2006  
**Time:** 11:46 AM  
**Direction:** W  
**Photo by:** Eisenbrandt  
**Exposure #:** 023  
**Comments:** Area Blick's Construction is dumping fill material and leveling off.

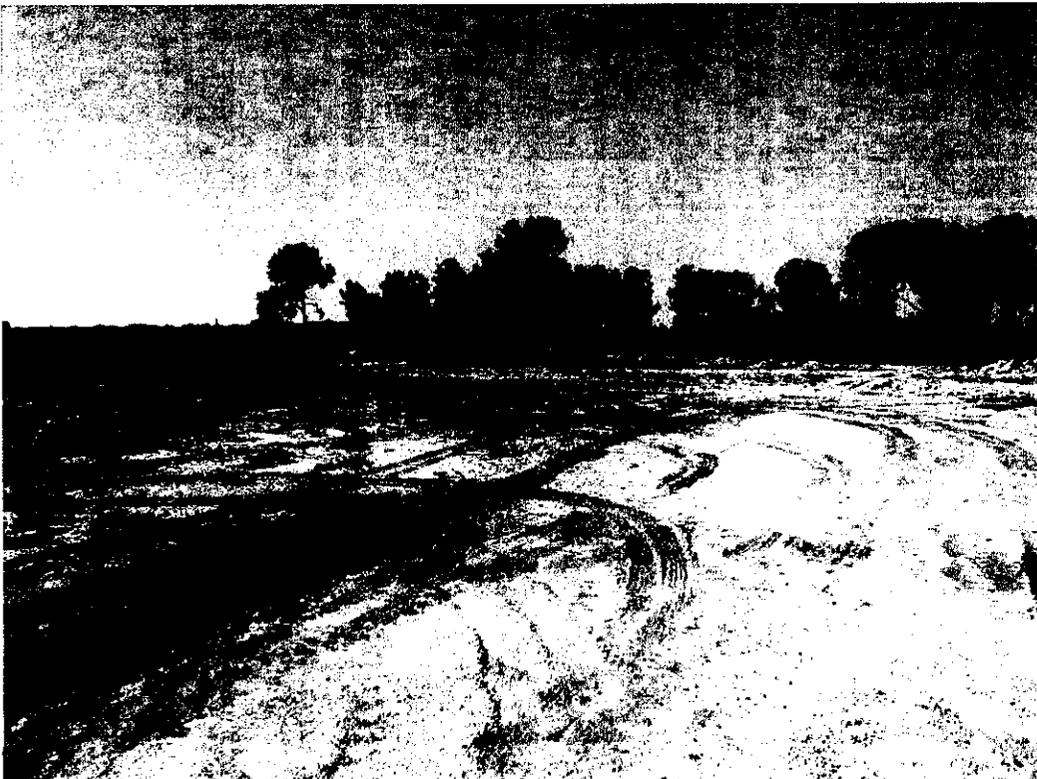
**Date:** September 20, 2006  
**Time:** 11:46 AM  
**Direction:** SW  
**Photo by:** Eisenbrandt  
**Exposure #:** 024  
**Comments:** More area that Blick's Construction is filling and leveling off.

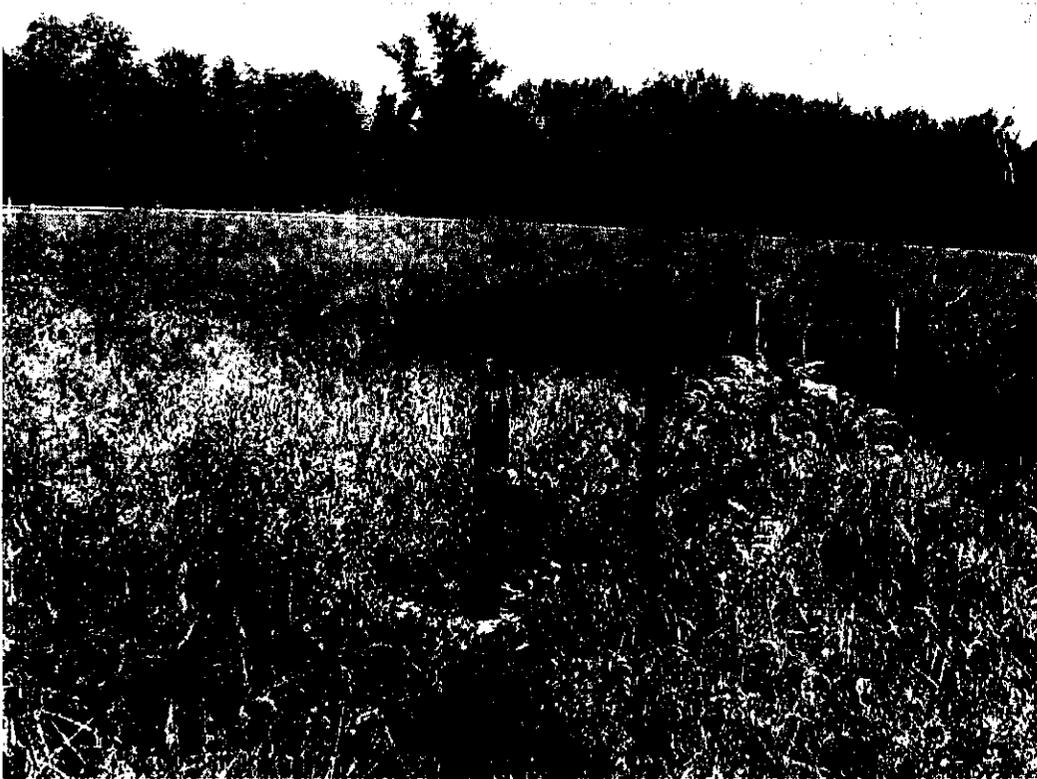
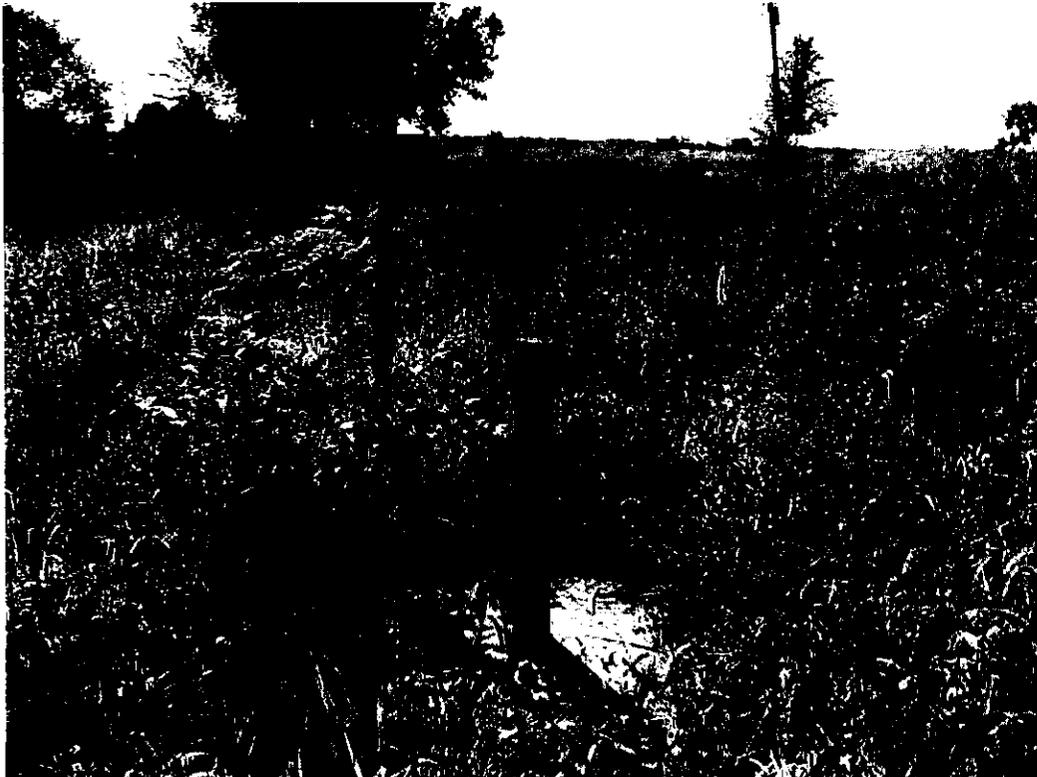
Photographs 027 and 028 show groundwater monitoring well R101. This replacement well is located on the northeast corner of the Site No.1. The well was properly locked, clearly labeled, had adequate drainage around the well, had a drain hole in the bottom of the protective casing, and had a good surface seal.

**Date:** September 20, 2006  
**Time:** 11:50 AM  
**Direction:** NE  
**Photo by:** Eisenbrandt  
**Exposure #:** 027  
**Comments:**  
Groundwater Monitoring  
Well G101(R101).

**Date:** September 20, 2006  
**Time:** 11:50 AM  
**Direction:** S  
**Photo by:** Eisenbrandt  
**Exposure #:** 028  
**Comments:**  
Groundwater Monitoring  
Well G101(R101).

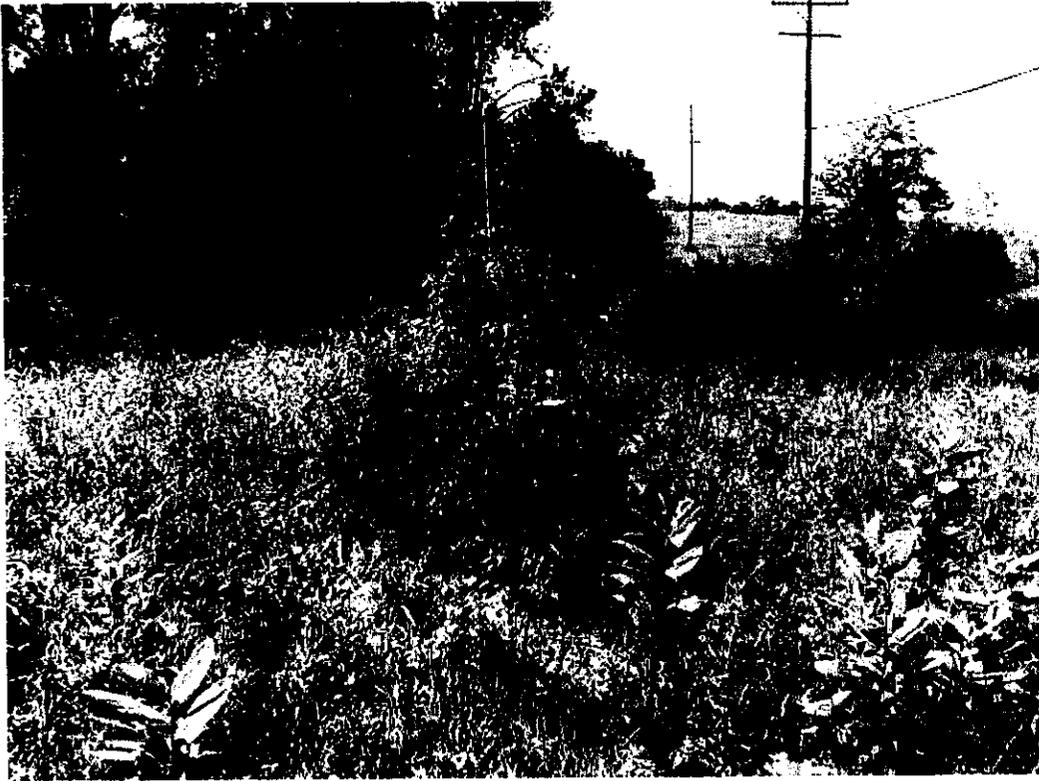
**Date:** September 20, 2006  
**Time:** 11:56 AM  
**Direction:** SW  
**Photo by:** Eisenbrandt  
**Exposure #:** 029  
**Comments:**  
Groundwater Monitoring  
Well G104 hidden in the  
vegetation.
