BEFORE THE ILLINOIS POLLUTION CONTROL BOARD  
ADMINISTRATIVE CITATION

# Open Dump Inspection Checklist

**DATE:** October 5, 2006  
**TO:** DLPC / Division File  
**FROM:** Paul Eisenbrandt, DLPC/FOS Springfield Region  
**SUBJECT:** LPC #0010650002 – Adams County  
Quincy/Blickhan Landfill  
FOS File

The purpose of this memorandum is to serve as the Narrative Inspection Report Document of a September 20, 2006 landfill inspection at the above referenced site. The inspection took place from approximately 10:40 am to 12:40 pm, and thirty-five (35) digital photographs were taken. The weather at the time of the inspection was sunny and about 82°F. Mr. C. John Blickhan was interviewed during the inspection.

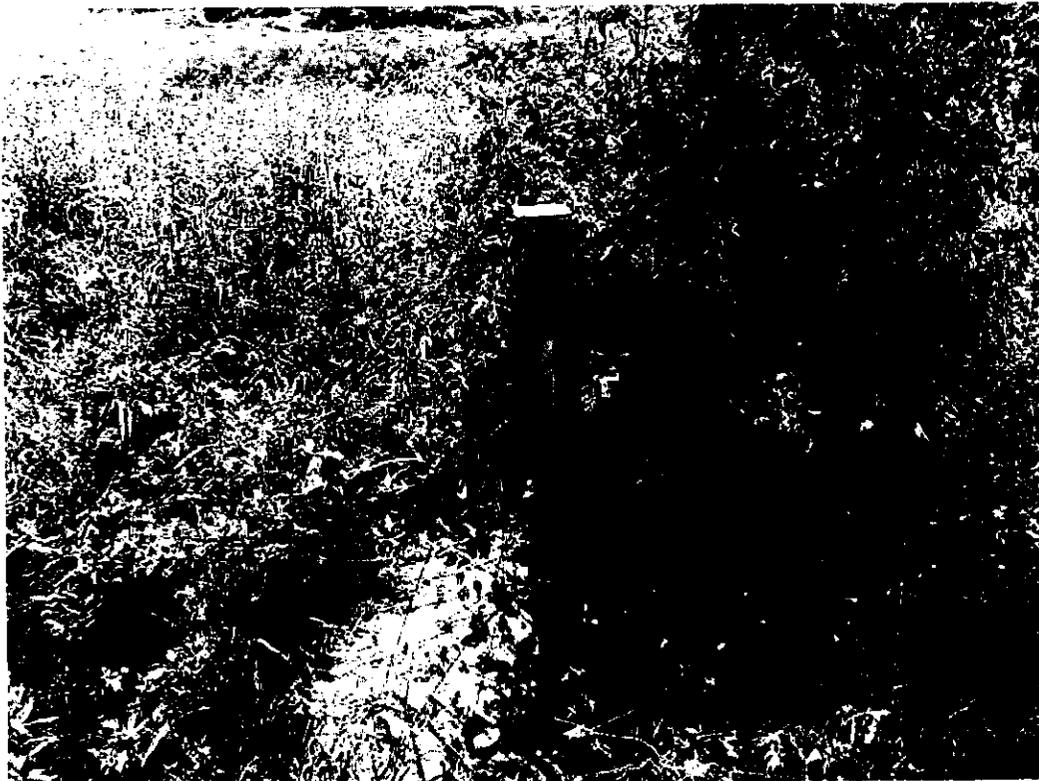
**Date:** September 20, 2006  
**Time:** 11:56 AM  
**Direction:** SE  
**Photo by:** Eisenbrandt  
**Exposure #:** 030  
**Comments:**  
Groundwater Monitoring  
Well G104.

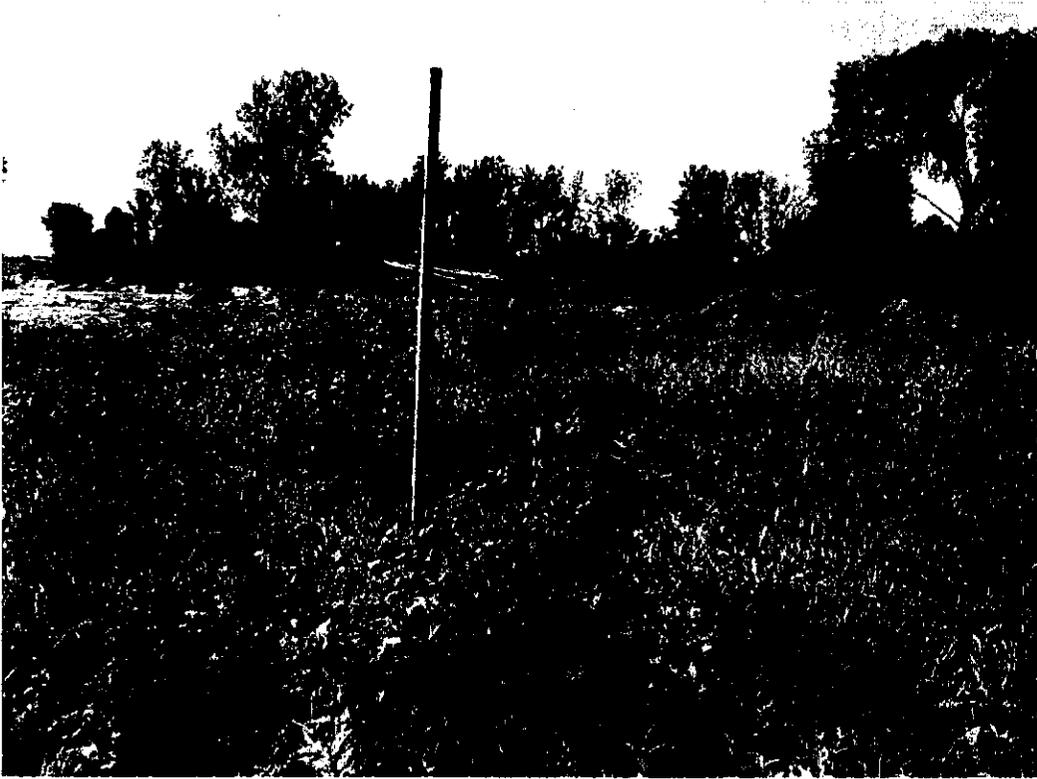
**Date:** September 20, 2006  
**Time:** 12:05 PM  
**Direction:** SW  
**Photo by:** Eisenbrandt  
**Exposure #:** 031  
**Comments:**  
Groundwater Monitoring  
Well G105.
