ADMINISTRATIVE CITATION

AC **07-63**
(IEPA No. 157-07-AC)

Open Dump Inspection Checklist

NARRATIVE INSPECTION REPORT

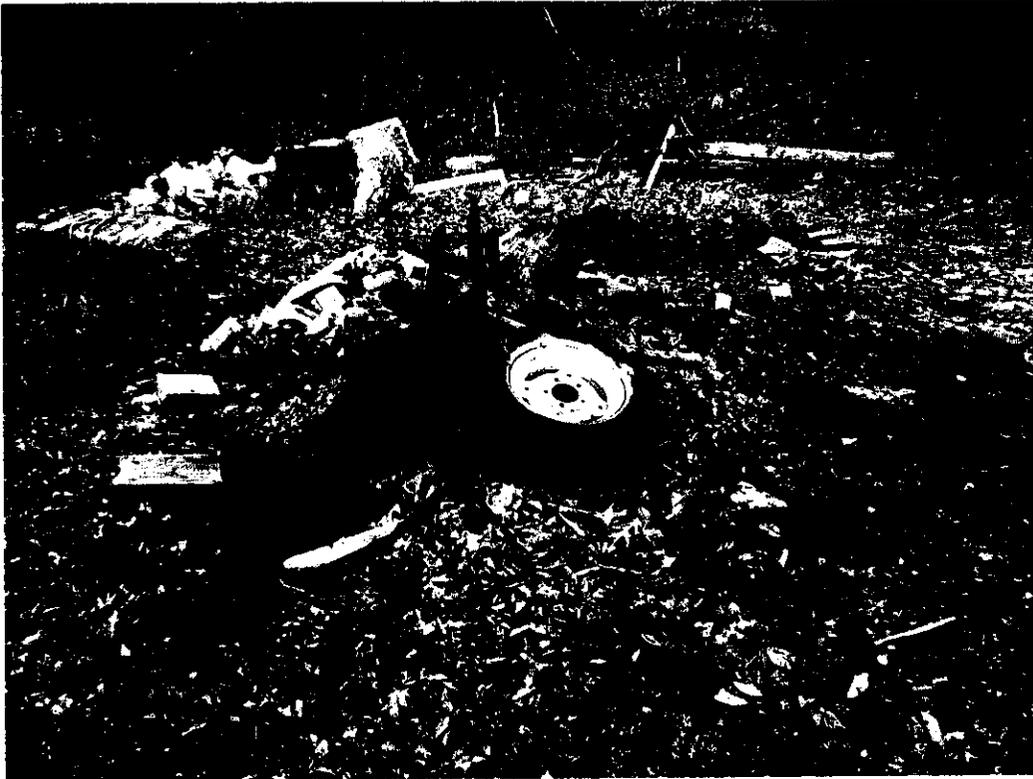
Date: 4/23/2007
Time: 10:37 A.M.
Direction: northwest
Photo by: S. Williams
Exposure #: 001
Comments: burn pile
with tire on rim,
metal & charred
furniture

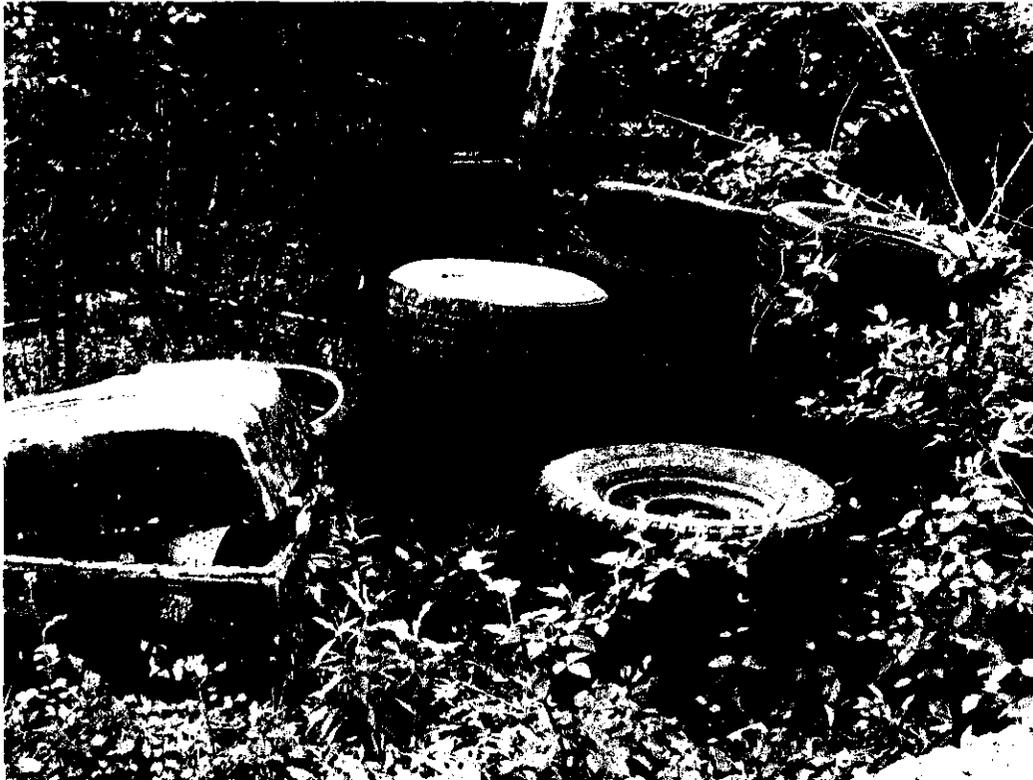
Date: 4/23/2007
Time: 10:39 A.M.
Direction: southeast
Photo by: S. Williams
Exposure #: 003
Comments: 28 tires

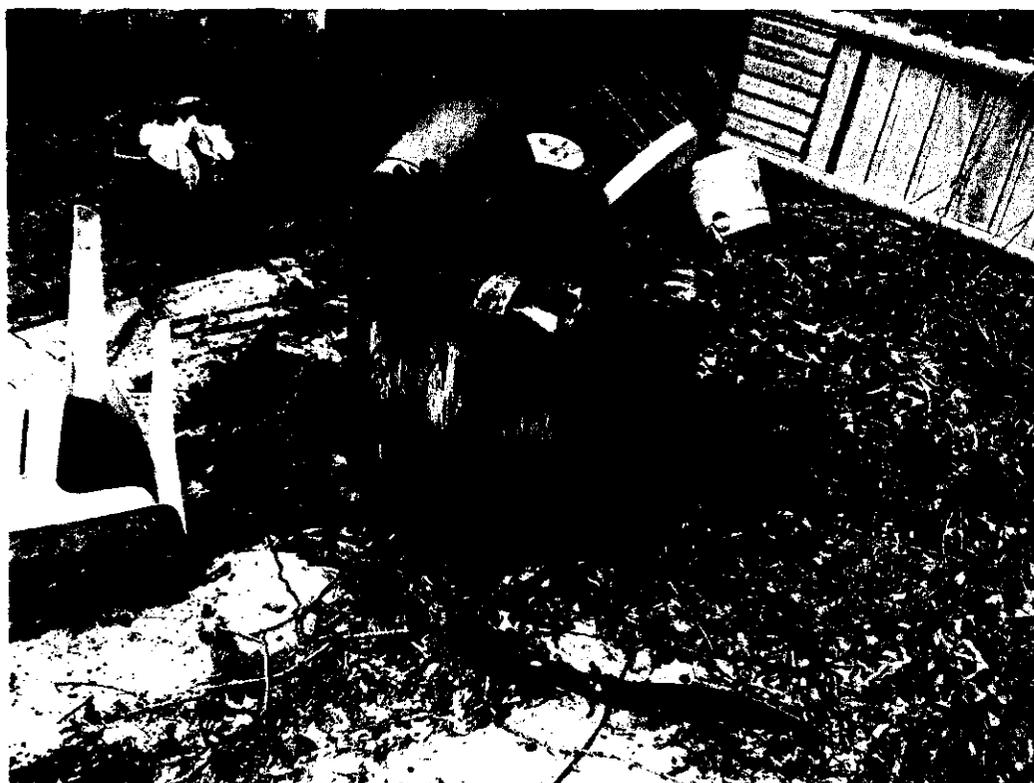
**Date: 4/23/2007
Time: 10:47 A.M.
Direction: southwest
Photo by: S. Williams
Exposure #: 010
Comments: metal tub
apparently used to
burn electronics &
wood**

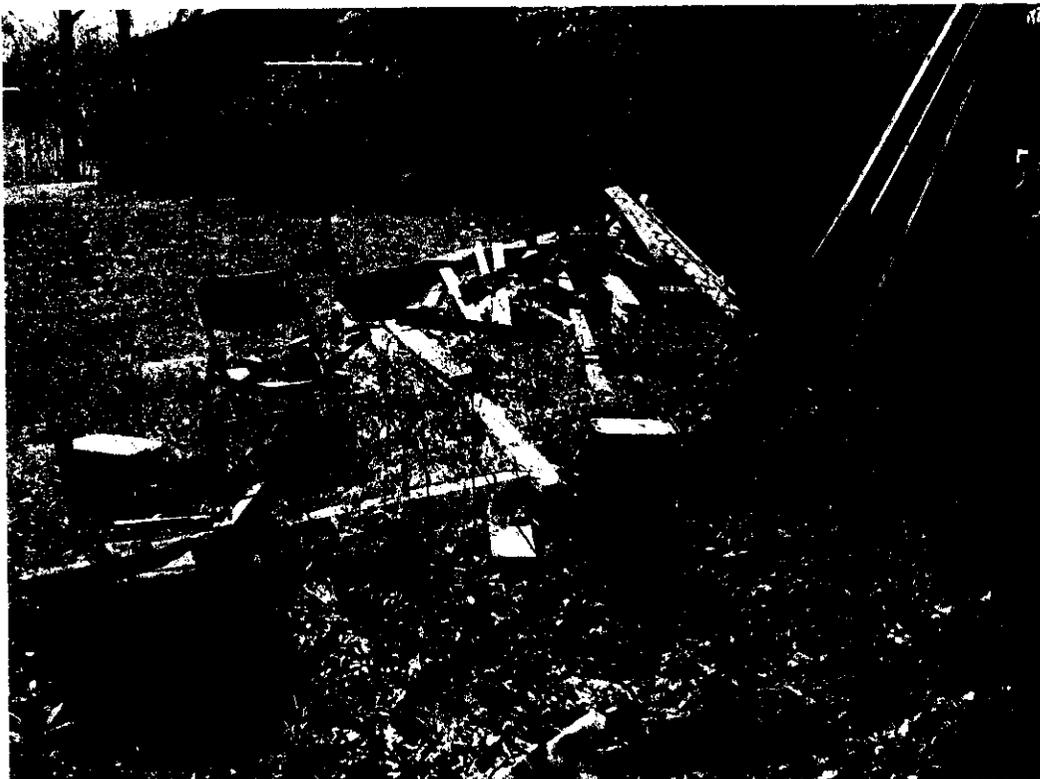
**Date: 4/23/2007
Time: 10:48 A.M.
Direction: southeast
Photo by: S. Williams
Exposure #: 012
Comments: metal,
demolition wood, a
broken wheel barrel &
carpeting**

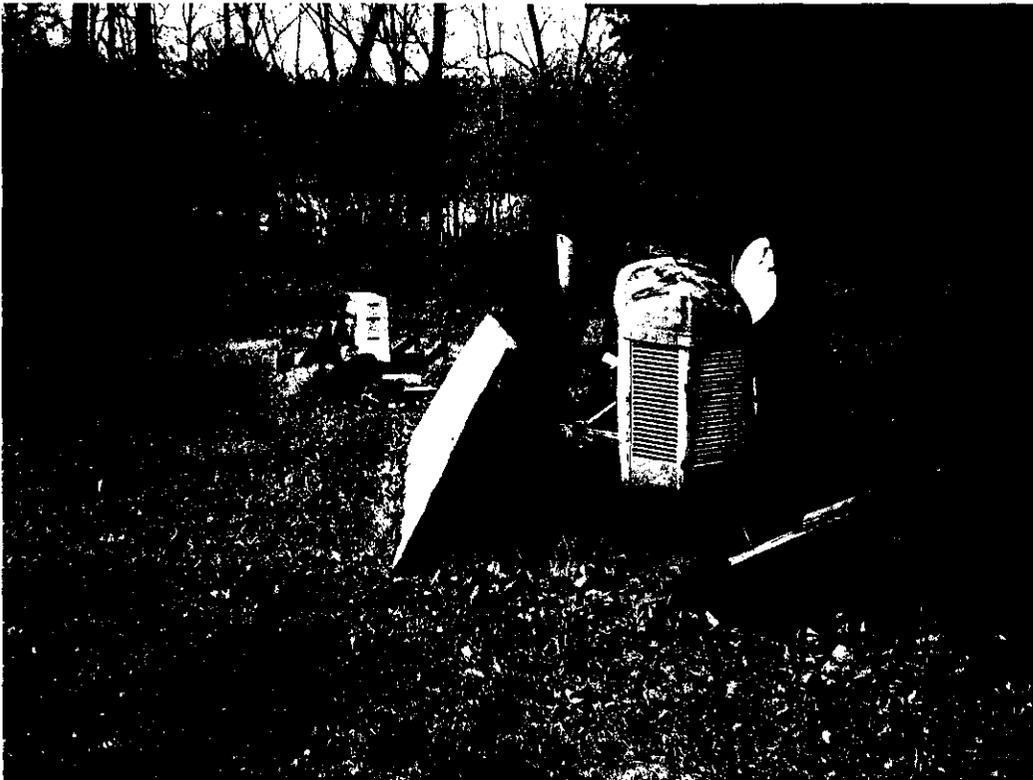
Date: 4/23/2007
Time: 10:52 A.M.
Direction: southwest
Photo by: S. Williams
Exposure #: 013
Comments: finish
mower, demolition
wood, a tractor & a
wheel barrel

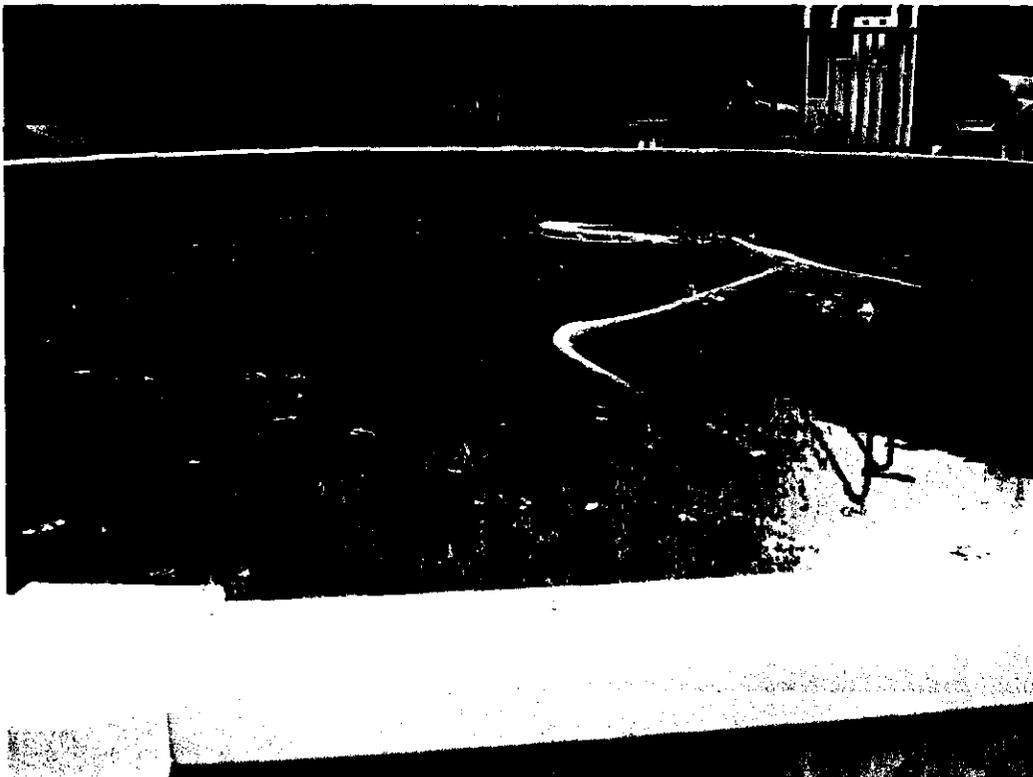
Date: 4/23/2007
Time: 10:54 A.M.
Direction: northeast
Photo by: S. Williams
Exposure #: 014
Comments: swimming
pool containing dirty,
stagnant water

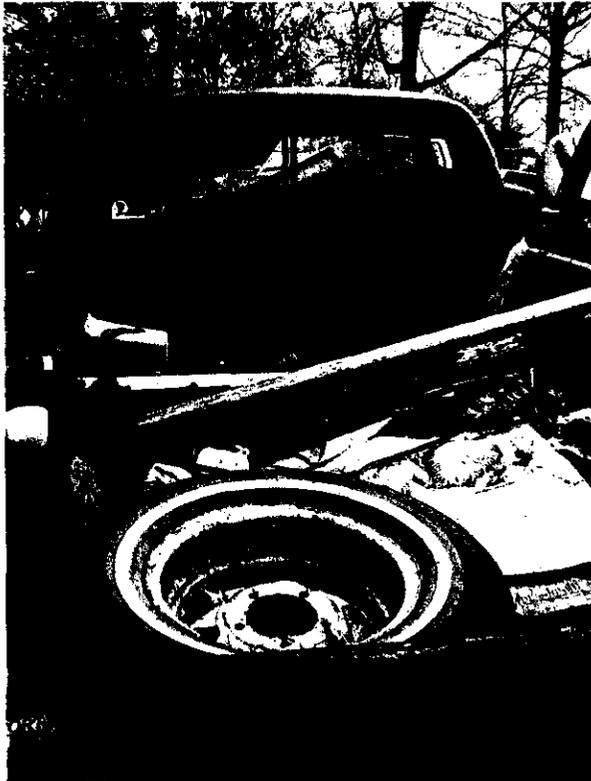
**Date: 4/23/2007
Time: 10:57 A.M.
Direction: northeast
Photo by: S. Williams
Exposure #: 016
Comments: truck bed
containing weathered
wood, rusted metal,
worn cardboard & a
tire; materials are
being stored in the
cab of the truck, some
of which are broken**

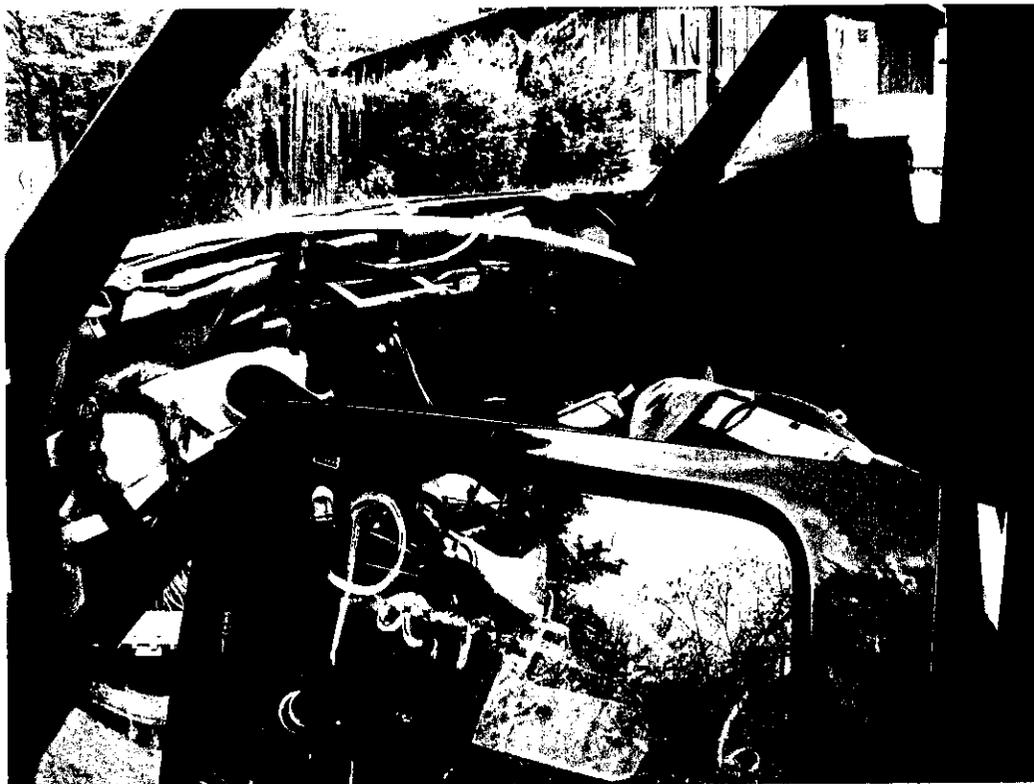
**Date: 4/23/2007
Time: 10:59 A.M.
Direction: northeast
Photo by: S. Williams
Exposure #: 017
Comments: heavily gutted truck storing some vehicle parts being exposed to the elements**

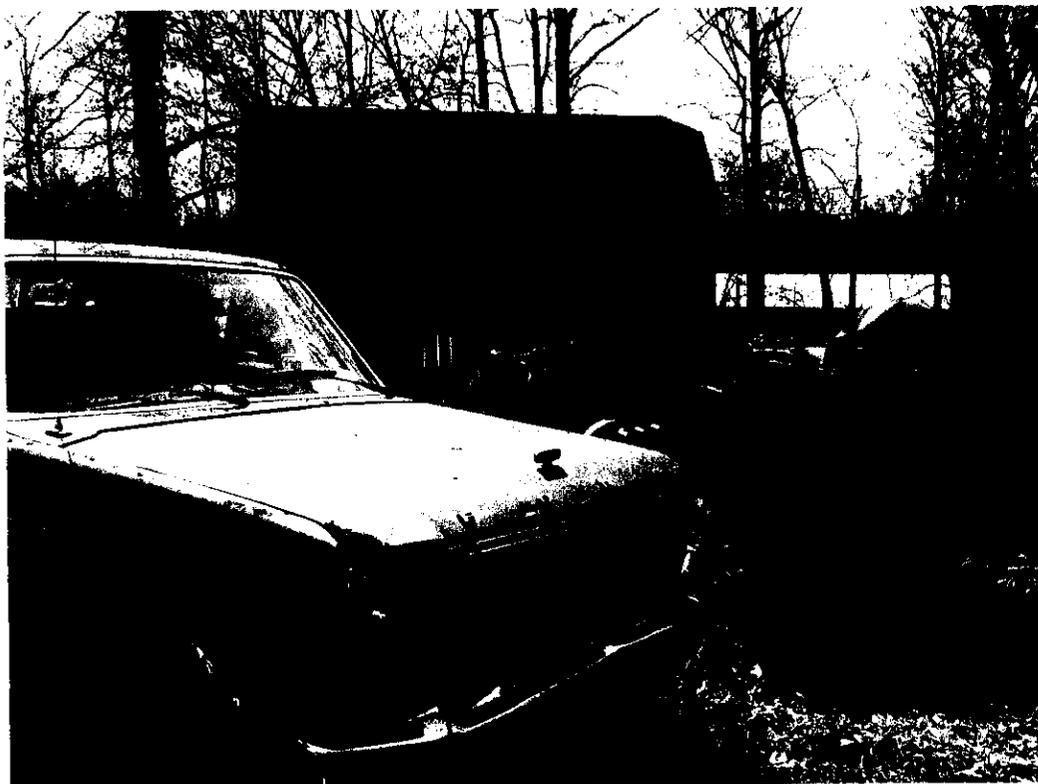
**Date: 4/23/2007
Time: 10:59 A.M.
Direction: south
Photo by: S. Williams
Exposure #: 018
Comments: two trucks storing waste, three push mowers, a rusted bicycle & a riding lawnmower**

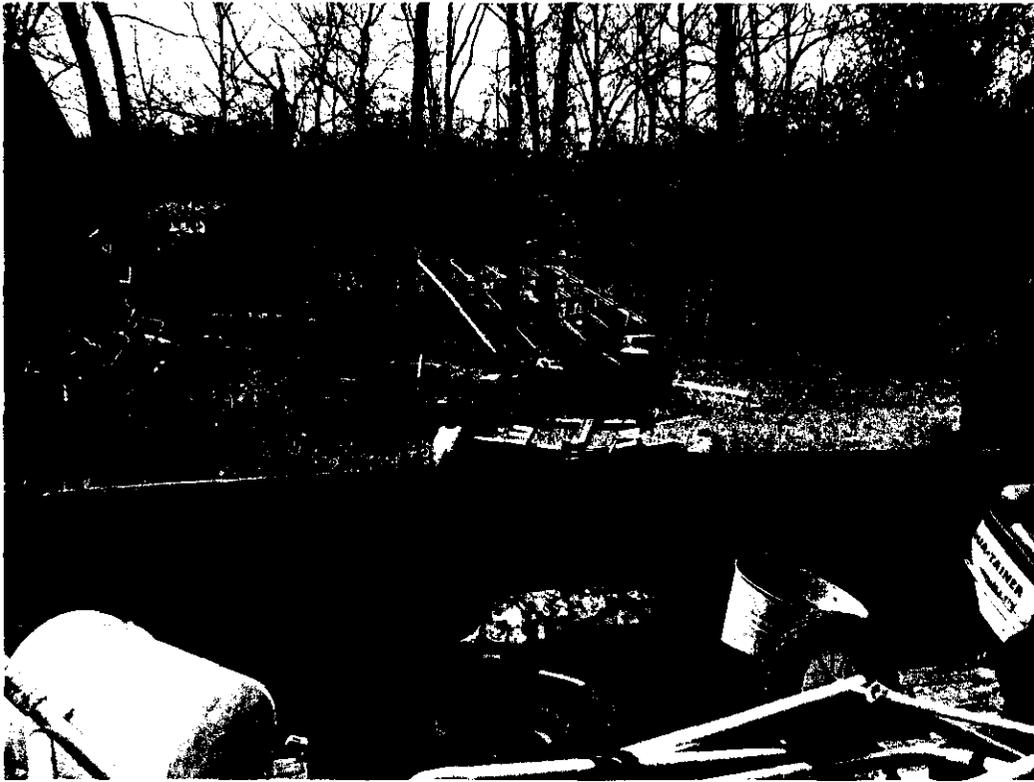
Date: 4/23/2007
Time: 11:01 A.M.
Direction: southwest
Photo by: S. Williams
Exposure #: 019
Comments: tire &
other waste in the
back of a truck, three
riding lawn mowers,
two bicycles, three
tires & two trailers

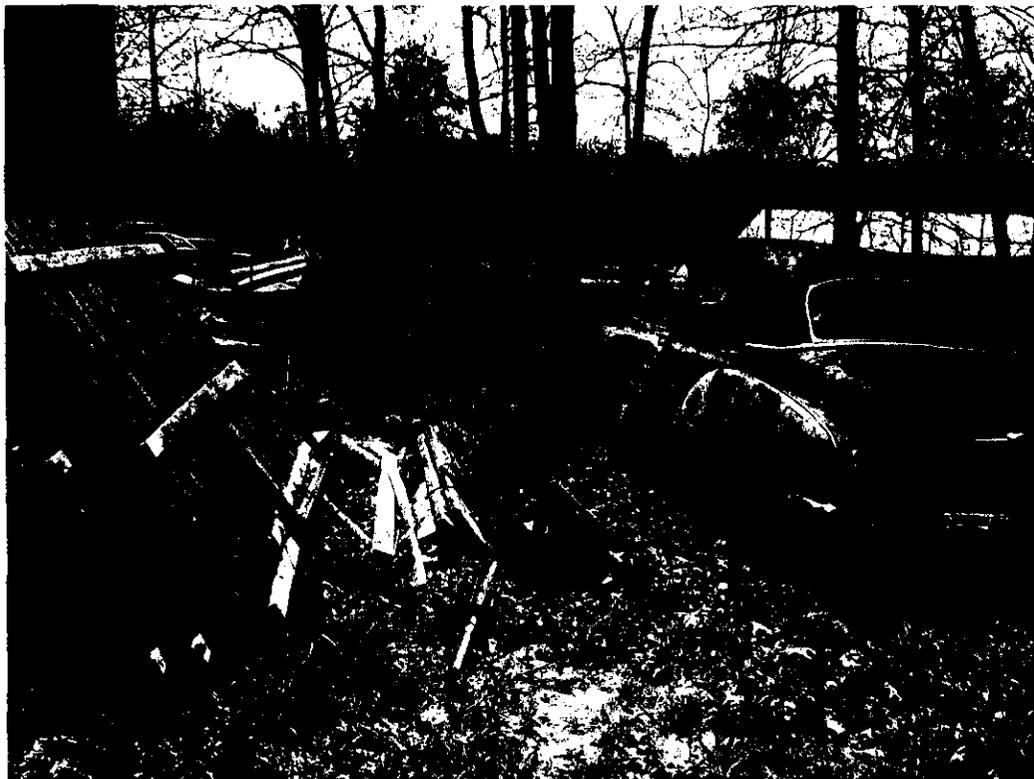
Date: 4/23/2007
Time: 11:01 A.M.
Direction: southeast
Photo by: S. Williams
Exposure #: 020
Comments: car,
weathered fencing, a
tire, variety of metal
& demolition debris

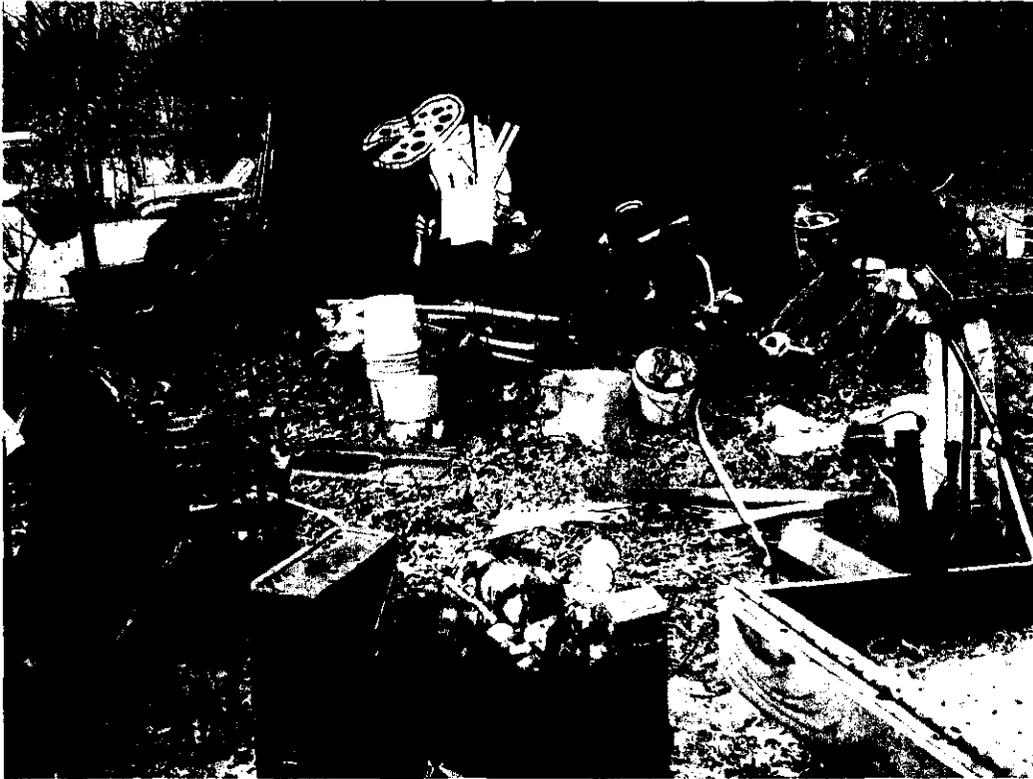
**Date: 4/23/2007
Time: 11:04 A.M.
Direction: southwest
Photo by: S. Williams
Exposure #: 021
Comments: a riding
lawnmower, a bucket
of fluorescent light
bulbs, electrical outlet
box, furniture, glass,
cardboard tubes &
tires**

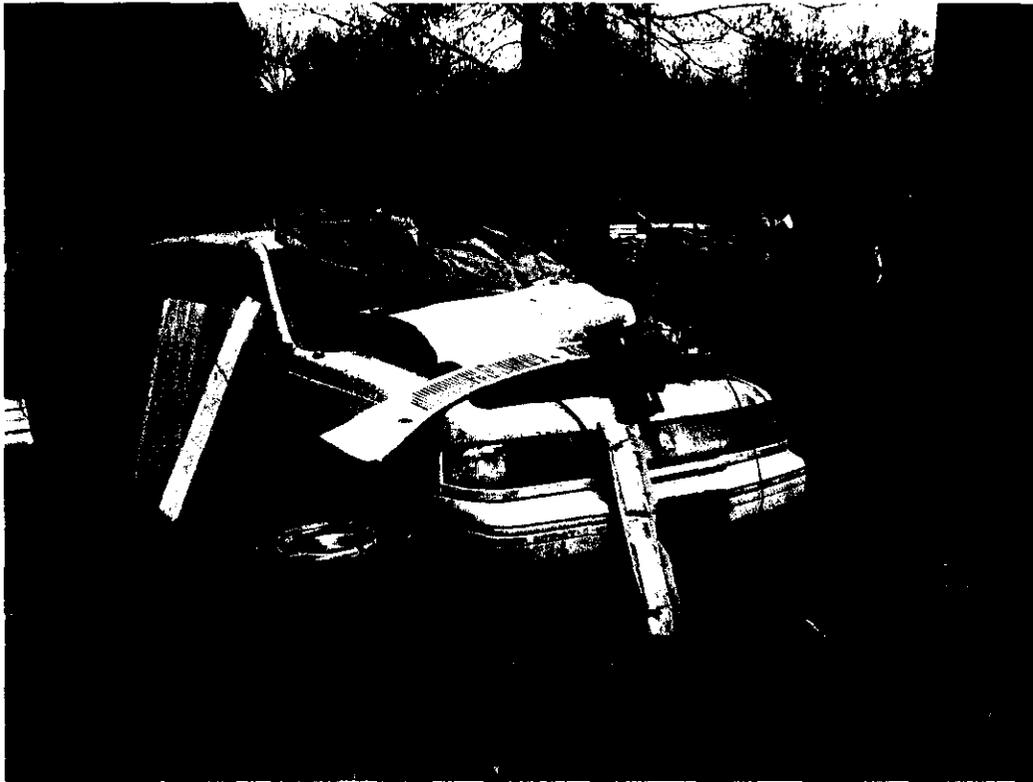
Date: 4/23/2007
Time: 11:07 A.M.
Direction: northwest
Photo by: S. Williams
Exposure #: 023
Comments: a car,
tires, vehicle parts &
demolition debris

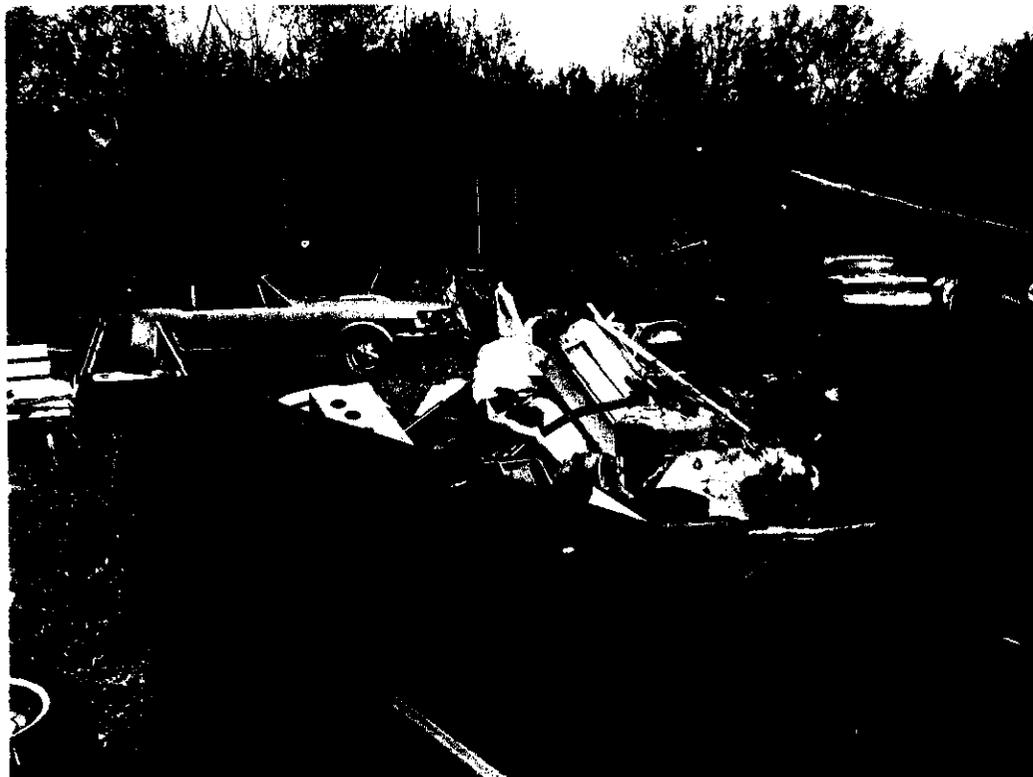
Date: 4/23/2007
Time: 11:11 A.M.
Direction: north
Photo by: S. Williams
Exposure #: 024
Comments: a riding
lawnmower, pickup
truck with a variety of
waste in the bed & a
box of fluorescent
light bulbs

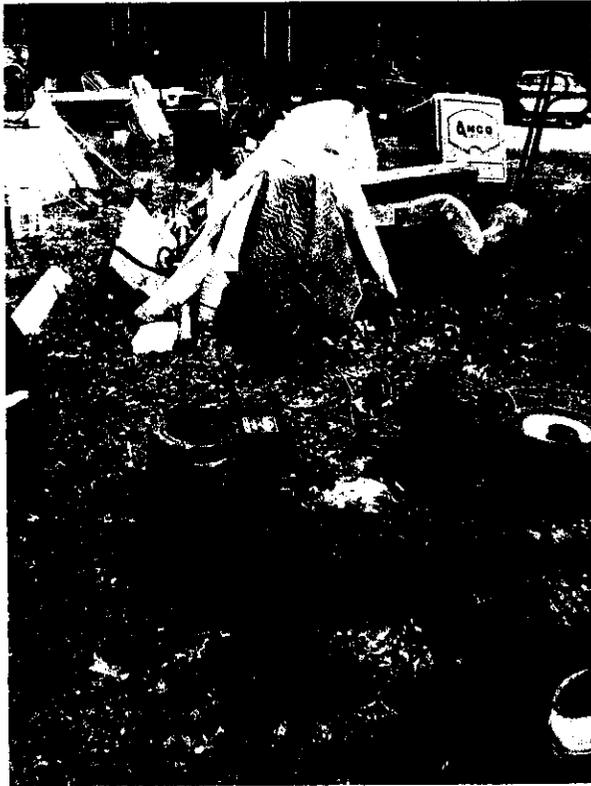
**Date: 4/23/2007
Time: 11:18 A.M.
Direction: northwest
Photo by: S. Williams
Exposure #: 027
Comments: tires,
furniture, textiles,
metal, plastics,
electrical cords & a
lawnmower motor**

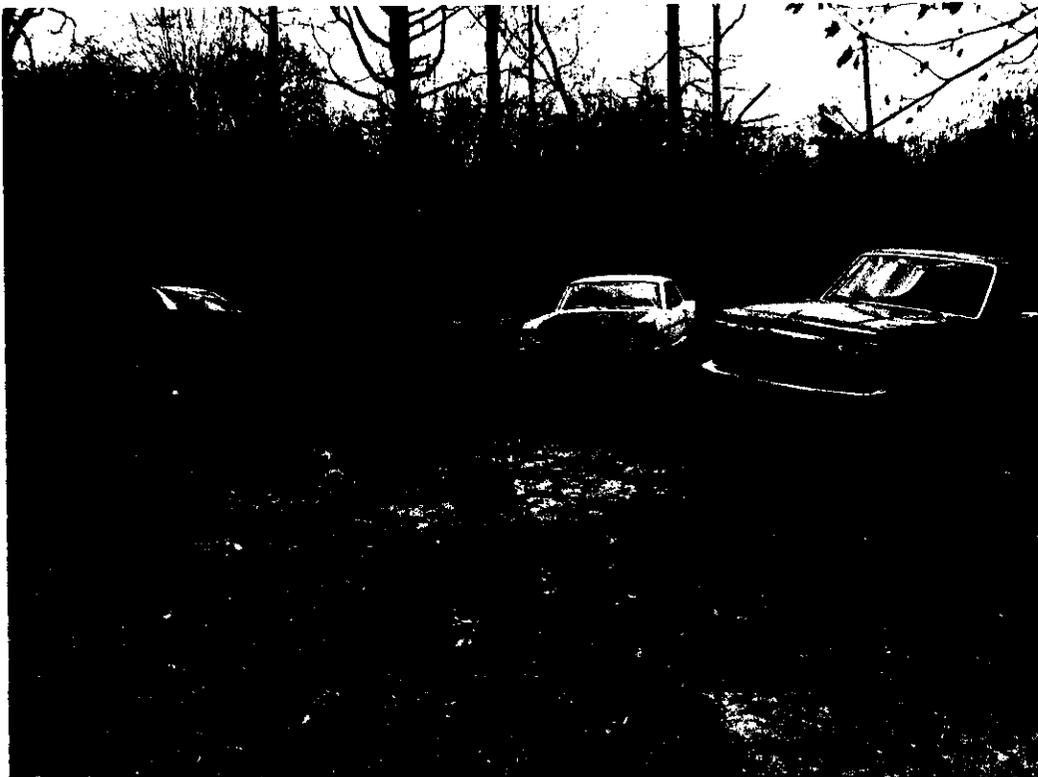
**Date: 4/23/2007
Time: 11:23 A.M.
Direction: southeast
Photo by: S. Williams
Exposure #: 032
Comments: three
vehicles**

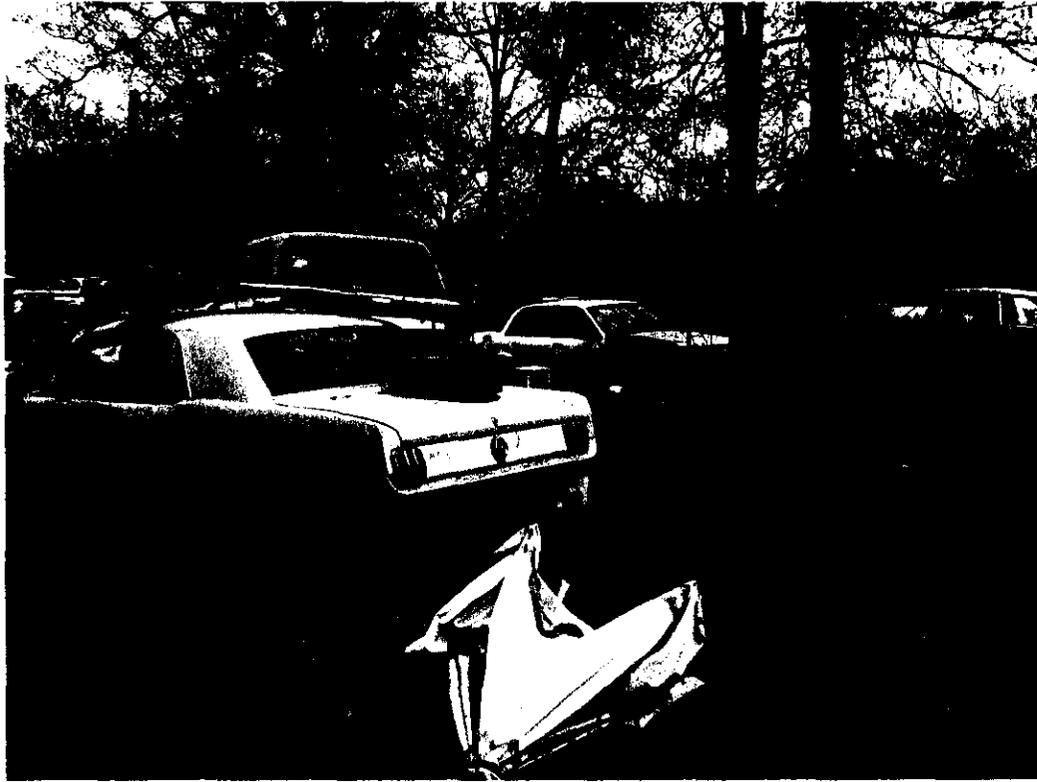
Date: 4/23/2007
Time: 11:24 A.M.
Direction: northeast
Photo by: S. Williams
Exposure #: 033
Comments: tires,
vehicle parts &
vehicles – the left
rear tire on the
Mustang appears to
be partially sunk into
the ground

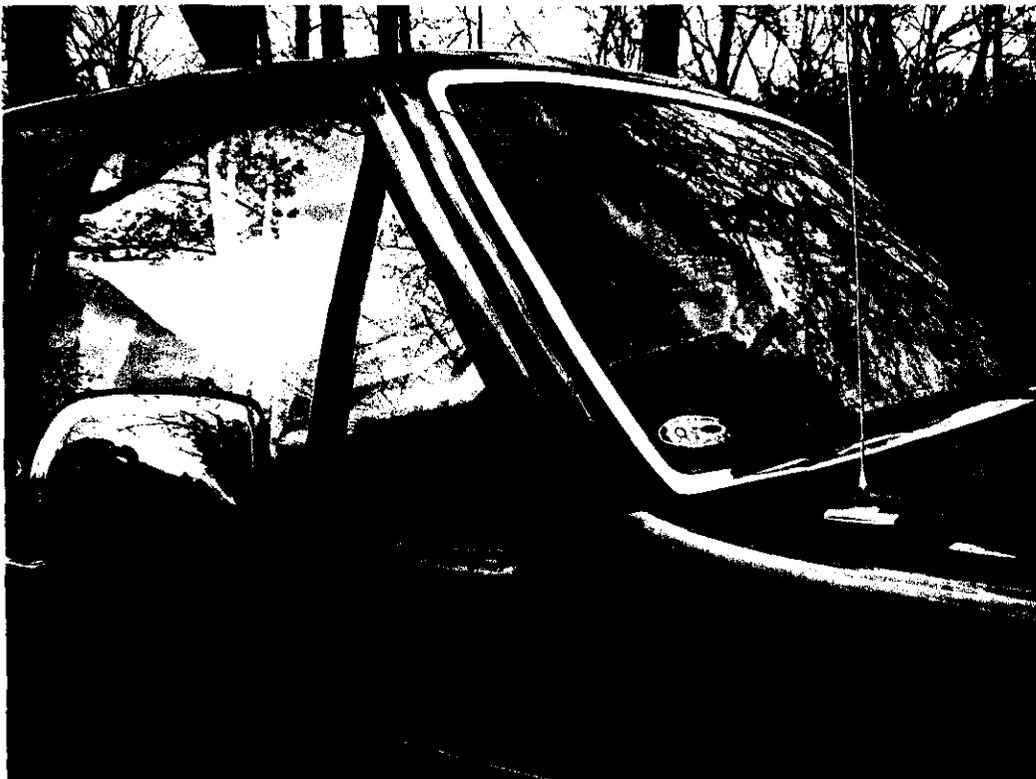
Date: 4/23/2007
Time: 11:25 A.M.
Direction: southwest
Photo by: S. Williams
Exposure #: 034
Comments: truck
storing what appears
to be Styrofoam as
well as other items

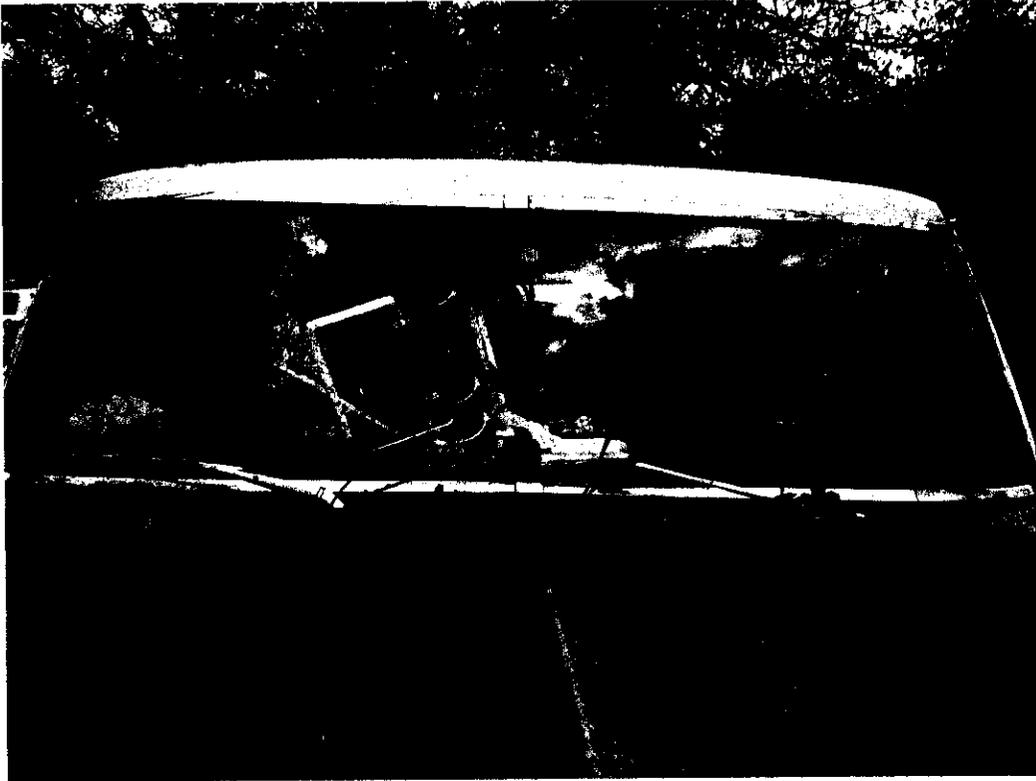
Date: 4/23/2007
Time: 11:28 A.M.
Direction: northwest
Photo by: S. Williams
Exposure #: 037
Comments: items
being stored in the
cab of a truck

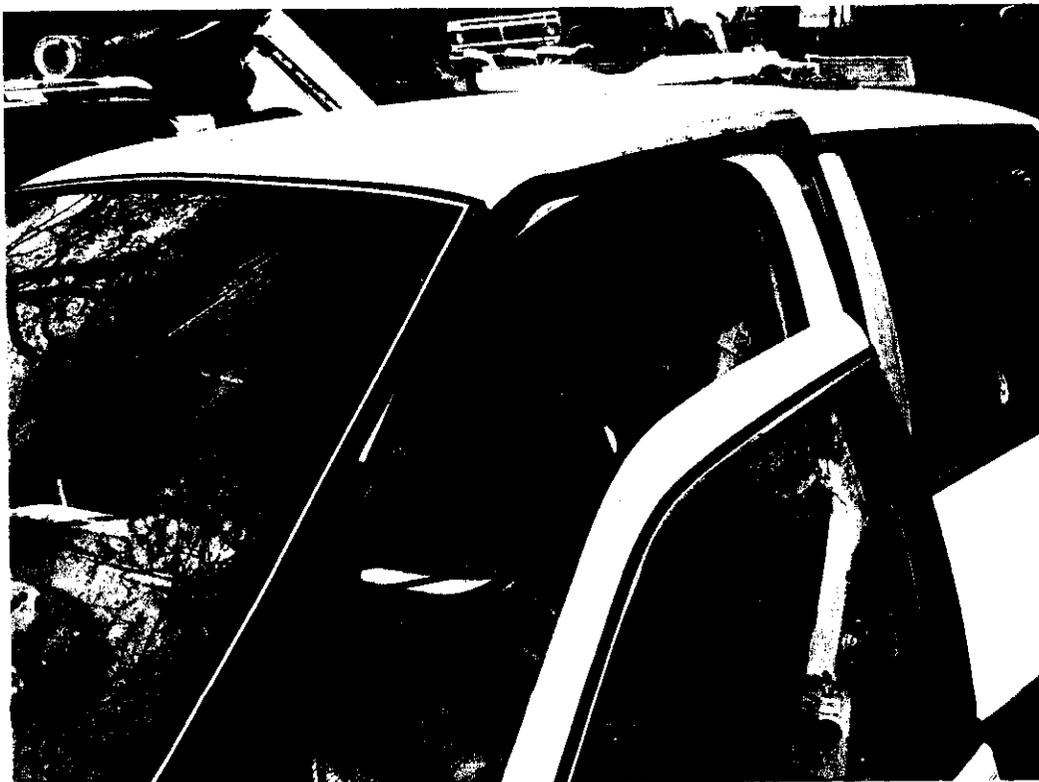
Date: 4/23/2007
Time: 11:30 A.M.
Direction: northwest
Photo by: S. Williams
Exposure #: 038
Comments: metal,
weathered cardboard,
a weed eater &
Christmas decoration
being stored in a
vehicle & being
exposed to the
elements

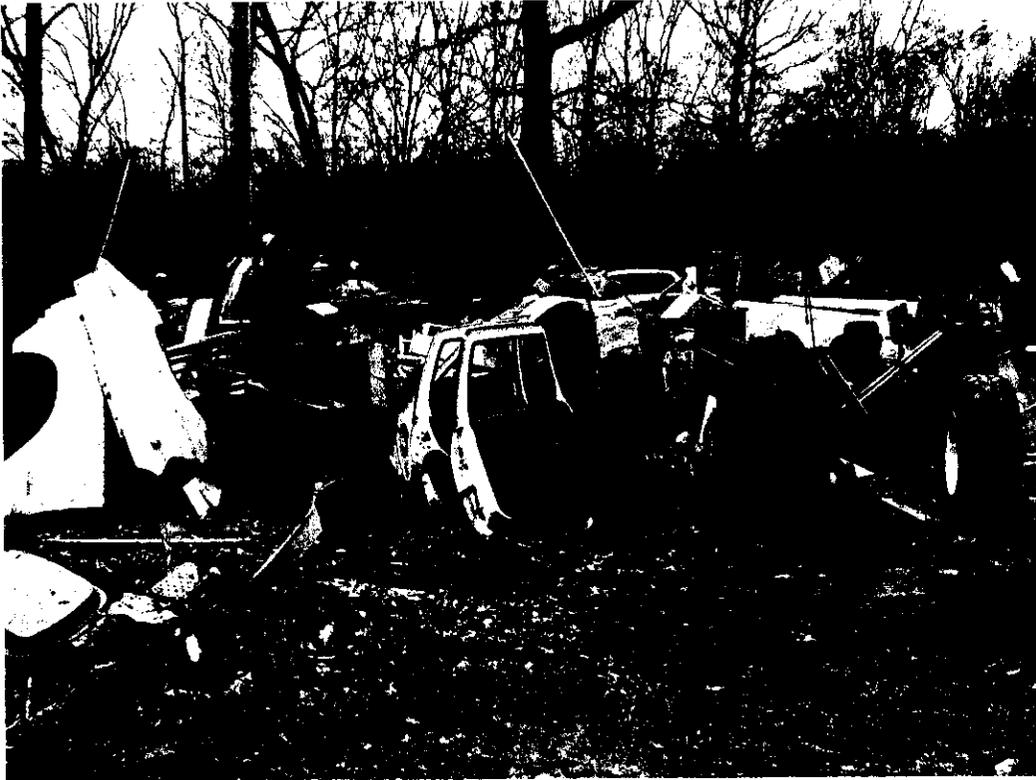
Date: 4/23/2007
Time: 11:31 A.M.
Direction: southwest
Photo by: S. Williams
Exposure #: 039
Comments: tires,
vehicle parts,
demolition debris,
furniture, road
barricade, electrical
lamp, variety of
metal, wood cabinet,
various cords & a
lawnmower motor

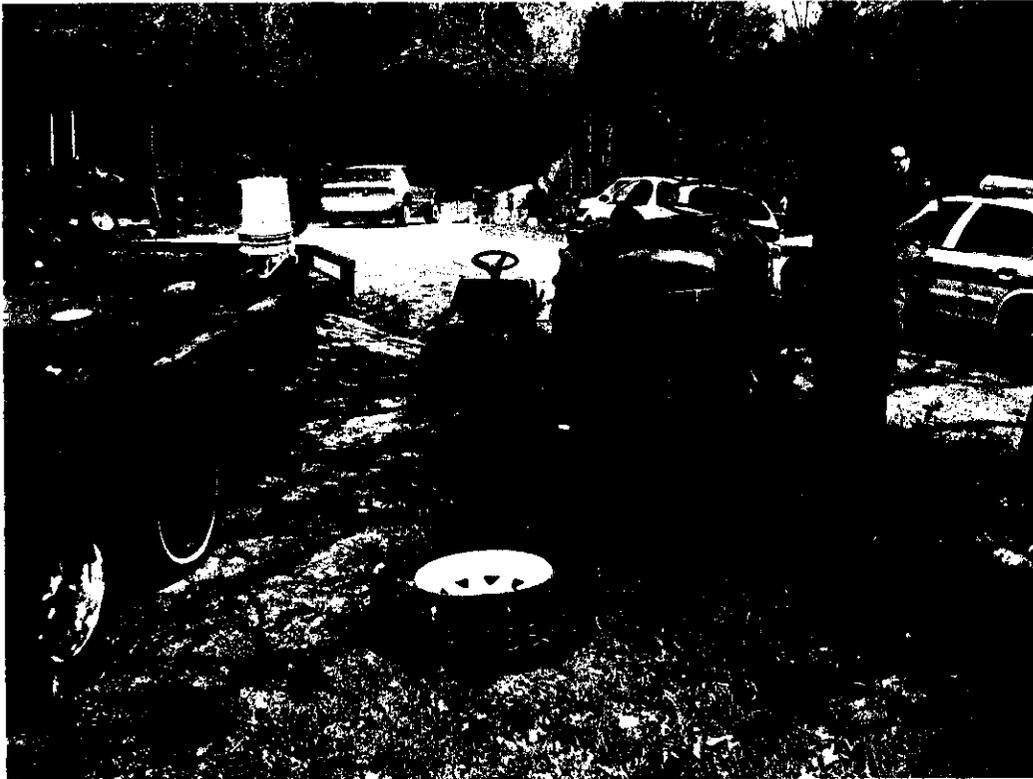
**Date: 4/23/2007
Time: 11:34 A.M.
Direction: northwest
Photo by: S. Williams
Exposure #: 041
Comments: riding
lawnmower, tractor,
metal & tires**
