Re: Illinois Environmental Protection Agency v. Brian Bellemey
IEPA File No. 140-08-AC; 1210205002—Marion County

ADMINISTRATIVE CITATION

FACILITY: Junction City/Bellemeay

The purpose of this memorandum is to serve as the narrative for a July 23, 2008 inspection conducted at the above referenced site. The inspection took place between 1:05 pm and 1:20 pm. Seven digital photographs were taken. The weather conditions were sunny and approximately 80°F. Mr. Bob Glammeyer was interviewed briefly at the start of the inspection.

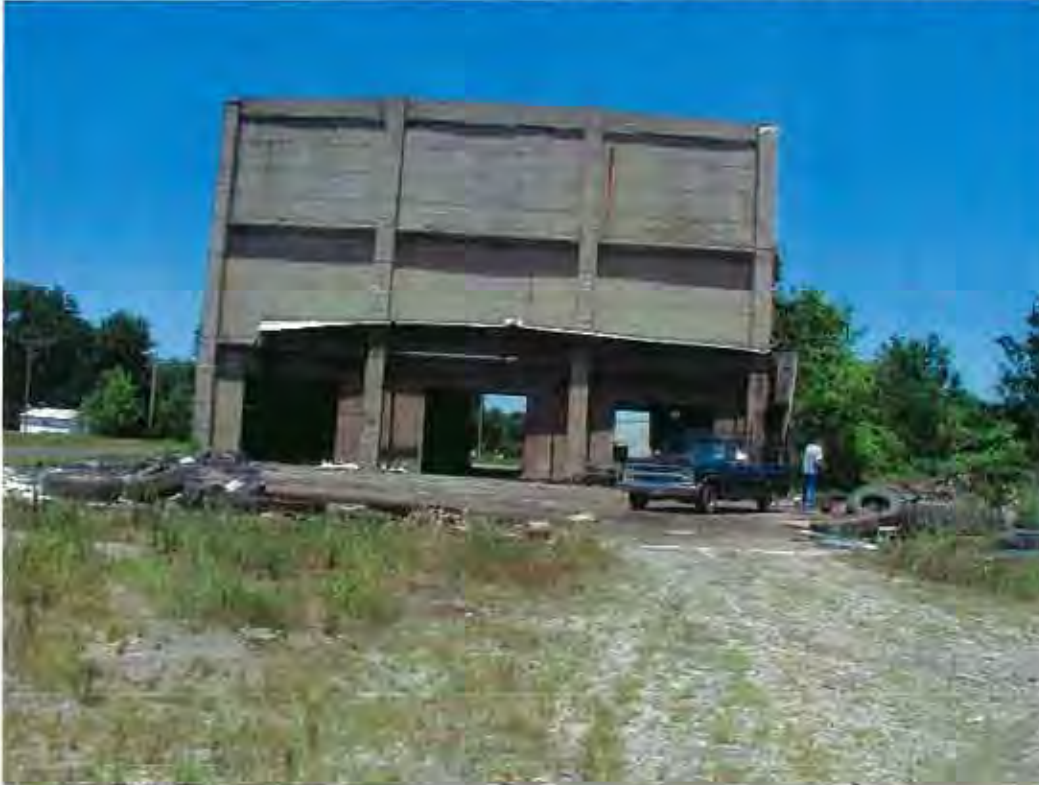
Date: 23 July 2008
Time: 1:14 pm
Direction: N
Photo by: M. Cozadd
Exposure #: 001
Comments: Former location of metal building that was located adjacent to southern edge of concrete building. Metal building removed since the previous inspection on April 2, 2008.

During the July 23, 2008 inspection, I observed that the metal building adjacent to the large concrete building has been removed from the site sometime after the previous inspection on April 2, 2008 (see attached photos #001 and #007). The property owner or operator failed to submit to the Illinois EPA the required 10-day notification of demolition and renovation form for the removal of the metal building. The site will be referred to the Illinois EPA's Bureau of Air for possible enforcement action.

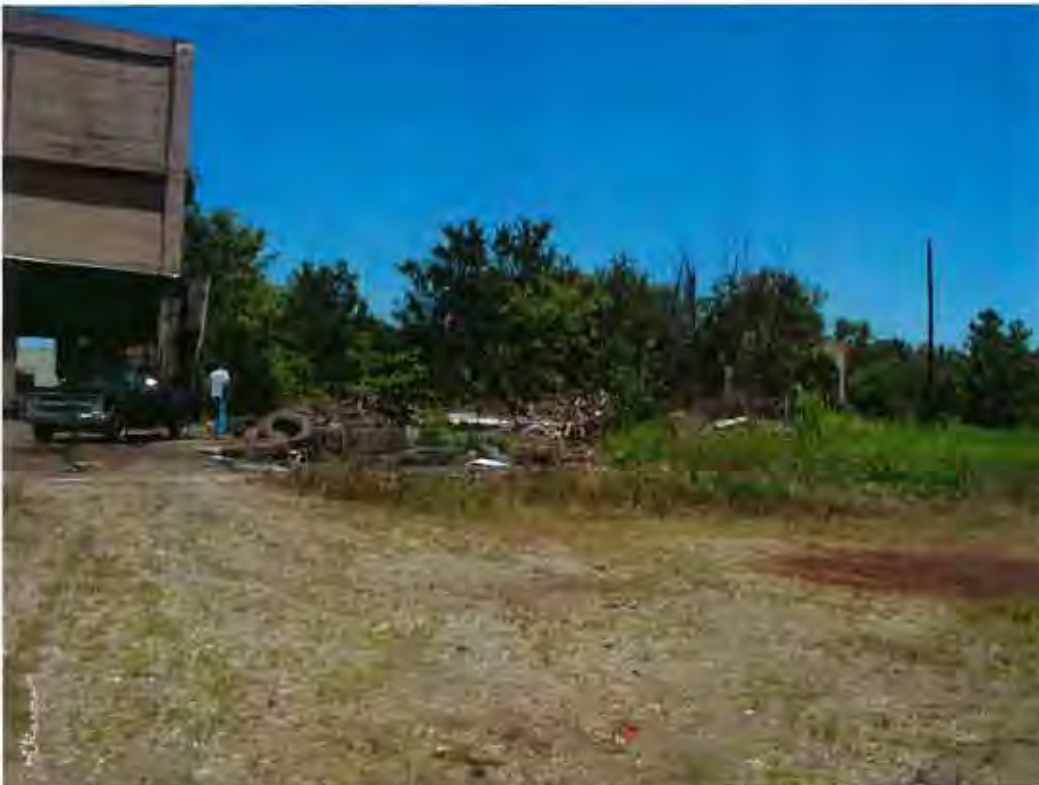
Date: 23 July 2008
Time: 1:14 pm
Direction: NE
Photo by: M. Cozadd
Exposure #: 002
Comments: Used tires, damaged dimensional lumber, broken concrete, siding, and other miscellaneous waste materials piled outdoors east of building.

The removal of the metal building was the only significant change observed at the site. The remainder of the site appeared unchanged since the April 2, 2008 inspection. The waste materials near the building are shown in the attached photos #001 through #004. The waste materials included used tires, damaged dimensional lumber, broken concrete, and siding. The attached photo #005 shows the drums in the small metal shed adjacent to the east wall of the building. The drums were also observed during the previous inspection on April 2, 2008. The attached photo #006 illustrate the damaged dimensional lumber, railroad ties, concrete blocks, siding, and insulation near the concrete structure on the eastern half of the site. The waste materials observed at the site appeared unchanged since the previous inspection on April 2, 2008.

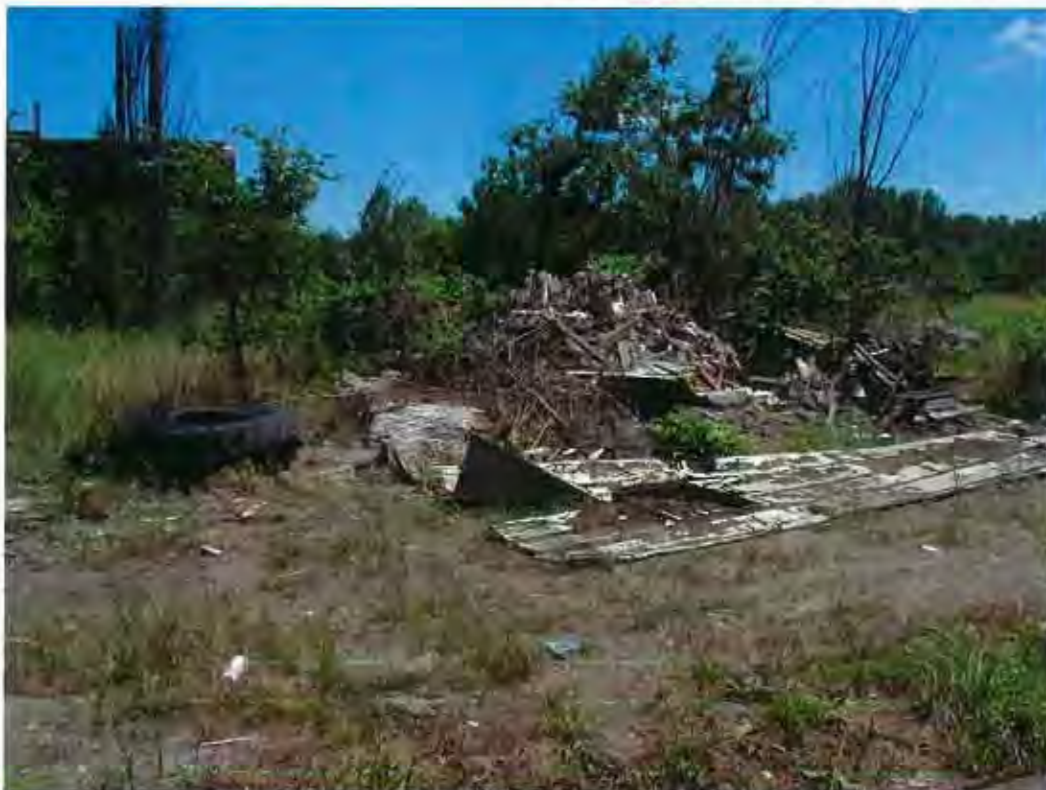
Date: 23 July 2008
Time: 1:15 pm
Direction: E
Photo by: M. Cozadd
Exposure #: 003
Comments: Used tires, damaged dimensional lumber, broken concrete, siding, and other miscellaneous waste materials piled outdoors east of building. The pile of waste materials appeared unchanged since the previous inspection on April 2, 2008.

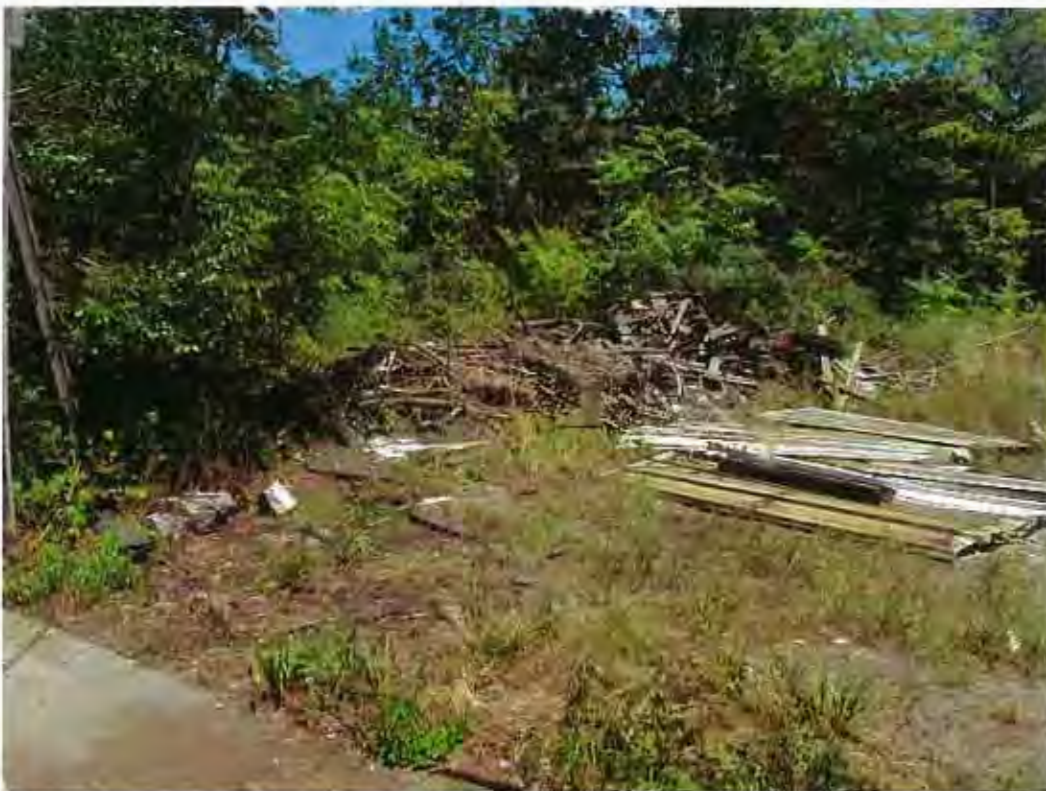
Date: 23 July 2008
Time: 1:15 pm
Direction: NE
Photo by: M. Cozadd
Exposure #: 004
Comments: Damaged dimensional lumber, siding, and landscape waste piled outdoors east of building. The pile of waste materials appeared unchanged since the previous inspection on April 2, 2008.

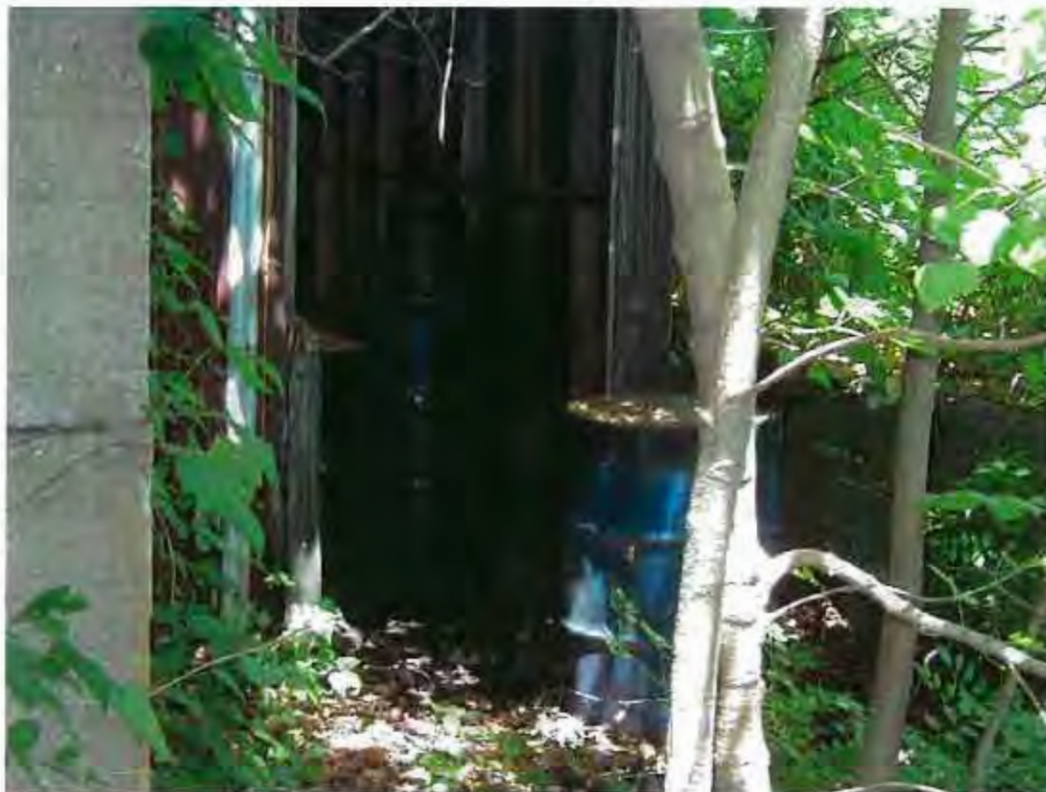
Date: 23 July 2008
Time: 1:15 pm
Direction: N
Photo by: M. Cozadd
Exposure #: 005
Comments: Drums in small metal shed adjacent to east wall of building. Drums were also observed during the previous inspection on April 2, 2008.

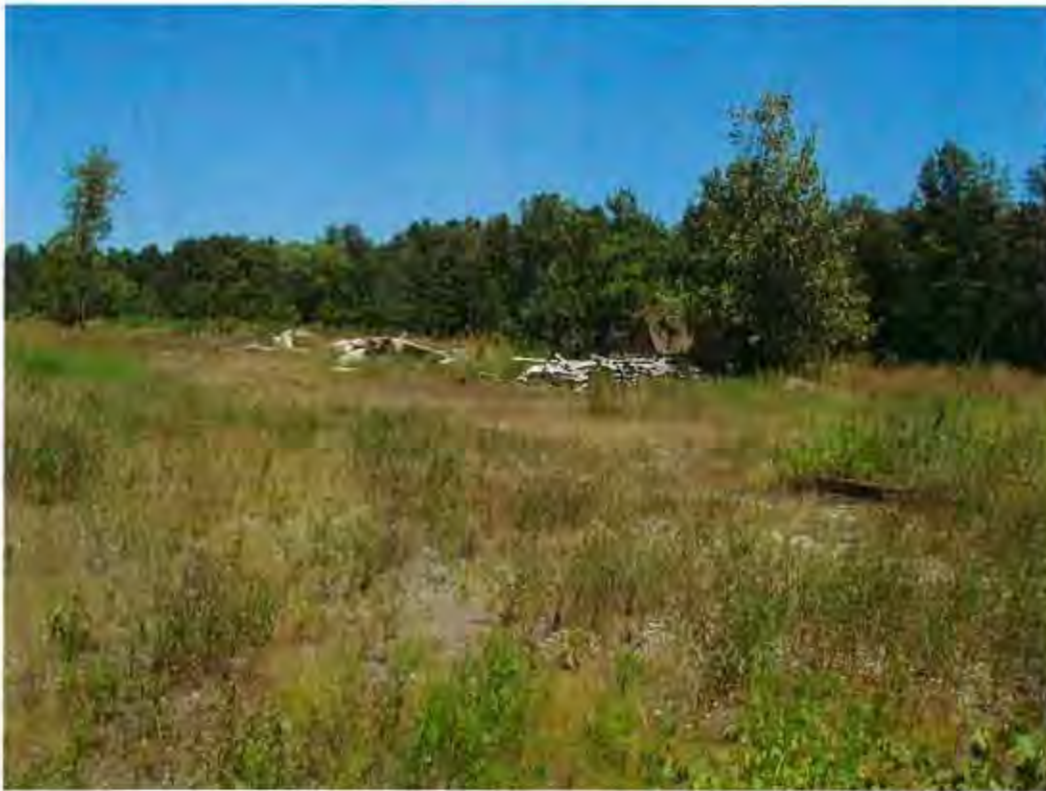
Date: 23 July 2008
Time: 1:17 pm
Direction: NE
Photo by: M. Cozadd
Exposure #: 006
Comments: Damaged dimensional lumber, railroad ties, concrete blocks, siding, and insulation near concrete structure. The pile of waste materials appeared unchanged since the previous inspection on April 2, 2008.

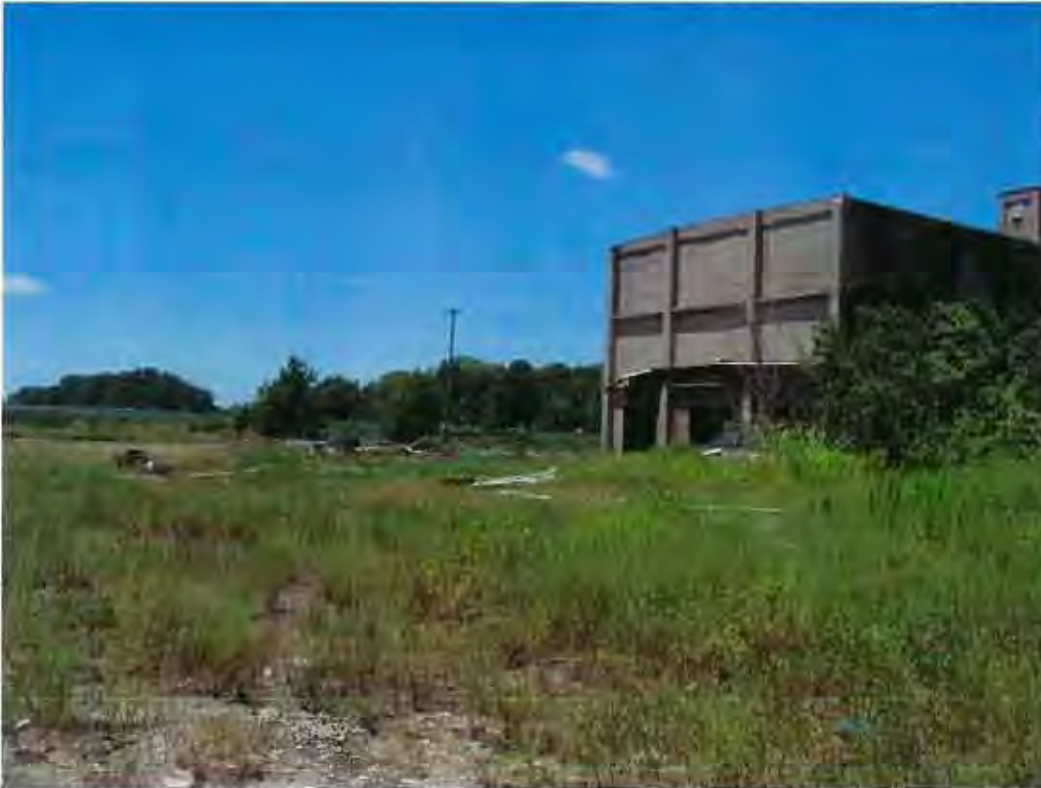
Date: 23 July 2008
Time: 1:18 pm
Direction: W
Photo by: M. Cozadd
Exposure #: 007
Comments: Former location of metal building that was located adjacent to southern edge of concrete building. Metal building removed since the previous inspection on April 2, 2008.

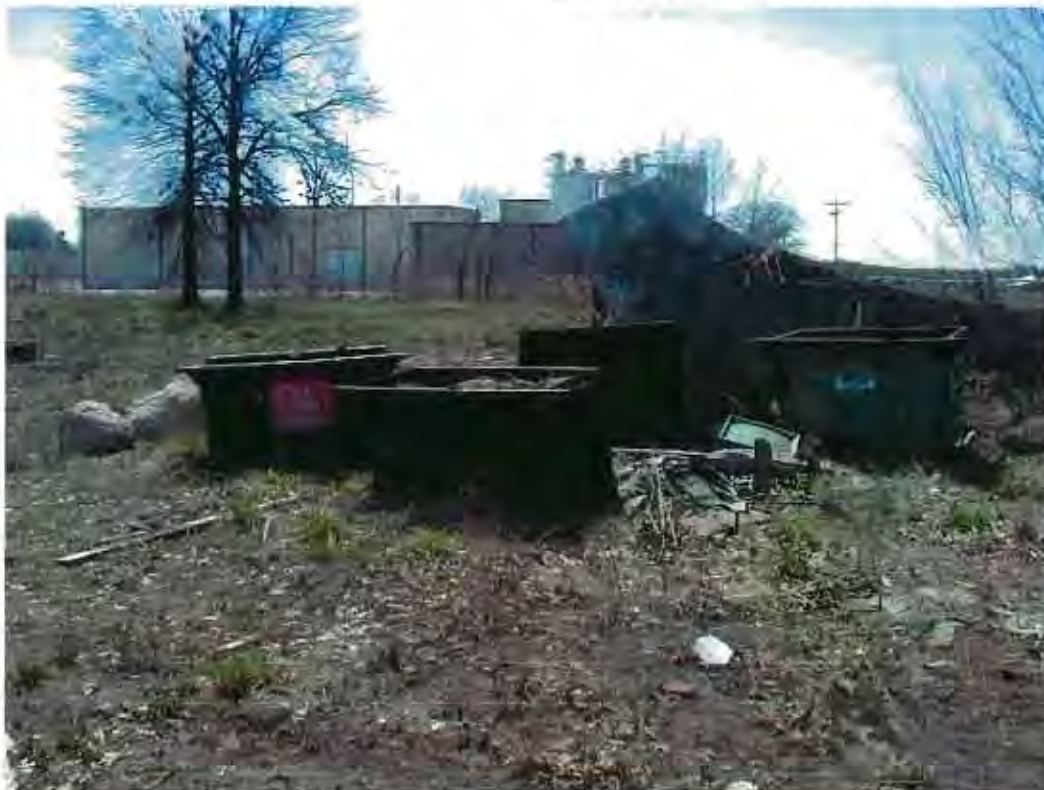
Date: 2 April 2008
Time: 12:22 pm
Direction: S
Photo by: M. Cozadd
Exposure #: 001
Comments: Dumpster with roofing shingles. Broken concrete, damaged dimensional lumber, one television, and roofing shingles on ground near dumpsters.

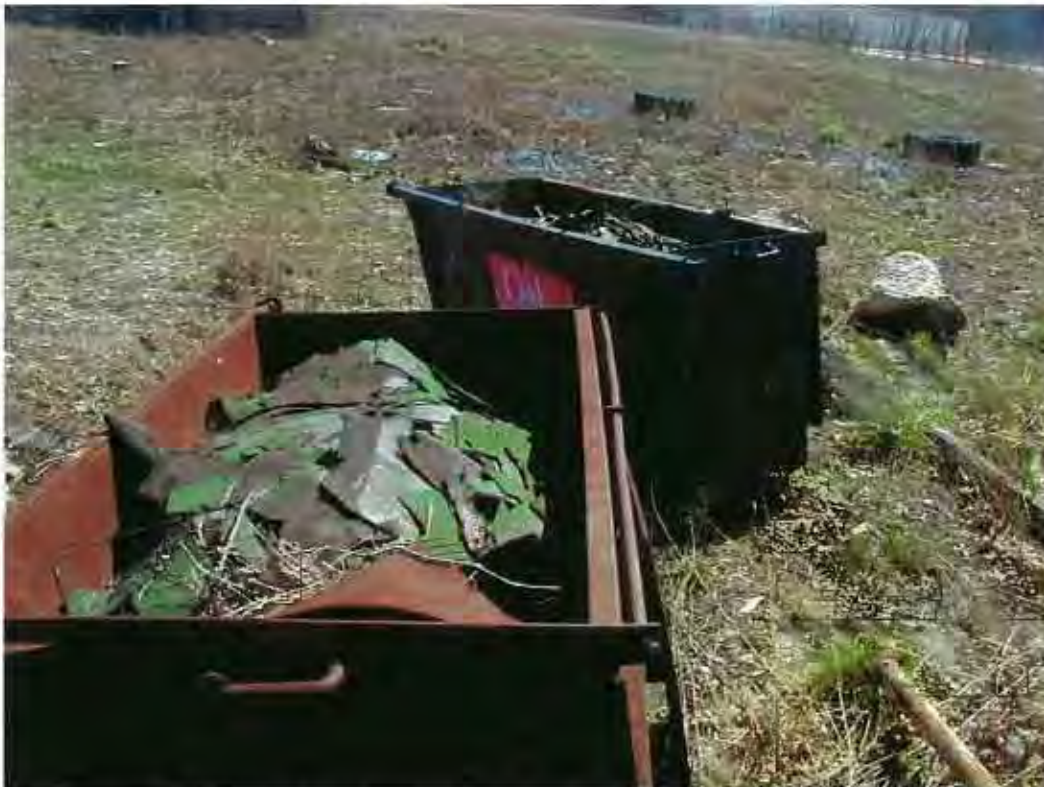
Date: 2 April 2008
Time: 12:22 pm
Direction: E
Photo by: M. Cozadd
Exposure #: 002
Comments: View of roofing shingles inside dumpsters.

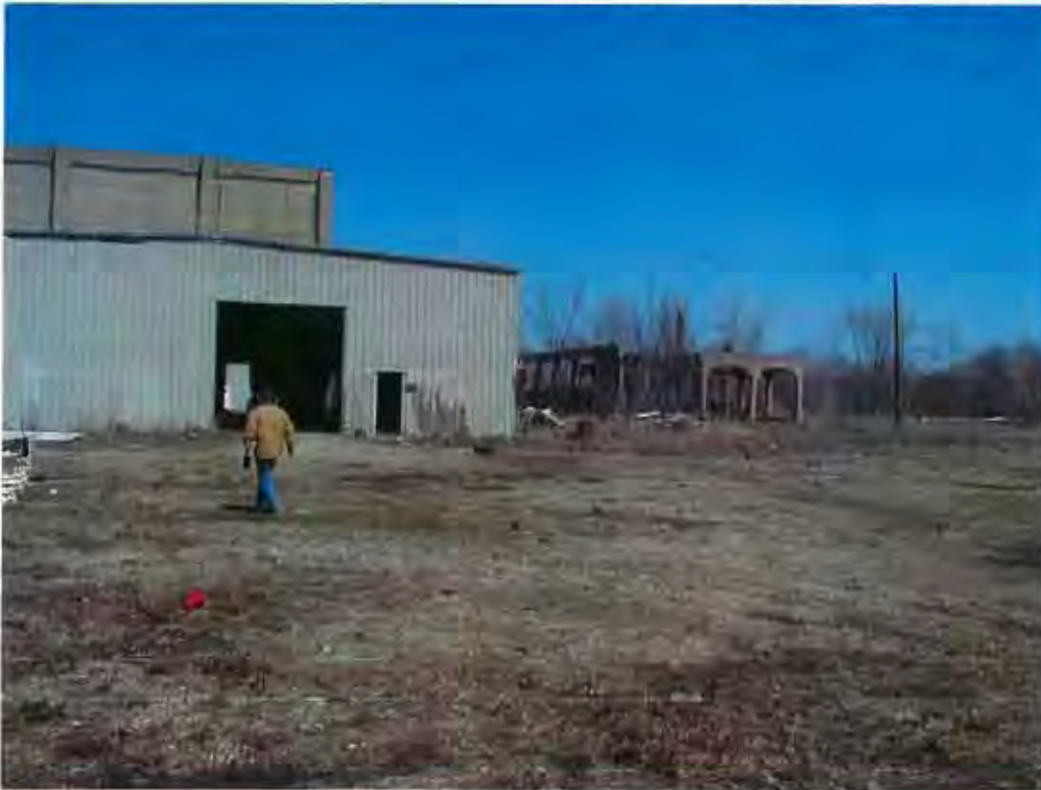
Date: 2 April 2008
Time: 12:22 pm
Direction: NE
Photo by: M. Cozadd
Exposure #: 003
Comments: Large building on western edge of site. Waste materials piled on east side of large building.

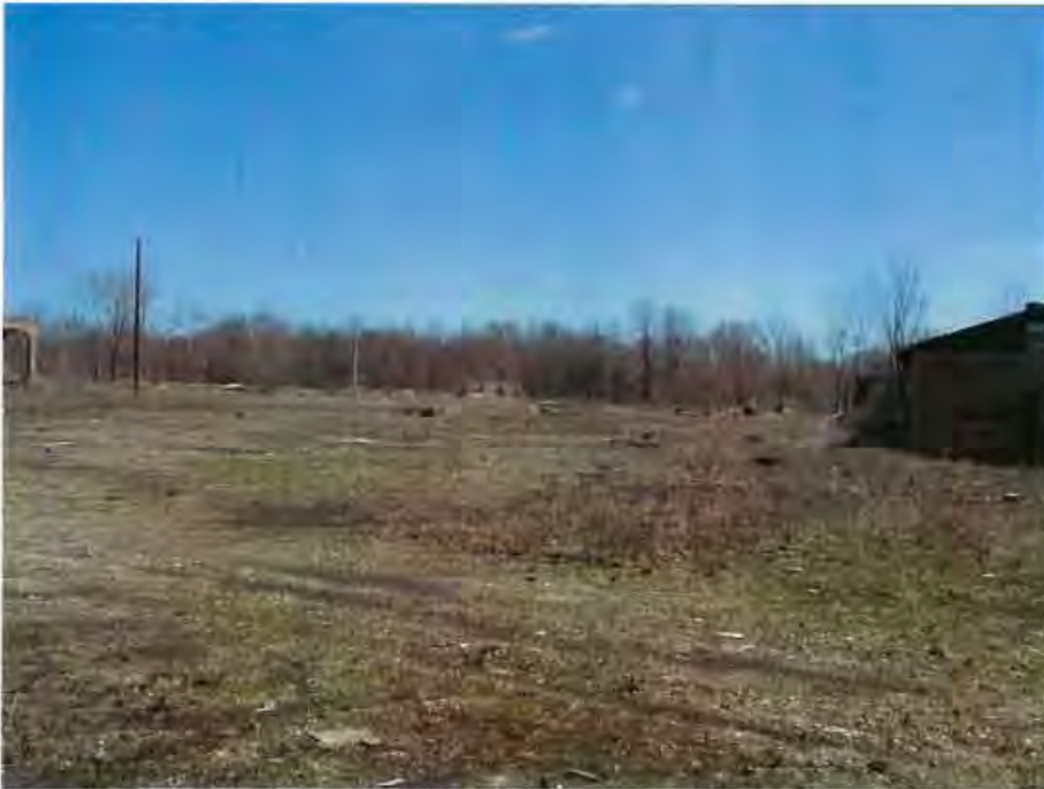
Date: 2 April 2008
Time: 12:22 pm
Direction: E
Photo by: M. Cozadd
Exposure #: 004
Comments: 10+ used or waste tires scattered on ground throughout site.

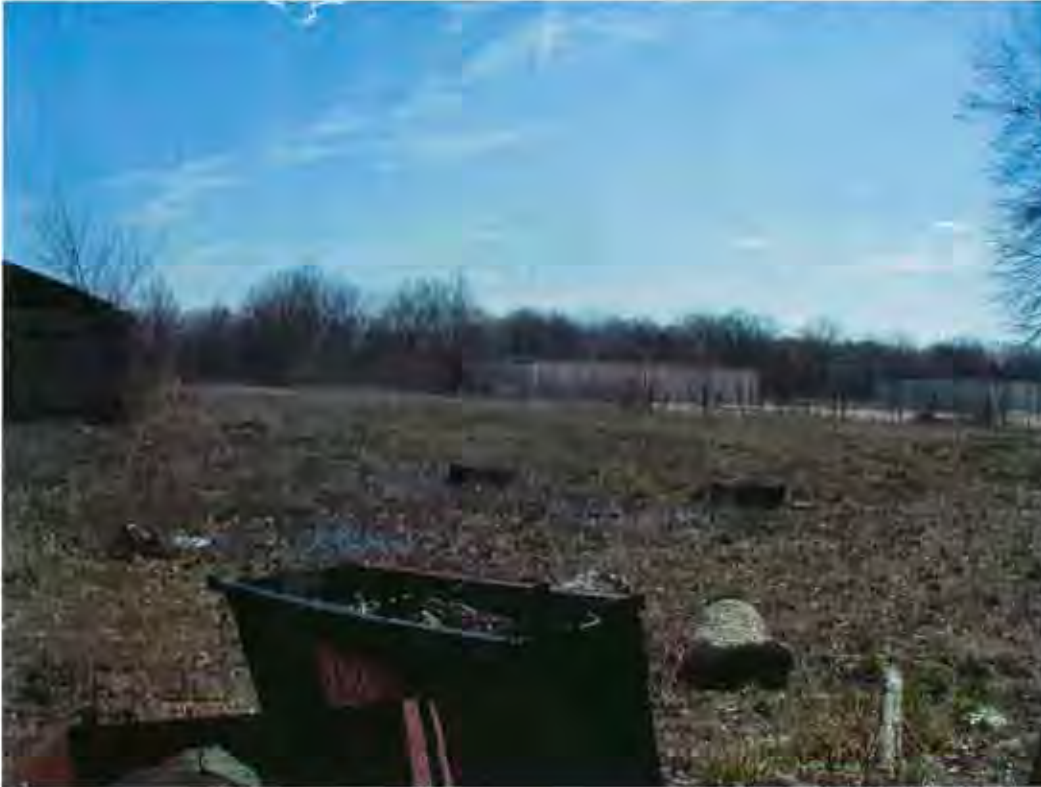
Date: 2 April 2008
Time: 12:22 pm
Direction: SE
Photo by: M. Cozadd
Exposure #: 005
Comments: Dumpsters with roofing shingles, broken concrete, and two used or waste tires near southwest corner of site.

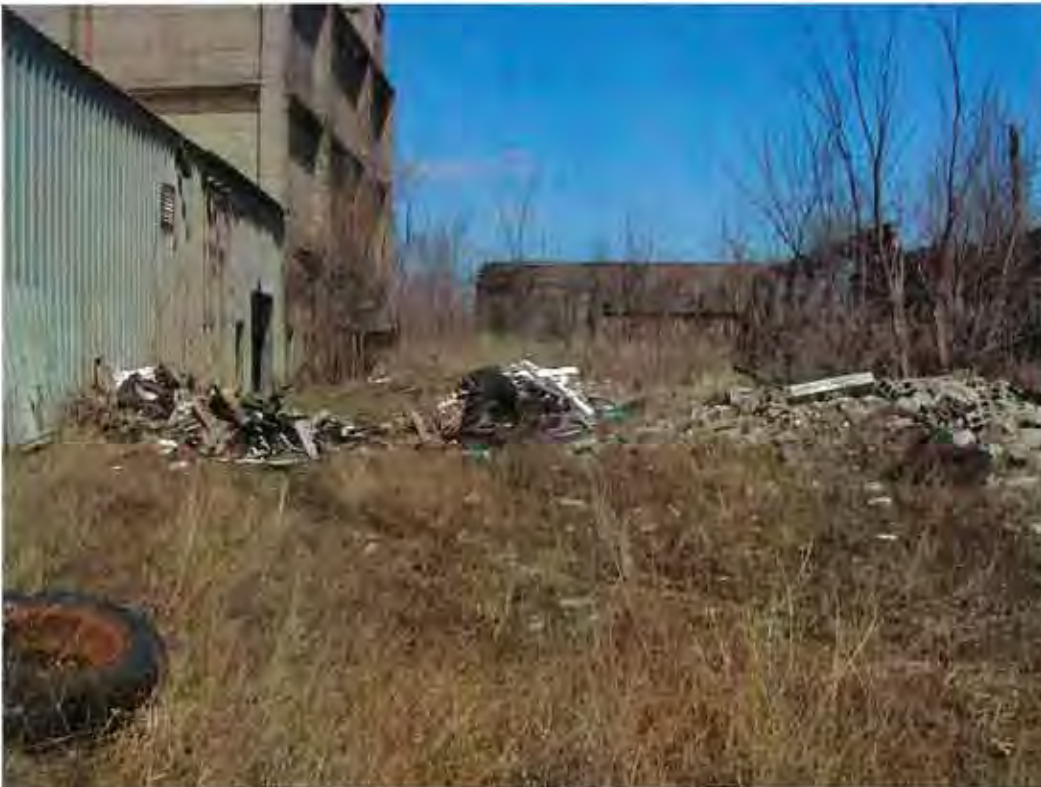
Date: 2 April 2008
Time: 12:23 pm
Direction: N
Photo by: M. Cozadd
Exposure #: 006
Comments: Damaged dimensional lumber, broken concrete, 10+ used or waste tires, bricks, shingles, broken glass, and other miscellaneous waste materials piled outdoors on east side of large building.

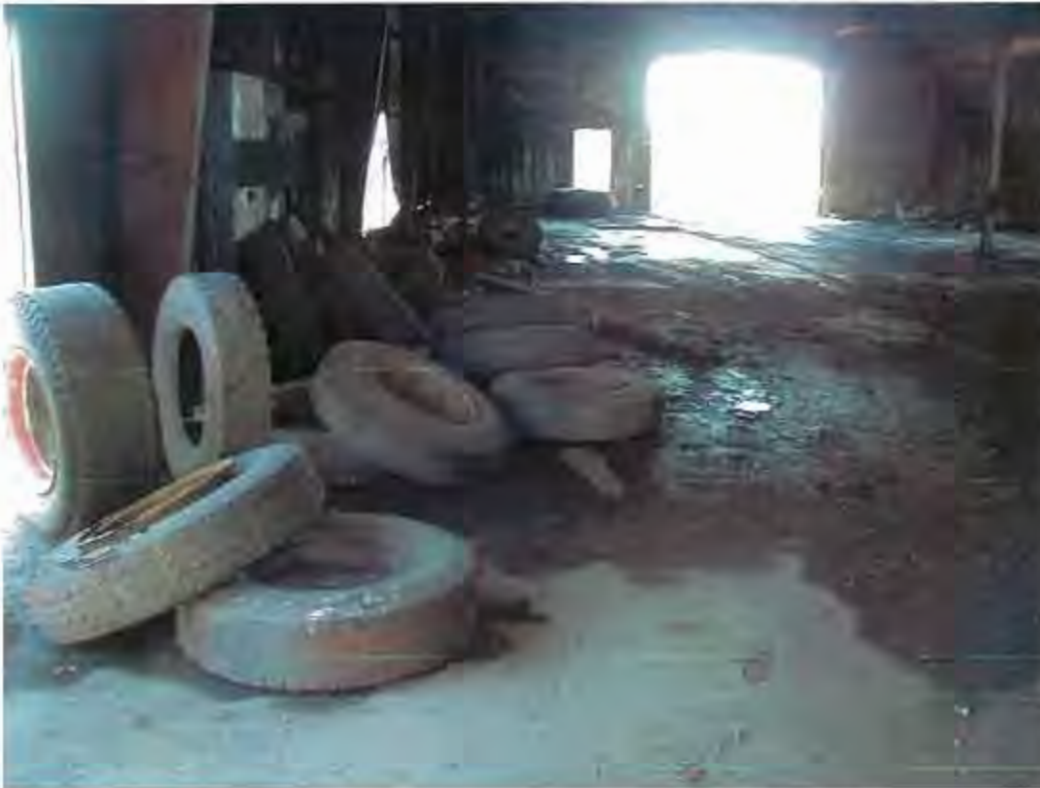
Date: 2 April 2008
Time: 12:25 pm
Direction: S
Photo by: M. Cozadd
Exposure #: 007
Comments: Used or waste tires inside large building. The entire building contained about 110 used or waste tires. The majority of the used or waste tires were on rims.

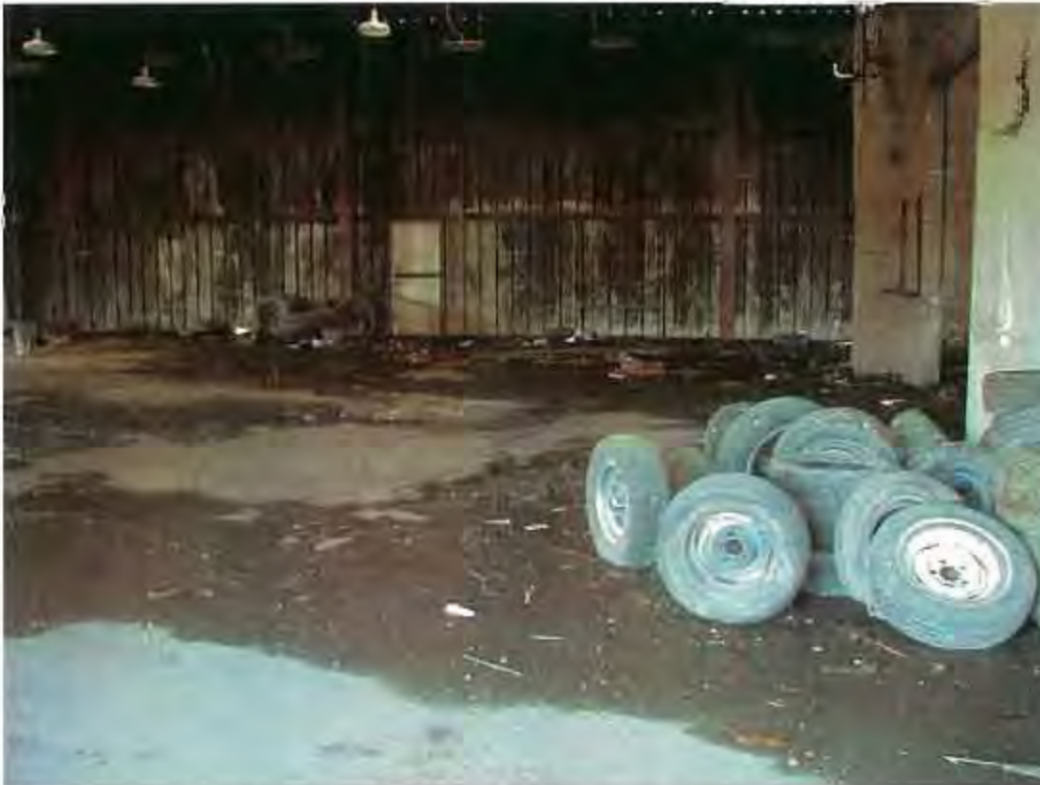
Date: 2 April 2008
Time: 12:25 pm
Direction: W
Photo by: M. Cozadd
Exposure #: 008
Comments: Used or waste tires inside large building. The entire building contained about 110 used or waste tires. The majority of the used or waste tires were on rims.

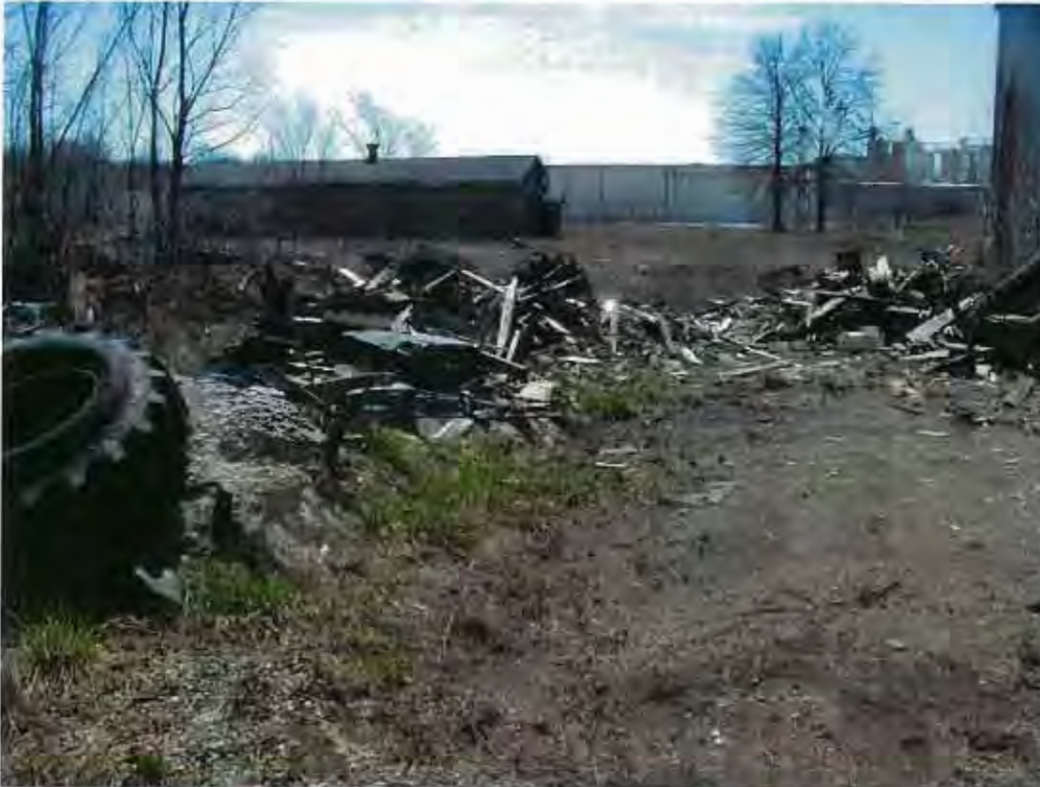
Date: 2 April 2008
Time: 12:26 pm
Direction: S
Photo by: M. Cozadd
Exposure #: 009
Comments: Damaged dimensional lumber, broken concrete, 10+ used or waste tires, bricks, shingles, broken glass, and other miscellaneous waste materials piled outdoors on east side of large building.

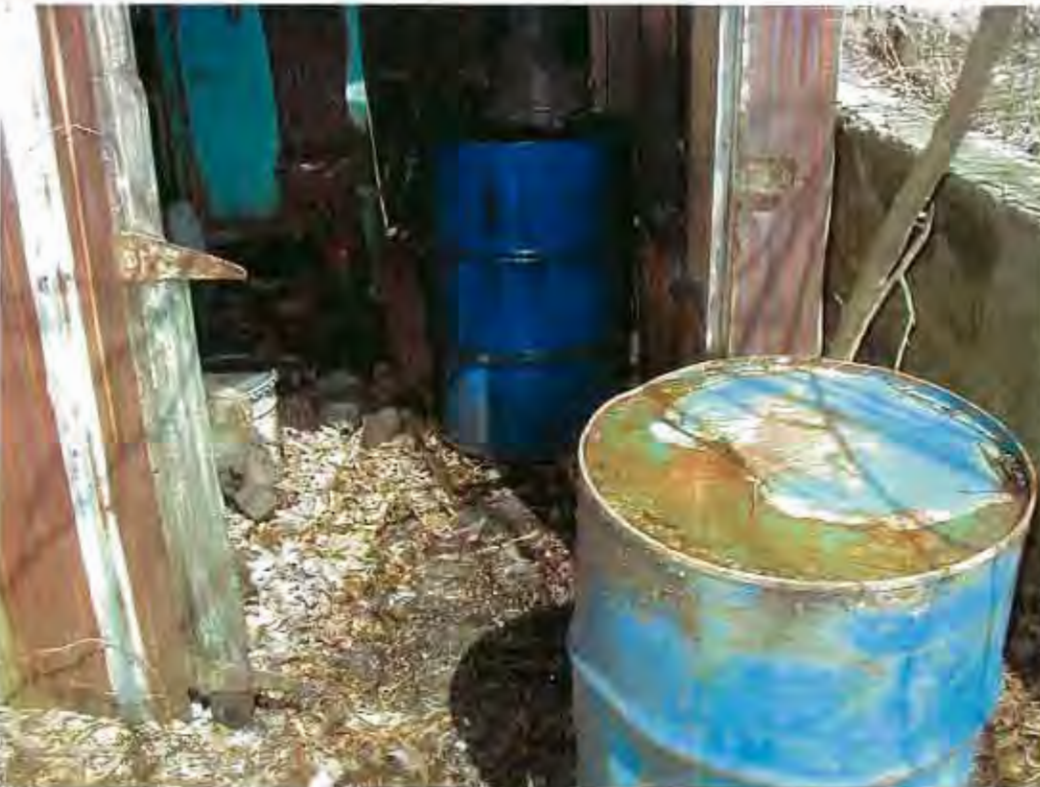
Date: 2 April 2008
Time: 12:27 pm
Direction: N
Photo by: M. Cozadd
Exposure #: 010
Comments: One empty blue 55-gallon drum in foreground. The small metal shed adjacent to the east wall of the large building contained one blue 55-gallon drum, several 1-gallon paint cans, 5-gallon plastic buckets, and other containers in various sizes. The blue 55-gallon drum inside the shed was full of used oil. All the containers were in poor condition.

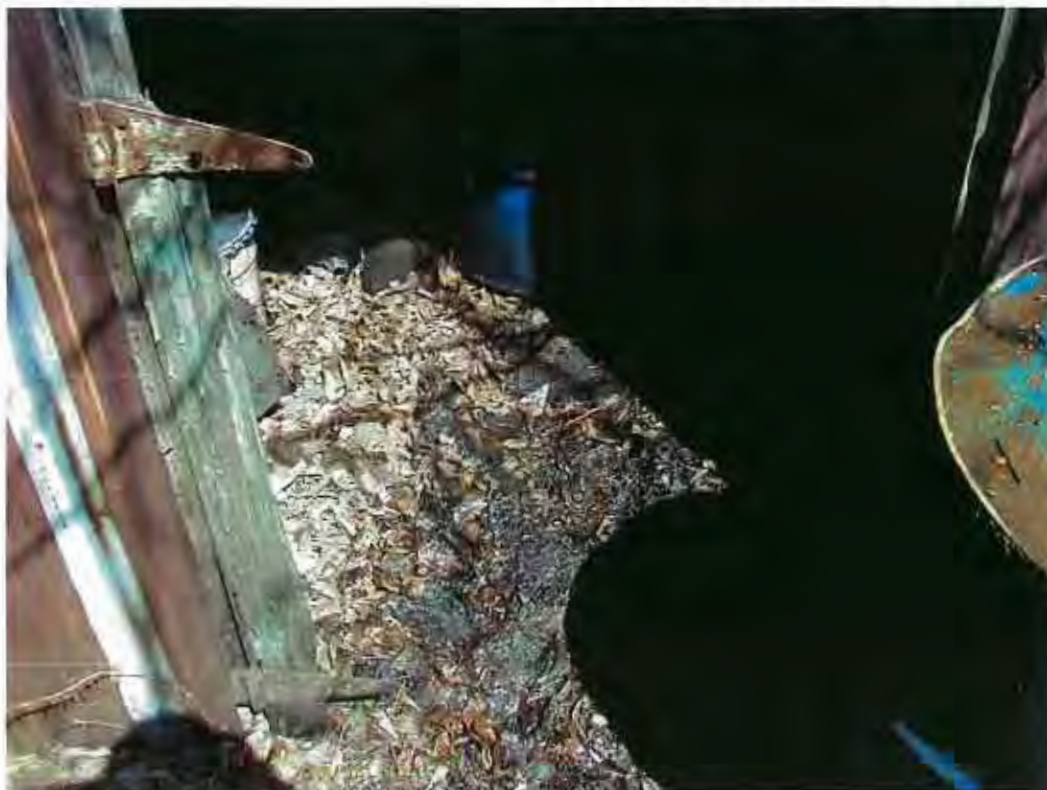
Date: 2 April 2008
Time: 12:28 pm
Direction: N
Photo by: M. Cozadd
Exposure #: 011
Comments: Used oil spilled on the floor of the shed.

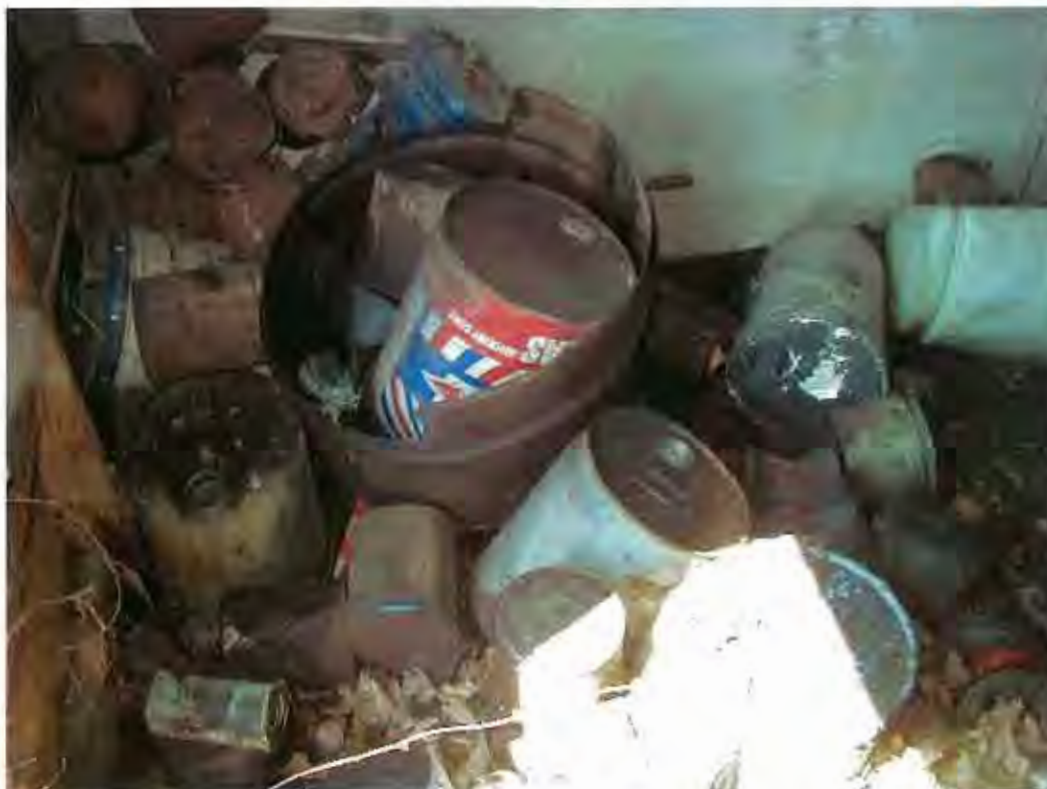
Date: 2 April 2008
Time: 12:28 pm
Direction: W
Photo by: M. Cozadd
Exposure #: 012
Comments: Containers inside small shed in poor condition.

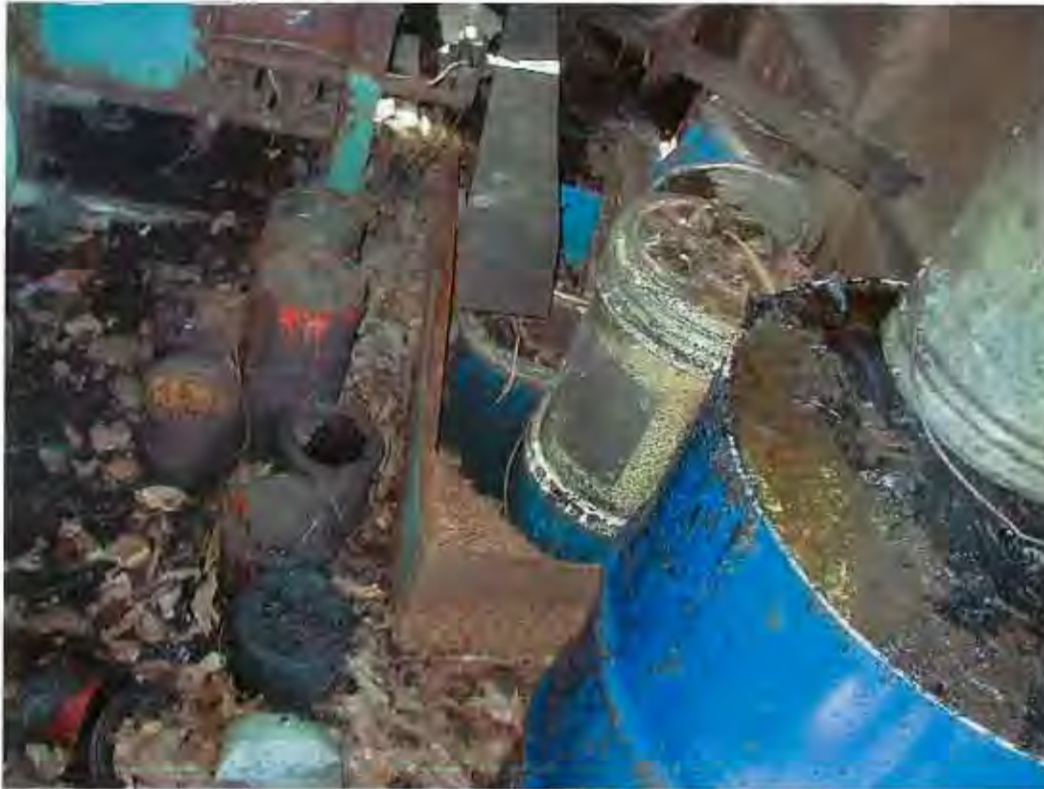
Date: 2 April 2008
Time: 12:29 pm
Direction: N
Photo by: M. Cozadd
Exposure #: 013
Comments: Containers
in small shed in poor
condition.

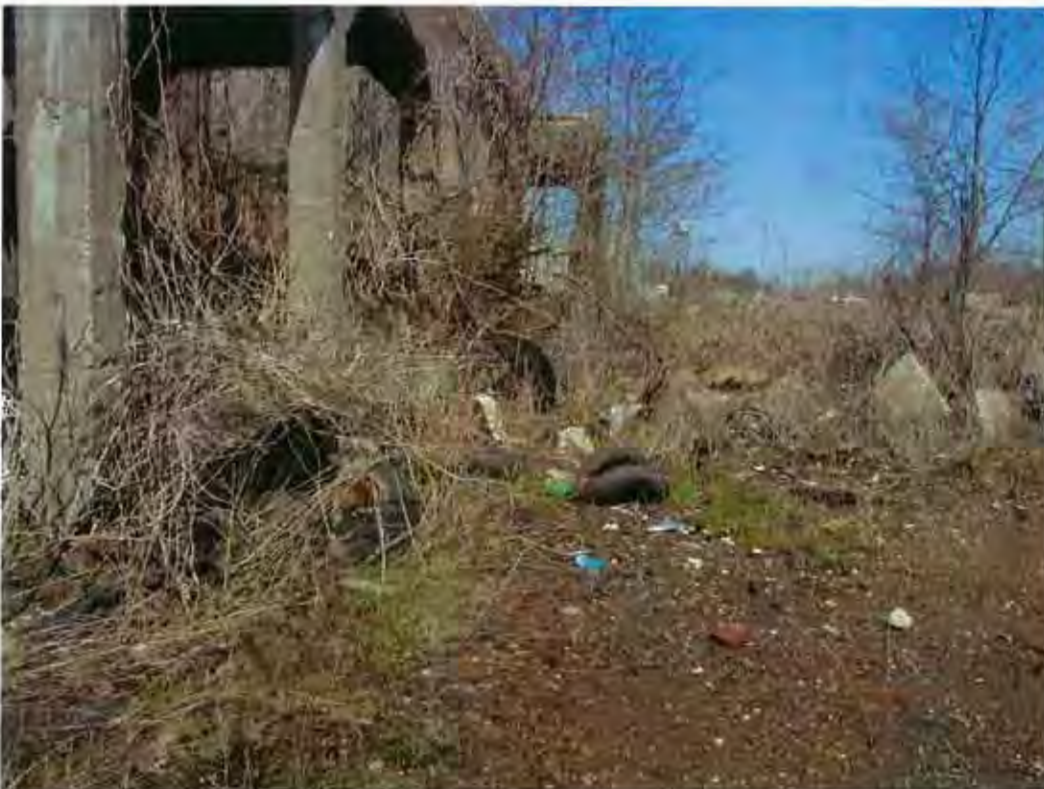
Date: 2 April 2008
Time: 12:30 pm
Direction: N
Photo by: M. Cozadd
Exposure #: 014
Comments: 12+ used or
waste tires.

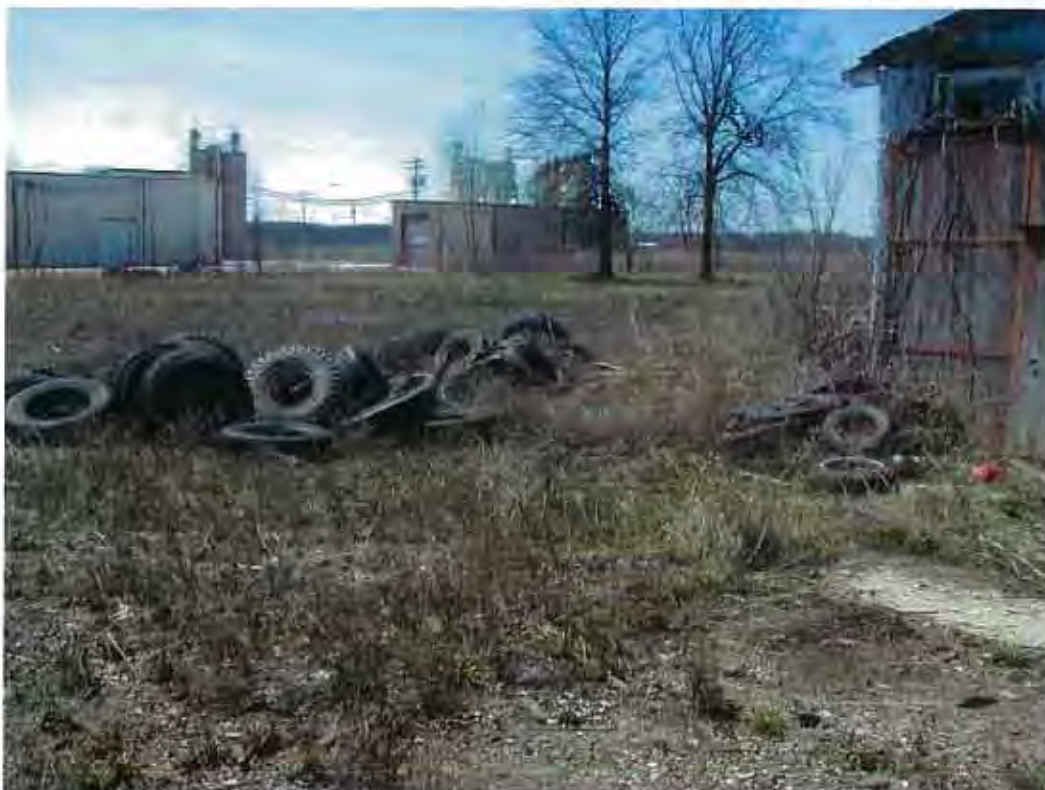
Date: 2 April 2008
Time: 12:32 pm
Direction: SW
Photo by: M. Cozadd
Exposure #: 015
Comments: 60+ used or waste tires on and off rims piled outdoors near southeast corner of west building on southern half of site. Most of the tires were truck tires.

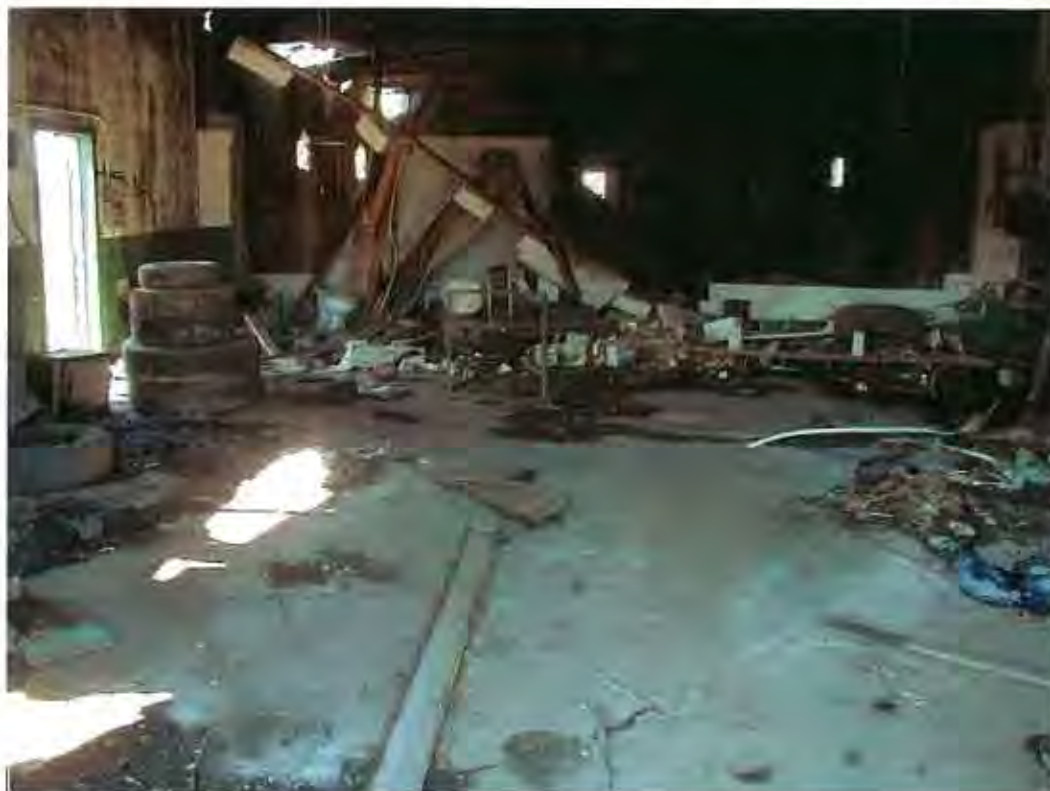
Date: 2 April 2008
Time: 12:32 pm
Direction: W
Photo by: M. Cozadd
Exposure #: 016
Comments: 14 used or waste tires and other waste materials inside west building on southern half of site.

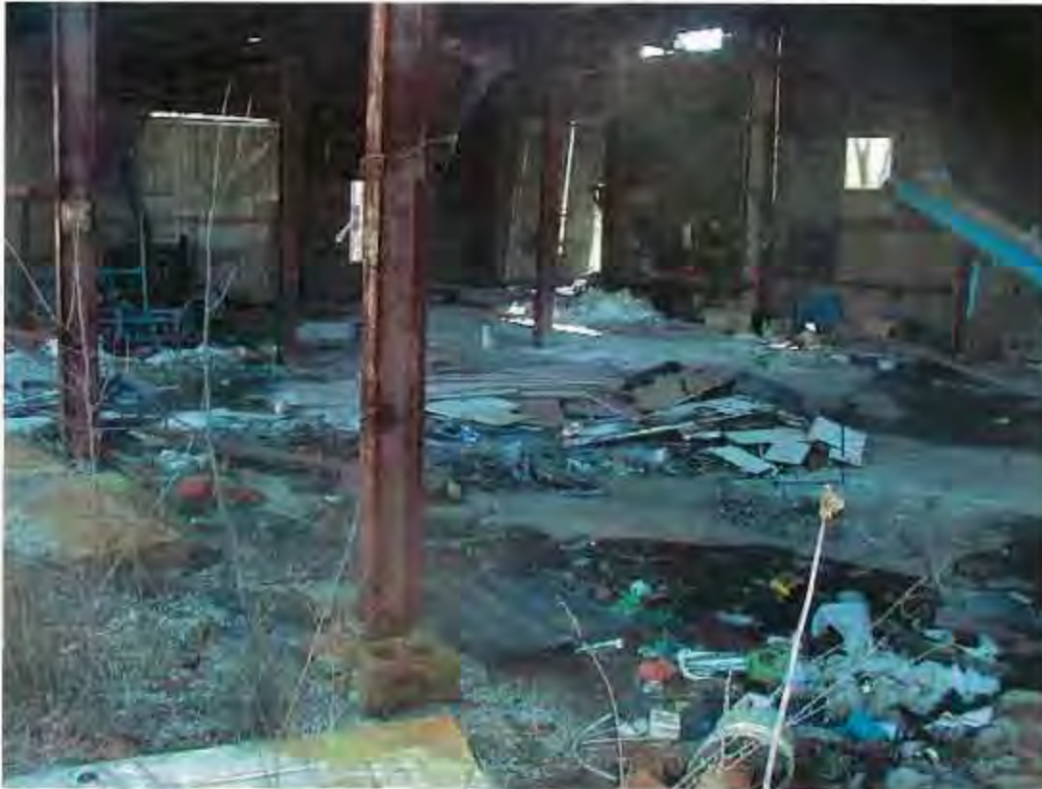
Date: 2 April 2008
Time: 12:34 pm
Direction: SE
Photo by: M. Cozadd
Exposure #: 017
Comments: Waste materials inside east building on southern half of site.

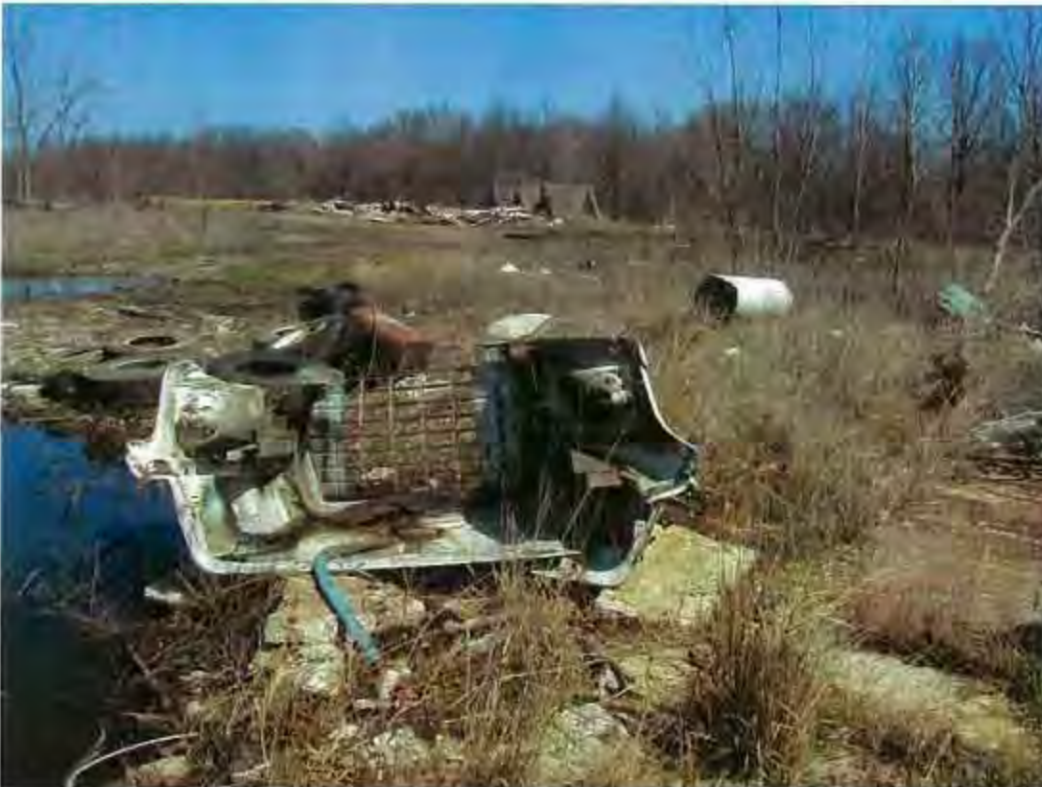
Date: 2 April 2008
Time: 12:35 pm
Direction: NE
Photo by: M. Cozadd
Exposure #: 018
Comments: 15+ used or waste tires, scrap metal, and broken concrete scattered outdoors in foreground. General construction or demolition debris piled near concrete structure in background.
