Re: Illinois Environmental Protection Agency v. Brian Bellemey
IEPA File No. 140-08-AC; 1210205002—Marion County

ADMINISTRATIVE CITATION

FACILITY: Junction City/Bellemeay

The purpose of this memorandum is to serve as the narrative for a July 23, 2008 inspection conducted at the above referenced site. The inspection took place between 1:05 pm and 1:20 pm. Seven digital photographs were taken. The weather conditions were sunny and approximately 80°F. Mr. Bob Glammeyer was interviewed briefly at the start of the inspection.

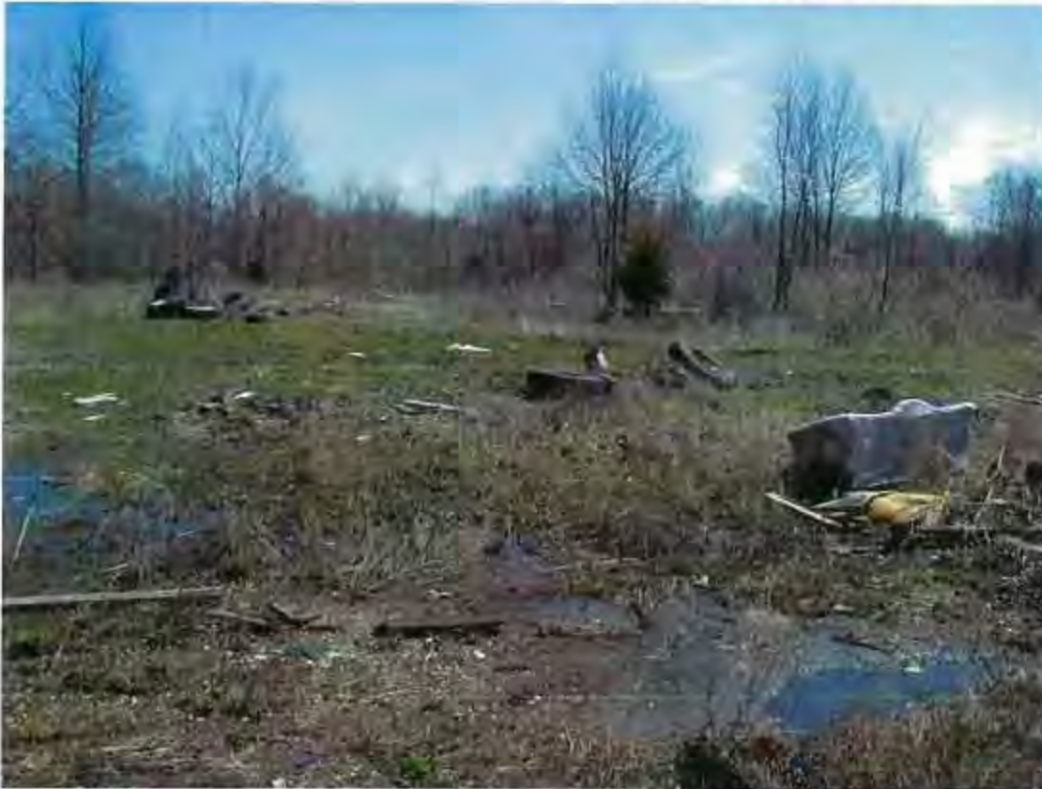
Date: 2 April 2008
Time: 12:36 pm
Direction: E
Photo by: M. Cozadd
Exposure #: 019
Comments: A couch, damaged dimensional lumber, and 10+ used or waste tires scattered on eastern half of site.

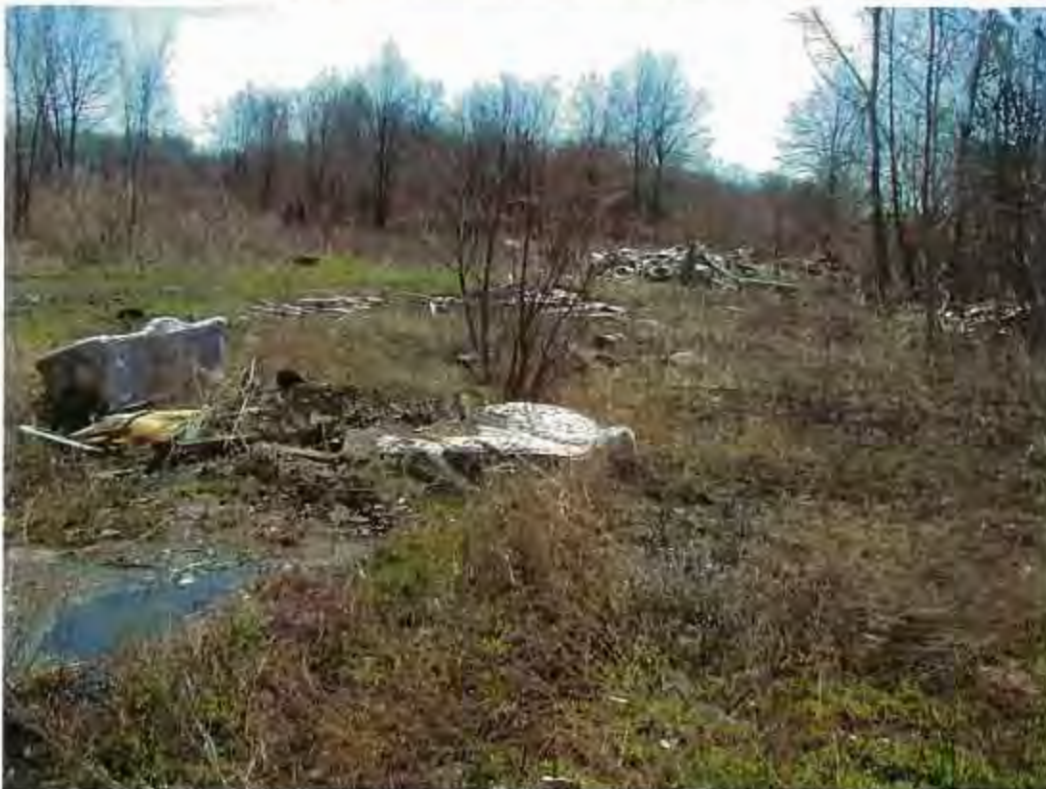
Date: 2 April 2008
Time: 12:36 pm
Direction: S
Photo by: M. Cozadd
Exposure #: 020
Comments: A couch, used or waste tires, damaged dimensional lumber, household trash, and other miscellaneous waste materials on eastern half of site.

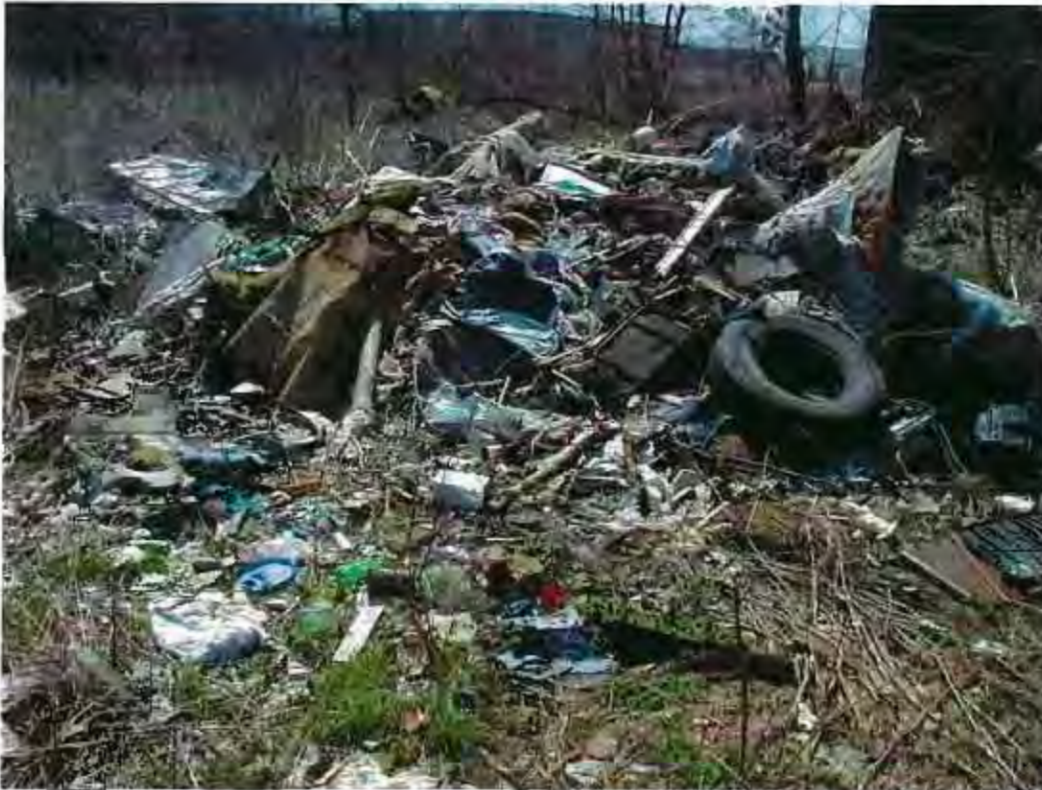
Date: 2 April 2008
Time: 12:37 pm
Direction: SW
Photo by: M. Cozadd
Exposure #: 021
Comments:
Miscellaneous waste materials including used or waste tires, damaged dimensional lumber, household waste, carpeting, a freezer without a door, clothing, chairs, and scrap metal.

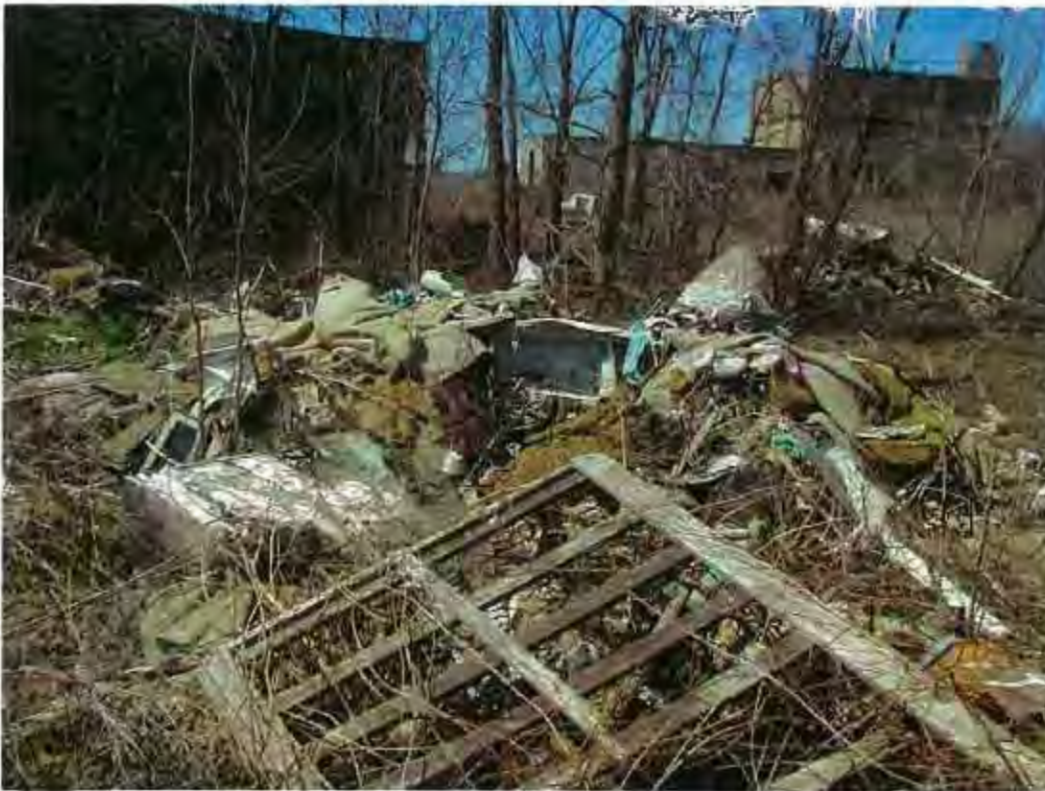
Date: 2 April 2008
Time: 12:40 pm
Direction: NW
Photo by: M. Cozadd
Exposure #: 022
Comments:
Miscellaneous waste materials including used or waste tires, damaged dimensional lumber, household waste, carpeting, a freezer without a door, clothing, chairs, and scrap metal.

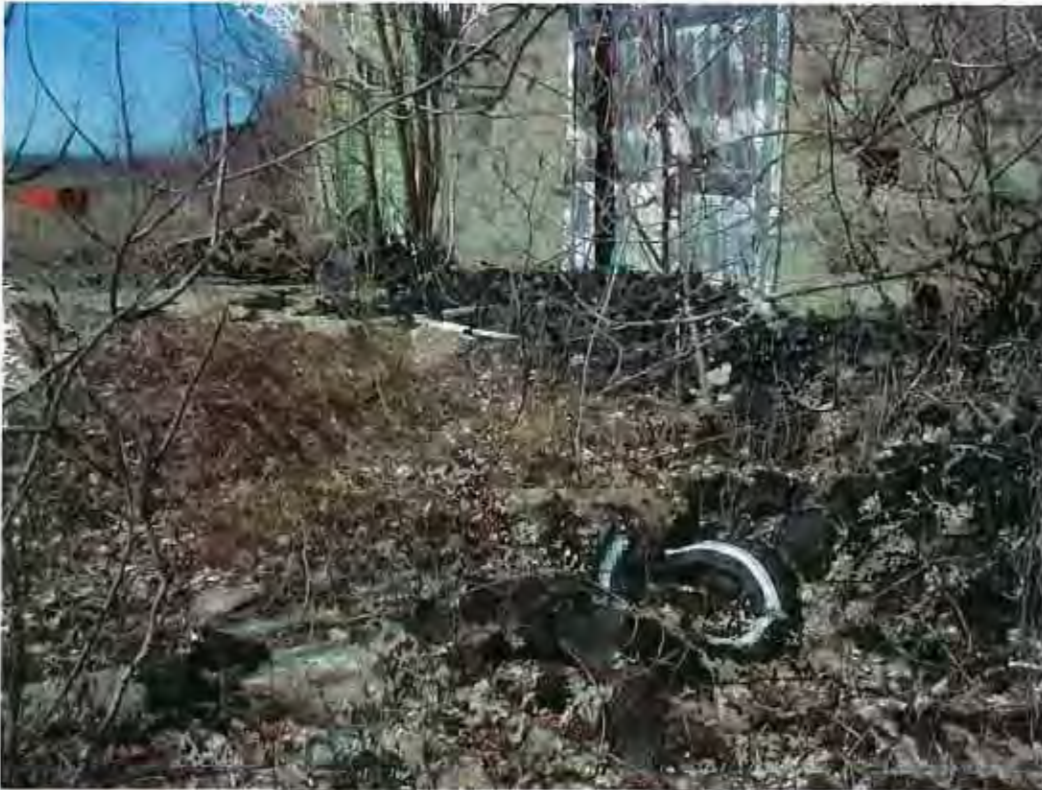
Date: 2 April 2008
Time: 12:40 pm
Direction: NW
Photo by: M. Cozadd
Exposure #: 023
Comments: Tire shred outdoors south of east building on southern half of site.

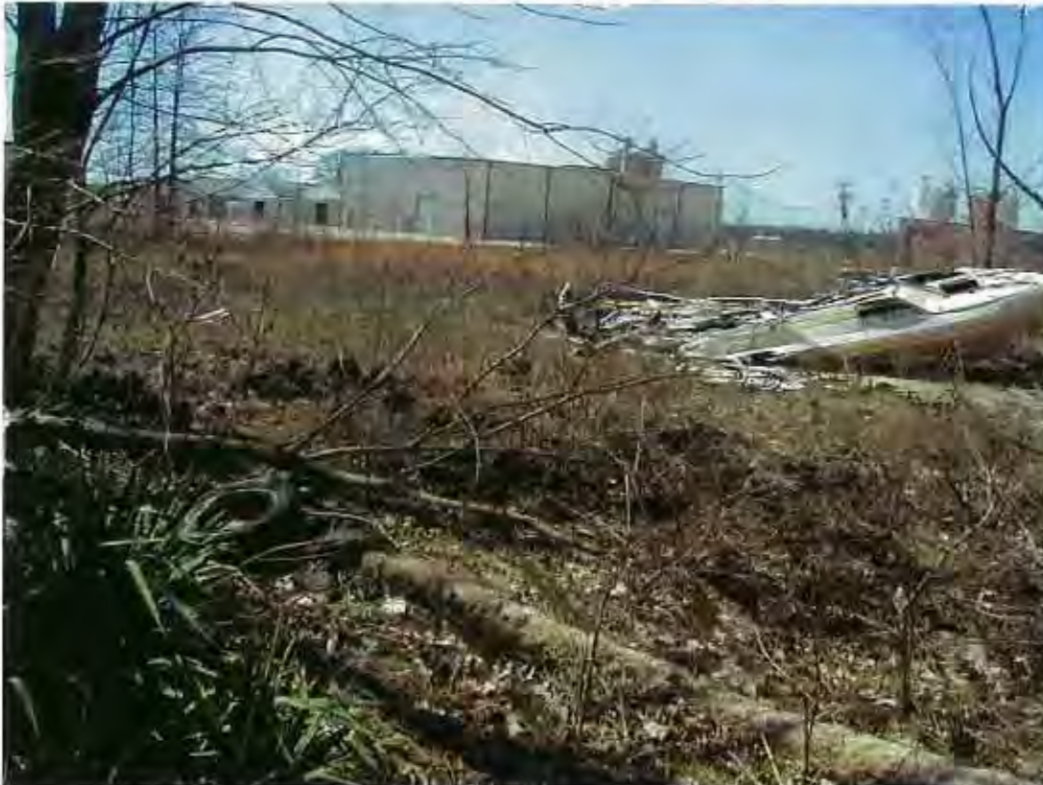
Date: 2 April 2008
Time: 12:40 pm
Direction: W
Photo by: M. Cozadd
Exposure #: 024
Comments: Tire shred, 2 used or waste tires, damaged dimensional lumber, and a boat outdoors south of east building on southern half of site.

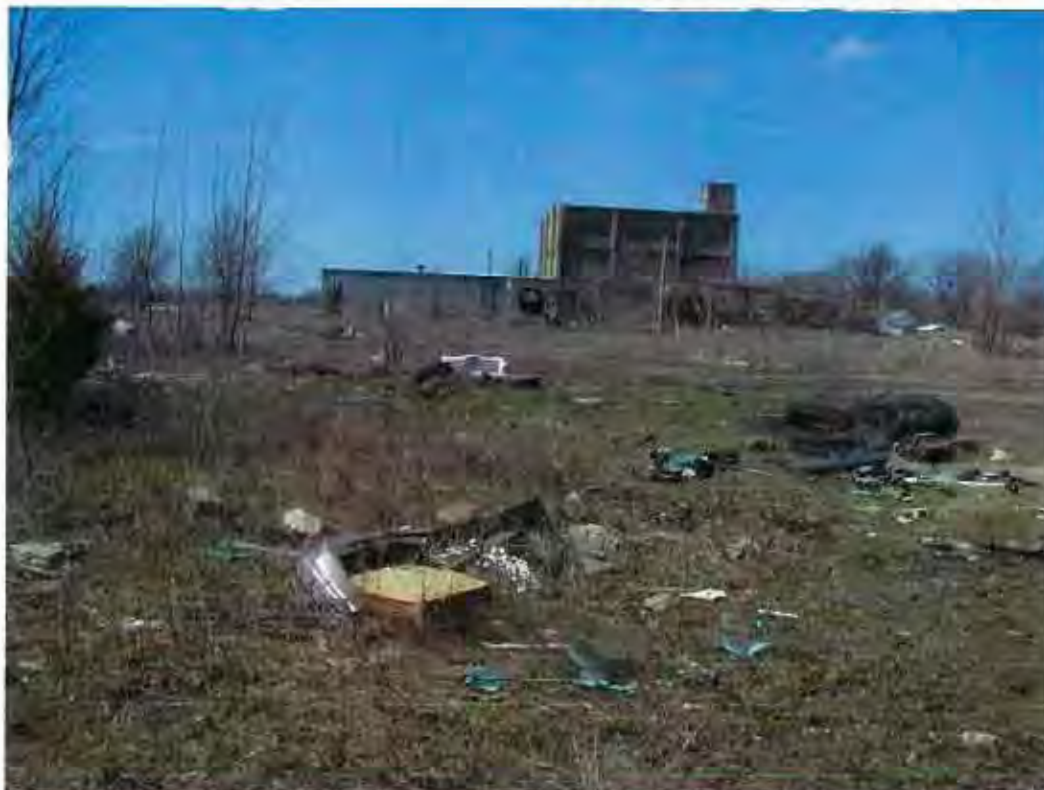
Date: 2 April 2008
Time: 12:42 pm
Direction: NW
Photo by: M. Cozadd
Exposure #: 025
Comments: A couch, damaged dimensional lumber, 10+ used or waste tires, and other miscellaneous waste materials scattered on eastern half of site.

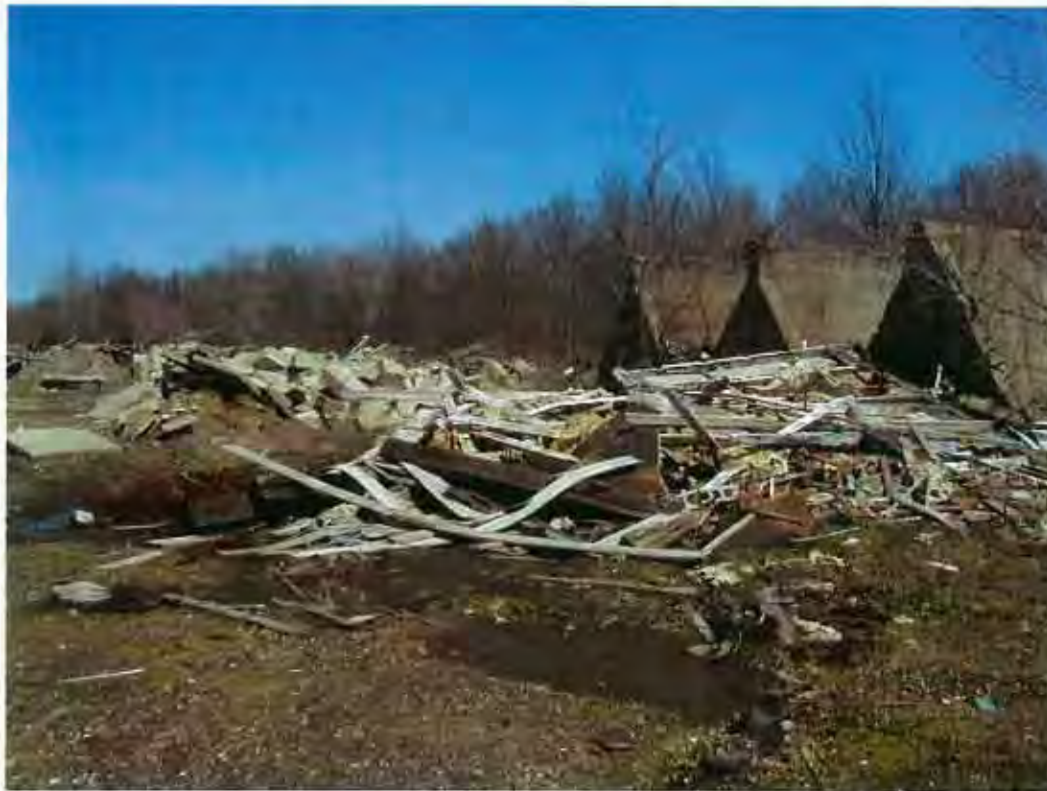
Date: 2 April 2008
Time: 12:43 pm
Direction: NE
Photo by: M. Cozadd
Exposure #: 026
Comments: Damaged dimensional lumber, railroad ties, concrete blocks, siding and insulation near concrete structure.

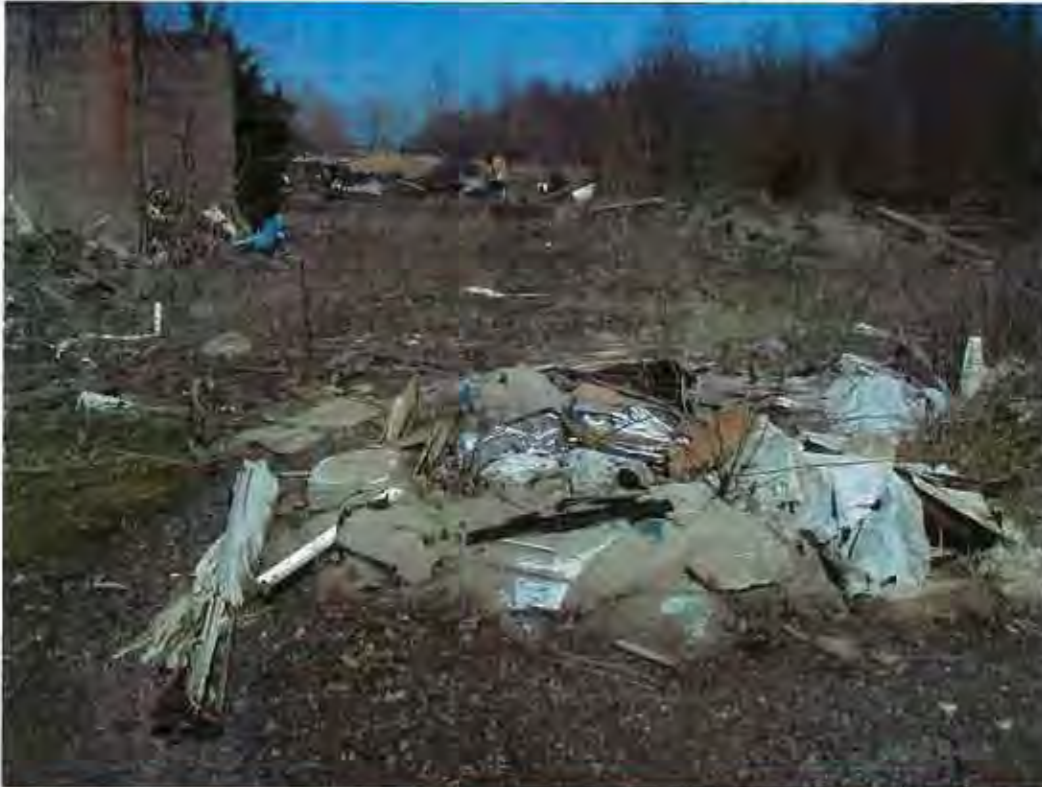
Date: 2 April 2008
Time: 12:44 pm
Direction: N
Photo by: M. Cozadd
Exposure #: 027
Comments: Damaged dimensional lumber, telephone poles, railroad ties, and scrap metal near concrete structure.

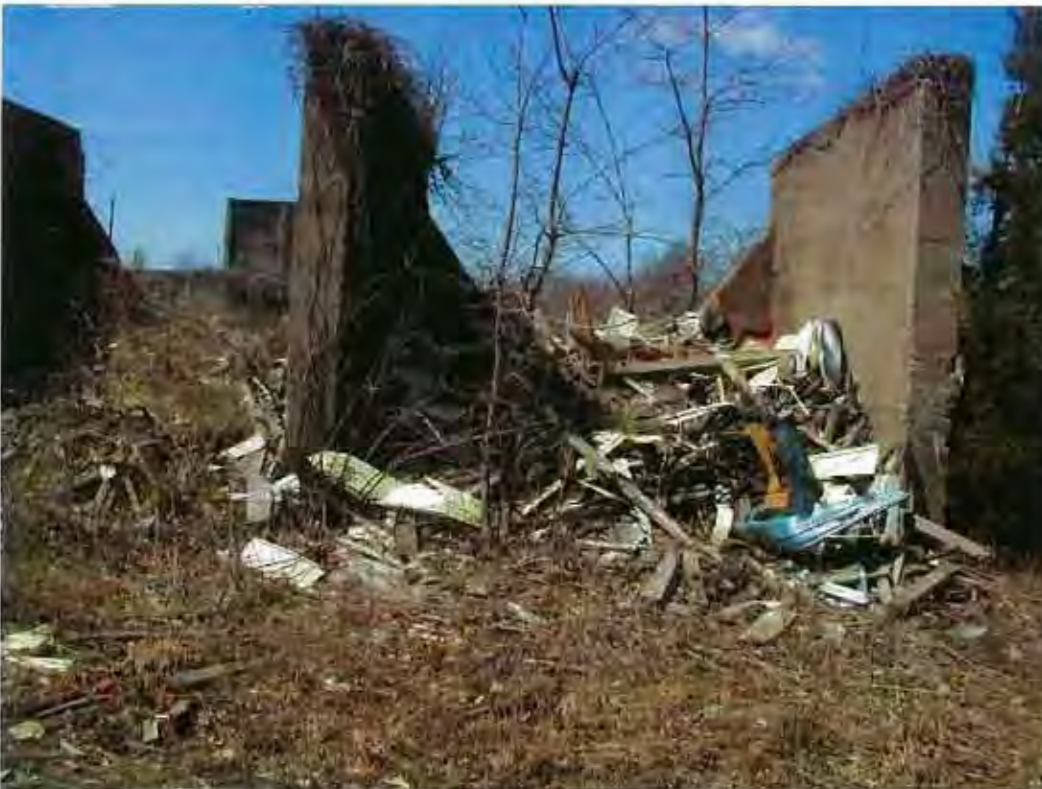
Date: 2 April 2008
Time: 12:44 pm
Direction: W
Photo by: M. Cozadd
Exposure #: 028
Comments: Damaged dimensional lumber, scrap metal, and siding in concrete structure.

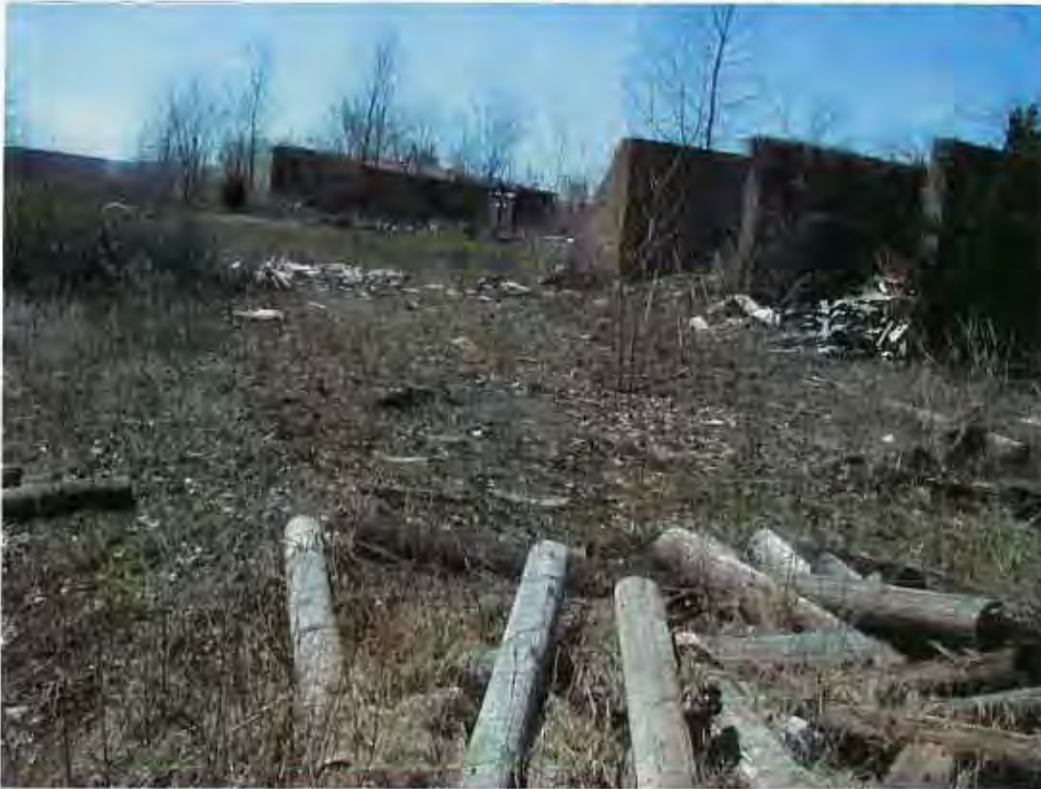
Date: 2 April 2008
Time: 12:45 pm
Direction: SW
Photo by: M. Cozadd
Exposure #: 029
Comments: Telephone poles, damaged dimensional lumber, siding, and other miscellaneous waste materials.

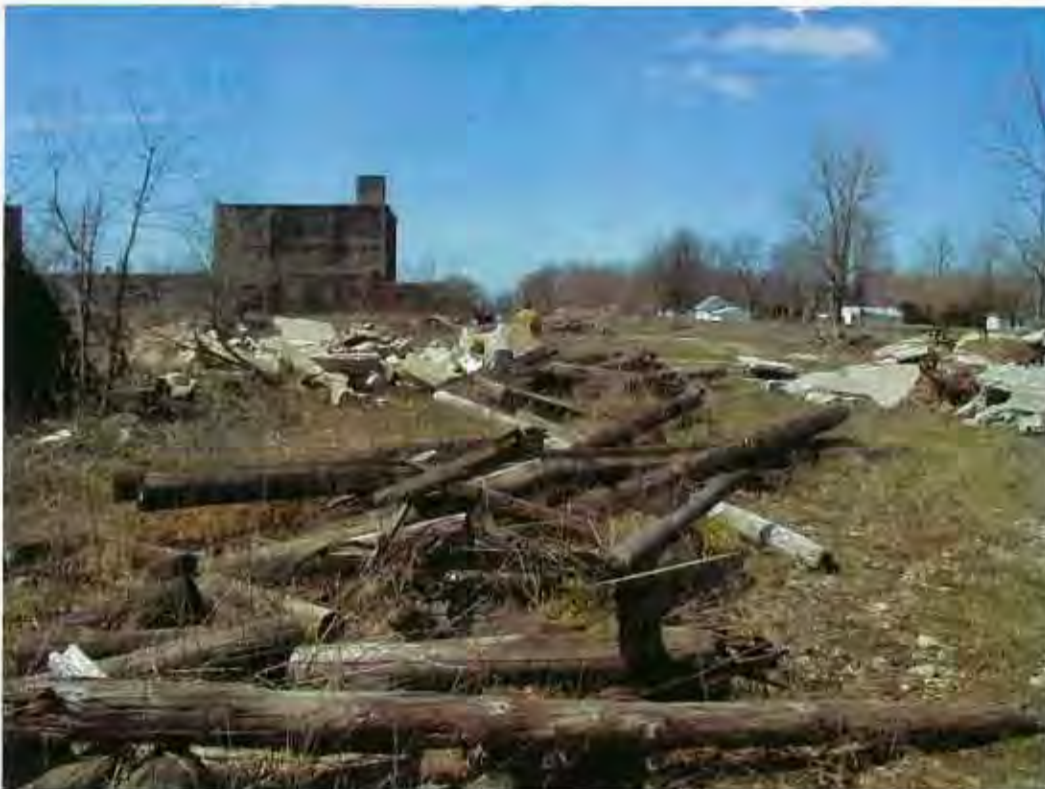
Date: 2 April 2008
Time: 12:45 pm
Direction: W
Photo by: M. Cozadd
Exposure #: 030
Comments: Telephone poles, broken concrete, landscape waste, scrap metal, and damaged dimensional lumber near northeast corner of site.

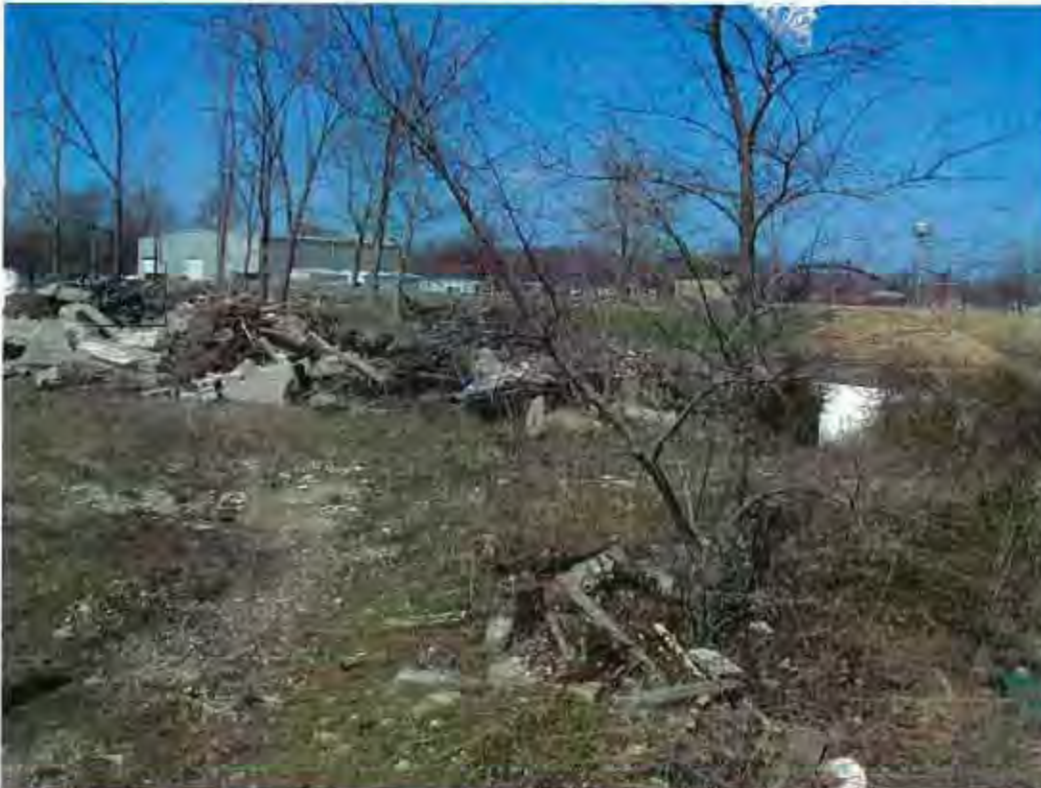
Date: 2 April 2008
Time: 12:45 pm
Direction: NW
Photo by: M. Cozadd
Exposure #: 031
Comments: Broken concrete, landscape waste, scrap metal, and damaged dimensional lumber near northeast corner of site.

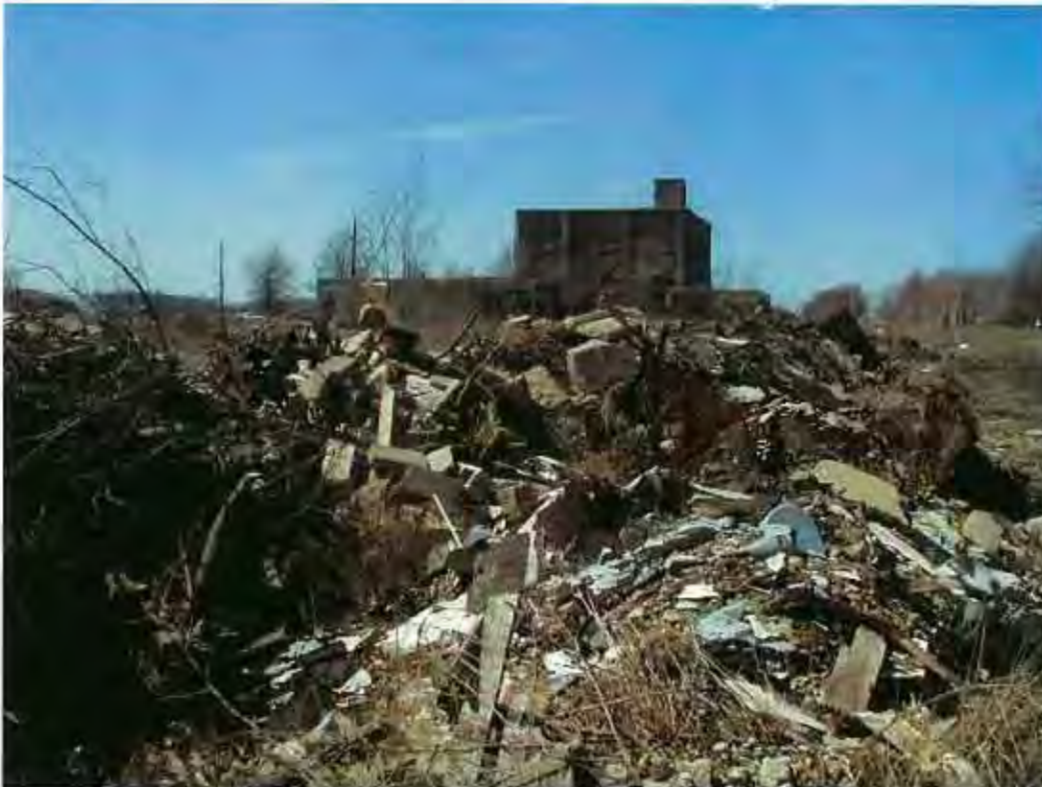
Date: 2 April 2008
Time: 12:46 pm
Direction: W
Photo by: M. Cozadd
Exposure #: 032
Comments: Broken concrete, landscape waste, scrap metal, and damaged dimensional lumber near northeast corner of site.

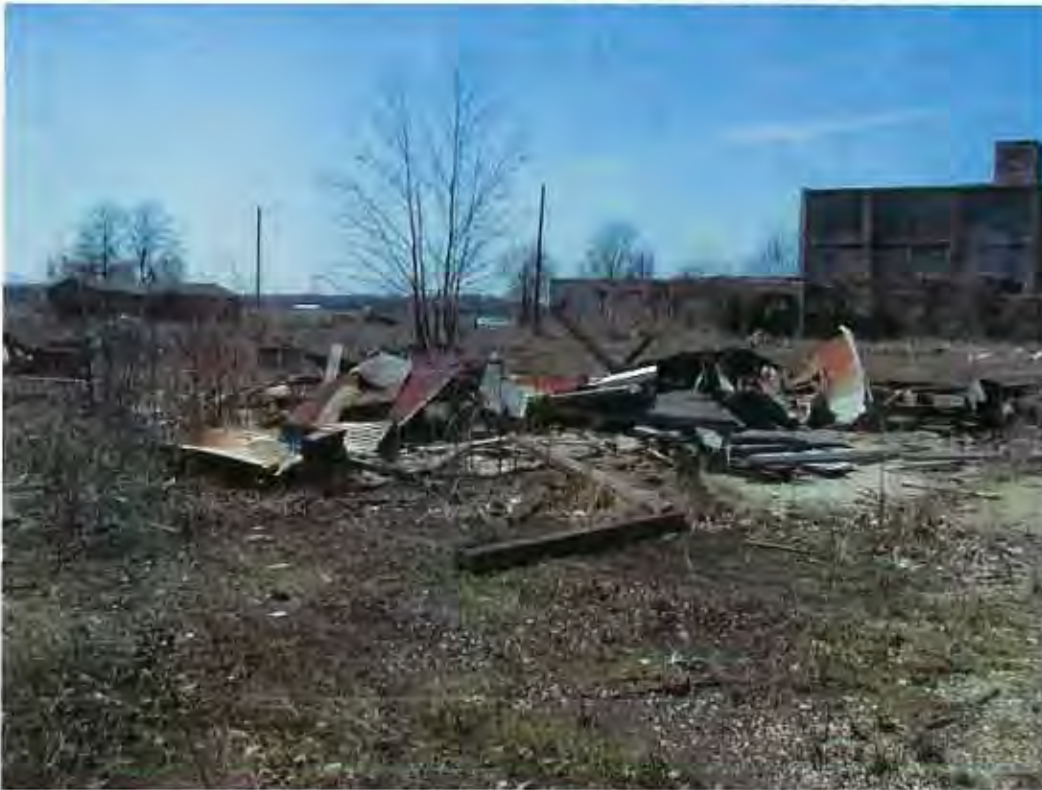
Date: 2 April 2008
Time: 12:47 pm
Direction: SW
Photo by: M. Cozadd
Exposure #: 033
Comments: Scrap metal
and damaged
dimensional lumber.

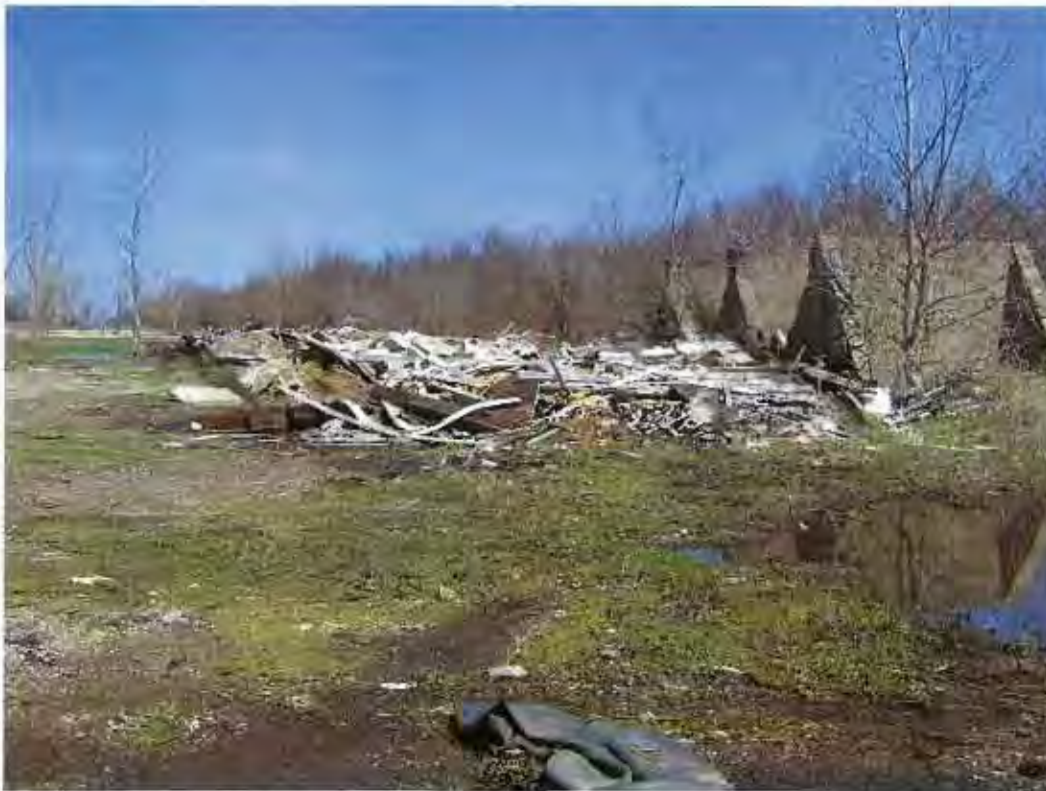
Date: 2 April 2008
Time: 12:20 pm - 1:25 pm
Direction: NE
Photo by: C. Cahnovsky
Exposure #: 034
Comments: Damaged
dimensional lumber,
railroad ties, concrete
blocks, siding and
insulation near concrete
structure.

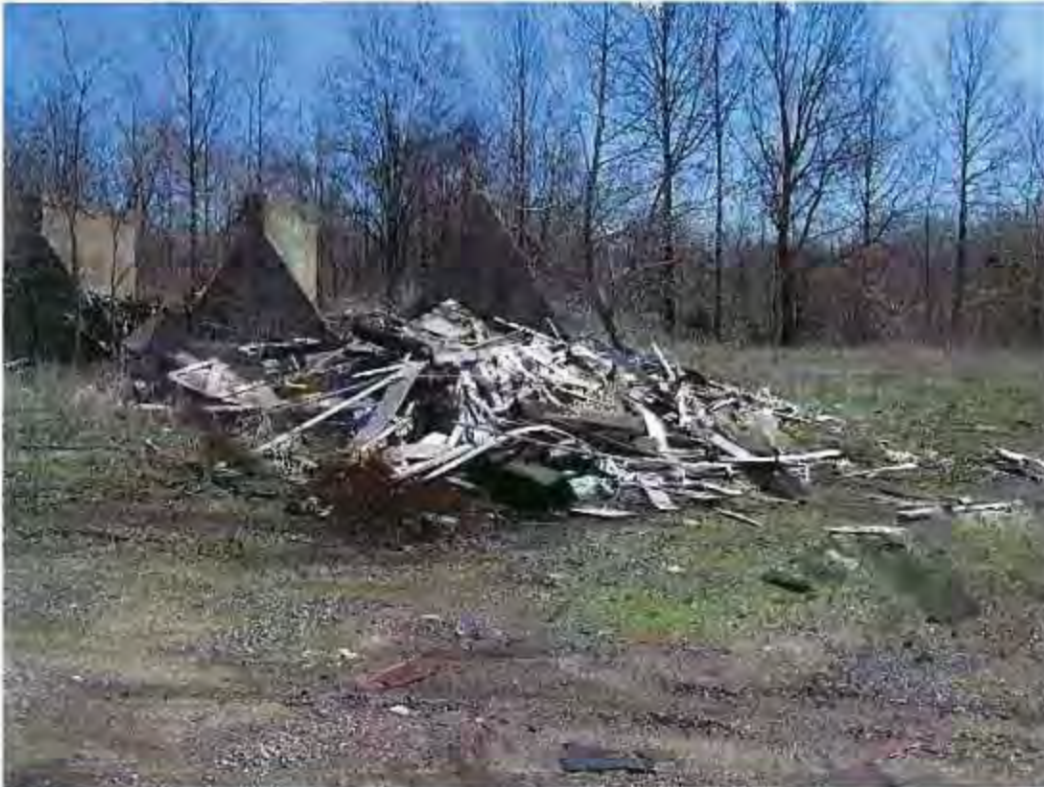
Date: 2 April 2008
Time: 12:20 pm - 1:25 pm
Direction: E
Photo by: C. Cahnovsky
Exposure #: 035
Comments: Damaged dimensional lumber, railroad ties, concrete blocks, siding and insulation near concrete structure.

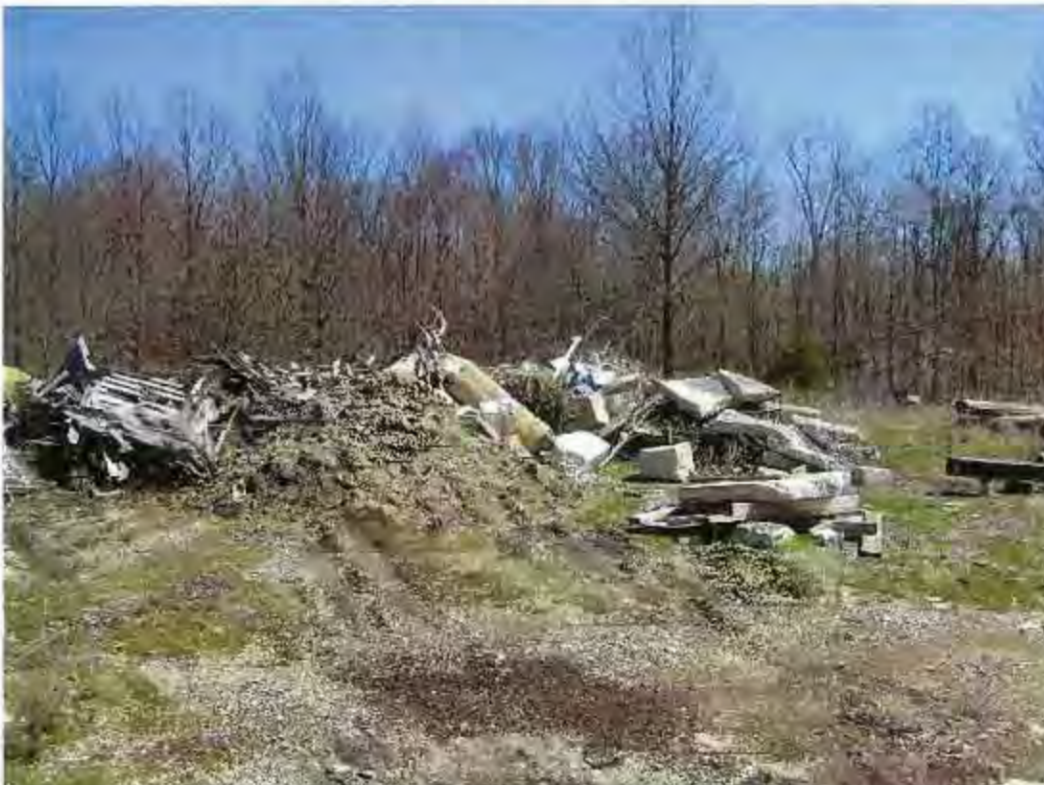
Date: 2 April 2008
Time: 12:20 pm - 1:25 pm
Direction: E
Photo by: C. Cahnovsky
Exposure #: 036
Comments: Broken concrete, landscape waste, scrap metal, and damaged dimensional lumber near northeast corner of site.

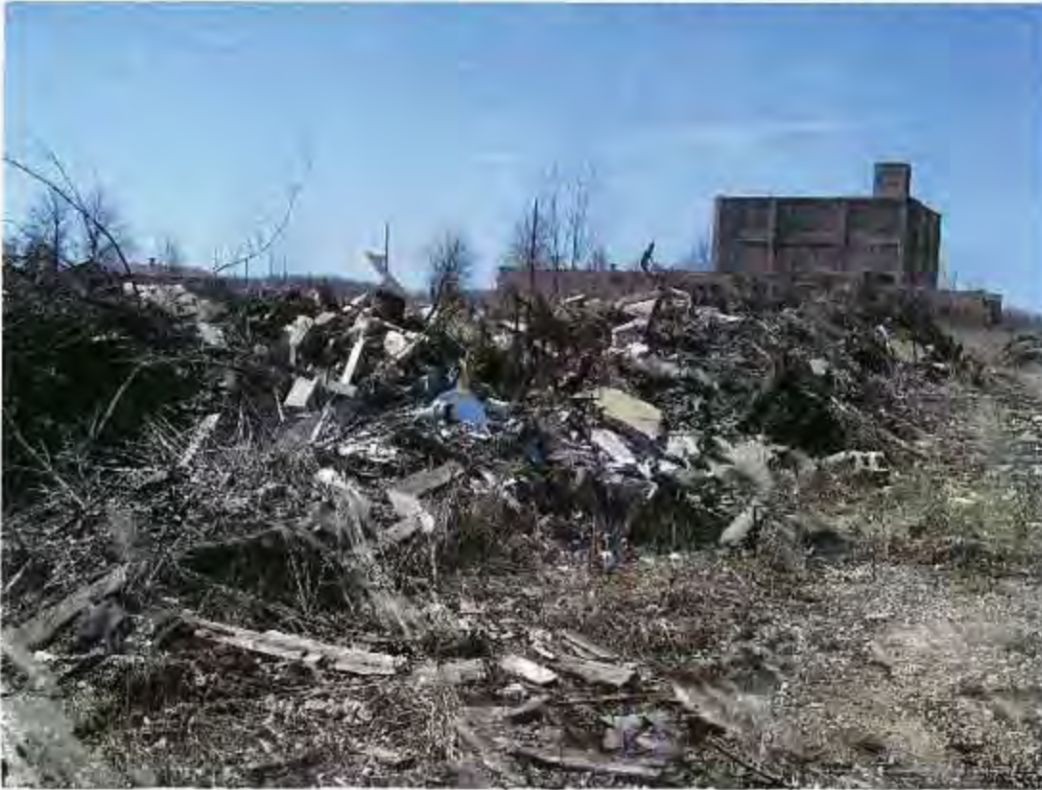
Date: 2 April 2008
Time: 12:20 pm - 1:25 pm
Direction: SW
Photo by: C. Cahnovsky
Exposure #: 037
Comments: Broken concrete, landscape waste, scrap metal, and damaged dimensional lumber near northeast corner of site.
