BEFORE THE ILLINOIS POLLUTION CONTROL BOARD
ADMINISTRATIVE CITATION

Open Dump Inspection Checklist

MEMORANDUM

Subject: LPC# 1250205071 – Mason County
Havana/Jackson 2
Complaint C-07-101-C
FOS File

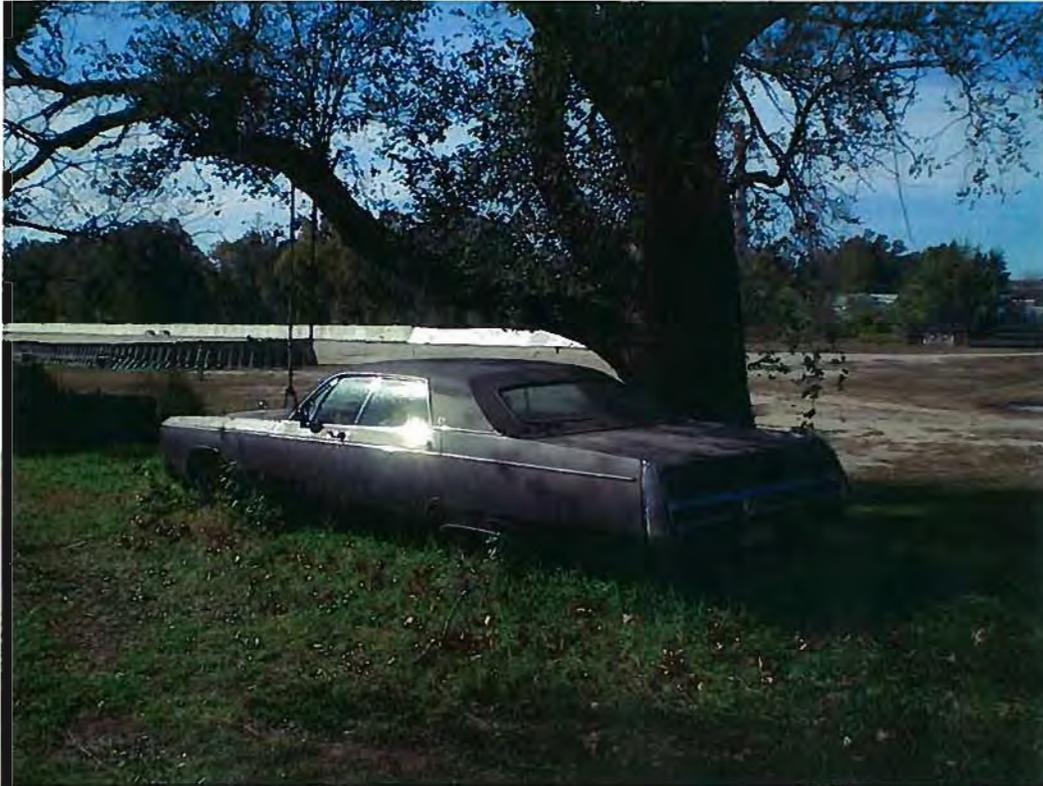
Date: October 28, 2008
Time: 11:44 am
Direction: Southwest
Photo by: W Zierath
Exposure #: 001
Comments:
Abandoned car in the northwest part of the site. The gray and white structure in the background is a grain storage facility on another property.

There had been five abandoned cars on this site during the April 22, 2008 inspection. Two of the cars had been removed prior to the October 28, 2008 investigation. The three remaining abandoned cars are shown in photographs 1250205071~10282008-001, 1250205071~10282008-002, and 1250205071~10282008-012. The area where the other two cars used to be is shown in photograph 1250205071~10282008-005. There was one abandoned pickup truck on the site. This pickup truck is shown in photographs 1250205071~10282008-008, 1250205071~10282008-009, and 1250205071~10282008-010.

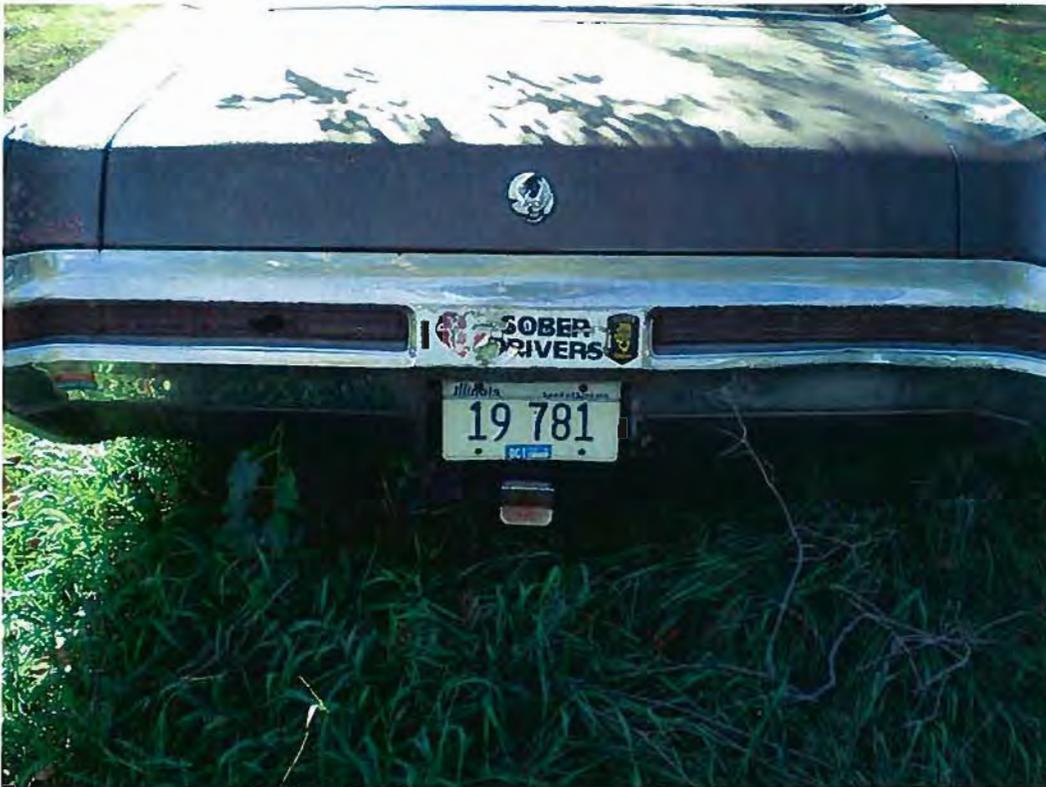
Date: October 28, 2008
Time: 11:44 am
Direction: South
Photo by: W Zierath
Exposure #: 002
Comments: The rear license plate on the abandoned car shown in photograph 001. The sticker on the license plate expired in October, 1993.

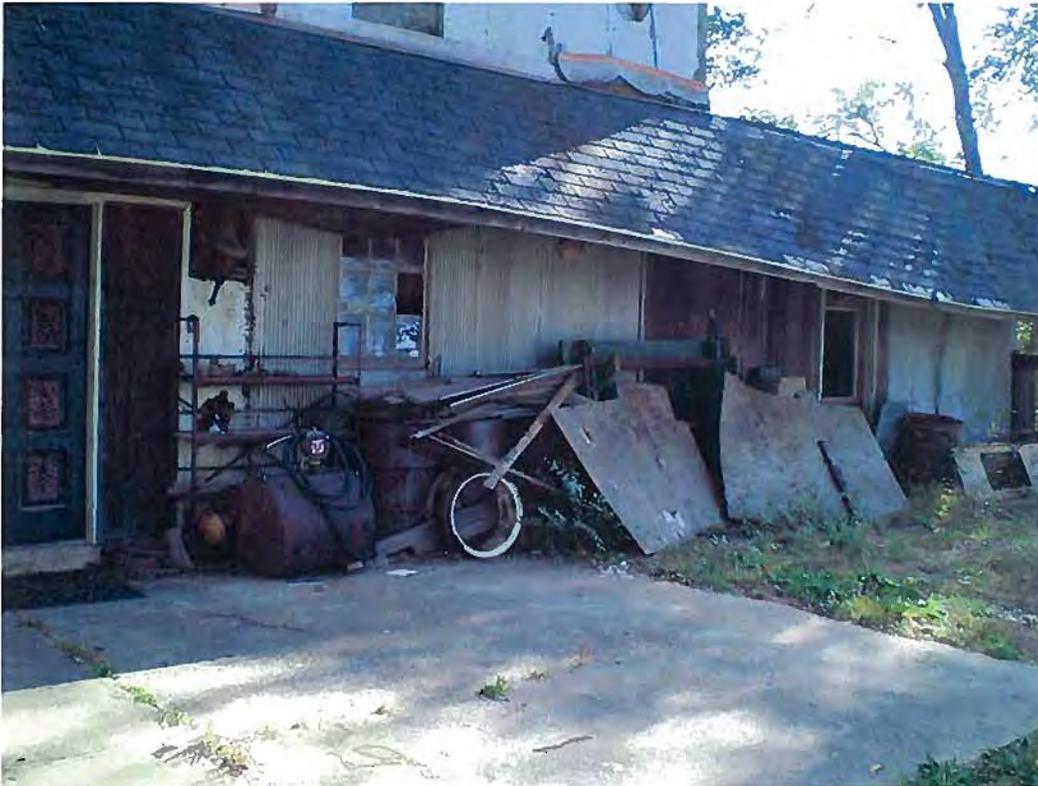
Date: October 28, 2008
Time: 11:44 am
Direction: Southeast
Photo by: W Zierath
Exposure #: 003
Comments: Junk along the west side of the building, including demolition waste (including boards and plywood), scrap metal and 55-gallon drums. It is usually possible to determine if drums are empty by rapping on them. The weight of wood on top of the drums prevented the successful use of that method in this case.

There was scrap metal and wooden demolition waste, along with three possibly empty 55-gallon drums located along the west side of the north building at this site. This waste is shown in photographs 1250205071~10282008-003 and 1250205071~10282008-004.

The drums located along the west side of the north building had wood boards stacked on them along with other items leaning against them. The usual method for determining

whether drums contain liquids or solids is to rap on the sides of the drums. Empty drums ring with a distinctive sound. However, significant weight on top of an empty drum will deaden the sound. For this reason I was unable to determine if the drums were empty or contained wastes. Apparent violations of 35 Ill. Adm. Code 722.111 (hazardous waste determination) and 808.121 (special waste determination) are marked to address the necessity that any wastes in the drums be identified and the disposed of properly.

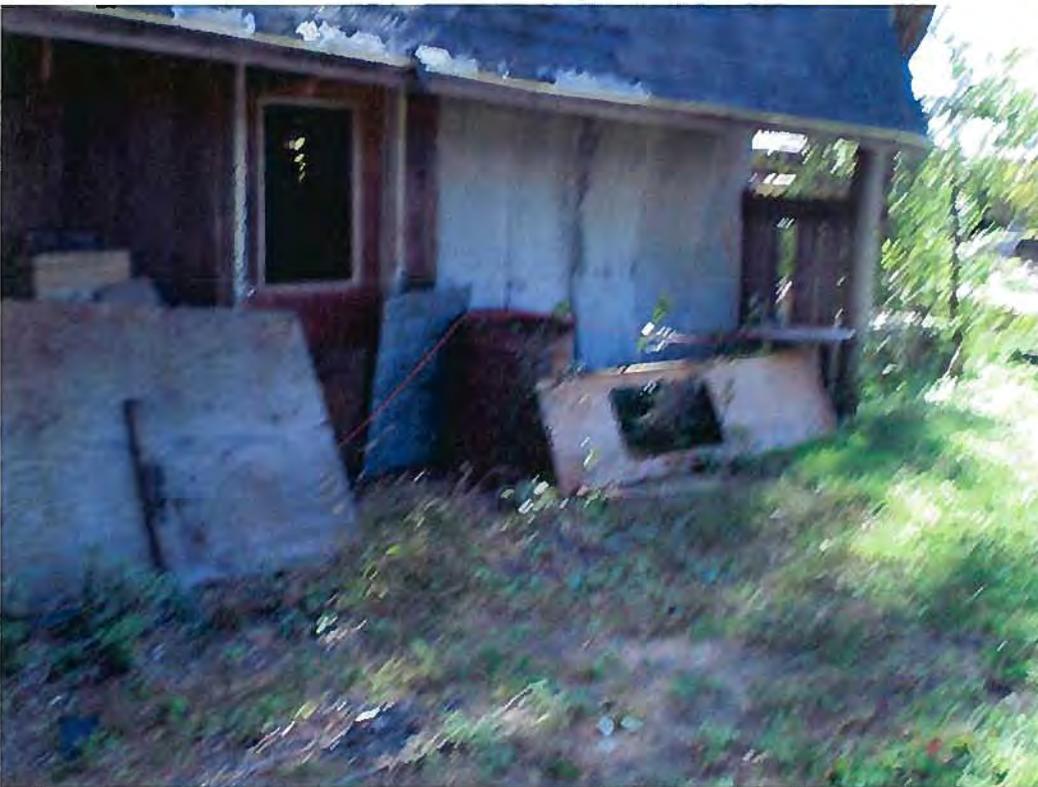
Date: October 28, 2008
Time: 11:45 am
Direction: Southeast
Photo by: W Zierath
Exposure #: 004
Comments: Junk along the west side of the building, including demolition waste (including plywood and an old door), scrap metal and an open empty drum.

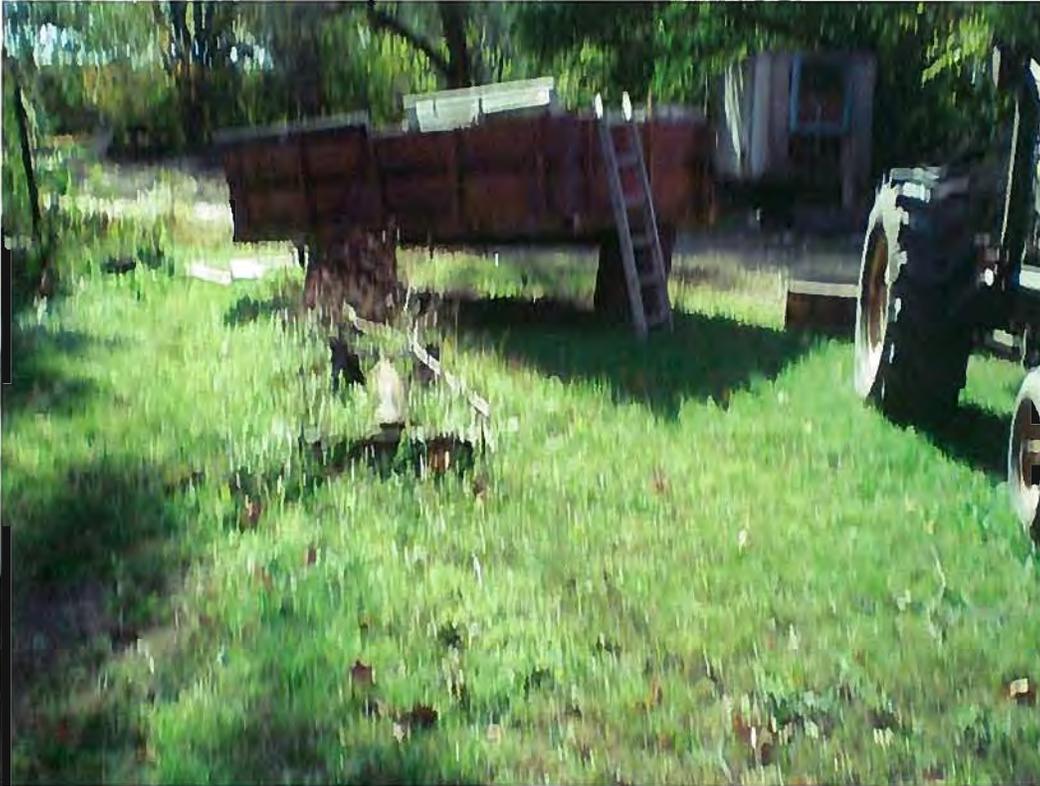
Date: October 28, 2008
Time: 11:45 am
Direction: South
Photo by: W Zierath
Exposure #: 005
Comments: An old trailer that contains old windows and other demolition waste. The large tire to the right of the trailer is a tractor apparently being used during the cleanup. The semi trailer in the background is also shown in photograph 008. The tractor at the right edge of the photograph appeared to be a functional piece of equipment used for the clean up.

An orange trailer with old windows that was observed at the site during the April 22, 2008 investigation was located in the same location during this investigation. This trailer is shown in photograph 1250205071~10282008-005.

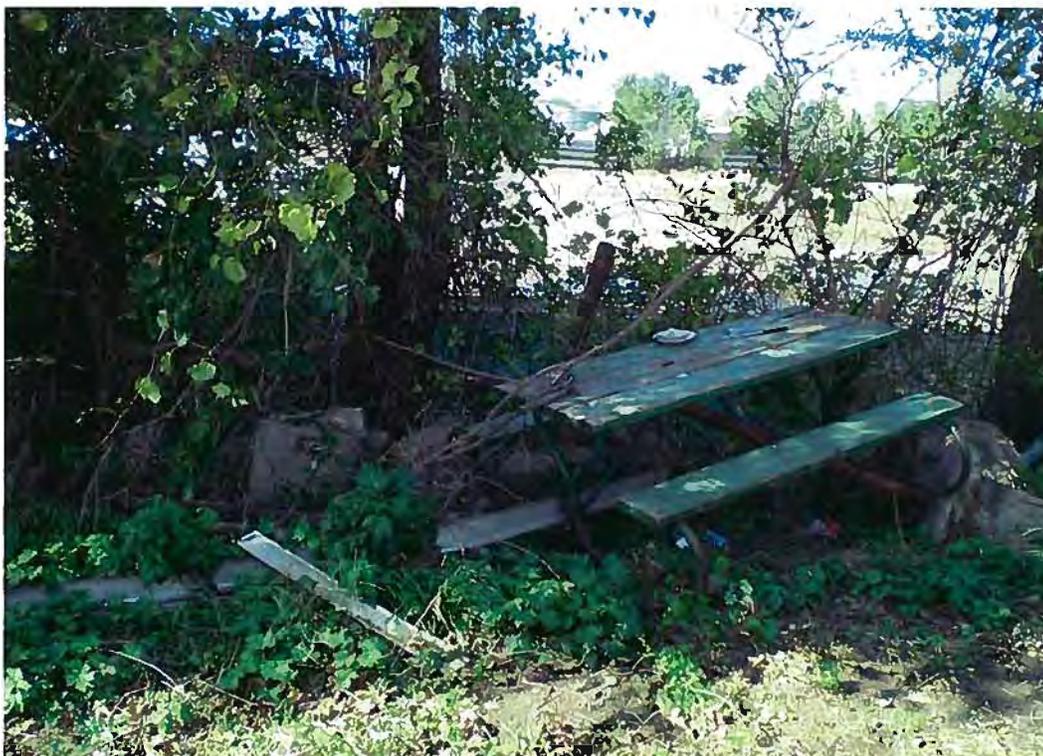
Date: October 28, 2008
Time: 11:45 am
Direction: West
Photo by: W Zierath
Exposure #: 006
Comments: Demolition waste and assorted junk (including a broken picnic table) along the west side of site. The dark green and black objects just beyond the woody vegetation were large plastic culvert sections. This type of material was being stored along the east and west edges of the property to the west and was not on the Jackson property.

There was wooden demolition waste, scrap metal and assorted junk located along the west side of the site. This waste is shown in photographs 1250205071~10282008-006, 1250205071~10282008-007, and 1250205071~10282008-008.

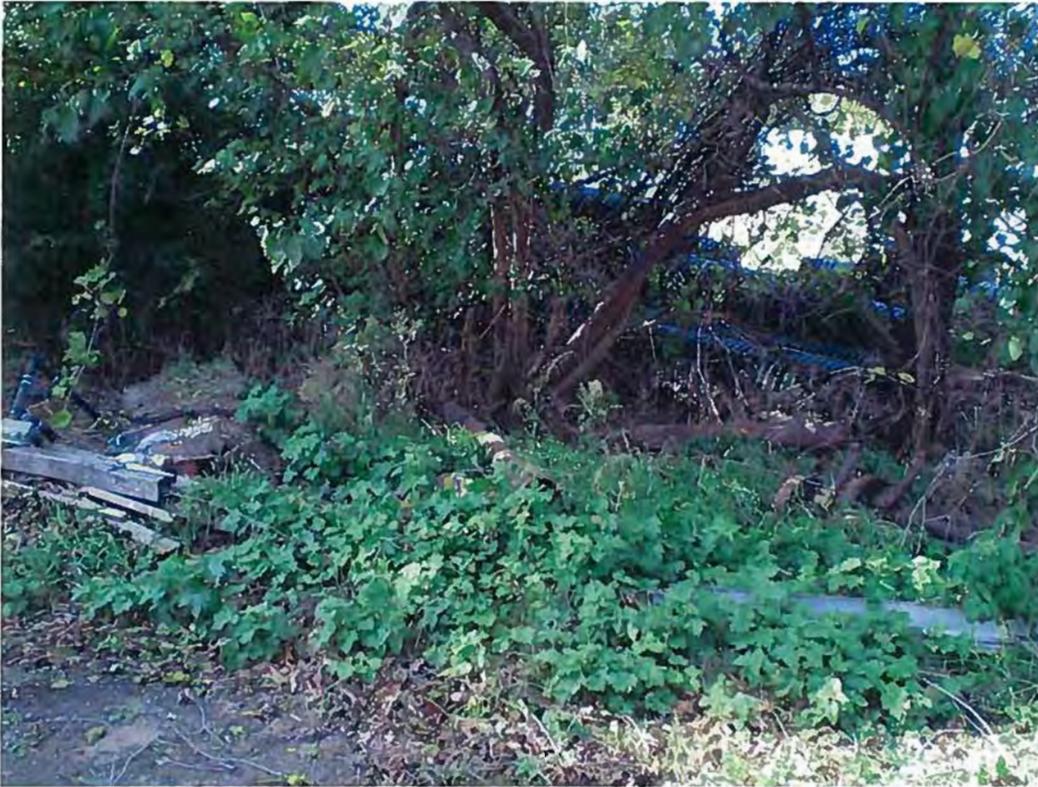
Date: October 28, 2008
Time: 11:45 am
Direction: Southwest
Photo by: W Zierath
Exposure #: 007
Comments: Demolition waste (wooden boards) along the west side of the site. Note: The black plastic culvert sections are on the property to the west.

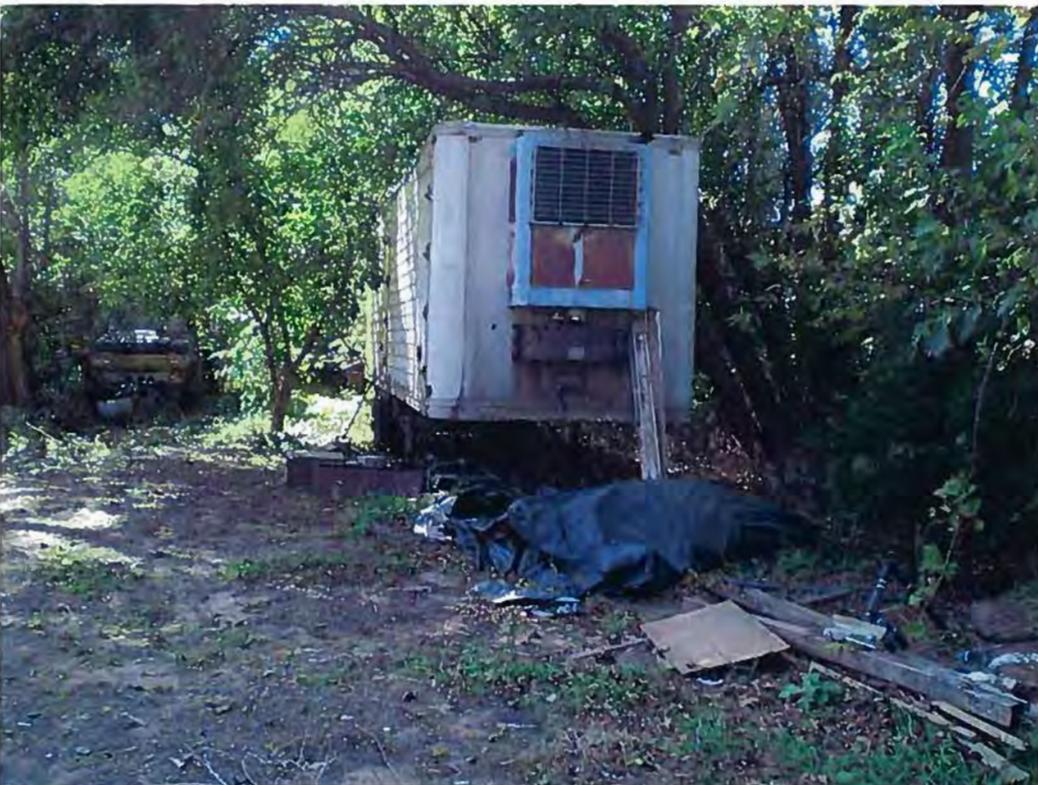
Date: October 28, 2008
Time: 11:46 am
Direction: South
Photo by: W Zierath
Exposure #: 008
Comments: Demolition waste (boards), a bicycle frame and an old semi trailer along the west side of the site. The vehicle near the left edge of the photograph is also shown in photographs 009 and 010.

The semi trailer observed at this site during the April 22, 2008 investigation was still present during this investigation. This semi trailer is shown in photograph 1250205071~10282008-008.

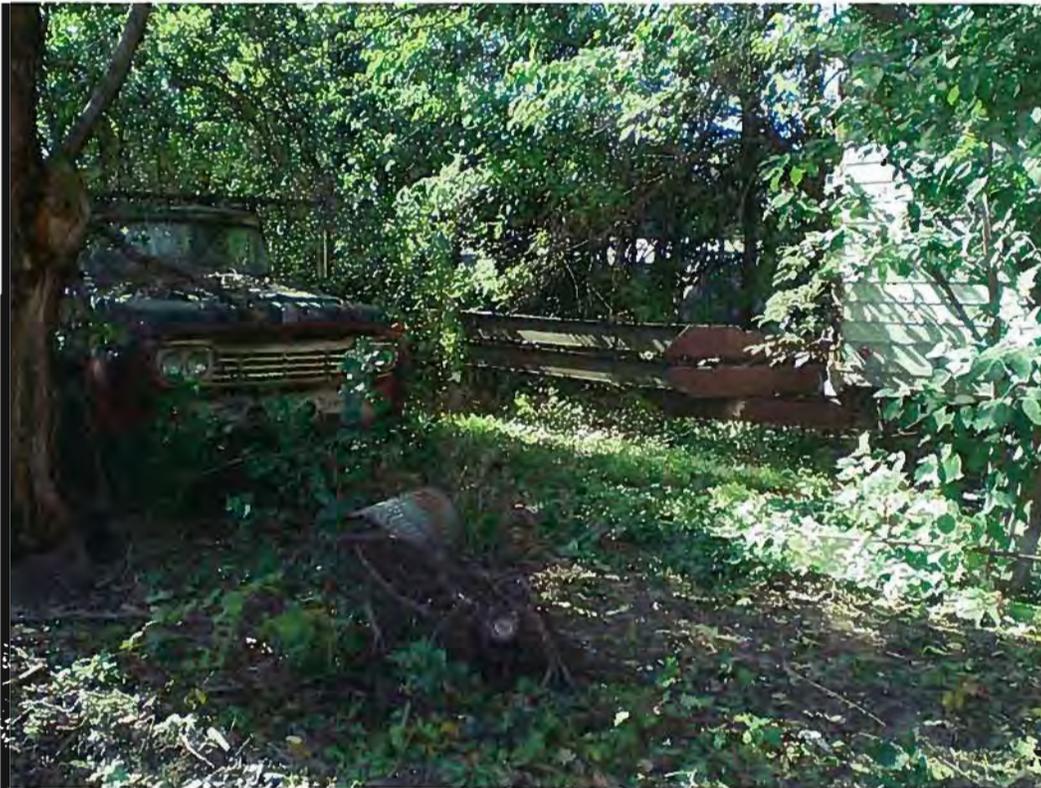
Date: October 28, 2008
Time: 11:46 am
Direction: Southwest
Photo by: W Zierath
Exposure #: 009
Comments: Old mobile home frames, an old trash can and an abandoned truck in the southern part of the site.

As observed during the April 22, 2008 investigation, there were the metal frames from the bases of mobile homes behind the semi trailer. The mobile home bases are shown in photograph 1250205071~10282008-009.

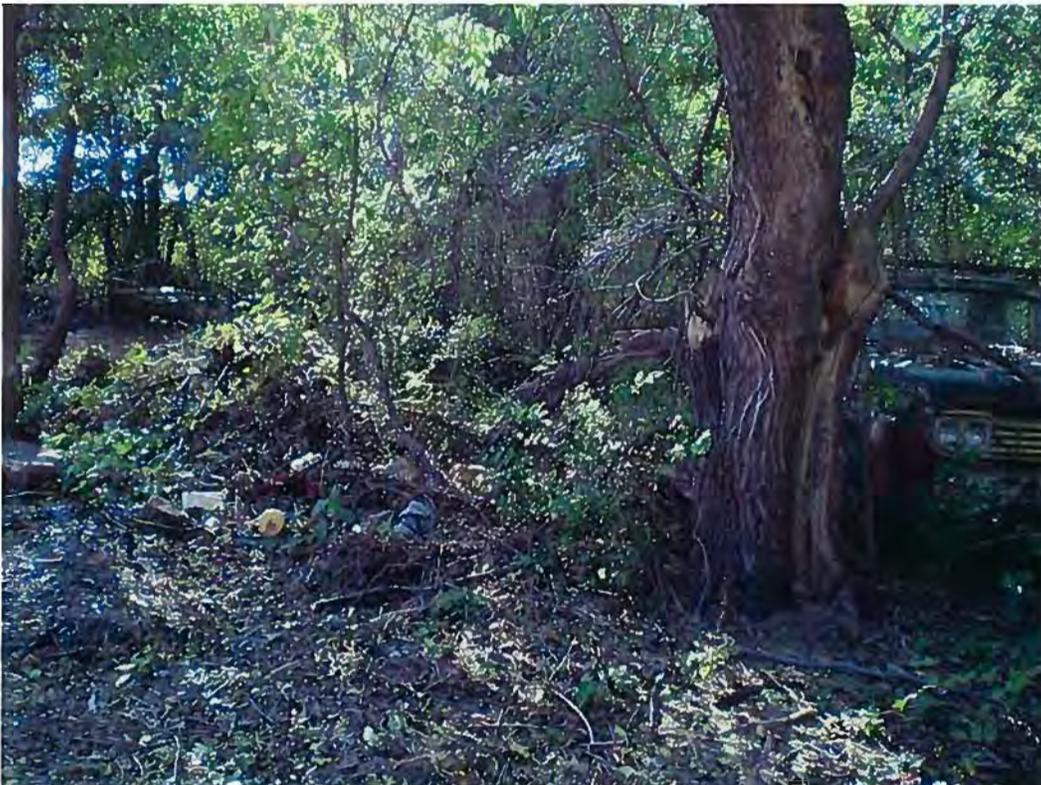
Date: October 28, 2008
Time: 11:46am
Direction: South
Photo by: W Zierath
Exposure #: 010
Comments: Demolition waste (partly covered by fallen branches) and a few pieces of household waste in the southern part of the site.

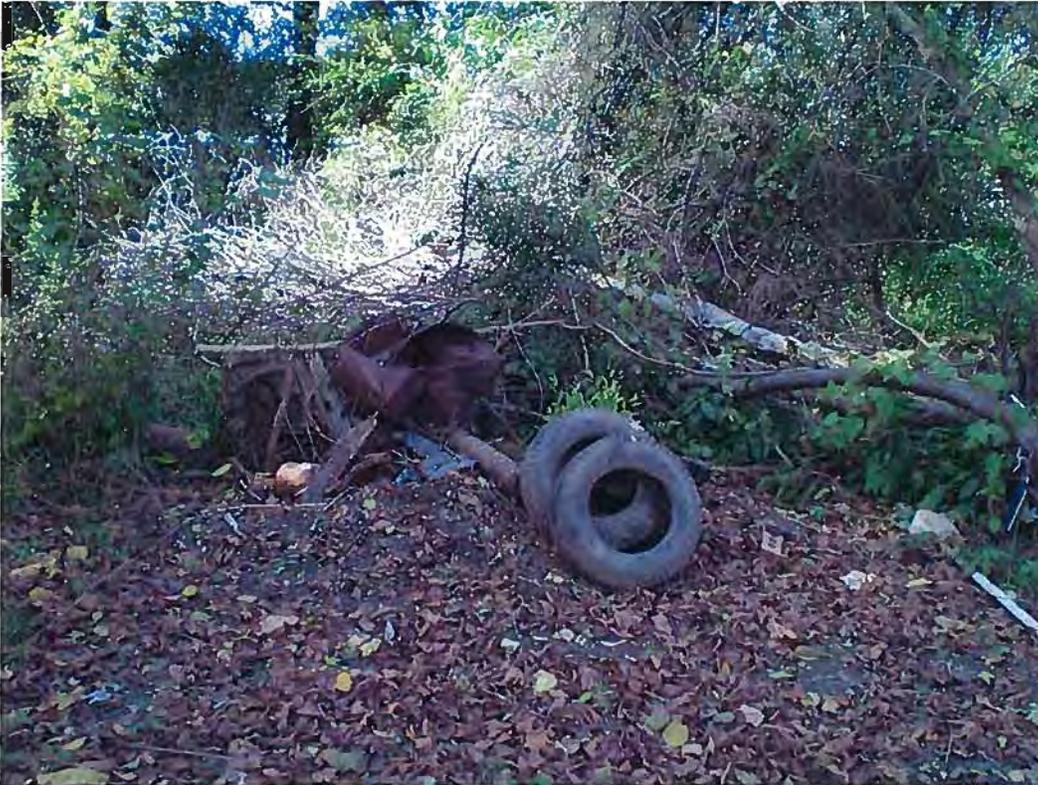
Date: October 28, 2008
Time: 11:47 am
Direction: West
Photo by: W Zierath
Exposure #: 011
Comments: Two used tires (off rims) and scrap metal (including the remains of a 55-gallon drum) in the southern part of the site.

There was scattered junk in the wooded area at the south end of the site. This waste included two used tires not on rims. The waste in the southern end of the site is shown in photographs 1250205071~10282008-010, 1250205071~10282008-011, 1250205071~10282008-013, 1250205071~10282008-014, 1250205071~10282008-015, 1250205071~10282008-016, 1250205071~10282008-017, and 1250205071~10282008-018.

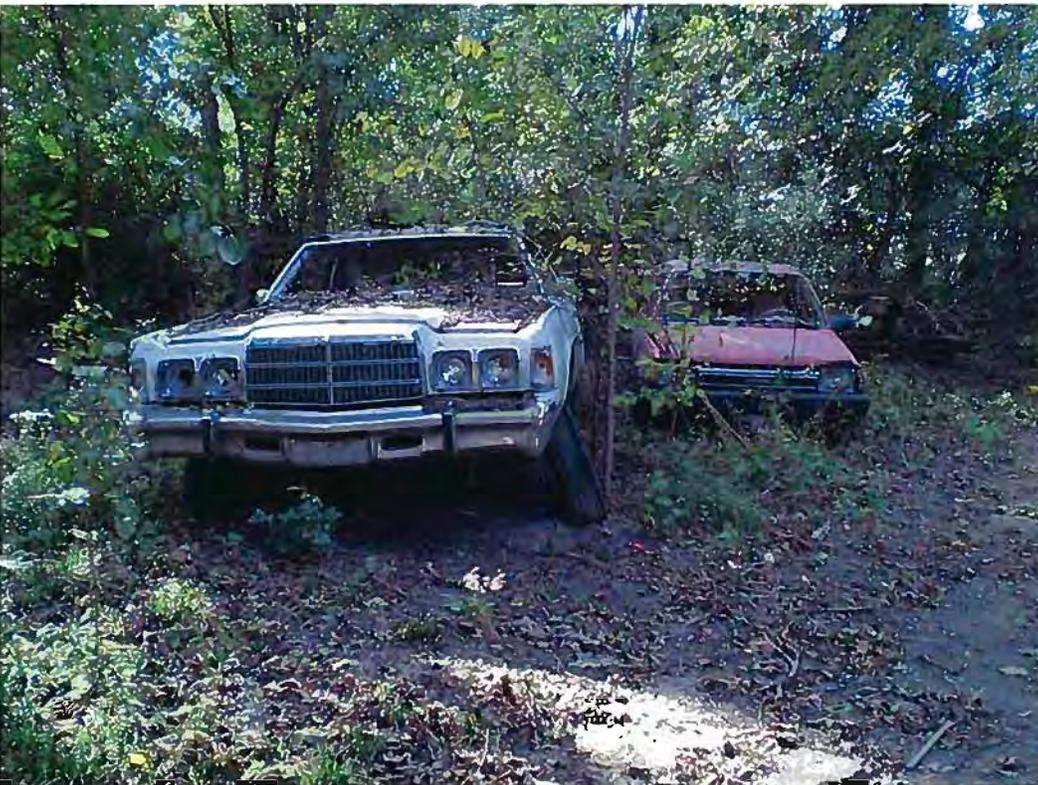
Date: October 28, 2008
Time: 11:47 am
Direction: South
Photo by: W Zierath
Exposure #: 012
Comments: Two abandoned cars in the southern part of the site. Neither car was licensed, had usable tires or windows.

There were two abandoned mobile homes on this property during the April 22, 2008 investigation. The two mobile homes had been removed prior to the October 28, 2008 investigation. The previous locations of these two mobile homes are shown in photographs 1250205071~10282008-008 and 1250205071~10282008-012.

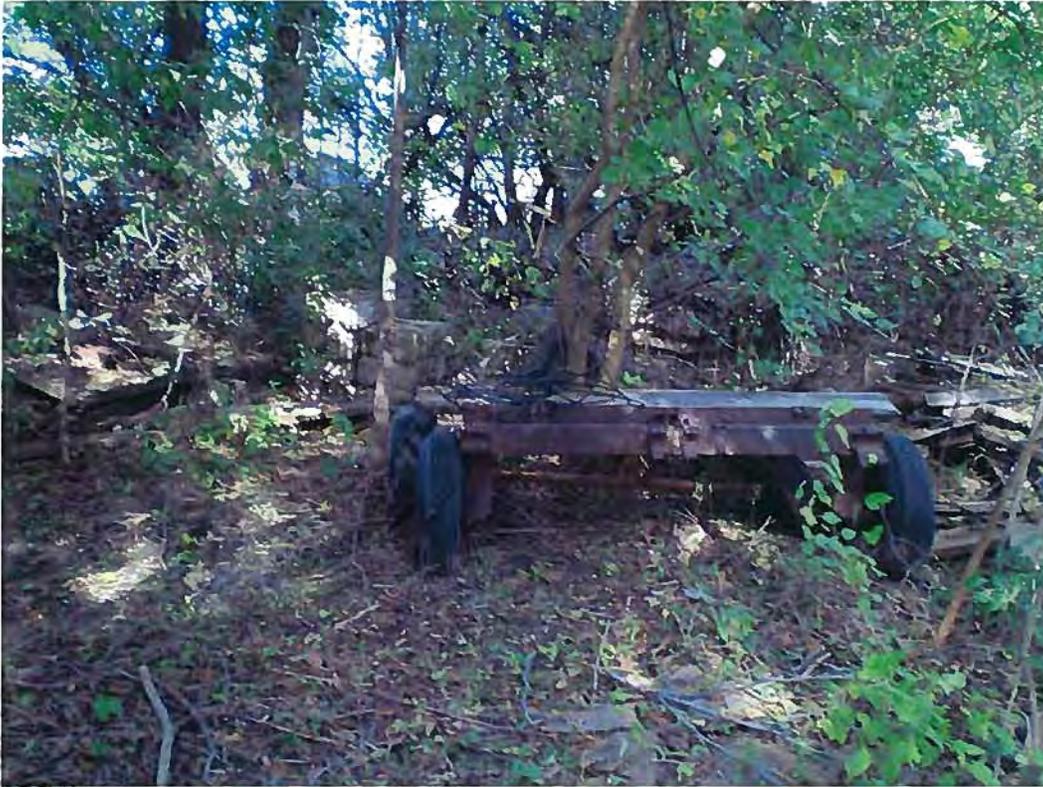
Date: October 28, 2008
Time: 11:48 am
Direction: South
Photo by: W Zierath
Exposure #: 013
Comments: Piles of wood demolition waste (boards) in the south part of the site. It was not clear if the trailer shown in this photograph was usable.

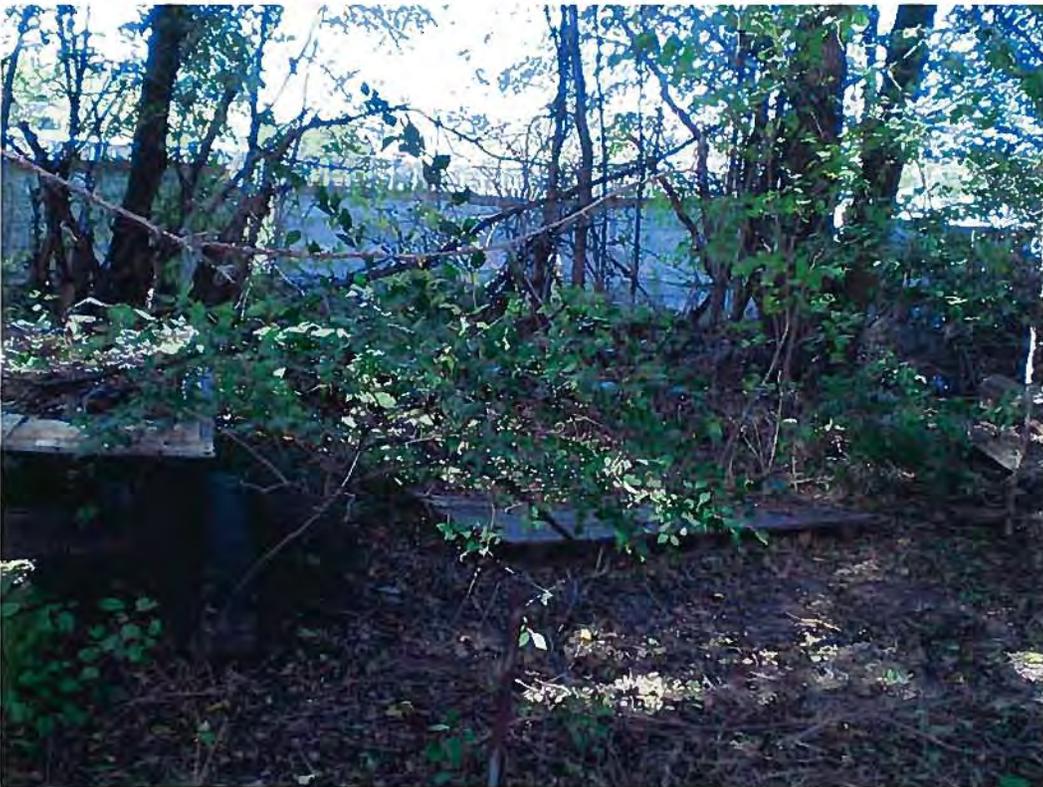
Date: October 28, 2008
Time: 11:48 am
Direction: West
Photo by: W Zierath
Exposure #: 014
Comments: Wood demolition waste (boards) in the south area of the site.

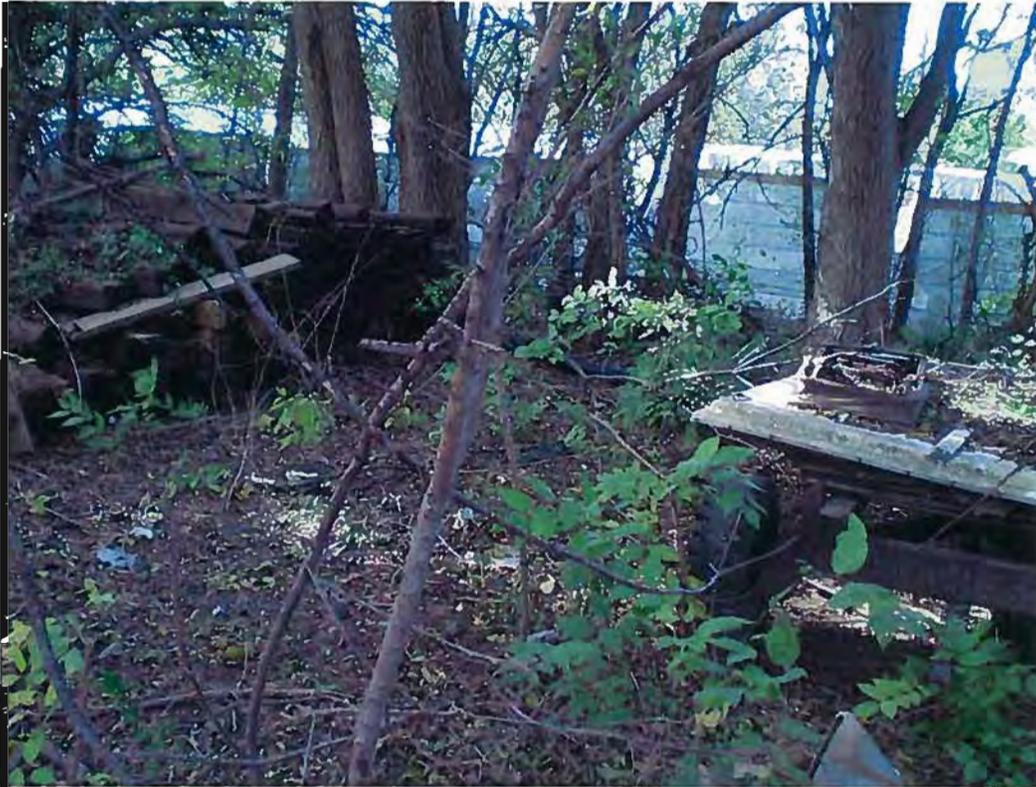
Date: October 28, 2008
Time: 11:48 am
Direction: Southwest
Photo by: W Zierath
Exposure #: 015
Comments: Wood
demolition waste and a
stack of railroad ties in
the south area of the
site.

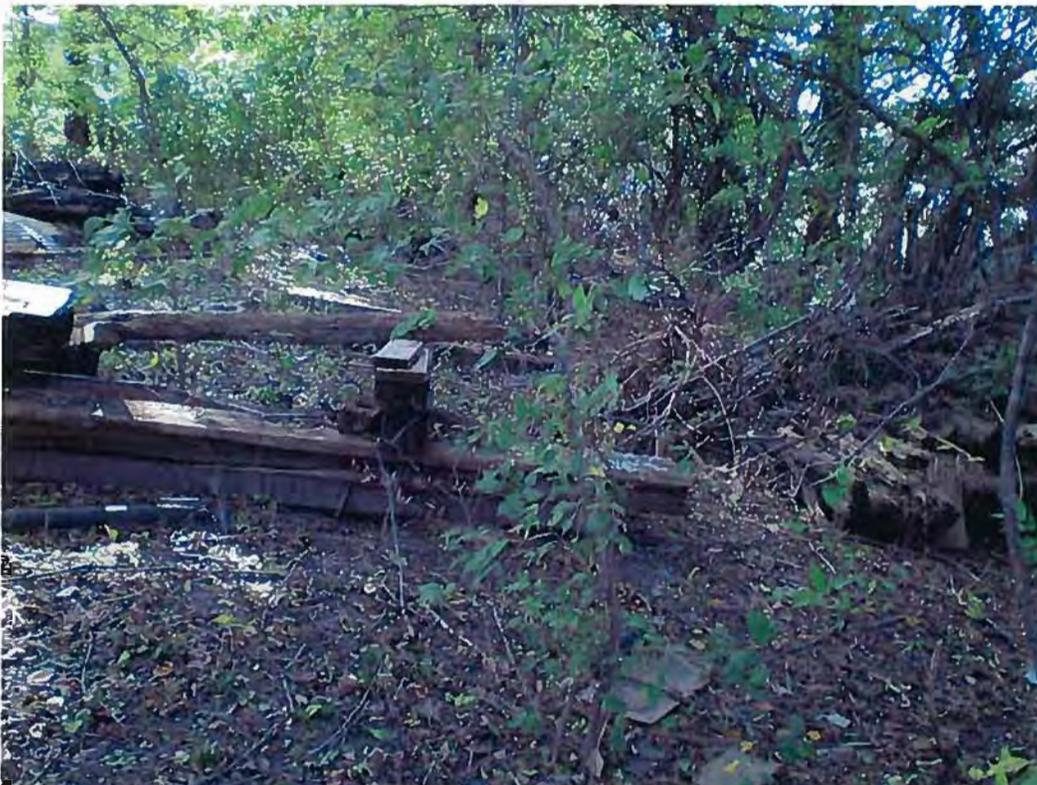
Date: October 28, 2008
Time: 11:48 am
Direction: South
Photo by: W Zierath
Exposure #: 016
Comments: Wood
demolition waste
(boards) in the south
area of the site.

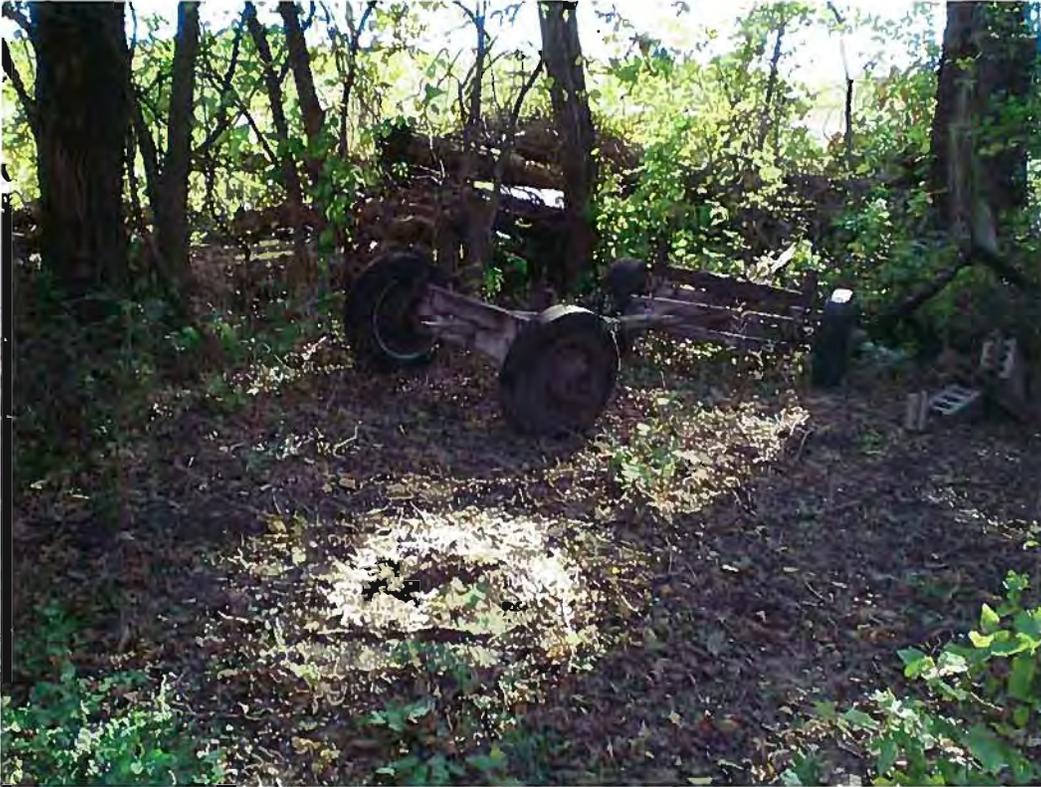
Date: October 28, 2008
Time: 11:48 am
Direction: South
Photo by: W Zierath
Exposure #: 017
Comments: Wood
demolition waste
(boards) in the south
area of the site. It was
not clear that the trailer
was not still usable.

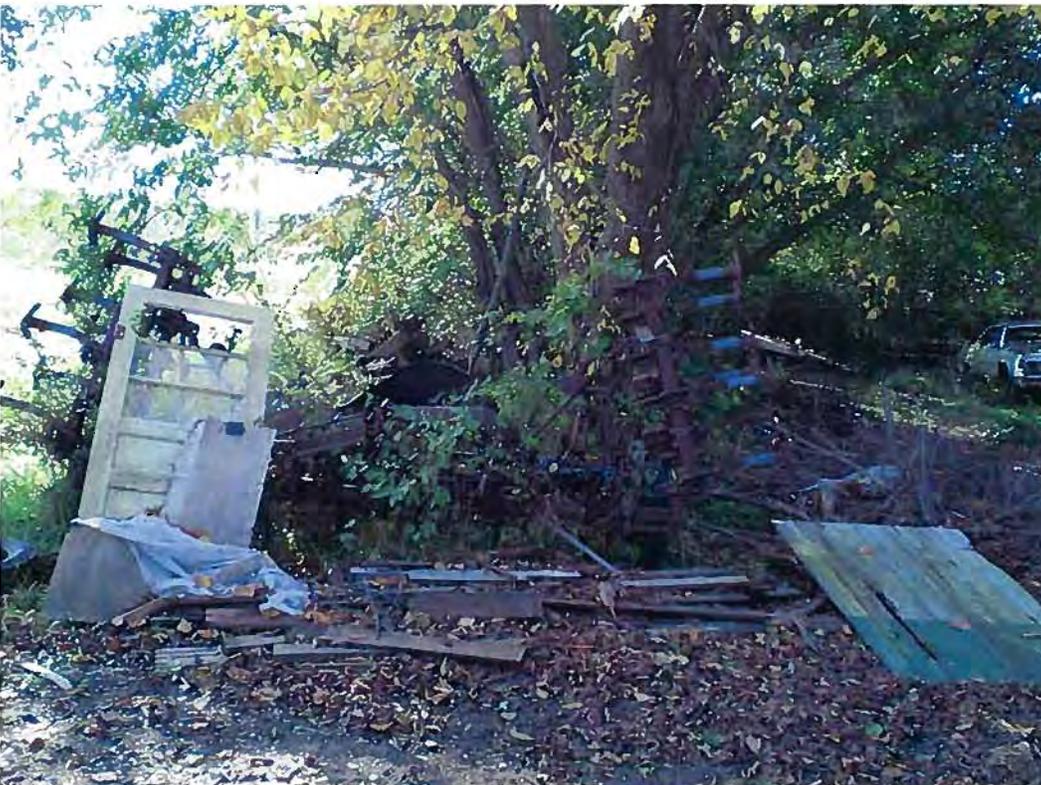
Date: October 28, 2008
Time: 11:49 am
Direction: South
Photo by: W Zierath
Exposure #: 018
Comments: Wood
demolition waste, a
piece of used
corrugated metal, an
old door, scrap metal
in the south area of the
site. While the amount
of woody vegetation
around the cultivator
shown in this
photograph indicates
that it hadn't been
moved for some time,
but it was unclear that
it had been discarded.

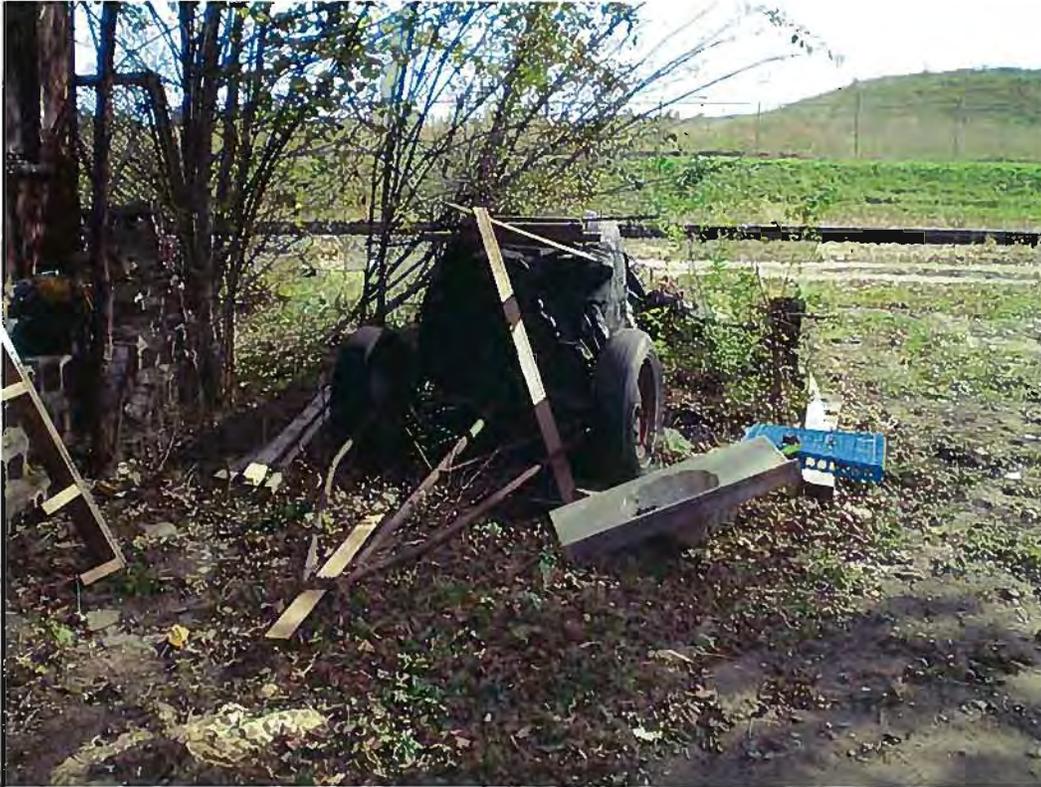
Date: October 28, 2008
Time: 11:49 am
Direction: East
Photo by: W Zierath
Exposure #: 019
Comments: Scrap metal, demolition waste (a few boards) concrete blocks and other junk (including a bathroom sink) on the east side of the site. It was not clear if the trailer shown in the photograph was usable.

At the south end of the south building was a small amount of scrap metal, demolition waste and assorted junk. This waste is shown in photograph 1250205071~10282008-019.

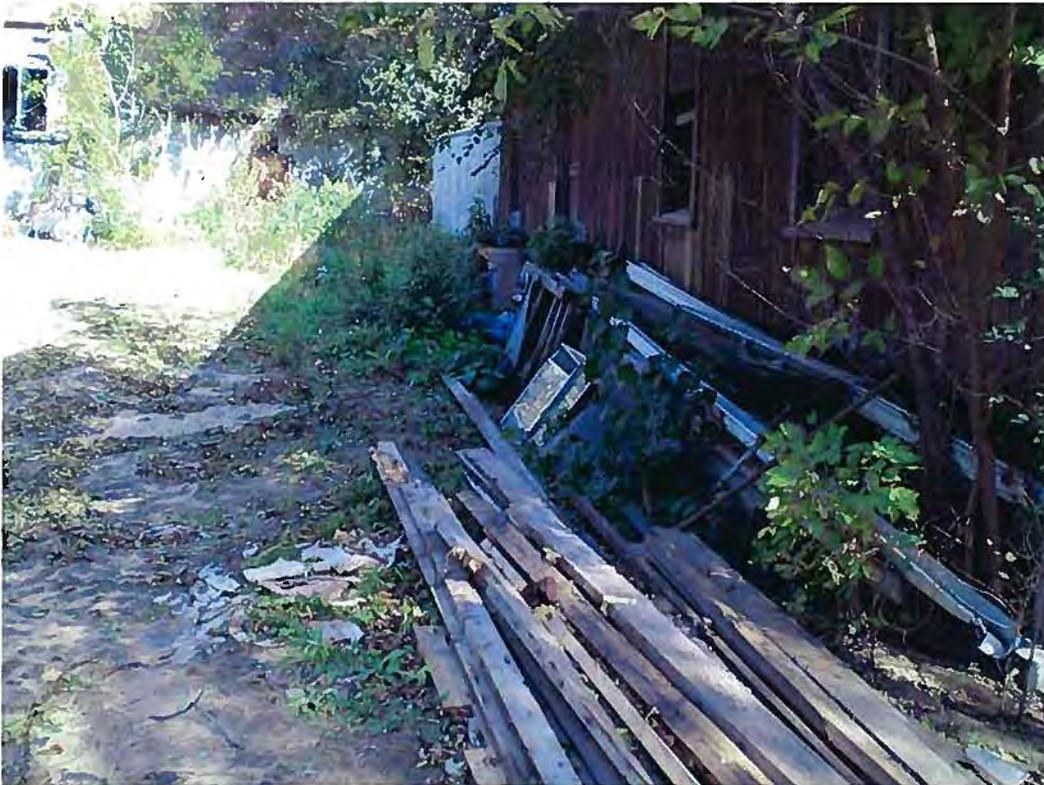
Date: October 28, 2008
Time: 11:49 am
Direction: North
Photo by: W Zierath
Exposure #: 020
Comments: Scrap metal and scrap wood stacked along the west side of the south building at the site.

There was wooden demolition waste stacked along the western wall of the south building. This demolition waste is shown in photograph 1250205071~10282008-020.

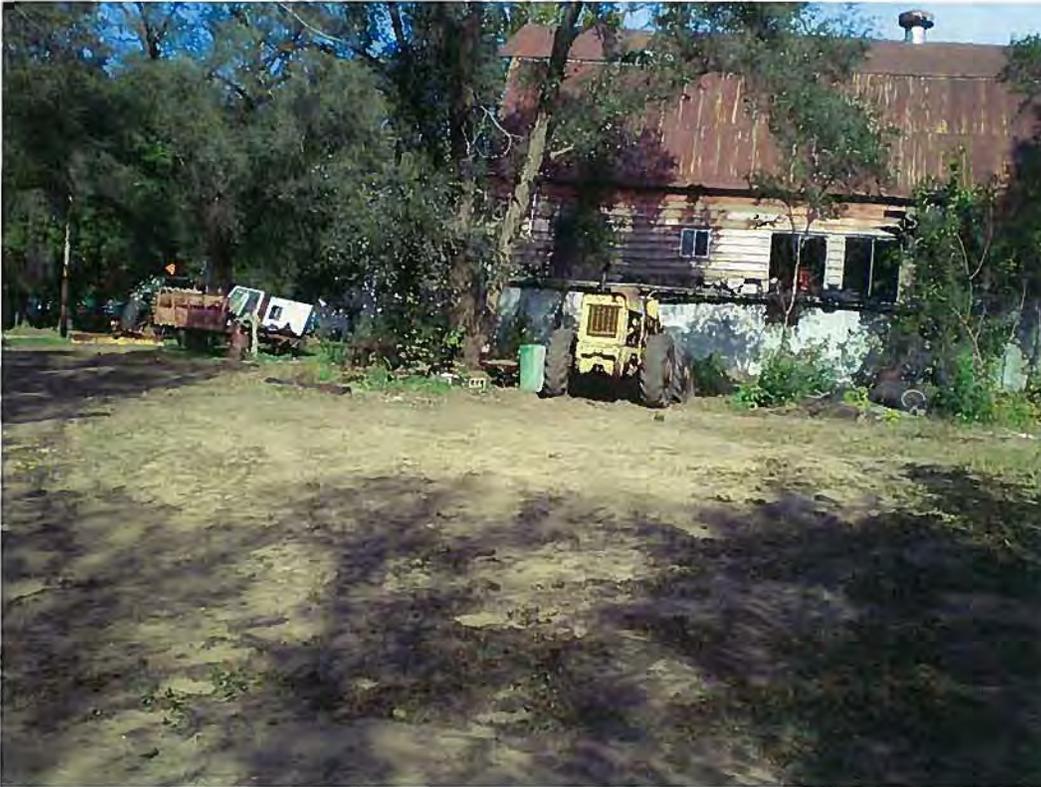
Date: October 28, 2008
Time: 11:49 am
Direction: North
Photo by: W Zlerath
Exposure #: 021
Comments: The area south of the north building. The yellow end loader appeared to be operable and in use during the clean up. There were 6 tires (on rims) leaned up against the building. Scattered wastes to the left of the end loader are shown in photograph 022.

Most of the waste in the area south of the north building and west of the south building had been removed prior to this investigation. The area is shown in photograph 1250205071~10282008-021. There were some used tires on rims leaning against the south wall. In addition, there was some scrap metal south of the southwest corner of the north building. This scrap metal is shown in photograph 1250205071~10282008-022.

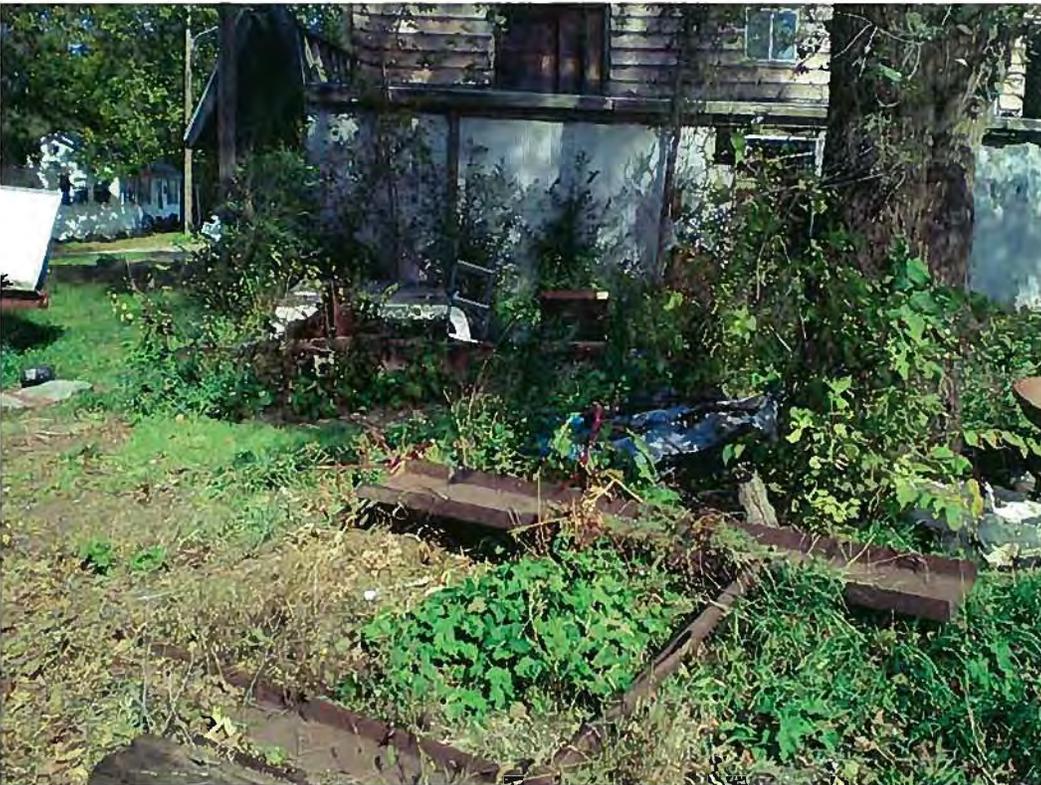
Date: October 28, 2008
Time: 11:50 am
Direction: North
Photo by: W Zlerath
Exposure #: 022
Comments: Scrap metal and other junk (including and old plastic tarp and an old truck topper) in the area immediately south of the southwest corner of the north building.
