Re: Illinois Environmental Protection Agency v. Info Corner Materials, Inc.
IEPA File No.15-09-AC: 1678220075—Sangamon County

ADMINISTRATIVE CITATION

4. That on January 9, 2009, Richard C. Johnson of the Illinois Environmental Protection Agency's ("Illinois EPA") Springfield Regional Office inspected the above-described facility. A copy of his inspection report setting forth the results of said inspection is attached hereto and made a part hereof.

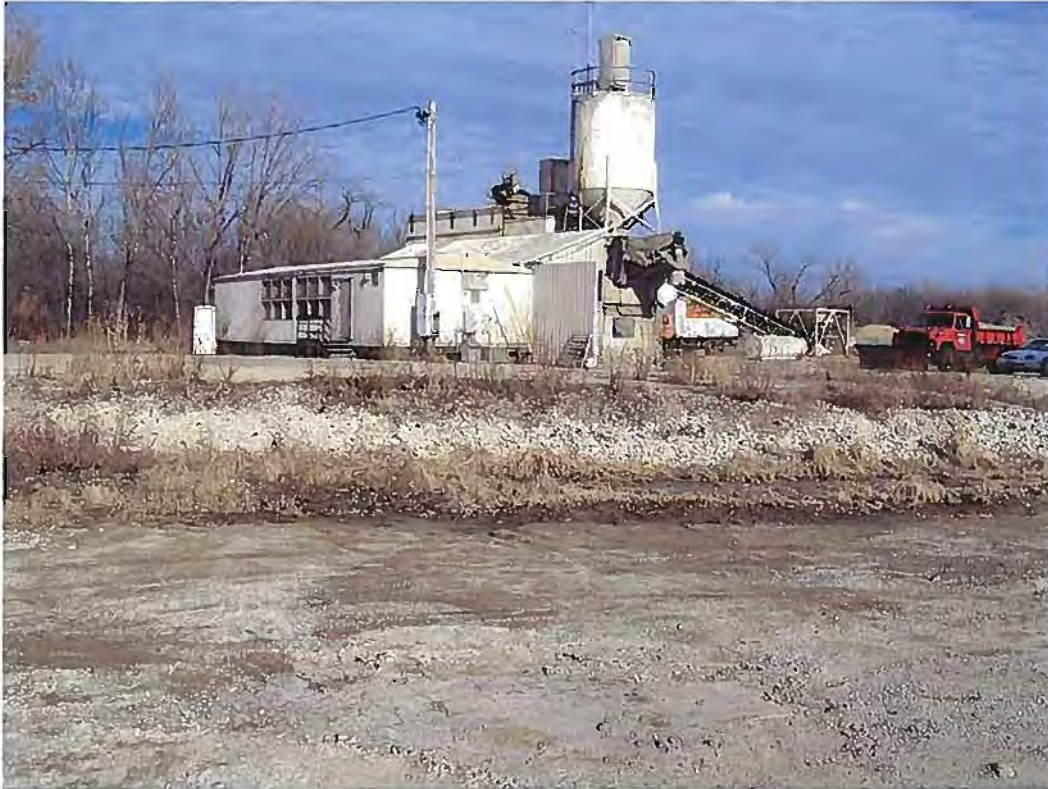
Date: January 9, 2009
Time: 1:37 pm
Direction:
North/northeast
Photo by: Rich Johnson
Exposure #: 001
Comments: Photograph shows the onsite office and aggregate mixing plant at the northwest region of the site.

An office building with a concrete plant sets at the northwest region of the site (see photos 1, 22, 28 and 31). I went to announce myself at the office but observed the office was closed and locked. From the appearance of the office, it appears to have been abandoned. Just east of the office is a warehouse building. There is a silo and conveyor set up which appears to be part of the plant operations for mixing milled asphalt, concrete, gravel, etc. to make paving aggregate. Parked by the office and a small shed was a dump truck labeled "Info Corner Materials" (see photos 1 and 2). Also observed near the shed was an end-loader (a Komatsu WA500).

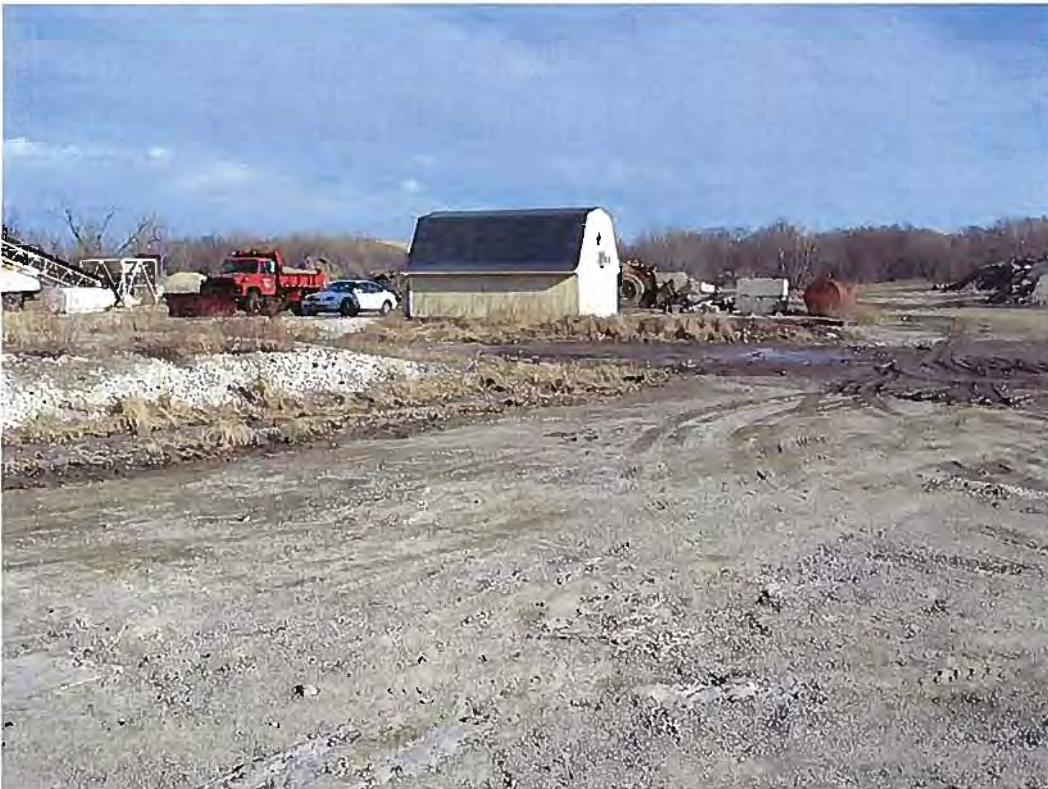
Date: January 9, 2009
Time: 1:37 pm
Direction: Northeast
Photo by: Rich Johnson
Exposure #: 002
Comments: Photograph shows a shed and a fuel tank setting in the western region of the site.

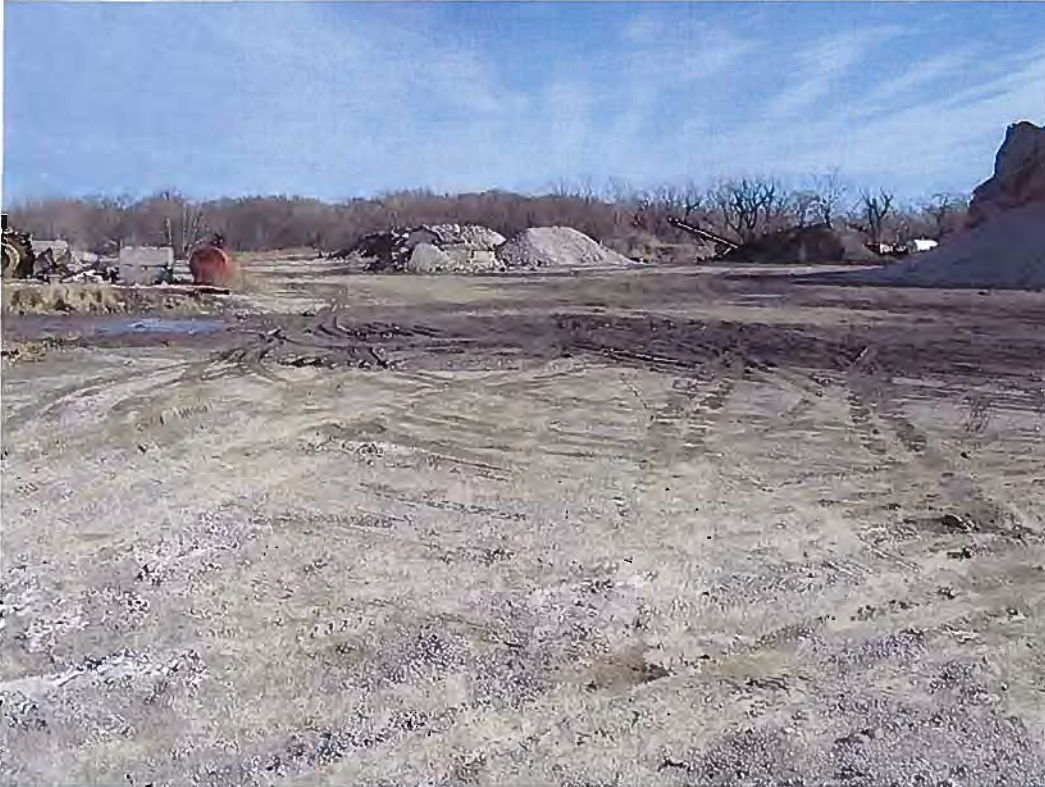
Date: January 9, 2009
Time: 1:37 pm
Direction: East
Photo by: Rich Johnson
Exposure #: 003
Comments: Photograph shows a pile of milled asphalt and gravel piles in the central region of the site.

During the investigation numerous piles of milled asphalt (see photographs 3, 4, 5 and 28), broken concrete both with and without rebar (see photos 6, 7, 8, 9, 10, 11, 12, 22 and 23), broken concrete mixed with broken asphalt (see photos 6, 7, 8, 9, 10, 11 and 22), and gravel (see photos 4 and 28) were observed around the site. It is suspected that these are materials used in making additional concrete and asphalt pavement, or stored prior to being used for fill.

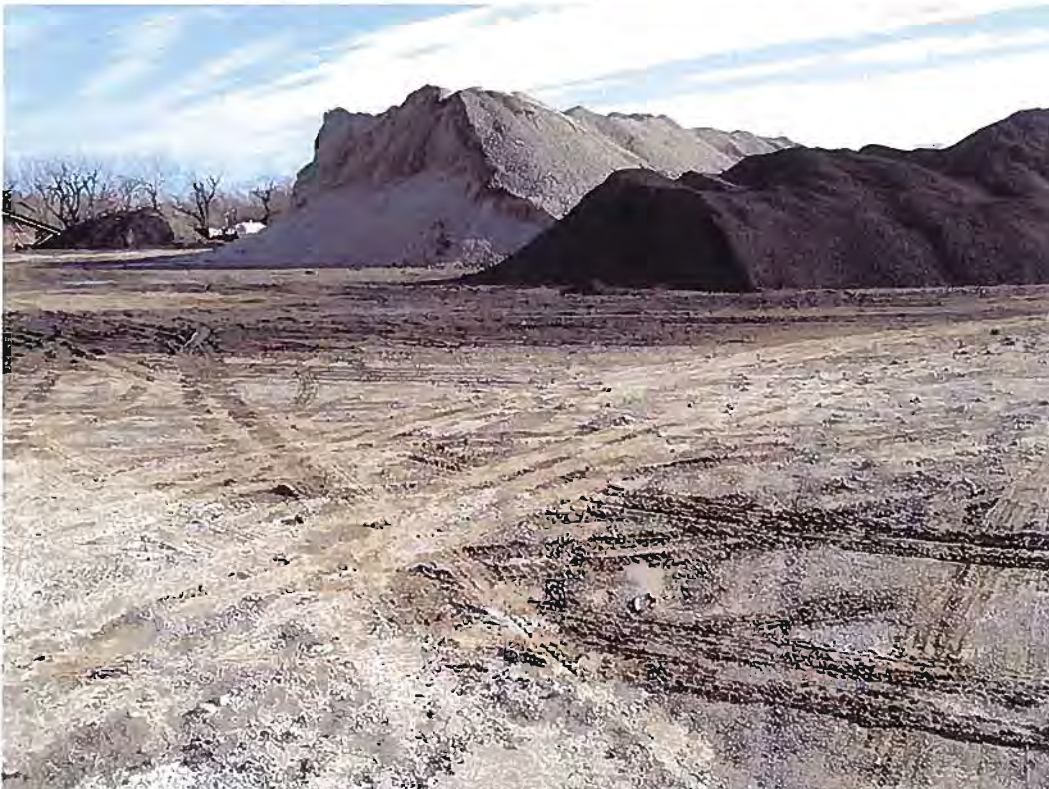
Date: January 9, 2009
Time: 1:37 pm
Direction: Southeast
Photo by: Rich Johnson
Exposure #: 004
Comments: Photograph shows a large pile of gravel and a pile of milled asphalt located in the central and southwest regions of the site.

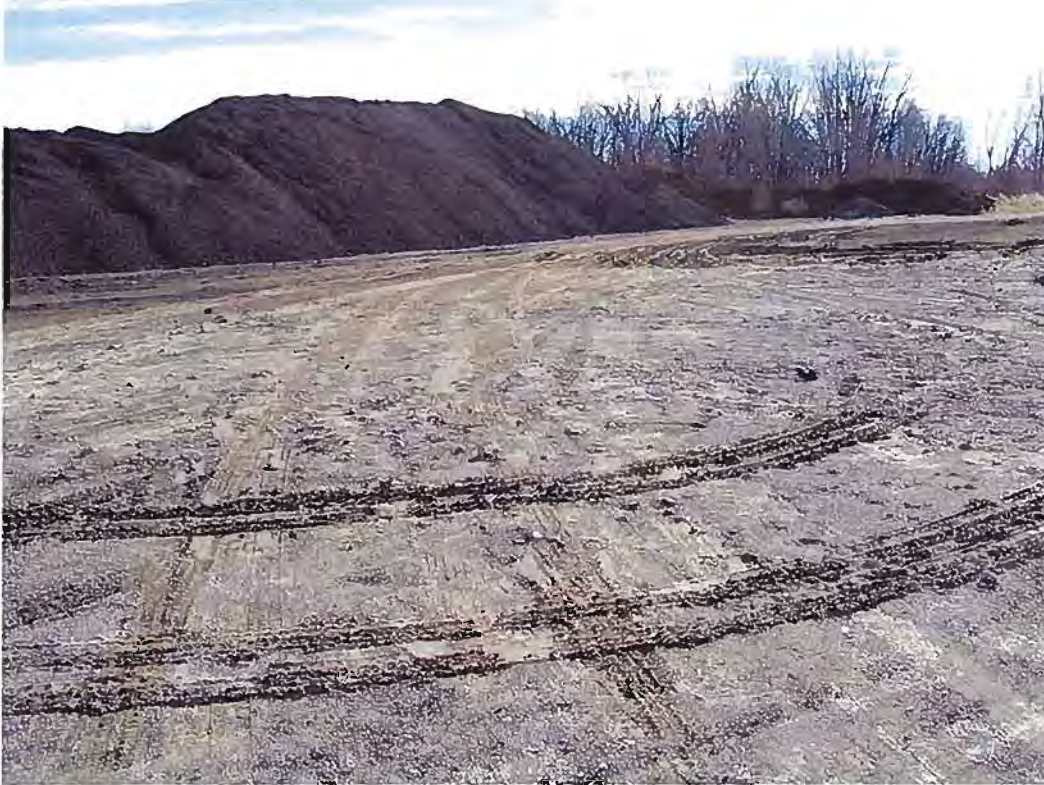
Date: January 9, 2009
Time: 1:37 pm
Direction: South
Photo by: Rich Johnson
Exposure #: 005
Comments: Photograph shows a large pile of milled asphalt in the southwest region of the site.

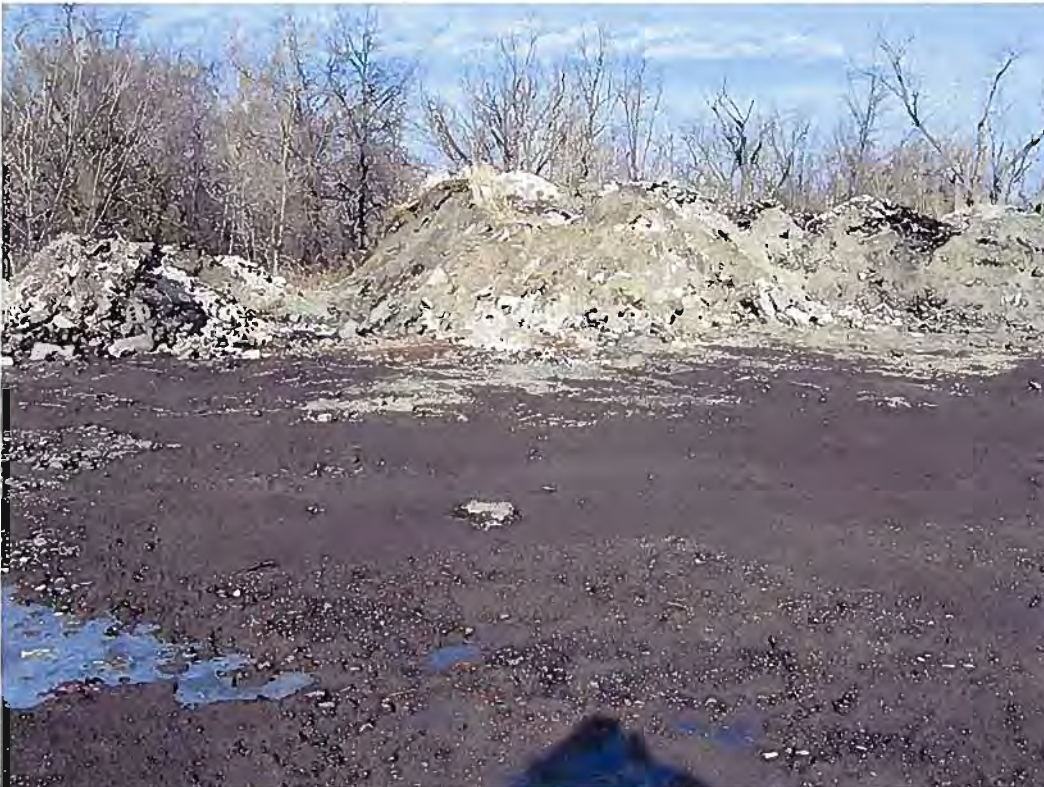
Date: January 9, 2009
Time: 1:41 pm
Direction: North
Photo by: Rich Johnson
Exposure #: 006
Comments: Photograph shows piles of brick, concrete and asphalt as well as some large piles with soil, concrete and asphalt setting in the northcentral region of the site.

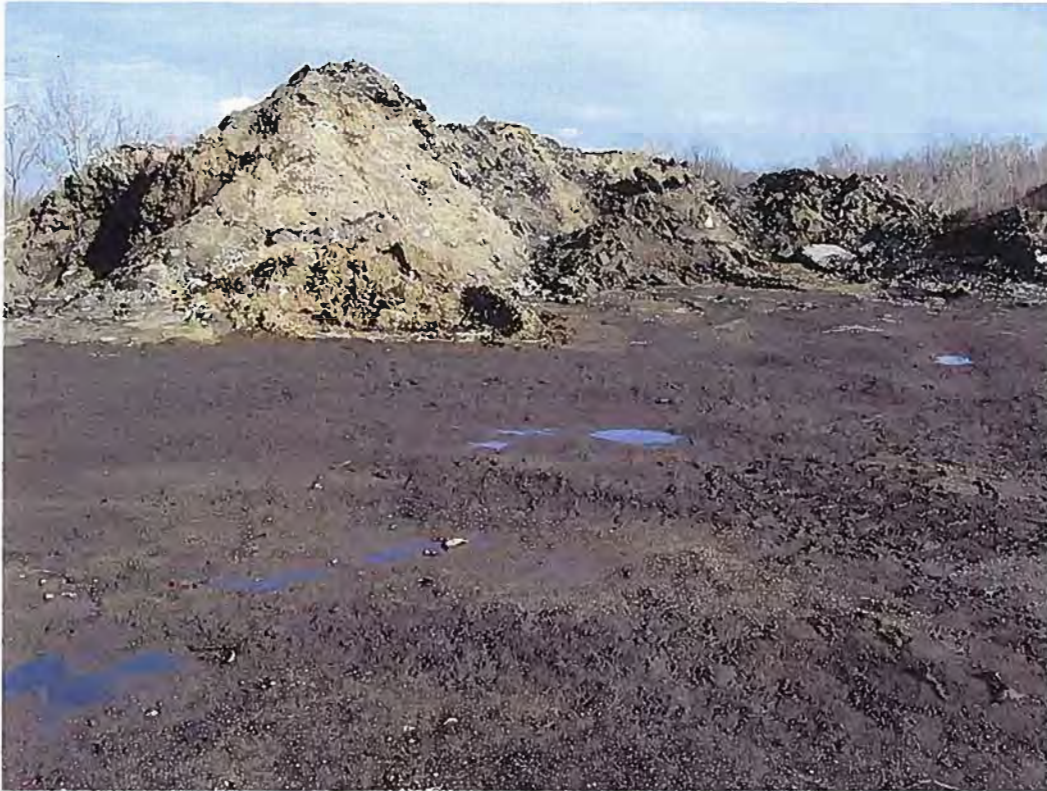
Date: January 9, 2009
Time: 1:41 pm
Direction: Northeast
Photo by: Rich Johnson
Exposure #: 007
Comments: Photograph shows piles with soil, concrete and asphalt located in the northcentral region of the site.

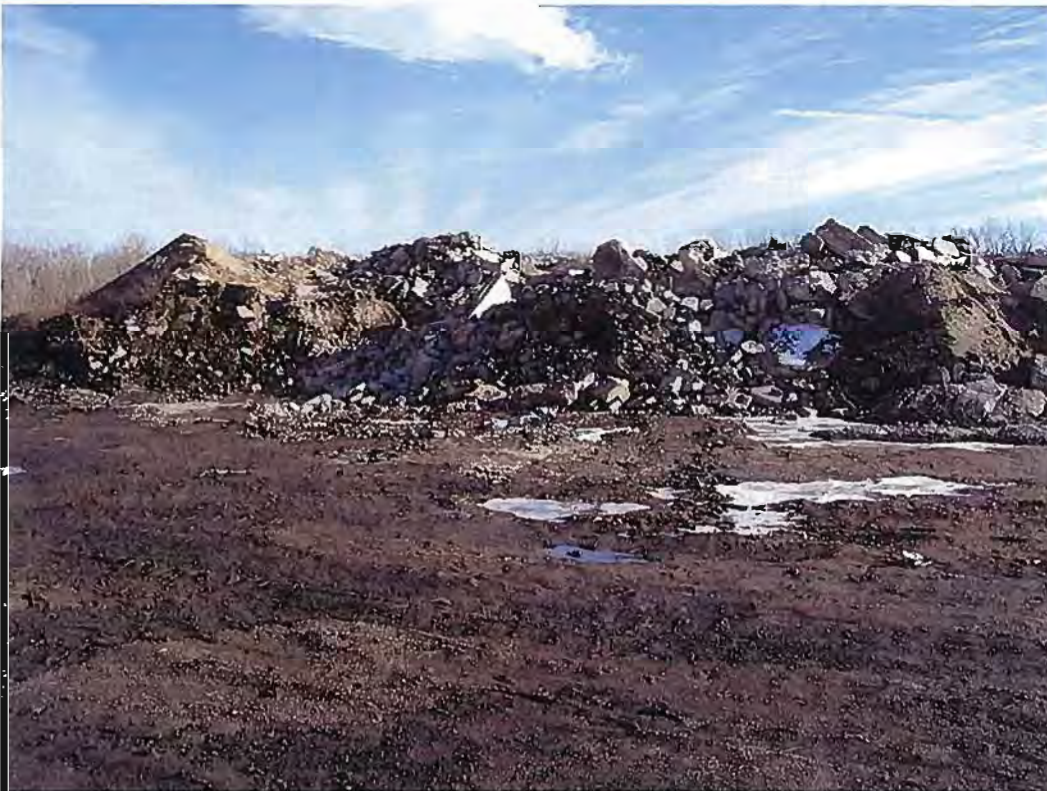
Date: January 9, 2009
Time: 1:41 pm
Direction: East
Photo by: Rich Johnson
Exposure #: 008
Comments: Photograph shows piles of mostly concrete and soil setting in the northcentral region of the site.

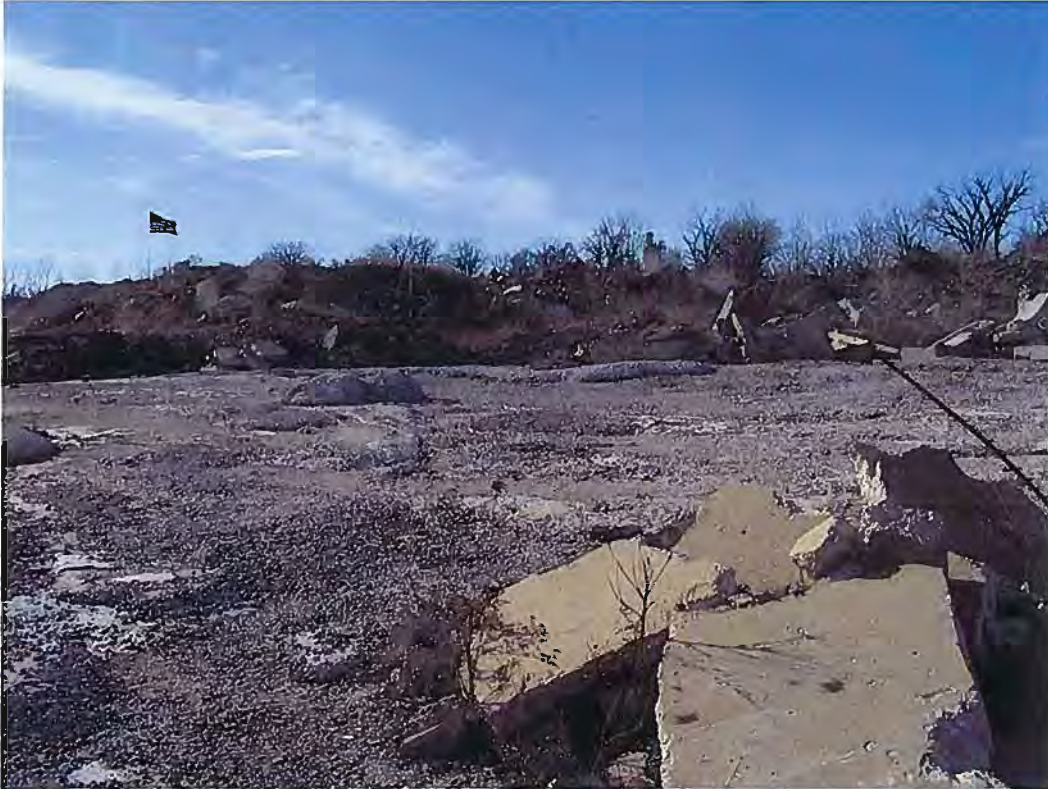
Photos 9, 10, 11 and 12 were taken at the northeast corner of the site. As can be seen in photos 9, 10 and 11 there have been concrete trucks cleaned out in this area. The ground was covered in a layer of hardened, grey concrete over much of this area. It was also evident that over an extended period of time the northeast area had been partly filled and leveled out with broken concrete, and other materials. The east edge of the filling goes down a steep slope an estimated 40 or 50 feet. Near the base of the slope is a small unnamed tributary that flows to the Sangamon River. Photos 12 and 13 show a small part of the eastern slope. It was noted that there were occasional broken concrete and other apparent Clean Construction or Demolition Debris (CCDD) along the slope. These materials probably meet the provisions of Section 3.160(b) of the Act as clean construction or demolition debris. Grass and weeds were covering much of the slope and appear to have prevented erosion.

Date: January 9, 2009
Time: 1:46 pm
Direction:
West/southwest
Photo by: Rich Johnson
Exposure #: 009
Comments: Photograph shows broken concrete and clean out concrete from concrete mixing trucks located in the northeast region of the site.

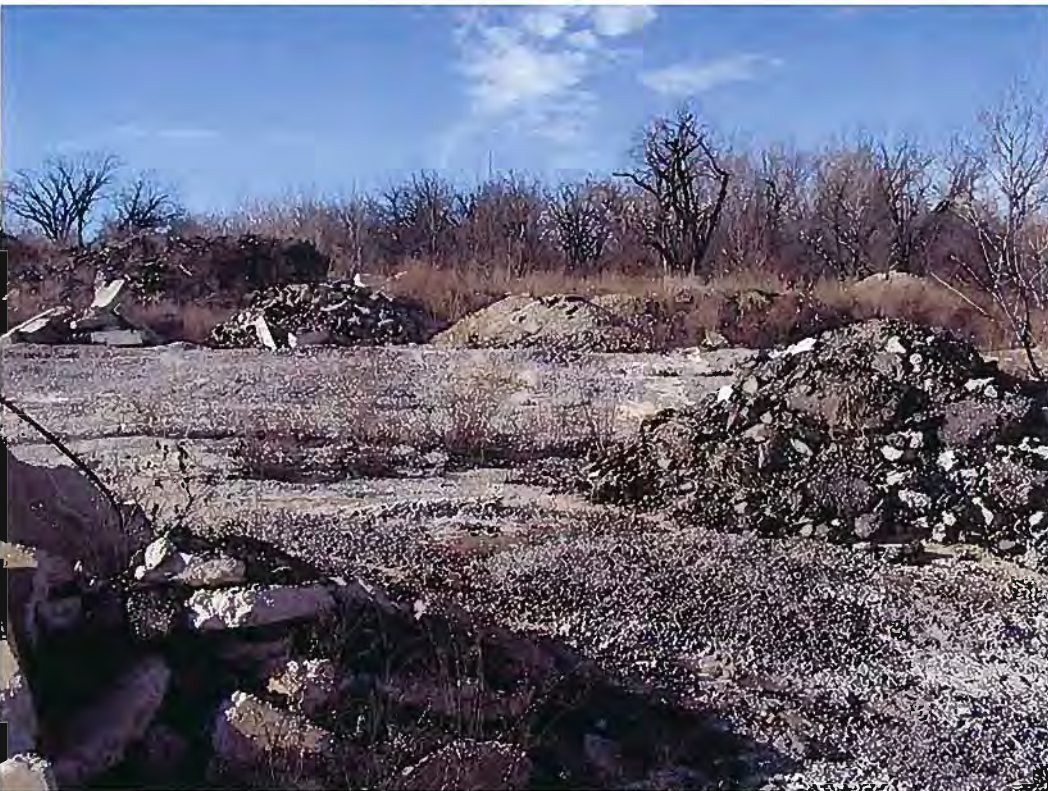
Date: January 9, 2009
Time: 1:46 pm
Direction: Northwest
Photo by: Rich Johnson
Exposure #: 010
Comments: Photograph shows piles of broken concrete and cleaned out concrete from concrete trucks in the northeast region of the site.

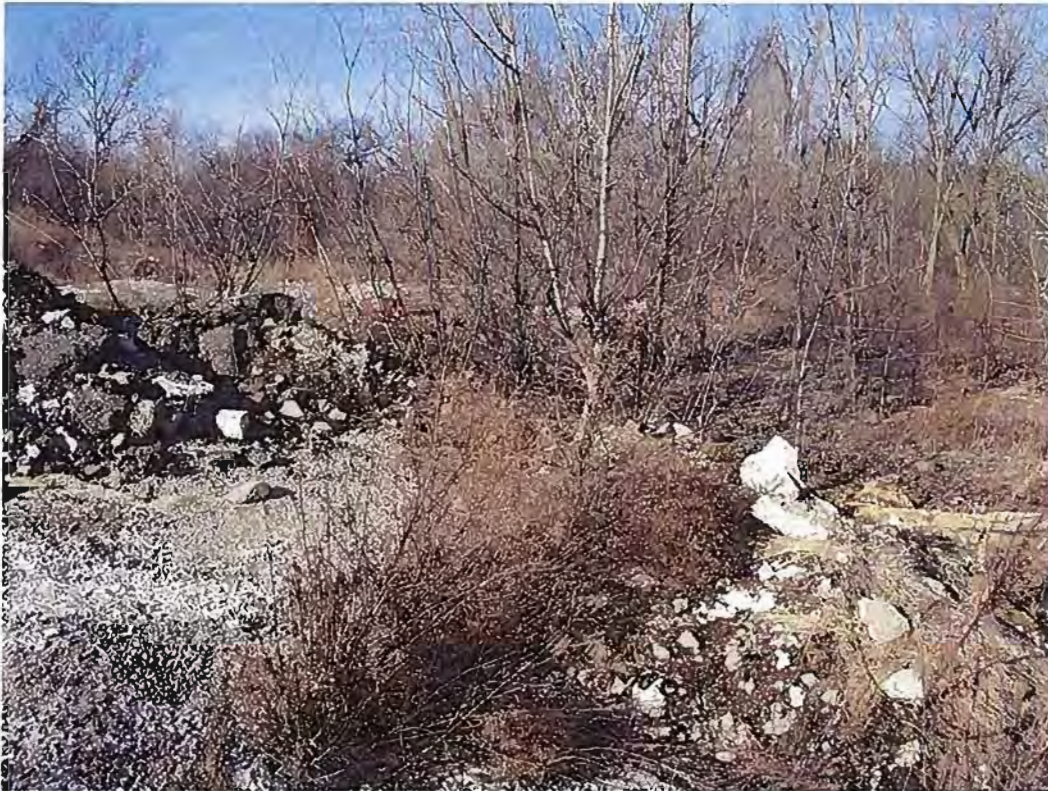
Date: January 9, 2009
Time: 1:46 pm
Direction:
North/northeast
Photo by: Rich Johnson
Exposure #: 011
Comments: Photograph shows small piles of asphalt and concrete as well as the cleaned out concrete mix discarded in the northeast region of the site.

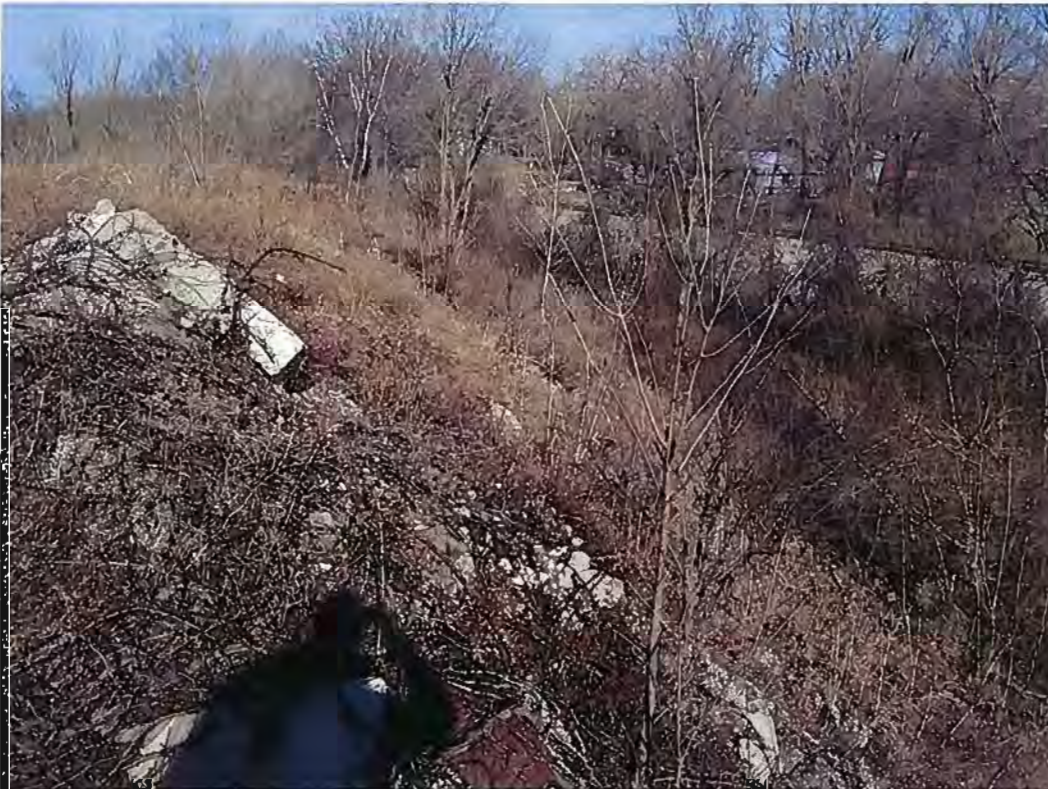
Date: January 9, 2009
Time: 1:56 pm
Direction:
North/northeast
Photo by: Rich Johnson
Exposure #: 012
Comments: Photograph shows part of the east slope of the property from the eastcentral region. Note the steep slope.

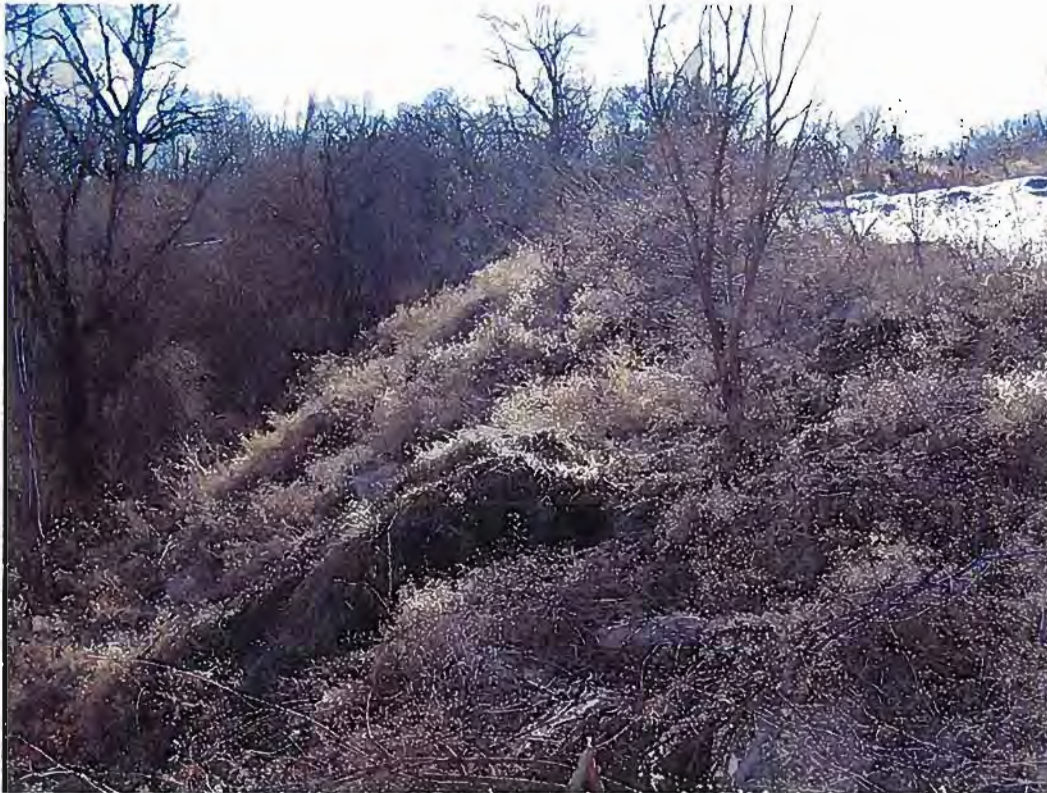
Walking south from the northeast region, I observed a large pile of waste near the east slope (see photos 13, 14 and 15). On inspecting the pile it was found to be small pieces of broken glass (see photos 16, 17, 18, 19, 20 and 21). The glass ranged from pebble to gravel size, and of various colors (clear, green, yellow, blue, brown, etc.). When I broke the surface of the glass, the other glass looked dirty and there appeared to be soil or dust mixed with it. It was also observed that there was a considerable amount of plastic debris

Date: January 9, 2009
Time: 1:56 pm
Direction: South
Photo by: Rich Johnson
Exposure #: 013
Comments: Photograph shows part of the east slope of the property from the eastcentral region. Note the pile of broken glass near the steep eastern slope.

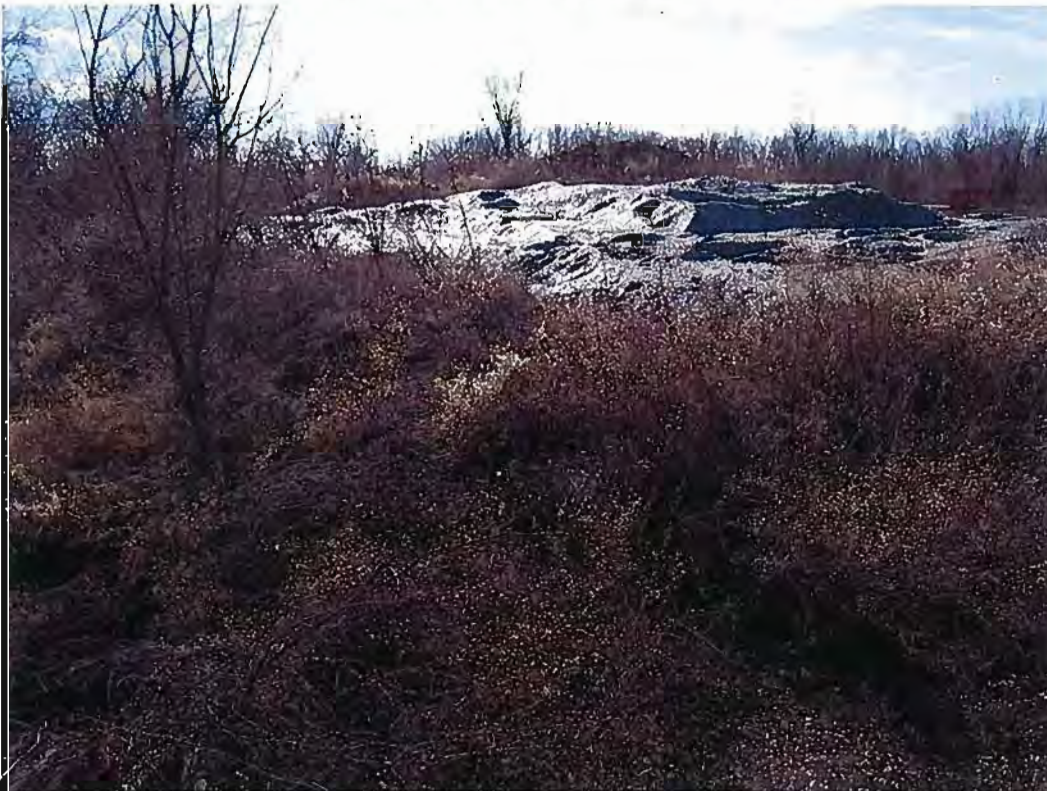
Date: January 9, 2009
Time: 1:56 pm
Direction: Southwest
Photo by: Rich Johnson
Exposure #: 014
Comments: Photograph shows broken glass piled in the eastcentral region of the site.

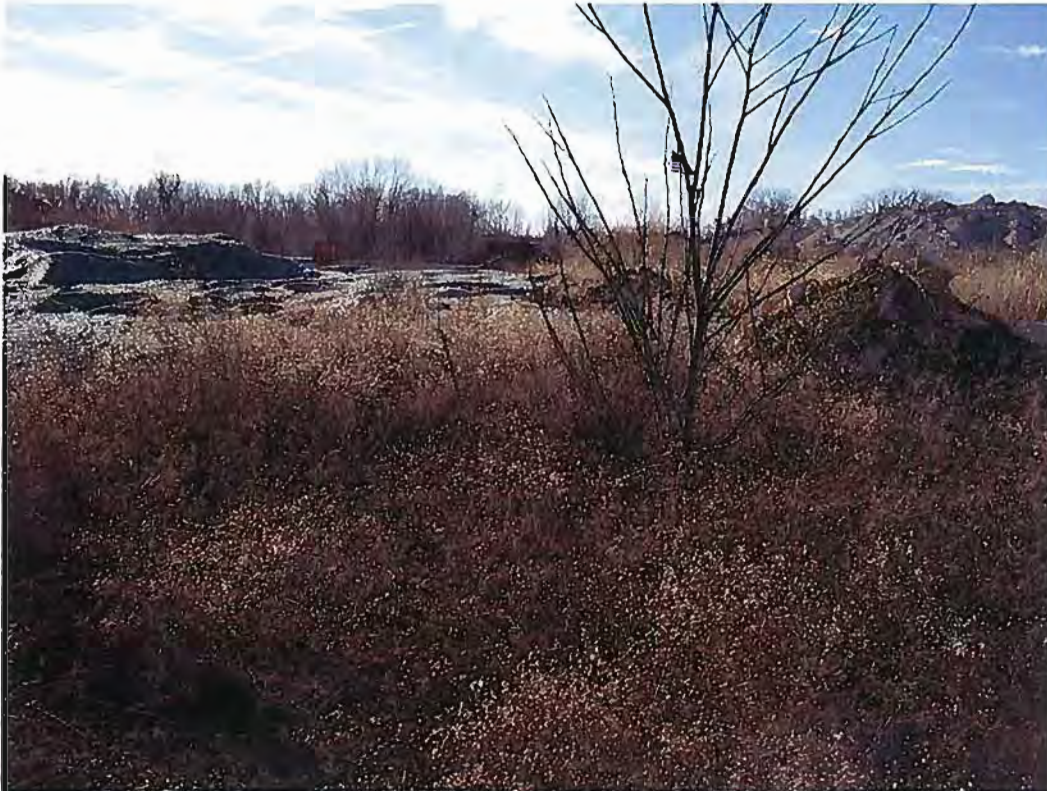
Date: January 9, 2009
Time: 1:56 pm
Direction: Southwest
Photo by: Rich Johnson
Exposure #: 015
Comments: Photograph shows broken glass piled in the eastcentral region of the site

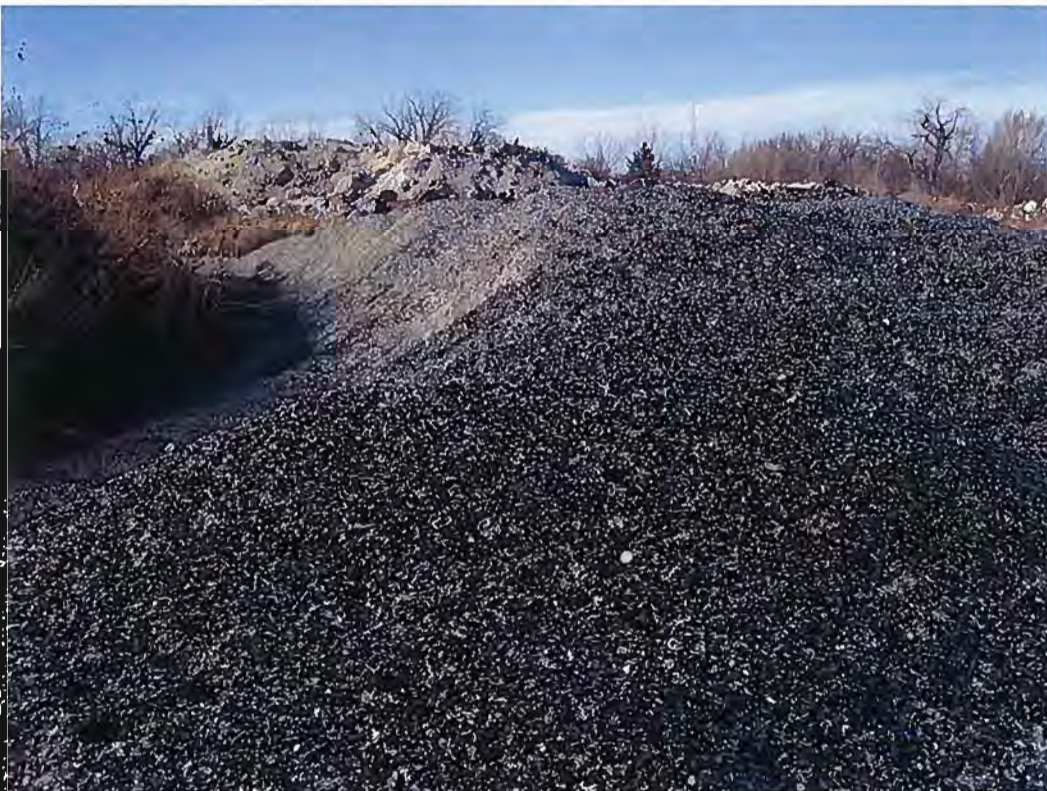
Date: January 9, 2009
Time: 1:58 pm
Direction: West
Photo by: Rich Johnson
Exposure #: 016
Comments: Photograph shows part of the pile of broken glass located in the eastcentral region of the site. Note the large pile of broken concrete in the background.

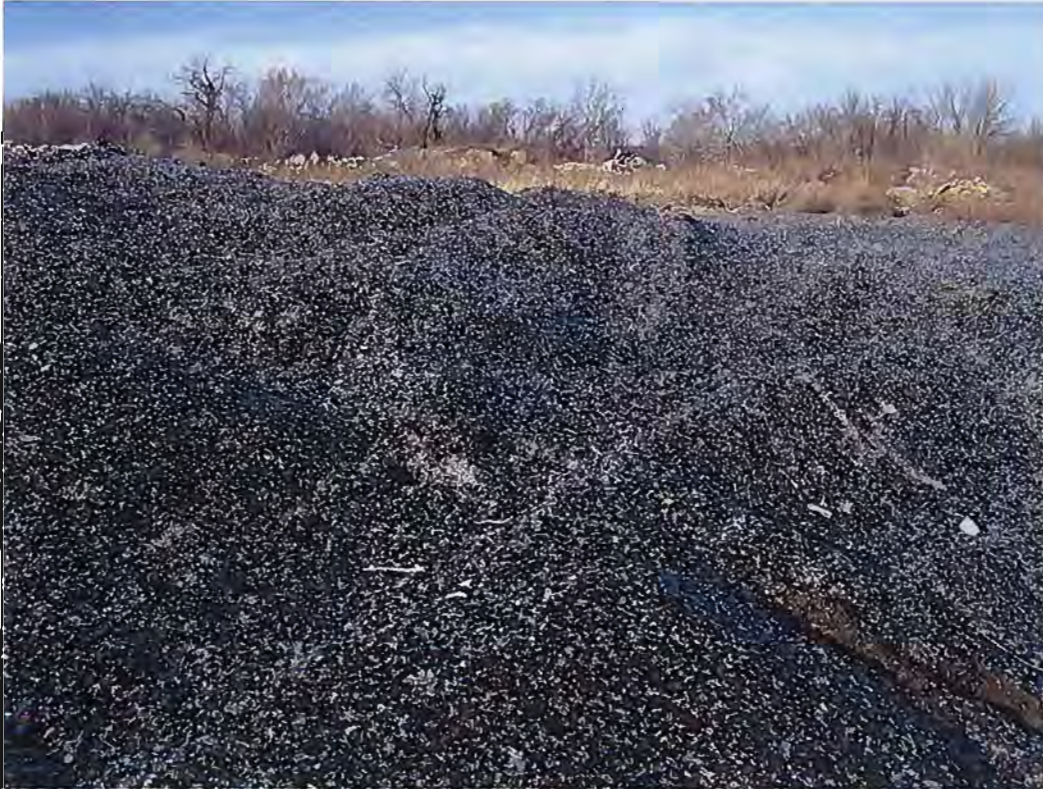
Date: January 9, 2009
Time: 1:58 pm
Direction: Northwest
Photo by: Rich Johnson
Exposure #: 017
Comments: Photograph shows a pile of broken glass located in the eastcentral region of the site.

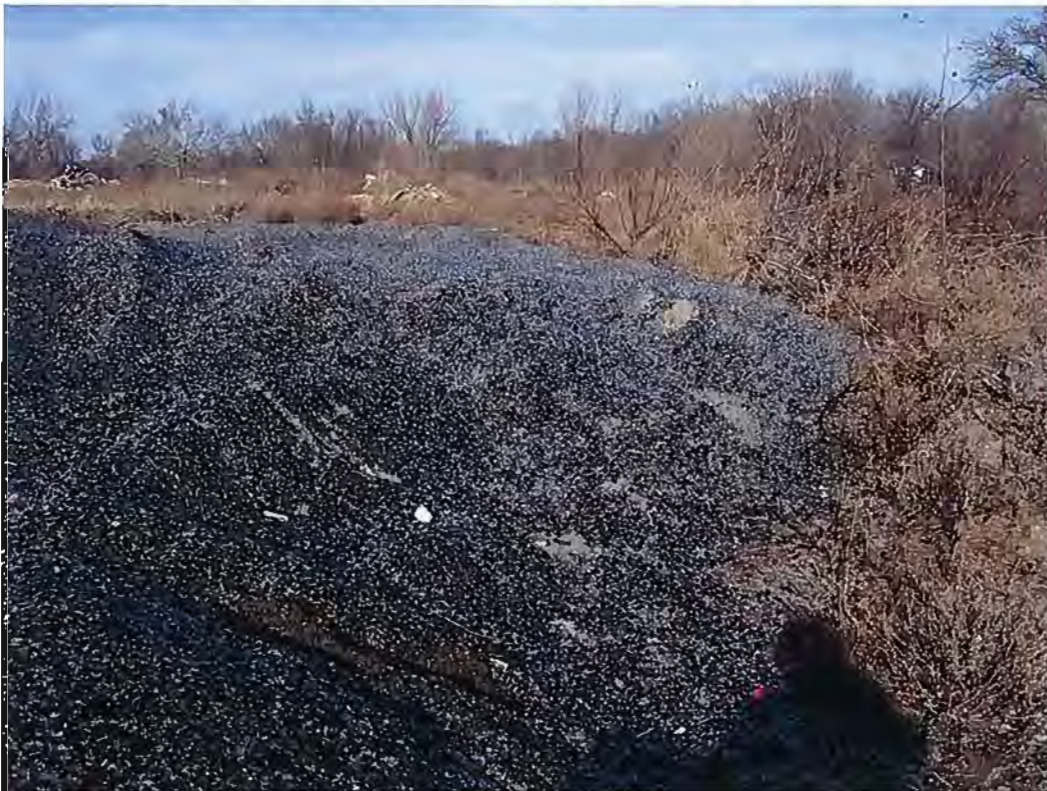
Date: January 9, 2009
Time: 1:58 pm
Direction: North
Photo by: Rich Johnson
Exposure #: 018
Comments: Photograph shows a pile of broken glass located in the eastcentral region of the site.

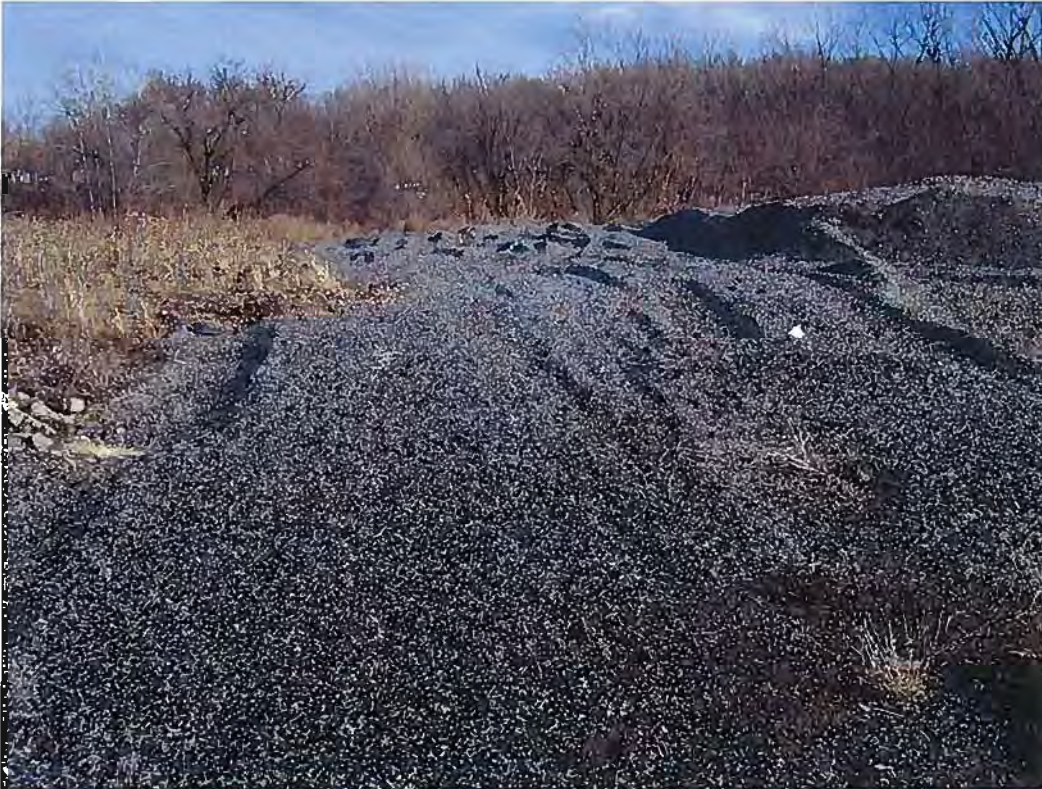
Date: January 9, 2009
Time: 2:00 pm
Direction: East/northeast
Photo by: Rich Johnson
Exposure #: 019
Comments: Photograph shows a pile of broken glass located in the eastcentral region of the site.

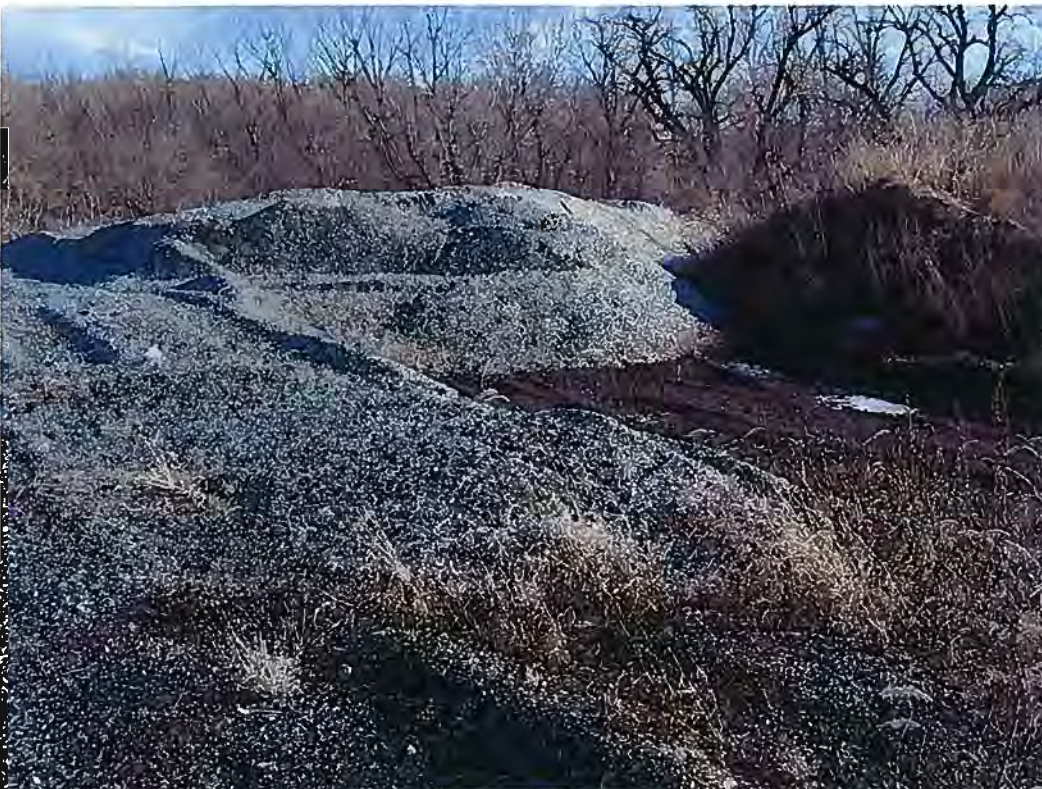
Date: January 9, 2009
Time: 2:00 pm
Direction: Southeast
Photo by: Rich Johnson
Exposure #: 020
Comments: Photograph shows a pile of broken glass located in the eastcentral region of the site.

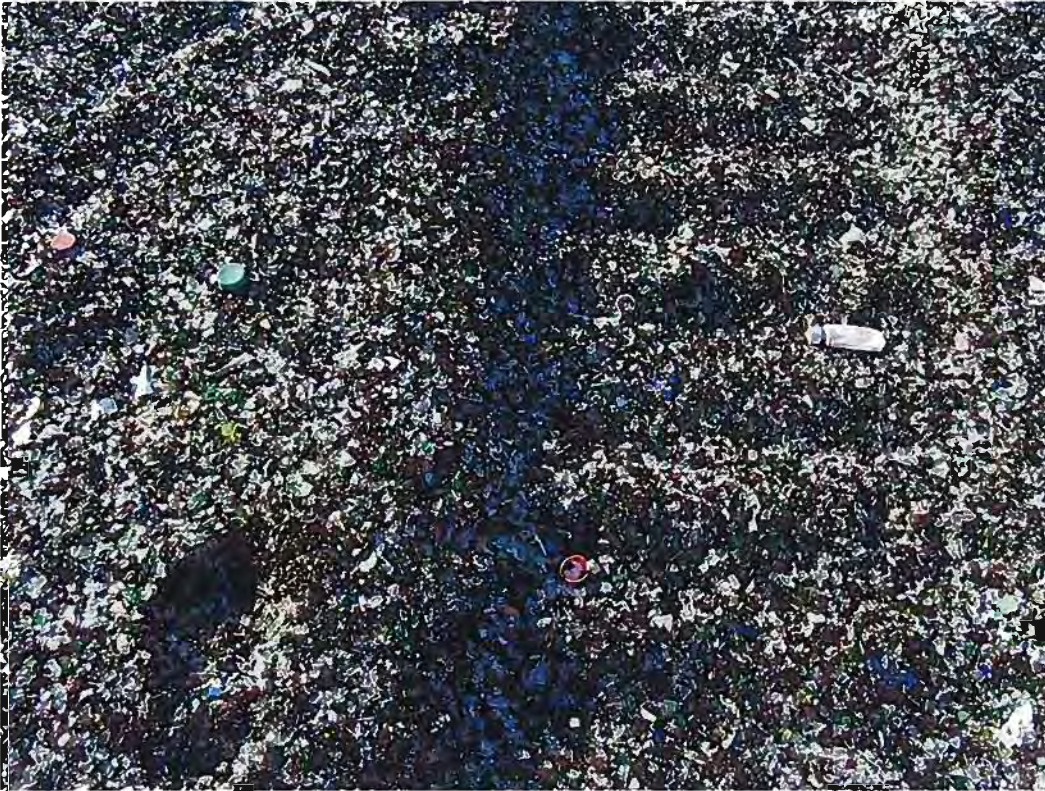
such as plastic bottles and caps mixed in with the glass (see photo 21). Measuring the area by “stepping it off,” I found it to be about 108 feet wide (at its widest), about 78 feet long to where it narrows to about 19 feet wide, and then another 54 feet long. Looking at the depth of broken glass from the south edge of the pile it looked 5 feet deep. Using these measurements, it was figured that there were approximately 1750 cubic yards of broken glass and debris in the area. Since this was near the eastern edge of the property, away from the different other piles that appeared to be part of the concrete/asphalt recycling or paving production (see photos 22, 23 and 24), it was determined that the glass was apparently discarded or abandoned. The mixture of broken glass and other waste is not considered “clean construction or demolition debris,” as defined in Section 3.160(b) of the Act. Therefore, it cannot be stored or disposed of at this site without an Illinois EPA permit.

Date: January 9, 2009
Time: 2:01 pm
Direction: West
Photo by: Rich Johnson
Exposure #: 021
Comments: Photograph shows a closer look at the broken glass piled in the eastcentral region of the site. Note there were plastic caps and bottles mixed in with the glass.

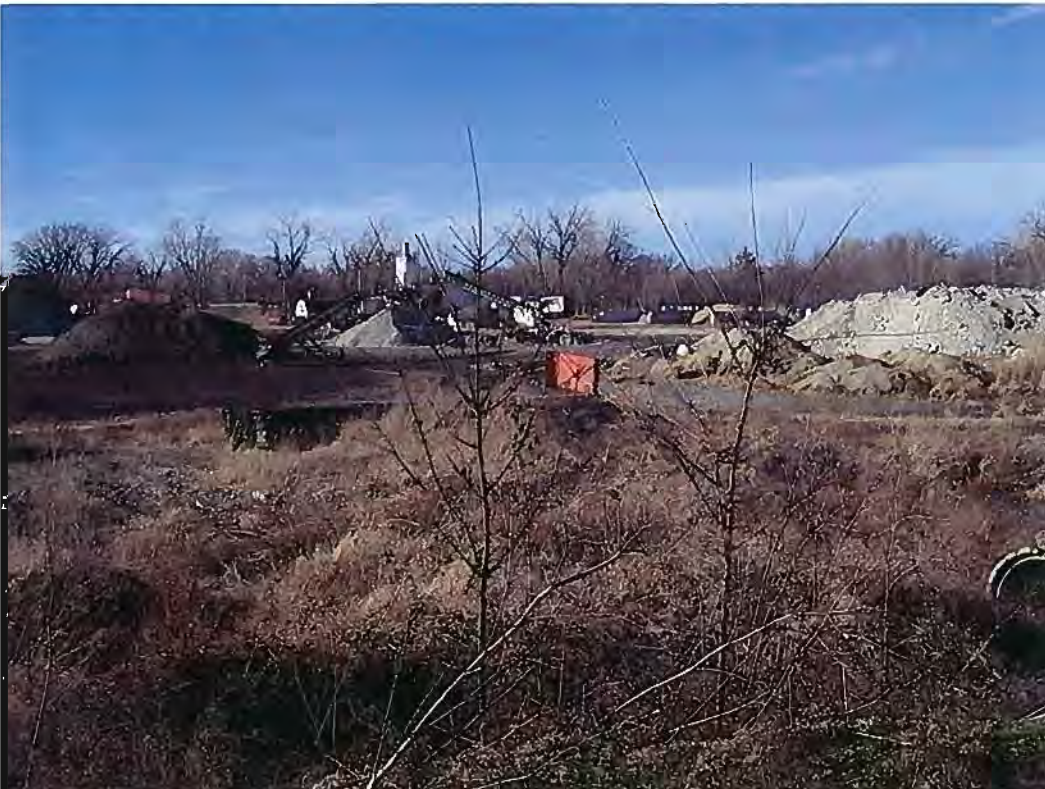
Date: January 9, 2009
Time: 2:04 pm
Direction: Northwest
Photo by: Rich Johnson
Exposure #: 022
Comments: Photograph shows gravel, broken concrete and milled asphalt piles located in the central region of the site.

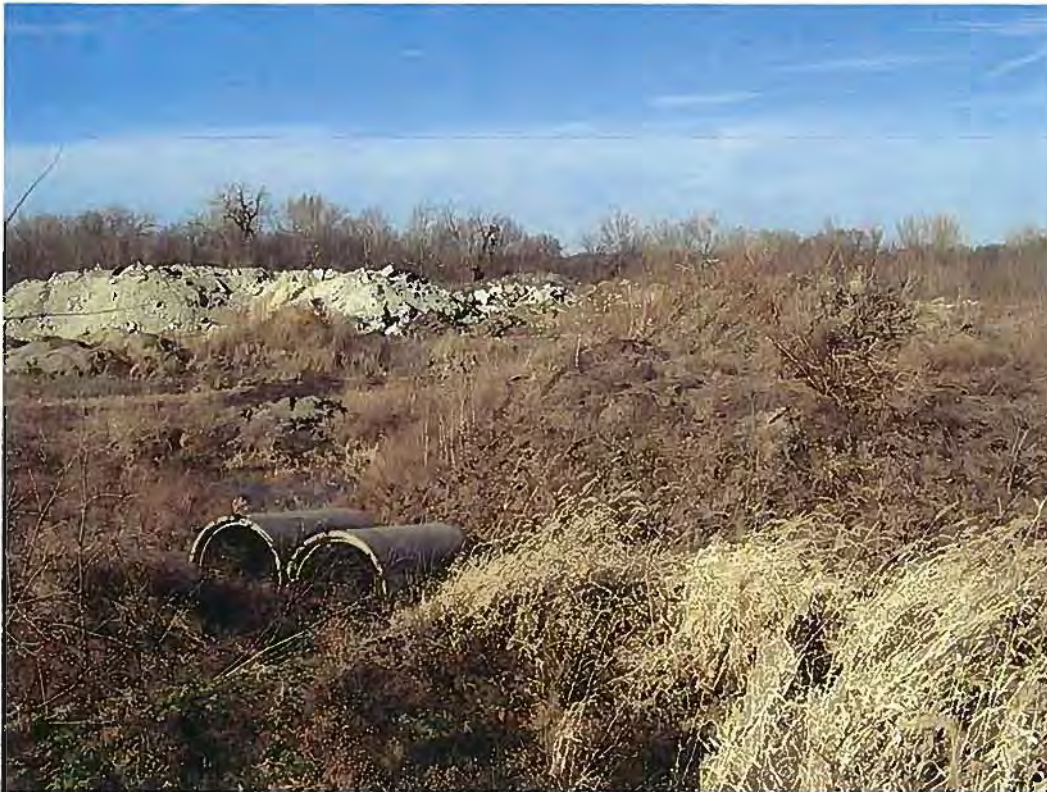
Date: January 9, 2009
Time: 2:04 pm
Direction: Northwest
Photo by: Rich Johnson
Exposure #: 023
Comments: Photograph shows broke concrete piles in the background and piles of soil in the foreground from an area in the southeast region

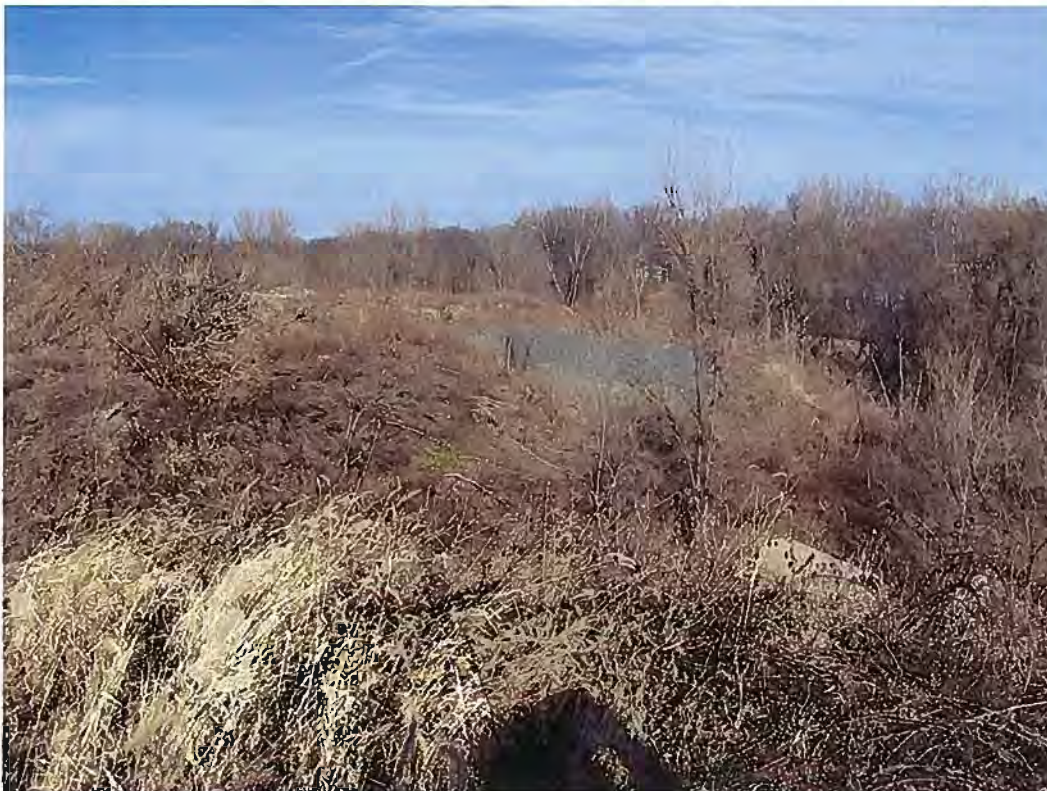
Date: January 9, 2009
Time: 2:04 pm
Direction: North
Photo by: Rich Johnson
Exposure #: 024
Comments: Photograph shows a pile of broken glass setting near the eastcentral region of the site. Note the ground slopes sharply east of the glass.
