Re: Illinois Environmental Protection Agency v. Info Corner Materials, Inc.
IEPA File No.15-09-AC: 1678220075—Sangamon County

ADMINISTRATIVE CITATION

4. That on January 9, 2009, Richard C. Johnson of the Illinois Environmental Protection Agency's ("Illinois EPA") Springfield Regional Office inspected the above-described facility. A copy of his inspection report setting forth the results of said inspection is attached hereto and made a part hereof.

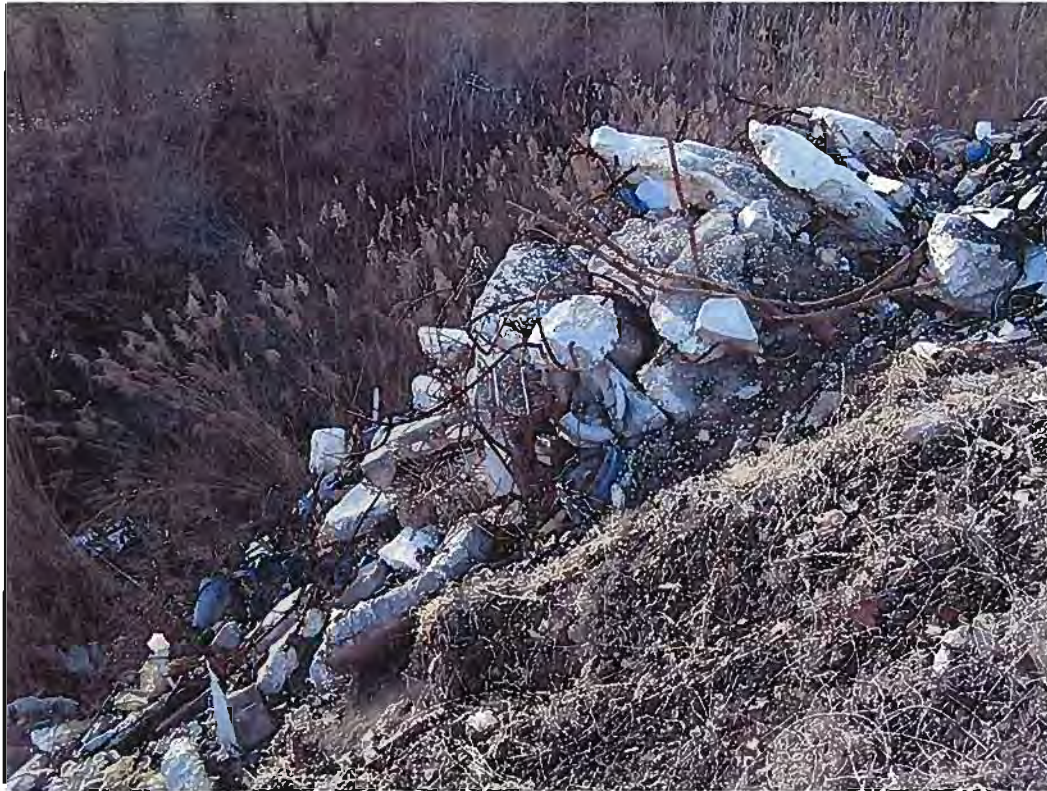
Continuing to the southeast corner of the property I observed some broken concrete with exposed rebar deposited down a slope (see photo 25). On closer inspection it was noted that there was other waste intermixed with the concrete and metal such as plastic. It was determined that the debris did not meet the criteria of a CCDD, therefore, until further information is available, it should be considered as general construction or demolition debris pursuant to 3.160(a) of the Act, and a waste. Near the edge of the slope by the above-mentioned waste was a pile of waste that included broken concrete, plastic, metal, dimensional lumber (charred), etc. as shown in photos 26 and 27. No determination was made that the wood had been burned onsite because it was in a pile with other waste that did not show signs of being burned.

Date: January 9, 2009
Time: 2:06 pm
Direction: Southwest
Photo by: Rich Johnson
Exposure #: 025
Comments: Photograph shows broken concrete with rebar dumped along a slope in the southeast region of the site.

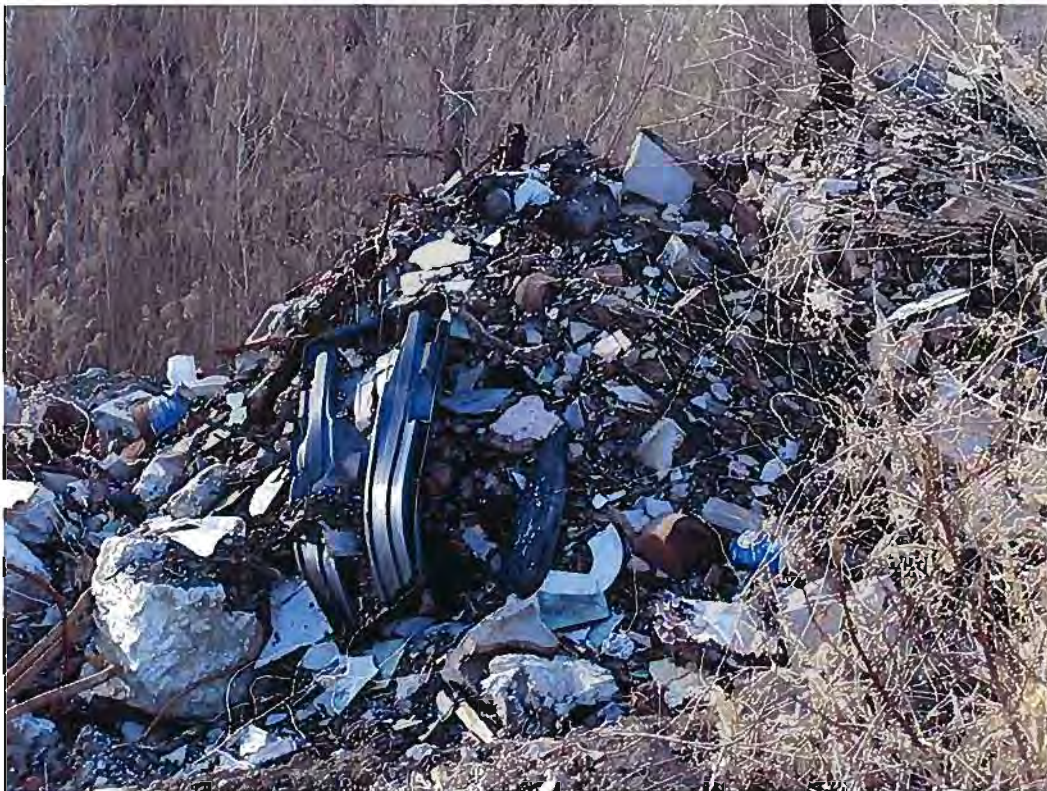
Date: January 9, 2009
Time: 2:06 pm
Direction: West
Photo by: Rich Johnson
Exposure #: 026
Comments: Photograph shows a pile of waste setting along the edge of a steep slope in the southeast region of the site. Note the plastic, the concrete, the metal, and wood in the pile.

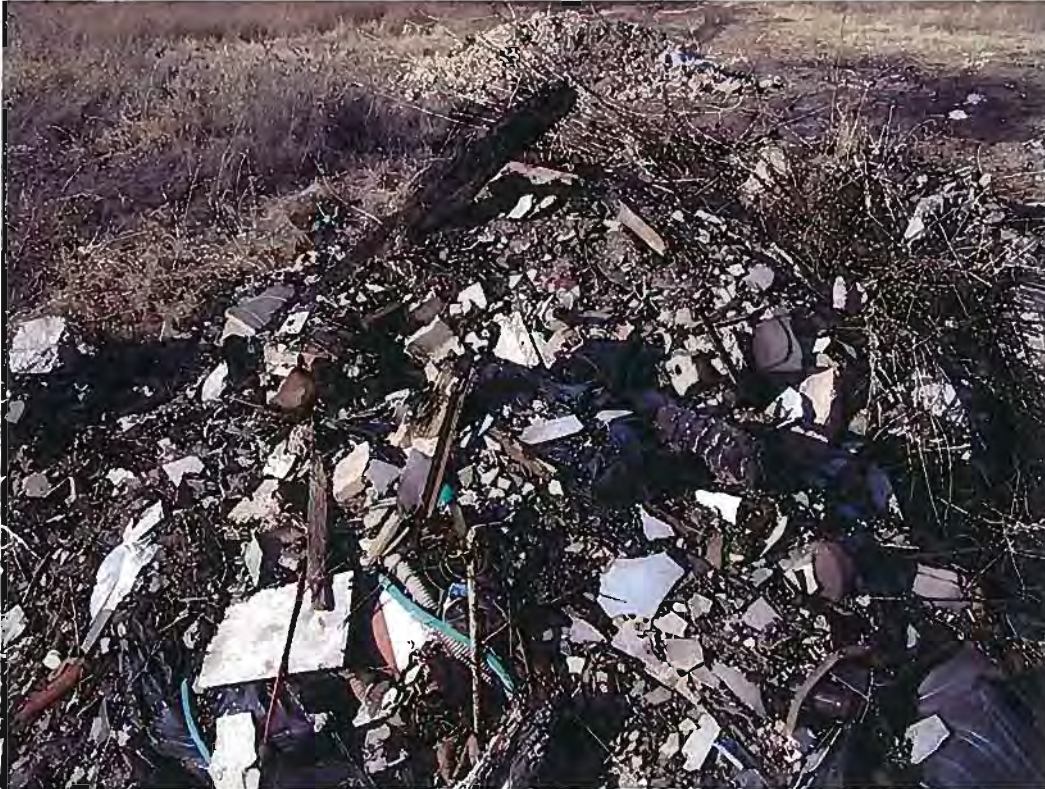
Just north of the above-mentioned pile (see photo 27), was a pile of unknown waste that appeared to be white, tan and brown (see photos 29 and 30). The waste appeared to be moist, and gave a slightly earthy smell (see photos 28, 29 and 30). Included in the pile was what appeared to be extruded noodles (see photos 28 and 29). Based on its unusual appearance (the clumps and noodles), it was suspected as being some type of commercial or industrial waste. Paper and other debris were mixed in with the other waste in the pile.

Date: January 9, 2009
Time: 2:07 pm
Direction: Northwest
Photo by: Rich Johnson
Exposure #: 027
Comments: Photograph shows pile of waste setting near the edge of a steep slope in the southeast region of the site. Note the burned dimensional lumber, garden hose, plastic, tin cans, and other waste in the pile. Also note that there was a tan colored pile of waste in the background.

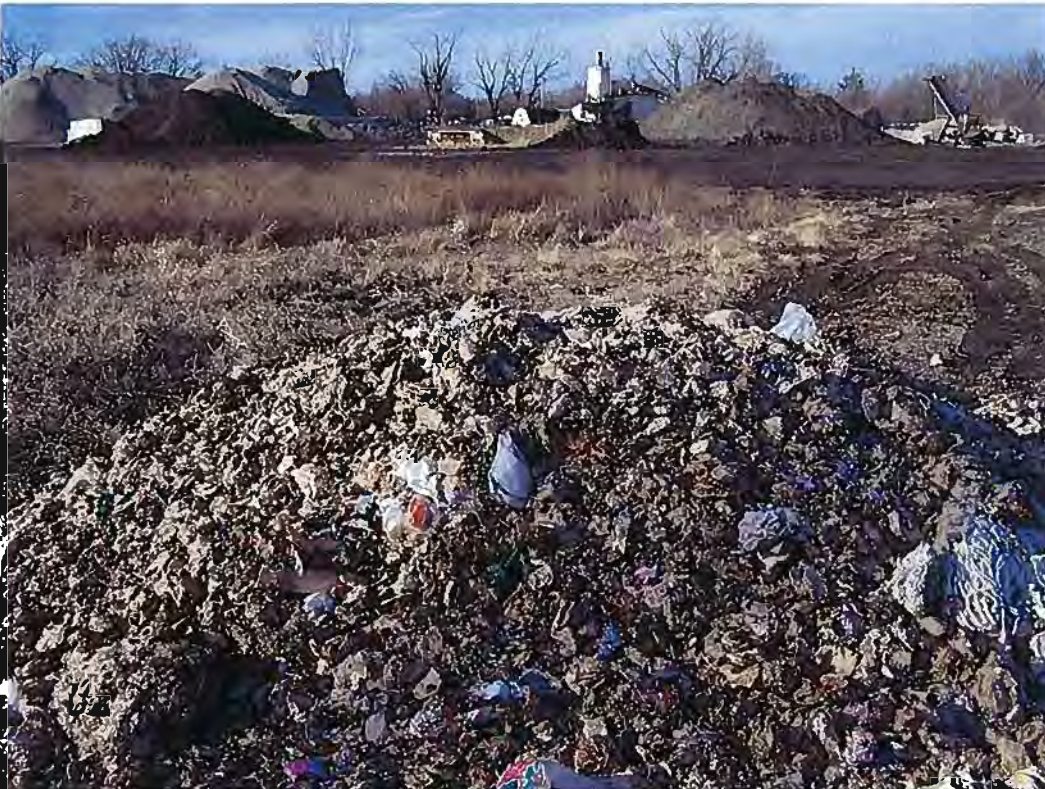
Date: January 9, 2009
Time: 2:09 pm
Direction: Northwest
Photo by: Rich Johnson
Exposure #: 028
Comments: Photograph shows a pile of tan unknown waste setting in the southeast region of the site.

Violations noted during the investigation are indicated on the checklist that accompanies this report. The owner/operator must also determine whether the contents of the drums, as well as the un-identified pile of white, tan and brown waste at the site, are hazardous or special wastes. No hazardous or special waste determinations will be required on the contents of the drums if it can be demonstrated that the contents are useable products and not wastes.

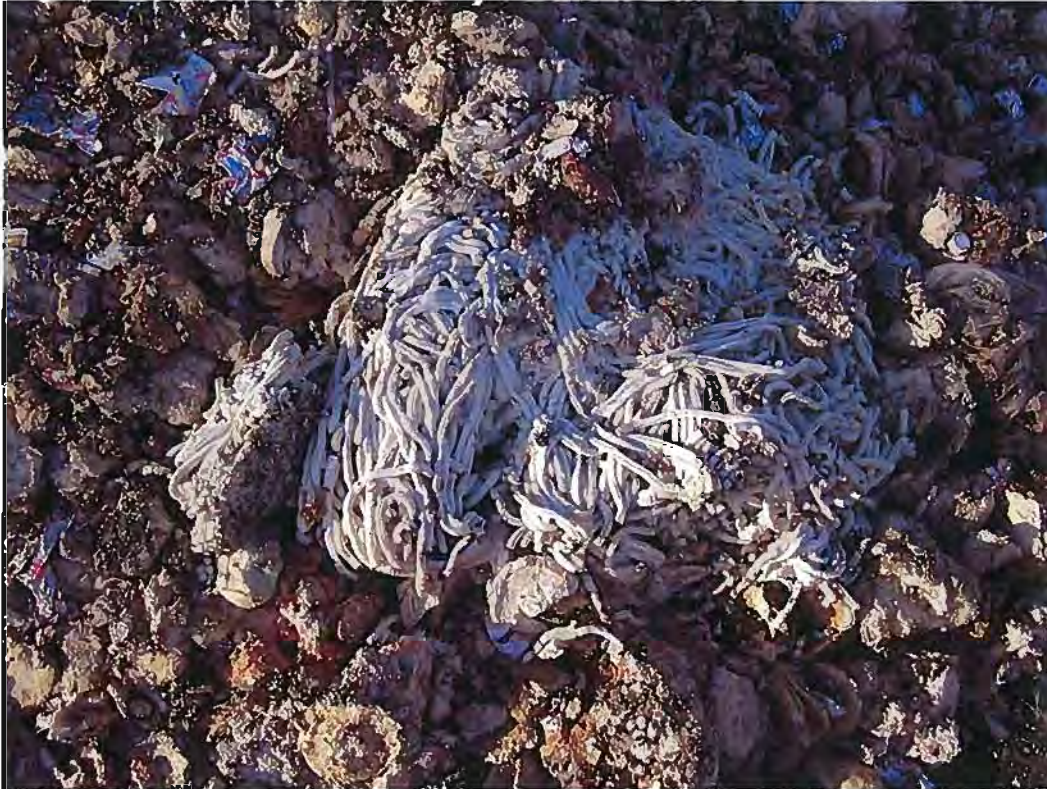
Date: January 9, 2009
Time: 2:09 pm
Direction: West
Photo by: Rich Johnson
Exposure #: 029
Comments: Photograph shows a white clump of unknown refuse in a pile of tan w unknown waste setting in the southeast region of the site

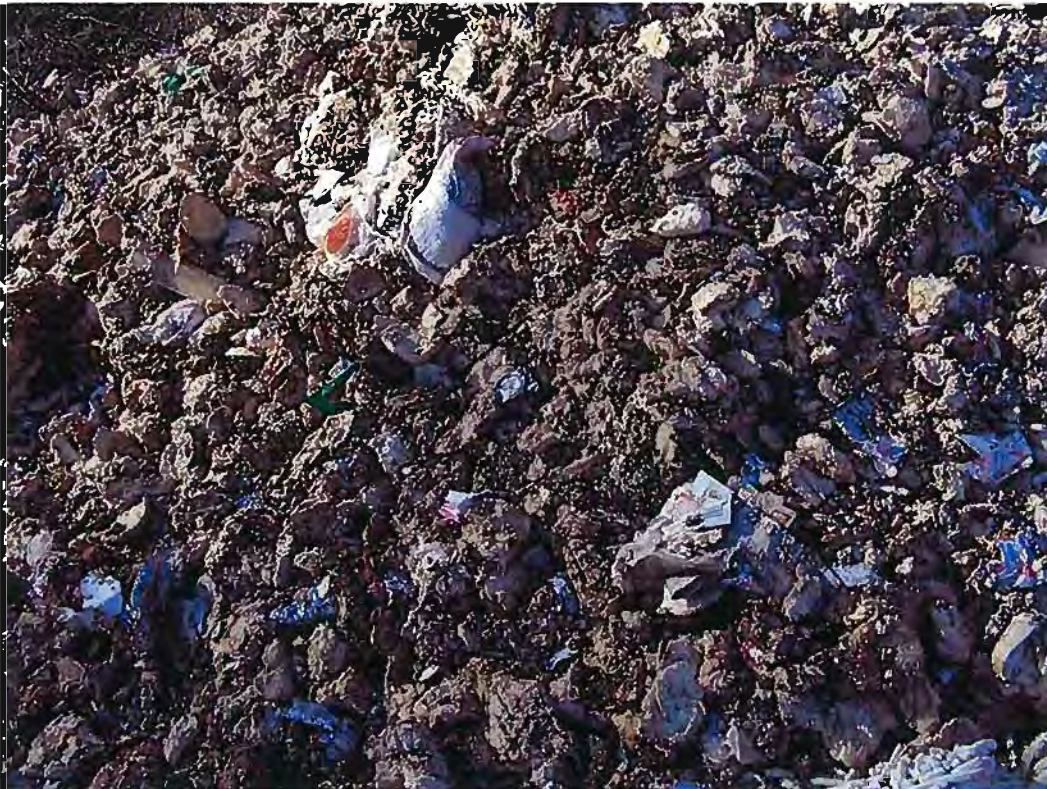
Date: January 9, 2009
Time: 2:10 pm
Direction: Northwest
Photo by: Rich Johnson
Exposure #: 030
Comments: Photograph shows a pile of tan waste setting in the southeast region of the site.

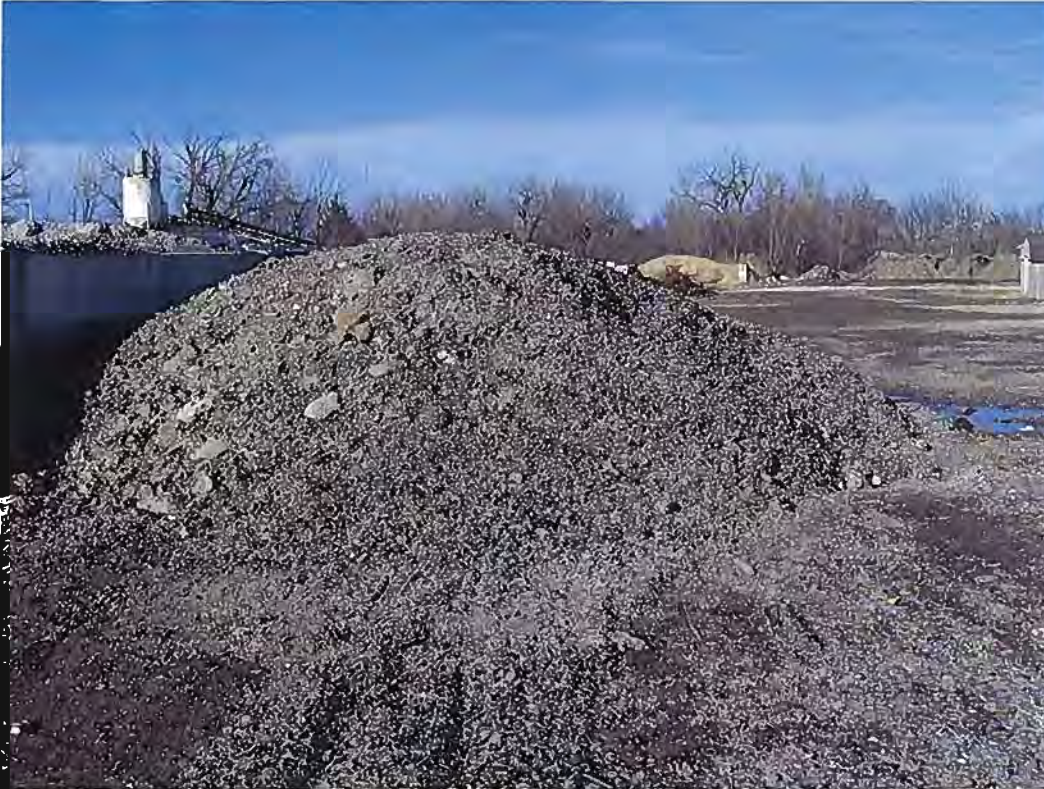
Walking to the southcentral region of the site I observed a concrete block wall. On the east side of the wall was a pile of debris (see photos 31, 32 and 33). The pile was composed of plastic, dirt or soil, some broken glass, and paper. It looked like some type of screened waste, possibly derived from separating the glass observed in the eastern region from the debris observed in the pile. Waste in this area appears to be located on the Leroy and Mary Jane Donley parcel.

Date: January 9, 2009
Time: 2:12 pm
Direction: North
Photo by: Rich Johnson
Exposure #: 031
Comments: Photograph shows a pile of waste setting along a concrete storage bin in the southcentral region of the site. Note the waste includes broken glass, plastic, paper and soil.

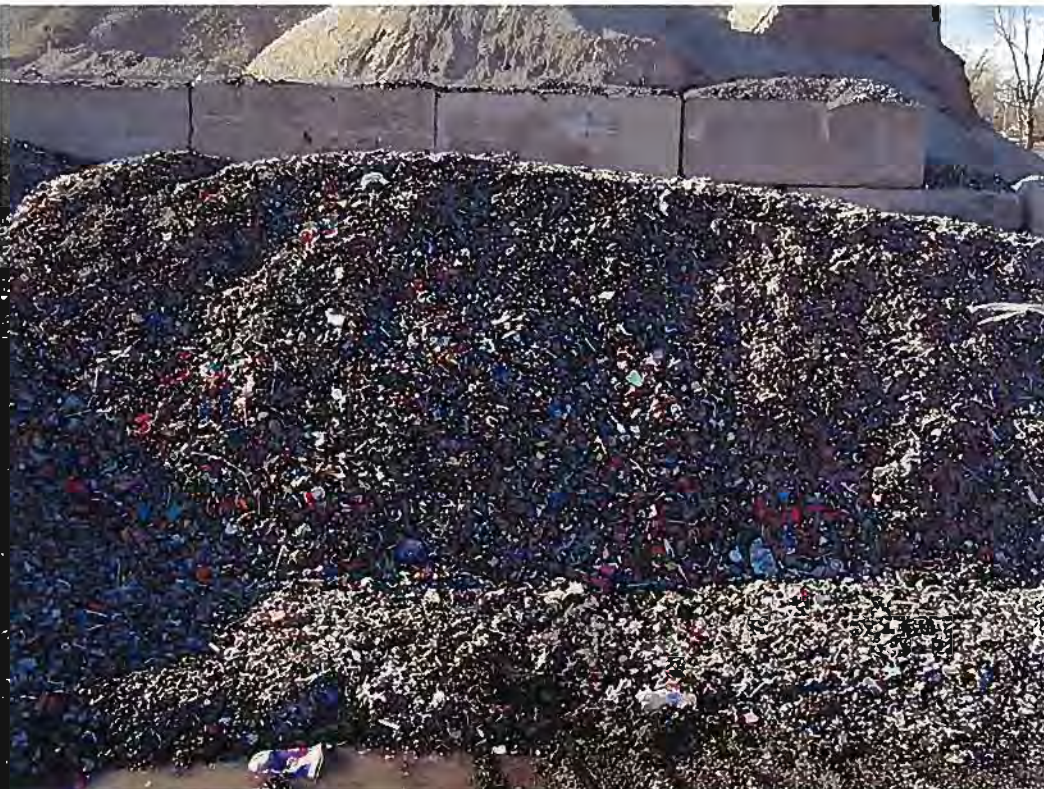
Date: January 9, 2009
Time: 2:14 pm
Direction: West
Photo by: Rich Johnson
Exposure #: 032
Comments: Photograph shows a pile of waste setting along a concrete storage bin in the southcentral region of the site. Note the waste includes broken glass, plastic, paper and soil.

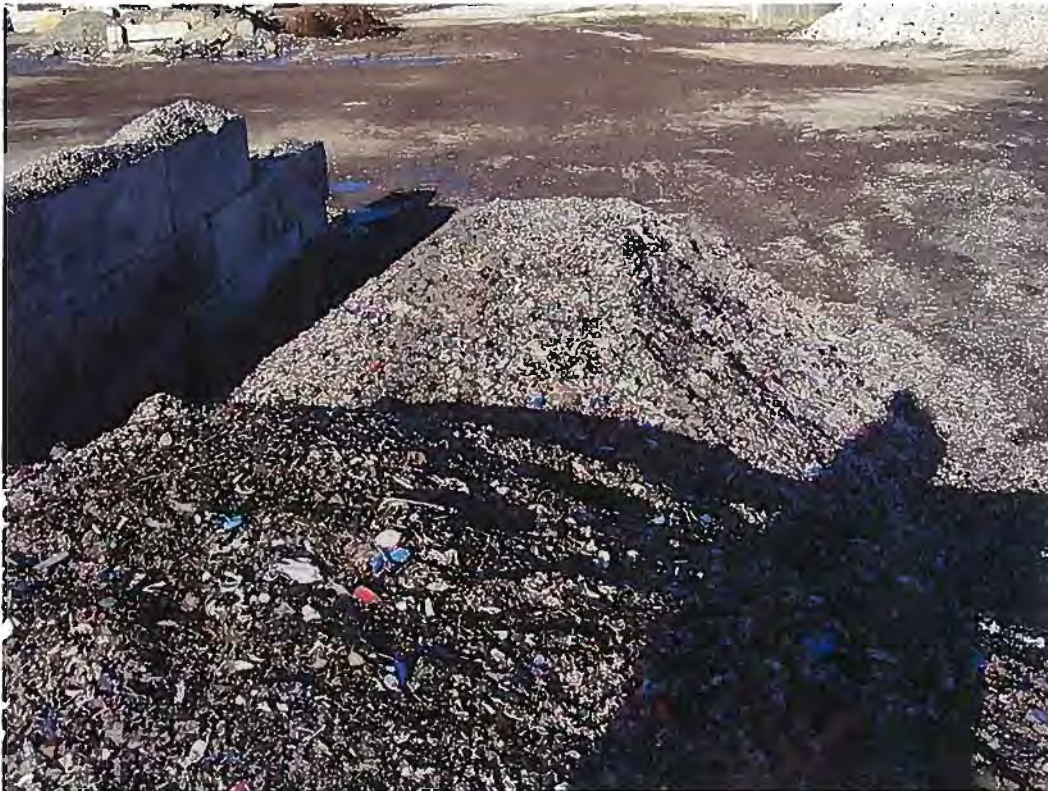
Date: January 9, 2009
Time: 2:15 pm
Direction: North
Photo by: Rich Johnson
Exposure #: 033
Comments: Photograph shows a pile of waste setting along a concrete storage bin in the southcentral region of the site. Note the waste includes broken glass, plastic, paper and soil.

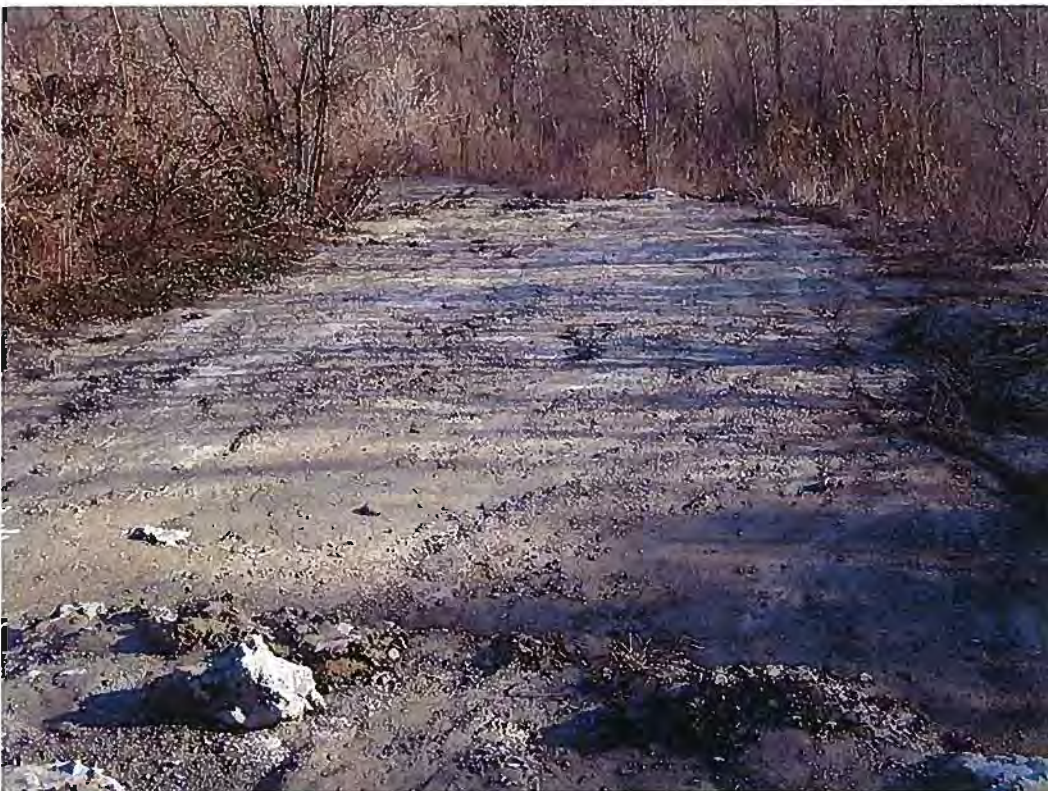
I noted what looked like waste from cleaning out concrete trucks in the southcentral region, south of the above-mentioned waste. It appeared that trucks would be cleaned out at the top of the slope allowing the liquid to flow down and harden (see photos 34 and 35). A large jumbled pile of dimensional lumber was setting at the top of the slope (see photos 35, 36 and 37). The lumber in the pile was somewhat weathered, and not neatly arranged or covered. In this condition and location, the jumbled pile of lumber is considered a waste by the Illinois EPA. Also near the pile was a boat, an anhydrous ammonia tank, a dump truck labeled “Info Corner Materials,” and other items.

Date: January 9, 2009
Time: 2:16 pm
Direction: Southeast
Photo by: Rich Johnson
Exposure #: 034
Comments: Photograph shows concrete that had been clean out of concrete mixing trucks and deposited in the southcentral region of the site.

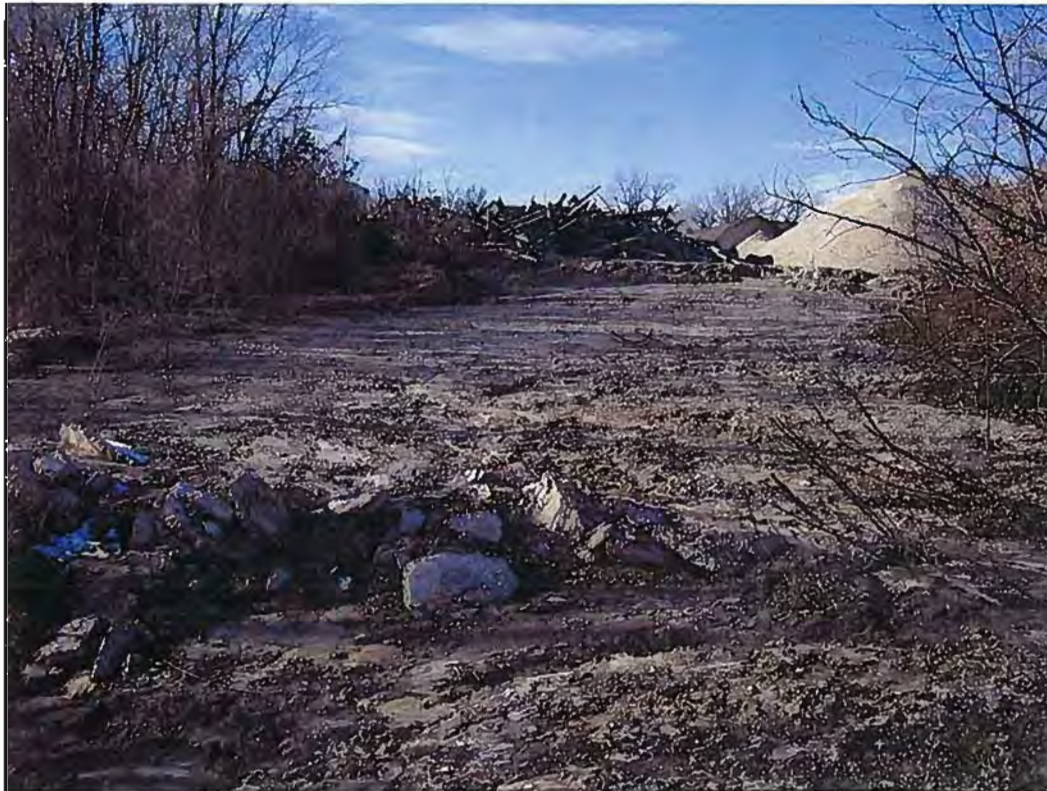
Date: January 9, 2009
Time: 2:17 pm
Direction:
West/northwest
Photo by: Rich Johnson
Exposure #: 035
Comments: Photograph shows concrete that had been clean out of concrete mixing trucks in the southcentral region of the site. Note that there was a pile of dimensional lumber at the end of the concrete waste.

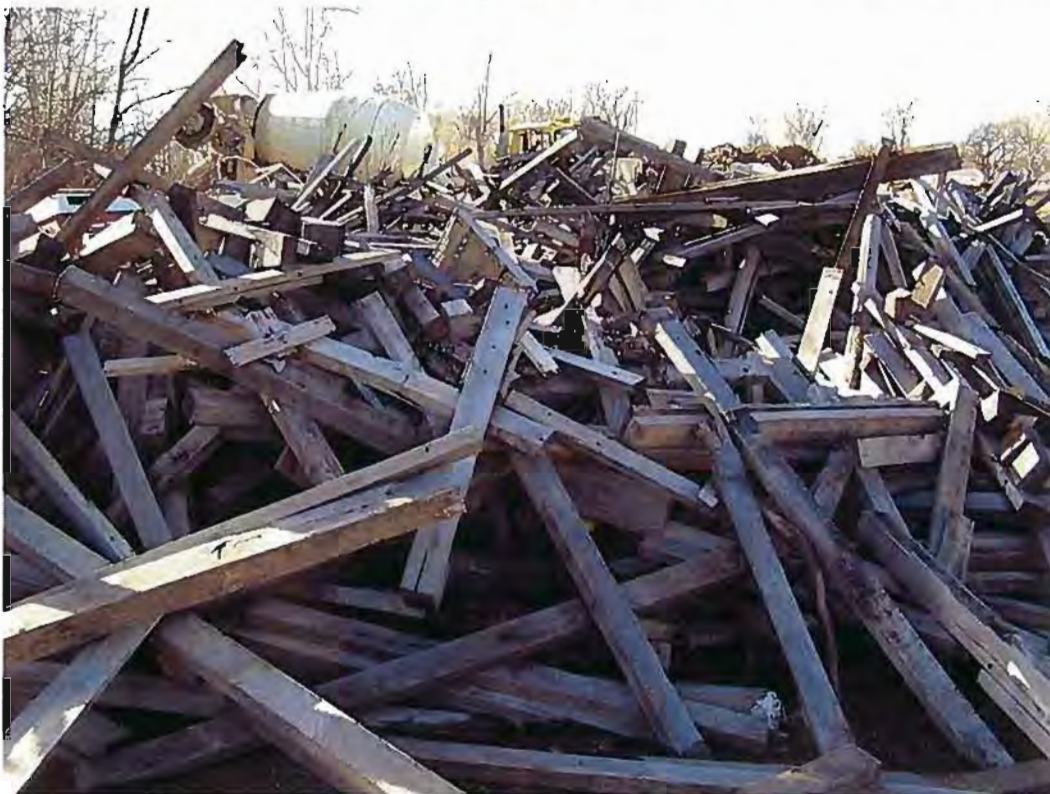
Date: January 9, 2009
Time: 2:17 pm
Direction: West
Photo by: Rich Johnson
Exposure #: 036
Comments: Photograph shows a pile of dimensional lumber piled in the southcentral region of the site.

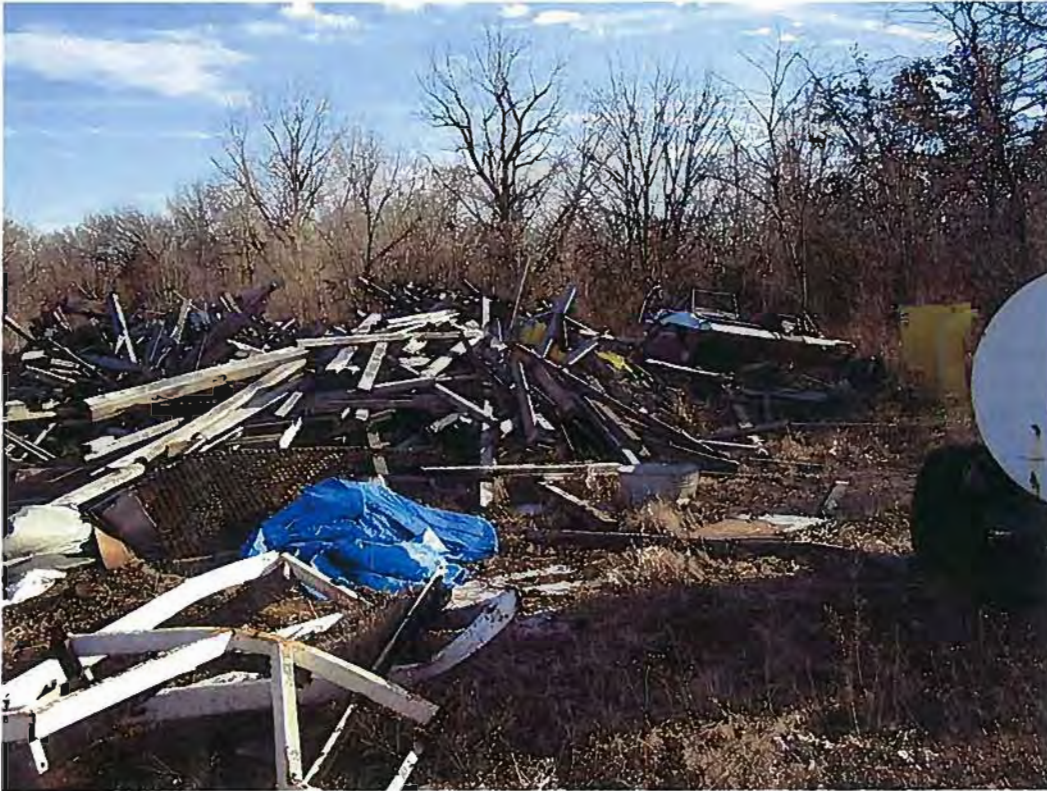
Date: January 9, 2009
Time: 2:18 pm
Direction: Southwest
Photo by: Rich Johnson
Exposure #: 037
Comments: Photograph shows a pile of dimensional lumber piled in the southcentral region of the site.

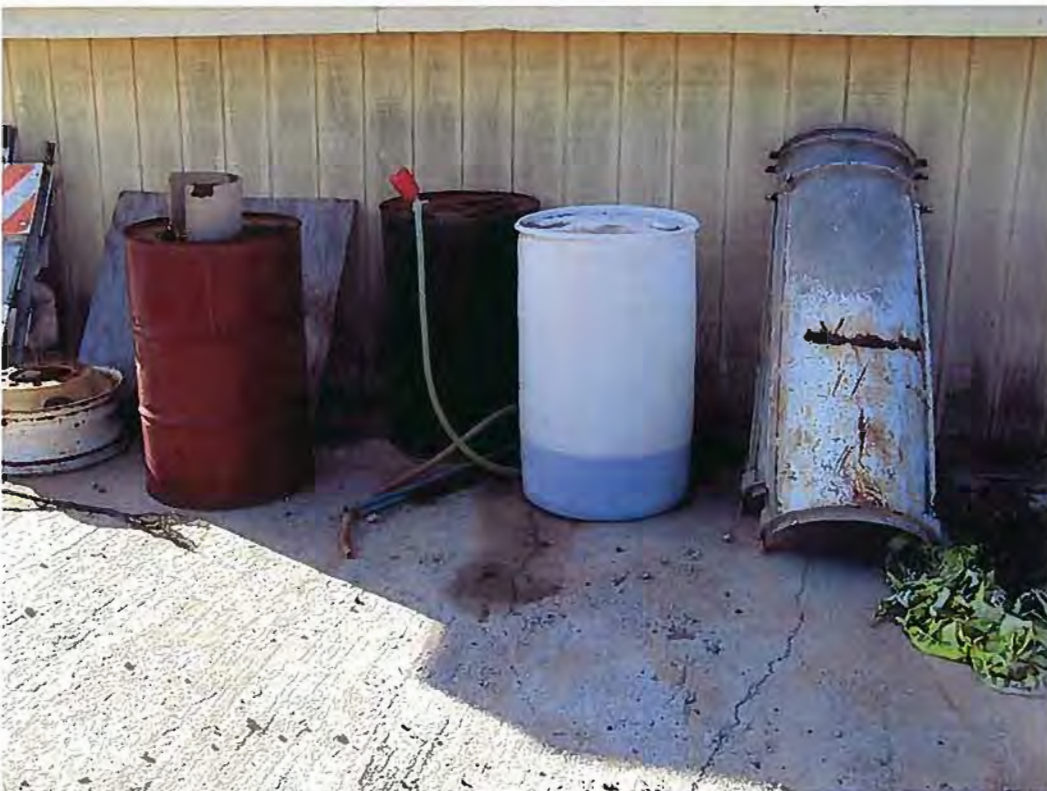
Walking back to the office I noted several 55-gallon drums setting south of the onsite shed (see photo 38). Two metal drums were pushed to determine if they contained anything. Both felt heavy. A translucent drum near the other two, appeared to have about 15 gallons of frozen liquid in it. Whether the drums contain product or waste is not known.

Date: January 9, 2009
Time: 2:24 pm
Direction: West
Photo by: Rich Johnson
Exposure #: 038
Comments: Photograph shows three 55-gallon drums setting along the east side of a small shed in the westcentral part of the site.

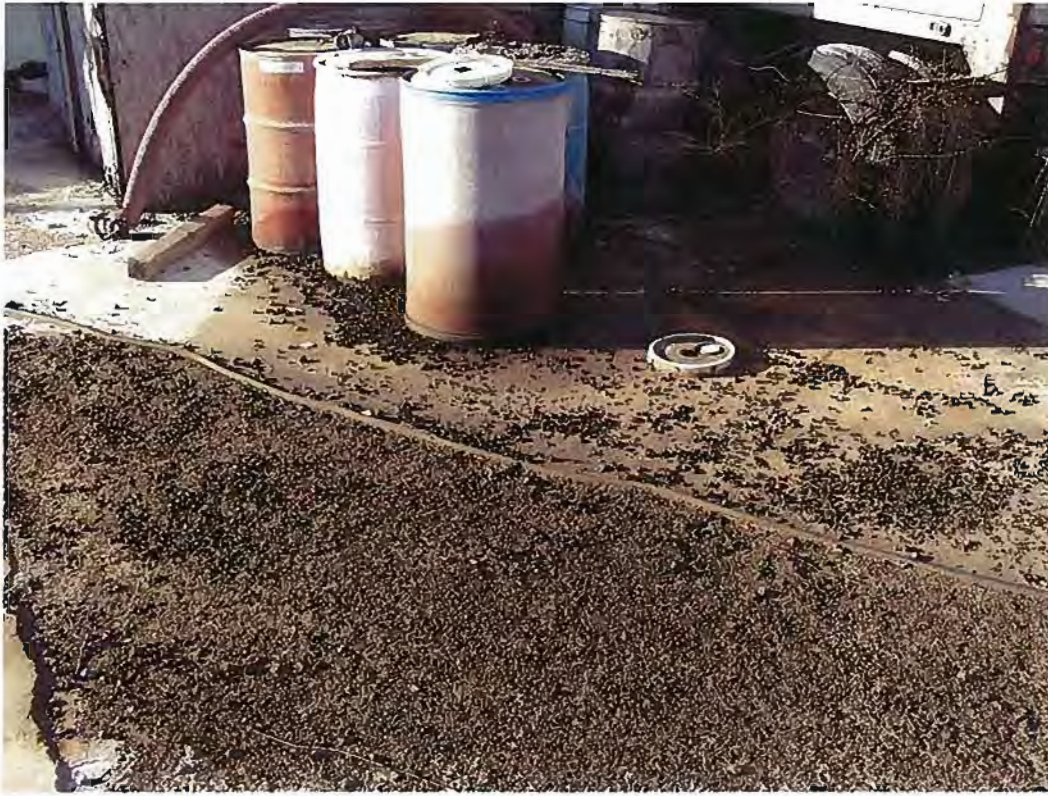
Eight more 55-gallon drums were observed south of the office and warehouse building (see photo 39). A dried dark stain was evident on the concrete pad below the drums. It appears that one or more of the drums may be leaking.

Date: January 9, 2009
Time: 2:26 pm
Direction:
West/northwest
Photo by: Rich Johnson
Exposure #: 039
Comments: Photograph shows eight 55-gallon drums setting along the east side of the office and mixing plant in the northwest region of the site.
