ILLINOIS ENVIRONMENTAL PROTECTION AGENCY

Re: Illinois Environmental Protection Agency v. Harold Dean Foster
IEPA File No. 340-11-AC; 1490850001—Pike County

Open Dump Inspection Checklist

NARRATIVE RE-INSPECTION REPORT DOCUMENT

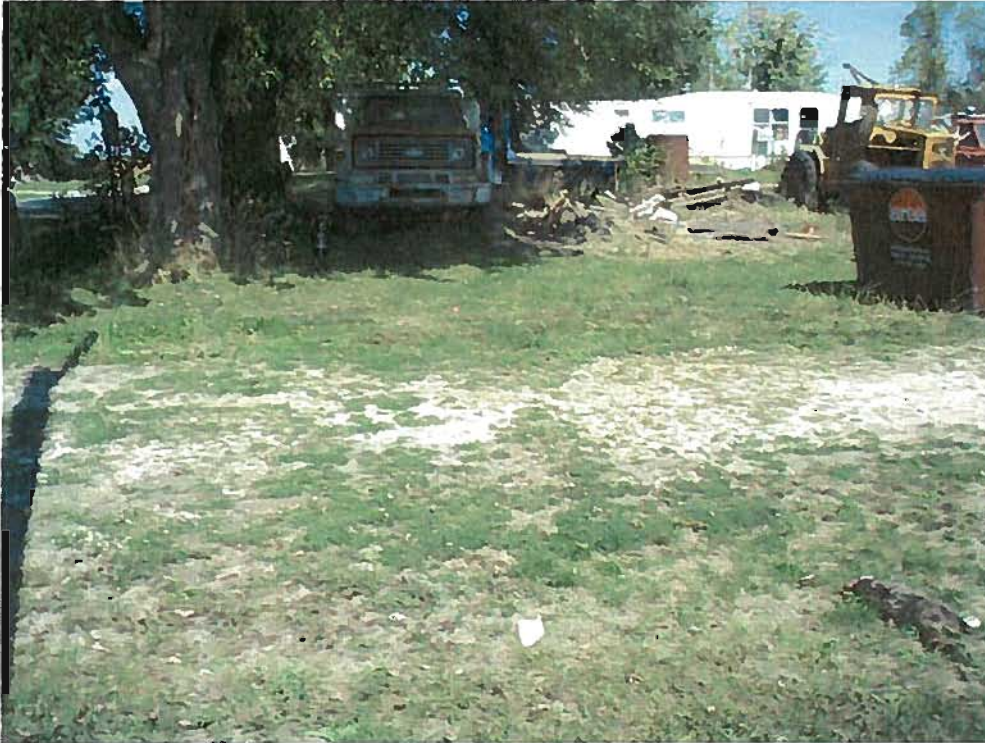
Date: September 23, 2011
Time: 12:20 p.m.
Direction: N
Photo by: Charlie King
Exposure #: 001
Comments: Overview of the southwest area of the site from the intersection of County Highway 8 to the south and 430th Street to the west. Wood, gas cylinders, paper, plastics and metals were on the ground in the distance. A dead cat is in the lower right corner of the photograph. A two cubic yard Area Disposal dumpster is also shown.

Photo # 001 shows an overview of the southwest area of the site from the intersection of County Highway 8 to the south and 430th Street to the west. Wood, gas cylinders, paper, plastics and metals were on the ground in the distance. A dead cat is in the lower right corner of the photograph. A two cubic yard Area Disposal dumpster is also shown.

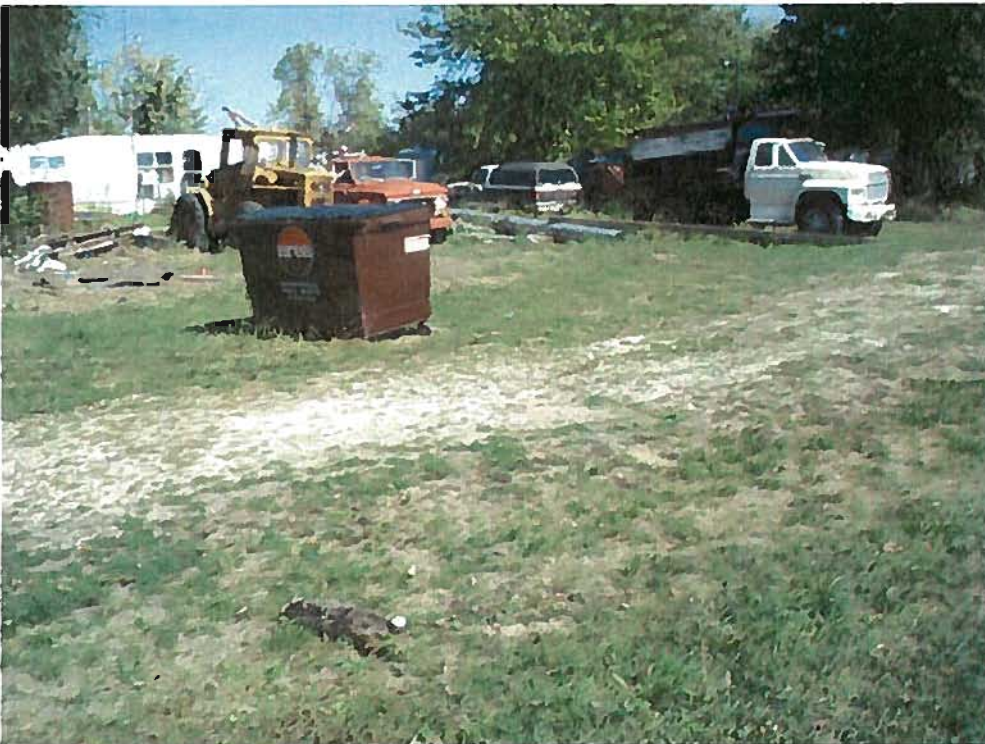
Date: September 23, 2011
Time: 12:20 p.m.
Direction: NE
Photo by: Charlie King
Exposure #: 002
Comments: More of the overview discussed in the description for photo # 001. Wood, bricks, concrete, corrugated metal pipe and vehicles are shown, along with the Area Disposal dumpster and the dead cat, which are also visible in photo # 001.

Photo# 002 shows more of the overview discussed in the description for photo # 001. Wood, bricks, concrete, corrugated metal pipe and vehicles are shown, along with the Area Disposal dumpster and the dead cat, which are also visible in photo # 001.

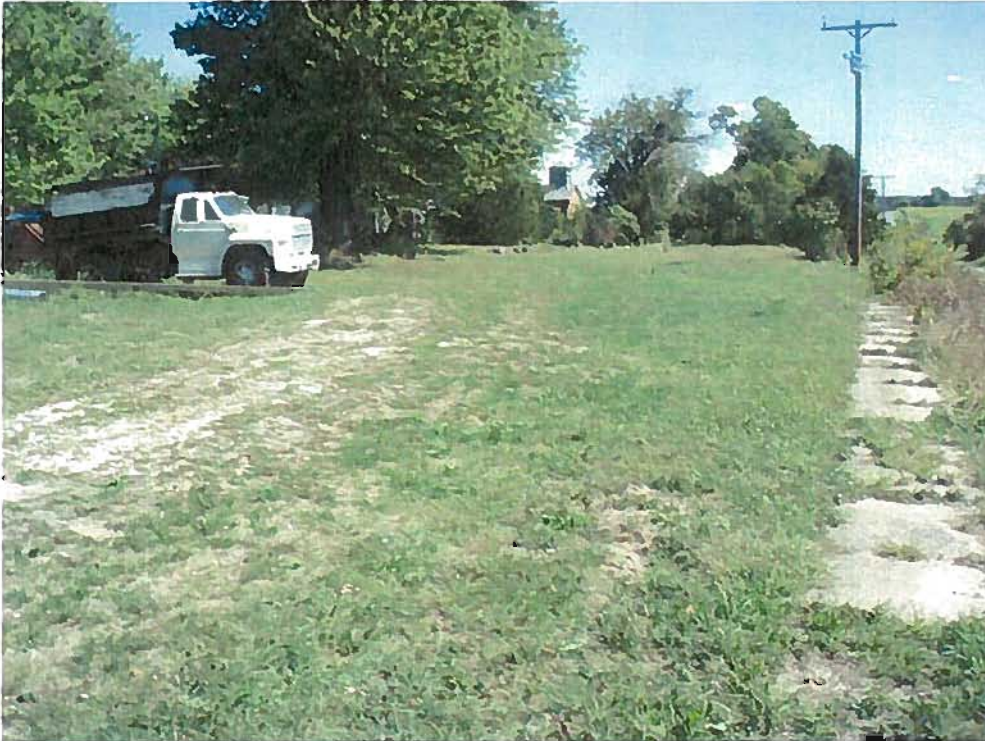
Date: September 23, 2011
Time: 12:20 p.m.
Direction: E
Photo by: Charlie King
Exposure #: 003
Comments: The third of three photos making up an overview of the south and southwest areas of the site. Photo #s 001 and 002 are also part of the overview. Most of this south area was void of wastes.

Photo # 003 shows the third of three photos making up an overview of the south and southwest areas of the site. Photo #s 001 and 002 are also part of the overview. Most of this south area was void of wastes.

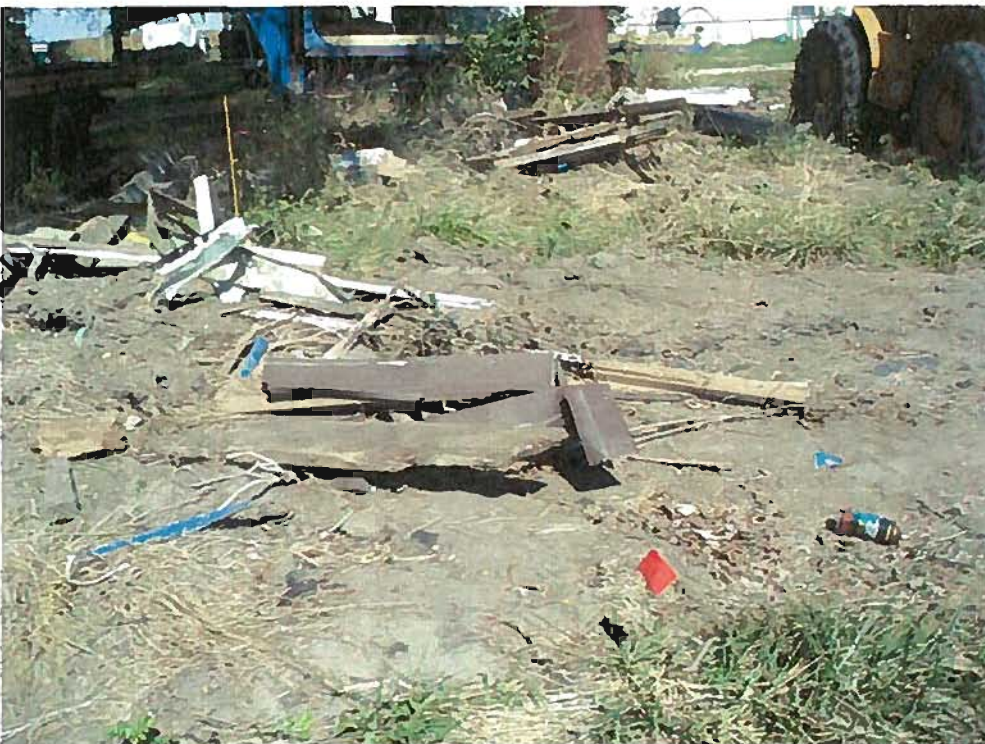
Date: September 23, 2011
Time: 12:21 p.m.
Direction: N
Photo by: Charlie King
Exposure #: 004
Comments: Metals, gas cylinders, wood and concrete chunks in an area measuring approximately 25' x 15' x 2'.

Photo # 004 shows metals, gas cylinders, wood and concrete chunks in an area measuring approximately 25' x 15' x 2'.

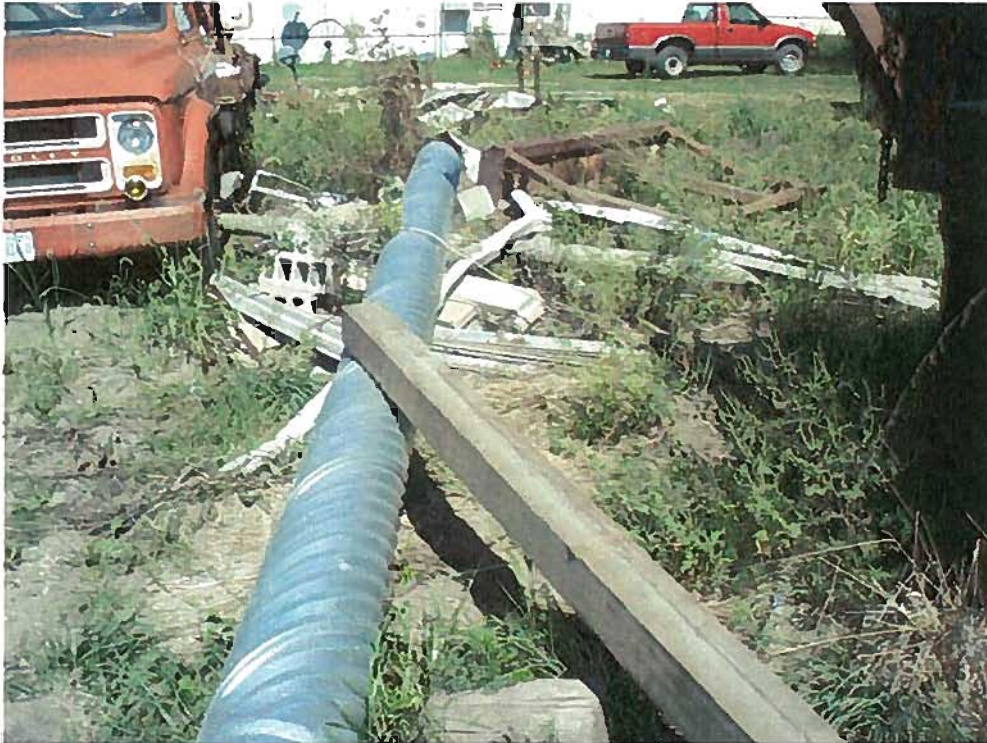
Date: September 23, 2011
Time: 12:23 p.m.
Direction:
Photo by: Charlie King
Exposure #: 005
Comments: A close-up of part of the area shown in photo # 002. Here, the wood, corrugated metal pipe, concrete blocks and metals can be more clearly seen. This area measured approximately 25' x 12' x 2'.

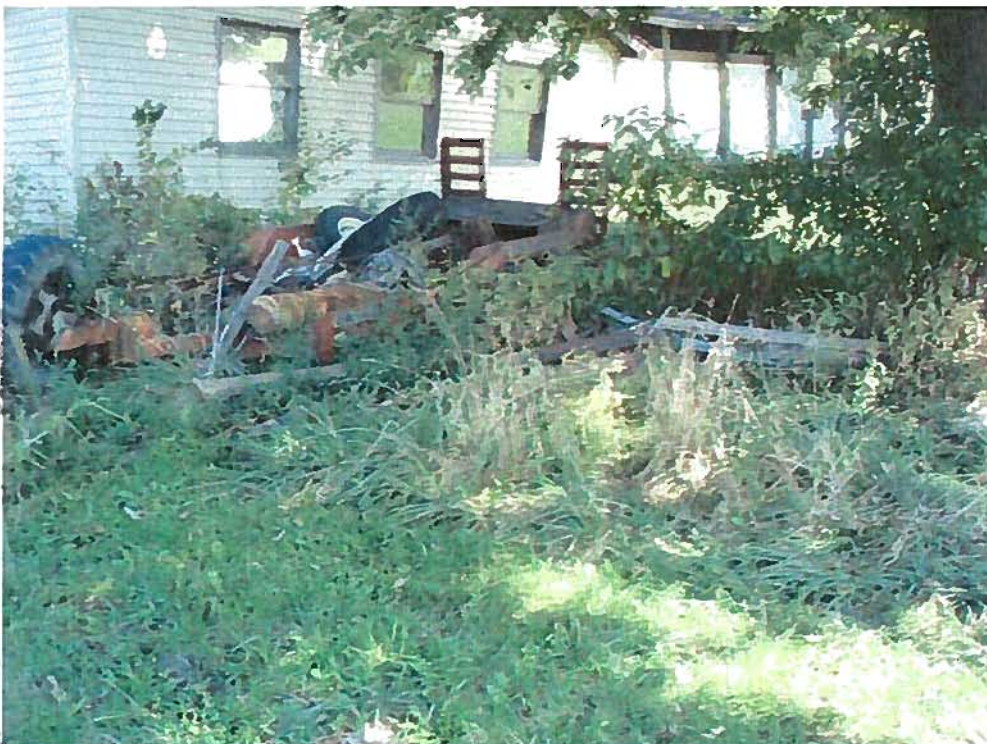
Date: September 23, 2011
Time: 12:24 p.m.
Direction: NE
Photo by: Charlie King
Exposure #: 006
Comments: Metals, used tires on-rims, wood and plastics located in front of, or just south of, the partial shed used for storage. This partial shed appears to be starting to fall apart, and is leaning forward on the right side in this photograph.

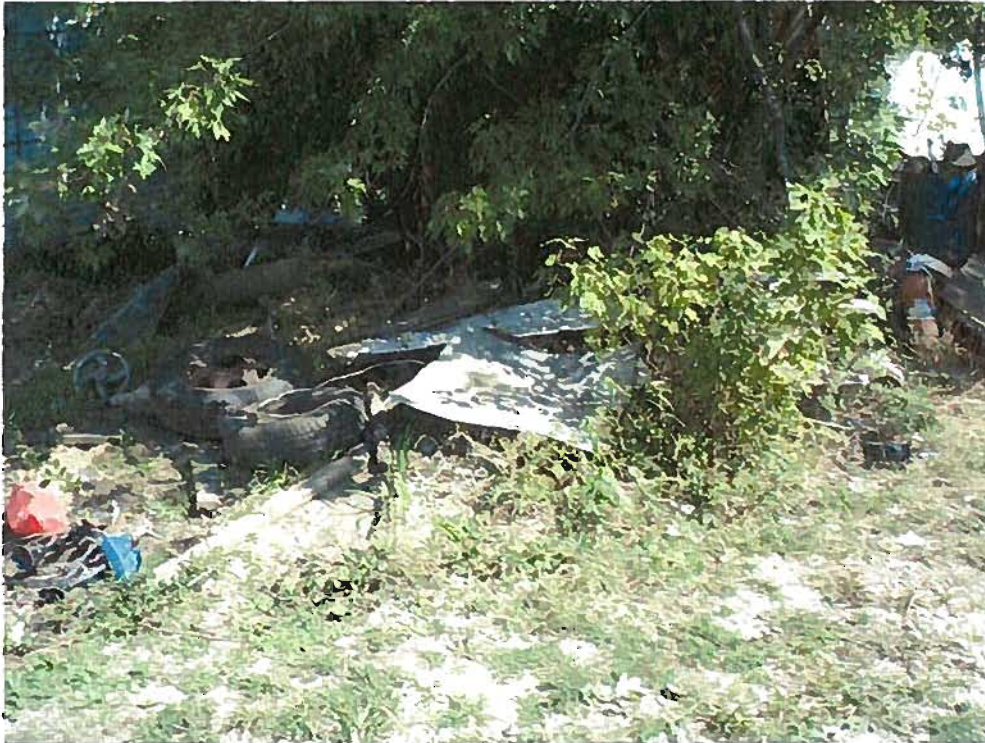
Date: September 23, 2011
Time: 12:27 p.m.
Direction: NE
Photo by: Charlie King
Exposure #: 007
Comments: Wood, used tires on-rims, metals, plastics, toys, a fire extinguisher, gas cylinders, plastics and glass in an area measuring approximately 12' x 10' x 2', just north and northwest of the dilapidated partial shed shown in photo # 006.

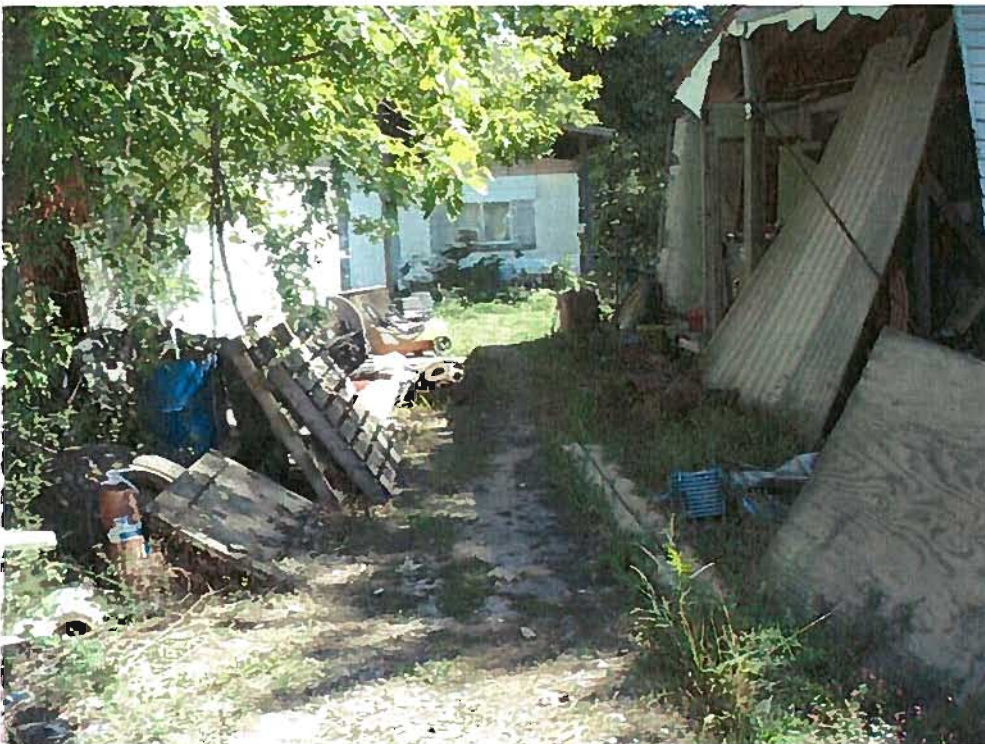
Date: September 23, 2011
Time: 12:27 p.m.
Direction:
Photo by: Charlie King
Exposure #: 008
Comments: North of the dilapidated shed shown in photo # 006, wood, used tires on-rims, metals, an air compressor, wood pallets, and an open blue metal 55-gallon drum filled with metals on the north side of the path between those wastes and the partial shed, measuring 20' x 10' x 5'. The fire extinguisher shown in photo # 007 is also visible.

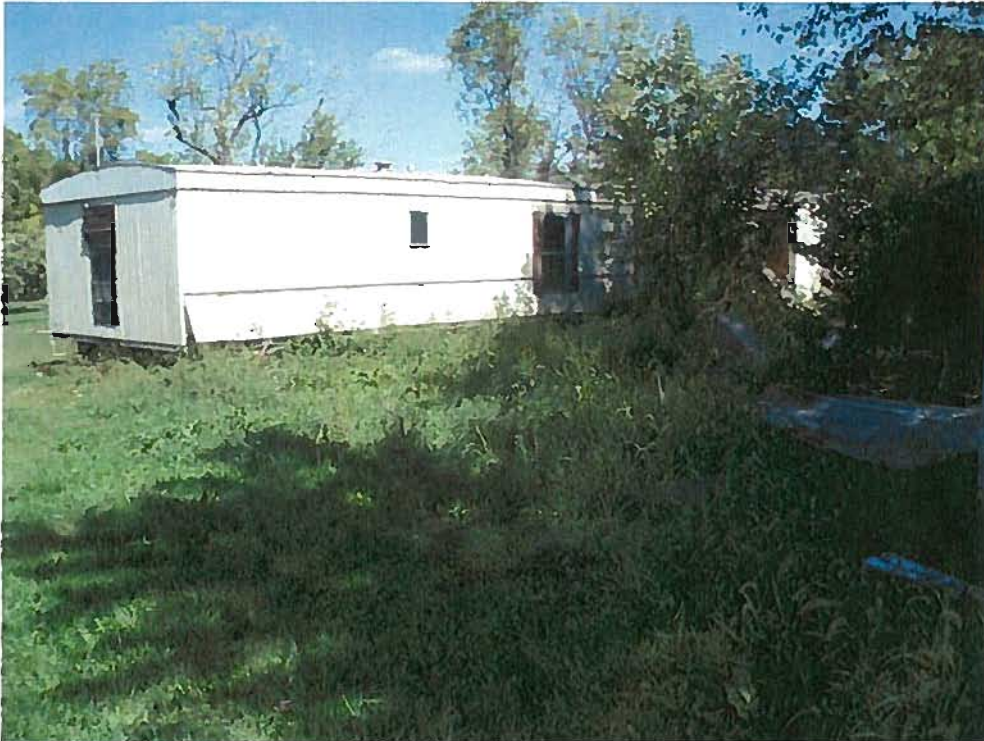
Date: September 23, 2011
Time: 12:30 p.m.
Direction: NE
Photo by: Charlle King
Exposure #: 009
Comments: An uninhabited junk mobile home measuring approximately 14' x 70' x 9'.

Photo # 009 shows an un-inhabited junk mobile home measuring approximately 14' x 70' x 9'.

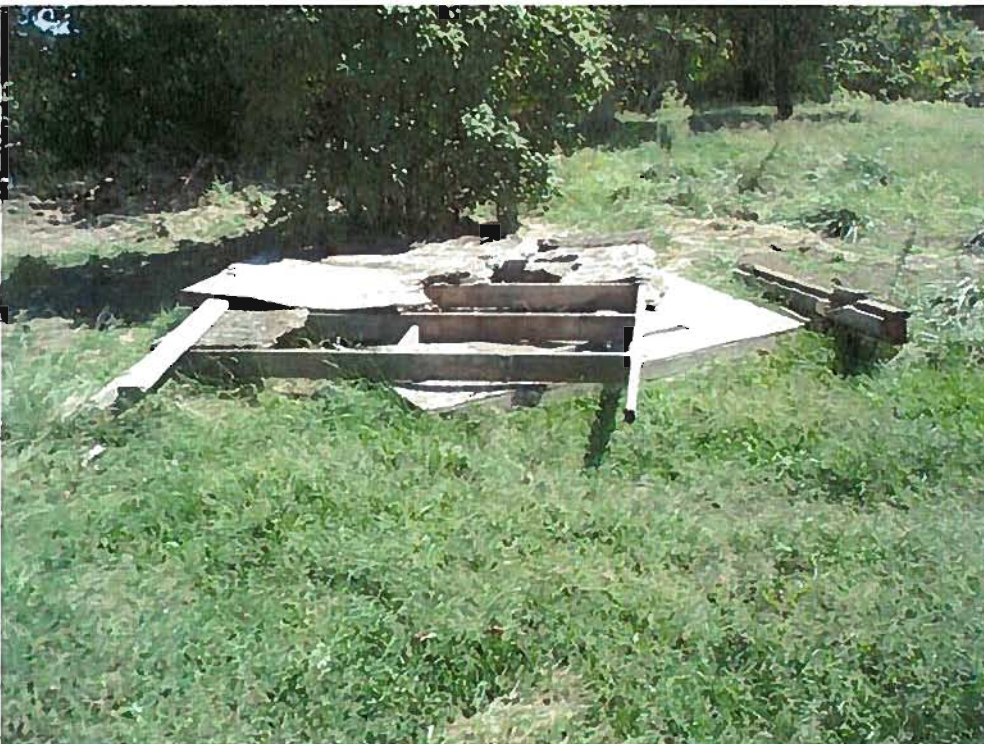
Date: September 23, 2011
Time: 12:31 p.m.
Direction: E
Photo by: Charlie King
Exposure #: 010
Comments: Part of an old roof measuring 10' x 10' x 1'.

Photo # 010 shows part of an old roof measuring 10' x 10' x 1'.

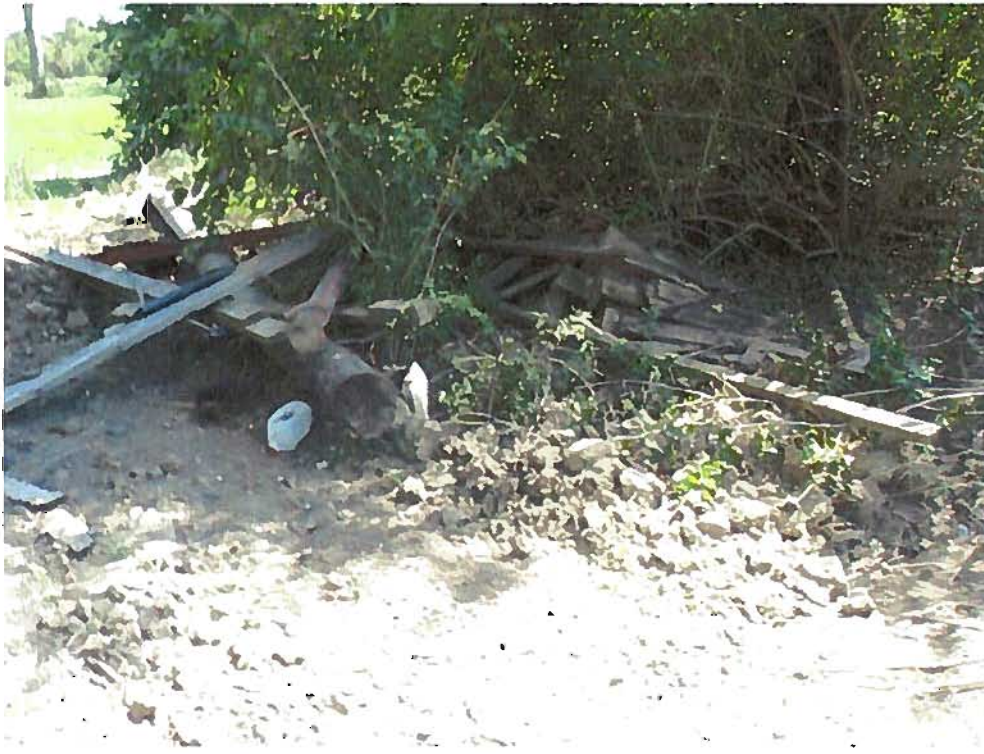
Date: September 23,
2011
Time: 12:32 p.m.
Direction: SE
Photo by: Charlie King
Exposure #: 011
Comments: Used tires
on-rims, shingles,
plastic jugs and wood,
measuring
approximately 12' x 8' x
2', just SE of Mr.
Foster's home.

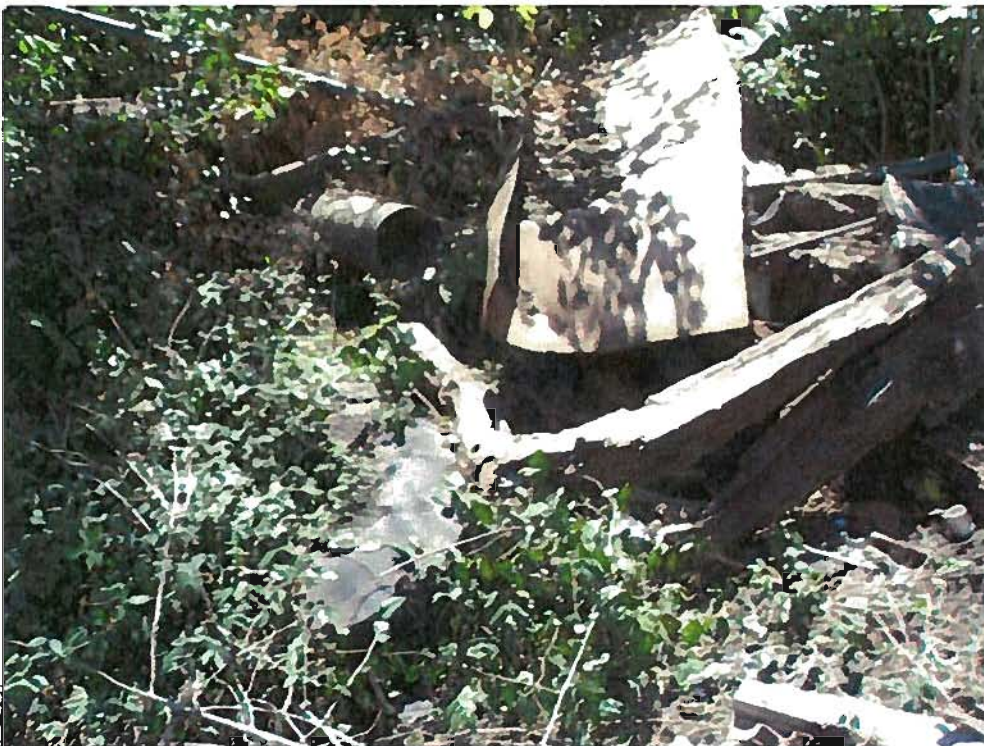
Date: September 23,
2011
Time: 12:34 p.m.
Direction: S
Photo by: Charlie King
Exposure #: 012
Comments: Metals,
used tires on-rims and
wood on the far east
side of the south side
of the property. The
wastes here measured
approximately 10' x 10'
x 2'.

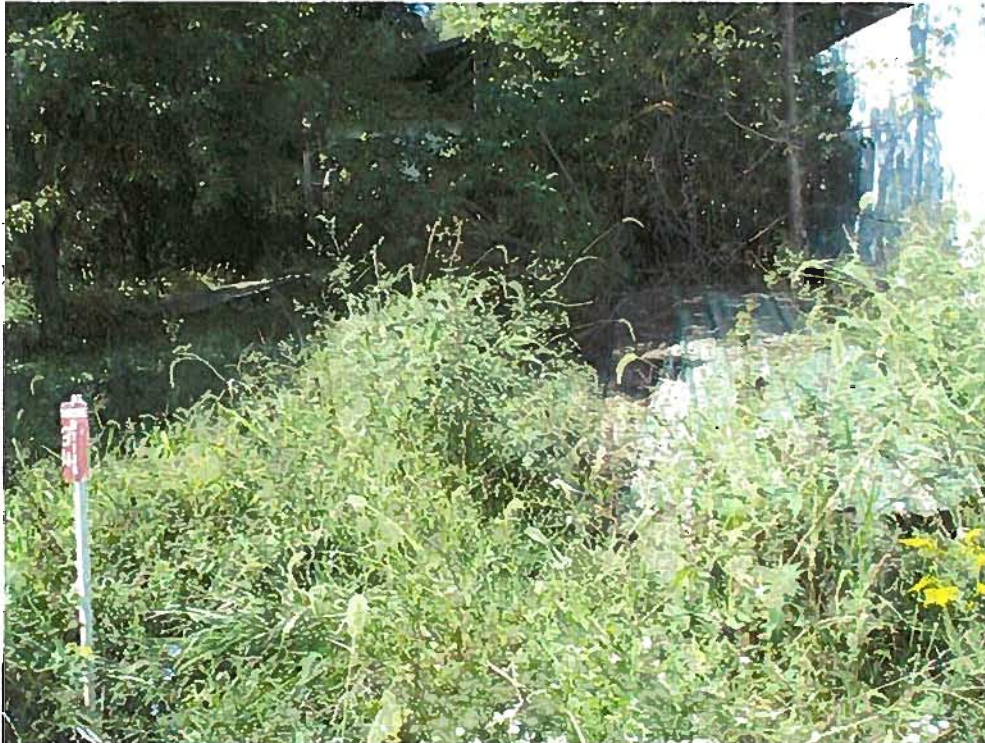
Date: September 23, 2011
Time: 12:35 p.m.
Direction: W
Photo by: Charlie King
Exposure #: 013
Comments: Corrugated tin barely visible to the left and more clearly visible to the right, measured together approximately 15' x 5' x 2'.

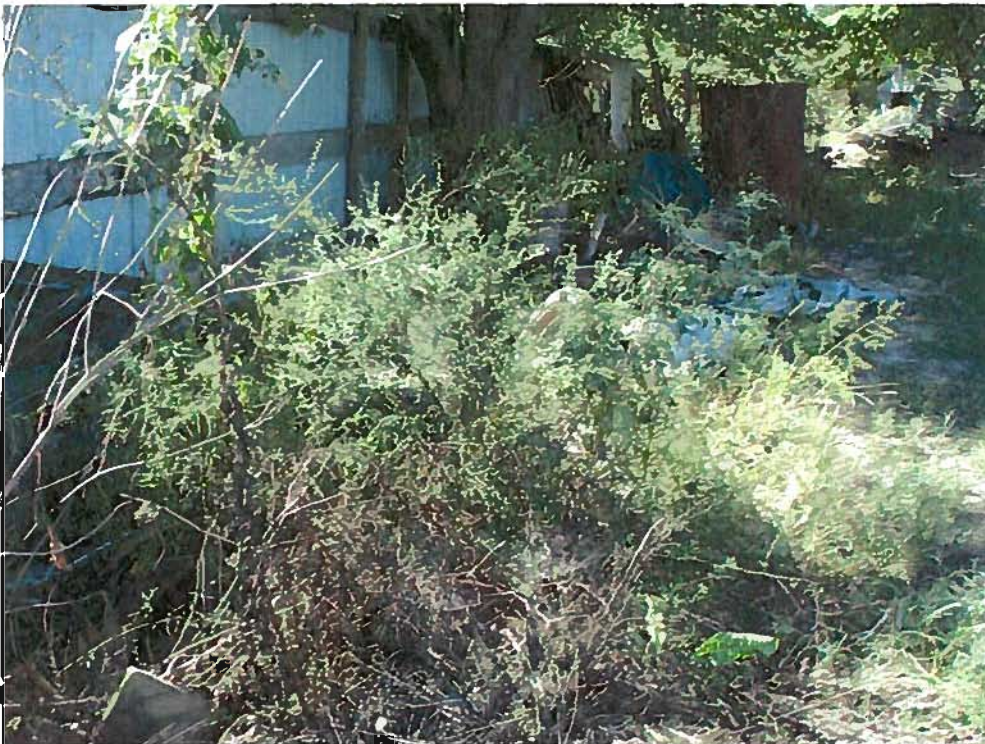
Date: September 23, 2011
Time: 12:36 p.m.
Direction: W
Photo by: Charlie King
Exposure #: 014
Comments: Wood, used tires on-rims, tarps and plastics, north of the fence that is north of Mr. Foster's mobile home. This area of wastes measured approximately 60' x 5' x 3'.

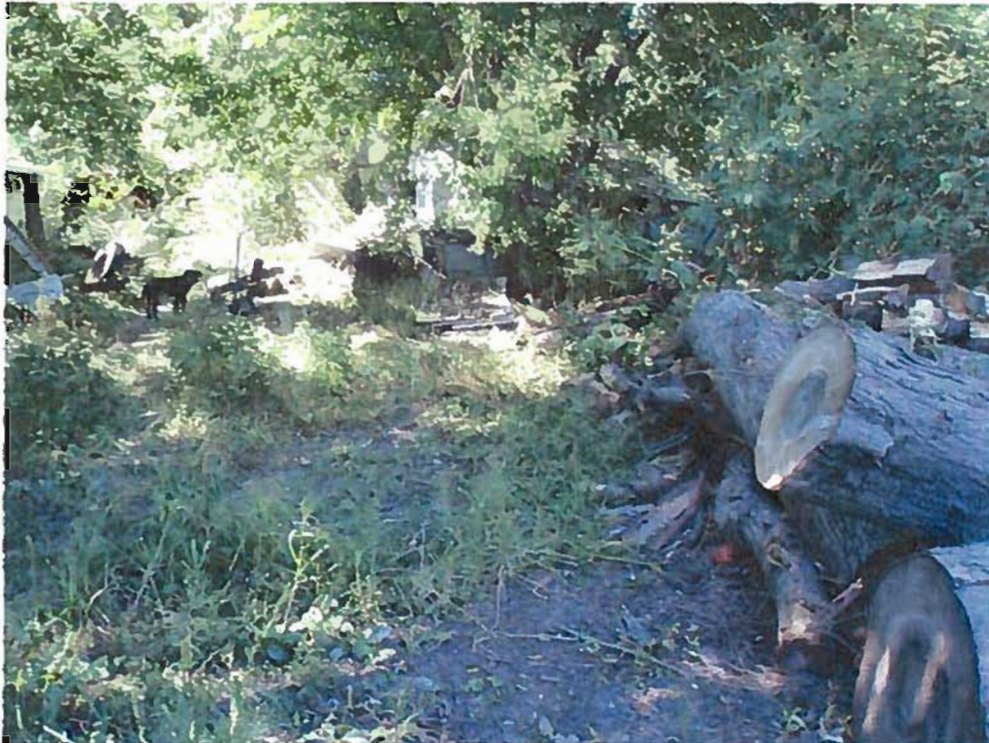
Date: September 23, 2011
Time: 12:38 p.m.
Direction: W
Photo by: Charlie King
Exposure #: 015
Comments: More tires off-rims, metals and wood wastes. This area measured 20' x 20' x 2', and did not include the landscape wastes in the right foreground, because Mr. Foster sells cut wood for firewood.

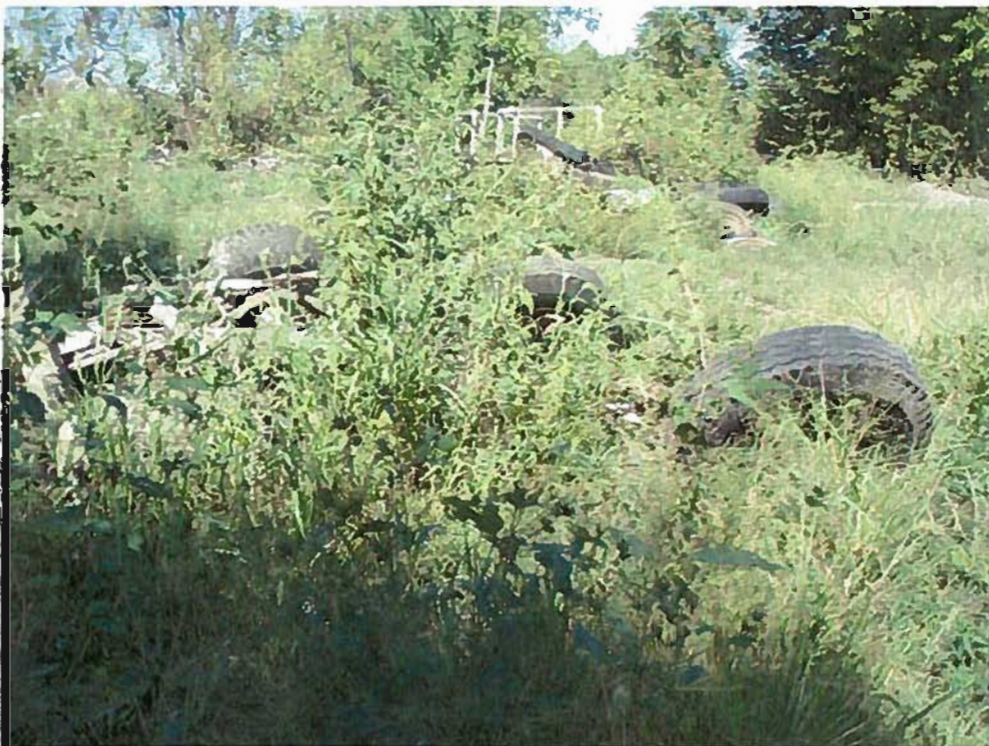
Date: September 23, 2011
Time: 12:39 p.m.
Direction: NW
Photo by: Charlie King
Exposure #: 016
Comments: Two piles of wood, metals and used tires on-rims. The one in the background measured approximately 12' x 10' x 3'. The one in the foreground measured approximately 15' x 8' x 3'.

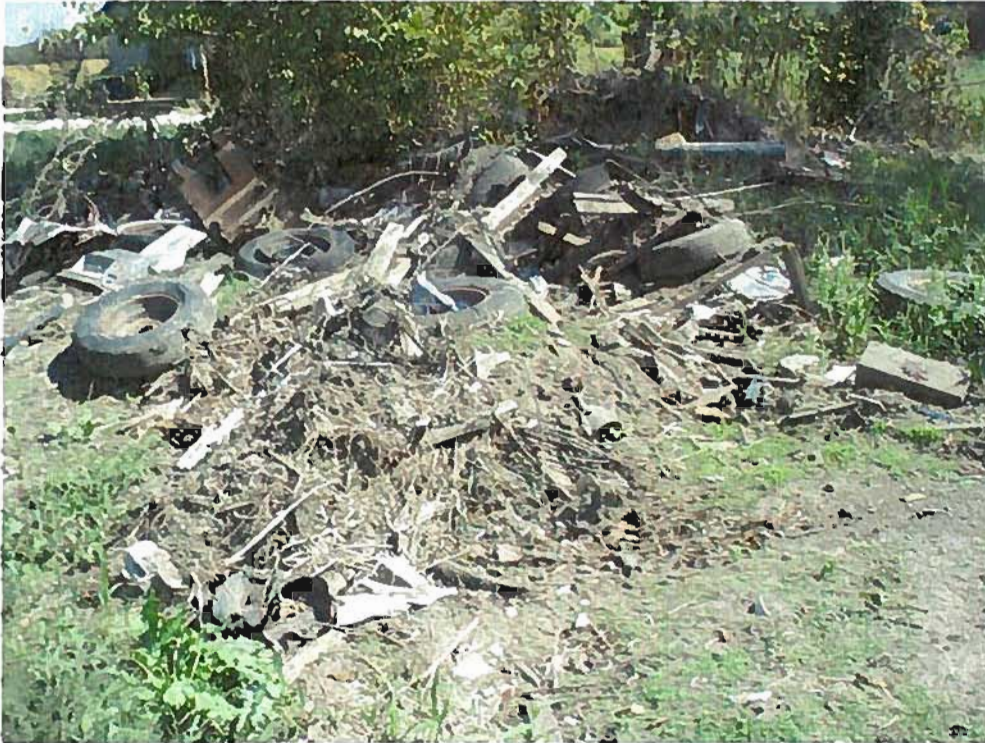
Date: September 23, 2011
Time: 12:41 p.m.
Direction: NE
Photo by: Charlie King
Exposure #: 017
Comments: Used tires on-rims, wood and metals measured approximately 35' x 30' x 2'.

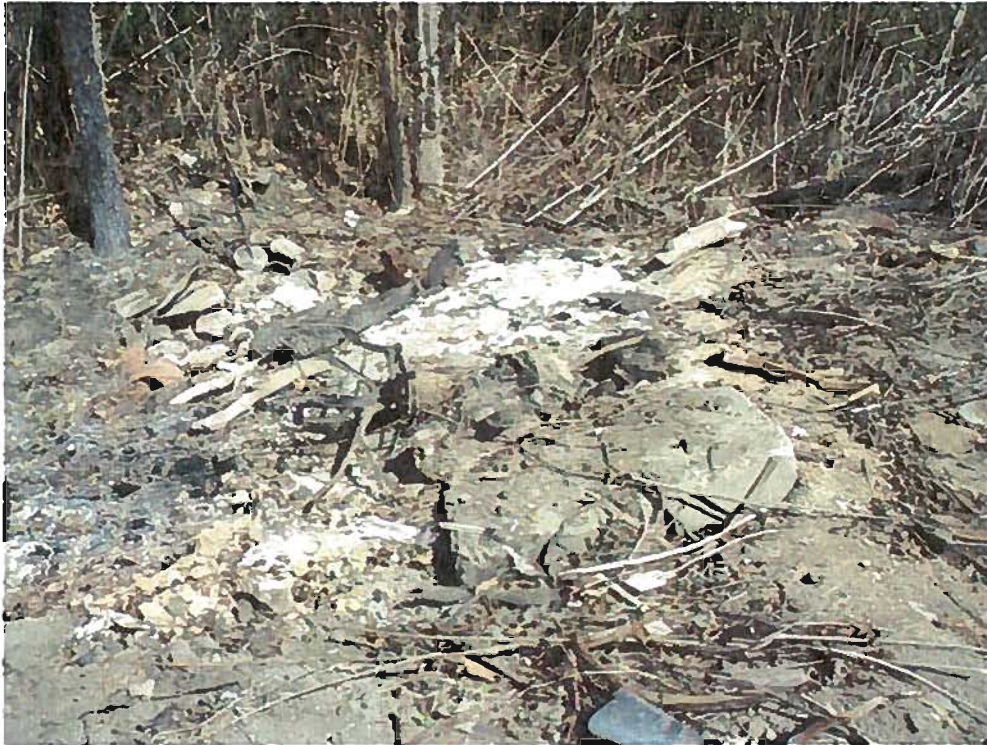
Date: September 23, 2011
Time: 12:44 p.m.
Direction: N/NE
Photo by: Charlie King
Exposure #: 019
Comments: Springs, metals, plastic fibers and ashes were observed in this recent open burning area measured approximately 20' x 12' x 2'.

Photo # 019 shows springs, metals, plastic fibers and ashes were observed in this recent open burning area measured approximately 20' x 12' x 2'.

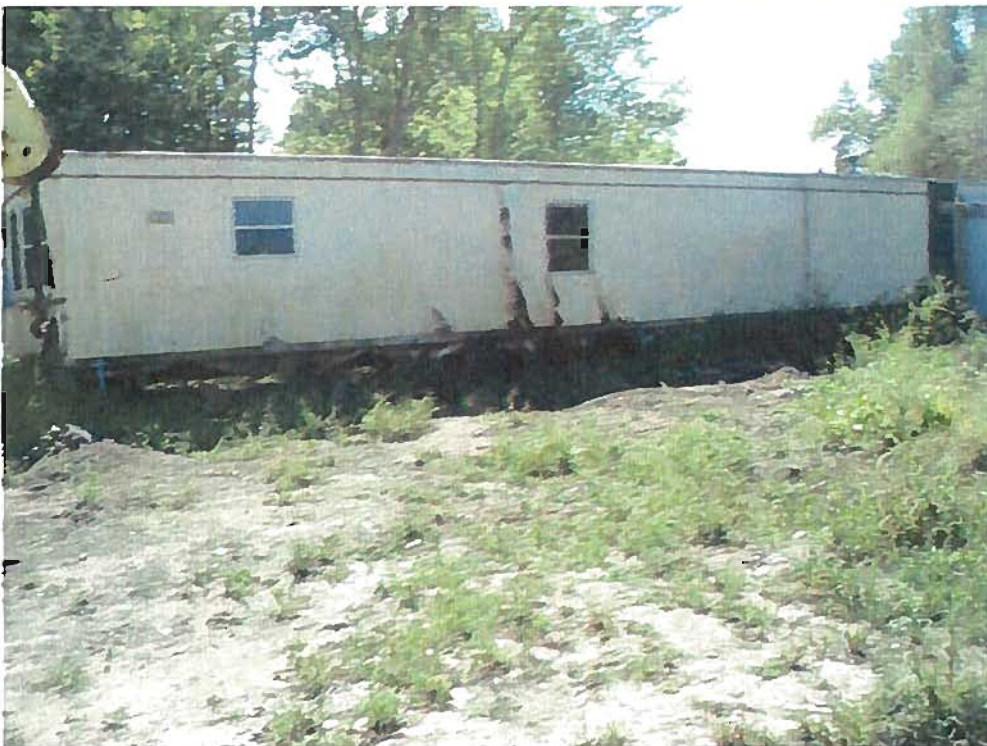
Date: September 23, 2011
Time: 12:46 p.m.
Direction: S/SW
Photo by: Charlie King
Exposure #: 020
Comments: The opposite side of the junk mobile home shown in photo # 009.

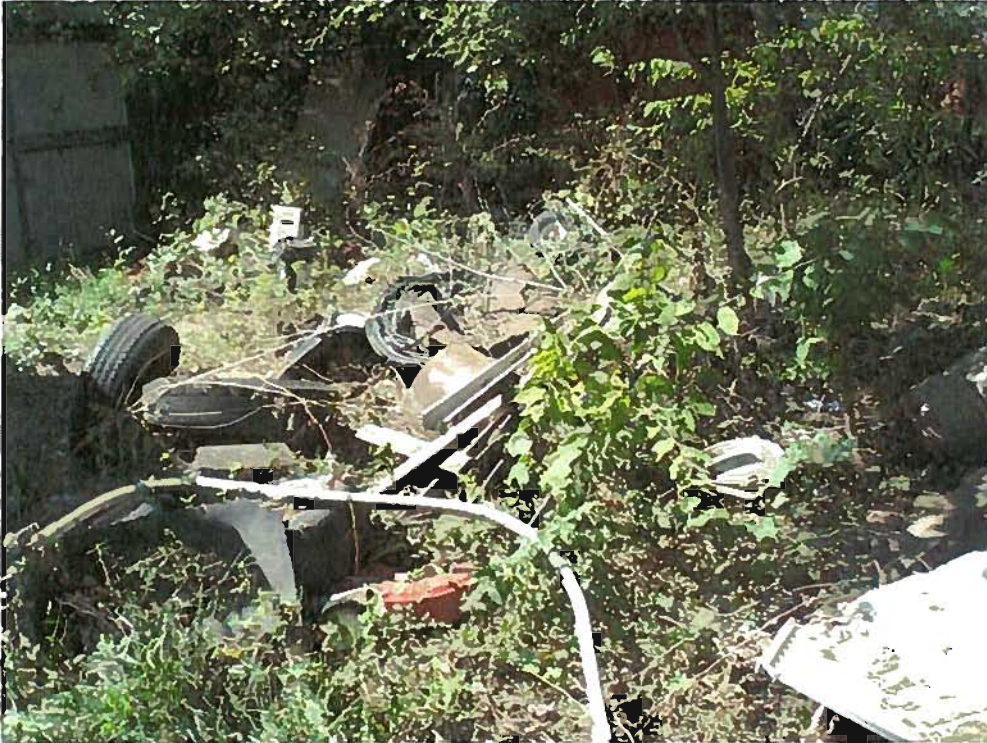
Date: September 23, 2011
Time: 12:51 p.m.
Direction: W
Photo by: Charlie King
Exposure #: 021
Comments: Metals, used tires on-rims, conduits, a lawn mower, black cable, concrete blocks and wood wastes measured approximately 35' x 35' x 2'.

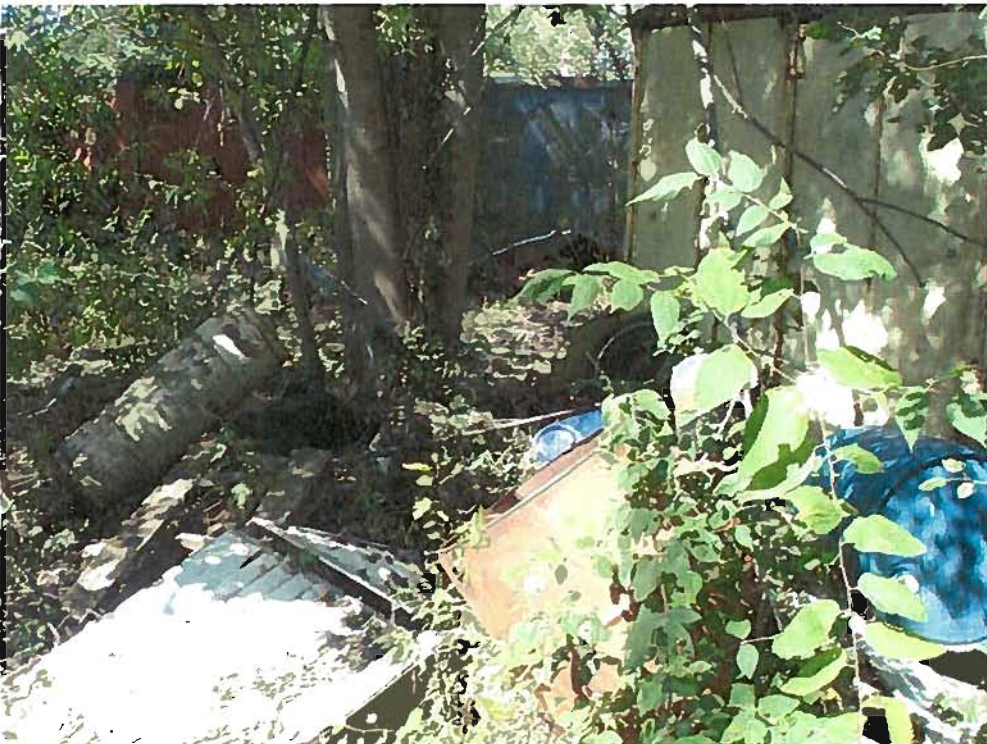
Date: September 23, 2011
Time: 12:51 p.m.
Direction: NW
Photo by: Charlie King
Exposure #: 022
Comments: A continuation of the open dumped wastes shown in photo # 021. Metals, a plastic drum, a used tire on-rim and a gas cylinder were observed. The total area was provided in the description of photo # 021.

Photo # 022 shows a continuation of the open dumped wastes shown in photo # 021. Metals, a plastic drum, a used tire on-rim and a gas cylinder were observed. The total area was provided in the description of photo # 021.
