BEFORE THE ILLINOIS POLLUTION CONTROL BOARD

PCB No. 13-3
(Enforcement-Land)

LPC# 1258075001 - Mason County
Manito/Fisher, Edward
FOS File
March 23, 2011 Inspection

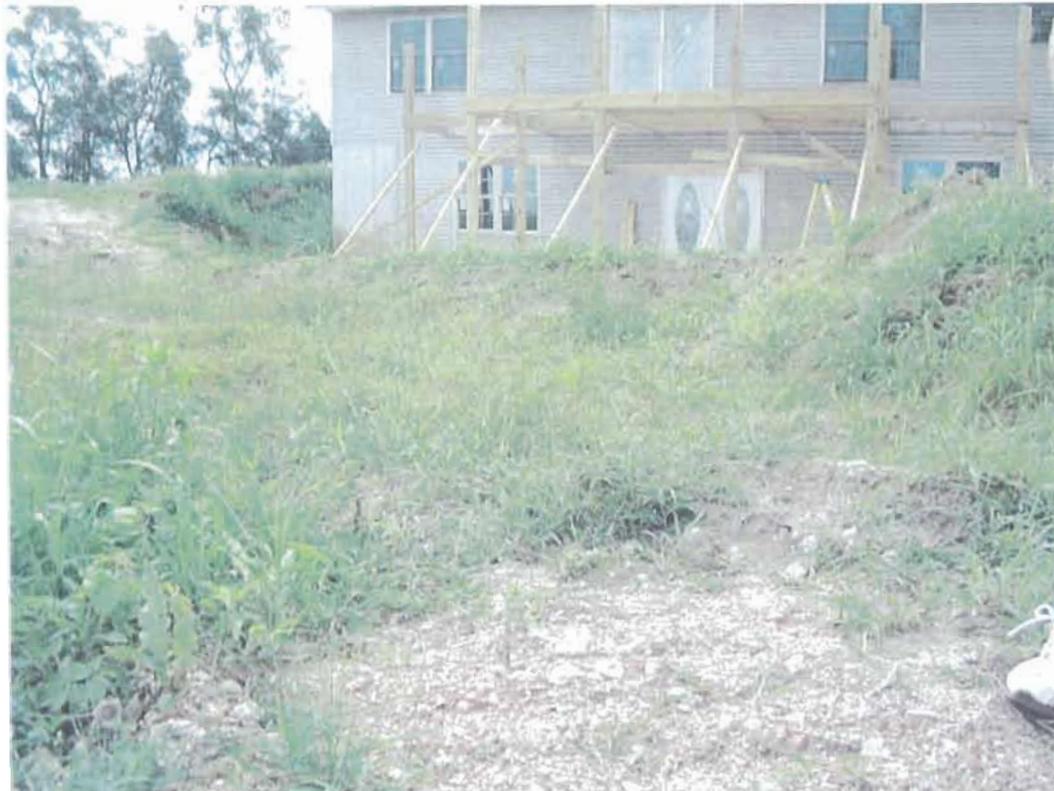
Date: August 4, 2010
Time: 10:24 AM
Direction: NE
Photo by: Eisenbrandt
Exposure #: 002
Comments: Rear side of house under construction. Ground covered with broken brick and mortar.

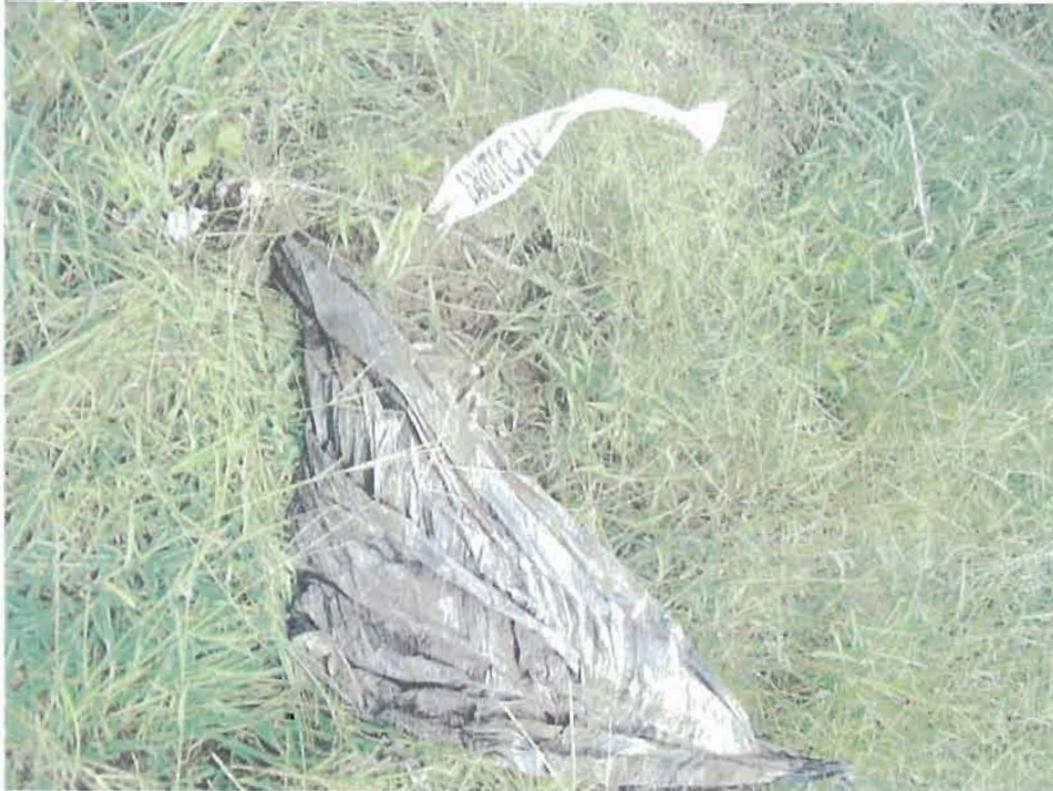
Date: August 4, 2010
Time: 10:27 AM
Direction: W
Photo by: Eisenbrandt
Exposure #: 003
Comments: Dirty black plastic bag and a piece of plastic "Caution" tape among the weeds.

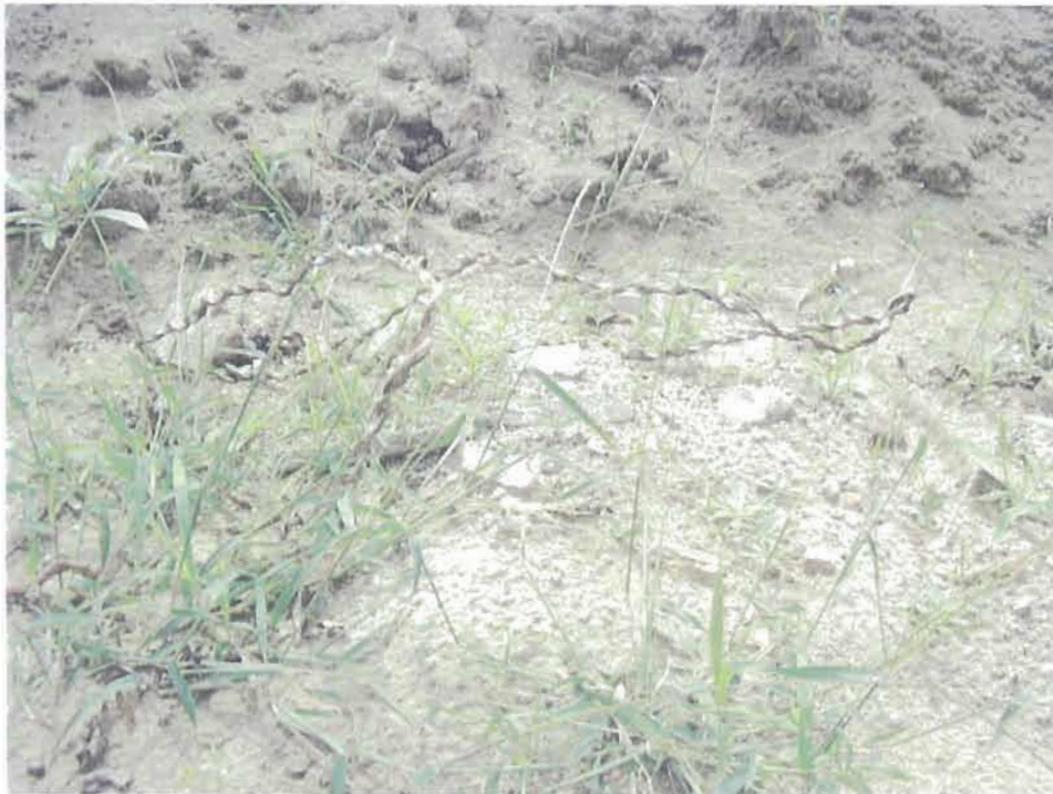
Date: August 4, 2010
Time: 10:27 AM
Direction: E
Photo by: Eisenbrandt
Exposure #: 004
Comments: A rusty unwound piece of Greenfield (flexible conduit) and pieces of brick and mortar.

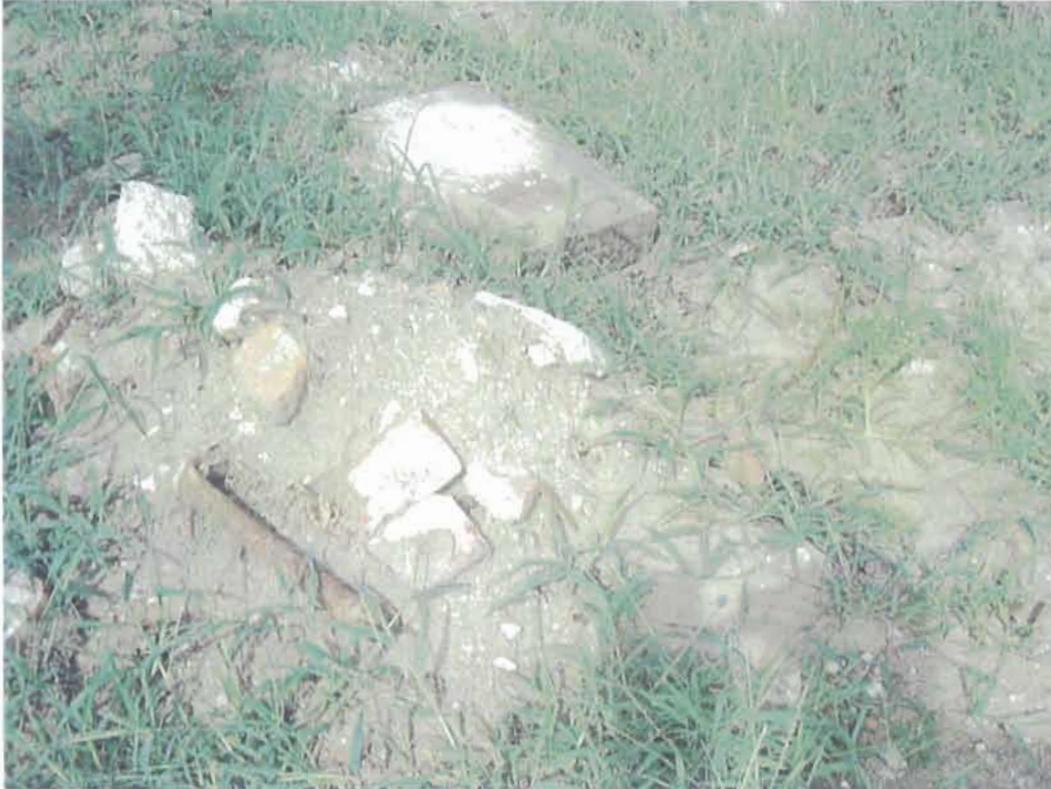
Date: August 4, 2010
Time: 10:30 AM
Direction: W
Photo by: Eisenbrandt
Exposure #: 005
Comments: A cut-off section of a glue-lam beam, chunks of brick, concrete, scraps of rusty metal were observed in the fill material.

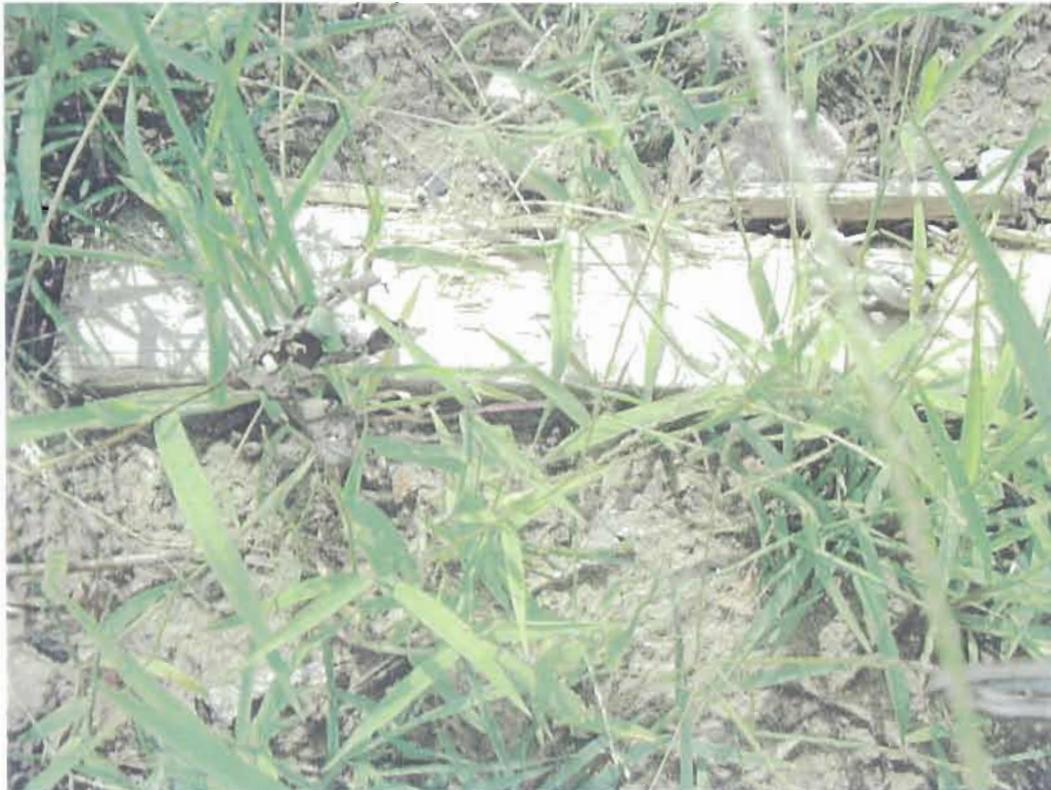
Date: August 4, 2010
Time: 10:32 AM
Direction: E
Photo by: Eisenbrandt
Exposure #: 006
Comments: Damage to dimensional lumber and mortar.

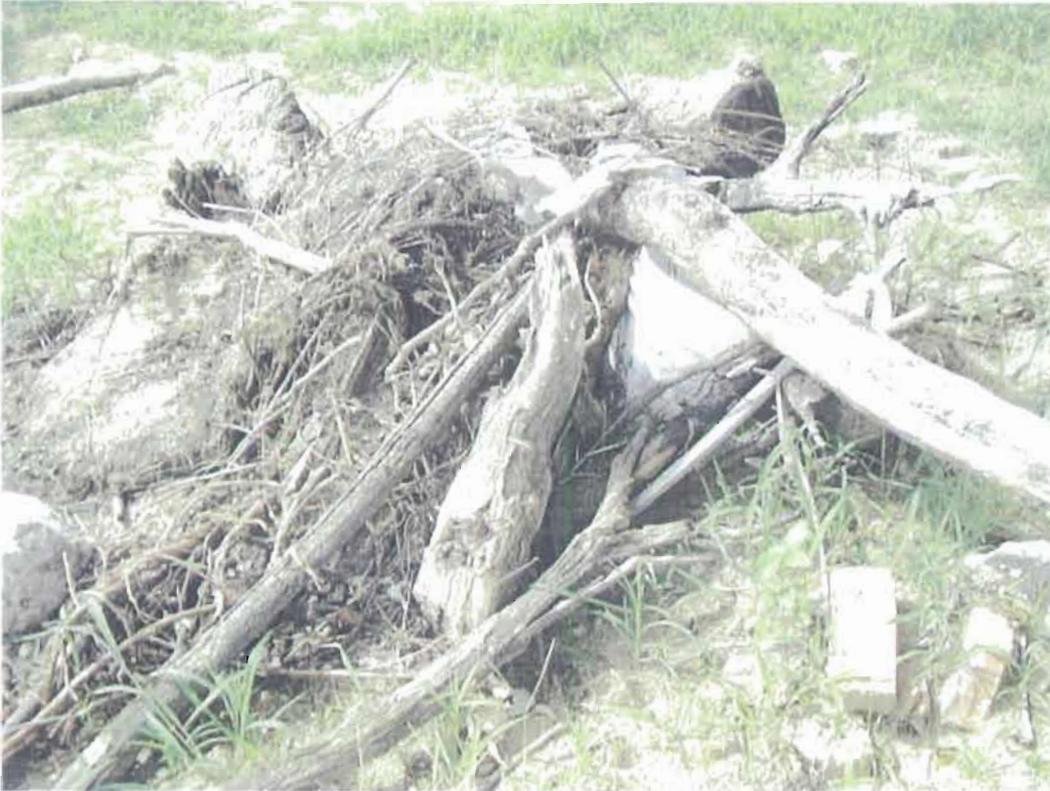
Date: August 4, 2010
Time: 10:32 AM
Direction: SE
Photo by: Eisenbrandt
Exposure #: 007
Comments: A debris pile containing landscape waste, brick, a white plastic bucket, a survey stake, and metal wire.

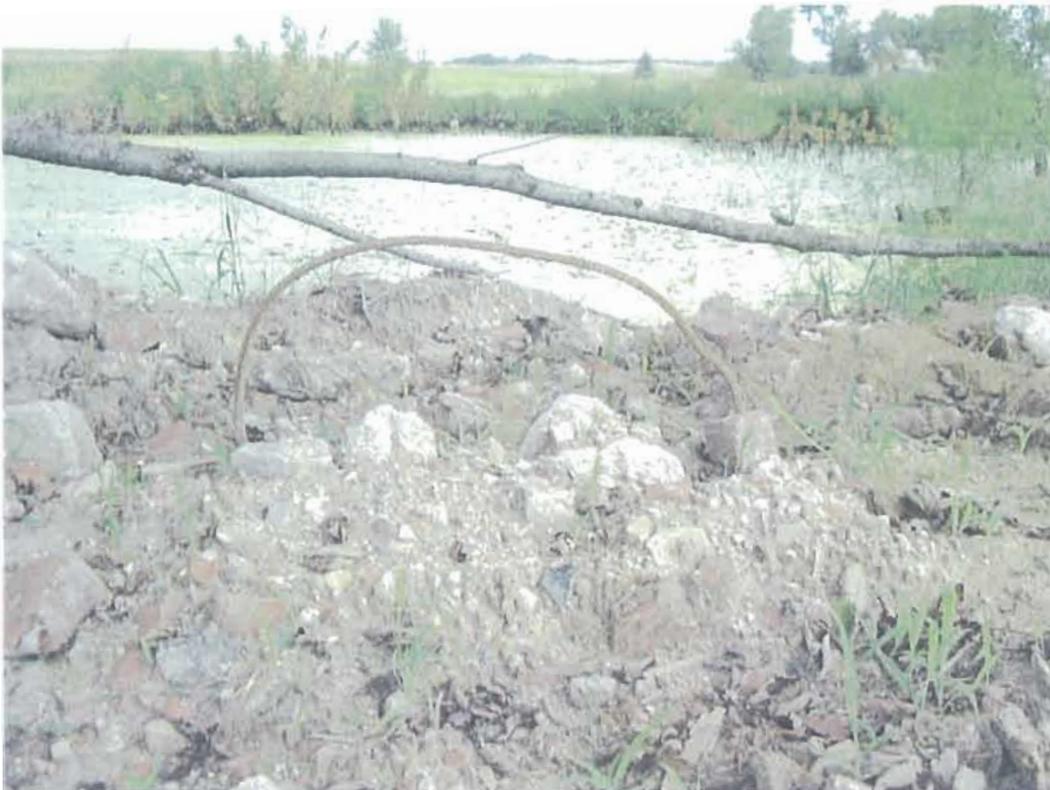
Date: August 4, 2010
Time: 10:34 AM
Direction: NW
Photo by: Eisenbrandt
Exposure #: 008
Comments: Brick and mortar, and a piece of protruding rebar on the edge of the pond. Black plastic, carpet, asphalt shingles, and broken glass were observed in the unclean fill material.

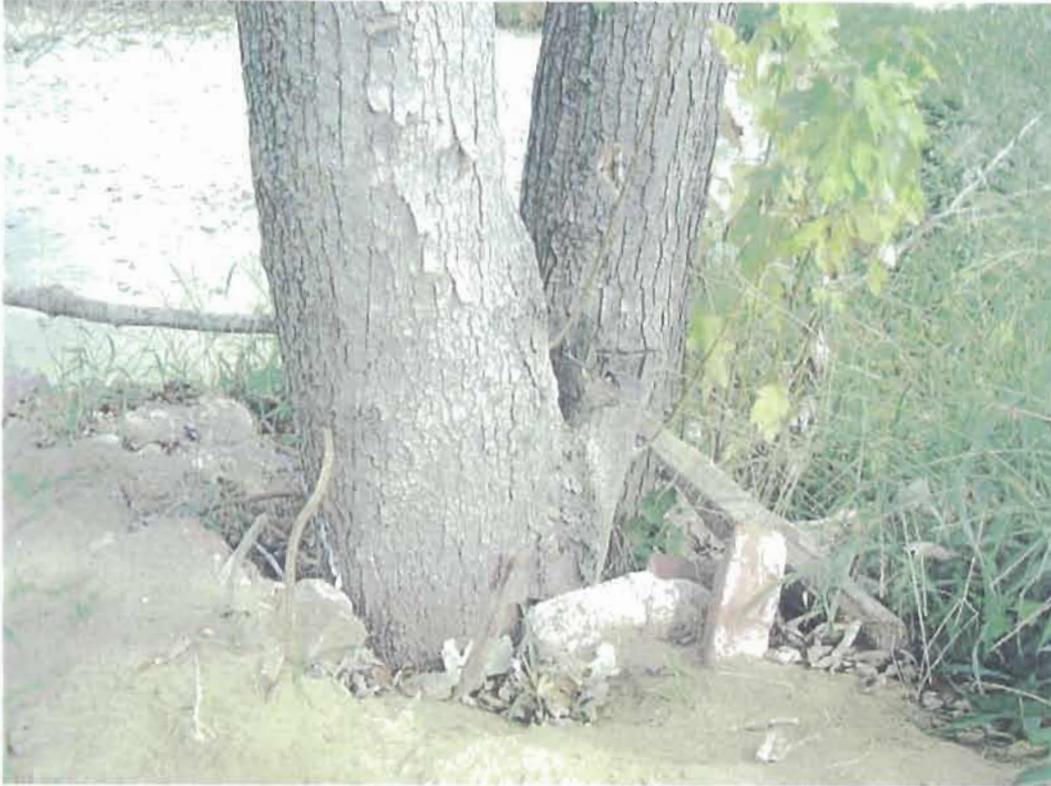
Date: August 4, 2010
Time: 10:34 AM
Direction: W
Photo by: Eisenbrandt
Exposure #: 009
Comments: Dimensional lumber scrap, metal, rusty rebar, brick, and concrete.

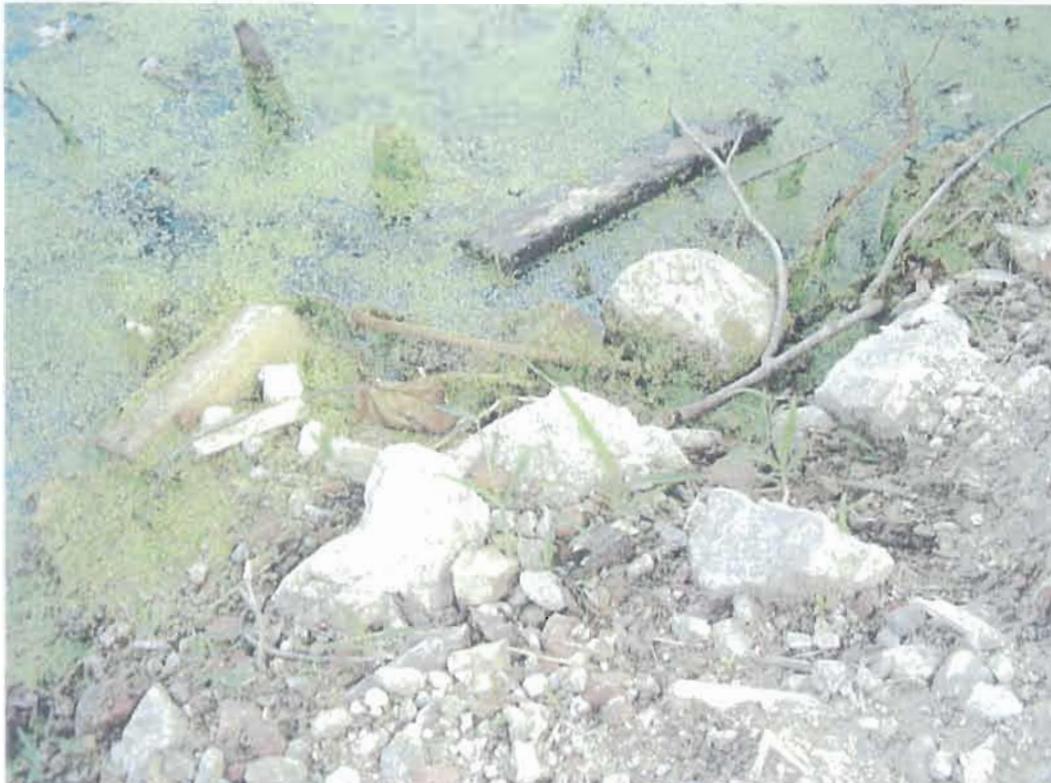
Date: August 4, 2010
Time: 10:36 AM
Direction: NW
Photo by: Eisenbrandt
Exposure #: 010
Comments: Rebar, scrap lumber, brick, and concrete in the pond.

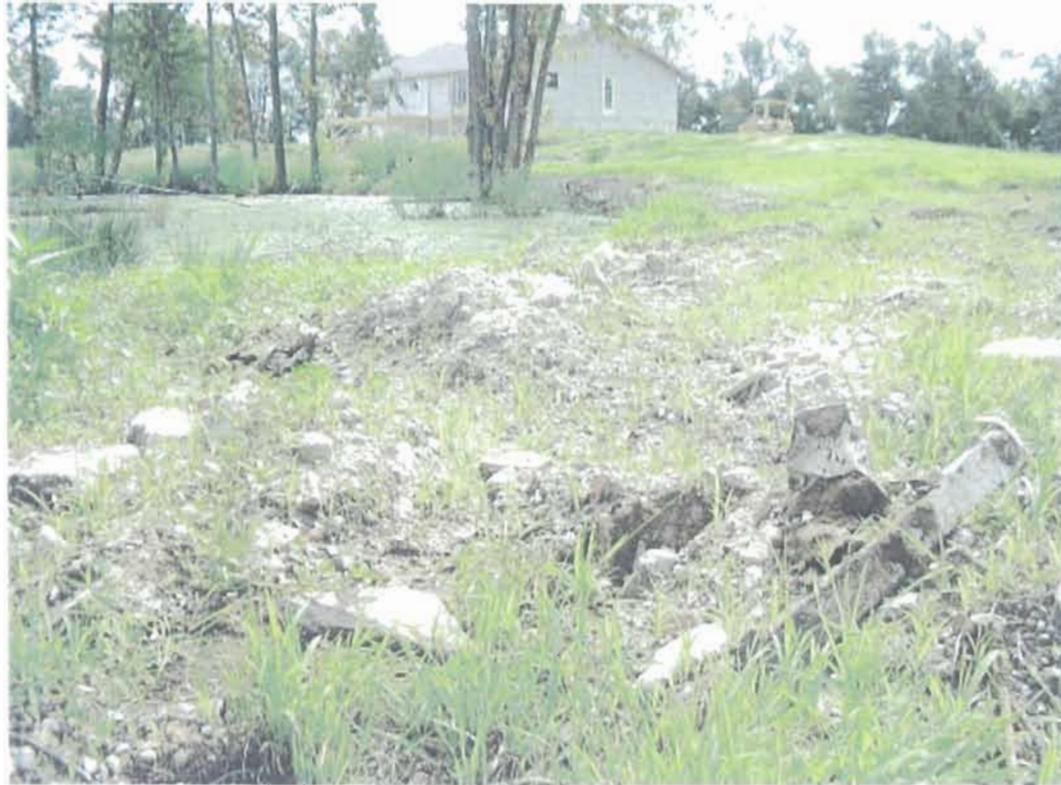
Date: August 4, 2010
Time: 10:46 AM
Direction: NE
Photo by: Eisenbrandt
Exposure #: 012
Comments: Scrap metal visible in the foreground.

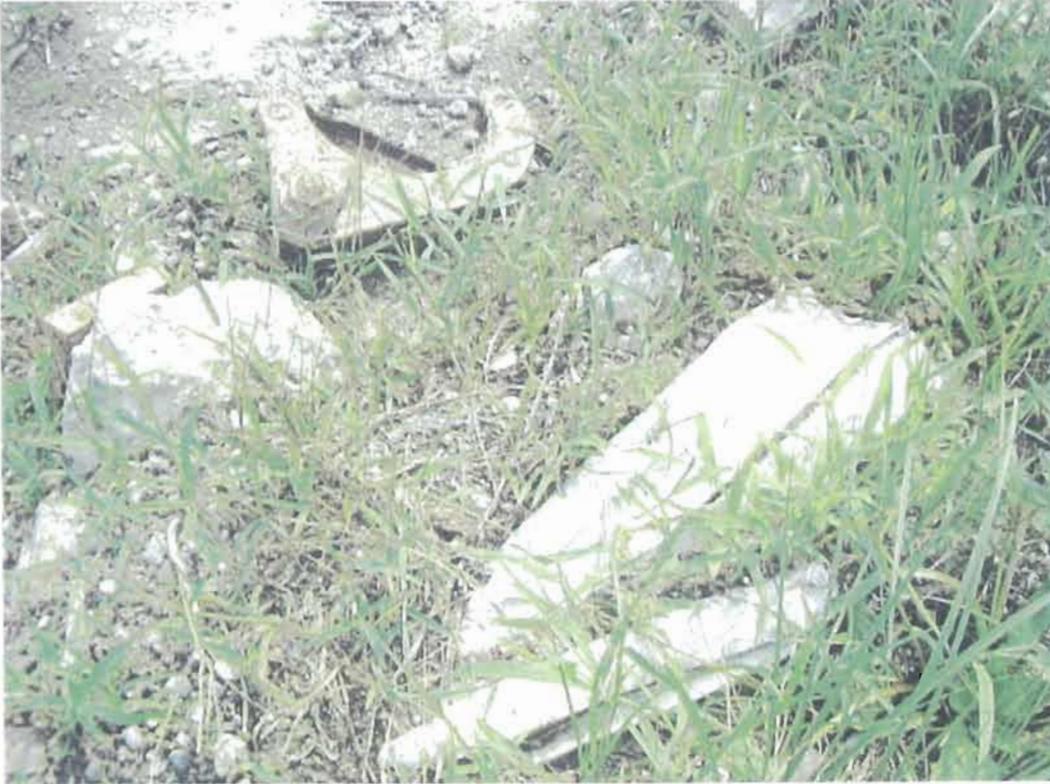
Date: August 4, 2010
Time: 10:47 AM
Direction: E
Photo by: Eisenbrandt
Exposure #: 013
Comments: Rusty iron
and scrap aluminum
intermixed with fill material.

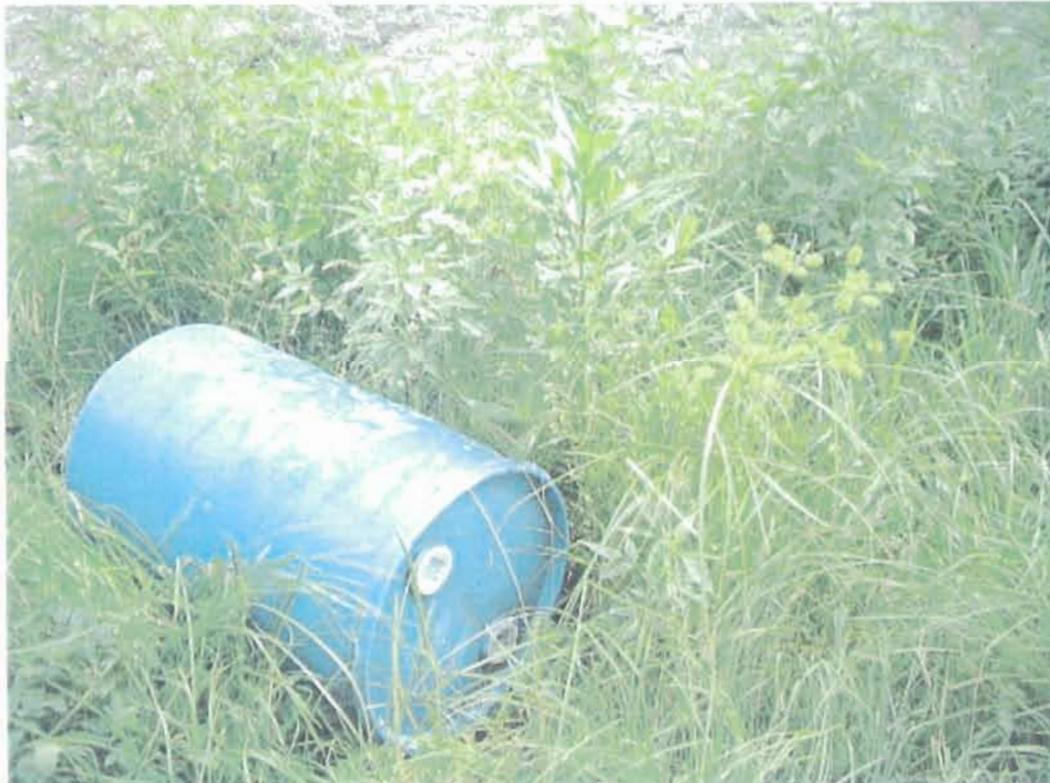
Date: August 4, 2010
Time: 10:49 AM
Direction: NE
Photo by: Eisenbrandt
Exposure #: 014
Comments: An open
dumped blue plastic drum.
Drum appeared mostly
empty with a small amount
of liquid residue.

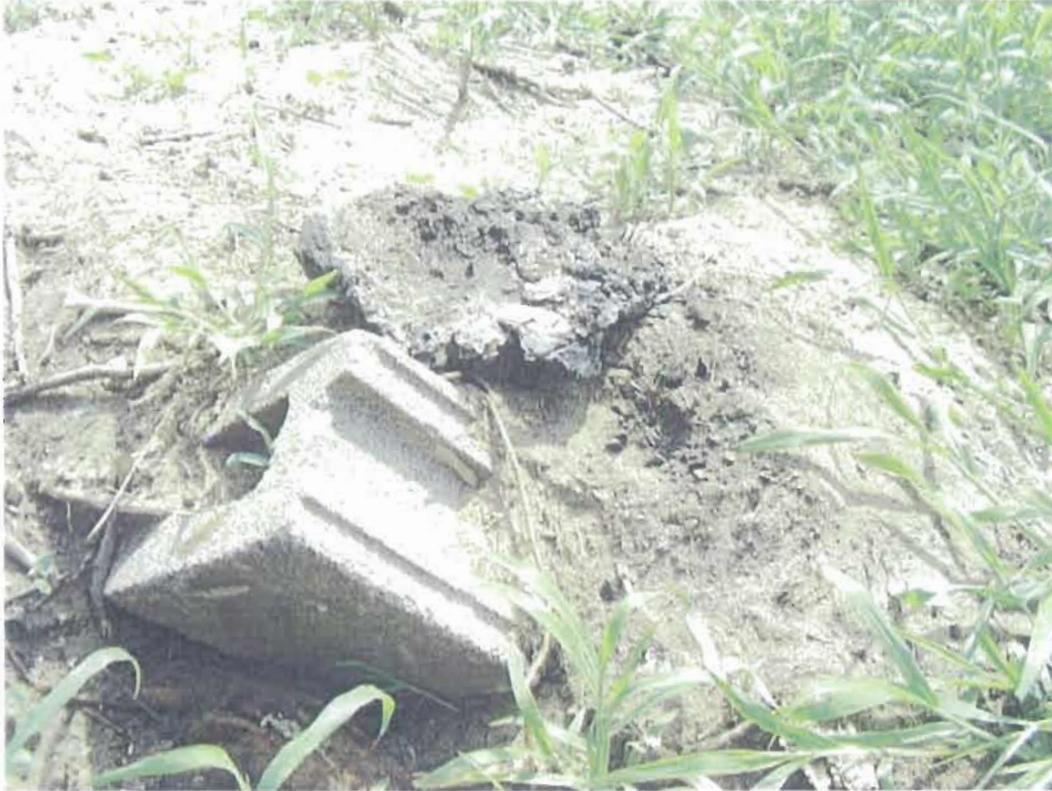
Date: August 4, 2010
Time: 10:52 AM
Direction: NE
Photo by: Eisenbrandt
Exposure #: 017
Comments: A cinder block, rusty scrap metal, and charred wood.

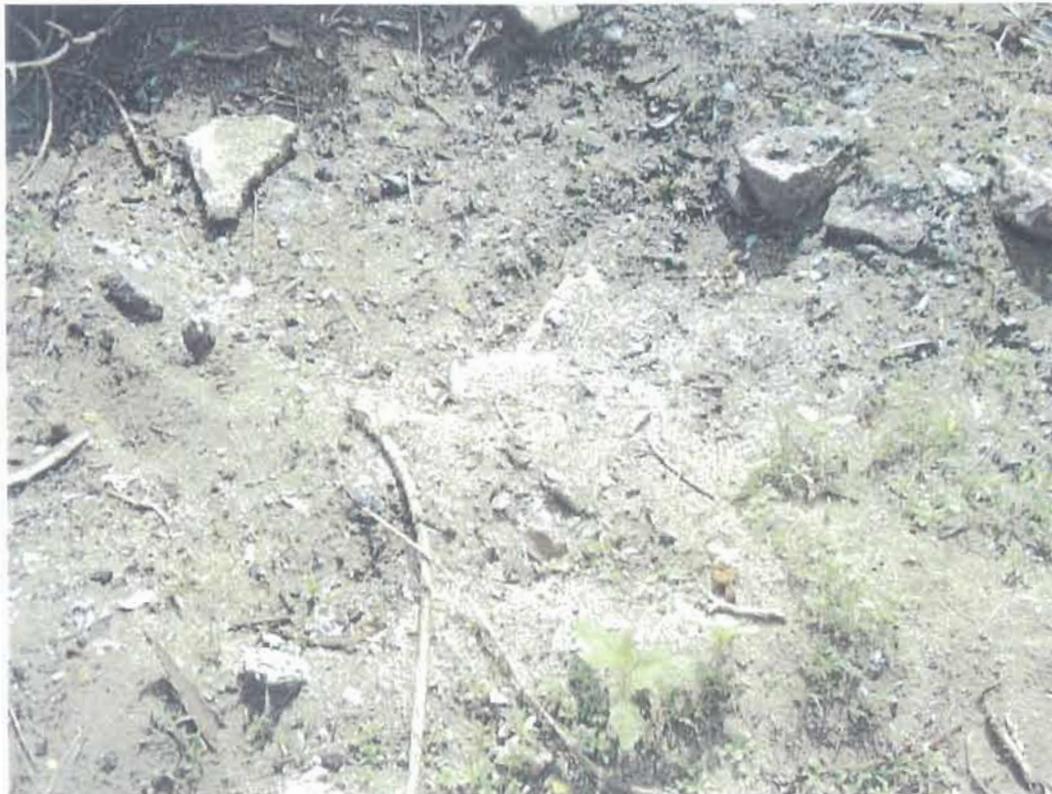
Date: August 4, 2010
Time: 10:52 AM
Direction: NE
Photo by: Eisenbrandt
Exposure #: 018
Comments: Ash and charred waste. A blue green residue was also observed in the ashes.

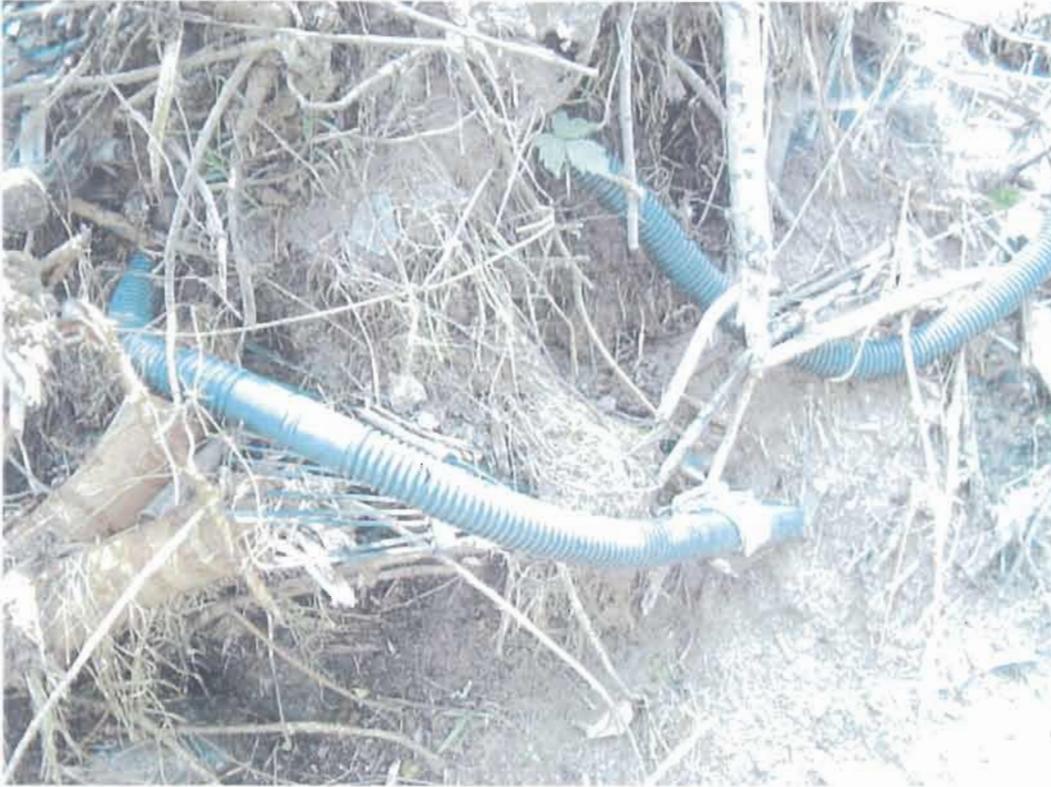
Date: August 4, 2010
Time: 10:54 AM
Direction: E
Photo by: Eisenbrandt
Exposure #: 021
Comments: Black plastic hose, a fan rake, broken glass, intermixed with landscape waste in a partially burnt debris pile.

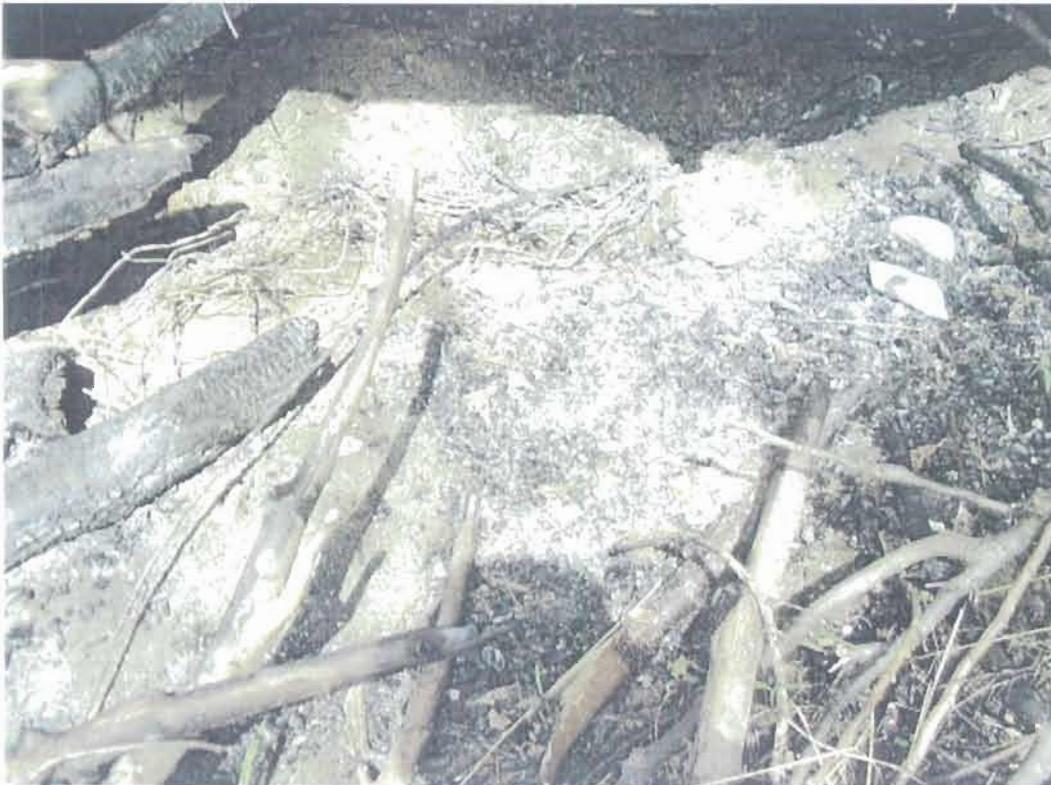
Date: August 4, 2010
Time: 10:56 AM
Direction: W
Photo by: Eisenbrandt
Exposure #: 022
Comments: Charred wire and broken porcelain among the ash and landscape waste.

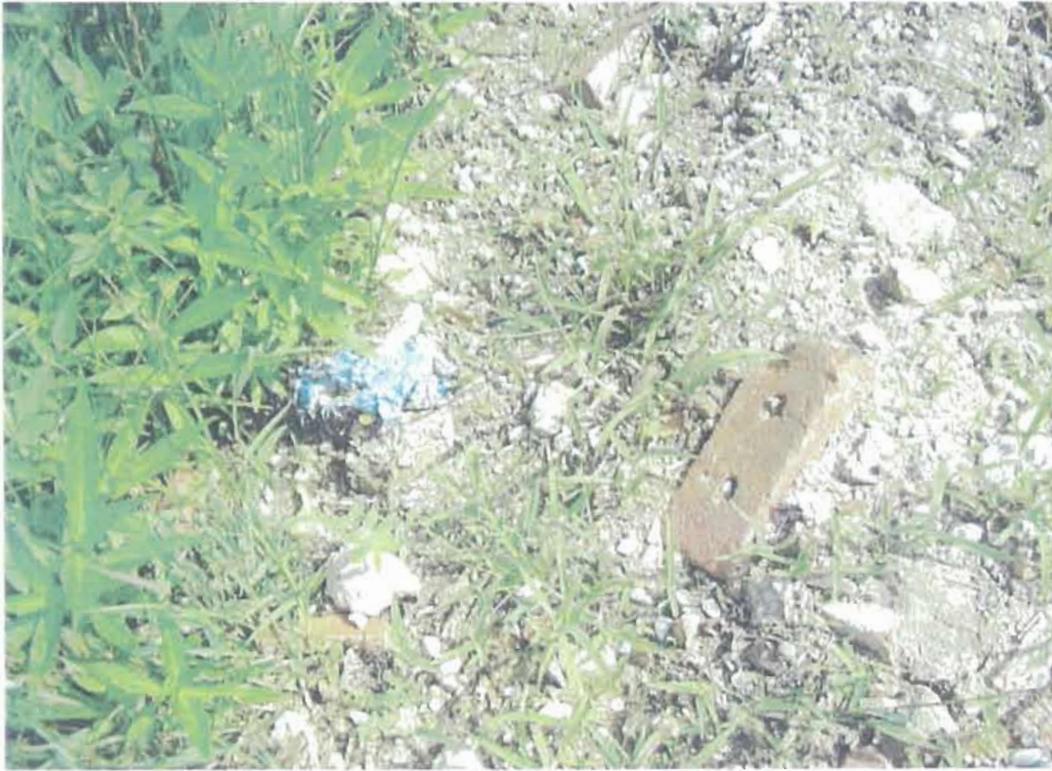
Date: August 4, 2010
Time: 10:57 AM
Direction: N
Photo by: Eisenbrandt
Exposure #: 023
Comments: Brick, mortar,
and blue debris intermixed
with the fill material.

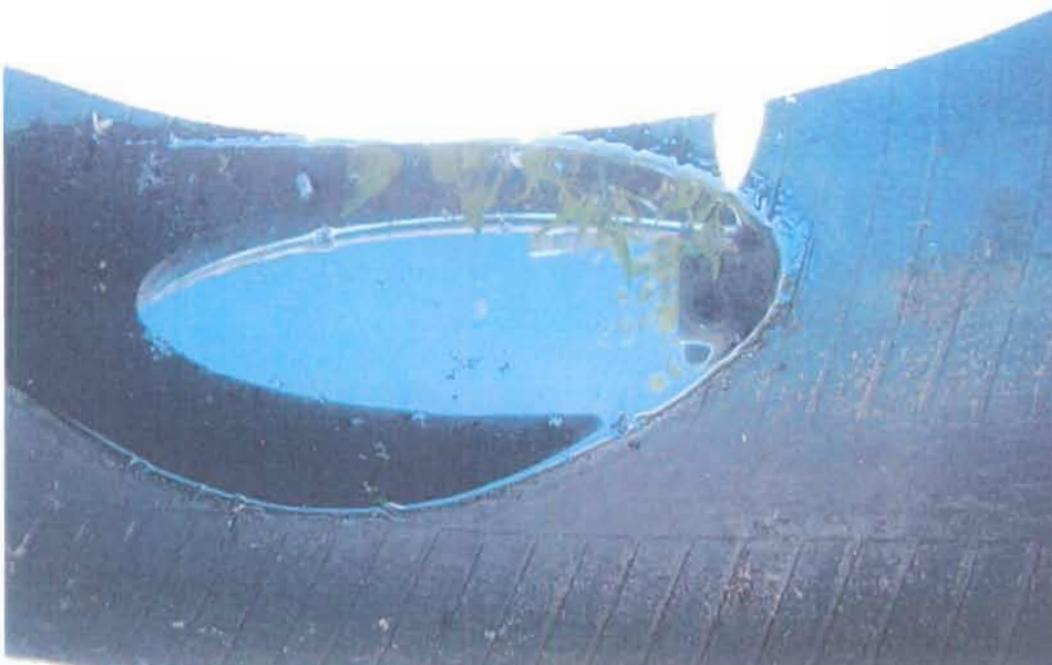
The Respondent caused or allowed water to accumulate in used or waste tires at the corporate site as depicted in Complaint Exhibit 2, August 4, 2010, Exposures 4, 33, pp. 2, 17, and March 23, 2011, Exposures 40 and 41 pp. 38 and 39. (See, Paragraph 18, Count IV of the Complaint and Eisenbrandt Affidavit).

Date: August 4, 2010.
Time: 11:42 AM
Direction: W
Photo by: Eisenbrandt
Exposure #: 004
Comments: The used tire (seen in the photograph above) leaning against the building was off-rim and contained water.

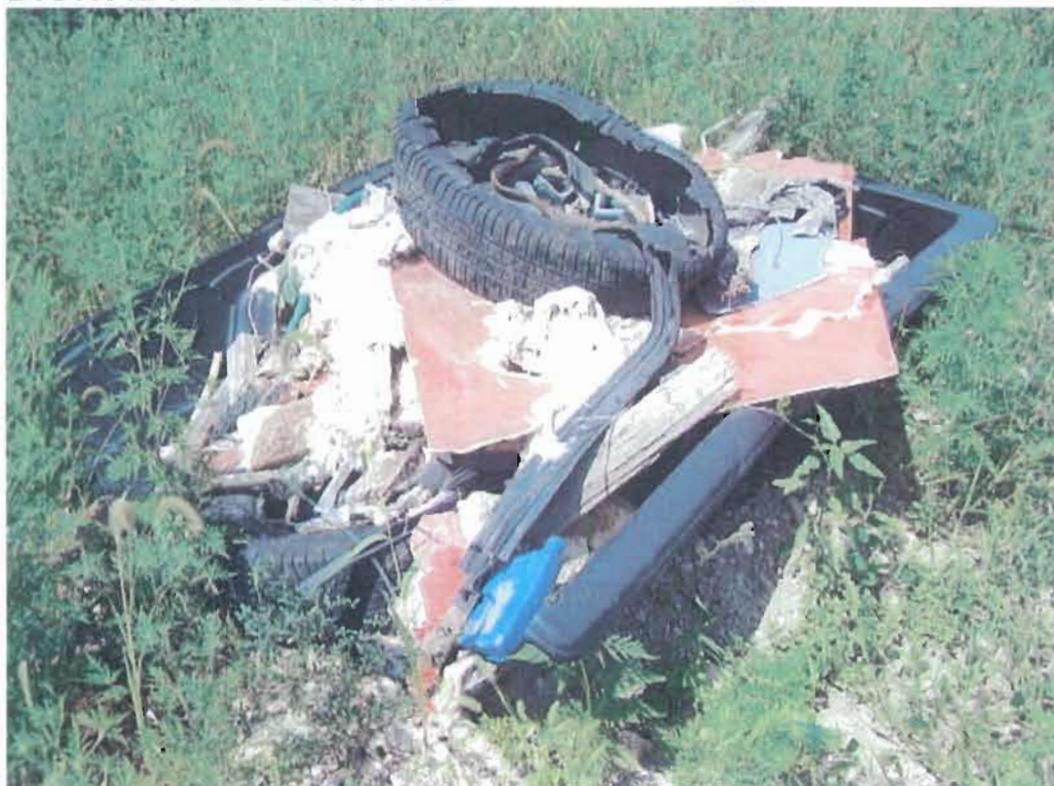
Date: August 4, 2010.
Time: 11:43 AM
Direction: SE
Photo by: Eisenbrandt
Exposure #: 005
Comments: A pickup truck bed liner filled with waste. Two used tires (both off-rim), fiberglass insulation, damage scrap lumber, plastic sheeting, a garden hose, and a plastic bottle were among the waste observed.

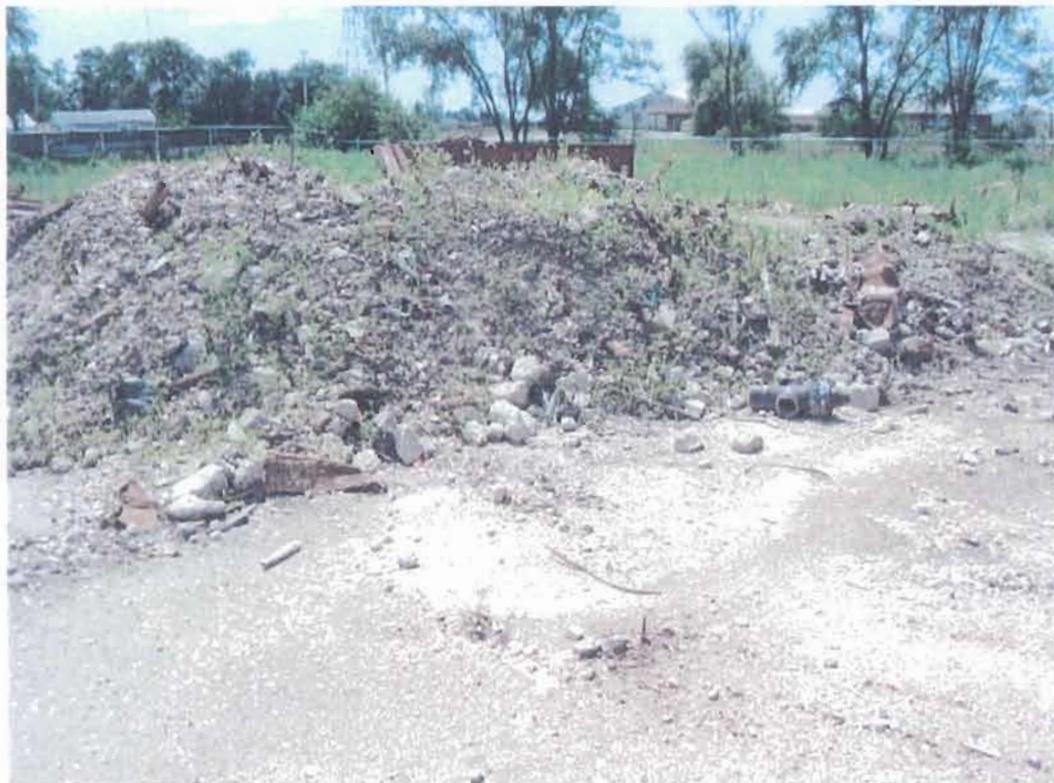
Date: August 4, 2010.
Time: 11:45 AM
Direction: SE
Photo by: Eisenbrandt
Exposure #: 006
Comments: A pile of demolition debris with the start of weedy vegetation.

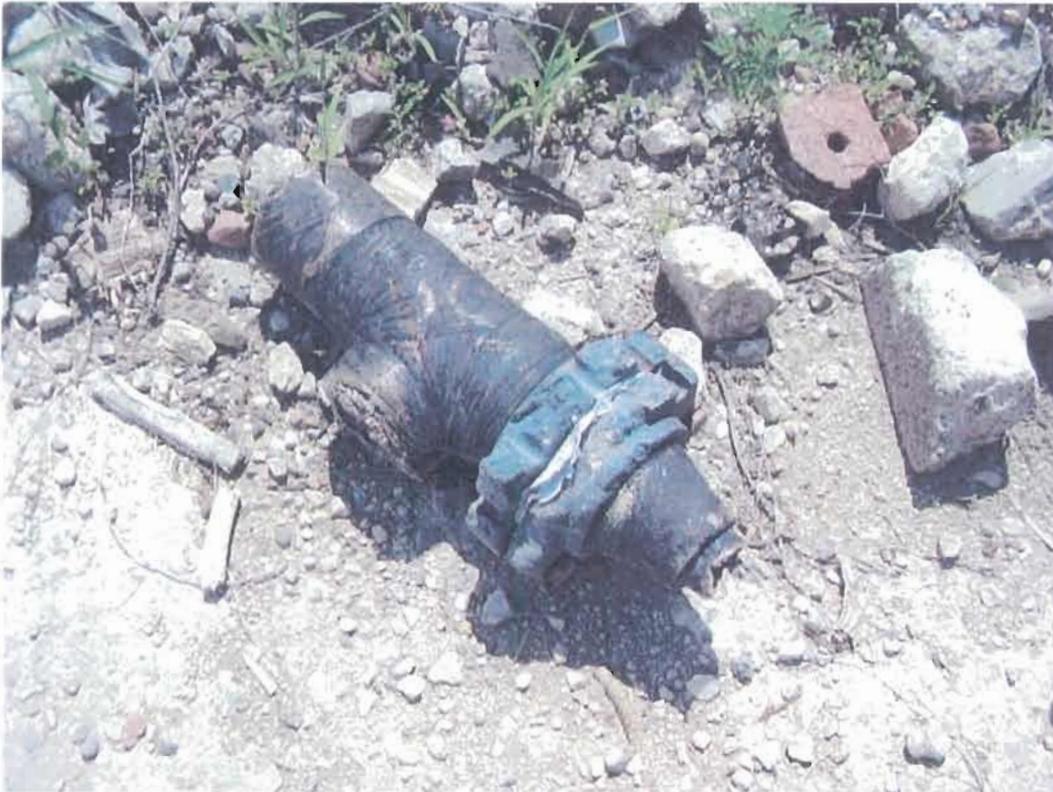
Date: August 4, 2010.
Time: 11:45 AM
Direction: SE
Photo by: Eisenbrandt
Exposure #: 007
Comments: Crushed splinters of lumber, a section of pipe, brick, and concrete were observed in the debris pile.

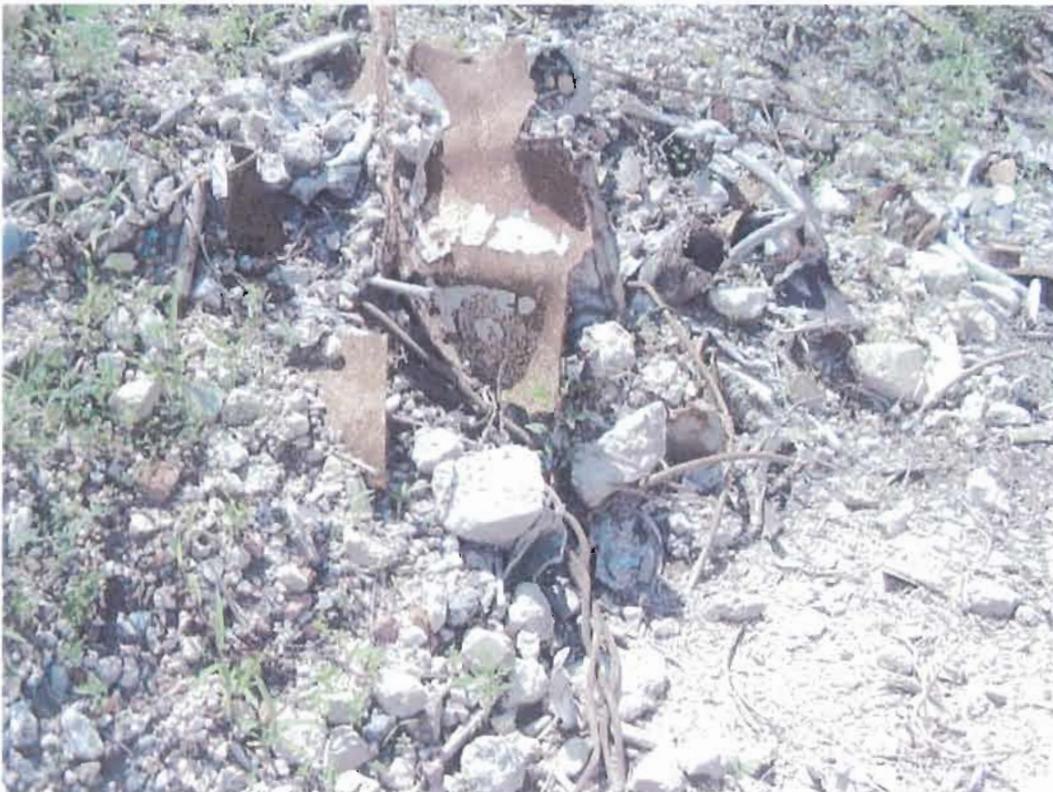
Date: August 4, 2010.
Time: 11:45 AM
Direction: S
Photo by: Eisenbrandt
Exposure #: 008
Comments: The demolition debris pile also contained copious amounts of rusty scrap metal.

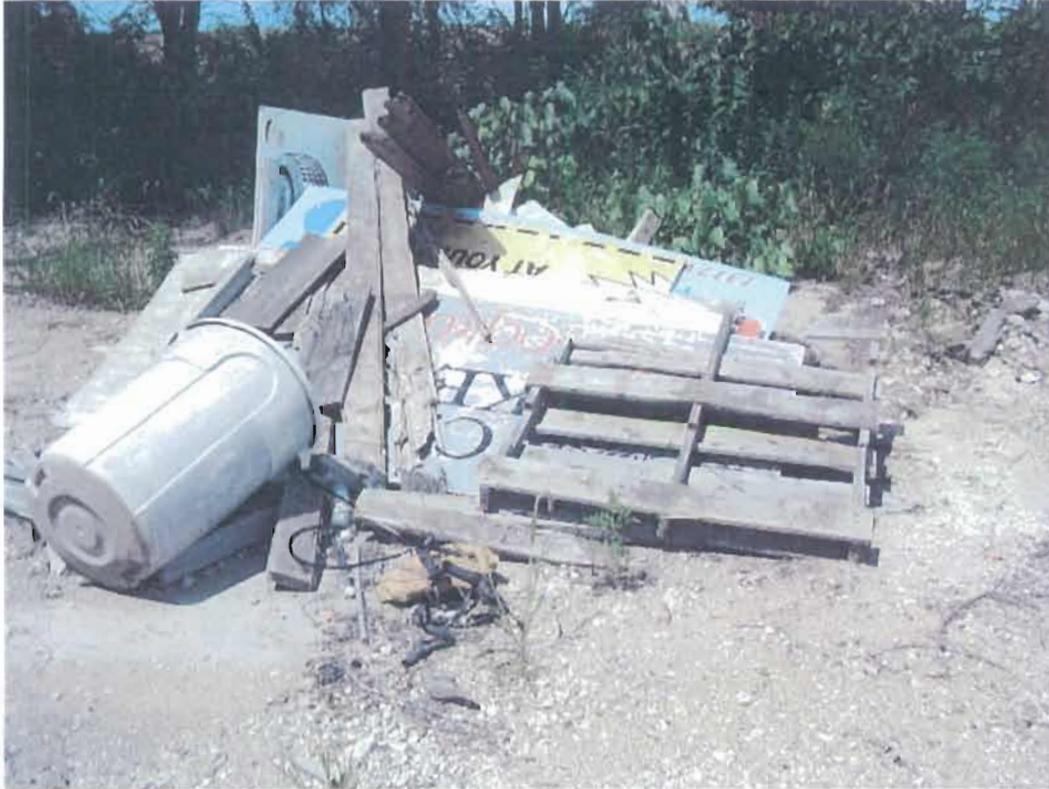
Date: August 4, 2010.
Time: 11:45 AM
Direction: SW
Photo by: Eisenbrandt
Exposure #: 009
Comments: A pile of waste. Broken pallets, damaged dimensional lumber, discarded signage, metal bands, and foam insulation were among the waste observed.

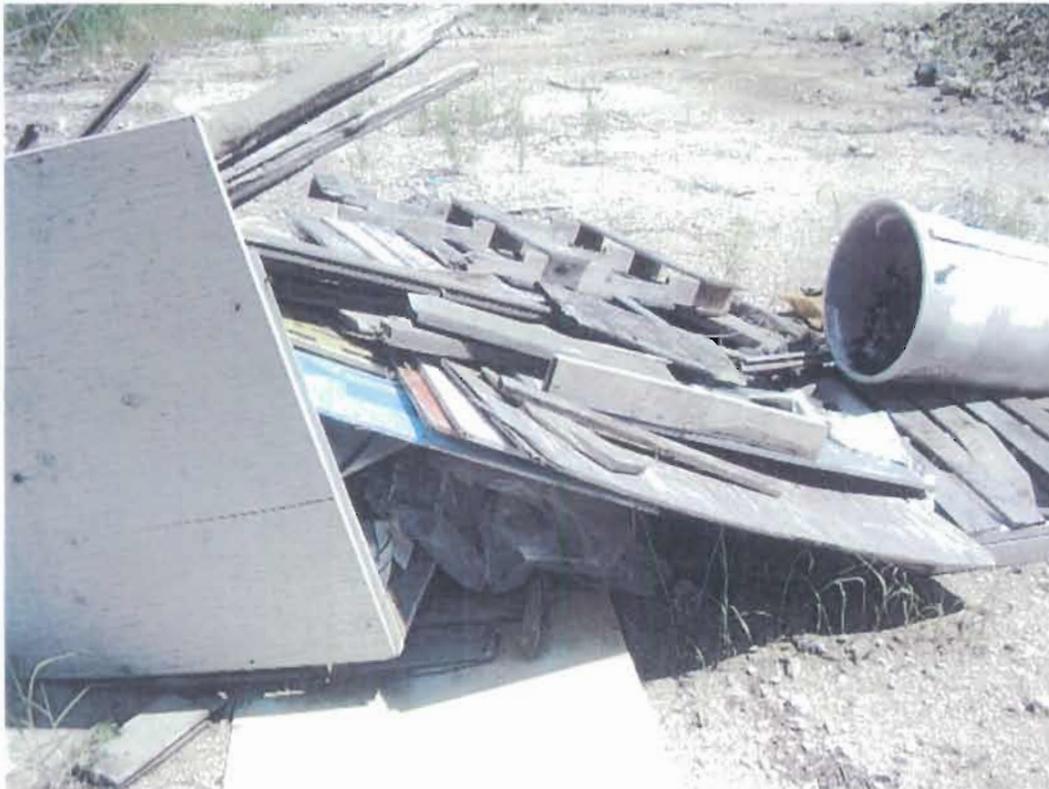
Date: August 4, 2010.
Time: 11:45 AM
Direction: N
Photo by: Eisenbrandt
Exposure #: 010
Comments: Alternate view of the pile of waste. Plywood, processed lumber, and plastic sheeting were observed.

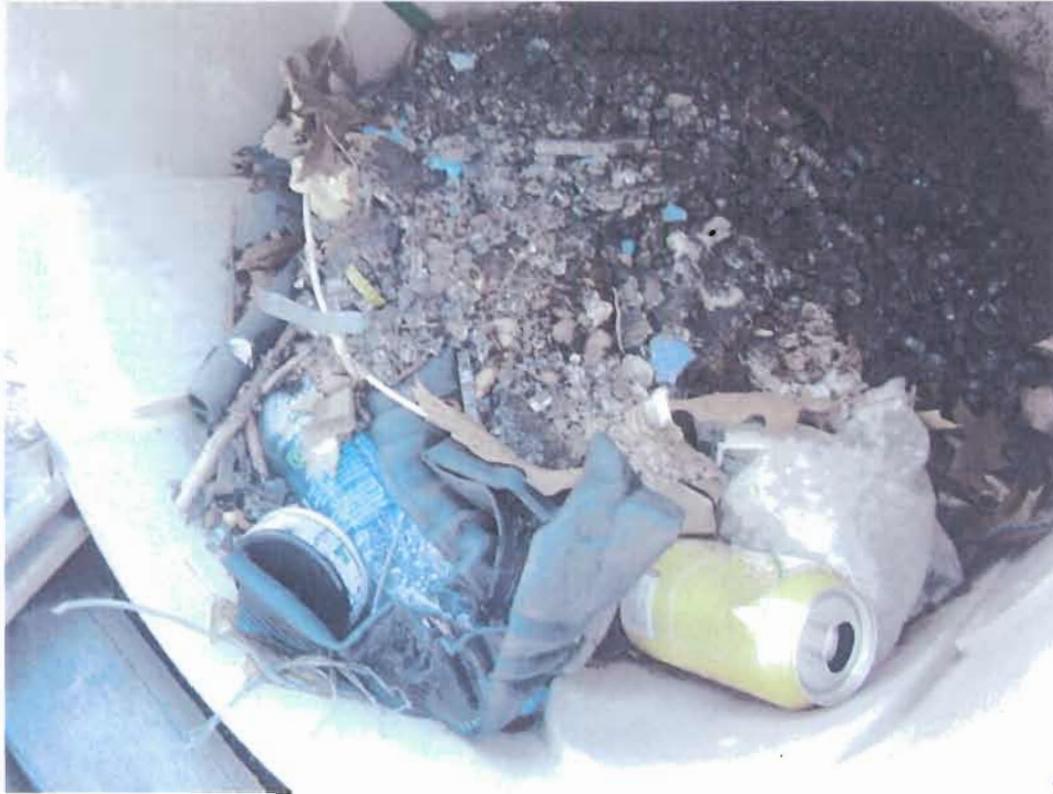
Date: August 4, 2010.
Time: 11:45 AM
Direction: E
Photo by: Eisenbrandt
Exposure #: 011
Comments: The beige plastic garbage can (on its side and seen in the previous two photographs) contained broken glass, plastic, a piece rubber hose, an aluminum can, and miscellaneous waste.

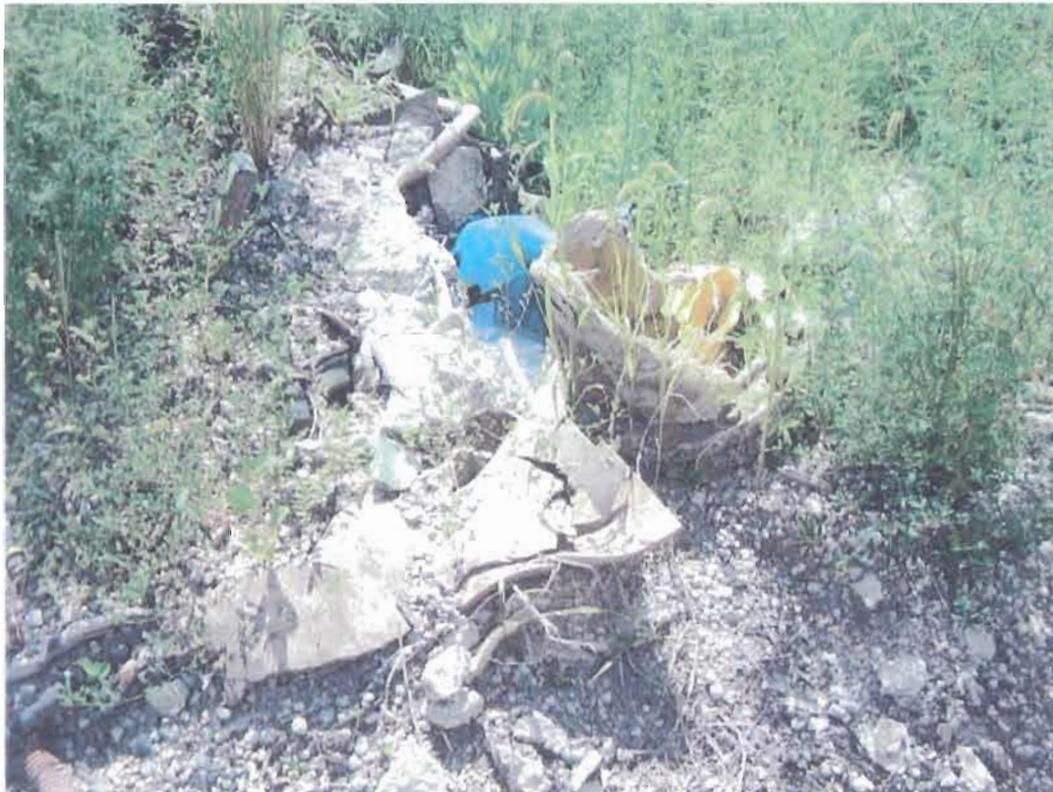
Date: August 4, 2010.
Time: 11:46 AM
Direction: SE
Photo by: Eisenbrandt
Exposure #: 012
Comments: Fiberglass pipe, blue plastic scrap, insulation, and scrap metal.
