BEFORE THE ILLINOIS POLLUTION CONTROL BOARD

PCB No. 13-3
(Enforcement-Land)

LPC# 1258075001 - Mason County
Manito/Fisher, Edward
FOS File
March 23, 2011 Inspection

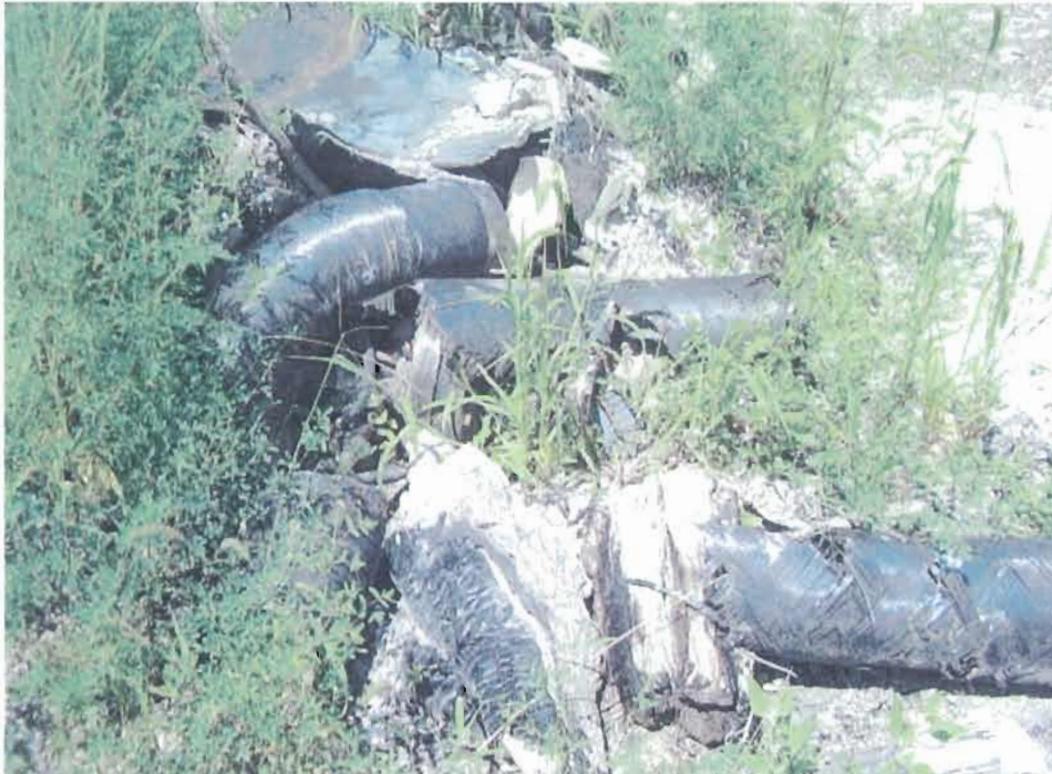
Date: August 4, 2010.
Time: 11:46 AM
Direction: W
Photo by: Eisenbrandt
Exposure #: 013
Comments: Fiberglass pipe, charred landscape debris, and miscellaneous waste.

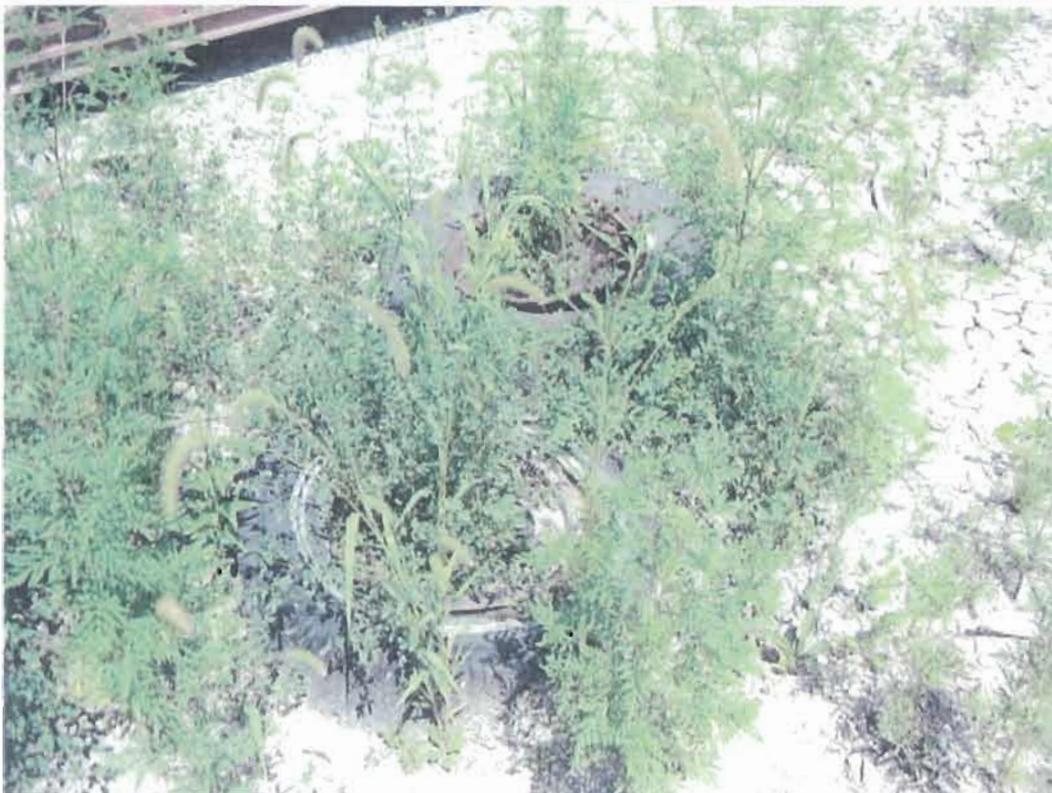
Date: August 4, 2010.
Time: 11:47 AM
Direction: SE
Photo by: Eisenbrandt
Exposure #: 014
Comments: Two on-rim used tires with weedy vegetation growing through them.

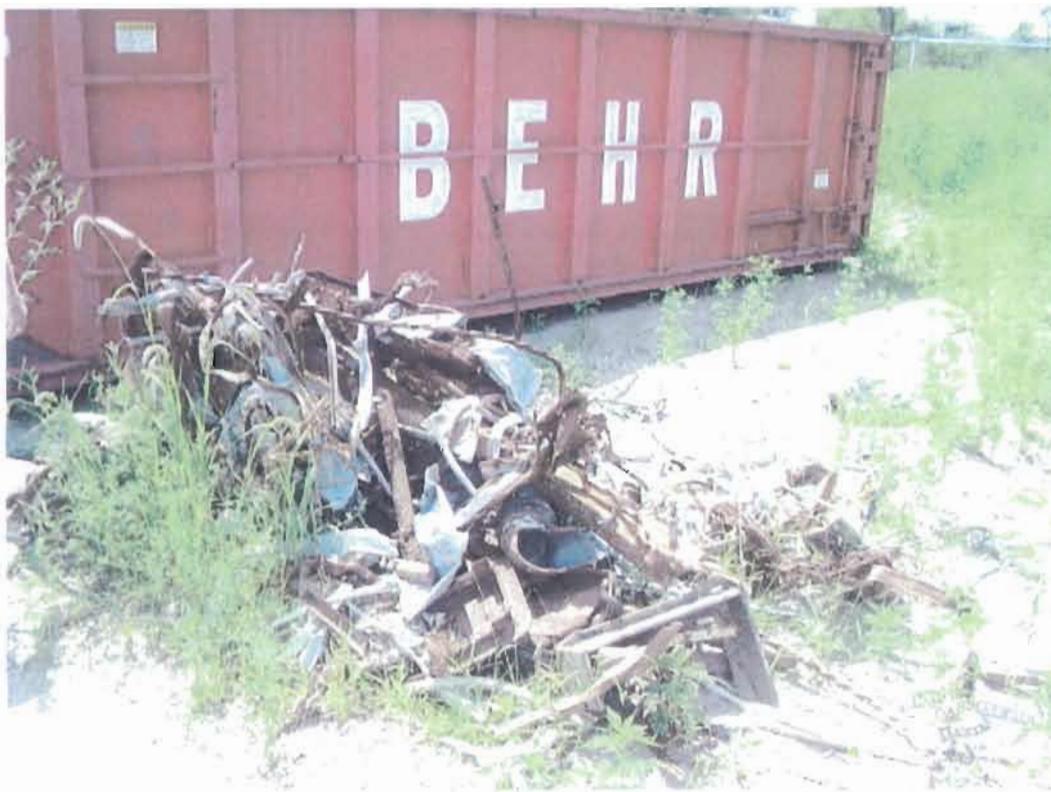
Date: August 4, 2010.
Time: 11:48 AM
Direction: SE
Photo by: Eisenbrandt
Exposure #: 016
Comments: A pile of scrap metal beside a recycling dumpster.

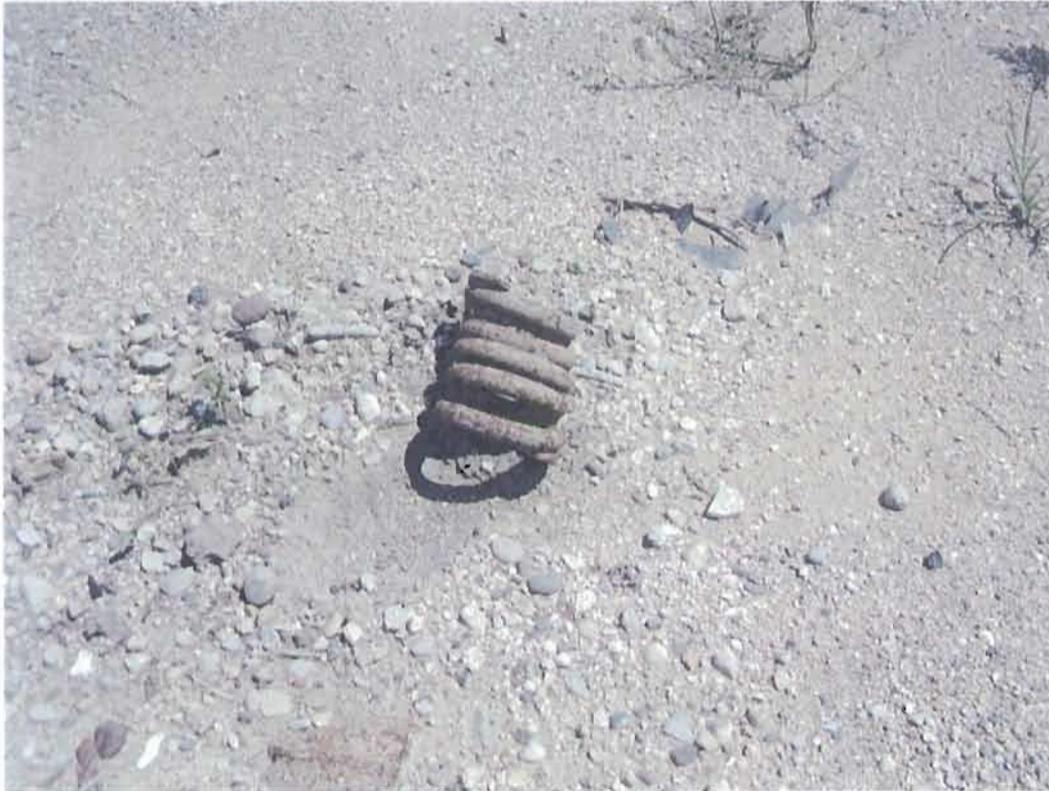
Date: August 4, 2010.
Time: 11:48 AM
Direction: E
Photo by: Eisenbrandt
Exposure #: 017
Comments: A rusty spring, rusty scrap metal, and plastic debris observed on the ground.

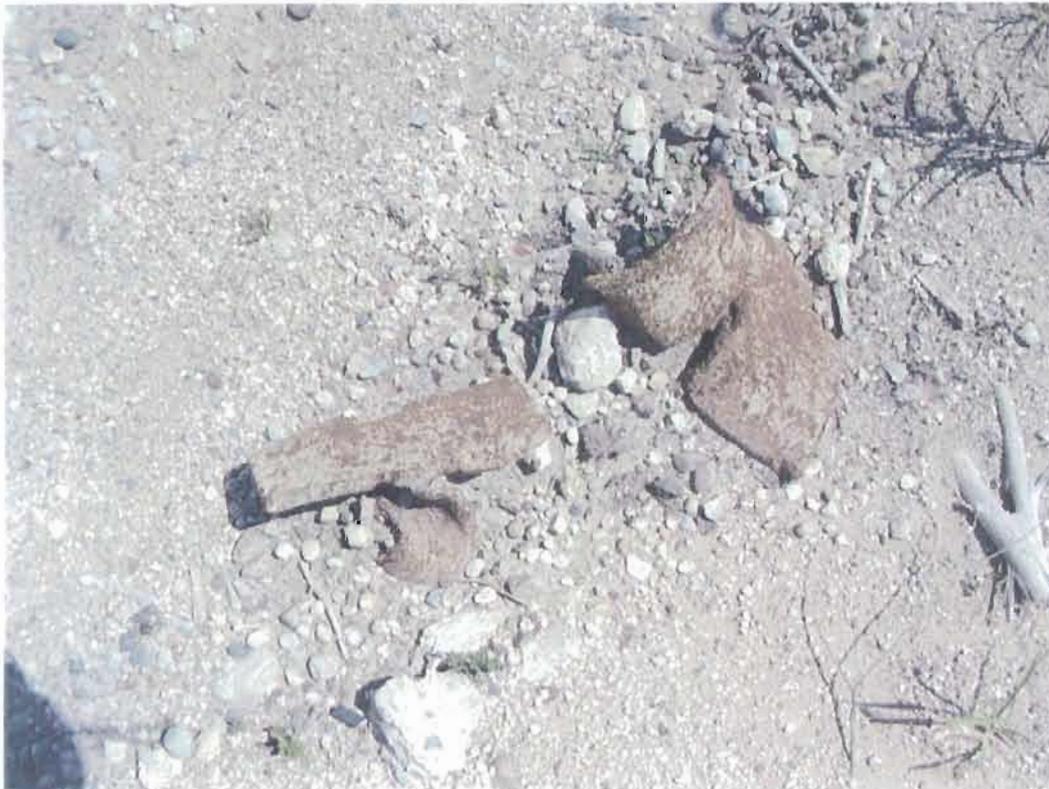
Date: August 4, 2010.
Time: 11:48 AM
Direction: NE
Photo by: Eisenbrandt
Exposure #: 018
Comments: Pieces of rusty scrap metal on the ground.

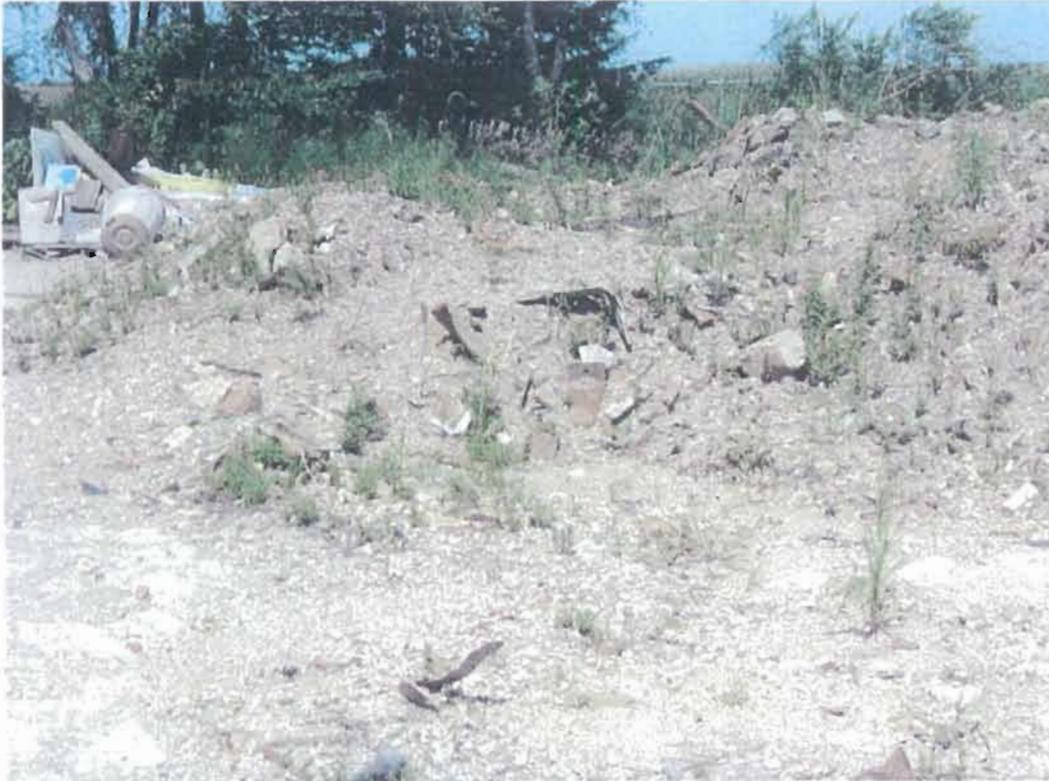
Date: August 4, 2010.
Time: 11:49 AM
Direction: SW
Photo by: Eisenbrandt
Exposure #: 019
Comments: A debris pile with copious amounts of scrap metal, splintered wood, and miscellaneous waste.

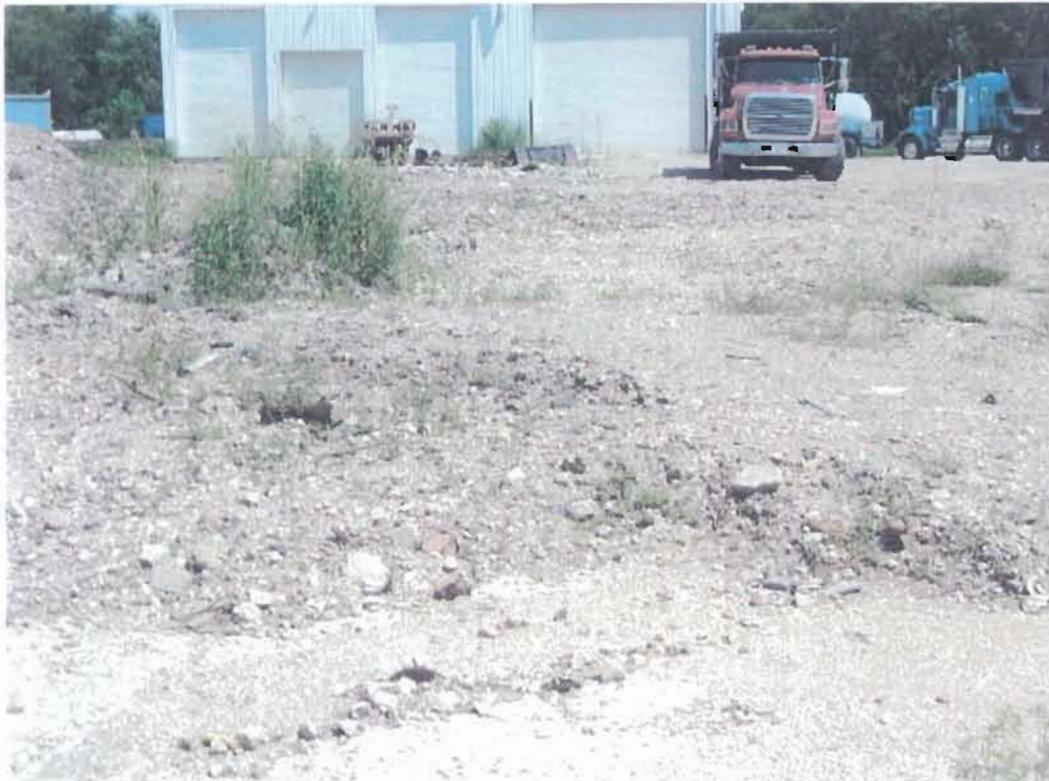
Date: August 4, 2010.
Time: 11:49 AM
Direction: N
Photo by: Eisenbrandt
Exposure #: 020
Comments: Ground surface south of the maintenance garage. Scrap metal, concrete, and brick were intermixed with miscellaneous demolition debris.

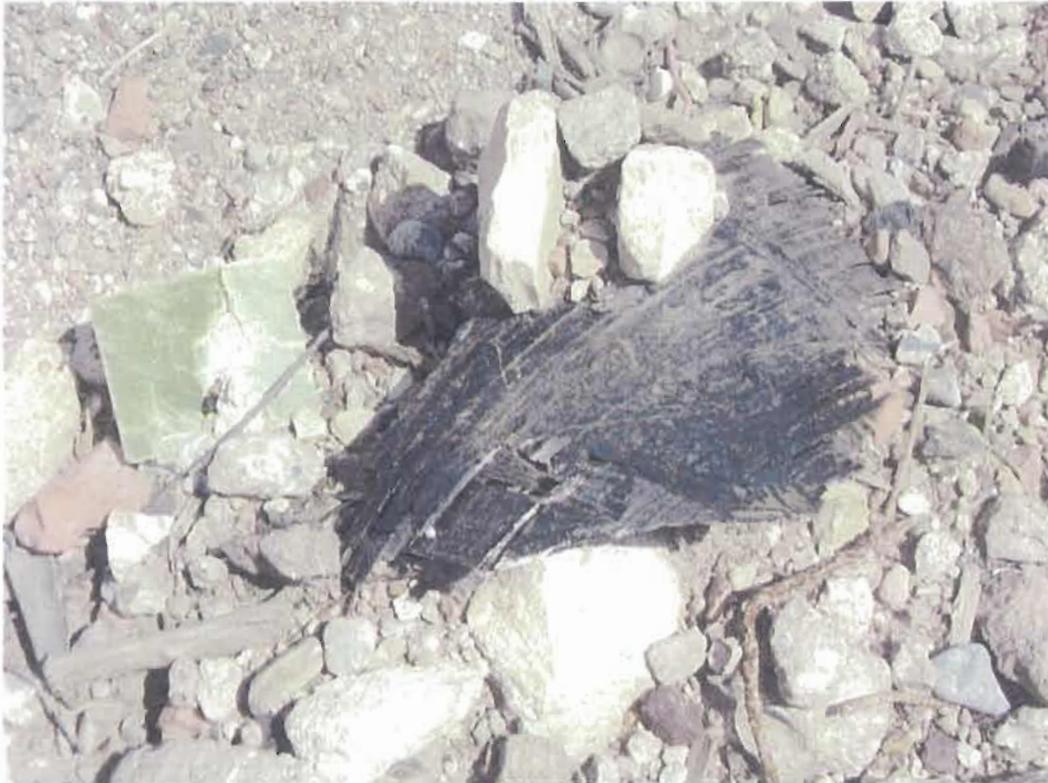
Date: August 4, 2010.
Time: 11:49 AM
Direction: N
Photo by: Eisenbrandt
Exposure #: 021
Comments: A close up photograph of the ground surface seen in Photograph 020. Rusty scrap metal, fiberglass, wire, splintered lumber, and scraps of plastic were observed intermixed with concrete, mortar, and brick fragments.

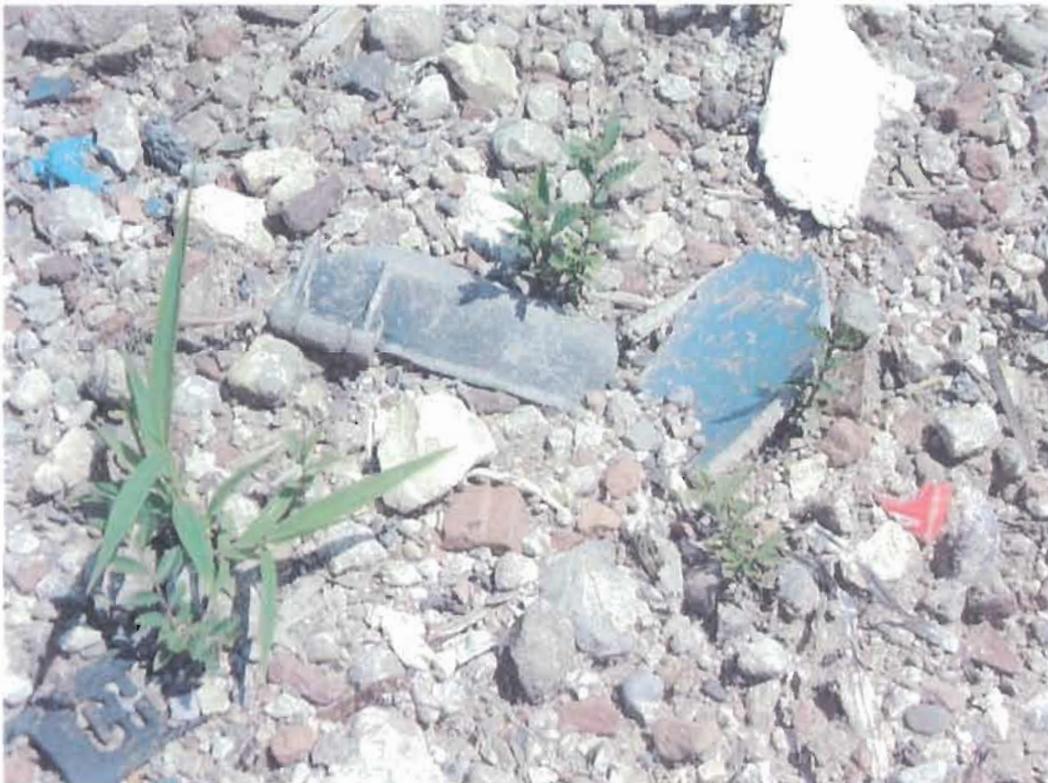
Date: August 4, 2010.
Time: 11:49 AM
Direction: SE
Photo by: Eisenbrandt
Exposure #: 022
Comments: Red, blue, and black plastic, carpet, black rubber, cast iron, and splinters of wood were observed on the ground.

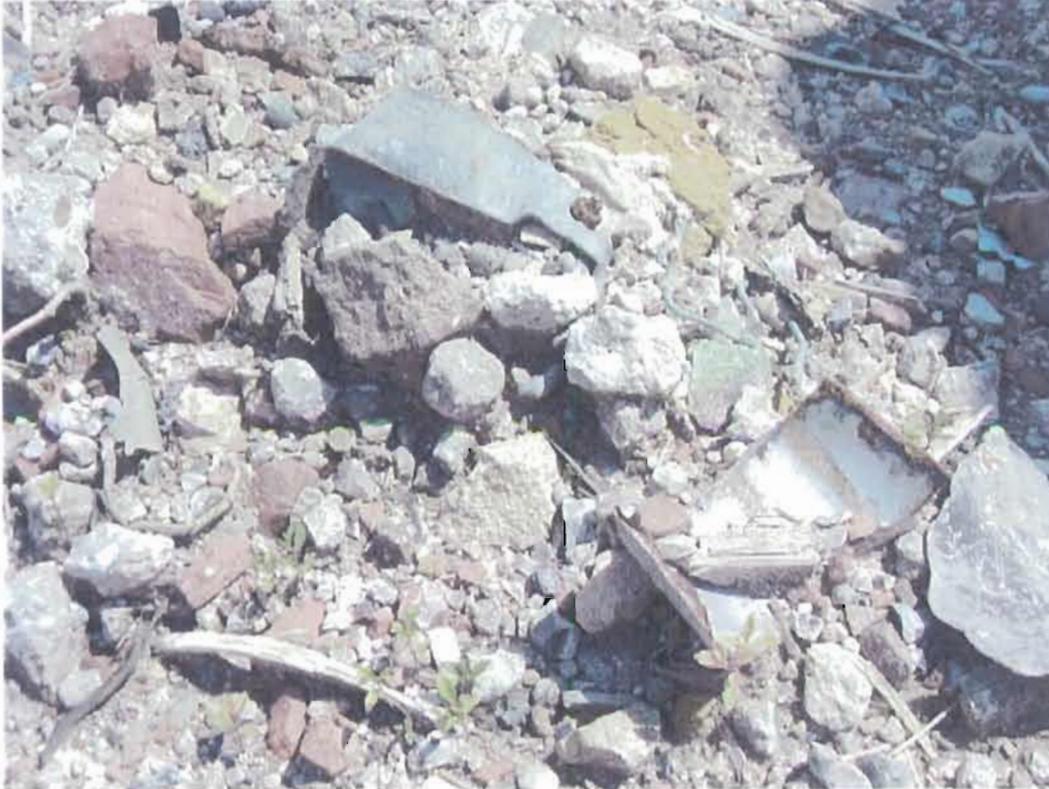
Date: August 4, 2010.
Time: 11:49 AM
Direction: NE
Photo by: Eisenbrandt
Exposure #: 023
Comments: Another example of the demolition debris spread across the site. Copper wire, scrap metal, electrical wire, foam, and asphalt materials were observed on the ground.

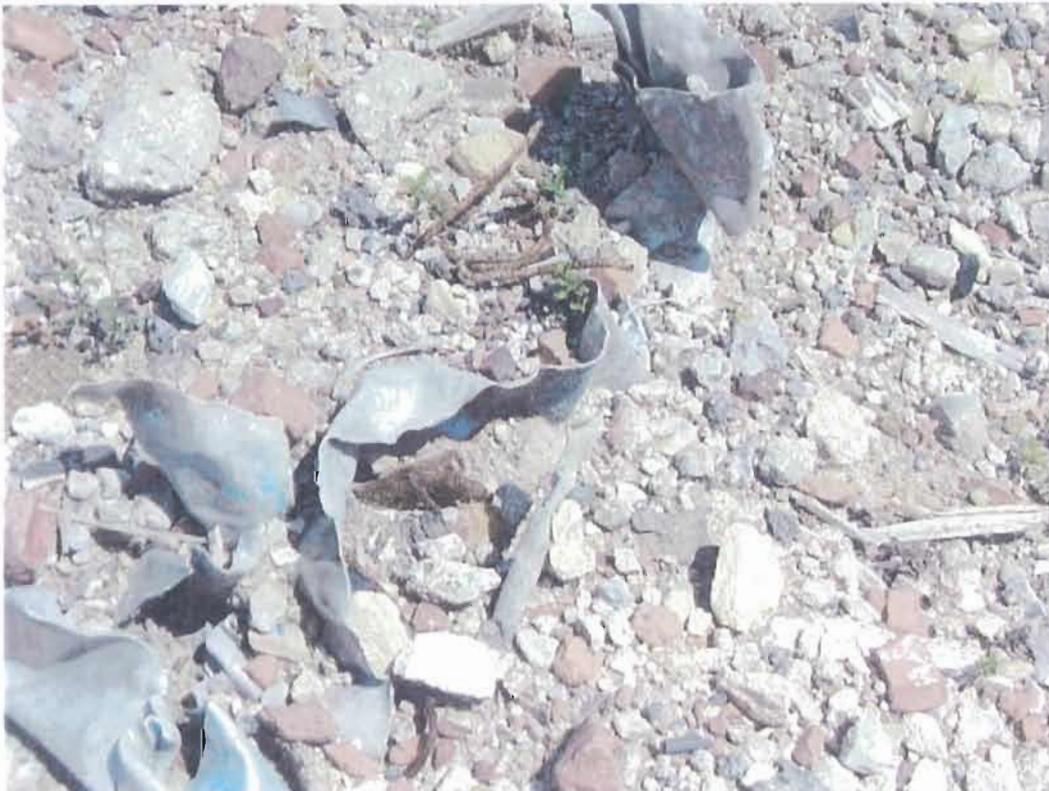
Date: August 4, 2010.
Time: 11:50 AM
Direction: NE
Photo by: Eisenbrandt
Exposure #: 024
Comments: Rusty iron fragments, fiberglass, splintered wood, and malleable metal were observed on the ground surface.

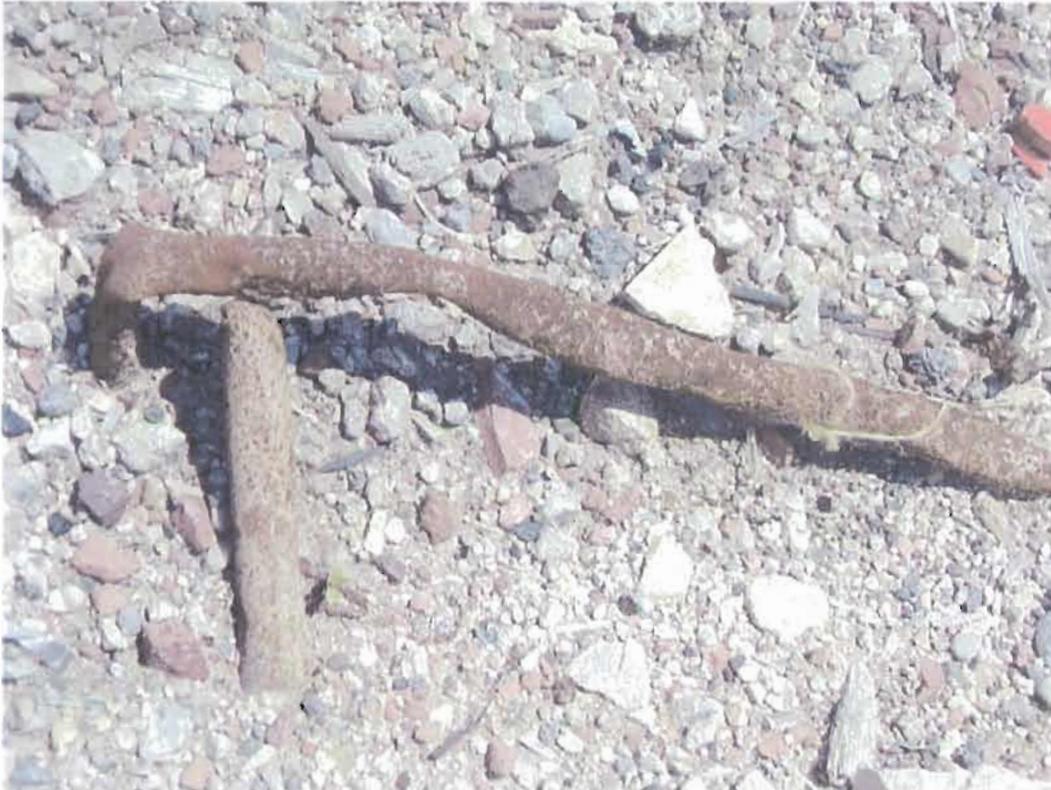
Date: August 4, 2010.
Time: 11:50 AM
Direction: N
Photo by: Eisenbrandt
Exposure #: 025
Comments: Rusty scrap metal and miscellaneous waste observed on the ground surface.

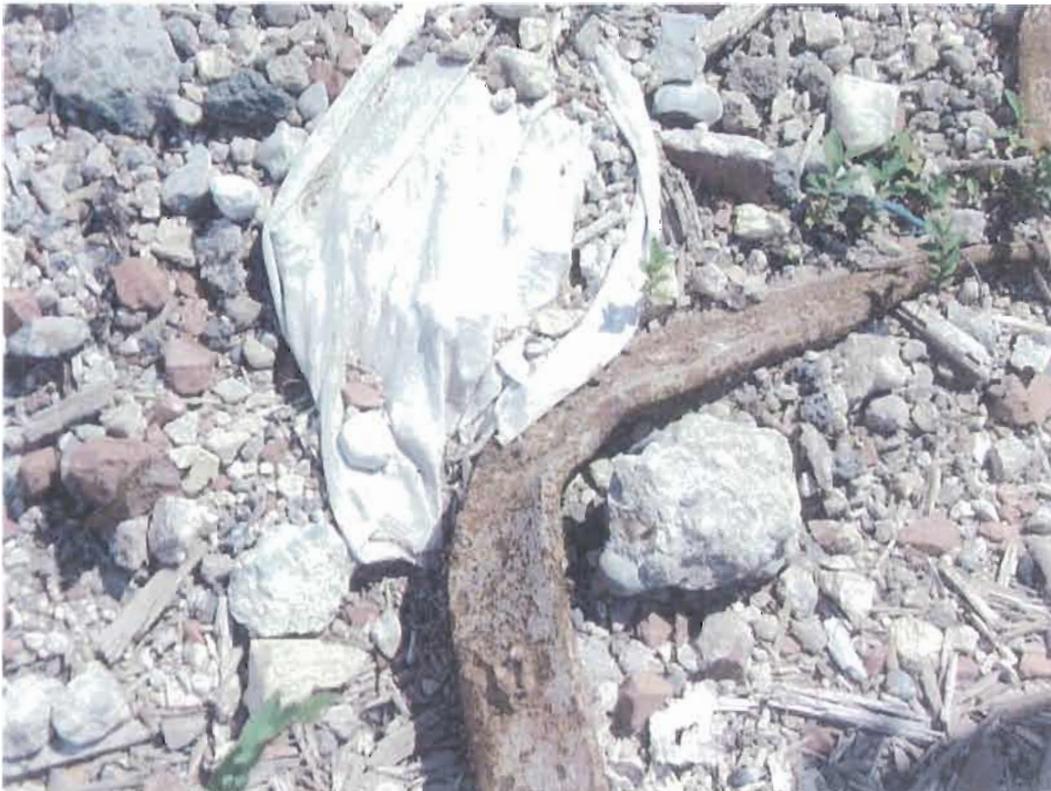
Date: August 4, 2010.
Time: 11:50 AM
Direction: N
Photo by: Eisenbrandt
Exposure #: 026
Comments: Scrap metal, splintered wood, fabric-like material, and metal wire were observed on the ground.

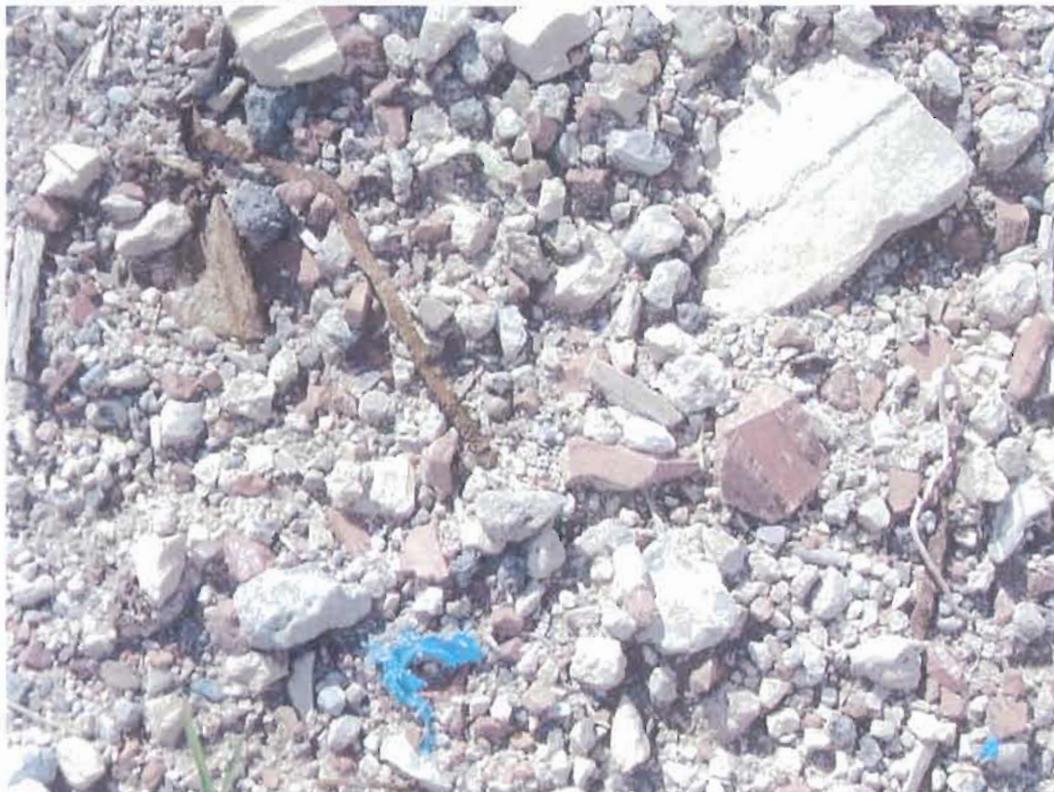
Date: August 4, 2010.
Time: 11:50 AM
Direction: SW
Photo by: Eisenbrandt
Exposure #: 027
Comments: Wire, blue plastic, scrap wood, and rusty metal on the ground.

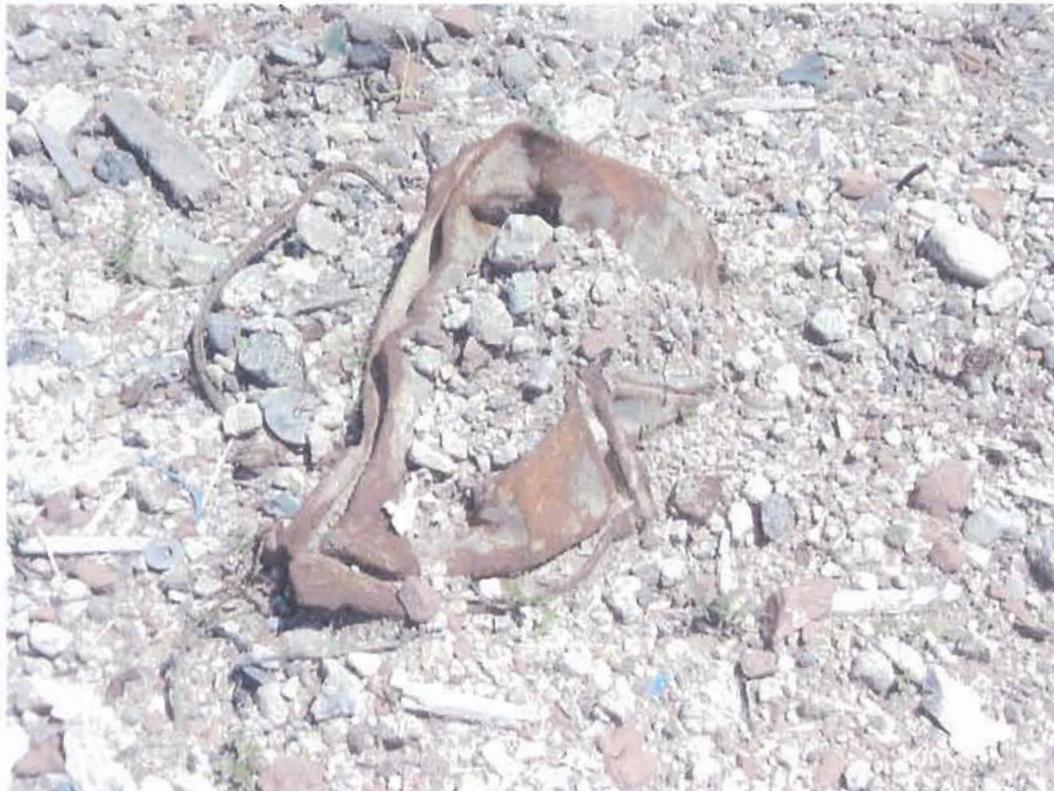
Date: August 4, 2010.
Time: 11:50 AM
Direction: NE
Photo by: Eisenbrandt
Exposure #: 028
Comments: Rusty scrap metal intermixed with demolition debris on the ground.

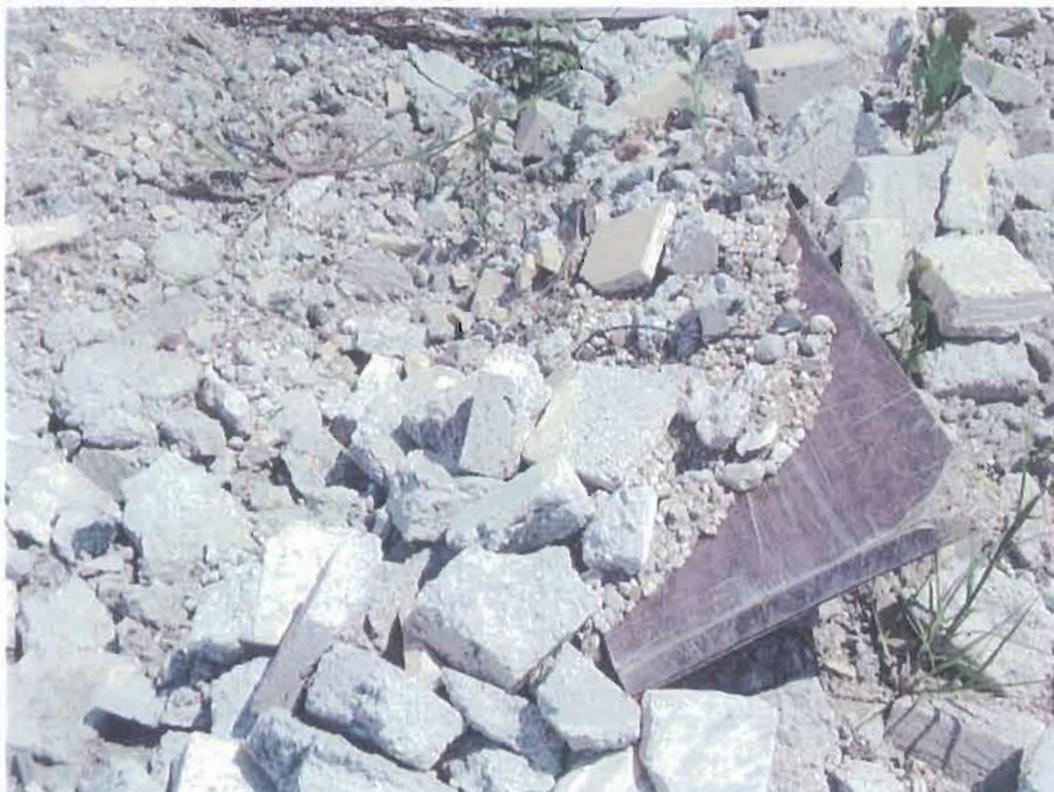
Date: August 4, 2010.
Time: 11:51 AM
Direction: W
Photo by: Eisenbrandt
Exposure #: 031
Comments: More waste partially buried.

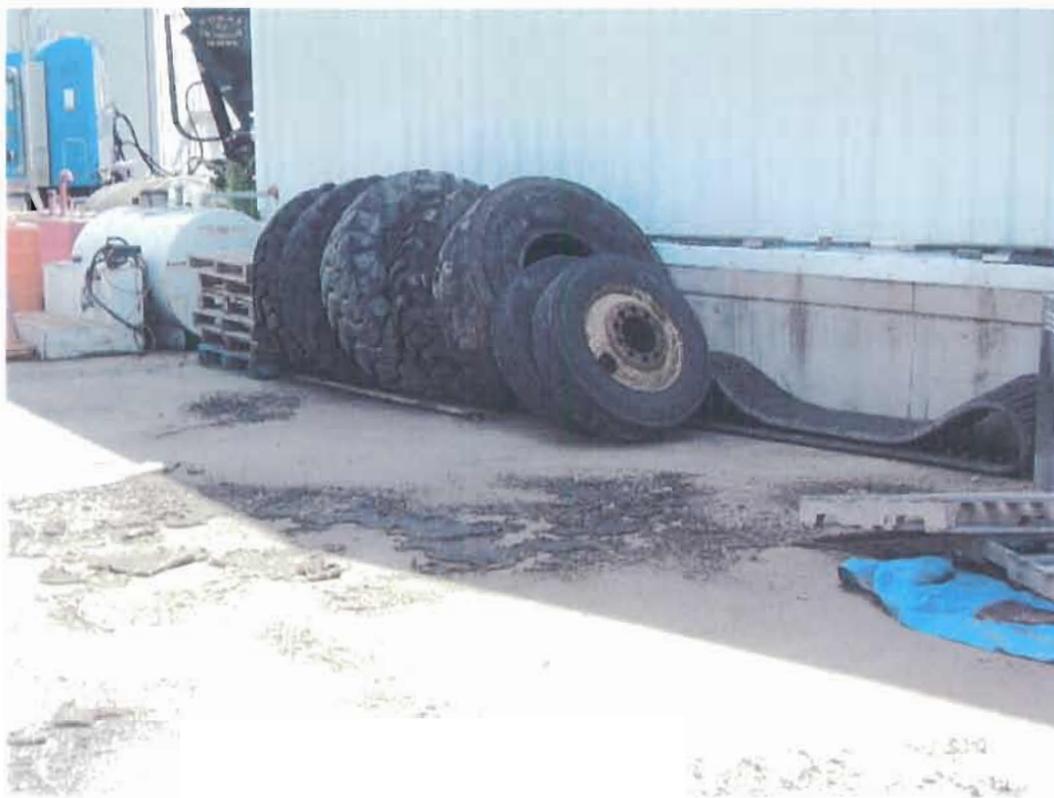
Date: August 4, 2010.
Time: 11:52 AM
Direction: NE
Photo by: Eisenbrandt
Exposure #: 032
Comments: Used tires stored along the west wall of the maintenance building.

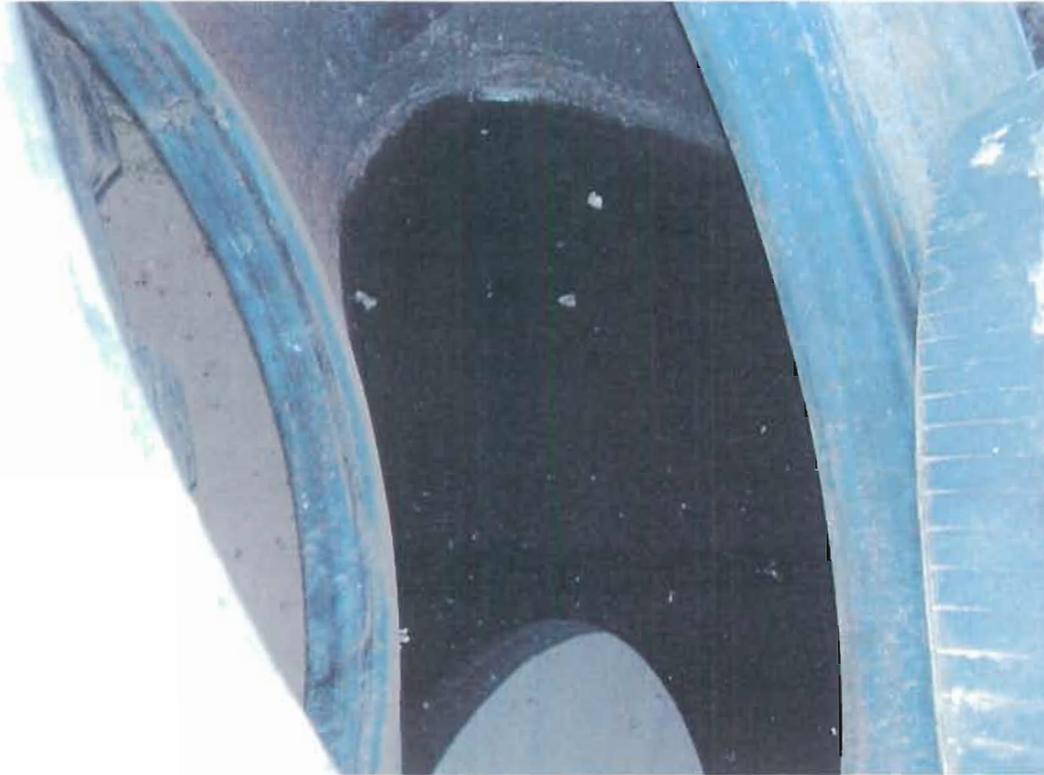
The Respondent caused or allowed water to accumulate in used or waste tires at the corporate site as depicted in Complaint Exhibit 2, August 4, 2010, Exposures 4, 33, pp. 2, 17, and March 23, 2011, Exposures 40 and 41 pp. 38 and 39. (See, Paragraph 18, Count IV of the Complaint and Eisenbrandt Affidavit).

Date: August 4, 2010.
Time: 11:53 AM
Direction: E
Photo by: Eisenbrandt
Exposure #: 033
Comments: Water was observed in the used tires seen in Photograph 032.

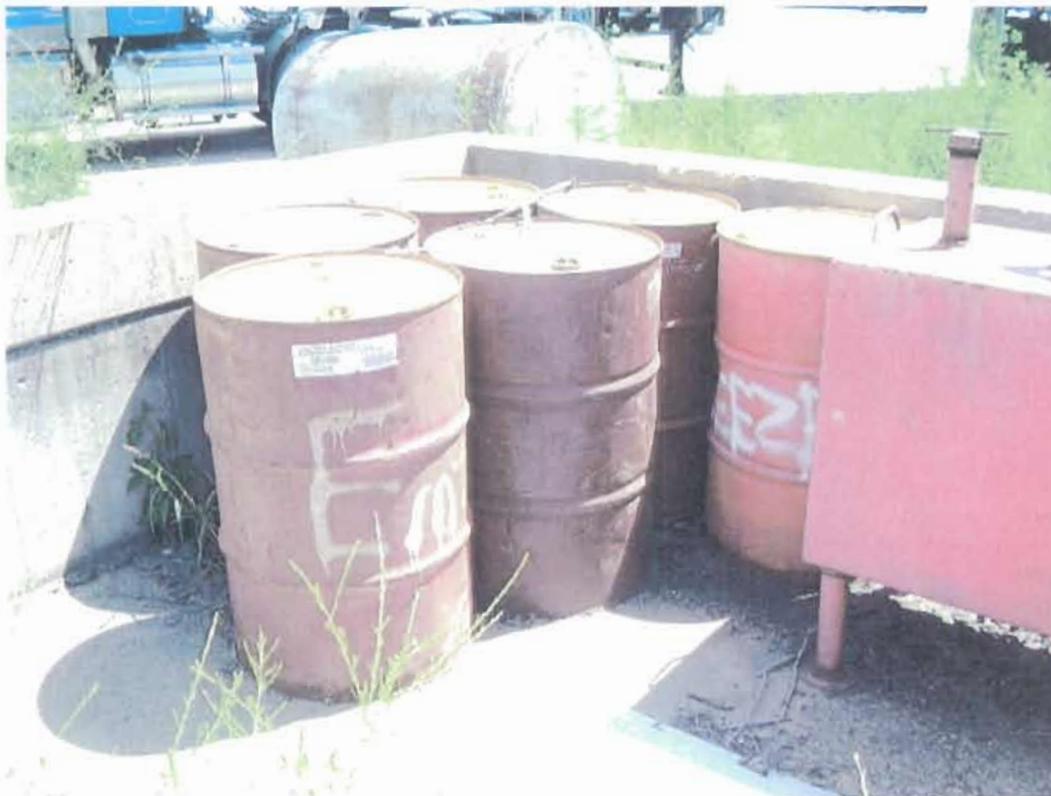
Date: August 4, 2010.
Time: 11:53 AM
Direction: NE
Photo by: Eisenbrandt
Exposure #: 034
Comments: Six 55-gallon drums stored in the concrete containment area. One of the drums was labeled antifreeze and appeared full. Another drum was labeled "Empty" yet was full of liquid.
