**Illinois Environmental Protection Agency
Bureau of Land – Field Operations Section – Marion
Narrative Inspection Report**

LPC #: 0258035005 – Clay County

Site Name: Xenia / Bailey, Darren A. & Cynthia J. Trust

Subject: Open Dump Inspection at Darren A. & Cynthia J. Bailey Site

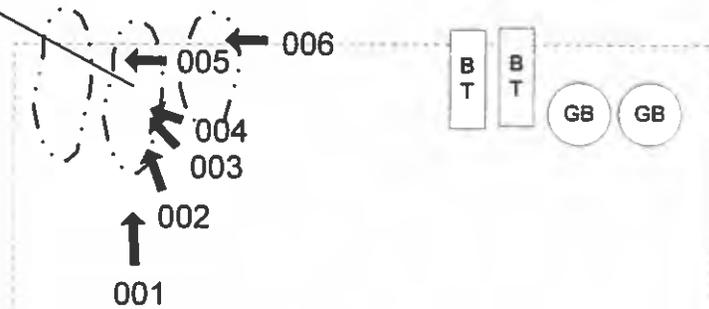
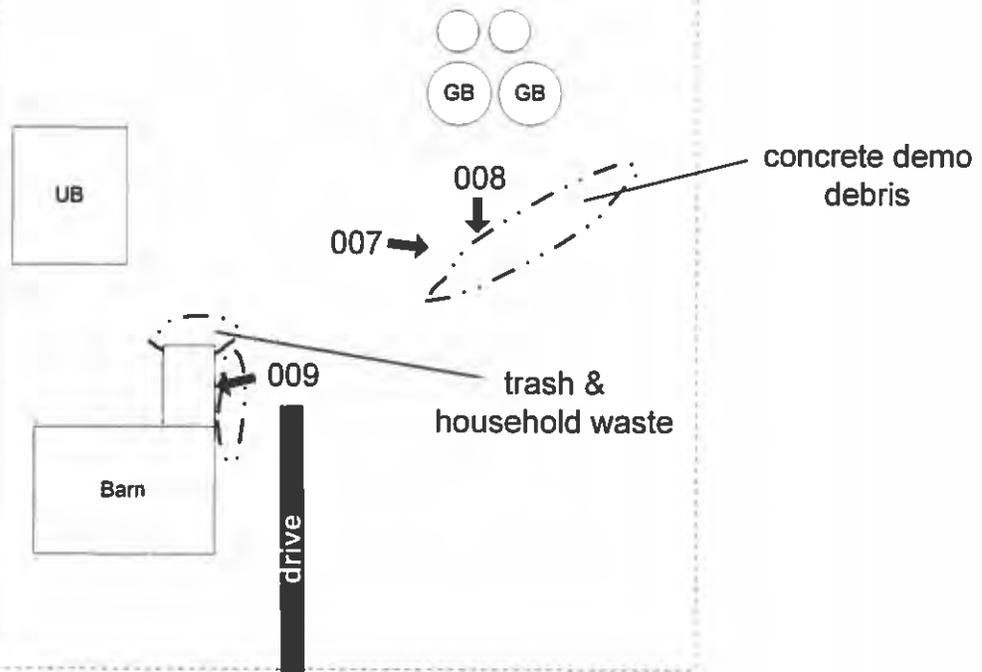
Illinois Environmental Protection Agency
Bureau of Land – Field Operations Section – Marion
Inspection Site Sketch

mixed demo
debris piles

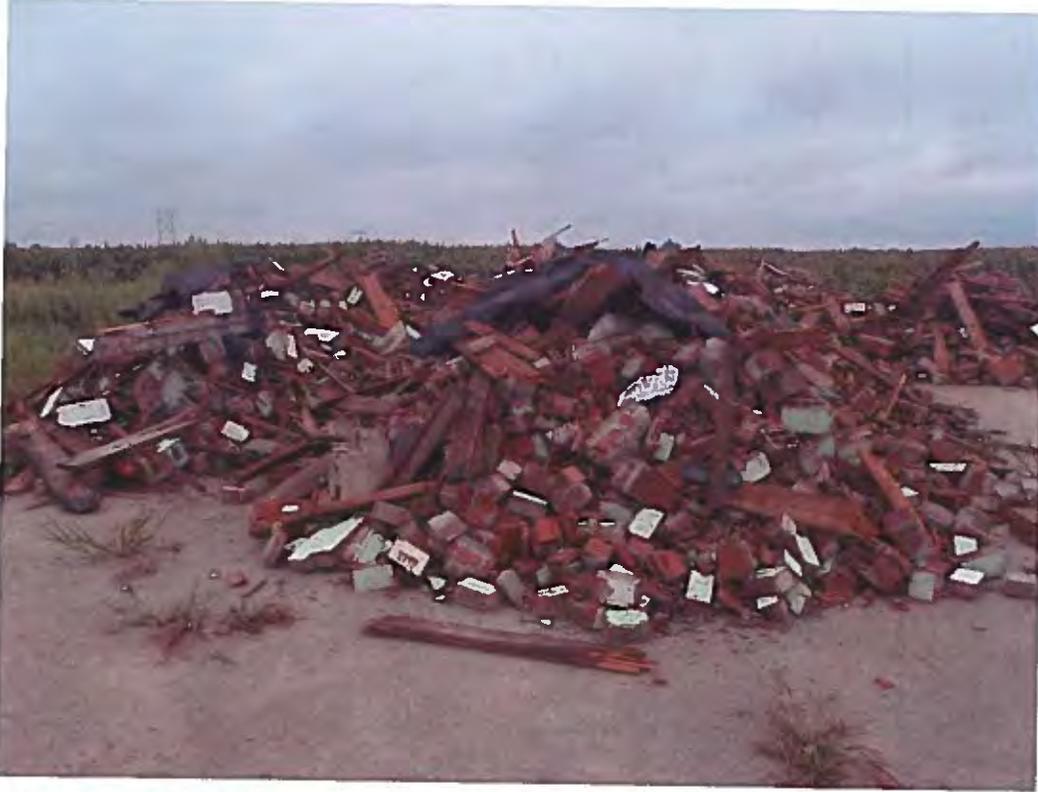
Date: 08/17/2017
Time: 9:20 a.m.
Direction: north
Photo by: G. Gross
Exposure #: 001
Comments: general
demolition debris

General Construction / Demolition Debris: Nine (9) piles of general construction / demolition debris had recently been dumped at the site. The waste piles were dumped at the northwest end of a gravel lot adjacent to two silos and two semi-box trailers. The demolition debris consisted of, but was not limited to: solid bricks, hollow core “grid shaped” bricks, concrete blocks, dimensional lumber, and roofing materials (photos 001-006). Some of the bricks and blocks were painted. The paint colors were white and mint green. The roofing material was in wide pieces similar to the kind that comes on a roll. The roofing material was black in color and some pieces had fibrous edges. The amount of debris was estimated to be ~100 cubic yards.

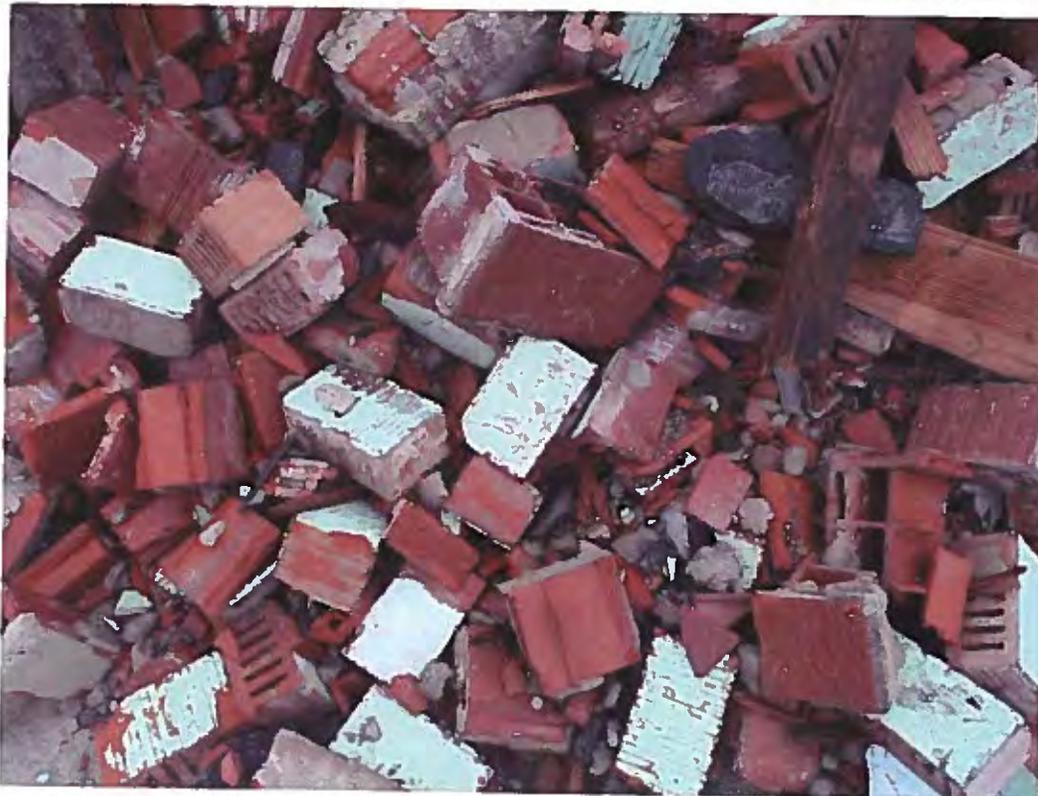
Date: 08/17/2017
Time: 9:21 a.m.
Direction: north
Photo by: G. Gross
Exposure #: 002
Comments: general
demolition debris;
painted bricks and
lumber

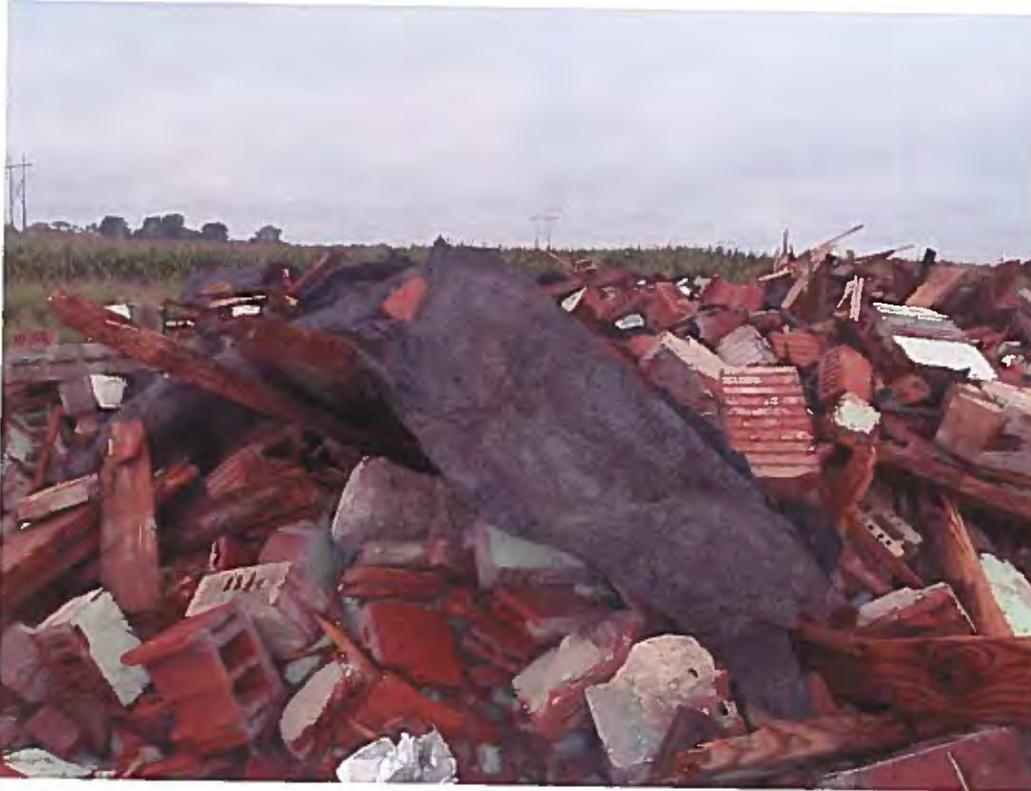
Date: 08/17/2017
Time: 9:21 a.m.
Direction: northwest
Photo by: G. Gross
Exposure #: 003
Comments: general
demolition debris;
painted bricks,
lumber, and roofing
material

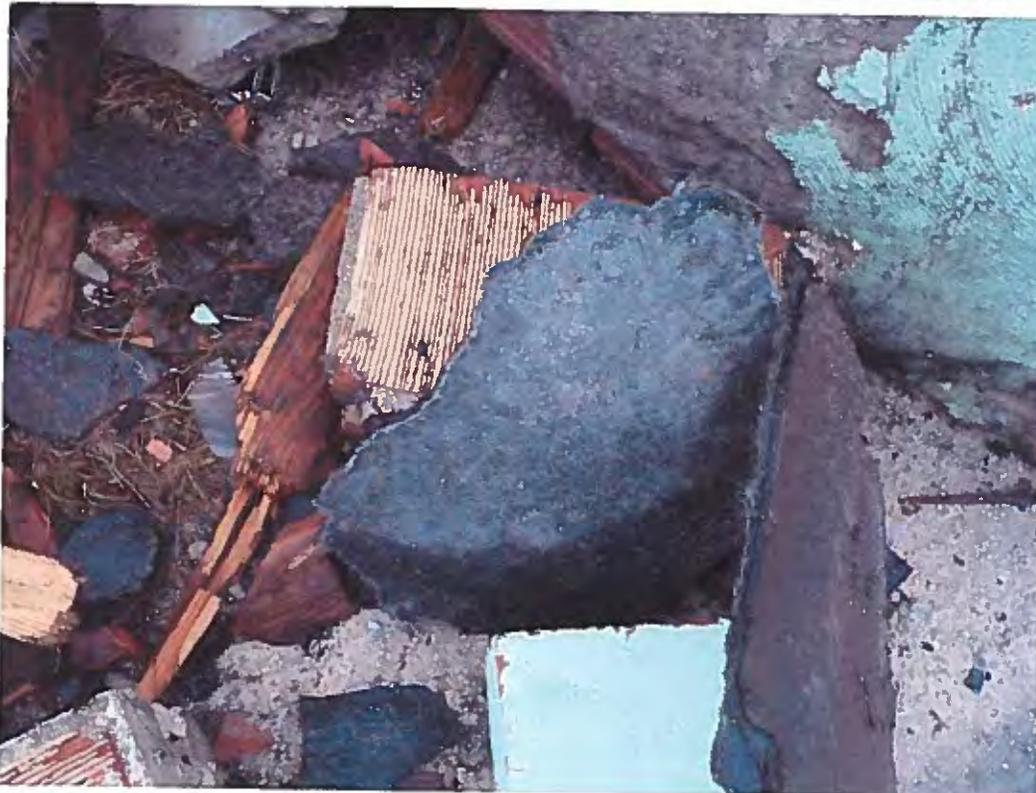
Date: 08/17/2017
Time: 9:22 a.m.
Direction: west
Photo by: G. Gross
Exposure #: 004
Comments: general
demolition debris;
roofing material with
fibrous edge

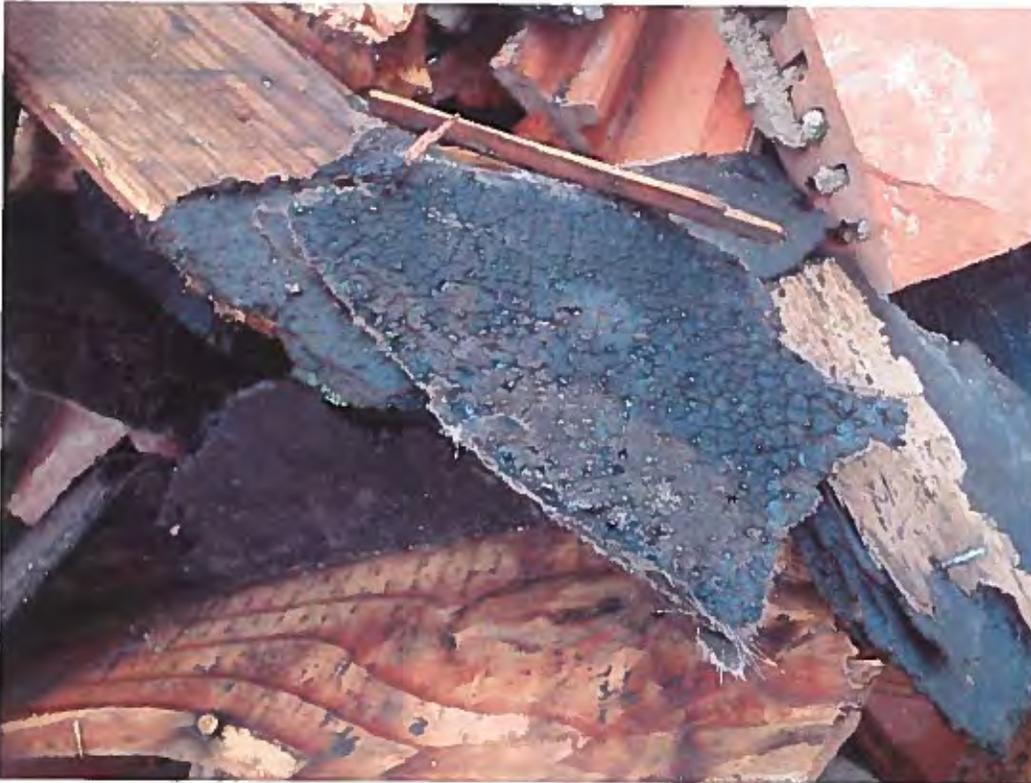
Date: 08/17/2017
Time: 9:23 a.m.
Direction: west
Photo by: G. Gross
Exposure #: 005
Comments: general
demolition debris;
roofing material with
fibrous edge

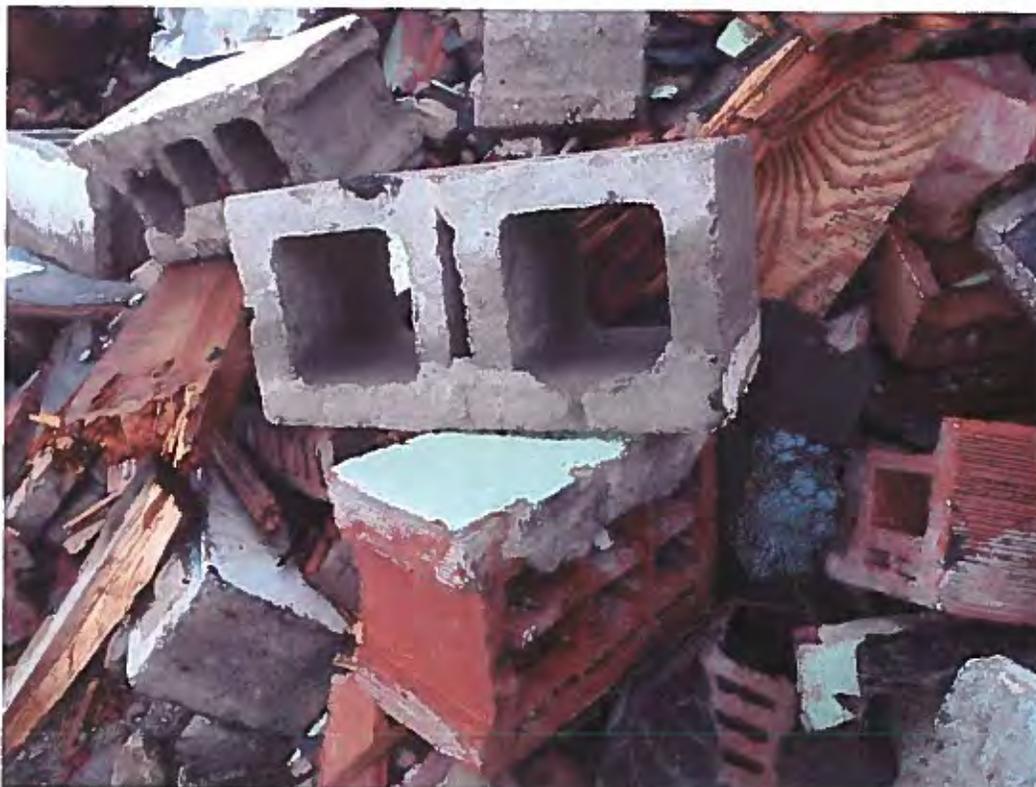
Date: 08/17/2017
Time: 9:24 a.m.
Direction: west
Photo by: G. Gross
Exposure #: 006
Comments: general
demolition debris;
painted bricks and
blocks

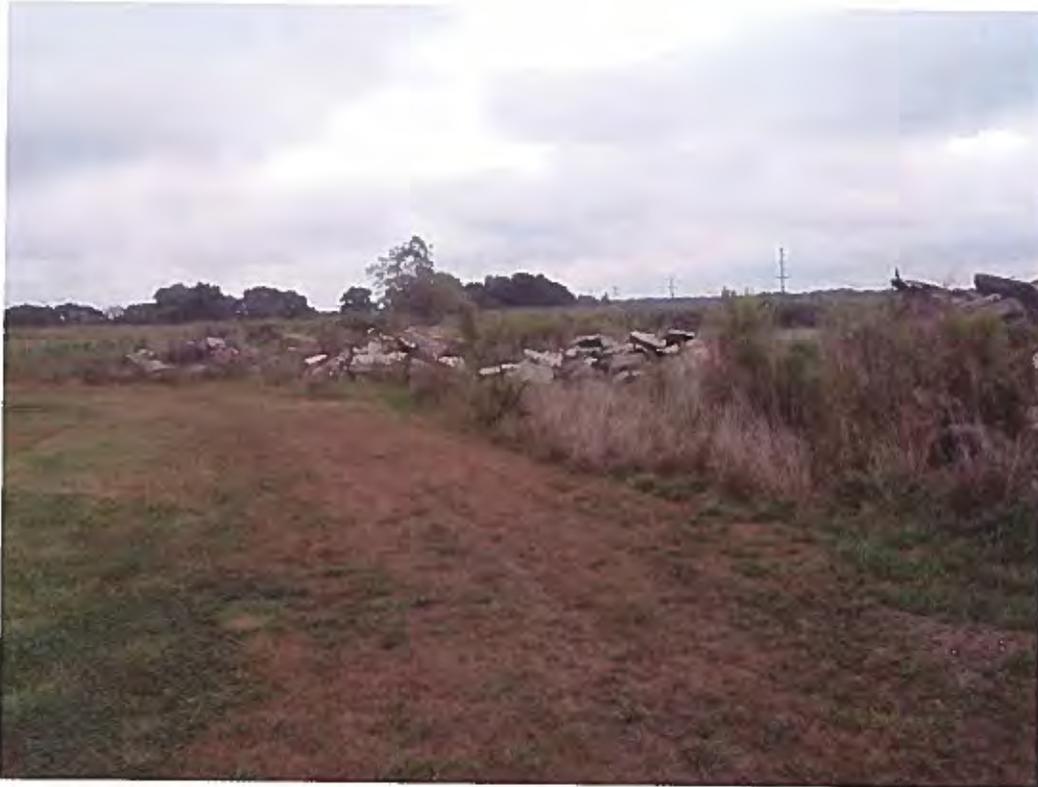
Clean Construction / Demolition Debris: Six (6) piles of clean construction / demolition debris had been dumped at the site. The waste piles were dumped southeast of four grain silos. The demolition debris consisted of, but was not limited to: concrete slabs, concrete blocks, and stone (photo 007). None of the material appeared to be painted. The concrete material appeared to have been there for several years based on overgrowth in weeds and trees (photo 008). The amount of debris was estimated to be 130 cubic yards.

Date: 08/17/2017
Time: 9:27 a.m.
Direction: east
Photo by: G. Gross
Exposure #: 007
Comments: clean
demolition debris;
old piles

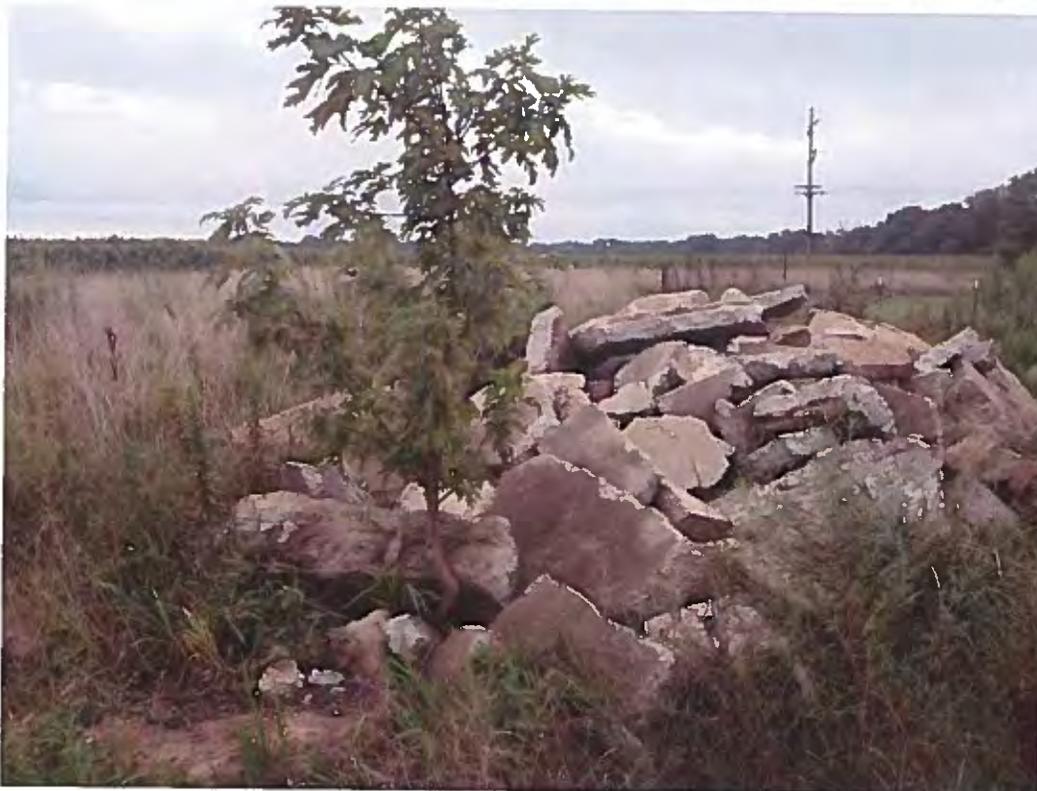
Date: 08/17/2017
Time: 9:28 a.m.
Direction: south
Photo by: G. Gross
Exposure #: 008
Comments: clean
demolition debris;
old piles

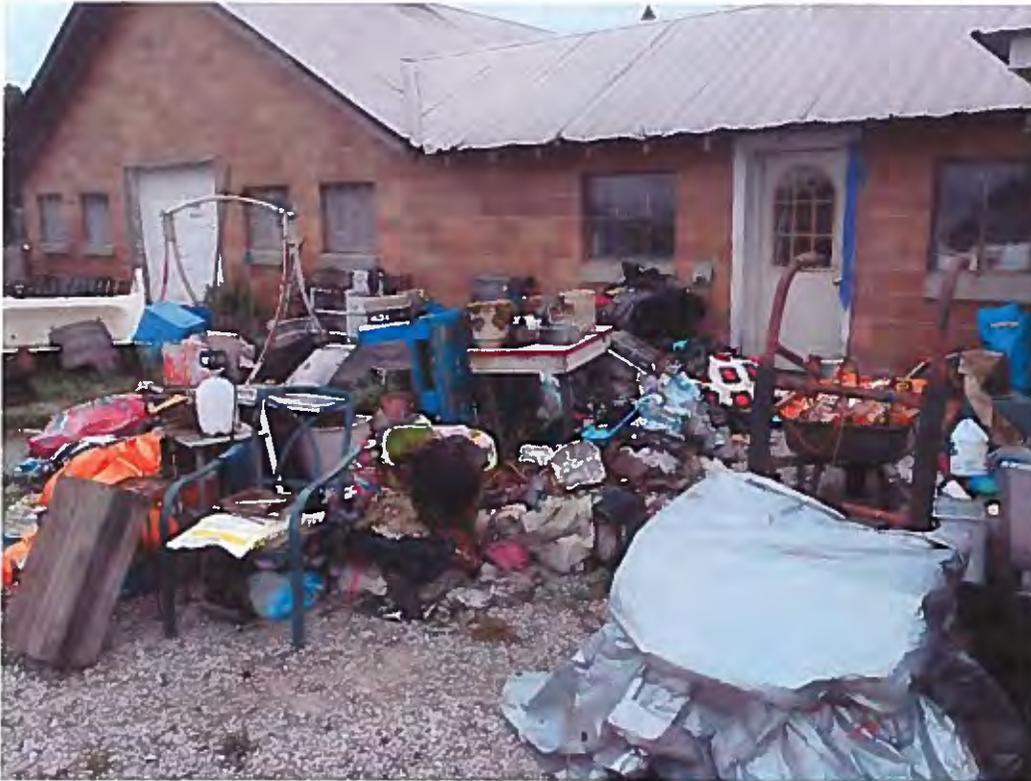
Domestic Waste and Other Open Dumped Items: Various open dumped domestic “household” and trash-like items were cluttered around the entrance to one of the farm buildings (photo 009). Open dumped items included but were not limited to: pallets, clothing, empty dog food bags, plastic jugs, plastic buckets, laundry baskets, plastic tubs, furniture, bathroom tub, household trash, and a deer head. The items were exposed to the elements and did not appear to be in use.

Date: 08/17/2017
Time: 9:29 a.m.
Direction: west
Photo by: G. Gross
Exposure #: 009
Comments: open
dumped household
items and trash

Telephone Interview of Darren Bailey: I spoke to Mr. Bailey later that afternoon. I informed him of the complaint. He recalled speaking with me in 2014 concerning his open dump on the same farm. He admitted that the village hall debris had been hauled to his farm. He said there was a miscommunication with his workers and they took the debris without inspecting it. He said he had intended to use it in a wash area as fill. I informed him that the concrete and brick was not considered clean demolition debris because it was painted and contained lumber and roofing materials. I informed him that brick was not authorized to be used as rip-rap. Because of these issues, the debris would have to be disposed at a landfill. Because no one had filed an asbestos notification, I asked him to contact Ron Robeen with Illinois EPA Bureau of Air to get guidance on cleanup and disposal procedures before hauling it to a landfill. Mr. Bailey said he didn't know who the Mayor of Xenia was and asked for his name. I gave him the information. I asked him how long the piles of concrete had been onsite. Mr. Bailey said they had been there at least 6 or 7 years. I informed him that clean concrete and stone could be used as rip-rap but it should be used within a year of receipt and not speculatively accumulated. I inquired about he the "junk" scattered around the entrance to the block barn building. Mr. Bailey said he had a tenant living there. He said she liked to collect things. I informed him that the waste around the barn also need to be cleaned up. He agreed to cooperate and clean up the site.
