BEFORE THE ILLINOIS POLLUTION CONTROL BOARD
ADMINISTRATIVE CITATION

Illinois Environmental Protection Agency Open Dump Inspection Checklist

County: Fulton BOL #: 0578125003 Region: 3 - Peoria
 Site Name: Wilson, Floyd & Vickie
 Site Address: E Back Rd City: Lewistown, IL. 61542
 Inspector: Robert J. Wagner Interviewed: Daniel Houghton Bryan Shepard
 Date: 09/13/2017 Current Est. 1820 yds³
 Complaint #: C-2017-099-P and C-2017-100-P Waste Amt.

Inspection Date: September 13, 2017

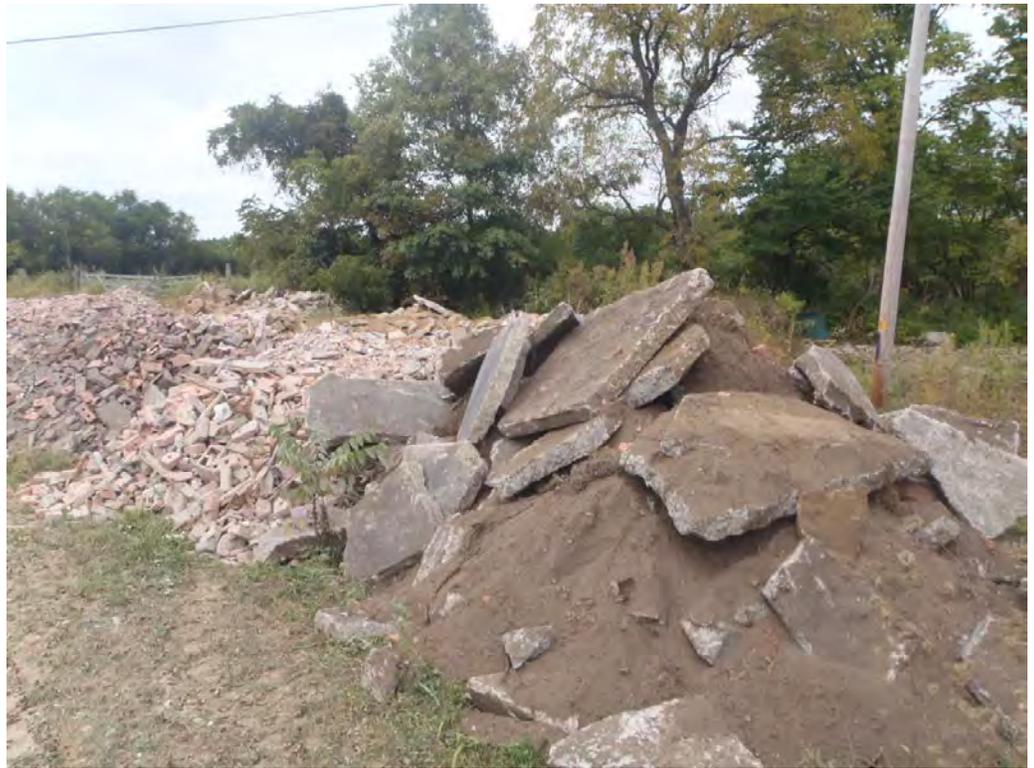
0578125003~09132017-001.jpg

COMMENTS: The photograph shows chunks of concrete with no protruding metal bars, red brick, processed wood, and electrical conduit.

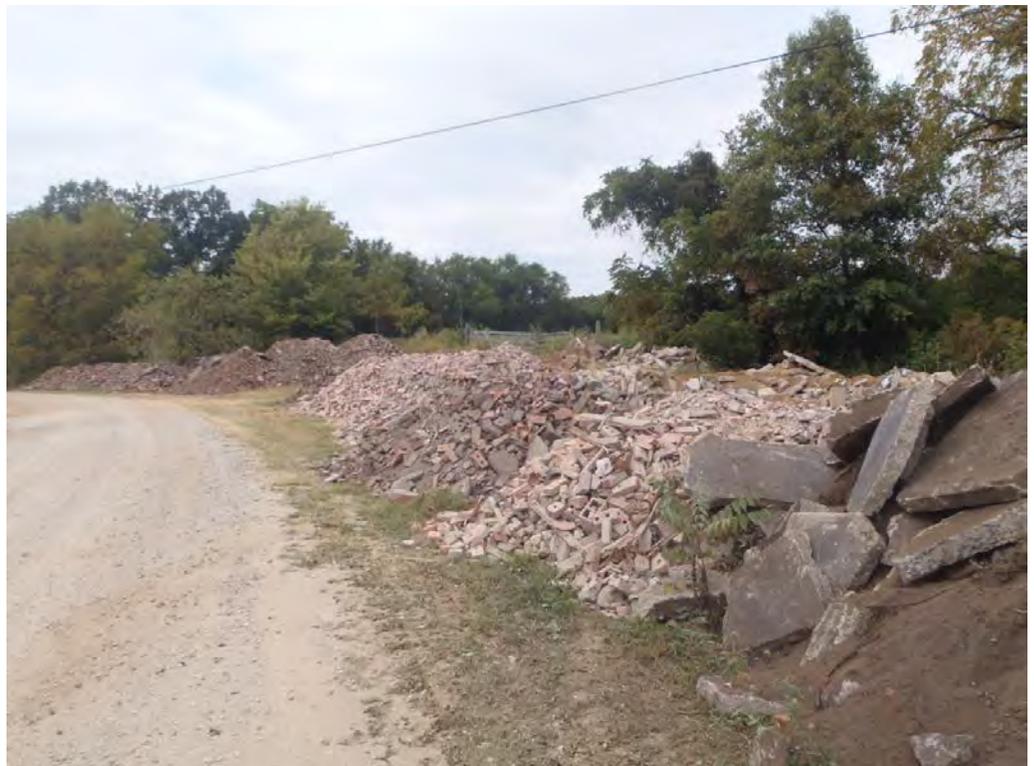
0578125003~09132017-002.jpg

COMMENTS: The photograph shows chunks of concrete with no protruding metal bars, red brick, processed wood, and electrical conduit.

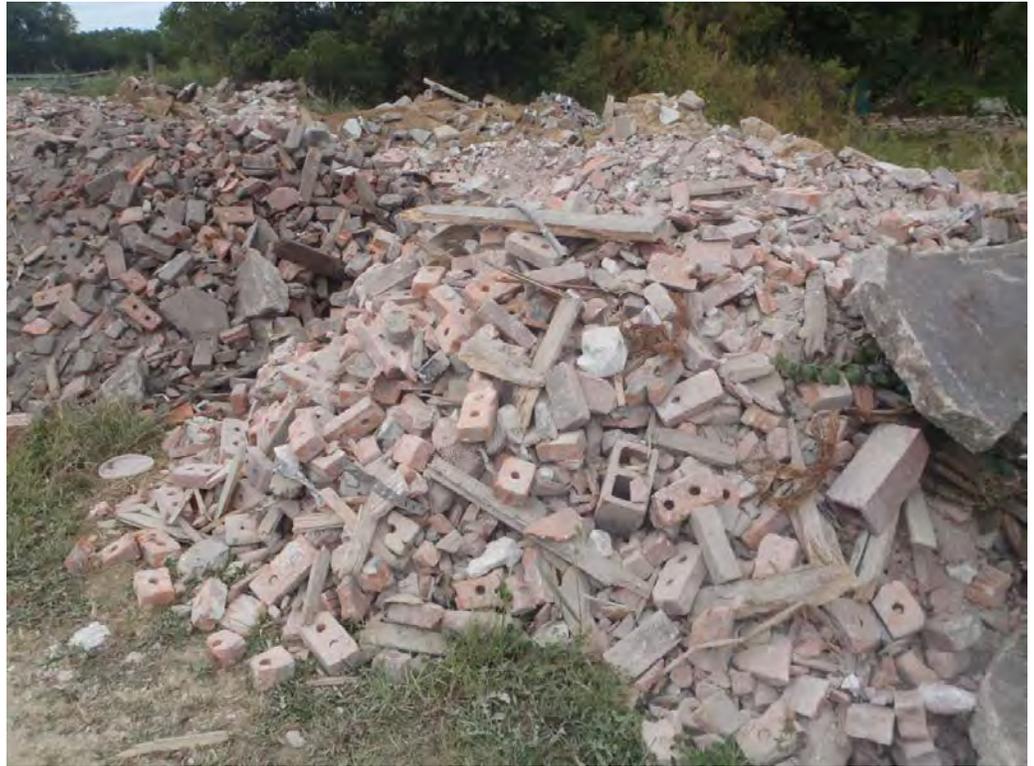
0578125003~09132017-003.jpg

COMMENTS: The photograph shows chunks of concrete with no protruding metal bars, red brick, processed wood, stucco mesh, concrete block, metal debris, electrical conduit, and a plastic container lid.

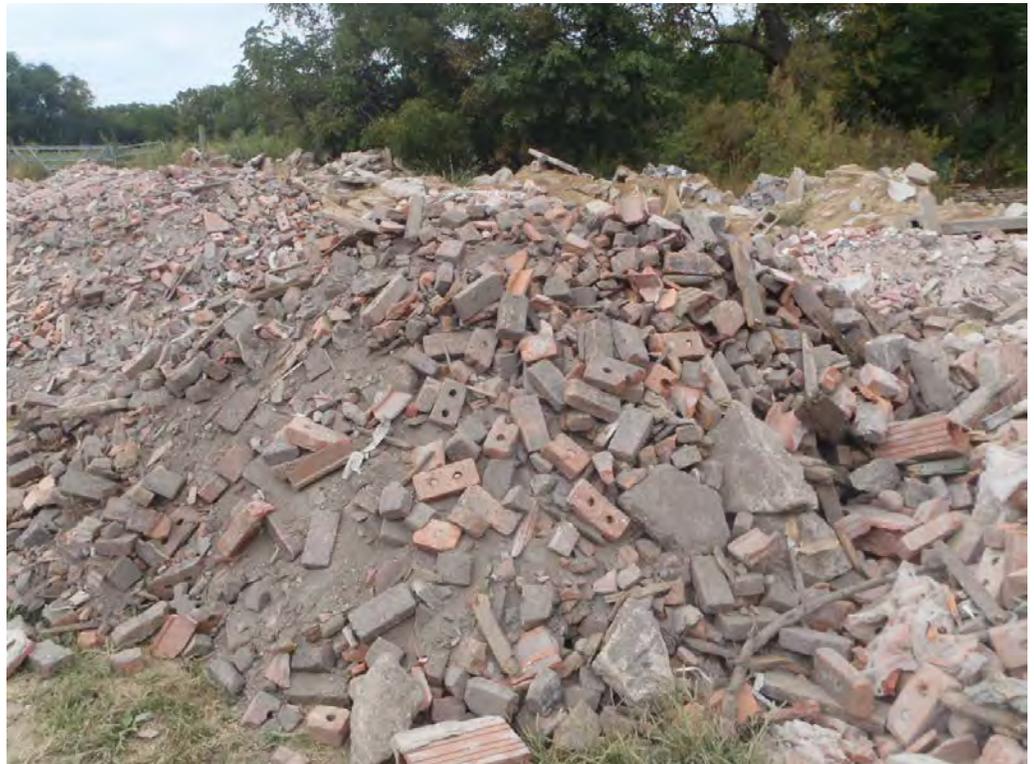
0578125003~09132017-004.jpg

COMMENTS: The photograph shows chunks of concrete with no protruding metal bars, red brick, processed wood, concrete block, electrical conduit, concrete pavers, and plastic sheeting.

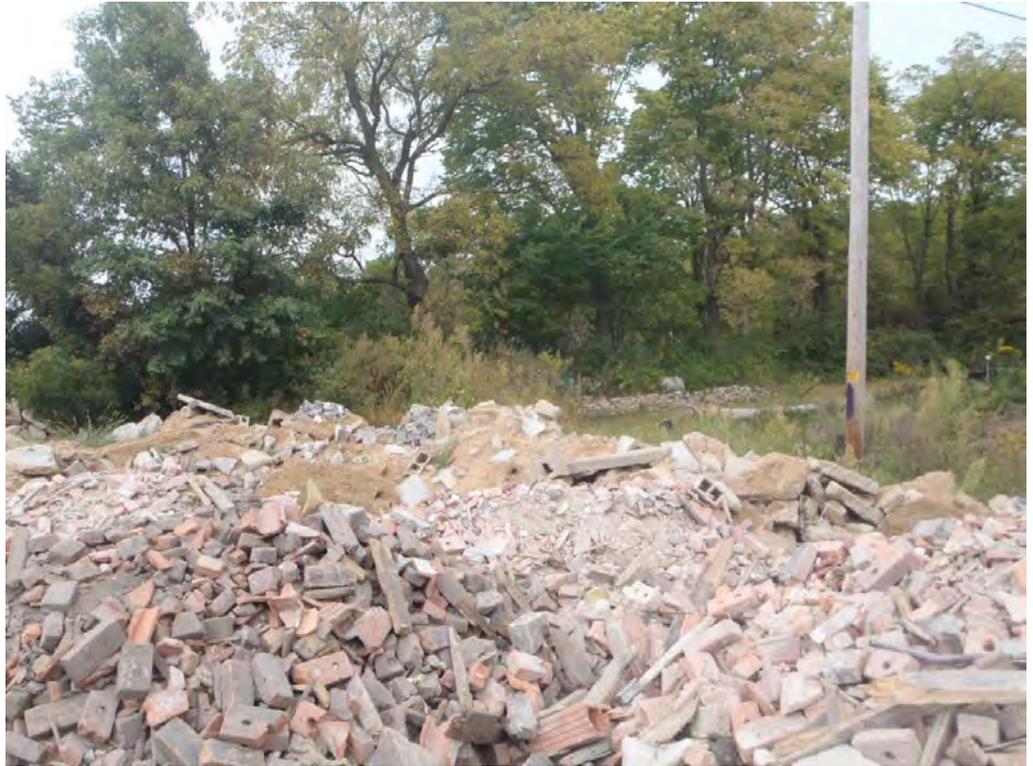
0578125003~09132017-005.jpg

COMMENTS: The photograph shows chunks of concrete with no protruding metal bars, red brick, processed wood, concrete block, electrical conduit, concrete pavers, and plastic sheeting.

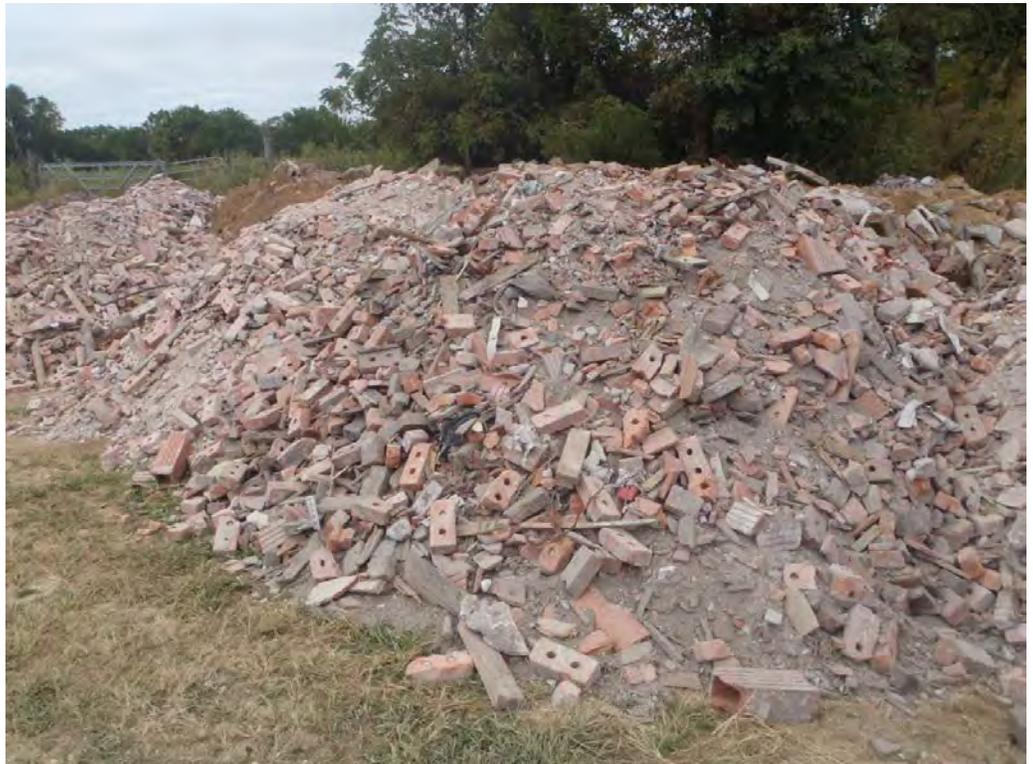
0578125003~09132017-006.jpg

COMMENTS: The photograph shows chunks of concrete with no protruding metal bars, red brick, processed wood, stucco mesh, concrete block, metal debris, electrical conduit, paper, clothing, and plastic debris.

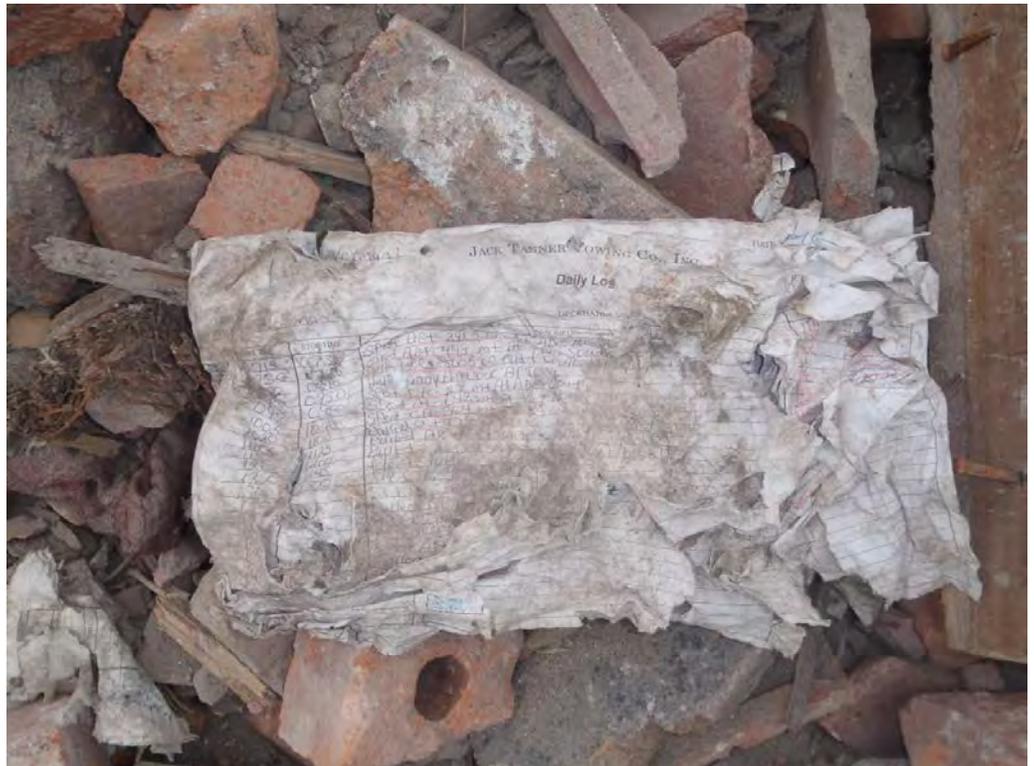
0578125003~09132017-007.jpg

COMMENTS: The photograph shows the daily log for Jack Tanner Towing Co., Inc.

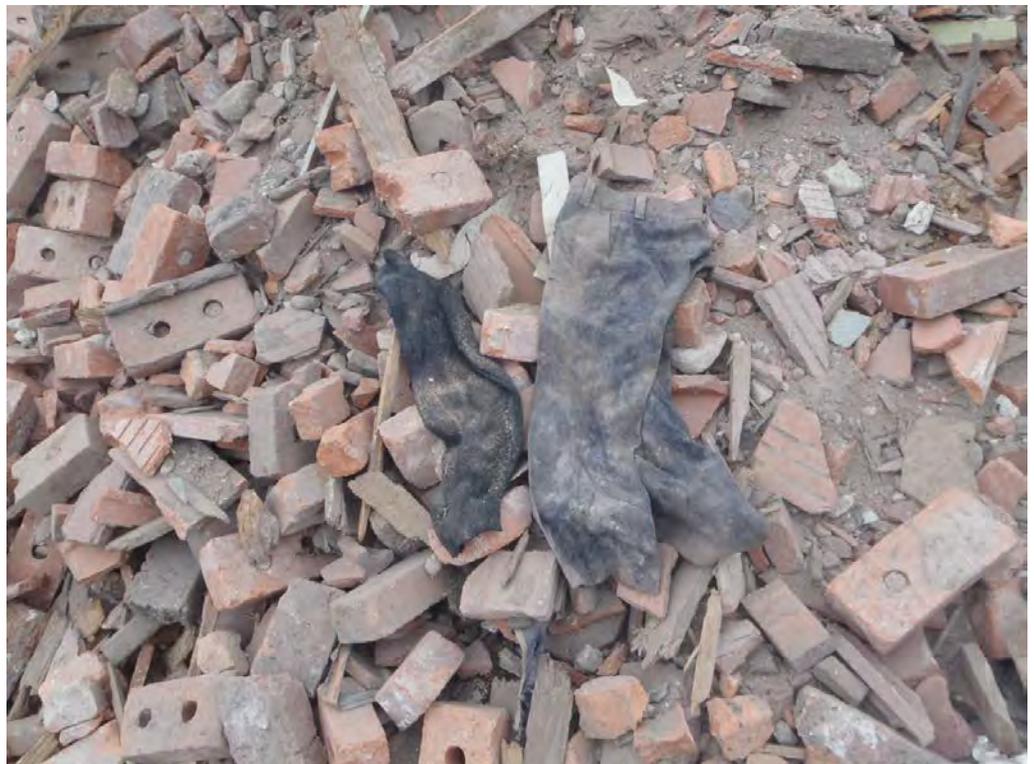
0578125003~09132017-008.jpg

COMMENTS: The photograph shows red brick, processed wood, metal debris, paper, and clothing.

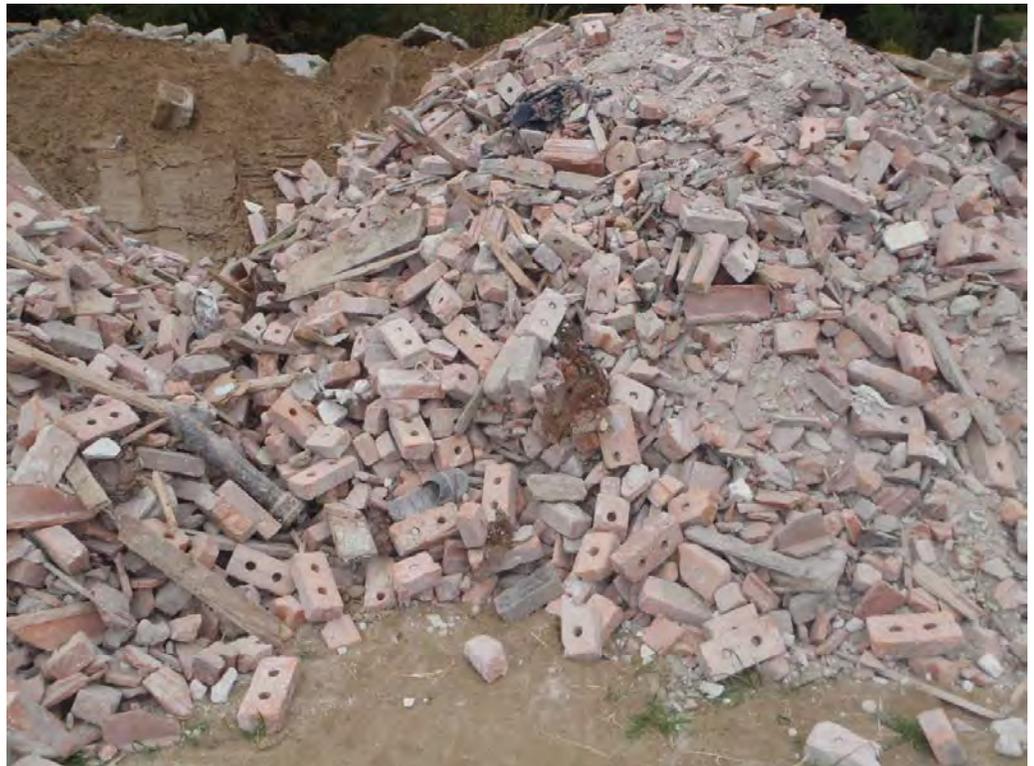
0578125003~09132017-009.jpg

COMMENTS: The photograph shows chunks of concrete with no protruding metal bars, red brick, processed wood, stucco mesh, concrete block, metal debris, electrical conduit, sewer pipe, paper, clothing, and a flip flop.

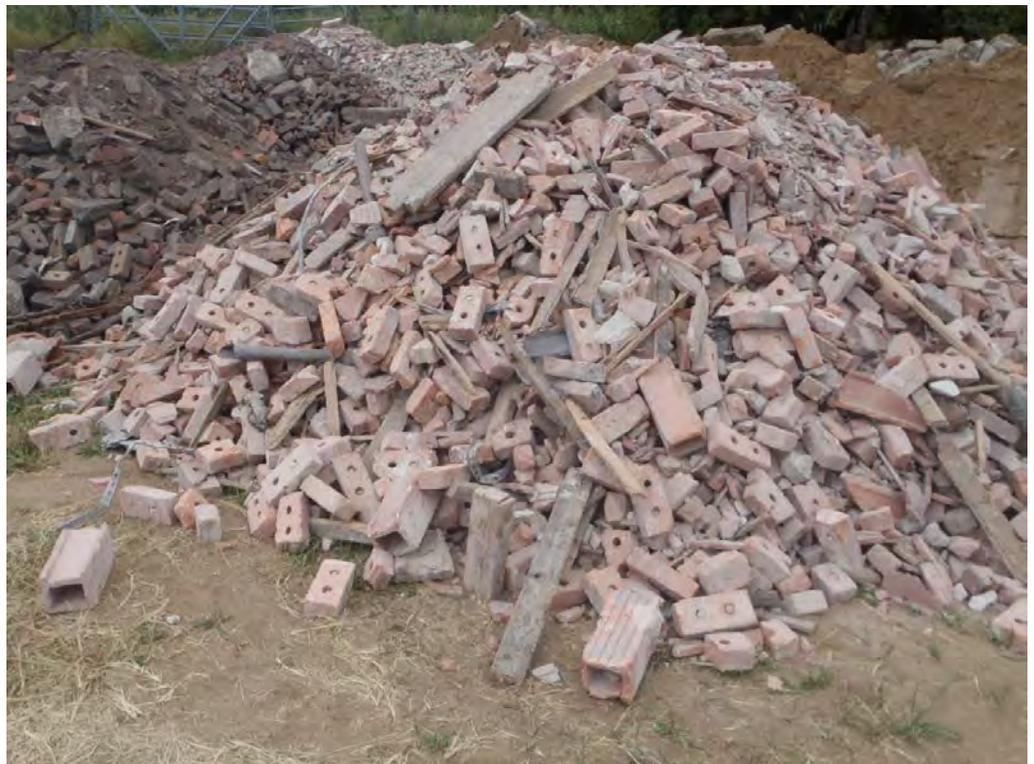
0578125003~09132017-010.jpg

COMMENTS: The photograph shows chunks of concrete with no protruding metal bars, red brick, processed wood, stucco mesh, concrete block, metal debris, electrical conduit, sewer pipe, clothing, and a flip flop.

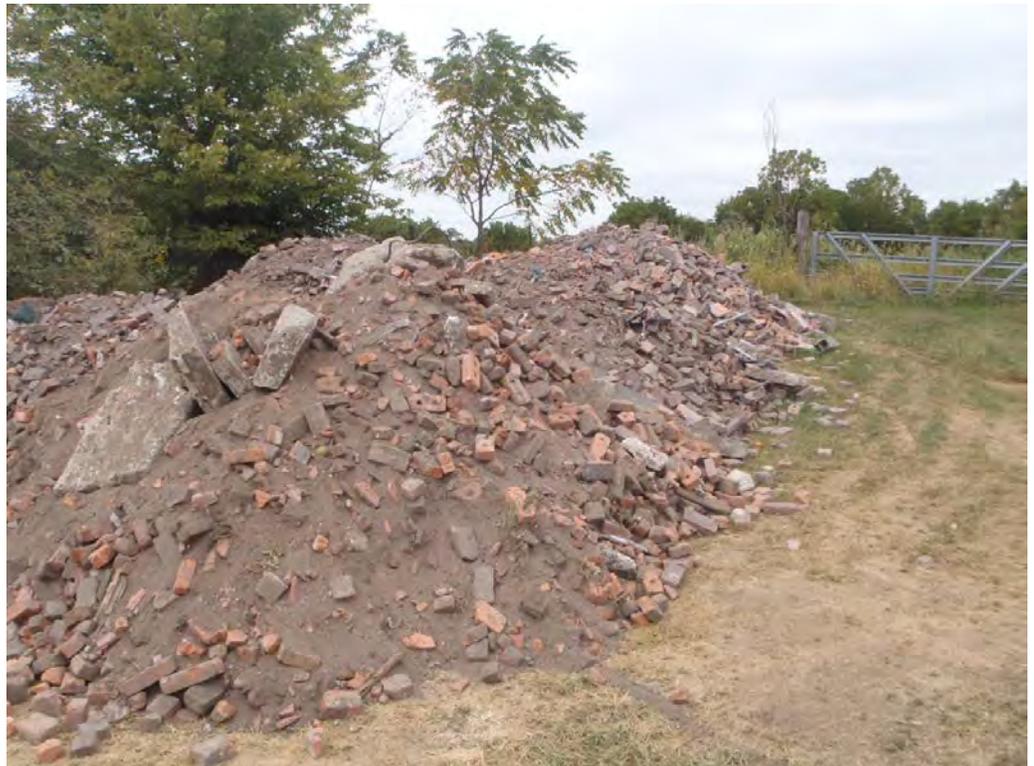
0578125003~09132017-011.jpg

COMMENTS: The photograph shows chunks of concrete with no protruding metal bars, chunks of concrete with protruding metal bars, red brick, processed wood, concrete block, metal debris, electrical conduit, and a tennis ball.

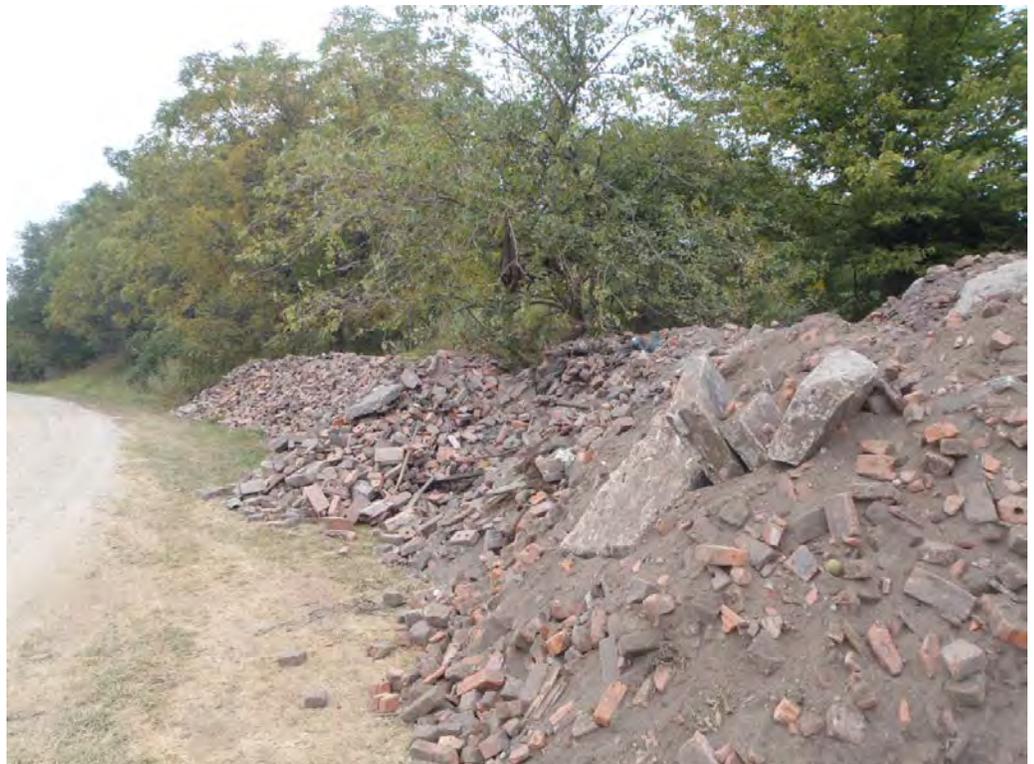
0578125003~09132017-012.jpg

COMMENTS: The photograph shows chunks of concrete with no protruding metal bars, red brick, processed wood, concrete block, metal debris, paper, clothing, and a tennis ball.

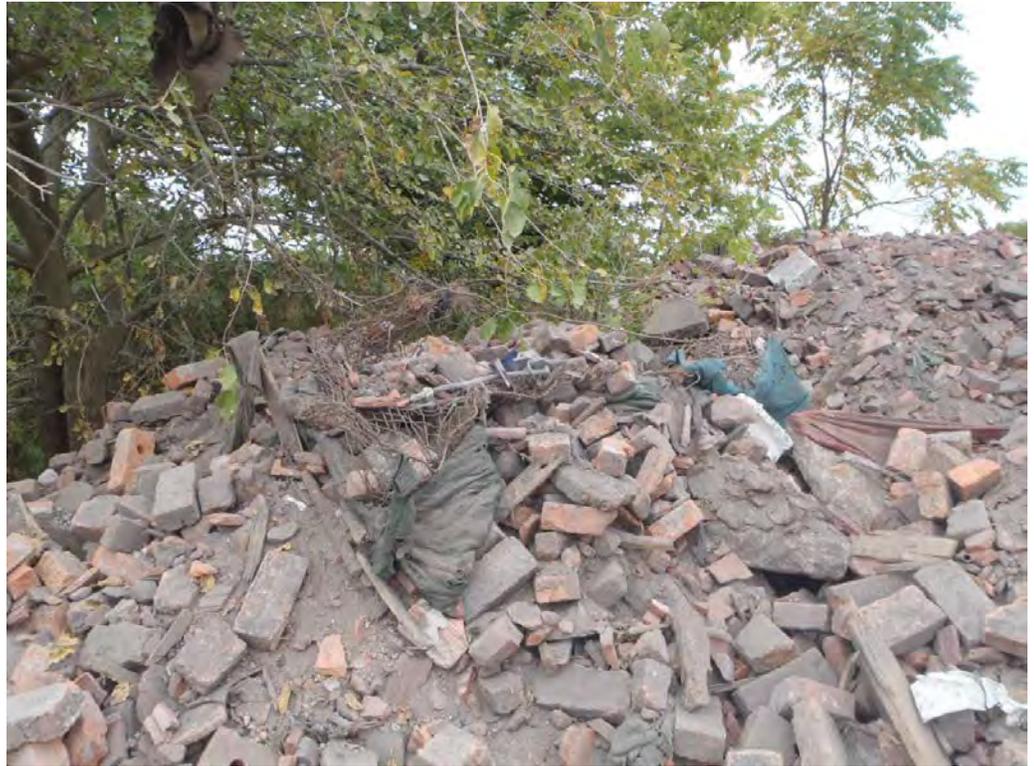
PHOTOGRAPH FILE NAME:
0578125003~09132017-013.jpg

COMMENTS: The photograph
shows chunks of concrete with no
protruding metal bars, red brick,
processed wood, concrete block,
metal debris, paper, clothing, an
anchor bolt, and a wire fence.

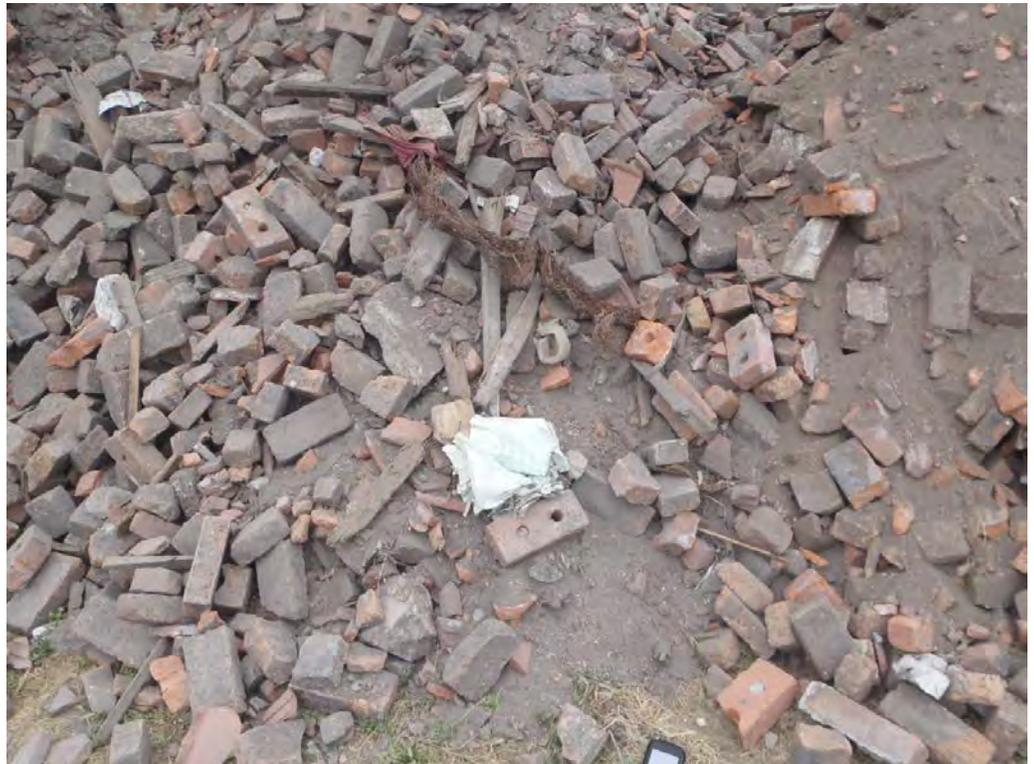
PHOTOGRAPH FILE NAME:
0578125003~09132017-014.jpg

COMMENTS: The photograph
shows red brick, processed wood,
stucco mesh, metal debris, clothing,
and paper. The paper was a log
book for the American River
Transportation Co., P.O. Box 1470
Vender #789042, Decatur, IL,
62525.

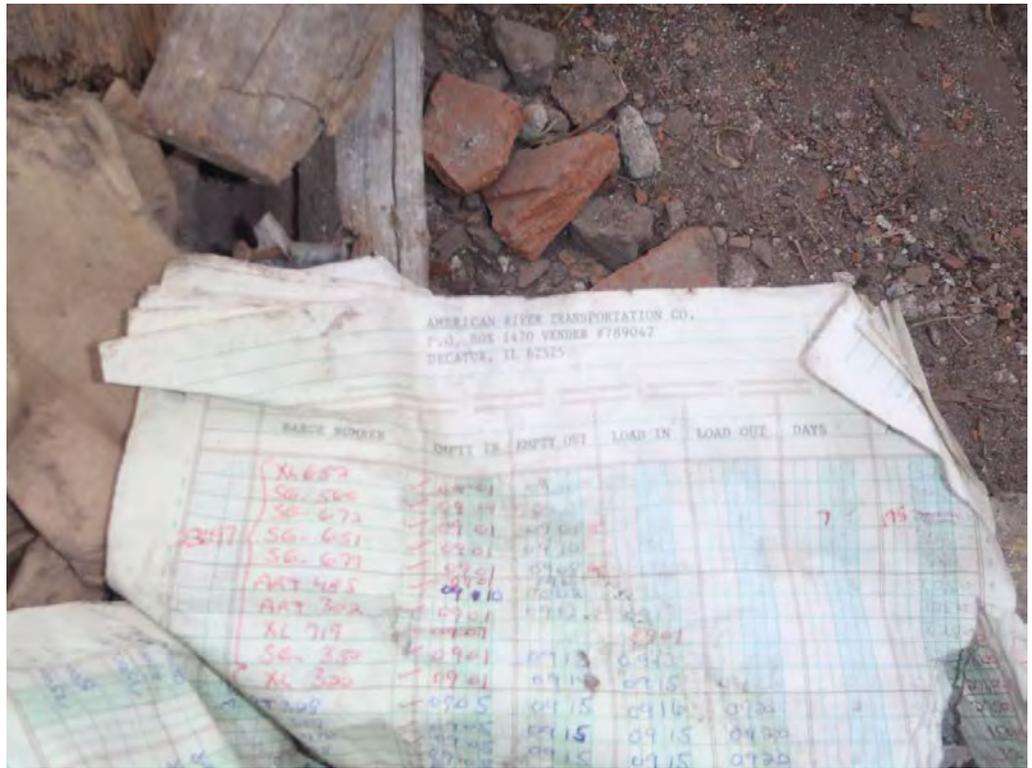
PHOTOGRAPH FILE NAME:
0578125003~09132017-015.jpg

COMMENTS: The photograph
shows a log book for the American
River Transportation Co., P.O. Box
1470 Vender #789042, Decatur, Il.,
62525.

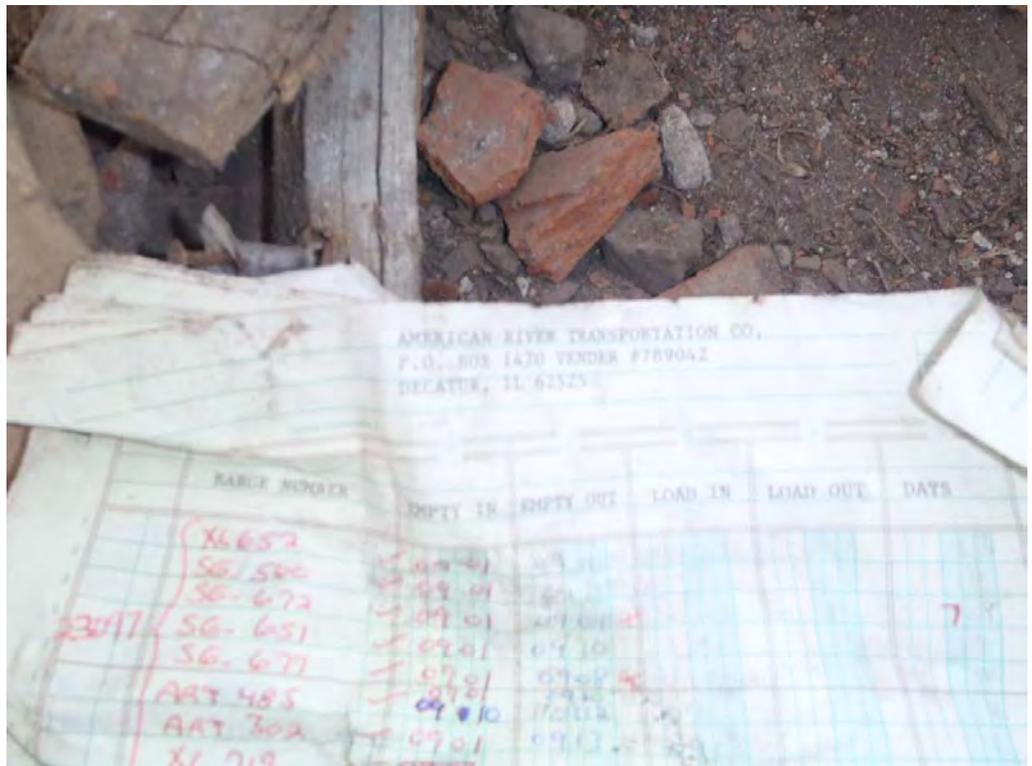
PHOTOGRAPH FILE NAME:
0578125003~09132017-016.jpg

COMMENTS: The photograph
shows a log book for the American
River Transportation Co., P.O. Box
1470 Vender #789042, Decatur, Il.,
62525.

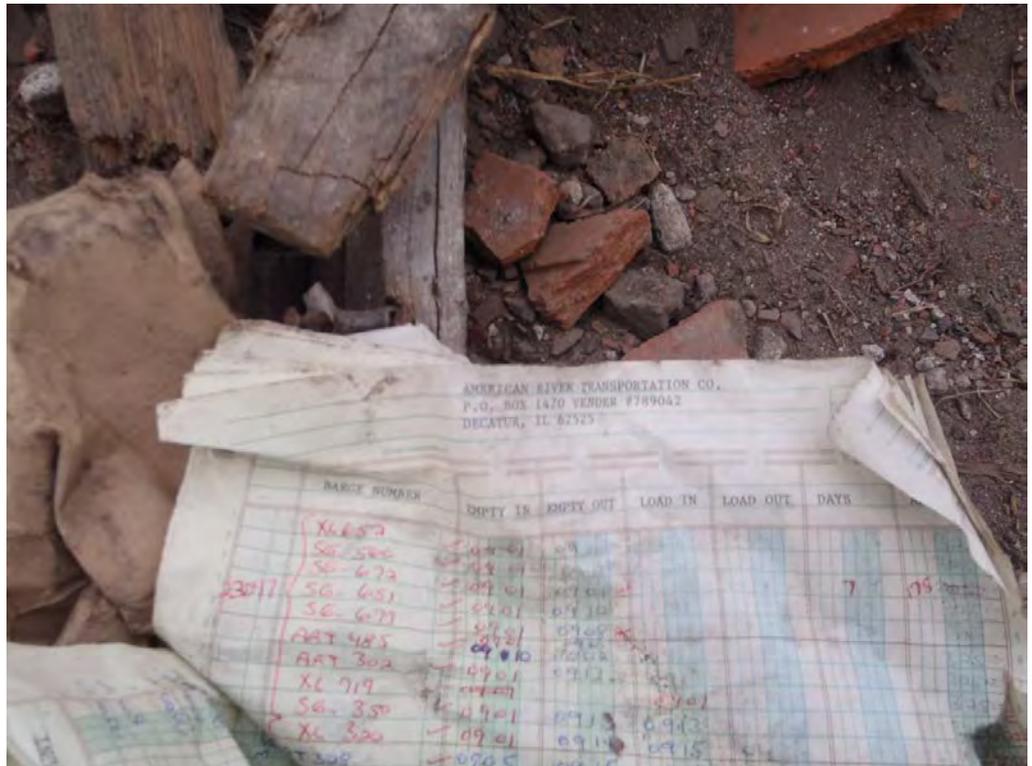
PHOTOGRAPH FILE NAME:
0578125003~09132017-017.jpg

COMMENTS: The photograph shows a log book for the American River Transportation Co., P.O. Box 1470 Vender #789042, Decatur, Il., 62525.

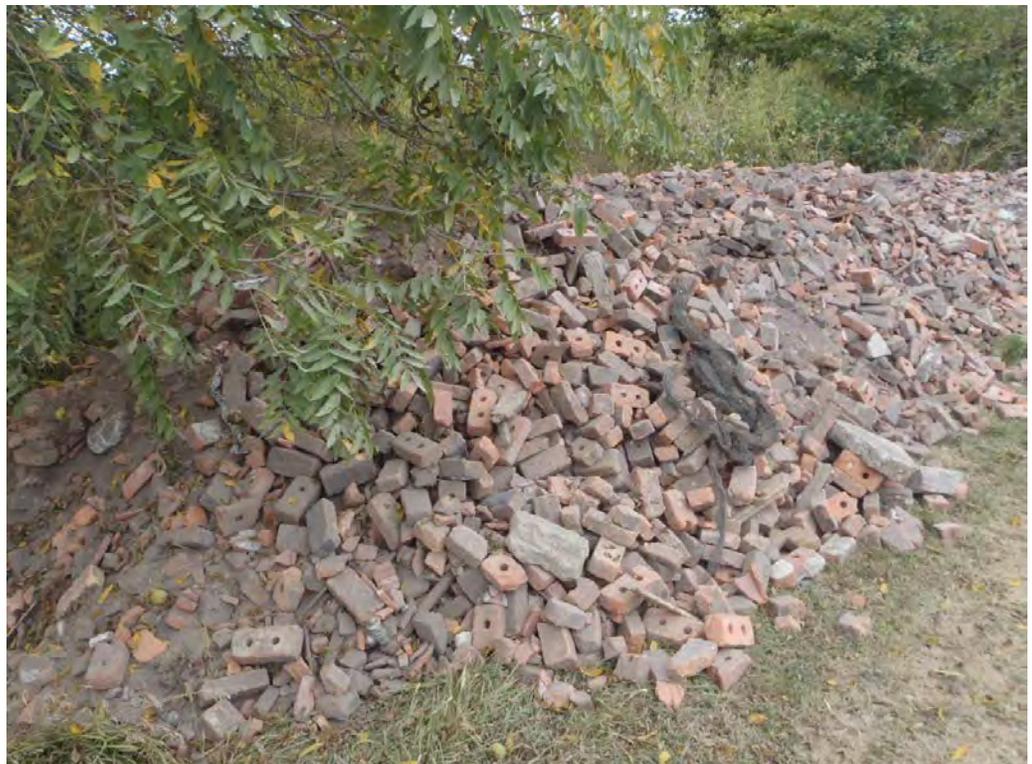
PHOTOGRAPH FILE NAME:
0578125003~09132017-018.jpg

COMMENTS: The photograph shows chunks of concrete with no protruding metal bars, red brick, processed wood, metal debris, paper, fabric, and a tennis ball.

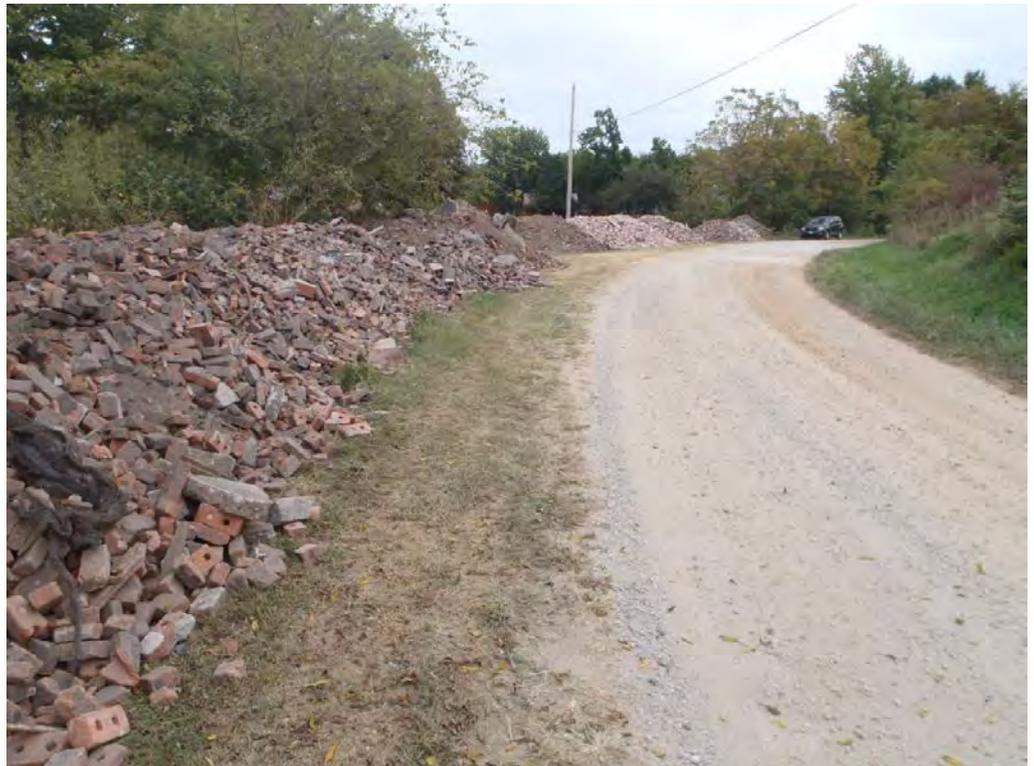
0578125003~09132017-019.jpg

COMMENTS: The photograph shows chunks of concrete with no protruding metal bars, red brick, processed wood, metal debris, paper, and fabric.

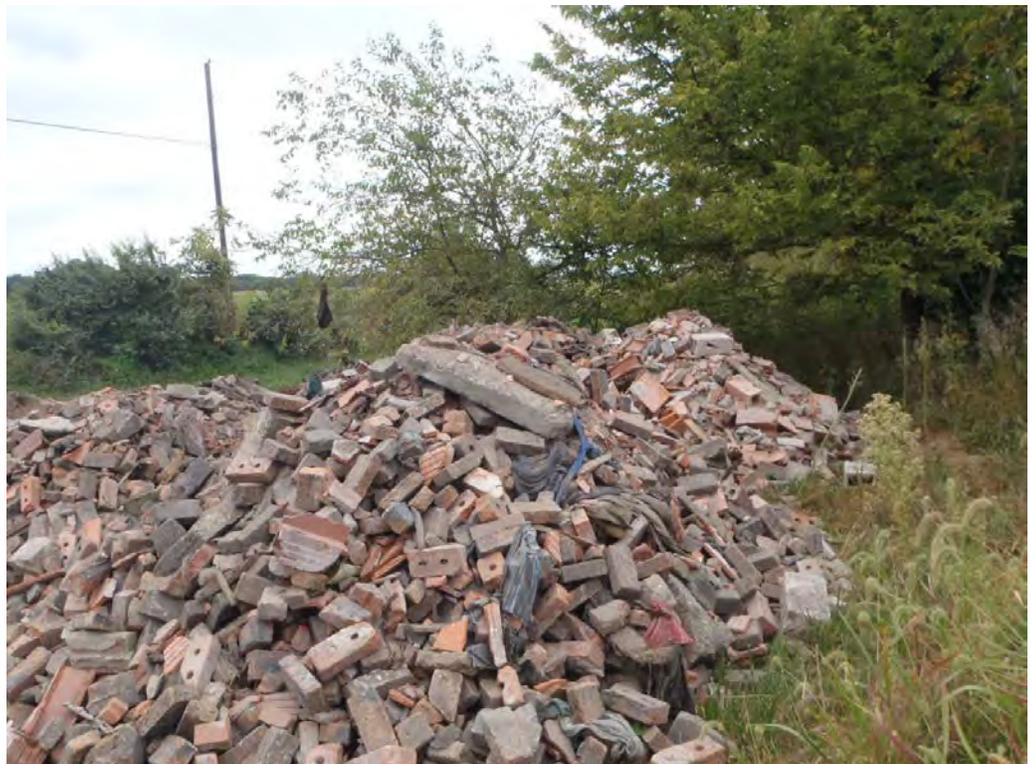
0578125003~09132017-020.jpg

COMMENTS: The photograph shows chunks of concrete with no protruding metal bars, red brick, processed wood, concrete block, metal debris, and clothing.

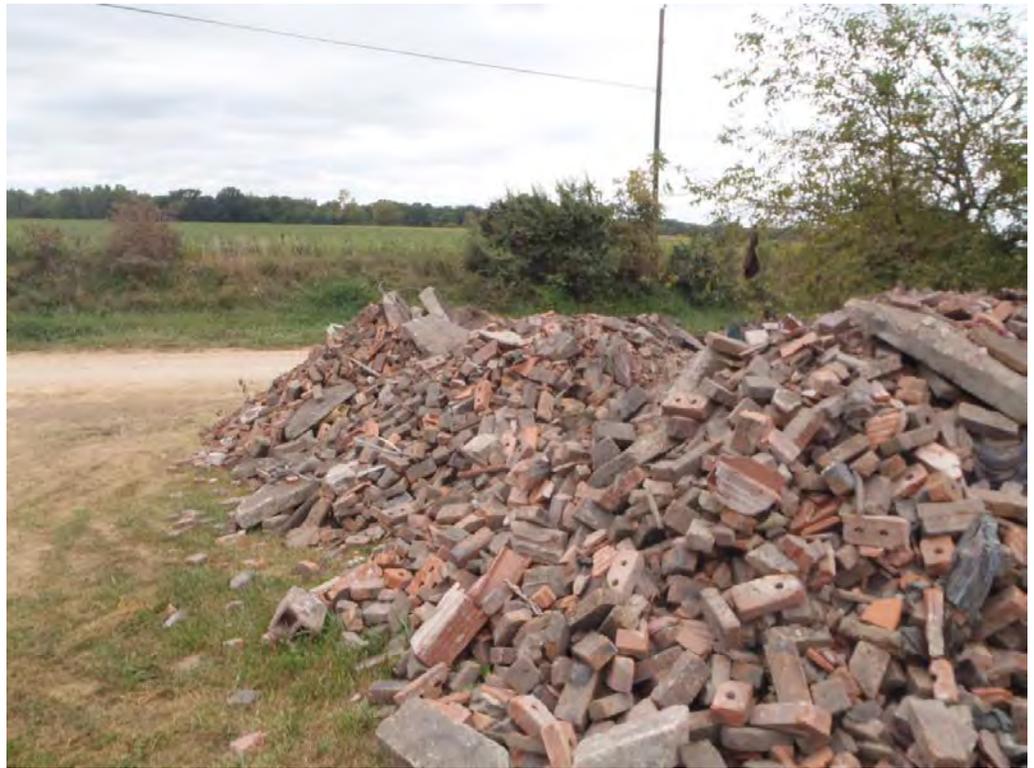
0578125003~09132017-021.jpg

COMMENTS: The photograph shows chunks of concrete with no protruding metal bars, a chunk of concrete with protruding metal bars, red brick, processed wood, concrete block, metal debris, electrical conduit, and fabric.

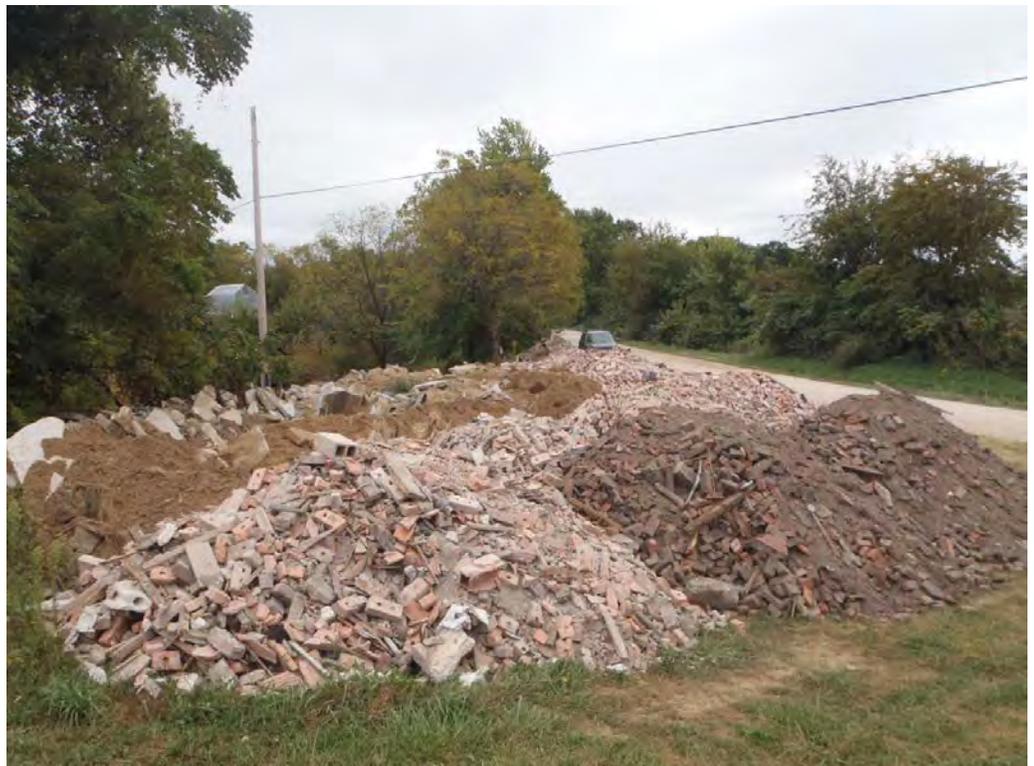
0578125003~09132017-022.jpg

COMMENTS: The photograph shows chunks of concrete with no protruding metal bars, red brick, processed wood, concrete block, metal debris, and electrical conduit.

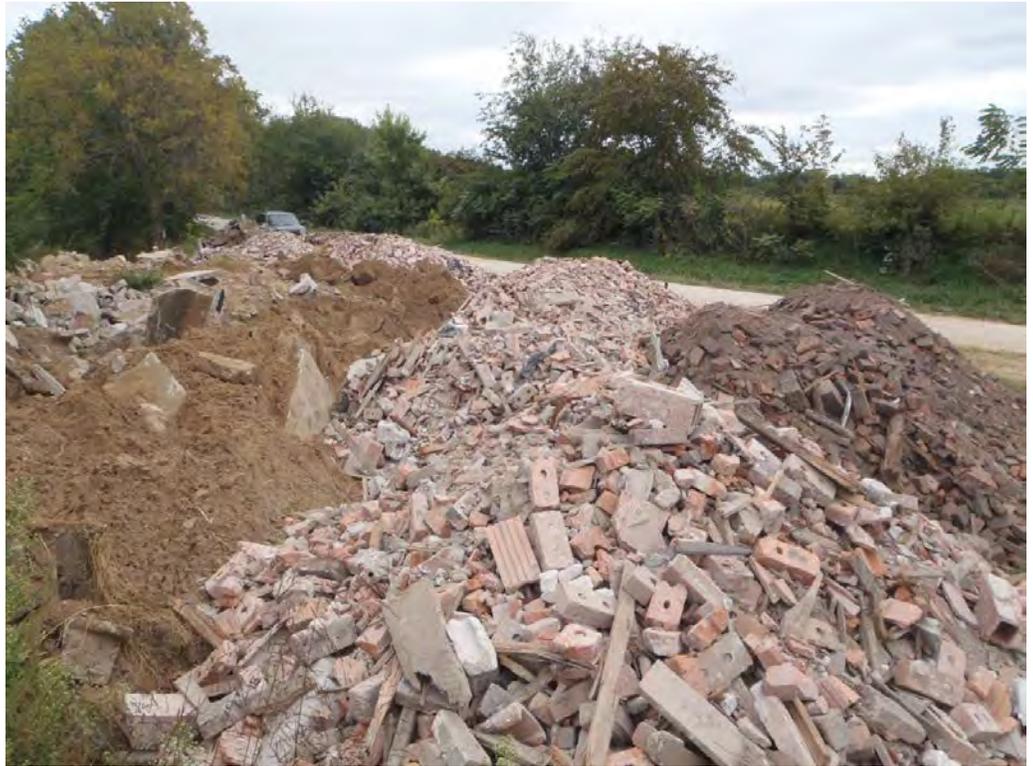
0578125003~09132017-023.jpg

COMMENTS: The photograph shows chunks of concrete with no protruding metal bars, red brick, processed wood, concrete block, metal debris, and electrical conduit.

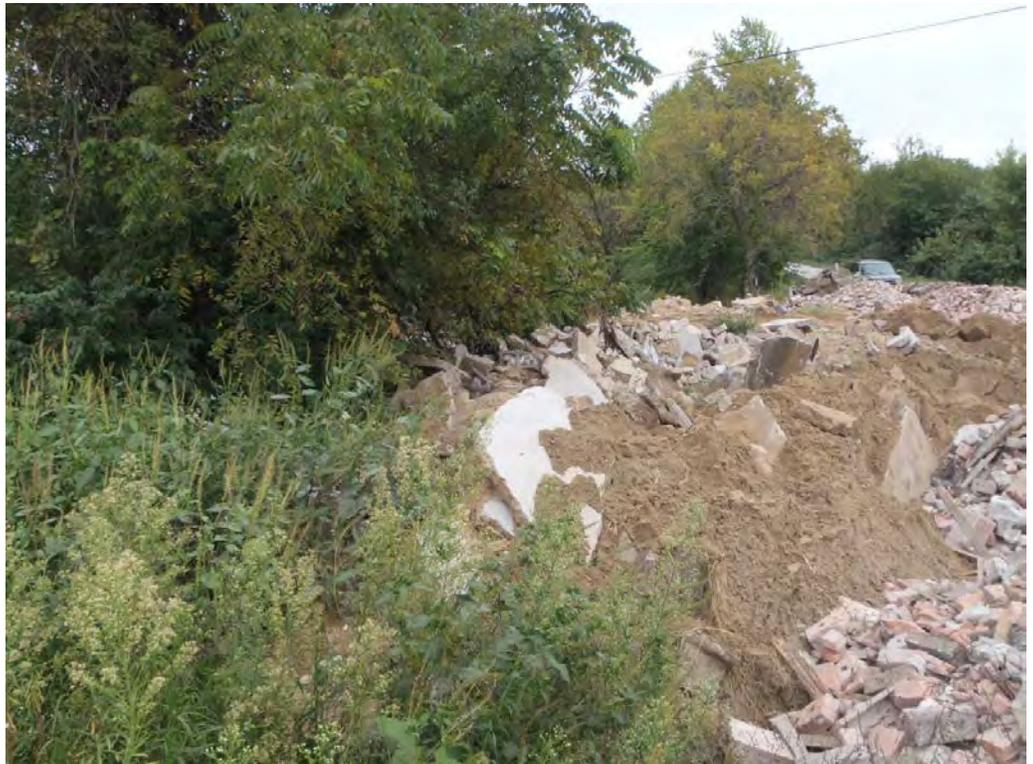
0578125003~09132017-024.jpg

COMMENTS: The photograph shows chunks of concrete with no protruding metal bars, red brick, processed wood, concrete block, metal debris, and electrical conduit.

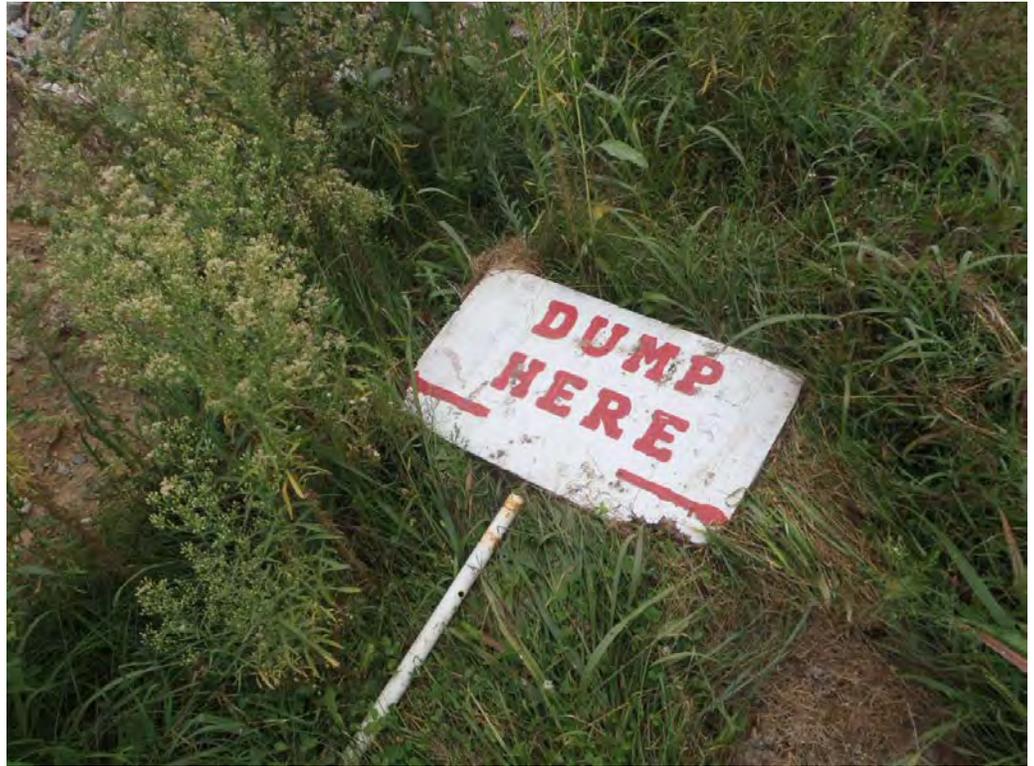
0578125003~09132017-025.jpg

COMMENTS: The photograph shows a sign. The sign had DUMP HERE written on it.

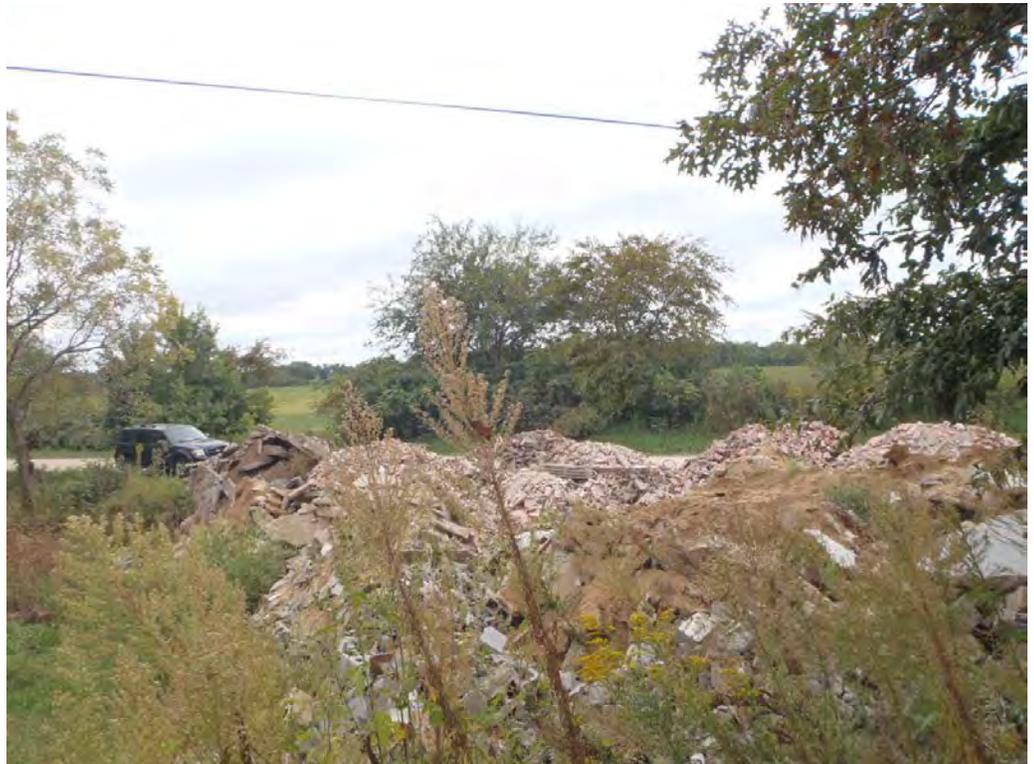
0578125003~09132017-026.jpg

COMMENTS: The photograph shows chunks of concrete with no protruding metal bars, red brick, processed wood, concrete block, metal debris, and electrical conduit.

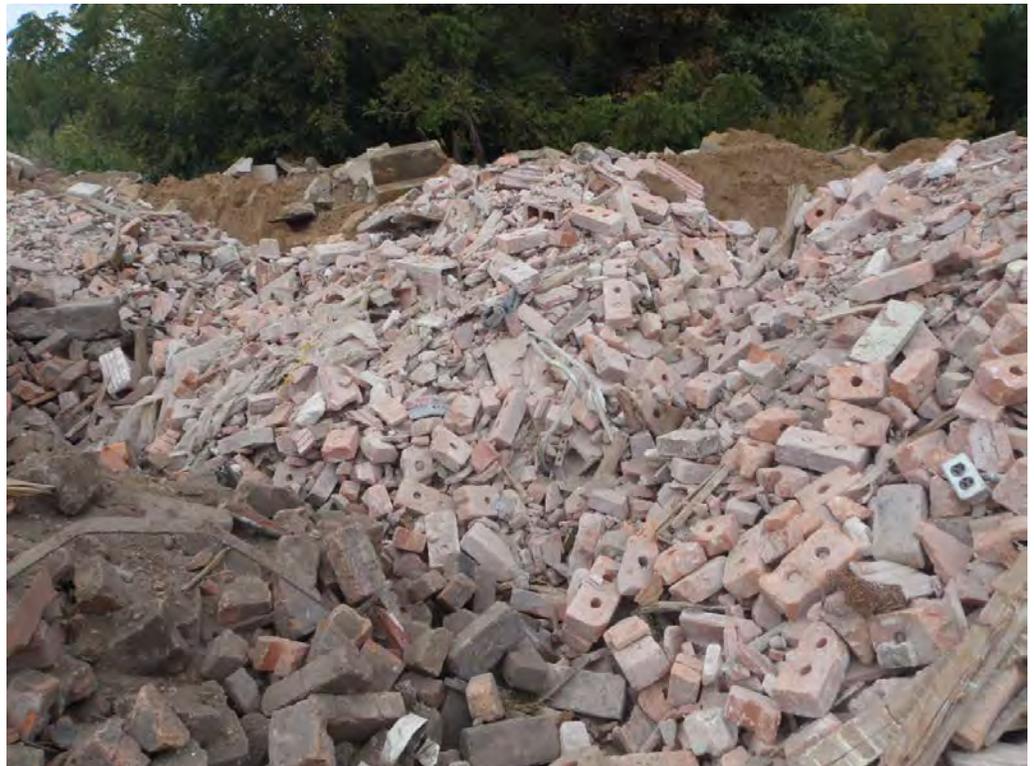
0578125003~09132017-027.jpg

COMMENTS: The photograph shows chunks of concrete with no protruding metal bars, red brick, processed wood, concrete block, metal debris, electrical conduit, electrical outlet, and stucco mesh.
