ILLINOIS ENVIRONMENTAL PROTECTION AGENCY

ADMINISTRATIVE CITATION

ILLINOIS ENVIRONMENTAL PROTECTION AGENCY
Open Dump Inspection Checklist

NARRATIVE INSPECTION REPORT DOCUMENT

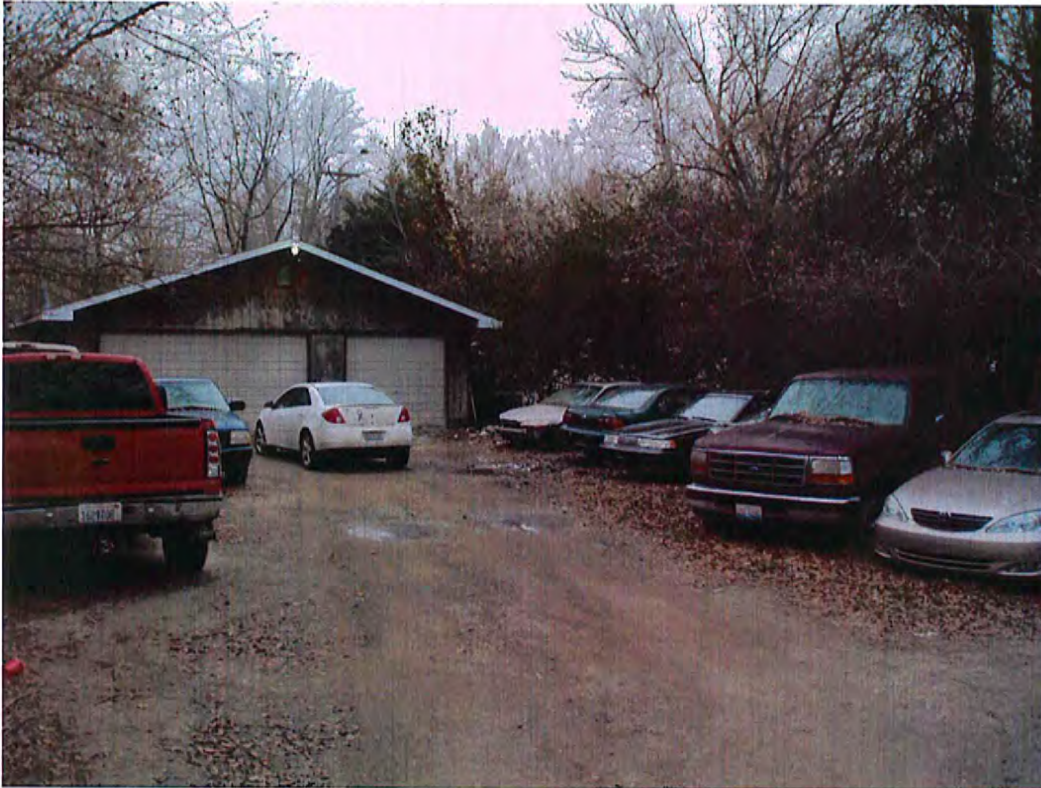
Date: December 2, 2014
Time: 9:32 a.m.
Direction: N/NE
Photo by: Charlie King
Exposure #: 001
Comments: An overview of the property from behind the house, looking towards the business. Some of the vehicles shown had license plates, while others did not.

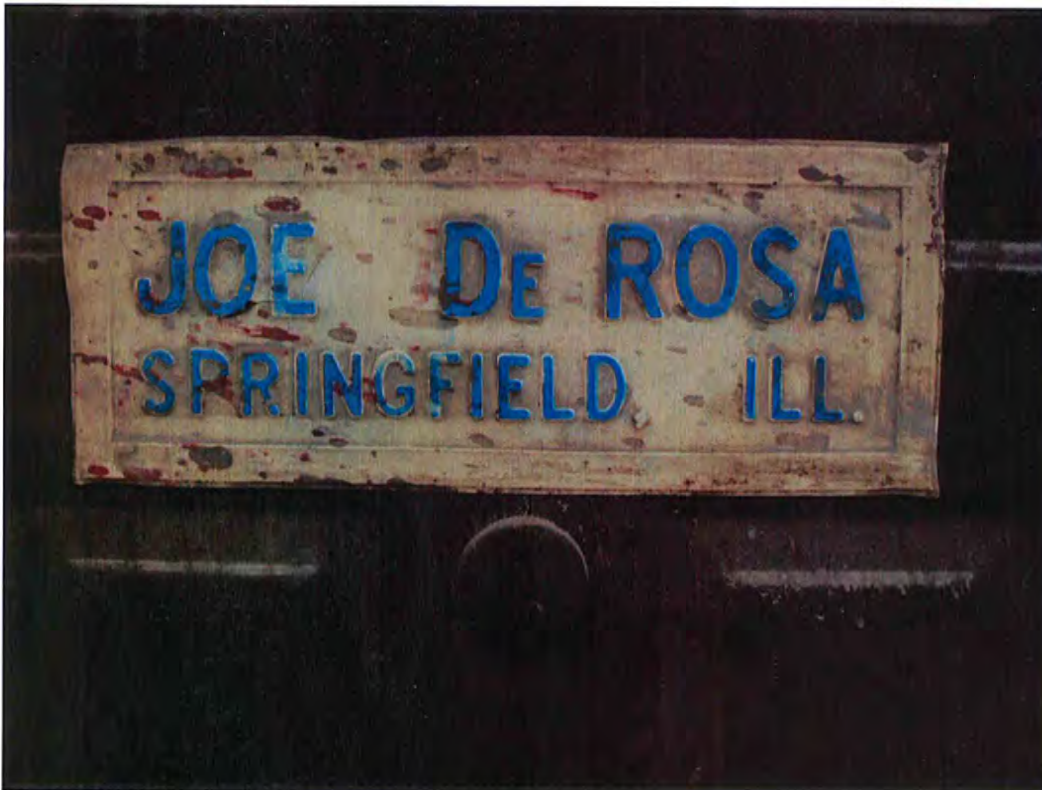
Photo # 002 shows the name of one of the owners on the east door of the garage shown in photo # 001.

Date: December 4, 2014
Time: 9:34 a.m.
Direction: E
Photo by: Charlie King
Exposure #: 002
Comments: The name of one of the owners on the east door of the garage shown in photo # 001.

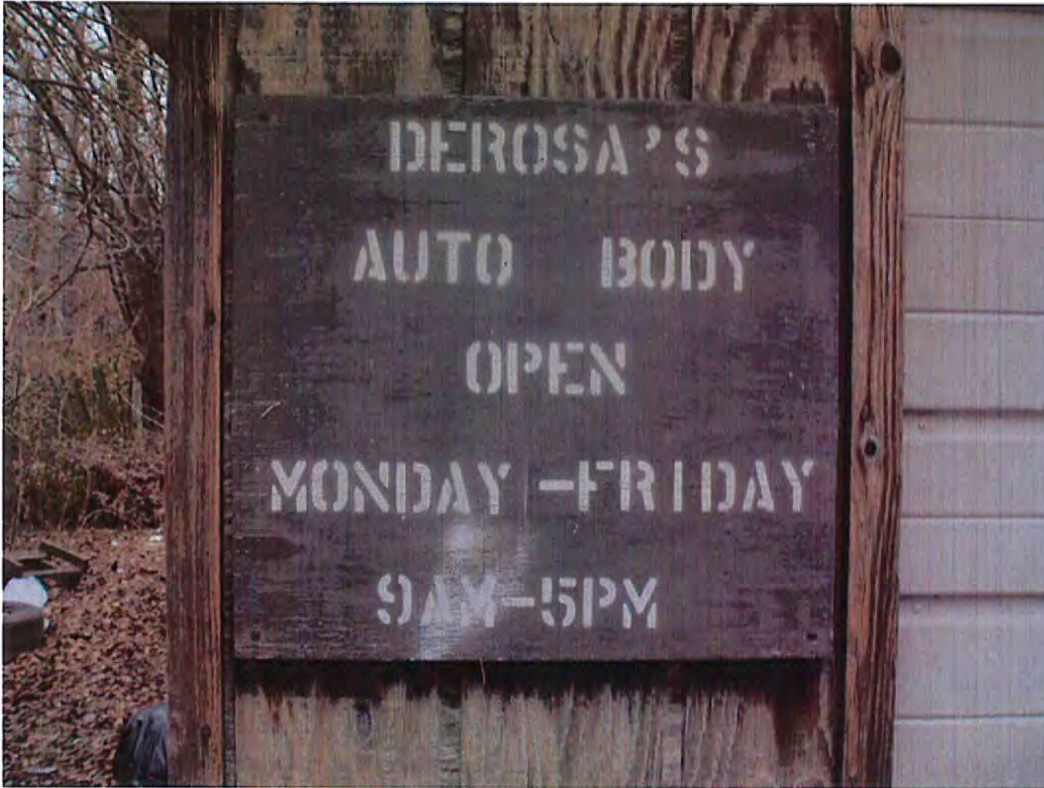
Date: December 2, 2014
Time: 9:35 a.m.
Direction: N
Photo by: Charlie King
Exposure #: 003
Comments: The name on the sign on the left front of the garage. Note that the sign says, "Derosa's Auto Body, Open, Monday – Friday, 9 am – 5 p.m. We arrived on-site at 9:28 a.m. We knocked on the door shown in photo # 002 several times. Smoke was emitting from the chimney, but no one answered the door.

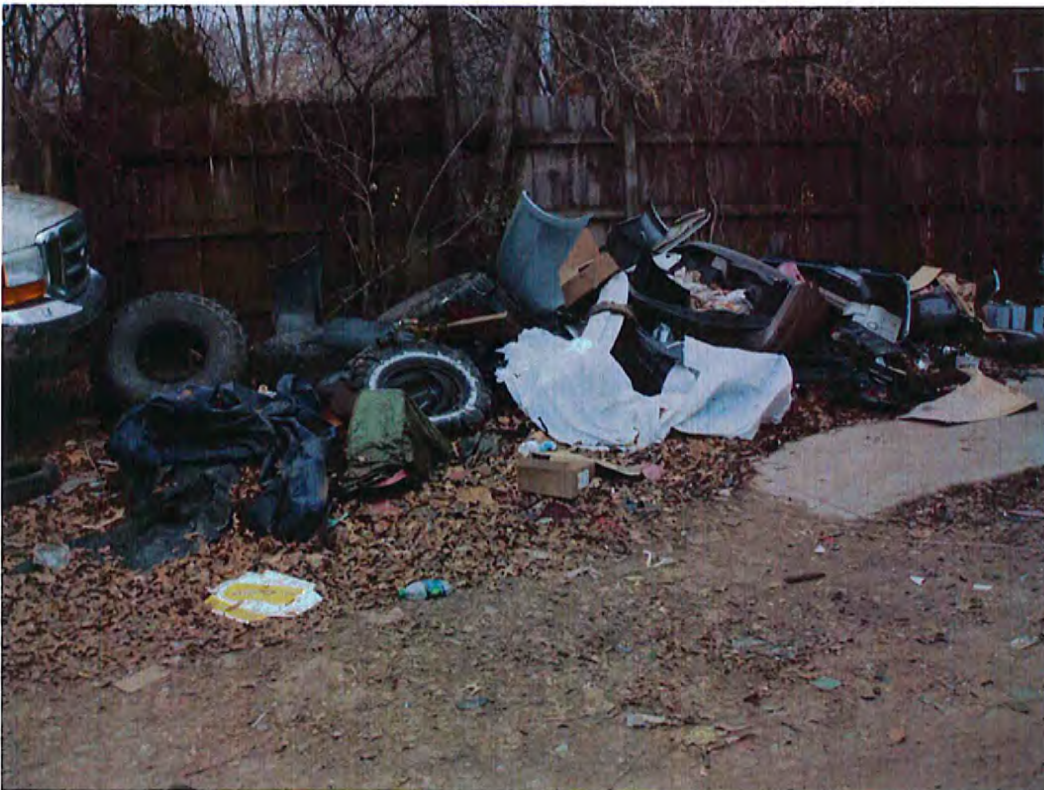
Date: December 4, 2014
Time: 9:36 a.m.
Direction: W
Photo by: Charlie King
Exposure #: 004
Comments: Wastes in a pile on the ground at the front of the garage at the west side of the property. It measured approximately 20' x 10' x 3' and consisted of used tires with water in them, plastic car parts, cardboard, cloth, tarps and carpet.

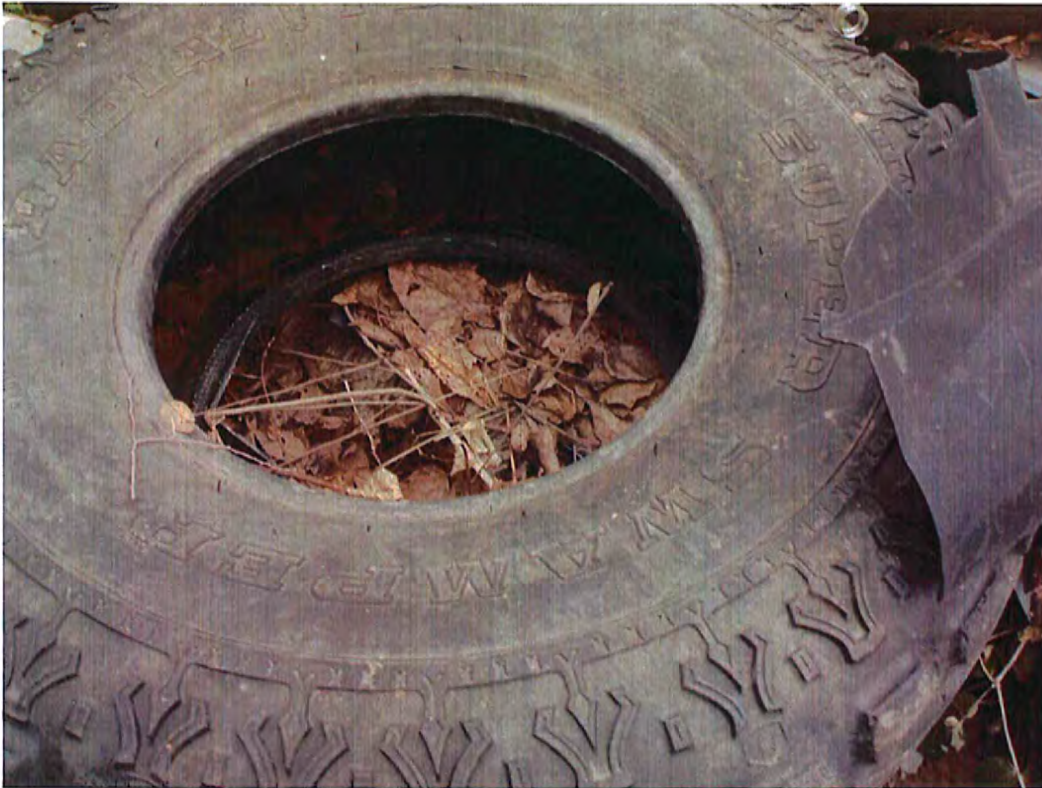
Photo # 005 shows water in a used tire.

Date: December 2, 2014
Time: 10:38 a.m.
Direction: W
Photo by: Charlie King
Exposure #: 005
Comments: Water in a used tire.

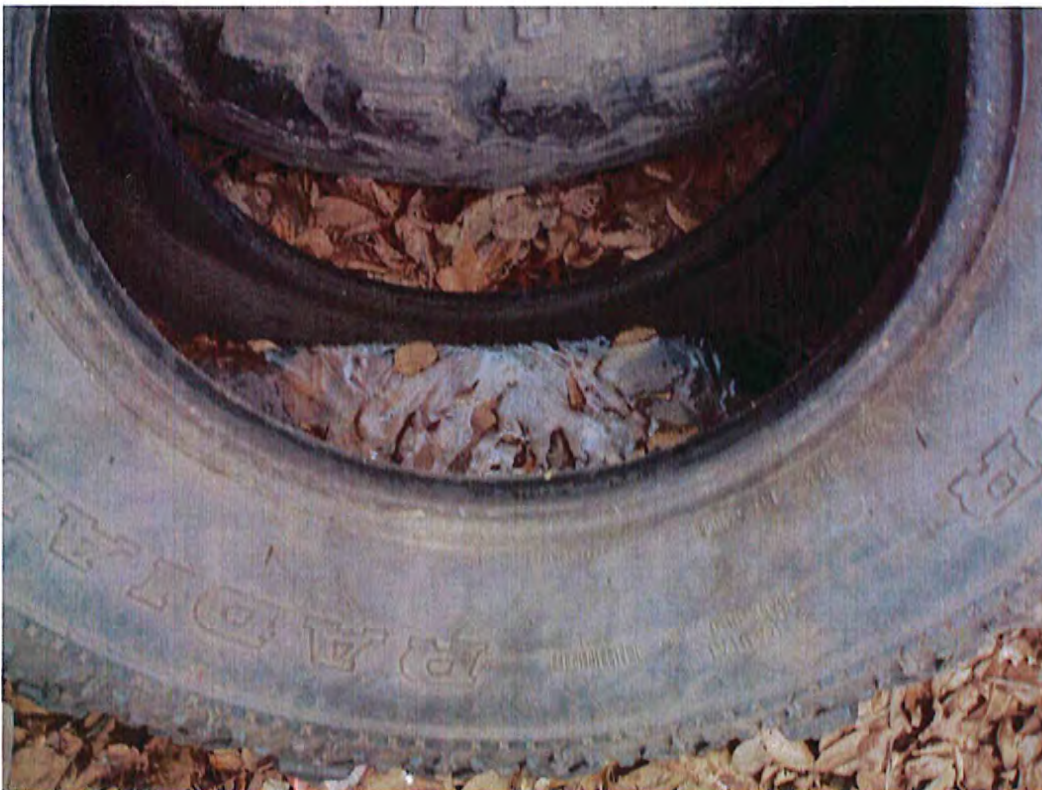
Date: December 4, 2014
Time: 10:38 a.m.
Direction: W
Photo by: Charlie King
Exposure #: 006
Comments: Water and ice in another used tire.

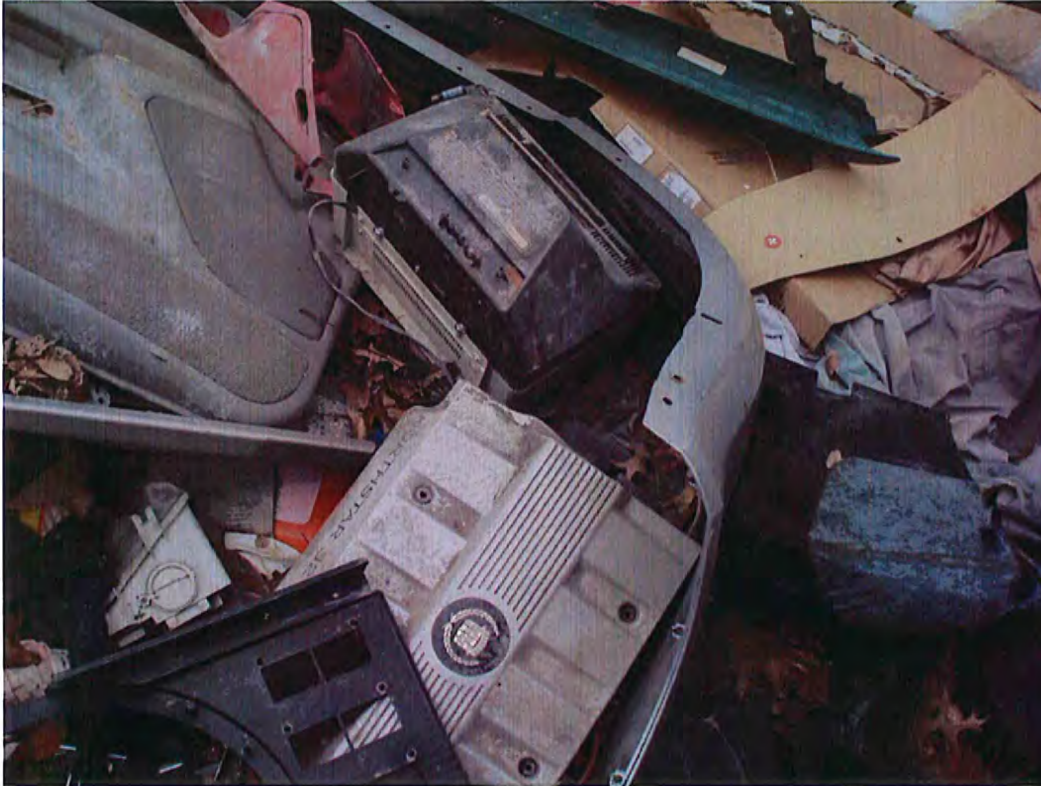
Date: December 2, 2014
Time: 10:40 a.m.
Direction: W/NW
Photo by: Charlie King
Exposure #: 007
Comments: A television, a Cadillac car part, a vehicle fender, cardboard, the inside of a car door, a tarp, plastics and metals.

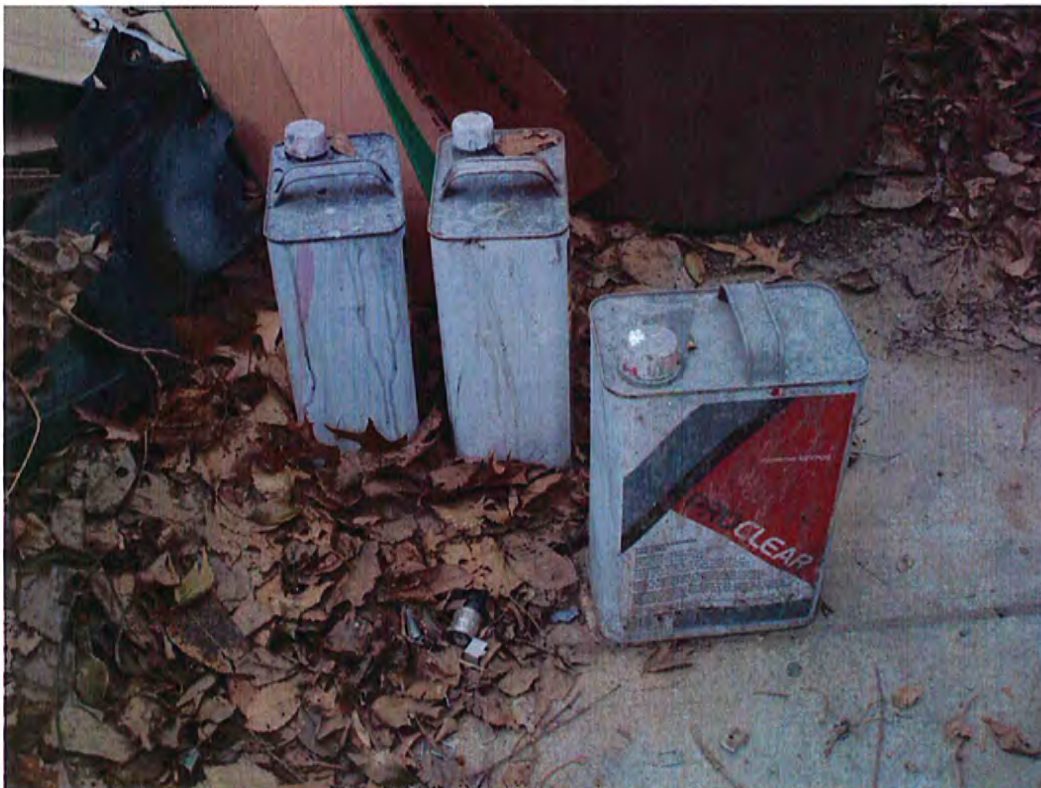
Photo # 008 shows three one-gallon cans of Pro Clear, a solvent stored outdoors. Paint is on all three cans. Each can was approximately $\frac{3}{4}$'s full, but the actual contents are unknown. The paint on the cans might reflect paint related waste solvent, but the actual contents are unknown at this point. Hazardous and Non-Hazardous Waste Determinations must be made on the contents of each can, if the cans contain waste. Such determinations are not required for useable product.

Date: December 4, 2014
Time: 10:41 a.m.
Direction: S
Photo by: Charlie King
Exposure #: 008
Comments: three one-gallon cans of Pro Clear, a solvent on the ground. Paint is on all three cans. Each can was approximately $\frac{3}{4}$'s full, but the actual contents are unknown. The paint on the cans might reflect contents of paint related waste solvent, but the actual contents are unknown.

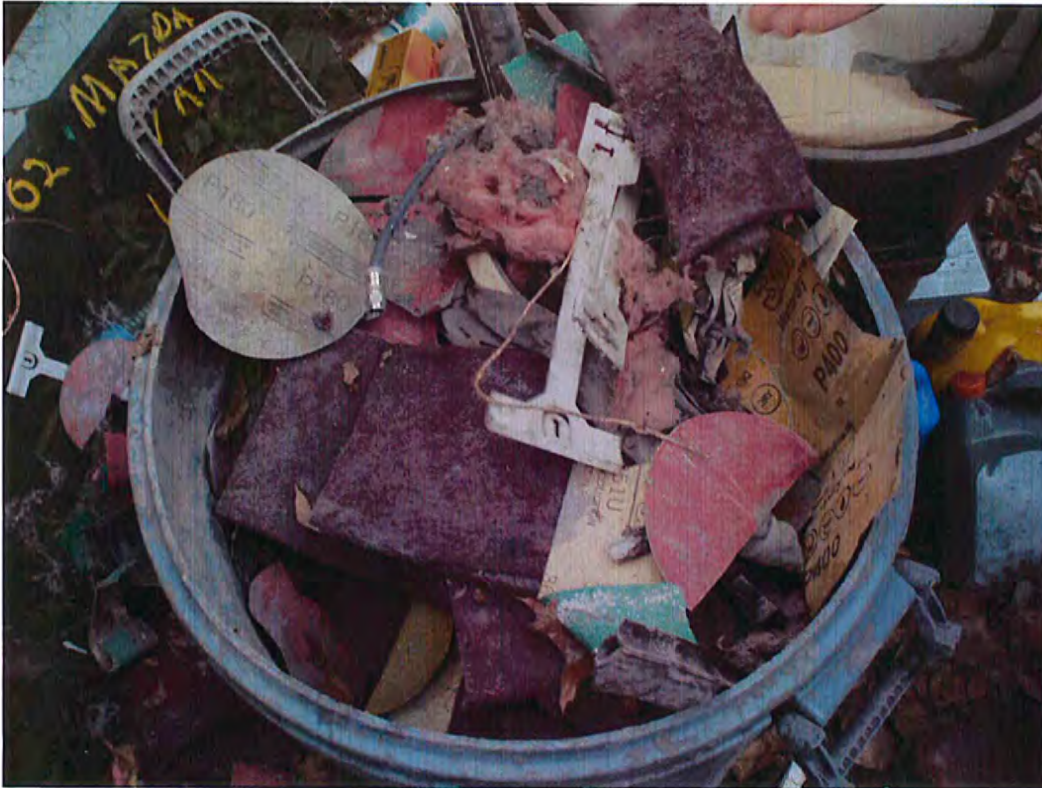
Date: December 2, 2014
Time: 10:42 a.m.
Direction: N
Photo by: Charlie King
Exposure #: 009
Comments: Paint filters, sand paper a painter's mask, plastic and wiring. There were three of these plastic barrels. The others contained, plastics, paper and food can wastes.

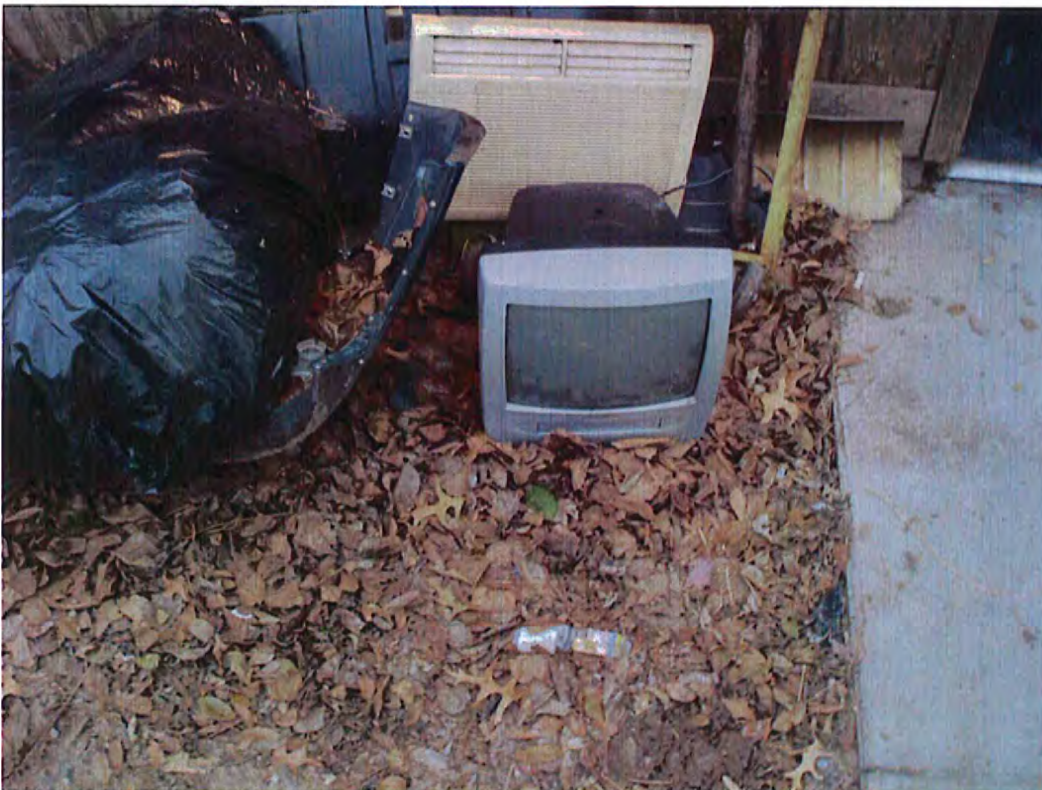
Date: December 4, 2014
Time: 10:43 a.m.
Direction: E
Photo by: Charlie King
Exposure #: 010
Comments: Another television set on the ground, just outside of the door to the facility.

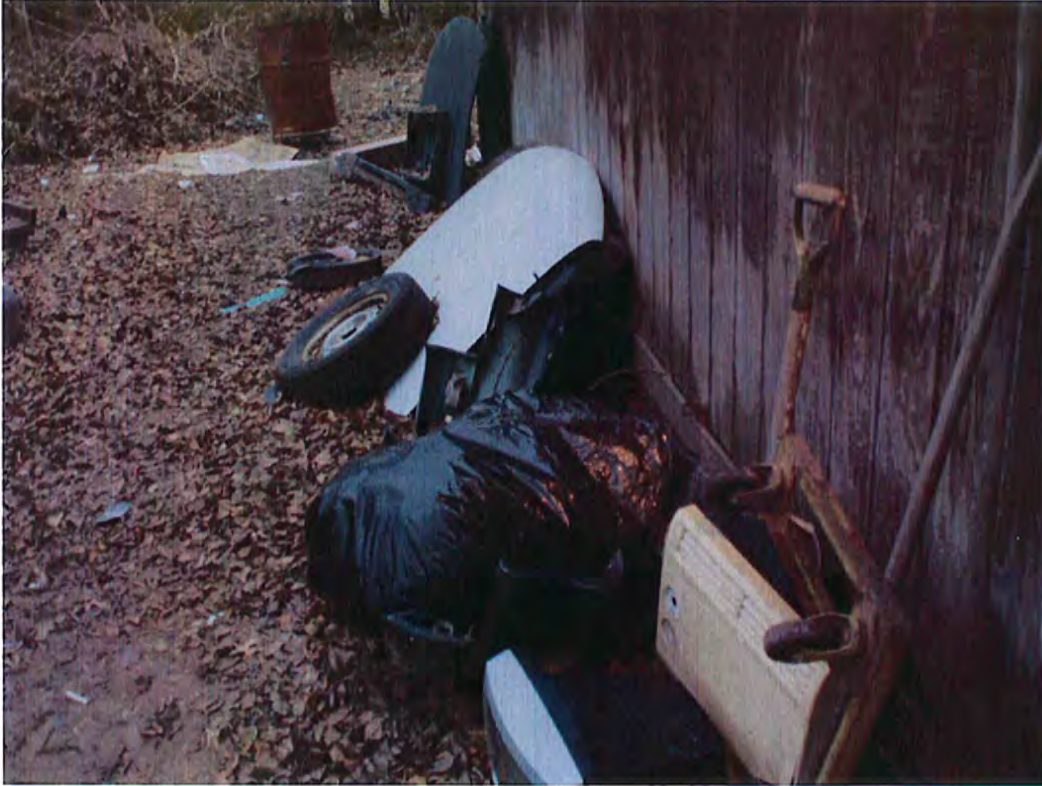
Date: December 2, 2014
Time: 10:44 a.m.
Direction: NE
Photo by: Charlie King
Exposure #: 011
Comments: The west side of the garage building with apparent wastes in an area of approximately 15' x 5' x 2'. Wastes included a used tire on-rim, the television shown in photo # 010, a shovel, plastics, metals, car parts, black garbage bags with unknown contents and wood.

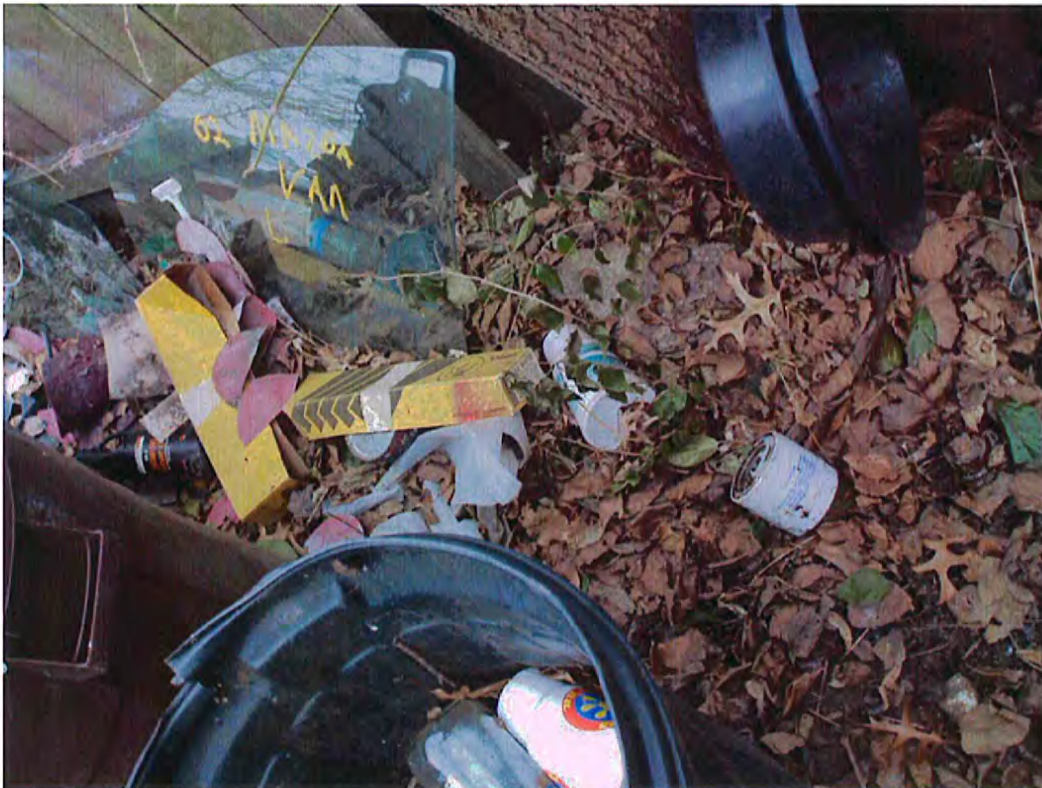
Date: December 4, 2014
Time: 10:46 a.m.
Direction: SE
Photo by: Charlie King
Exposure #: 012
Comments: An oil filter, plastics, a bucket with cans and bottles, a spilled bucket with paper and plastic refuse, and wood. Along the west side of the garage building.

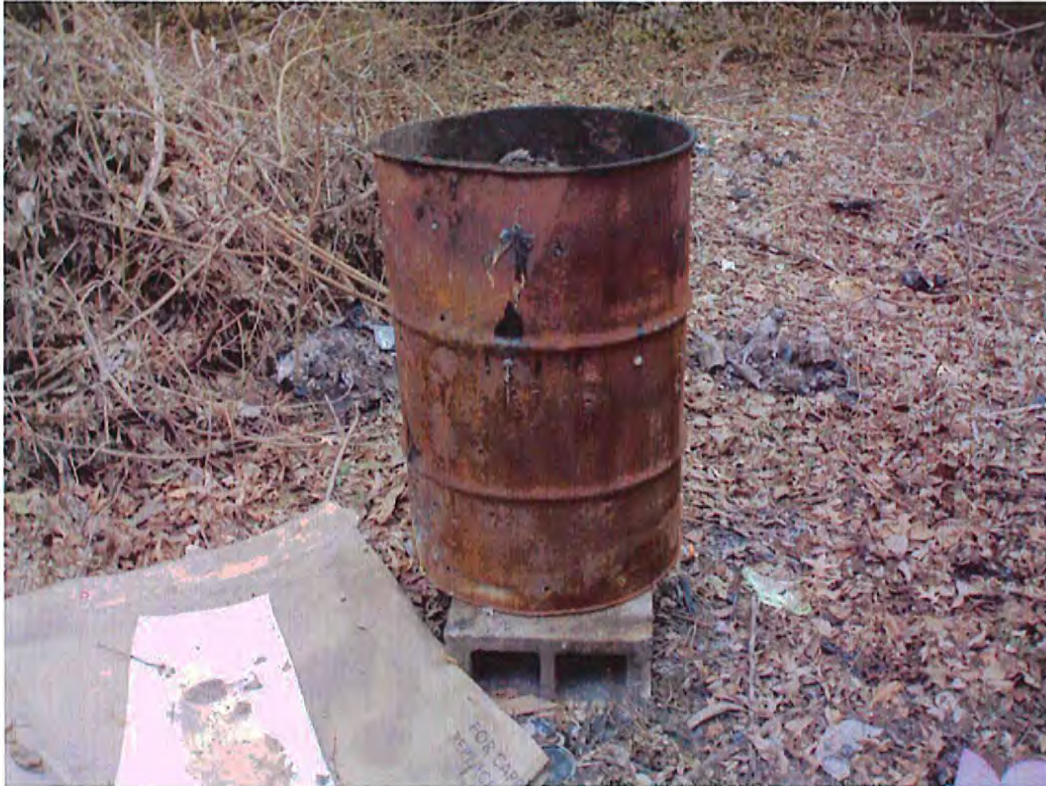
Photo # 013 shows an old burn barrel on concrete blocks near the back of the building. Cardboard is in the left foreground of the photo.

Date: December 2, 2014
Time: 10:47 a.m.
Direction: N
Photo by: Charlie King
Exposure #: 013
Comments: An old
burn barrel on concrete
blocks near the back of
the building.
Cardboard is in the left
foreground of the
photo.

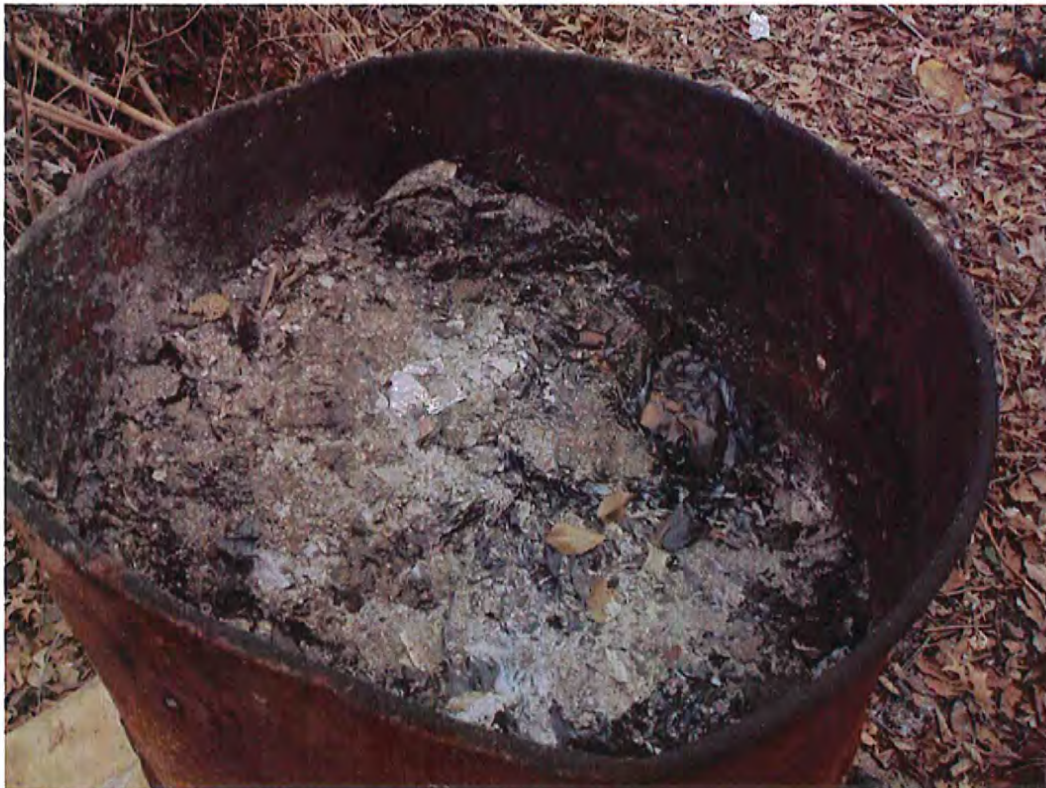
Photo # 014 shows the inside of the burn barrel shown in photo # 013 contained ashes.

Date: December 4, 2014
Time: 10:47 a.m.
Direction: N
Photo by: Charlie King
Exposure #: 014
Comments: Inside of
the burn barrel shown
in photo # 013
contained ashes.

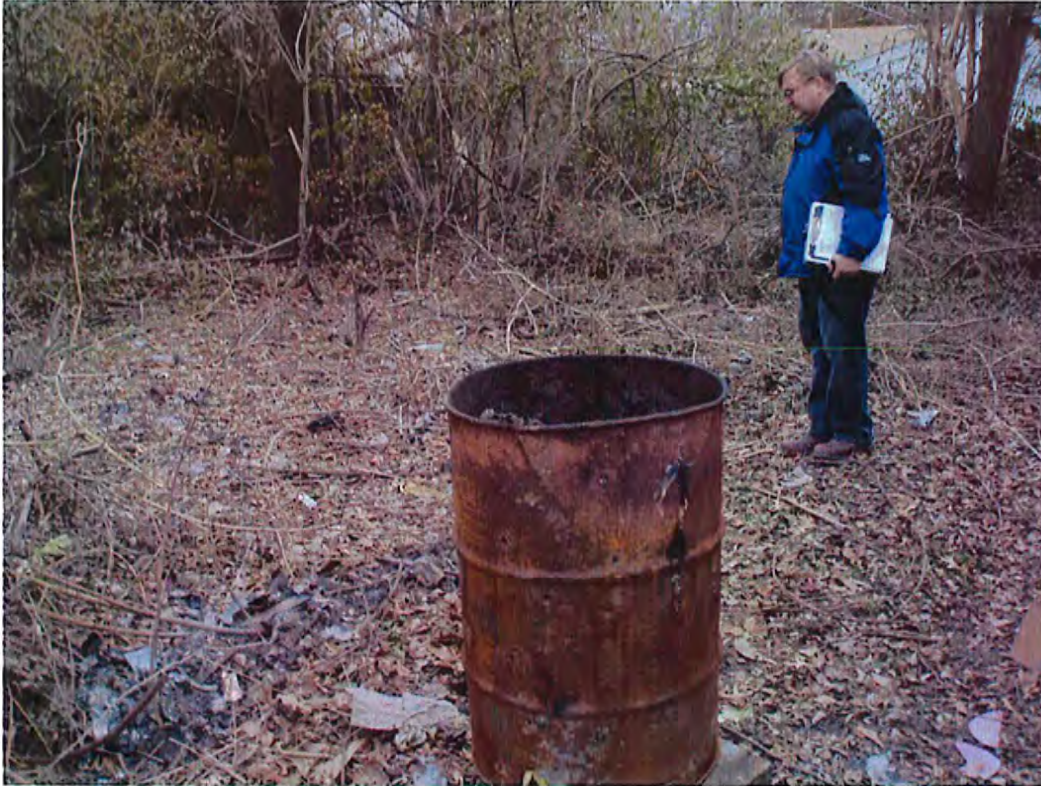
Date: December 2, 2014
Time: 10:48 a.m.
Direction: N
Photo by: Charlie King
Exposure #: 015
Comments: IEPA/BOA Inspector John Blazis observes wastes on the ground behind the business. Primarily bottles, cans and ashes littered the backyard.

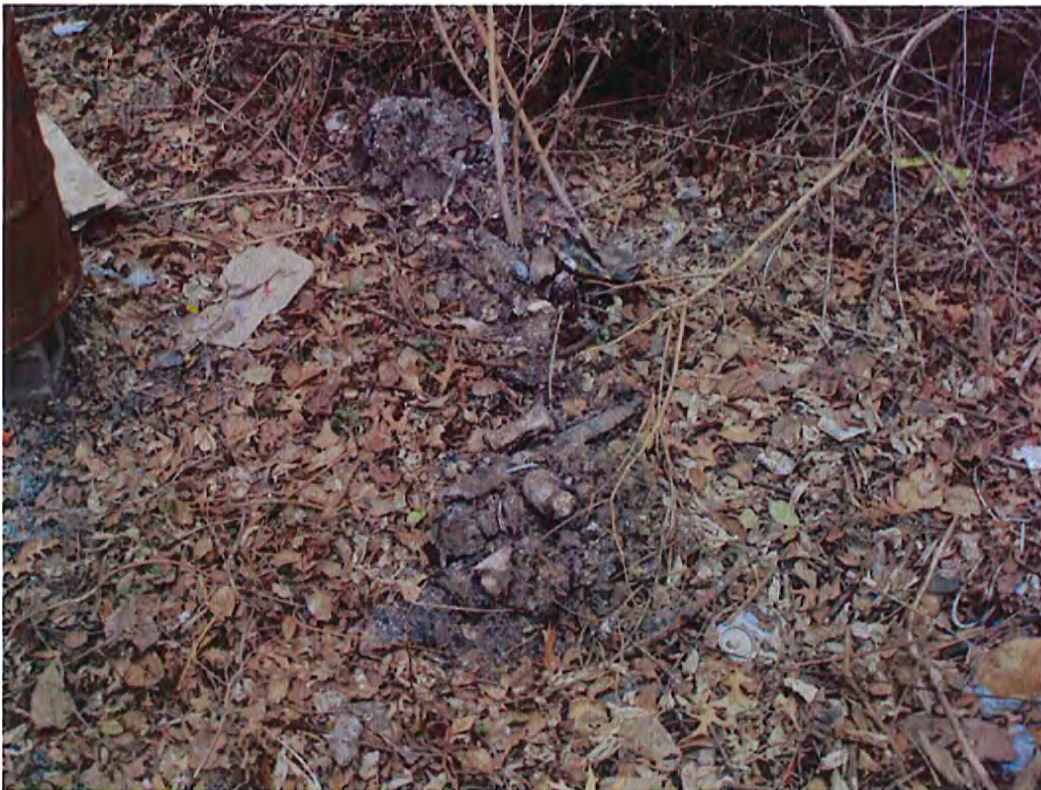
Photo # 016 shows ashes and other burnt wastes dumped on the ground, apparently after being burned in the burn barrel shown at the far left, and in photo #s 13, 14 and 15. The other burnt wastes included paper, cardboard, bottles and cans.

Date: December 4, 2014
Time: 10:49 a.m.
Direction: W
Photo by: Charlie King
Exposure #: 016
Comments: Ashes and other burnt wastes dumped on the ground apparently after being burned in the burn barrel shown at the far left, and in photo #'s 13, 14 and 15. The other burnt wastes included a paper, cardboard, bottles and cans.

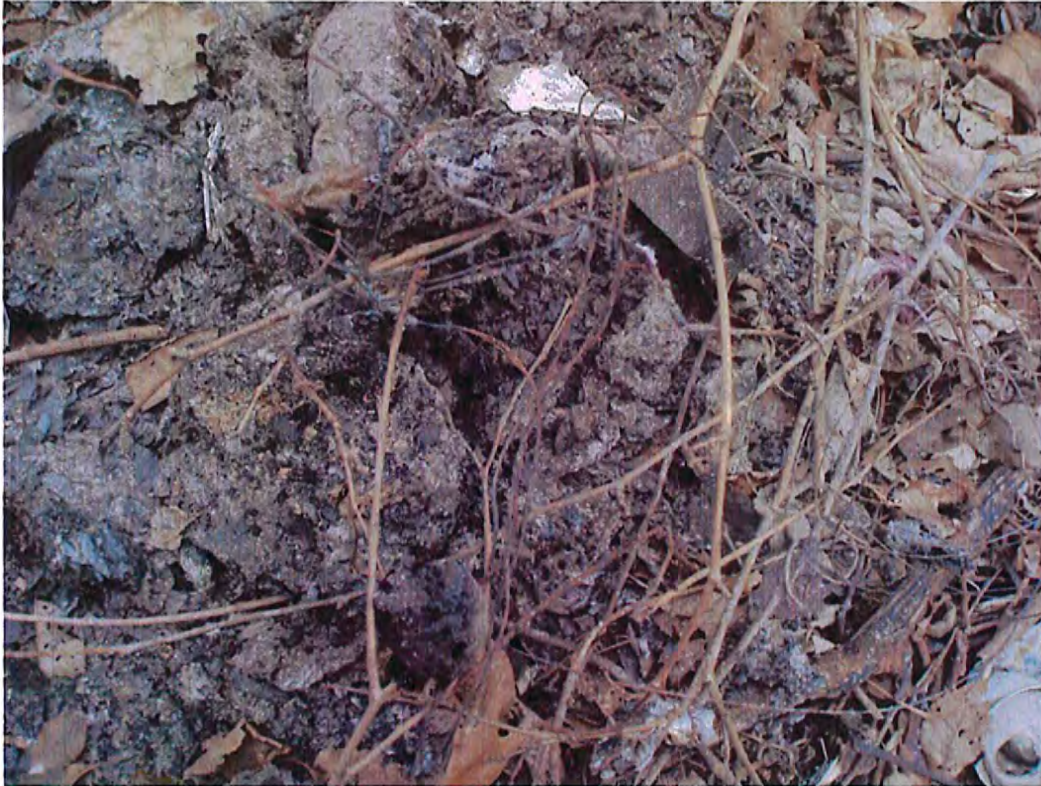
Photo # 017 shows a close-up of burned copper wire dumped with the other ashes on the ground.

Date: December 2, 2014
Time: 10:51 a.m.
Direction: W
Photo by: Charlie King
Exposure #: 017
Comments: A close-up of burned copper wire dumped with the other ashes on the ground.

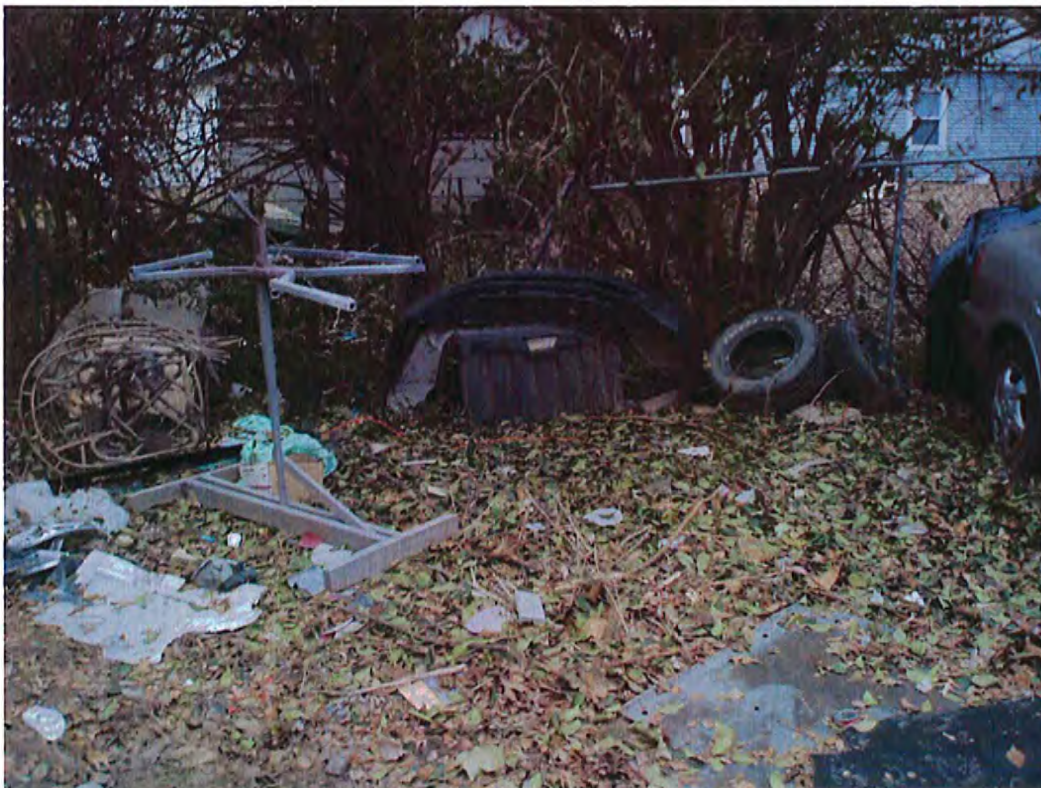
Date: December 4, 2014
Time: 10:54 a.m.
Direction: E
Photo by: Charlie King
Exposure #: 018
Comments: On the east side of the front of the garage, wastes observed include a used tire, plastics, a paint tree, cloth, metals and wood.

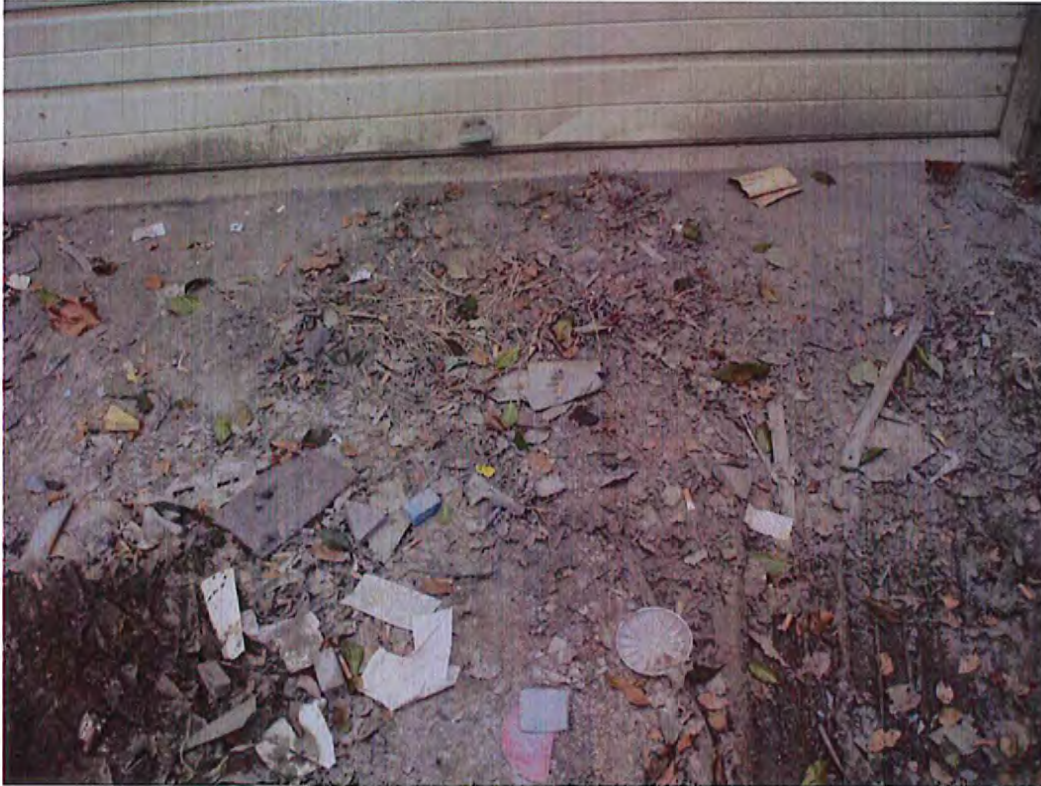
Date: December 2, 2014
Time: 10:54 a.m.
Direction: N
Photo by: Charlie King
Exposure #: 019
Comments: Paint, sweepings or overspray on the ground in front of the right garage door.

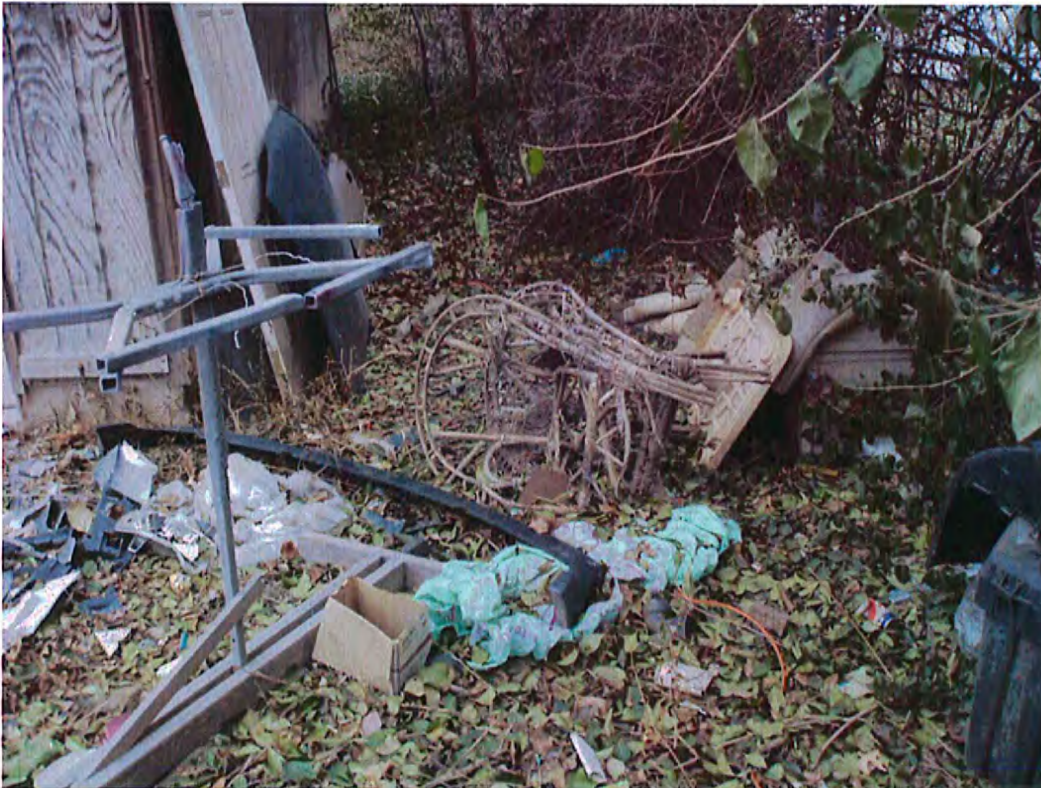
Date: December 4, 2014
Time: 10:55 A.M.
Direction: N
Photo by: Charlie King
Exposure #: 020
Comments: Wastes on the east side of the facility. Paper, plastics an empty white drum, wood and clothing wastes, and the paint tree shown in photo # 018.

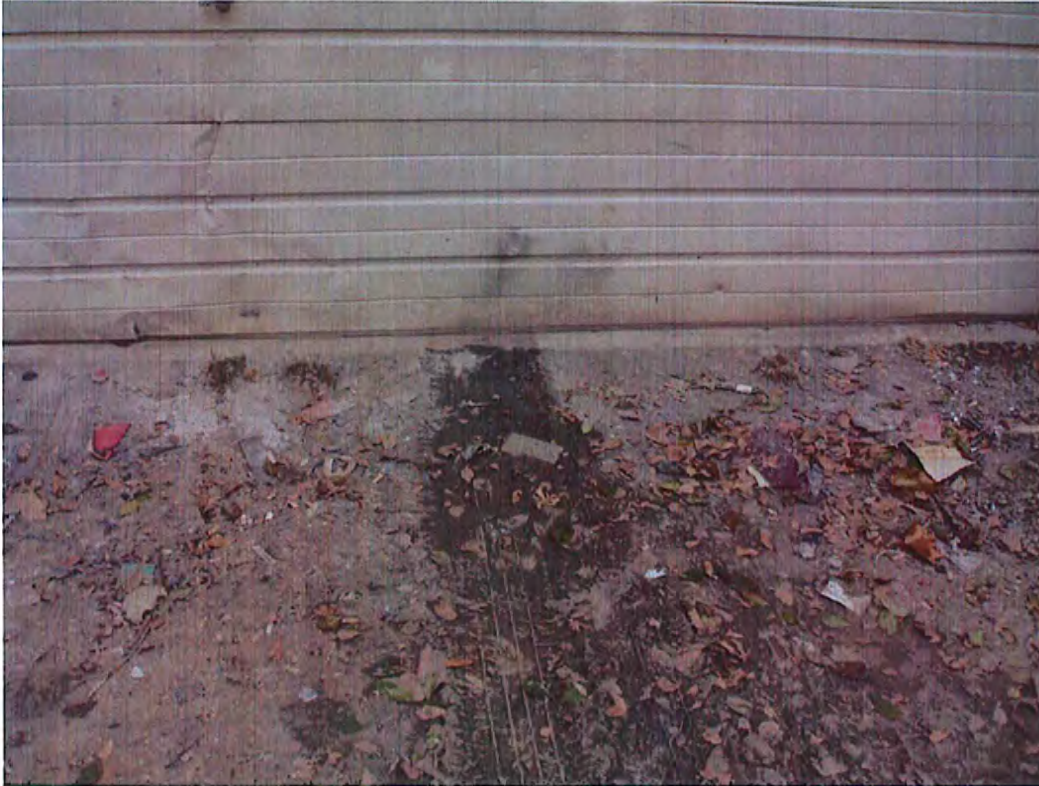
Date: December 2, 2014
Time: 10:57 a.m.
Direction: N
Photo by: Charlie King
Exposure #: 021
Comments: Apparent
paint overspray or
paint sweepings on the
ground in front of the
left garage door.
Wastes measured
approximately 2' x 8' x
< 1'.
