Re: Illinois Environmental Protection Agency v Eric Lane, John Rudd, Bob Whitaker and American Demolition Corporation  
IEPA File No. 38-15-AC; 1438055008

BEFORE THE ILLINOIS POLLUTION CONTROL BOARD  
ADMINISTRATIVE CITATION

1438055008 -- Peoria County  
Lane, Eric  
FOS  
Inspection Dates: December 17, 2014 & December 18, 2014  
Inspector: Robert J. Wagner  
Site Sketch A

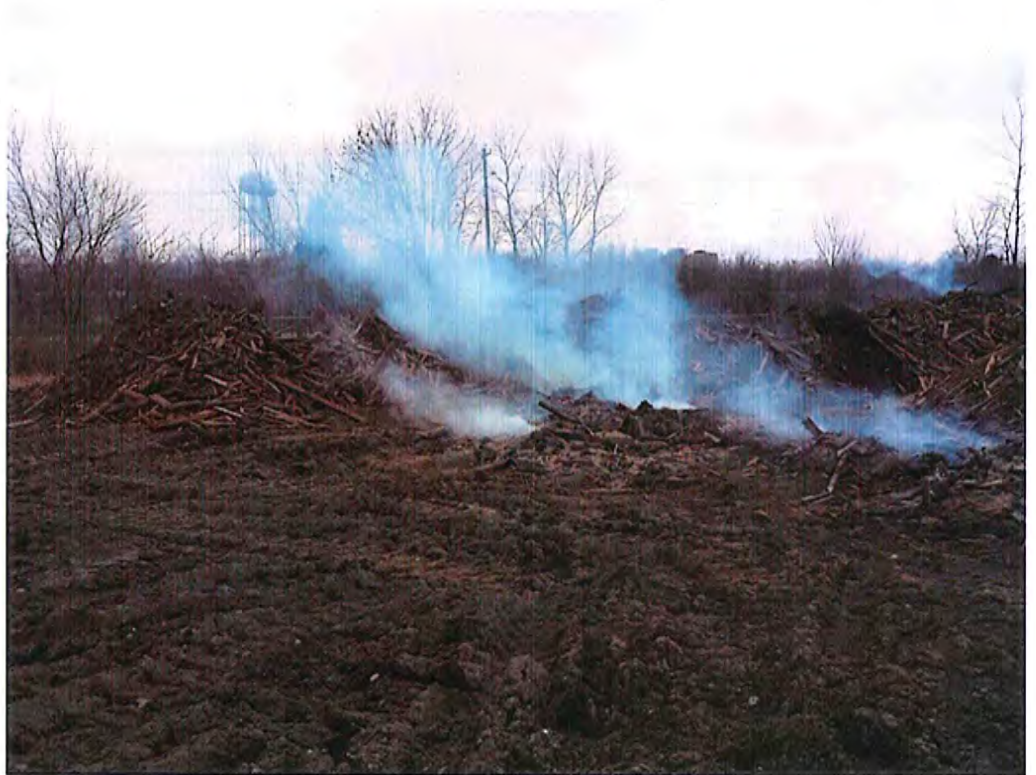
**PHOTOGRAPH FILE NAME:**  
1438055008~12172014-001.jpg

**COMMENTS:** The photograph  
shows demolition debris burning on  
the site. The demolition debris  
consists of metal sheeting, metal  
bars and processed wood.

Photographs 1, 2 and 7 show the piles of demolition debris. See site sketch A. The demolition debris consists of metal sheeting, metal bars, fibrous material and processed wood. Photographs 3 and 4 show what is left of a burning pile of demolition debris consisting of the smoldering remains of metal sheeting, metal bars, metal pipes, and processed wood. Four of the five piles were in a cone shape configuration and were approximately 6 feet in height and 15 feet wide at their base. I used the formula for a right circular cone to estimate the amount of demolition debris in each of the piles ( $V = \pi r^2 h / 3$ ). Each of the four piles contained approximately 13 cu yds of demolition debris. I estimate the total amount of demolition debris in this area to be approximately 52 cu yds.

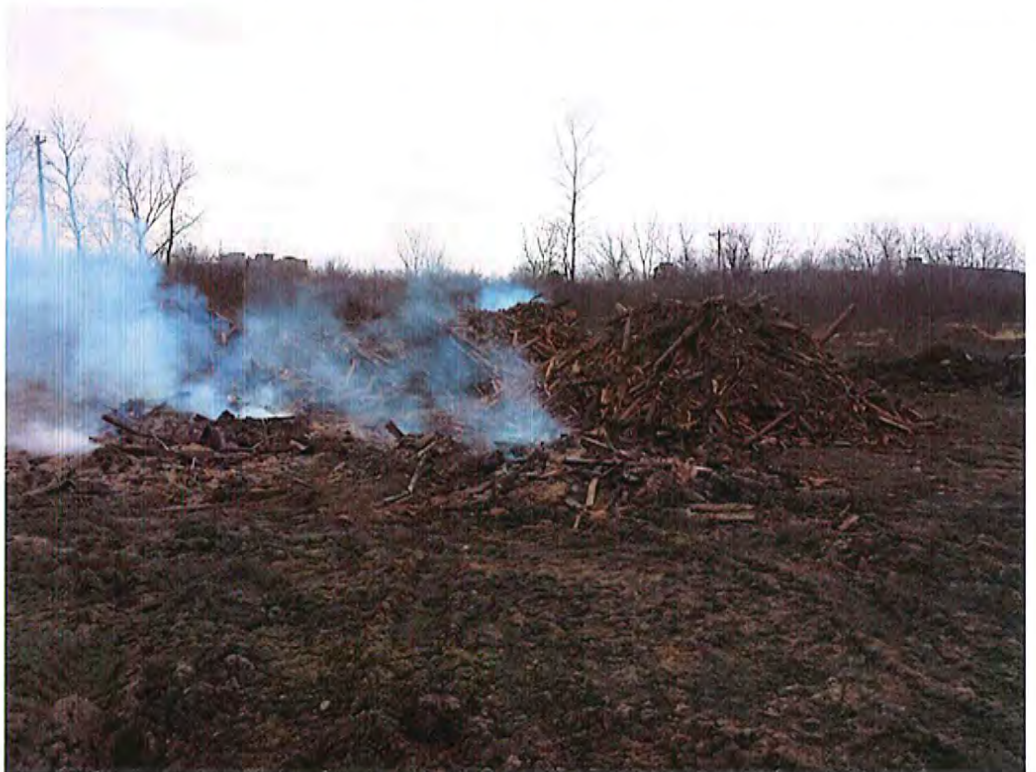
**PHOTOGRAPH FILE NAME:**  
1438055008~12172014-002.jpg

**COMMENTS:** The photograph  
shows demolition debris burning on  
the site. The demolition debris  
consists of metal sheeting, metal  
bars and processed wood.

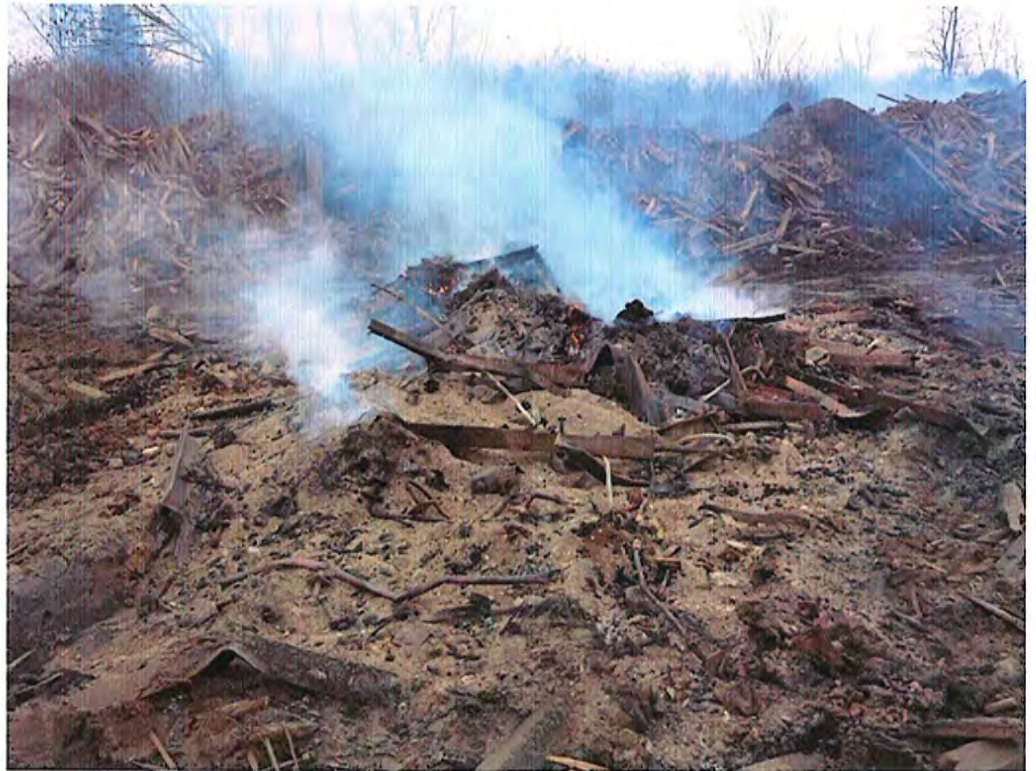
**PHOTOGRAPH FILE NAME:**  
1438055008~12172014-003.jpg

**COMMENTS:** The photograph  
shows demolition debris burning on  
the site. The demolition debris  
consists of metal sheeting, metal  
bars, metal pipes and processed  
wood.

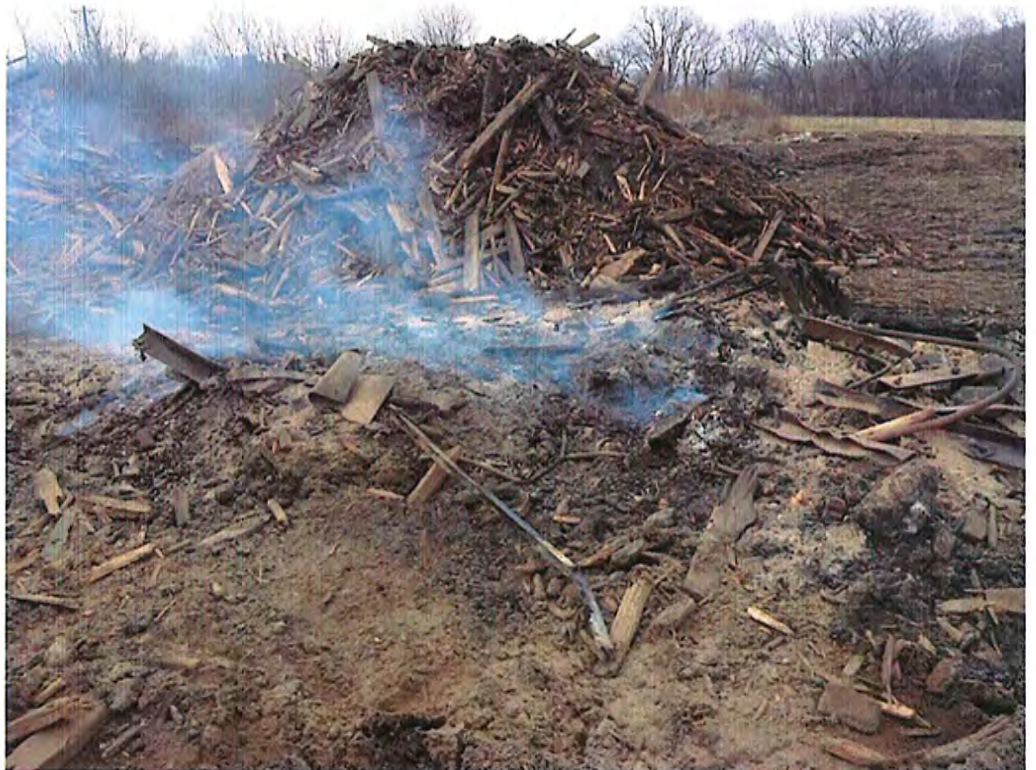
**PHOTOGRAPH FILE NAME:**  
1438055008~12172014-004.jpg

**COMMENTS:** The photograph  
shows demolition debris burning on  
the site. The demolition debris  
consists of metal sheeting, metal  
bars, metal pipes and processed  
wood.

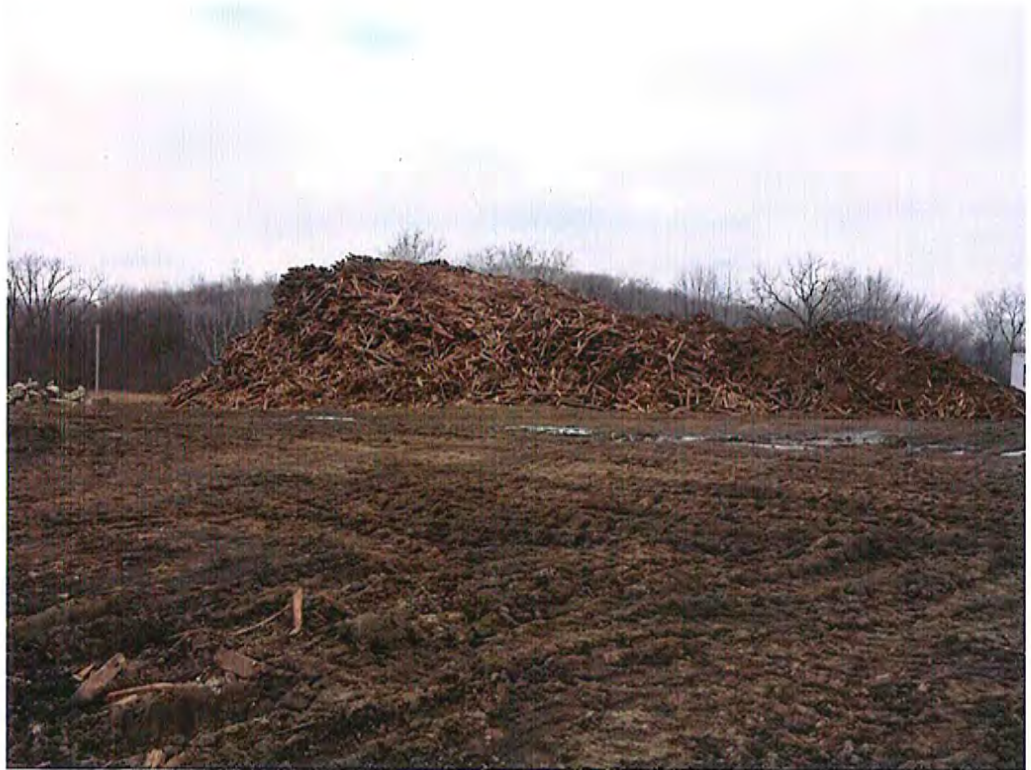
1438055008~12172014-005.jpg

**COMMENTS:** The photograph shows a pile of demolition debris. The pile of demolition debris consists of metal sheeting, metal pipes, metal bands, electrical wire, electrical conduit, metal bars and processed wood.

Photographs 5, 6, 9, 12, 13, 14, 16, 17, and 19 show the large pile of demolition debris that I observed from the east bound lane of US Route 24. See site sketch A. This pile of demolition debris consisted of metal sheeting, metal pipes, metal bands, electrical wire, electrical conduit, metal bars, and processed wood. This pile was located to the north of the piles of burning demolition debris. I estimate the size of this pile to be approximately 200 feet long by 50 feet wide by 25 feet high in size (9259 cu yds.).

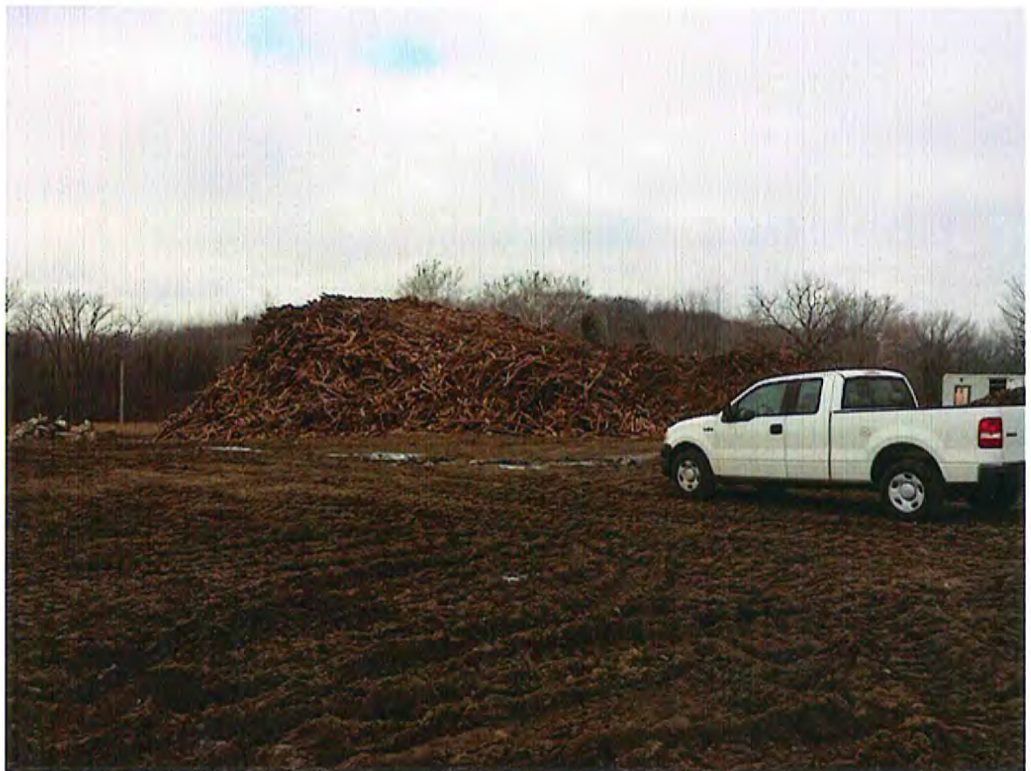
1438055008~12172014-006.jpg

**COMMENTS:** The photograph shows a pile of demolition debris. The pile of demolition debris consists of metal sheeting, metal pipes, metal bands, electrical wire, electrical conduit, metal bars and processed wood.

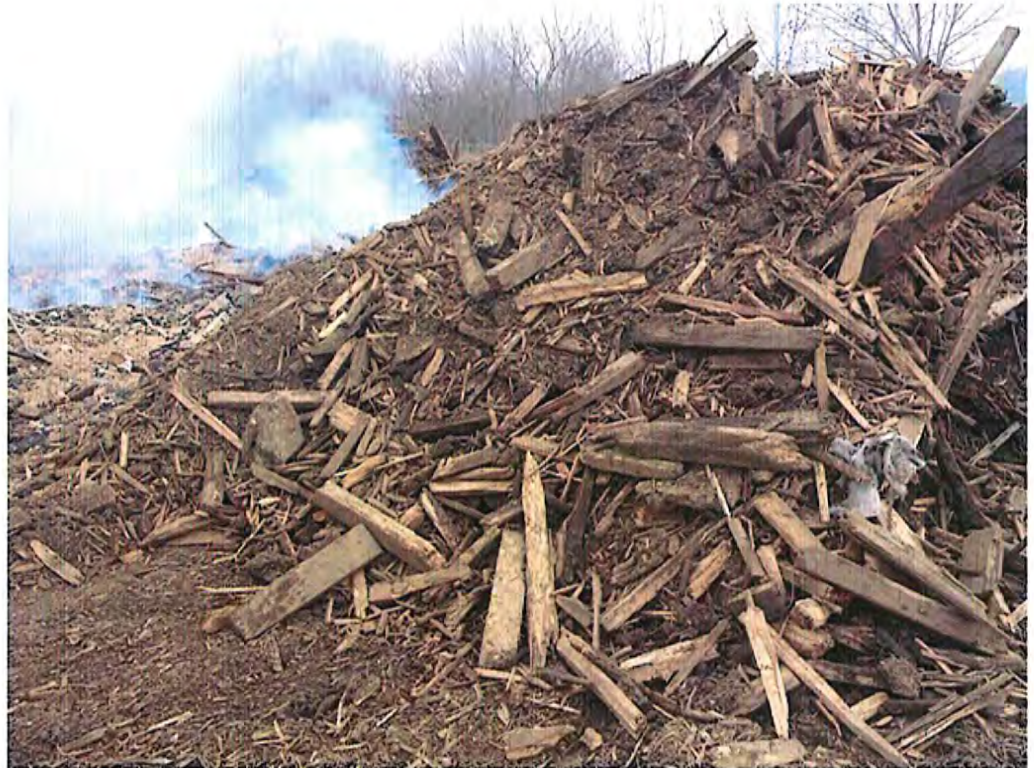
1438055008~12172014-007.jpg

**COMMENTS:** The photograph shows demolition debris burning on the site. The demolition debris consists of metal sheeting, metal bars, fibrous material and processed wood.

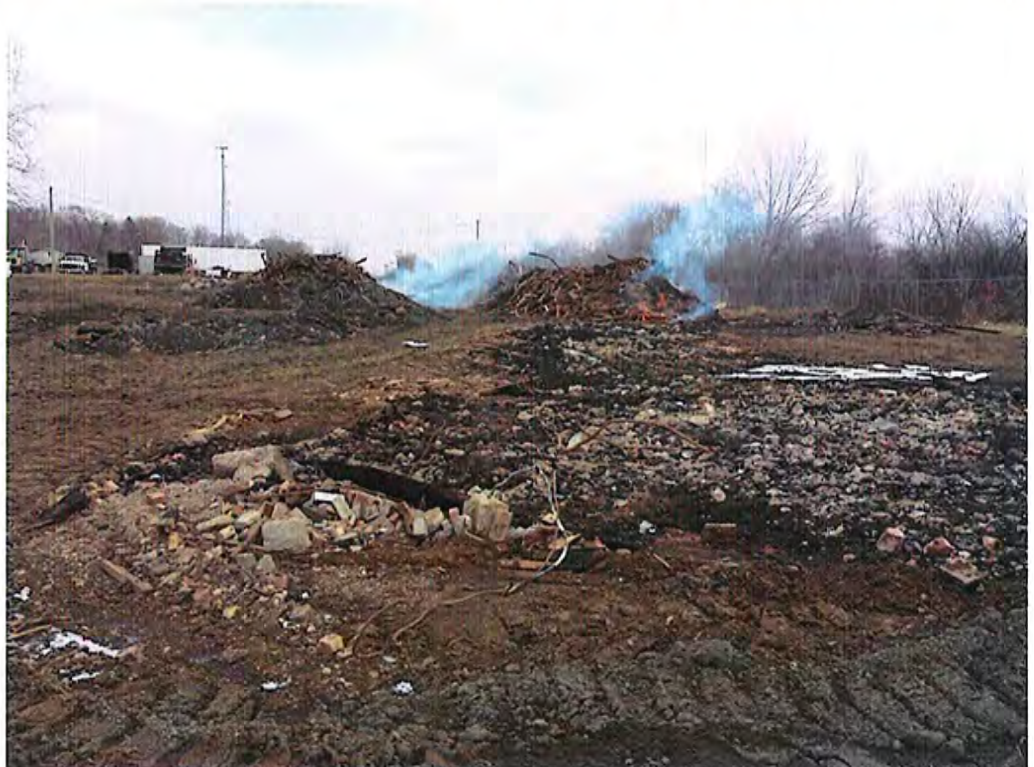
1438055008~12172014-008.jpg

**COMMENTS:** The photograph shows red brick commingled with concrete block, chunks of concrete, wire and metal rebar. These items were protruding from the ground. Evidence indicates that open burning has taken place in this area of the property. This evidence is the charred remains of processed wood and metal debris. In the foreground of the photograph are the burning piles of demolition debris.

the far southwest corner of the property. Evidence indicates that open burning has taken place in this area of the property. This evidence is the charred remains of processed wood and metal debris protruding from the ground. In the foreground of the photographs are the burning piles of demolition debris. I estimate the size of this area to be approximately 100 feet long by 50 feet wide by 1 feet deep in size (185 cu yds.). I used 1 foot as the standard depth measurement to get an approximate estimate of the amount of demolition debris buried in this area of the property. The depth of the demolition debris in this area of the property could be less or it could be more.

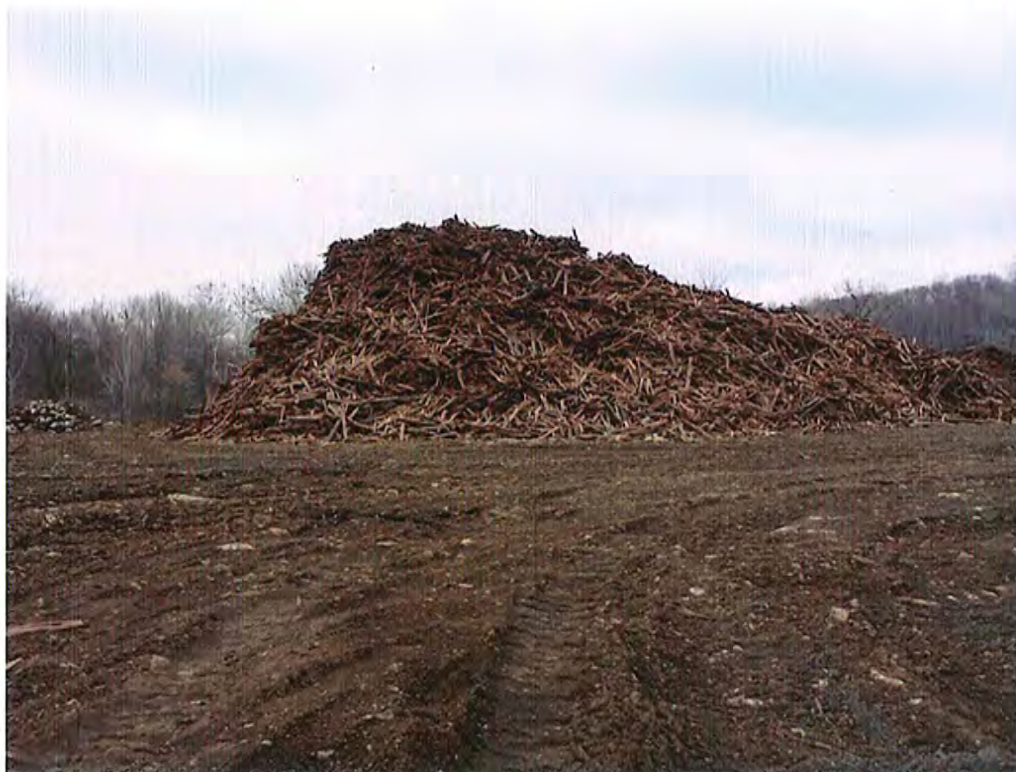
1438055008~12172014-009.jpg

**COMMENTS:** The photograph shows a pile of demolition debris. The pile of demolition debris consists of metal sheeting, metal pipes, metal bands, electrical wire, electrical conduit, metal bars and processed wood.

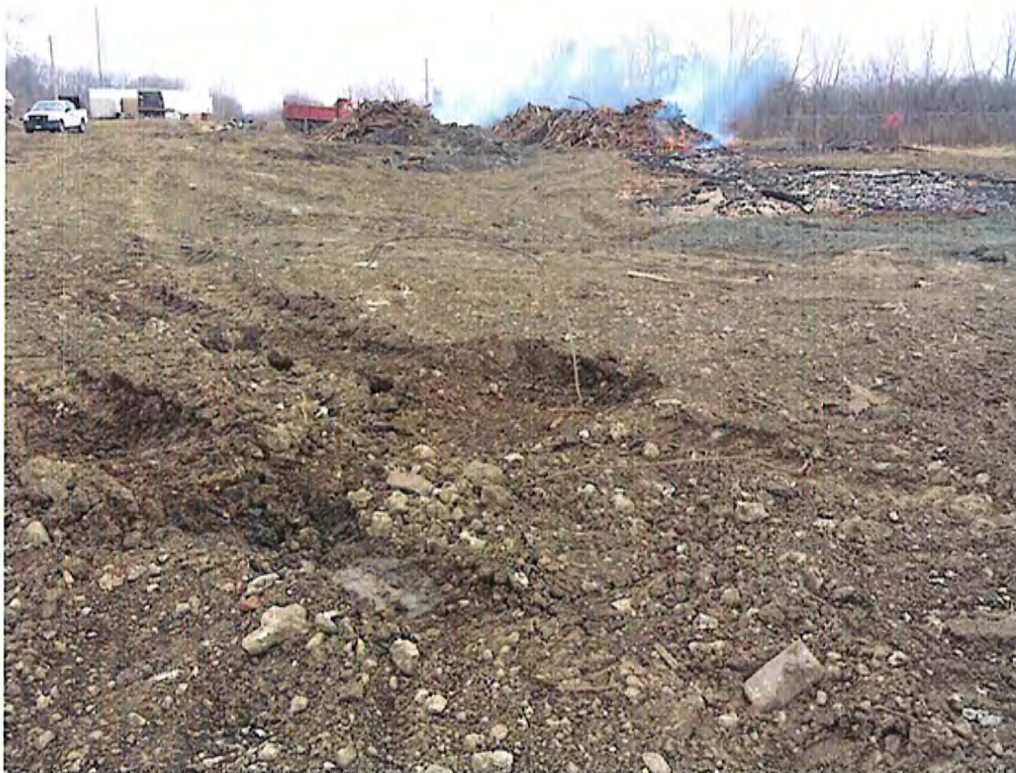
1438055008~12172014-010.jpg

**COMMENTS:** The photograph shows red brick commingled with concrete block, chunks of concrete, wire and metal rebar. These items were protruding from the ground. Evidence indicates that open burning has taken place in this area of the property. This evidence is the charred remains of processed wood and metal debris. In the foreground of the photograph are the burning piles of demolition debris.

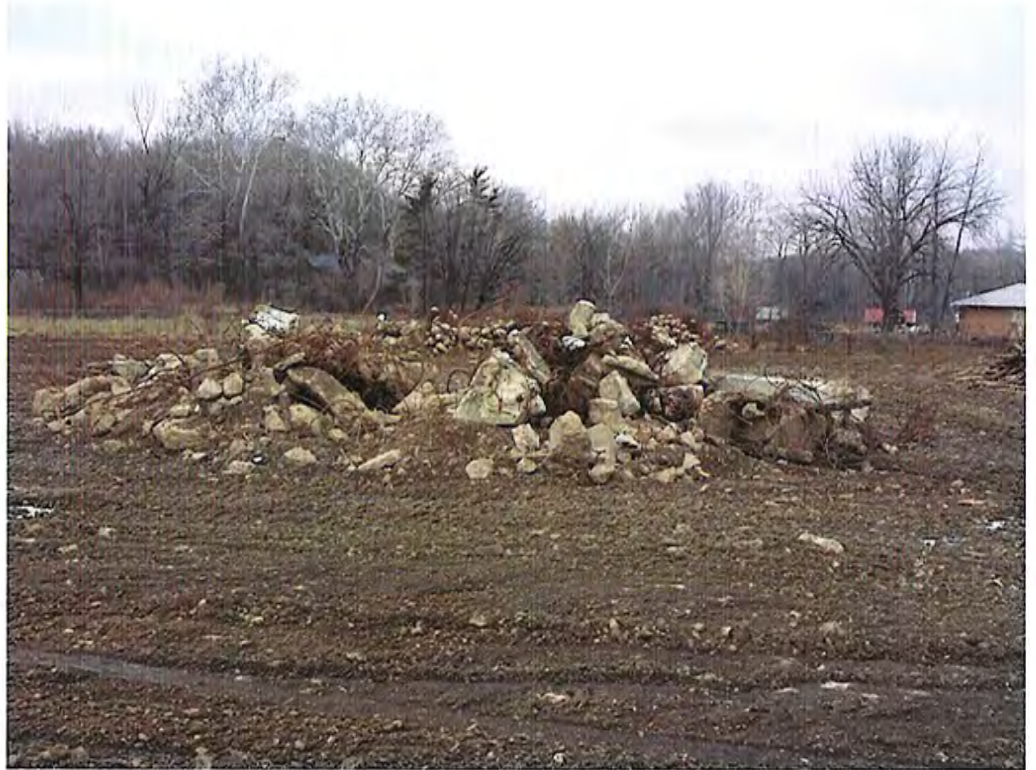
1438055008~12172014-011.jpg

**COMMENTS:** The photograph shows a pile of concrete chunks with protruding steel bars and steel wire.

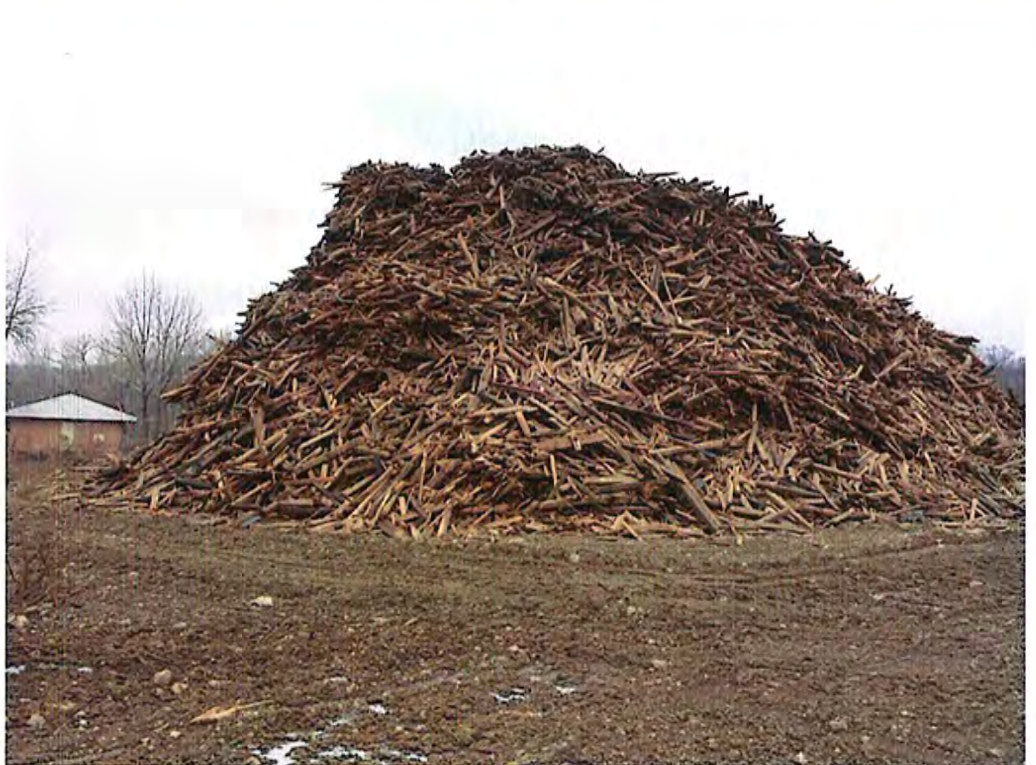
1438055008~12172014-012.jpg

**COMMENTS:** The photograph shows a pile of demolition debris. The pile of demolition debris consists of metal sheeting, metal pipes, metal bands, electrical wire, electrical conduit, metal bars and processed wood.

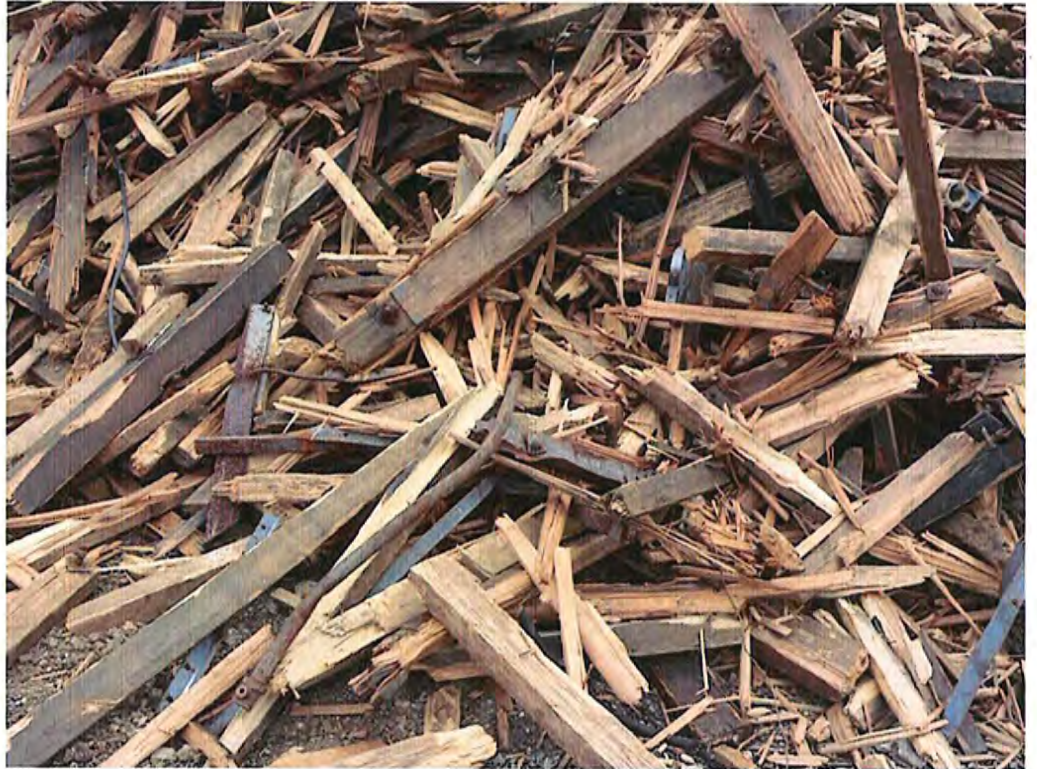
**PHOTOGRAPH FILE NAME:**  
1438055008~12172014-013.jpg

**COMMENTS:** The photograph  
shows a pile of demolition debris.  
The pile of demolition debris  
consists of metal sheeting, metal  
pipes, metal bands, electrical wire,  
electrical conduit, metal bars and  
processed wood.

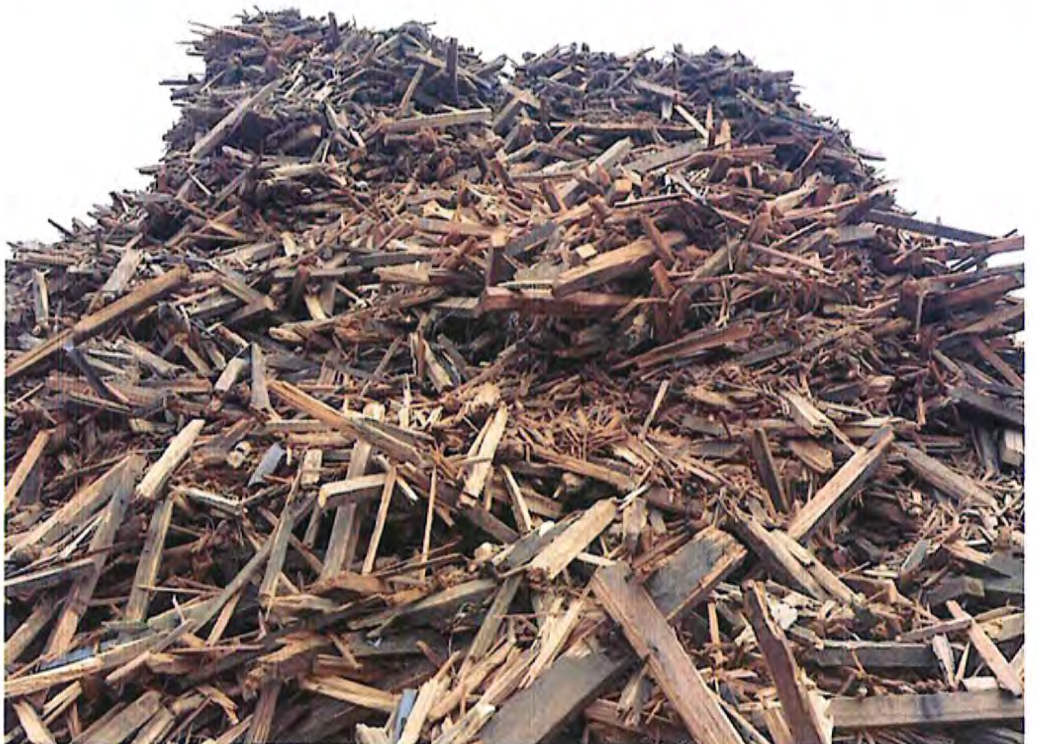
**PHOTOGRAPH FILE NAME:**  
1438055008~12172014-014.jpg

**COMMENTS:** The photograph  
shows a pile of demolition debris.  
The pile of demolition debris  
consists of metal sheeting, metal  
pipes, metal bands, electrical wire,  
electrical conduit, metal bars and  
processed wood.

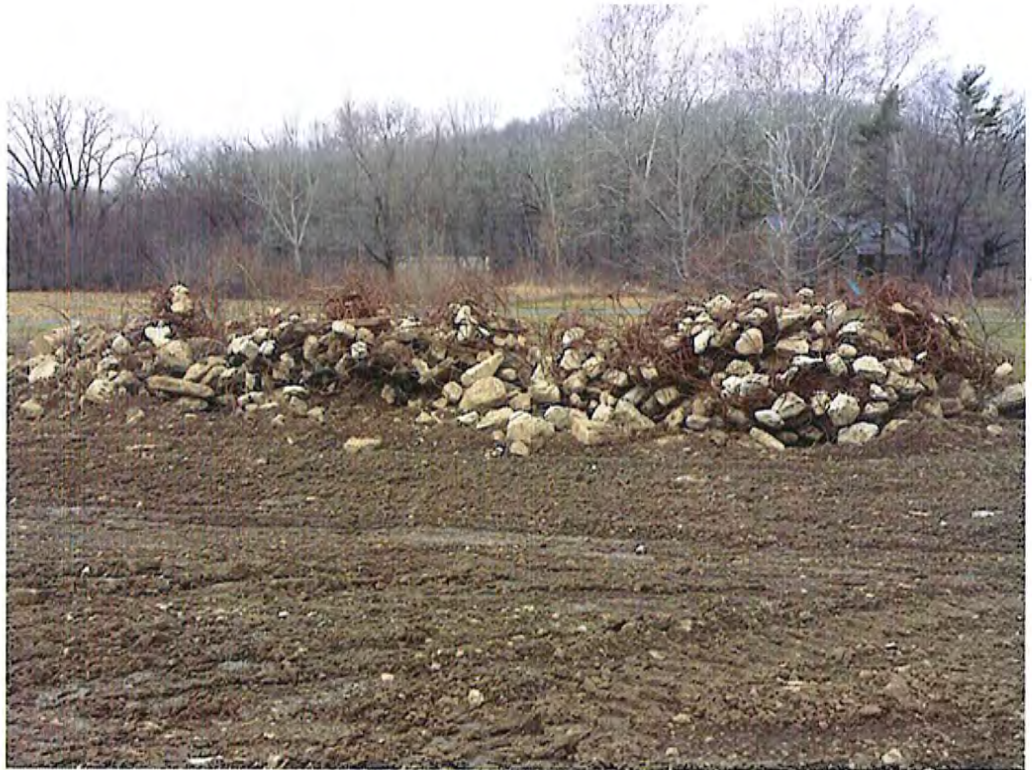
1438055008~12172014-015.jpg

**COMMENTS:** The photograph  
shows a pile of concrete chunks  
with protruding steel bars and steel  
wire.

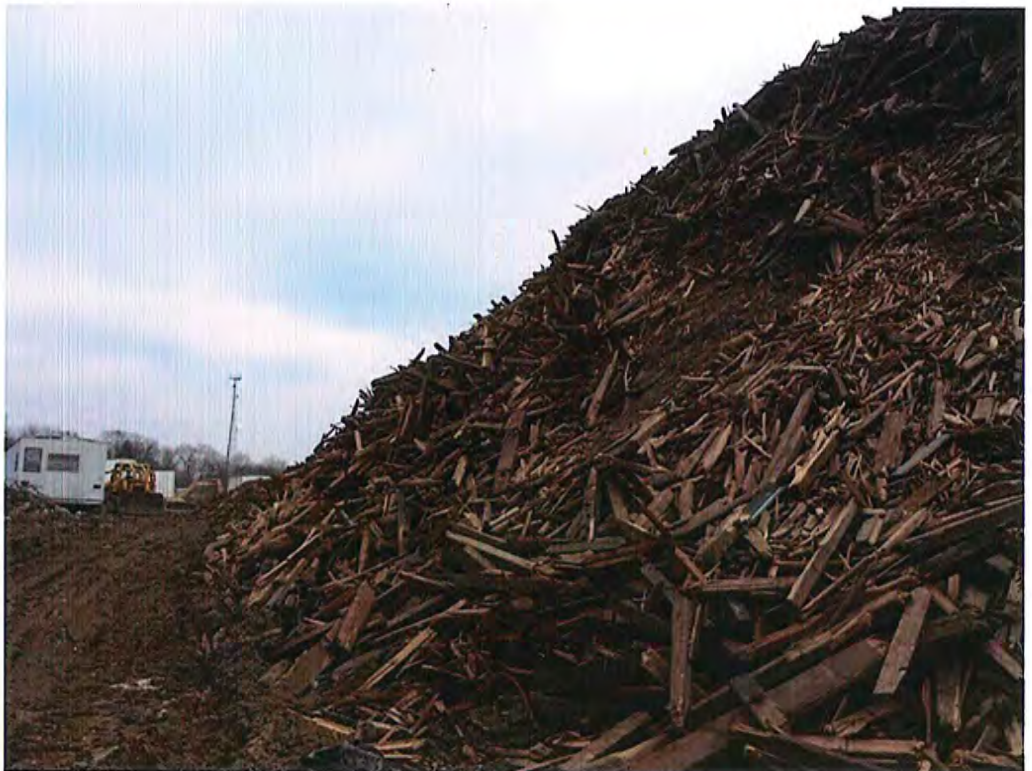
1438055008~12172014-016.jpg

**COMMENTS:** The photograph  
shows a pile of demolition debris.  
The pile of demolition debris  
consists of metal sheeting, metal  
pipes, metal bands, electrical wire,  
electrical conduit, metal bars and  
processed wood.

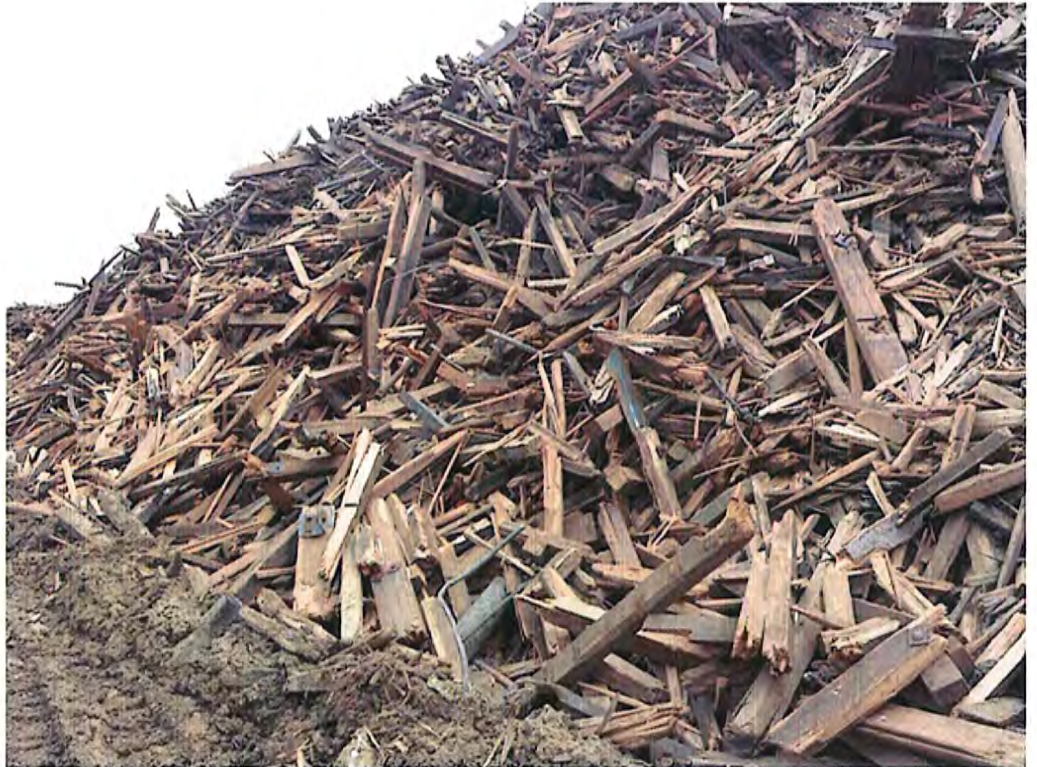
**PHOTOGRAPH FILE NAME:**  
1438055008~12172014-017.jpg

**COMMENTS:** The photograph  
shows a pile of demolition debris.  
The pile of demolition debris  
consists of metal sheeting, metal  
pipes, metal bands, electrical wire,  
electrical conduit, metal bars and  
processed wood.

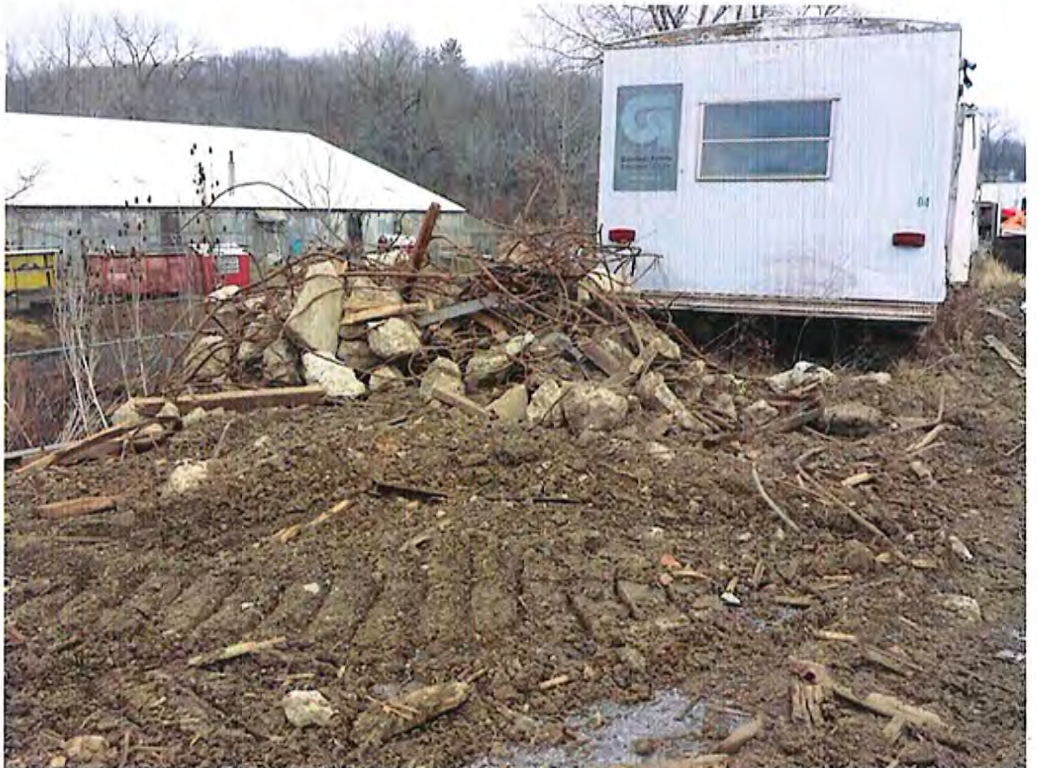
**PHOTOGRAPH FILE NAME:**  
1438055008~12172014-018.jpg

**COMMENTS:** The photograph  
shows a pile of concrete chunks  
with protruding steel bars and steel  
wire.

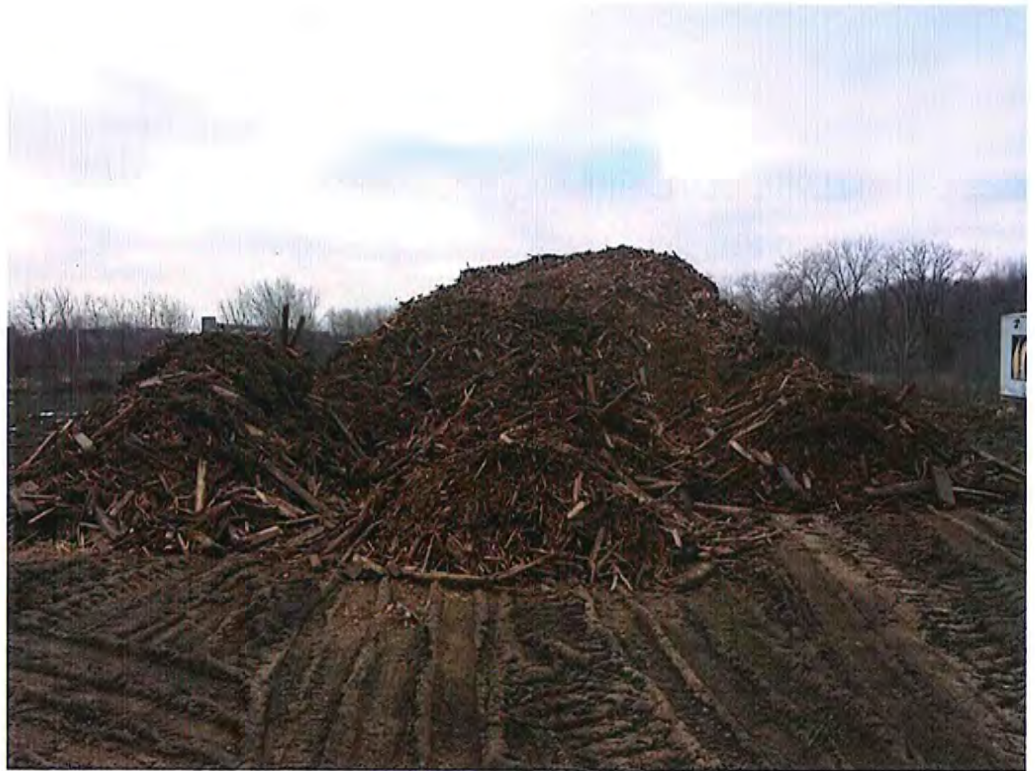
**PHOTOGRAPH FILE NAME:**  
1438055008~12172014-019.jpg

**COMMENTS:** The photograph  
shows a pile of demolition debris.  
The pile of demolition debris  
consists of metal sheeting, metal  
pipes, metal bands, electrical wire,  
electrical conduit, metal bars and  
processed wood.

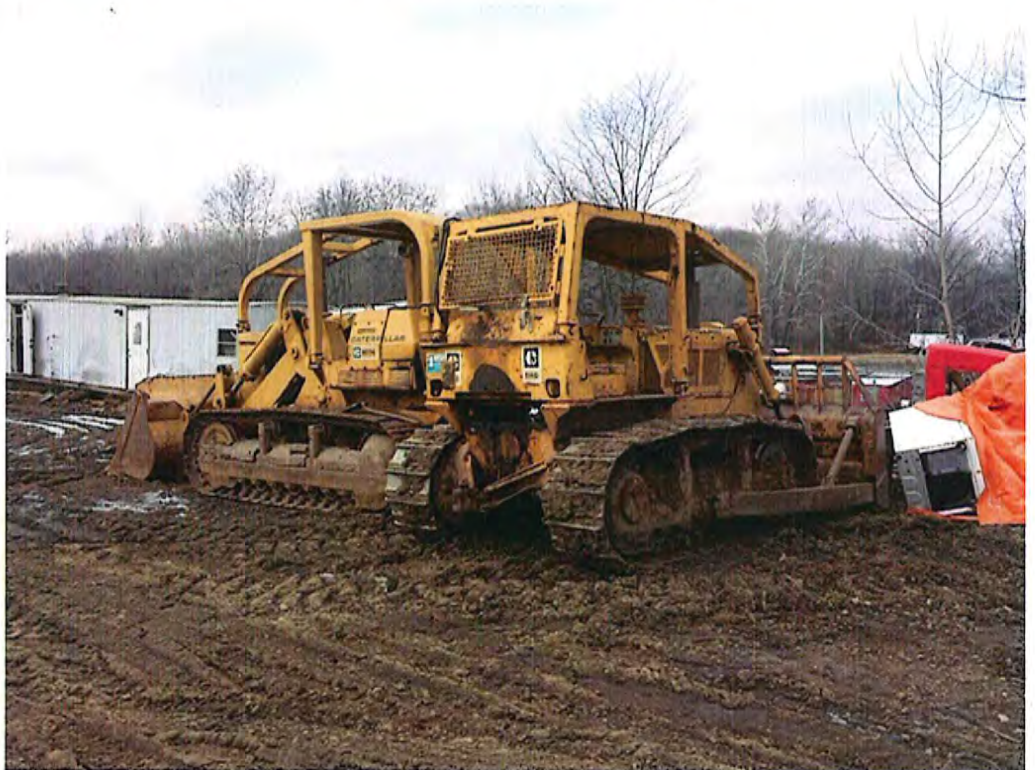
**PHOTOGRAPH FILE NAME:**  
1438055008~12172014-020.jpg

**COMMENTS:** The photograph  
shows a track loader tractor and a  
bulldozer tractor.

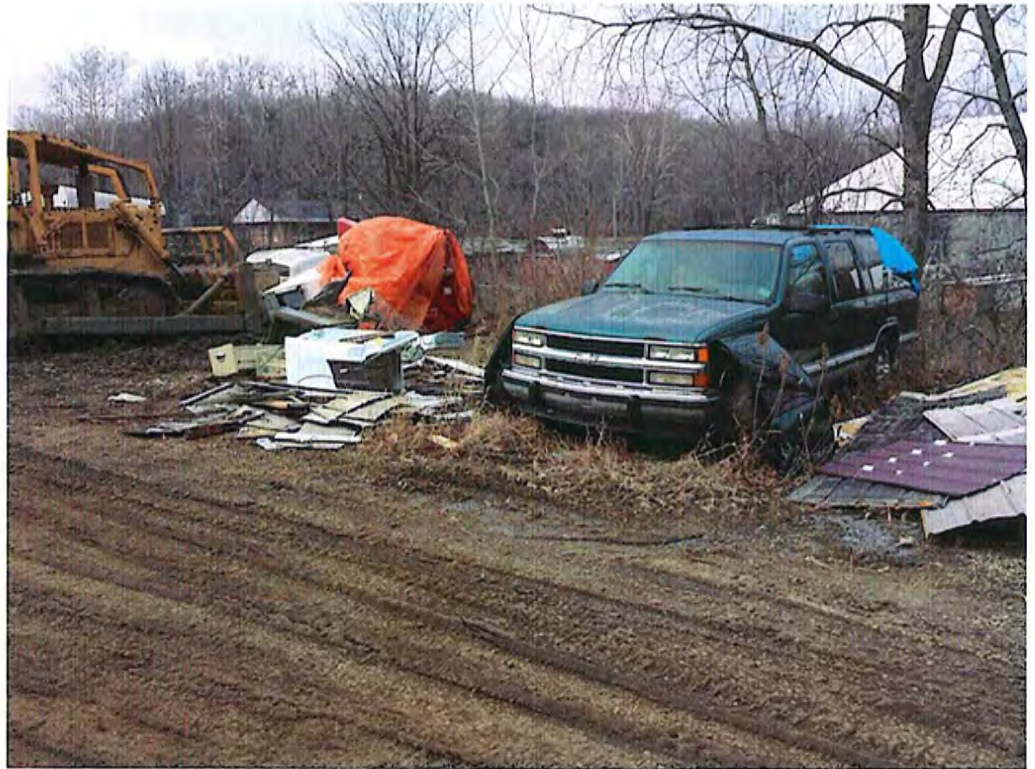
**PHOTOGRAPH FILE NAME:**  
1438055008~12172014-021.jpg

**COMMENTS:** The photograph  
shows pieces of metal and white  
goods.

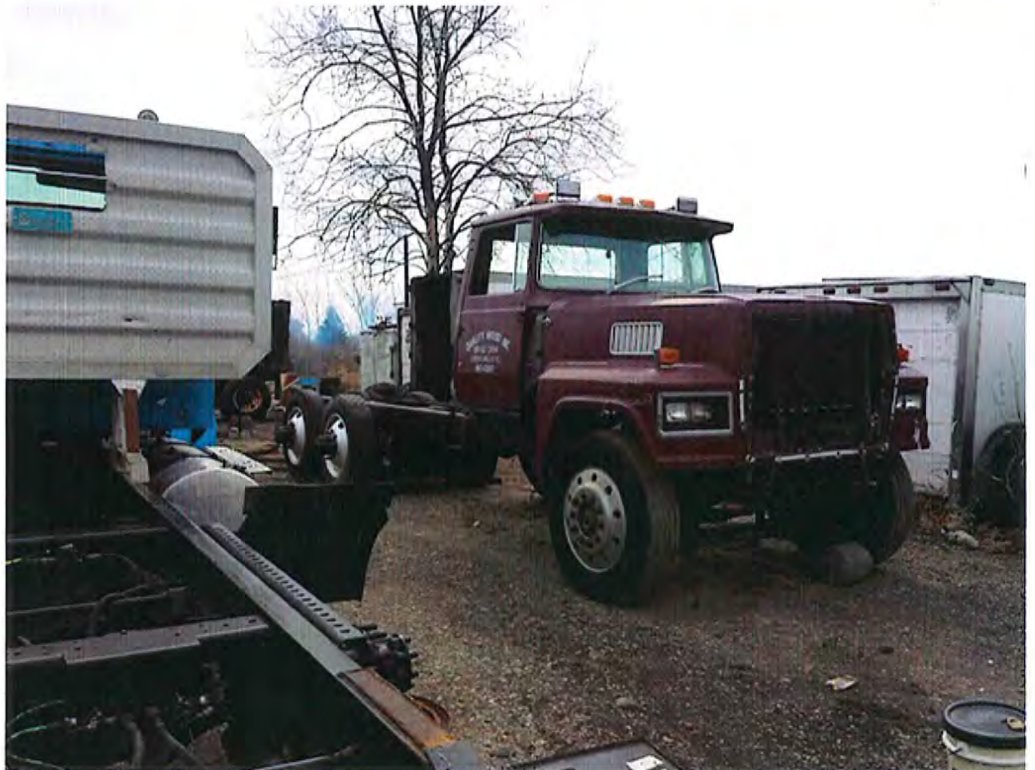
**PHOTOGRAPH FILE NAME:**  
1438055008~12172014-022.jpg

**COMMENTS:** The photograph  
shows a semi-truck.

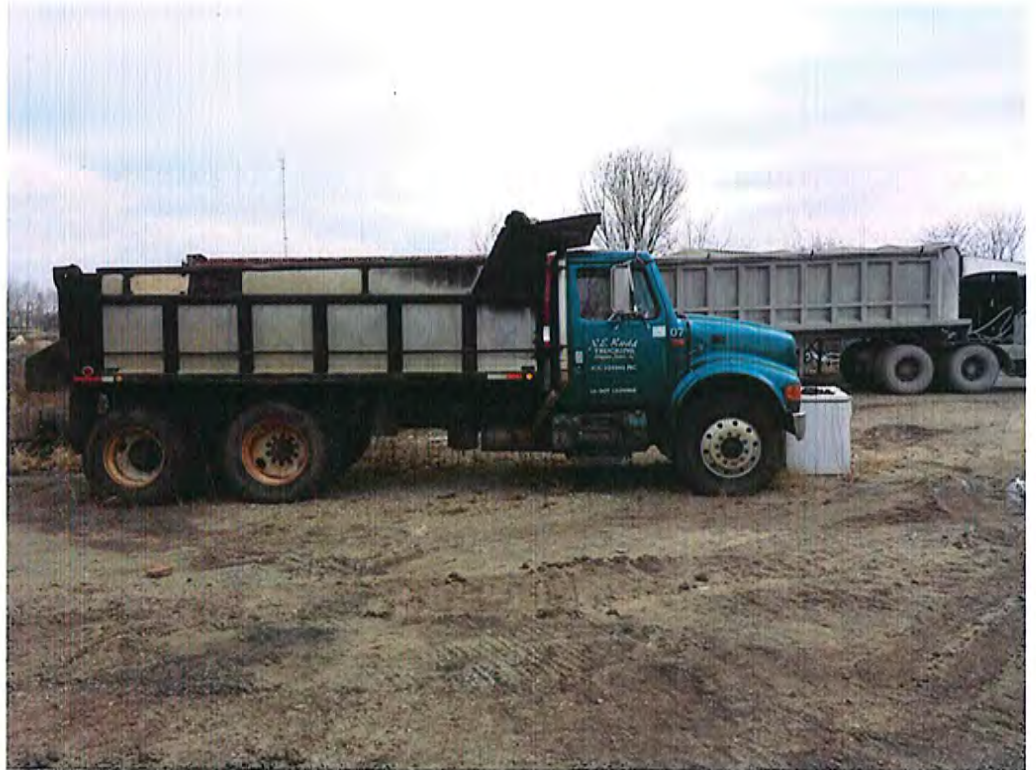
**PHOTOGRAPH FILE NAME:**  
1438055008~12172014-023.jpg

**COMMENTS:** The photograph  
shows a dump truck with NE Rudd  
written on the side of the cab.

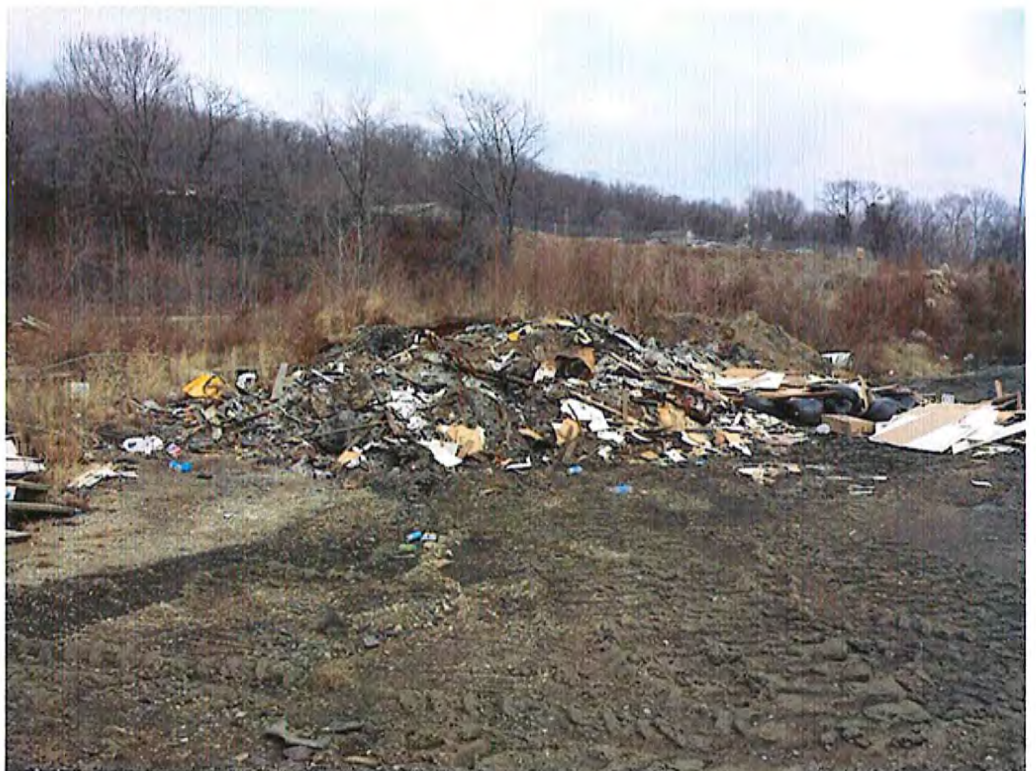
**PHOTOGRAPH FILE NAME:**  
1438055008~12172014-024.jpg

**COMMENTS:** The photograph  
shows garbage bags full of solid  
waste, cardboard, processed wood,  
paper and wallboard. The  
photograph also shows the charred  
remains of processed wood, plastic  
containers, metal debris, tire beads,  
wallboard, cardboard, paper,  
aluminum cans.

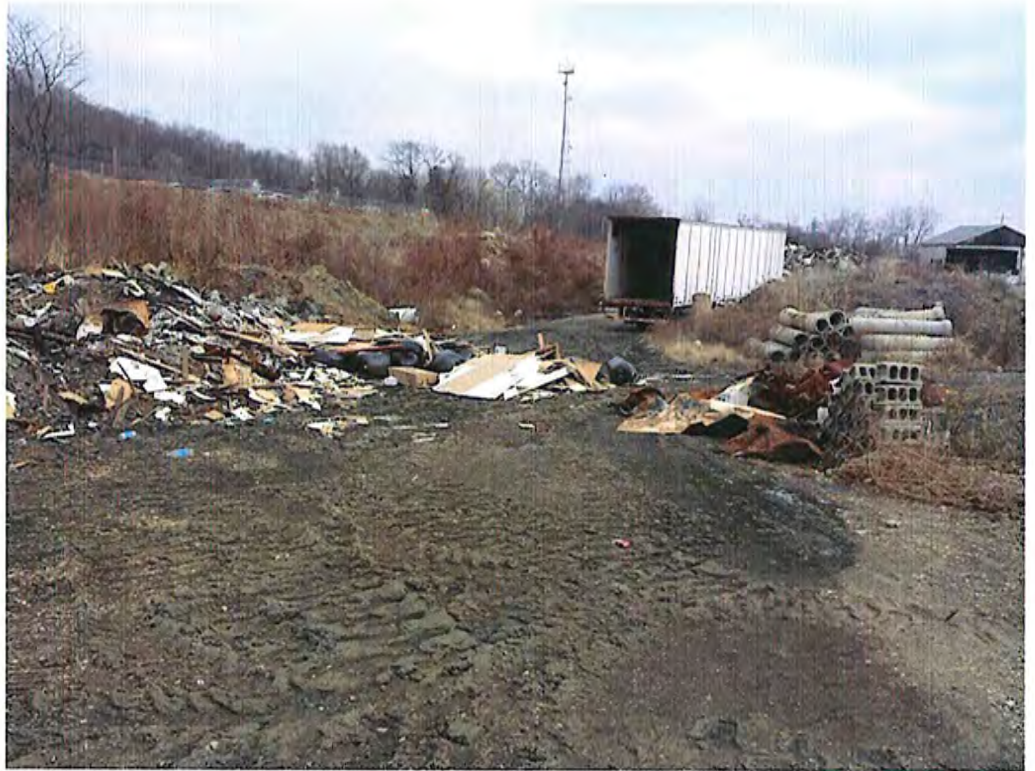
**PHOTOGRAPH FILE NAME:**  
1438055008~12172014-025.jpg

**COMMENTS:** The photograph shows garbage bags full of solid waste, cardboard, processed wood, paper and wallboard. The photograph also shows the charred remains of processed wood, plastic containers, metal debris, tire beads, wallboard, cardboard, paper, aluminum cans.

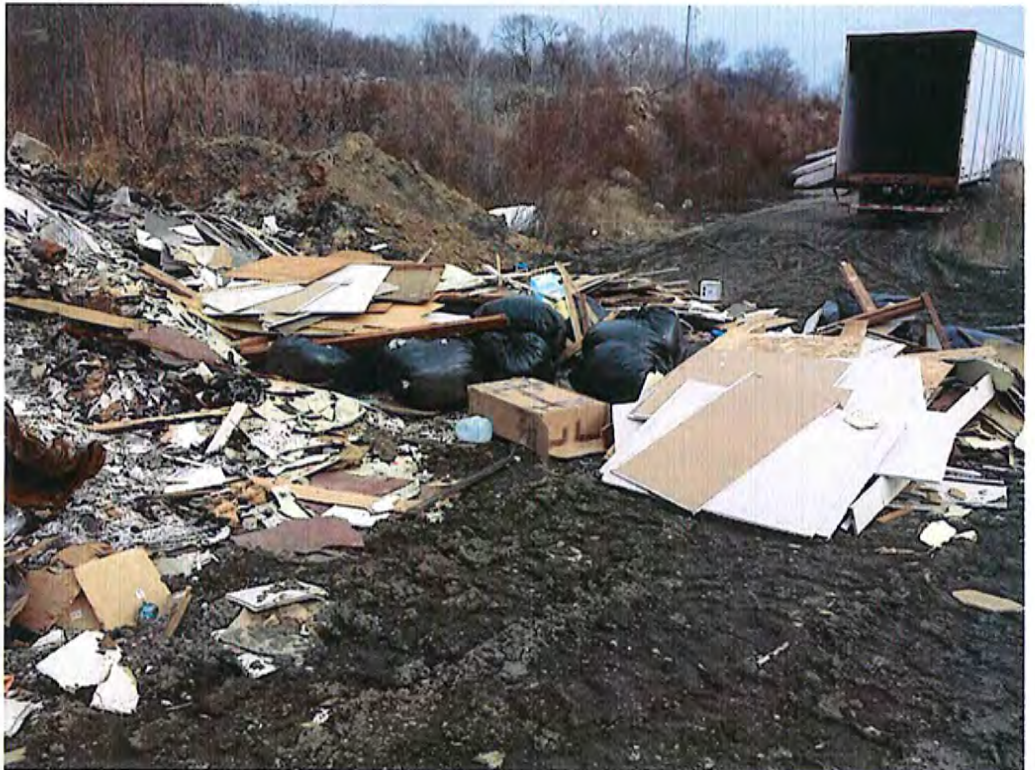
**PHOTOGRAPH FILE NAME:**  
1438055008~12172014-026.jpg

**COMMENTS:** The photograph shows garbage bags full of solid waste, cardboard, processed wood, paper and wallboard. The photograph also shows the charred remains of processed wood, plastic containers, metal debris, tire beads, wallboard, cardboard, paper, aluminum cans.
