Re: Illinois Environmental Protection Agency v Eric Lane, John Rudd, Bob Whitaker and American Demolition Corporation  
IEPA File No. 38-15-AC; 1438055008

BEFORE THE ILLINOIS POLLUTION CONTROL BOARD  
ADMINISTRATIVE CITATION

1438055008 -- Peoria County  
Lane, Eric  
FOS  
Inspection Dates: December 17, 2014 & December 18, 2014  
Inspector: Robert J. Wagner  
Site Sketch A

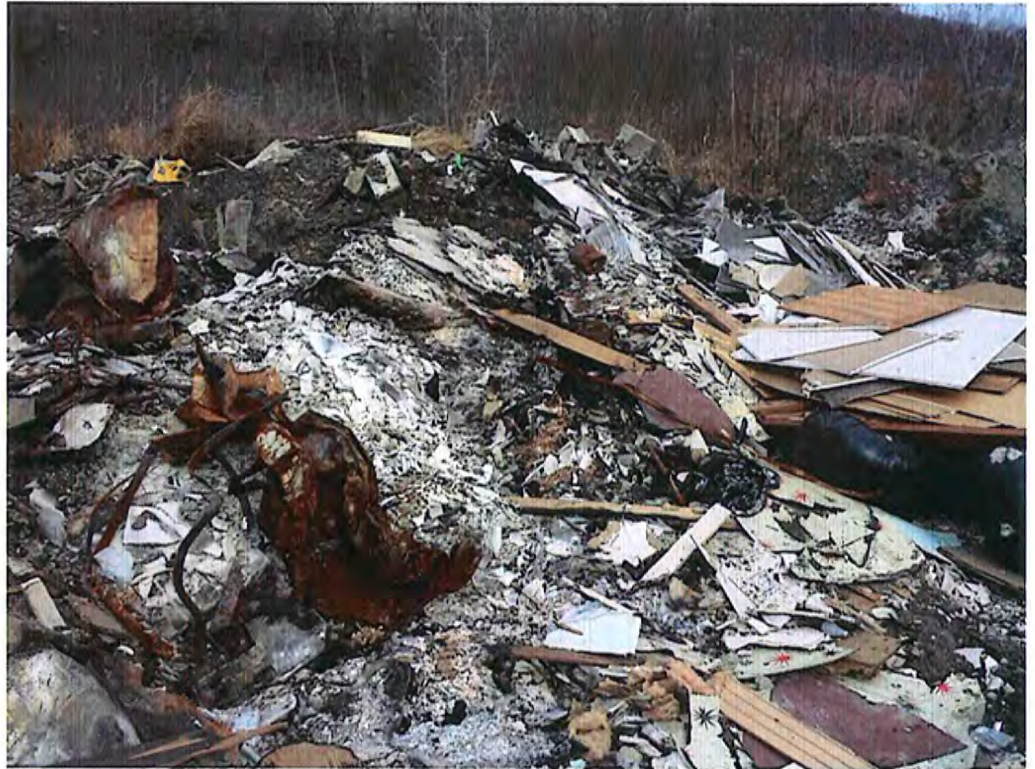
**COMMENTS:** The photograph shows garbage bags full of solid waste, cardboard, processed wood, paper and wallboard. The photograph also shows the charred remains of processed wood, plastic containers, metal debris, tire beads, wallboard, cardboard, paper, aluminum cans.

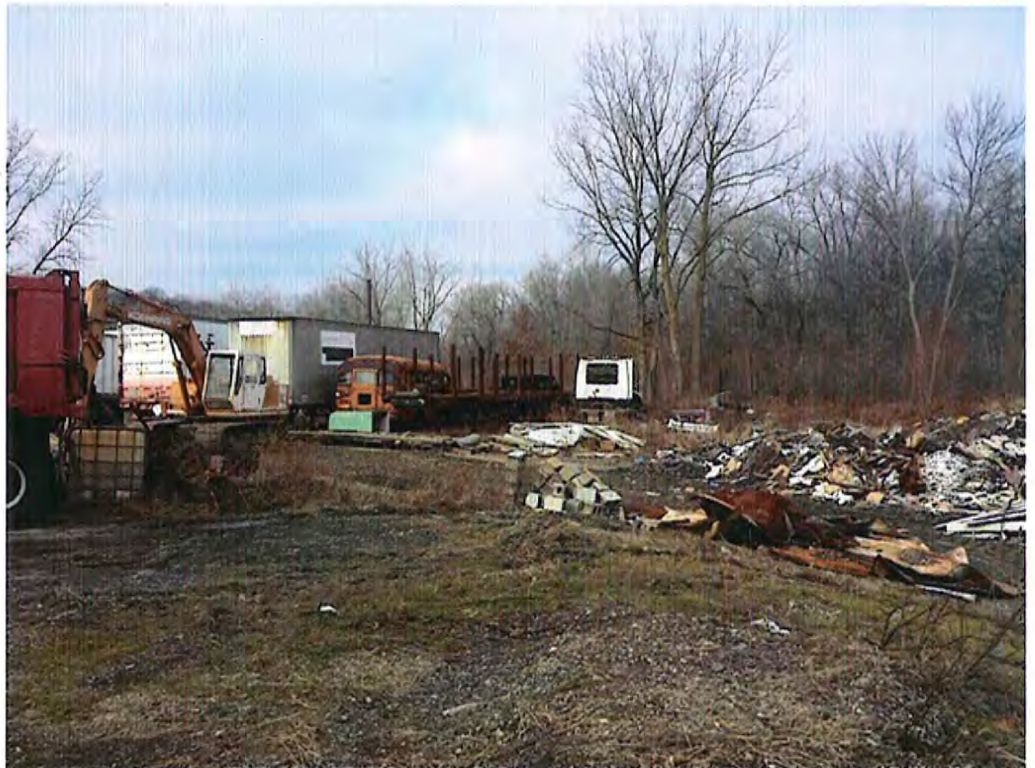
**PHOTOGRAPH FILE NAME:**  
1438055008~12172014-028.jpg

**COMMENTS:** The photograph shows an excavator tractor.

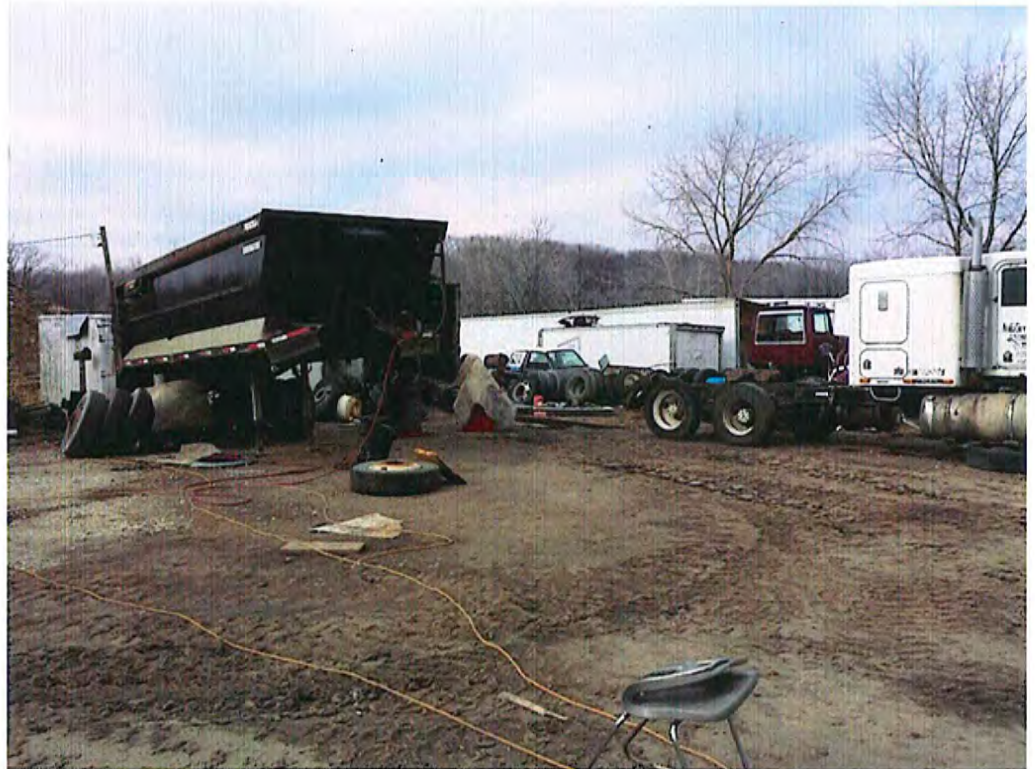
**COMMENTS:** The photograph shows an end dump trailer with tires in the foreground.

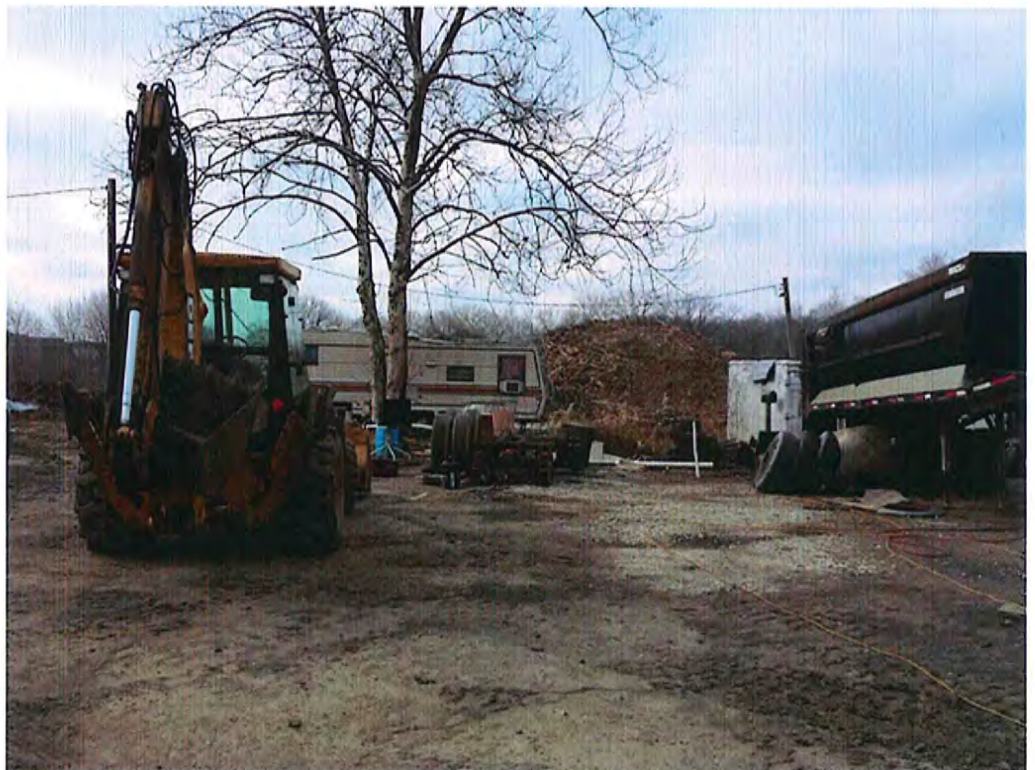
1438055008~12172014-030.jpg

**COMMENTS:** The photograph shows a backhoe tractor.

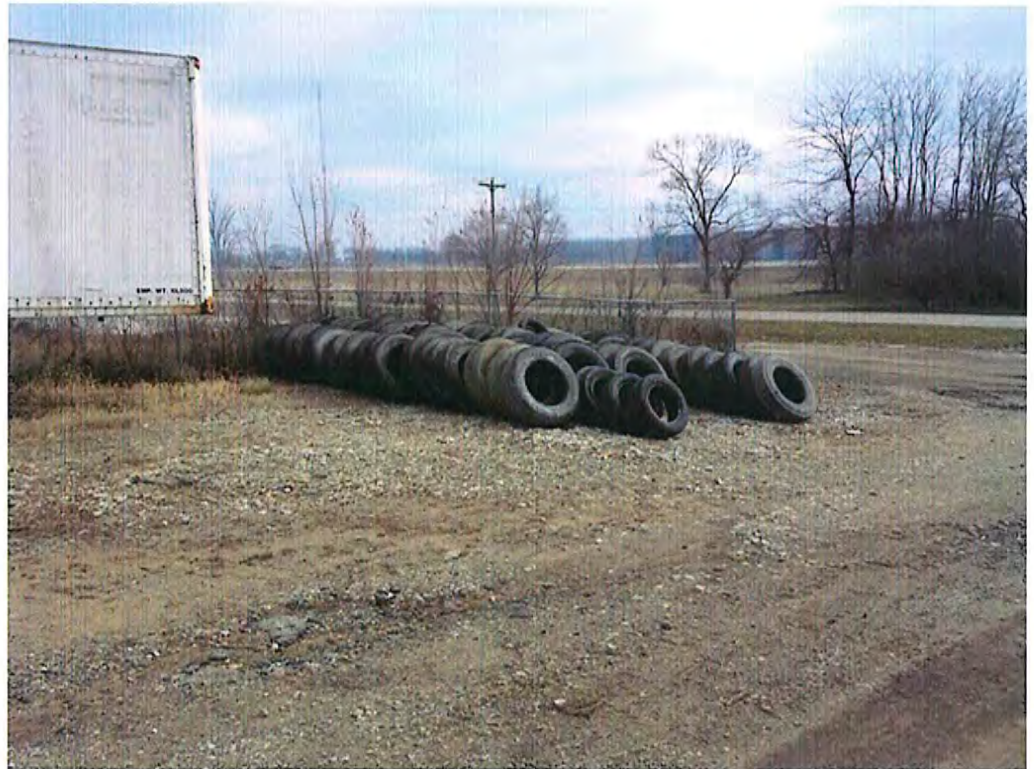
**COMMENTS:** The photograph shows tires at the west entrance to the site.

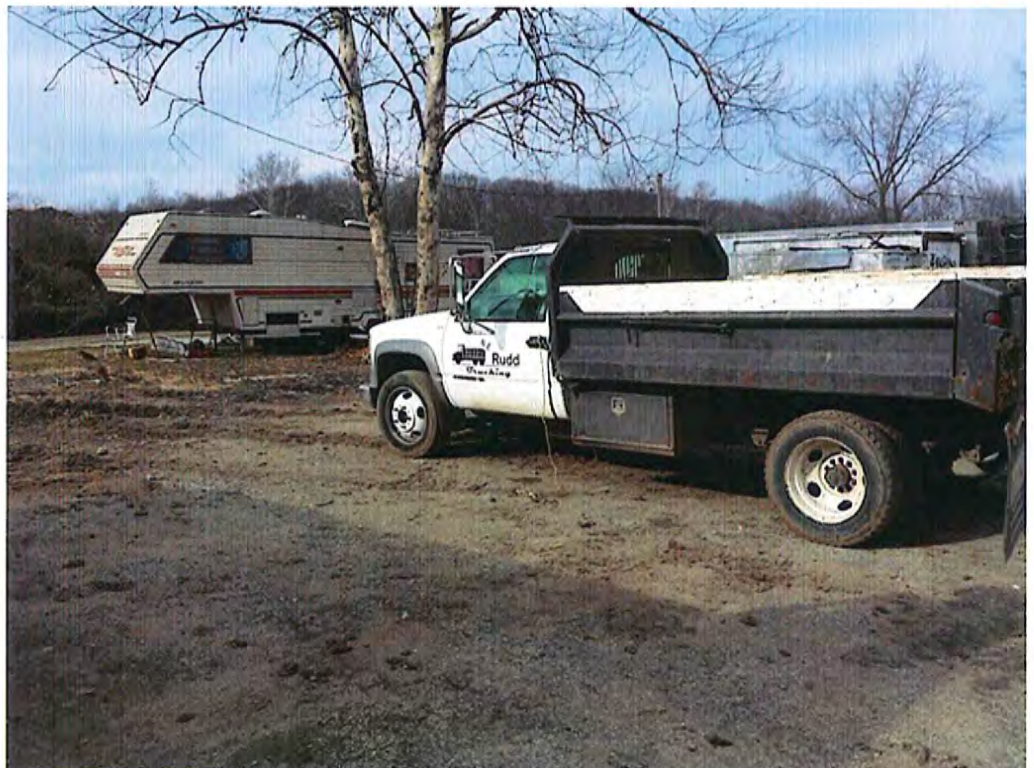
1438055008~12172014-032.jpg

**COMMENTS:** The photograph shows a utility dump truck with Rudd Trucking written on the cab.

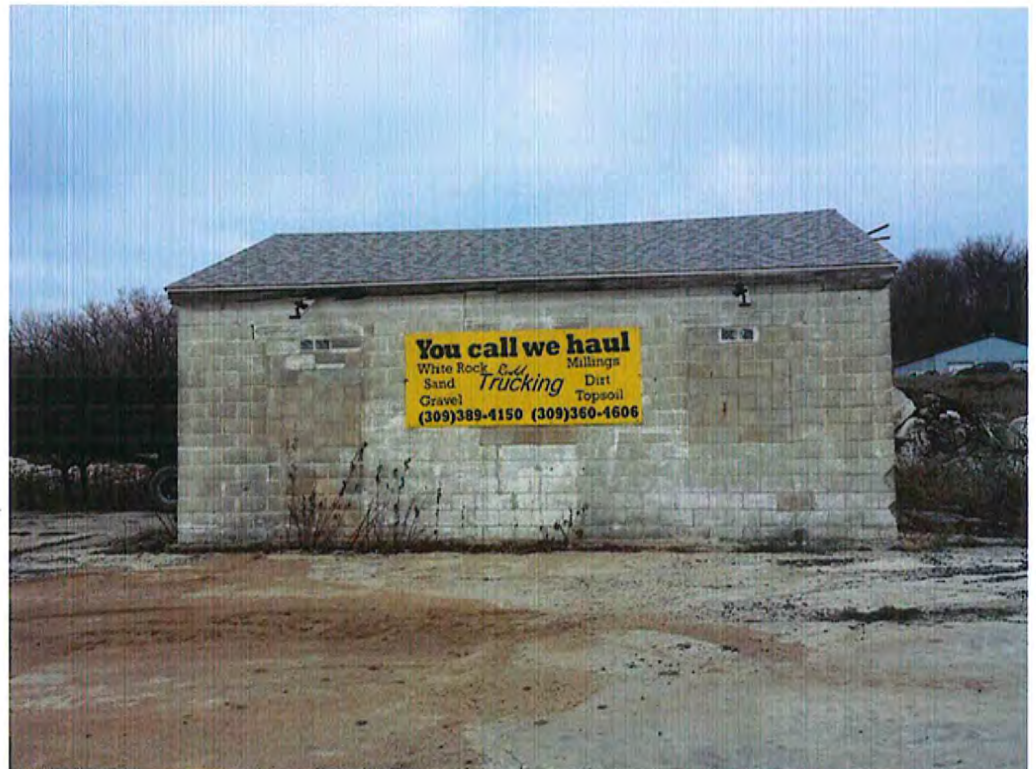
**PHOTOGRAPH FILE NAME:**  
1438055008~12172014-033.jpg

**COMMENTS:** the photograph  
shows a sign on a building located  
on the property. The sign read  
“You call we haul”.

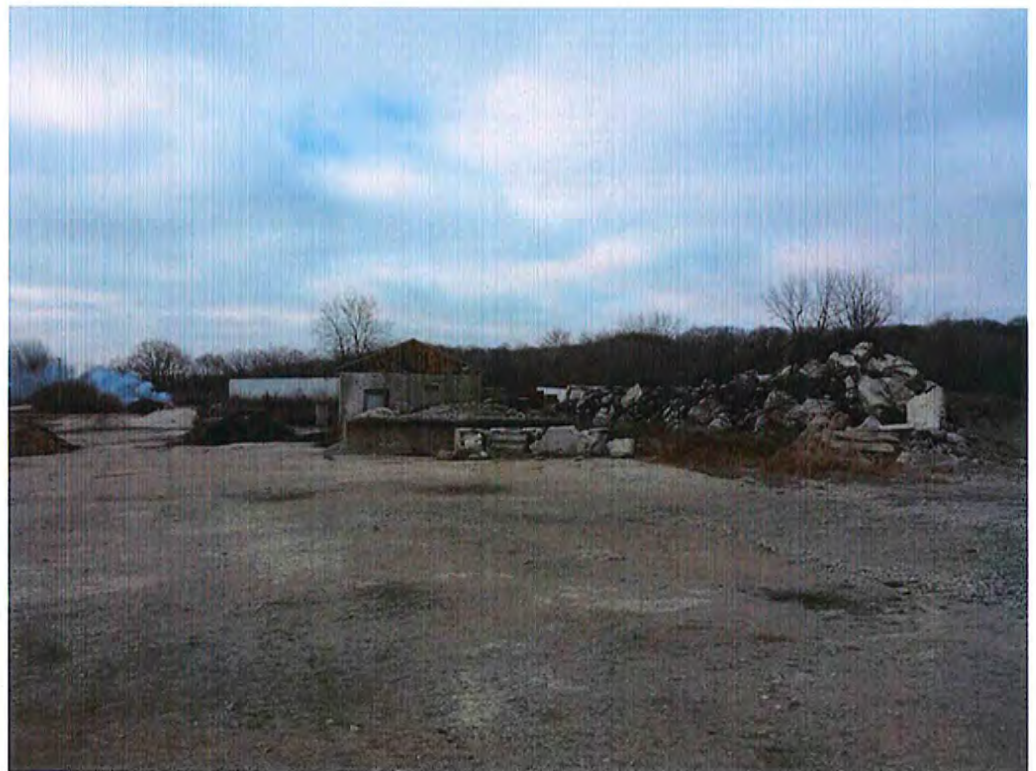
**COMMENTS:** The photograph  
shows a large pile of concrete  
chunks with protruding steel bars  
and steel wire. In the foreground of  
the photograph are the burning piles  
of demolition debris.

Photograph 34 shows a pile of concrete chunks with protruding steel bars and steel wire located in the eastern section of the property. In the foreground of the photograph are the burning piles of demolition debris. I estimate the size of this pile to be approximately 100 feet long by 25 feet wide by 10 feet high in size (925 cu yds.).

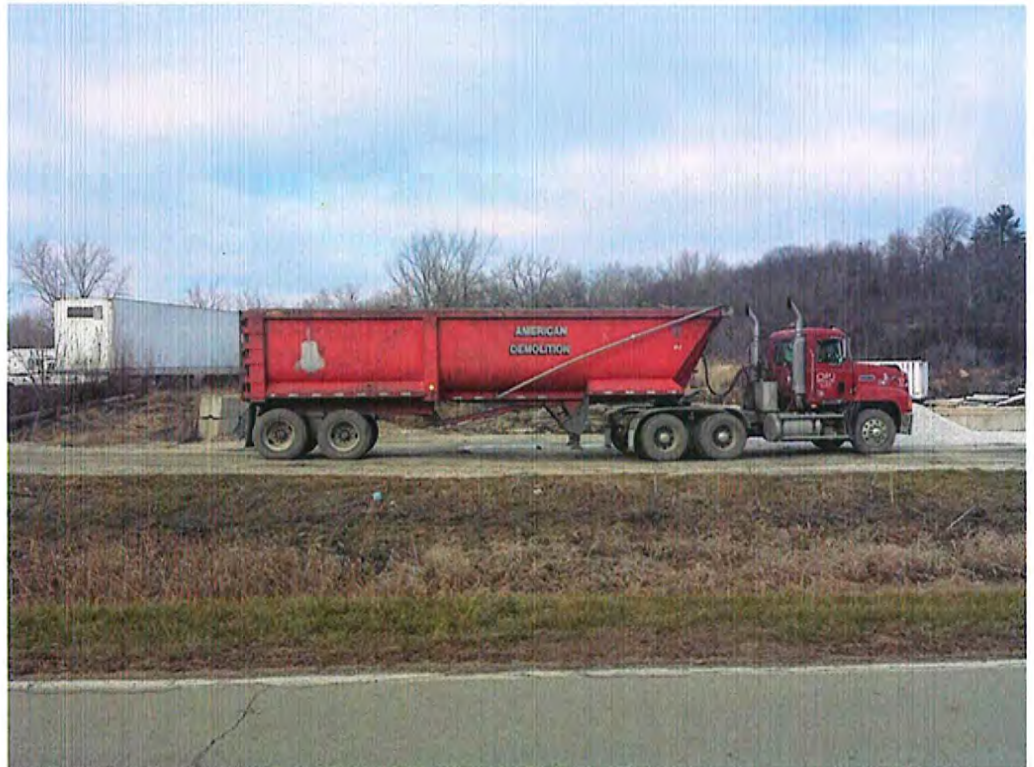
**COMMENTS:** Semi truck  
attached to an end dump trailer full  
of construction and demolition  
debris. Written on the red truck  
cab: OPJ Trucking Inc., Cicero  
Illinois. Written on the side of the  
red end dump trailer: American  
Demolition.

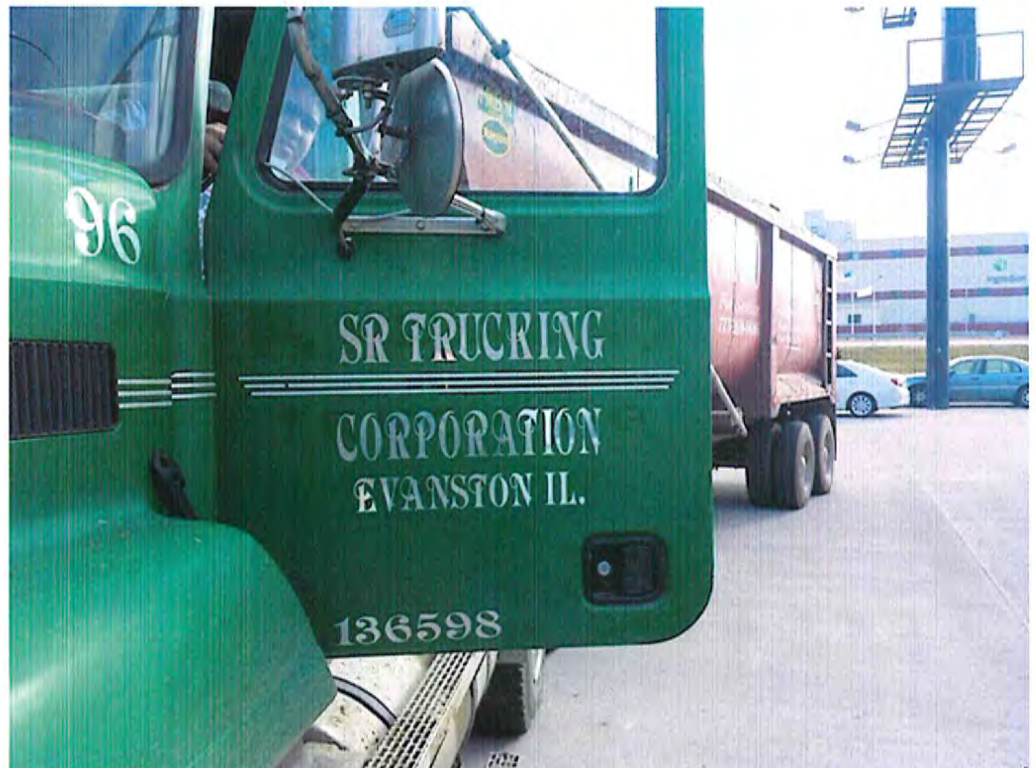
**COMMENTS:** The photograph  
shows a semi-truck attached to a  
dump trailer full of construction and  
demolition debris. Written on the  
green truck cab: SR Trucking  
Corporation, Evanston, Illinois.  
Written on the side of the red end  
dump trailer: Patino Trucking Inc.  
773-269-0086.

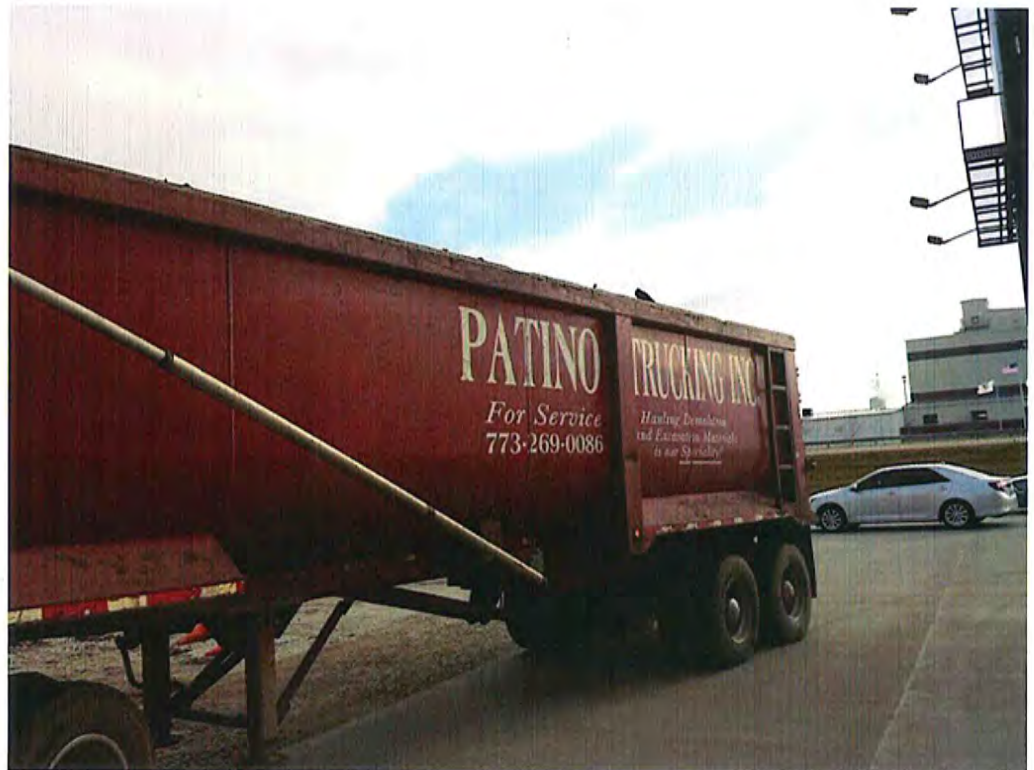
**COMMENTS:** The photograph  
shows a dump trailer full of  
construction and demolition debris.  
The Photograph was taken at the BP  
Gas Station, 8626 West Wheeler  
Road, Mapleton, Illinois. Written  
on the side of the dump trailer:  
Patino Trucking Inc. 773-269-0086.

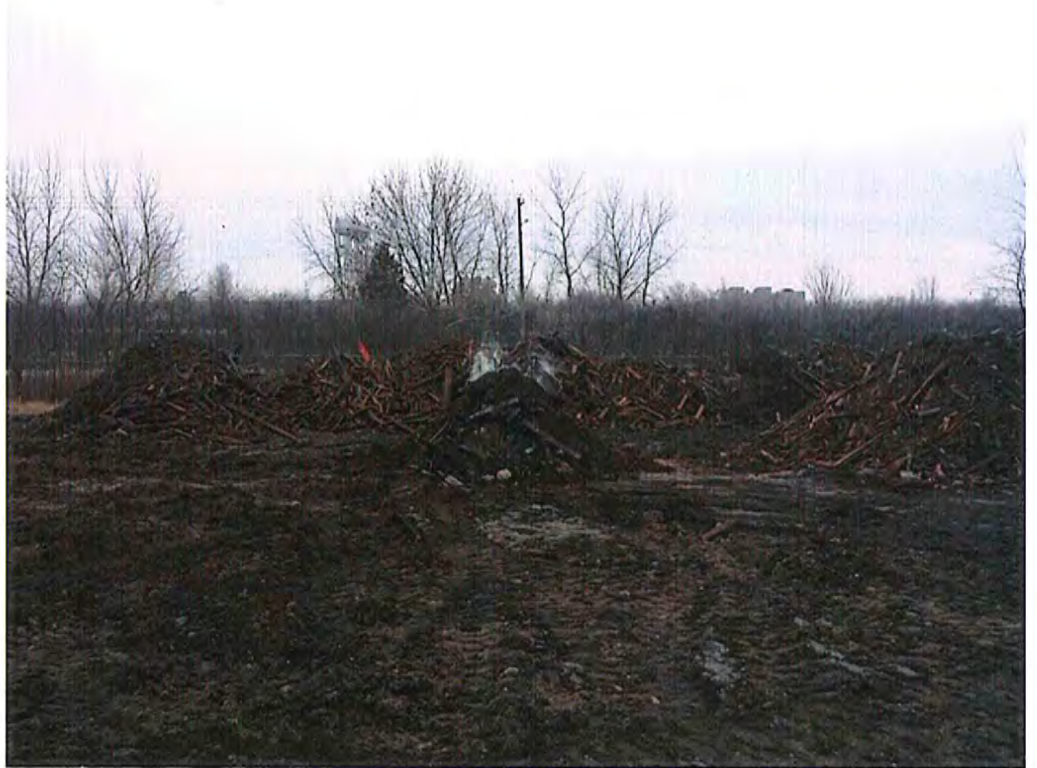
**COMMENTS:** The photograph  
shows demolition debris burning on  
the site. The demolition debris  
consists of metal sheeting, metal  
bars and processed wood.

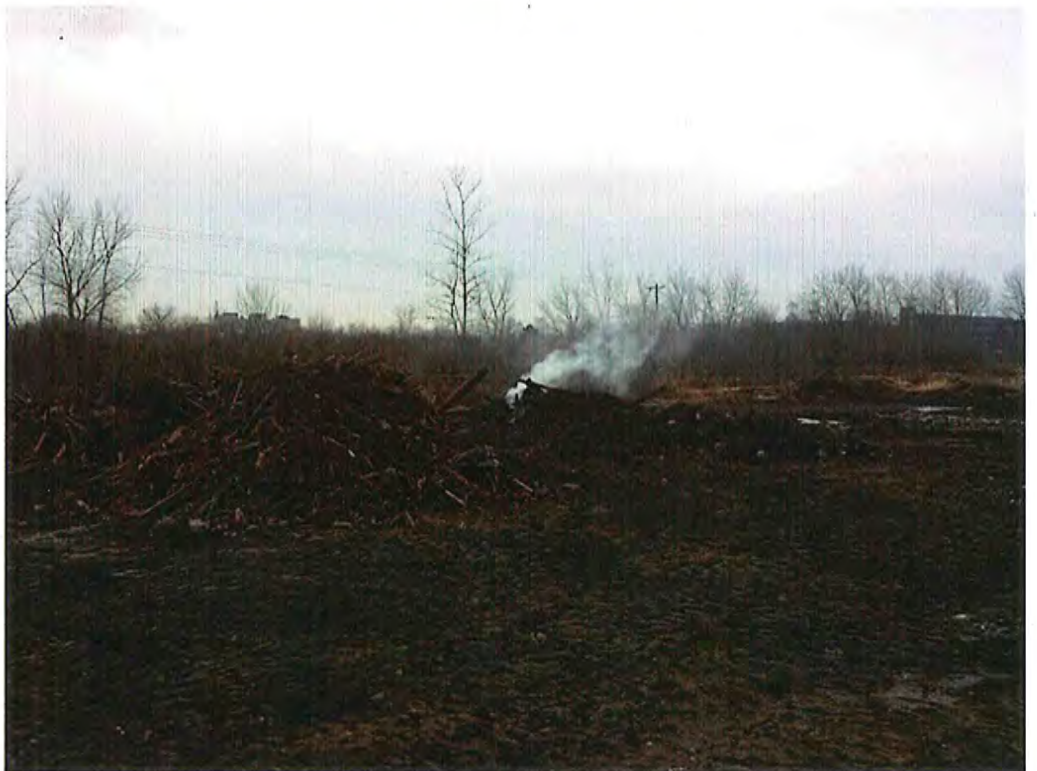
**COMMENTS:** The photograph  
shows demolition debris burning on  
the site. The demolition debris  
consists of metal sheeting, metal  
bars and processed wood.

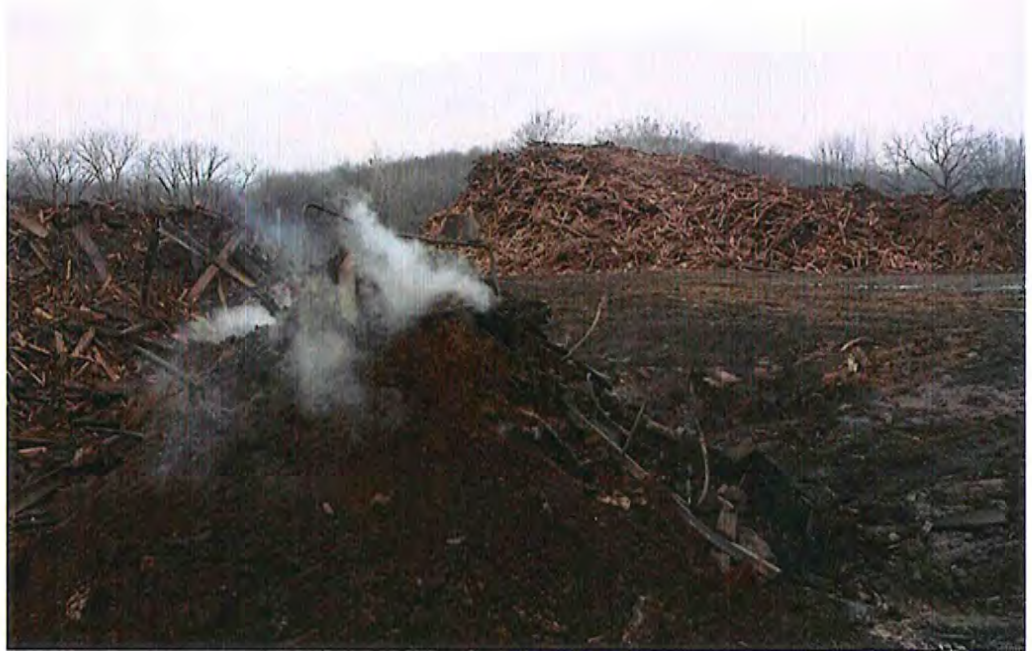
**COMMENTS:** The photograph  
shows demolition debris burning on  
the site. The demolition debris  
consists of metal sheeting, metal  
bars, metal pipes and processed  
wood.

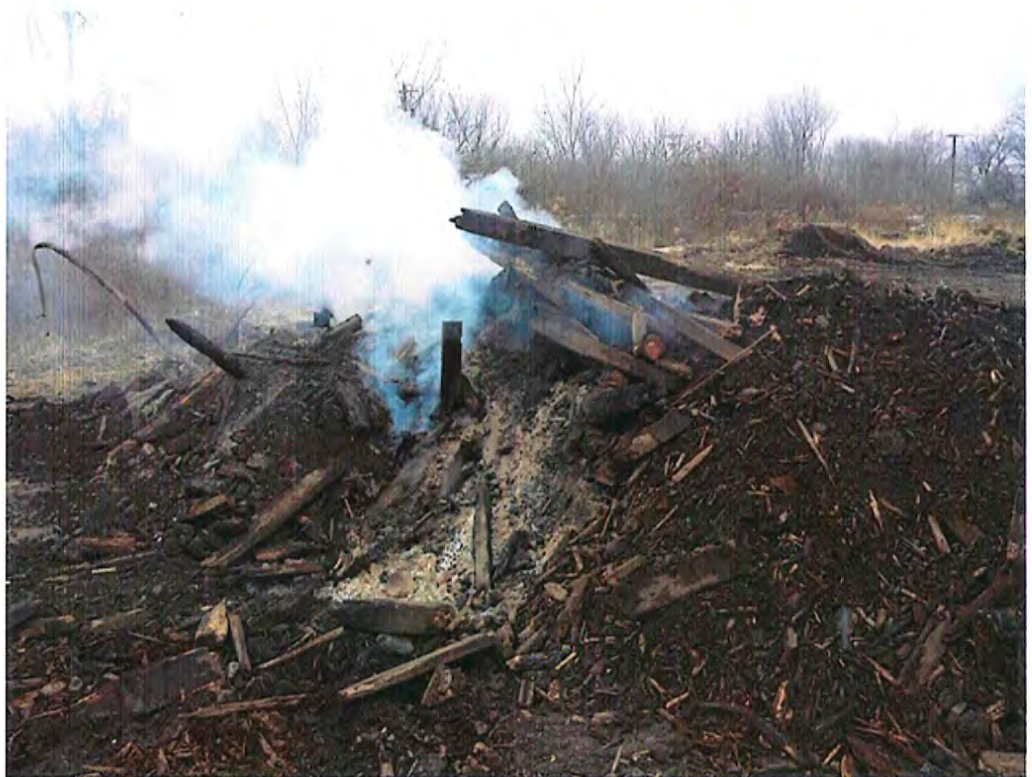
**COMMENTS:** The photograph  
shows demolition debris burning on  
the site. The demolition debris  
consists of metal sheeting, metal  
bars, metal pipes and processed  
wood.

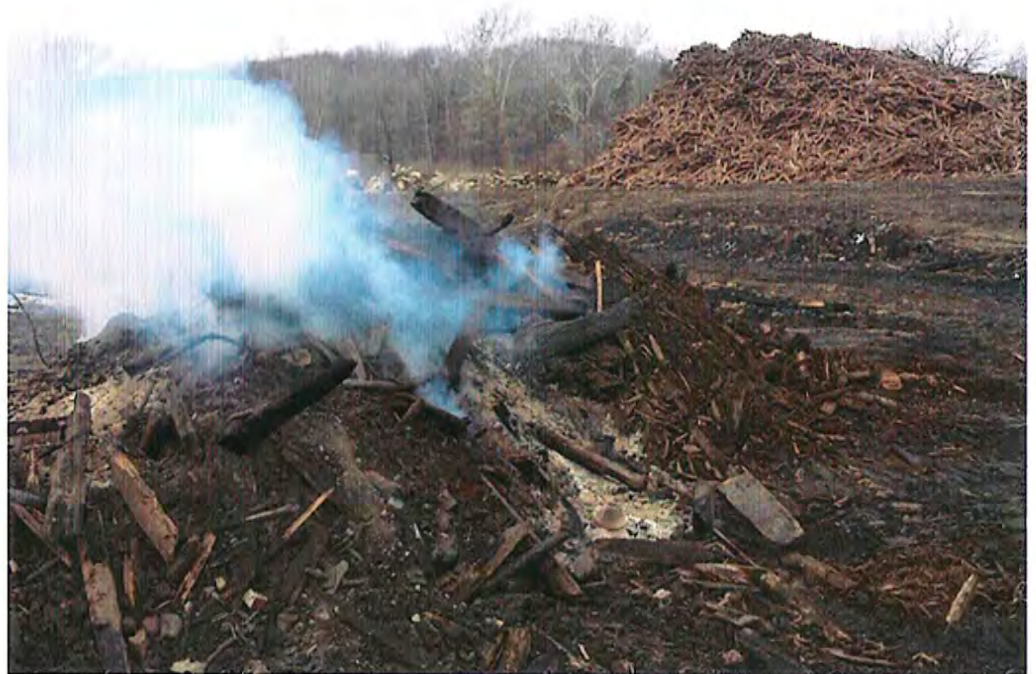
**COMMENTS:** The photograph  
shows demolition debris burning on  
the site. The demolition debris  
consists of metal sheeting, metal  
bars, metal pipes and processed  
wood.
