Illinois Environmental Protection Agency Open Dump Inspection Checklist

NARRATIVE INSPECTION REPORT DOCUMENT

On February 7, 2023, an open dump and open burn inspection was conducted at 916 ½ W Main St Streator, IL by Ms. Lauren Grumieaux and Ms. Myranda Posada representing the LaSalle County Land Use Department, under the delegation authority of the Illinois Environmental Protection Agency. The property is owned by Gregory Cravatta.

Cravatta Property 0998075005

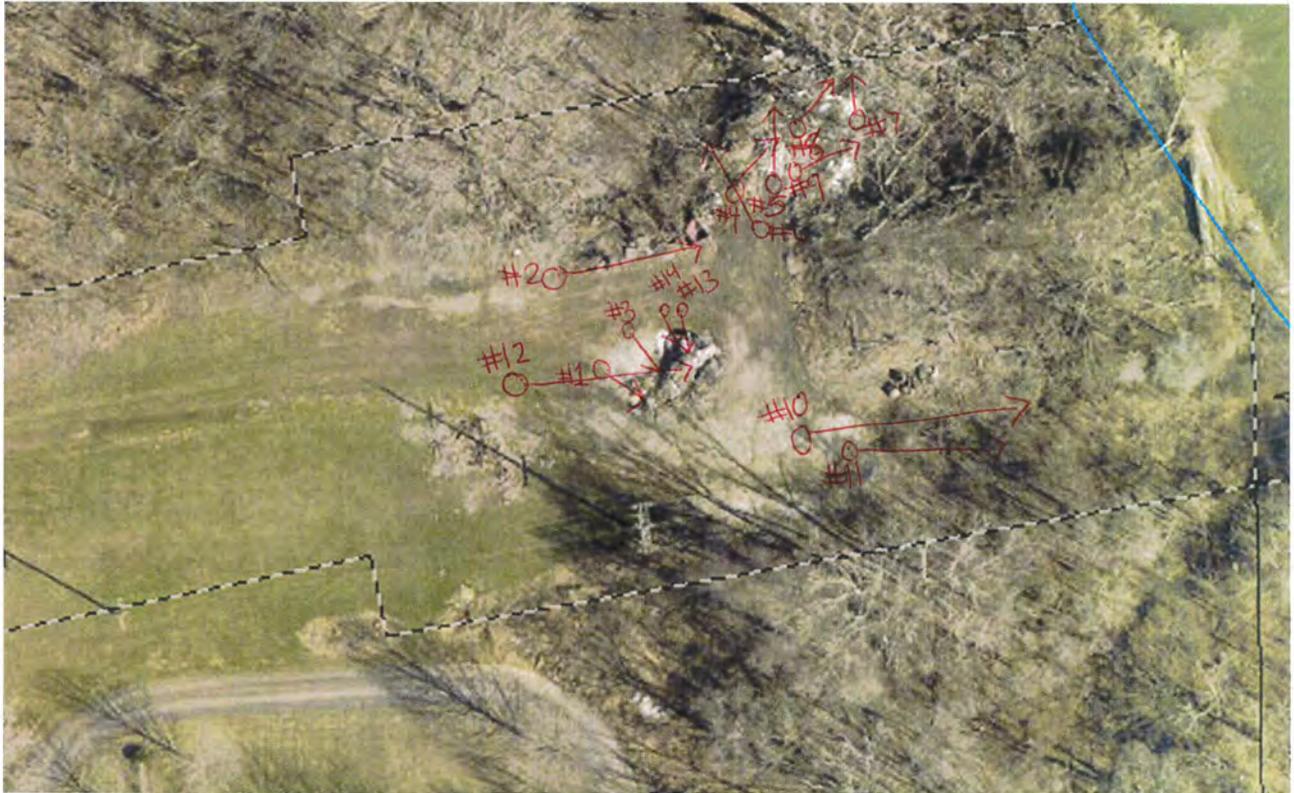
SITE SKETCH

Date of Inspection: 2/7/23 Inspector (s): L. Grumieau + M. Posada
Site Code: 0998075005 County: LASALLE
Site Name: Cravatta Property. Time: 1:59 - 3:18

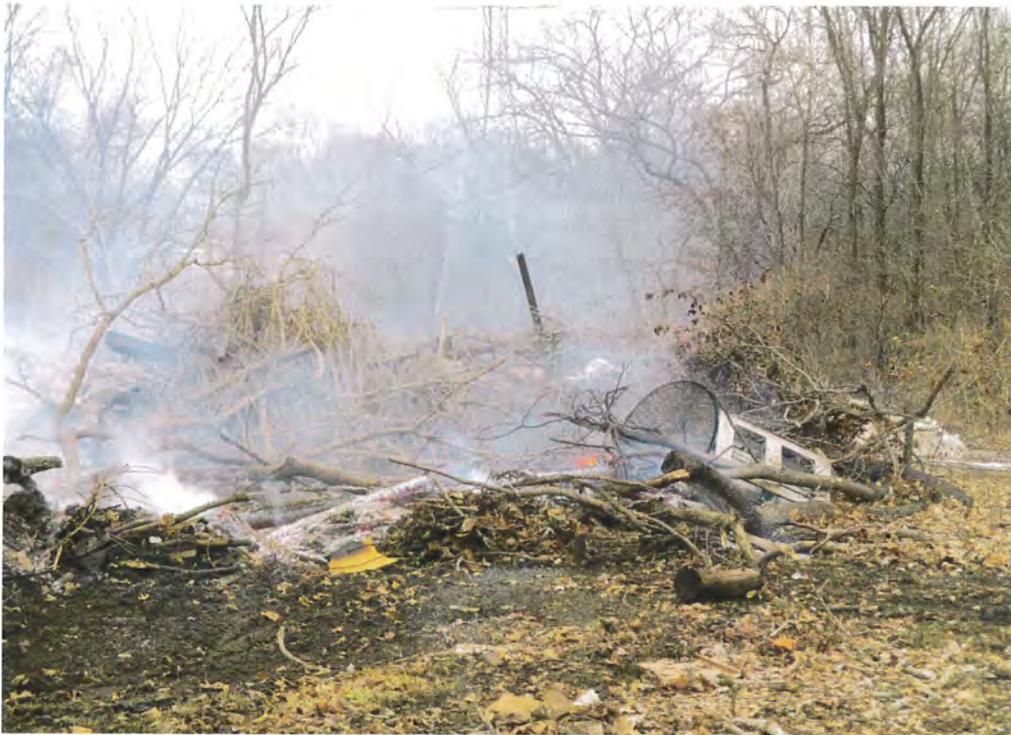
Date: 02/07/2023
Time: 2:20 PM
Direction: Southeast
Photo by:
L. Grumieaux
Exposure #: 1
Comments: The burn pile was smoldering, and outdoor furniture and a pallet were in the pile.

Looking to the southeast, I viewed the burn pile smoldering along with outdoor furniture and a pallet. (Photo #1) Making our way to the northern side of the property, we viewed more pallets, tires, gutters, tarping, and weathered construction materials lining the hillside. (Photo #2) Ms. Grumieaux asked if he had any intentions to burn the materials lining the area. Mr. Cravatta stated that those were materials that he had pulled out of the burn pile. Facing southeast, we viewed pieces of carpeting, siding, and landscape waste in the burn pile. (Photo #3) We then made our way back to the northern portion of the property, where we viewed a second burn pile. The second pile contained demolition and construction debris. (Photo #4) Ms. Grumieaux asked Mr. Cravatta if he was plowing the demolition and construction debris off the hillside and into the floodplain area. Mr. Cravatta stated that he doesn't have the means to push the waste over the hillside. Ms. Grumieaux pointed out that a plow was attached to the front of his truck, and the markings on the ground would indicate otherwise.

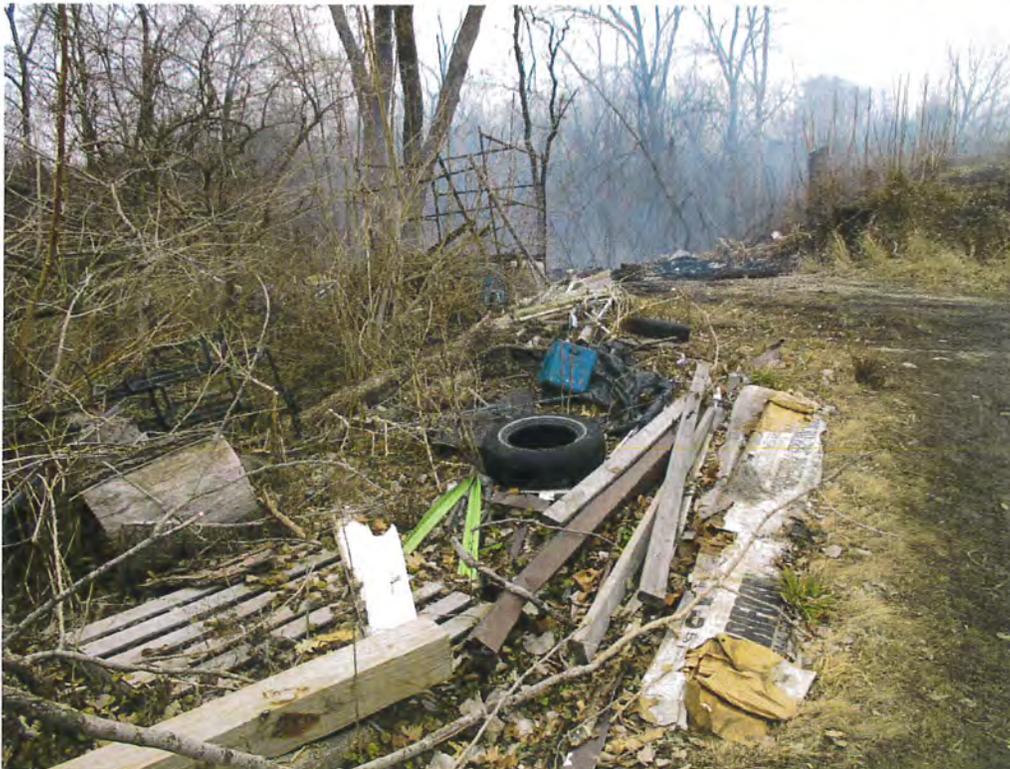
Date: 02/07/2023
Time: 2:21 PM
Direction: East
Photo by:
L. Grumieaux
Exposure #: 2
Comments: Pallets, tires, gutters, tarping, and weathered construction material.

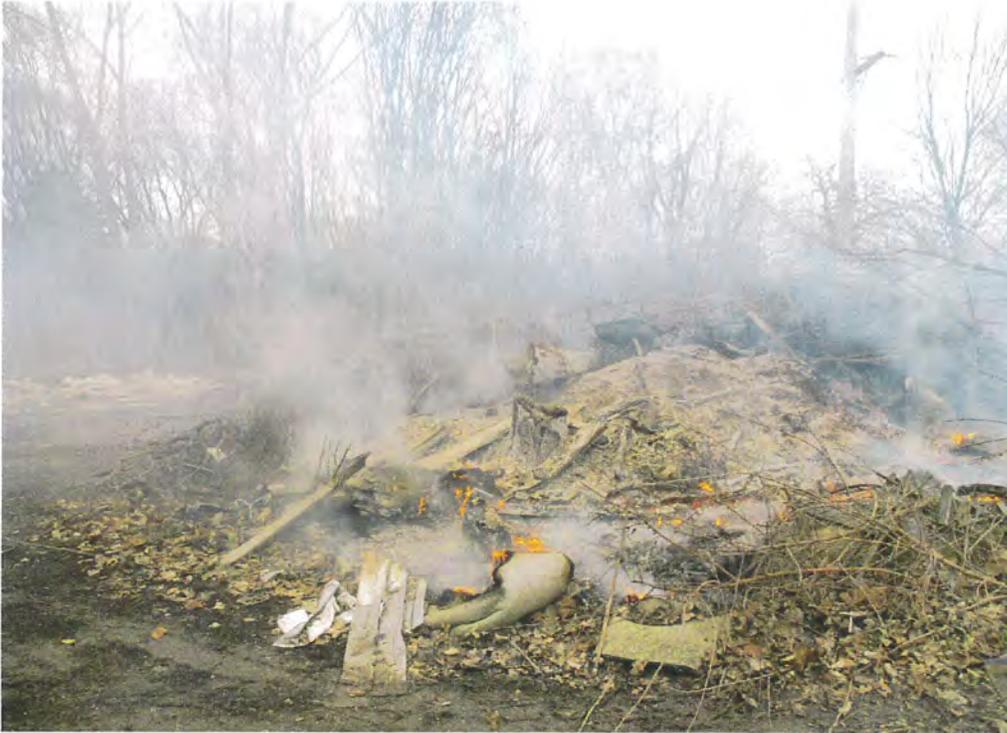
Date: 02/07/2023
Time: 2:21 PM
Direction: Southeast
Photo by:
L. Grumieaux
Exposure #: 3
Comments: Large
open burn pile,
pieces of carpeting,
siding, and
landscape waste.

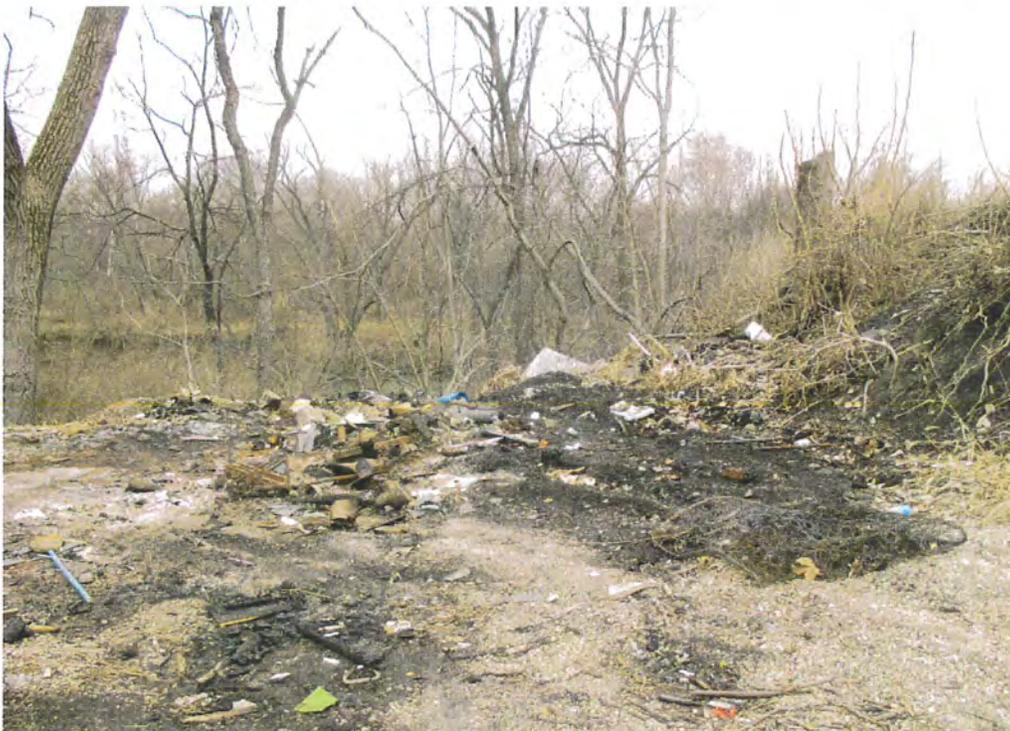
Date: 02/07/2023
Time: 2:22 PM
Direction: Northeast
Photo by:
L. Grumieaux
Exposure #: 4
Comments: Second
burn pile.
Demolition/
construction debris
within the pile.

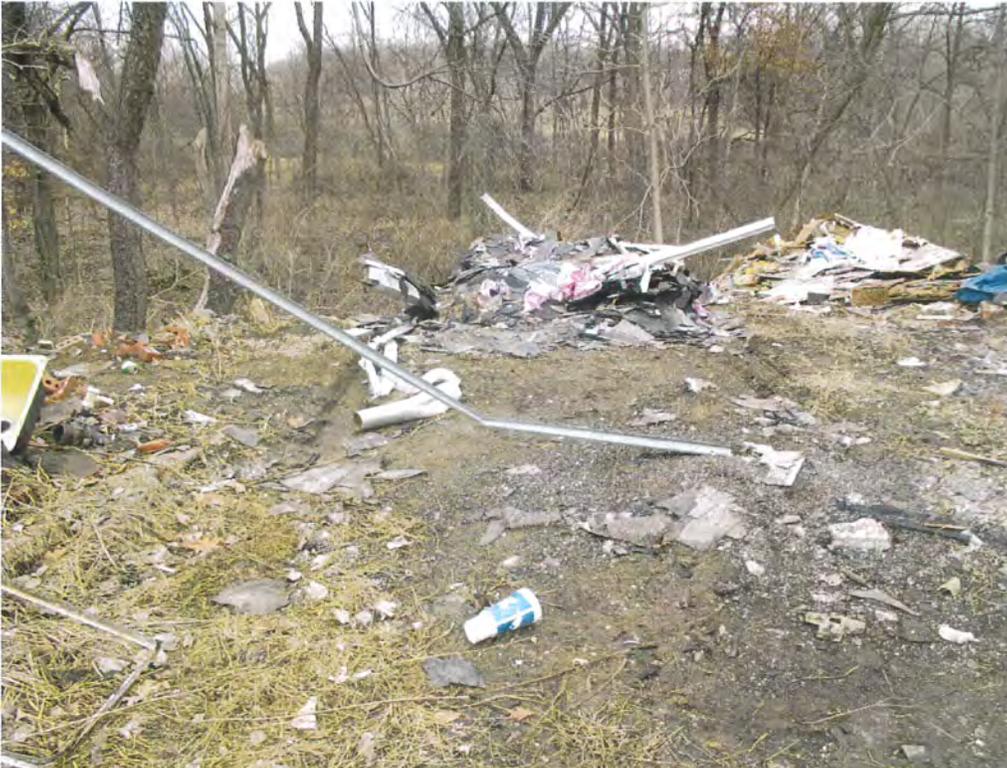
Date: 02/07/2023
Time: 2:22 PM
Direction: North
Photo by:
L. Grumieaux
Exposure #: 5
Comments: gutters,
shingles, litter, and
installation.

Continuing on, we viewed a pile of shingles near the edge of the hillside. I also viewed gutters and installations that appeared to have been recently dumped. (Photo #5) More construction materials were viewed lining the area. Some of the materials included a kitchen sink, garbage bins, blinds, and

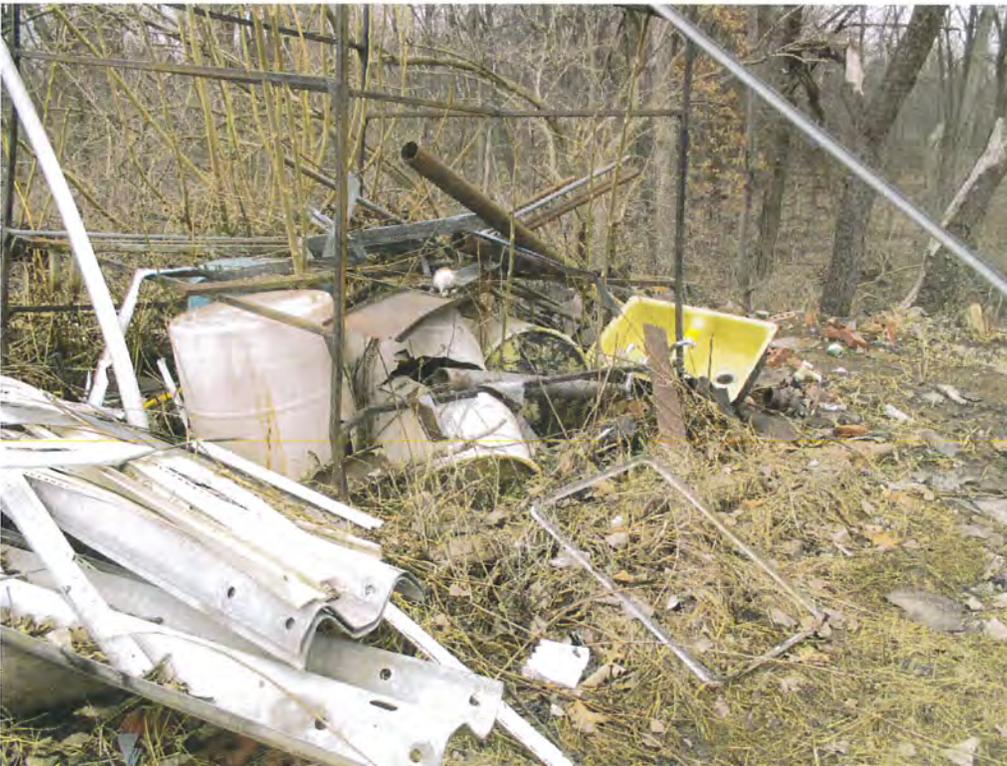
Date: 02/07/2023
Time: 2:22 PM
Direction: Northwest
Photo by:
L. Grumieaux
Exposure #: 6
Comments: Metal
racking, a pile of
garbage bins, blinds,
more metal,
construction debris,
and a kitchen sink.

metal racking. (Photo #6)

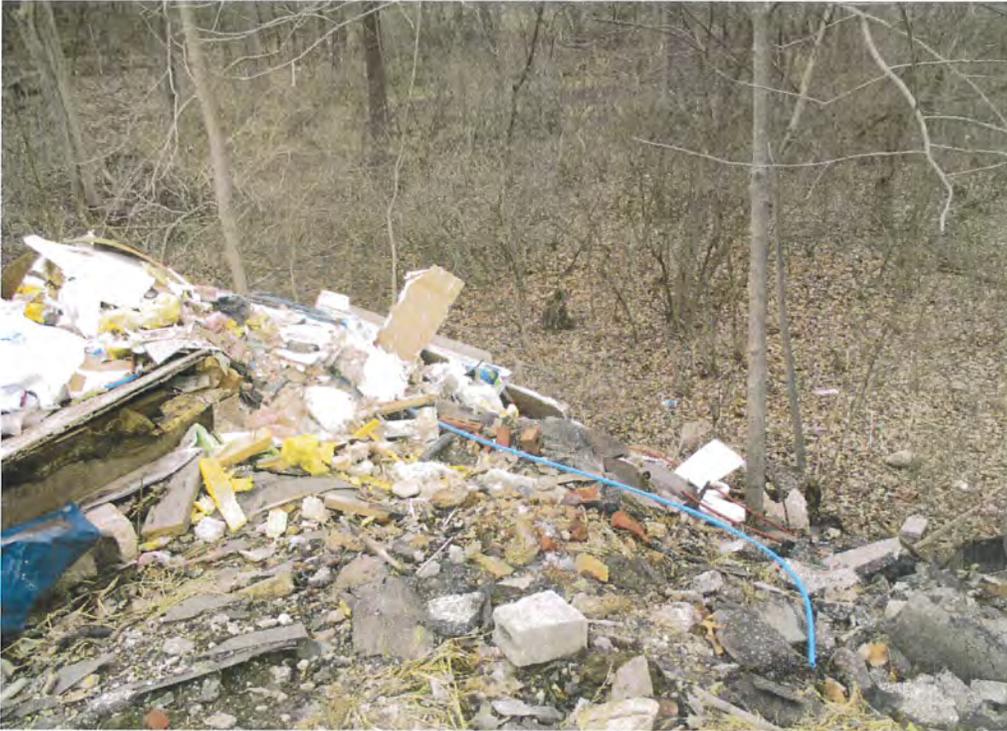
Date: 02/07/2023
Time: 2:23 PM
Direction: North
Photo by:
L. Grumieaux
Exposure #: 7
Comments:
Demolition debris
spilling over the cliff.

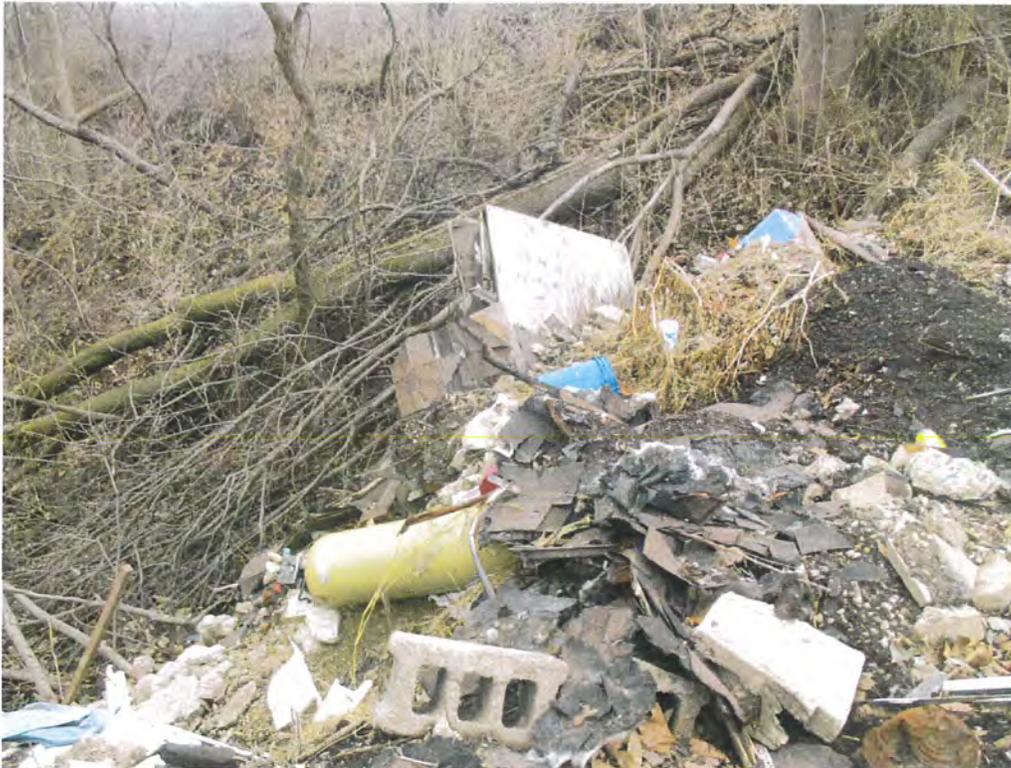
Date: 02/07/2023
Time: 2:23 PM
Direction: Northeast
Photo by:
L. Grumieaux
Exposure #:8
Comments: litter,
shingles, water
heater, charred
material, and
concrete blocks
spilling over the cliff.

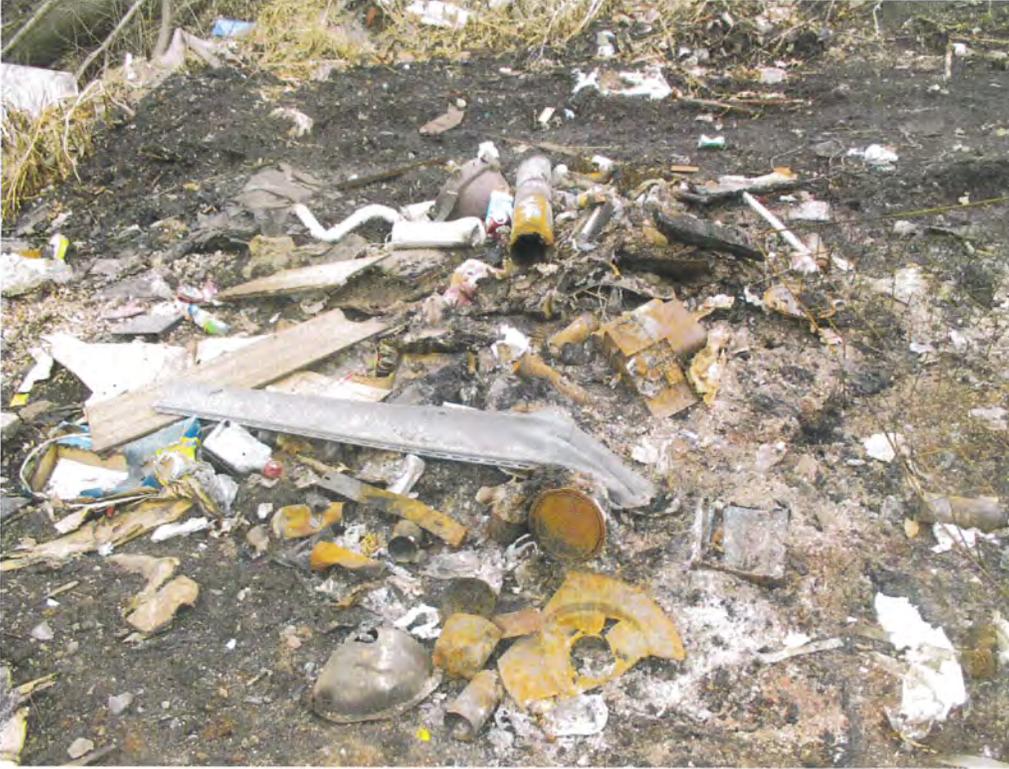
Date: 02/07/2023
Time: 2:24 PM
Direction: Northeast
Photo by:
L. Grumieaux
Exposure #: 9
Comments: second
burn pile containing-
charred metal,
siding, shingles, and
household waste.

Next, we inspected the hillside. More insulation and demolition debris were viewed spilling over into the hillside where the floodplain area is. I also viewed a water heater, more shingles, charred material, and concrete blocks spilling into the floodplain area as well. (Photo #7 & Photo #8) I inspected the second burn pile where I documented charred metal, springs, plastics, plumbing materials, siding, and more household waste. (Photo #9)

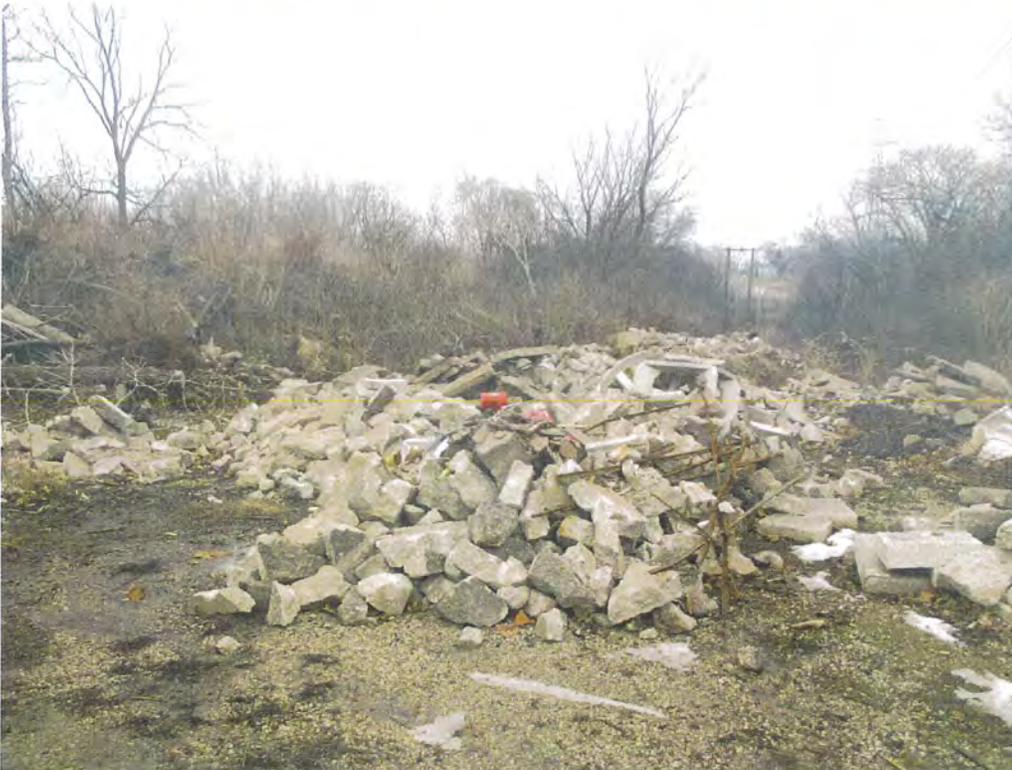
Date: 02/07/2023
Time: 2:34 PM
Direction: East
Photo by:
L. Grumieaux
Exposure #: 10
Comments: CCDD
containing rebar and
litter.

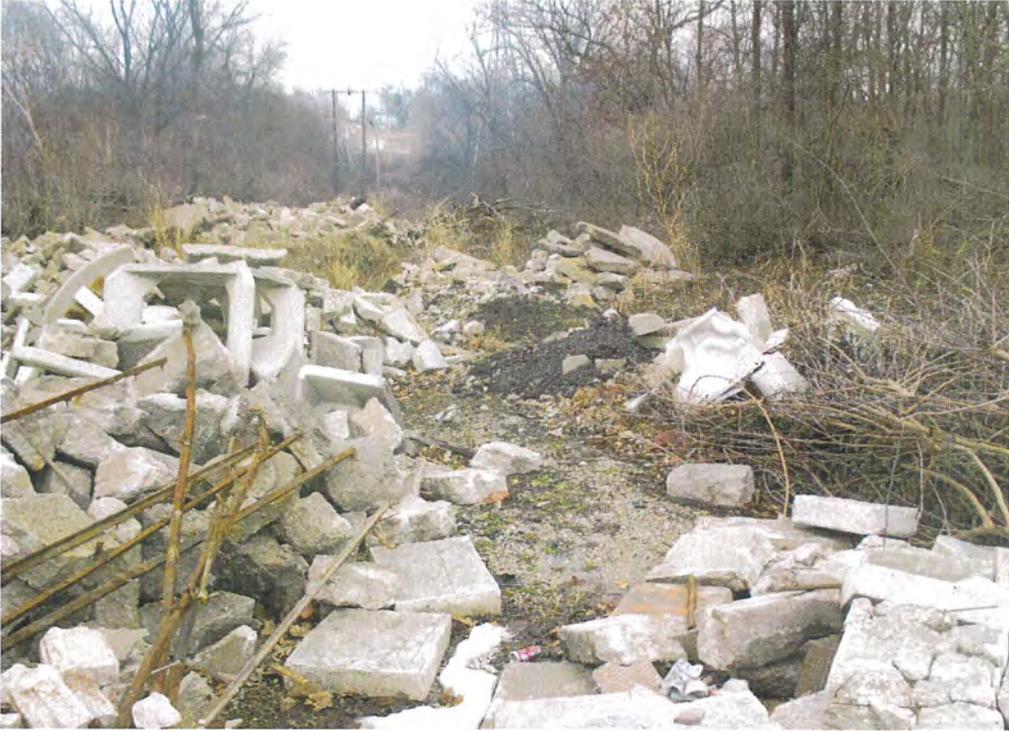
Date: 02/07/2023
Time: 2:35 PM
Direction: East
Photo by:
L. Grumieaux
Exposure #: 11
Comments: CCDD
comingled with
landscape waste
and a toilet.

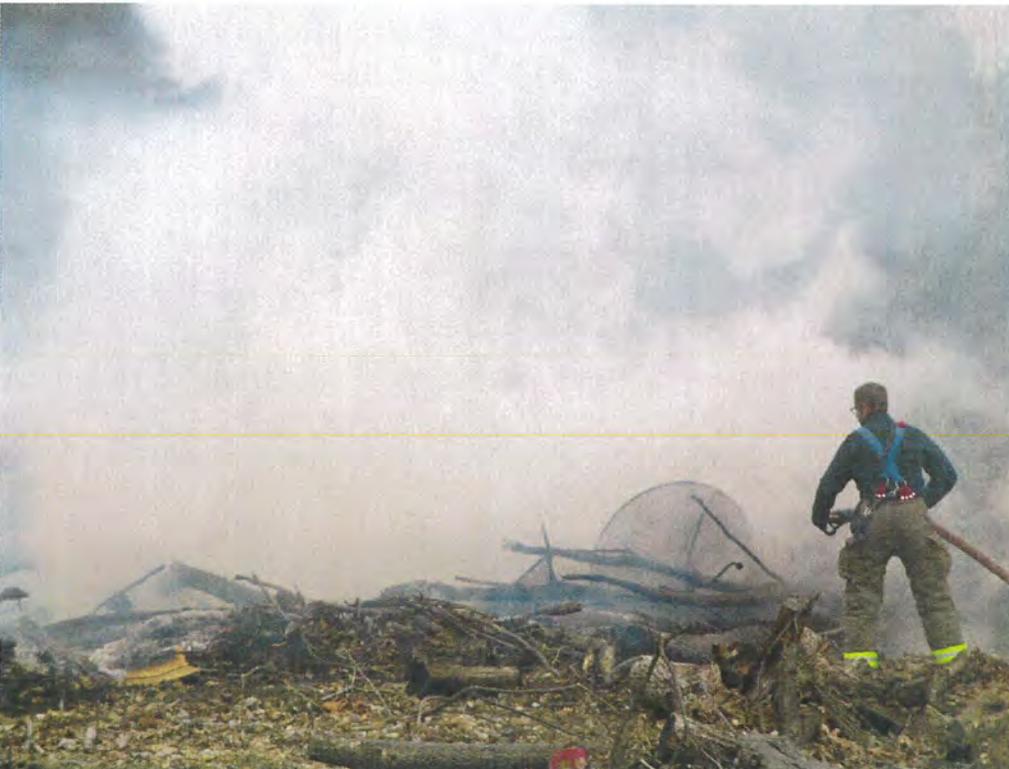
Date: 02/07/2023
Time: 2:56 PM
Direction: East
Photo by:
L. Grumieaux
Exposure #:12
Comments: Firemen
extinguishing the fire.

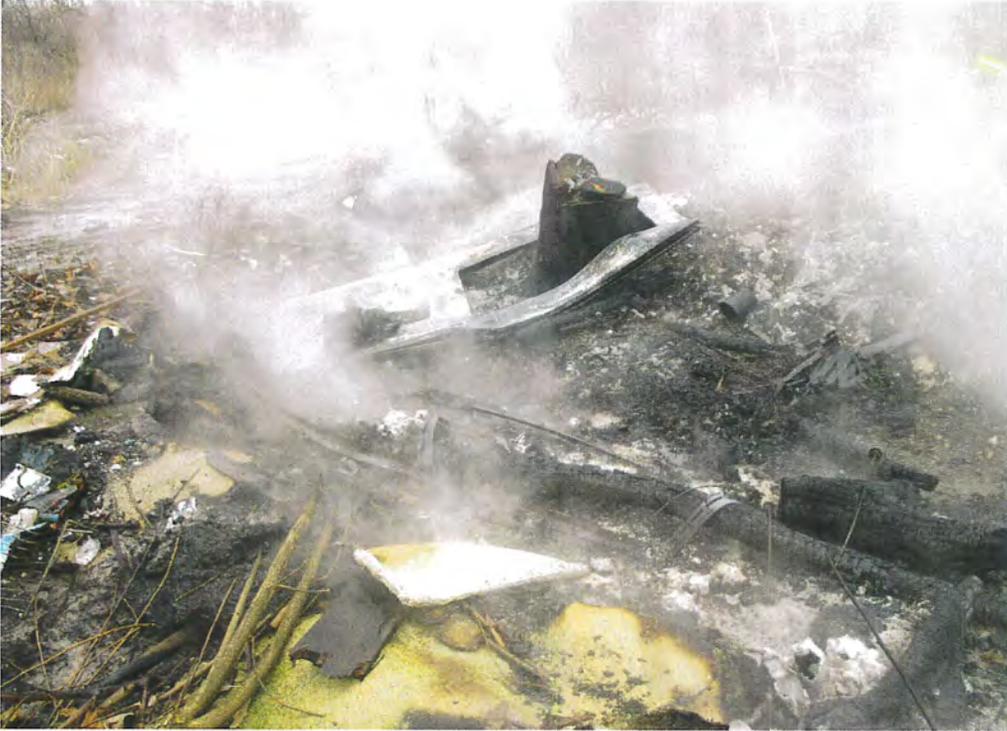
Date: 02/07/2023
Time: 3:11 PM
Direction: Southeast
Photo by:
L. Grumieaux
Exposure #: 13
Comments: A door,
and more carpeting
in the burn pile.

After the firemen extinguished the fire, we inspected the area more thoroughly. Facing southeast, I viewed a door frame that was not visible when the fire was burning. (Photo #13) Mr. Hoffmeyer was able to comb through the ash and charred materials. While sifting through the ash, Mr. Hoffmeyer discovered aerosol cans and stated that the explosion was likely due to the cans. While he and Captain Kupec continued to move the waste around, Mr. Hoffmeyer found charred metal car parts in the pile. (Photo #14) After documenting the charred materials, Ms. Grumieaux addressed the findings with Mr. Cravatta. She explained that moving forward, Mr. Cravatta would need to cease all open dumping and open burning. She also explained that the only material that he would be able to burn on site is landscape waste generated from the property. Mr. Cravatta stated to us that other people dump on his property, and he was not aware that it had gotten out of hand. Ms. Grumieaux informed him that all the burnt remains would need to be removed and taken to a permitted facility. She also addressed the waste strewn along the hillside and in the floodplain. She stated that the area would need to be excavated and all waste removed before we can consider closing the case with the IEPA. Mr. Cravatta left the area to make a phone call. Once Mr. Cravatta returned, he stated that he spoke to the person who is responsible for the open dumping. He stated that the property would be

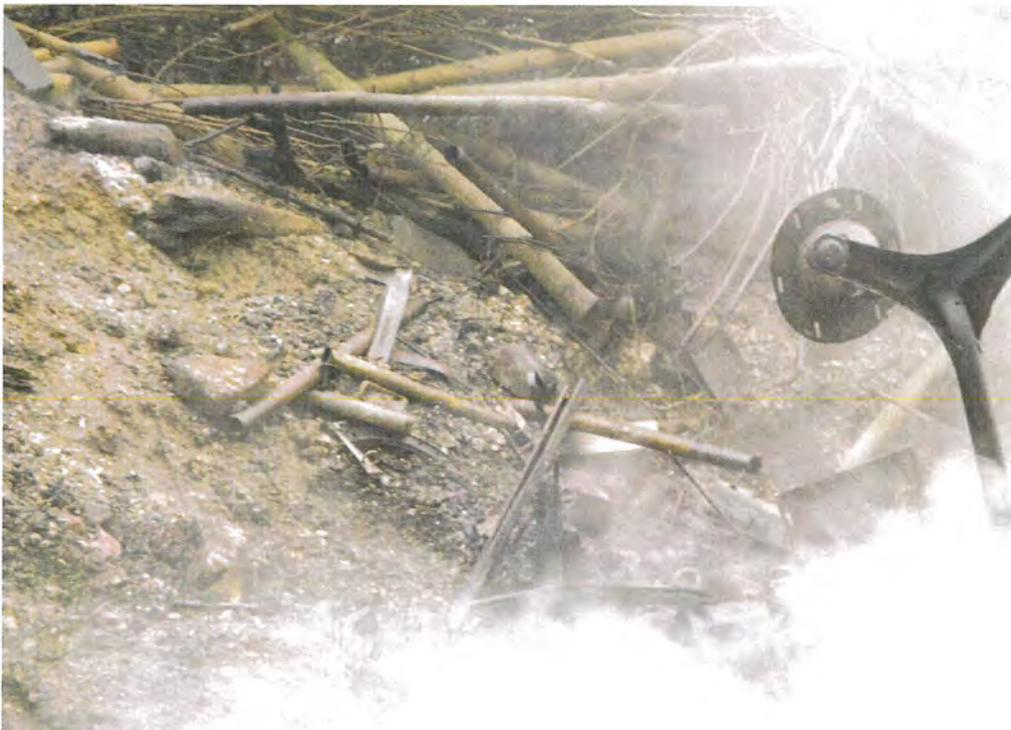
Date: 02/07/2023
Time: 3:11 PM
Direction: Southeast
Photo by:
L. Grumieaux
Exposure #:14
Comments: Charred
car parts in the burn
pile.

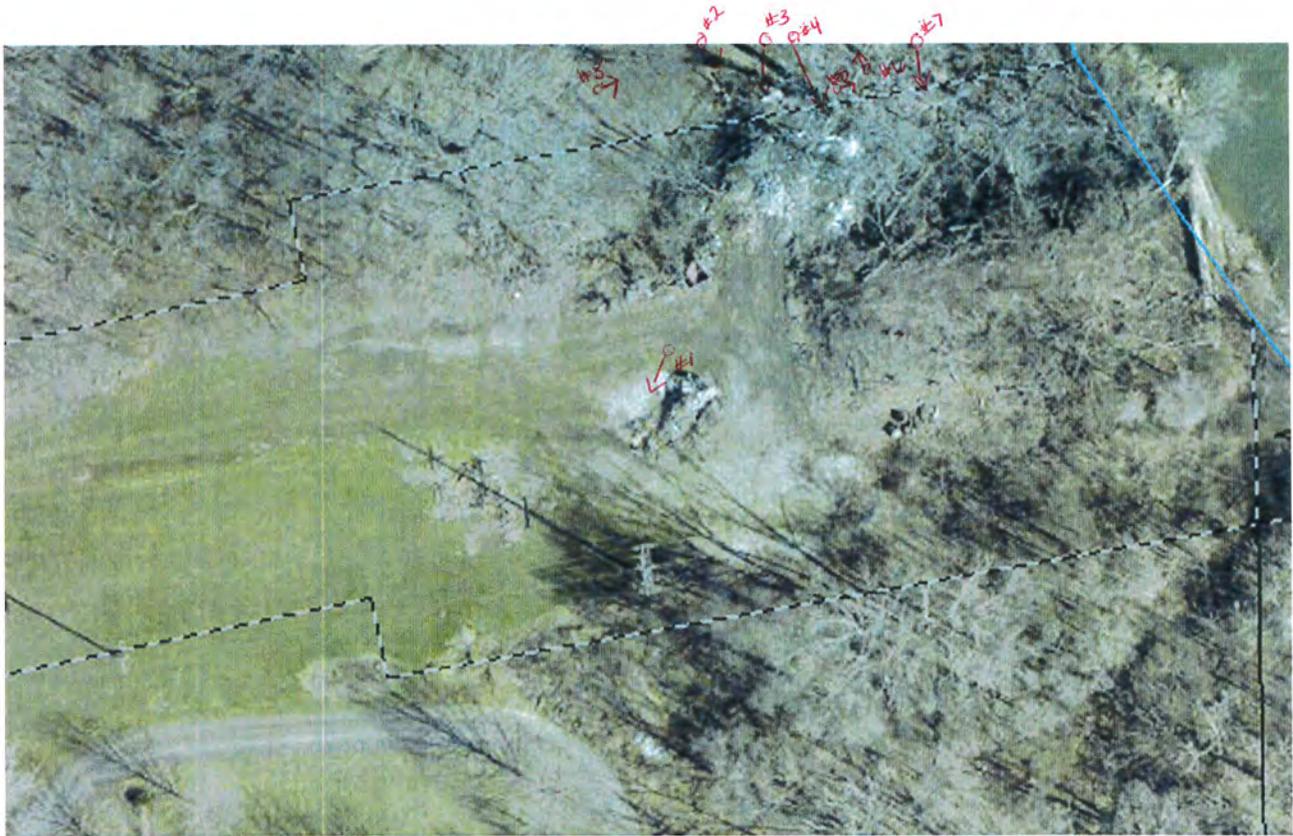
SITE SKETCH

Date of Inspection: 2/23/23 Inspector (s): L. Grumiec, B. Gift, M. Pasada
Site Code: 0998075005 County: LASALLE
Site Name: Cravatta Property Time: 9:36 to 10:00

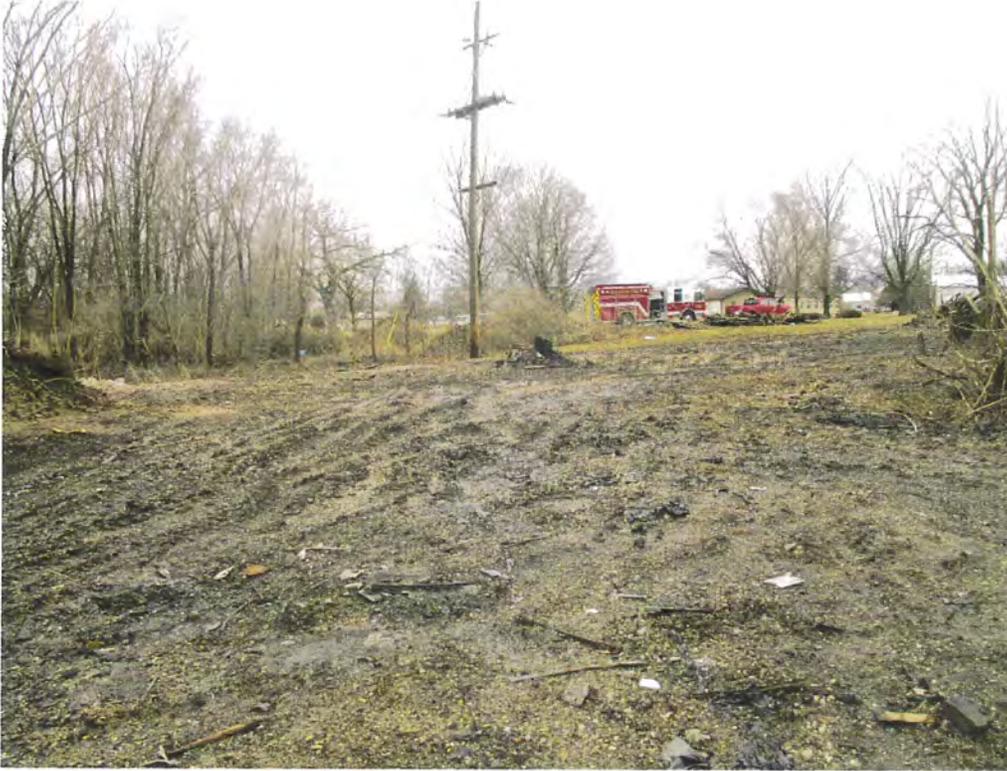
Date: 02/23/2023
Time: 9:42 AM
Direction: Southwest
Photo by:
L. Grumieaux
Exposure #: 1
Comments: The burn pile and waste were removed from the area.

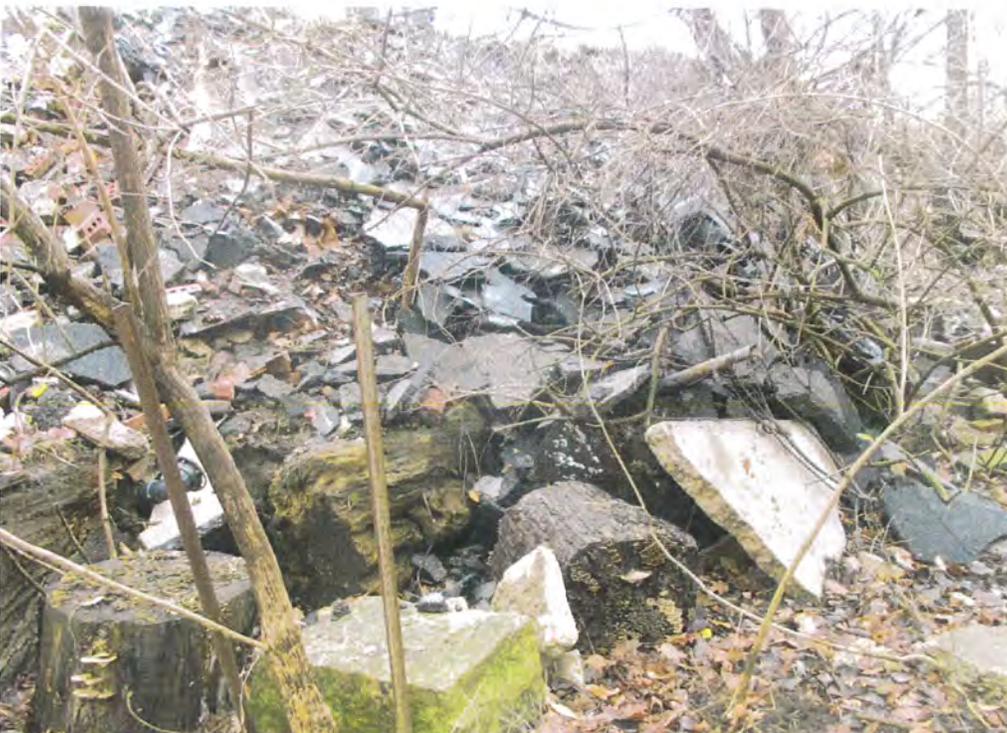
Date: 02/23/2023
Time: 9:44 AM
Direction: Southeast
Photo by:
L. Grumieaux
Exposure #:2
Comments: Shingles and Construction debris were viewed along the slop of the ravine.

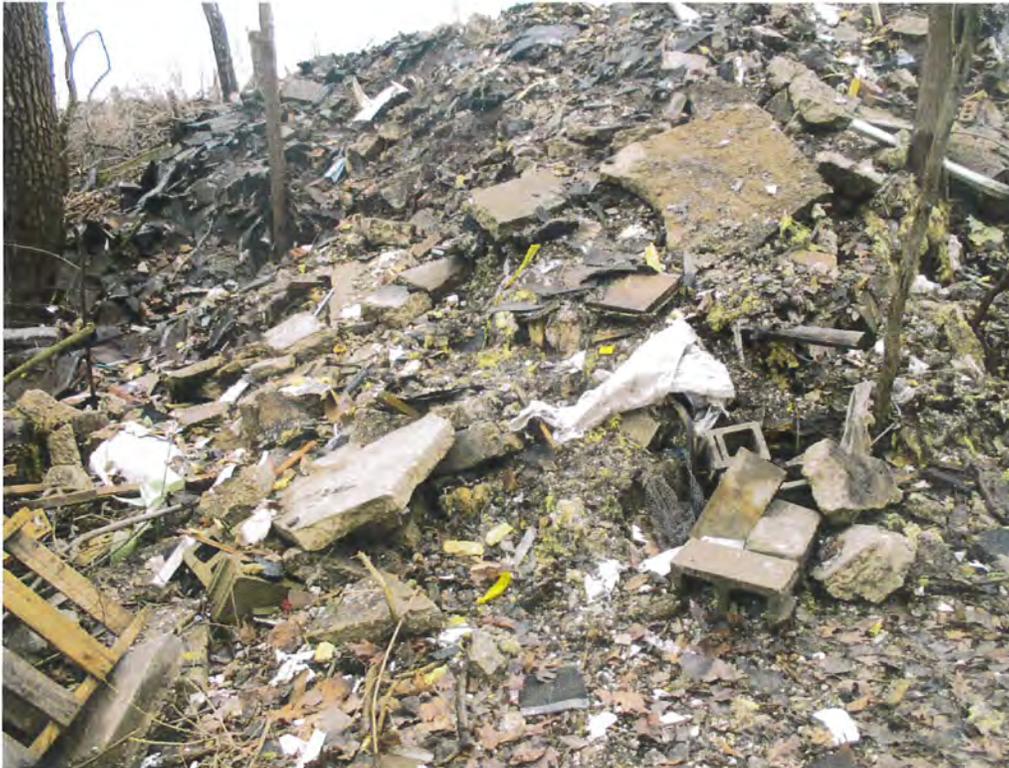
Date: 02/23/2023
Time: 9:45 AM
Direction: South
Photo by:
L. Grumieaux
Exposure #: 3
Comments:
Demolition debris
being pushed into
the floodplain.

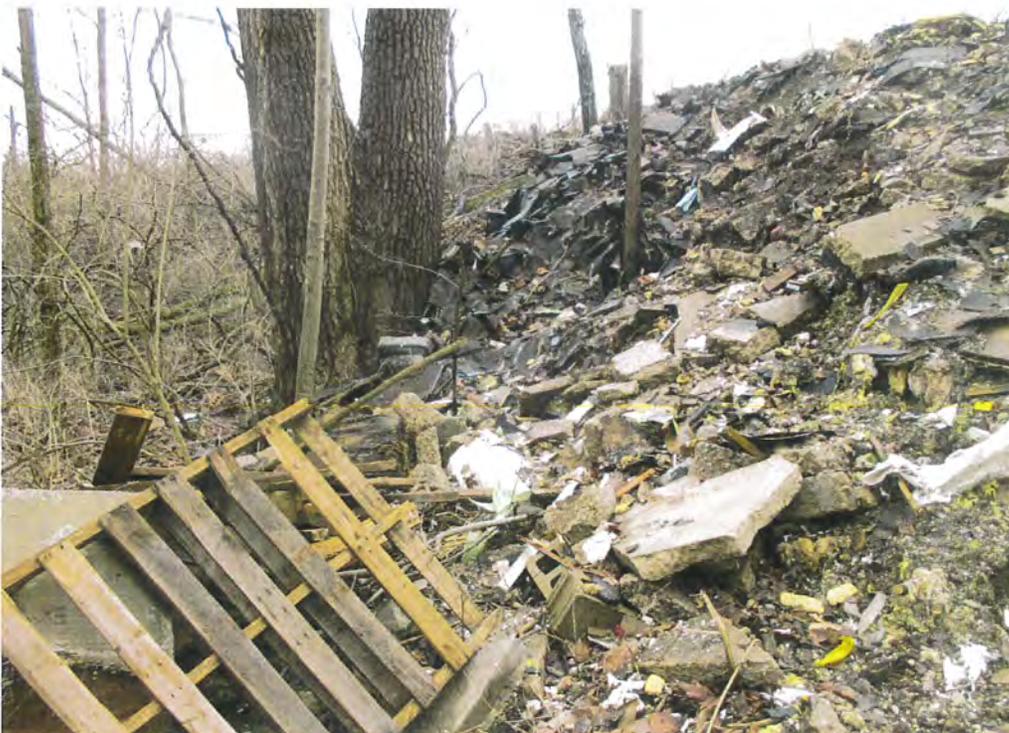
Date: 02/23/2023
Time: 9:45 AM
Direction: Southeast
Photo by:
L. Grumieaux
Exposure #: 4
Comments:
Demolition and
construction
materials.

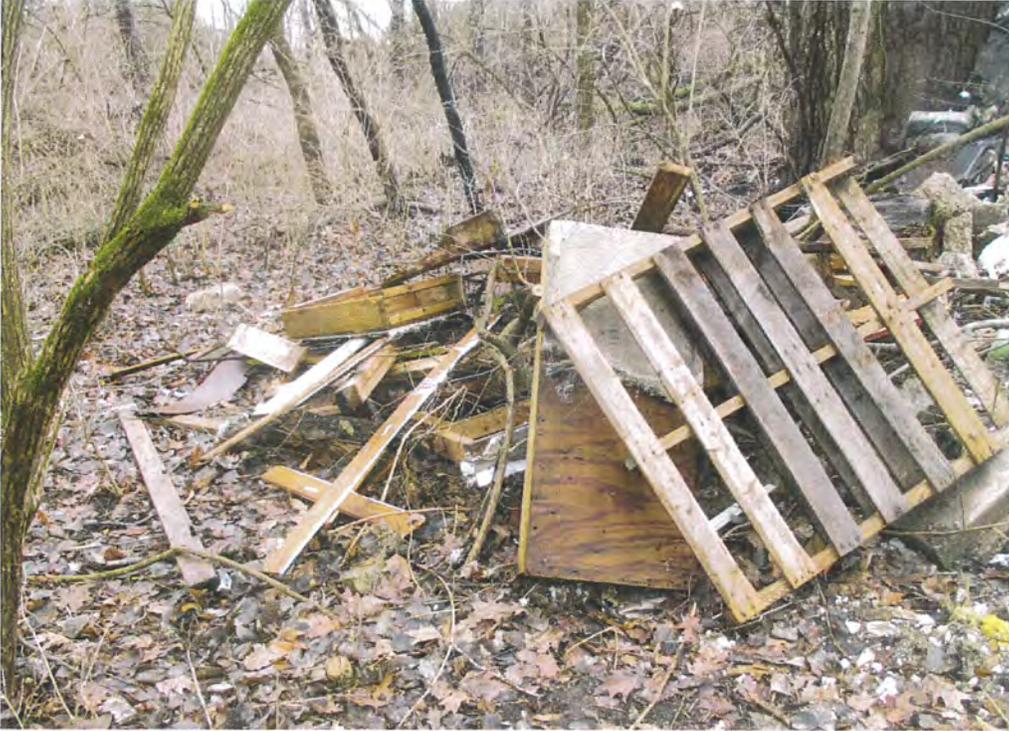
Date: 02/23/2023
Time: 9:45 AM
Direction: East
Photo by:
L. Grumieaux
Exposure #: 5
Comments: Furniture,
pallets, and more
construction
materials.

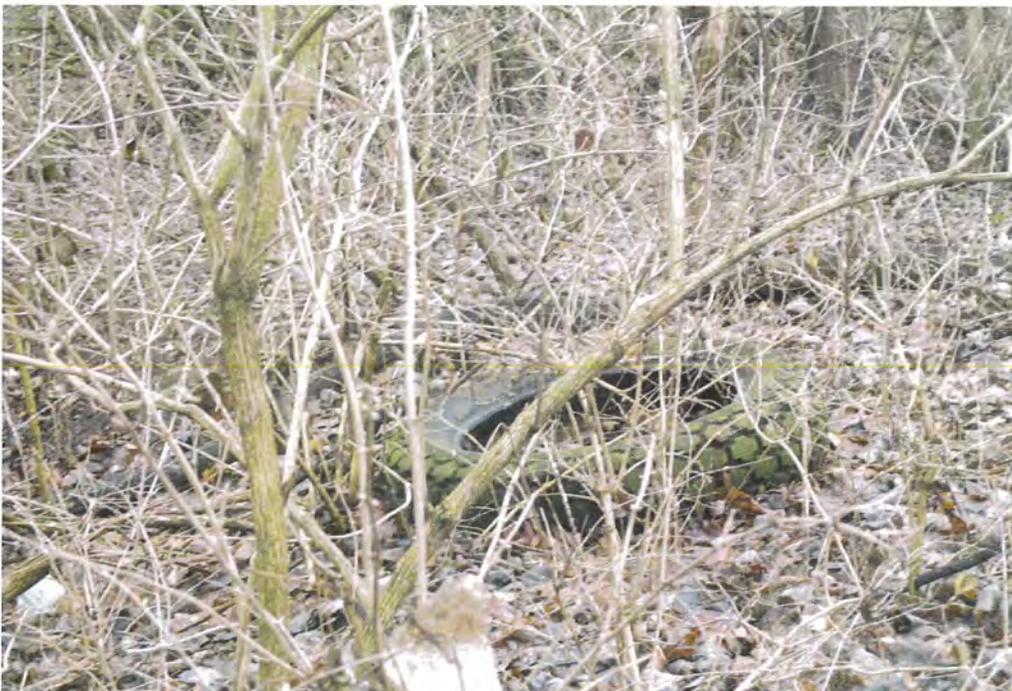
Date: 02/23/2023
Time: 9:46 AM
Direction: North
Photo by:
L. Grumieaux
Exposure #: 6
Comments: Waste
tire viewed in the
area.

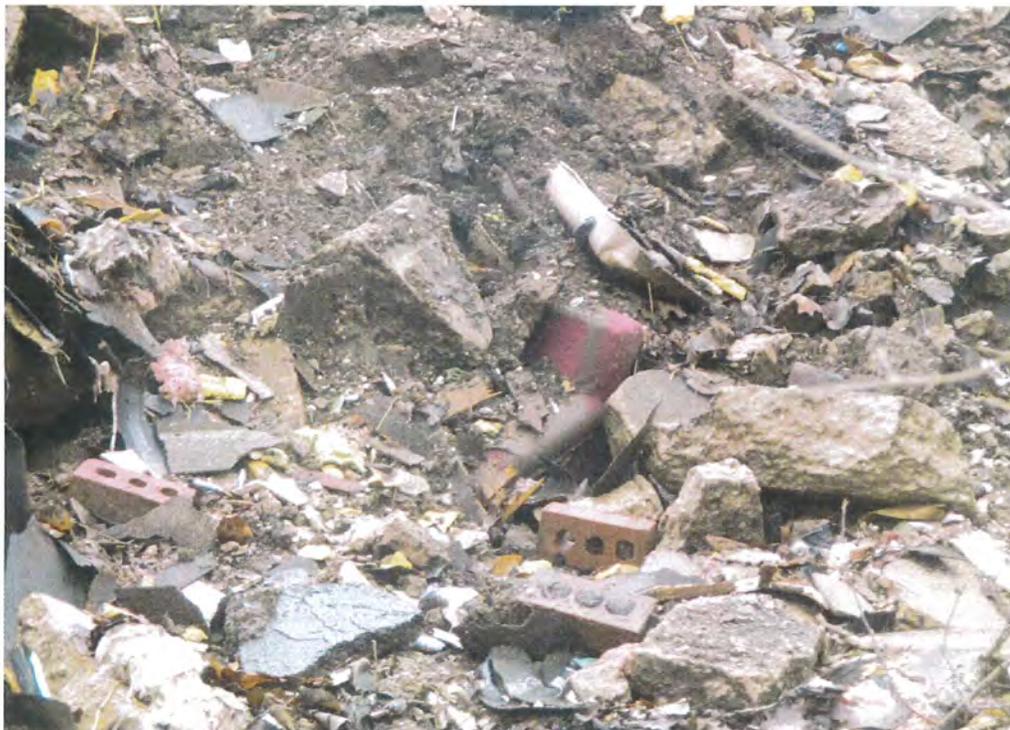
Date: 02/23/2023
Time: 9:53 AM
Direction: South
Photo by:
L. Grumieaux
Exposure #: 7
Comments: Furniture
and household items
protruding from the
construction and
demolition debris
along the hillside.

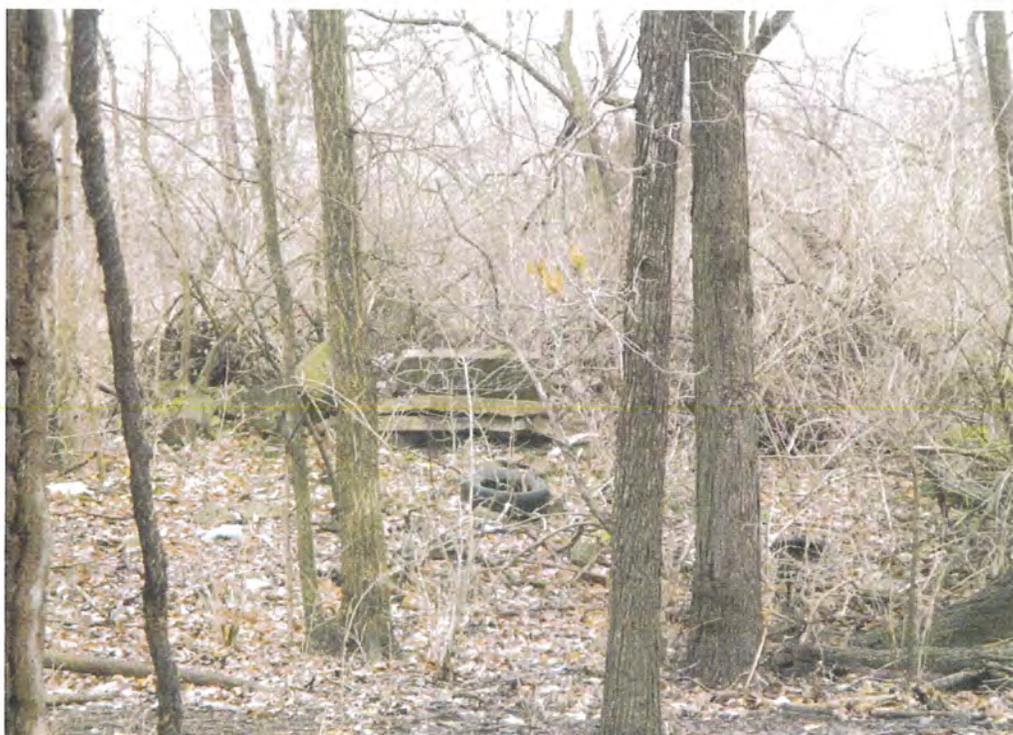
Date: 02/23/2023
Time: 9:55 AM
Direction: East
Photo by:
L. Grumieaux
Exposure #: 8
Comments: More
waste tires viewed.
