ADMINISTRATIVE CITATION

Inspection Report

BOL ID	1310155011	Evaluation Date	3/23/2023
USEPA Id		Region	Peoria
Site Name	Keith Rome	County	Mercer
Address	908 Madison St	Phone	
City/State/Zip	Keithsburg, IL 61442	EJ Status	None
Limited English	<input type="checkbox"/>	Primary Language	English

Solid Waste Program - Open Dump Inspection

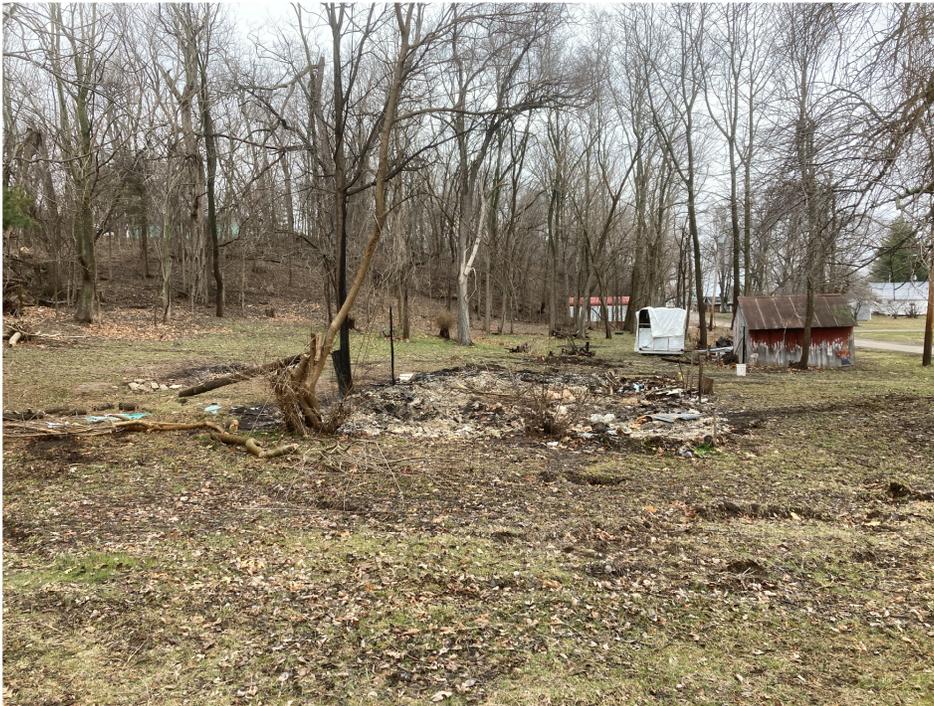
Bureau Id: 1310155011
Photo No.: 2
Photo Date: 3/23/2023
Photo Time: 10:59:30 AM
Direction: W
Taken By: Caleb Froidcoeur

The remains of a house the appears to have been burned.

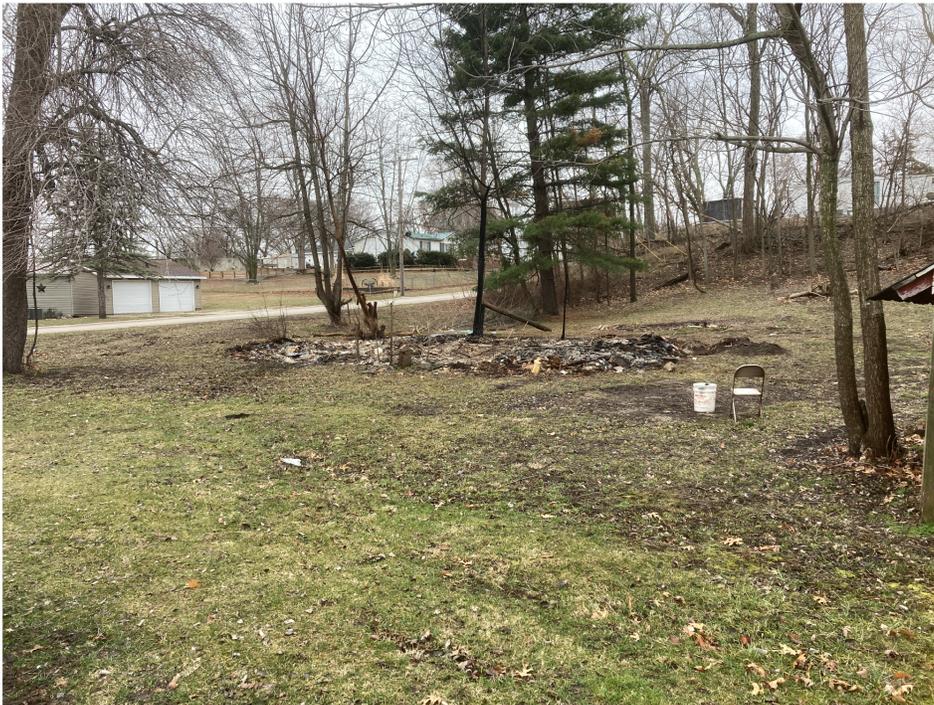
Bureau Id: 1310155011
Photo No.: 3
Photo Date: 3/23/2023
Photo Time: 11:00:57 AM
Direction: SE
Taken By: Caleb Froidcoeur

The remains of a house the appears to have been burned.

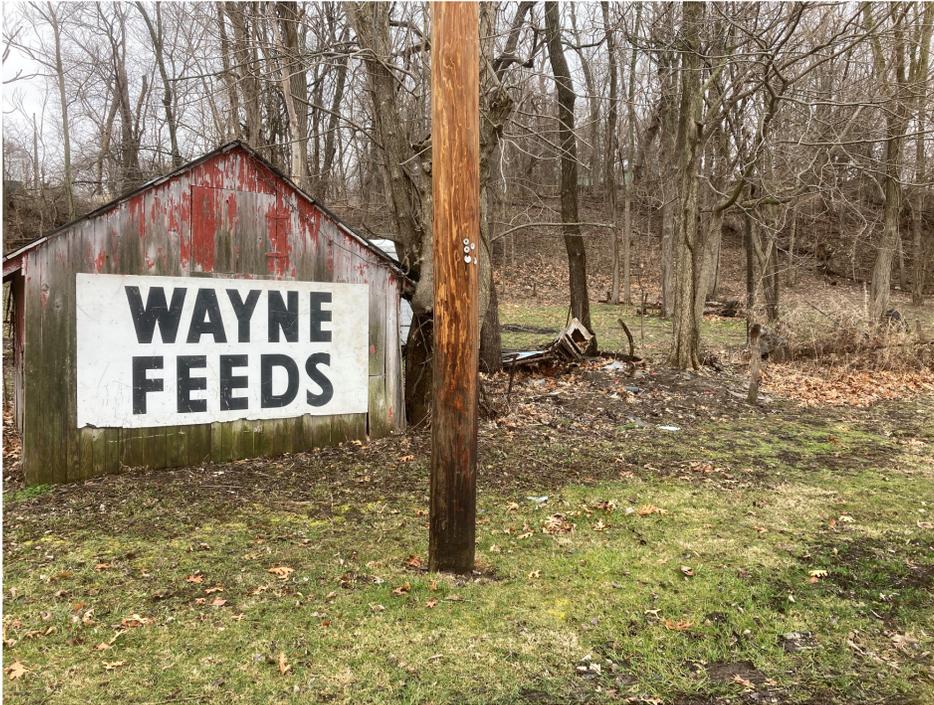
Bureau Id: 1310155011
Photo No.: 4
Photo Date: 3/23/2023
Photo Time: 11:01:01 AM
Direction: SE
Taken By: Caleb Froidcoeur

An overview of the current site conditions.

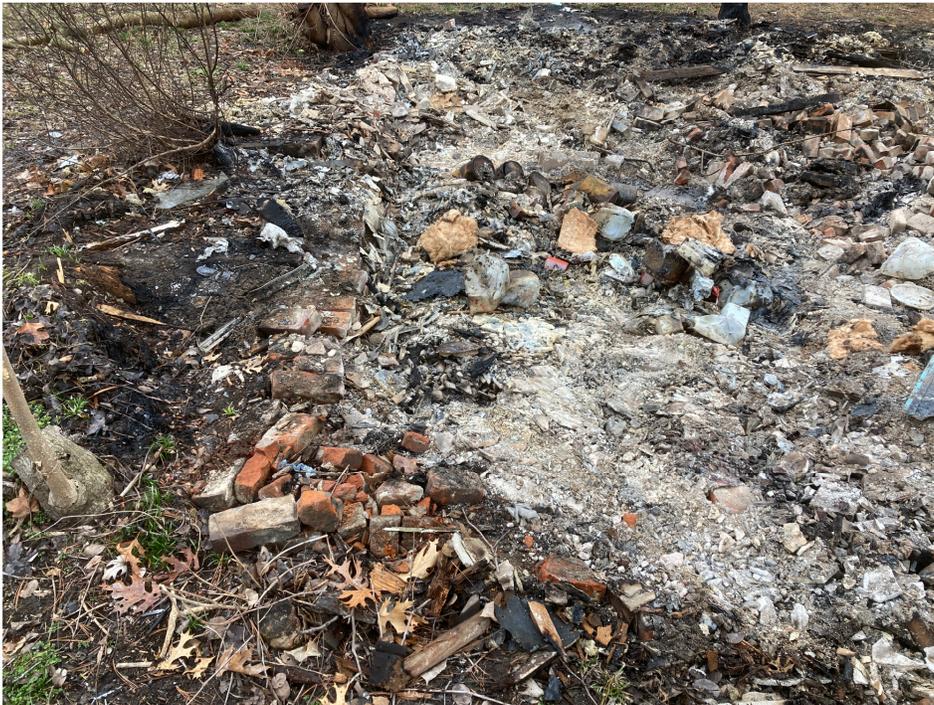
Bureau Id: 1310155011
Photo No.: 5
Photo Date: 3/23/2023
Photo Time: 11:01:52 AM
Direction: SW
Taken By: Caleb Froidcoeur

A burn pile containing GCDD and miscellaneous waste.

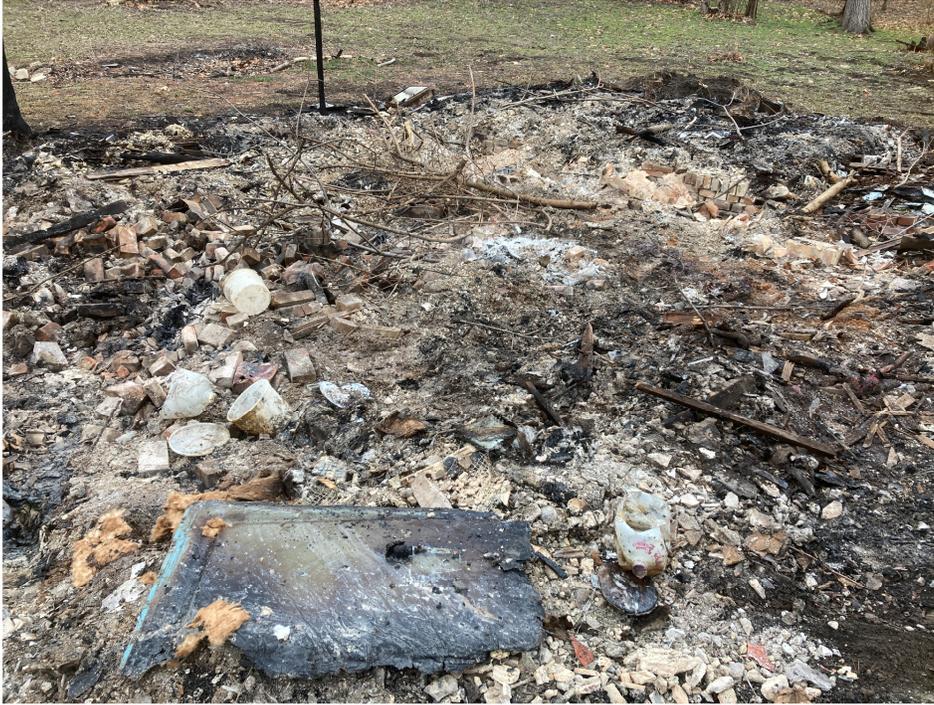
Bureau Id: 1310155011
Photo No.: 6
Photo Date: 3/23/2023
Photo Time: 11:01:57 AM
Direction: SW
Taken By: Caleb Froidcoeur

A burn pile containing GCDD and miscellaneous waste.

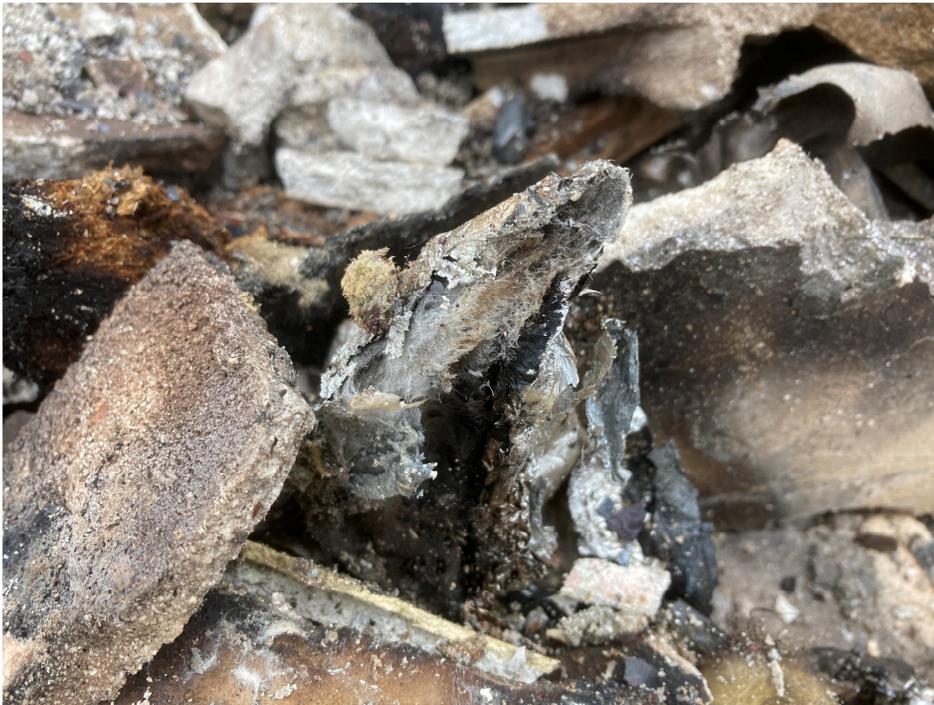
Bureau Id: 1310155011
Photo No.: 7
Photo Date: 3/23/2023
Photo Time: 11:03:26 AM
Direction: SW
Taken By: Caleb Froidcoeur

Burned insulation, suspected asbestos.

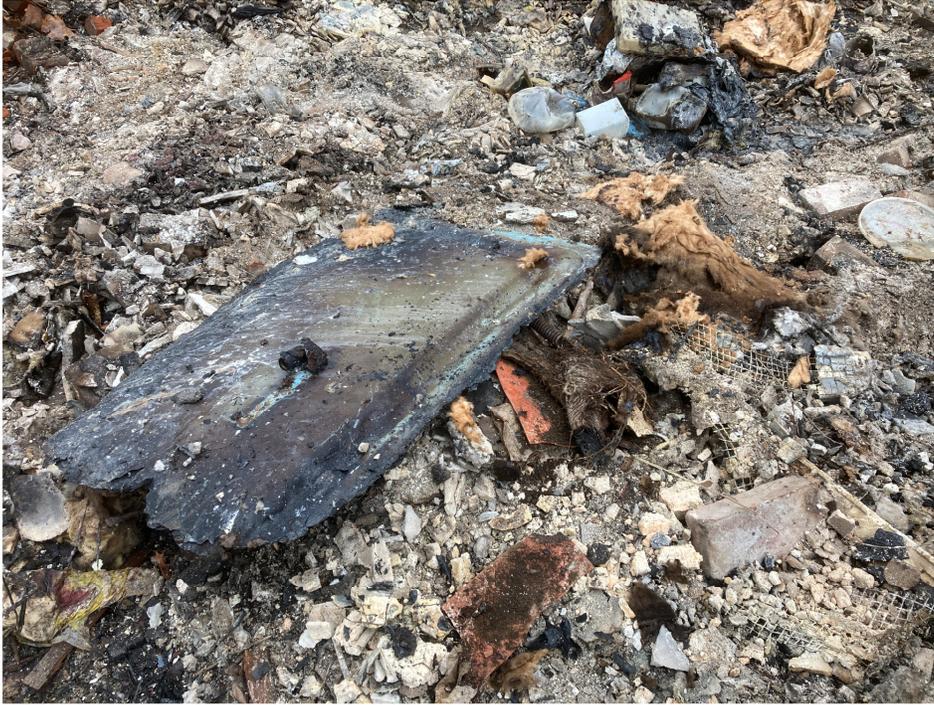
Bureau Id: 1310155011
Photo No.: 8
Photo Date: 3/23/2023
Photo Time: 11:03:56 AM
Direction: SE
Taken By: Caleb Froidcoeur

A burn pile containing GCDD and miscellaneous waste.

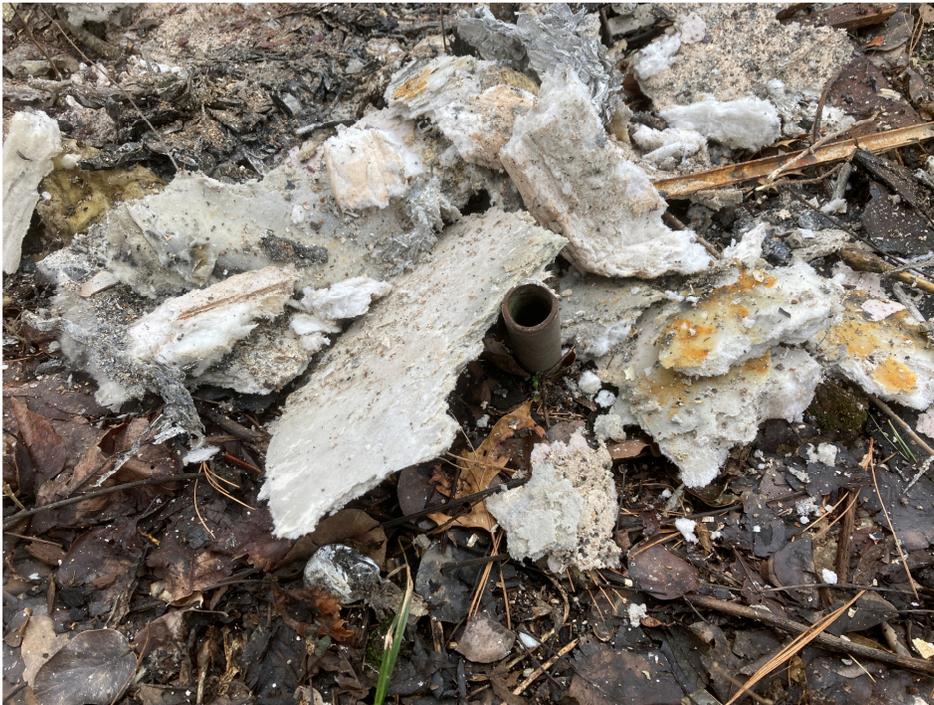
Bureau Id: 1310155011
Photo No.: 9
Photo Date: 3/23/2023
Photo Time: 11:04:24 AM
Direction: S
Taken By: Caleb Froidcoeur

Burned pipes and insulation.

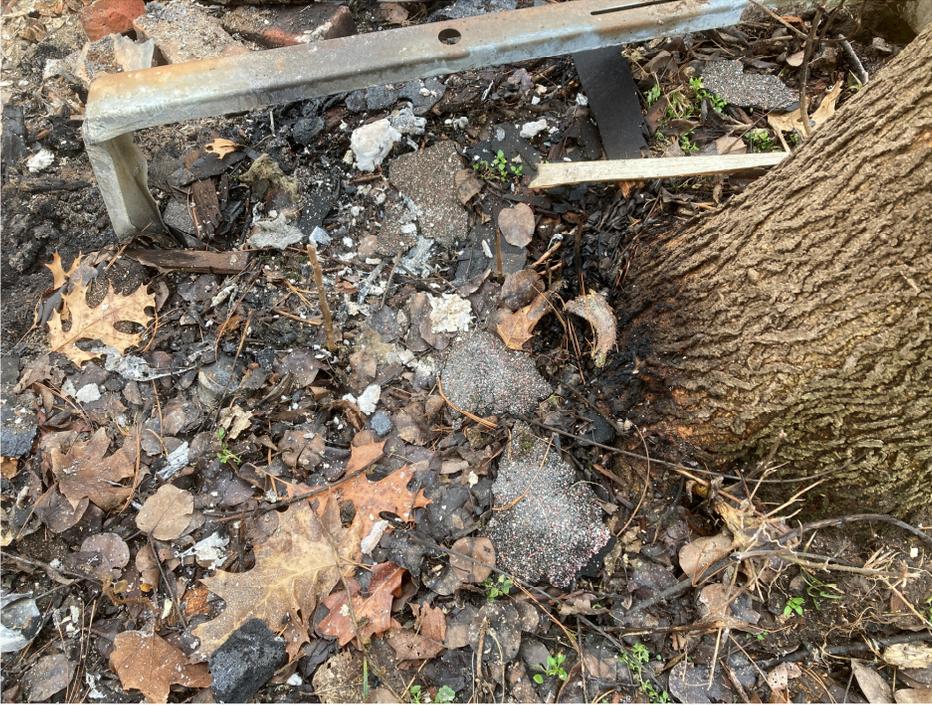
Bureau Id: 1310155011
Photo No.: 10
Photo Date: 3/23/2023
Photo Time: 11:04:51 AM
Direction: S
Taken By: Caleb Froidcoeur

Shingles in the burn pile.

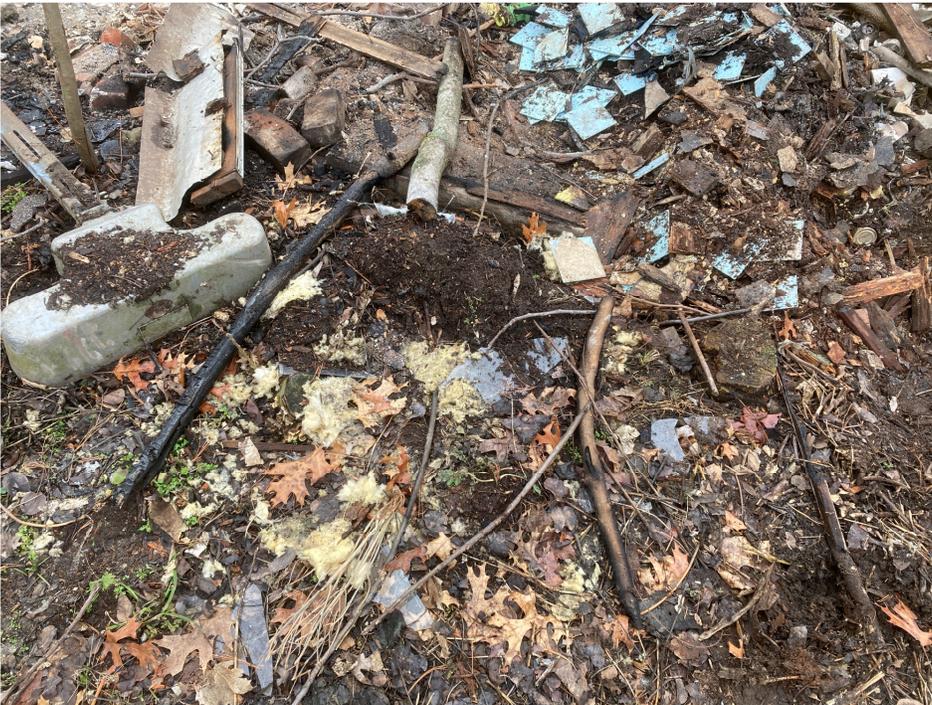
Bureau Id: 1310155011
Photo No.: 11
Photo Date: 3/23/2023
Photo Time: 11:05:19 AM
Direction: SE
Taken By: Caleb Froidcoeur

Glass and tiles in the burn pile.

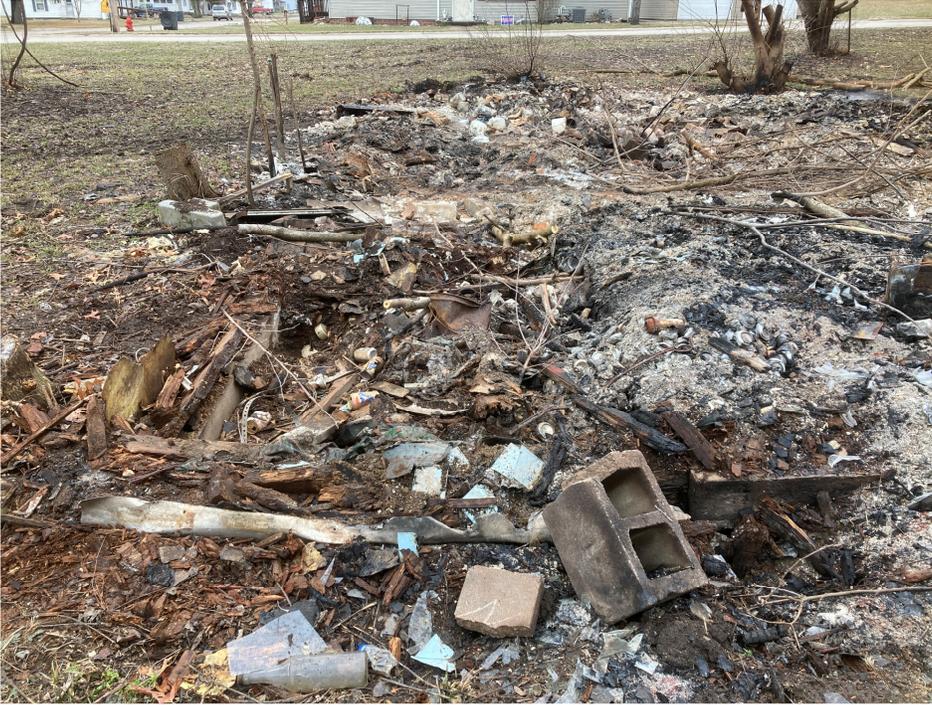
Bureau Id: 1310155011
Photo No.: 12
Photo Date: 3/23/2023
Photo Time: 11:05:58 AM
Direction: E
Taken By: Caleb Froidcoeur

Burned GCDD and municipal solid waste
in the burn pile.

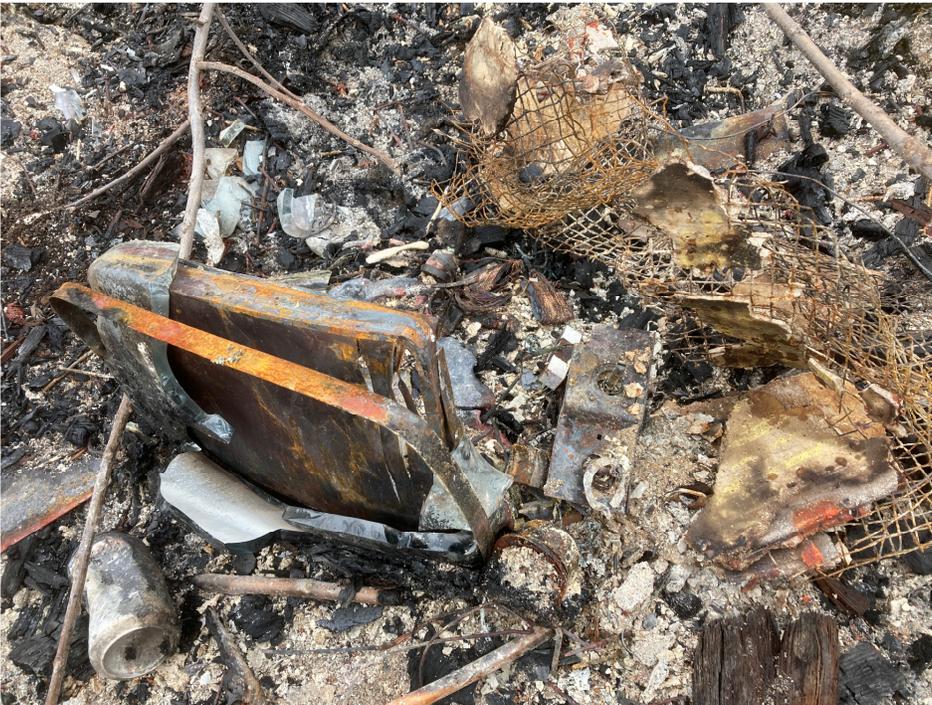
Bureau Id: 1310155011
Photo No.: 13
Photo Date: 3/23/2023
Photo Time: 11:07:17 AM
Direction: E
Taken By: Caleb Froidcoeur

Charred waste in the burn pile.

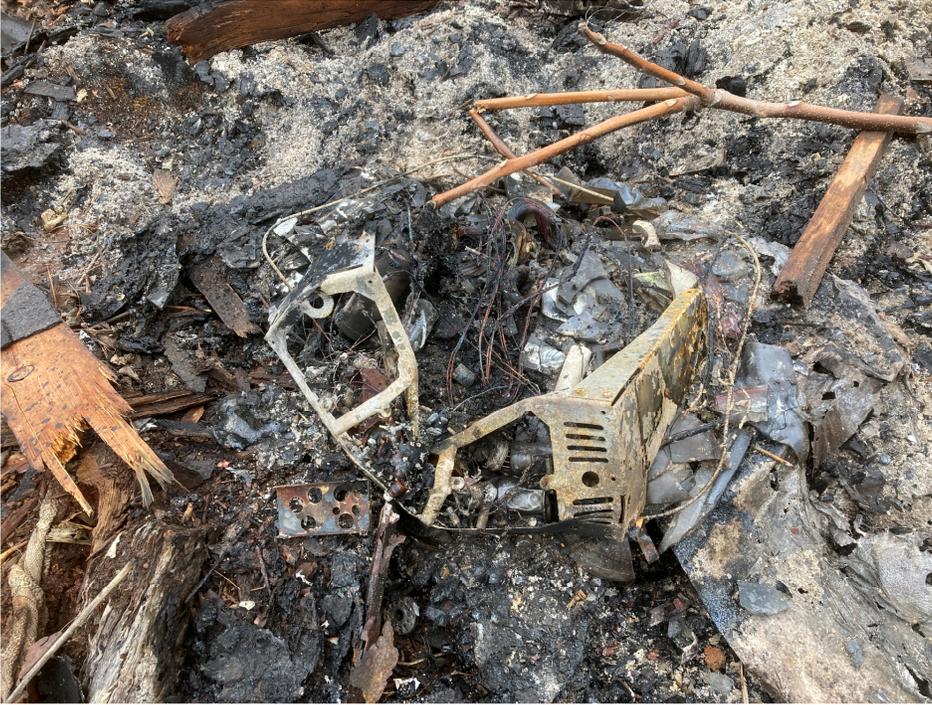
Bureau Id: 1310155011
Photo No.: 14
Photo Date: 3/23/2023
Photo Time: 11:07:53 AM
Direction: N
Taken By: Caleb Froidcoeur

An unidentifiable waste that appears to be an electronic device.

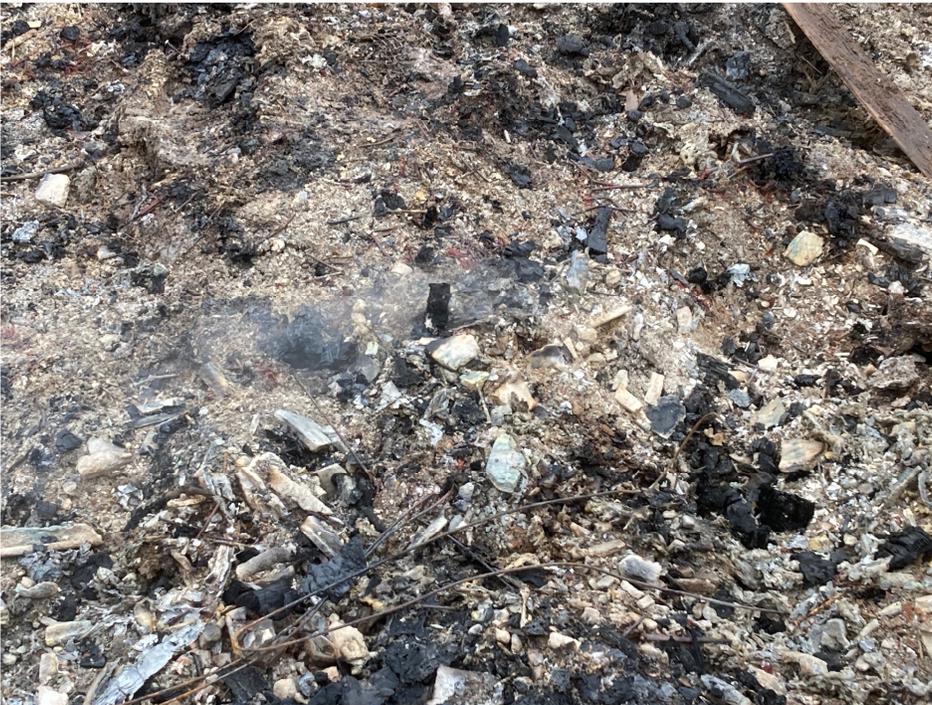
Bureau Id: 1310155011
Photo No.: 15
Photo Date: 3/23/2023
Photo Time: 11:09:02 AM
Direction: NW
Taken By: Caleb Froidcoeur

Smoke from the smoldering burn pile.

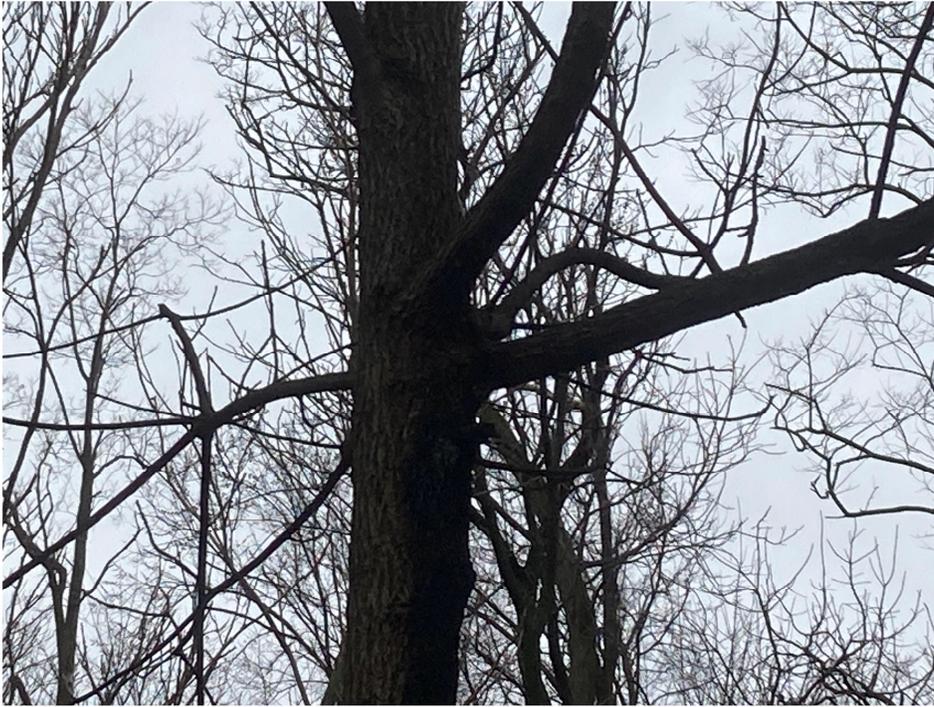
Bureau Id: 1310155011
Photo No.: 16
Photo Date: 3/23/2023
Photo Time: 11:09:50 AM
Direction: SW
Taken By: Caleb Froidcoeur

A nearby tree that was charred from the fire. Based on the height of the charring, it appears the building was not demolished before being burned.

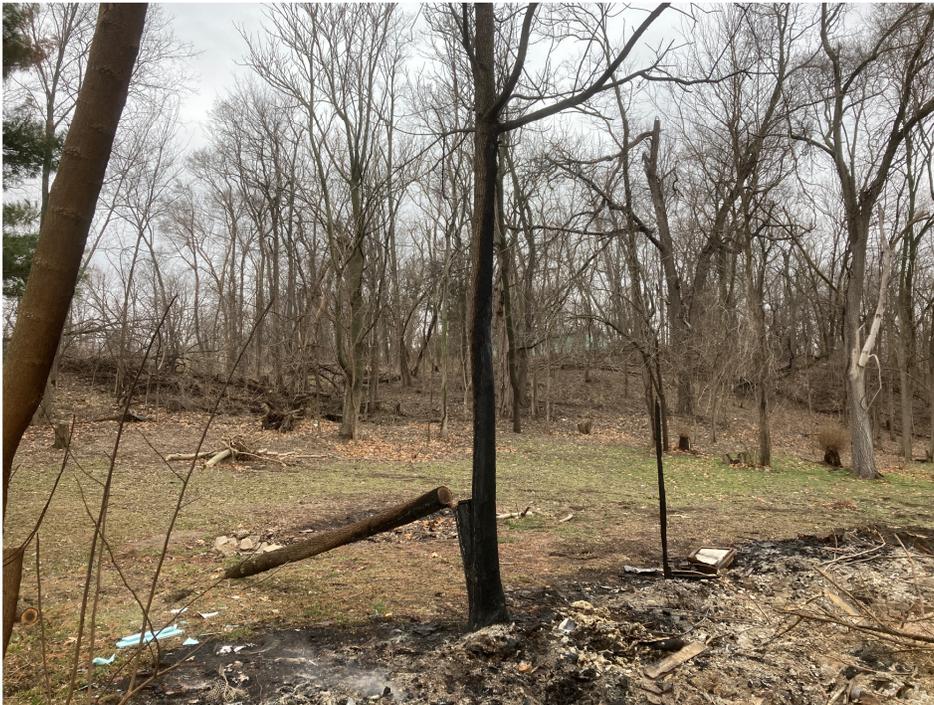
Bureau Id: 1310155011
Photo No.: 17
Photo Date: 3/23/2023
Photo Time: 11:10:09 AM
Direction: SW
Taken By: Caleb Froidcoeur

A nearby tree that was charred from the fire. Based on the height of the charring, it appears the building was not demolished before being burned.

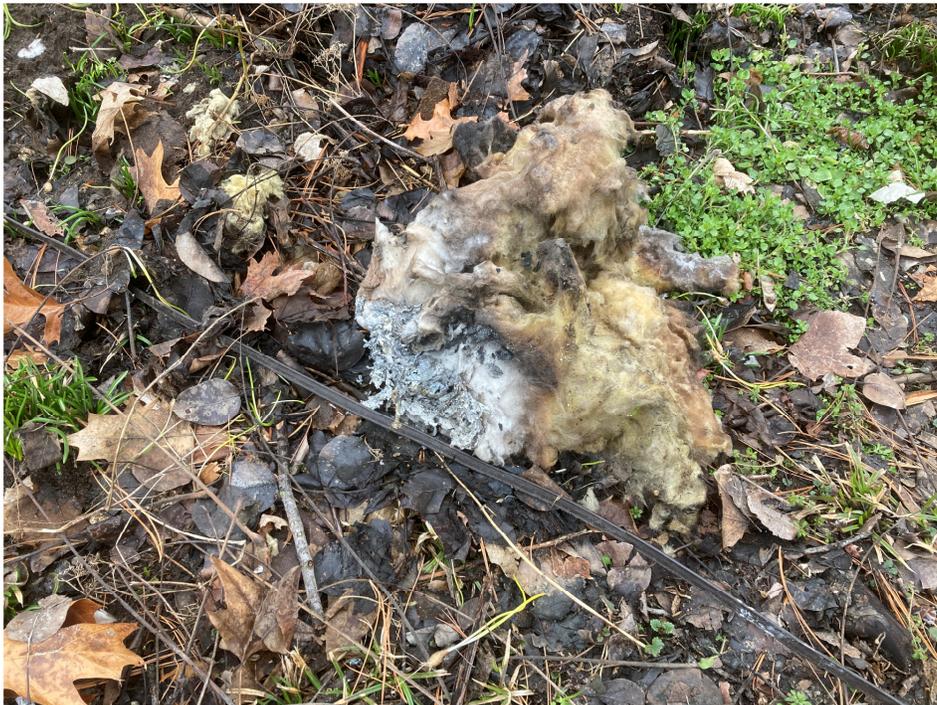
Photo No.: 18

Burned insulation found in the burn pile.
