Appendix R
Closure Documentation Report

Closure Documentation Report

**Modern Plating Corporation
Freeport, Illinois**

August 2001

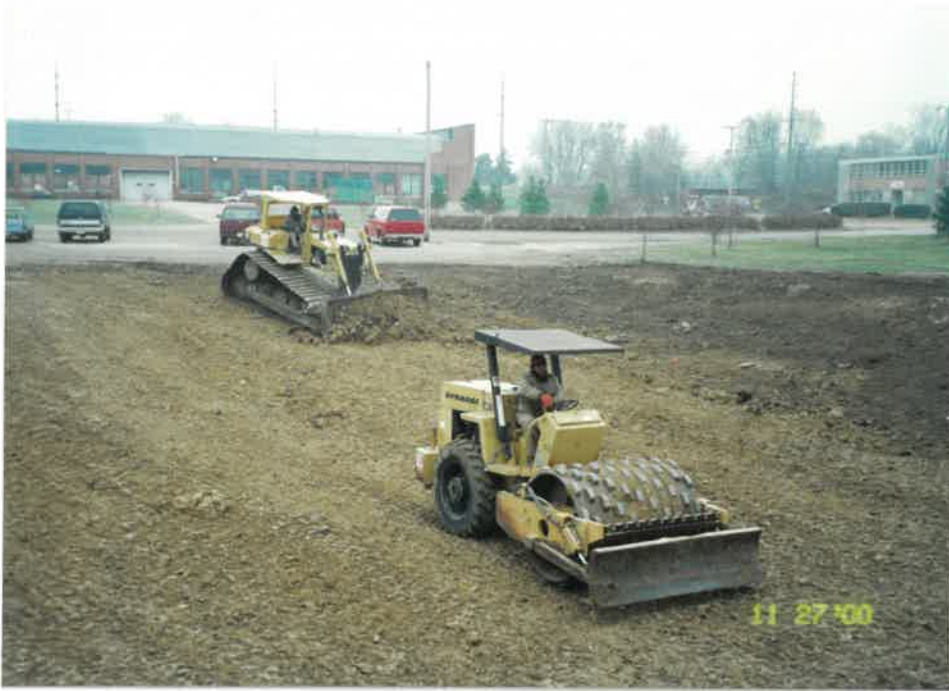
Photograph 1 November 27, 2000
Description: Backfilling and compacting clayey soil cap on Lagoon No. 1A excavation.

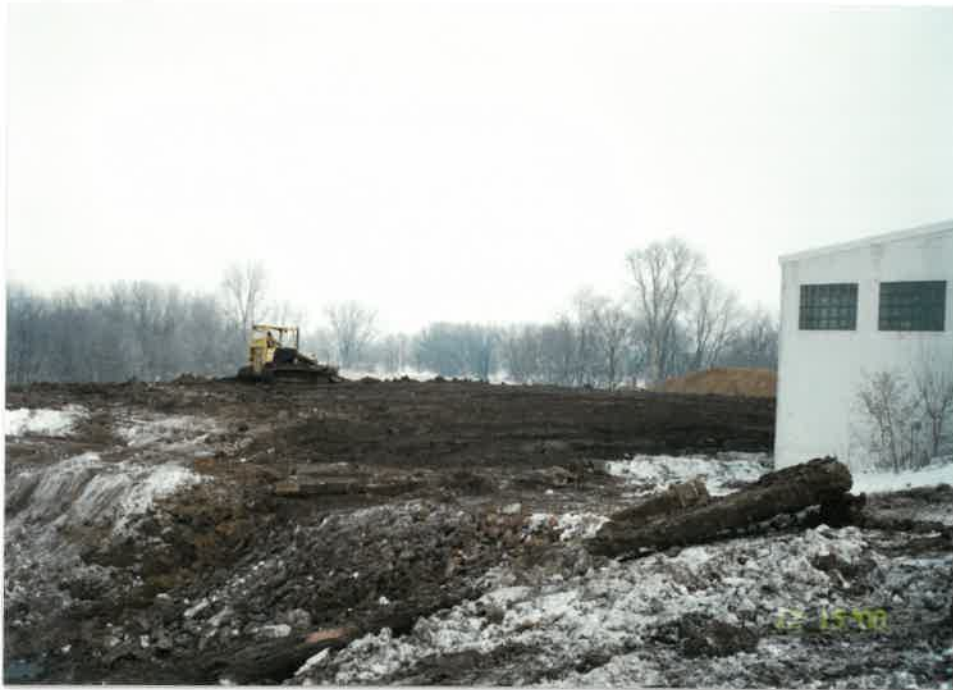
Photograph 3 December 15, 2000
Description: CAMU landfill top of sludge grades.

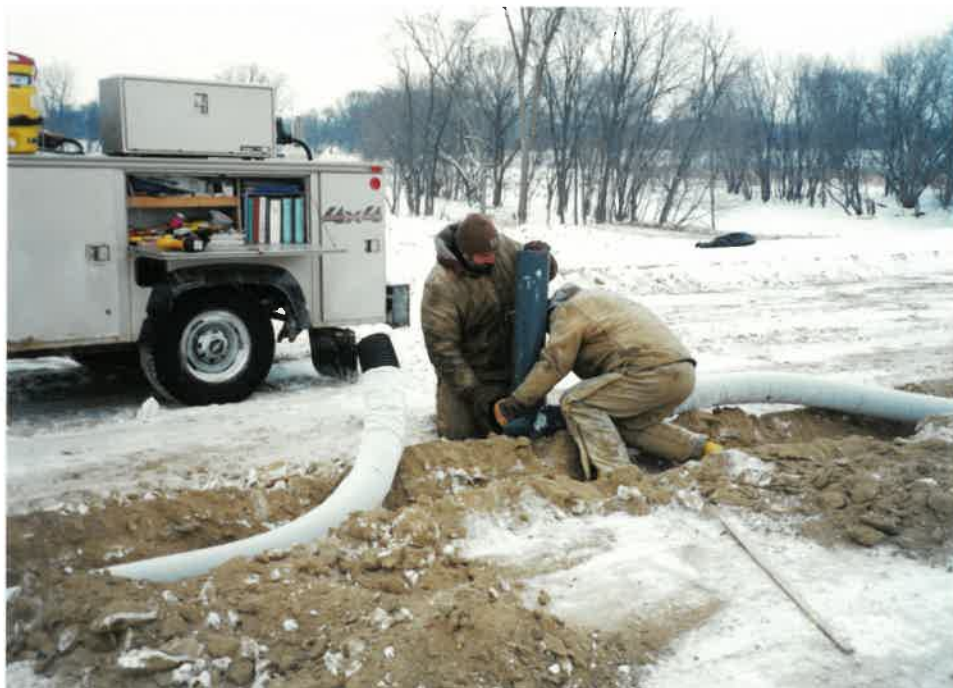
Photograph 4 December 26, 2000
Description: Installing gas vent piping in grading/gas venting layer.

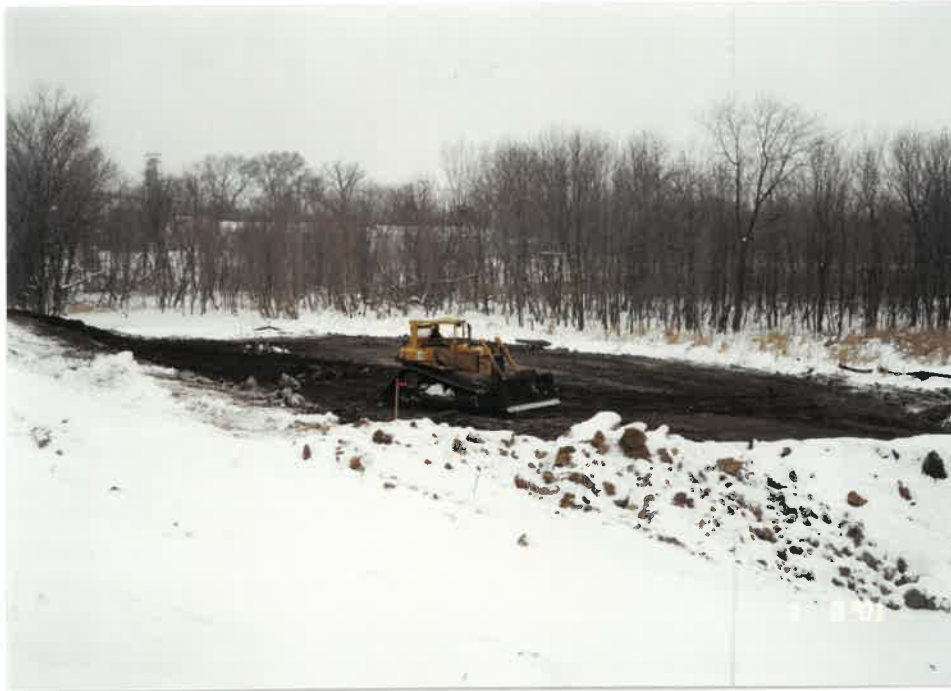
Photograph 5

Description: Restoring Wetland No. 2.

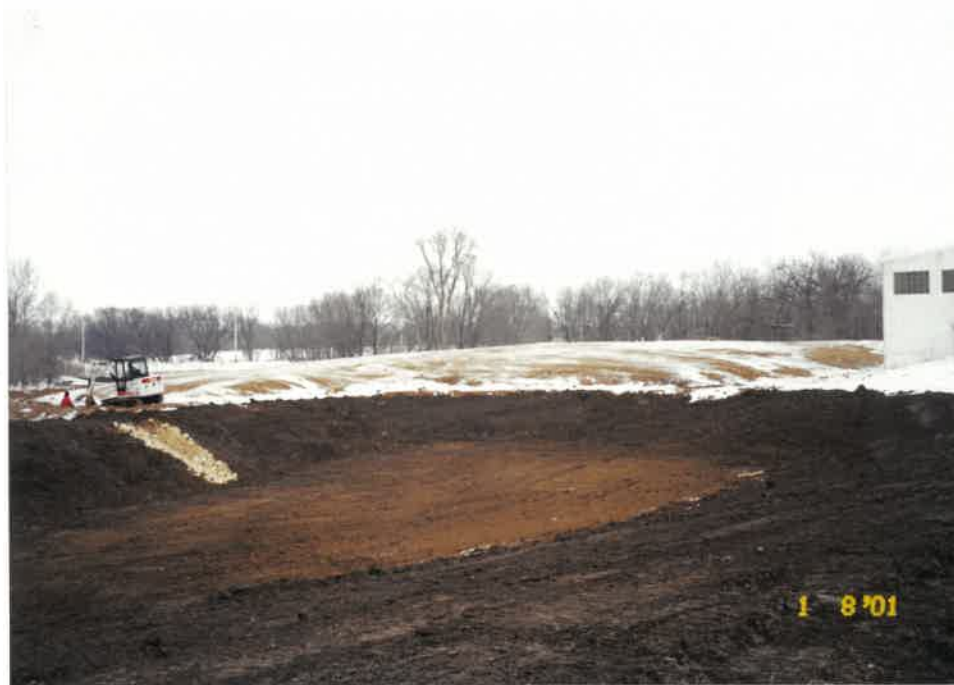
Photograph 6

Description: Lagoon No.1 excavation restored and converted to Sedimentation Basin No. 2.

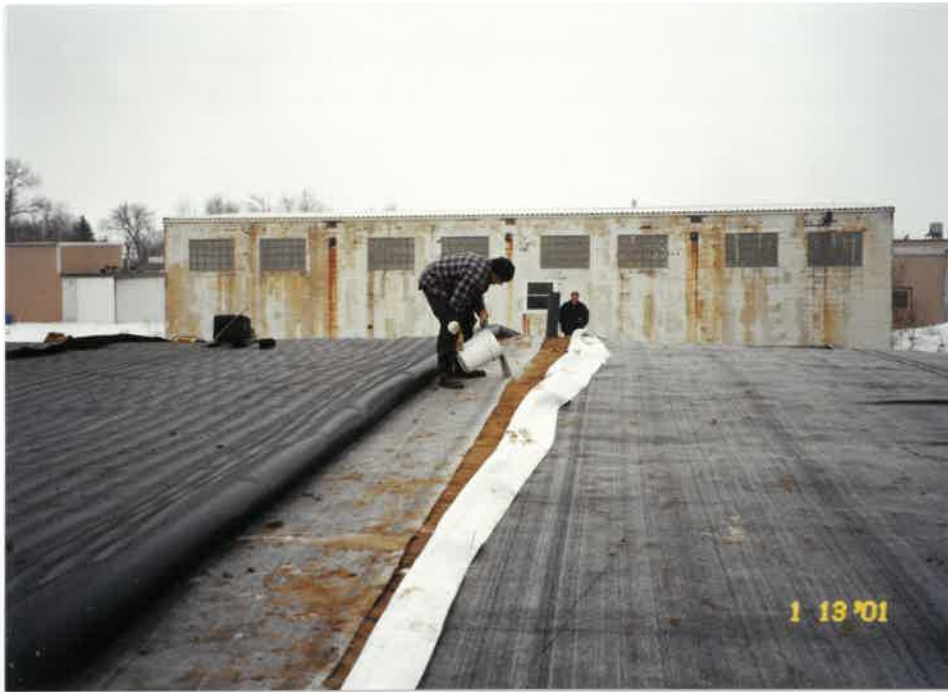
Photograph 7 January 13, 2001
Description: Placing GCL and geomembrane panels on CAMU landfill cap.

During the GCL panel placement, the length, panel location, and time of deployment were recorded on a Panel Placement Form. Copies of these forms are included in Appendix C4. Panel installation was observed for the following: the proper side of the GCL panels faced upward, the GCL rolls were handled properly, wrinkles larger than 1-in high and 6-in long were removed, and that there were no visible defects in the GCL rolls. Panel thicknesses were measured in the field using a micrometer at 5 locations per GCL roll. Drawing No. 3 shows the "as installed" panel locations and panel numbers. GCL seams were constructed with a minimum 8-in overlap between panels. Powdered bentonite was sprinkled between each panel overlap at a minimum rate of ¼-pound per lineal foot of seam. Immediately after deployment, the GCL was covered by the geomembrane to provide protection from moisture as shown on Photograph 7 (Appendix A).

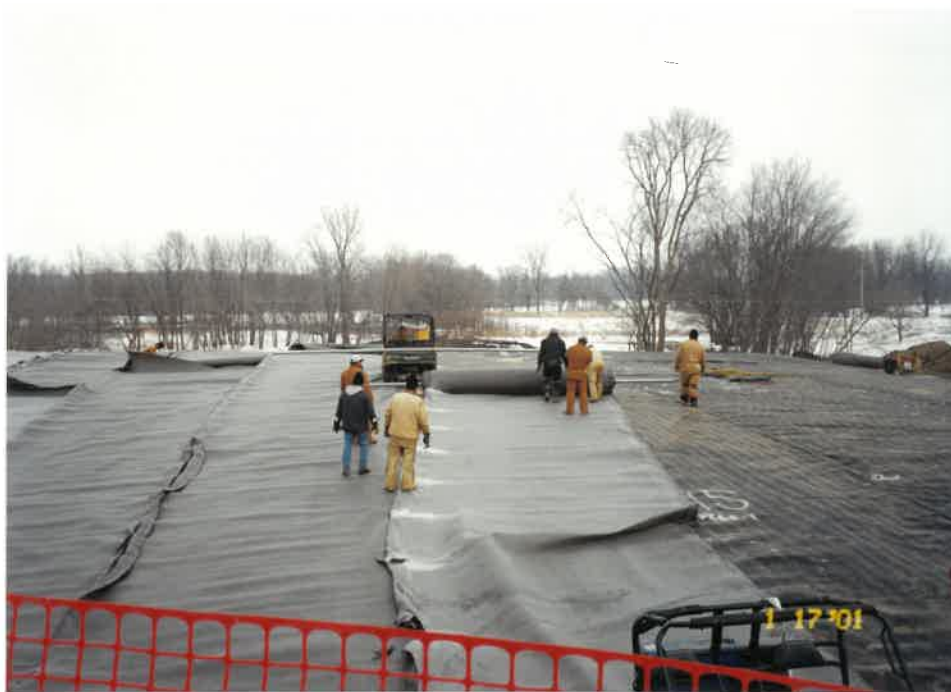
Photograph 8 January 17, 2001
Description: Deploying geocomposite on CAMU landfill cap.

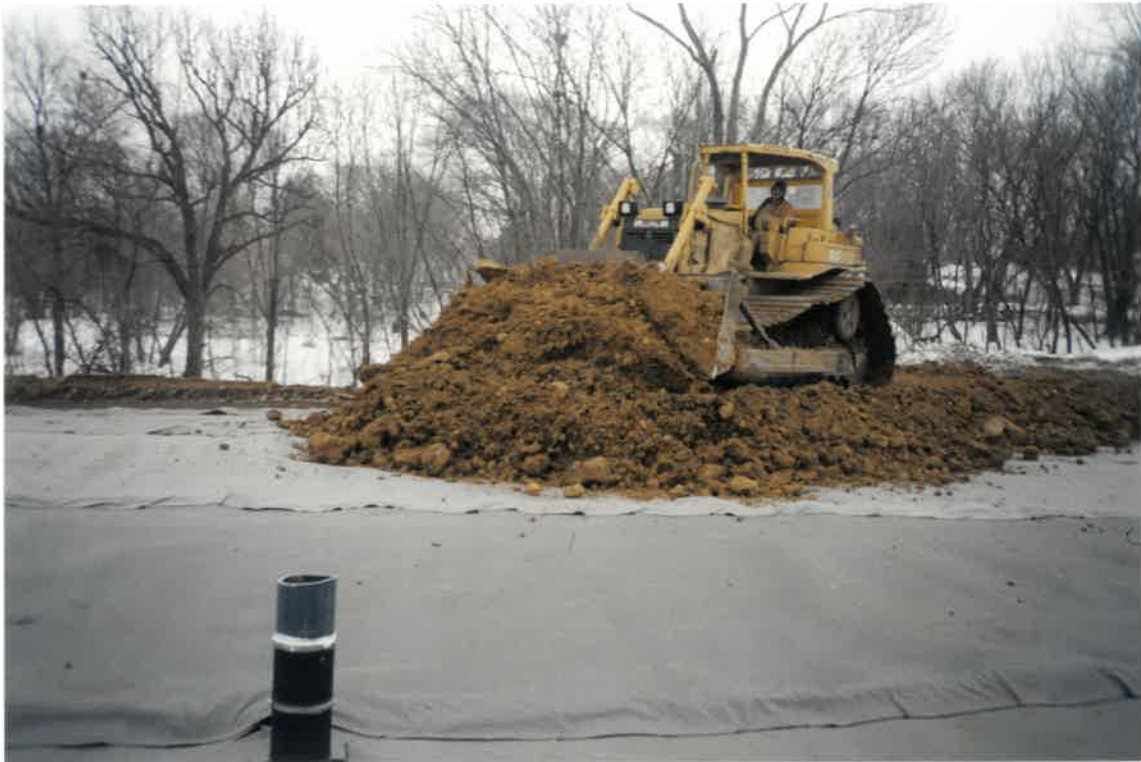
Photograph 9 January 19, 2001
Description: Placing rooting zone soils for CAMU landfill final cover.

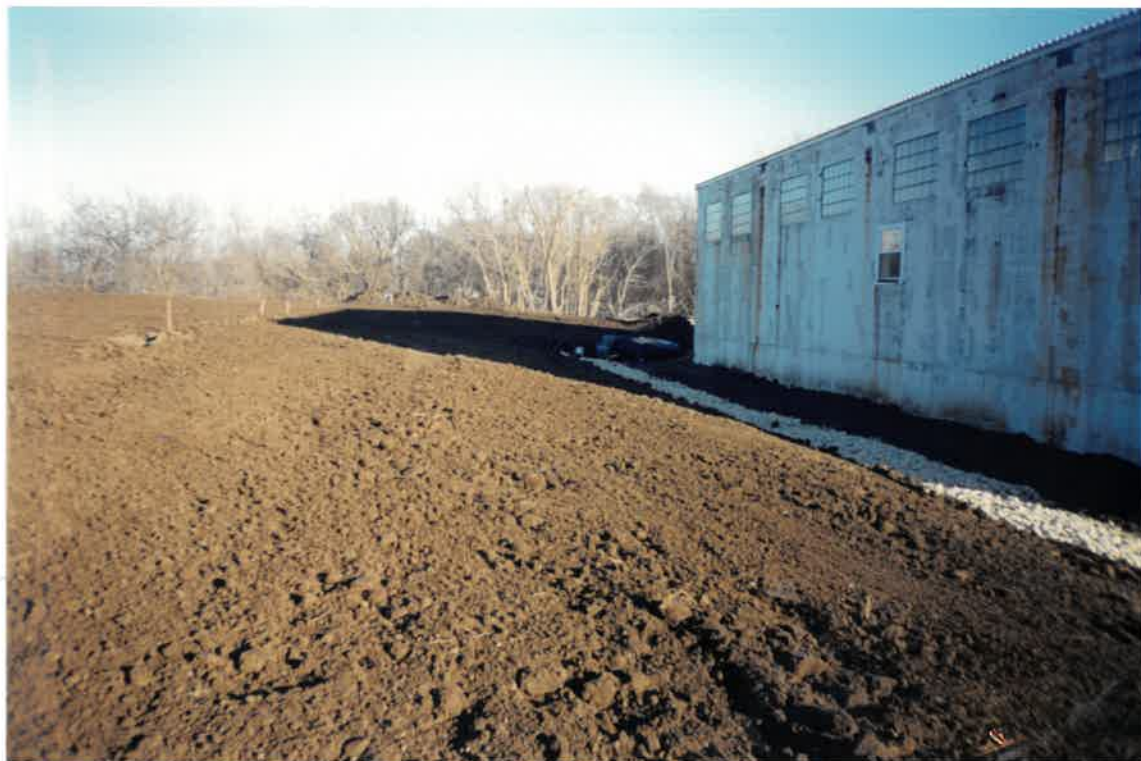
Photograph 10 January 25, 2001
Description: CAMU landfill final cover topsoil and rooting zone drainage system.

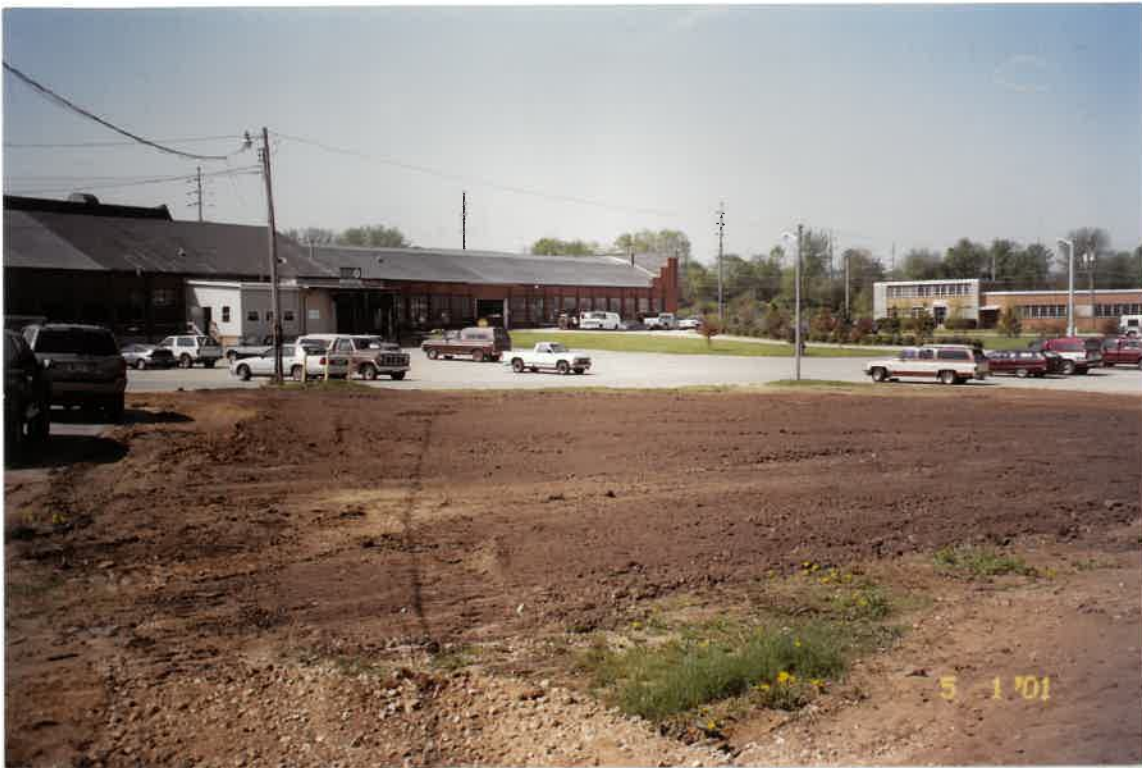
Photograph 11 May 1, 2001
Description: Restoration work partially completed for Cyanide Vault and Lagoon No. 0 (Topsoil placed and fine graded).

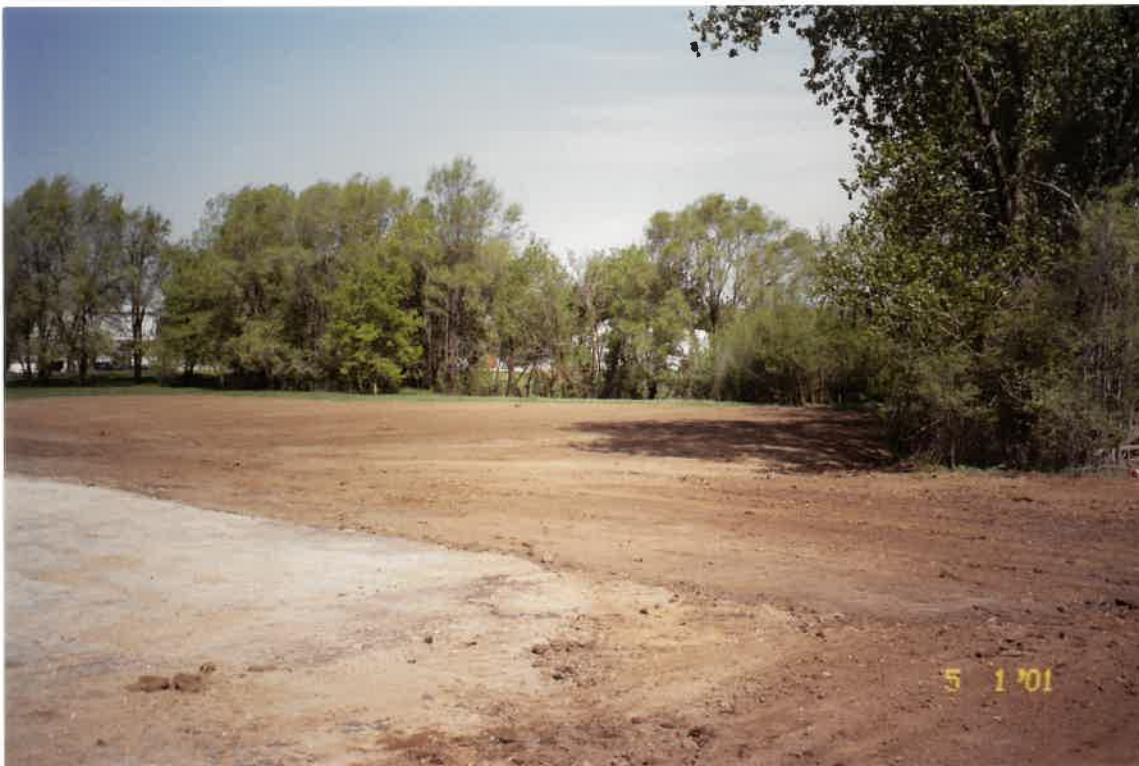
Photograph 12 May 1, 2001
Description: Restoration work in progress on Lagoon No. 1A (Topsoil placed and fine graded).

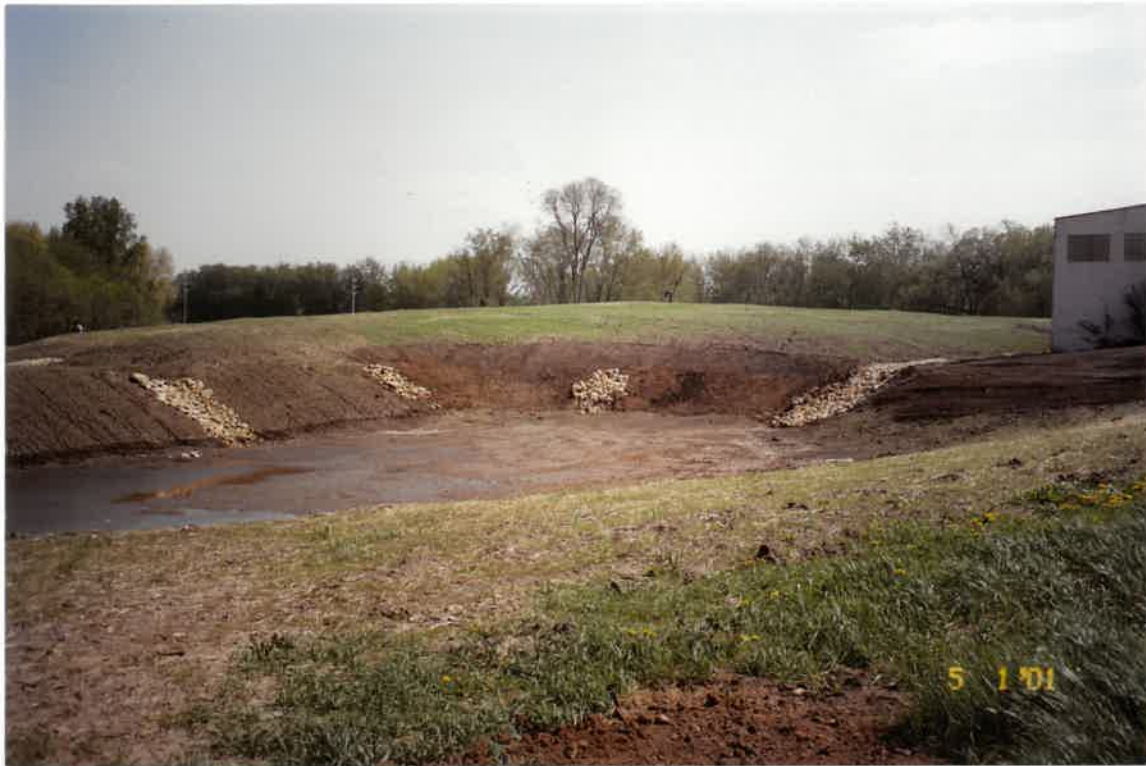
Photograph 13 May 1, 2001
Description: Sedimentation Basin No. 2 completed (Former location of Lagoon No. 1)

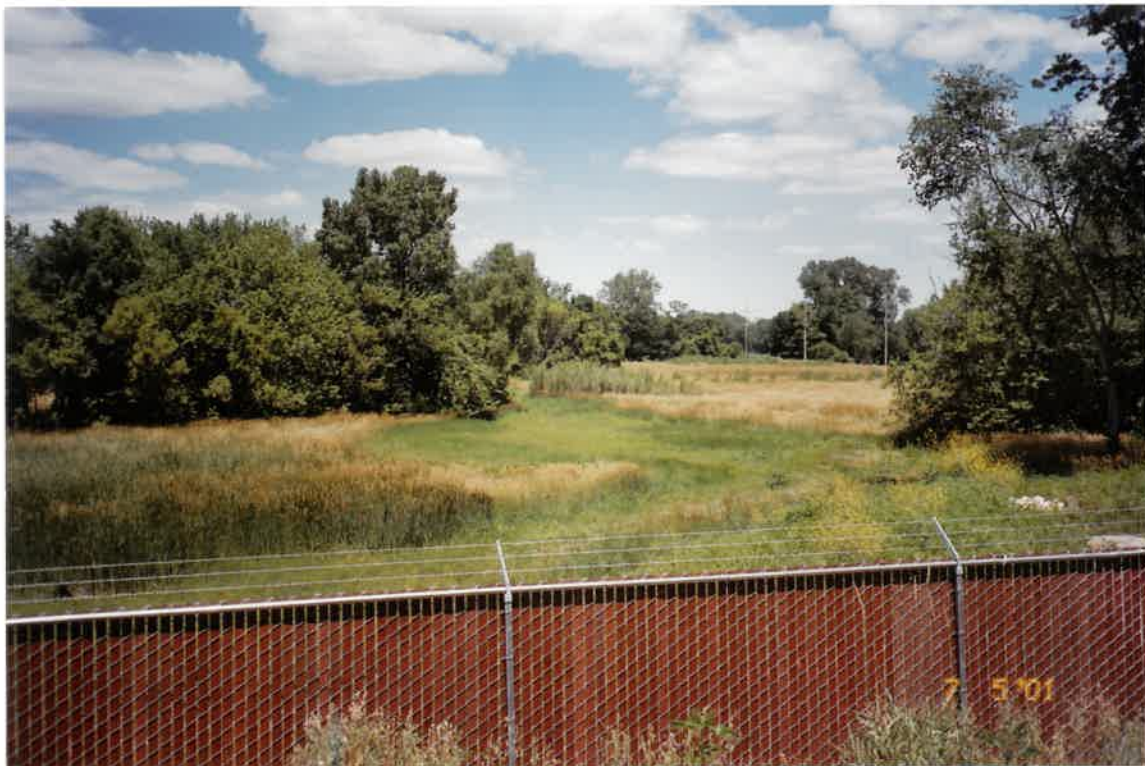
Photograph 14 July 5, 2001
Description: Restoration and revegetation of Wetlands 2 and 3 looking north.

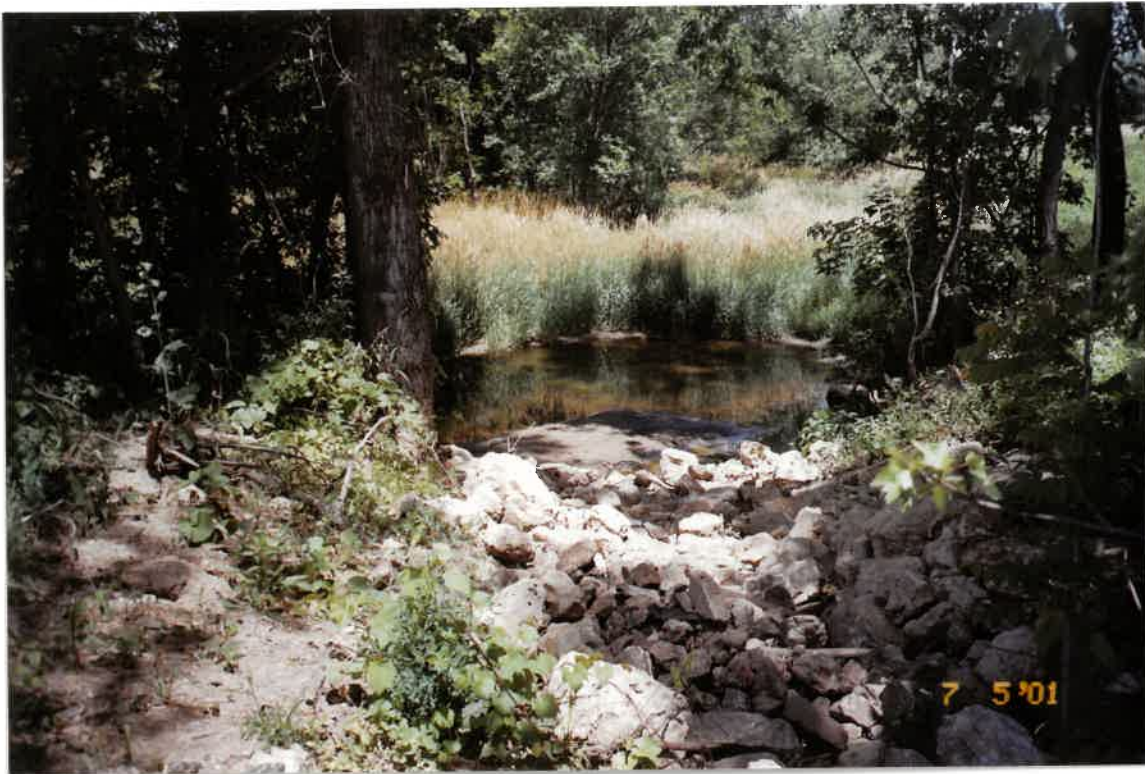
Photograph 15 July 5, 2001

Description: Restoration of Wetland 1A and the rip rap in the ditch.

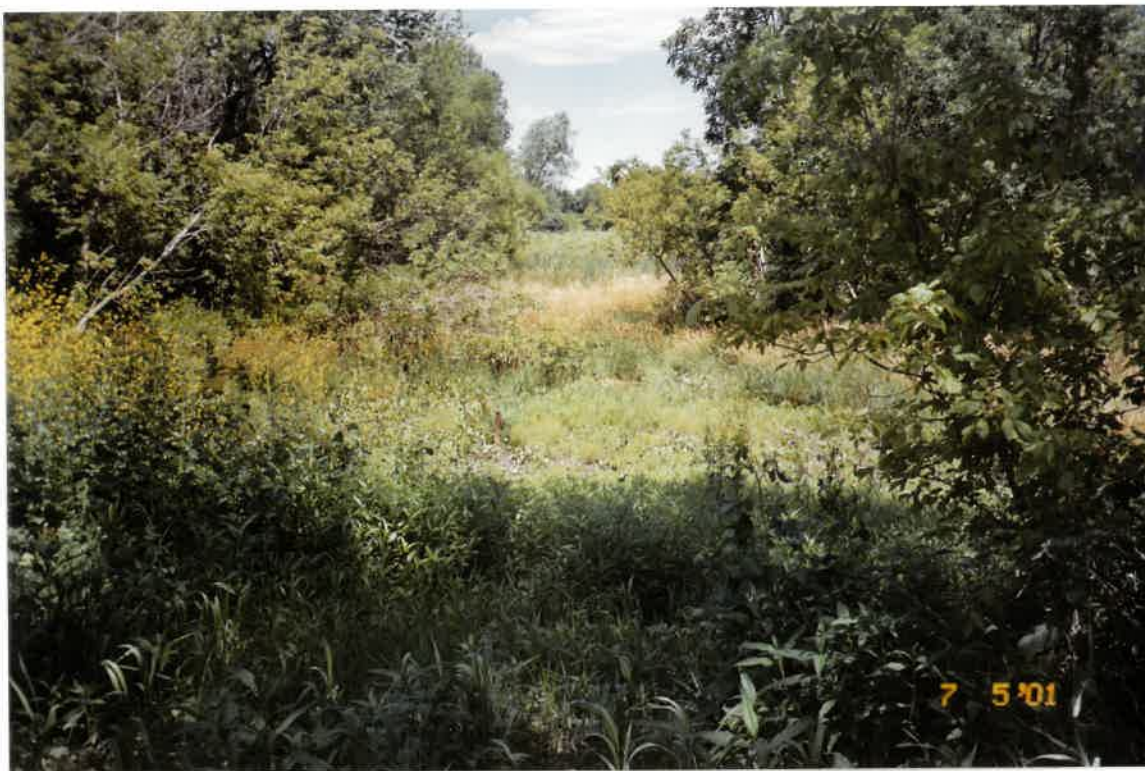
Photograph 16 July 5, 2001

Description: Restoration of Wetland No. 1.

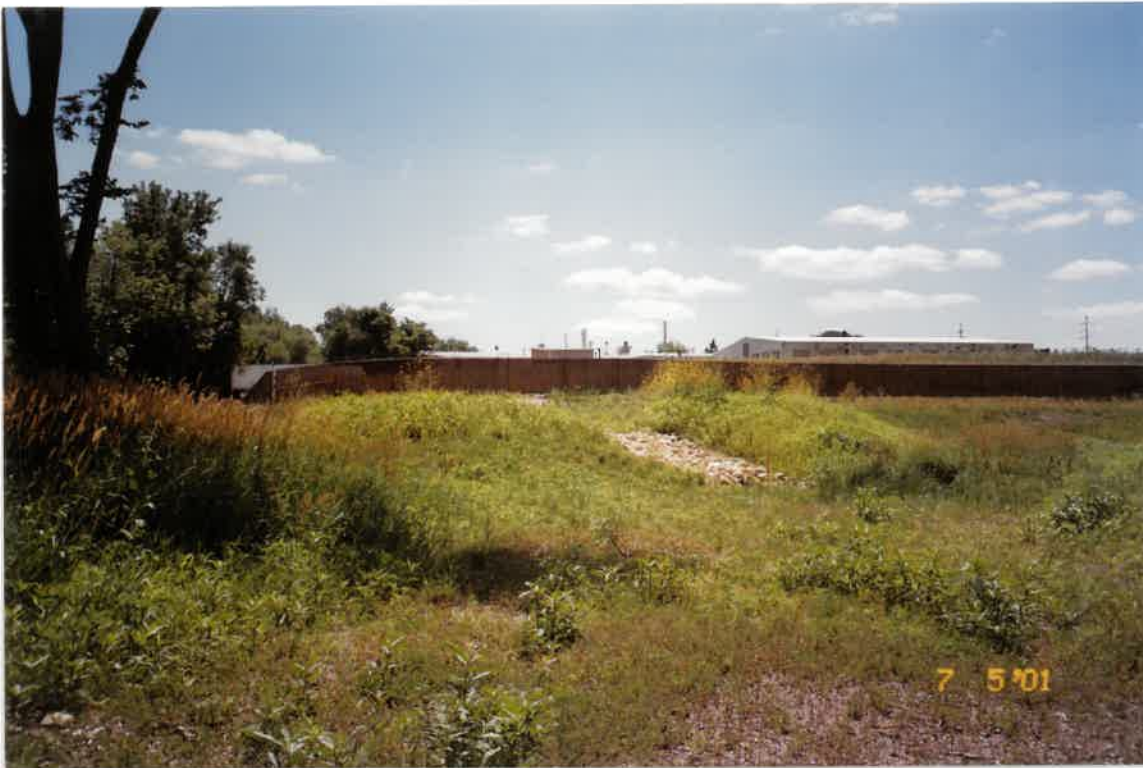
Photograph 17 July 5, 2001
Description: Security fencing around the CAMU looking south, riprapped spill way from Sedimentation Basin No. 1 in the foreground.

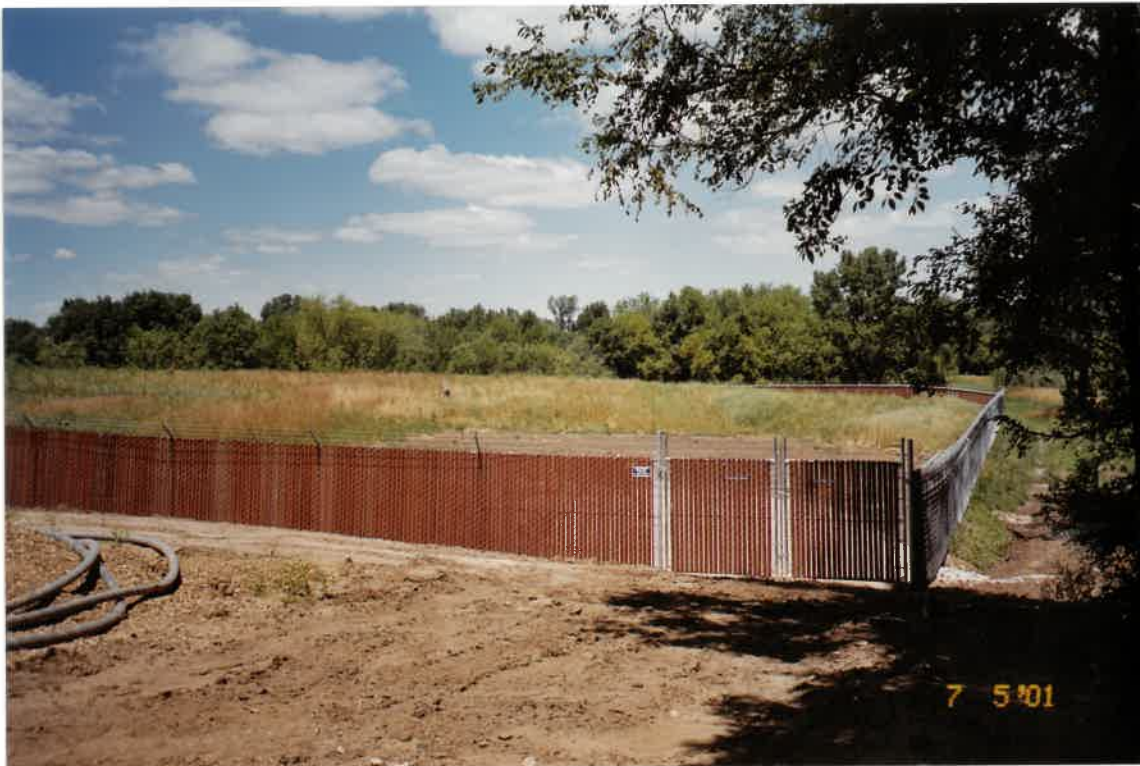
Photograph 18 July 5, 2001
Description: Security fencing around the CAMU looking north along the east side of the CAMU.

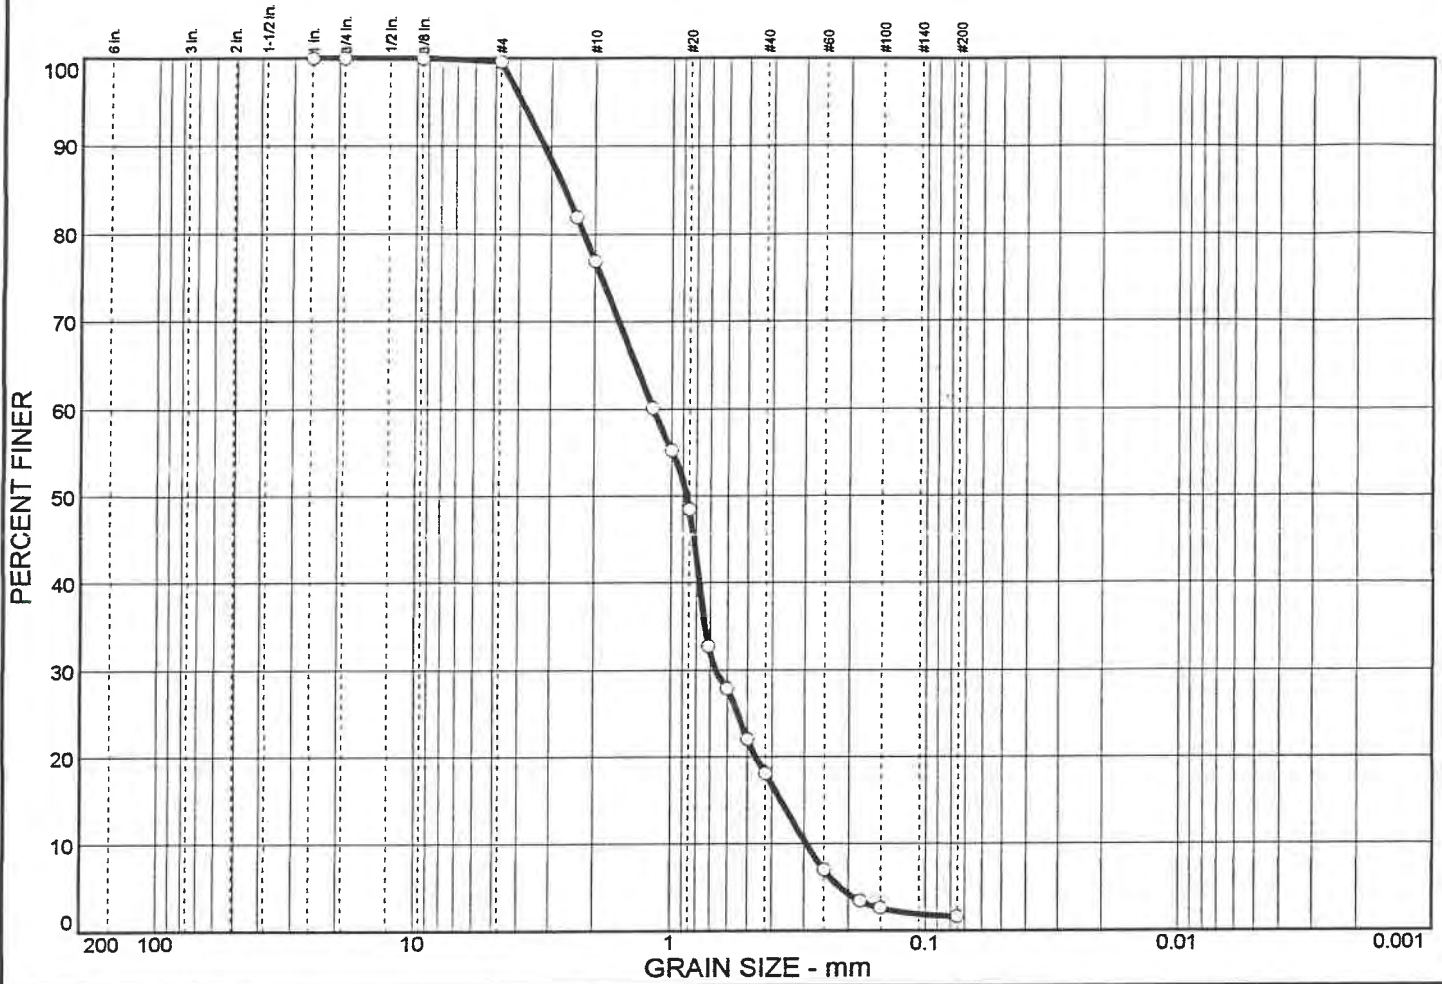
Grading/Gas Venting Layer Laboratory Report

% COBBLES	% GRAVEL		% SAND			% FINES			
	CRS.	FINE	CRS.	MEDIUM	FINE	SILT	CLAY		
0.0	0.0	0.4	22.7	58.8	16.5	1.6			
LL	PL	D ₈₅	D ₆₀	D ₅₀	D ₃₀	D ₁₅	D ₁₀	C _c	C _u
X		2.63	1.18	0.871	0.668	0.369	0.294	1.29	4.00

MATERIAL DESCRIPTION	USCS	AASHTO
○ Poorly Graded Sand	SP	A-1-b

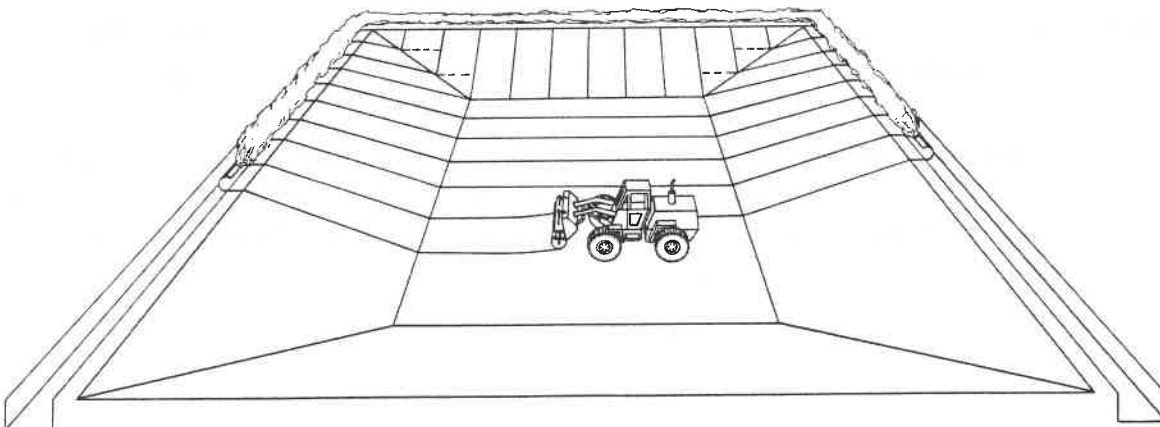
Figure 1. Typical Bentomat®/Claymax® installation strategy

- 5.3 GCL rolls should not be released on the slope and allowed to unroll freely by gravity.
- 5.4 Care must be taken to minimize the extent to which the GCL is dragged across the subgrade in order to avoid damage to the bottom surface of the GCL. A temporary geosynthetic subgrade covering commonly known as a slip sheet or rub sheet may be used to reduce friction damage during placement.

- 5.5 The GCL should be placed so that seams are parallel to the direction of the slope. End-of-roll seams should also be located at least 3 ft. (1 m) from the toe and crest of slopes steeper than 4H:1V.

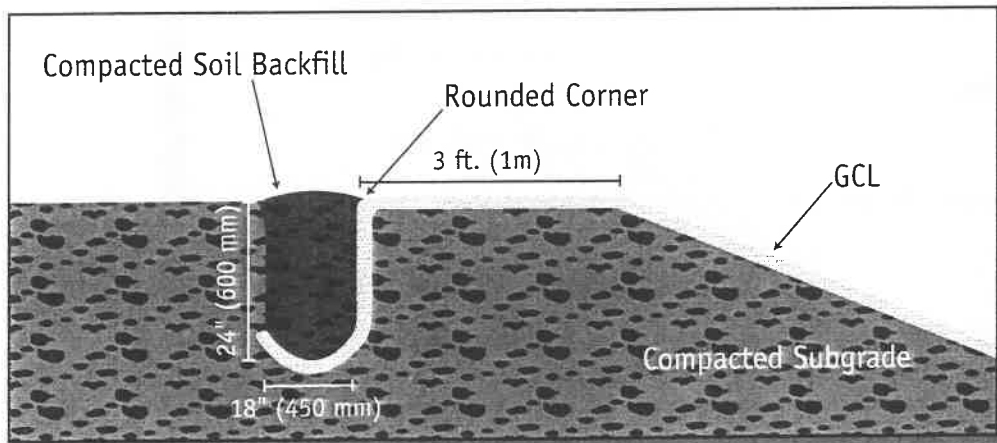
Figure 2. Typical anchor trench design

- 6.4 The GCL should be placed in the anchor trench such that it covers the entire trench floor but does not extend up the rear trench wall.

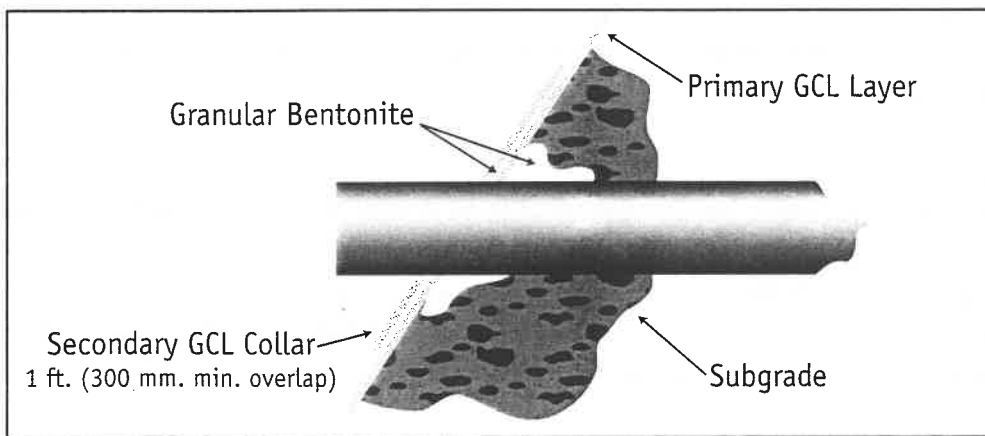
Figure 4a. Cross-section of a horizontal pipe penetration

- 8.3 When the GCL is placed over an earthen subgrade, a “notch” should be excavated into the subgrade around the penetration (Figure 4a). The notch should then be backfilled with granular bentonite or bentonite mastic.

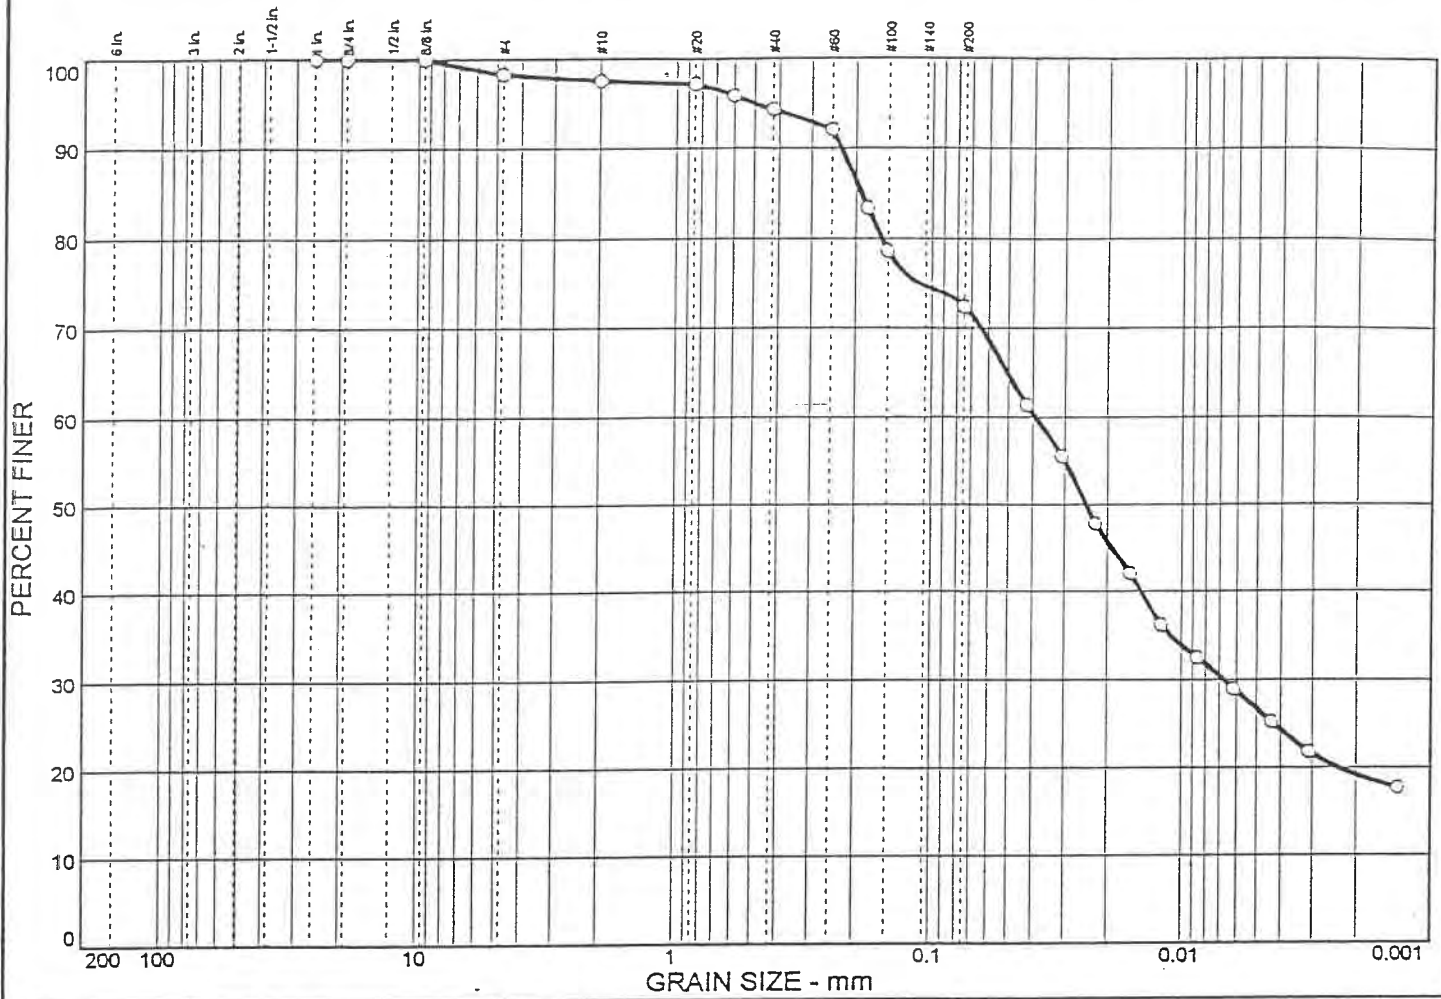
Rooting Zone Grain Size Analysis Giles Engineering Assoc., Inc.

% COBBLES	% GRAVEL		% SAND			% FINES	
	CRS.	FINE	CRS.	MEDIUM	FINE	SILT	CLAY
0.0	0.0	1.7	0.7	3.2	22.0	45.8	26.6

LL	PL	D ₈₅	D ₆₀	D ₅₀	D ₃₀	D ₁₅	D ₁₀	C _c	C _u
		0.191	0.0395	0.0247	0.0068

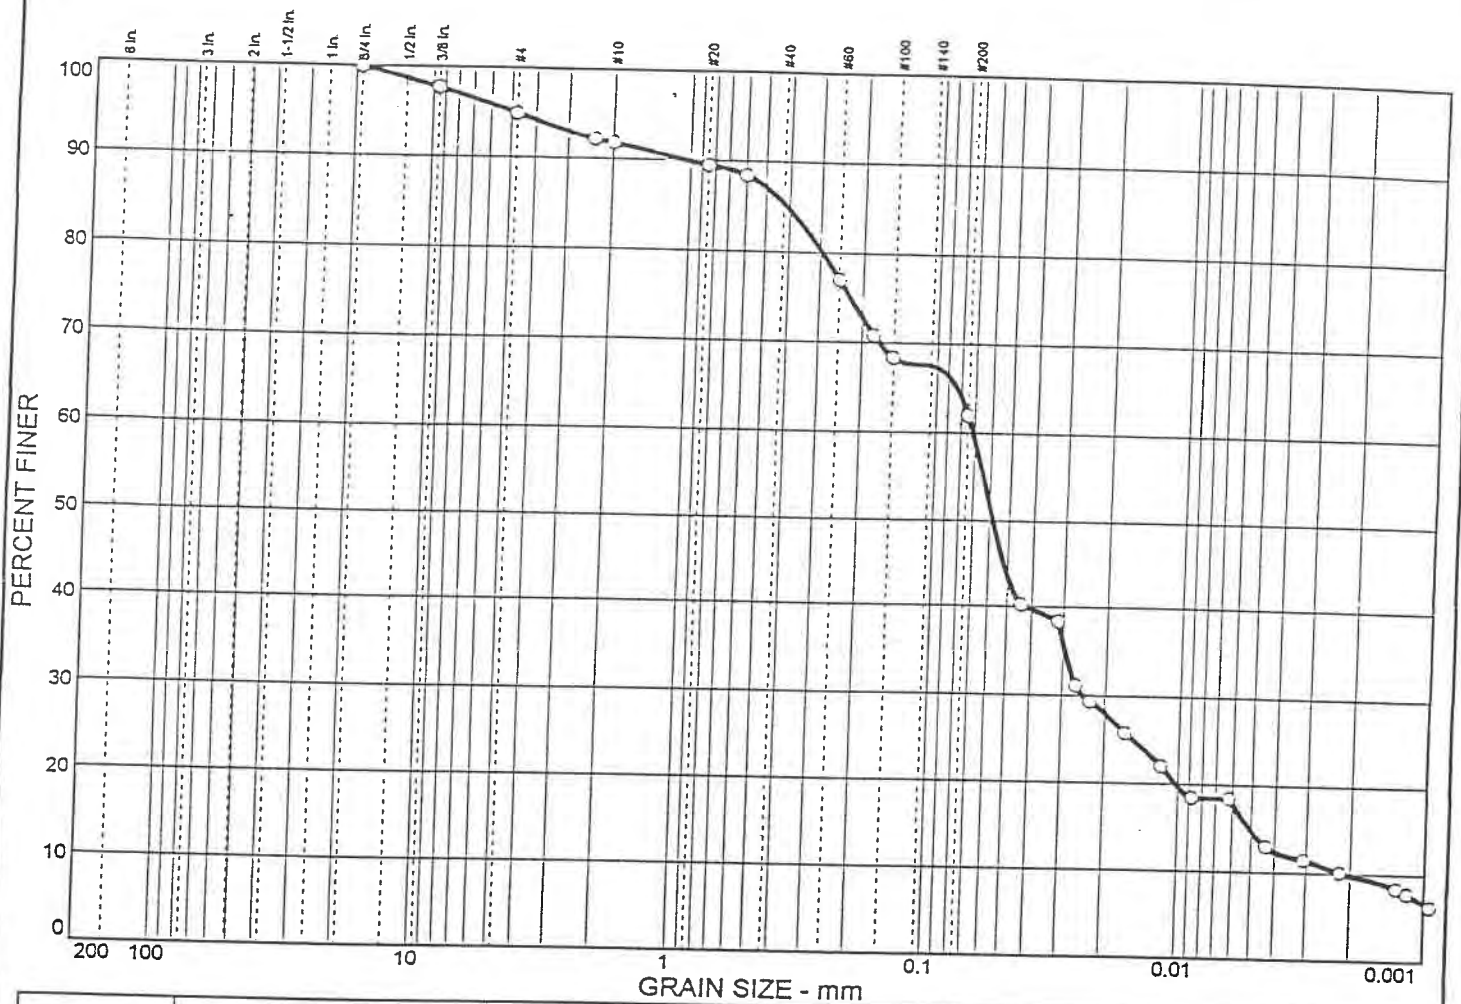
% COBBLES	% GRAVEL		% SAND			% FINES	
	CRS.	FINE	CRS.	MEDIUM	FINE	SILT	CLAY
0.0	0.0	5.1	3.1	6.4	23.5	47.2	14.7

LL	PL	D ₈₅	D ₆₀	D ₅₀	D ₃₀	D ₁₅	D ₁₀	C _c	C _u
29	16	0.413	0.0714	0.0582	0.0249	0.0051	0.0022	4.04	33.18
