ADMINISTRATIVE CITATION

AC 05-08  
 (IEPA No. 330-04-AC)

AFFIDAVIT

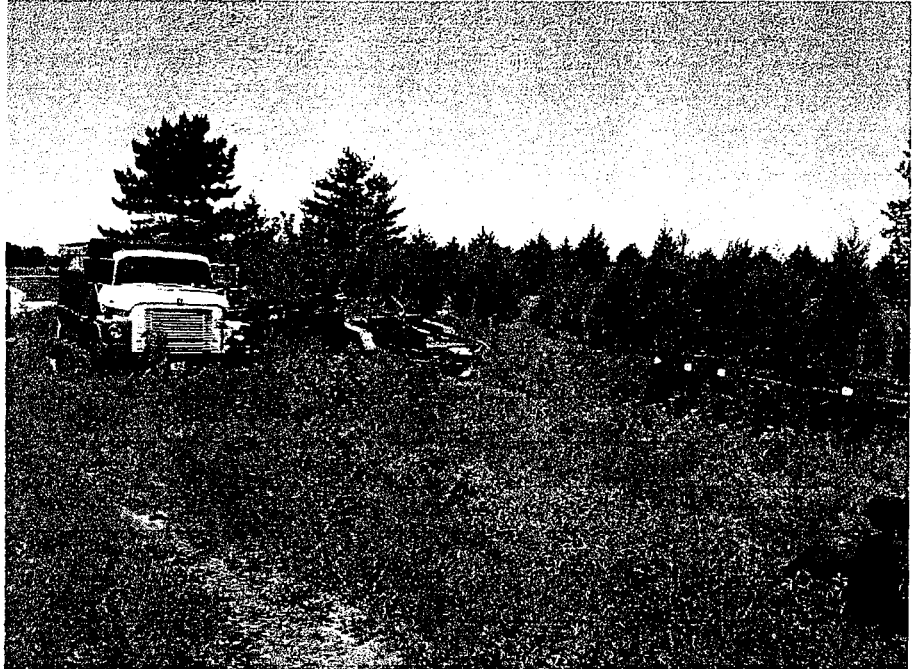
0170255004~05262004-001

**Comments:** IH dump truck  
containing approximately 120 off  
rim used tires, 2 trailers, and a corn  
planter parked inside gate at north  
entrance to IL EPA permitted soil  
treatment area

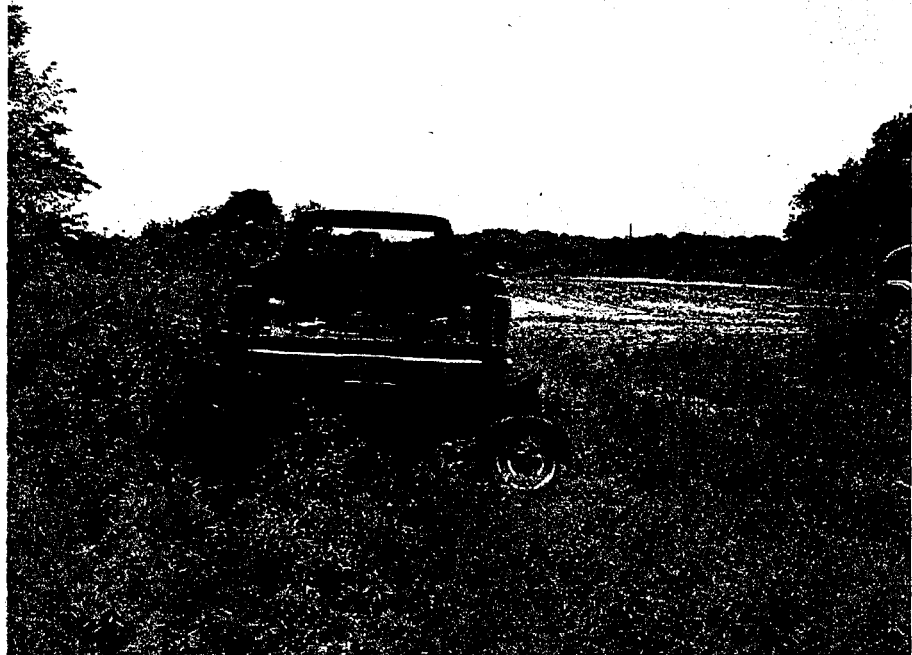
0170255004~05262004-002

**Comments:** Ford pickup truck  
without rear tires, supported by a  
stack of 4 on rim used tires at each  
corner of rear bumper, plus 2 on  
rim used tires

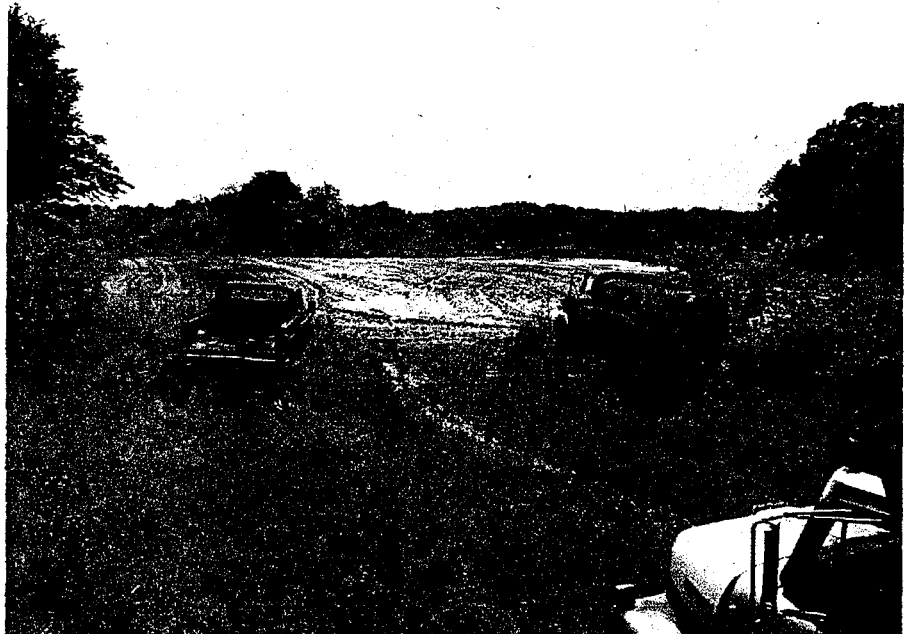
0170255004~05262004-004

**Comments:** north end of  
permitted soil treatment area, Ford  
pick up truck, and old Ford fuel  
truck

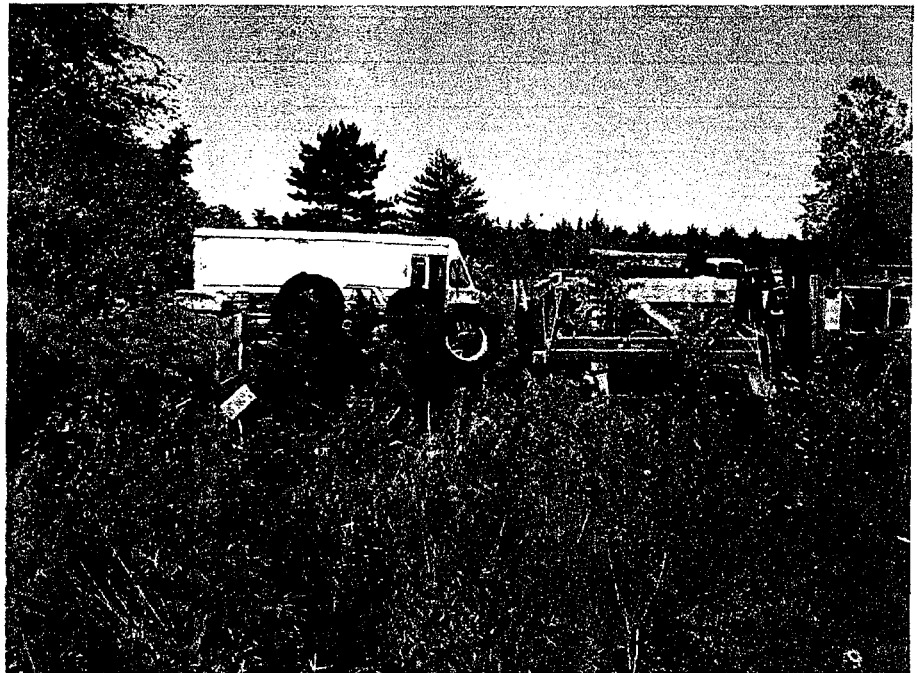
0170255004~05262004-006

**Comments:** trucks parked just  
north of NW corner of permitted  
soil treatment area

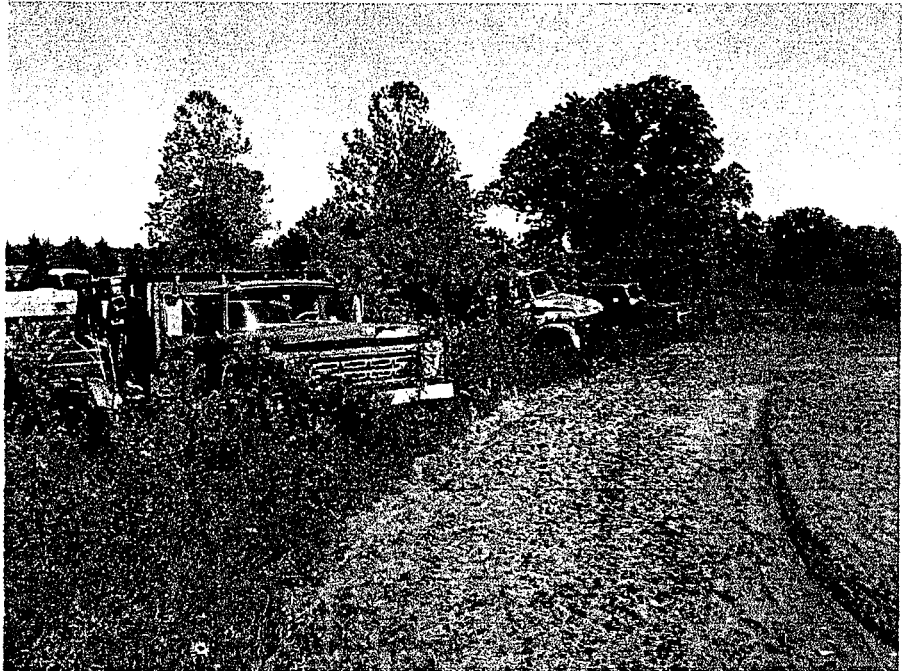
0170255004~05262004-007

**Comments:** trucks parked at north edge of permitted soil treatment area

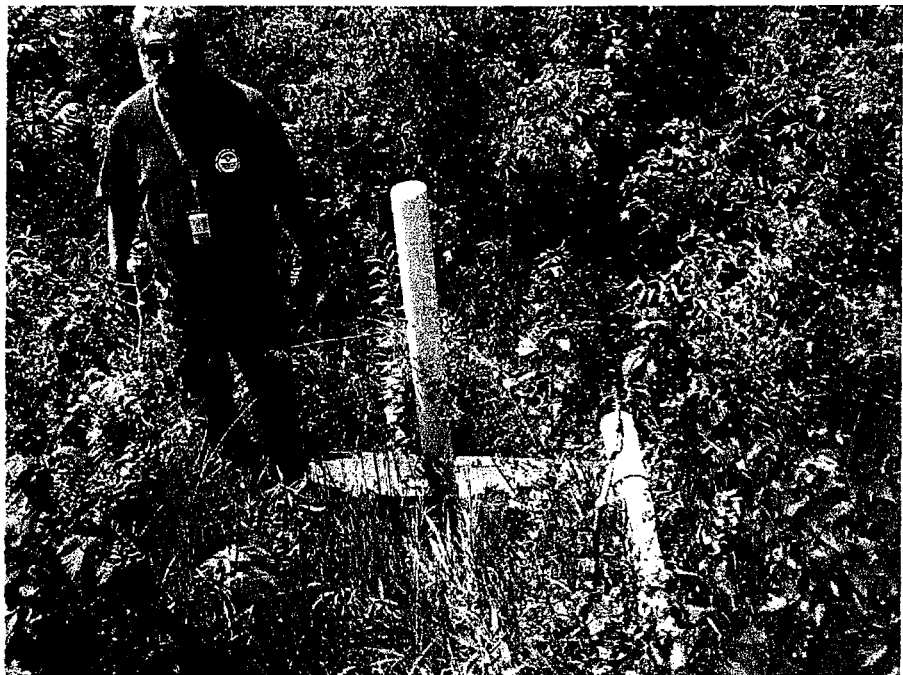
0170255004~05262004-008

At the west edge of the permitted soil treatment area was the leachate tank, with its attached fill pipe leading west from the treatment area, and an open standpipe in the center of the tank (see attached photo # -008). The tank was full of liquid, as observed through the standpipe.

**Comments:** leachate tank at west edge of permitted soil treatment area, with attached fill pipe at right and open stand pipe in center of tank

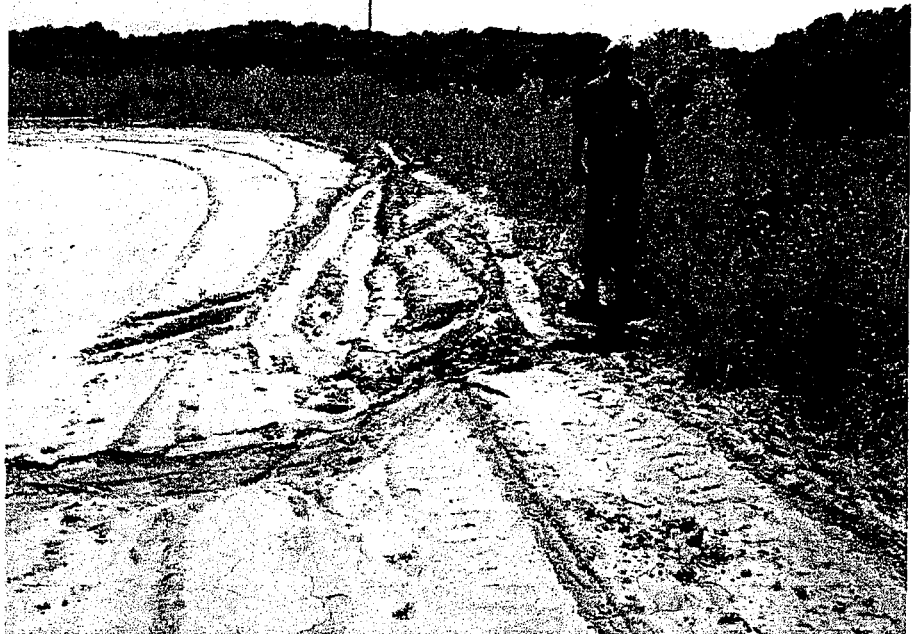
0170255004~05262004-009

Per the approved 1995-084 permit application, the treatment area was supposed to have perimeter berms that were to be "constructed to a height sufficient to prevent run-on or run-off of surface water." Photos # -009, -010, -016 & -017 show that run-off from the treatment area is not being prevented. Soil erosion has also been noted on the slope uphill of the leachate tank in the past. Information about the run-off from the permitted portion of the facility will be forwarded to the Illinois EPA's Bureau of Water for their information and review.

**Comments:** area near SW corner  
of permitted soil treatment area  
where drainage to west has eroded  
soil and exposed plastic liner and  
rubber drain hose

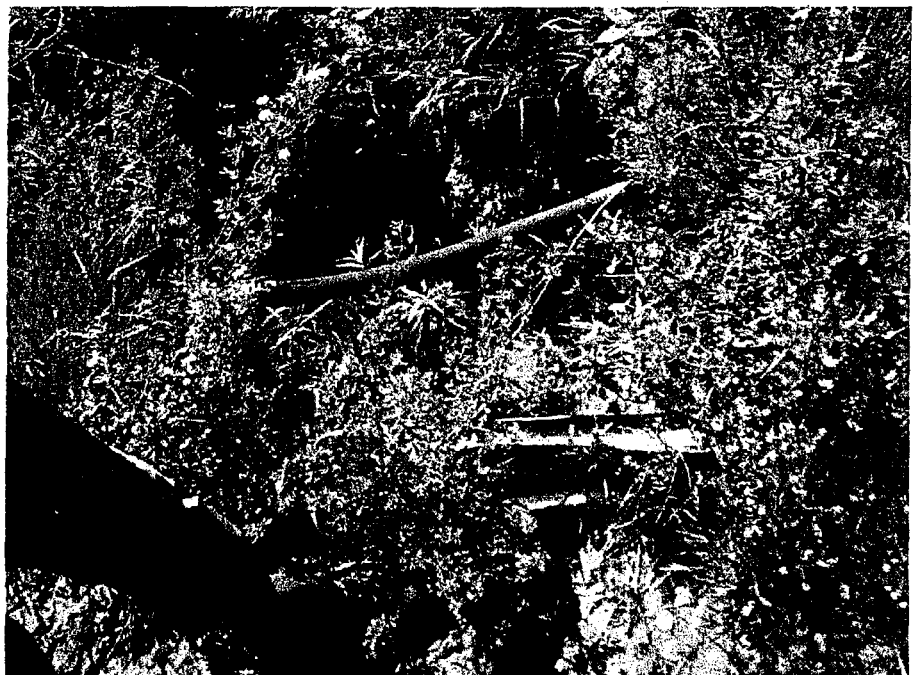
0170255004~05262004-010

**Comments:** plastic liner and  
rubber drain hose exposed by  
erosion at location shown in photo  
# -009

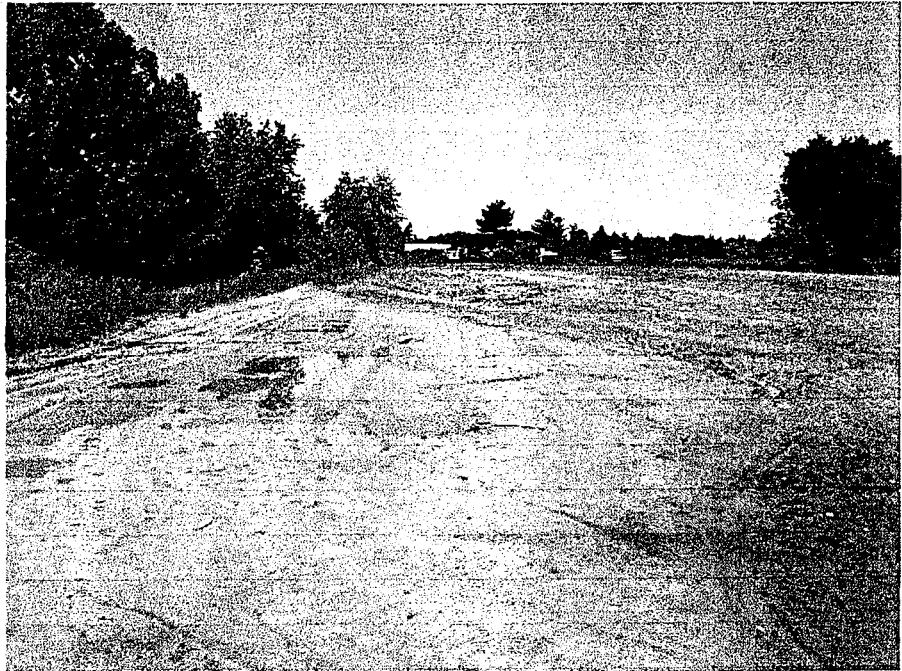
0170255004~05262004-011

**Comments:** SW corner of  
permitted soil treatment area

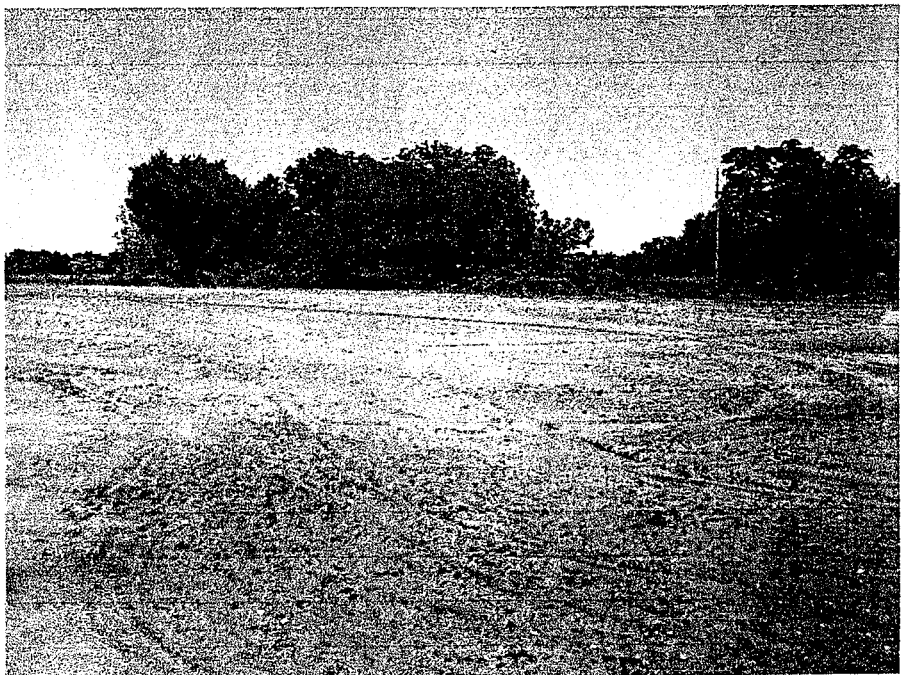
0170255004~05262004-012

**Comments:** south half of  
permitted soil treatment area

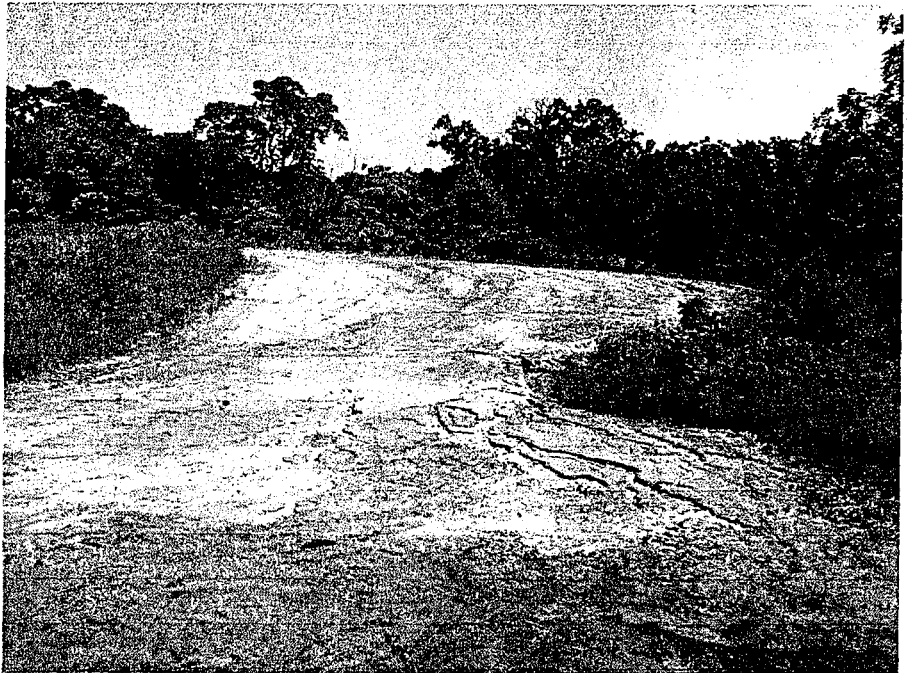
0170255004~05262004-013

**Comments:** area of bare soil south of permitted soil treatment area that drains toward weedy ravine at right

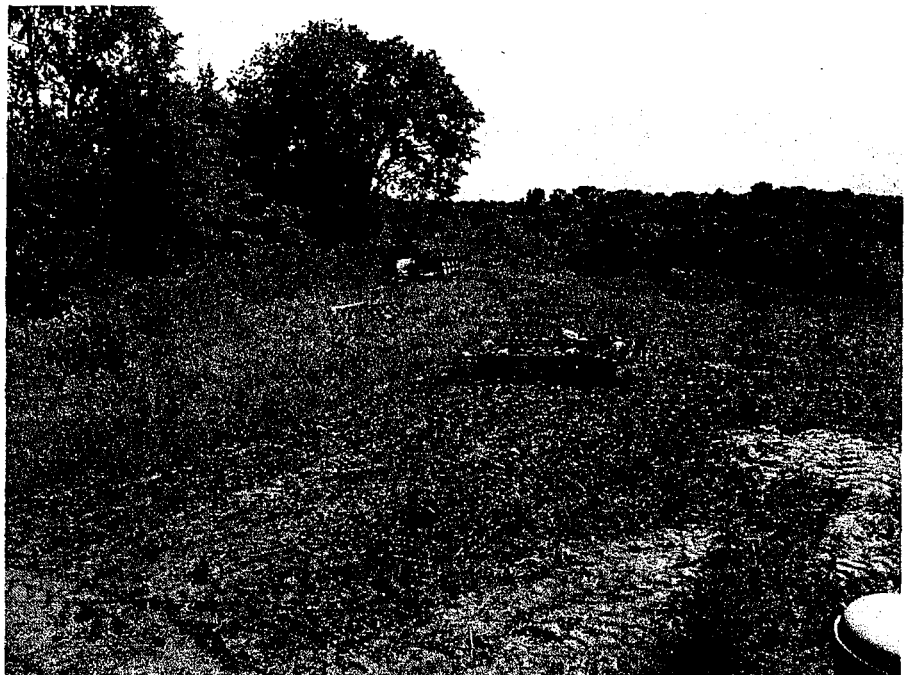
0170255004~05262004-014

**Comments:** disc parked next to soil scraper located south of permitted soil treatment area

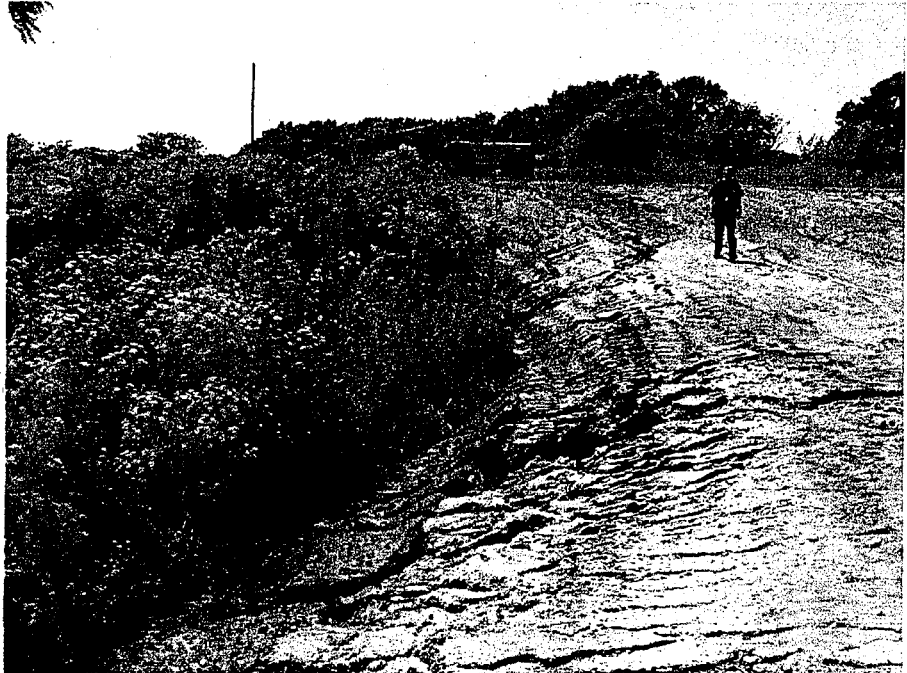
0170255004~05262004-015

**Comments:** eroded area in bare  
soil area shown in photo # -013;  
soil scraper in background

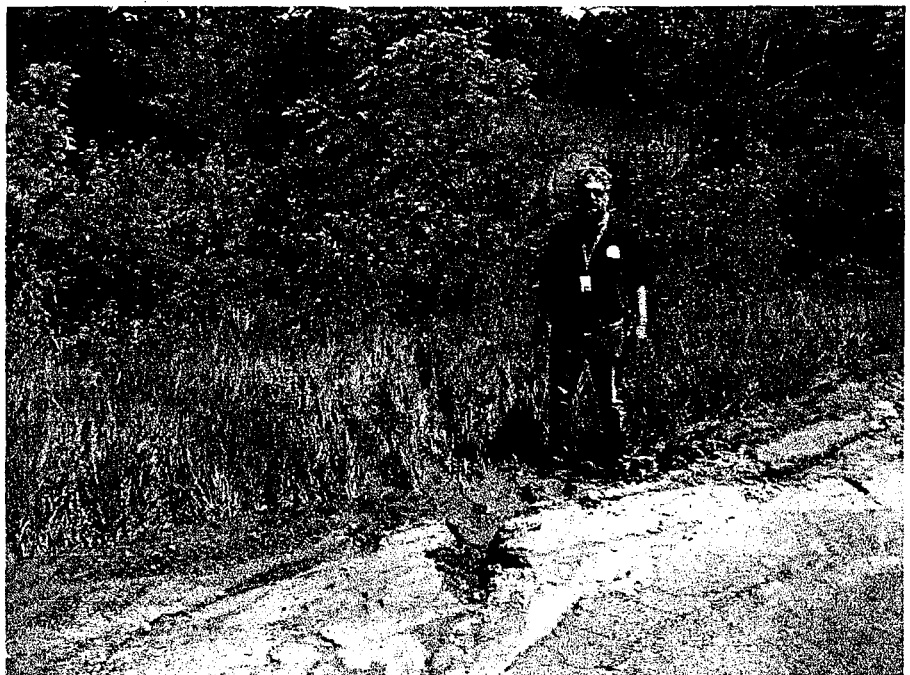
0170255004~05262004-016

**Comments:** soil eroding near NE  
edge of bare soil area. Drainage is  
toward neighbor's pond to east

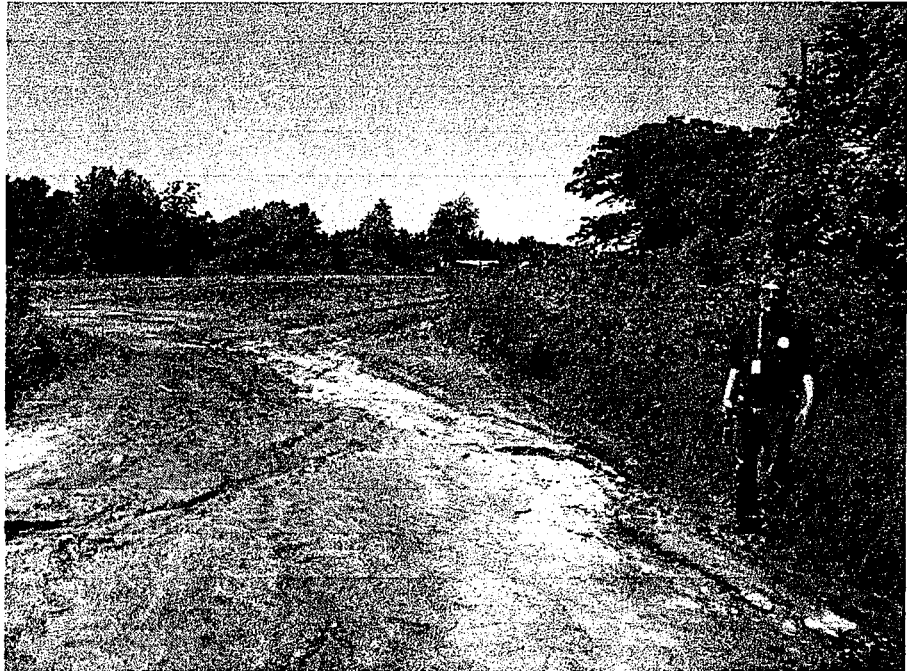
0170255004-05262004-017

**Comments:** eroded area also  
shown in photo # -016, and SE  
corner of permitted soil treatment  
area in background

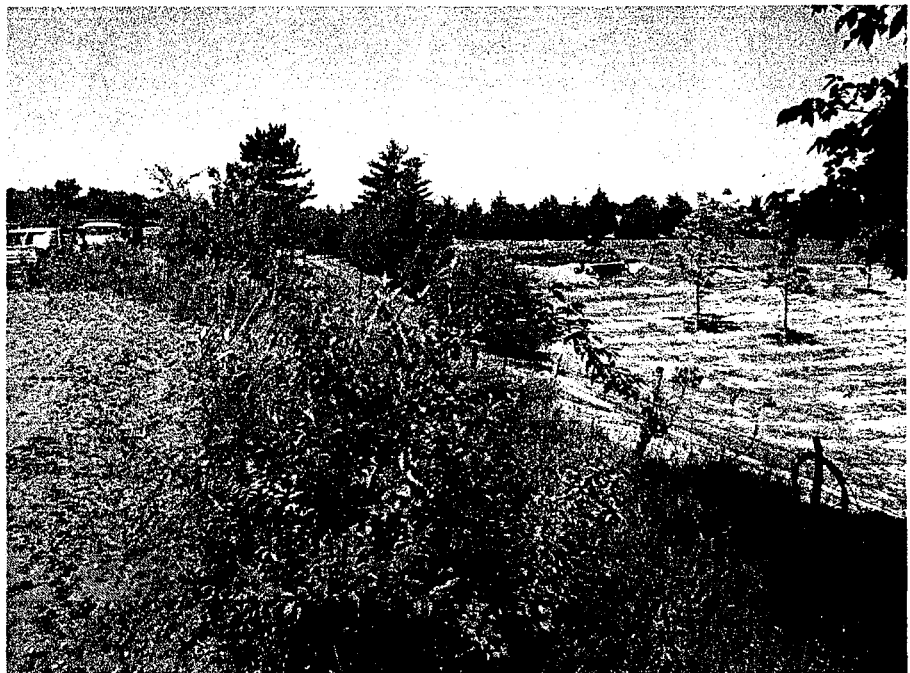
0170255004-05262004-018

East of the NE corner of permitted soil treatment area, approximately 60 feet away, is a neighbor's private well in the lawn (see attached photo # -018). The lawn is down slope of the permitted treatment area. The neighbor's fence is approximately 21 feet from the edge of the bare soil. According to the site permit, condition # 15, waste was prohibited from being applied within 200 feet of any private wells. The well will need to be sampled to verify whether it has been contaminated by any activities at the permitted area.

**Comments:** NE corner of  
permitted soil treatment area  
showing neighbor's fence, and well  
approximately 60 feet down slope  
to east

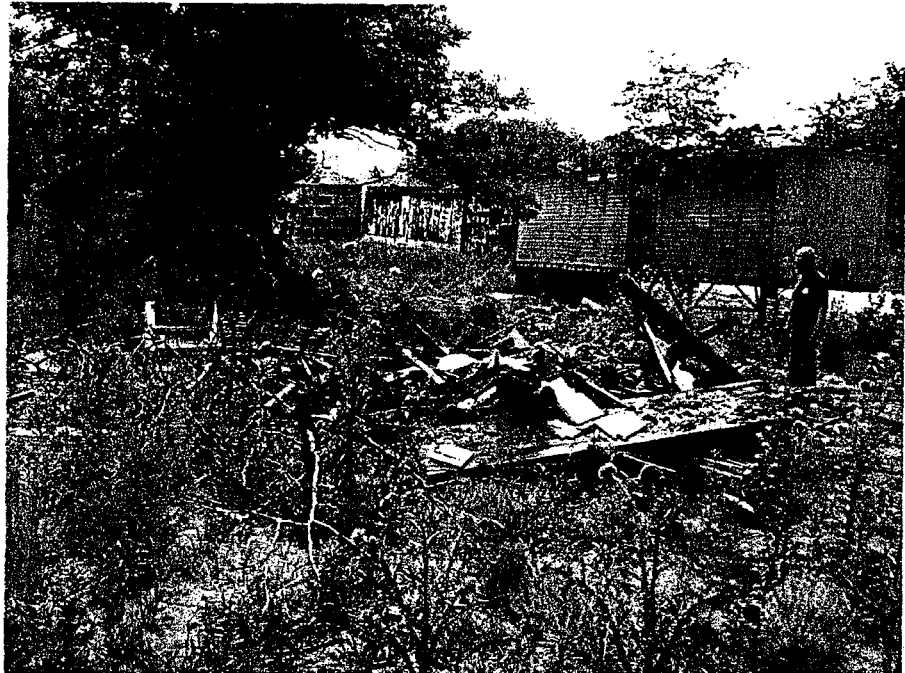
0170255004~05262004-019

Upon arrival at Mr. Gill's property, we noted an open dumped pile of about 20 cubic yards in volume containing wood, metal, wallboard, 3 rolls of wood fencing, clay tile, a window frame, and concrete blocks located NE of the maintenance shed on the Gill property (see attached photo # -019).

**Comments:** open dumped pile of wood, metal, wallboard, 3 rolls of wood fencing, clay tile, a window frame, and concrete blocks located northeast of shed on Gill property

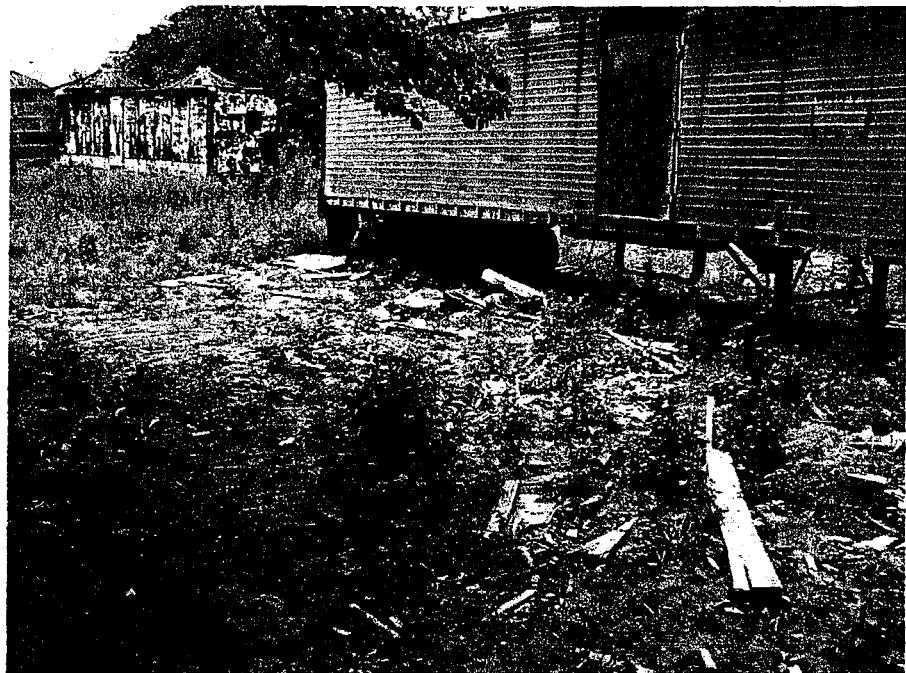
0170255004~05262004-020

Near the aforementioned pile on the ground were scattered wood and wallboard, a seat cushion, metal, and insulation (see attached photo # -020) next to a semi-trailer, which was not plated, and had its tires partially buried in the ground. Nearby, inside a rusty semi-trailer that had no roof, and which was not currently plated, were 4 old refrigerators, a washer, a dryer, and other old equipment (see attached photo # -021).

**Comments:** scattered wood, wallboard, a seat cushion, metal, and insulation next to semi-trailer also shown in photo # -019

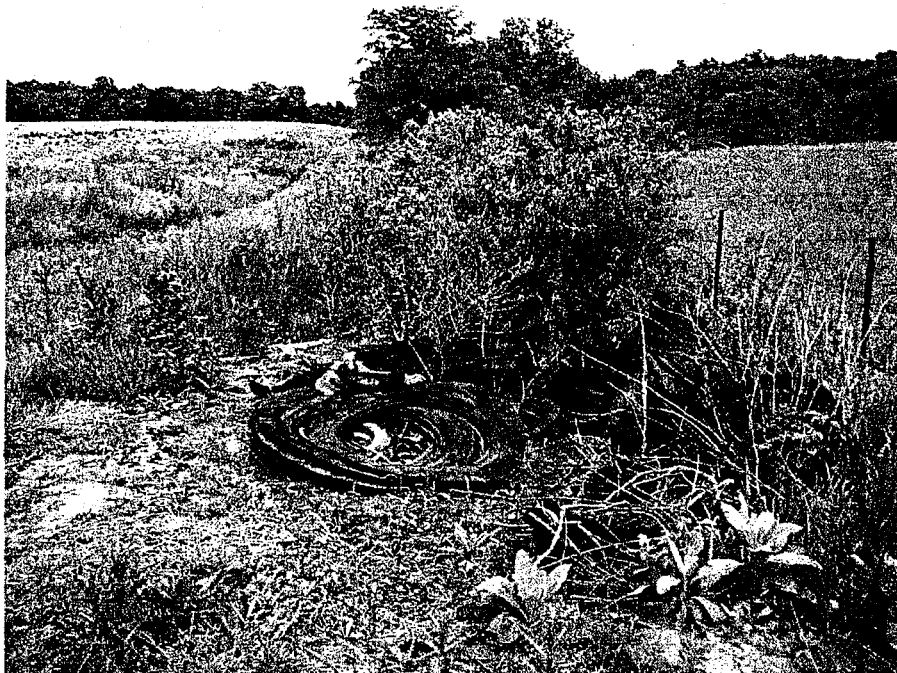
0170255004~05262004-022

**Comments:** tire sidewalls, and cut  
sections of used tires, some  
holding water, discarded along  
fence line

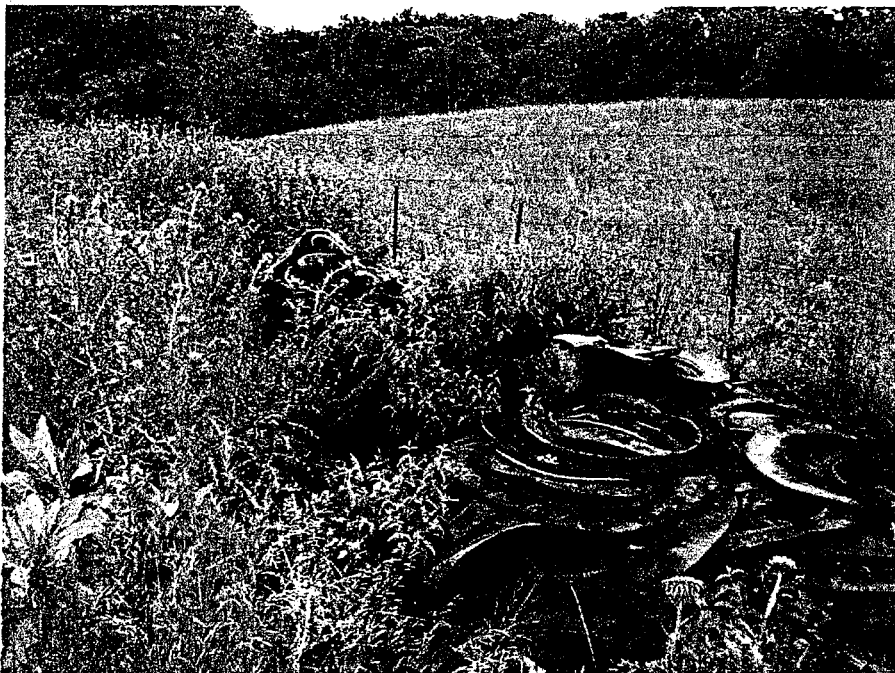
0170255004~05262004-023

**Comments:** tire sidewalls, cut tires  
sections, and some whole off rim  
used tires discarded along fence  
line

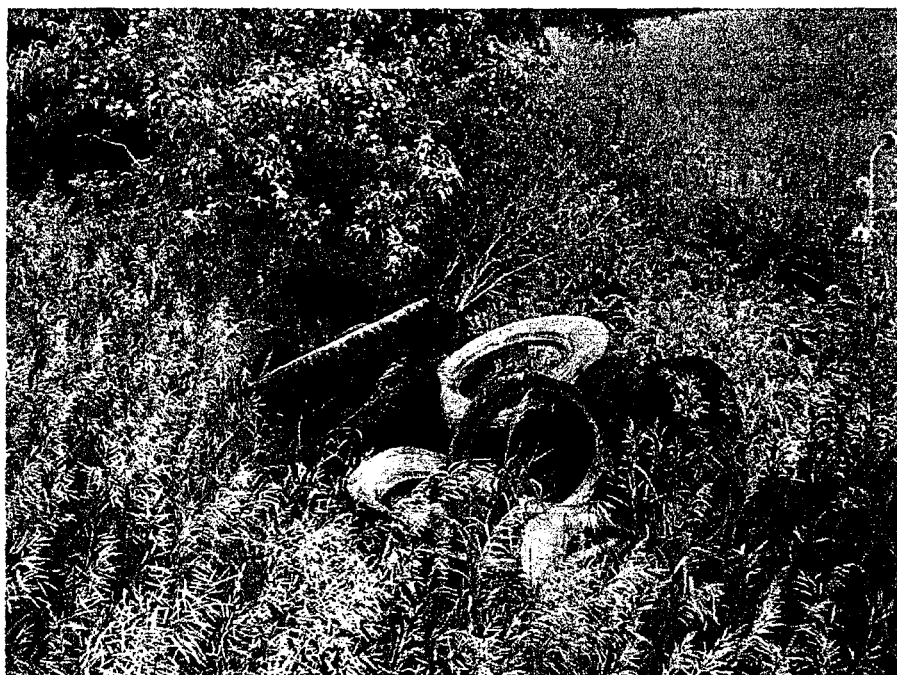
0170255004~05262004-024

**Comments:** whole tires, on and off  
rim, and tire sidewalls discarded  
along fence line

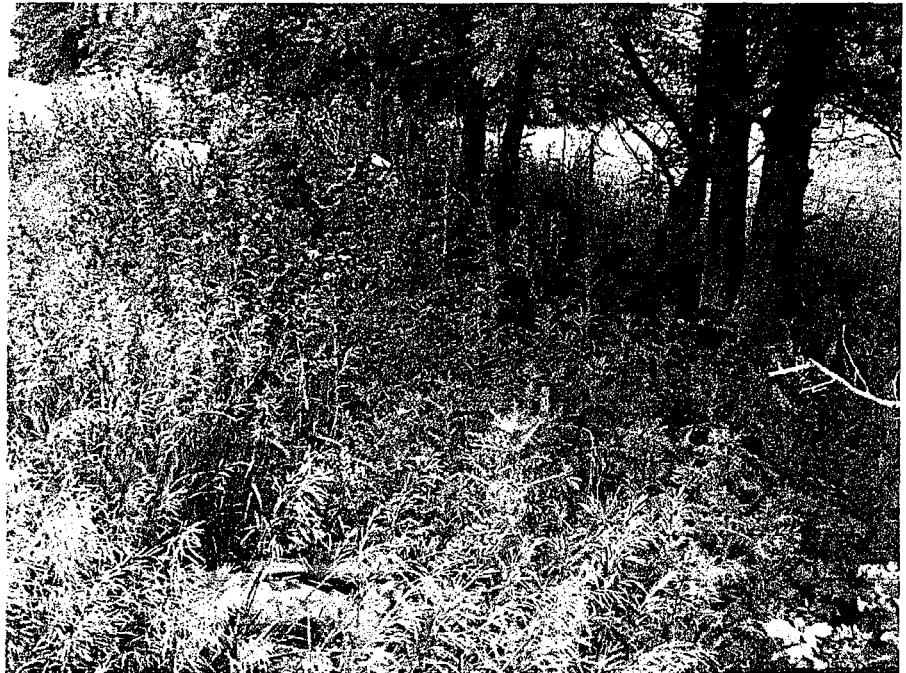
0170255004~05262004-025

**Comments:** tire inner tubes, tire sidewalls and whole used tires discarded along fence line

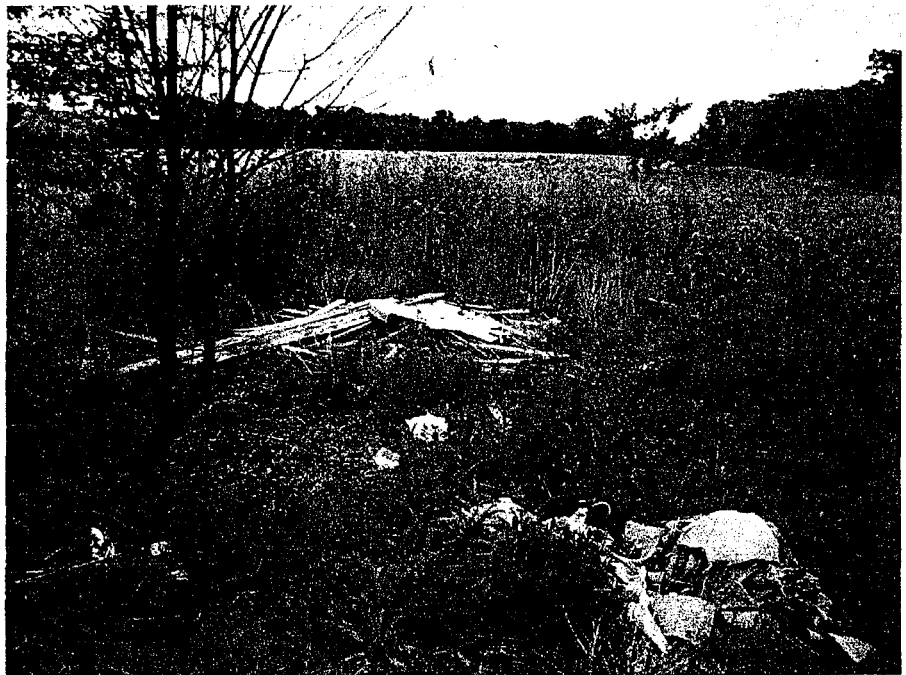
0170255004~05262004-026

**Comments:** pile of lumber, and drywall, stack of 10 off rim used tires to right of lumber, pile of carpeting, and stack of 9 spare on rim used tires and 1 used truck tire on rim in background to left of dead tree

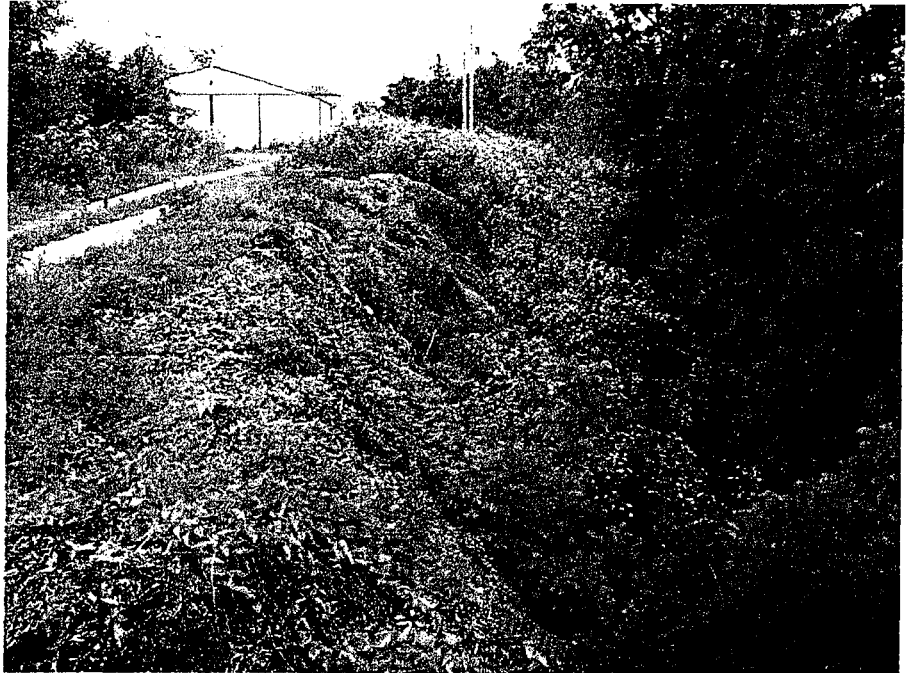
0170255004~05262004-027

Southwest of the maintenance shed on site wood chips have been discarded down the slope of the ravine south of road near the site entrance (see attached photos # -027 & -030). Other wastes such as lumber, metal, cardboard, and plastic have been observed discarded in this ravine in the past, as noted in photos # -003 & -004 taken on December 17, 2002. Thick weeds prevented us from seeing, or traveling safely to, the bottom of the ravine.

**Comments:** wood chips discarded  
down slope of ravine south of road  
near site entrance

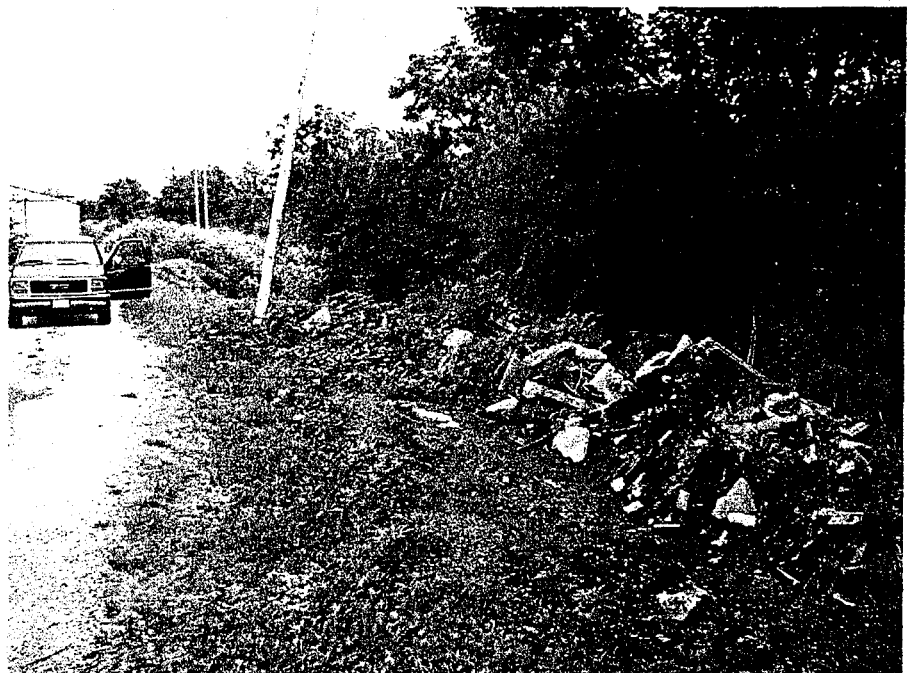
0170255004~05262004-028

**Comments:** pile containing broken  
concrete, brick, dirt, asphalt, wood  
and metal piled near site entrance

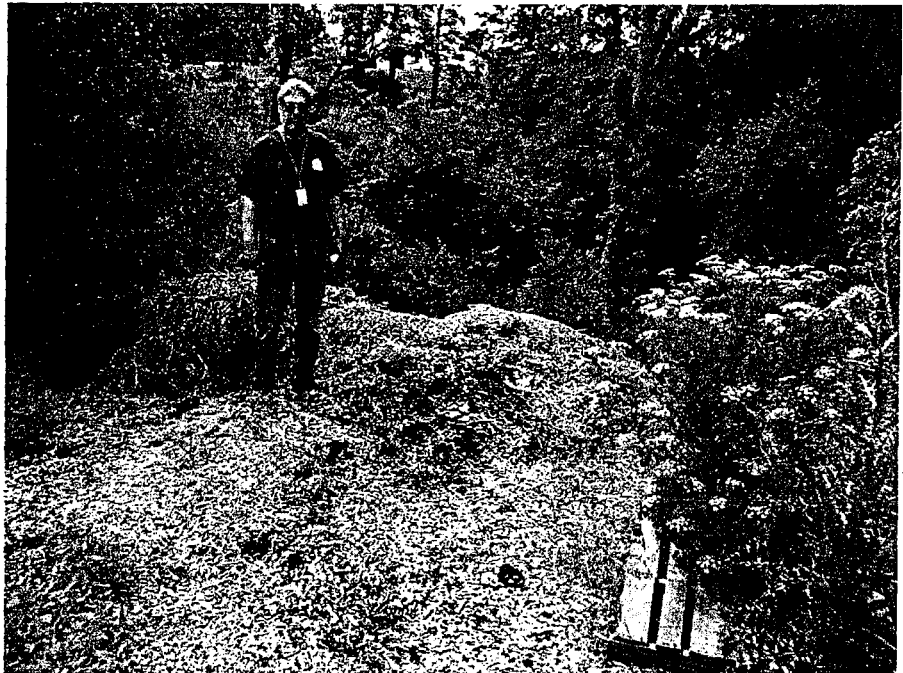
0170255004~05262004-029

**Comments:** pile of wood chips  
discarded at top of and down slope  
of ravine north of road near site  
entrance

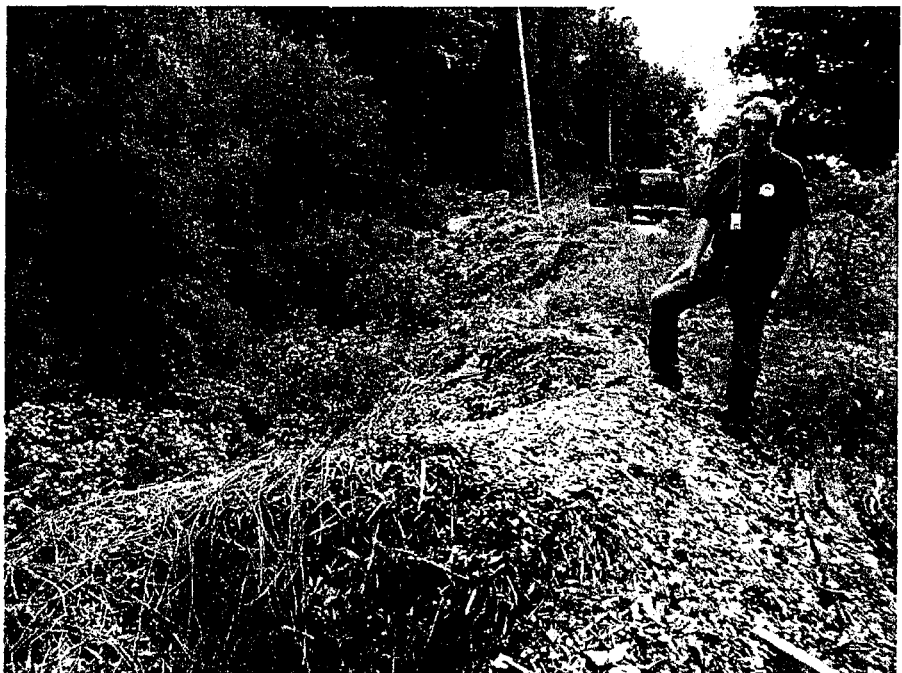
0170255004~05262004-030

**Comments:** wood chips discarded  
down slope of ravine south of road  
near site entrance

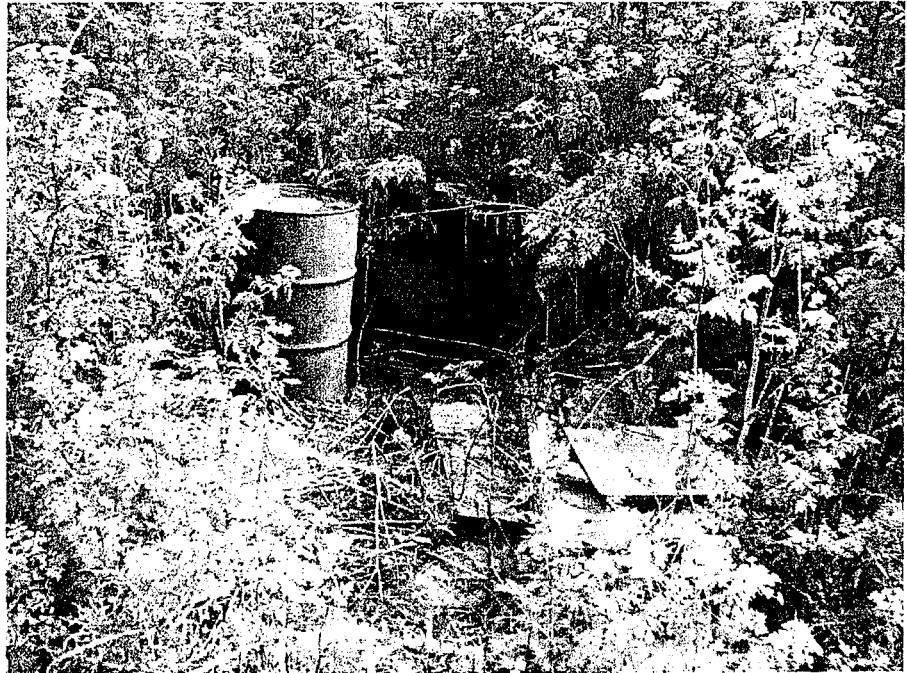
0170255004~05262004-031

**Comments:** empty drum at left,  
drum with liquid at right, and  
discarded sheet metal, all located  
south of road near site entrance

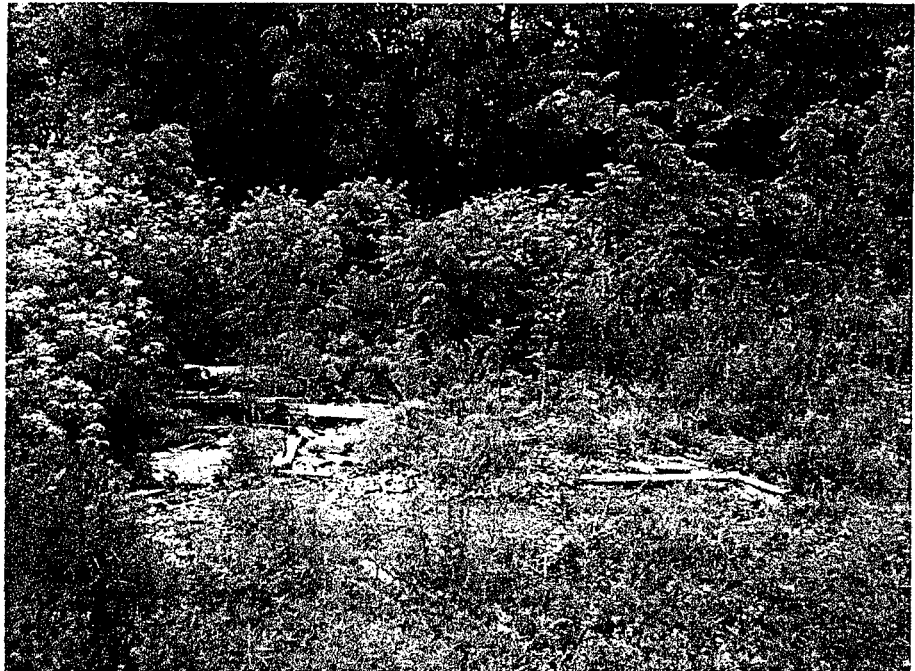
0170255004~05262004-033

**Comments:** discarded old lumber,  
and plastic pipe near NW corner of  
shed
