ADMINISTRATIVE CITATION

AC 05-70
(IEPA No. 145-05-AC)

The purpose of this memorandum is to serve as the narrative for an inspection conducted on April 1, 2005 of the above referenced site. The inspection took place from about 9:25 am to 11:00 am. The weather conditions were sunny and approximately 50°F. Eighty-one digital photographs were taken to document the conditions of the site. No one was interviewed during the inspection.

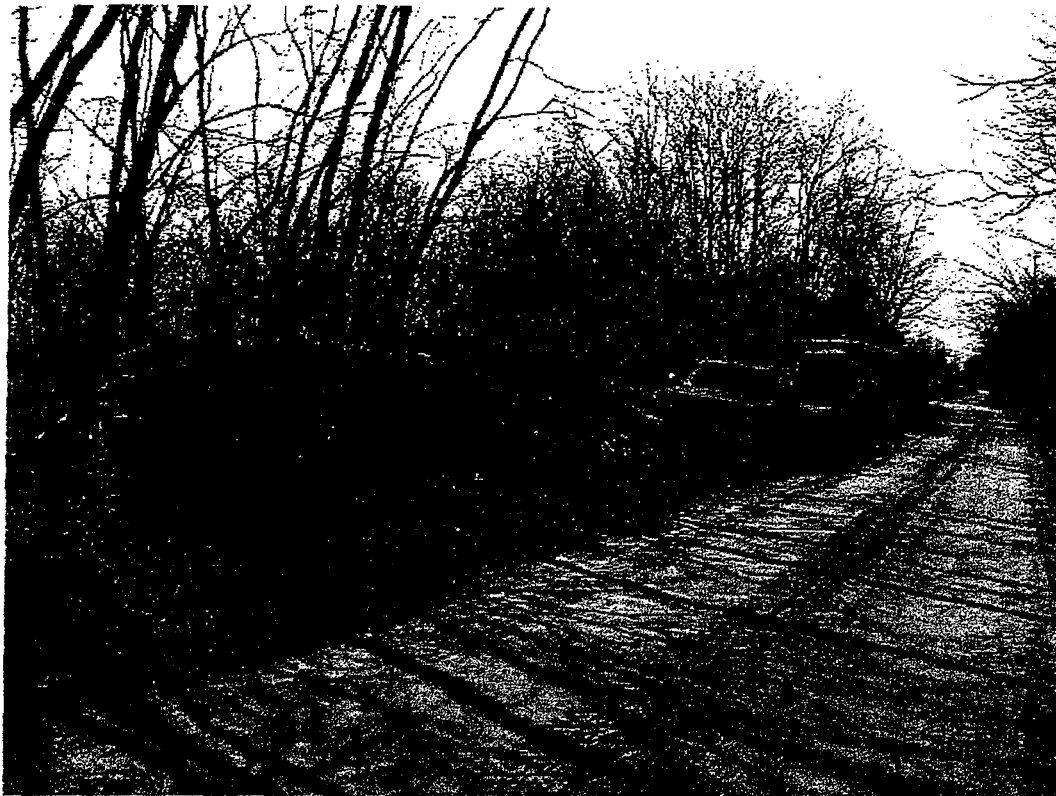
Date: April 1, 2005
Time: 9:31 am
Direction: SE
Photo by: M. Cozadd
Exposure #: 001
Comments: Abandoned vehicles, wagon full of damaged dimensional lumber, large metal tank and other miscellaneous scrap metal on north side of site along the sand road

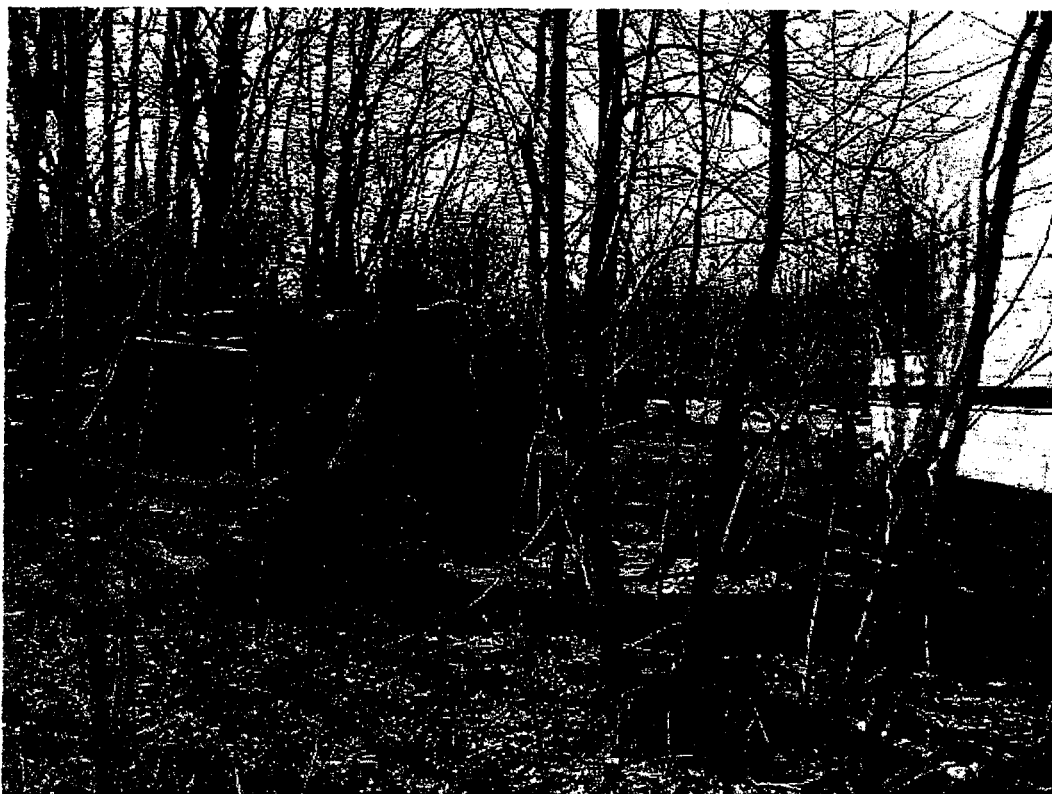
Date: April 1, 2005
Time: 9:32 am
Direction: SW
Photo by: M. Cozadd
Exposure #: 002
Comments: Camper, large metal tanks, farm equipment and other miscellaneous scrap metal on north side of mobile home

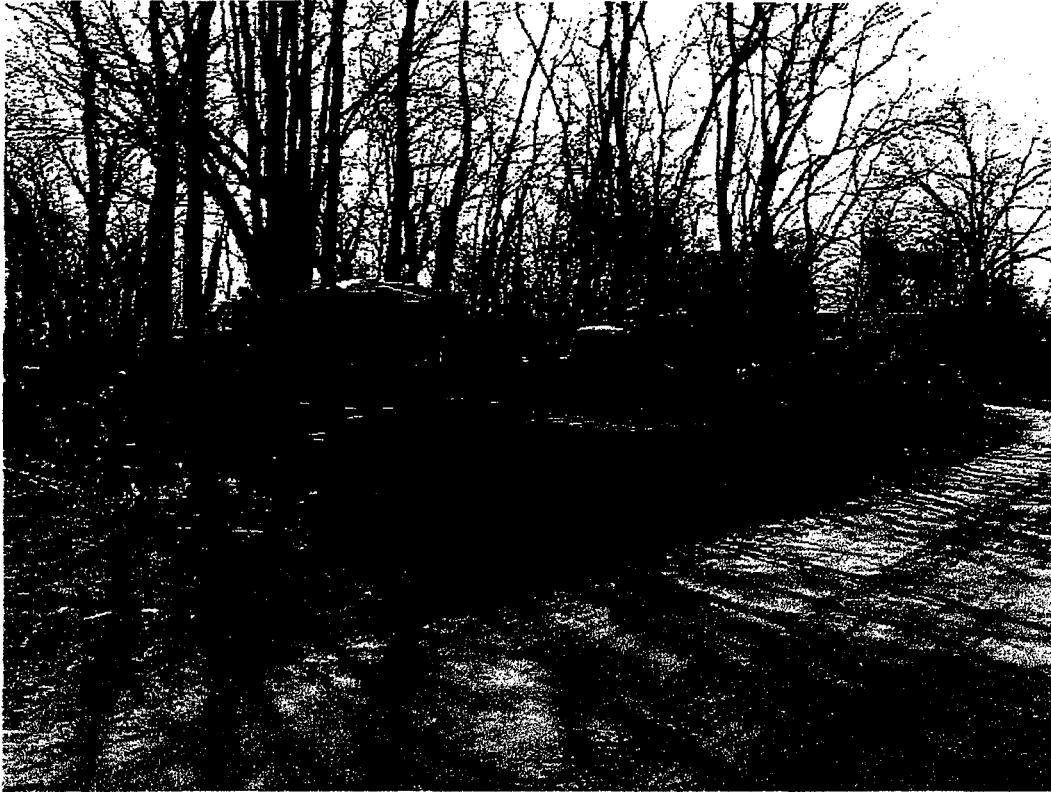
Date: April 1, 2005
Time: 9:33 am
Direction: SE
Photo by: M. Cozadd
Exposure #: 003
Comments: Abandoned vehicles, trailer, used tires and assorted scrap metal along sand road on north side of mobile home

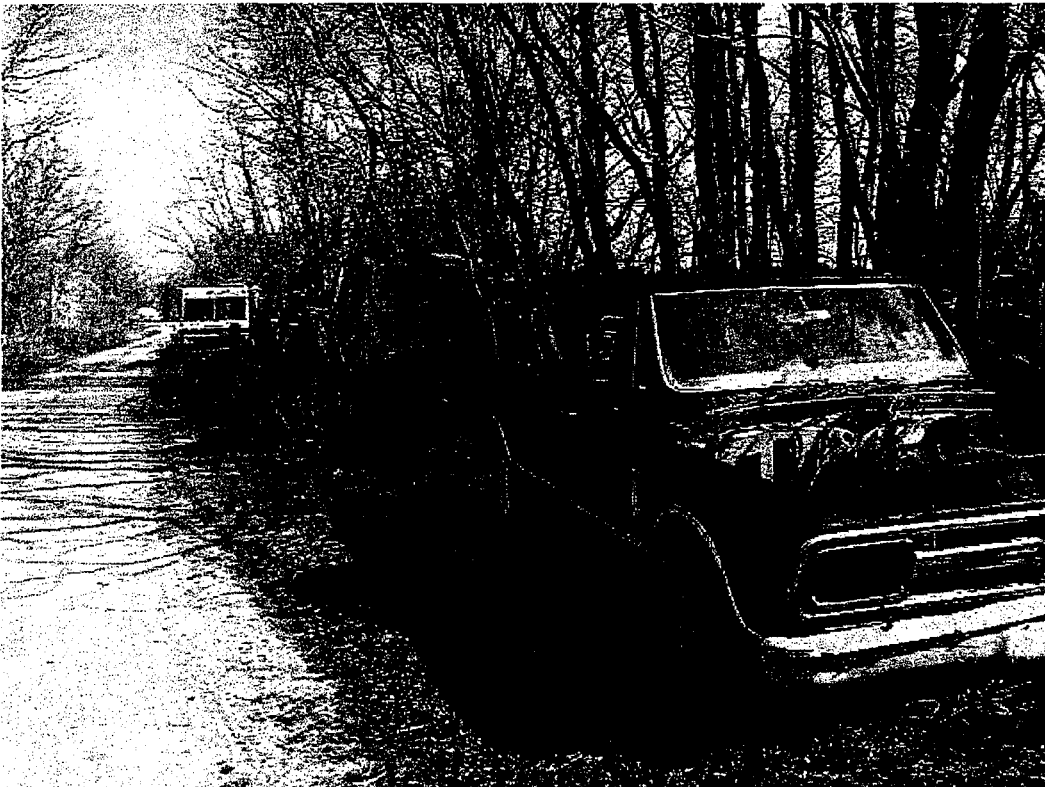
Date: April 1, 2005
Time: 9:35 am
Direction: NE
Photo by: M. Cozadd
Exposure #: 004
Comments: Abandoned vehicles along sand road looking north

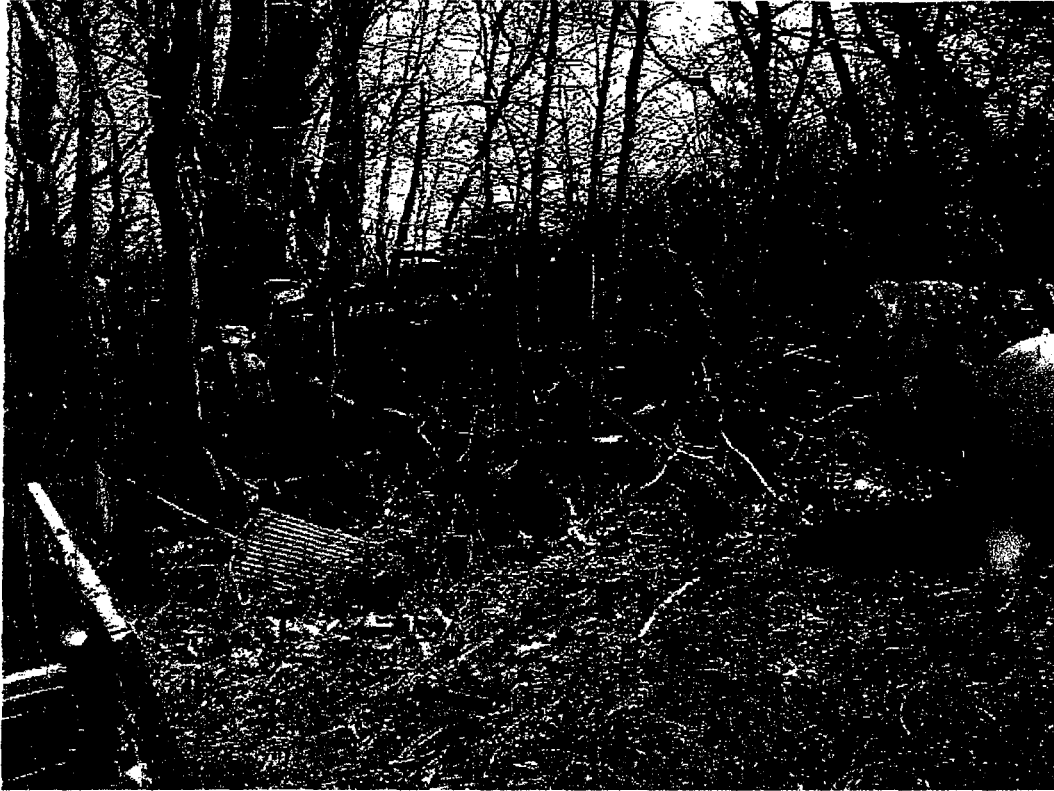
Date: April 1, 2005
Time: 9:35 am
Direction: NE
Photo by: M. Cozadd
Exposure #: 005
Comments: Scrap metal, damaged dimensional lumber and other assorted waste materials on north side of mobile home

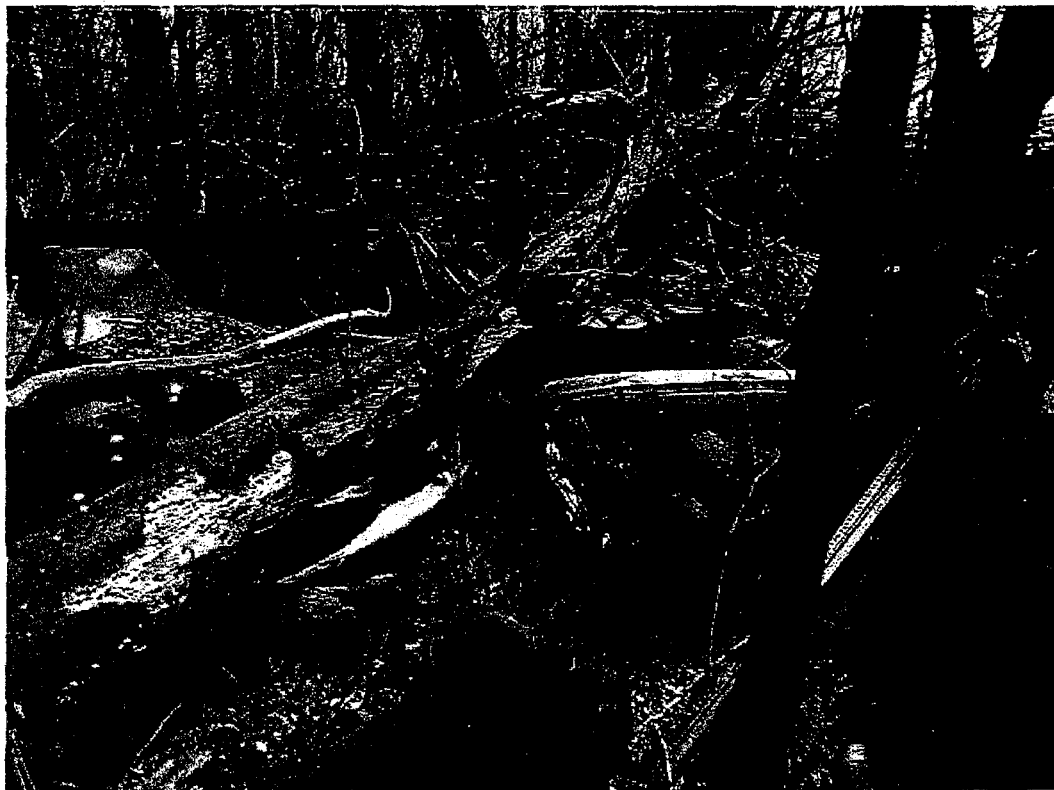
Date: April 1, 2005
Time: 9:36 am
Direction: NE
Photo by: M. Cozadd
Exposure #: 006
Comments: Abandoned vehicles and scrap metal

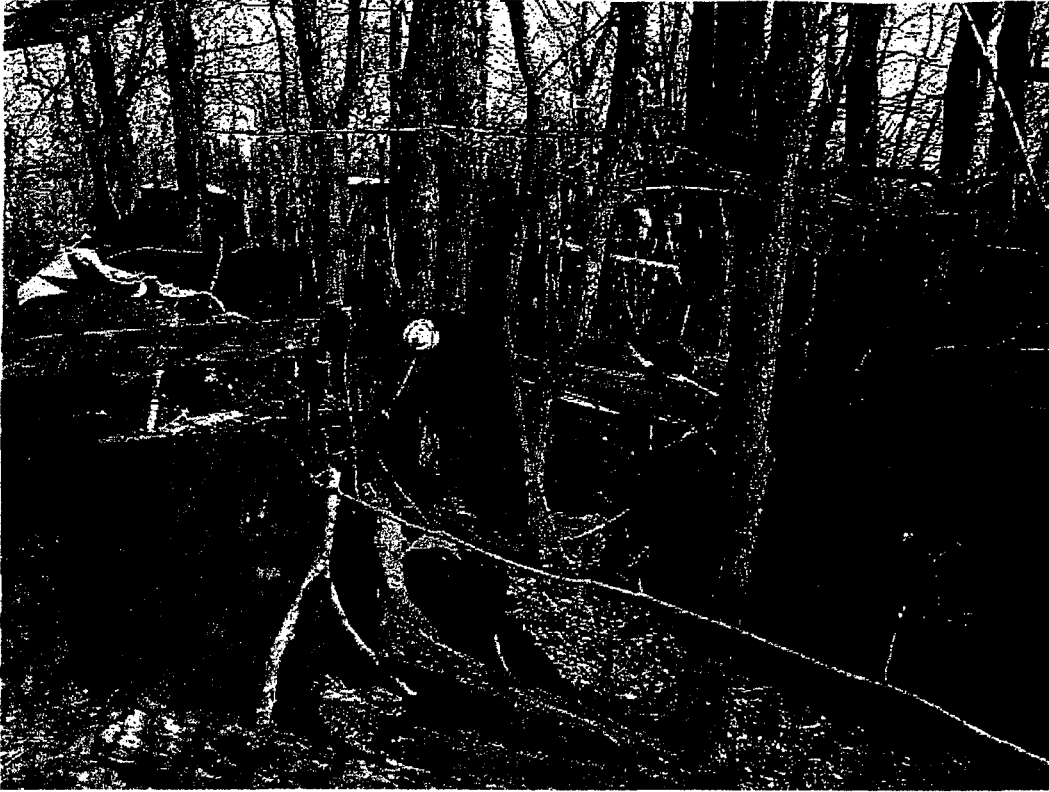
Date: April 1, 2005
Time: 9:36 am
Direction: N
Photo by: M. Cozadd
Exposure #: 007
Comments: Used tires,
metal drum, roller and
other scrap metal north
of mobile home in woods

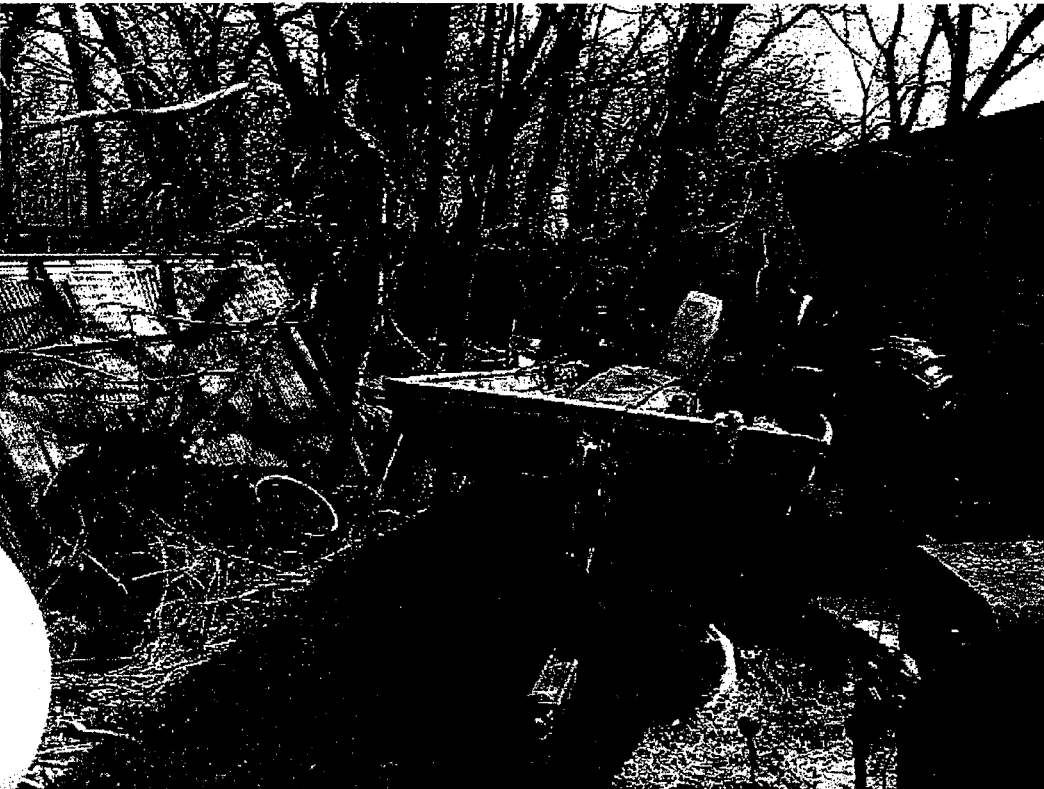
Date: April 1, 2005
Time: 9:37 am
Direction: E
Photo by: M. Cozadd
Exposure #: 008
Comments: Scrap
metal, tractors, used tires
and boat adjacent to
mobile home

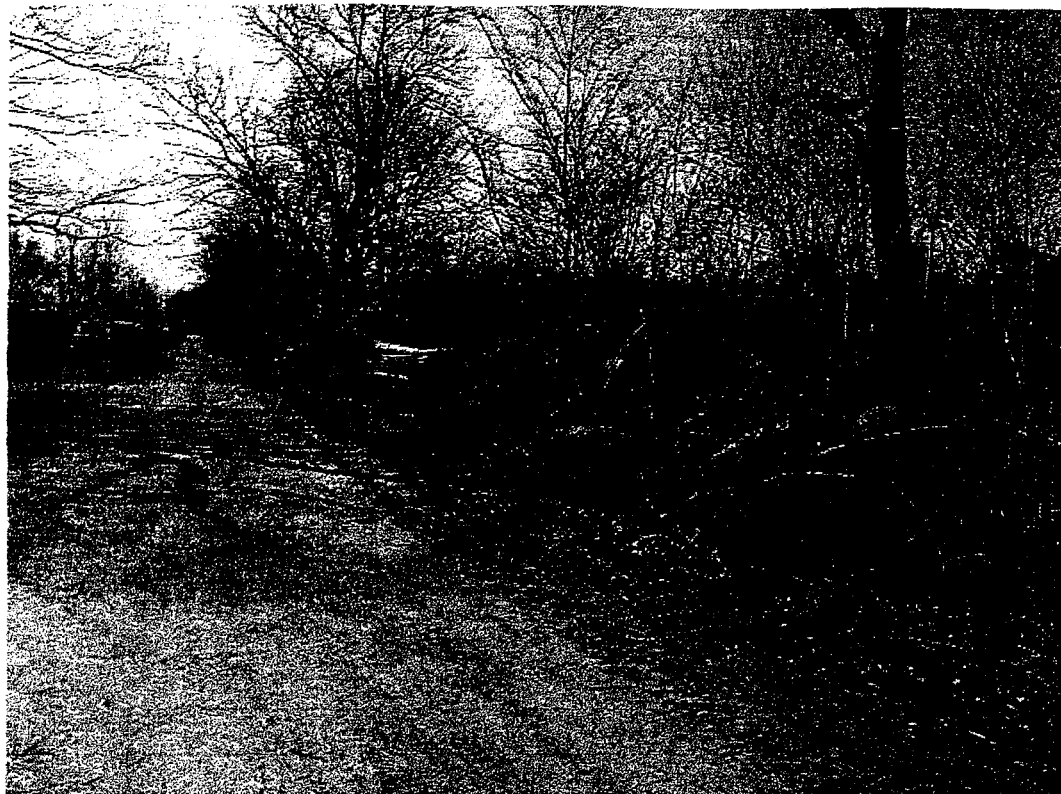
Debris is also located along the western edge of the sand road as shown in the attached photos #009, #012, #016, #048, #049, #058 and #075. The debris included used tires, axles, scrap metal, damaged dimensional lumber and miscellaneous debris.

Date: April 1, 2005
Time: 9:38 am
Direction: SW
Photo by: M. Cozadd
Exposure #: 009
Comments: Trash, used tires and scrap metal observed on the western side of sand road

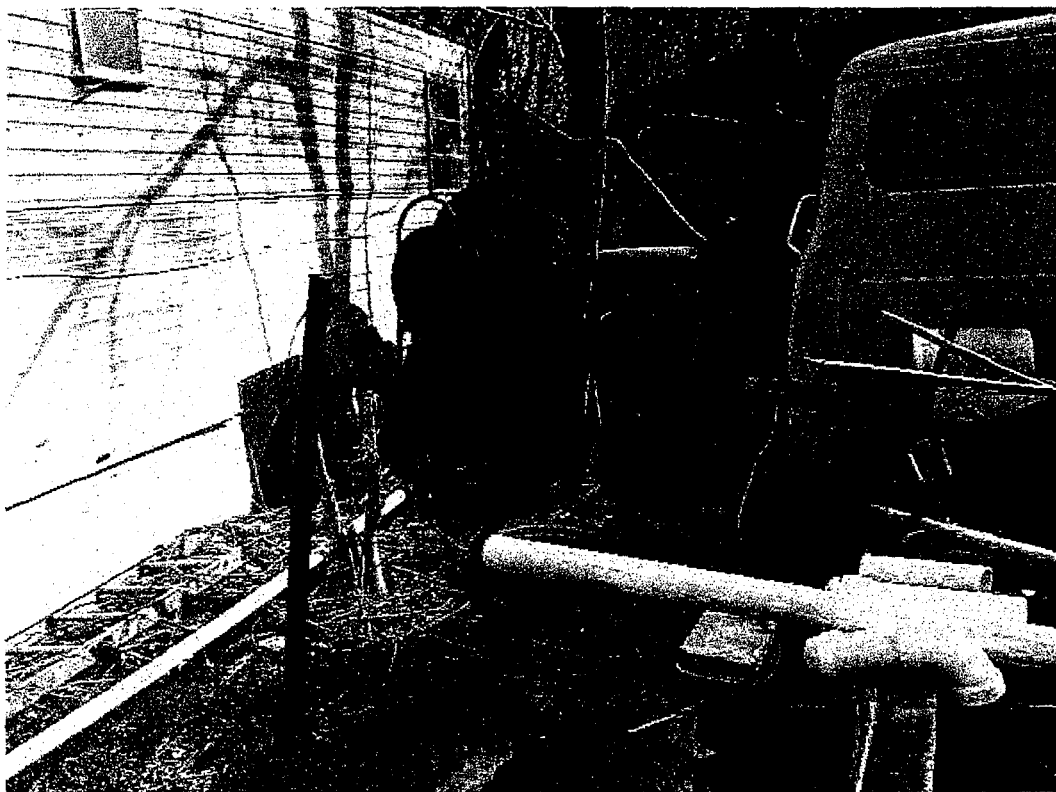
The attached photos #010 and #011 show the area in front of the garage. The area included 20+ used tires, scrap metal and three trucks. Additional 20+ tires and scrap metal were observed between the garage and the house as shown in the attached photo #022.

Date: April 1, 2005
Time: 9:40 am
Direction: E
Photo by: M. Cozadd
Exposure #: 010
Comments: Used tires, abandoned truck and scrap metal at the intersecting corner of mobile home and garage

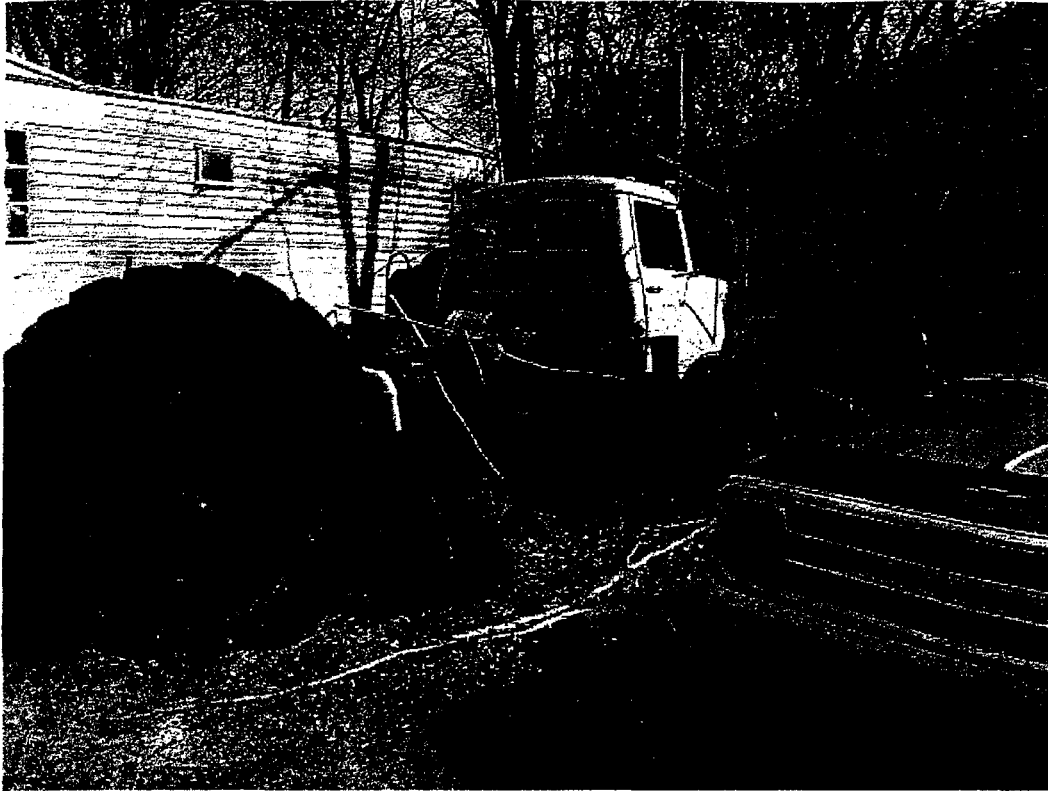
Date: April 1, 2005
Time: 9:41 am
Direction: NE
Photo by: M. Cozadd
Exposure #: 011
Comments: Used tires, abandoned trucks and scrap metal at the intersecting corner of mobile home and garage

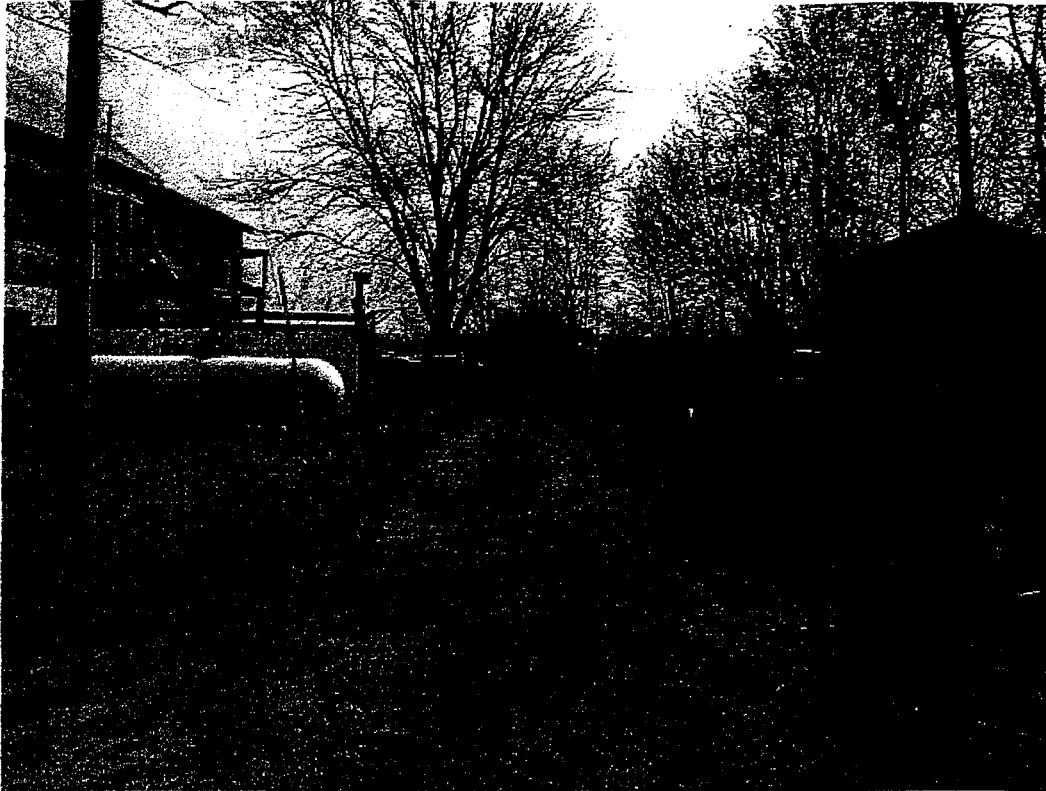
Date: April 1, 2005
Time: 9:42 am
Direction: E
Photo by: M. Cozadd
Exposure #: 013
Comments: Path on south side of house leading to backyard where scrap metal, abandoned vehicles, tractors and miscellaneous wastes are located

There are paths through the areas of waste across the entire site. The entrance to the path to the backyard is shown in the attached photo #013. A burn tank was observed on the south side of the house (see attached photo #018). The attached photo #017 is a close-up of the contents of the burn tank. I observed food containers, plastic bags, metal cans, plastic jugs, a milk jug, aluminum foil, paper, damaged dimensional lumber and paperboard containers on top of charred waste and ashes down toward the bottom of the tank. The areas adjacent to the house on the south and east sides are illustrated in the attached photos #019 and #020, respectively. These areas contained used tires, gas cylinders, tractors, a blue pickup truck, equipment, and scrap metal.

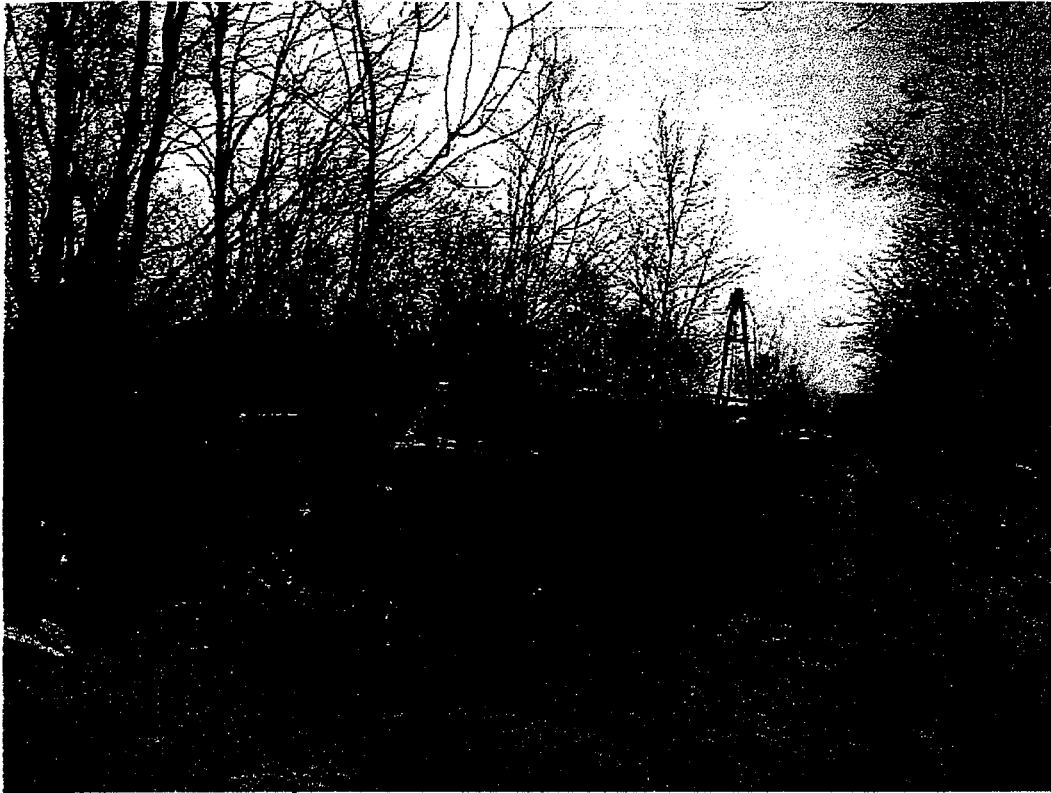
Date: April 1, 2005
Time: 9:42 am
Direction: S
Photo by: M. Cozadd
Exposure #: 015
Comments: Abandoned vehicles, used tires, damaged dimensional lumber and scrap metal located along sand road

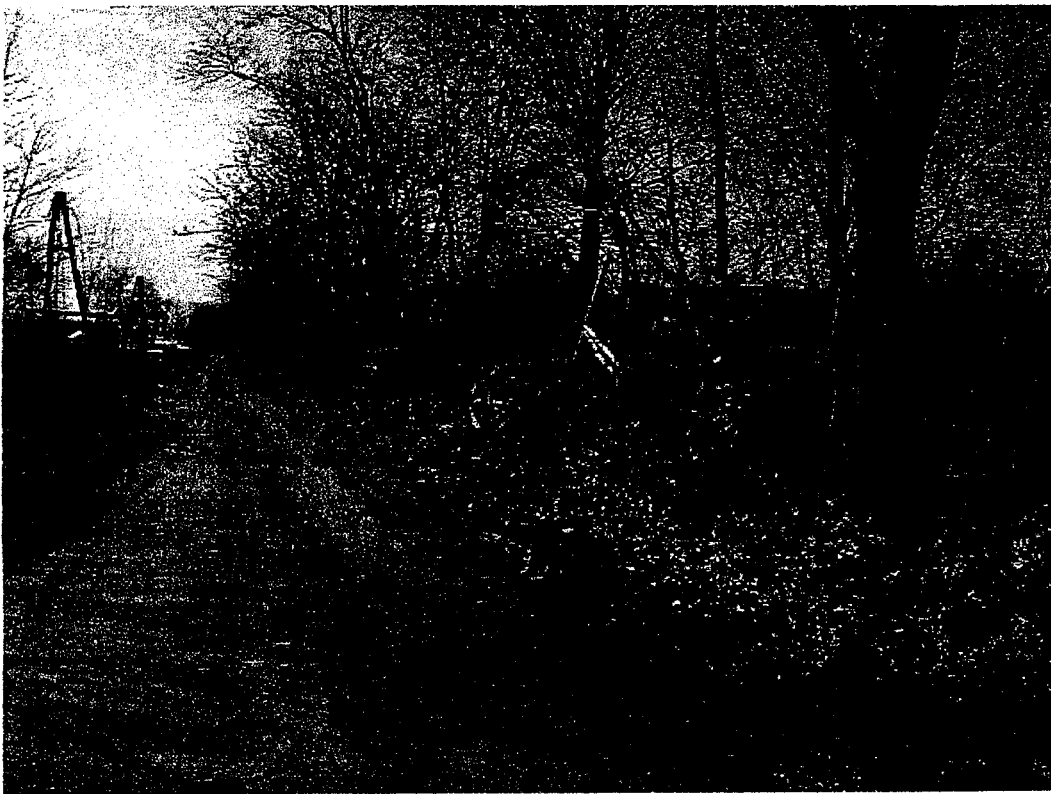
Date: April 1, 2005
Time: 9:42 am
Direction: SW
Photo by: M. Cozadd
Exposure #: 016
Comments: Scrap metal and miscellaneous debris along western edge of sand road

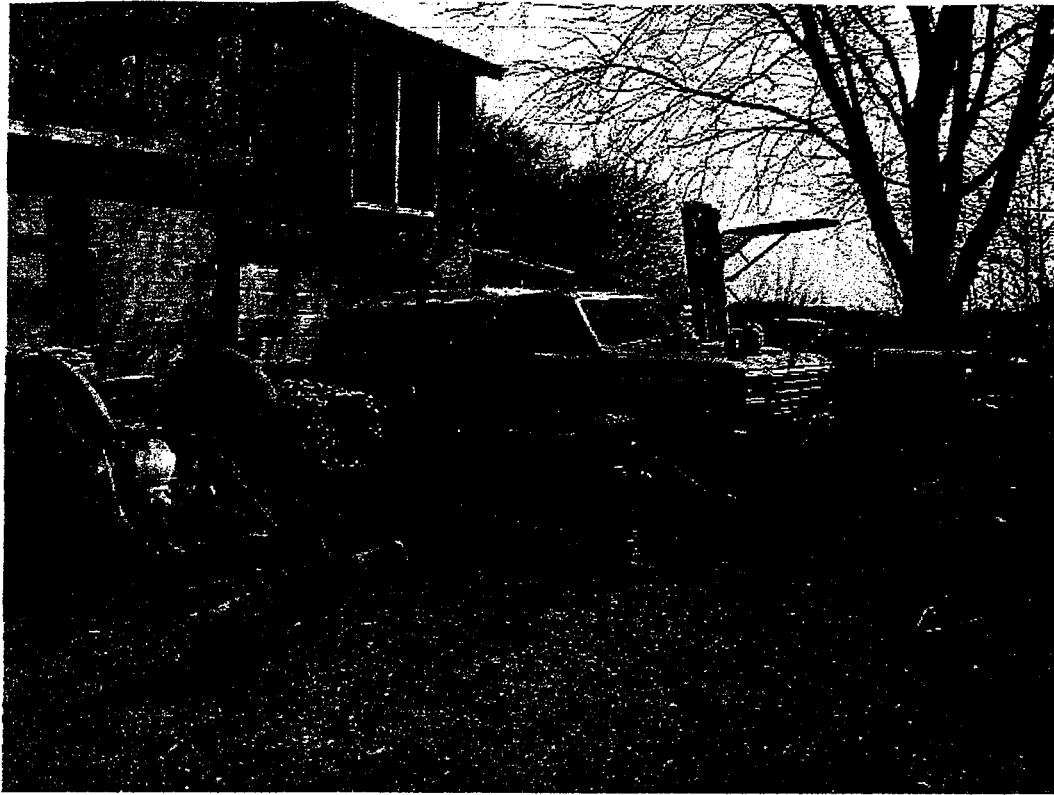
Date: April 1, 2005
Time: 9:45 am
Direction:
Photo by: M. Cozadd
Exposure #: 019
Comments: Tractors,
abandoned truck and
other equipment on
south side of house

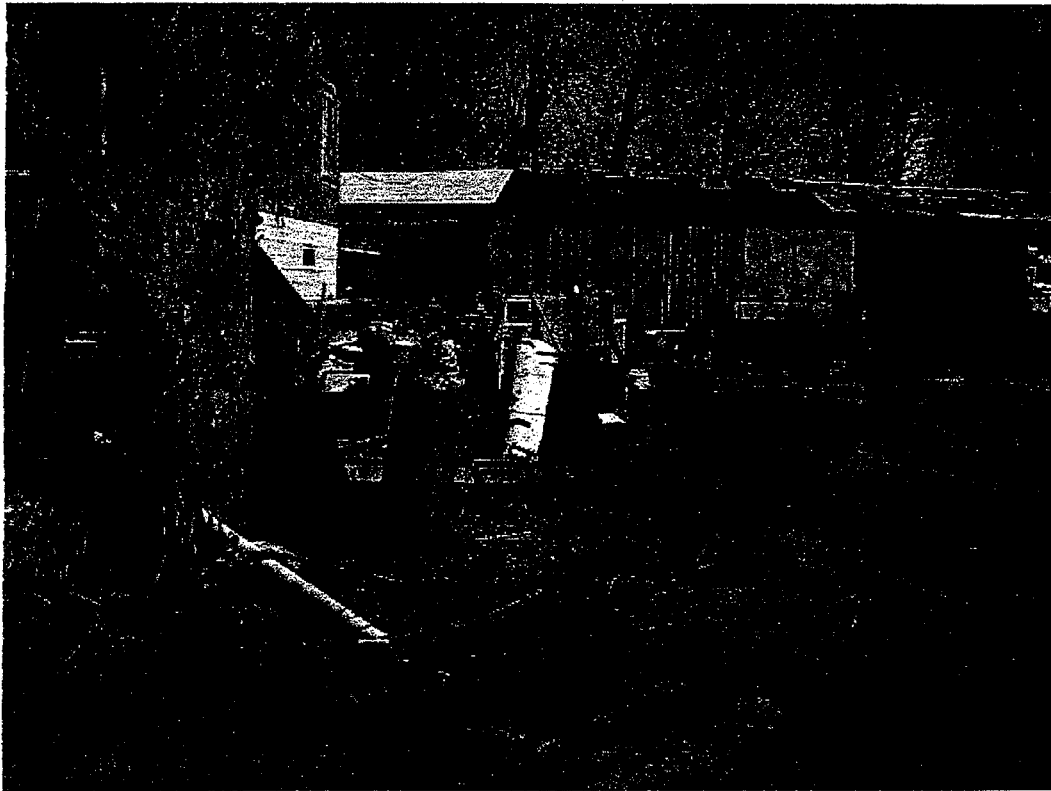
Date: April 1, 2005
Time: 9:46 am
Direction: N
Photo by: M. Cozadd
Exposure #: 020
Comments: Gas
cylinders, used tires and
scrap metal on east side
of house

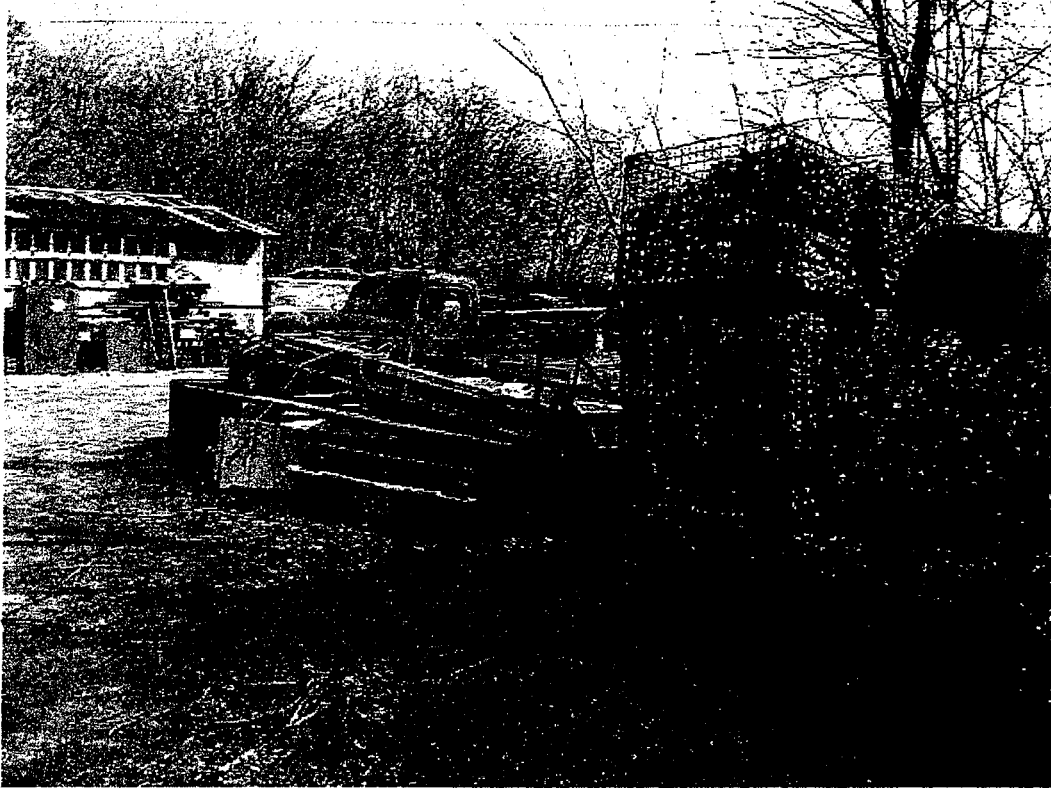
Date: April 1, 2005
Time: 9:46 am
Direction: NE
Photo by: M. Cozadd
Exposure #: 021
Comments: Metal bins
of aluminum cans,
abandoned vehicles and
scrap metal in backyard

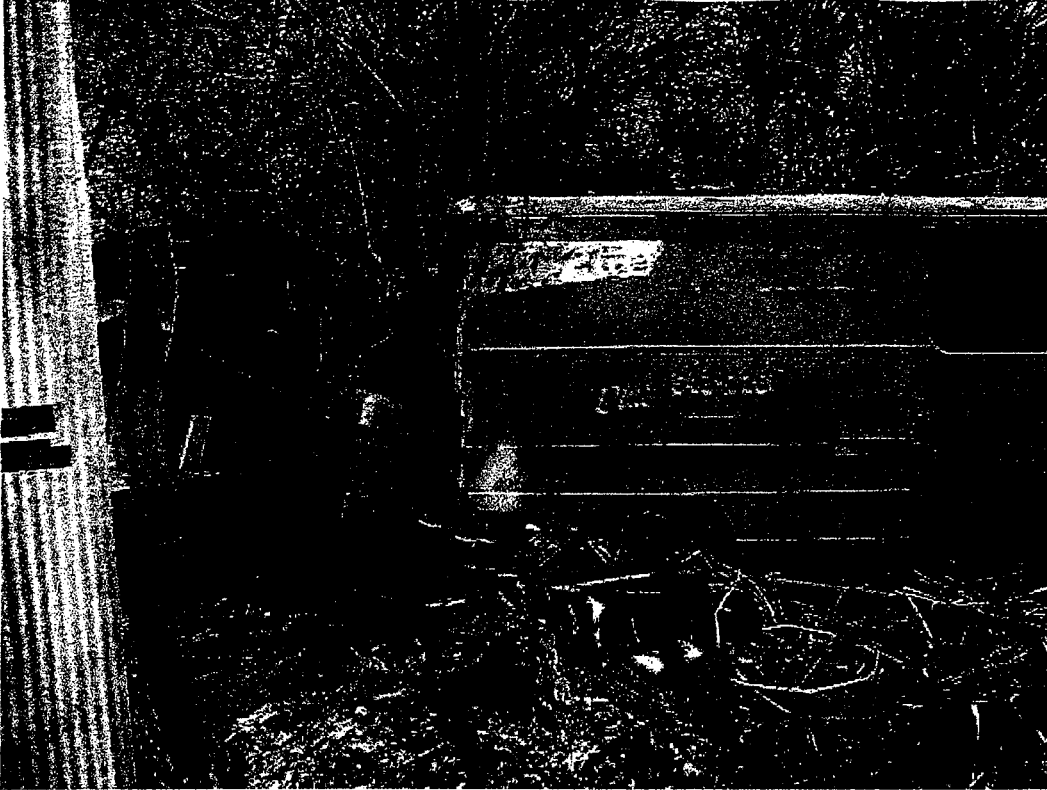
The attached photos #023 through #030 illustrate the area in back of the garage. This area contained an abandoned yellow van, a bus full of damaged dimensional lumber, used tires, buggies, golf carts, a low-boy, a camper, piles of scrap metal, 3+ tractors, 5+ abandoned vehicles, concrete blocks and miscellaneous waste materials. An overview of the eastern edge of the site is illustrated in the attached photo #031.

Date: April 1, 2005
Time: 9:48 am
Direction: NE
Photo by: M. Cozadd
Exposure #: 023
Comments: Abandoned yellow van, scrap metal, damaged dimensional lumber and miscellaneous debris in back of garage

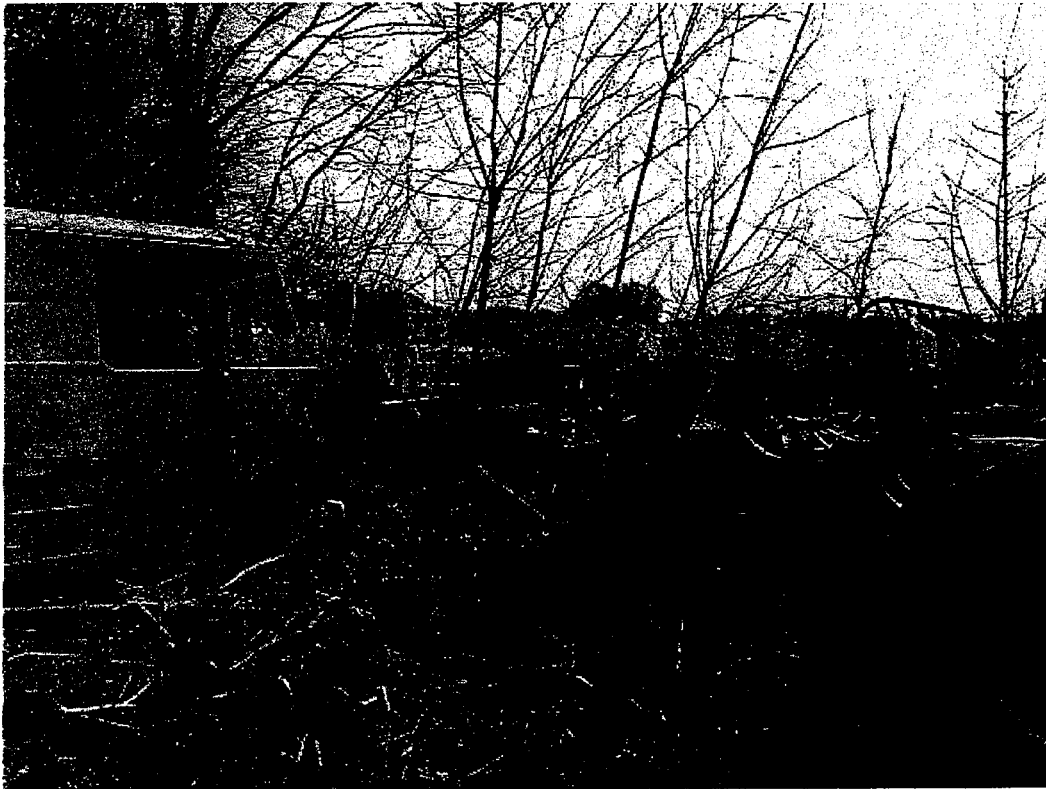
Date: April 1, 2005
Time: 9:48 am
Direction: NE
Photo by: M. Cozadd
Exposure #: 024
Comments: Abandoned yellow van, scrap metal, tractors, damaged dimensional lumber and miscellaneous debris in back of garage

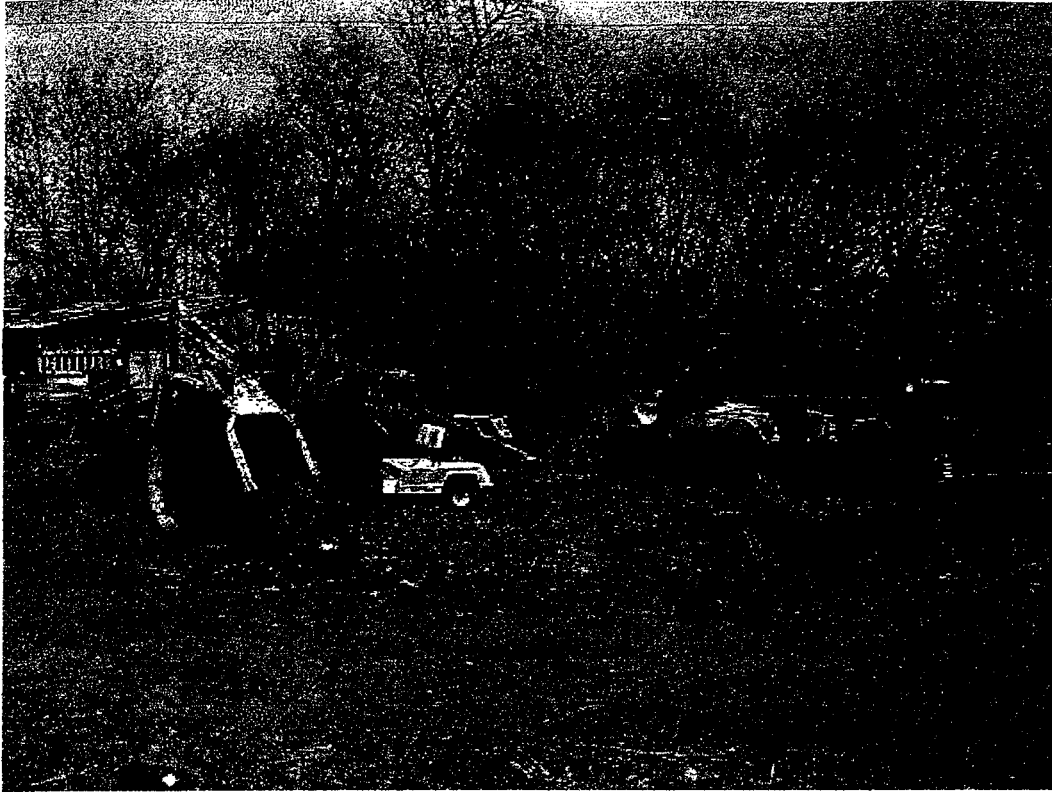
Date: April 1, 2005
Time: 9:52 am
Direction: NW
Photo by: M. Cozadd
Exposure #: 025
Comments: Overview of
area in back of garage

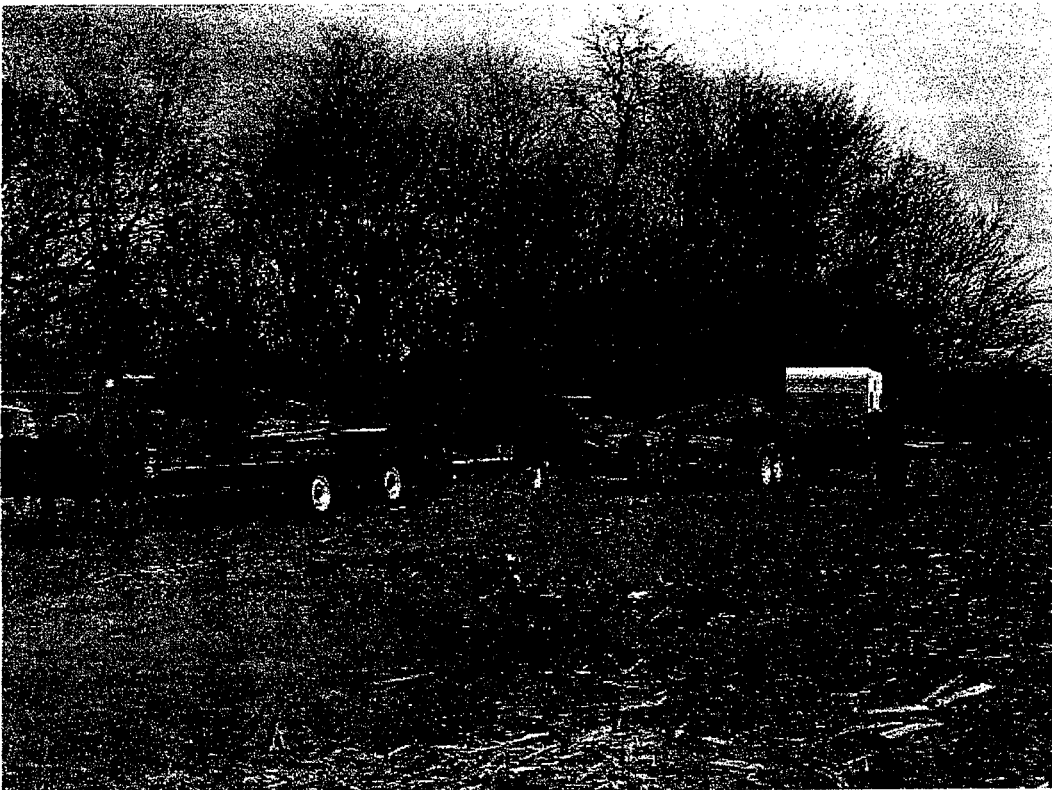
Date: April 1, 2005
Time: 9:52 am
Direction: N
Photo by: M. Cozadd
Exposure #: 026
Comments: Overview of
trailers, camper,
abandoned vehicles, and
scrap metal in back of
garage

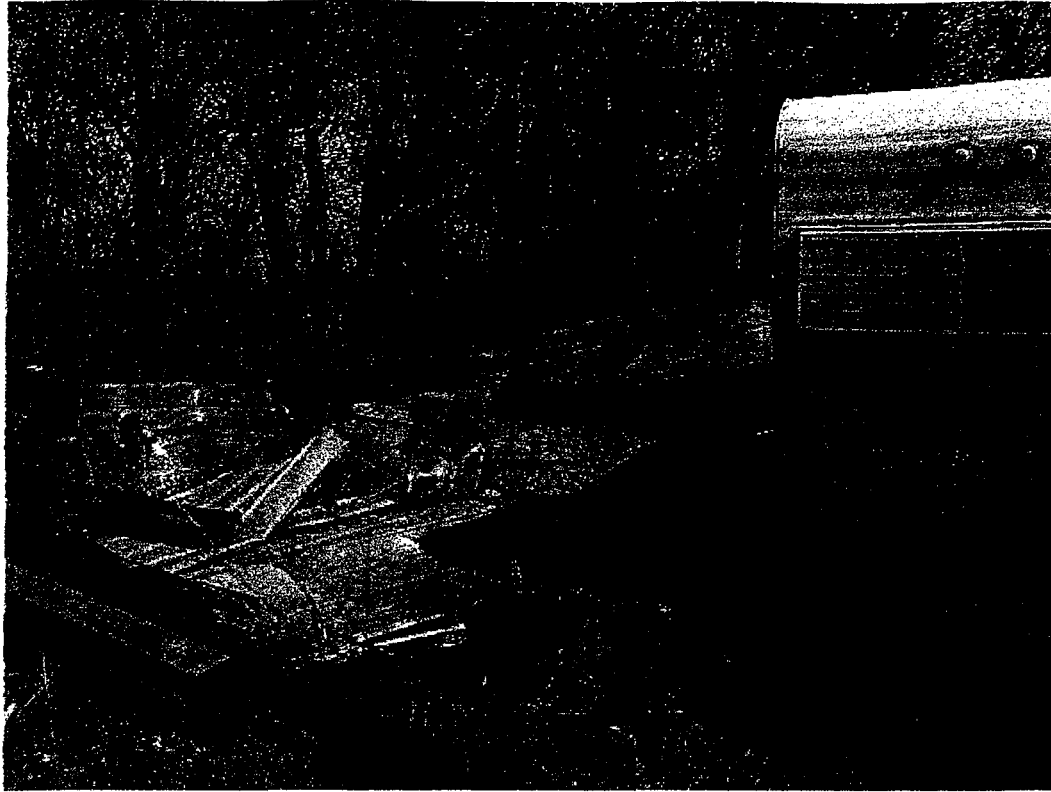
Date: April 1, 2005
Time: 9:54 am
Direction: NW
Photo by: M. Cozadd
Exposure #: 027
Comments: Close-up of
scrap metal near camper
in back of garage

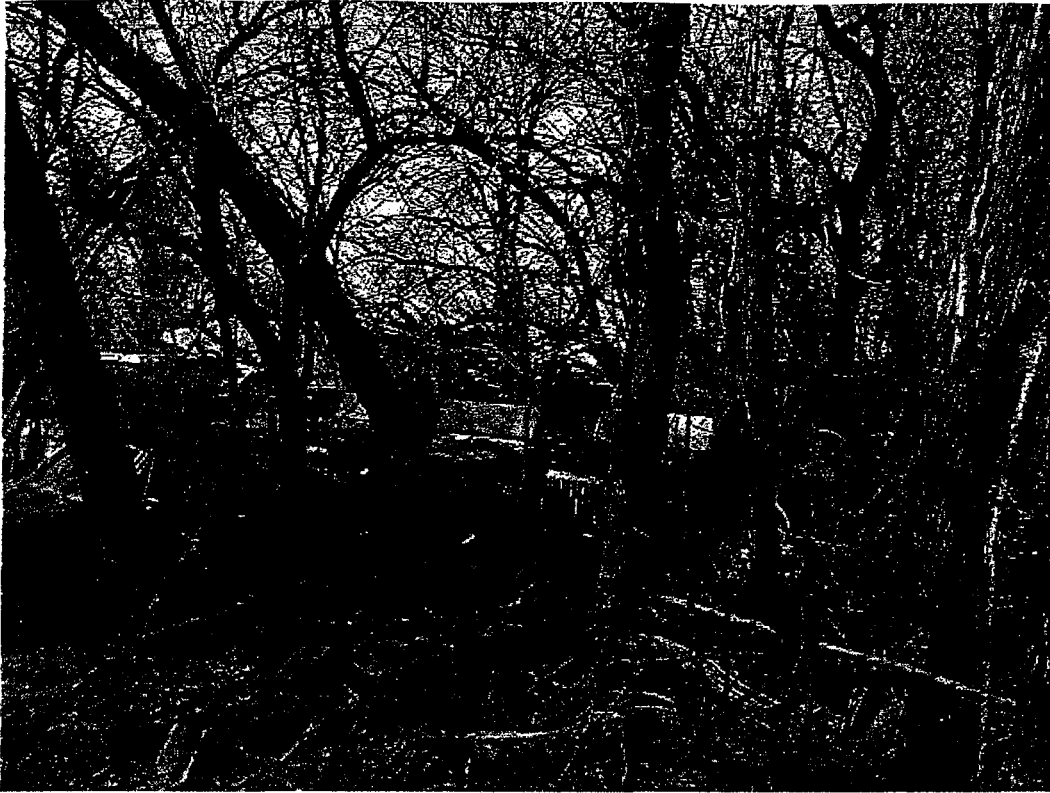
Date: April 1, 2005
Time: 9:54 am
Direction: SW
Photo by: M. Cozadd
Exposure #: 029
Comments: Close-up of abandoned vehicles, concrete blocks, scrap metal near northeast corner of garage

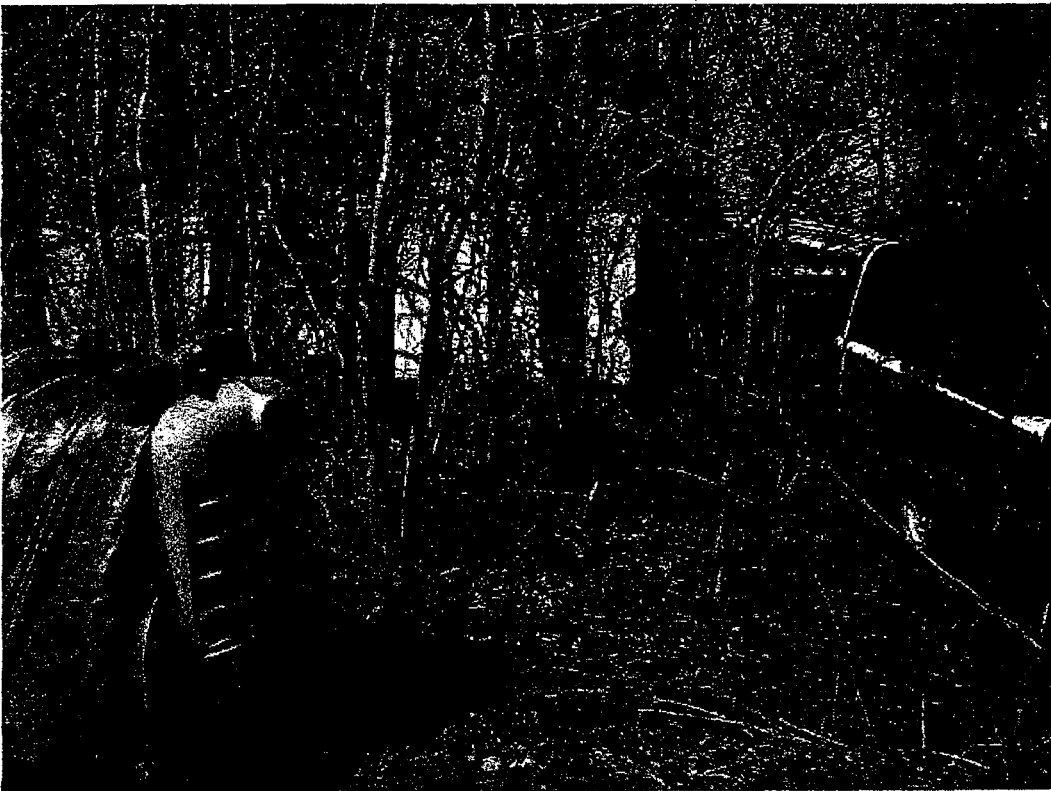
Date: April 1, 2005
Time: 9:59 am
Direction: W
Photo by: M. Cozadd
Exposure #: 032
Comments: Tractor, vehicles and mobile home abandoned near eastern edge of backyard

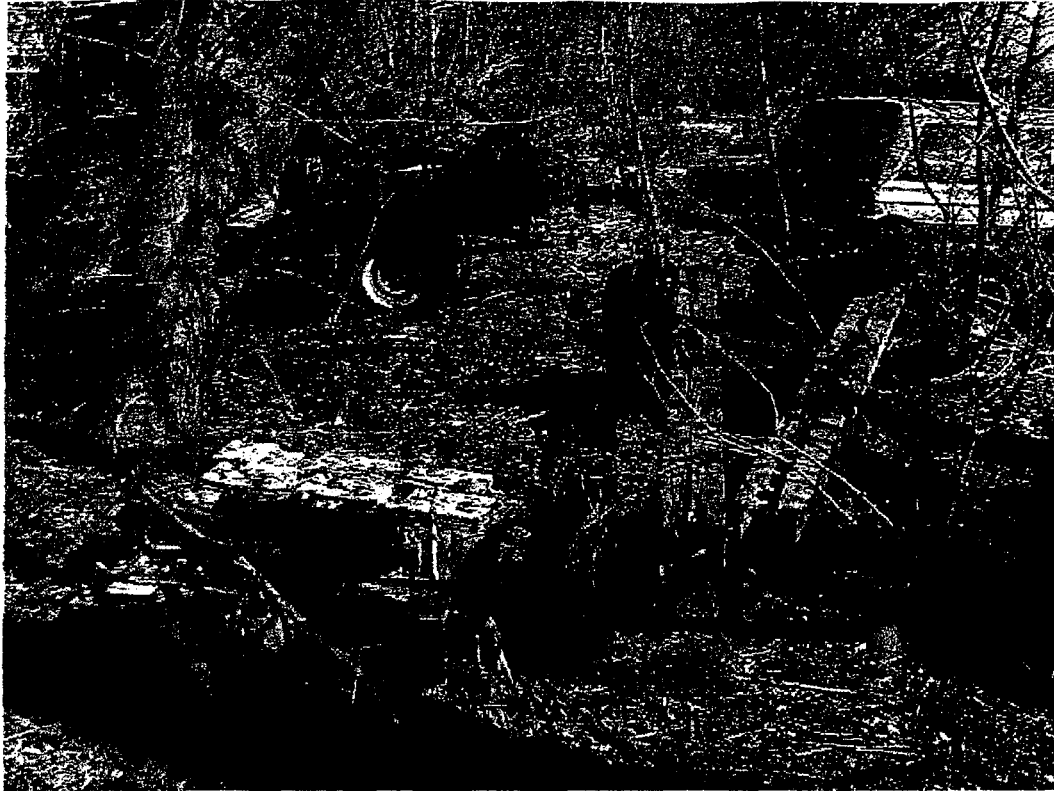
Date: April 1, 2005
Time: 10:00 am
Direction: N
Photo by: M. Cozadd
Exposure #: 033
Comments: Abandoned vehicles, broken lead acid batteries, damaged dimensional lumber, axles and other waste materials on south side of backyard
