ADMINISTRATIVE CITATION

AC 05-70
(IEPA No. 145-05-AC)

The purpose of this memorandum is to serve as the narrative for an inspection conducted on April 1, 2005 of the above referenced site. The inspection took place from about 9:25 am to 11:00 am. The weather conditions were sunny and approximately 50°F. Eighty-one digital photographs were taken to document the conditions of the site. No one was interviewed during the inspection.

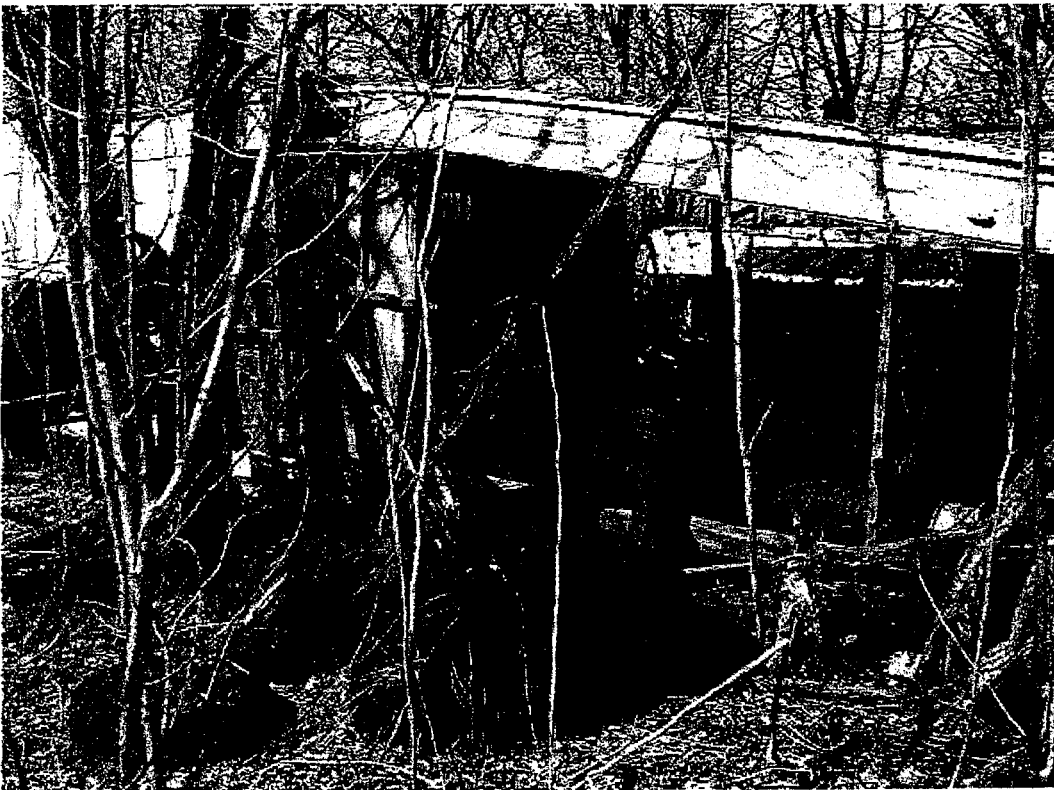
Date: April 1, 2005
Time: 10:01 am
Direction: SW
Photo by: M. Cozadd
Exposure #: 034
Comments: Used tires in and around abandoned mobile home

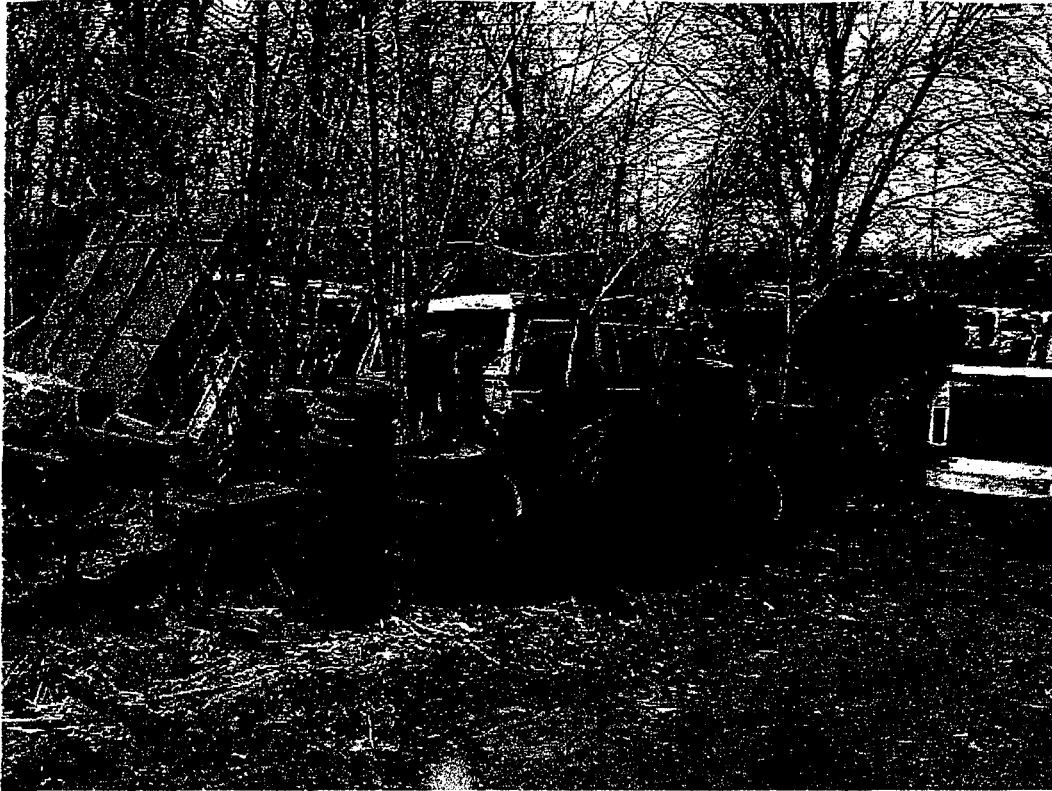
Date: April 1, 2005
Time: 10:07 am
Direction: SW
Photo by: M. Cozadd
Exposure #: 037
Comments: Used tires,
scrap metal and
abandoned vehicles in
backyard

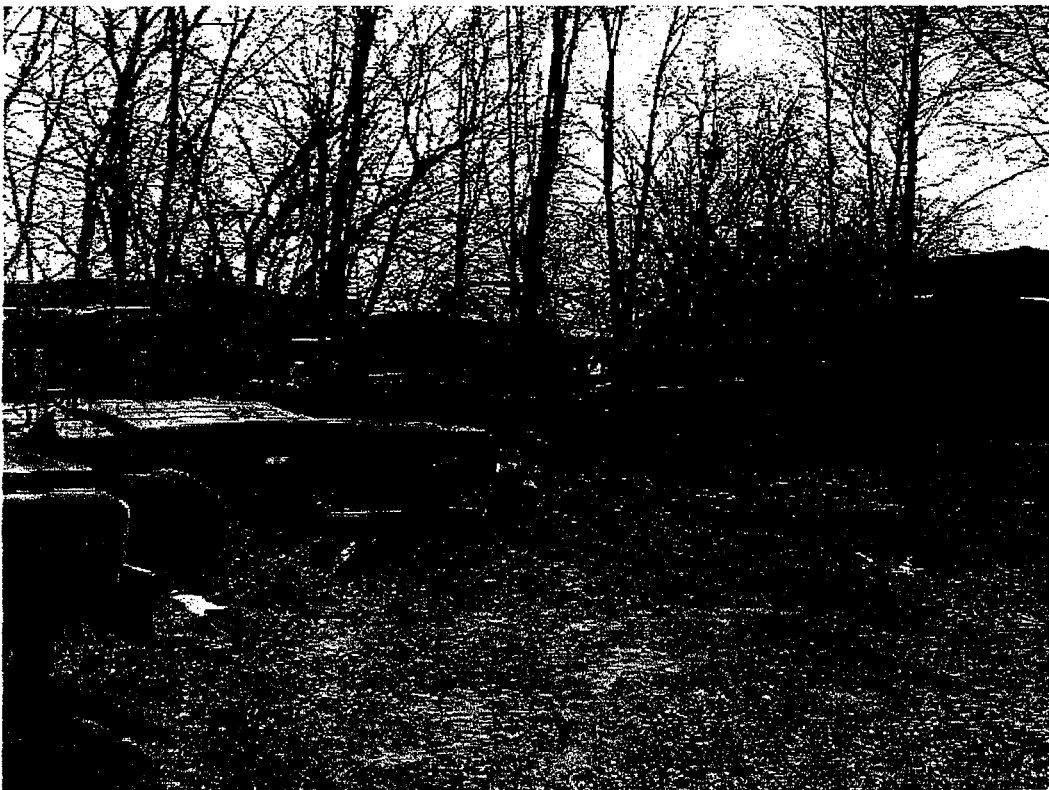
Date: April 1, 2005
Time: 10:11 am
Direction: SE
Photo by: M. Cozadd
Exposure #: 038
Comments: Abandoned
vehicles, tractors, trailer
axles and scrap metal in
front of RV shed

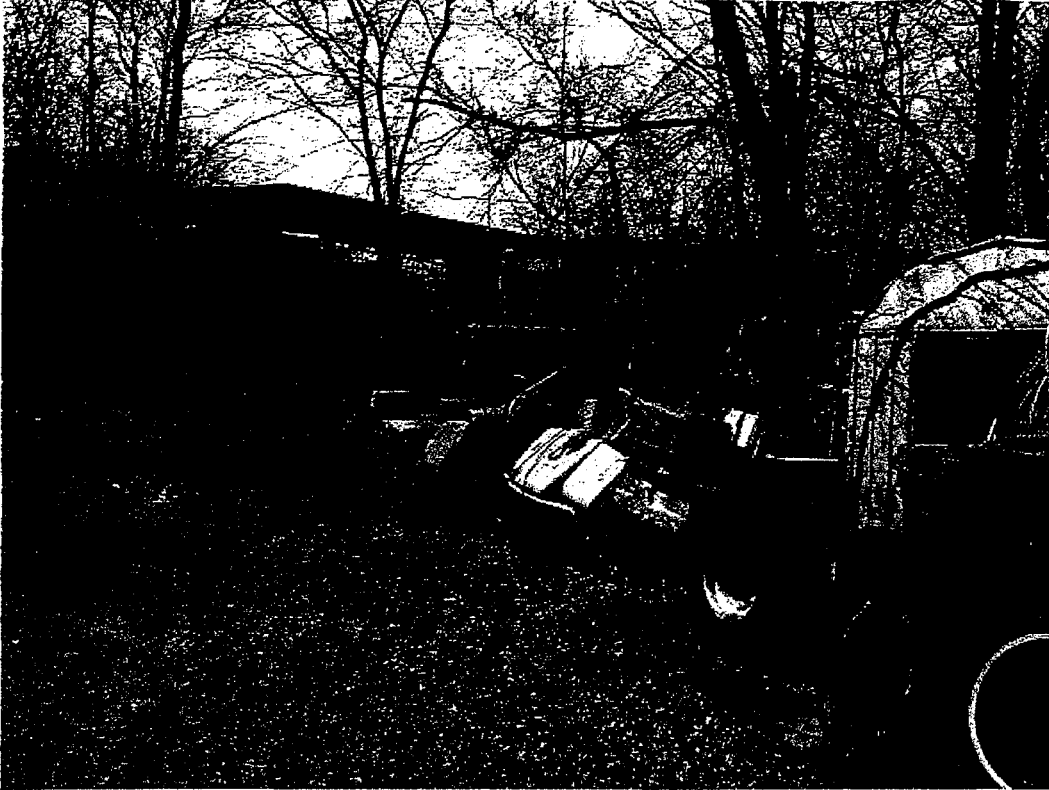
Date: April 1, 2005
Time: 10:11 am
Direction: SW
Photo by: M. Cozadd
Exposure #: 039
Comments: Used tires,
golf carts, green metal
trailer and other waste
materials in front of RV
shed

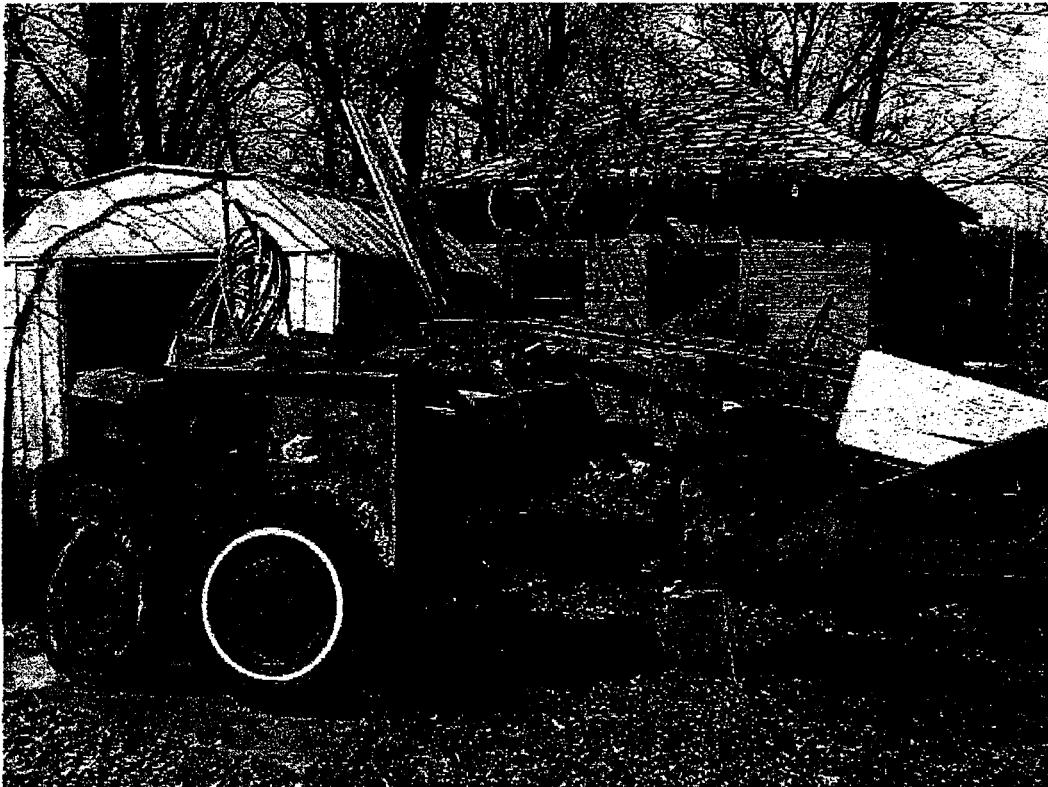
Date: April 1, 2005
Time: 10:11 am
Direction: W
Photo by: M. Cozadd
Exposure #: 040
Comments: Two small
sheds, used tires, farm
equipment and scrap
metal on south side of
house

The area south of the house and northwest of the RV shed is shown in the attached photos #014, #015, #039 through #041, #043 through #045, and #047. The attached photos #014 and #015 show the abandoned vehicles, used tires, damaged dimensional lumber, tow truck and scrap

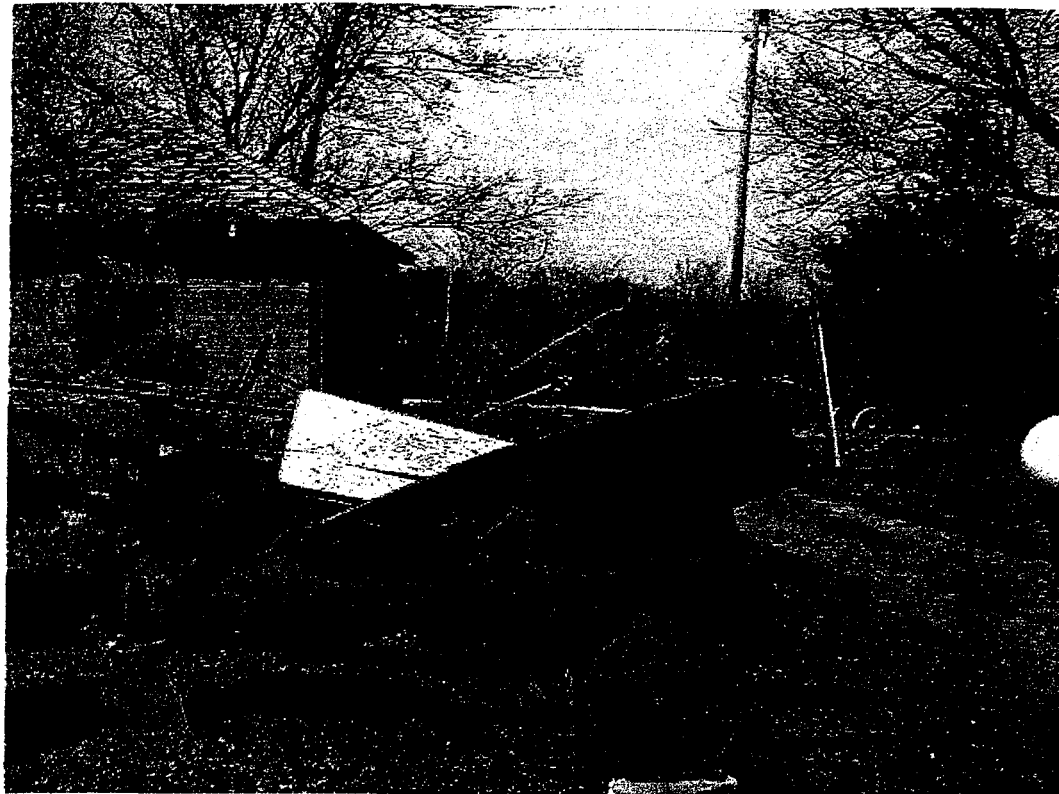
Date: April 1, 2005
Time: 10:11 am
Direction: W
Photo by: M. Cozadd
Exposure #: 041
Comments: Shed and farm equipment on south side of house across the path from the burn tank

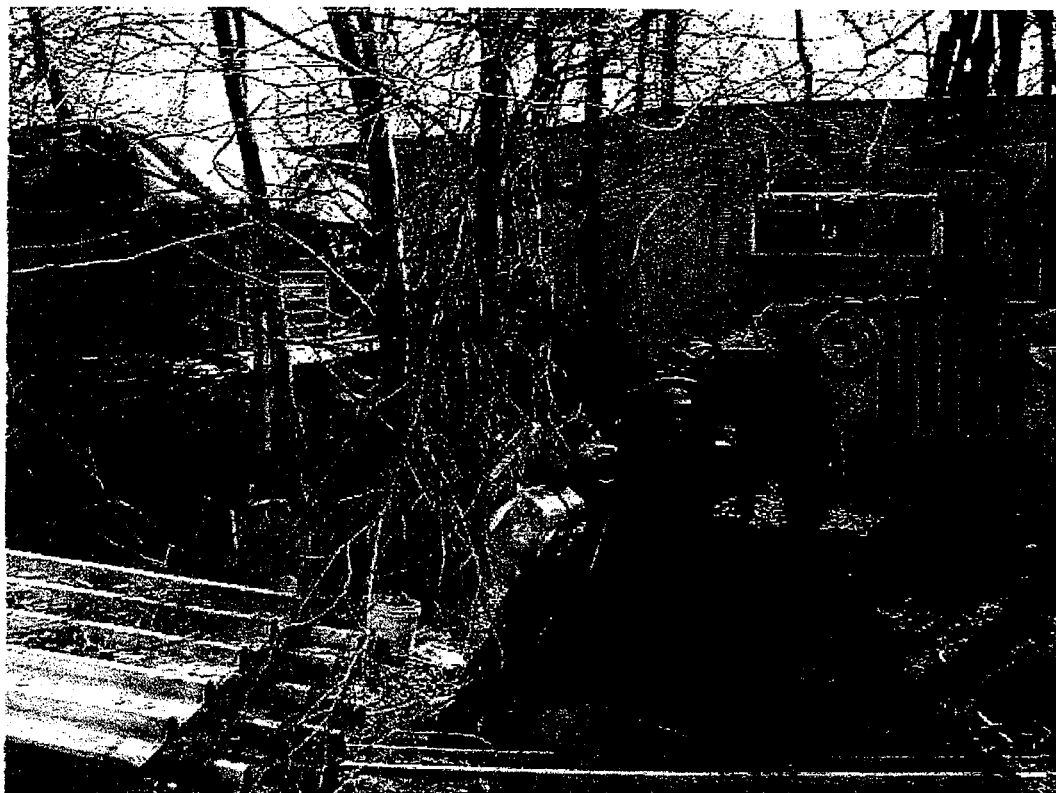
Date: April 1, 2005
Time: 10:12 am
Direction: E
Photo by: M. Cozadd
Exposure #: 042
Comments: Abandoned vehicles, used tires, corrugated metal sheeting and other various waste materials on west side of abandoned mobile homes

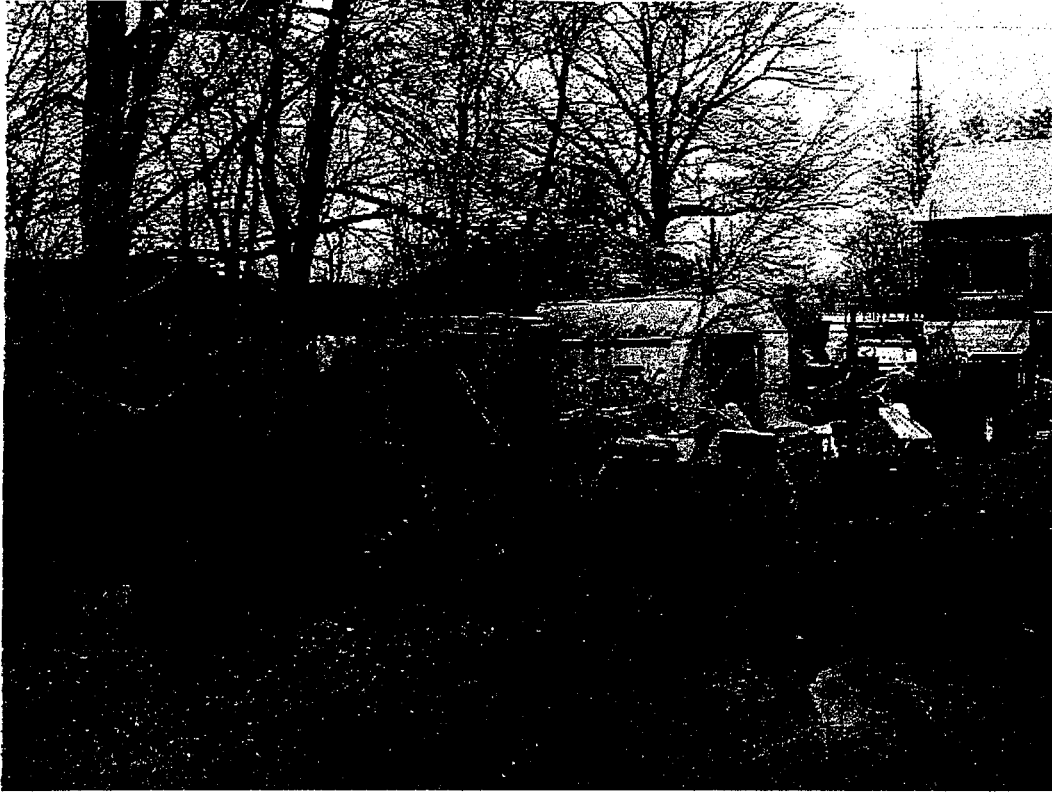
Date: April 1, 2005
Time: 10:14 am
Direction: NW
Photo by: M. Cozadd
Exposure #: 043
Comments: Golf carts,
tractors, used tires and
scrap metal on south
side of house

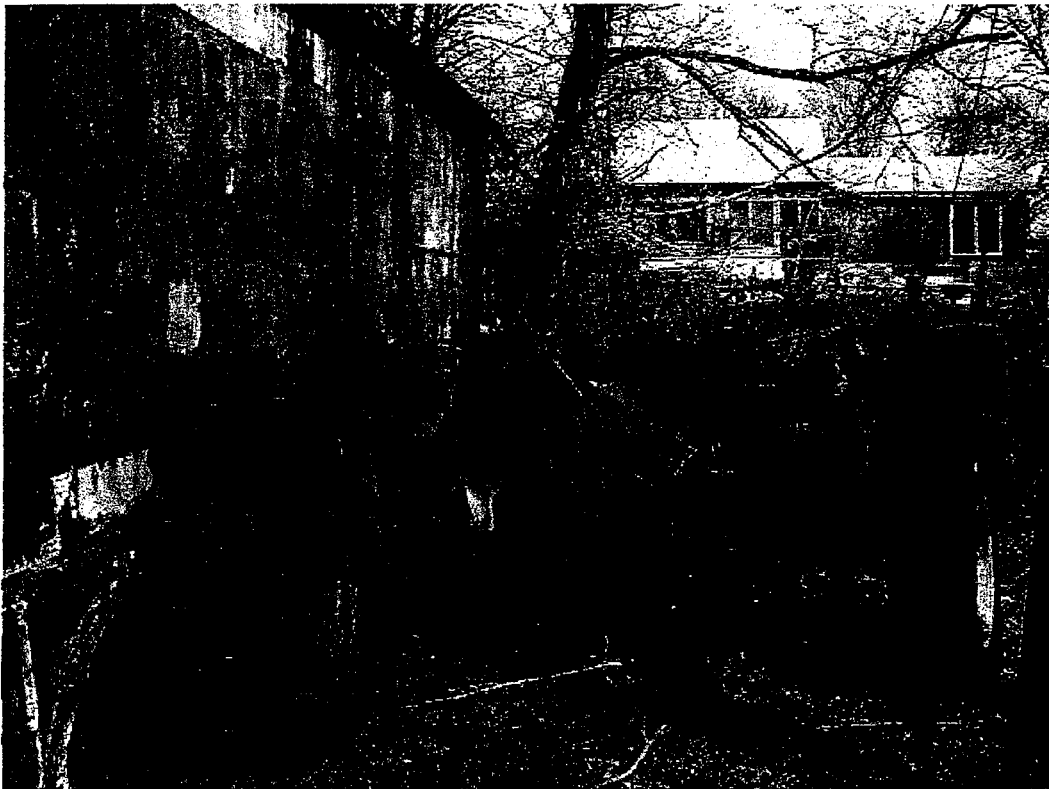
Date: April 1, 2005
Time: 10:14 am
Direction: N
Photo by: M. Cozadd
Exposure #: 044
Comments: Tractors
and used tires on east
side of large green metal
trailer

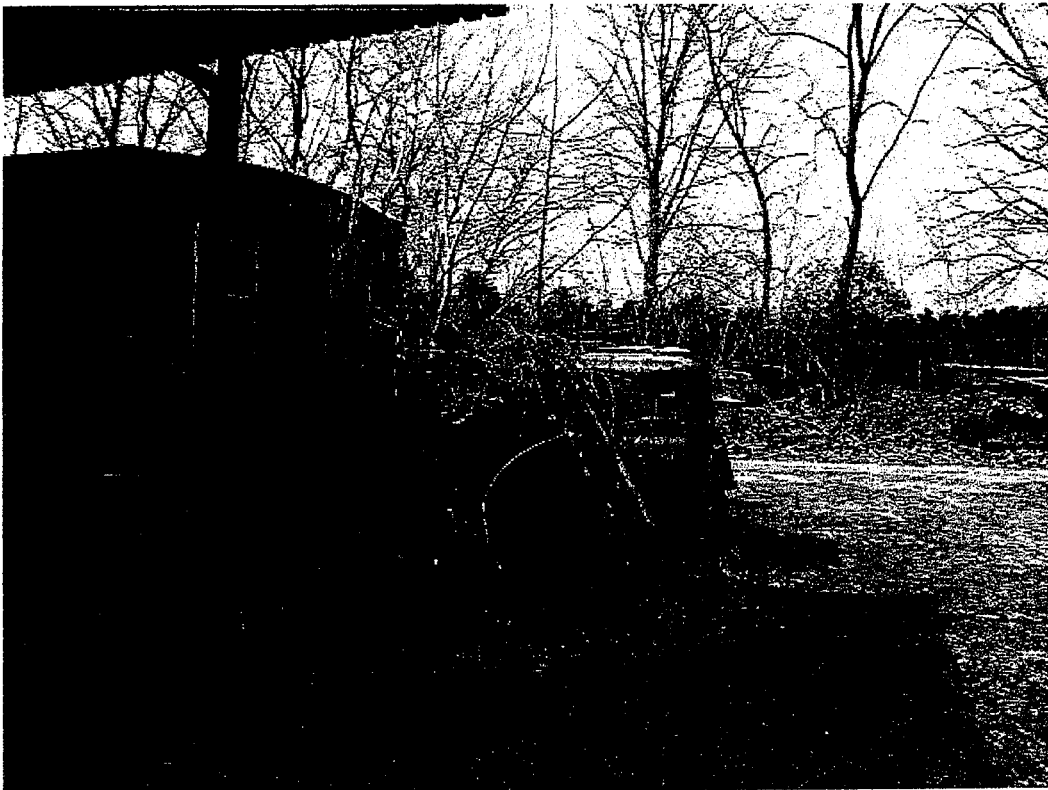
The attached photo #046 shows the front of the abandoned mobile home just to the west of the large RV shed. The truck body in front of mobile home was in same spot during the July 9, 1999 inspection. A tow truck, an abandoned pickup truck, scrap metal and miscellaneous debris were observed on the west side of the mobile home and RV shed.

Date: April 1, 2005
Time: 10:14 am
Direction: SW
Photo by: M. Cozadd
Exposure #: 046
Comments: Abandoned
mobile home and scrap
metal adjacent to RV
shed

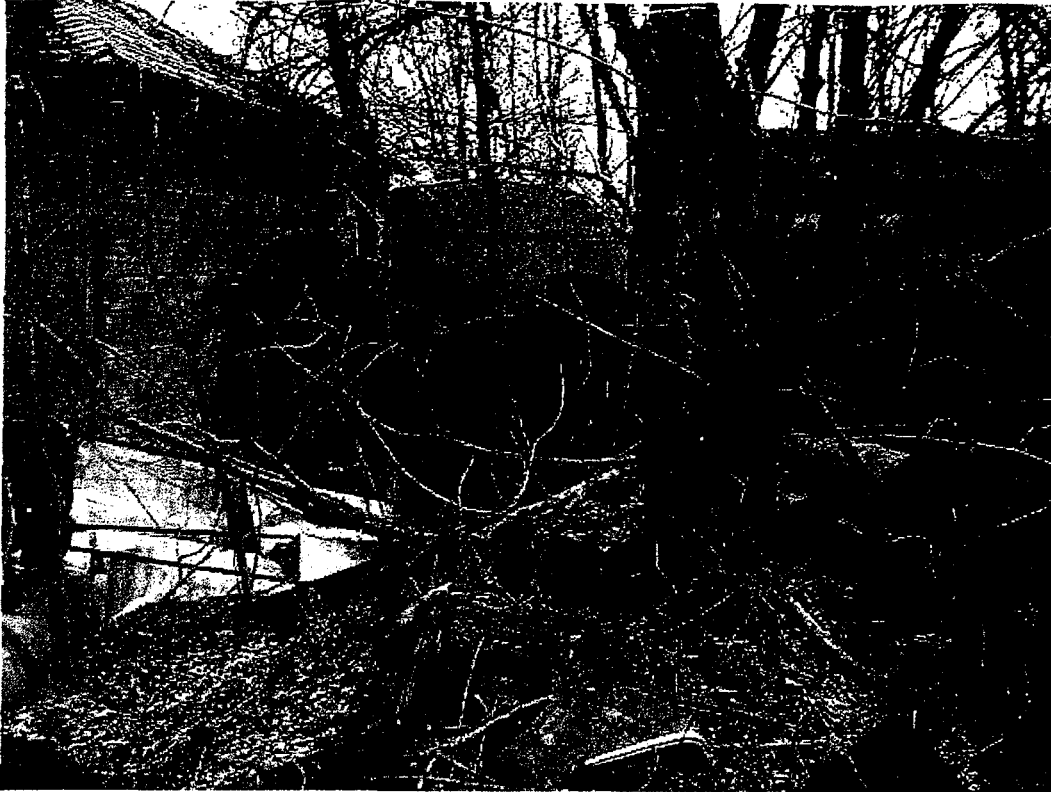
Date: April 1, 2005
Time: 10:18 am
Direction: E
Photo by: M. Cozadd
Exposure #: 047
Comments: Used tires, scrap metal and other miscellaneous debris near the intersecting corner of the two sheds

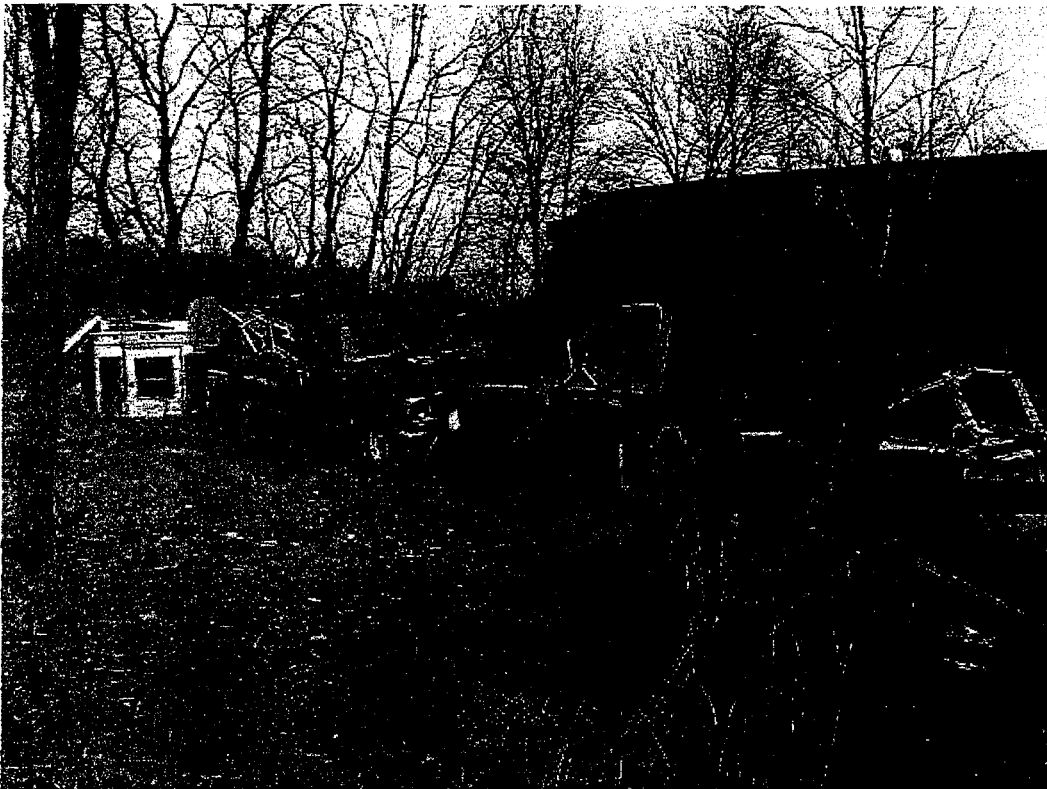
Date: April 1, 2005
Time: 10:25 am
Direction: NW
Photo by: M. Cozadd
Exposure #: 050
Comments: Very large metal tank, abandoned vehicles and scrap metal in back of RV shed

A very large metal tank was observed on the south side of the RV shed. Scrap metal, abandoned vehicles, golf carts, and miscellaneous waste were observed on the south side of the metal tank (see attached photo #050). The attached photo #051 shows the used tires, crane, scrap metal and abandoned vehicles on the east side of the metal tank. The red pickup truck is stacked on top of another vehicle.

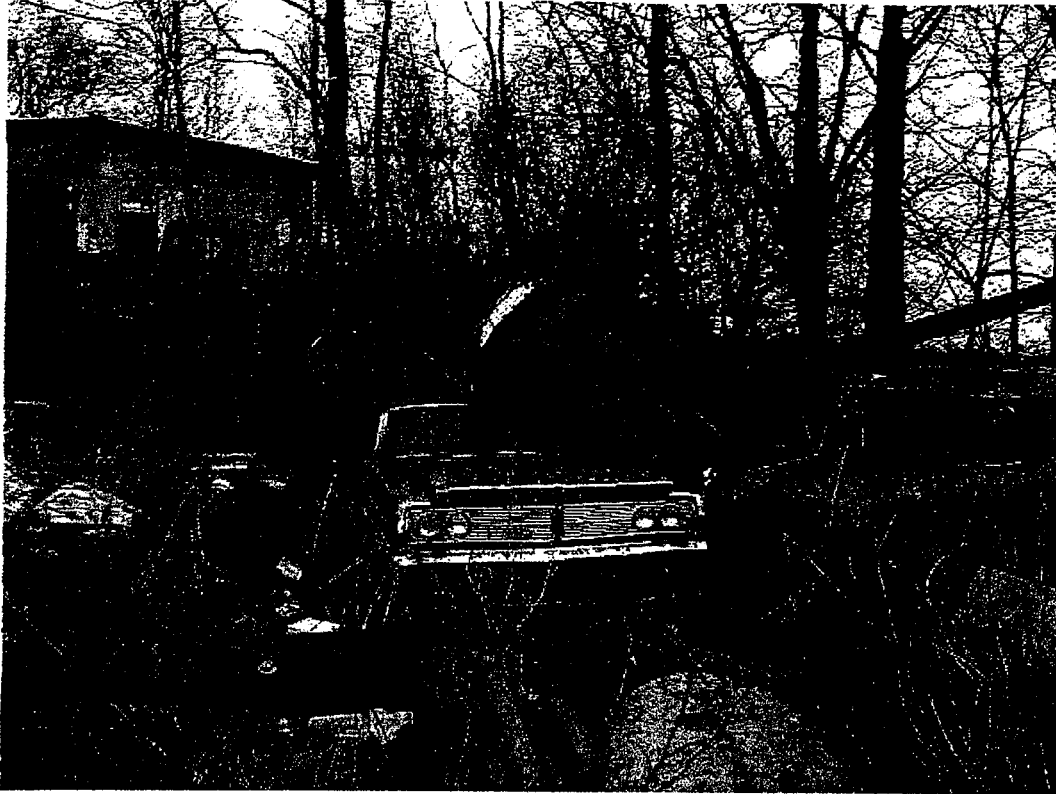
Date: April 1, 2005
Time: 10:25 am
Direction: N
Photo by: M. Cozadd
Exposure #: 051
Comments: Abandoned vehicles, scrap metal, crane and miscellaneous trash in back of abandoned mobile homes. Metal tank to the left in photo. Red truck is stacked on top of another abandoned vehicle.

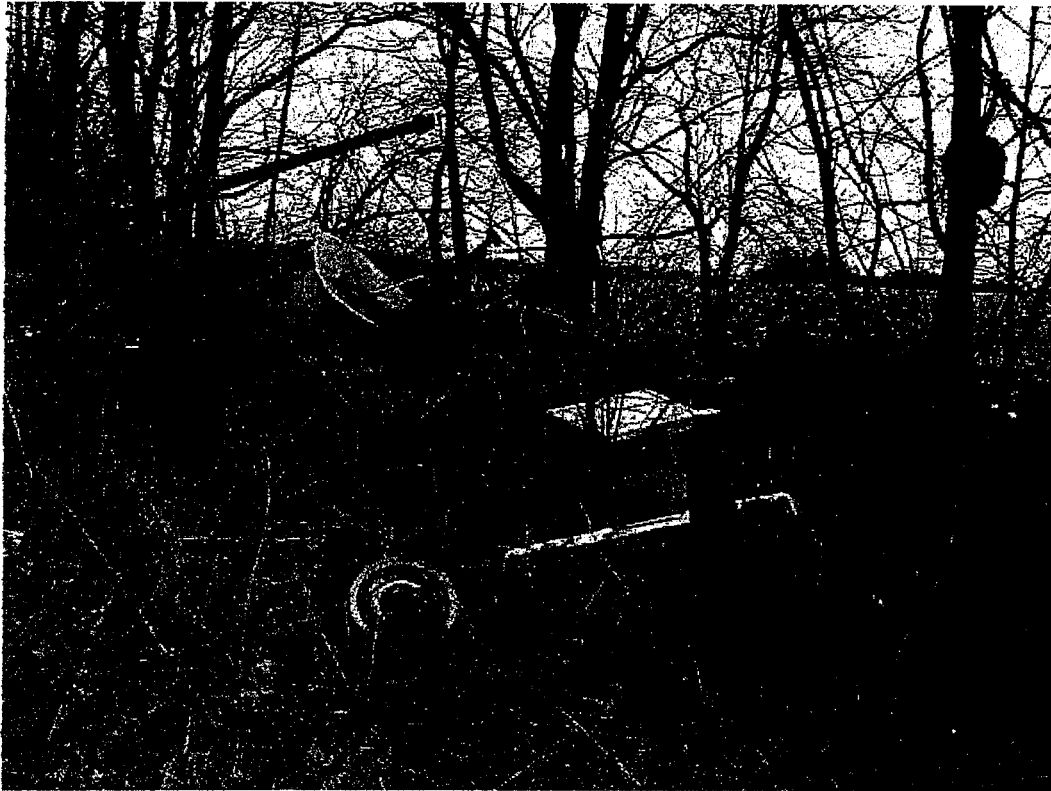
Date: April 1, 2005
Time: 10:25 am
Direction: NE
Photo by: M. Cozadd
Exposure #: 052
Comments: Scrap metal and used tires along eastern edge of site

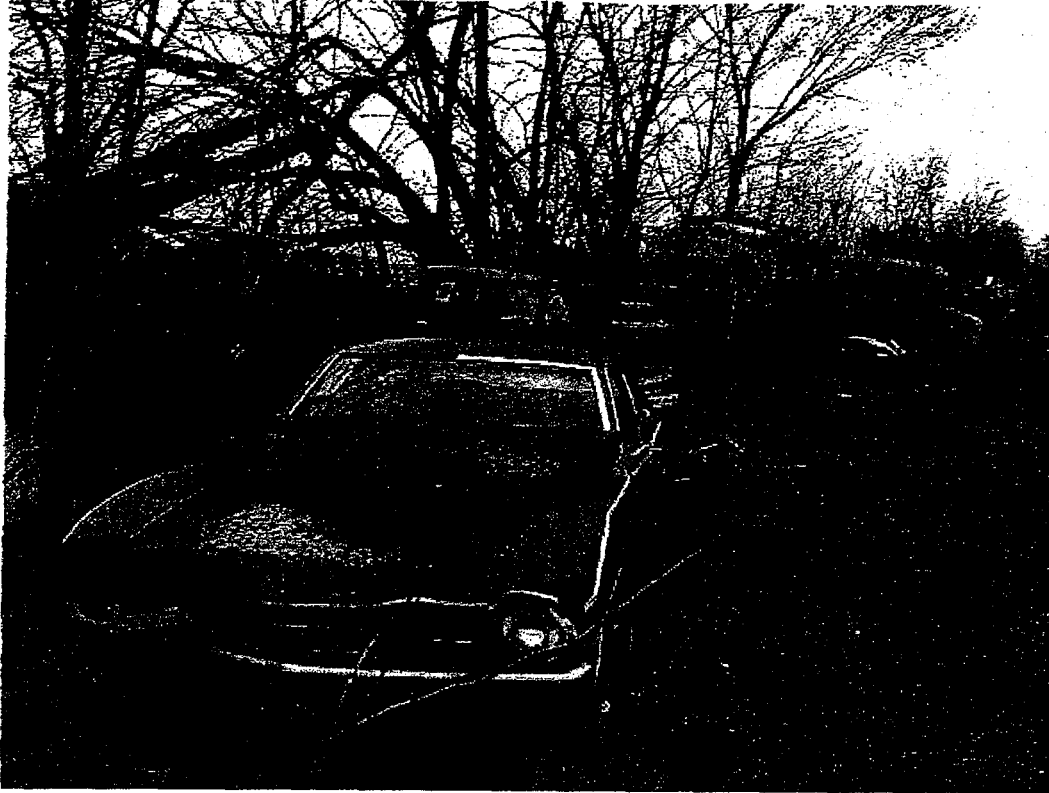
Date: April 1, 2005
Time: 10:26 am
Direction: SE
Photo by: M. Cozadd
Exposure #: 053
Comments: Abandoned vehicles, farm equipment and used tires along eastern edge of site

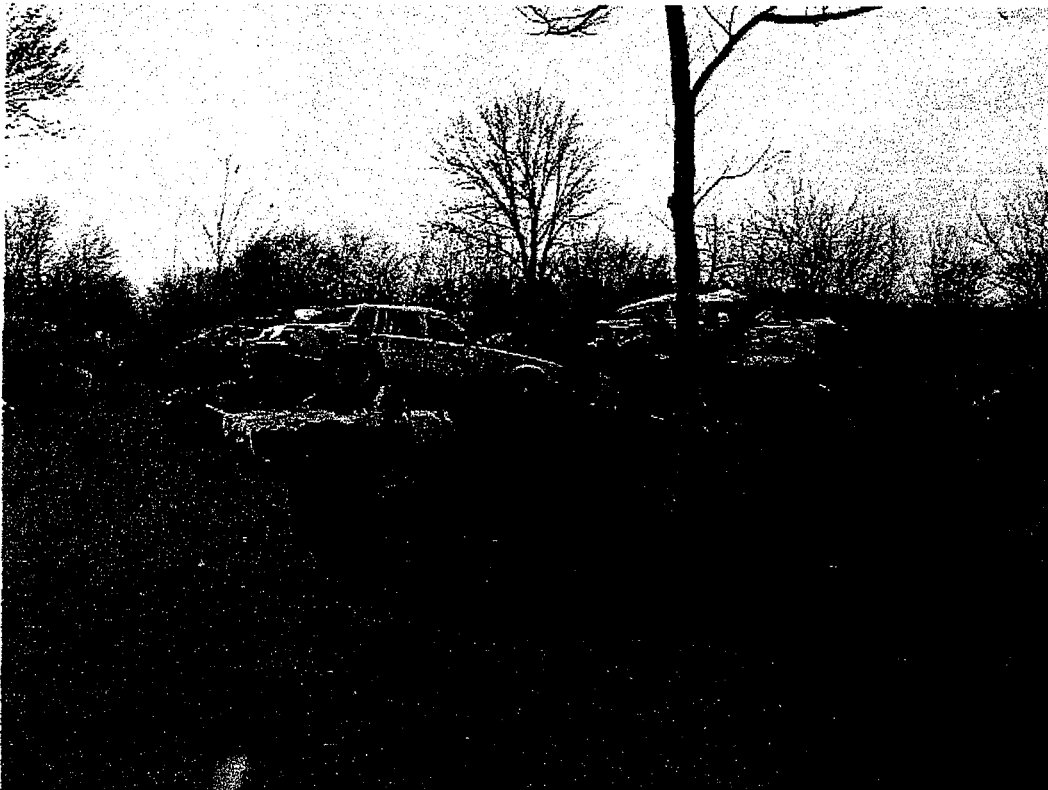
Date: April 1, 2005
Time: 10:26 am
Direction: SW
Photo by: M. Cozadd
Exposure #: 054
Comments: Tractors and abandoned vehicles in background that are stacked two high

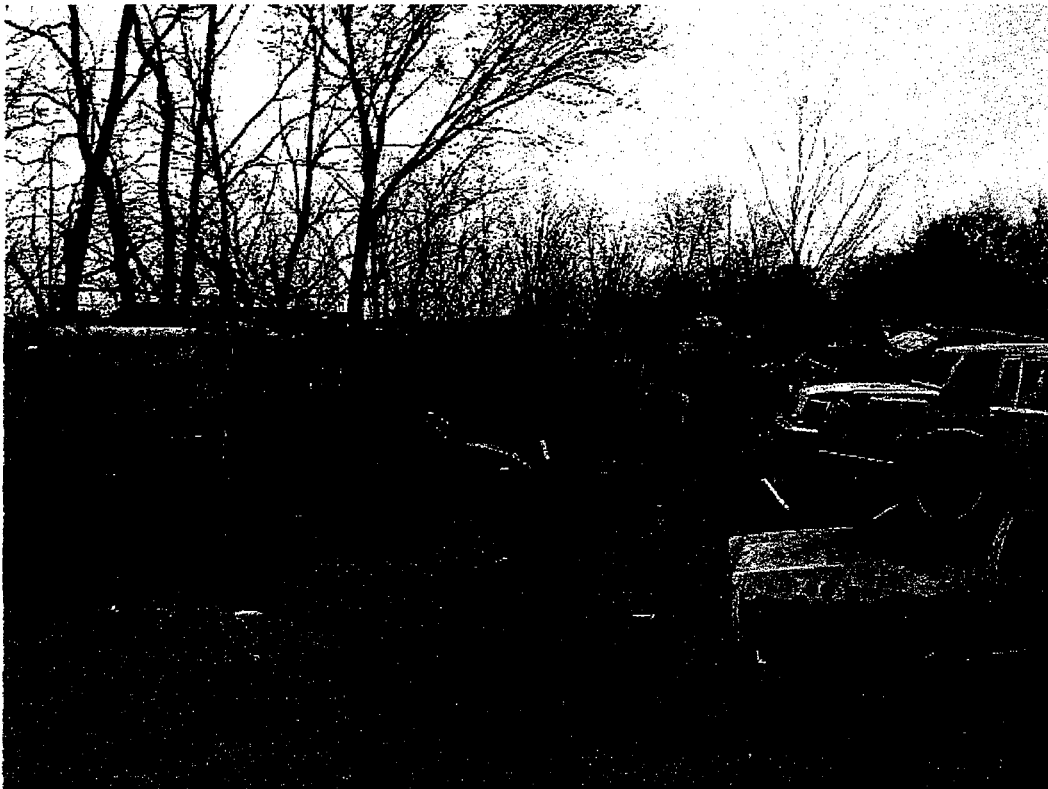
Date: April 1, 2005
Time: 10:28 am
Direction: S
Photo by: M. Cozadd
Exposure #: 056
Comments: Used tires
and abandoned vehicles

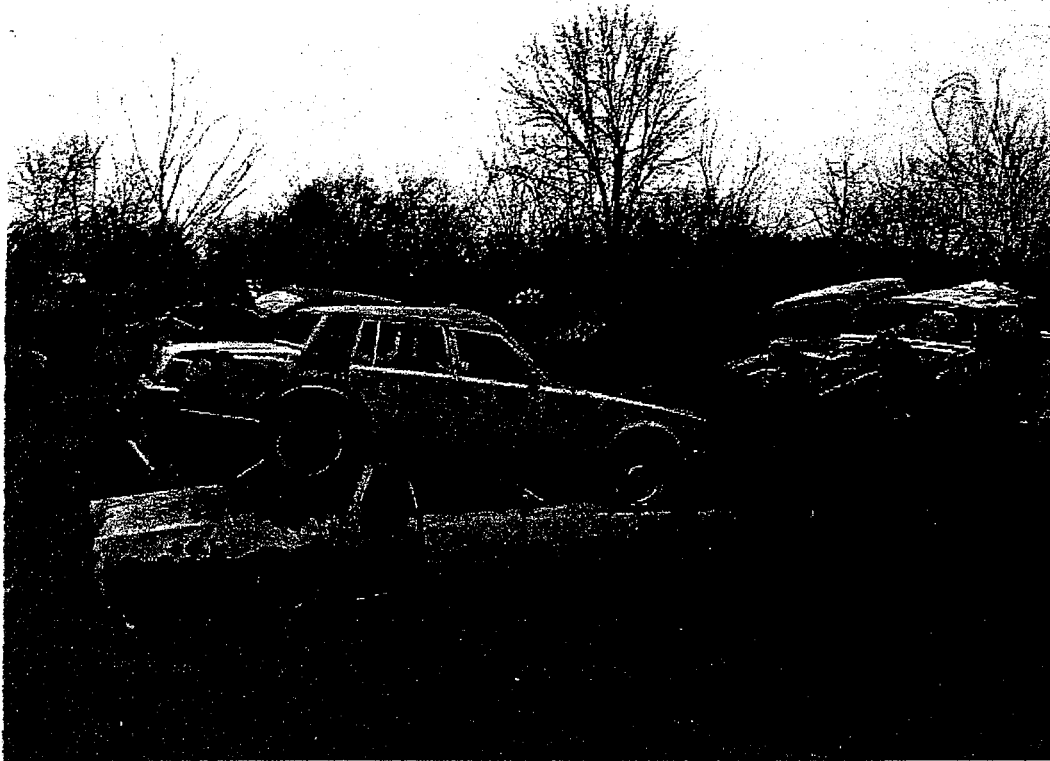
Date: April 1, 2005
Time: 10:28 am
Direction:
Photo by: M. Cozadd
Exposure #: 057
Comments: Abandoned
vehicles stacked two
high

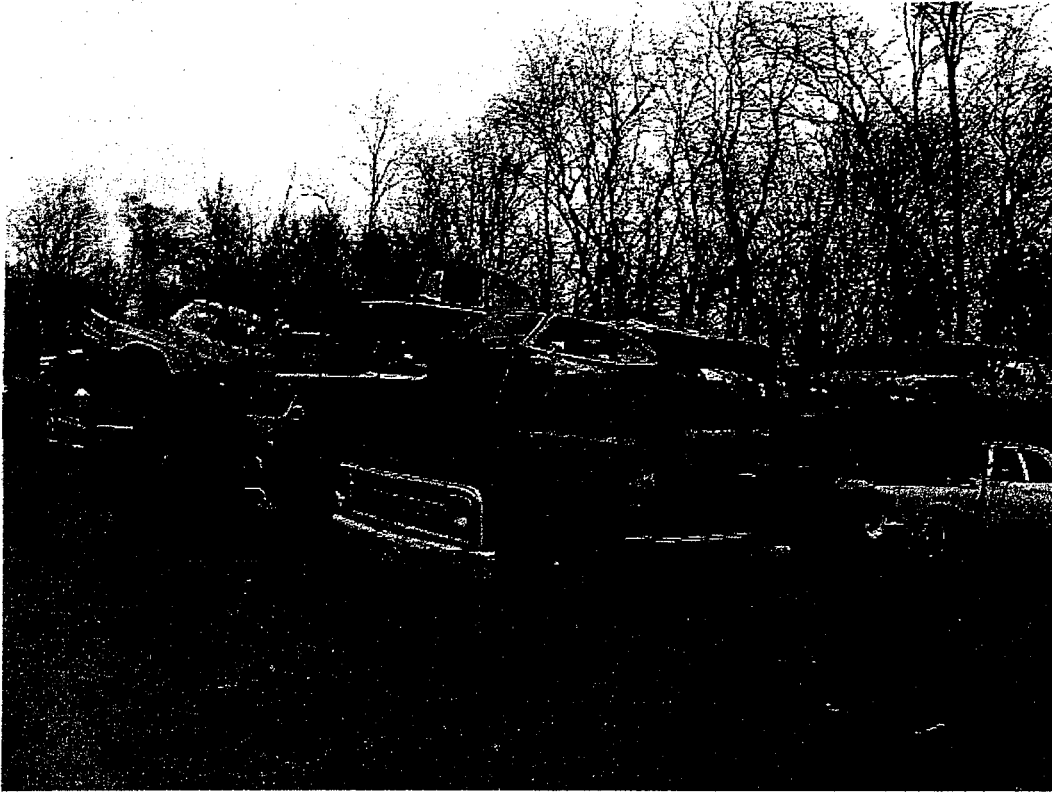
Date: April 1, 2005
Time: 10:31 am
Direction: NE
Photo by: M. Cozadd
Exposure #: 059
Comments: Abandoned vehicles stacked two high

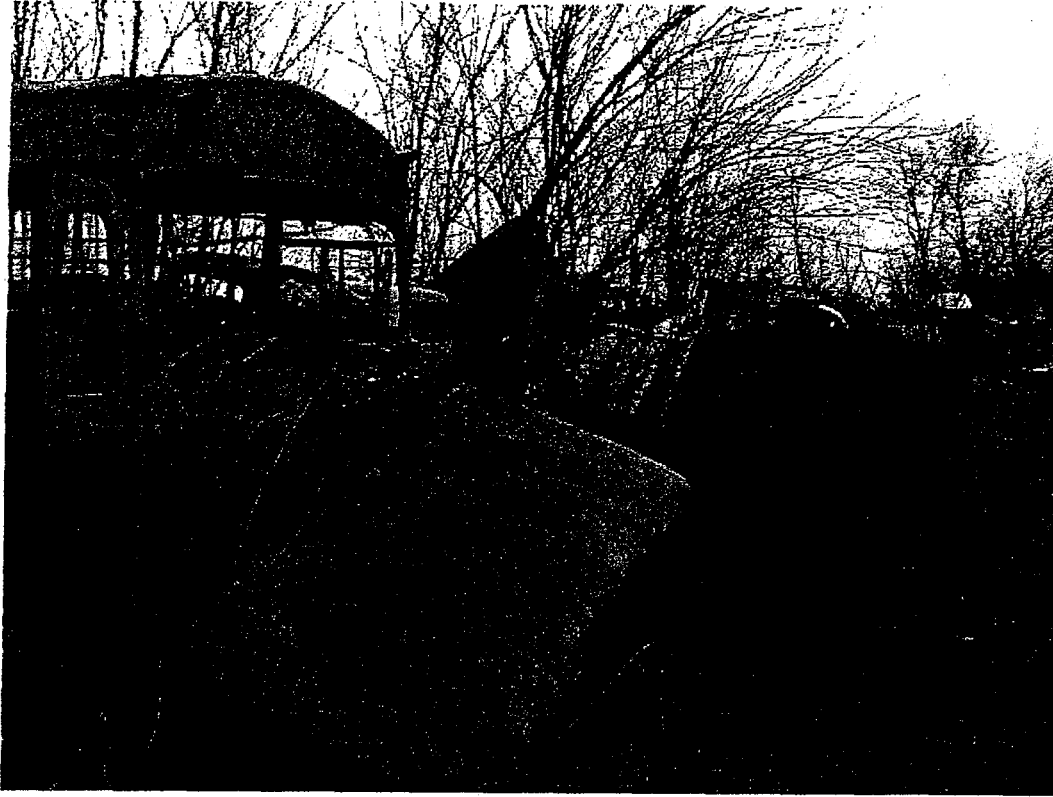
Date: April 1, 2005
Time: 10:32 am
Direction: S
Photo by: M. Cozadd
Exposure #: 061
Comments: Abandoned school bus, scrap metal, used tires and miscellaneous debris along eastern edge of site

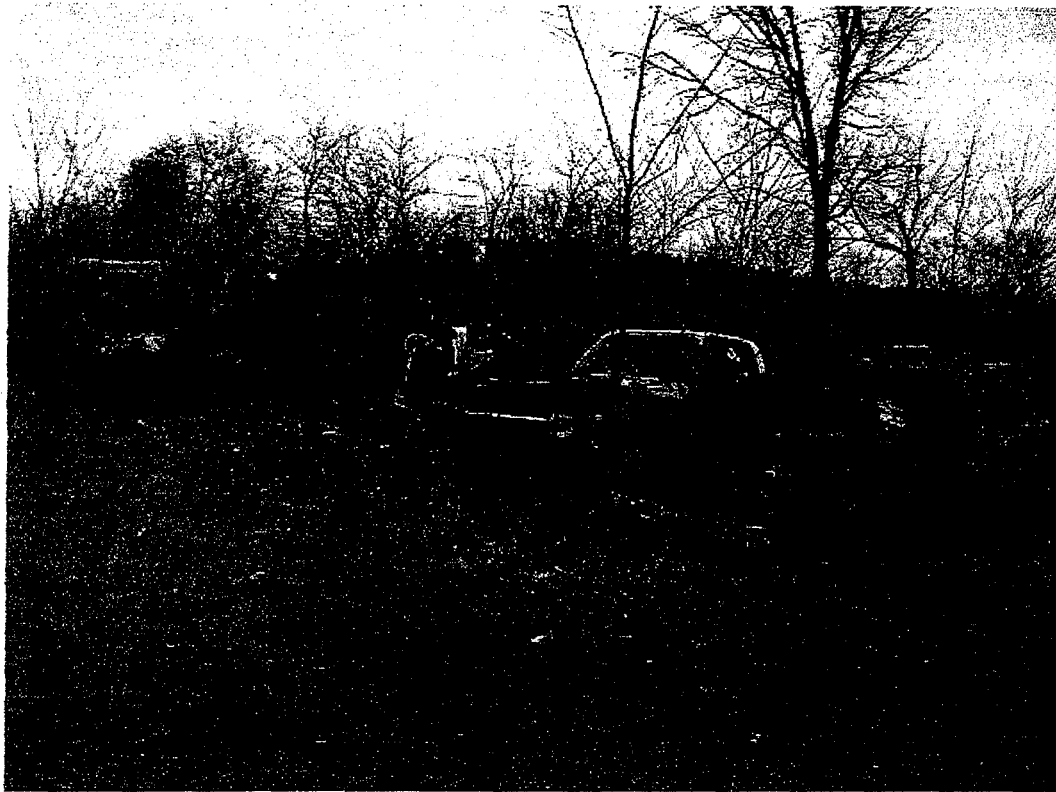
Date: April 1, 2005
Time: 10:32 am
Direction: NE
Photo by: M. Cozadd
Exposure #: 062
Comments: Scrap metal, abandoned vehicles, and pile of used tires along eastern edge of site

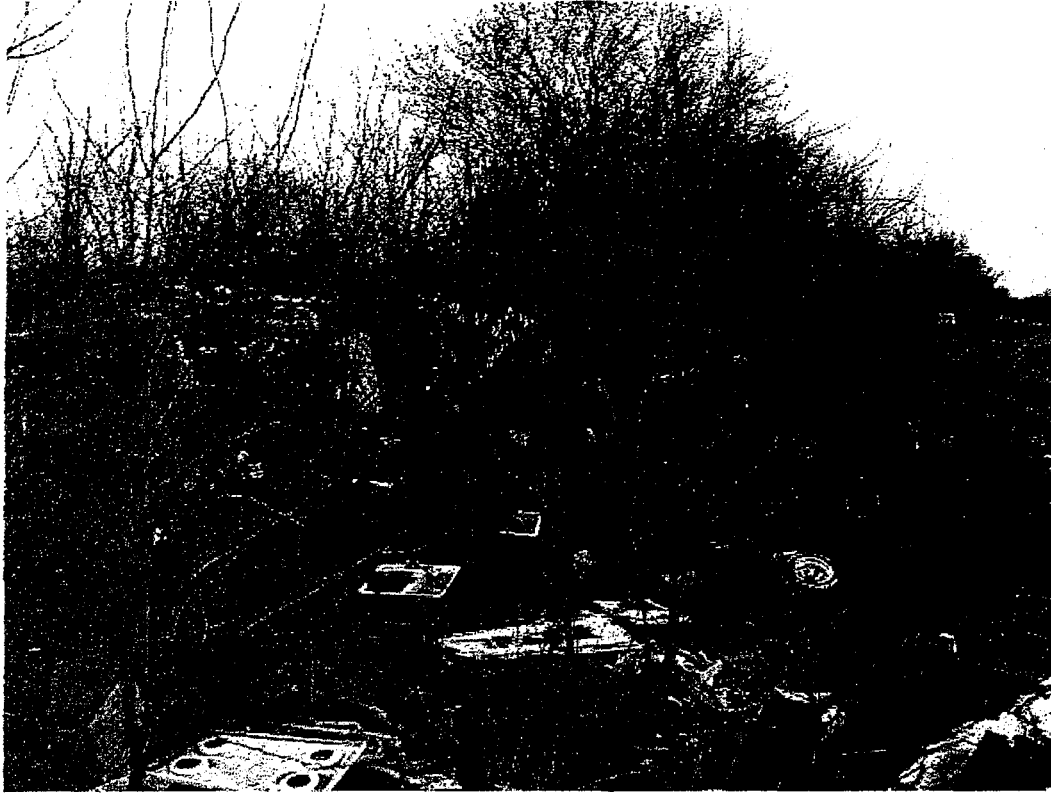
Date: April 1, 2005
Time: 10:35 am
Direction: N
Photo by: M. Cozadd
Exposure #: 065
Comments: Overview of
scrap metal and pile of
used tires on eastern
edge of site

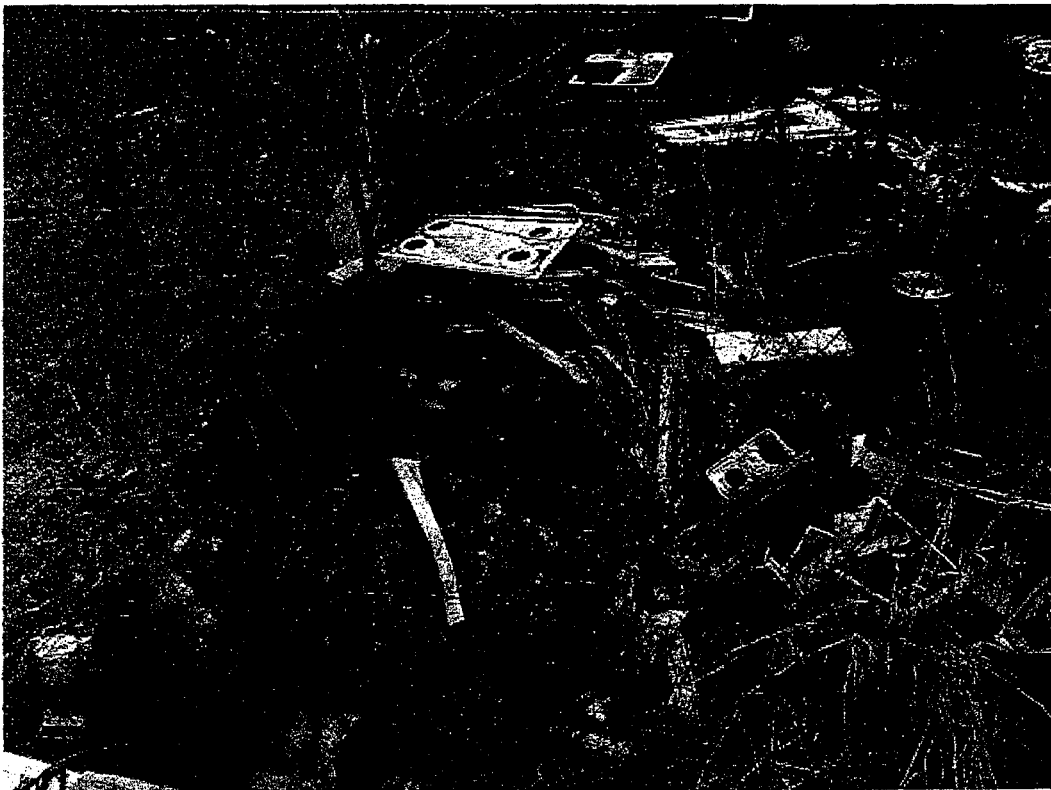
Date: April 1, 2005
Time: 10:35 am
Direction: NW
Photo by: M. Cozadd
Exposure #: 066
Comments: Scrap metal
and miscellaneous waste
scattered on ground

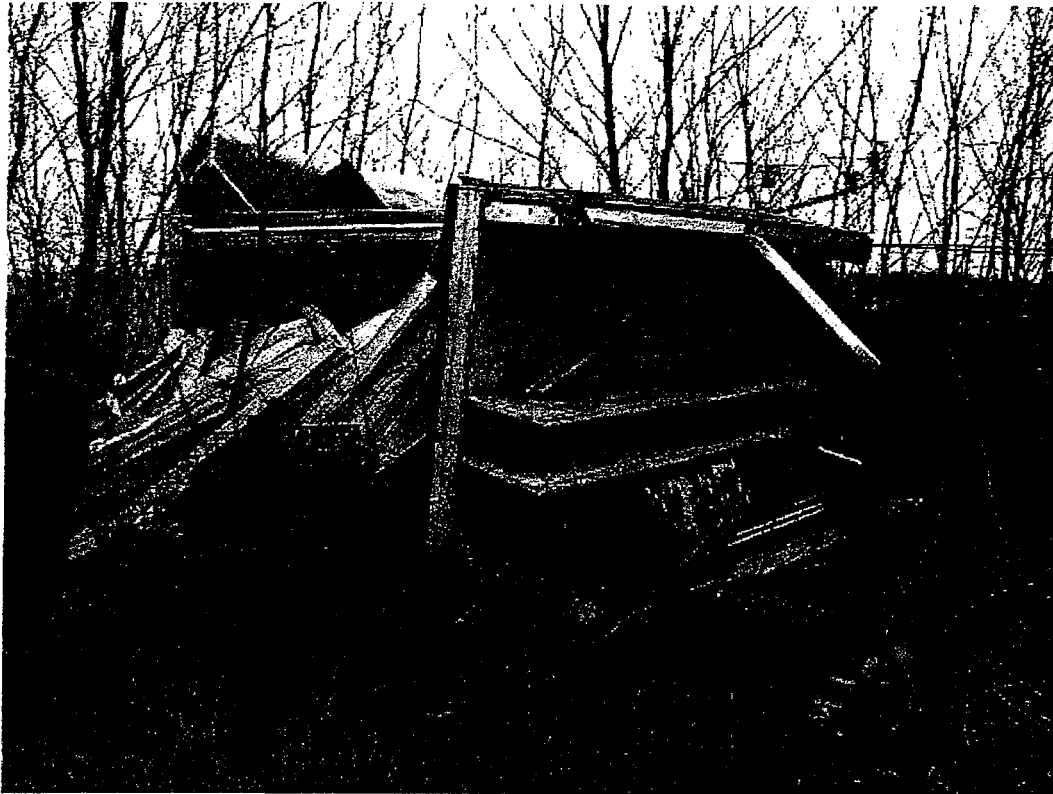
Date: April 1, 2005
Time: 10:34 am
Direction: SE
Photo by: M. Cozadd
Exposure #: 063
Comments: Metal shelving and other scrap metal

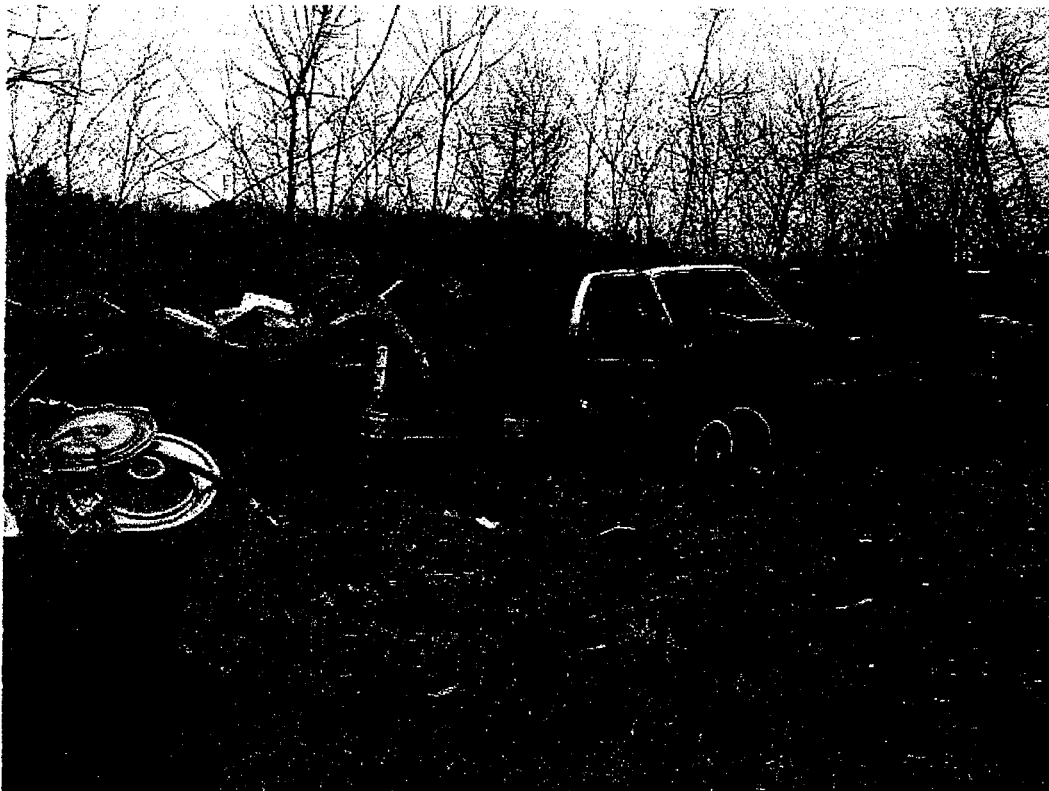
Date: April 1, 2005
Time: 10:34 am
Direction: SE
Photo by: M. Cozadd
Exposure #: 064
Comments: Abandoned vehicles and scrap metal near southern portion of site

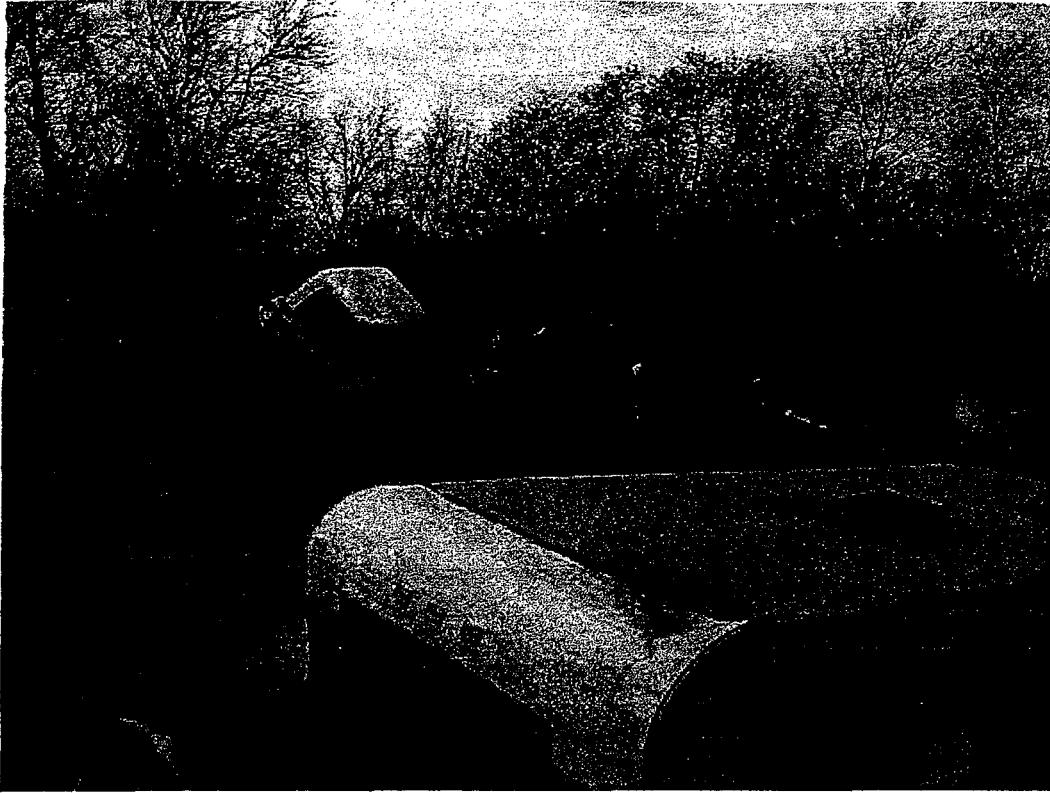
Date: April 1, 2005
Time: 10:39 am
Direction: S
Photo by: M. Cozadd
Exposure #: 069
Comments: Pile of
scrap metal and
abandoned vehicles on
south end of site.
Wooden crates contain
small gas tanks.
