ADMINISTRATIVE CITATION

AC 05-70
(IEPA No. 145-05-AC)

The purpose of this memorandum is to serve as the narrative for an inspection conducted on April 1, 2005 of the above referenced site. The inspection took place from about 9:25 am to 11:00 am. The weather conditions were sunny and approximately 50°F. Eighty-one digital photographs were taken to document the conditions of the site. No one was interviewed during the inspection.

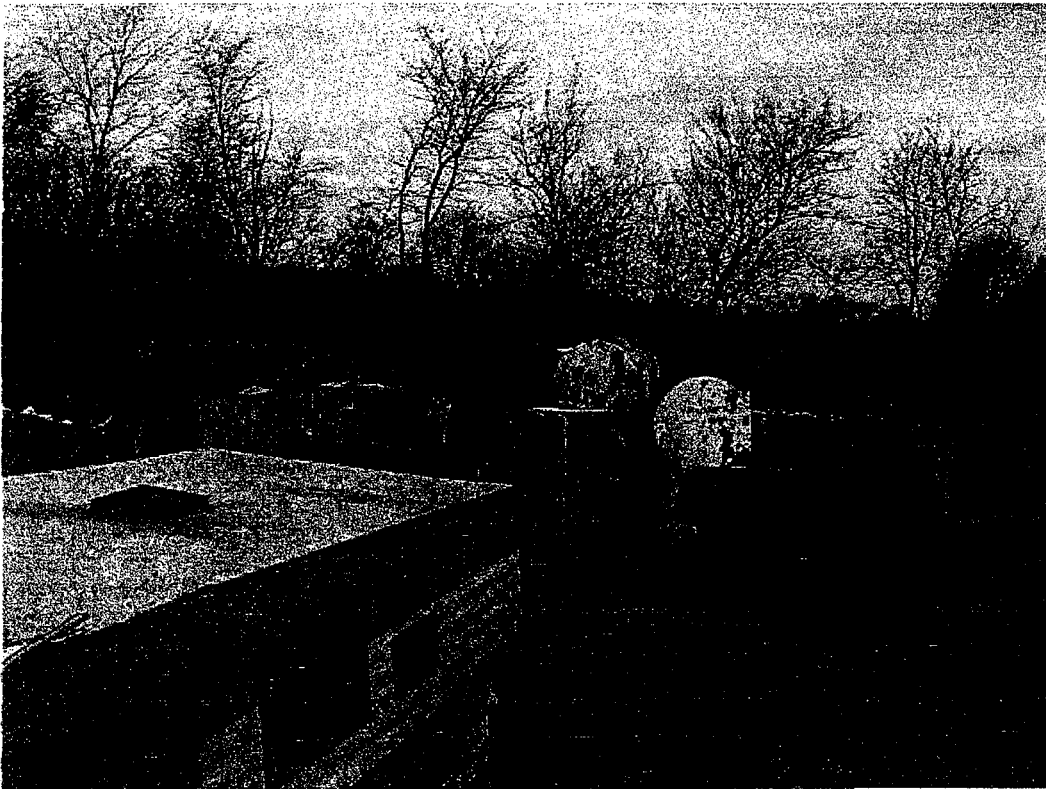
Date: April 1, 2005
Time: 10:39 am
Direction: W
Photo by: M. Cozadd
Exposure #: 070
Comments: Metal boxes
and metal tanks along
sand road

The area to the south of the stacked vehicles contained 4+ abandoned trucks and piles of scrap metal. The next area to the south contained 7+ large square metal boxes, 4+ metal tanks and scrap metal. The attached photo #070 shows the boxes and tanks in the background. The attached photo #071 shows several wood crates filled with gas tanks. Some of the gas tanks were observed spilled out of a crate on the ground.

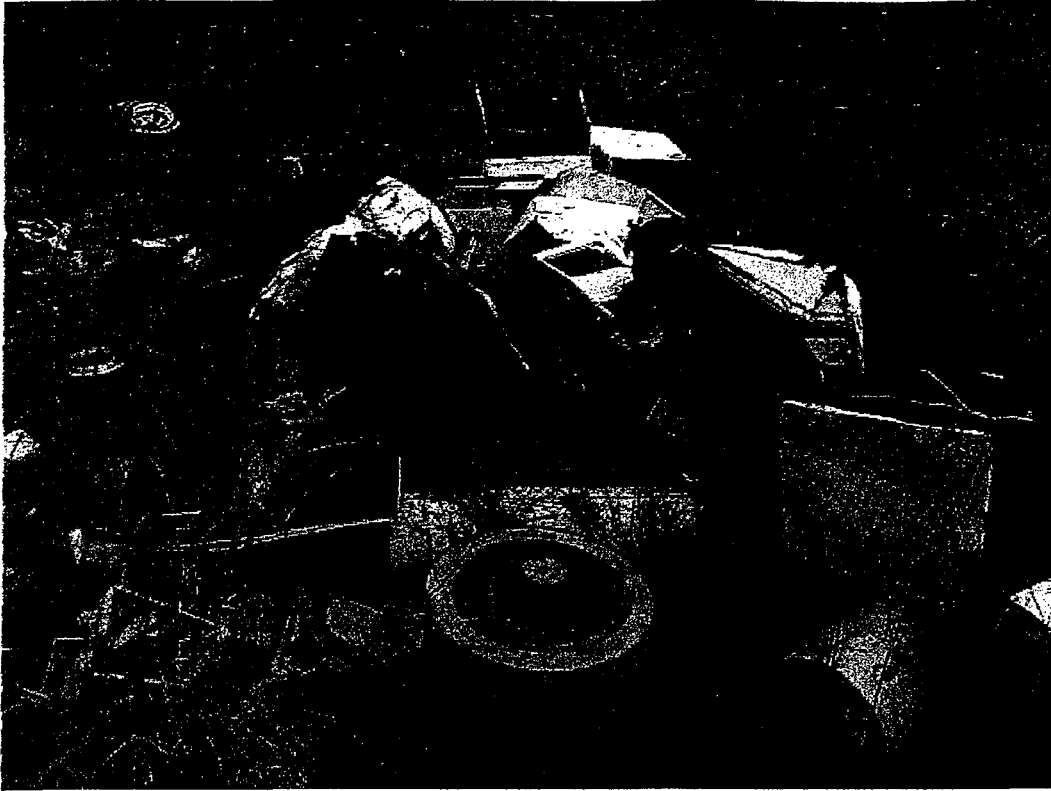
Date: April 1, 2005
Time: 10:35 am
Direction: NE
Photo by: M. Cozadd
Exposure #: 067
Comments: Pile of white goods south of the pile of used tires

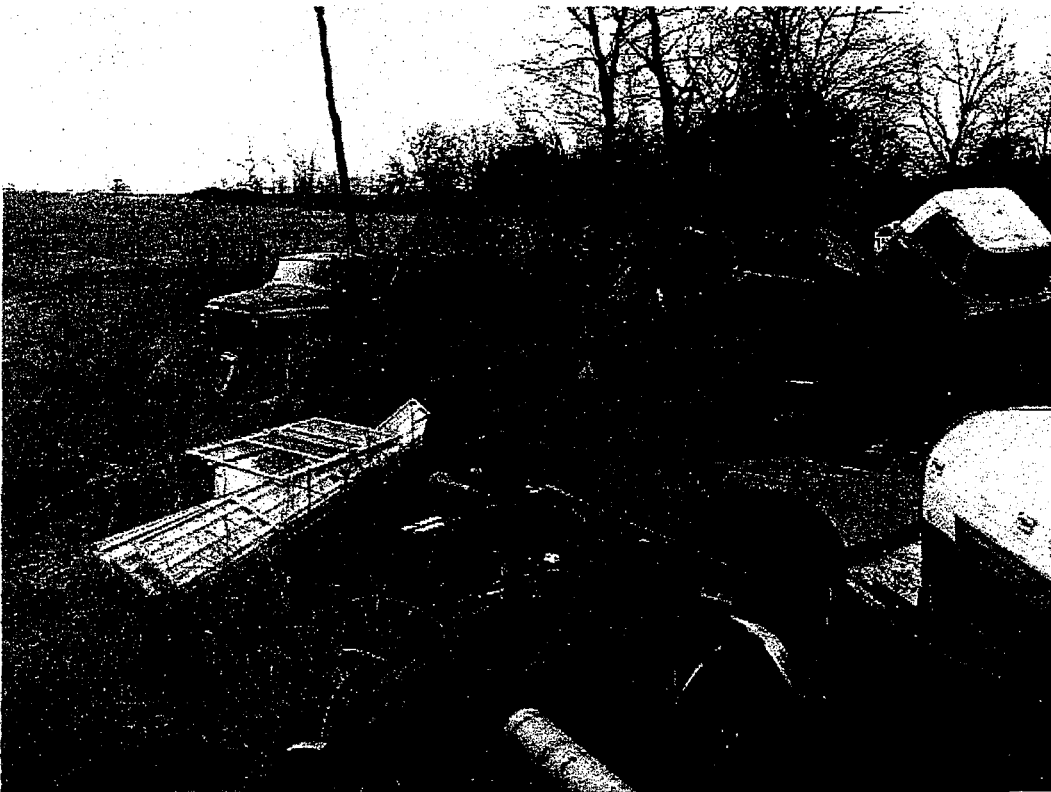
Date: April 1, 2005
Time: 10:39 am
Direction: SE
Photo by: M. Cozadd
Exposure #: 068
Comments: Pile of scrap metal and abandoned vehicles on south end of site

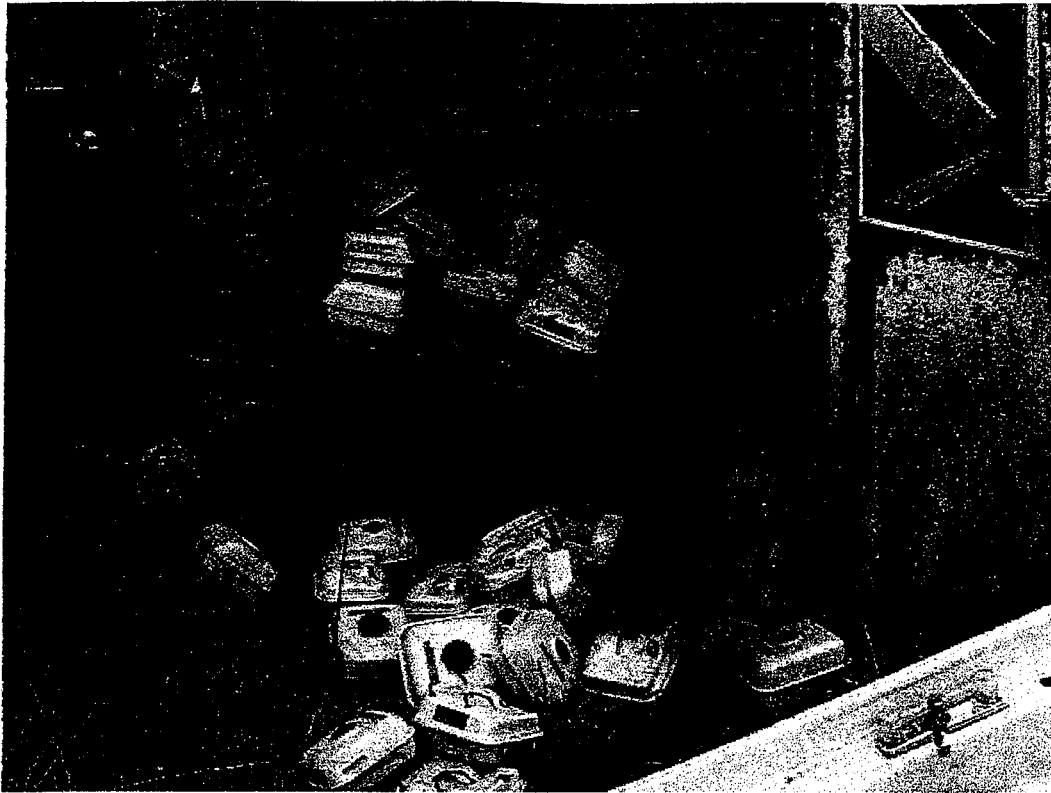
Date: April 1, 2005
Time: 10:40 am
Direction: SE
Photo by: M. Cozadd
Exposure #: 071
Comments: Gas tanks
in wood crates spilling on
ground

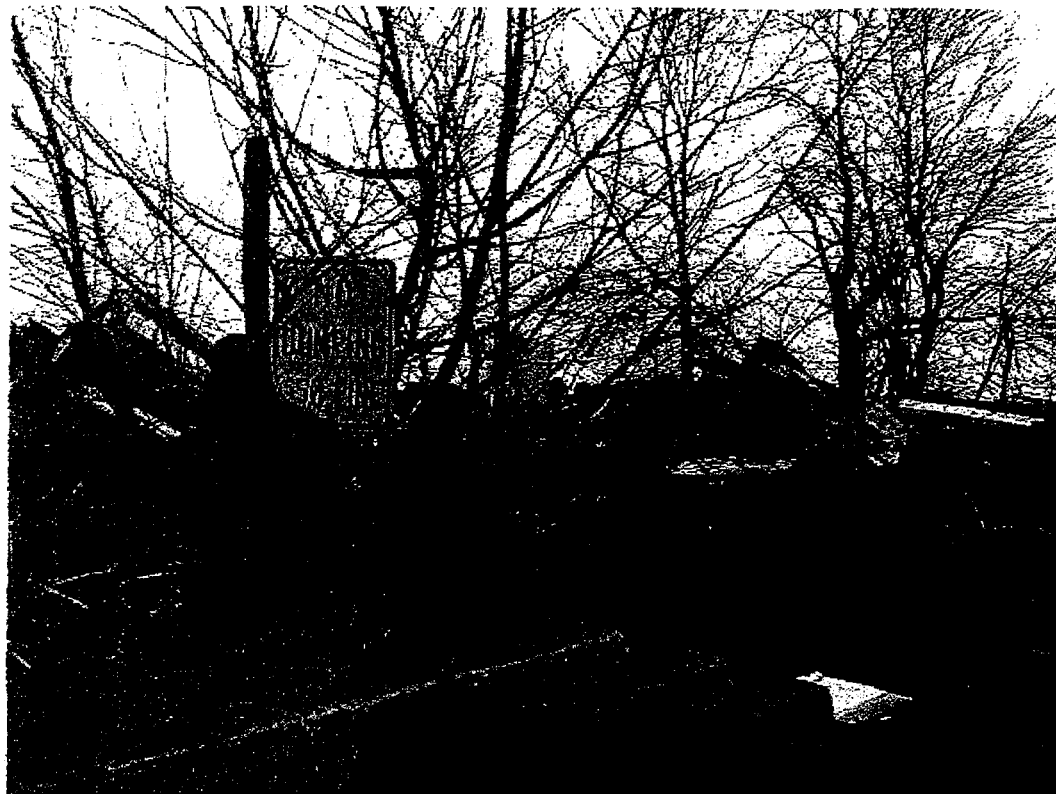
The large broken pieces of concrete just north of the large pile of tires and northwest of the large scrap metal pile are shown in the attached photos #073 and #074. The large pile of 500+ used tires on the southern end of the site is shown in the attached photos #076 and #077. This pile of used tires and the adjacent scrap metal pile were also observed at the site during the July 9, 1999 inspection. There is a significant increase in the amount of used tires and scrap metal in these piles. In addition, there is an overall increase in the amount of waste materials at the site since the previous inspection on August 27, 2002.

Date: April 1, 2005
Time: 10:44 am
Direction: SE
Photo by: M. Cozadd
Exposure #: 073
Comments: Broken
concrete pieces with pile
of scrap metal in
background

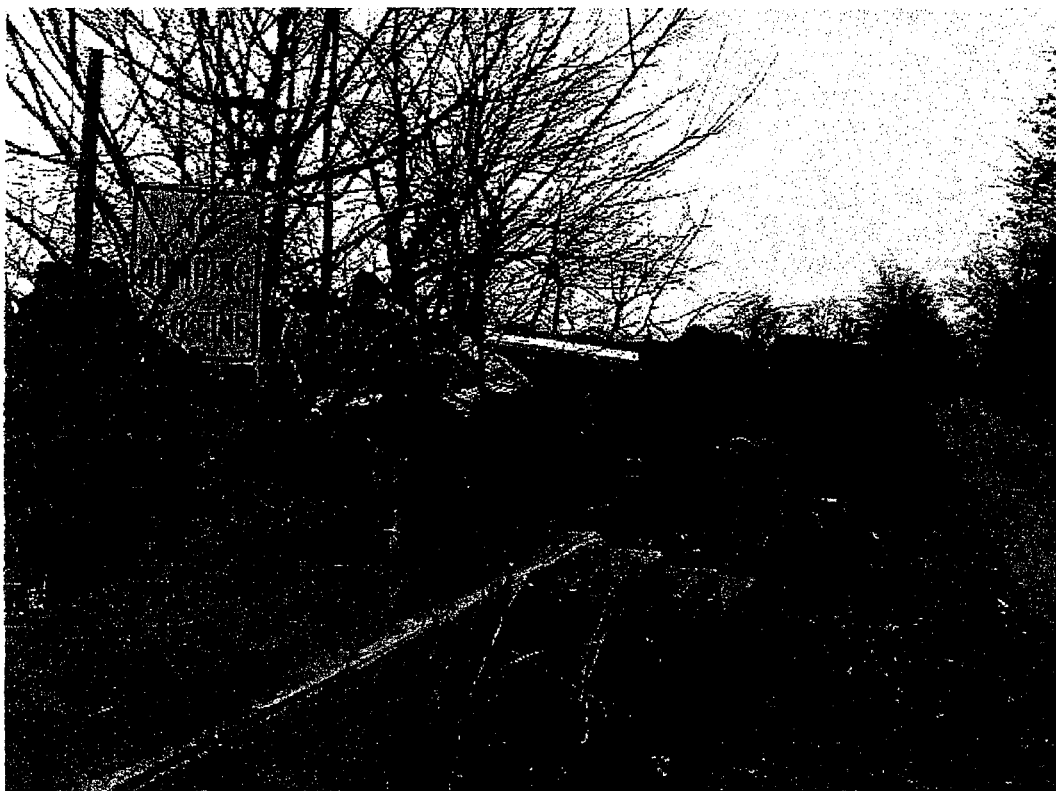
Date: April 1, 2005
Time: 10:44 am
Direction: S
Photo by: M. Cozadd
Exposure #: 074
Comments: Broken
concrete pieces with pile
of used tires in
background

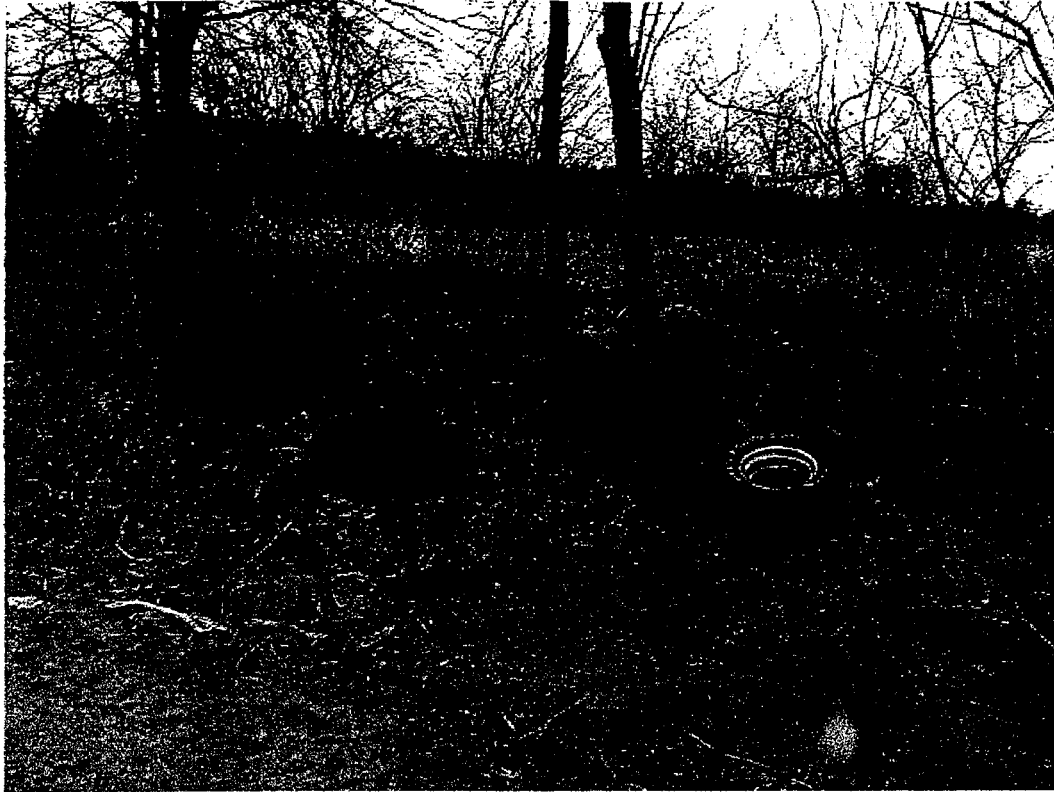
Date: April 1, 2005
Time: 10:44 am
Direction: SW
Photo by: M. Cozadd
Exposure #: 075
Comments: Used tires
on western edge of the
sand road

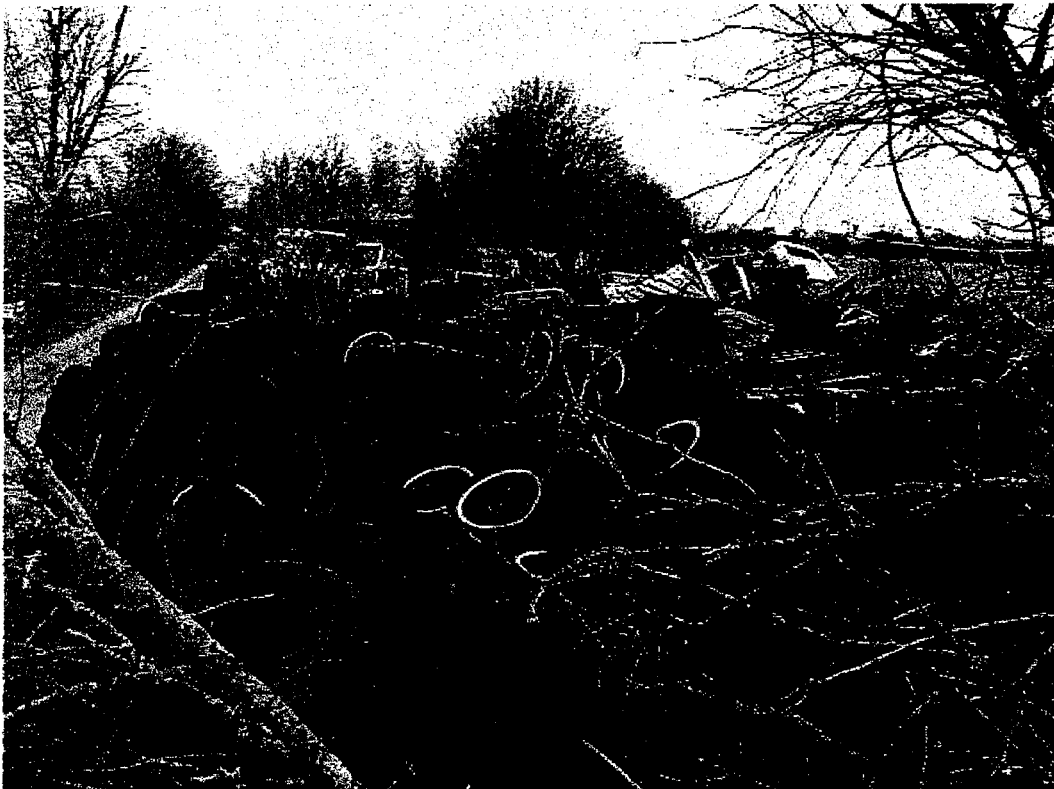
Date: April 1, 2005
Time: 10:46 am
Direction: N
Photo by: M. Cozadd
Exposure #: 076
Comments: Close-up
view of large pile of used
tires on south end of site

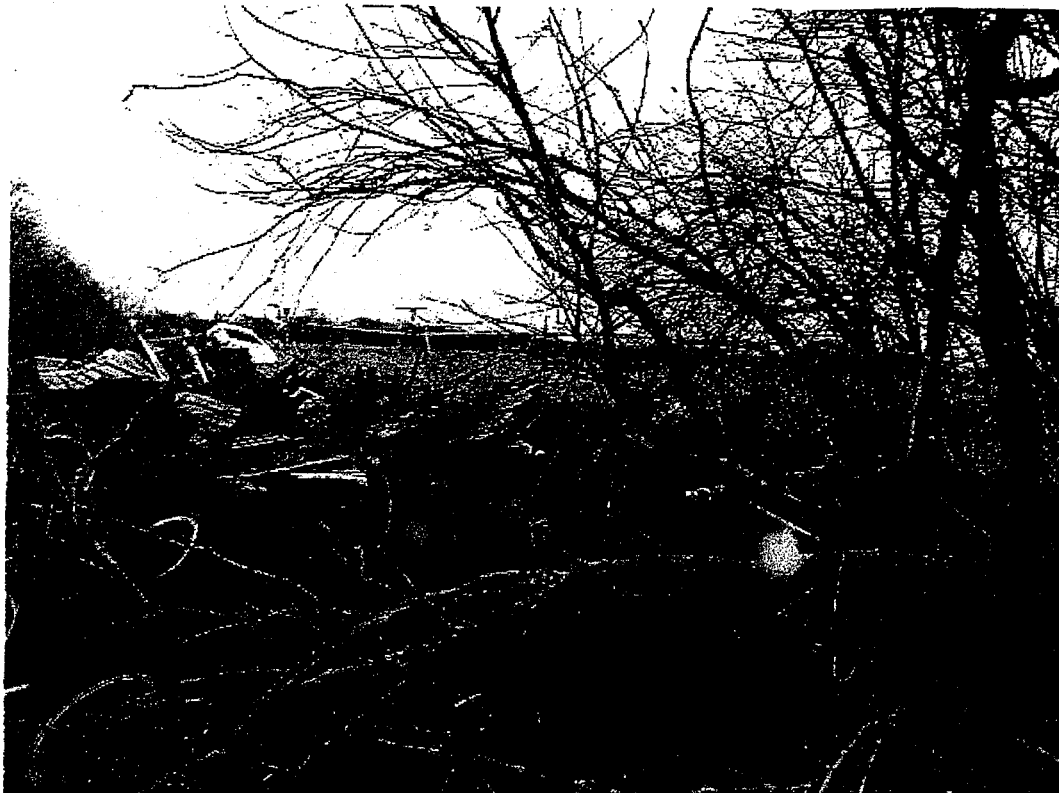
Date: April 1, 2005
Time: 10:46 am
Direction: NE
Photo by: M. Cozadd
Exposure #: 077
Comments: Used tire pile and scrap metal pile on south end of site

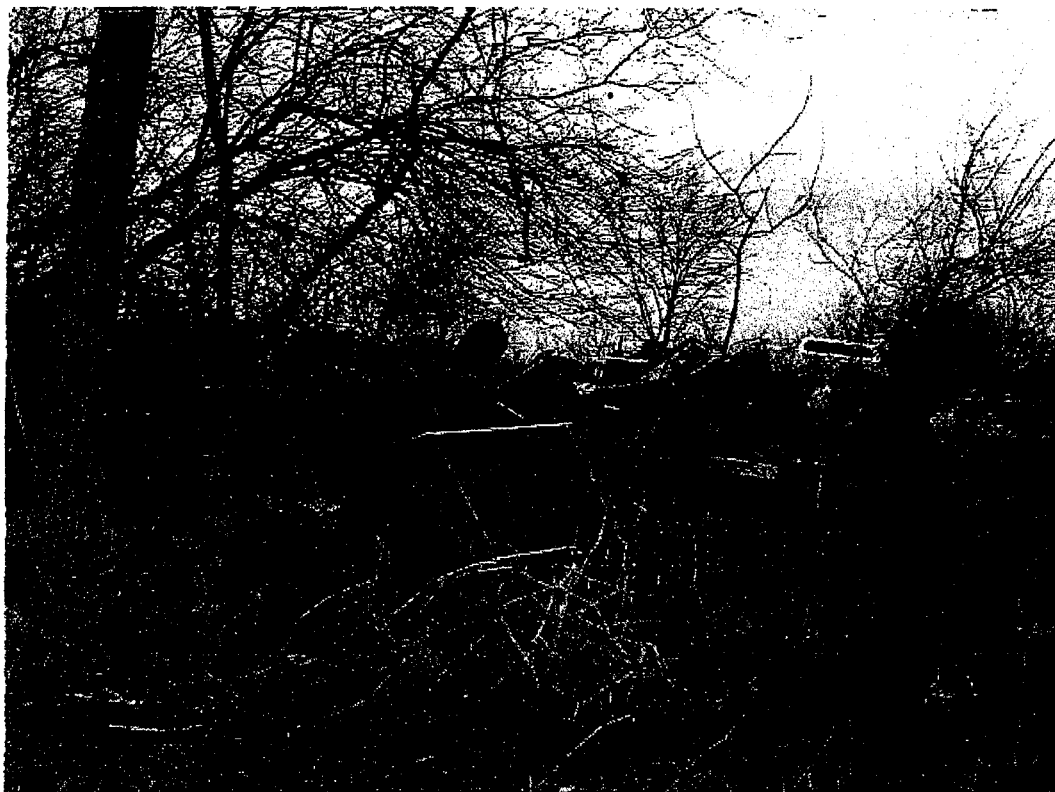
Date: April 1, 2005
Time: 10:46 am
Direction: NW
Photo by: M. Cozadd
Exposure #: 078
Comments: Scrap metal pile on south end of site

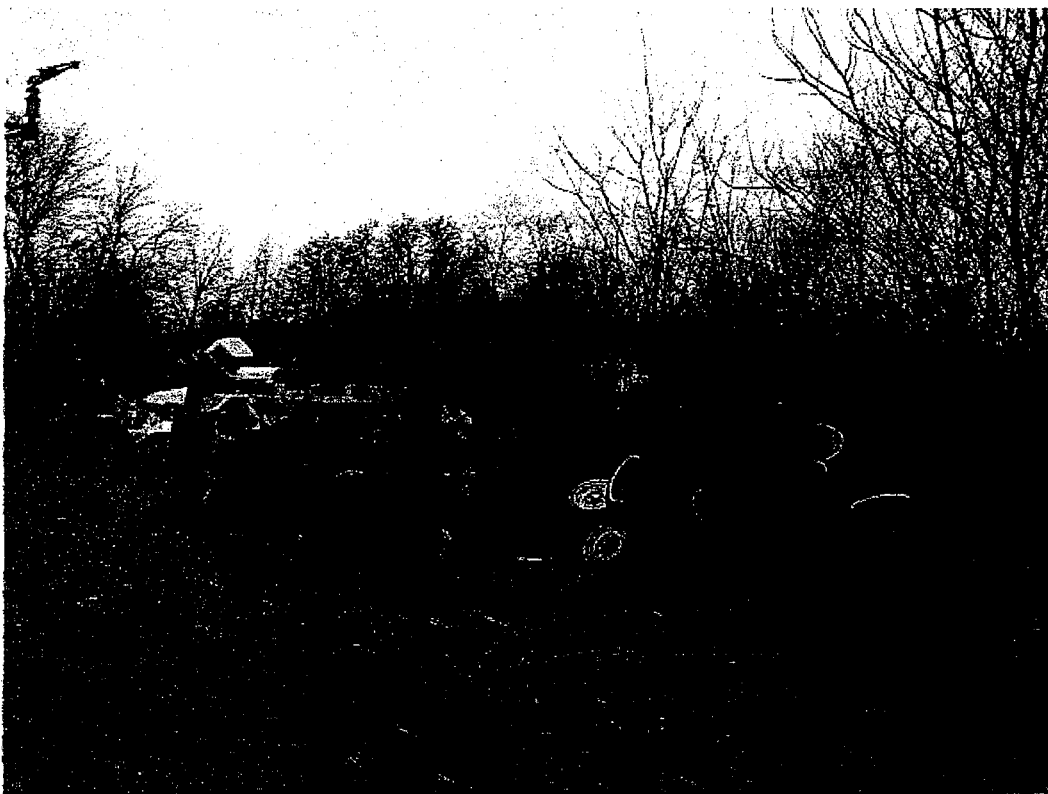
Date: April 1, 2005
Time: 10:47 am
Direction: SW
Photo by: M. Cozadd
Exposure #: 080
Comments: Pile of used
tires and metal rims on
eastern edge of site
