Re: Illinois Environmental Protection Agency v. John H. and Kathy D. Still
IEPA File No. 132-10-AC; 0098050005—Brown County

ADMINISTRATIVE CITATION

Subject: LPC# 0098050005 – Brown County
Mt. Sterling/Still
Complaints C-10-048-C and C-10-063-C
FOS File

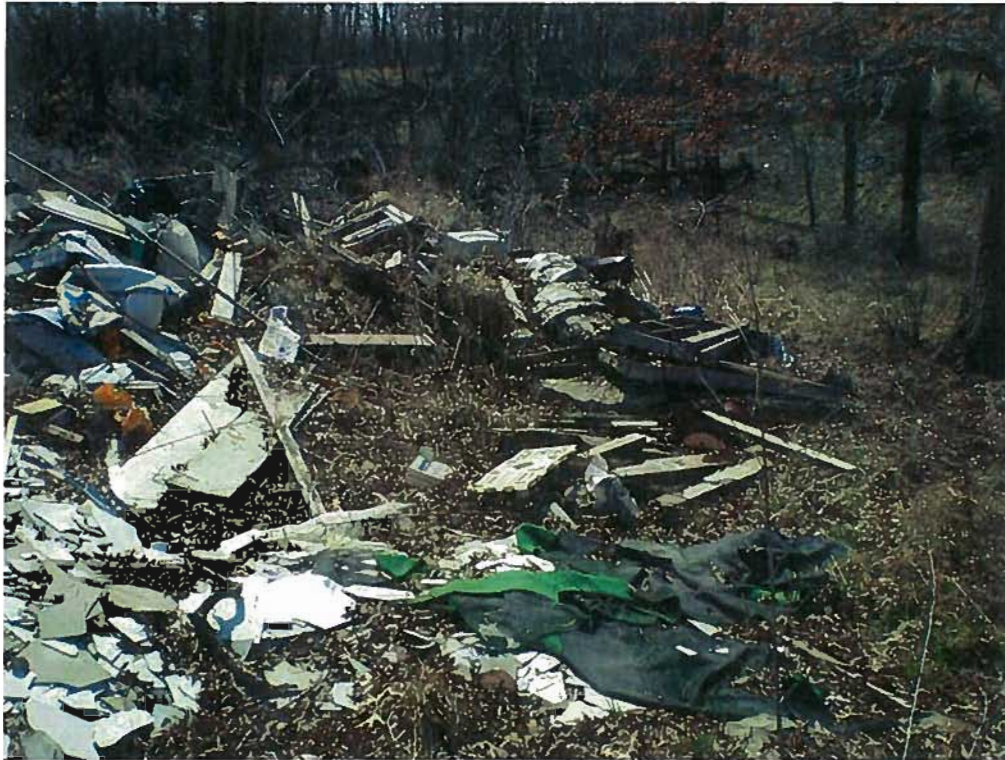
Date: March 18, 2010
Time: 12:31 PM
Direction: South
Photo by: W Zierath
Exposure #: 001
Comments: The west part of the site showing demolition waste including wood, aluminum siding, carpet, shingles and asbestos siding.

March 18 photograph 001 shows demolition waste including wood, aluminum siding, carpet, shingles and asbestos siding that is shown in October 16 photograph 004.

Wood demolition waste at the site is shown in March 18 photographs 001, 002, 003, 005, 006, 007, 008, 009, 010, 011, 013, 014, 015, 016, 018, 019, 021, and 026.

Waste aluminum siding is shown in March 18 photographs 001, 002, 003, 007, 008, and 009.

Asbestos siding demolition waste is shown in March 18 photographs 001, 002, 004, 007, 008, and 014.

Waste shingles are shown in March 18 photographs 001, 002, 007, 008, 013, 014, 015, 016, 017, 018, and 019.

Waste carpet is shown in March 18 photographs 001, 002, 007, and 008.

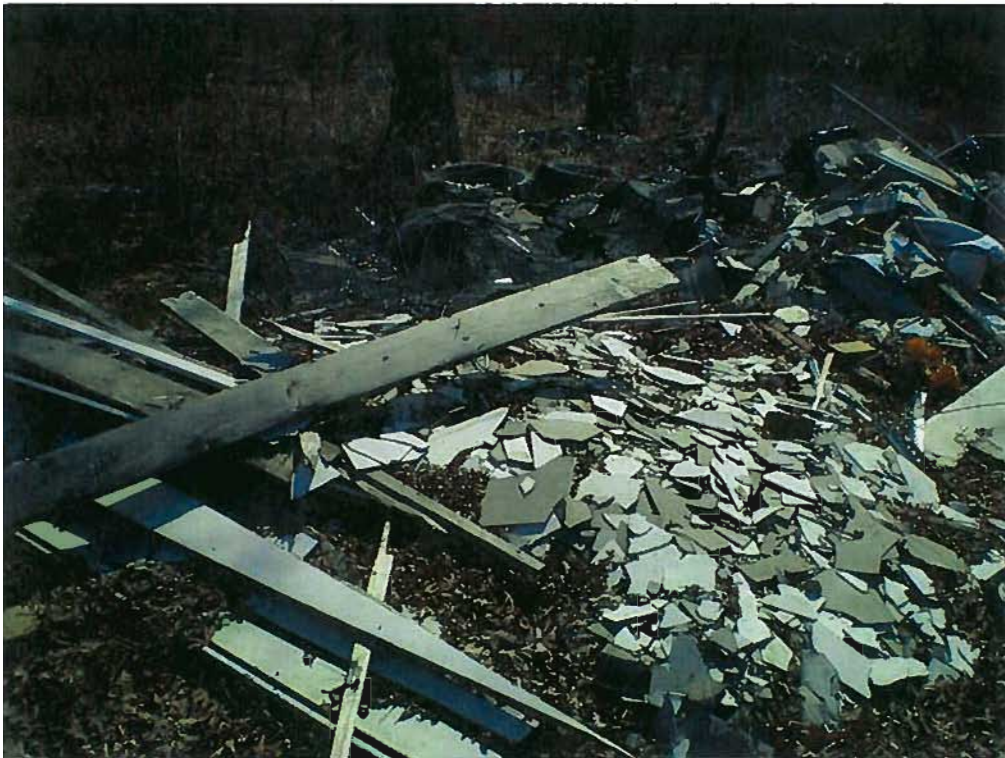
Date: March 18, 2010
Time: 12:32 PM
Direction: Southeast
Photo by: W Zierath
Exposure #: 002
Comments: The central part of the site showing demolition waste including wood, aluminum siding, carpet, shingles and asbestos siding.

March 18 photograph 002 shows demolition waste including wood, aluminum siding, carpet, shingles and asbestos siding that is shown in October 16 photograph 005.

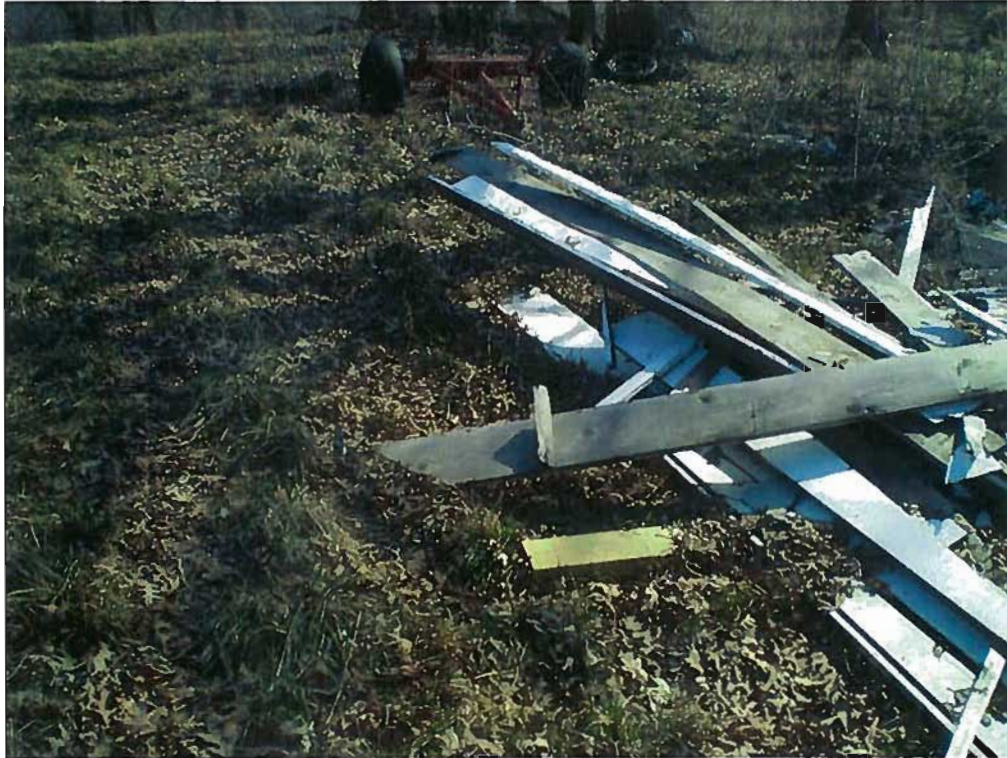
Date: March 18, 2010
Time: 12:32 PM
Direction: East
Photo by: W Zlerath
Exposure #: 003
Comments: The north edge of the site showing demolition waste including wood and aluminum siding.

March 18 photograph 003 shows demolition waste including wood and aluminum siding that is shown in October 16 photograph 006.

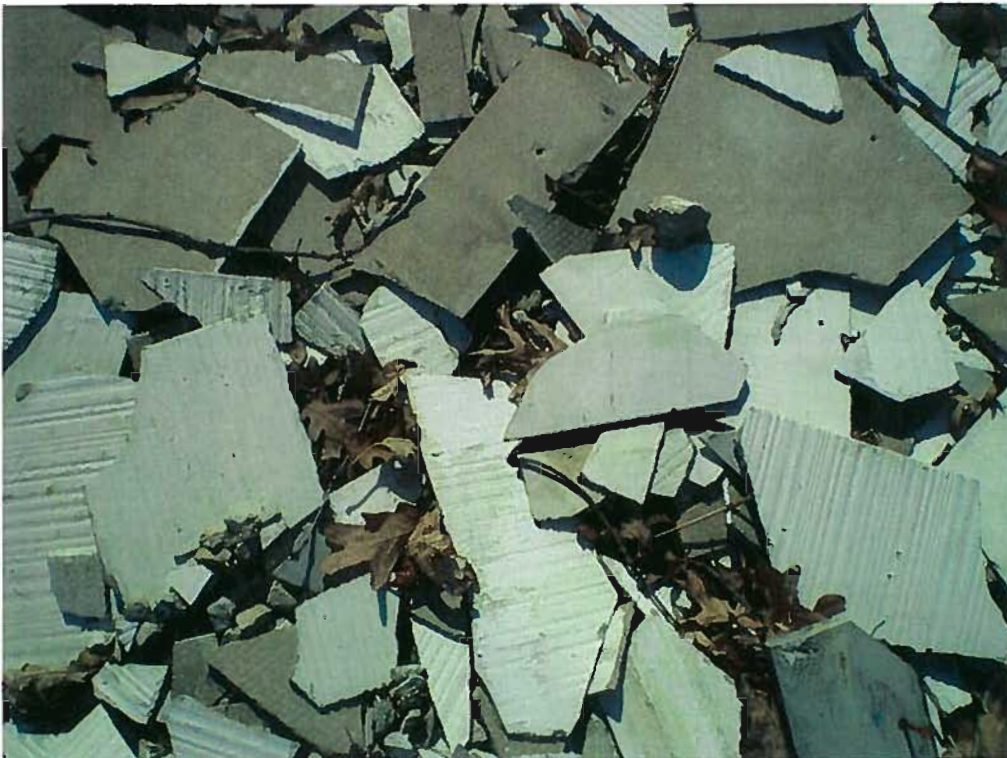
Date: March 18, 2010
Time: 12:32 PM
Direction: South
Photo by: W Zlerath
Exposure #: 004
Comments: The northern part of the site showing asbestos siding demolition waste.

March 18 photograph 004 shows asbestos siding demolition waste that is shown in October 16 photographs 007 and 008.

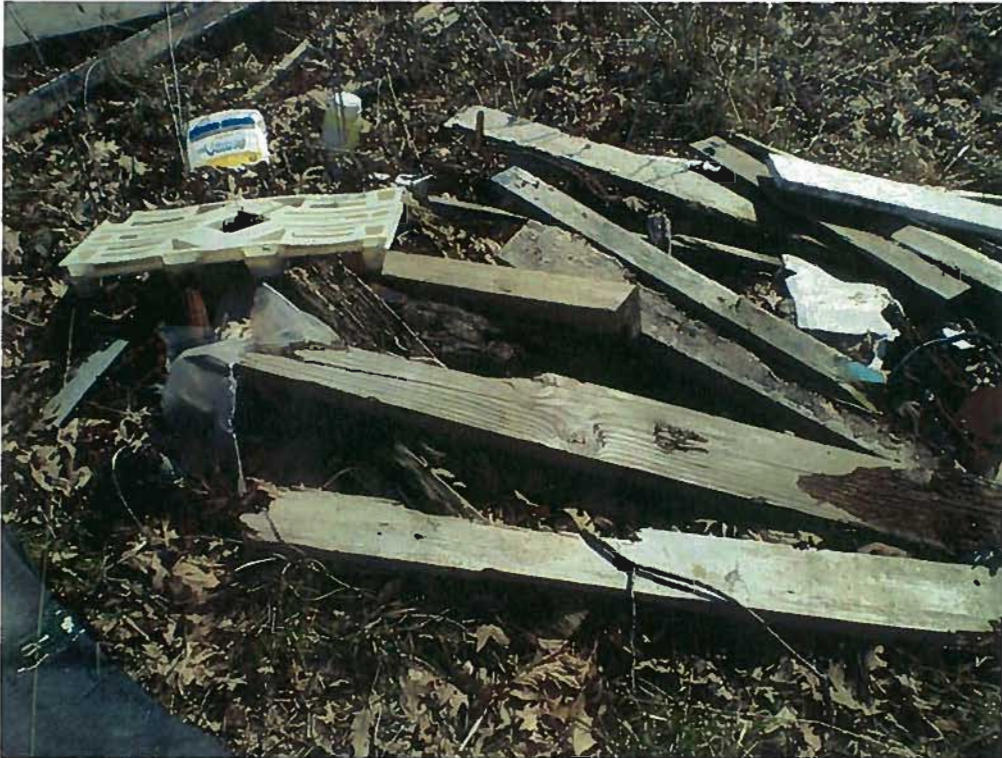
Date: March 18, 2010
Time: 12:32 PM
Direction: East
Photo by: W Zierath
Exposure #: 005
Comments: The west part of the site showing wood demolition waste and pieces of plastic.

Plastic waste is shown in March 18 photographs 005, 007, 008, and 009.

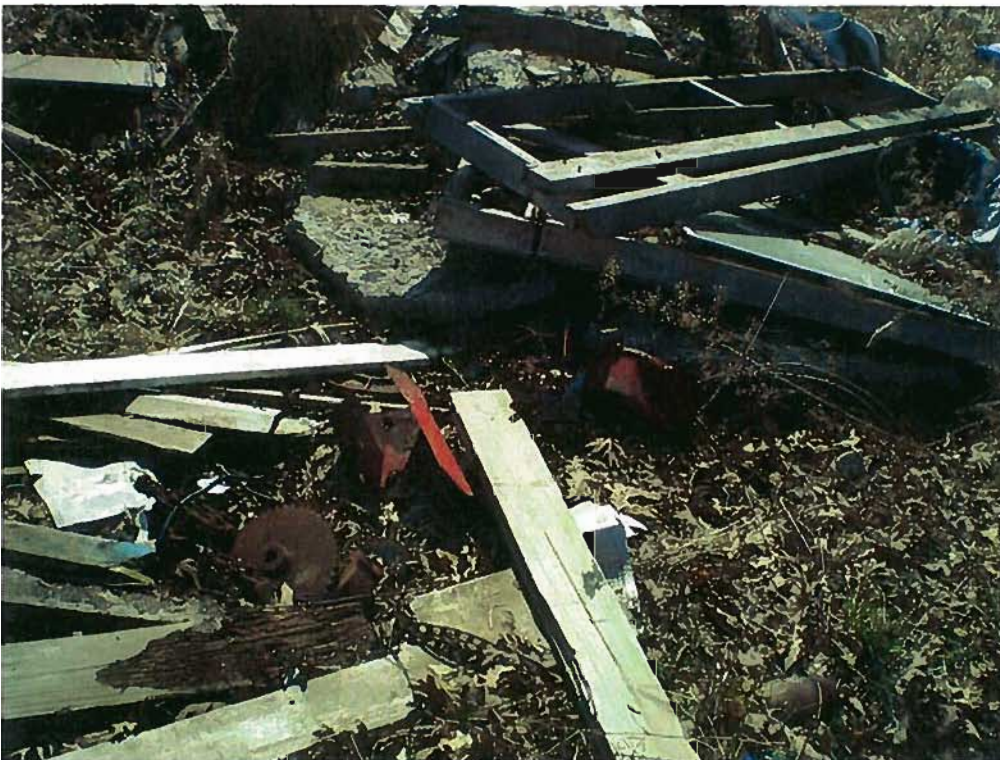
Date: March 18, 2010
Time: 12:32 PM
Direction: Southeast
Photo by: W Zierath
Exposure #: 006
Comments: The west part of the site showing wood demolition waste, scrap metal and broken concrete.

Broken concrete is shown in March 18 photograph 006.

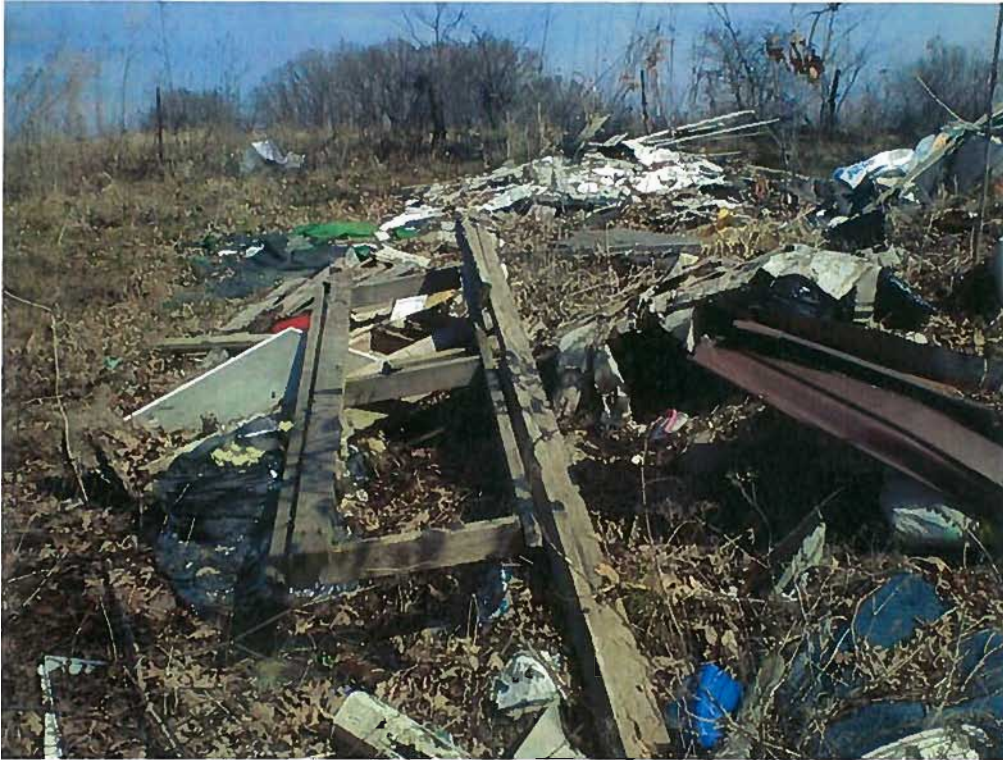
Date: March 18, 2010
Time: 12:33 PM
Direction: North
Photo by: W Zierath
Exposure #: 007
Comments: The west part of the site showing demolition waste including wood, aluminum siding, carpet, shingles, plastic and asbestos siding.

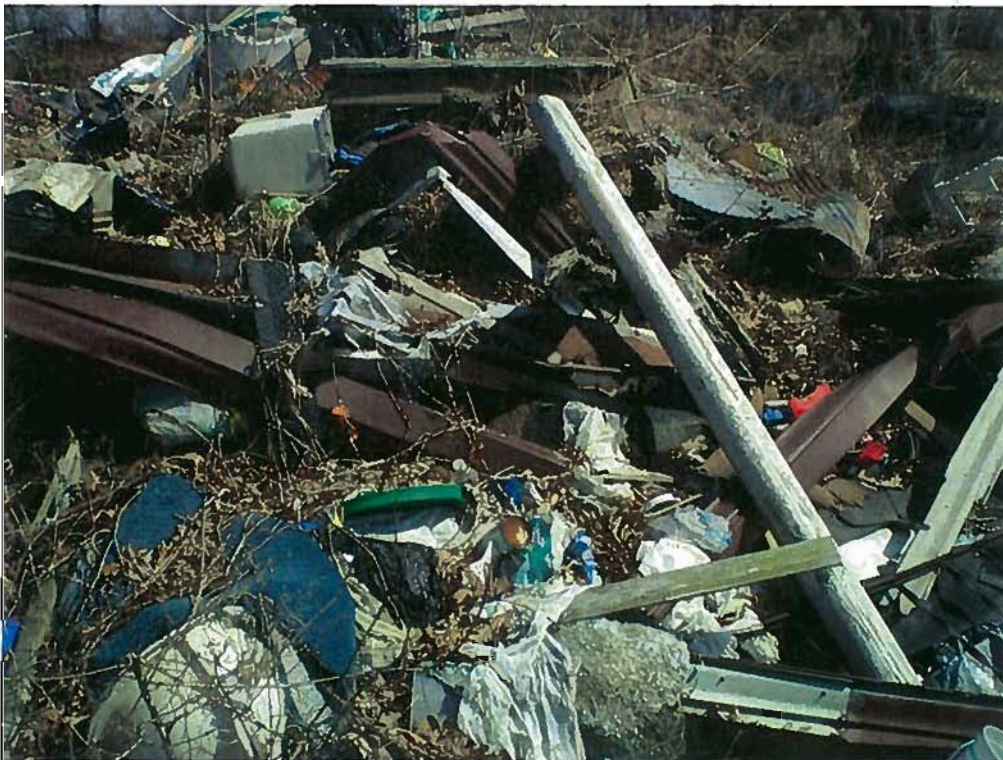
Date: March 18, 2010
Time: 12:33 PM
Direction: Northeast
Photo by: W Zierath
Exposure #: 008
Comments: The central part of the site showing demolition waste including wood, aluminum siding, carpet, shingles, plastic and asbestos siding.

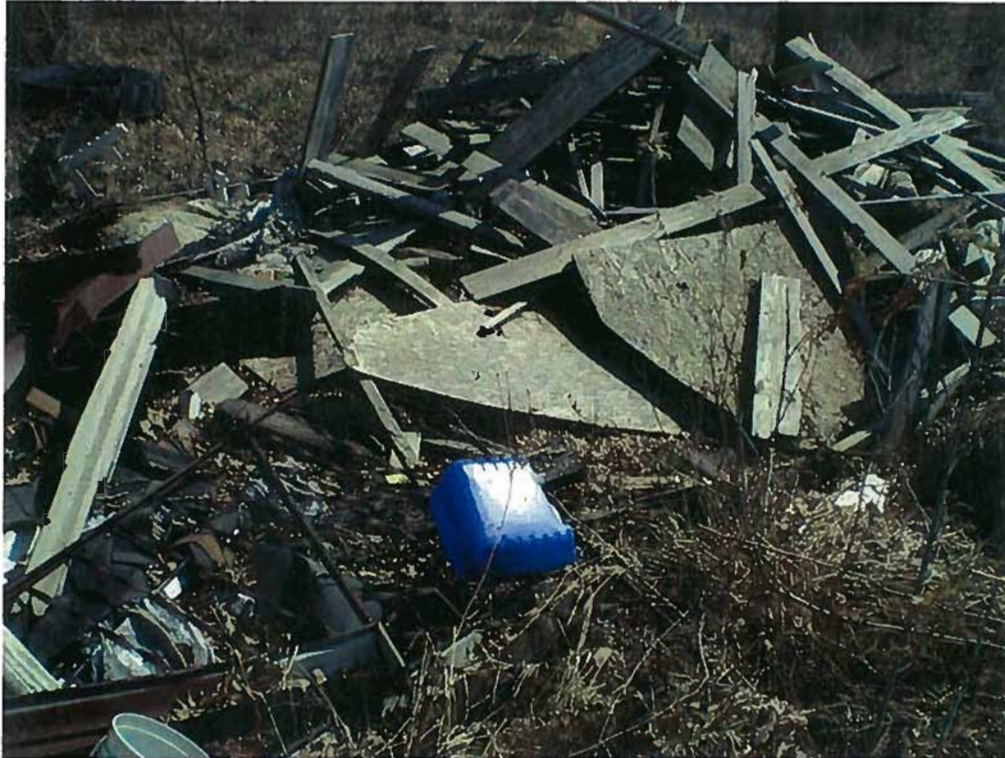
Date: March 18, 2010
Time: 12:33 PM
Direction: East
Photo by: W Zierath
Exposure #: 009
Comments: The central part of the site showing demolition waste including wood, aluminum siding and plastic.

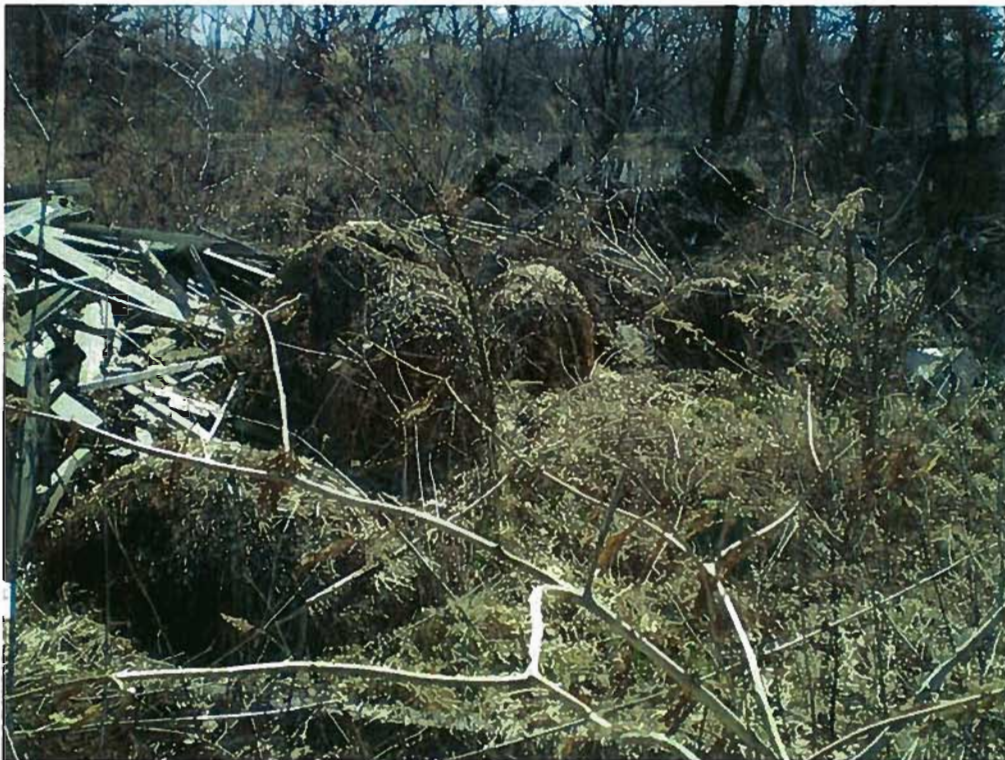
Date: March 18, 2010
Time: 12:33 PM
Direction: Southeast
Photo by: W Zierath
Exposure #: 010
Comments: The southwest part of the site showing wood demolition waste.

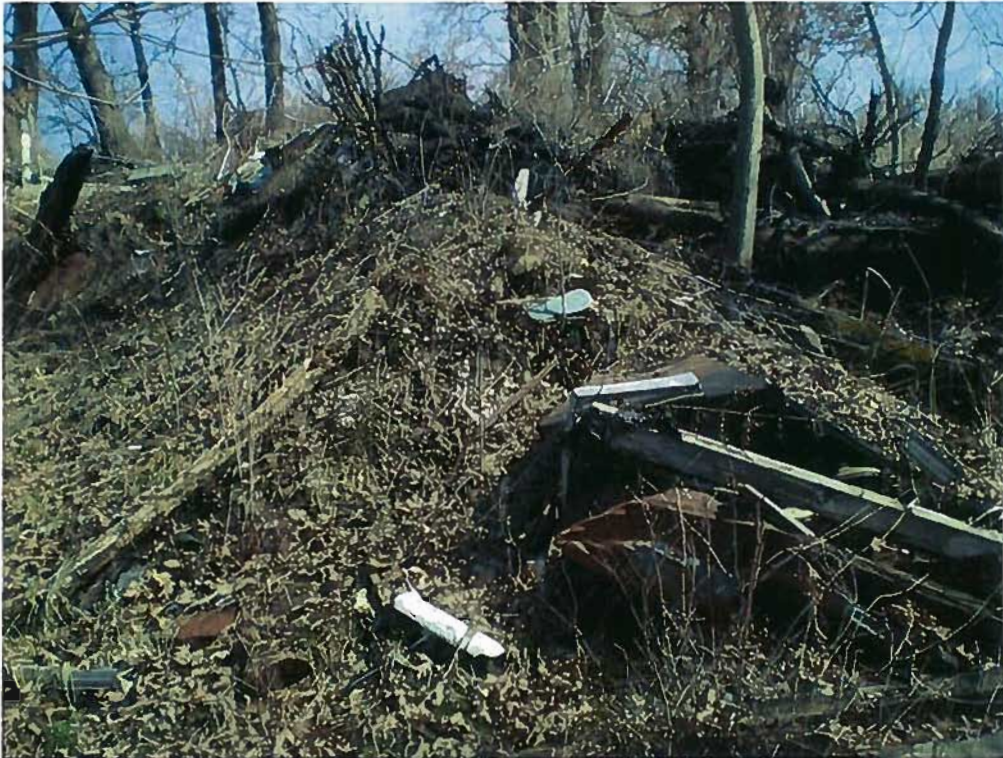
Date: March 18, 2010
Time: 12:34 PM
Direction: East
Photo by: W Zierath
Exposure #: 011
Comments: The south area of the site showing wood demolition waste.

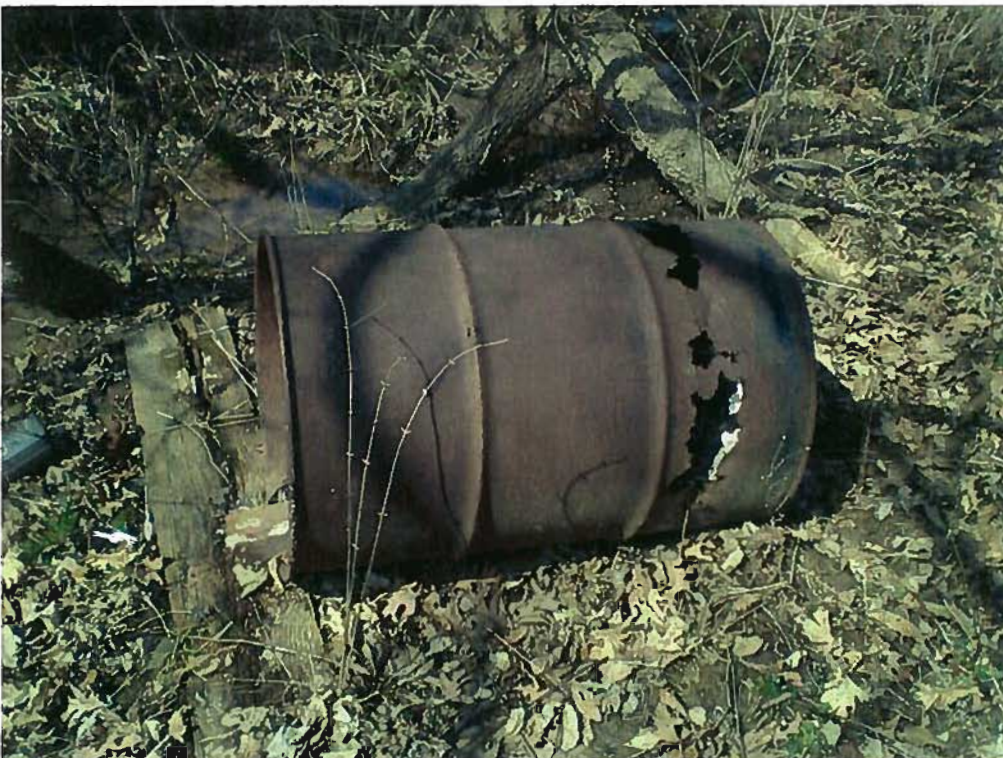
Date: March 18, 2010
Time: 12:34 PM
Direction: West
Photo by: W Zierath
Exposure #: 012
Comments: The west part of the site showing a former burn barrel.

An old burn barrel is shown in March 18 photograph 012.

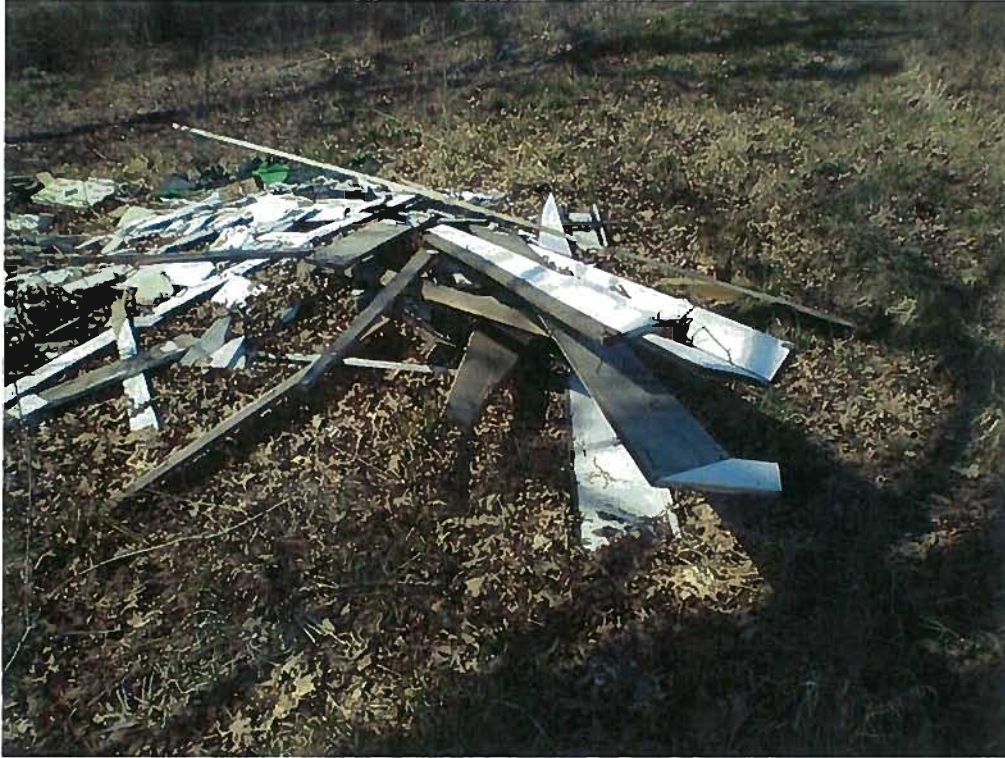
Date: March 18, 2010
Time: 12:35 PM
Direction: North
Photo by: W Zierath
Exposure #: 013
Comments: The north area of the site showing wood demolition waste, asbestos siding and shingles.

March 18 photograph 013 shows wood demolition waste, asbestos siding and shingles that are shown in October 16 photograph 009.

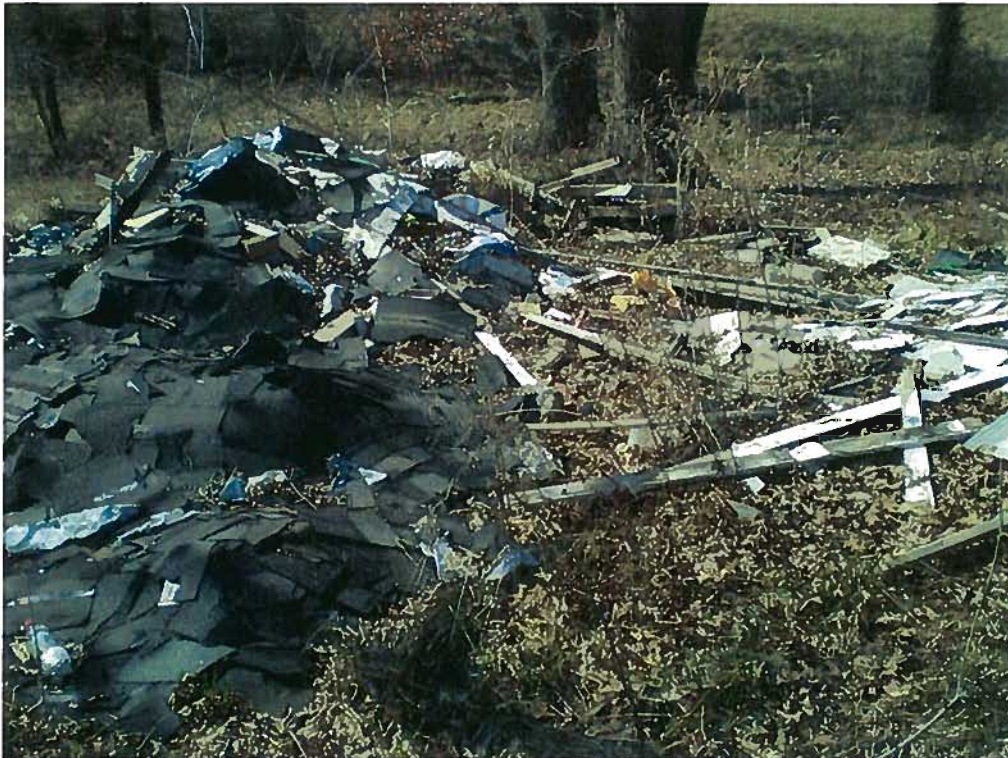
Date: March 18, 2010
Time: 12:35 PM
Direction: Northwest
Photo by: W Zierath
Exposure #: 014
Comments: The central area of the site showing wood demolition waste, asbestos siding and shingles.

March 18 photograph 014 shows wood demolition waste, asbestos siding and shingles that are shown in October 16 photograph 010.

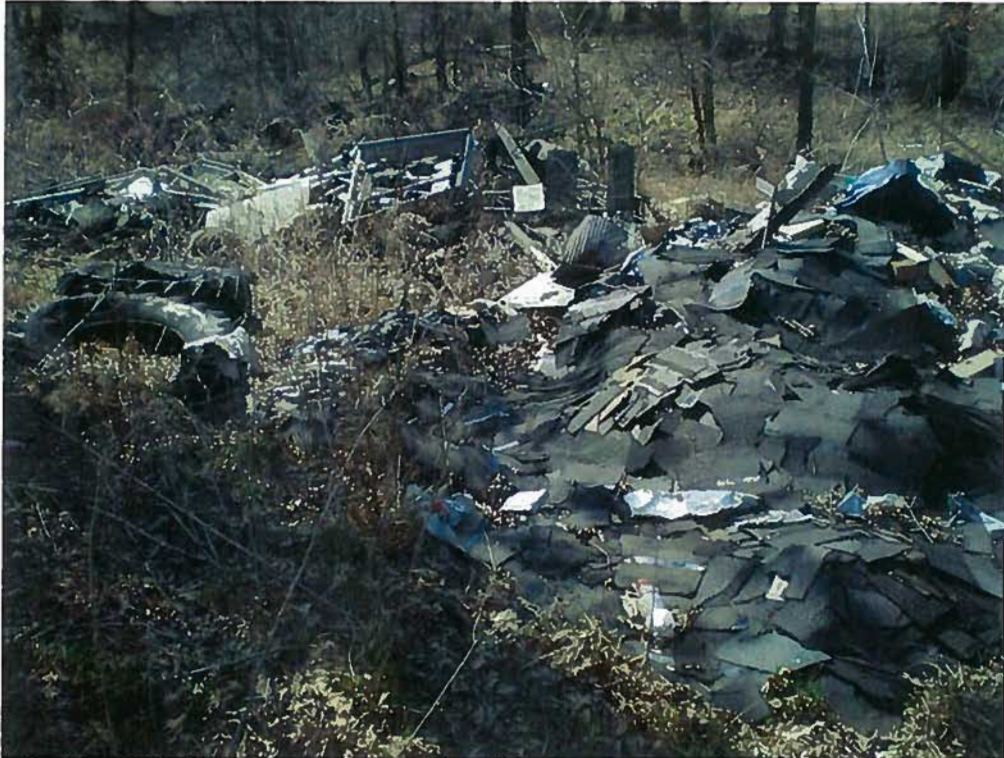
Date: March 18, 2010
Time: 12:35 PM
Direction: West
Photo by: W Zierath
Exposure #: 015
Comments: The central area of the site showing wood demolition waste and shingles, along with two used tires.

Used tires are shown in March 18 photographs 015, 016, 020, and 021.

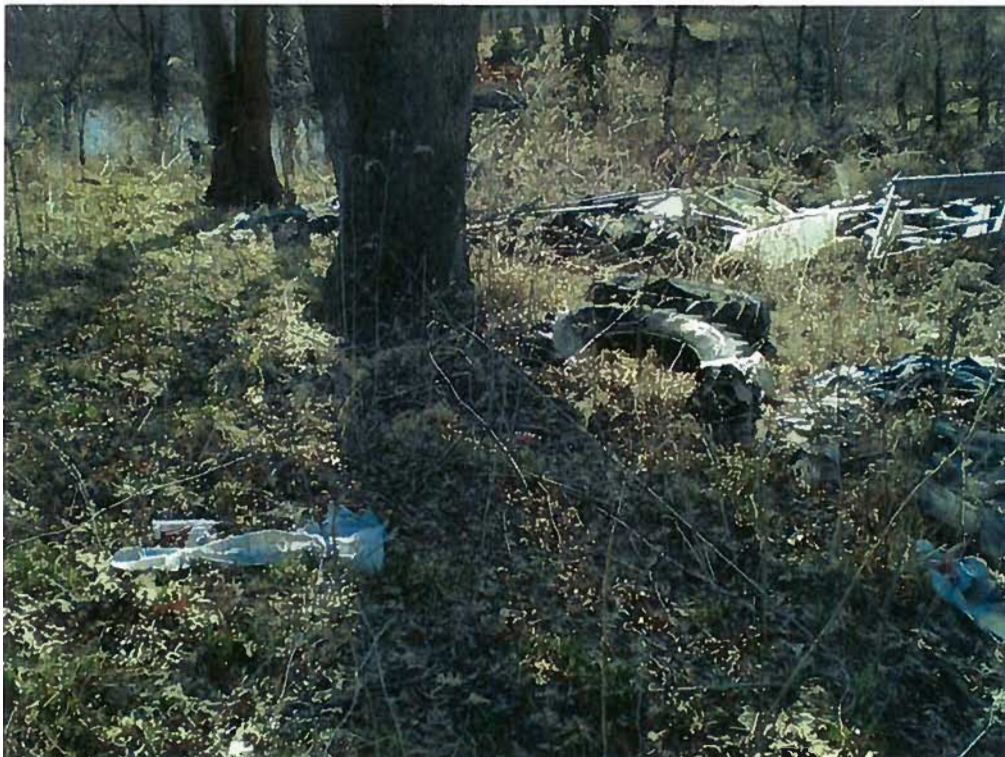
Date: March 18, 2010
Time: 12:36 PM
Direction: Southwest
Photo by: W Zierath
Exposure #: 016
Comments: The east area of the site showing wood demolition waste and shingles, along with two used tires.

March 18 photograph 016 shows wood demolition waste and shingles, along with two used tires that are shown in October 16 photograph 014.

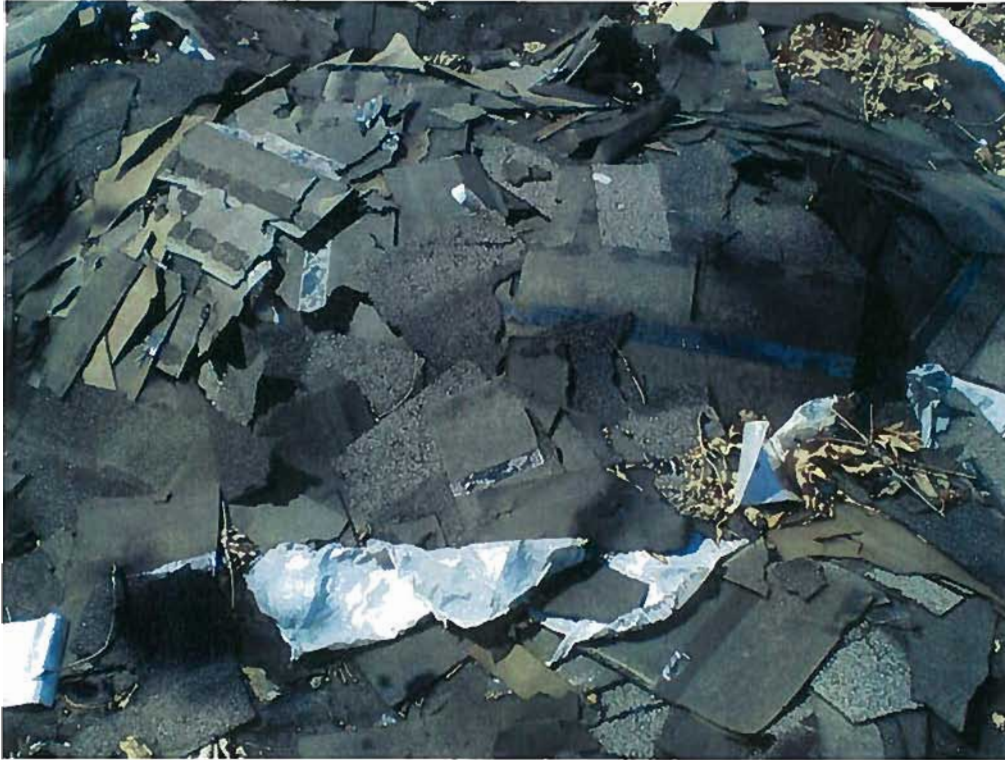
Date: March 18, 2010
Time: 12:36 PM
Direction: West
Photo by: W Zierath
Exposure #: 017
Comments: The central part of the site showing waste shingles.

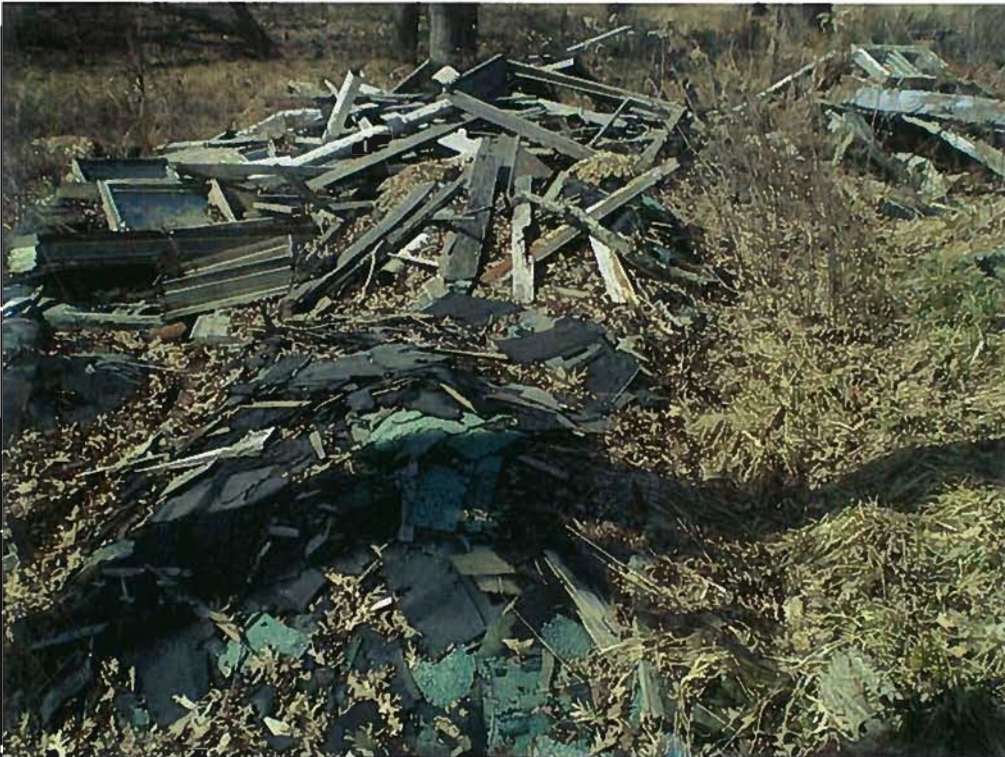
Date: March 18, 2010
Time: 12:36 PM
Direction: Southeast
Photo by: W Zierath
Exposure #: 018
Comments: The central area of the site showing wood demolition waste and used shingles.

March 18 photograph 018 shows wood demolition waste, asbestos siding and shingles that are shown in October 16 photograph 015.

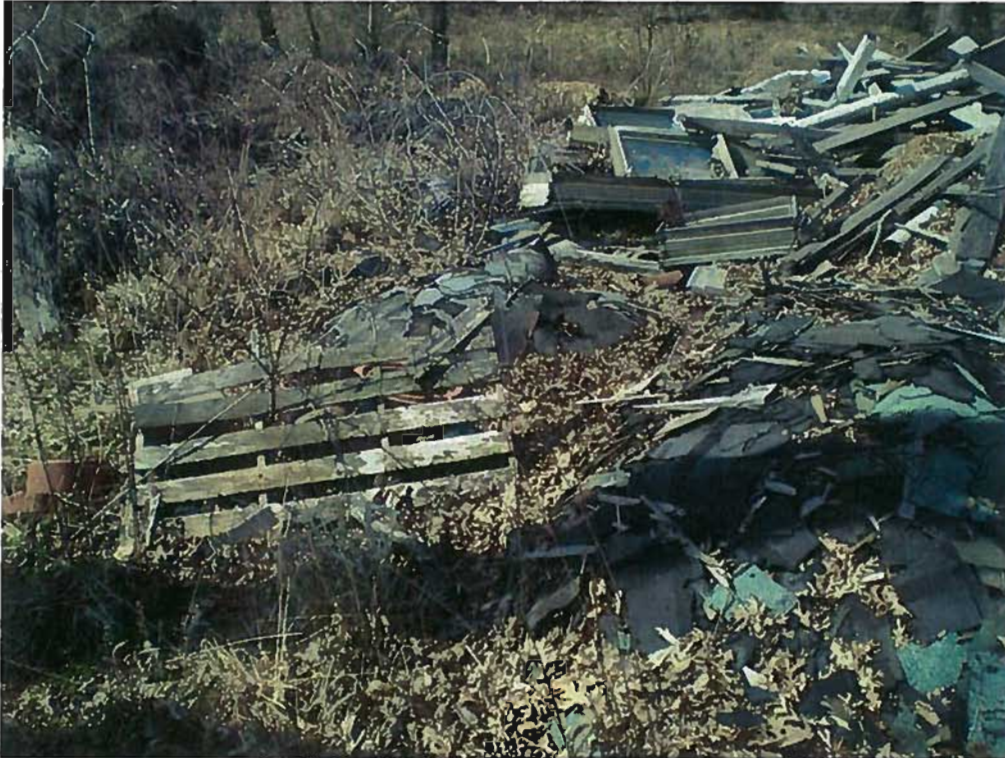
Date: March 18, 2010
Time: 12:36 PM
Direction: Southeast
Photo by: W Zlerath
Exposure #: 019
Comments: The south area of the site showing wood demolition waste and used shingles.

March 18 photograph 019 shows wood demolition waste and used shingles that are shown in October 16 photograph 016.

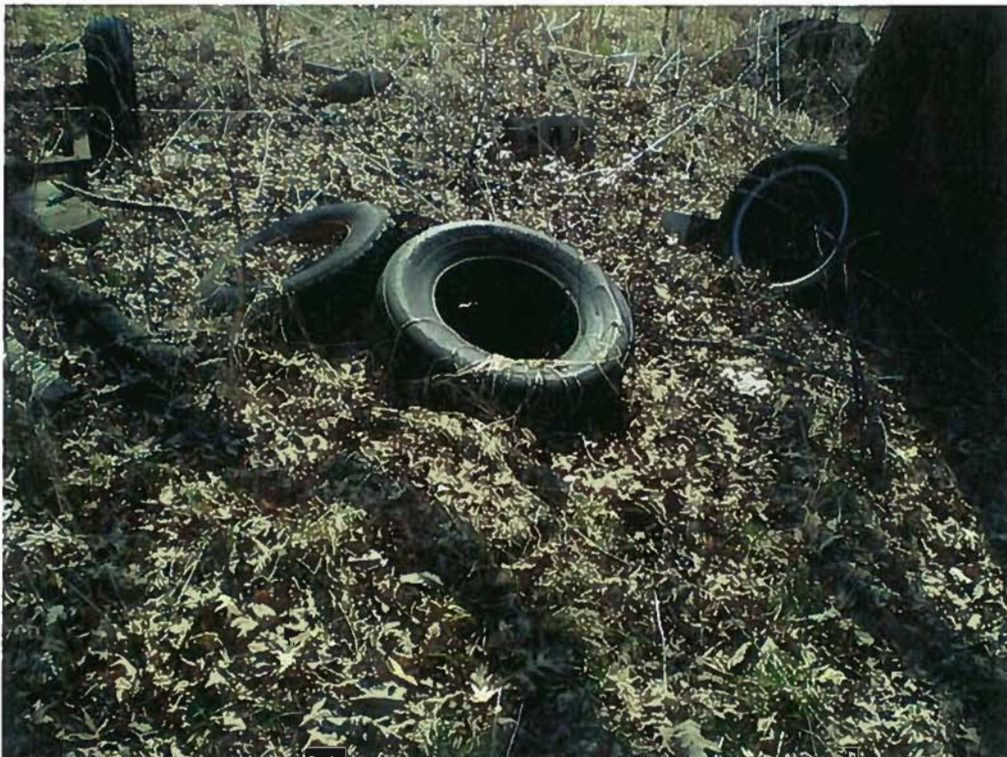
Date: March 18, 2010
Time: 12:37 PM
Direction: East
Photo by: W Zlerath
Exposure #: 020
Comments: The east area of the site showing four used tires.

There were fewer than 10 used tires at this site. Used tires are shown in March 18 photographs 015, 016, 020, and 021. One of the tires shown in photograph 020 contained water.

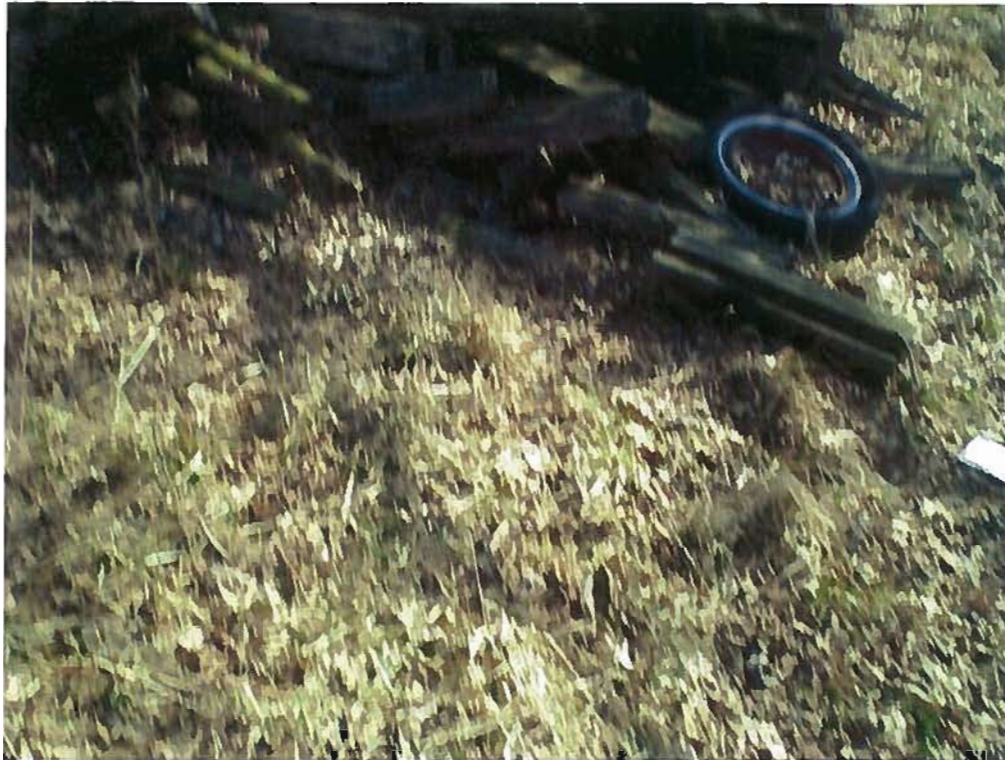
Date: March 18, 2010
Time: 12:37 PM
Direction: East
Photo by: W Zierath
Exposure #: 021
Comments: The area east of the site showing wood demolition waste and a used tire.

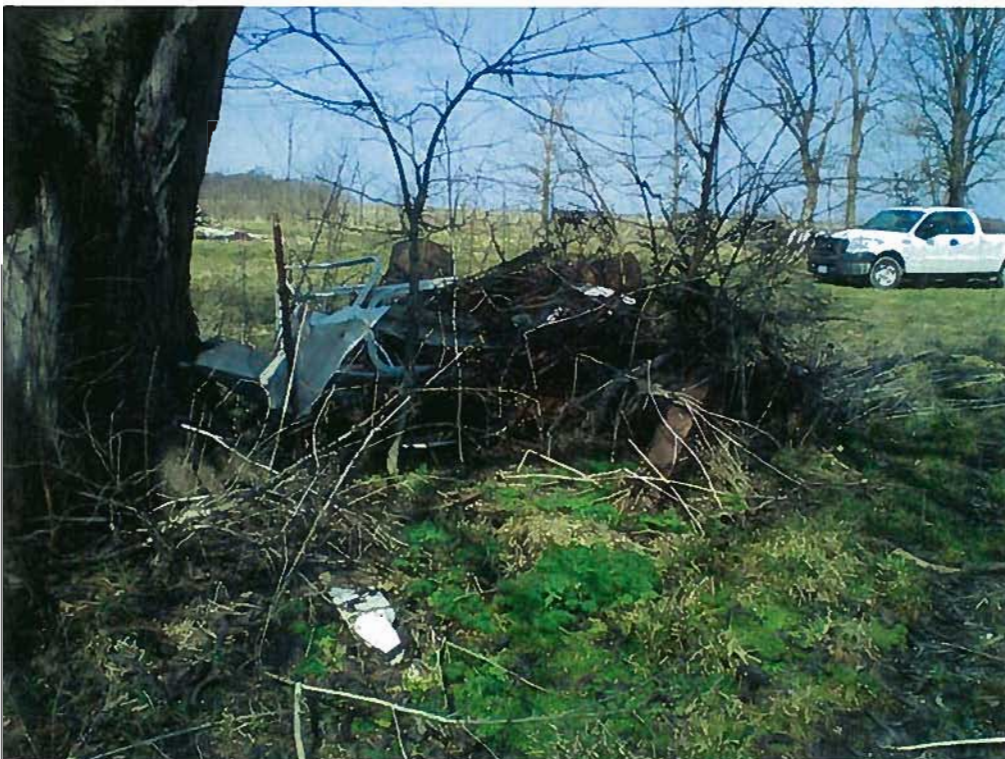
Date: March 18, 2010
Time: 12:41 PM
Direction: Northwest
Photo by: W Zierath
Exposure #: 022
Comments: The area north of the site showing a pile of scrap metal.

Scrap metal is shown in March 18 photograph 022.

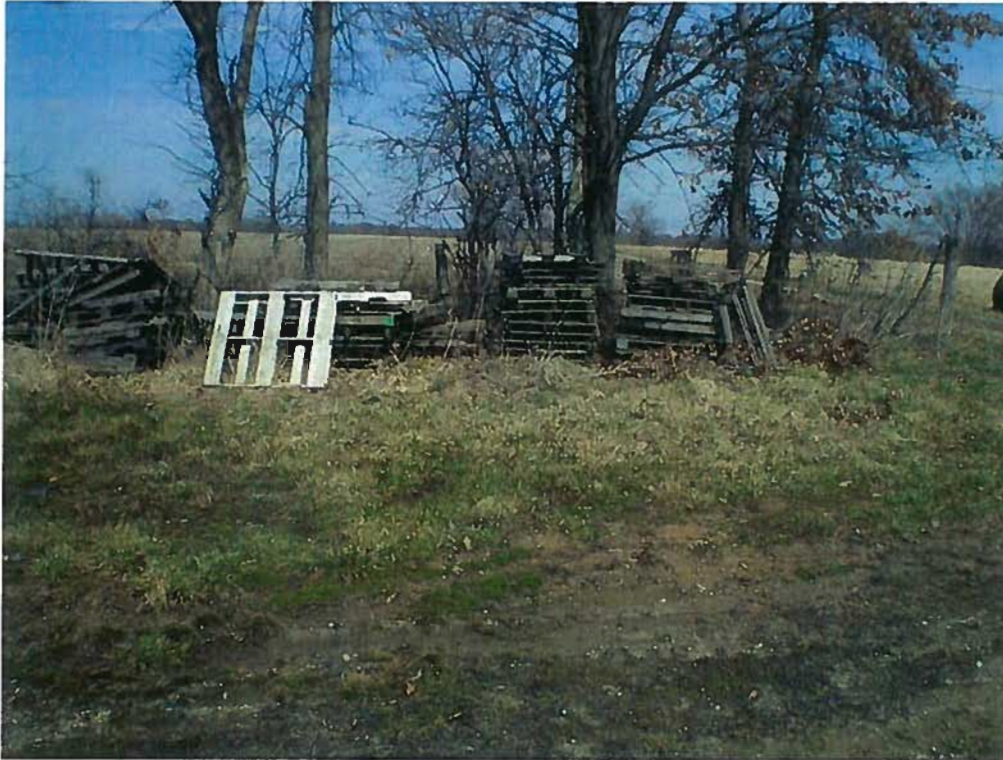
Date: March 18, 2010
Time: 12:42 PM
Direction: North
Photo by: W Zlerath
Exposure #: 023
Comments: North of the site showing a pile of used pallets.

Used pallets are shown in March 18 photographs 023, 024, 025, and 026.

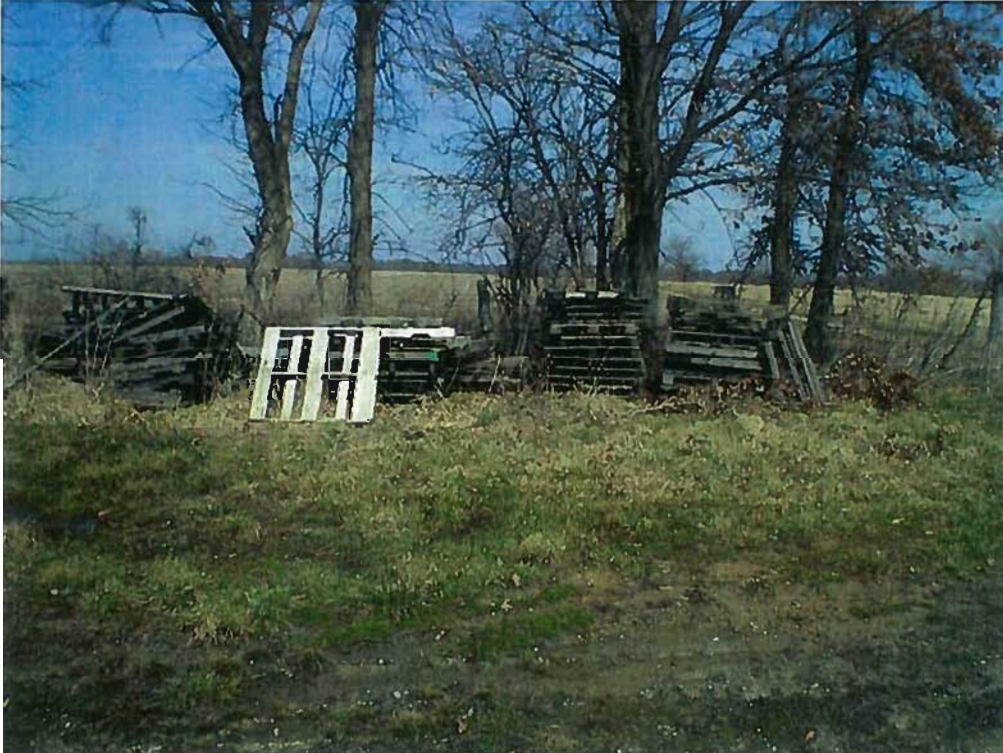
Date: March 18, 2010
Time: 12:42 PM
Direction: North
Photo by: W Zlerath
Exposure #: 024
Comments: North of the site showing a pile of used pallets.

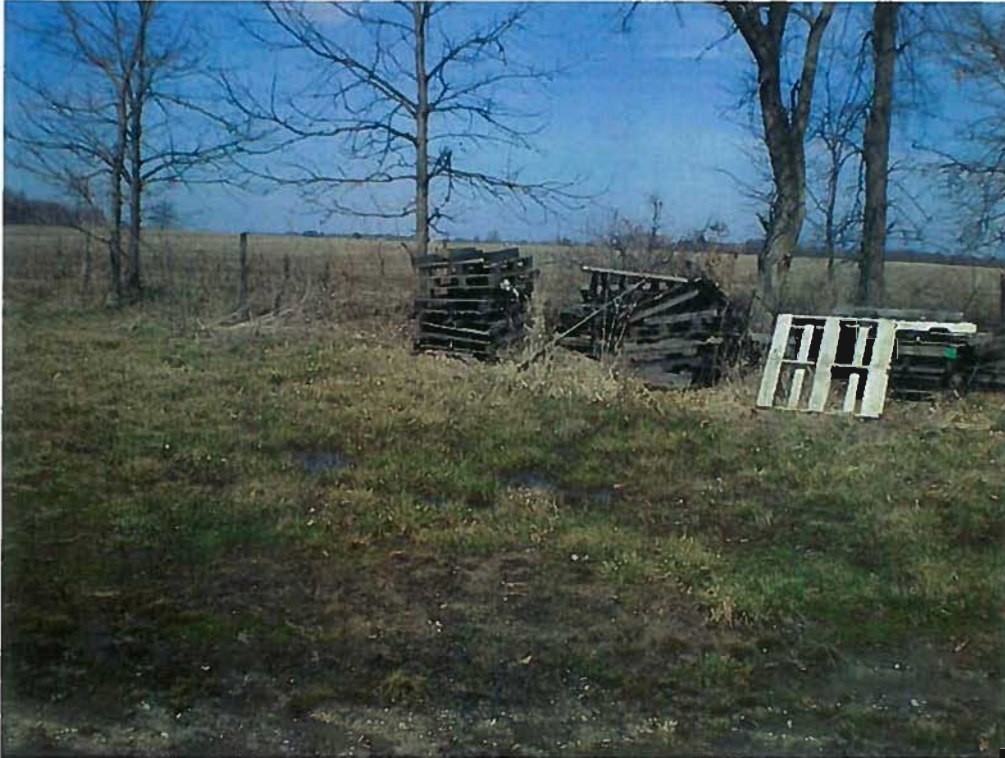
Date: March 18, 2010
Time: 12:42 PM
Direction: Northwest
Photo by: W Zlerath
Exposure #: 025
Comments: North of the site showing a pile of used pallets.

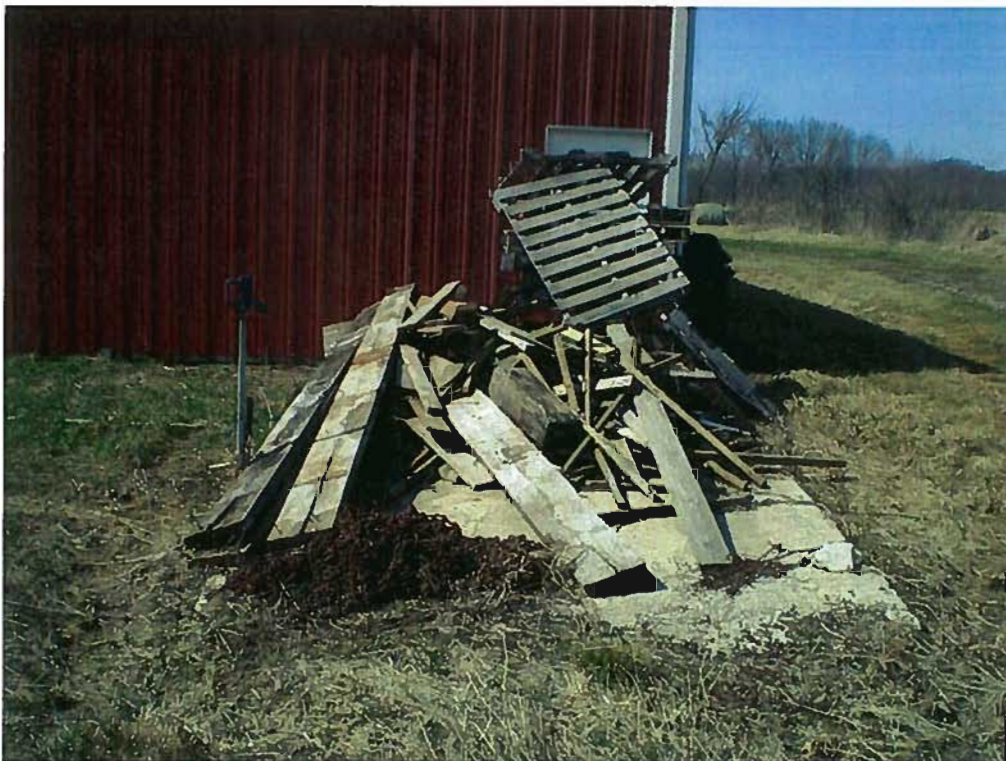
Date: March 18, 2010
Time: 12:42 PM
Direction: West
Photo by: W Zlerath
Exposure #: 026
Comments: North of the site showing a pile of used pallets and scrap lumber.
