Re: Illinois Environmental Protection Agency v. Patrick D. and Monique D. Patterson
IEPA File No. 128-11-AC: 1671209263—Sangamon County

ILLINOIS ENVIRONMENTAL PROTECTION AGENCY
Open Dump Inspection Checklist

ILLINOIS ENVIRONMENTAL PROTECTION AGENCY MEMORANDUM

SITE SKETCH

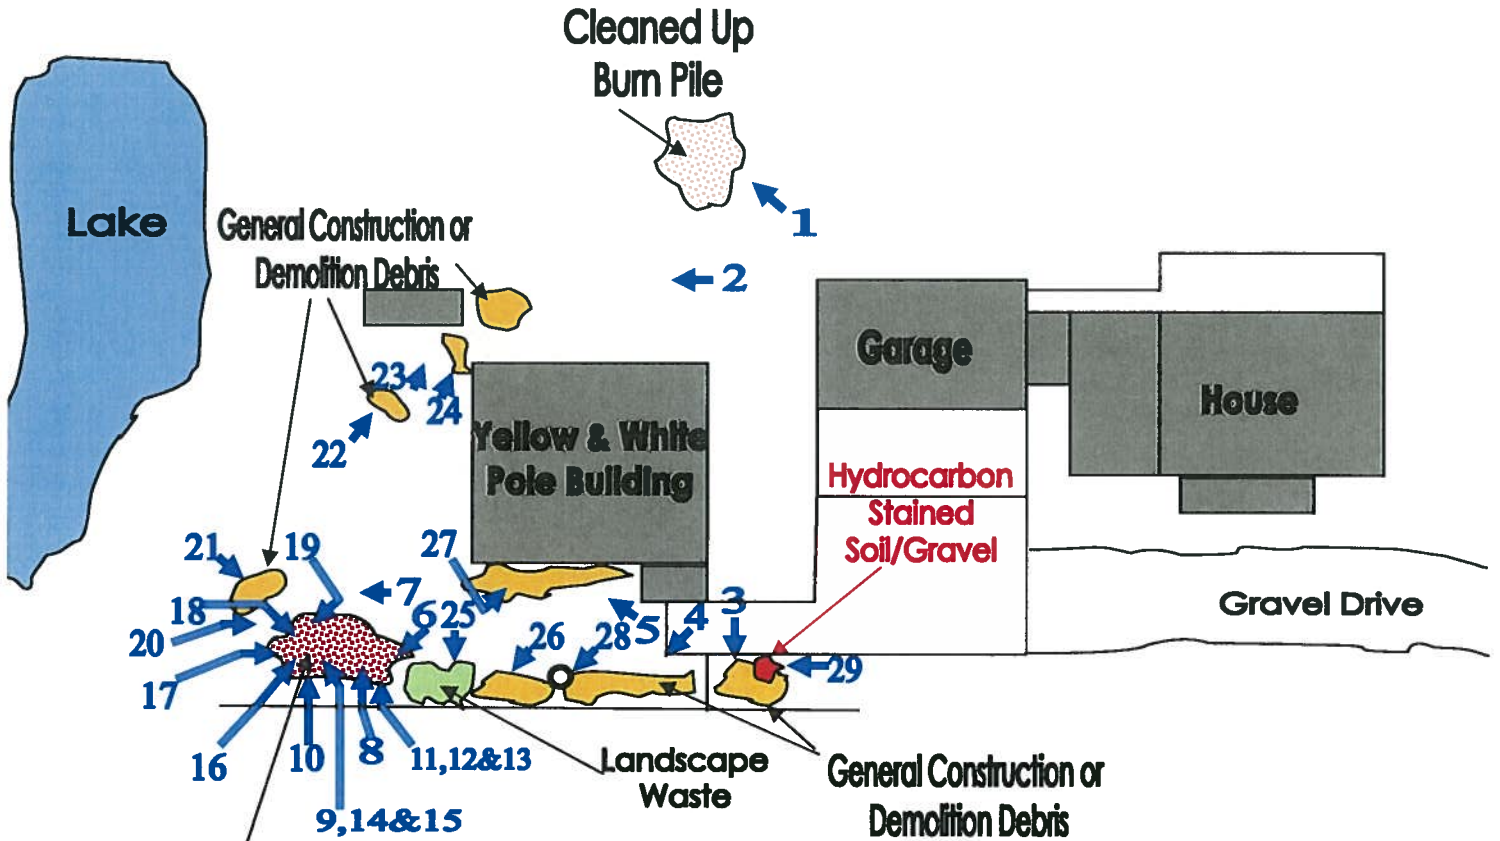
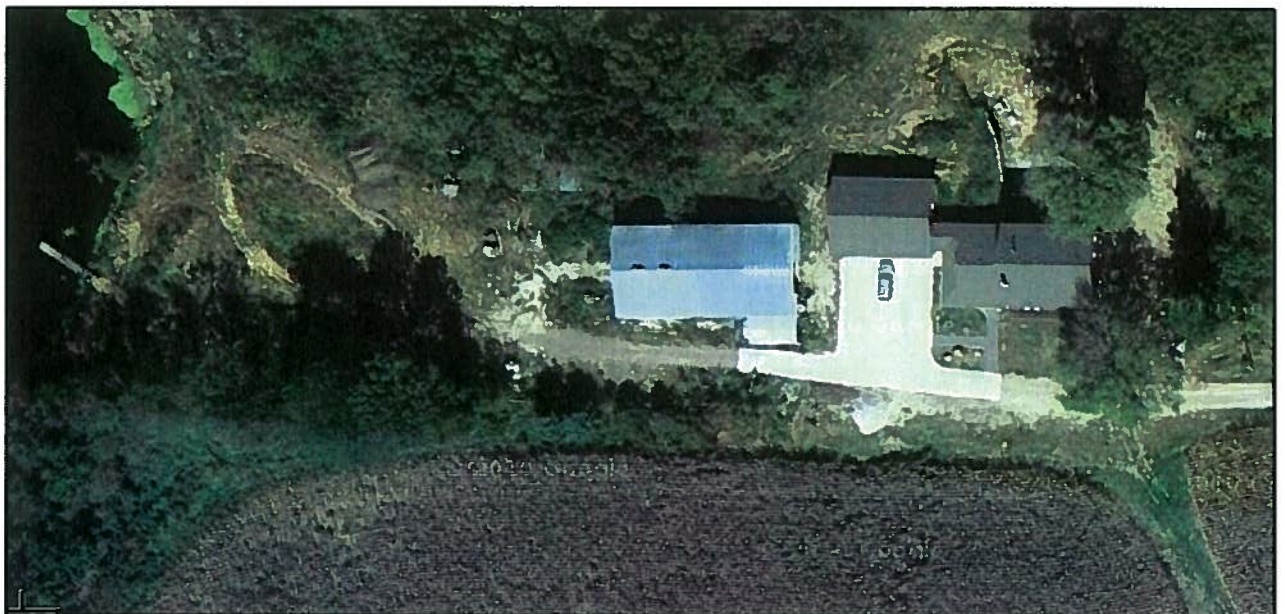
Burn Pile mixed with General Construction or Demolition Debris and Trade Waste

Measurements Approximate
Direction of Photo →
Not to Scale

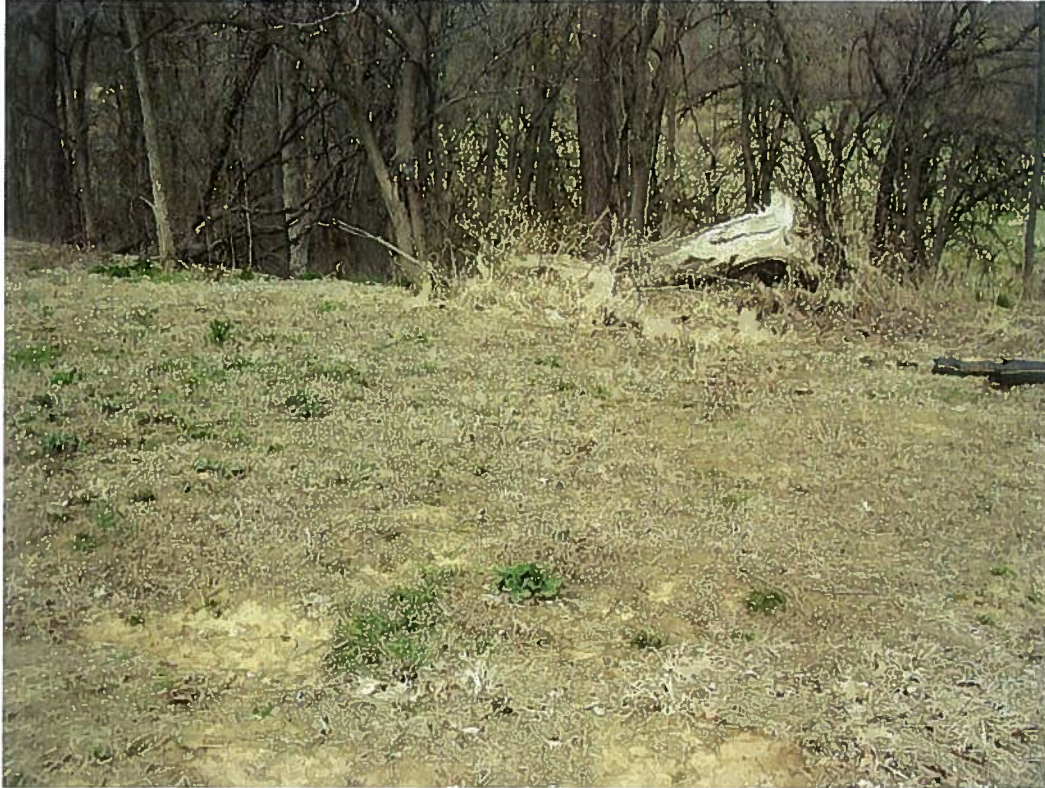
Date: April 6, 2011
Time: 11:29 AM
Direction: NW
Photo by: Eisenbrandt
Exposure #: 001
Comments: Area that had been an open burn pile. This area was cleaned up after the December 2009 inspection.

Mr. Patterson led the inspector across the breezeway to the back yard. Photographs 001 and 002 show an area that had been an open burn pile. The attached Site Sketch shows its approximate location that has been cleaned up since the December 2009 inspection. One tree stump remains in the area.

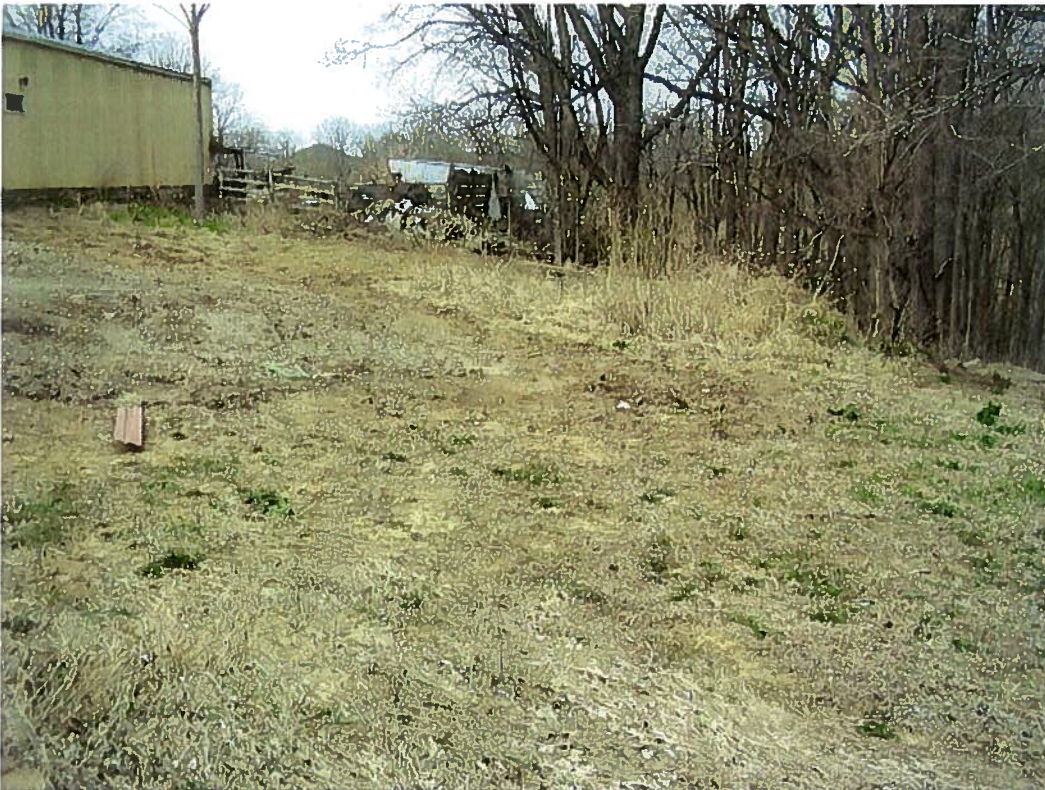
Date: April 6, 2011
Time: 11:29 AM
Direction: W
Photo by: Eisenbrandt
Exposure #: 002
Comments: Area mostly cleaned up after the December 2009 inspection. In the background of the photograph a pile of cinder blocks can be seen.

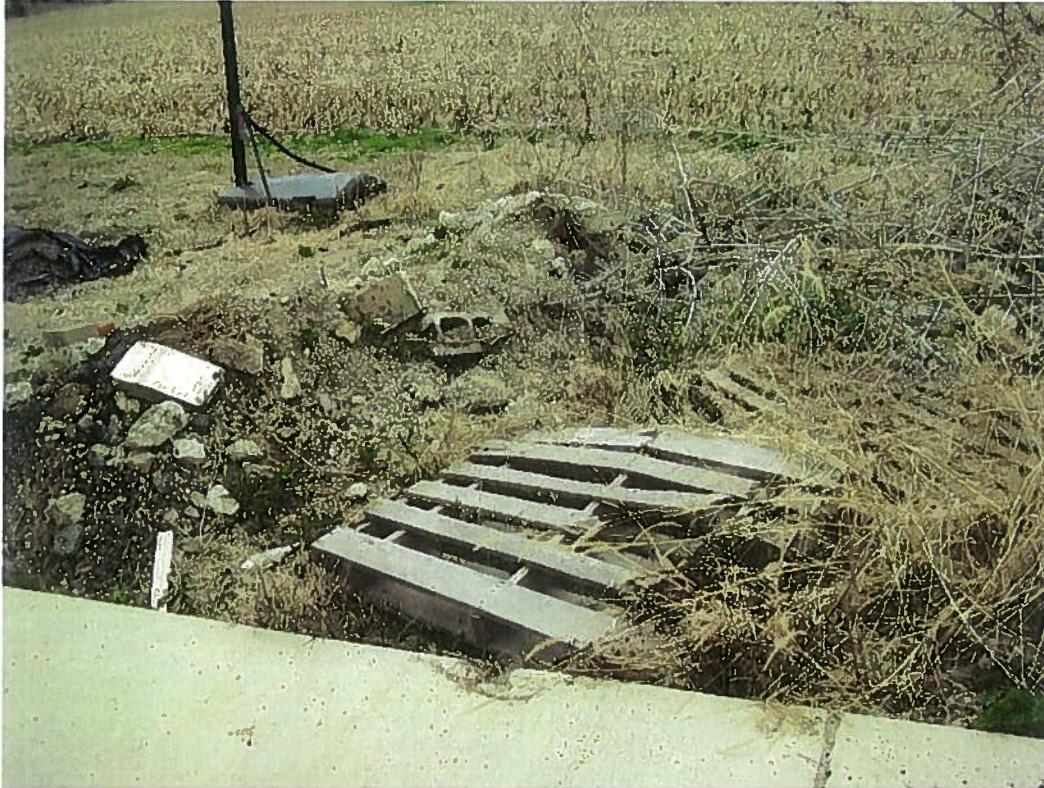
Date: April 6, 2011
Time: 11:32 AM
Direction: S
Photo by: Eisenbrandt
Exposure #: 003
Comments: Damaged wood pallets, cinder block, and a paint tray off the south side of the driveway.

Photograph 003 shows two damaged wooden pallets, cinder block, and a paint tray just off the south side of the new concrete driveway. Mr. Patterson claimed he was going to return the pallets to Lowes.

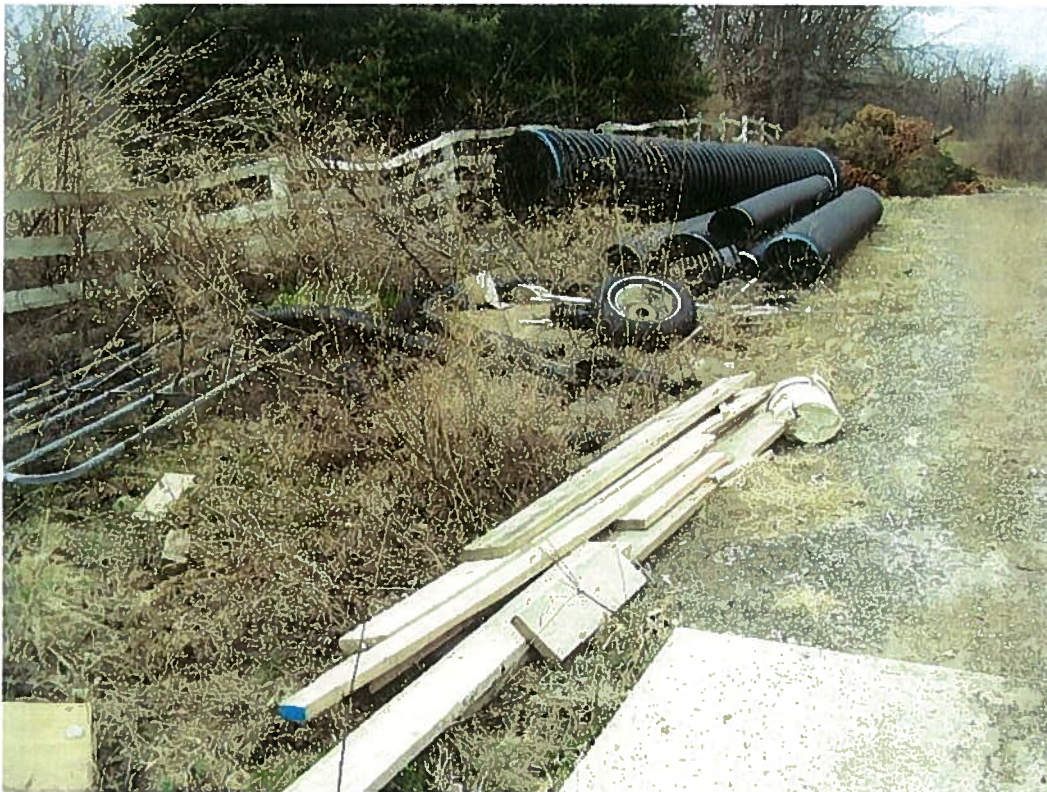
Date: April 6, 2011
Time: 11:32 AM
Direction: SW
Photo by: Eisenbrandt
Exposure #: 004
Comments: Drainage pipe, a cattle gate, an on-rim used tire, scrap lumber, a cardboard box, metal fence posts, and a smashed plastic bucket astray in the weeds along the driveway.

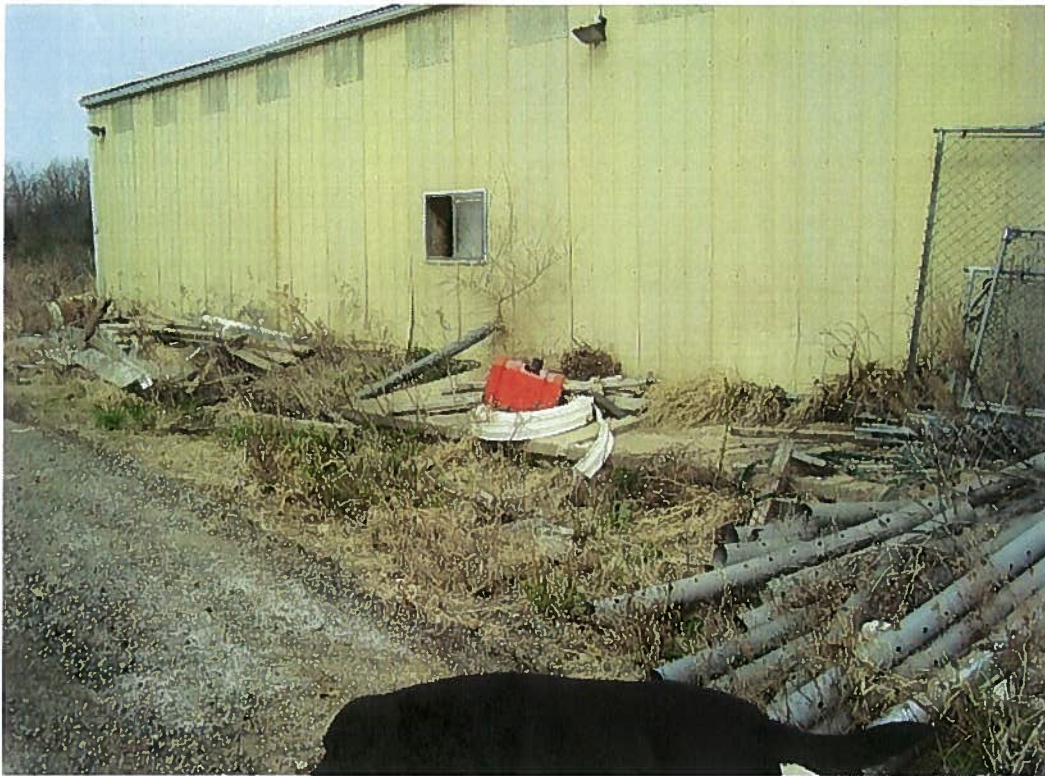
Date: April 6, 2011
Time: 11:32 AM
Direction: NW
Photo by: Eisenbrandt
Exposure #: 005
Comments: Plastic drain pipe, cyclone fencing, a garden hose, a pile of scrap lumber, and miscellaneous waste littered along the south side of the metal barn.

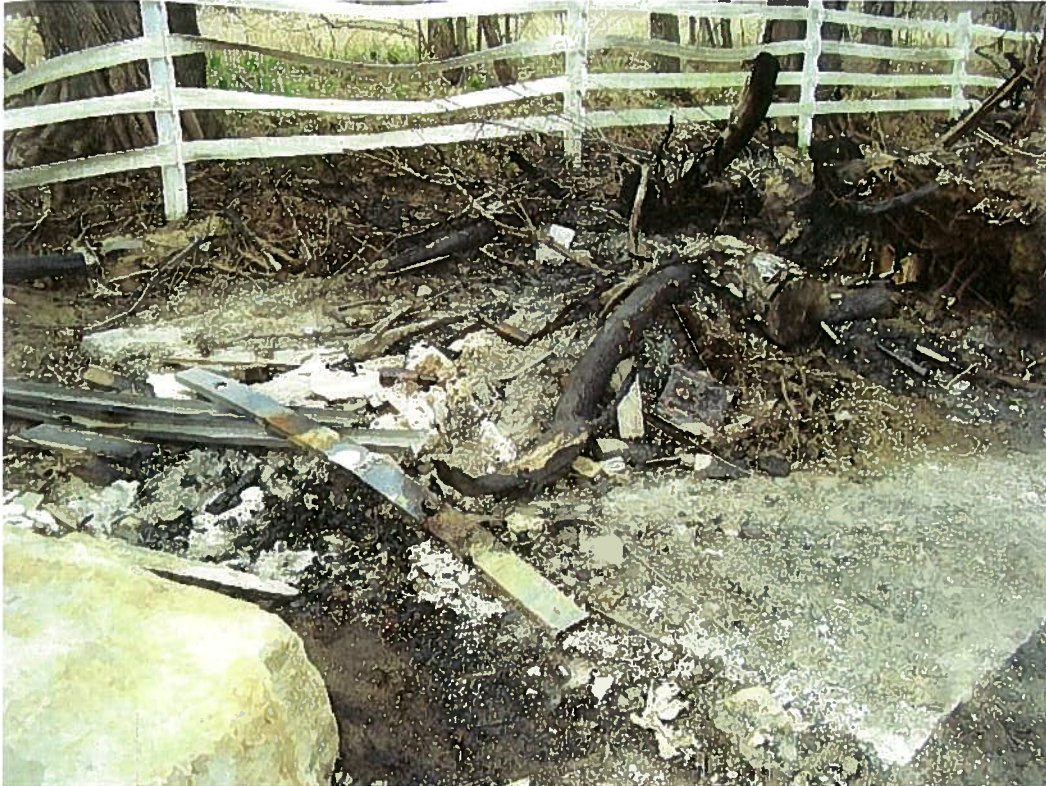
Date: April 6, 2011
Time: 11:33 AM
Direction: SW
Photo by: Eisenbrandt
Exposure #: 006
Comments: An open burn pile that was not present during the December 2009 inspection. Charred metal studs, drywall, beer bottles, and landscape waste were observed.

After walking around the south side of the metal barn, the inspector observed a large open burn pile. Photographs 006 through 021 show the burn pile that contained landscape waste, general construction or demolition debris, and a small amount of household waste. This open burn pile was not present during the December 2009 inspection. Photograph 006 shows charred metal studs, drywall, beer bottles, and partially burned landscape waste on a concrete pad.

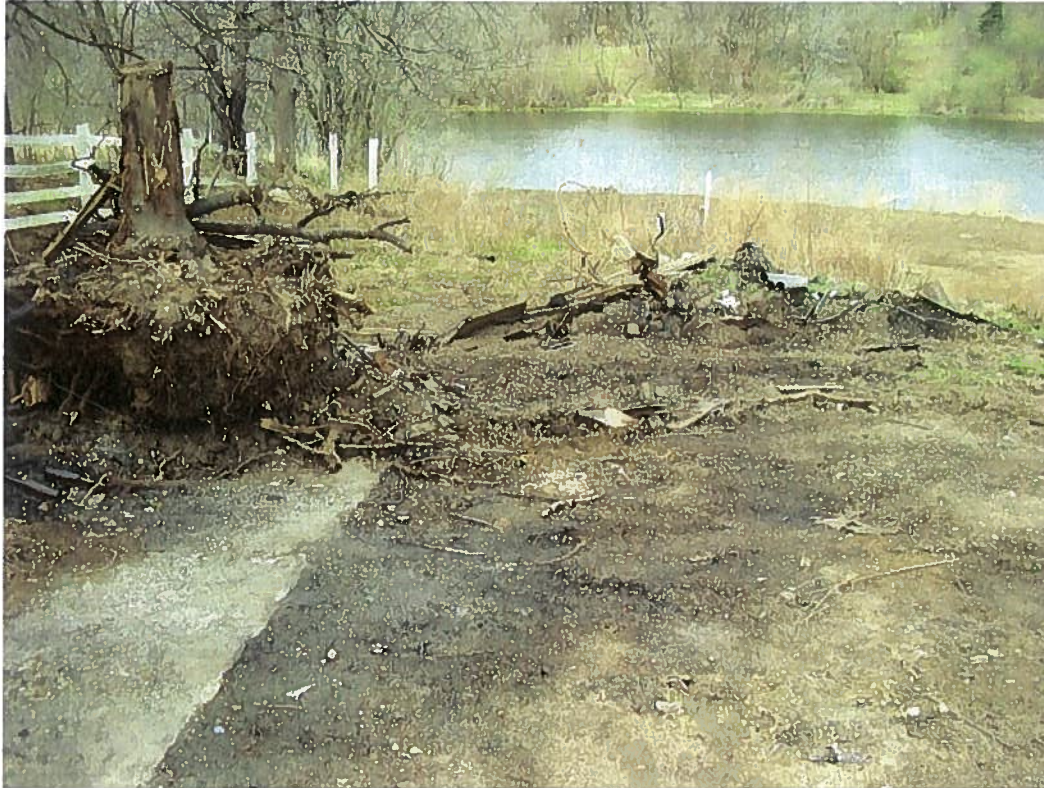
Date: April 6, 2011
Time: 11:33 AM
Direction: W
Photo by: Eisenbrandt
Exposure #: 007
Comments: Landscape waste intermixed with miscellaneous debris near the open burn pile. The ground surface slopes into the pond seen in the background.

Photograph 007 shows landscape waste intermixed with miscellaneous debris adjacent to the open burn pile. The ground surface from beneath the burn pile and surrounding area slopes into the pond seen in the background of Photograph 007. Soil and surface water samples were not collected during this April 6, 2011 inspection.

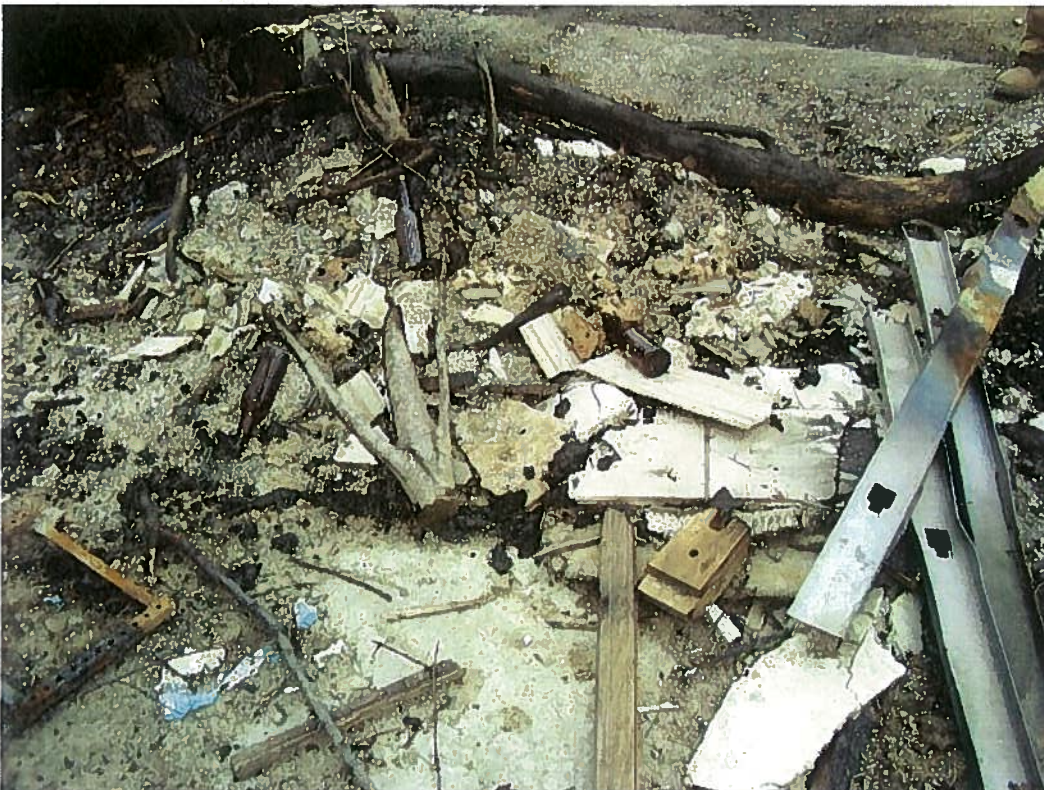
Date: April 6, 2011
Time: 11:33 AM
Direction: N
Photo by: Eisenbrandt
Exposure #: 008
Comments: Charred debris including beer bottles, metal studs, drywall, lumber, tile, scrap metal, and landscape waste.

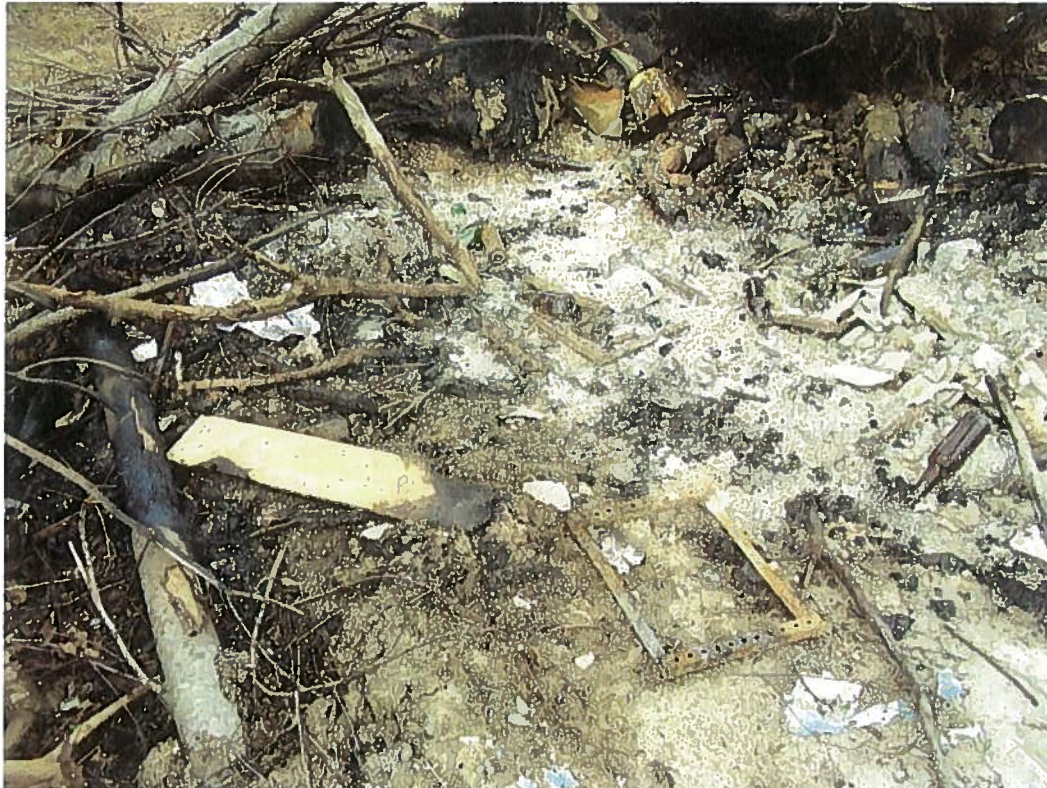
Date: April 6, 2011
Time: 11:33 AM
Direction: NW
Photo by: Eisenbrandt
Exposure #: 009
Comments: Alternate view of the open burn pile.

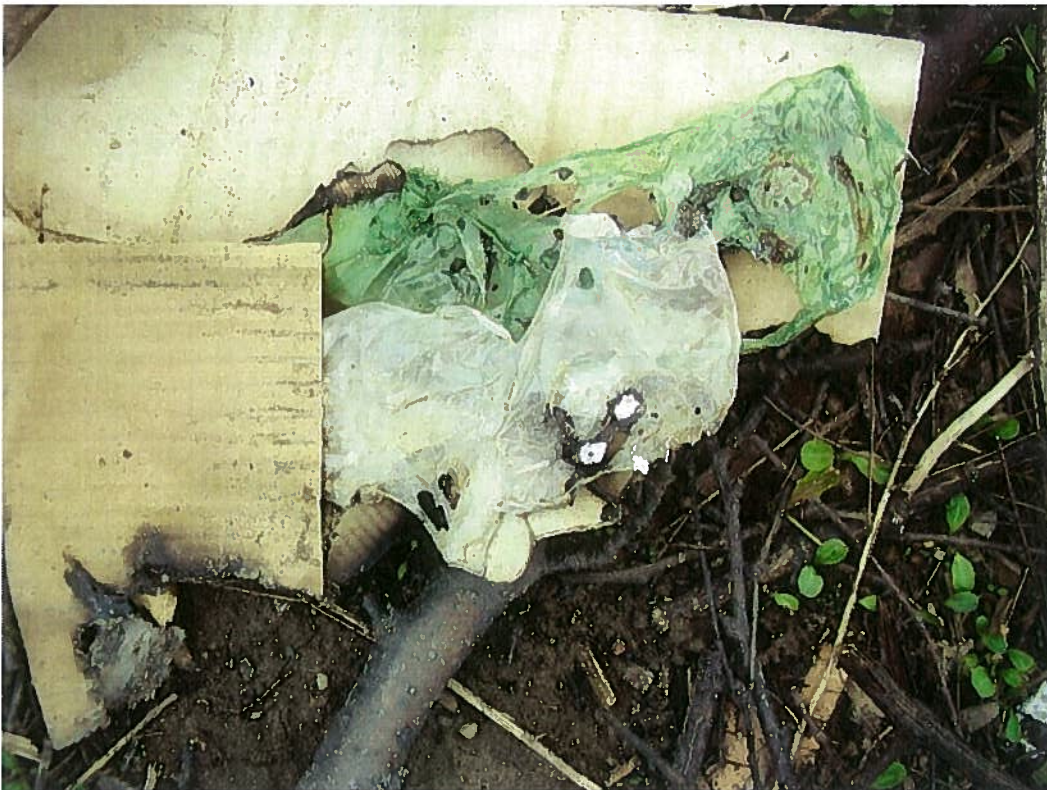
Date: April 6, 2011
Time: 11:34 AM
Direction: N
Photo by: Eisenbrandt
Exposure #: 010
Comments: Melted plastic and charred cardboard.

Photograph 010 shows melted plastic and charred cardboard. Photograph 011 is of charred processed lumber and drywall. Photograph 012 shows charred lumber, drywall, and fiberglass strands that had been burnt. Photograph 013 shows more charred lumber and ceramic tile with the backer board still attached. Photograph 014 shows a rusty aerosol can, green beverage glass, remains of aluminum cans, and ash. Photograph 015 shows scrap metal, a beer bottle, rebar, blackened cinder block, and a recessed light fixture that had been burned. Photograph 016 shows an electrical breaker box and burnt wire. All of these wastes charred wastes and ash demonstrate apparent open dumping and open burning has occurred again on the Patterson site.

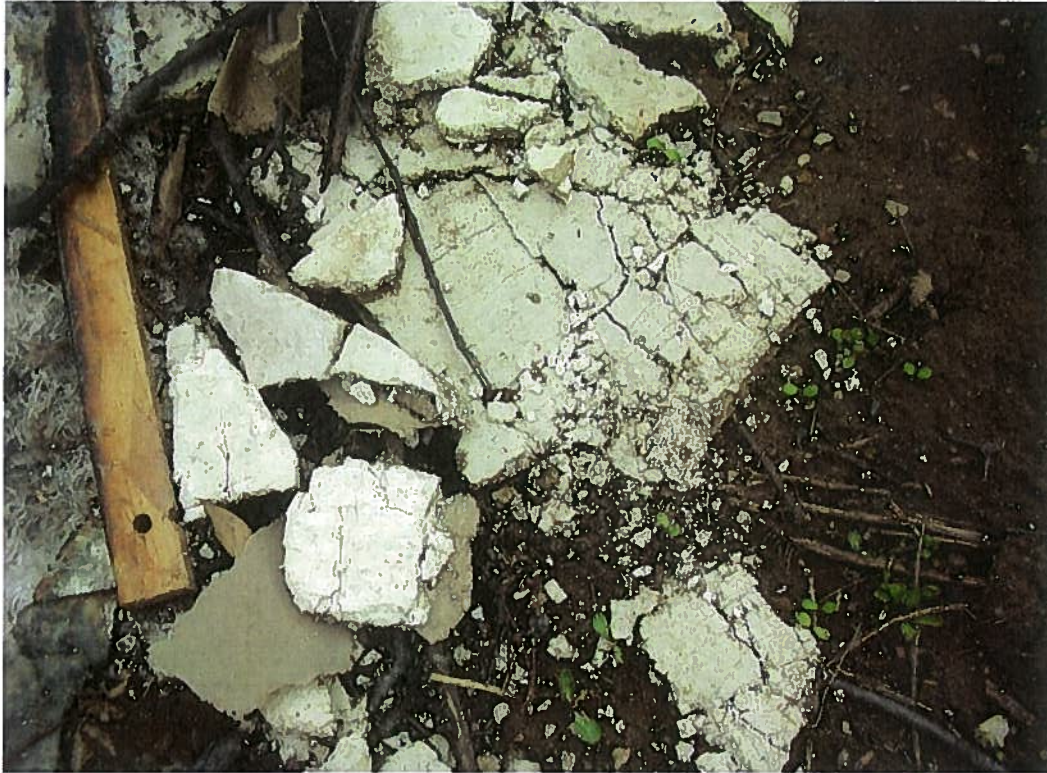
Date: April 6, 2011
Time: 11:34 AM
Direction: N
Photo by: Eisenbrandt
Exposure #: 011
Comments: Charred processed lumber and drywall.

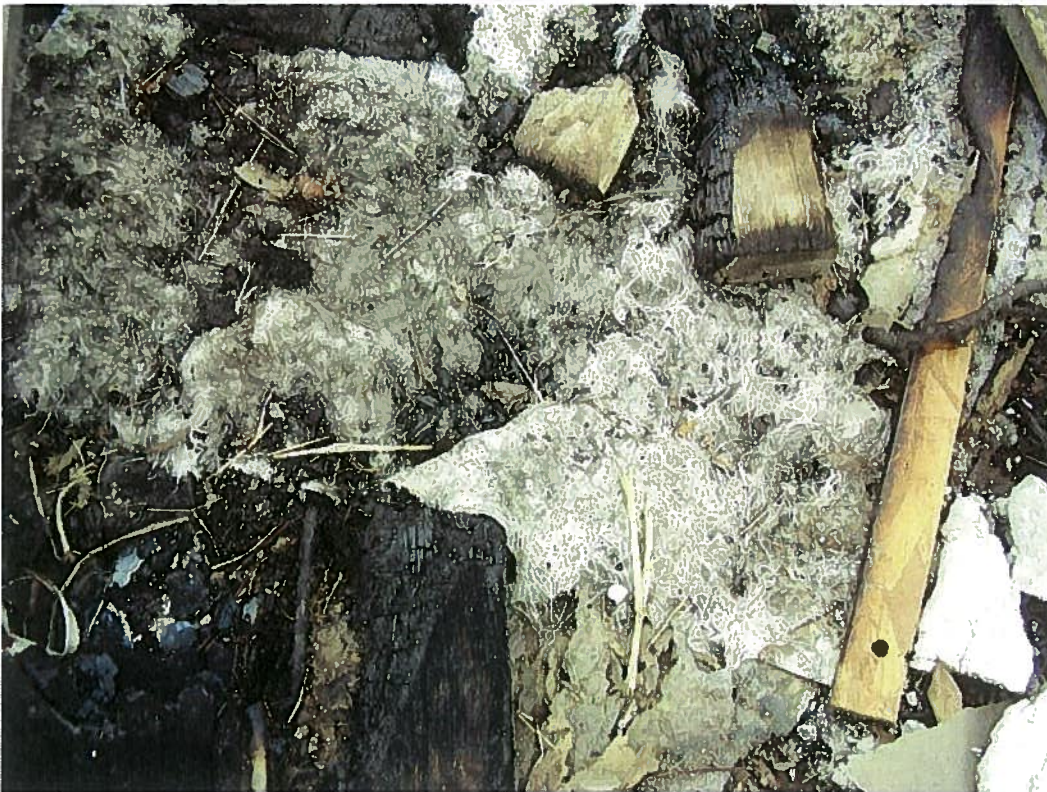
Date: April 6, 2011
Time: 11:34 AM
Direction: N
Photo by: Eisenbrandt
Exposure #: 012
Comments: Charred lumber, drywall, and fiberglass strands.

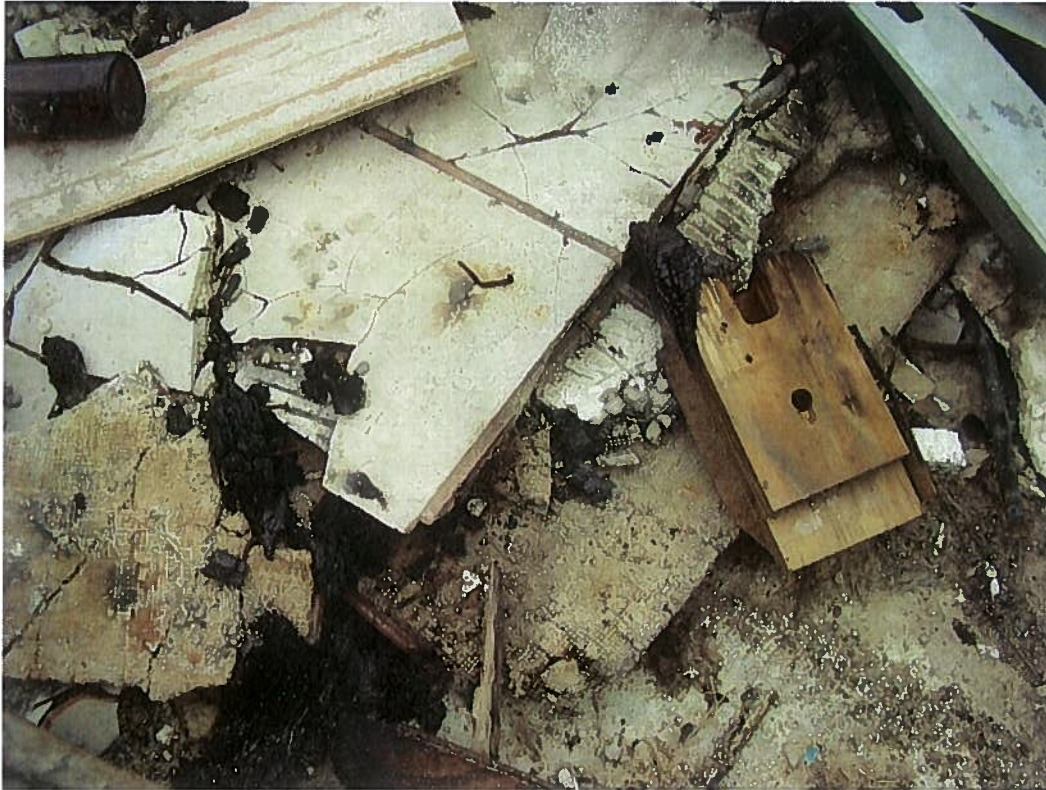
Date: April 6, 2011
Time: 11:34 AM
Direction: N
Photo by: Eisenbrandt
Exposure #: 013
Comments: Charred
lumber and ceramic tile.

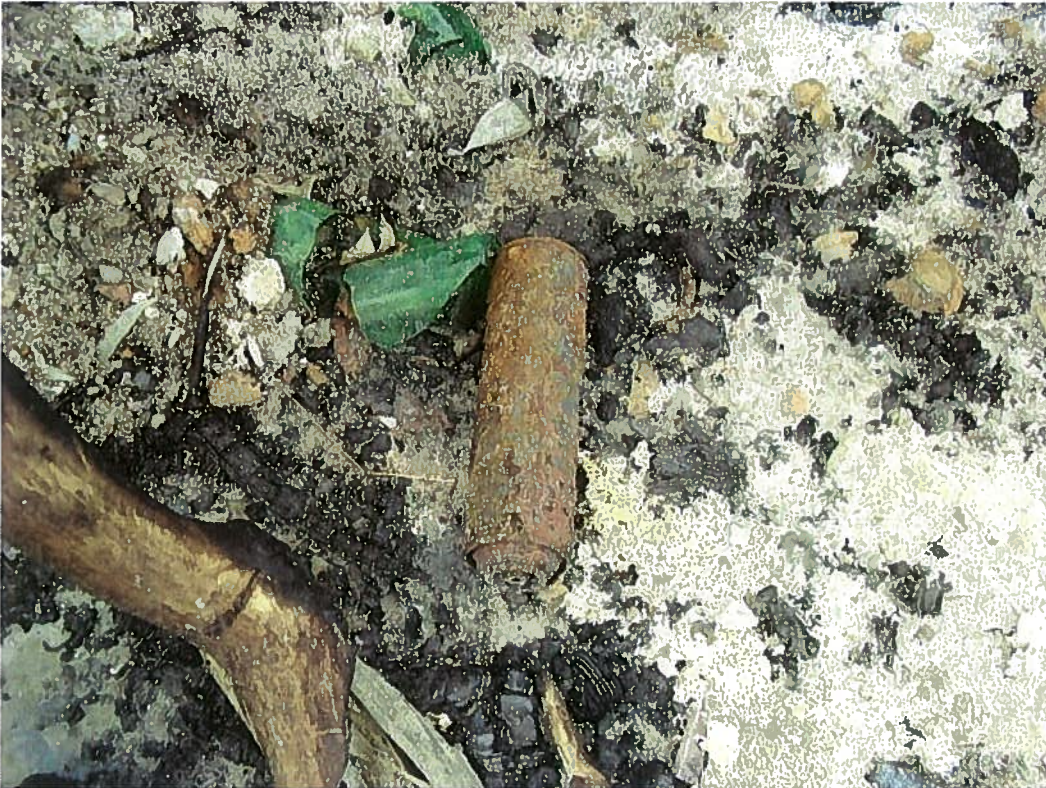
Date: April 6, 2011
Time: 11:34 AM
Direction: NW
Photo by: Eisenbrandt
Exposure #: 014
Comments: A rusty
aerosol can, green
beverage glass, remains of
aluminum cans, and ash.

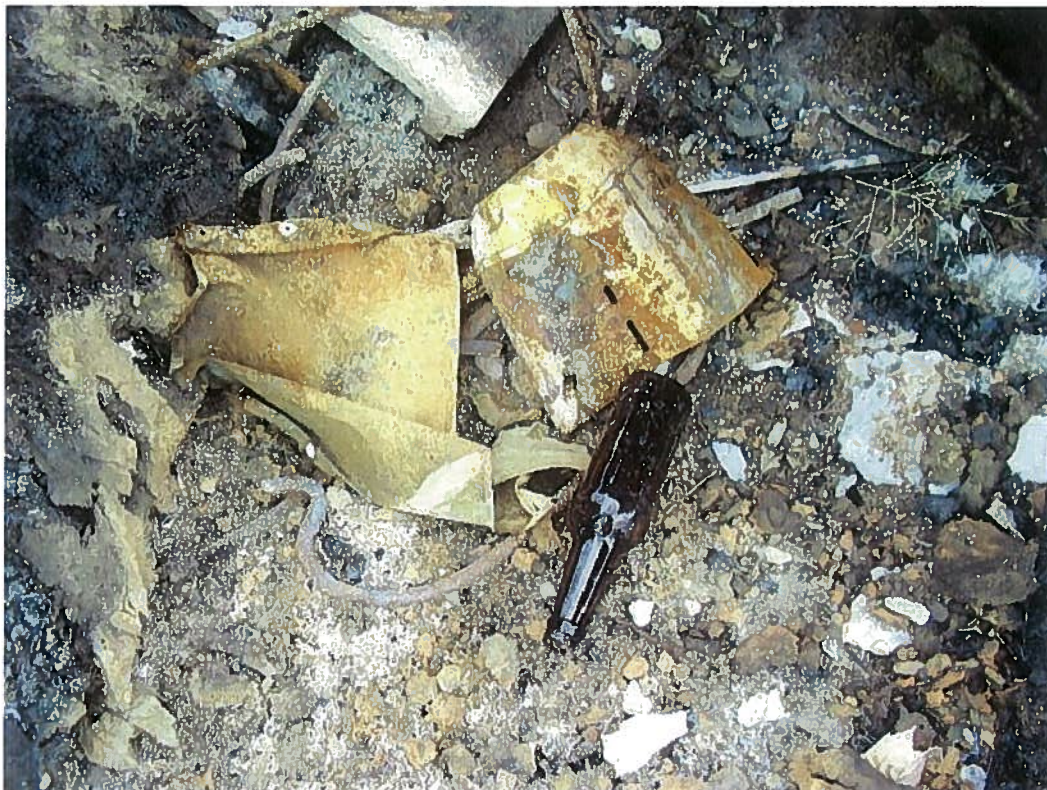
Date: April 6, 2011
Time: 11:34 AM
Direction: NW
Photo by: Eisenbrandt
Exposure #: 015
Comments: Scrap metal, a beer bottle, rebar, cinder block, and a recessed light fixture.

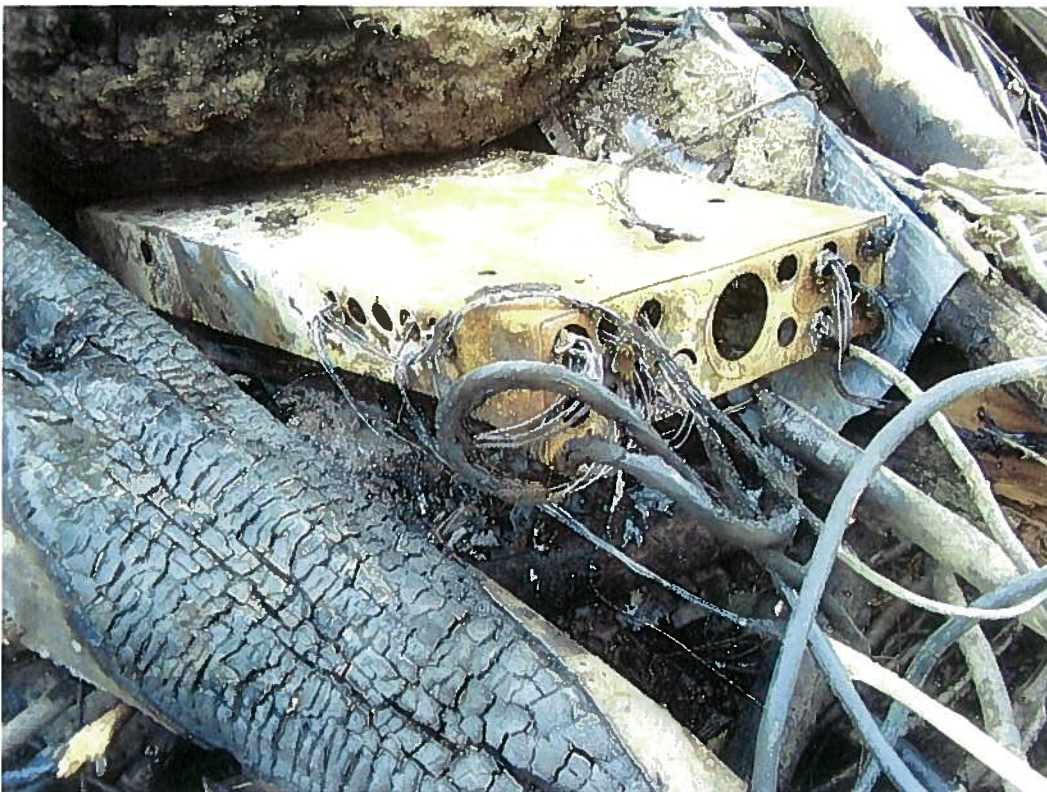
Date: April 6, 2011
Time: 11:35 AM
Direction: NE
Photo by: Eisenbrandt
Exposure #: 016
Comments: A charred electrical breaker box and burnt wire.

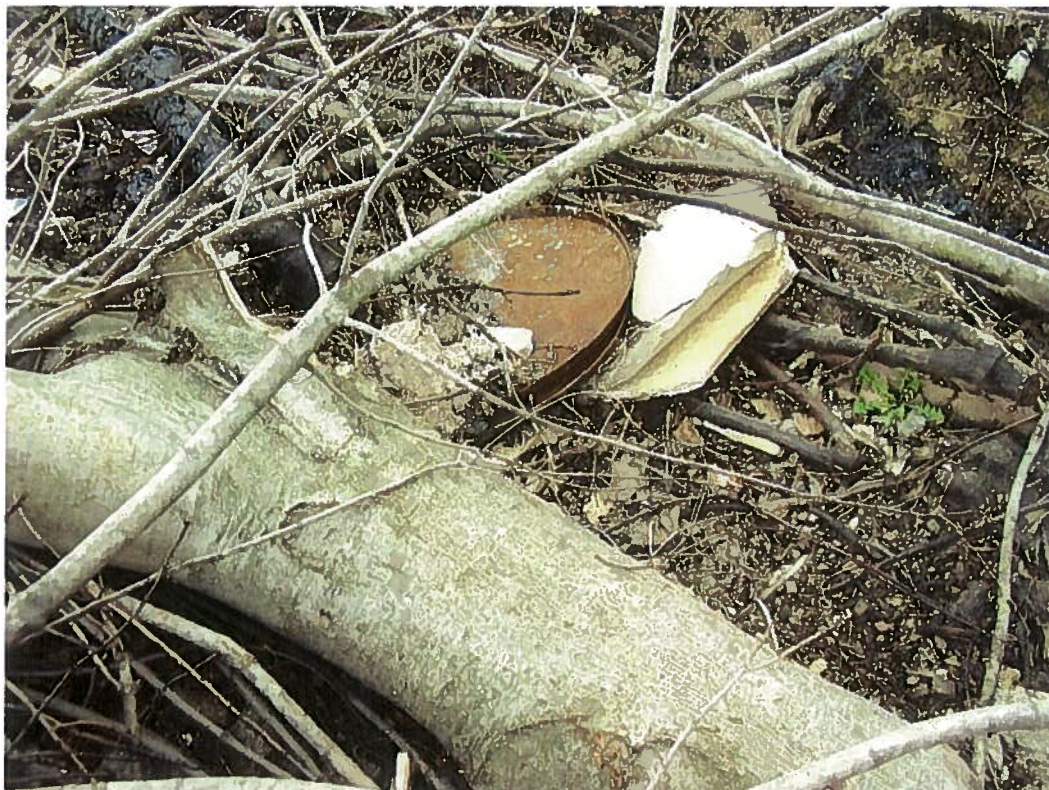
Date: April 6, 2011
Time: 11:35 AM
Direction: E
Photo by: Eisenbrandt
Exposure #: 017
Comments: A rusty lid, drywall scrap, and landscape waste.

Photograph 017 shows a rusty lid and drywall scrap among landscape waste. Mr. Patterson claimed he does not operate his business out of his home. Photograph 018 shows a partially burnt PVC pipe, a charred 2x4, rusty scrap metal, tile backer board, siding, electric wire, cinder block, and landscape waste. Photograph 019 shows the charred PVC pipe, cinder block, Dura rock (tile backer board), and scrap metal. Nearby, carpet, scrap metal, and a trowel can be seen in Photograph 020. Photograph 021 shows an alternate view of the open burn pile and miscellaneous open dumped General Construction or Demolition Debris. Concrete, rock, black plastic, a burned rake, a wood pallet, rusty metal, and dimensional lumber can also be seen intermixed with gravel and dirt.

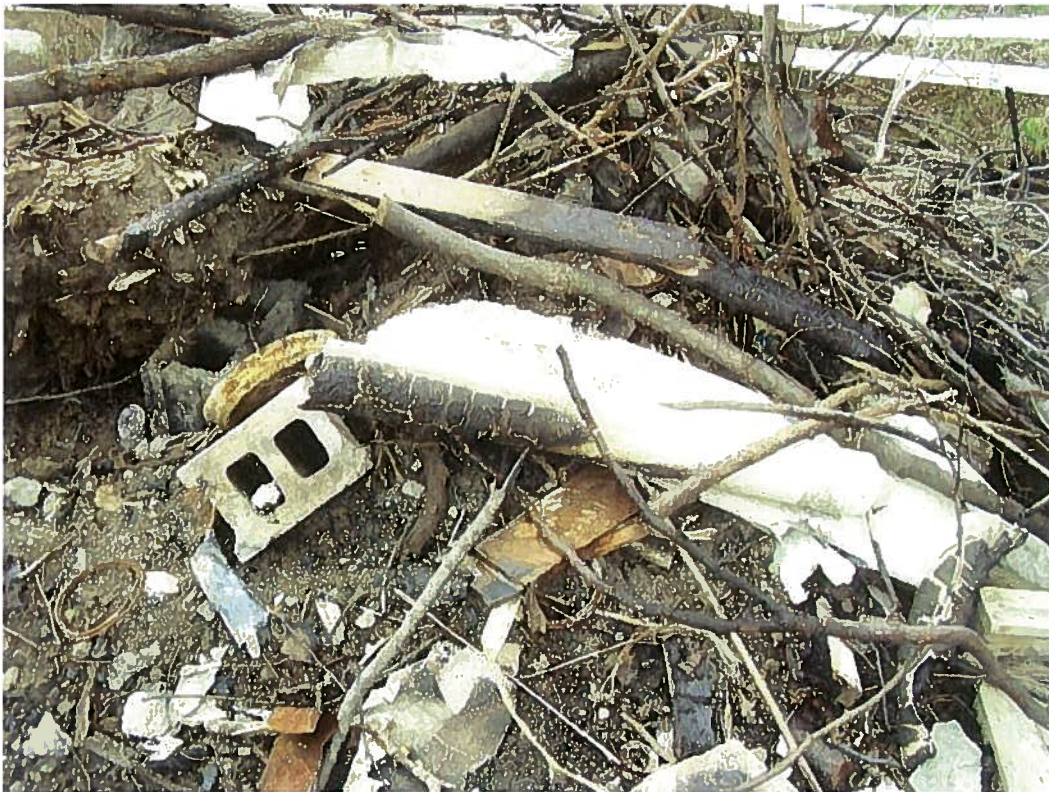
Date: April 6, 2011
Time: 11:35 AM
Direction: SE
Photo by: Eisenbrandt
Exposure #: 018
Comments: Partially burnt PVC pipe, a charred 2x4, rusty scrap metal, tile backer board, siding, electric wire, and landscape waste.

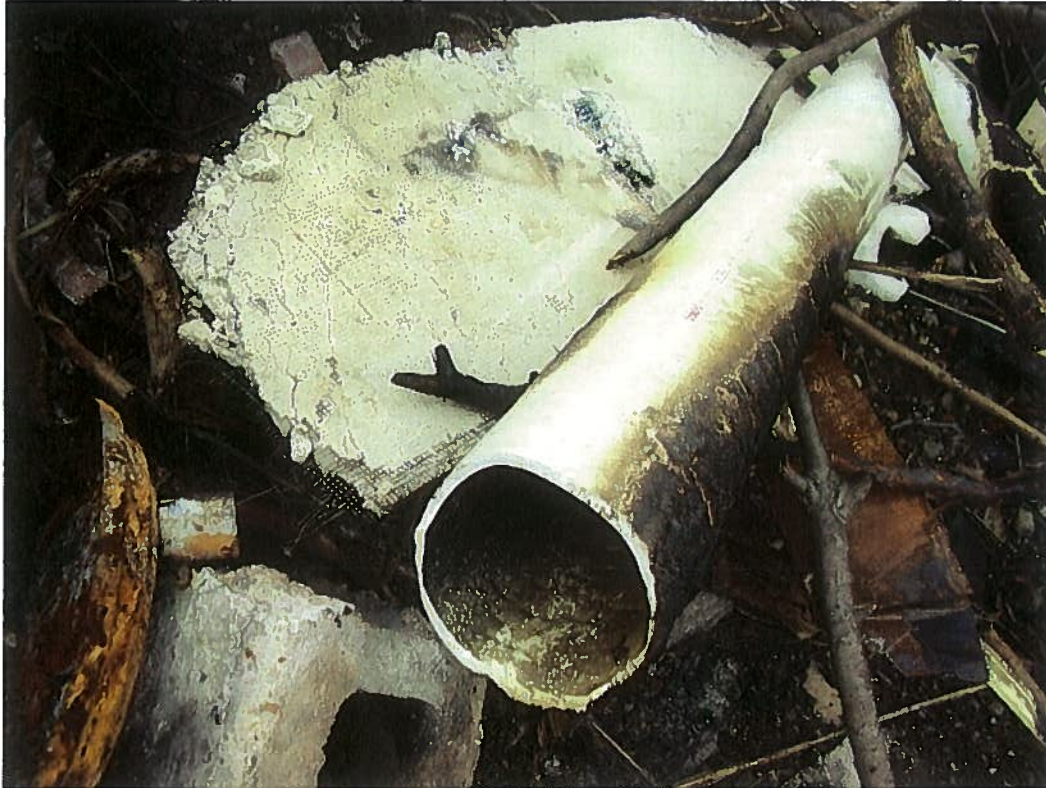
Date: April 6, 2011
Time: 11:35 AM
Direction: SW
Photo by: Eisenbrandt
Exposure #: 019
Comments: Charred PVC pipe, cinder block, Dura rock, and scrap metal.

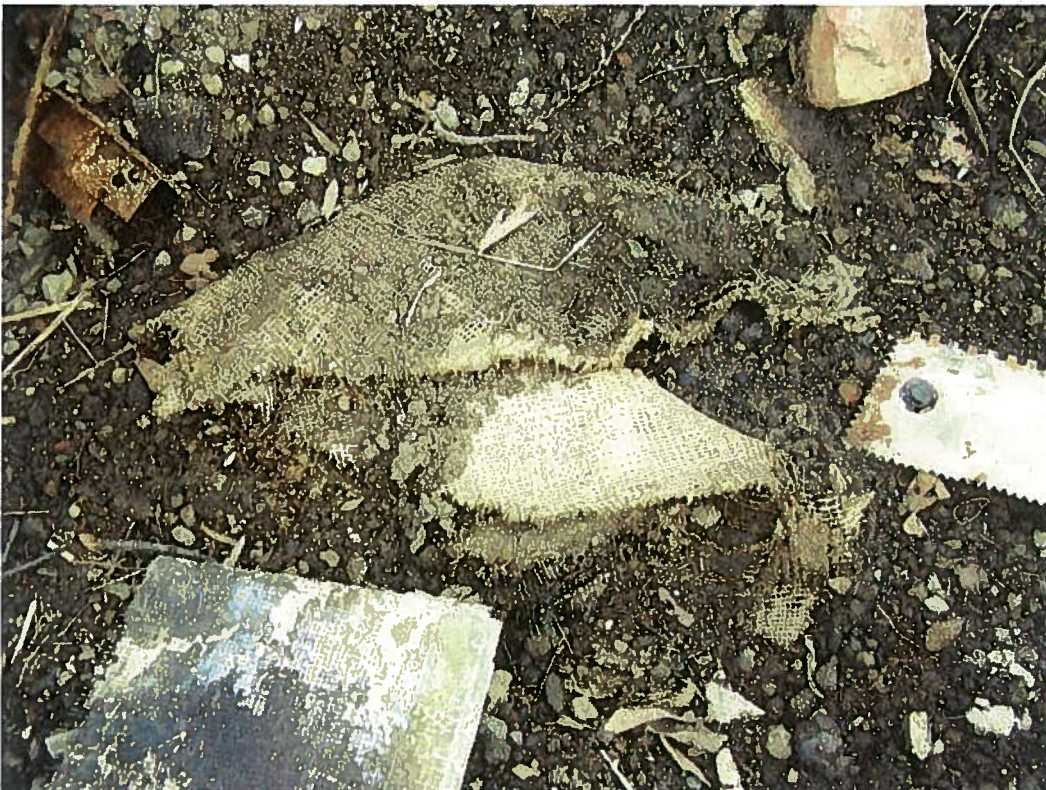
Date: April 6, 2011
Time: 11:35 AM
Direction: E
Photo by: Eisenbrandt
Exposure #: 020
Comments: Carpet, scrap metal, and a trowel.

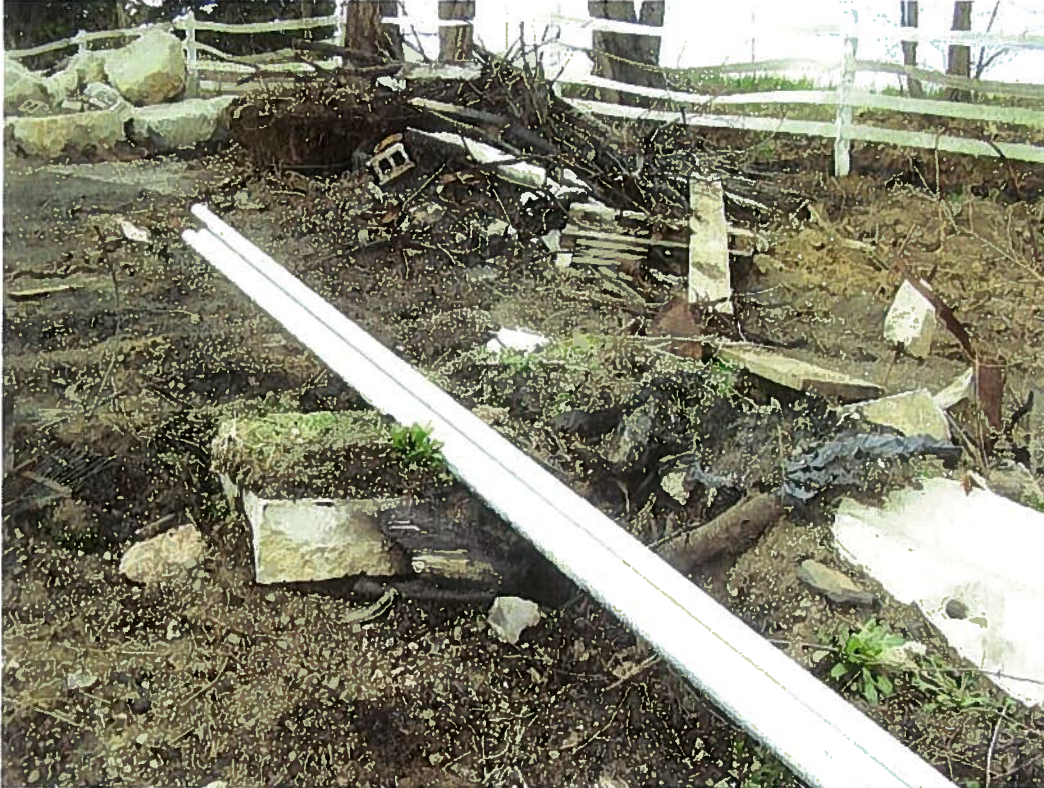
Date: April 6, 2011
Time: 11:36 AM
Direction: SE
Photo by: Eisenbrandt
Exposure #: 021
Comments: Alternate view of the open burn pile and miscellaneous open dumped General Construction or Demolition Debris. Concrete, rock, black plastic, a burned rake, a wood pallet, rusty metal, and dimensional lumber were among the waste intermixed with gravel and dirt.

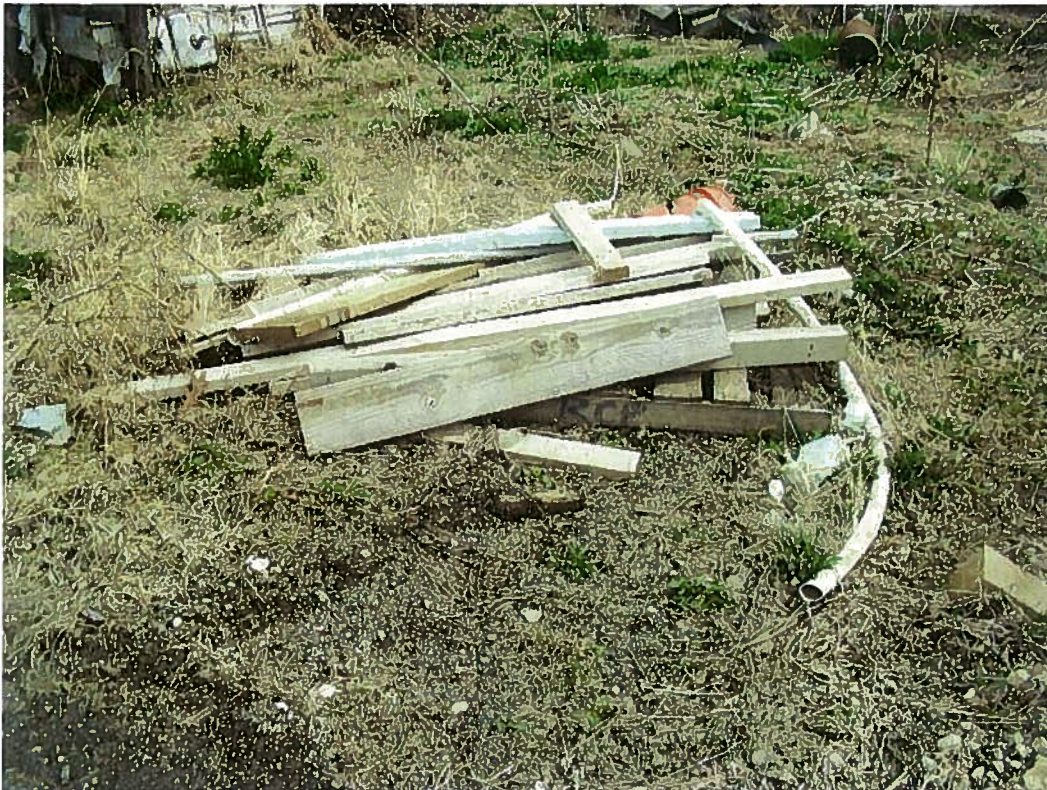
Date: April 6, 2011
Time: 11:37 AM
Direction: NE
Photo by: Eisenbrandt
Exposure #: 022
Comments: Plastic pipe, a plastic bucket, and scraps of lumber.

Photograph 022 shows plastic pipe, a plastic bucket, and scraps of lumber to the north of the burn pile. Photographs 023 and 024 show a pile of rubber horse stall mats in the weeds. Mr. Patterson asked what was wrong with the horse mats. He claimed he tore them out of the barn and poured a concrete floor. The inspector asked if he had any horses to which he answered
