Re: Illinois Environmental Protection Agency v. Patrick D. and Monique D. Patterson
IEPA File No. 128-11-AC: 1671209263—Sangamon County

ILLINOIS ENVIRONMENTAL PROTECTION AGENCY
Open Dump Inspection Checklist

ILLINOIS ENVIRONMENTAL PROTECTION AGENCY MEMORANDUM

SITE SKETCH

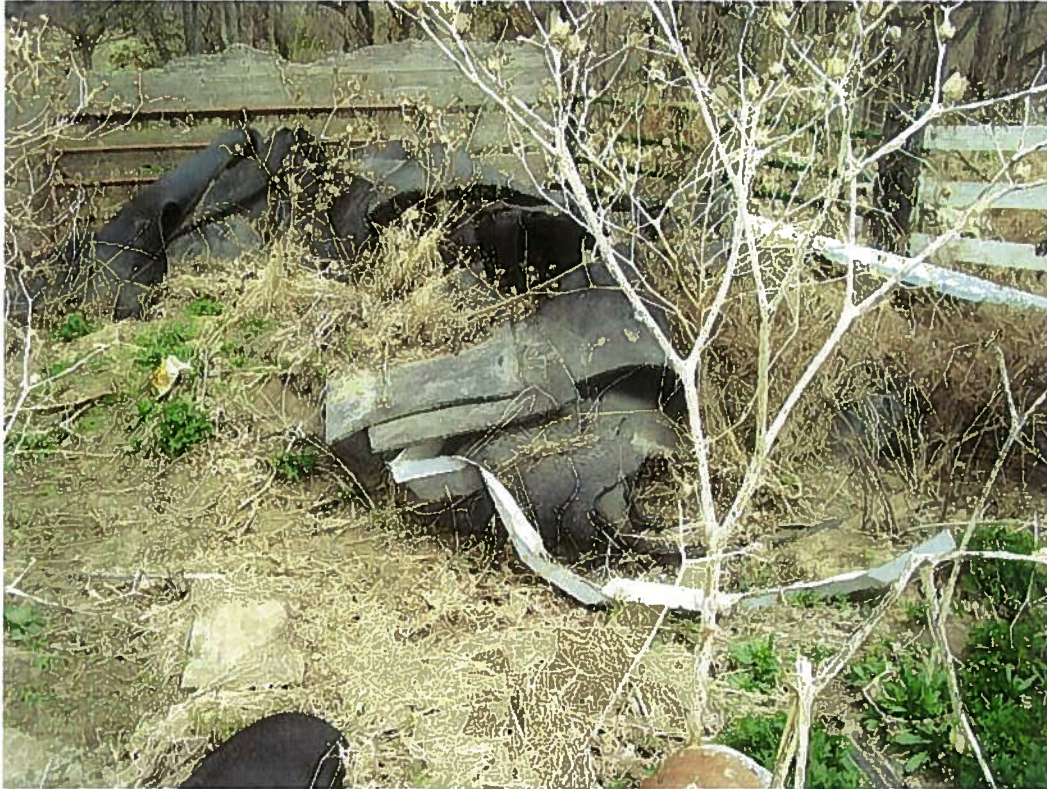
Date: April 6, 2011
Time: 11:37 AM
Direction: NE
Photo by: Eisenbrandt
Exposure #: 023
Comments: A pile of rubber horse stall mats.

Photograph 022 shows plastic pipe, a plastic bucket, and scraps of lumber to the north of the burn pile. Photographs 023 and 024 show a pile of rubber horse stall mats in the weeds. Mr. Patterson asked what was wrong with the horse mats. He claimed he tore them out of the barn and poured a concrete floor. The inspector asked if he had any horses to which he answered

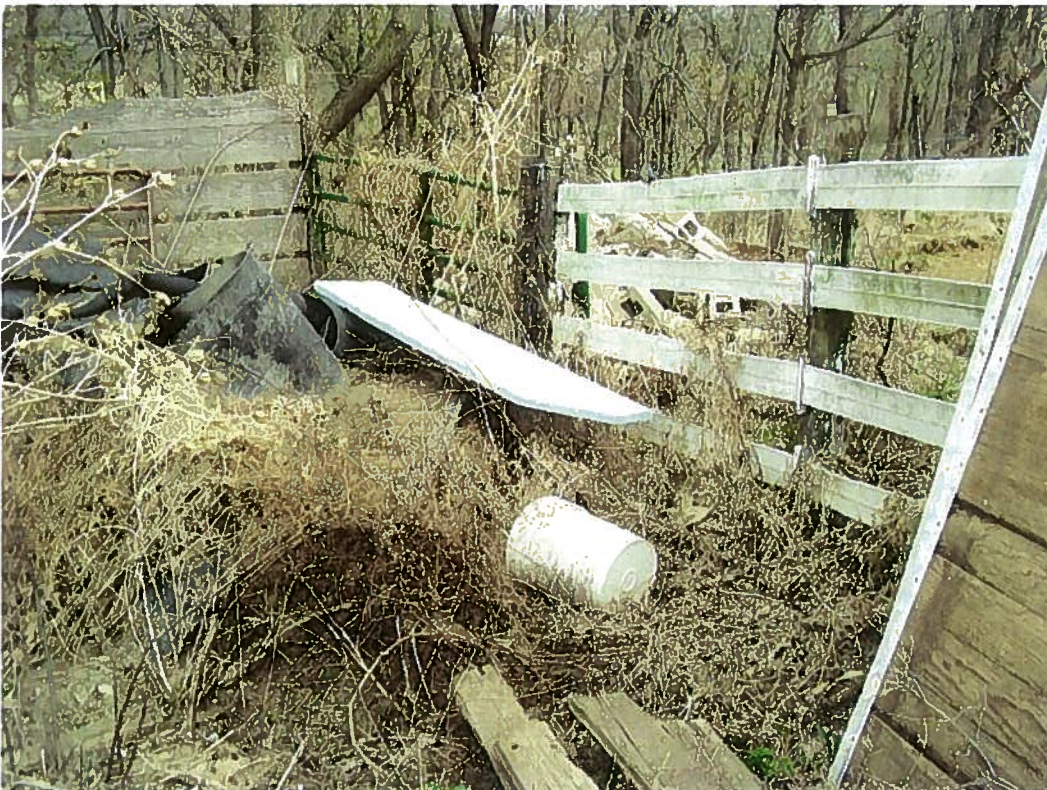
Date: April 6, 2011
Time: 11:37 AM
Direction: NE
Photo by: Eisenbrandt
Exposure #: 024
Comments: Drywall corner beads, Styrofoam, scrap lumber among the weeds in the foreground. In the background (seen through the fence) is a pile of cinder block and demolition debris.

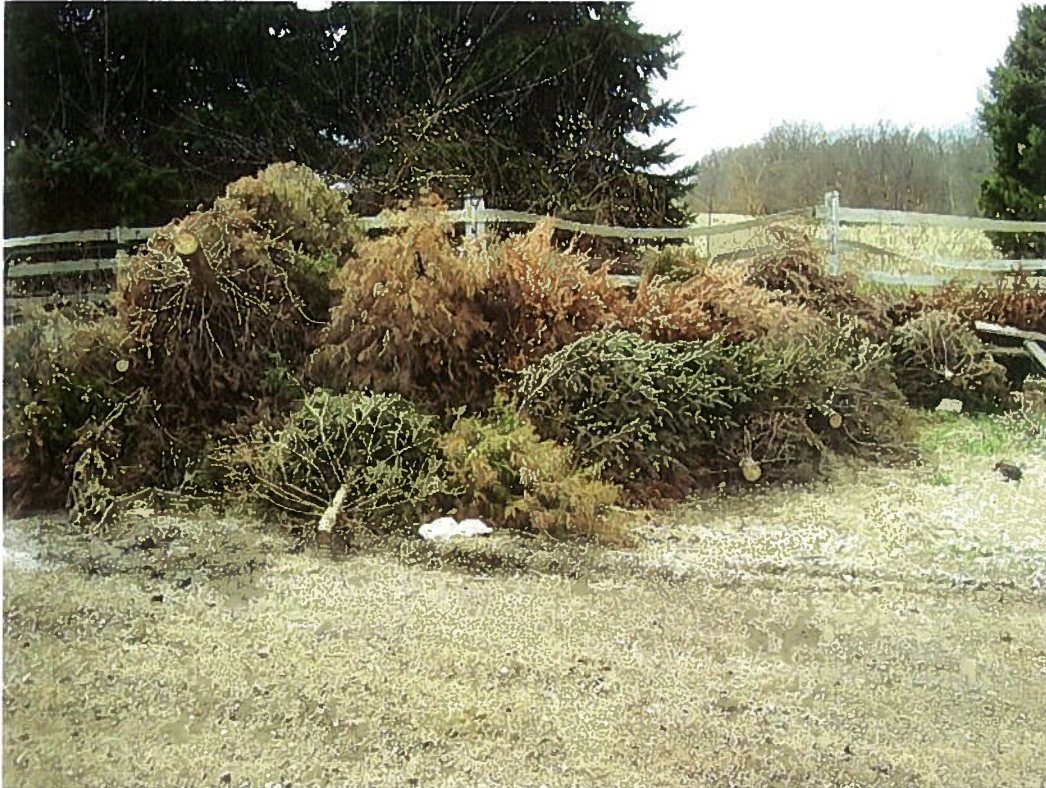
Date: April 6, 2011
Time: 11:38 AM
Direction: S
Photo by: Eisenbrandt
Exposure #: 025
Comments: Approximately two dozen off-site generated Christmas trees.

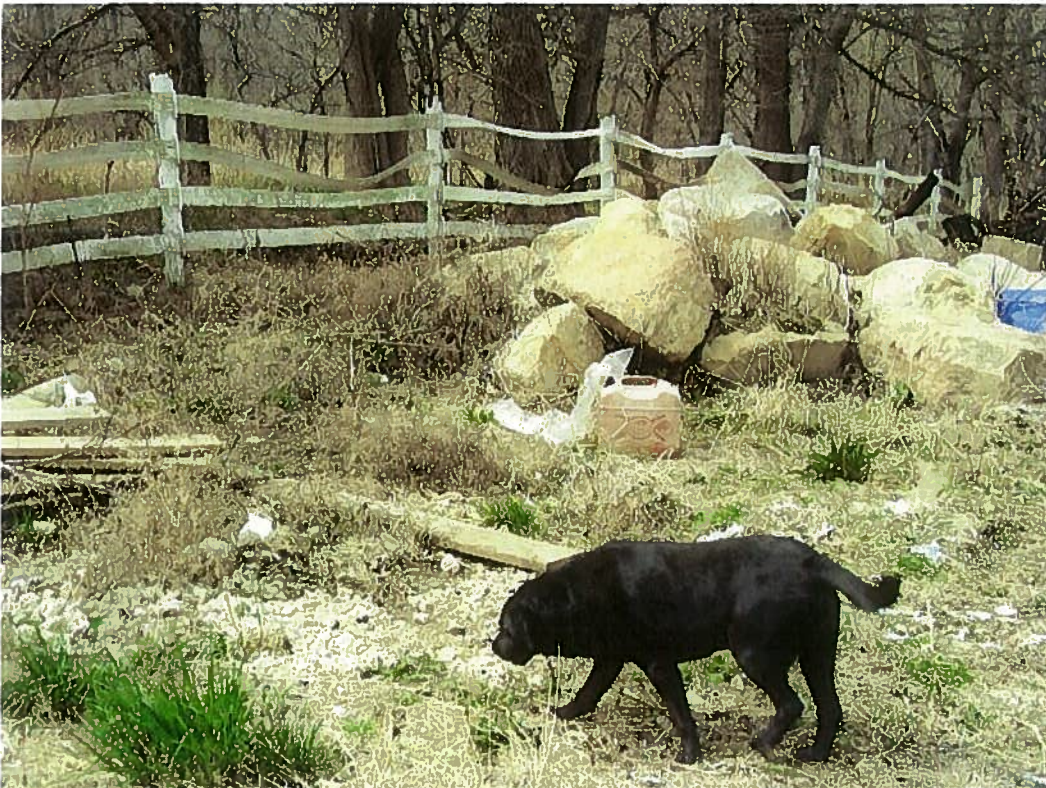
Date: April 6, 2011
Time: 11:38 AM
Direction: SW
Photo by: Eisenbrandt
Exposure #: 026
Comments: A gasoline can and lumber.

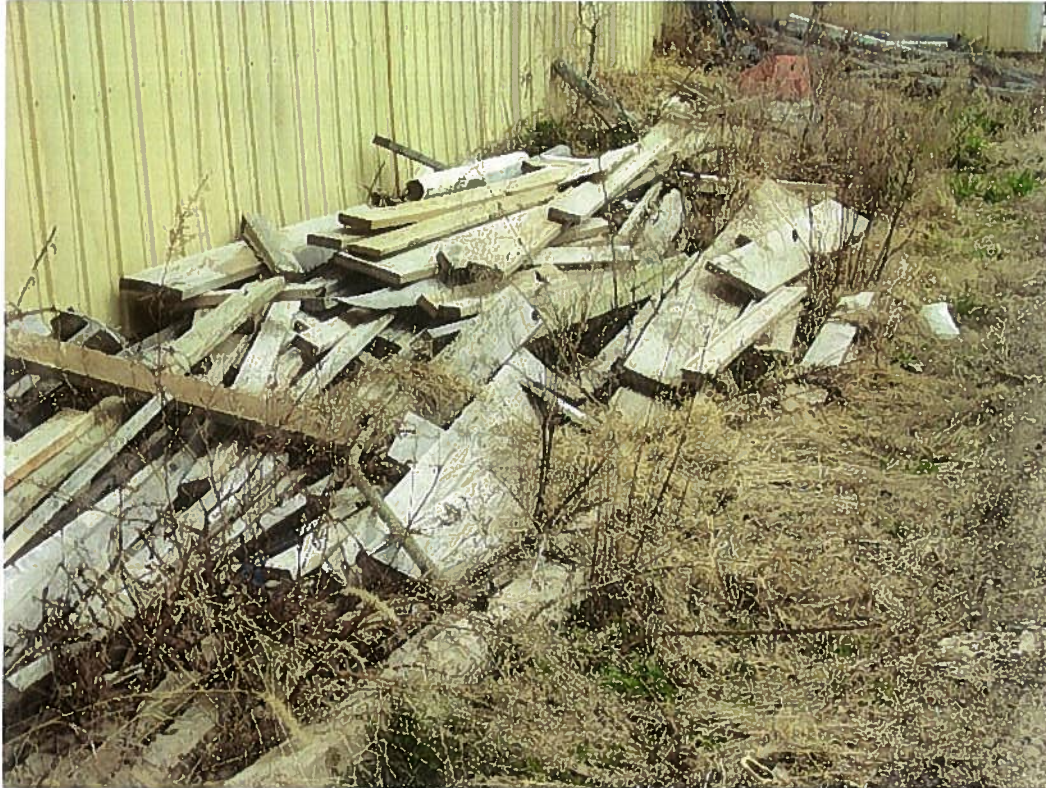
Date: April 6, 2011
Time: 11:38 AM
Direction: NE
Photo by: Eisenbrandt
Exposure #: 027
Comments: Metal pipe, scraps of dimensional lumber, and plastic pipe.

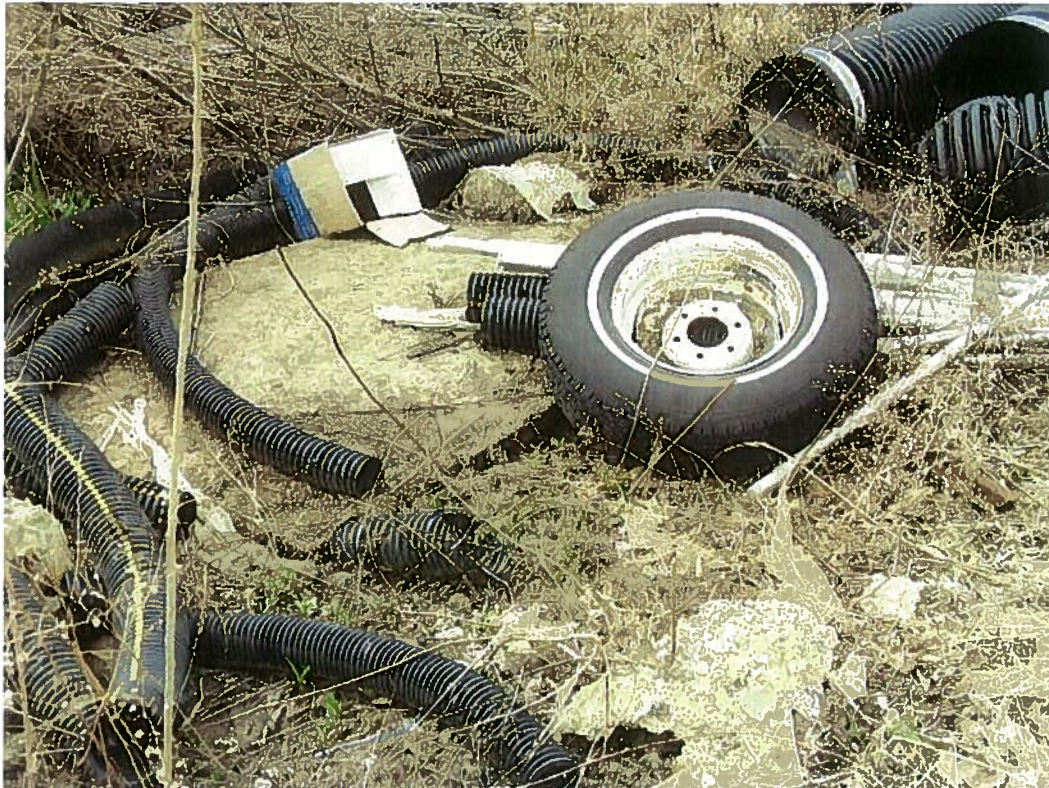
Date: April 6, 2011
Time: 11:39 AM
Direction: SW
Photo by: Eisenbrandt
Exposure #: 028
Comments: Black plastic drain tile, an on-rim used tire, metal pipe, a cardboard box, concrete debris, and rusty scrap metal.

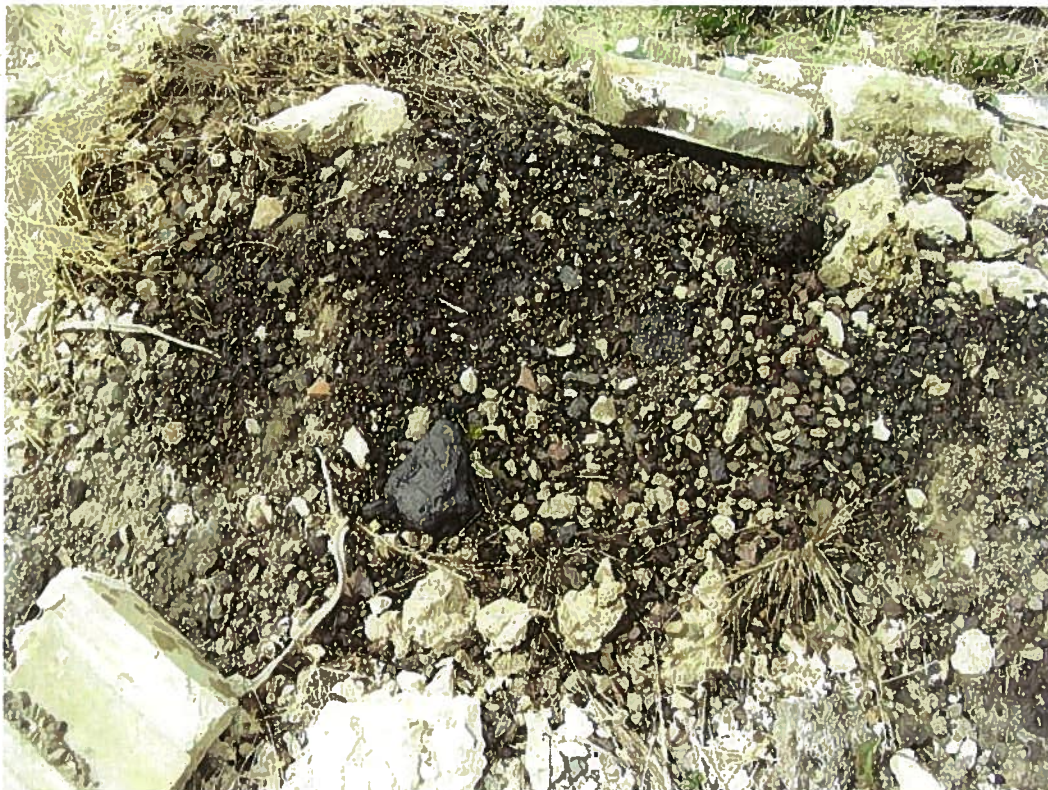
Date: April 6, 2011
Time: 11:40 AM
Direction: W
Photo by: Eisenbrandt
Exposure #: 029
Comments: Dark staining
from an open dumped
hydrocarbon material.
